# Building and Timber Pest Inspection Report

Inspection Date: Fri, 27 Feb 2026

Property Address: 5 Summit Mews, Hillside VIC 3037, Australia

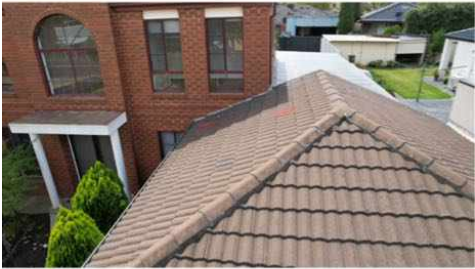
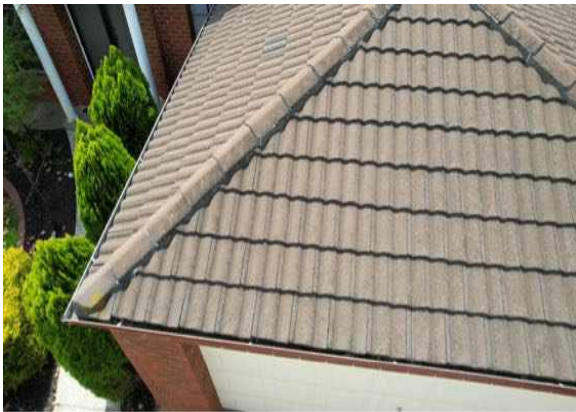
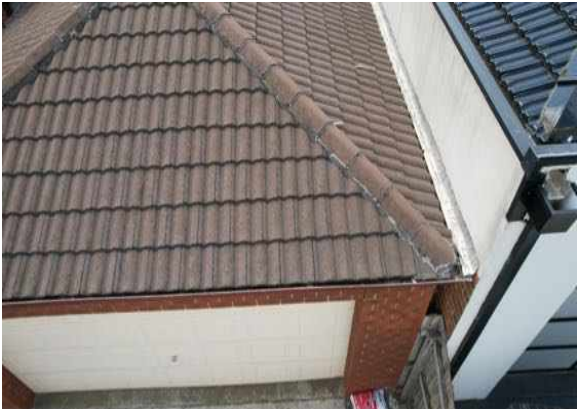
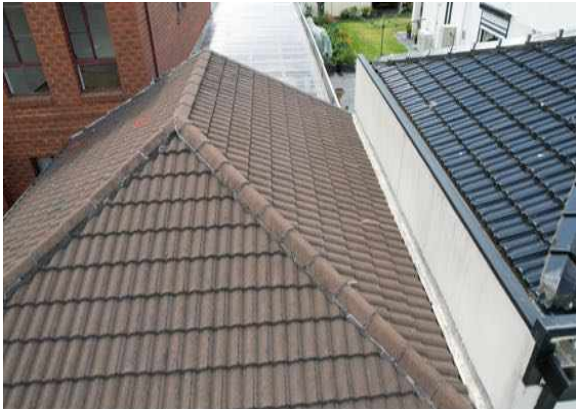
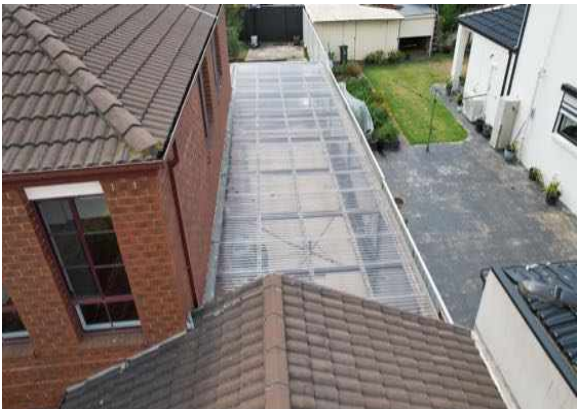
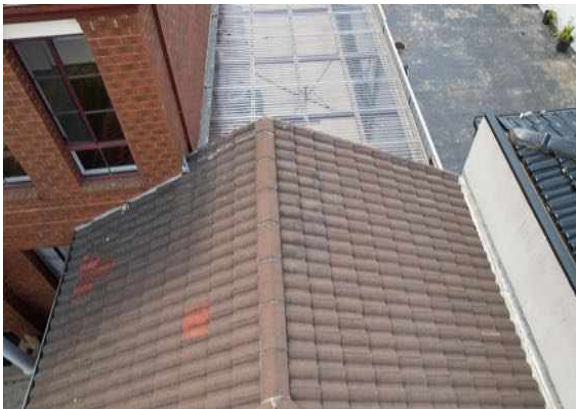
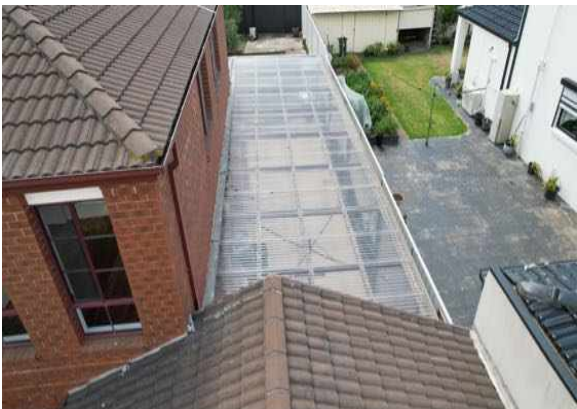
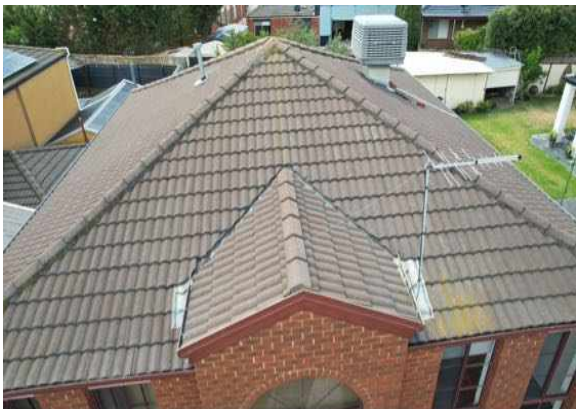
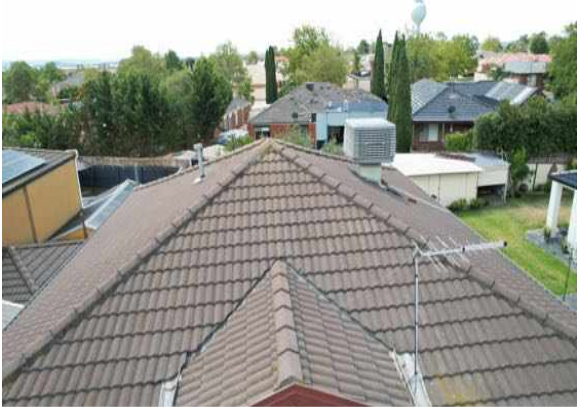
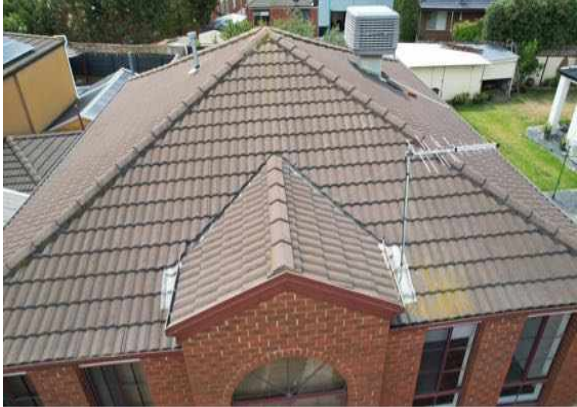
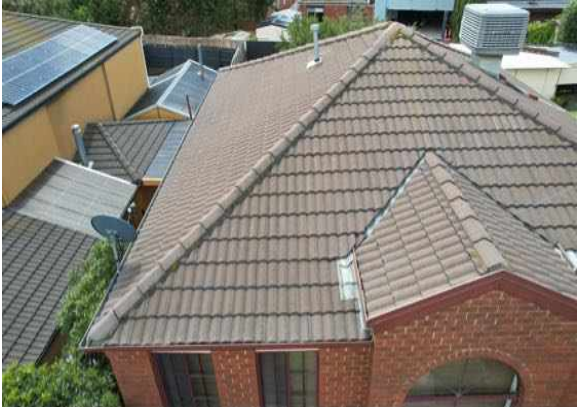
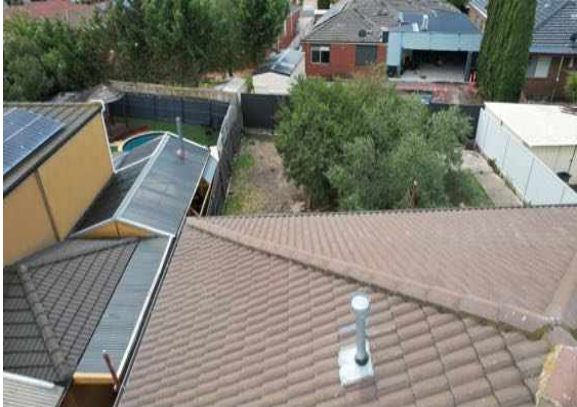
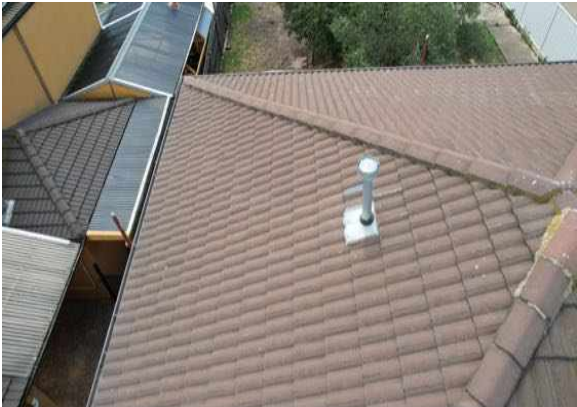
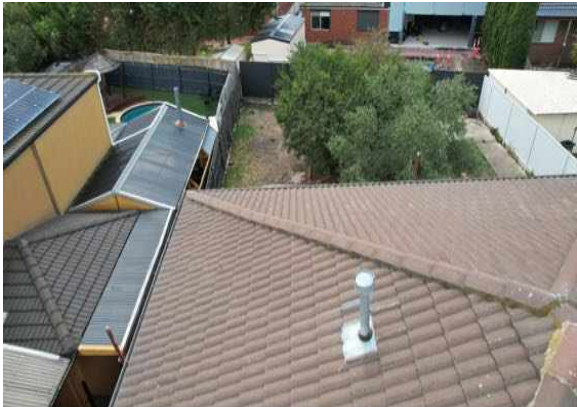
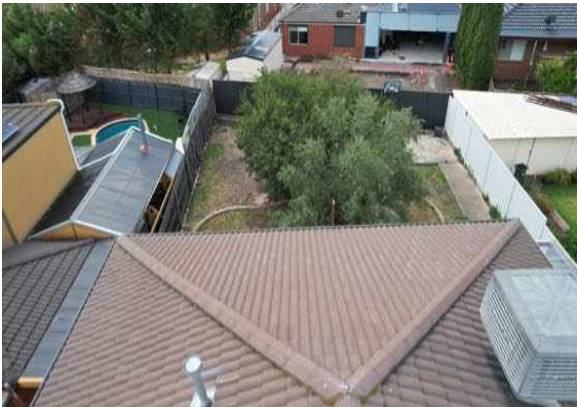
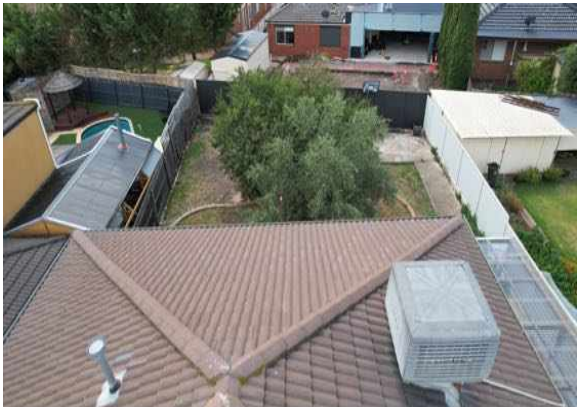
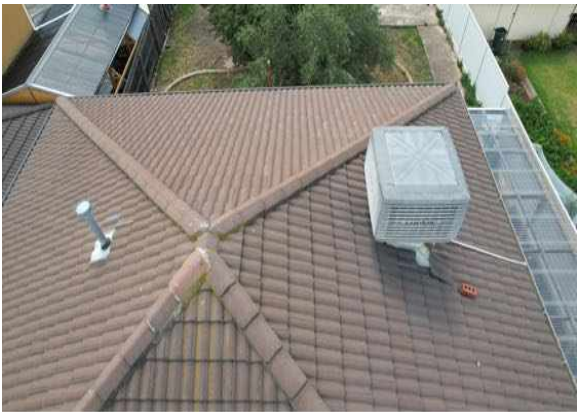
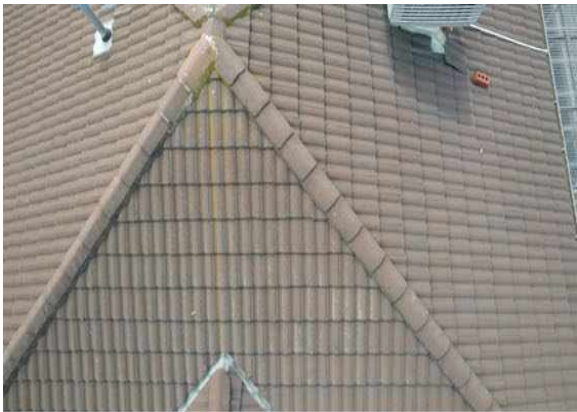
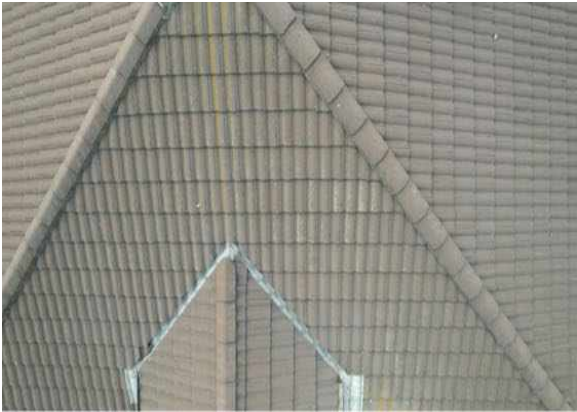
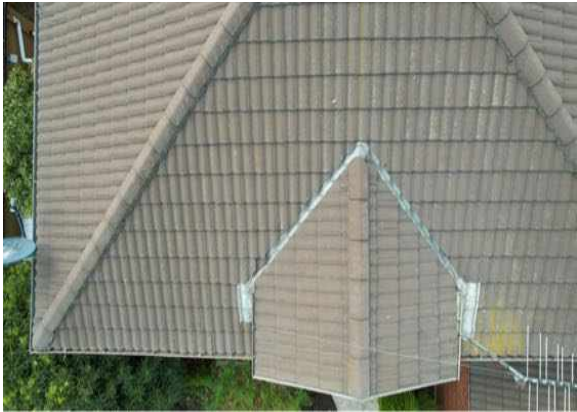
Building: Main Building  
Location: All Areas > All Areas  
Finding: Additional Photos  
Information: Additional photos are provided for your general reference

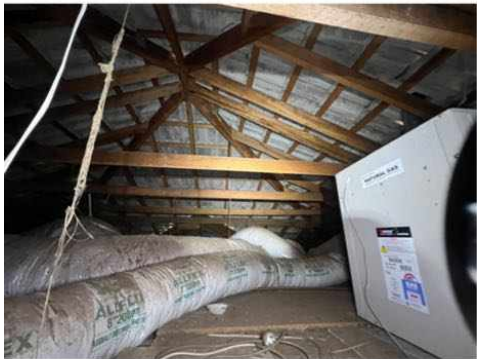
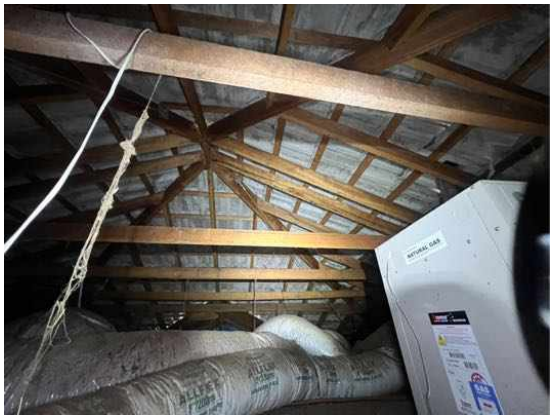
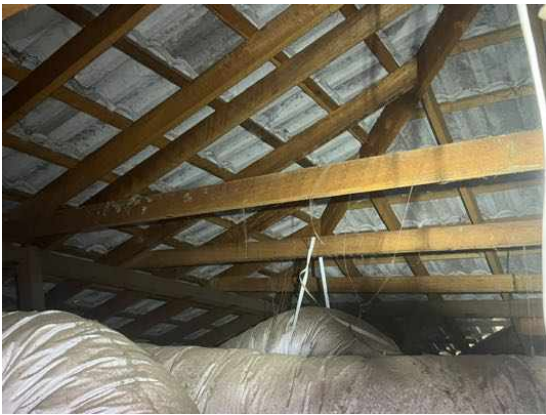
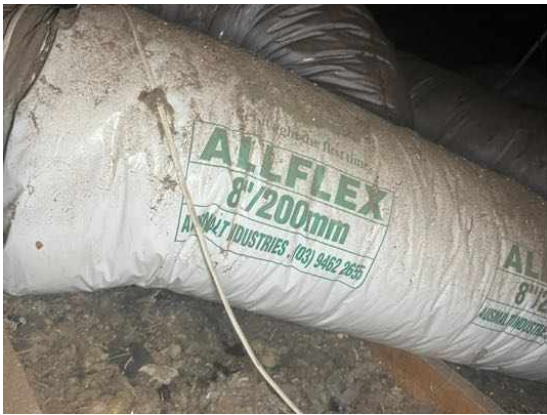
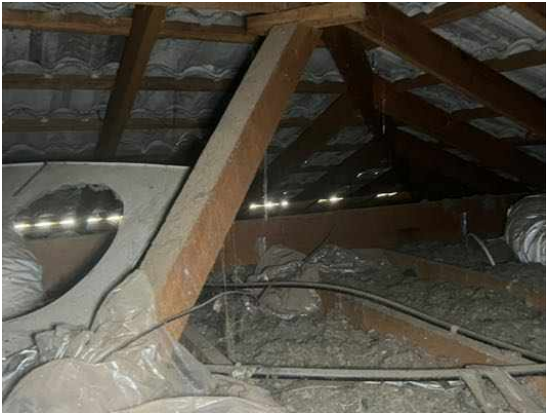
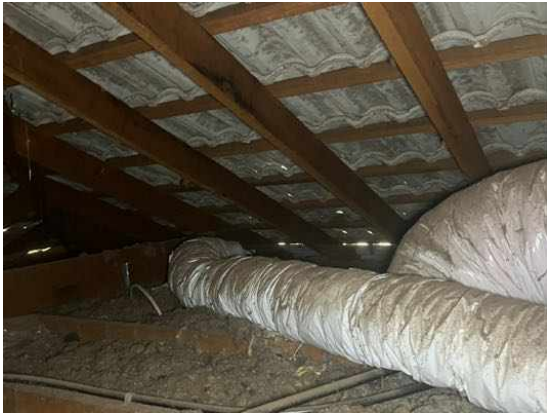
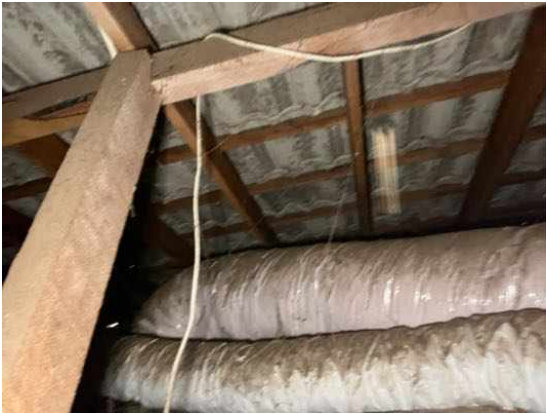
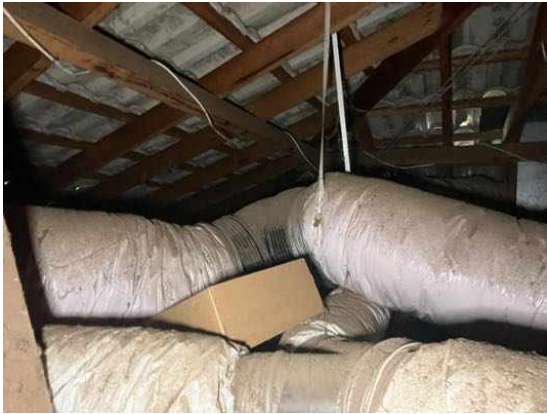
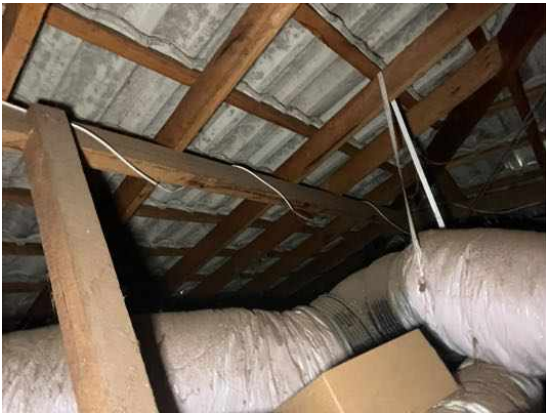
Building: Main Building  
Location: All Areas > All Areas  
Finding: Additional Photos - Obstructions and Limitations-insulation-ducting  
Information: These photographs are an indication of the obstructions and limitations which impeded full inspection of the property at the time of inspection. These obstructions can hide an array of defects and should be removed to allow full inspection to be carried out. A re-inspection is recommended once the areas are made accessible.

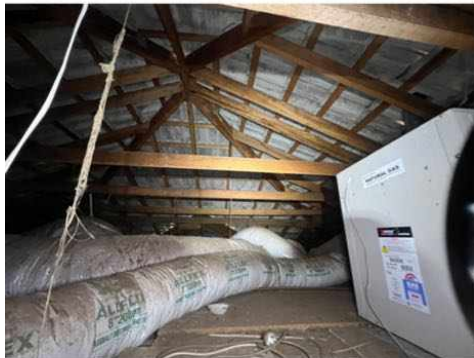
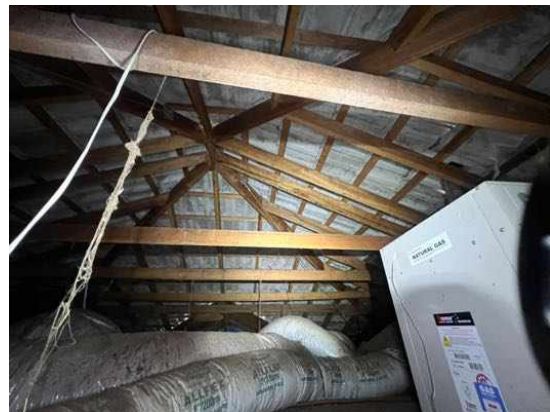
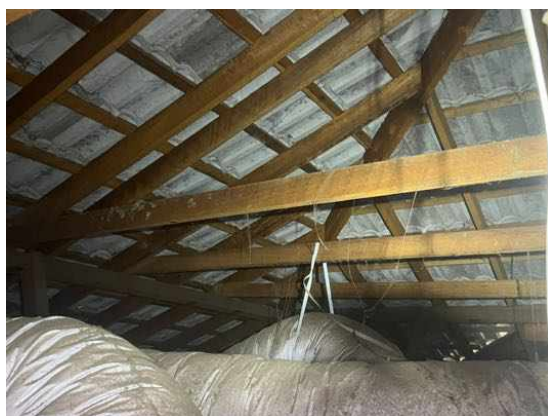
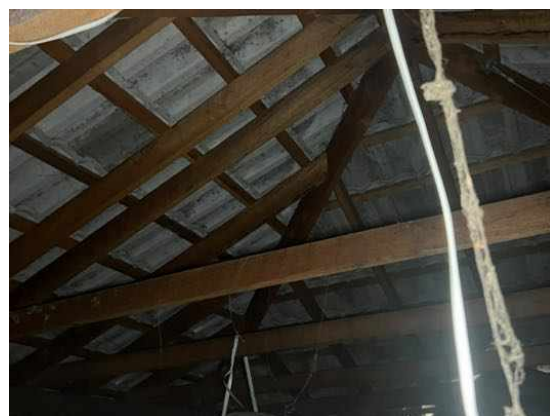
Building: Main Building  
Location: All Areas > All Areas  
Finding: Pest -Obstructions & Limitations-roof void-  
Information:

These photographs are an indication of the obstructions and limitations which impeded full inspection of the property at the time of inspection. These obstructions can hide an array of defects and should be removed to allow full inspection to be carried out. A re-inspection is recommended once the areas are made accessible.

Therefore, It is critical that before proceeding further, an inspection and possibly a treatment or advice regarding a treatment, be sourced form a Licenced Termite Timber Pest Controller.

This further inspection will further reduce any damage to the timber elements.

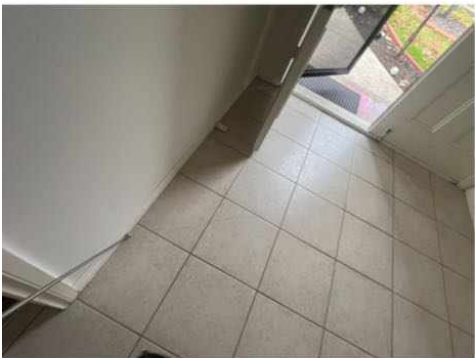
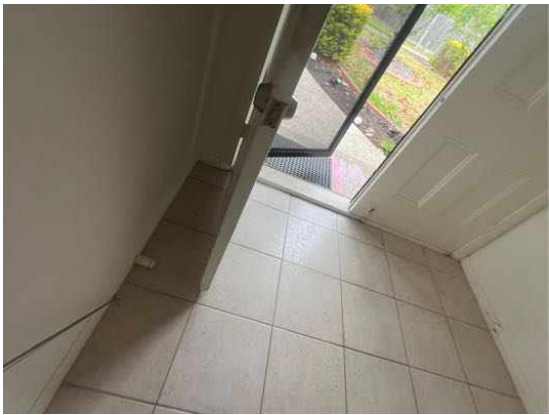
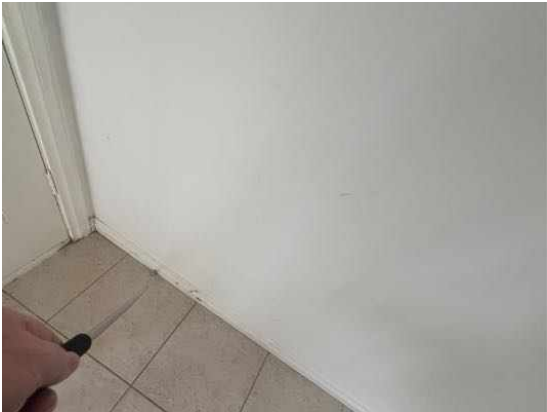
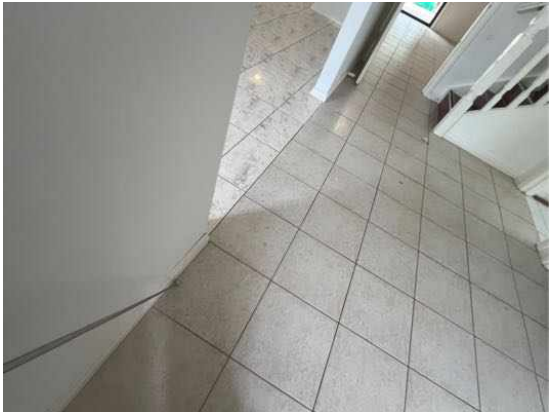
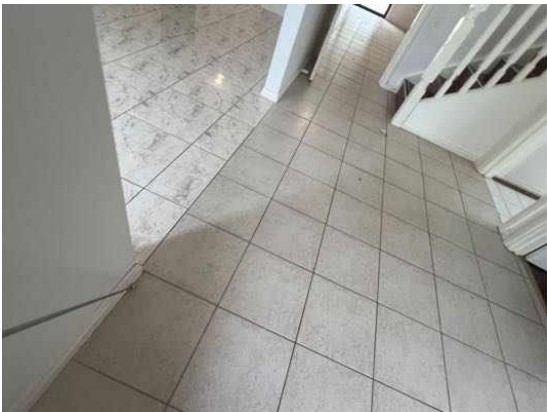
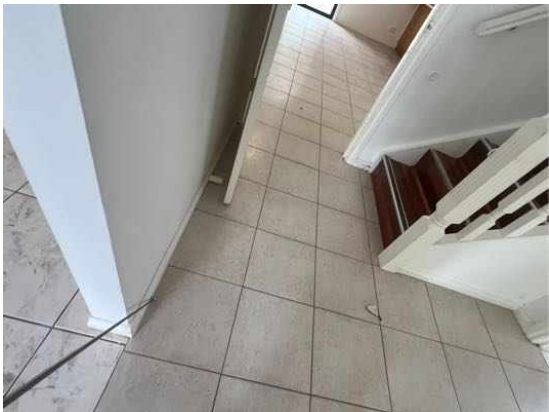
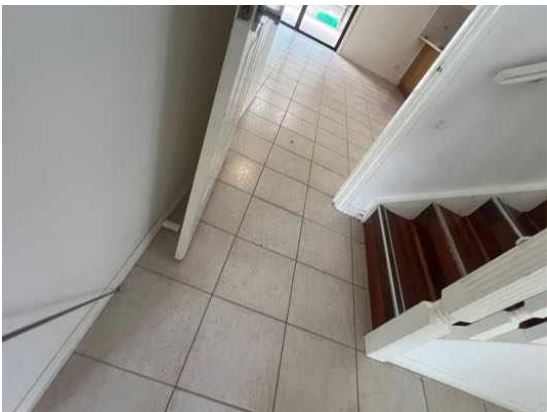
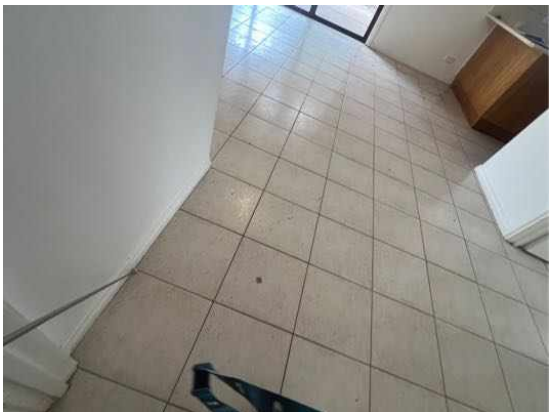
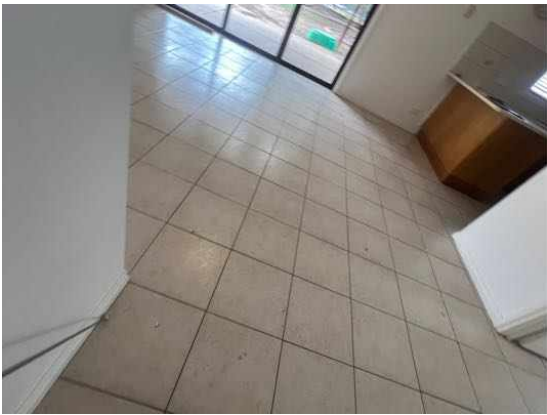
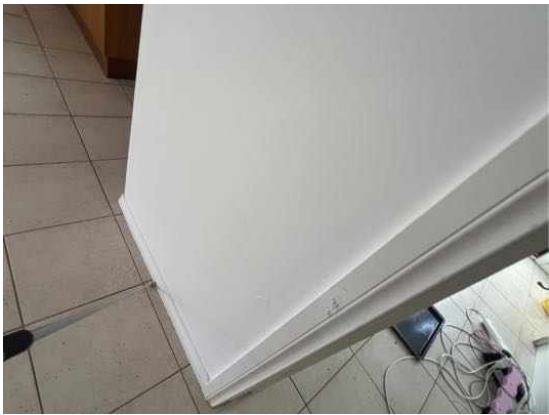
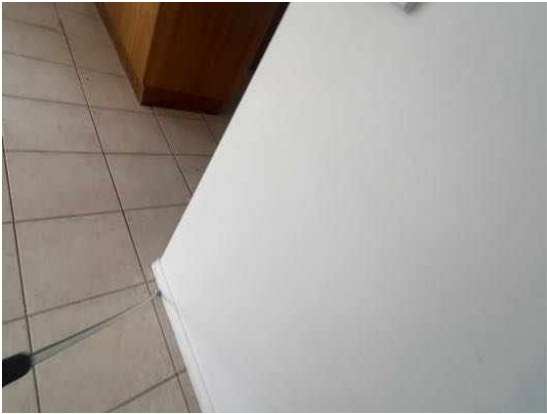
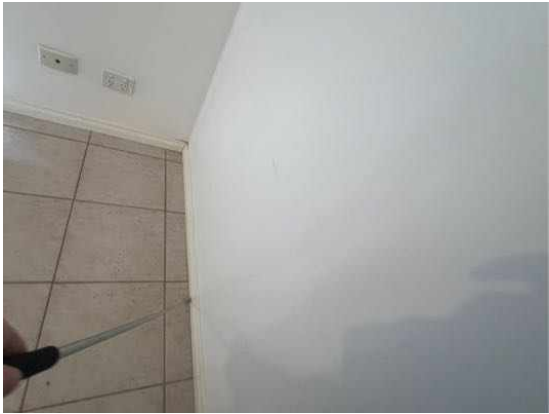
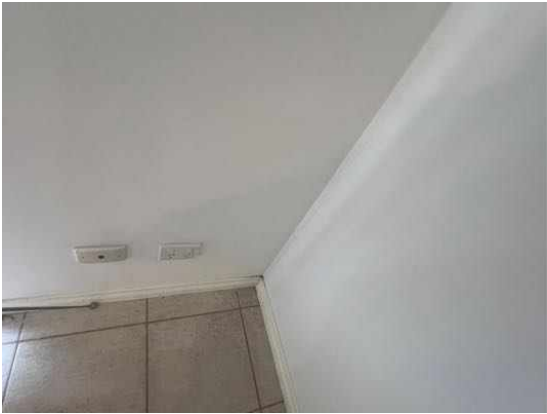
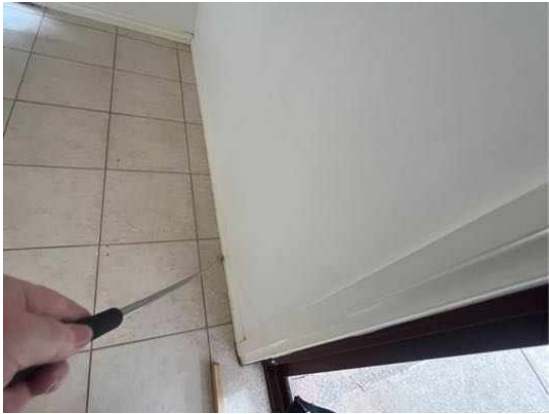
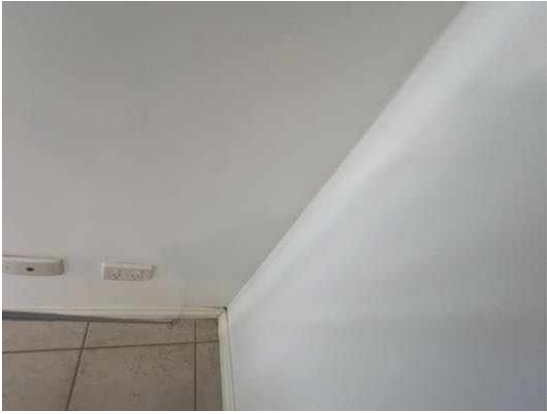
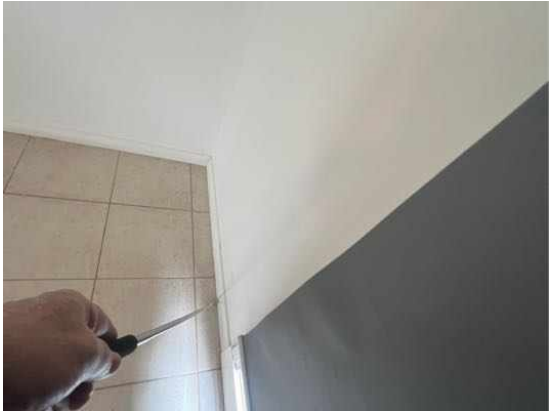
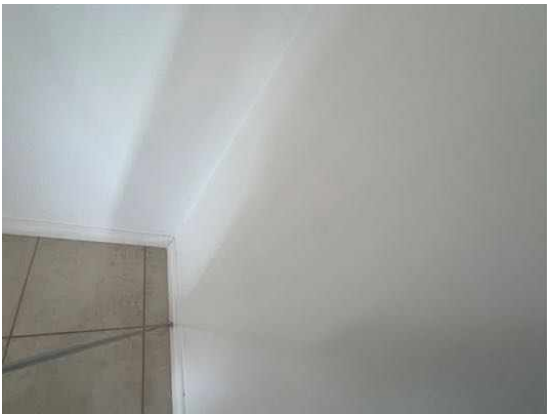
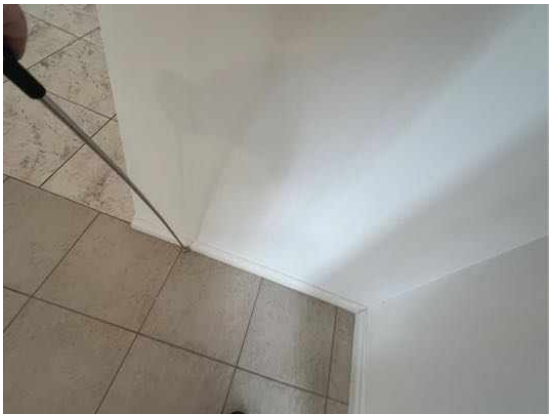
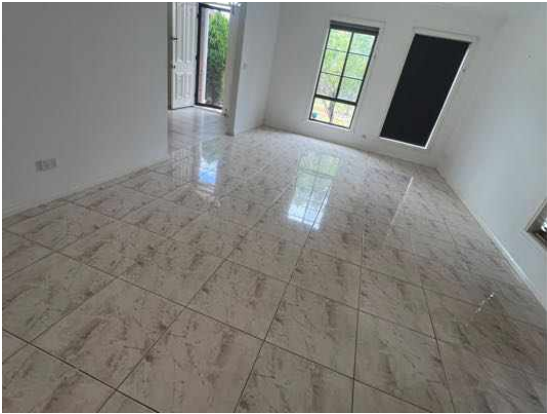
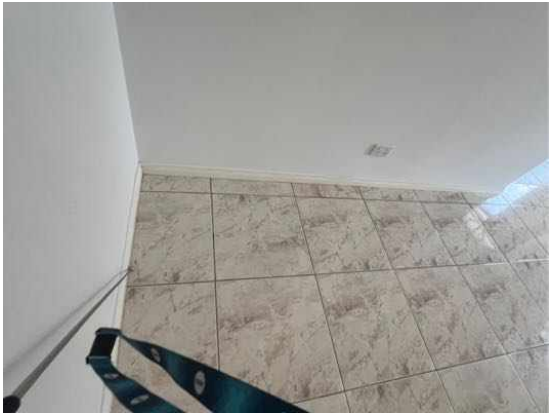
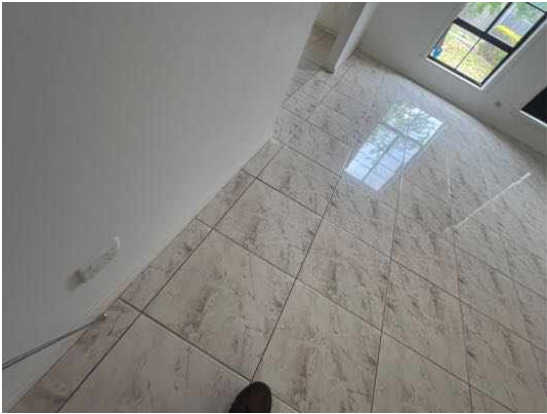
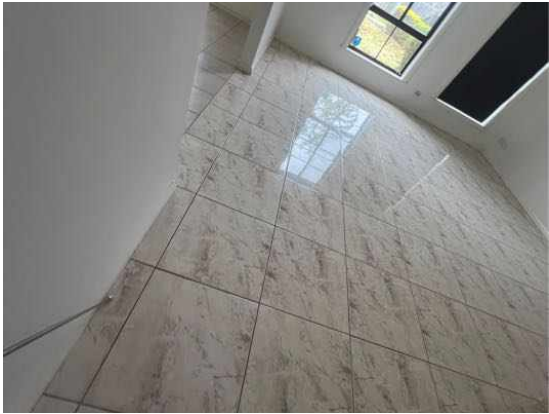
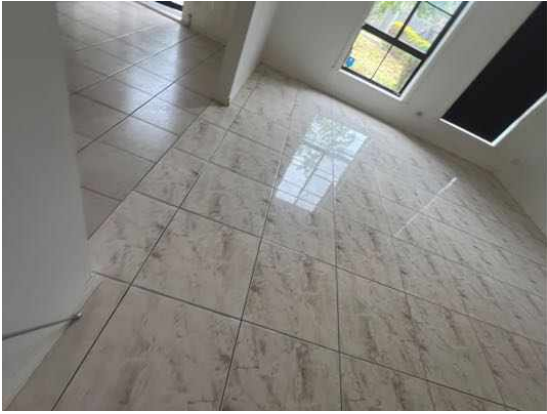
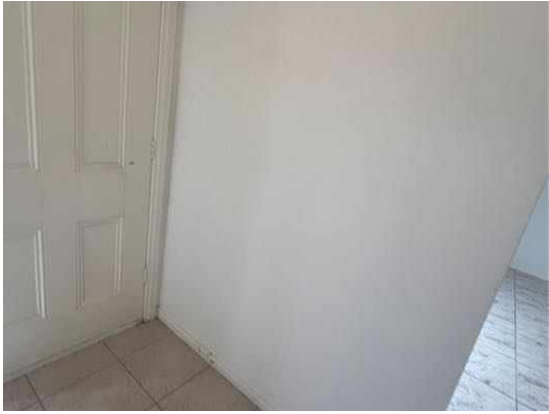
Building: Main Building  
Location: All Areas > All Areas  
Finding: Pest inspection-FYI-Methodology-and inspection of cabinetry  
Information: As part of the course of the Pest Inspection-we /knock on skirting boards and architraves to determine if Pests are present-we also visually examine in and around internal cabinetry-as note in images supplied-

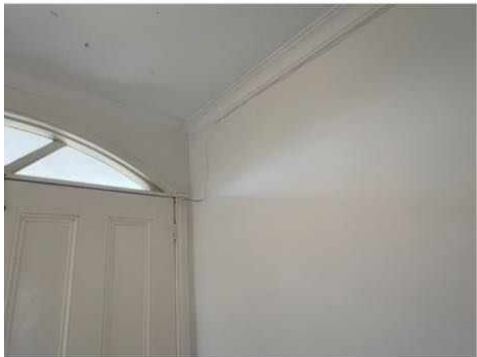
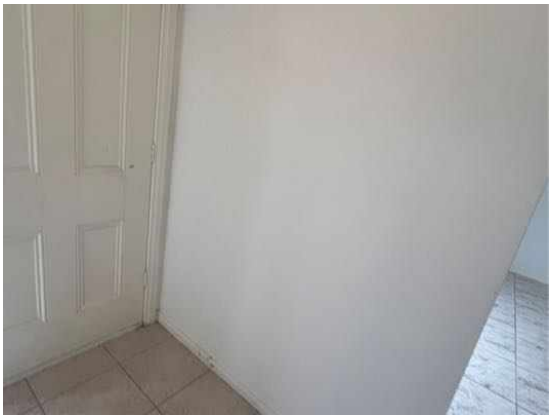
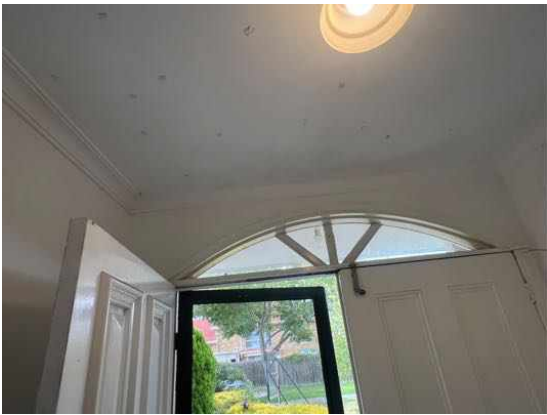
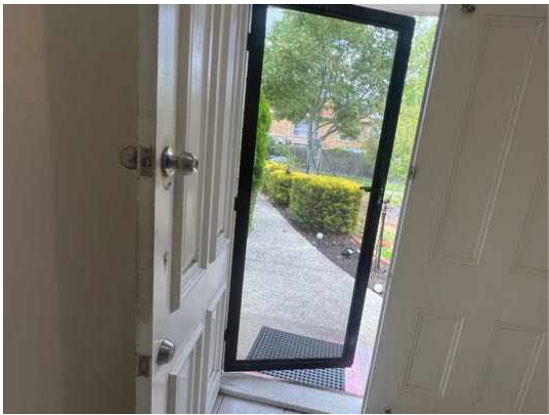
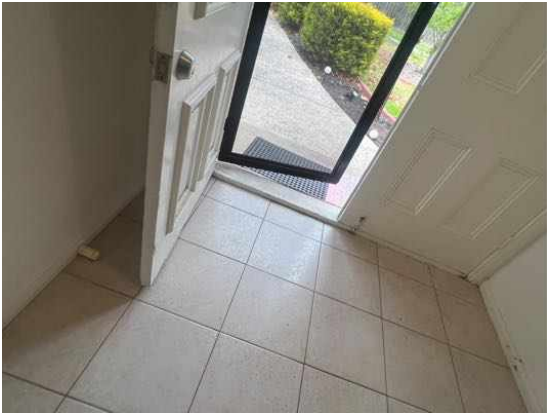
Building: Main Building  
Location: Entry > All Areas  
Finding: Additional Photos - Obstructions and Limitations  
Information: These photographs are an indication of the obstructions and limitations which impeded full inspection of the property at the time of inspection. These obstructions can hide an array of defects and should be removed to allow full inspection to be carried out. A re-inspection is recommended once the areas are made accessible.

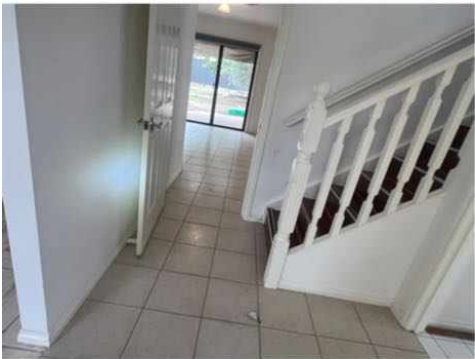
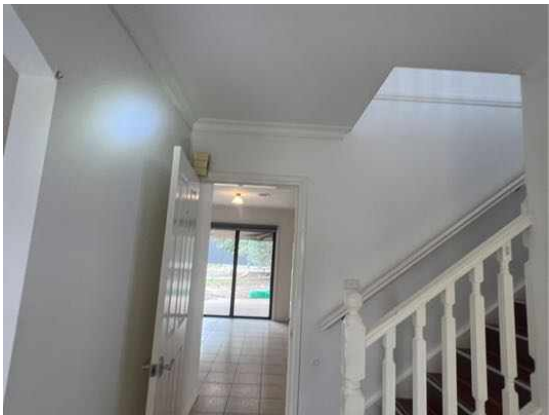
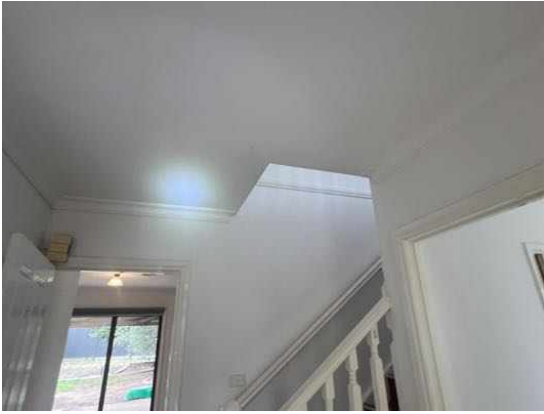
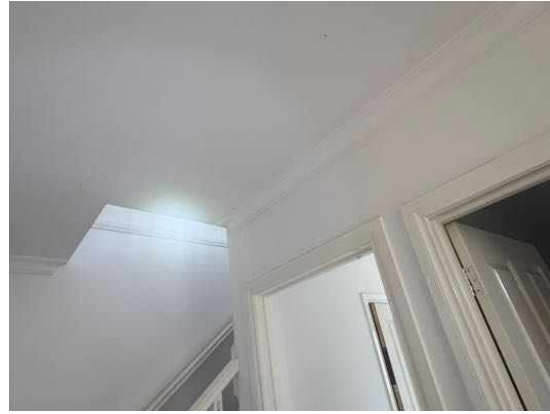
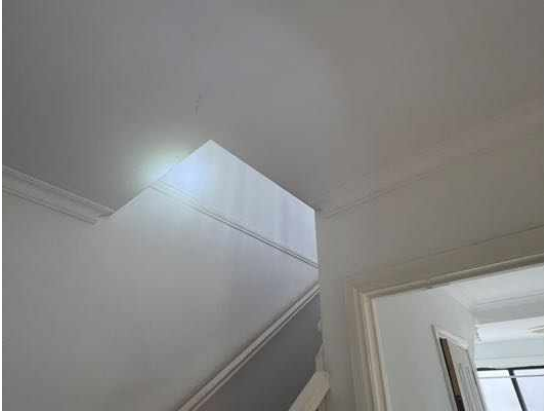
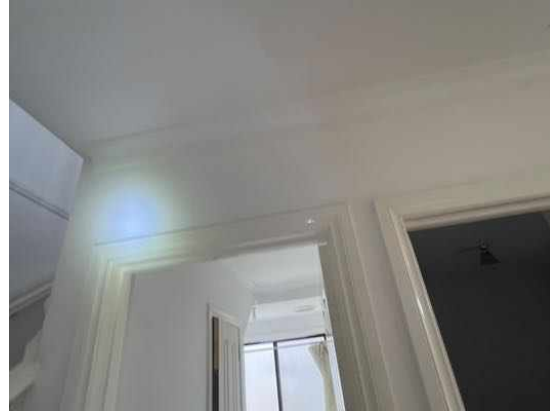
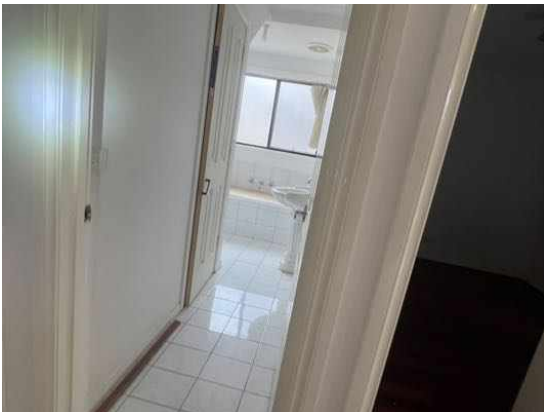
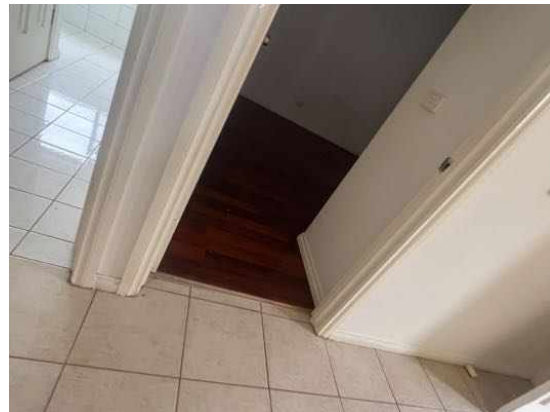
Building: Main Building  
Location: Foyer > All Areas  
Finding: Additional Photos - Obstructions and Limitations  
Information: These photographs are an indication of the obstructions and limitations which impeded full inspection of the property at the time of inspection. These obstructions can hide an array of defects and should be removed to allow full inspection to be carried out. A re-inspection is recommended once the areas are made accessible.

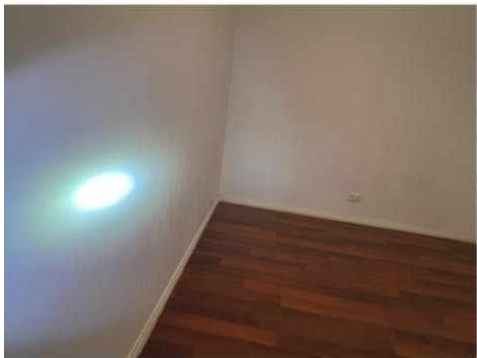
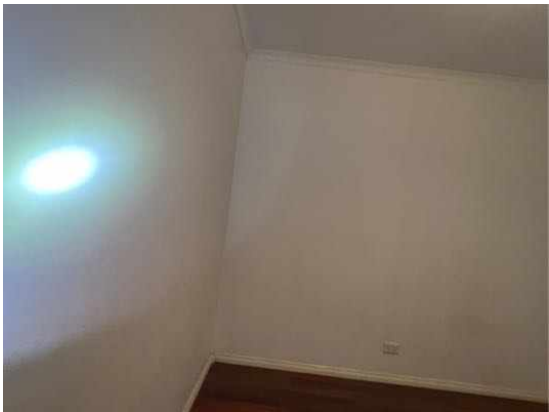
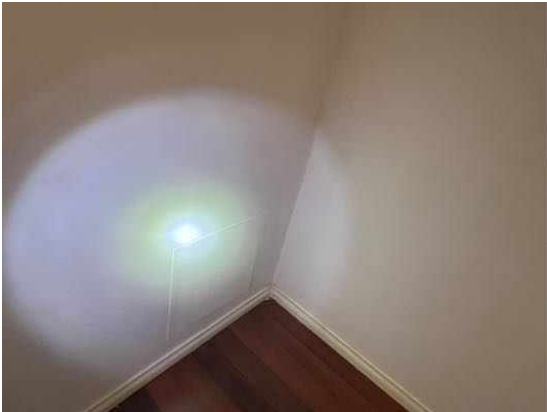
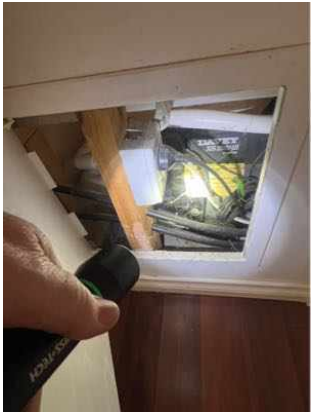
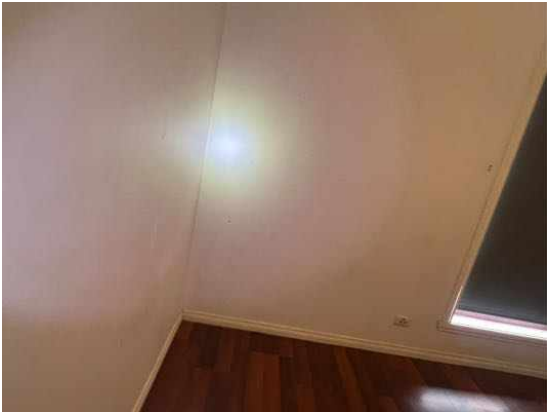
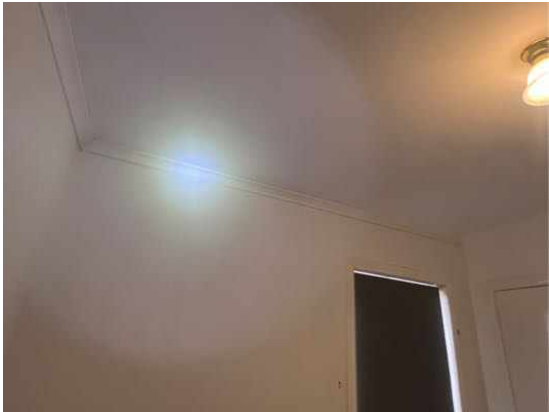
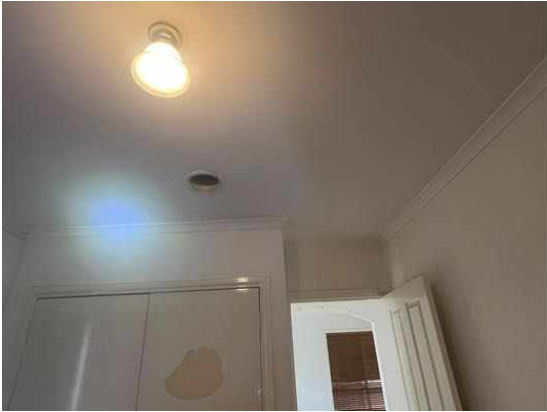
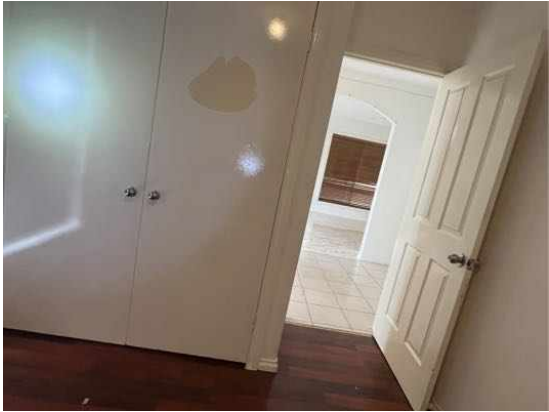
Building: Main Building  
Location: Bedroom > All Areas  
Finding: Additional Photos - Obstructions and Limitations  
Information: These photographs are an indication of the obstructions and limitations which impeded full inspection of the property at the time of inspection. These obstructions can hide an array of defects and should be removed to allow full inspection to be carried out. A re-inspection is recommended once the areas are made accessible.

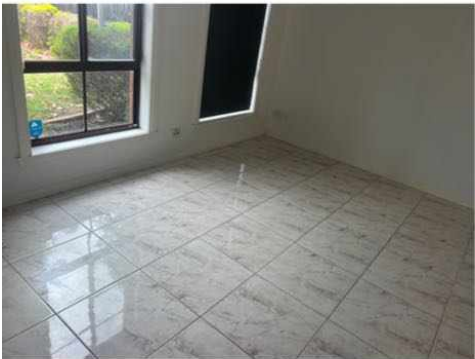
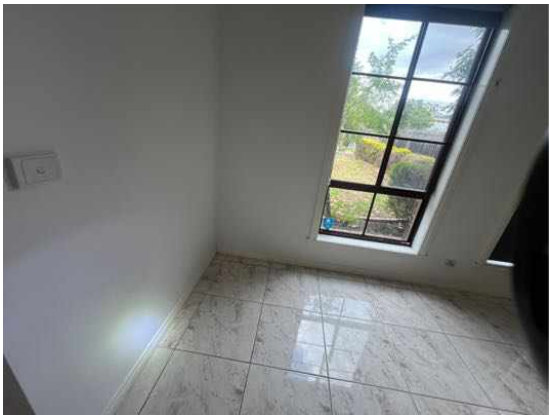
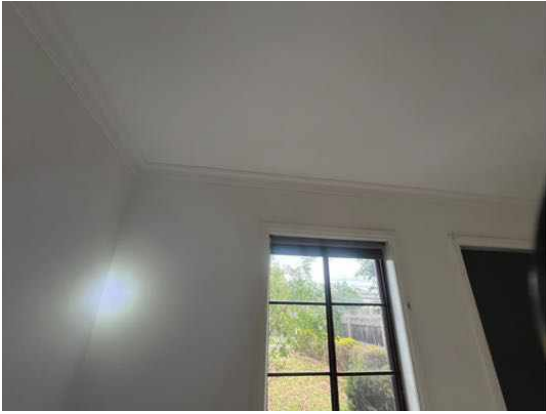
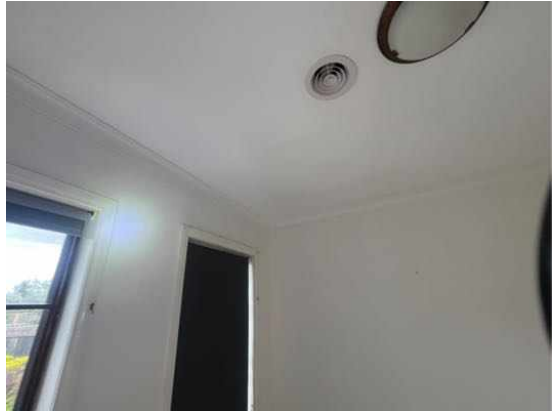
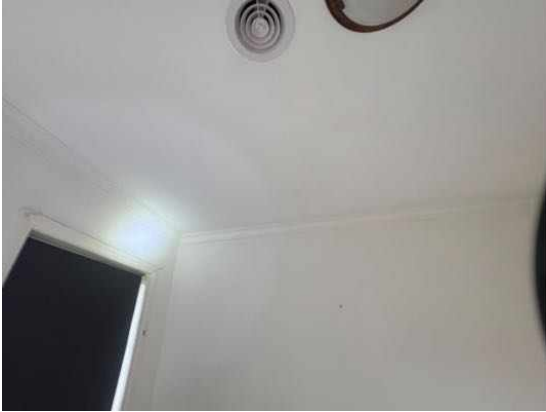
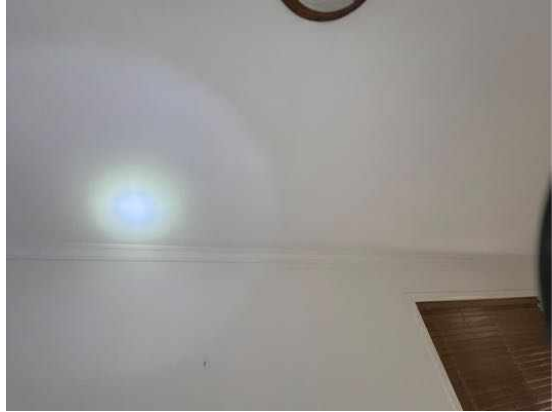
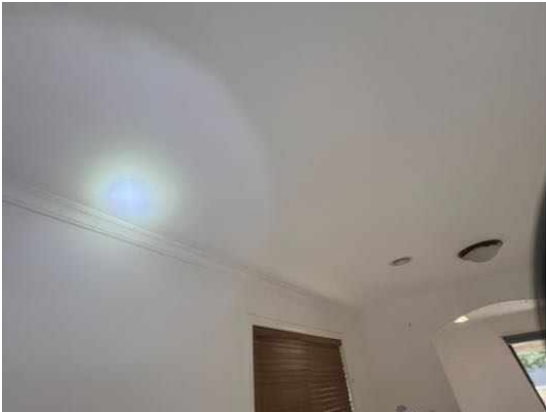
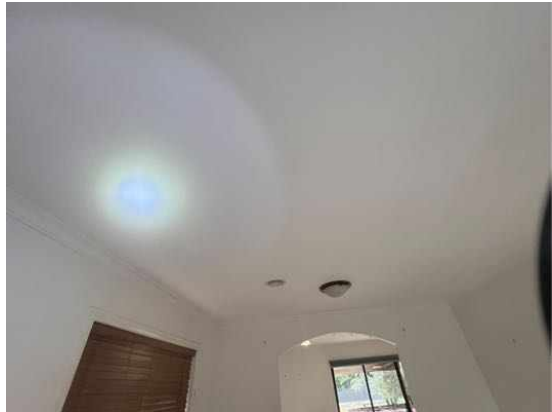
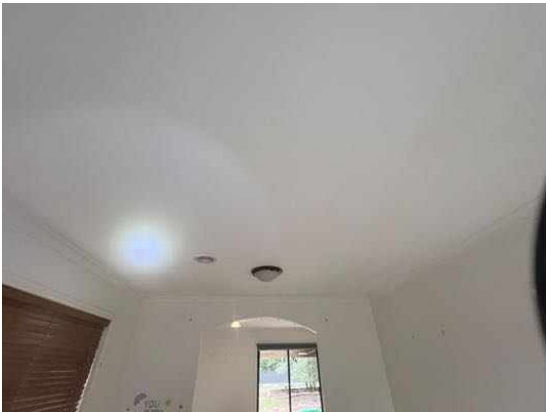
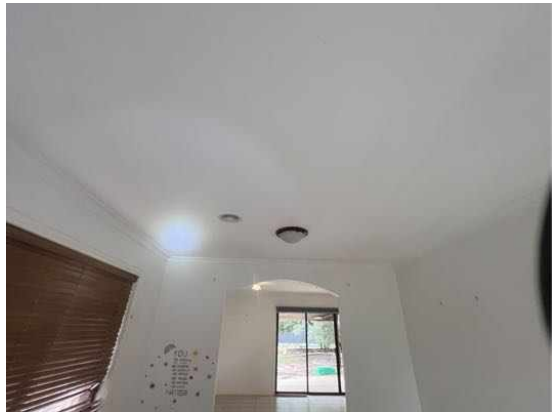
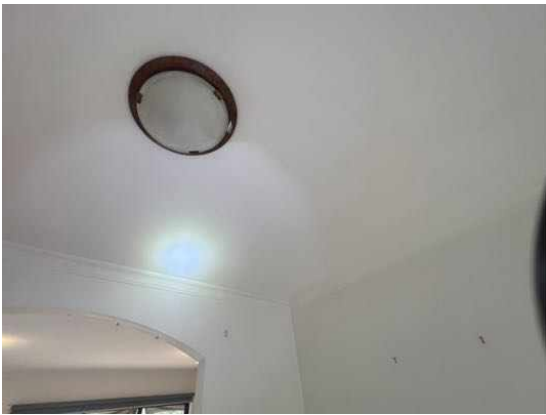
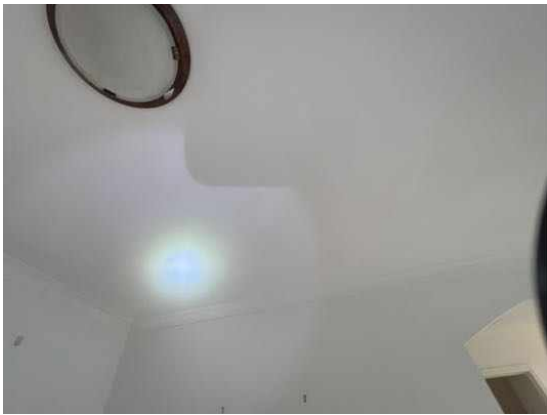
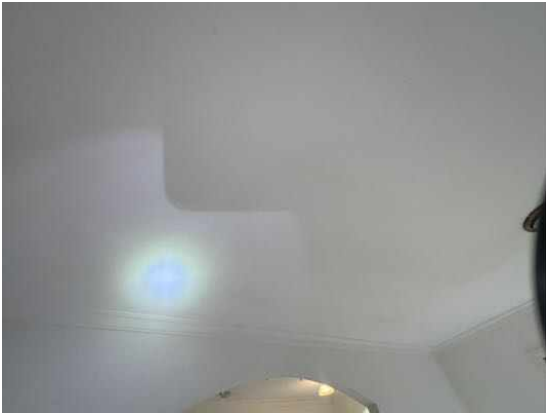
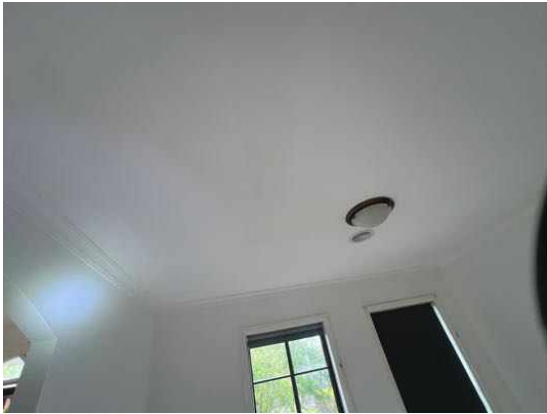
Building: Main Building  
Location: Living Room > All Areas  
Finding: Additional Photos - Obstructions and Limitations  
Information: These photographs are an indication of the obstructions and limitations which impeded full inspection of the property at the time of inspection. These obstructions can hide an array of defects and should be removed to allow full inspection to be carried out. A re-inspection is recommended once the areas are made accessible.
