# Building and Timber Pest Inspection Report

Inspection Date: Fri, 27 Feb 2026

Property Address: 5 Summit Mews, Hillside VIC 3037, Australia

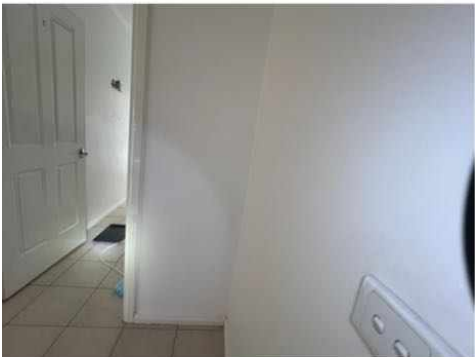
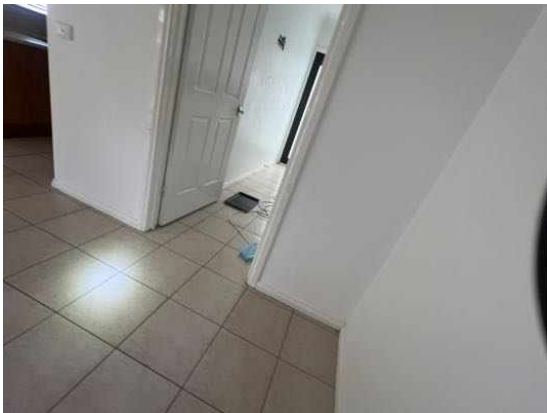
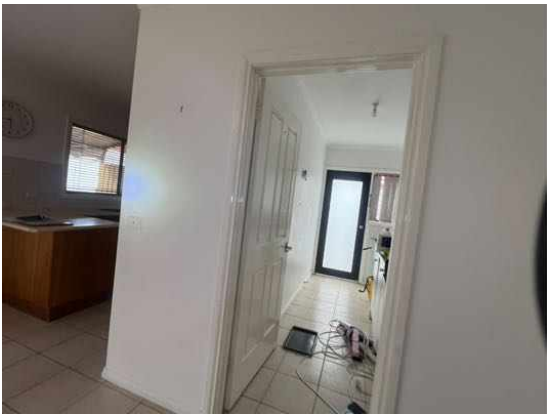
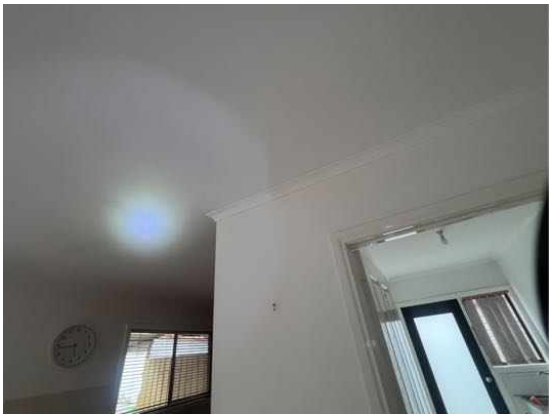
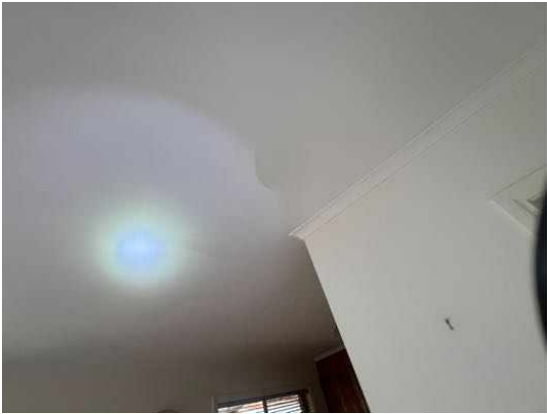
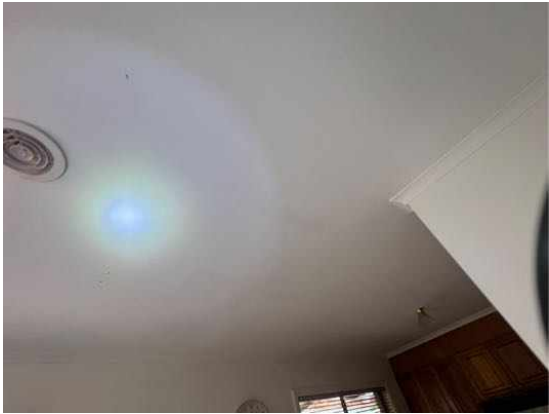
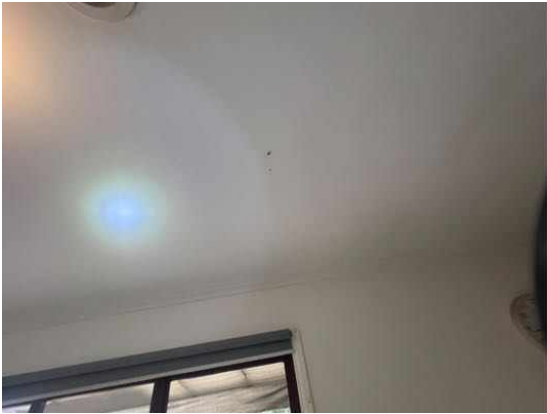
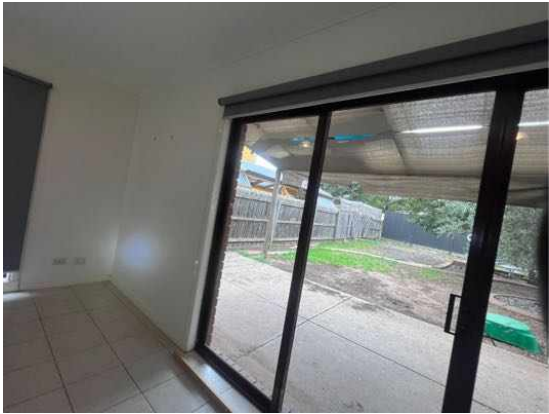
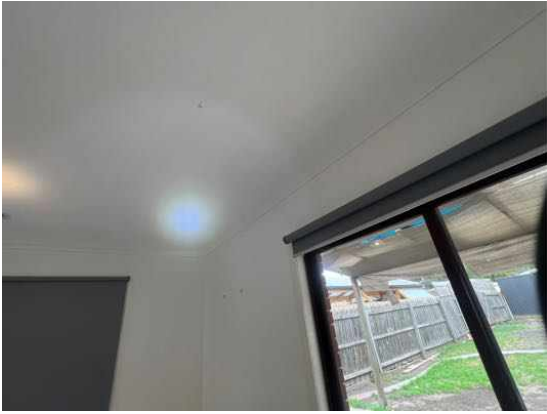
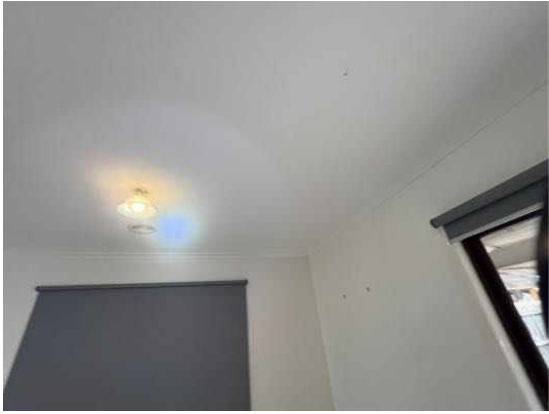
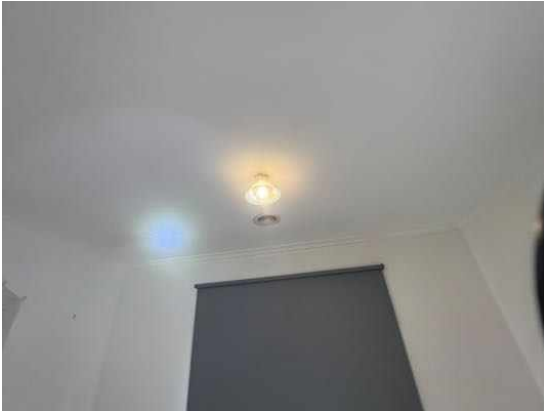
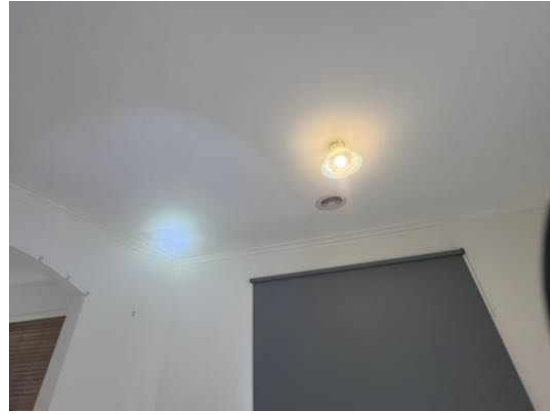
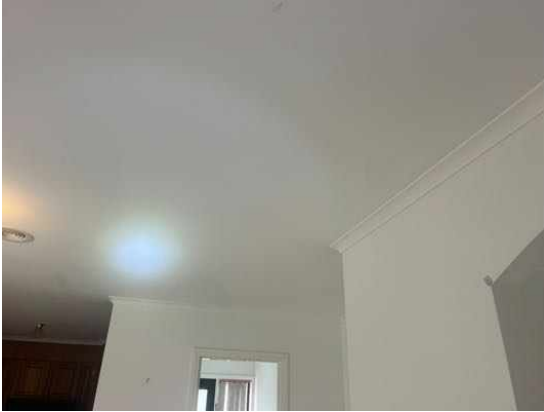
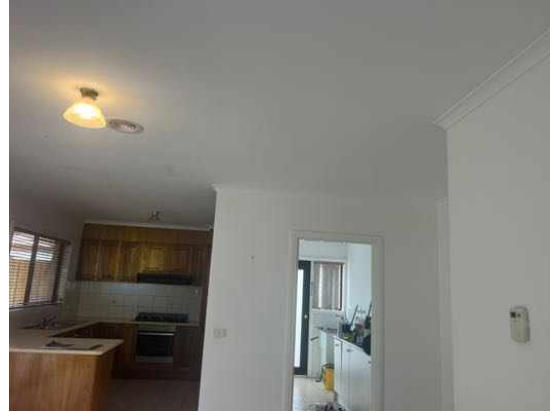
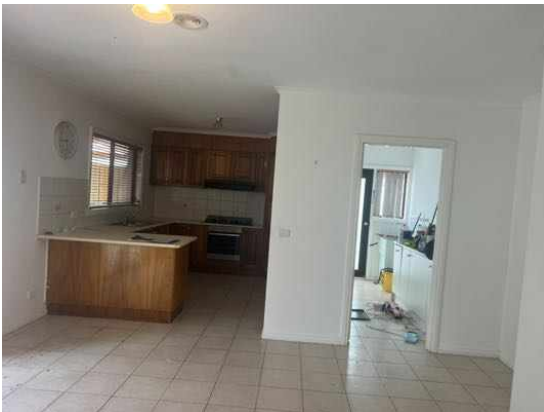
Building: Main Building  
Location: Dining Room > All Areas  
Finding: Additional Photos - Obstructions and Limitations  
Information: These photographs are an indication of the obstructions and limitations which impeded full inspection of the property at the time of inspection. These obstructions can hide an array of defects and should be removed to allow full inspection to be carried out. A re-inspection is recommended once the areas are made accessible.

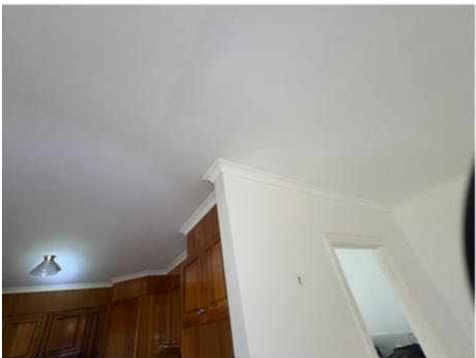
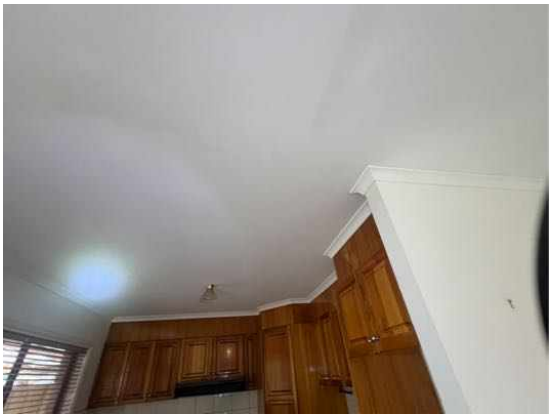
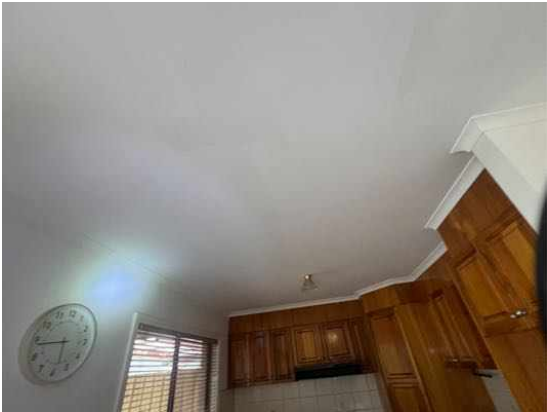
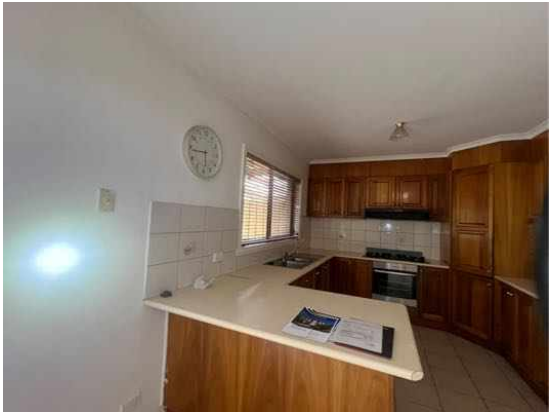
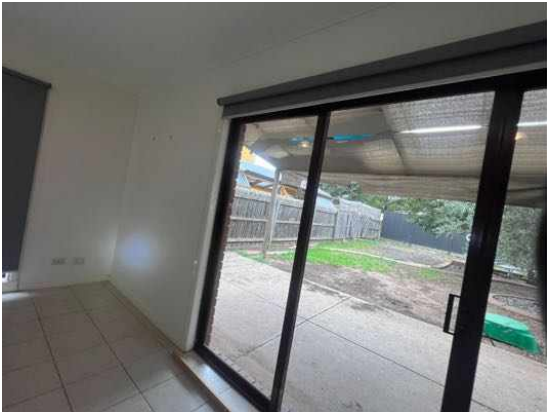
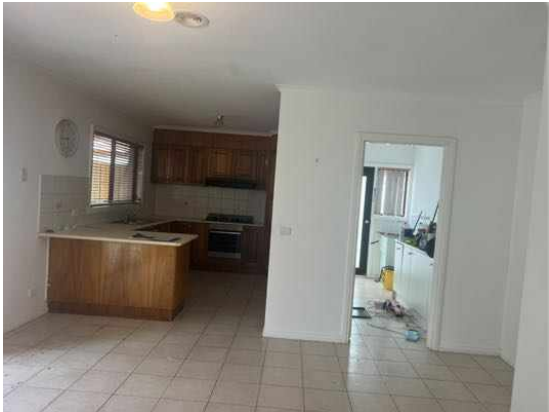
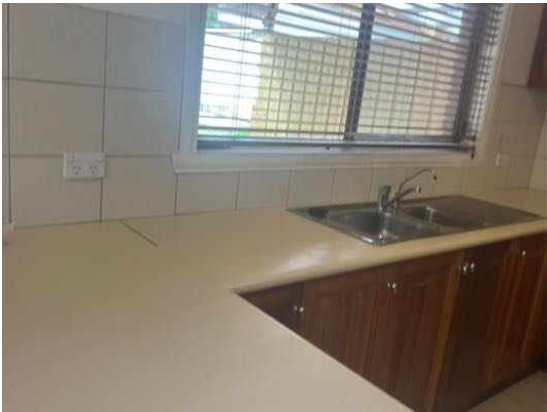
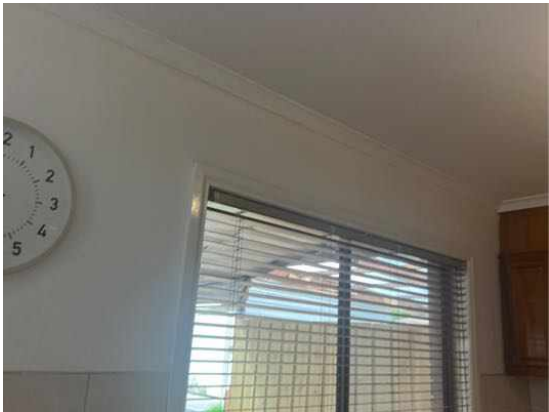
Building: Main Building  
 Location: Kitchen > All Areas  
 Finding: Additional Photos - Obstructions and Limitations  
 Information: These photographs are an indication of the obstructions and limitations which impeded full inspection of the property at the time of inspection. These obstructions can hide an array of defects and should be removed to allow full inspection to be carried out. A re-inspection is recommended once the areas are made accessible.

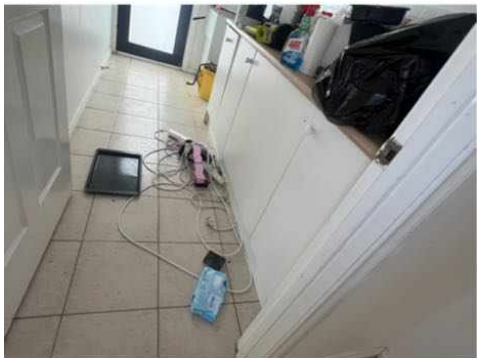
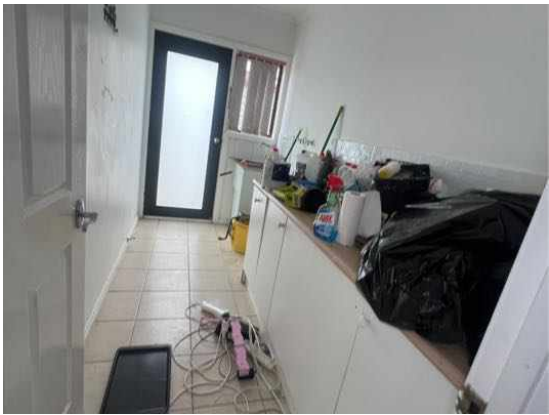
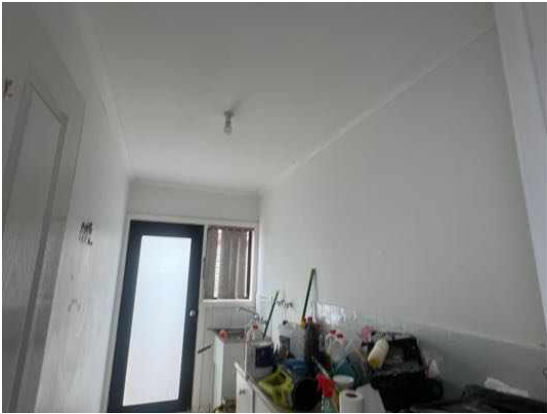
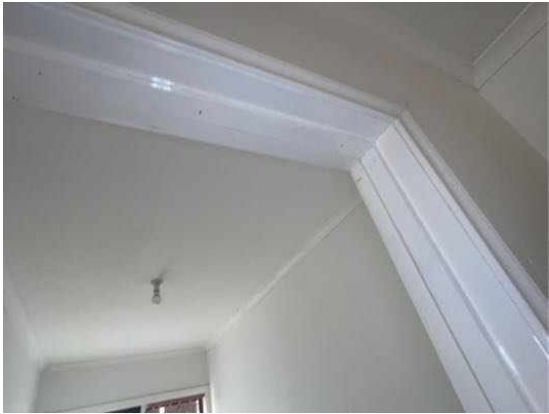
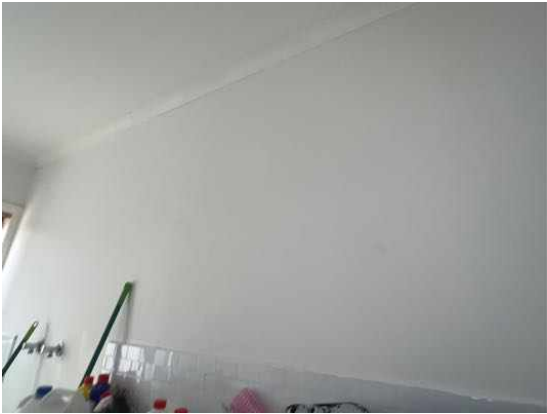
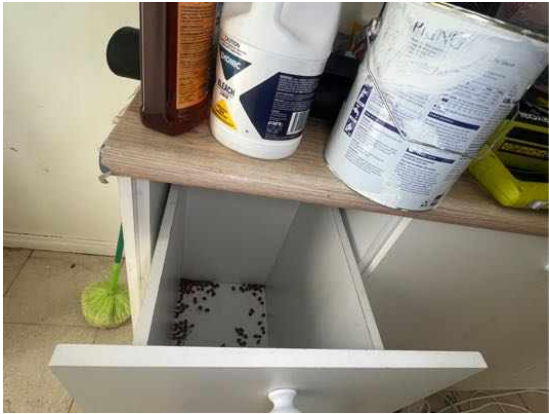
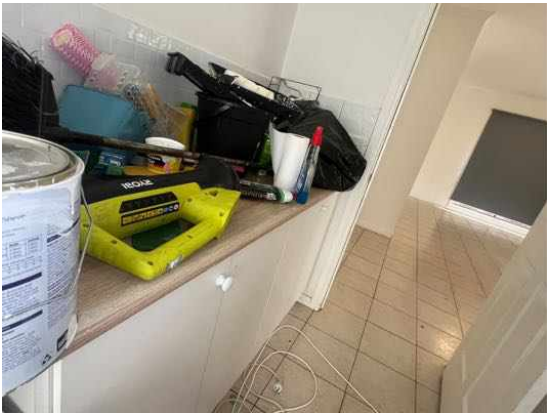
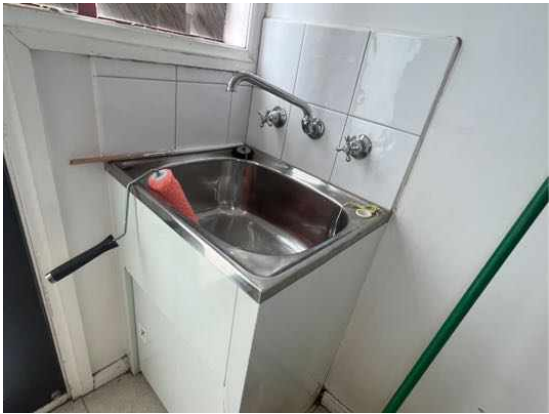
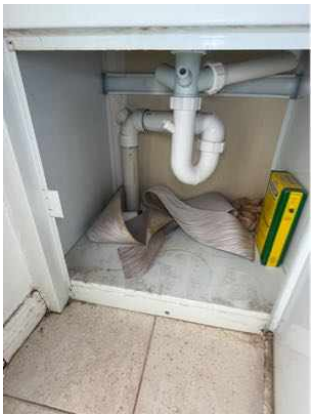
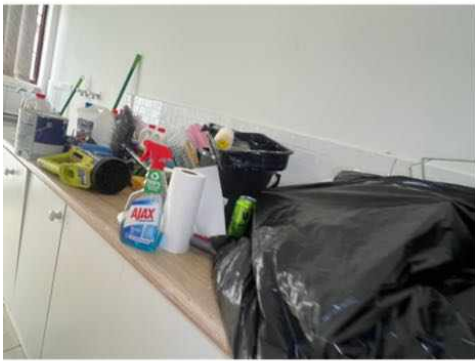
Building: Main Building  
Location: Laundry > All Areas  
Finding: Additional Photos - Obstructions and Limitations  
Information: These photographs are an indication of the obstructions and limitations which impeded full inspection of the property at the time of inspection. These obstructions can hide an array of defects and should be removed to allow full inspection to be carried out. A re-inspection is recommended once the areas are made accessible.

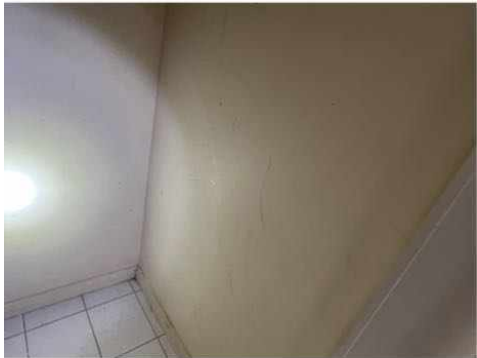
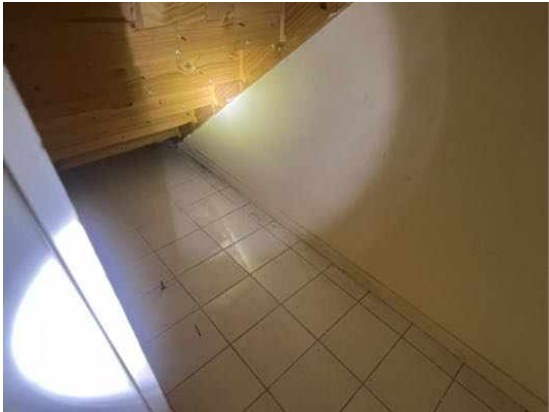
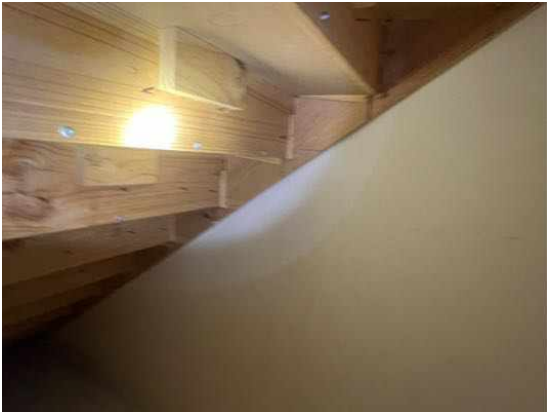
Building: Main Building  
 Location: Under Stair Void or Storeroom > All Areas  
 Finding: Additional Photos  
 Information: Additional photos are provided for your general reference

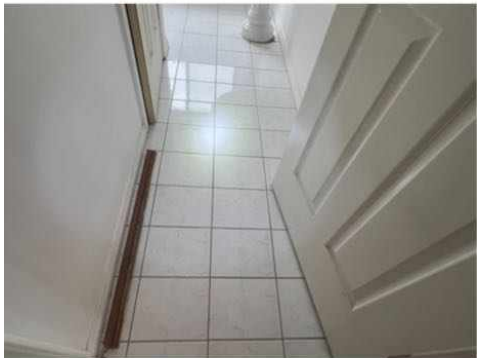
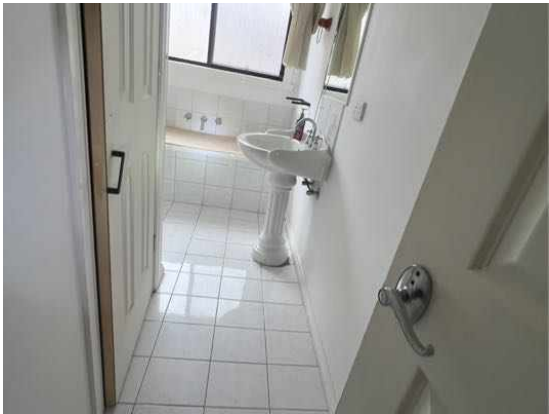
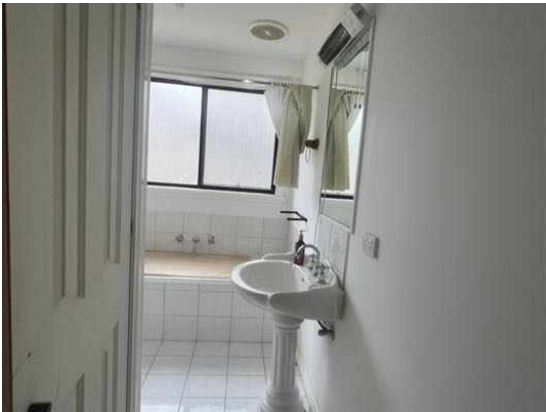
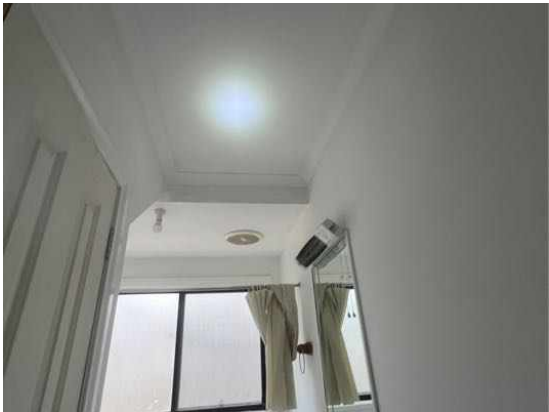
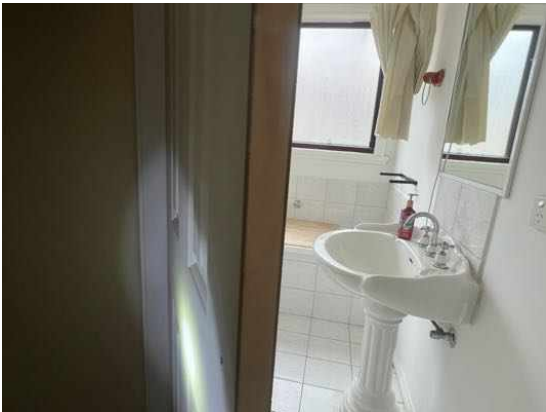
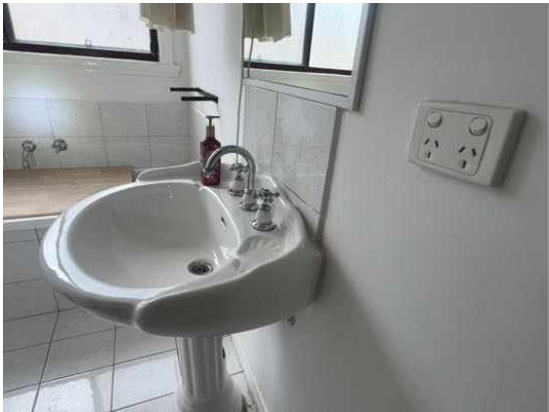
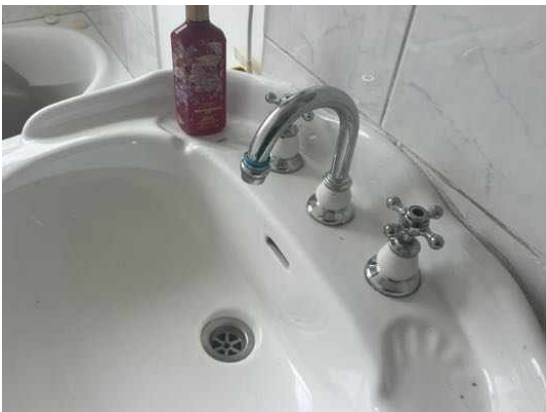
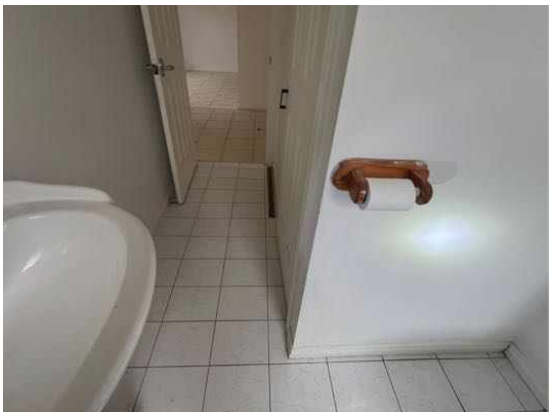
Building: Main Building  
 Location: Bathroom > All Areas  
 Finding: Additional Photos

Information: Additional photos are provided for your general reference

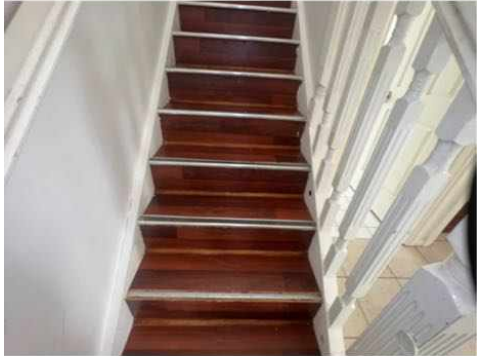
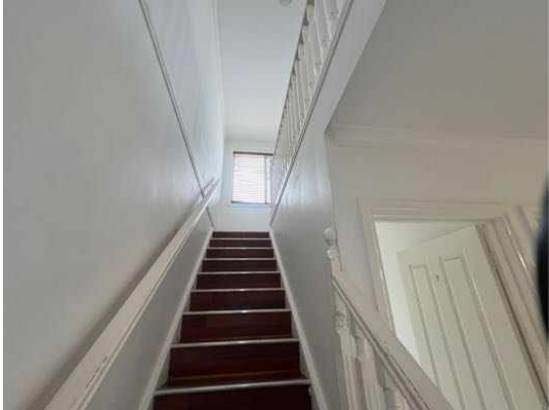
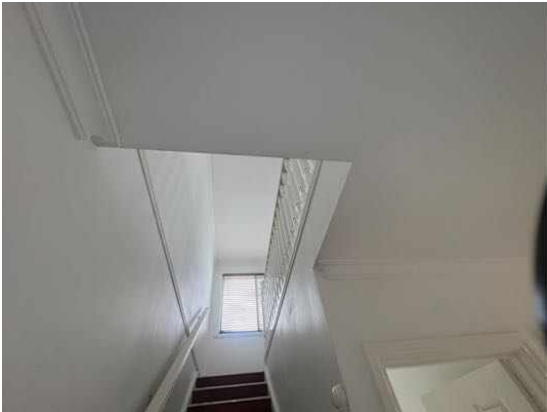
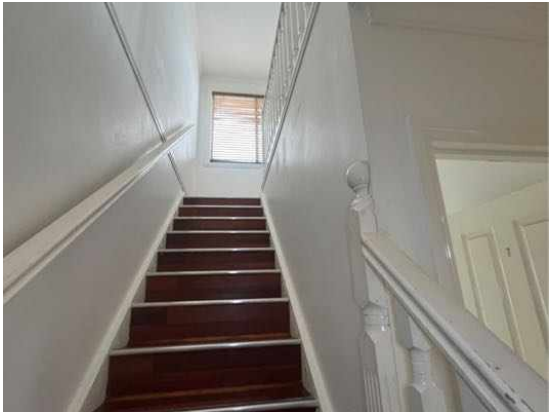
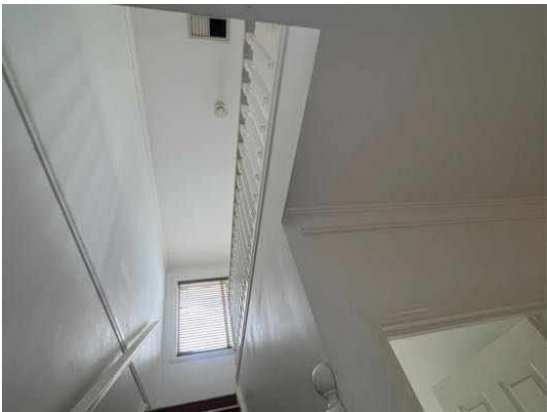
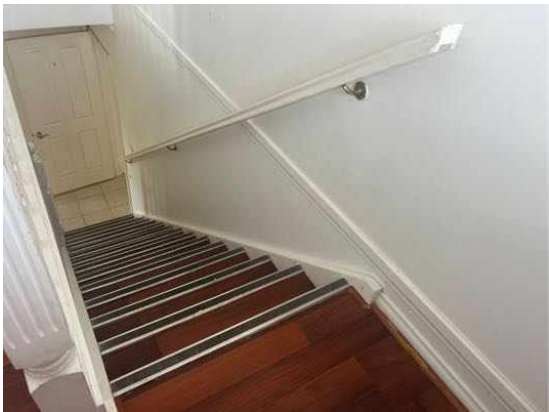
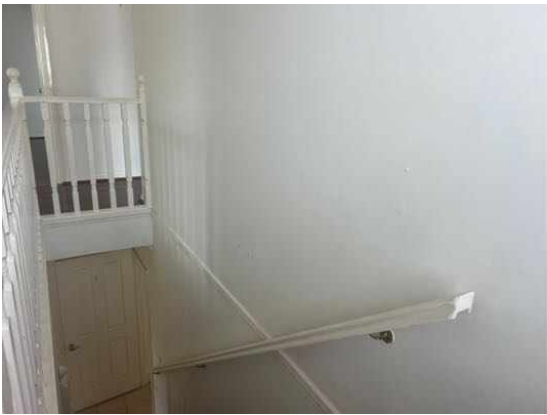
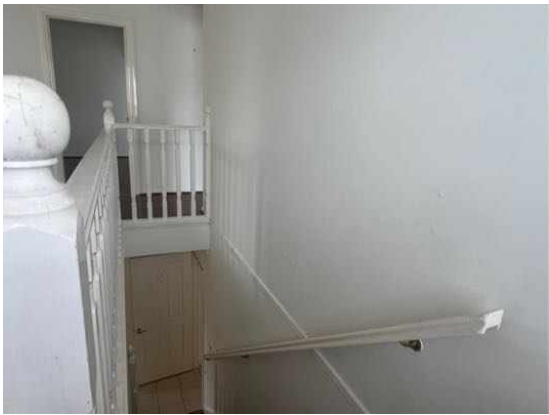
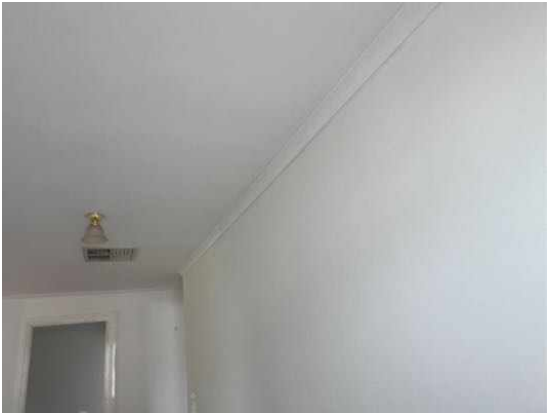
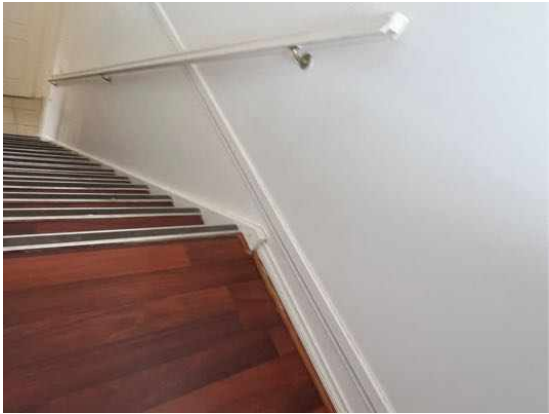
Noted Item

Building: Main Building  
Location: Upstairs > All Areas  
Finding: Additional Photos  
Information: Additional photos are provided for your general reference

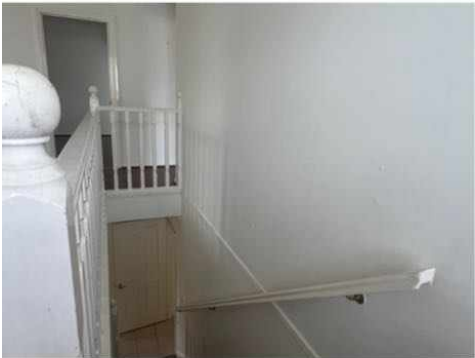
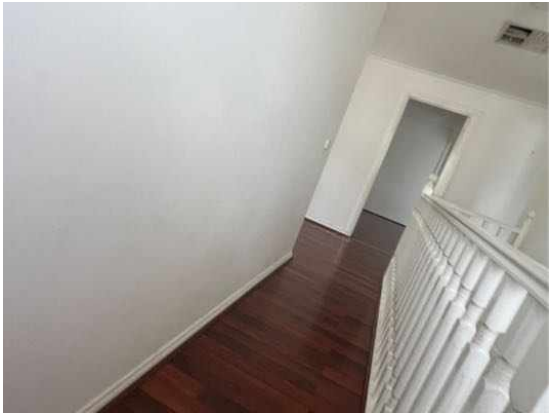
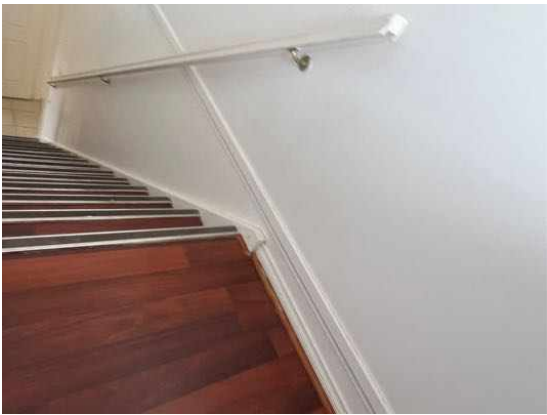
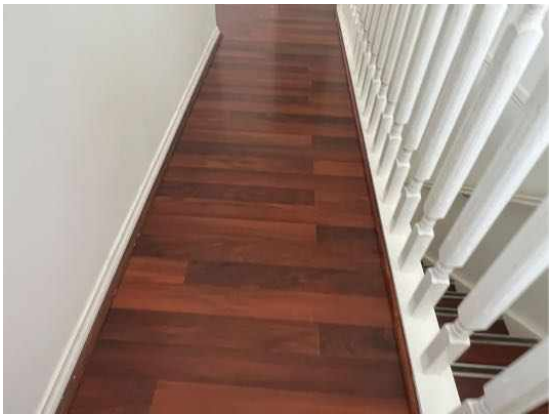
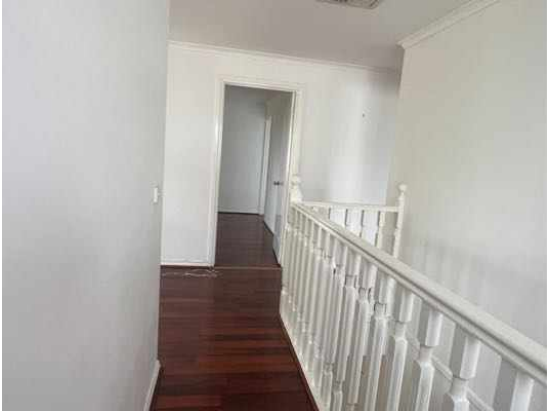
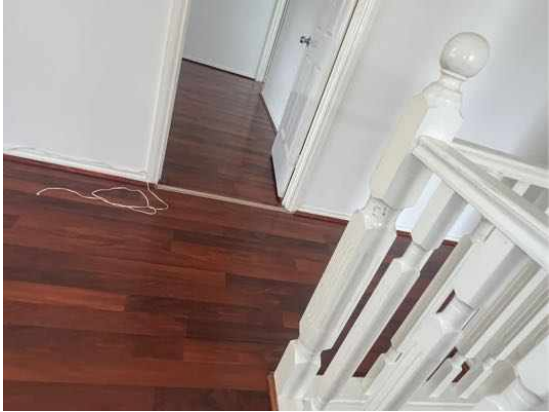
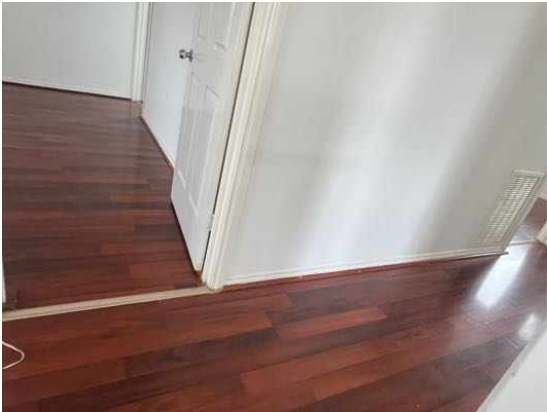
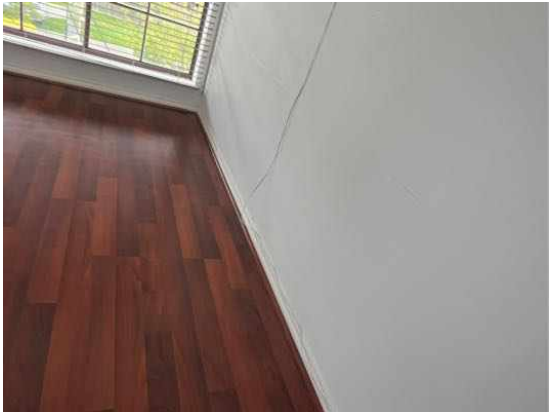
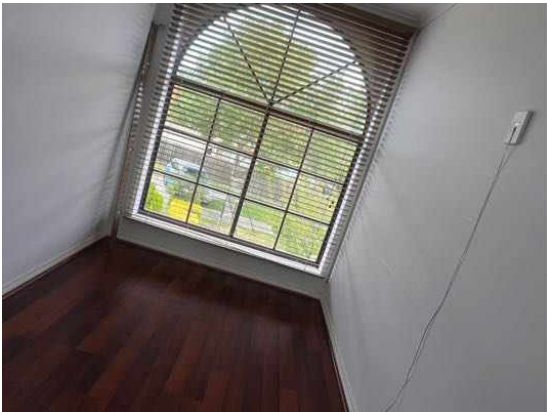
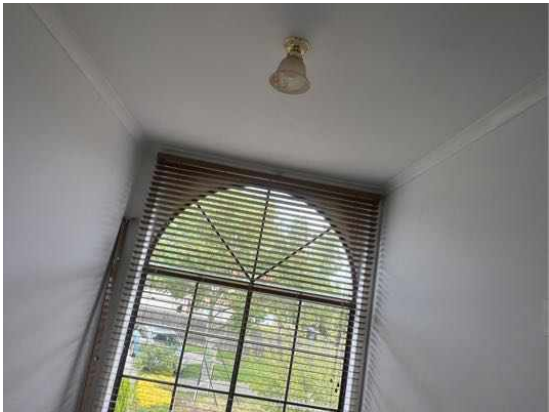
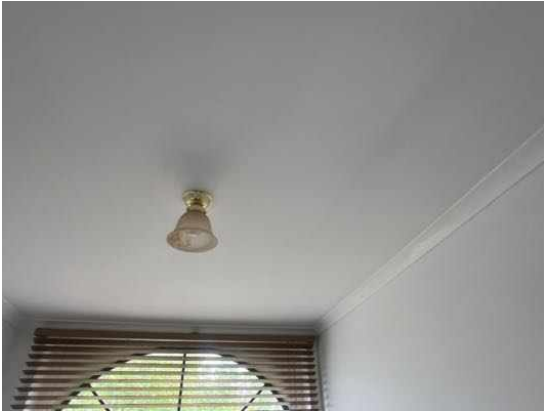
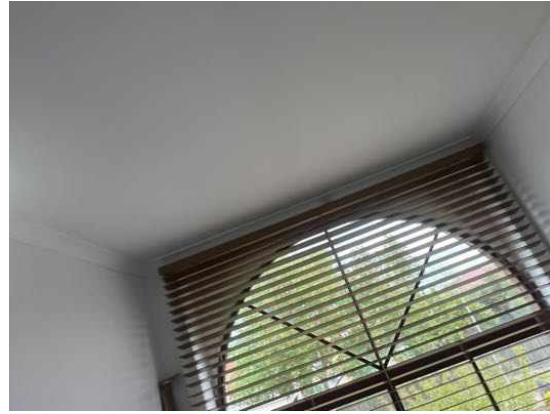
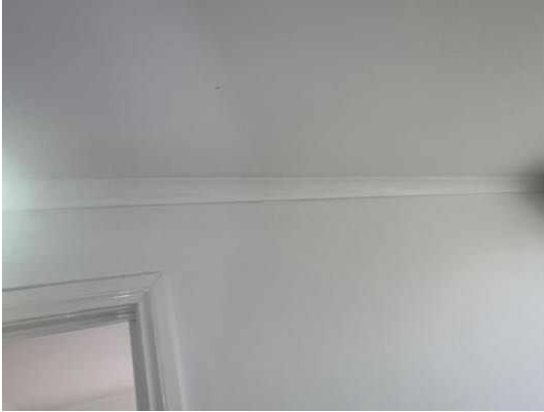
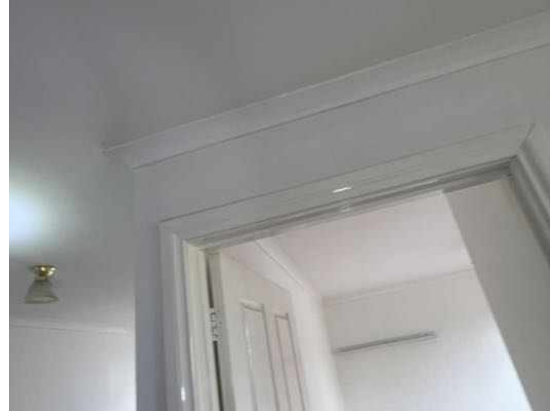
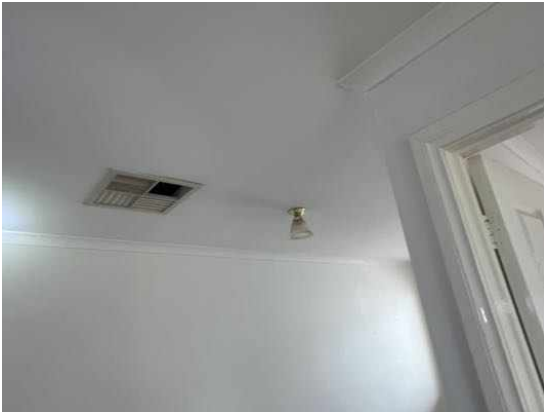
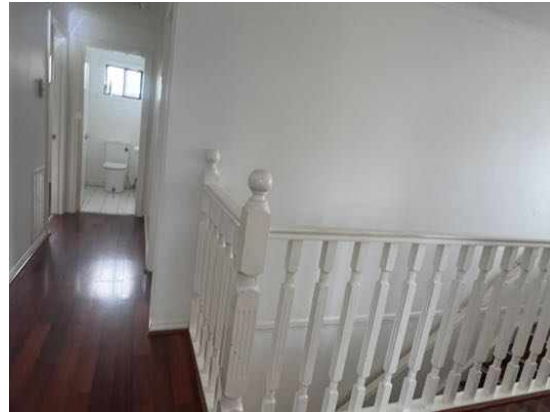
**Noted Item**

Building: Main Building  
Location: Stair Landing > All Areas  
Finding: Additional Photos  
Information: Additional photos are provided for your general reference

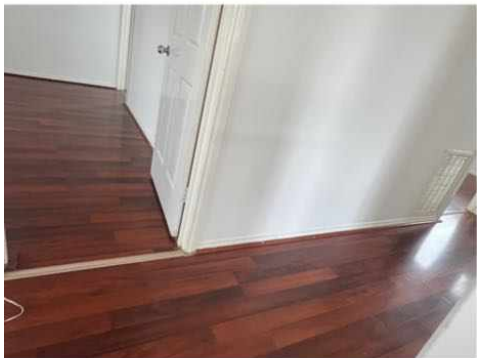
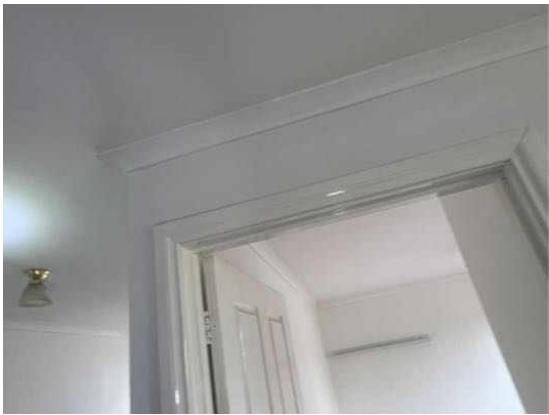
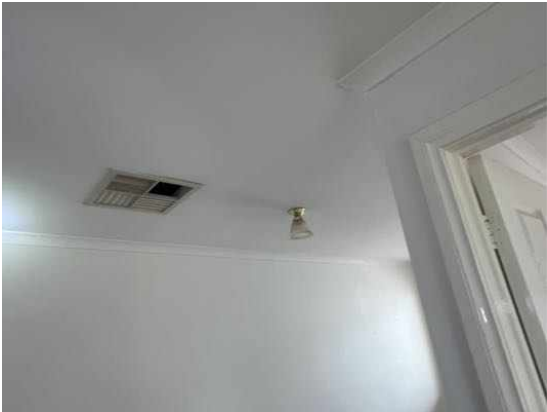
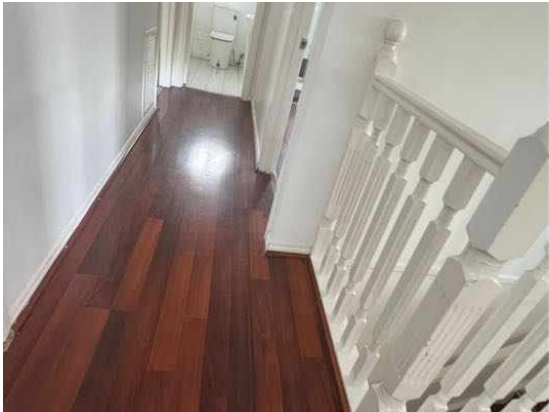
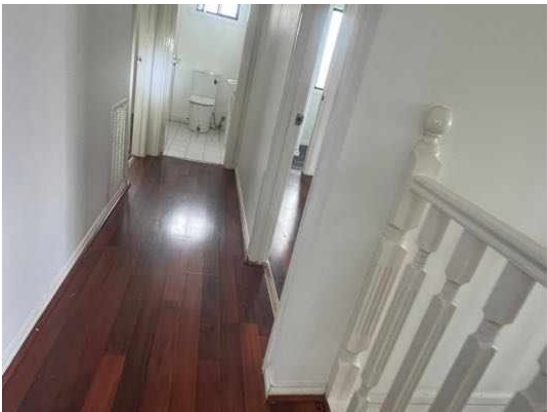
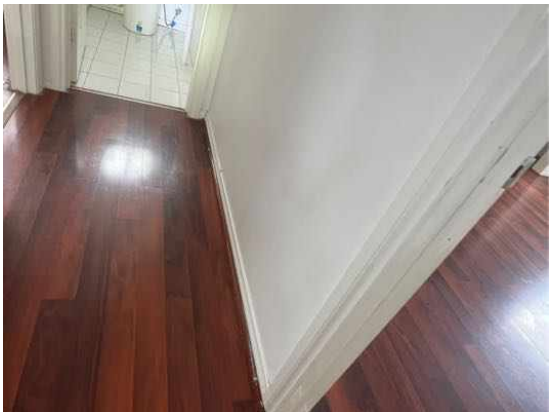
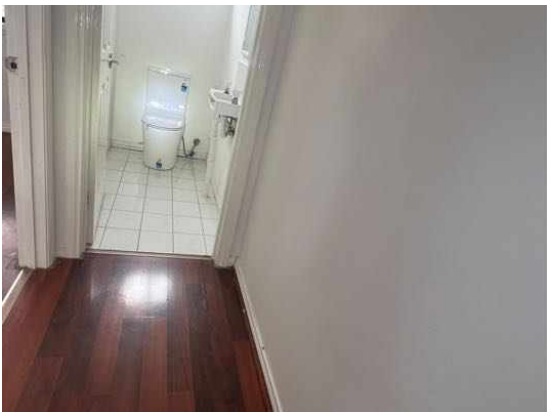
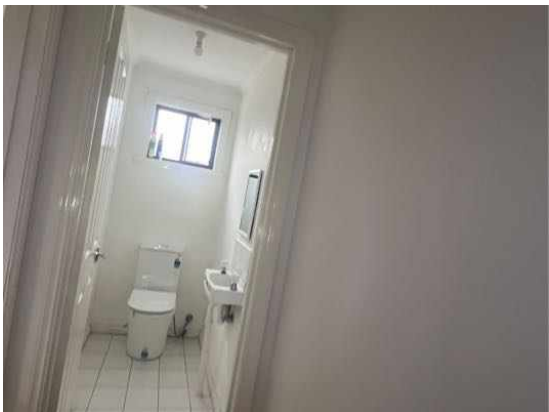
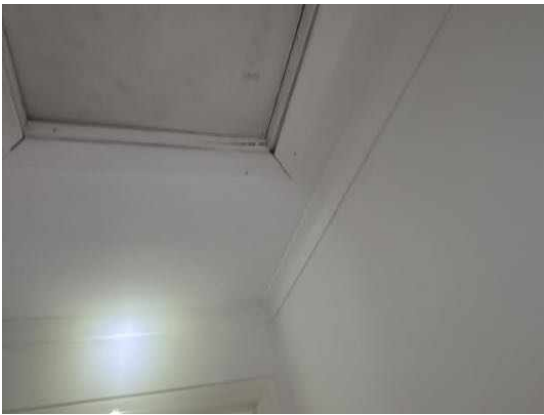
Building:	Main Building
Location:	Hallway > All Areas
Finding:	Additional Photos - Obstructions and Limitations
Information:	These photographs are an indication of the obstructions and limitations which impeded full inspection of the property at the time of inspection. These obstructions can hide an array of defects and should be removed to allow full inspection to be carried out. A re-inspection is recommended once the areas are made accessible.

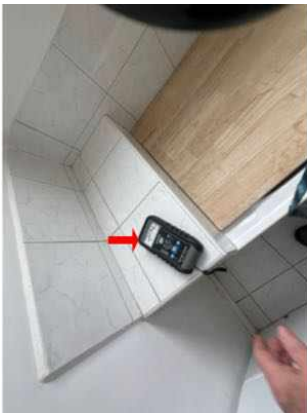
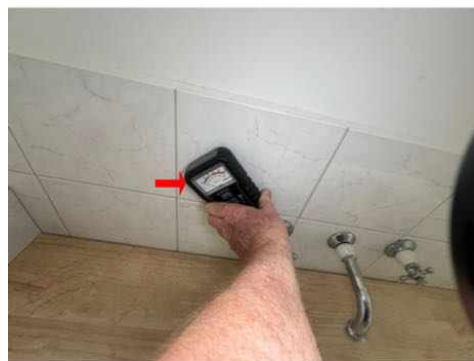
Building: Main Building  
 Location: Bathroom > All Areas  
 Finding: Additional Photos-moisture readings taken from all wet area walls & floors-and found to be within tolerance  
 Information: Additional photos are provided for your general reference. Arrows have been included to highlight areas of importance. Please discuss these photos with your building consultant for clarification.

NB-Thermal camera used to further identify any potential seal breaches-and leaking-

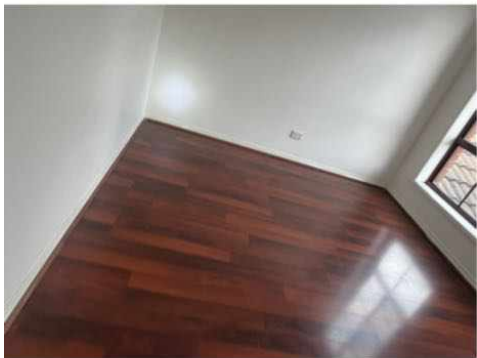
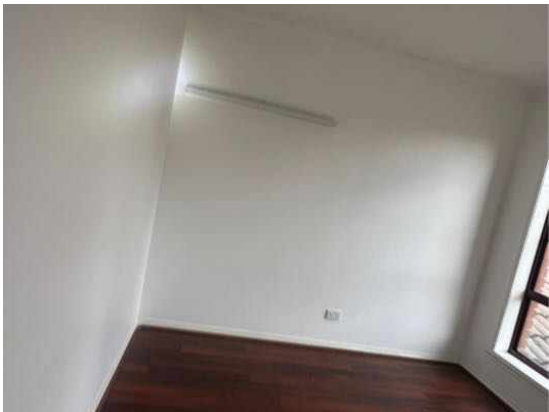
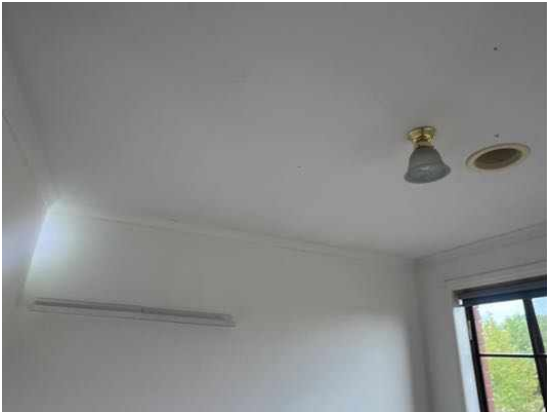
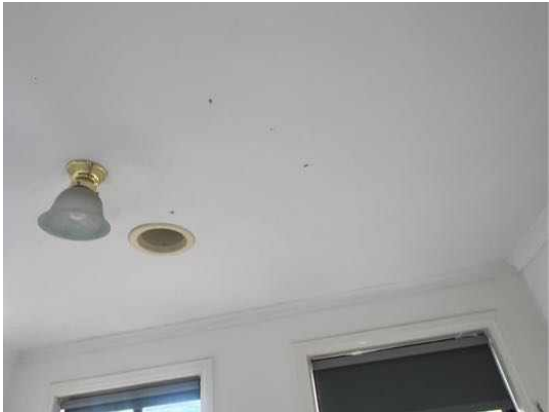
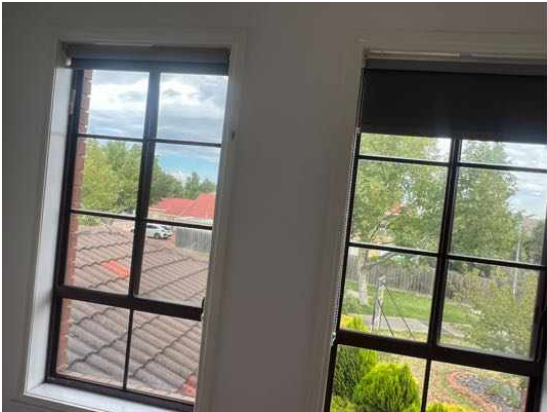
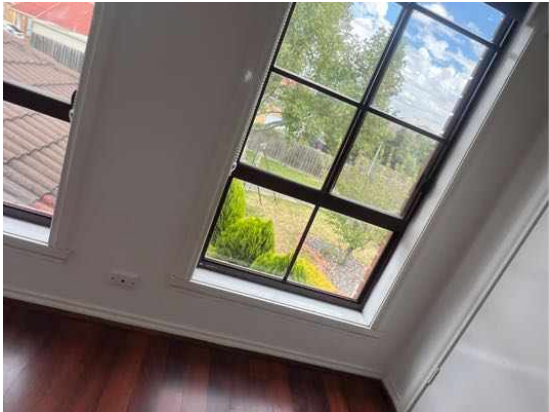
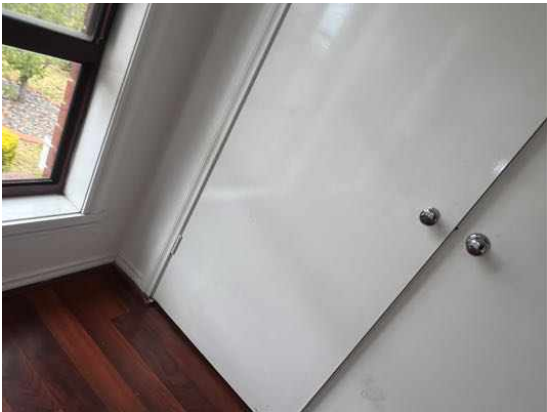
Building: Main Building  
 Location: Bedroom 2 > All Areas  
 Finding: Additional Photos  
 Information: Additional photos are provided for your general reference

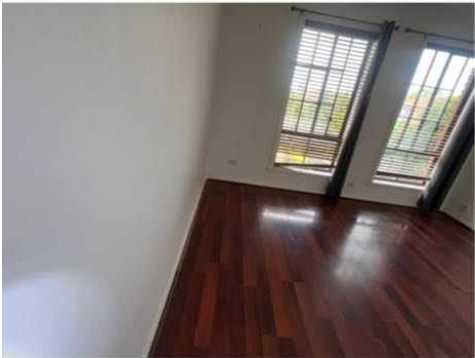
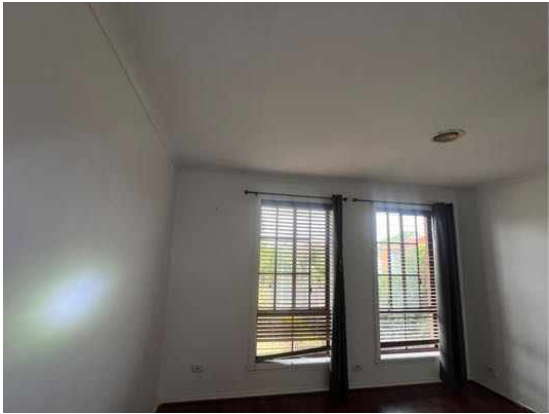
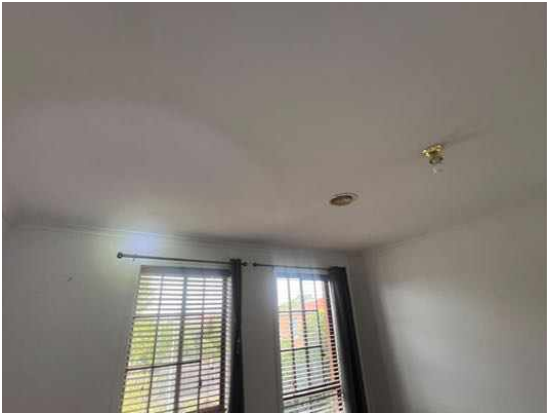
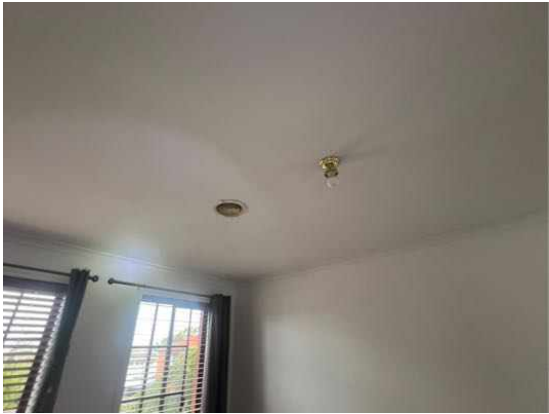
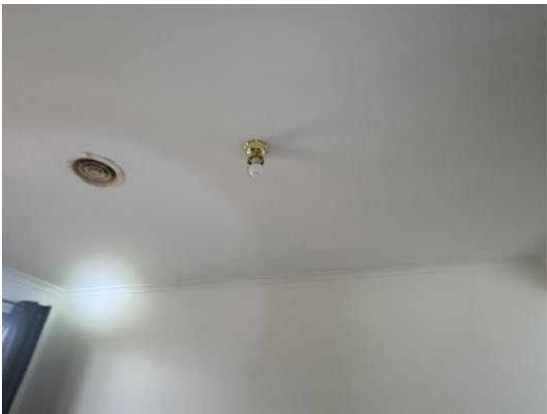
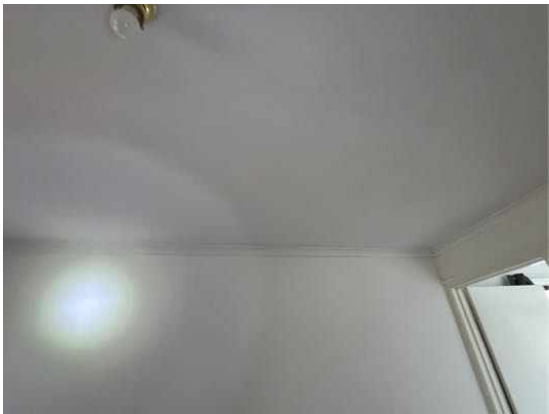
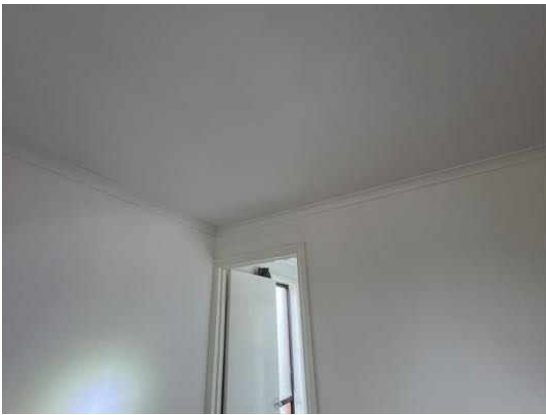
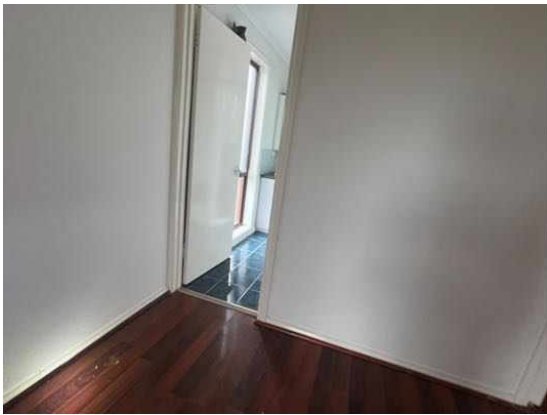
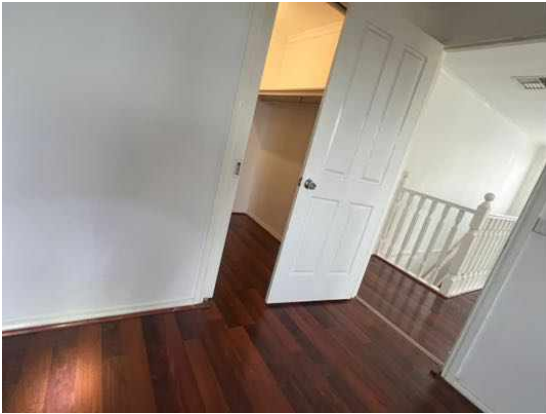
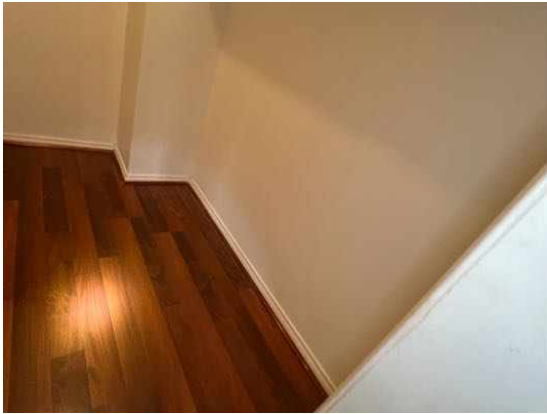
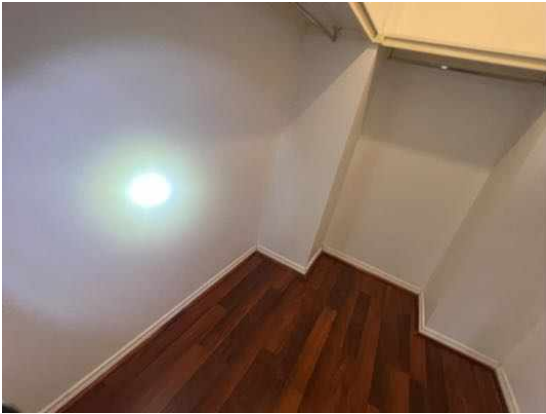
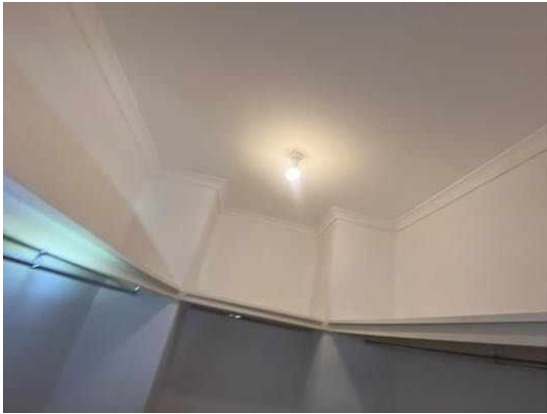
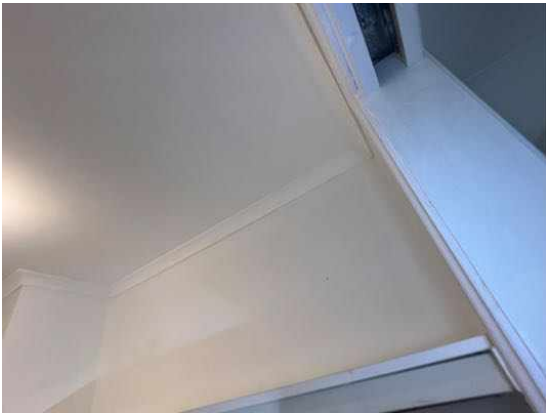
Building: Main Building  
Location: Bedroom - Master > All Areas  
Finding: Additional Photos - Obstructions and Limitations  
Information: These photographs are an indication of the obstructions and limitations which impeded full inspection of the property at the time of inspection. These obstructions can hide an array of defects and should be removed to allow full inspection to be carried out. A re-inspection is recommended once the areas are made accessible.
