# Building and Timber Pest Inspection Report

Inspection Date: Fri, 27 Feb 2026

Property Address: 5 Summit Mews, Hillside VIC 3037, Australia

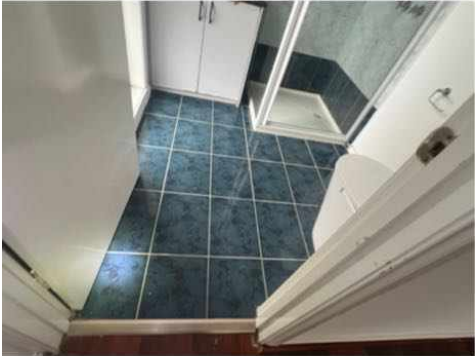
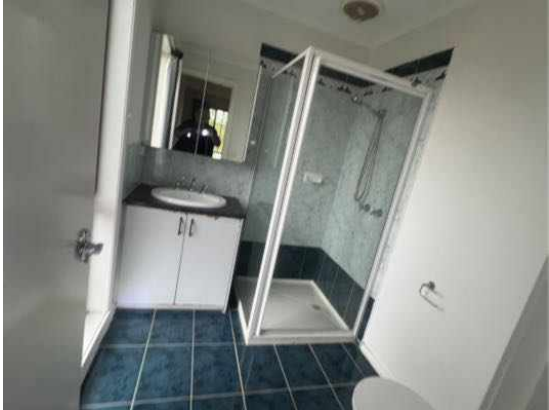
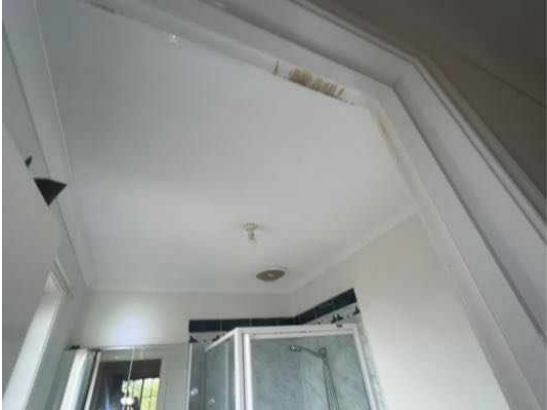
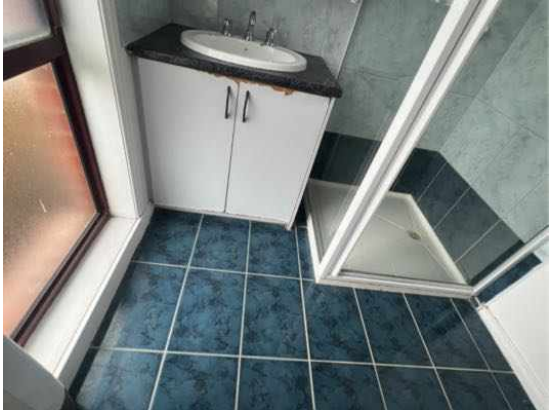
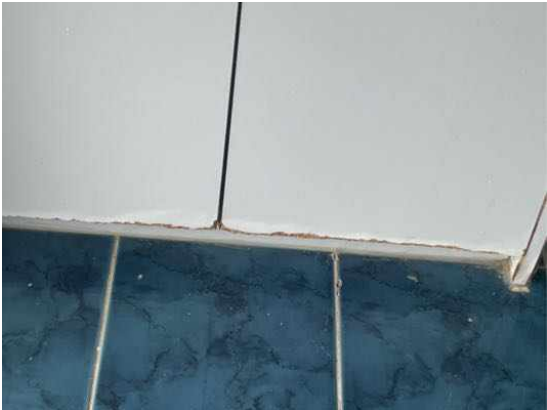
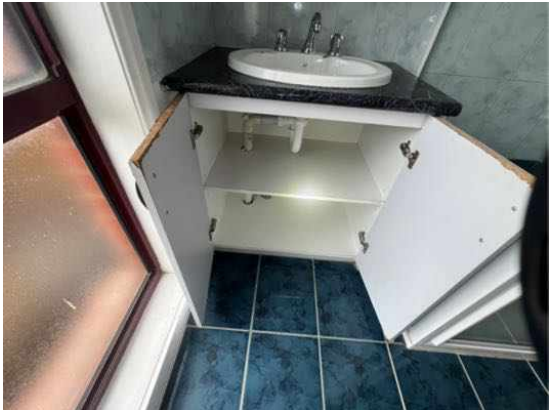
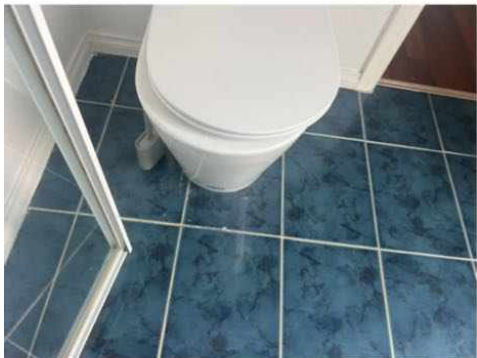
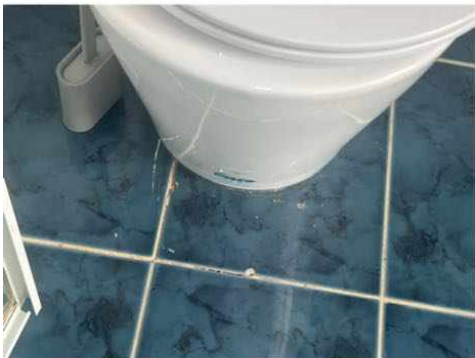
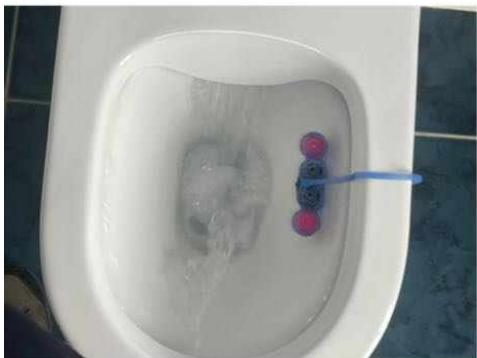
Building: Main Building  
Location: Ensuite - Master > All Areas  
Finding: Additional Photos  
Information: Additional photos are provided for your general reference

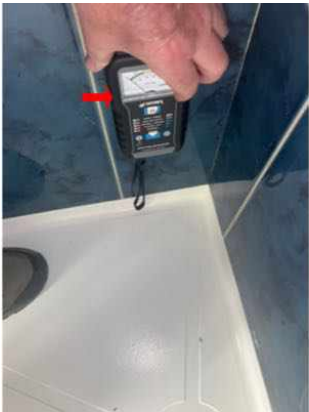
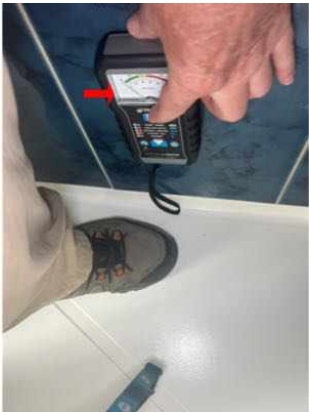
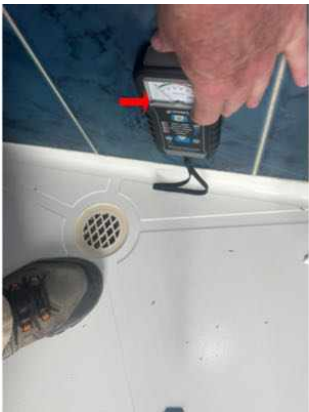
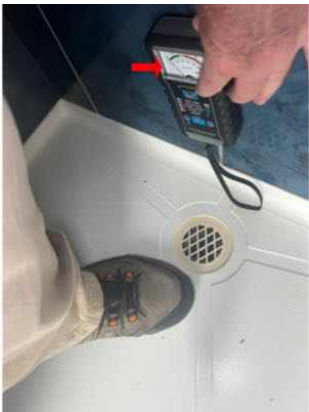
Building: Main Building  
Location: Ensuite - Master > Rear Right  
Finding: Additional Photos-moisture readings taken from all wet area walls & floors-and found to be within tolerance  
Information: Additional photos are provided for your general reference. Arrows have been included to highlight areas of importance. Please discuss these photos with your building consultant for clarification.

NB-Thermal camera used to further identify any potential seal breaches-and leaking-

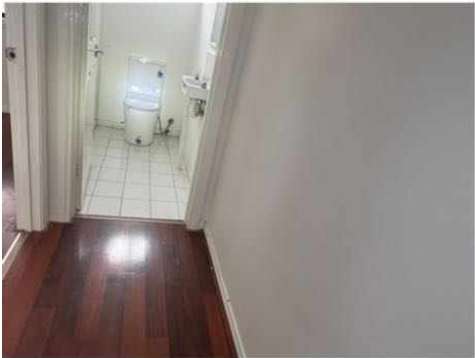
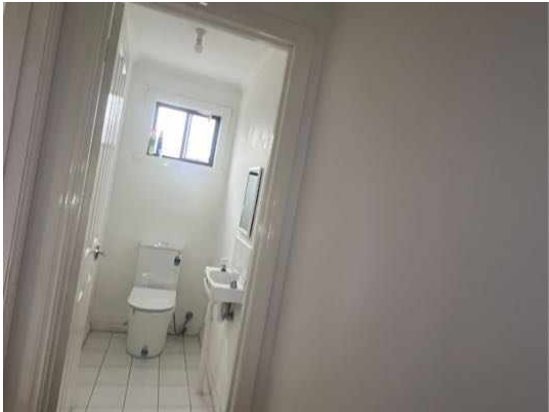
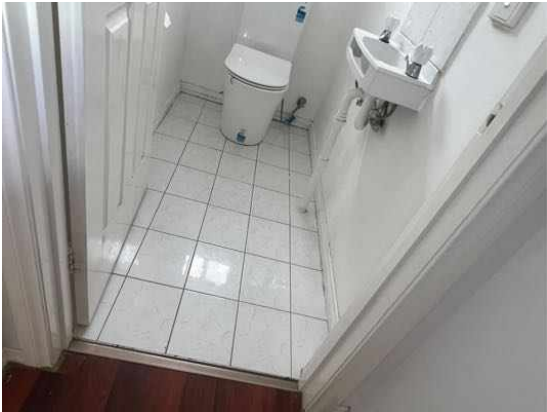
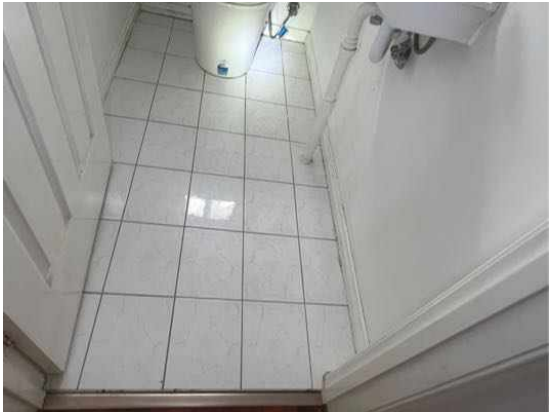
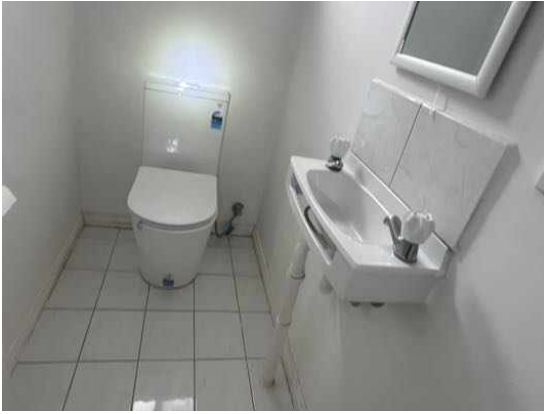
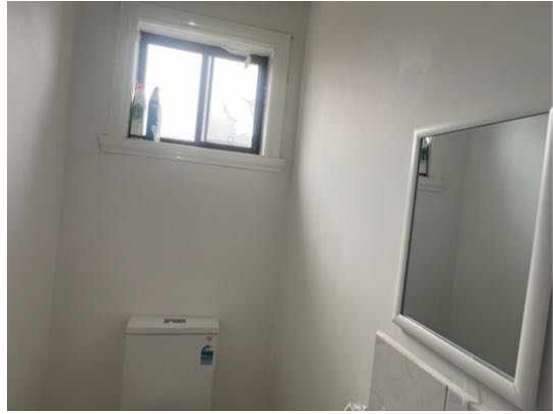
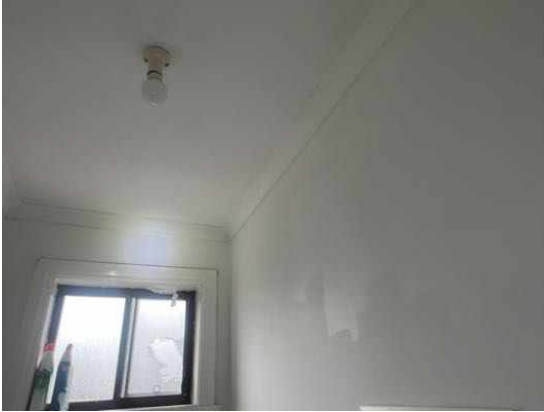
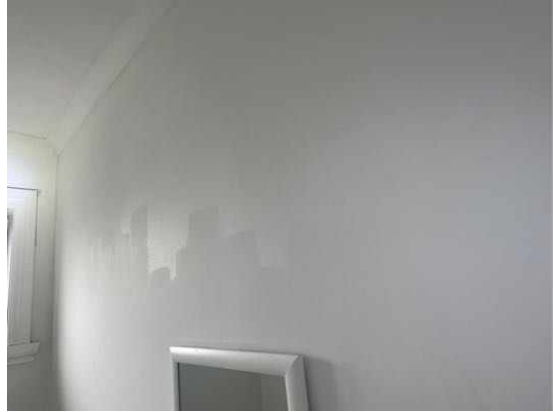
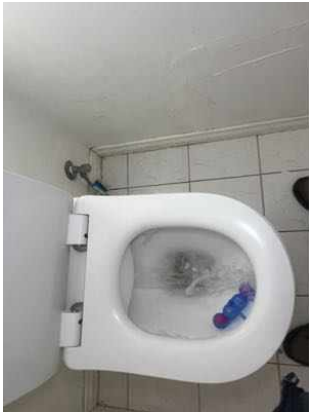
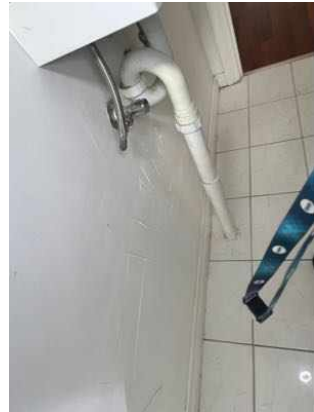
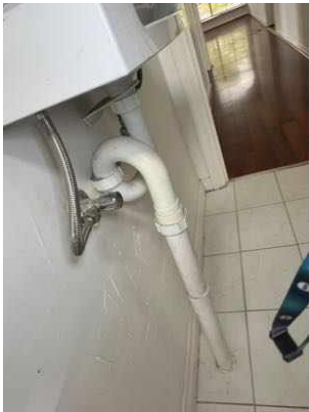
Building: Main Building  
Location: Toilet (WC) > All Areas  
Finding: Additional Photos  
Information: Additional photos are provided for your general reference

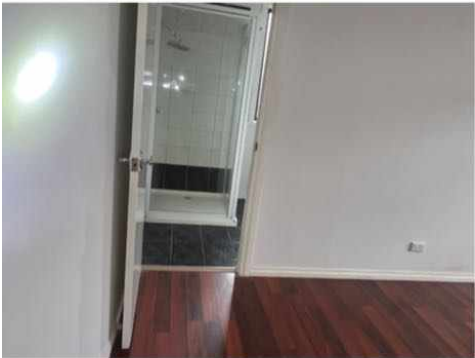
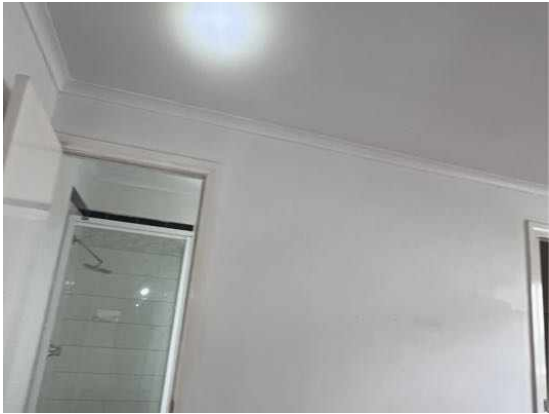
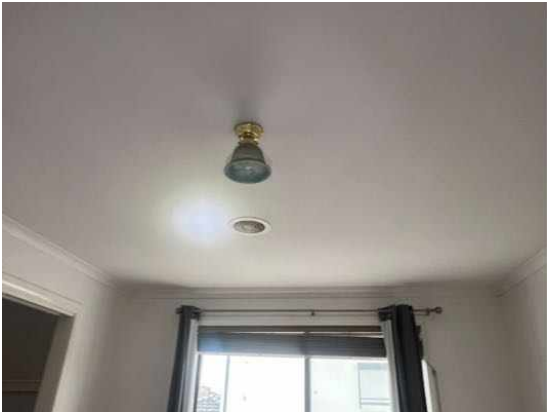
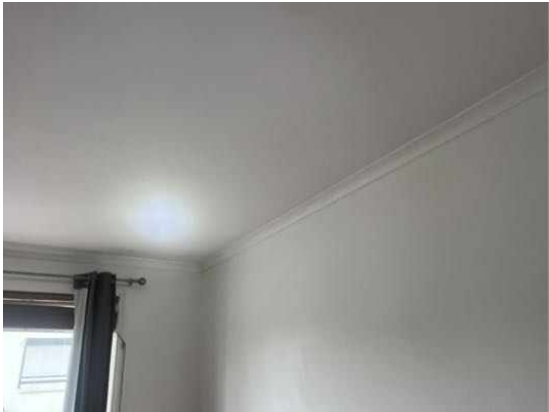
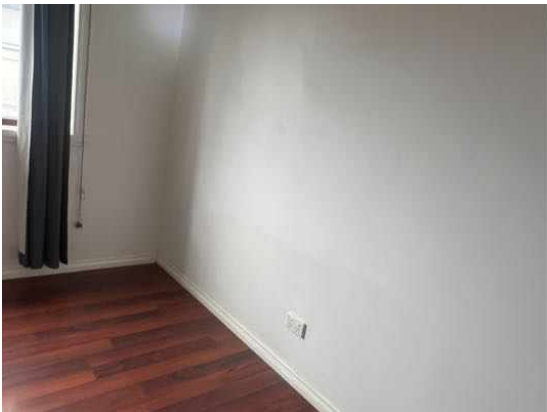
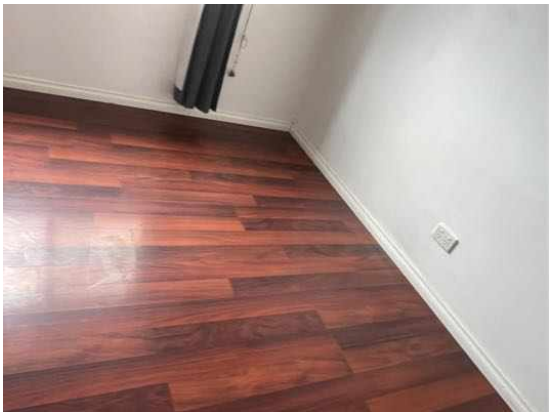
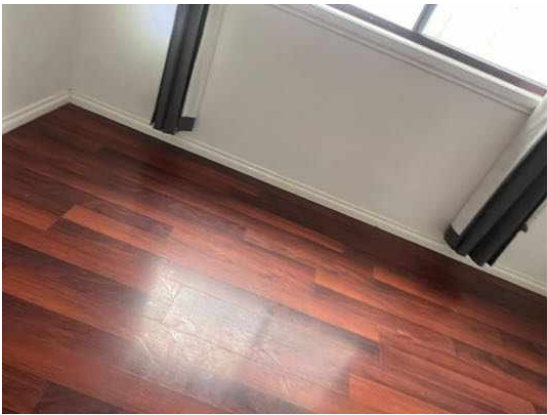
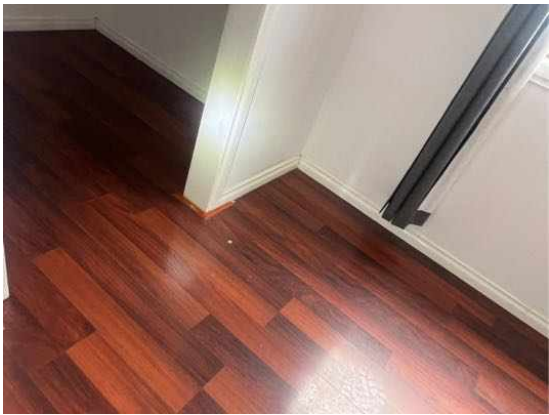
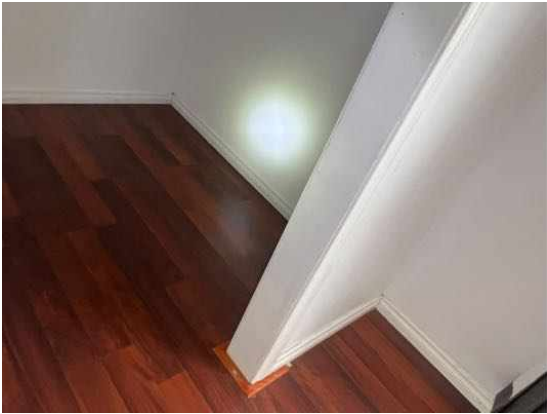
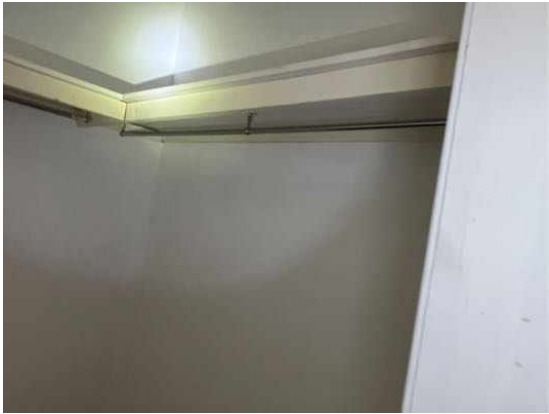
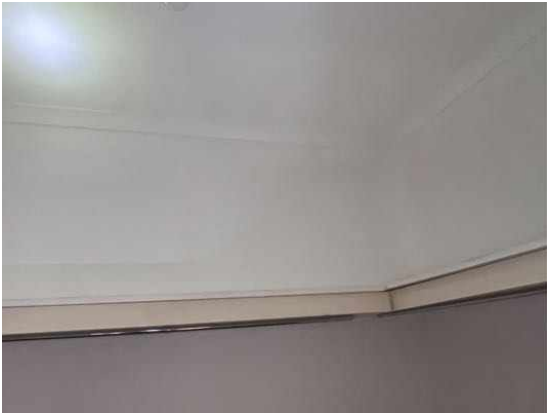
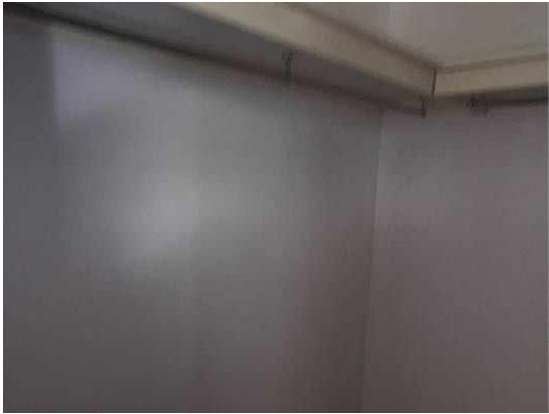
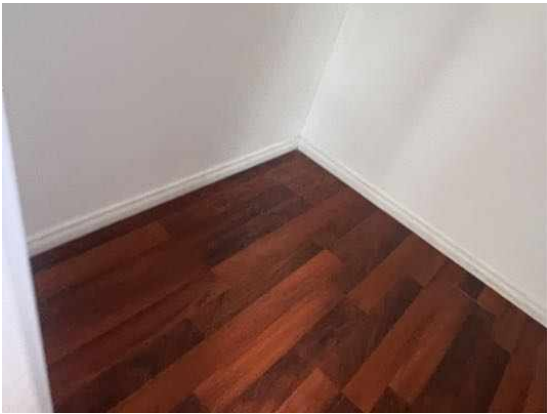
Building: Main Building  
Location: Bedroom 4 > All Areas  
Finding: Additional Photos - Obstructions and Limitations  
Information: These photographs are an indication of the obstructions and limitations which impeded full inspection of the property at the time of inspection. These obstructions can hide an array of defects and should be removed to allow full inspection to be carried out. A re-inspection is recommended once the areas are made accessible.

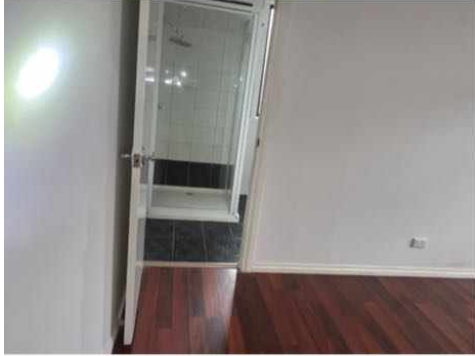
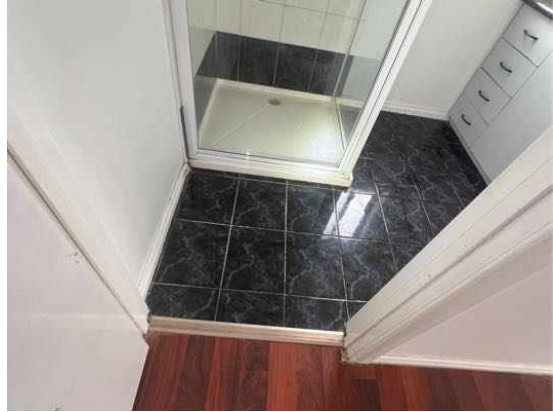
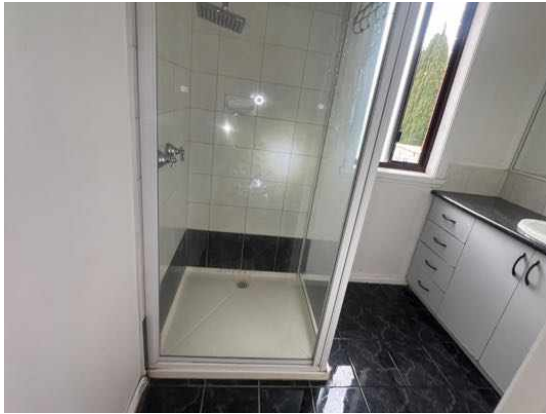
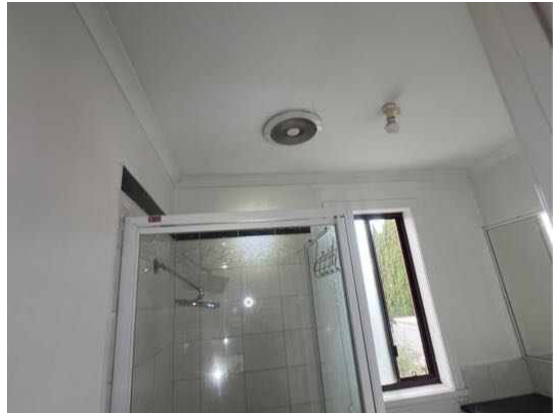
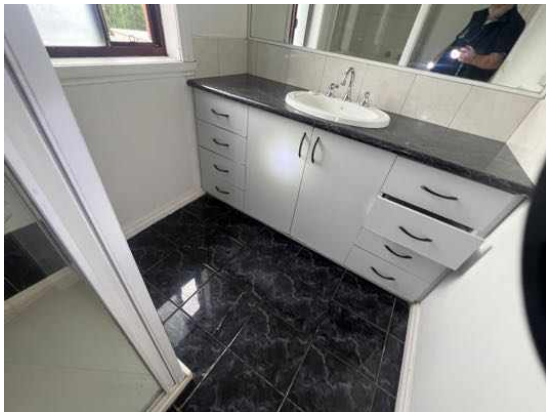
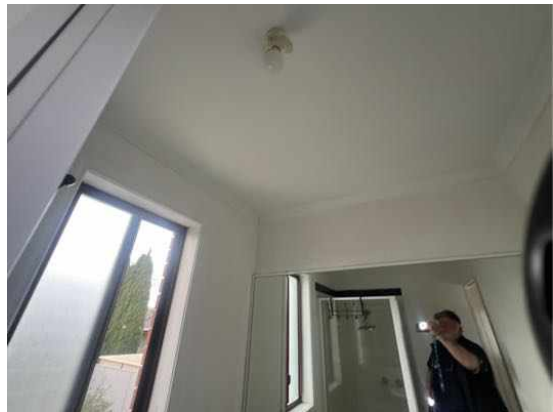
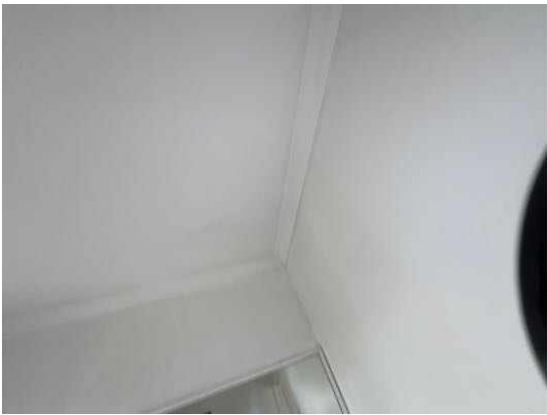
Building: Main Building  
Location: Ensuite - Other > All Areas  
Finding: Additional Photos  
Information: Additional photos are provided for your general reference

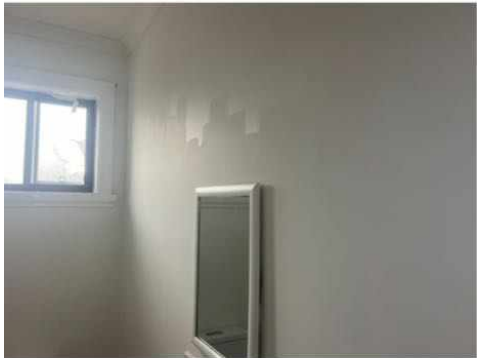
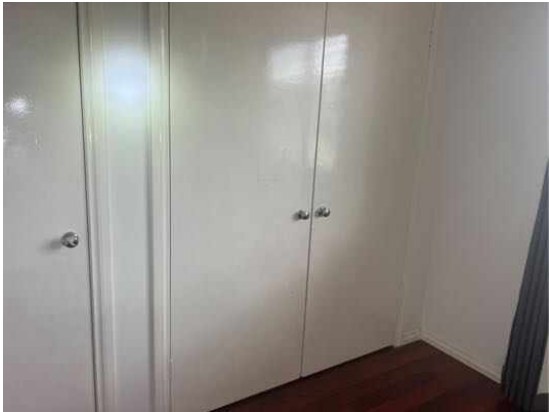
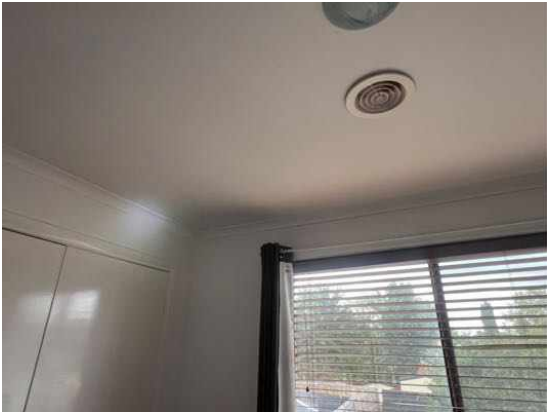
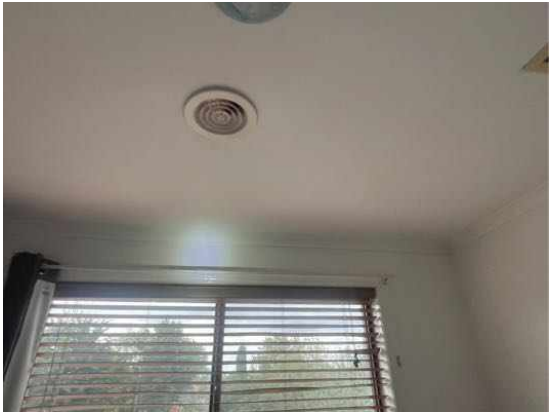
Building: Main Building  
Location: Bedroom 5 > All Areas  
Finding: Additional Photos  
Information: Additional photos are provided for your general reference

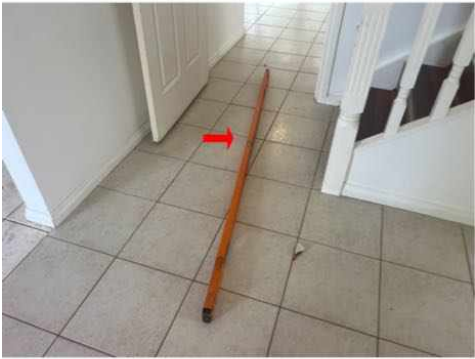
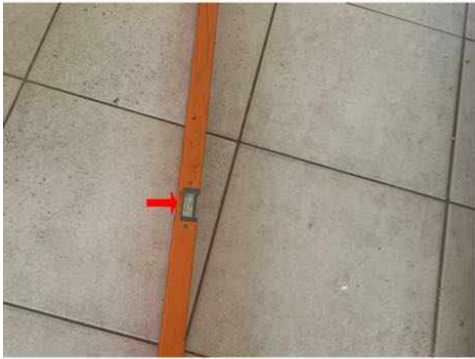
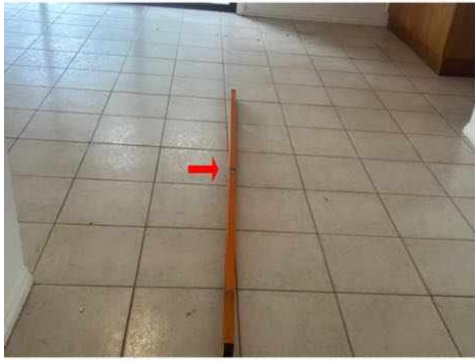
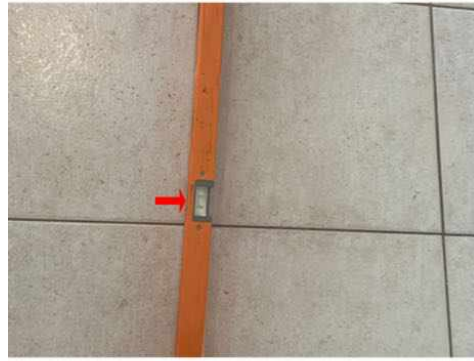
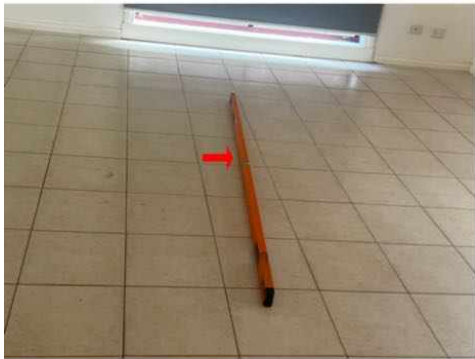
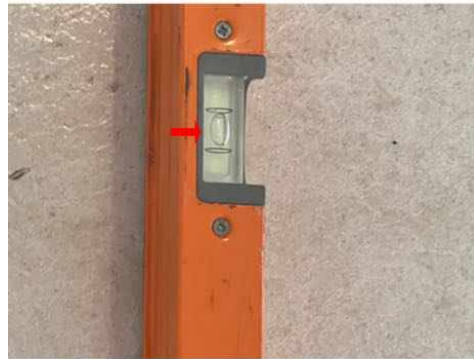
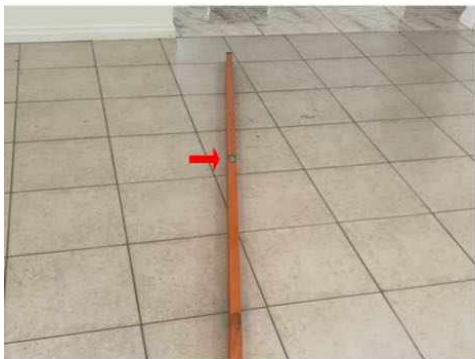
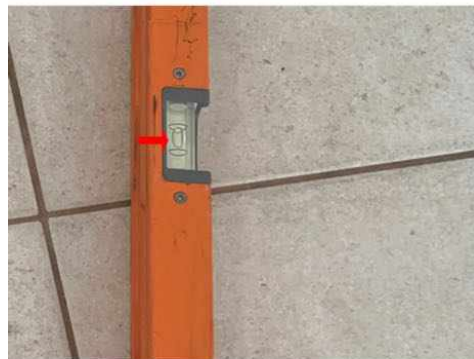
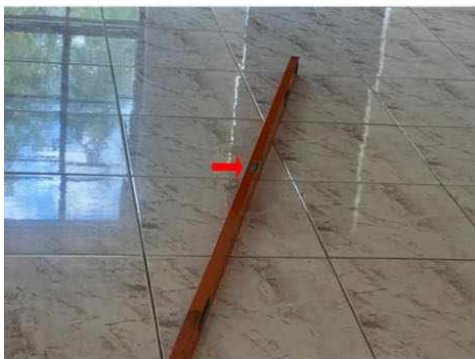
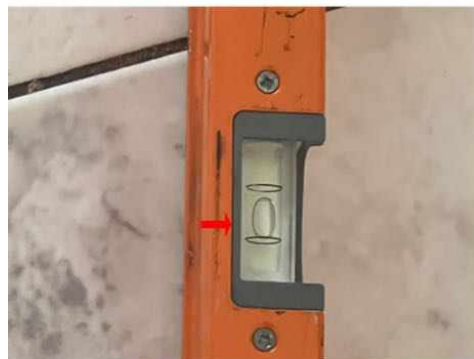
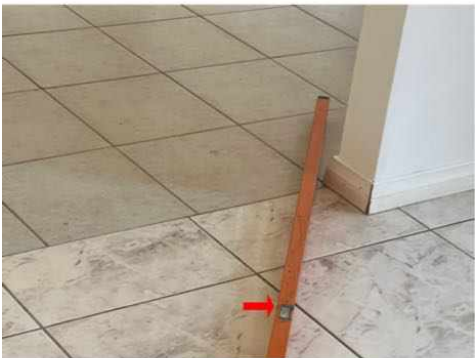
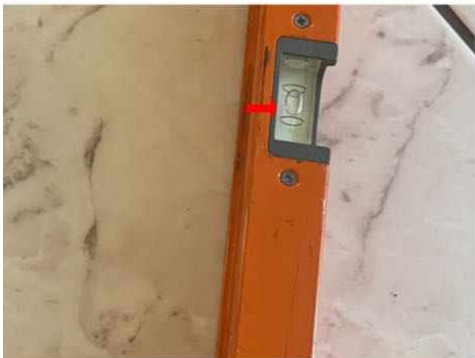
Building: Main Building  
 Location: All Areas > Centre, All Areas  
 Finding: Additional images of levels taken to floors -found to be within tolerance.-ground floor  
 Information: At the time of the inspection it was noted that Additional images of levels taken to floors -found to be within tolerance.
