Building and Timber Pest Inspection Report

Inspection Date: Tue, 3 Feb 2026

Property Address: 20 Aberfeldy Cres, St Andrews NSW 2566, Australia

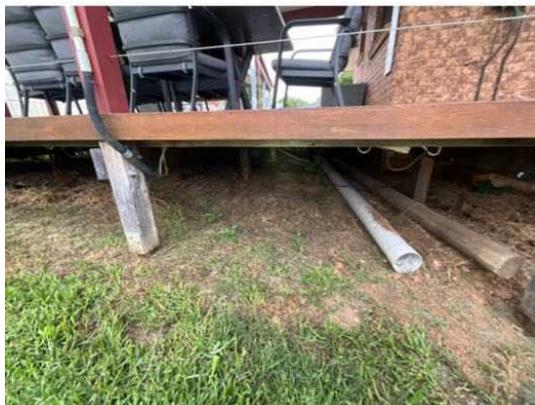
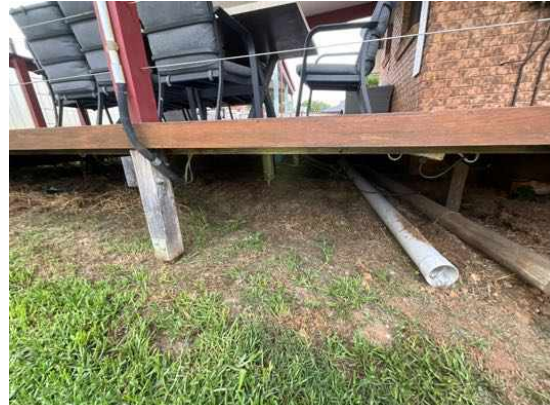
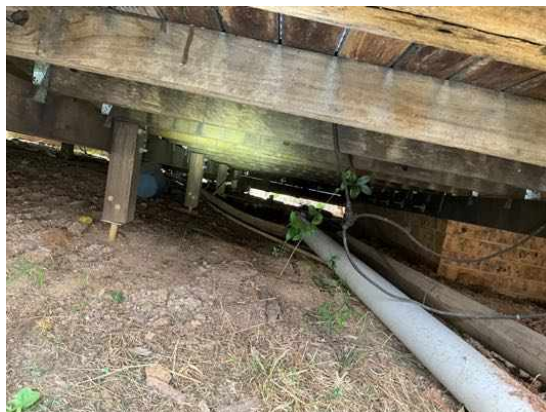
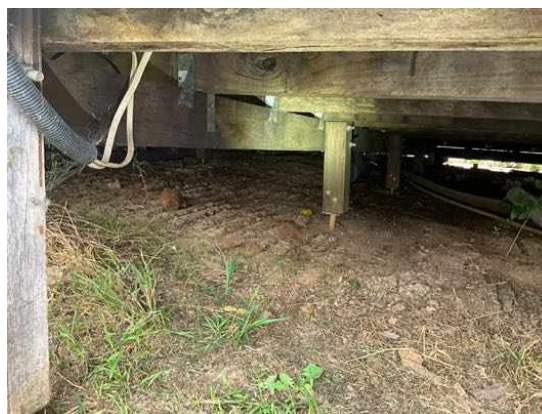
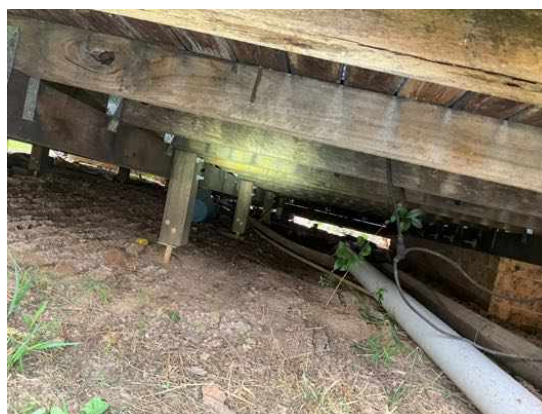
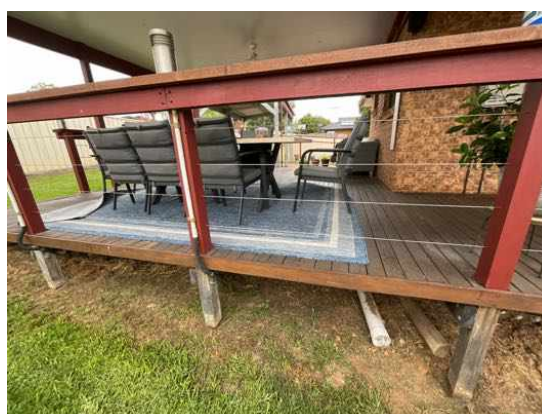
External timber structures are also constantly exposed to weather deteriorates in an exhilarate manner, ongoing assessments are required.

It is highly recommended that a structural engineer further, assess the external timber balcony or a deck to inform the client of its load capacity.

Regular maintenance inspections by competent practitioners is needed.

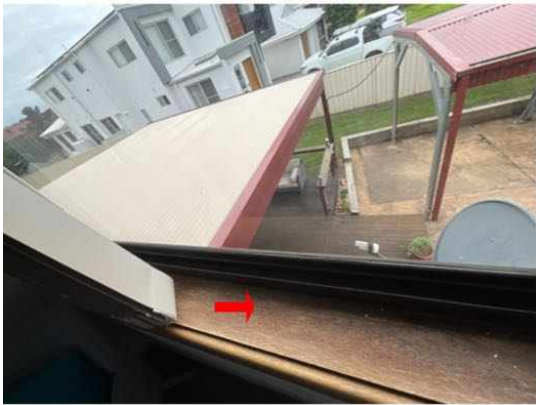
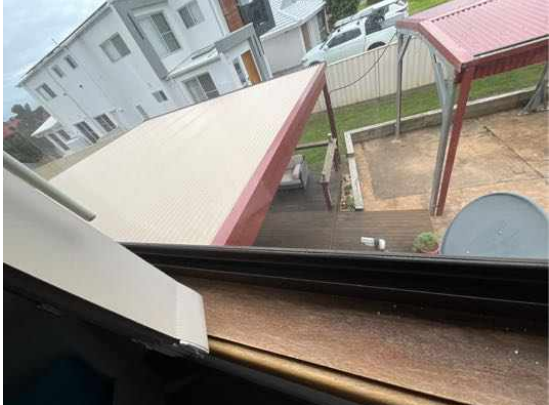
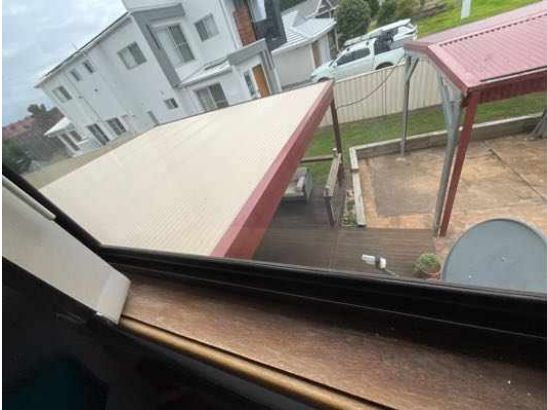
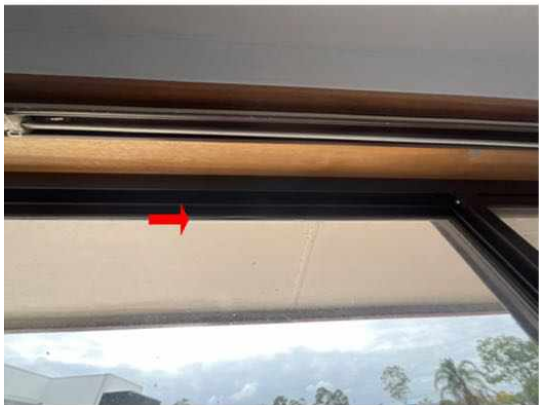
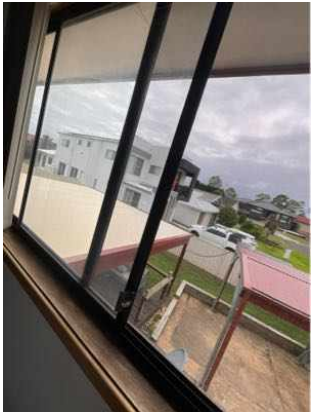
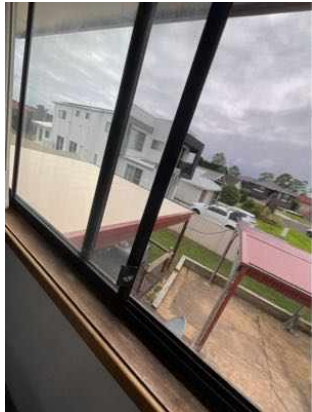
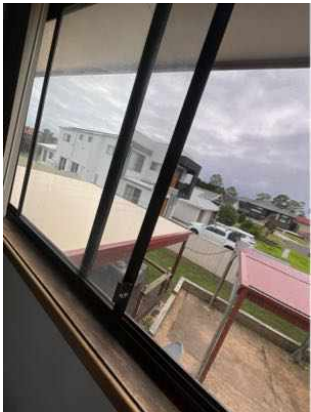
Finding 1.02

Building:	Main Building
Location:	All Areas
Finding:	Window child lock missing
Information:	The window in question lacks a child lock mechanism, which poses a potential safety risk to young occupants in the premises. As per Australian Standards windows accessible to children should be equipped with appropriate child safety locks to prevent accidental opening, reducing the risk of falls and ensuring compliance with safety regulations.

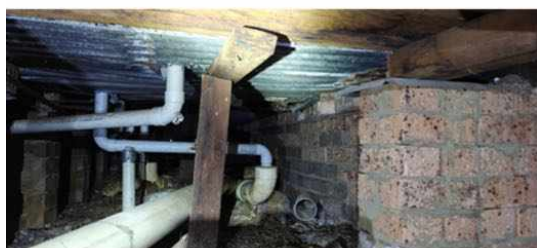
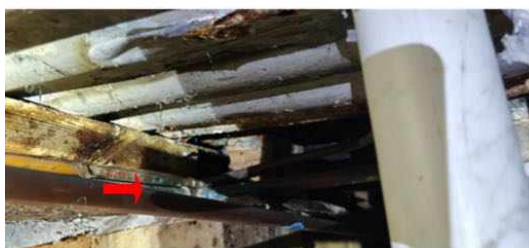
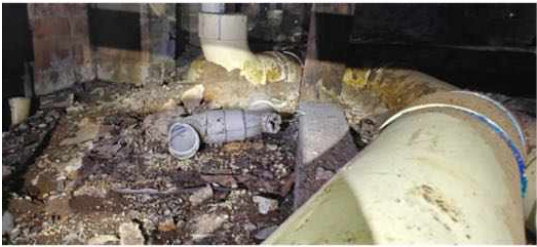
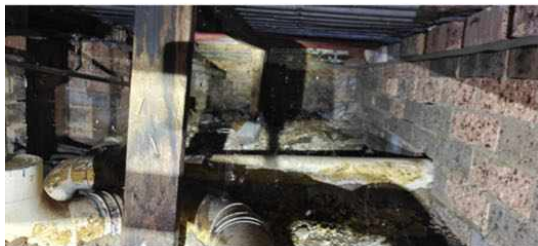
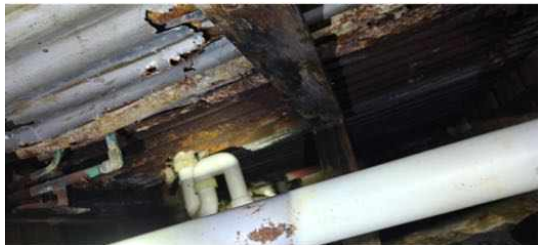
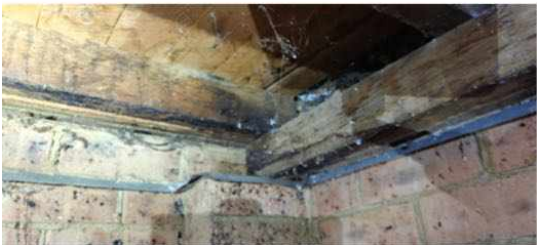
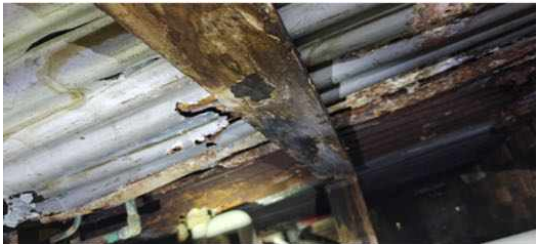
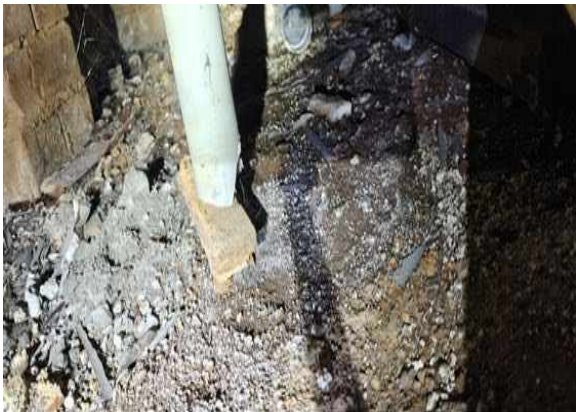
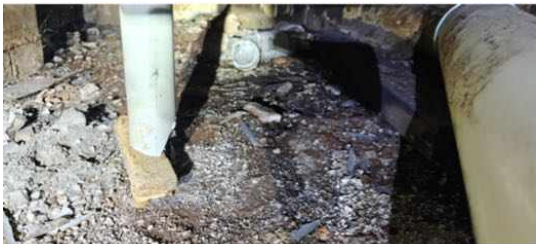
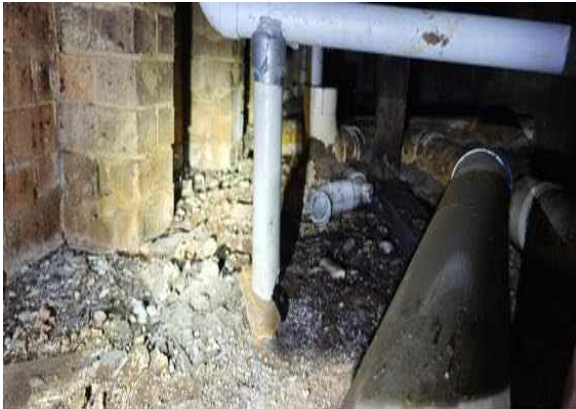
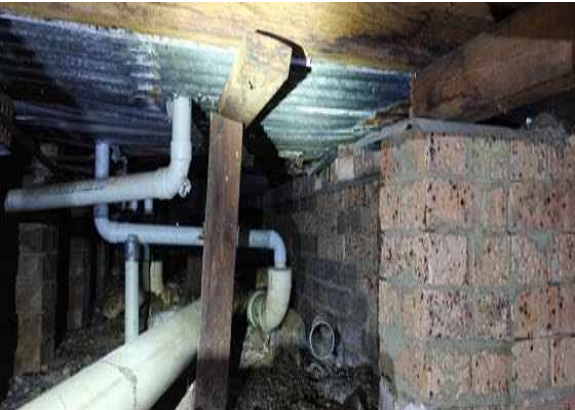
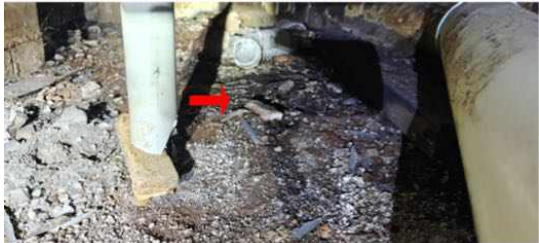
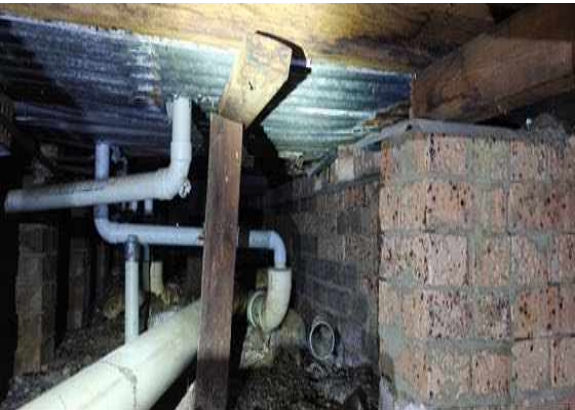
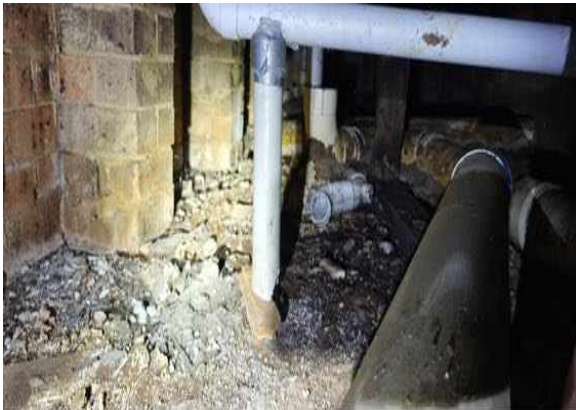
Finding 2.01

Building: Main Building
Location: Subfloor
Finding: Subfloor- leaking plumbing fittings
Information: Evidence of leaking plumbing fittings was observed within the subfloor area. Moisture staining and timber deterioration suggest prolonged water exposure from faulty pipe joints or fixtures.

- Structural damage to timber framing and flooring due to continuous moisture exposure.
- Mould growth and decay, posing potential health risks and further degradation of building materials.
- Pest attraction, as damp environments are conducive to termites and other pests.
- Non-compliance with plumbing standards and risk of escalation if not addressed promptly.

Who Can Fix It:

- A licensed plumber should be engaged to identify the exact source of leakage, repair or replace faulty fittings, and confirm watertight integrity. A builder may also be required to assess and rectify any structural damage.

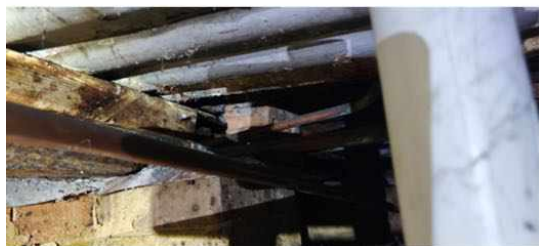
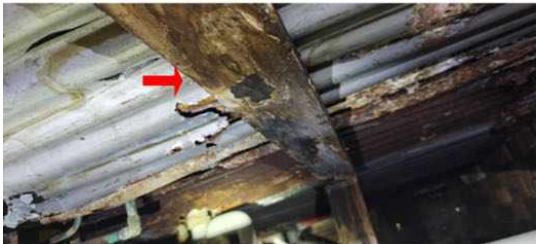
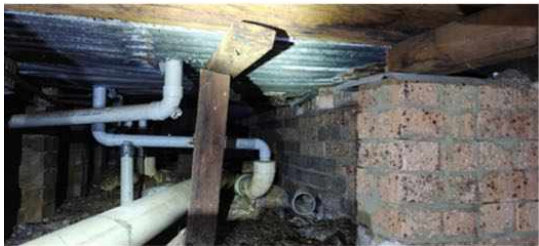
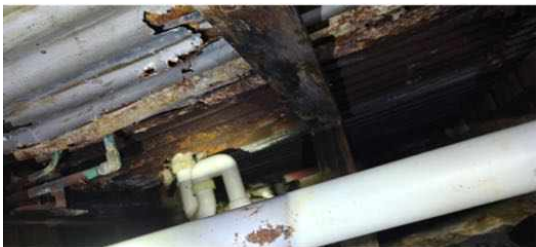
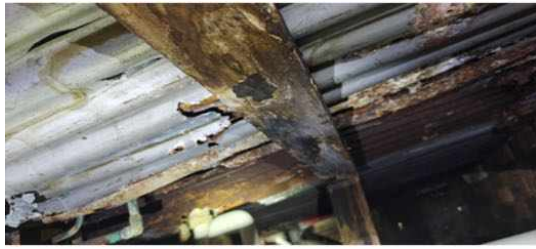
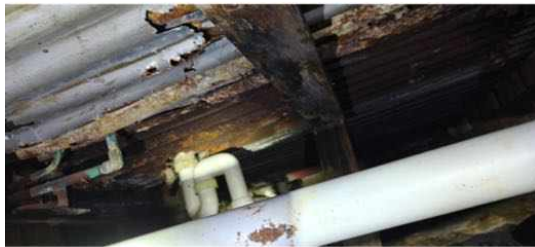
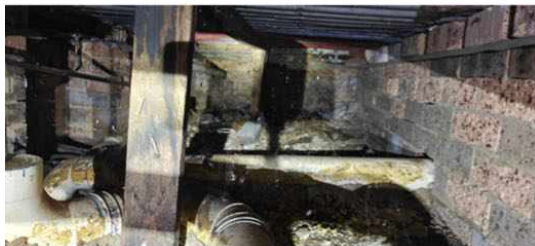
Finding 2.02

Building:	Main Building
Location:	Subfloor
Finding:	Subfloor- Wood Rot in Bearer and Joist
Information:	The bearer and joist in the subfloor show significant wood rot, which has compromised the structural integrity of the timber. Wood rot typically occurs due to prolonged exposure to moisture, and in this case, it has led to severe decay, weakening the timber and reducing its load-bearing capacity. This deterioration poses a critical risk to the overall stability of the floor structure.

- **Structural Risk:** High risk of structural failure in the affected area due to compromised load-bearing capacity. If left unaddressed, this could lead to sagging, uneven floors, or even collapse in extreme cases.
- **Safety Risk:** Elevated safety risk for occupants, as a weakened subfloor could fail under load, posing a potential hazard.
- **Moisture and Decay Propagation Risk:** The presence of rot in the timber can spread if the source of moisture is not addressed, potentially affecting adjacent timbers and leading to widespread damage.

This defect should be classified as a major defect due to the severe impact on

structural integrity and safety. Immediate action is required to rectify the issue and maintain the building's stability.

Recommendation for Rectification:

- **Engage a Licensed Carpenter or Structural Engineer:** A qualified carpenter or structural engineer should assess the extent of the damage and replace the affected bearer and joist. They will ensure the replacement timbers are adequately treated and installed to meet structural standards.
- **Address Moisture Source:** It is critical to identify and eliminate the moisture source contributing to the wood rot. Improving subfloor ventilation, repairing leaks, or installing a moisture barrier may be necessary to prevent future decay.

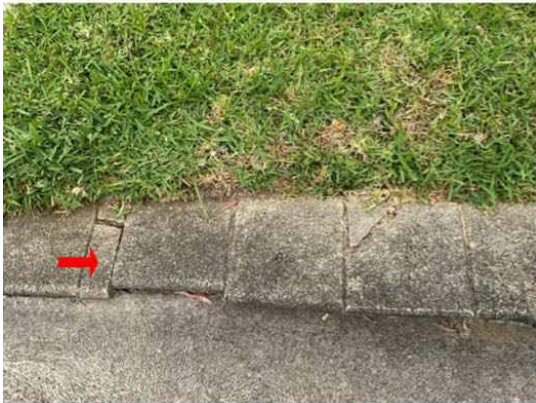
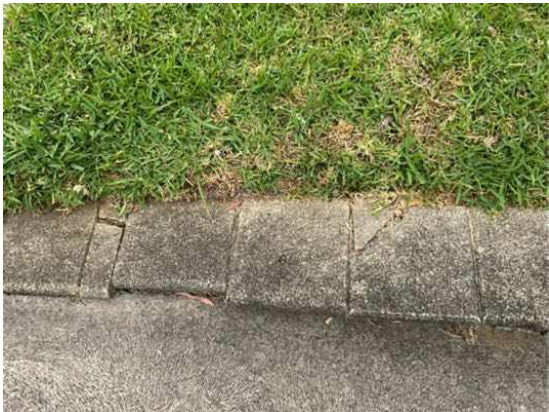
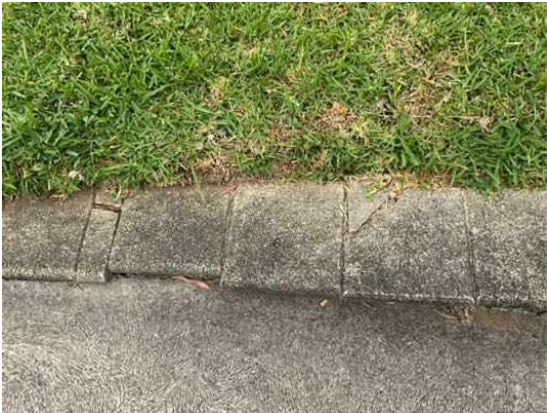
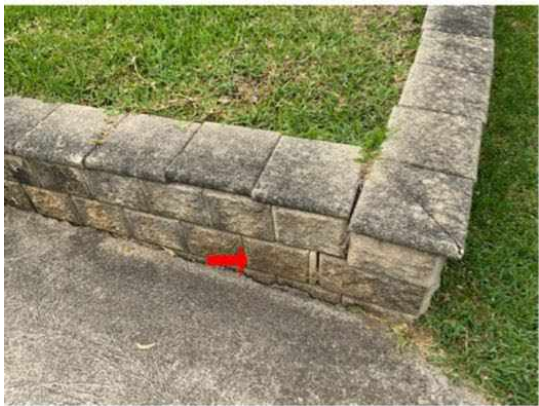
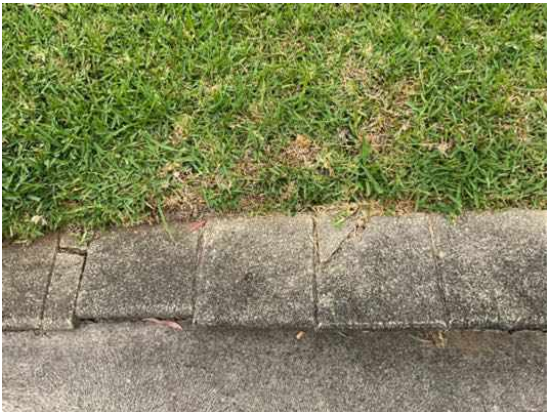
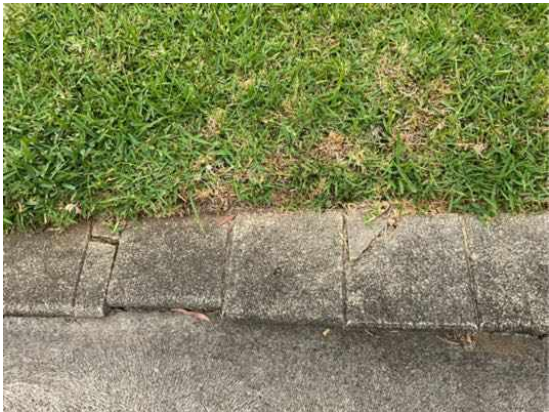
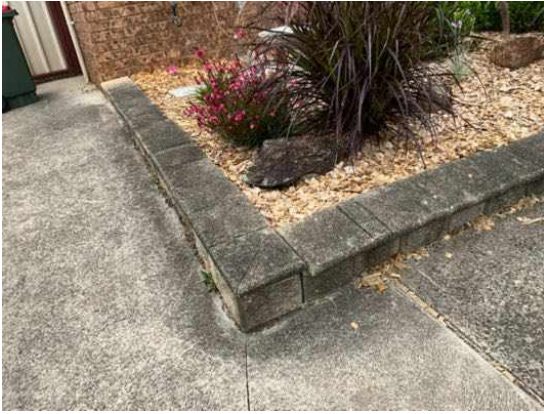
Building:	Main Building
Location:	All Areas
Finding:	Retaining wall Brickwork - Cracking [Repair required]
Information:	An approximate 10mm crack has been observed in the brick retaining wall, raising concerns about its stability and long-term durability. Immediate attention and repair are required to address this structural issue."

To fix this, you should consider consulting with a professional mason or a construction contractor experienced in brickwork and retaining walls. They can assess the extent of the damage and provide the necessary repairs or recommendations for the best course of action.

A qualified bricklayer should be contacted immediately to estimate and perform repair and restoration works. Consultation with a structural engineer may be required where structural instability is found to be the underlying cause of the cracking.

Always contact a building inspector should cracks widen, lengthen, or become more numerous.

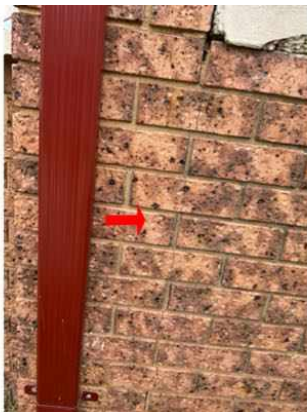
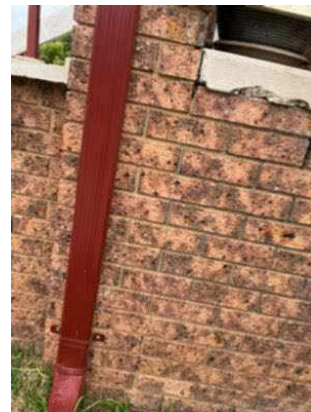
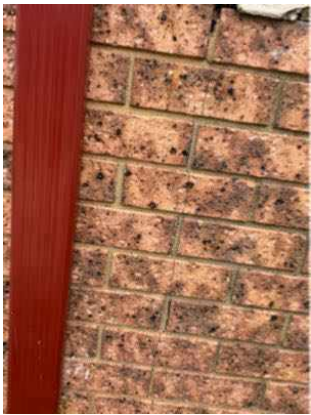
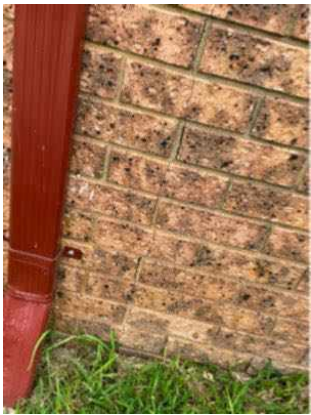
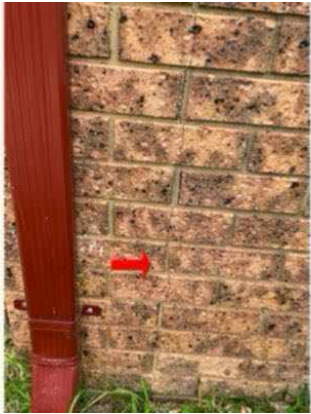
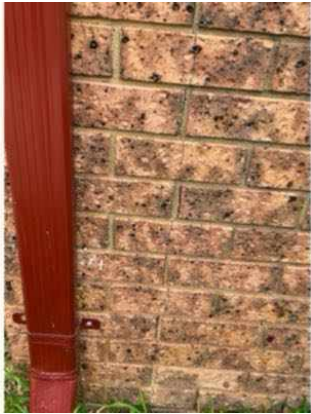
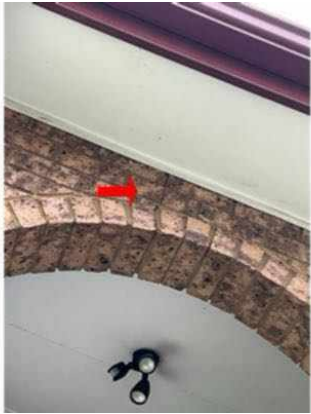
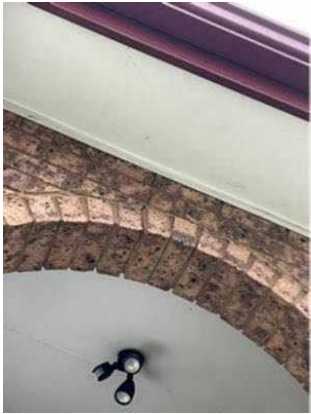
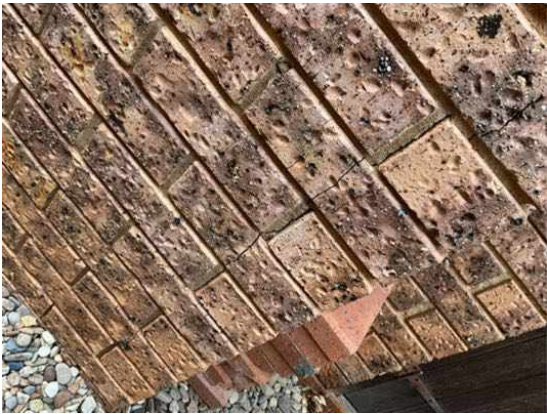
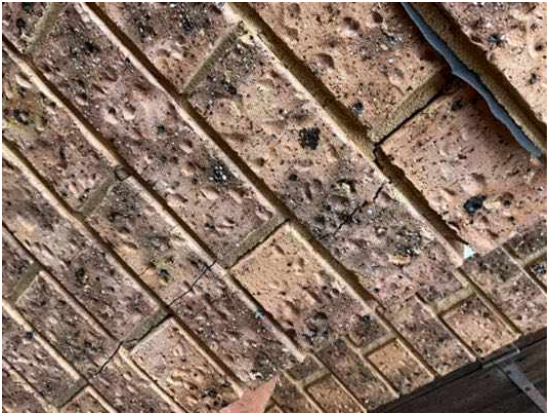
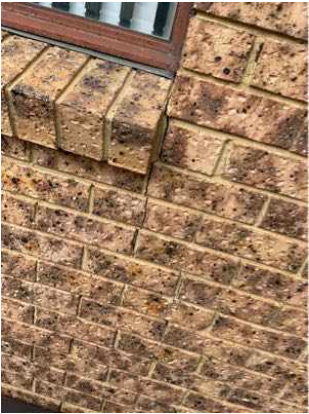
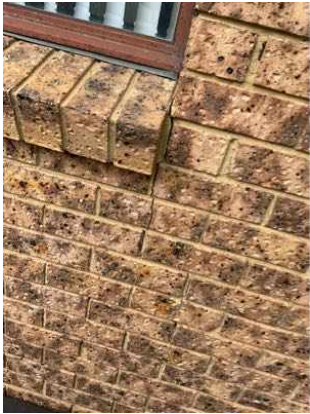
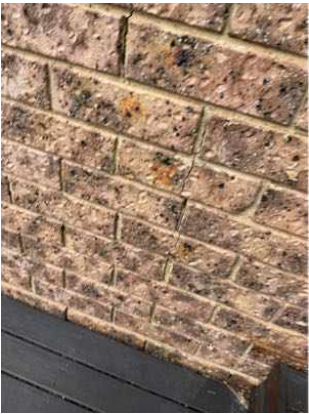
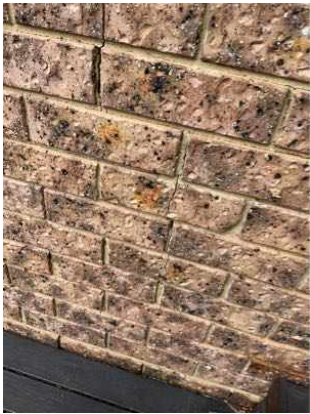
Finding 3.02

Finding: Brickwork - Cracking [Fine]

Information: Although fine cracks are quite noticeable, they are often only considered to be an appearance defect and usually do not indicate any structural damage. Generally, the cause of a fine crack is indicative of a separation between brickwork and mortar throughout the structure, but single bricks may also show cracks of this nature.

Cracking of this nature can generally be repaired with minor filling and should be conducted by a qualified bricklayer.

Always contact a building inspector should cracks widen lengthen or become more numerous.

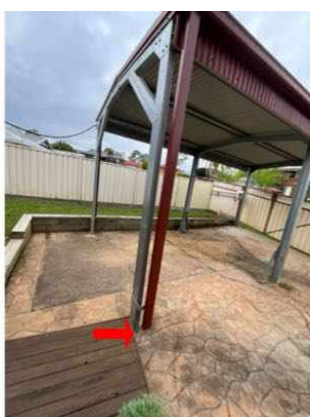
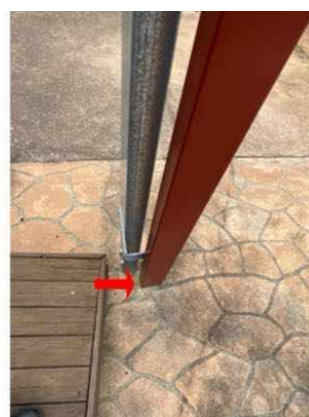
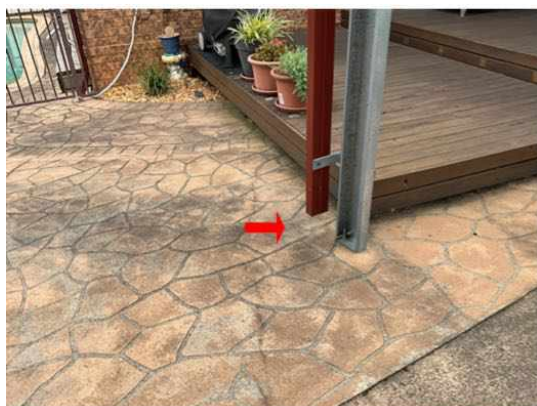
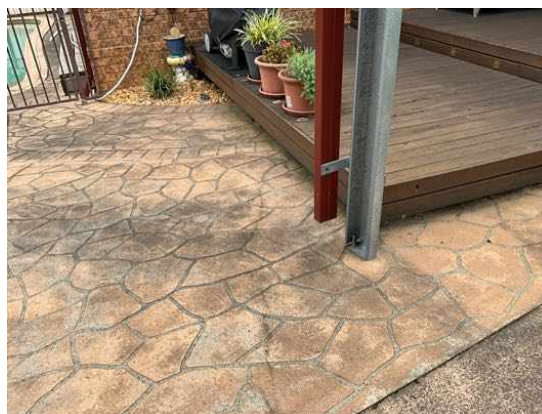
Finding 3.03

Building:	Main Building
Location:	Pergola
Finding:	Disconnected downpipe
Information:	A notable defect with a disconnected downpipe, compromising the efficient drainage of rainwater from the roof. This disconnectivity poses an increased risk of water accumulation, potentially leading to foundation erosion, water damage to the property, and a conducive environment for mold growth.”

1. Foundation Erosion: Accumulated water around the foundation due to the disconnected downpipe can lead to soil erosion, jeopardizing the stability of the property's foundation.
2. Water Damage: Uncontrolled water runoff can result in water penetrating the building envelope, causing interior water damage to walls, ceilings, and other structural components.
3. Mold Growth: The presence of excess moisture provides an ideal environment for mold growth, posing health risks and necessitating costly remediation.

Engage a qualified and licensed roofing or gutter specialist to address the disconnected downpipe. This professional will reconnect the downpipe to ensure proper water drainage, mitigating the associated risks and preserving the integrity of the property.

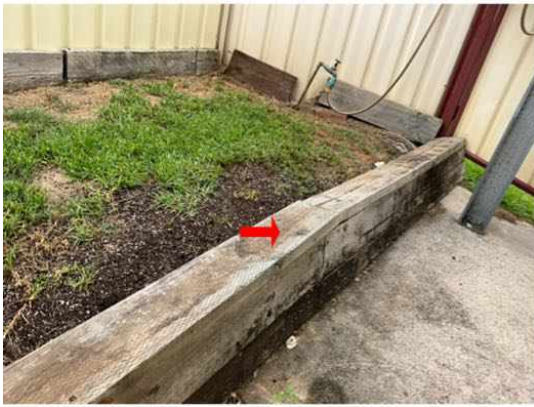
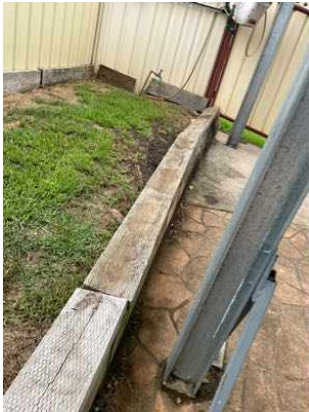
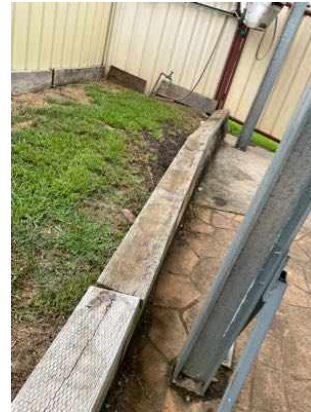
Finding 3.04

Building:	Main Building
Location:	Yard
Finding:	Timber retaining wall exhibits visible structural movement
Information:	The timber retaining wall exhibits visible structural movement, including leaning vertical posts, joint separation, and misalignment of timber logs. Soil erosion and organic debris around the base further suggest instability.

This is classified as a major structural defect under AS 4349.1-2007, as it affects the stability and load-bearing capacity of the retaining wall. There is a risk of collapse, posing a hazard to nearby structures, occupants, and vegetation. Failure of the wall may also result in soil displacement and drainage issues.

- **Inspection:** A qualified structural engineer should conduct a detailed assessment to determine the cause and extent of movement.
- **Repair:** Rectification work should be performed by a licensed builder or landscaper with experience in retaining structures, following engineering specifications.
- **Prevention:** Ensure proper drainage, footing depth, and wall anchorage in the rebuild to prevent recurrence.

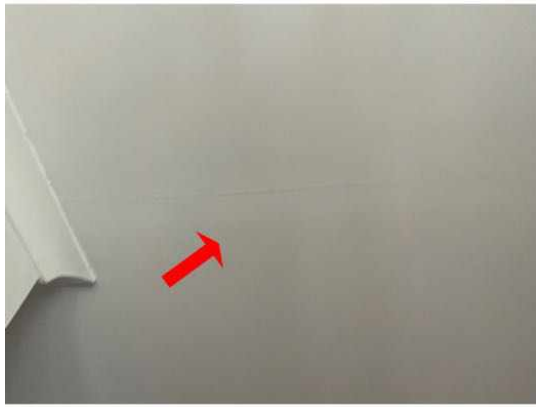
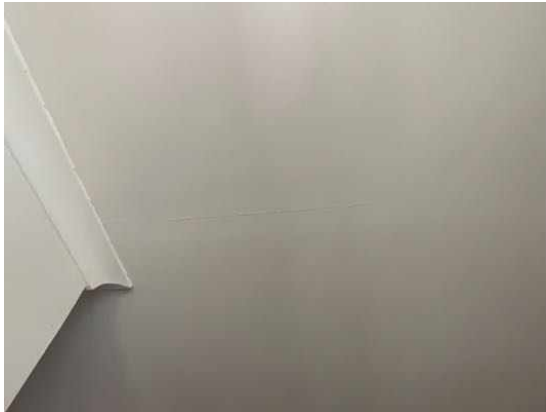
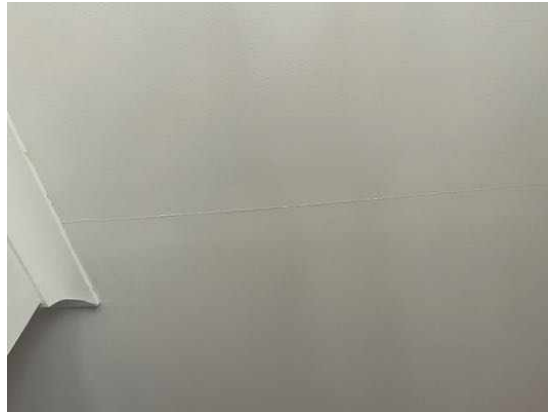
Finding 3.05

Building:	Main Building
Location:	Living Room
Finding:	Ceilings - Crack (Fine)
Information:	Fine cracks are observed in the ceiling, suggesting potential structural issues or settling.

The presence of fine cracks in the ceiling poses a risk of further structural damage, compromising the integrity of the building. Additionally, it may indicate underlying issues such as foundation problems or insufficient support.

A structural engineer or a qualified contractor should be consulted to assess the cause of the cracks and recommend appropriate repairs. Addressing the underlying issues is crucial to prevent further damage and maintain the safety and stability of the structure.

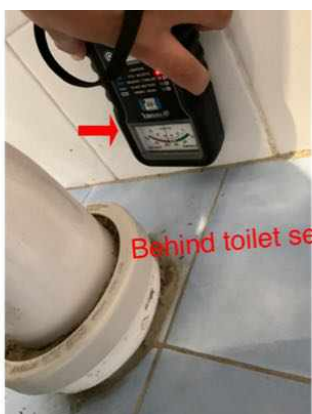
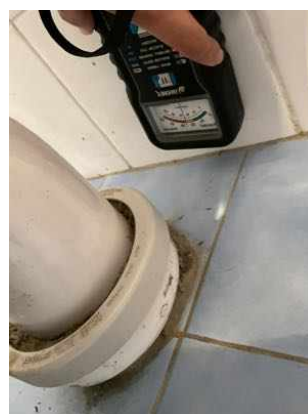
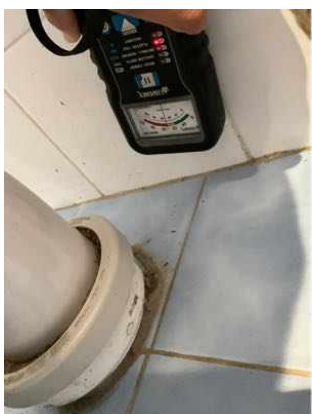
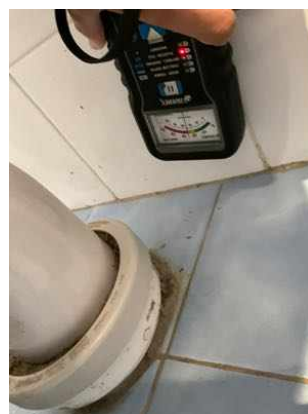
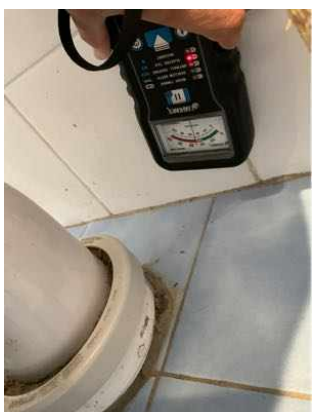
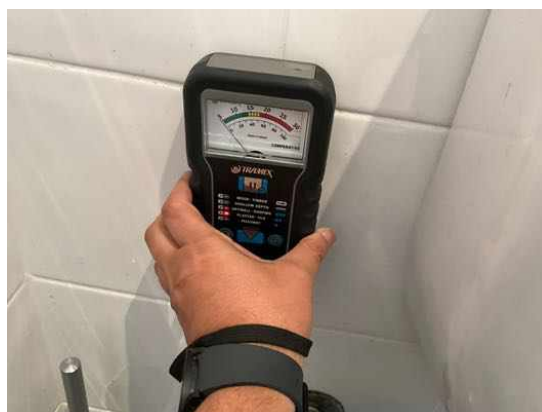
Finding 3.06

Building:	Main Building
Location:	Toilet (WC)
Finding:	Evidence of excessive moisture was present at the time of inspection
Information:	Excessive moisture is present behind the bathroom tiles, indicating a potential water leakage issue within the wall.

The prolonged presence of moisture can lead to mold growth, deteriorate the structure, and create an environment conducive to health hazards. Additionally, it may compromise the adhesive holding the tiles, leading to their detachment.

A licensed plumber or a qualified contractor specializing in water damage remediation should investigate the source of the moisture, fix any leaks, and address the damage. Additionally, replacing affected tiles and ensuring proper waterproofing are crucial to preventing future issues.

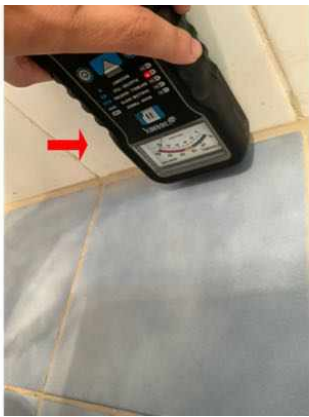
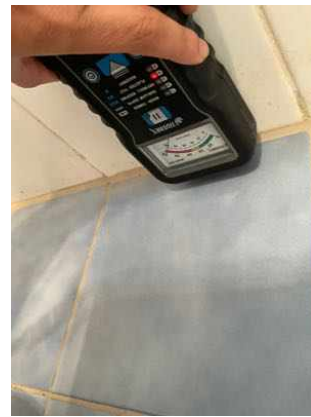
Finding 3.07

Building: Main Building
 Location: Bathroom
 Finding: Shower - Damp
 Information:

Damp is evident to the lower 300mm of wall to the shower alcove. This defect is quite common, and is suspected to have been caused by moisture permeating through the grouting in this area, which shows evidence of deterioration. Leaking pipes within the adjoining wall is also a possible cause.

Unmanaged damp in the shower recess is likely to facilitate the formation and development of mould and fungi growth, decaying associated building materials and compromising their structural integrity. It is important to address damp conditions, as the World Health Organisation notes that excess moisture leads - on almost all indoor materials - to growth of microbes such as moulds, fungi and bacteria, which subsequently emit spores and other matter into the indoor air. Exposure to these contaminants is associated with a wide range of respiratory and other health-related problems.

Consultation with a qualified plumber or bathroom specialist is advised immediately to identify the cause of damp and to perform remedial works as required. Where excessive mould growth is present, further inspection by a specialist environmental health inspector should also be considered.

Always ensure that sealant and grout is in good condition to prevent any moisture issues occurring in the future.

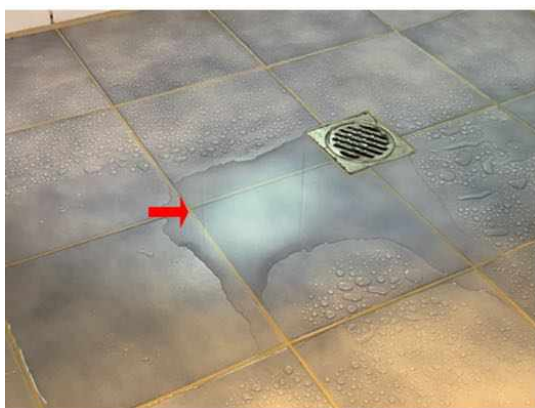
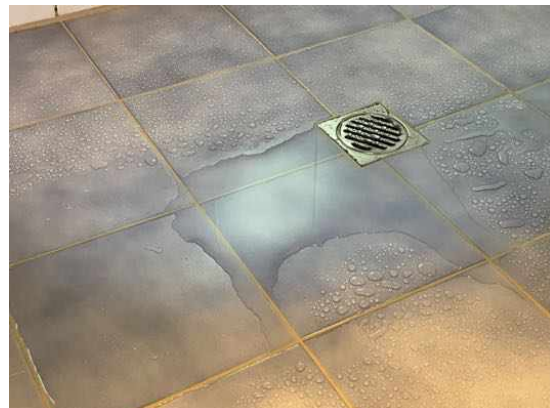
Finding 3.08

Building:	Main Building
Location:	Bathroom
Finding:	Shower base - Water pooling
Information:	Evidence of water pooling around the floor waste in the shower recess was noticed at the time of inspection. It is suspected that this excessive moisture is attributed to insufficient fall in the shower floor tiles.

This pooling is minor overall but is still considered unsatisfactory, as standard tiling practices would not permit this situation to occur. Pooling water around floor wastes can create a slip hazard in extreme cases and create conditions that are conducive to mould growth over time. Where left unmanaged, the degradation of sealant and grouting is also likely to occur, possibly necessitating further repair works.

Remedial works may involve some sections of tiling and flooring repair and replacement. A tiling contractor or bathroom specialist should be appointed to provide further advice on reparation options and to perform works as necessary.

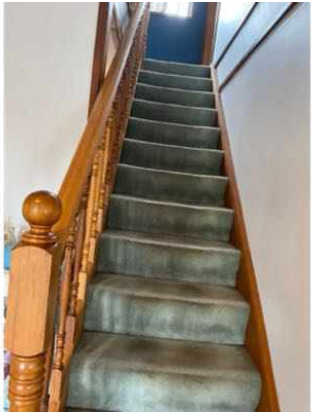
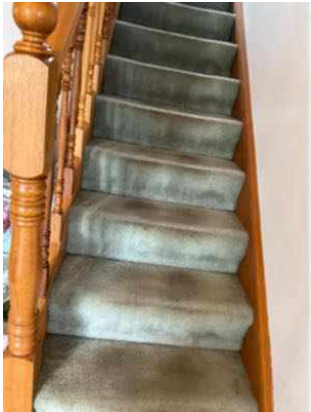
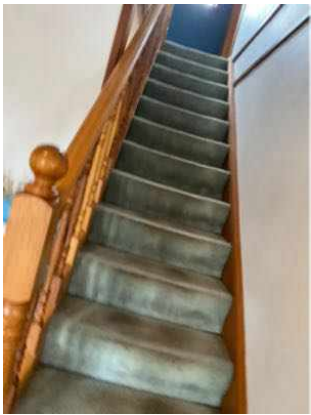
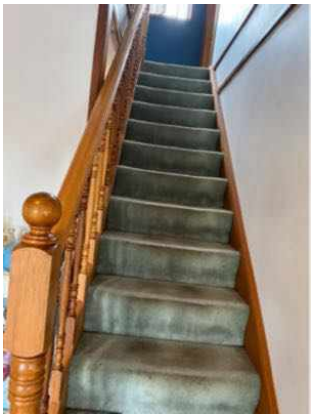
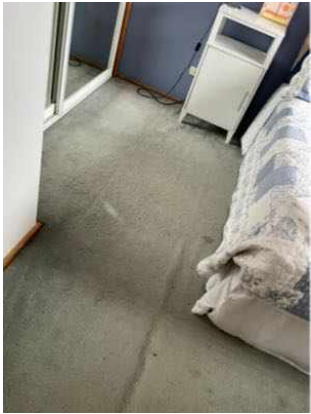
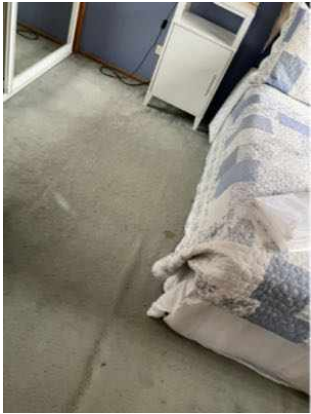
The risk associated with aging carpets includes diminished appearance, decreased comfort, potential tripping hazards due to frayed edges, and a negative impact on indoor air quality if fibers begin to degrade and release particles into the air.

Professional carpet cleaning and restoration services can address issues such as deep cleaning to rejuvenate colors, repairing frayed edges, and restoring fibers. Additionally, replacing the carpets entirely may be necessary in severe cases of aging or damage beyond repair.

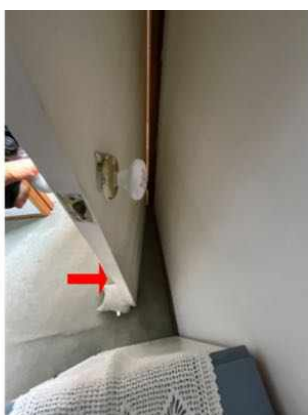
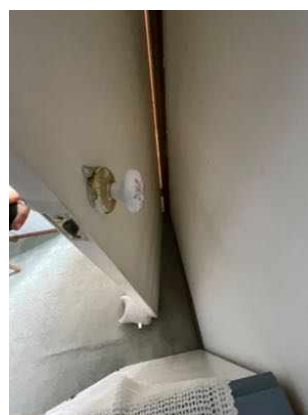
Finding 3.10

Building: Main Building
 Location: All Areas
 Finding: Missing Door Stopper
 Information: The door lacks a stopper, which is essential to prevent the door from swinging too far and potentially damaging the wall or the door handle. The absence of a door stopper increases the likelihood of impact damage to both the door and surrounding surfaces over time.

- **Damage Risk:** Moderate risk of damage to the door handle, wall, or door itself from repeated impacts when the door is opened forcefully or by a gust of wind.
- **Wear and Tear Risk:** Increased wear on door hardware and hinges due to the potential for abrupt stops without a dedicated stopper.

This issue is a minor defect but should be addressed to prevent potential damage and maintain the integrity of the door and surrounding areas.

- **Engage a Handyperson or Carpenter:** A handyperson or carpenter should install a suitable door stopper to prevent excessive door movement. This could be a floor-mounted or wall-mounted stopper depending on the space and door design.

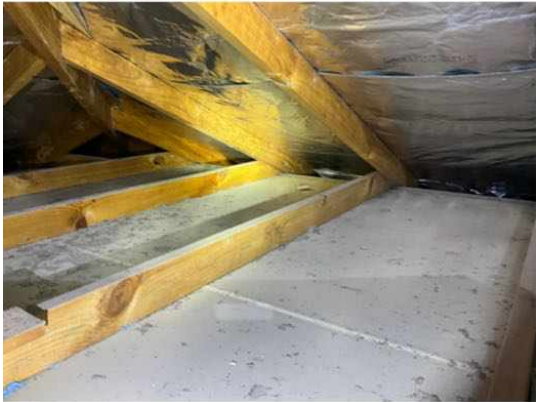
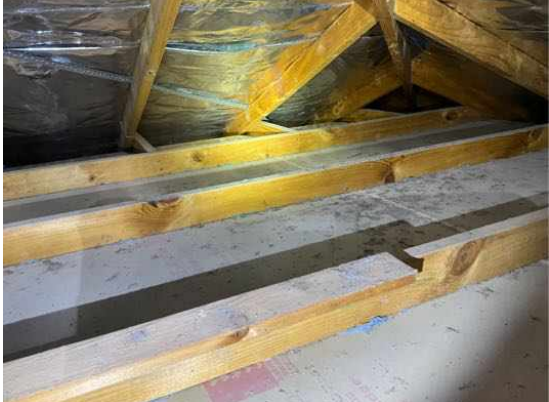
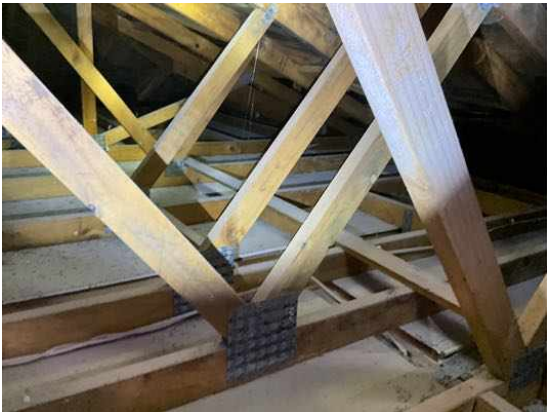
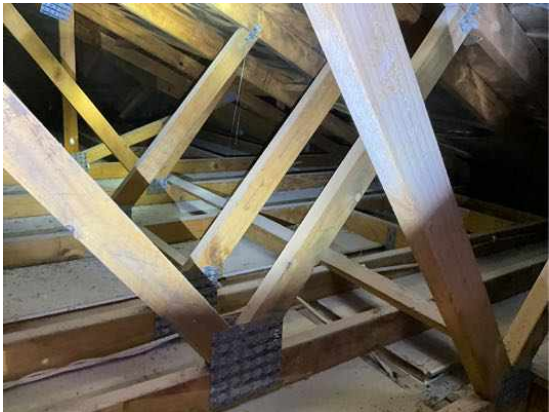
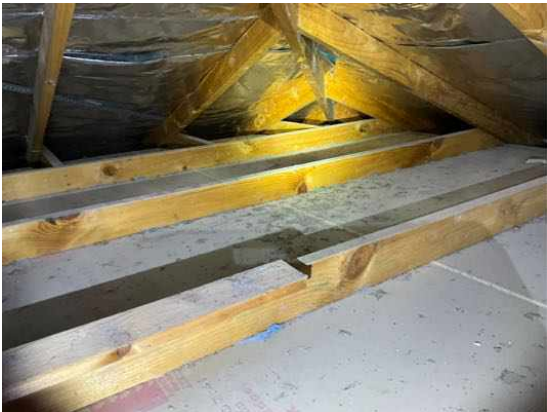
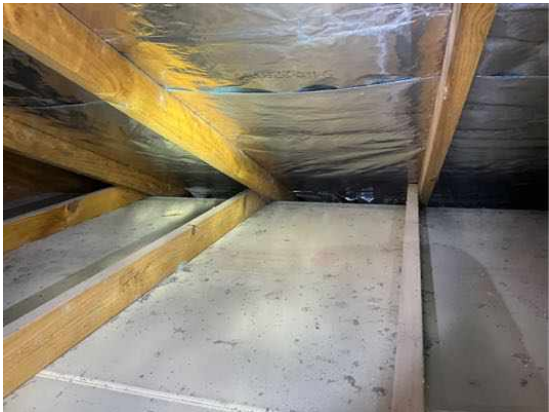
Finding 3.11

Building: Main Building
 Location: Roof Void
 Finding: Insulation - Missing
 Information: Upon inspection of the roof void it was noted that insulation is not present.

Where insulation is absent, the area does not meet current Australian Standards. Installation of adequate insulation is required and should be conducted as soon as possible.

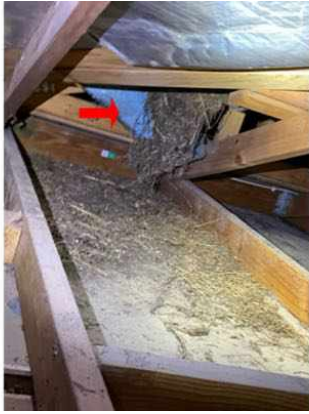
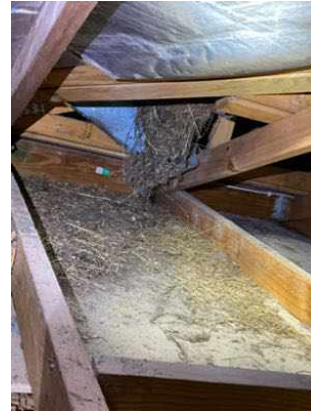
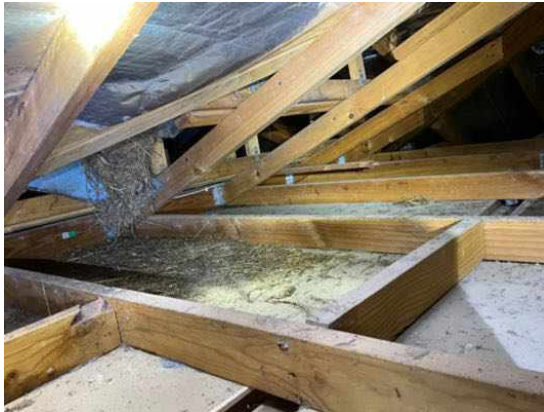
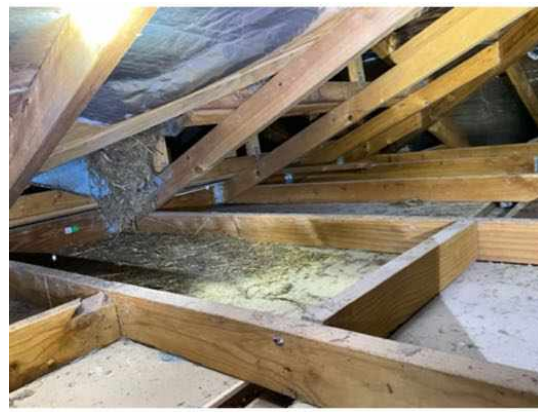
Finding 3.12

Building:	Main Building
Location:	Roof Void
Finding:	Sarking - Damaged
Information:	Sarking, a laminated aluminium foil applied to the interior of the roof covering, assists in insulating the property and acting as a vapour-barrier to the roof void and, subsequently, to the household.

Where sarking is damaged, both insulation and moisture protection of the property are inhibited. This creates a loss of energy and thus negatively impacts the energy efficiency of the property, allowing potential for moisture ingress from condensation or leaking roof tiles.

It is important to repair any holes or damaged sections of sarking to ensure that the building material is fully functional. A registered builder or qualified carpenter should be consulted to provide further advice on this defect and to perform rectification works at client discretion.

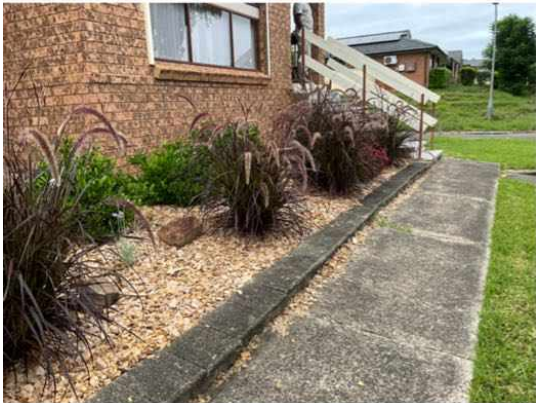
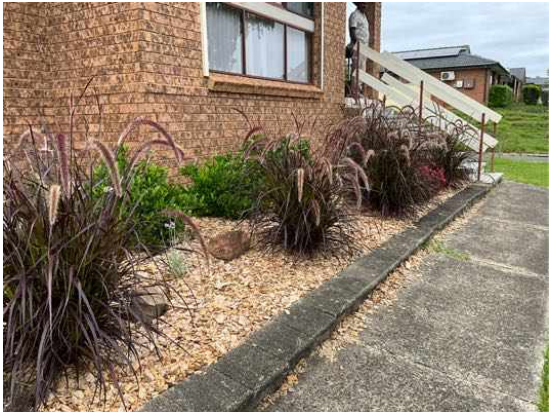
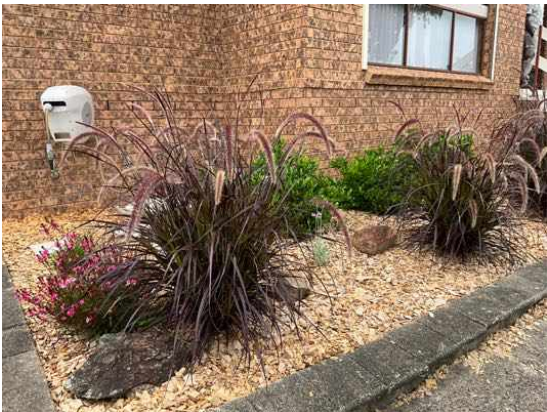
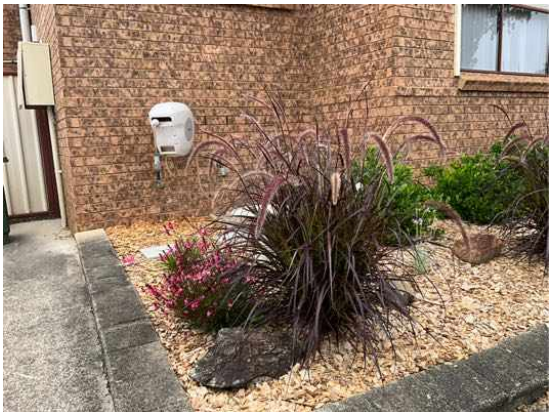
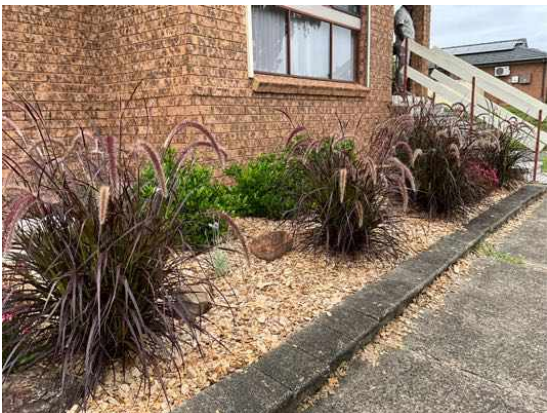
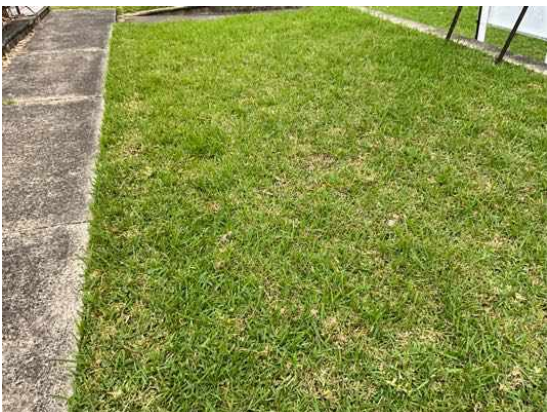
Finding 6.02

Building: Main Building
Location: All Areas
Finding: Dense vegetation around a property can increase the risk of termite infestation
Information: The presence of dense vegetation around a property can increase the risk of termite infestation, as it provides a conducive environment for them. To address this, consider maintaining a clear space between the vegetation and your home. If you suspect a termite issue, it's advisable to consult with a licensed pest control professional for inspection and treatment.
