Building and Timber Pest Inspection Report

Inspection Date: Tue, 3 Feb 2026

Property Address: 20 Aberfeldy Cres, St Andrews NSW 2566, Australia

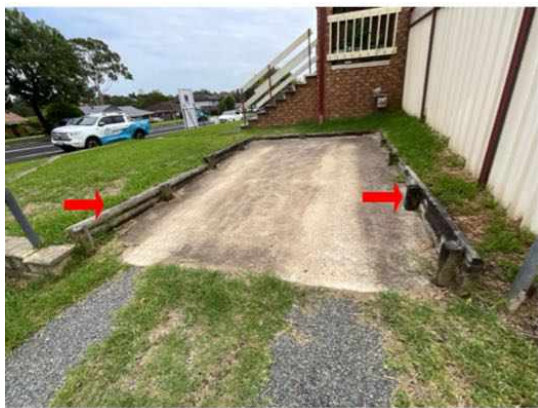
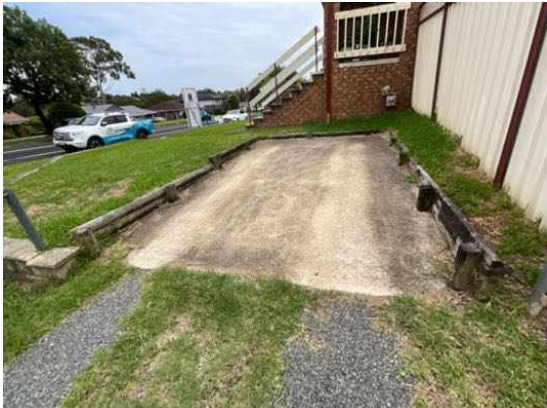
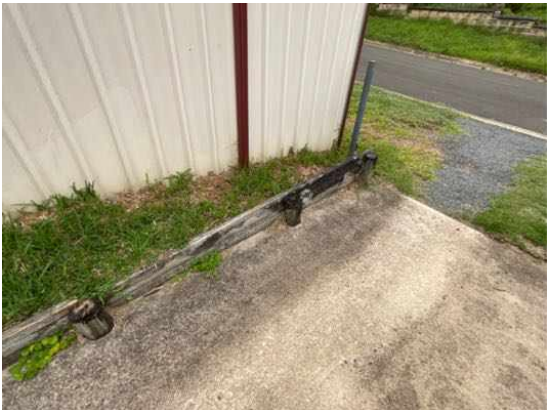
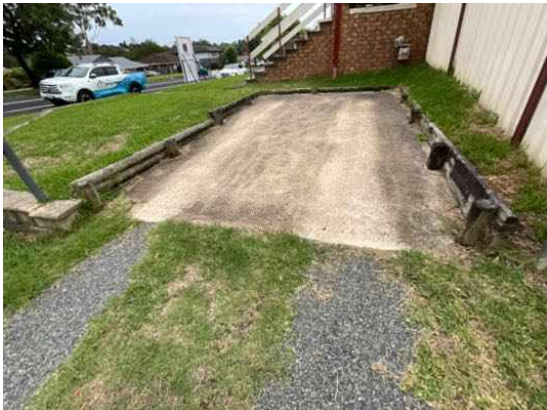
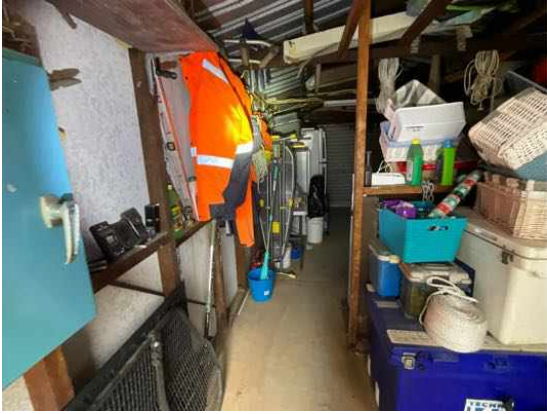
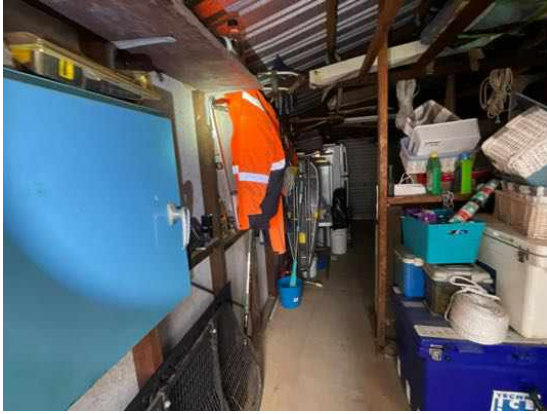
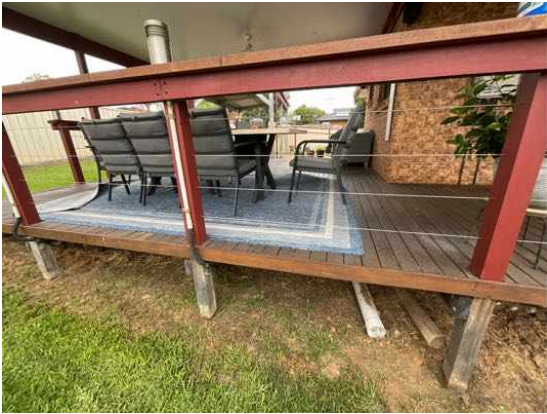
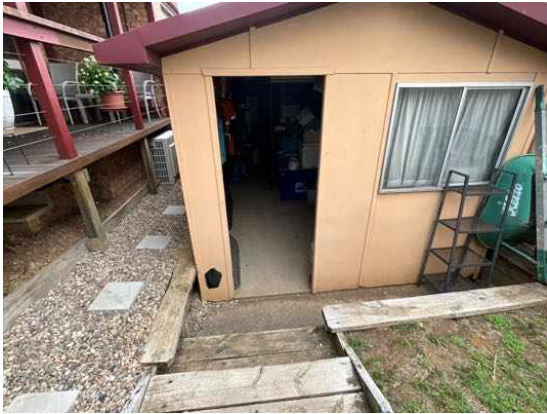
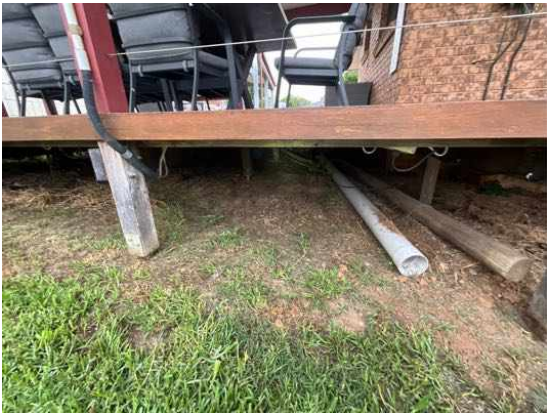
Building: Main Building
Location: All Areas
Finding: Timber on ground / conducive conditions to termite damage
Information: Timber on the ground is indeed conducive to termite damage. Termites are known to thrive in moist environments, and wood in contact with soil or moisture is more susceptible to infestation.

To prevent this, it's important to keep timber elevated and away from direct ground contact. Regular inspections and proper termite control measures are also essential to protect your wooden structures from termite damage.

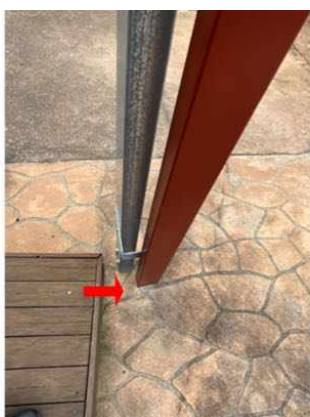
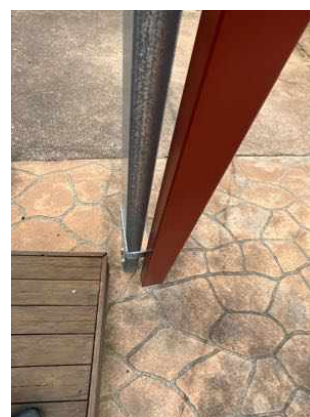
Finding 6.04

Building:	Main Building
Location:	Pergola
Finding:	Downpipes not connected- Conducive conditions for timber pest
Information:	Unconnected downpipes can indeed pose a risk for attracting termites, as they provide a source of moisture near a building's foundation. Termites are attracted to moisture and wood, so it's important to address this issue to prevent potential infestations. Connecting downpipes to the stormwater system or ensuring proper drainage away from the building can help mitigate this a licensed plumber is the most qualified professional to handle plumbing-related tasks, including connecting downpipes to the stormwater system. They have the necessary expertise and tools to ensure proper installation.

Please remember that proper installation is essential to ensure effective drainage and prevent future issues, so it's often best to hire a qualified professional, especially for complex or extensive downpipe installations.

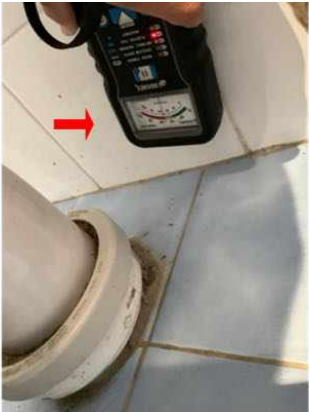
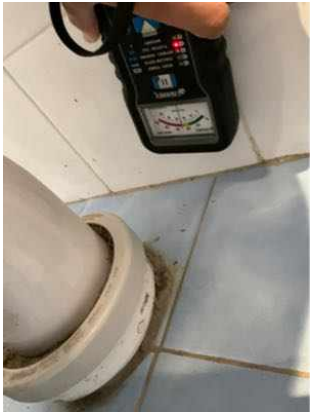
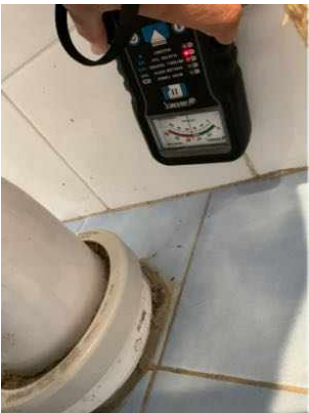
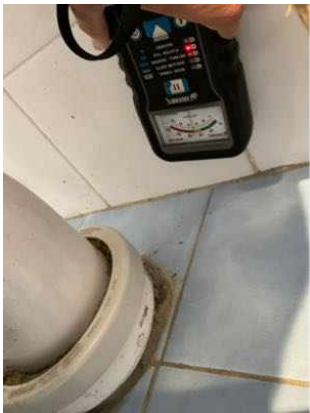
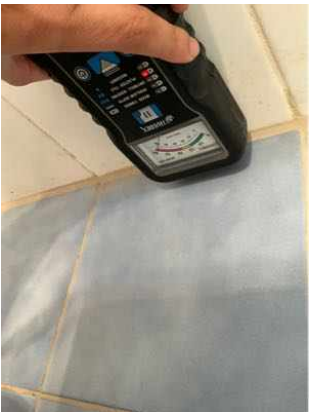
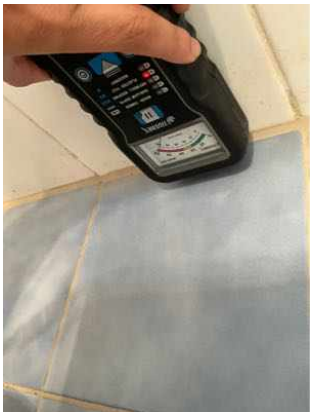
Finding 6.05

Building:	Main Building
Location:	Toilet (WC)
Finding:	Excessive moisture - Conducive to Timber pest
Information:	Excessive moisture can attract termites and produce conditions that promote fungal growth and wood decay.

Excessive moisture is generally caused by deteriorated inadequate or missing roof drainage leaking plumbing pipes or fixtures poorly plumbed HWS overflows or condenser units and poor site drainage.

If mould growth has been found there may be environmental biological or health issues involved. In these cases an appropriately qualified inspector should also be contacted.

Prior to any remedial works being performed a qualified plumber should be appointed to further inspect the property and to identify the cause of the excessive moisture.

Works to remove affected building elements may then be necessary and should be performed by an appropriate tradesperson.

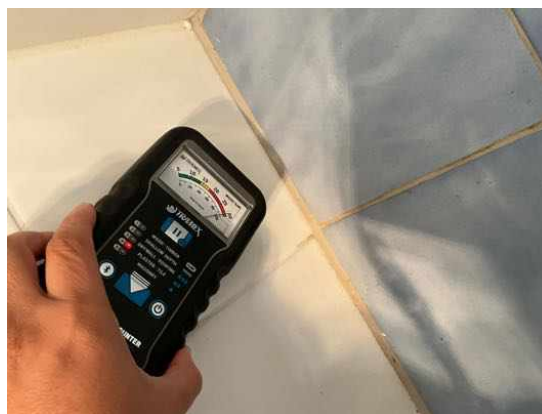
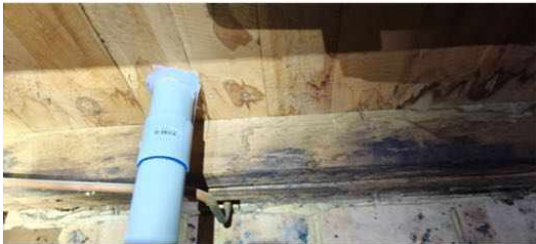
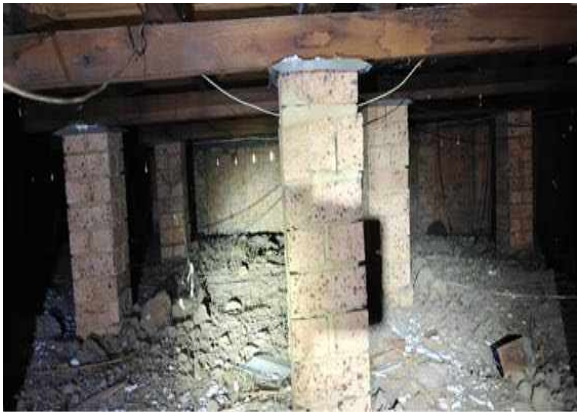
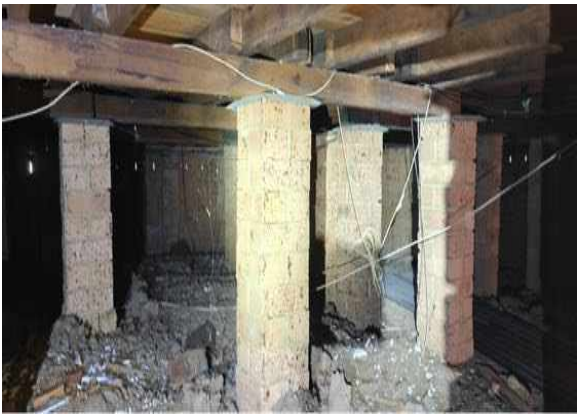
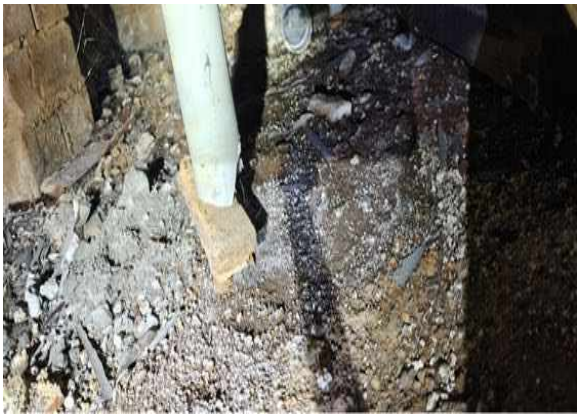
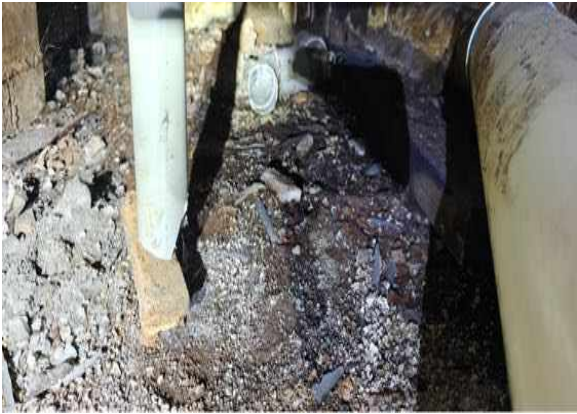
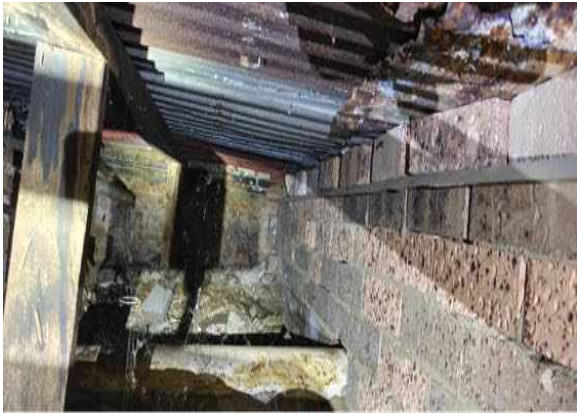
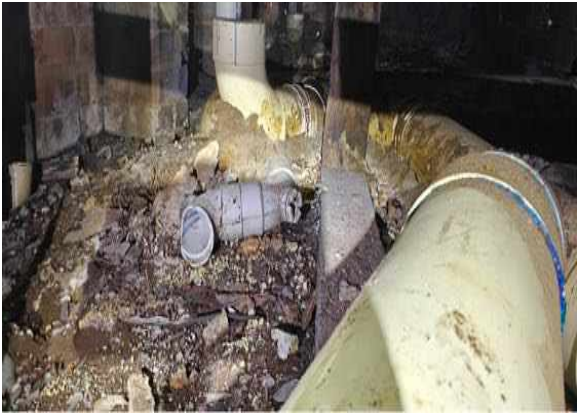
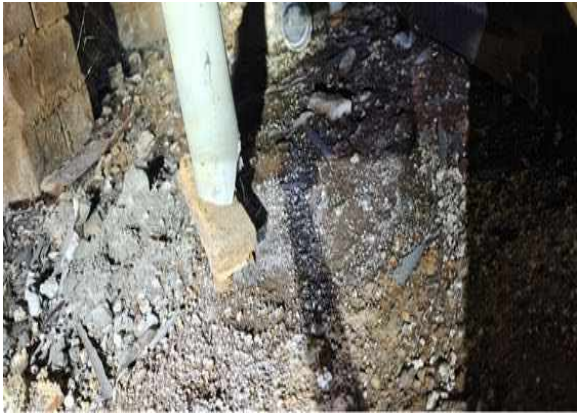
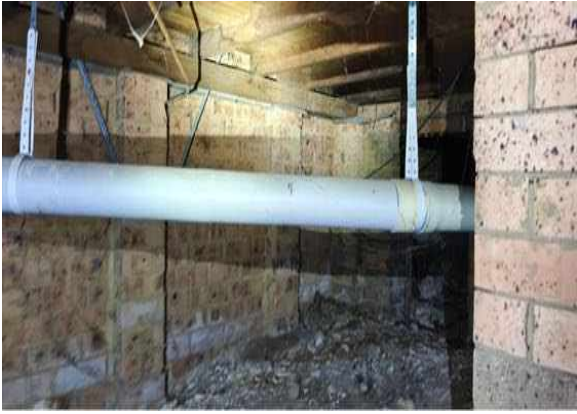
Finding 6.06

Building:	Main Building
Location:	Subfloor
Finding:	Subfloor - poor ventilation, inadequate site drainage, water stains
Information:	The subfloor lacks adequate ventilation, suffers from inadequate site drainage, exhibits water stains, creating conducive conditions for timber pests such as termites.

Risk: The combination of poor ventilation, inadequate drainage, water stains significantly increases the risk of timber pest infestations. Termites are attracted to moist environments and can thrive in subfloors with high humidity levels and water damage. The lack of proper ventilation and drainage exacerbates moisture retention, providing an ideal habitat for timber pests to establish colonies and cause extensive damage to the subfloor structure. Additionally, water stains indicate previous or ongoing moisture issues, which further attract timber pests and contribute to the deterioration of timber materials.

A licensed pest control professional specializing in timber pest management should be consulted to assess the extent of the infestation and develop a comprehensive treatment plan. They can implement strategies to eliminate existing timber pests, such as termites and prevent future infestations by addressing underlying moisture issues. Additionally, a qualified plumber or builder may be needed to improve subfloor ventilation, enhance site drainage, repair water-damaged areas. Regular inspections and maintenance are essential to ensure ongoing protection against timber pests and maintain the structural integrity of the subfloor.

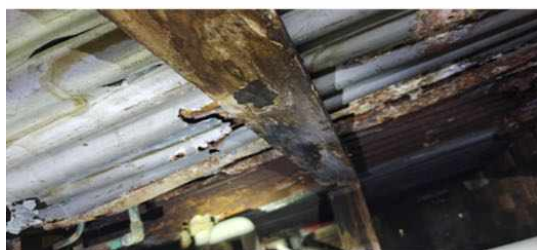
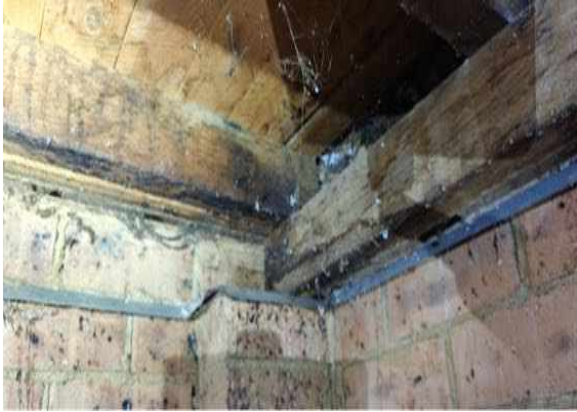
Finding 7.01

Building:	Main Building
Location:	Subfloor
Finding:	Wood rot
Information:	This building element shows evidence of wood rot. Wood rot, also known as Fungal Decay, occurs when timbers and other cellulose building materials are exposed to damp conditions on an ongoing basis. This could be the result of exposure to weathering over a prolonged period of time, or the attraction of excessive moisture from other abutting building materials. Contributing factors also include poor air ventilation in the area.

Wood rot is often associated with general damp problems and is evidenced by a 'musty' smell or mould and mildew occurring on surfaces. If left unmanaged, damp conditions can lead to further health problems and the decay of timbers will continue.

Early intervention and regular maintenance, particularly of exterior timbers, will prolong the useful life of these building elements. Prior to any works being performed, the cause of the moisture that has created the visible wood rot should be identified and addressed in a suitable manner. Replacement of affected timbers may then be a necessary step in protecting surrounding building elements from such deterioration.

A qualified plumber may be appointed to assess the cause of excessive moisture and to provide advice on any remedial works as required. A qualified carpenter or registered builder may also be required to replace affected building materials.

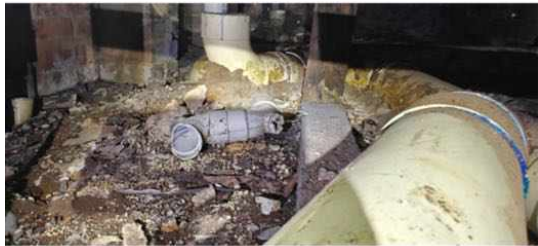
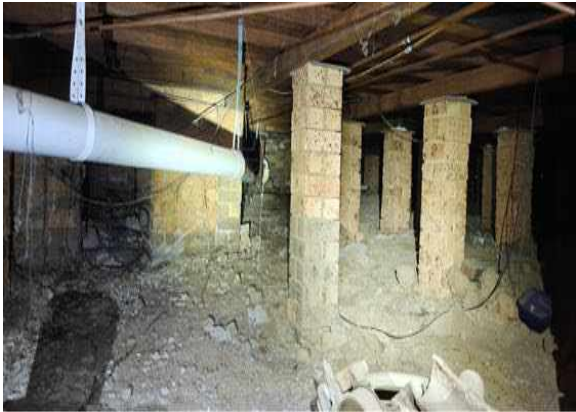
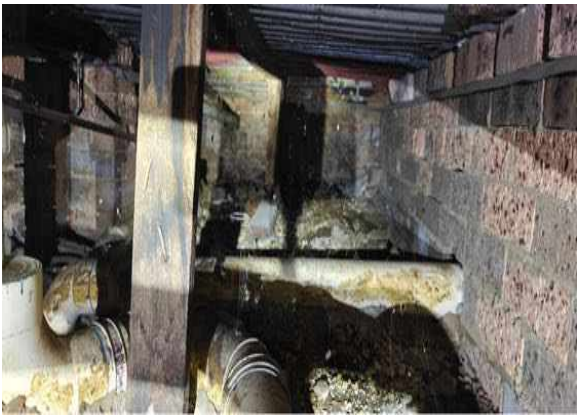
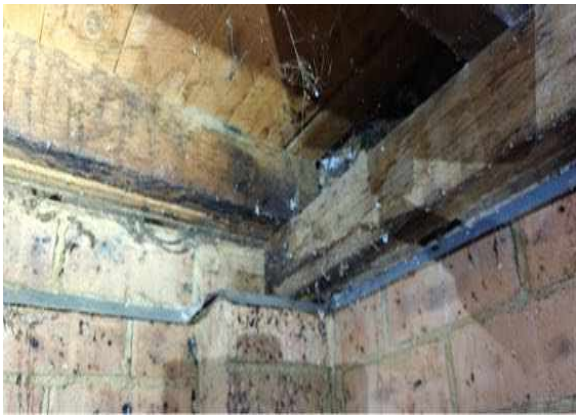
Building: Main Building
Location: All Areas
Finding: Additional Photos - Obstructions and Limitations
Information: These photographs are an indication of the obstructions and limitations which impeded full inspection of the property at the time of inspection. These obstructions can hide an array of defects and should be removed to allow full inspection to be carried out. A re-inspection is recommended once the areas are made accessible.
