Building Inspection Report

Inspection Date: Tue, 10 Mar 2026

Property Address: 1/8 Hunter Ct, Ringwood East VIC 3135,
Australia

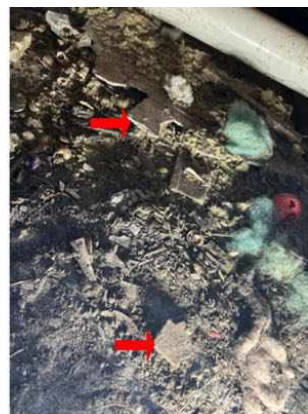
Building:	Main Building
Location:	Subfloor
Finding:	Asbestos - Suspected ACM Identified on Site
Information:	Reporting on Asbestos is outside the Scope of this Report. This suspected defect is highlighted as a caution only. We suspect, based on our experience in the building industry, that there is a higher risk of the identified building element containing asbestos.

As Asbestos Reporting is outside the scope of this report, we advise that you consider a separate Asbestos Inspection and Condition Audit, which can include the taking of samples for definitive confirmation of the presence of Asbestos.

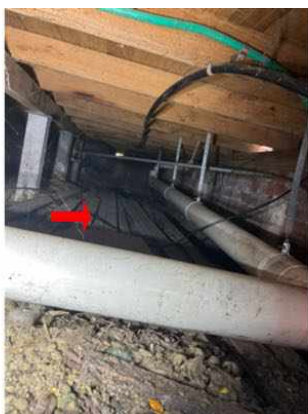
Building:	Main Building
Location:	All Areas
Finding:	Stored timbers - subfloor space or external area
Information:	The storing of timbers in the subfloor space or around the external property increases the risk of termite activity being present. As they are likely to come into contact with weather conditions or excessive moisture wood rot is likely to develop on timbers that are not treated.

It is highly recommended that any stored timbers be immediately removed from areas in which they may attract any termite / timber pest attack. Minimisation of risk / prevention of termite attack is far more adequate than dealing with the presence of termite activity.

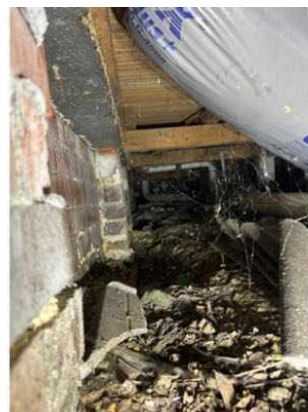
Defects 3.16

Building:	Main Building
Location:	All Areas
Finding:	Subfloor - Debris
Information:	An array of debris was found in the subfloor area at the time of inspection. Debris in this area restricts subfloor ventilation and creates potential for concealed pest entry. Stored timbers and other materials may also make the area susceptible to termite

A clear and empty subfloor will be better ventilated and easier to maintain in a dry condition. The removal of any timber debris is vital in minimising the risk of termite or wood borer activity.

Debris in the subfloor should be removed as soon as possible. Depending on the location and amount of debris and stored items, the homeowner may elect to undertake this task. Alternatively there are a large number of rubbish removal subcontractors that could undertake these works.

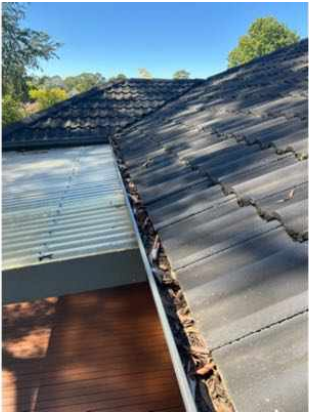
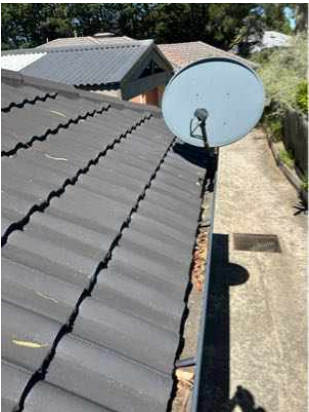
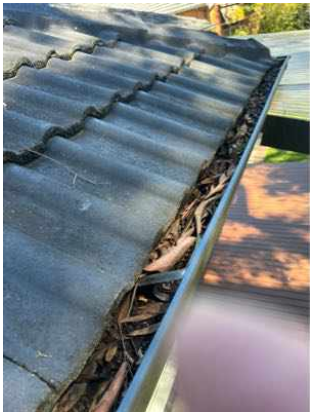
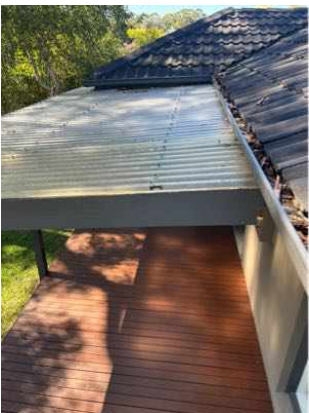
Defects 3.17

Building:	Main Building
Location:	All Areas
Finding:	Gutters - Blocked
Information:	Roof plumbing structures, such as guttering and downpipes, should be free of all debris to prevent blockages. Blockages of the guttering and downpipes will lead to pooling and accumulated water overflows, which is likely to subsequently flood eaves and exterior walls.

Blocked gutters are likely to lead to high levels of moisture in the affected areas. Such moisture will not only cause rust and decay of the associated building materials, but can also provide conditions that are conducive to termite and timber pest activity. Blockages in gutters should therefore be removed immediately to ensure dry conditions are maintained.

Consult a Licensed Plumber for further specific advice on remedial works that may be required. In the interim, it is highly advised that blocked gutters be removed by the homeowner or a general handyperson as a matter of urgency.

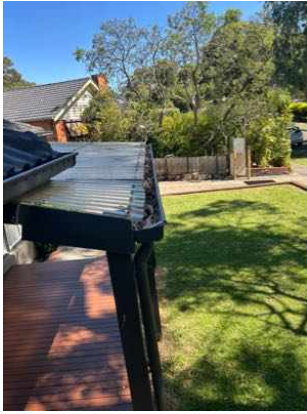
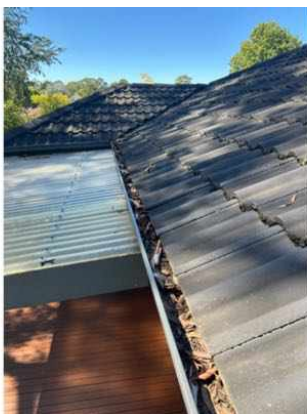
Defects 3.18

Building:	Main Building
Location:	Porch
Finding:	Polycarbonate sheeting - Damaged
Information:	The polycarbonate sheeting has deteriorated as a result of exposure to weather conditions over a prolonged period of time. Exposure to elements, such as heavy rain and hailstorms, is likely to damage polycarbonate sheeting, which is not as strong as other roof coverings.

Further deterioration of the polycarbonate sheeting is likely to occur if left unmanaged. Such deterioration creates potential for water penetration and secondary damage to the internal roofing structure, accelerating deterioration of all associated building elements.

Repair and replacement of several sections of the sheeting is required. Appointment of a roofing restorer is required to perform these works as soon as possible to prevent any further damage being sustained.

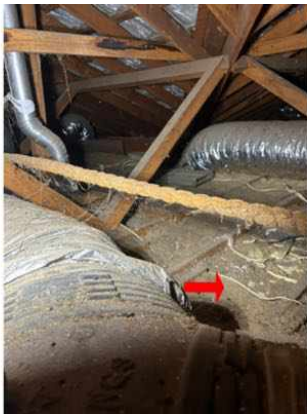
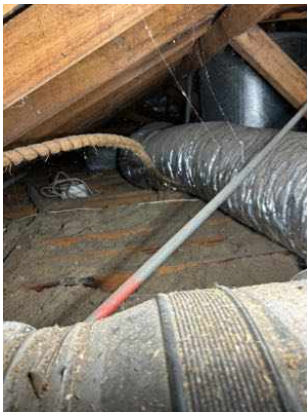
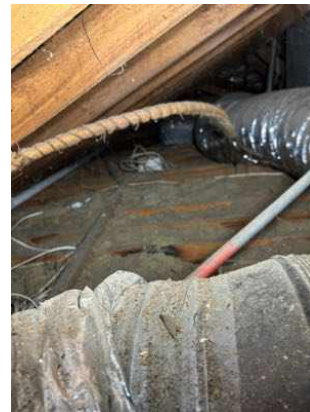
Defects 3.19

This type of insulation is susceptible to settling and reducing in volume, detracting from its effectiveness and resulting in an overall loss of energy within the household. Additionally, the reduction in volume has led to an uneven distribution of insulation within the ceiling void, further detracting from its effectiveness.

It is highly advised that this insulation be removed and replaced with a more appropriate material. This will ensure that the property is adequately insulated and will promote an increase in energy efficiency within the property. An insulation contractor should be appointed to provide further advice on replacement options and to perform works as necessary.

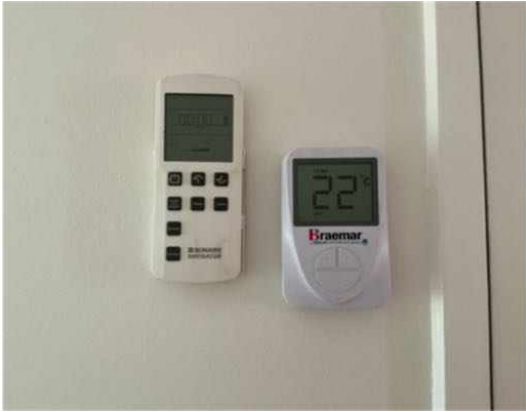
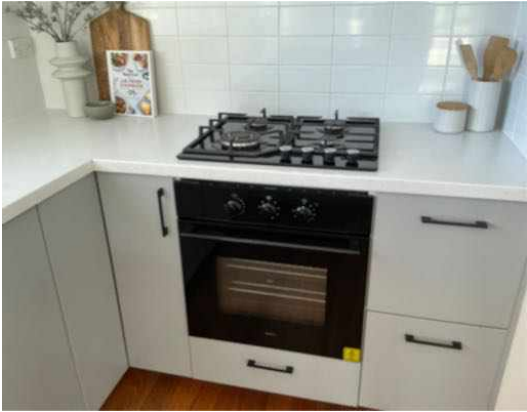
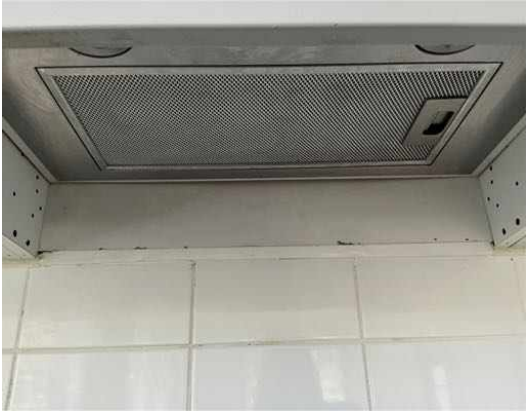
Building: Main Building
 Location: All Areas
 Finding: Warranty - Expired
 Information: Where appliances are beyond their warranty period, the owner should be prepared to meet the cost of replacement or repair of the item at any time. The operation of the appliance can not be guaranteed and further inspection by an appropriately qualified tradesperson may be required.

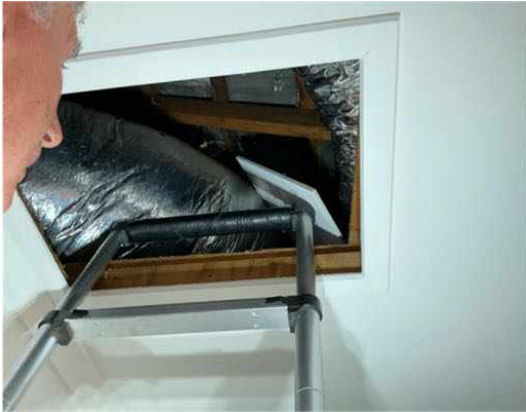
Building: Main Building
Location: Roof Void
Finding: Roof void access limitations
Information: Limited access to the roof void was present due to facts including but not limited to access hatch size or placement, ductwork or roof framing, for this reason access to the roof void was minimal.

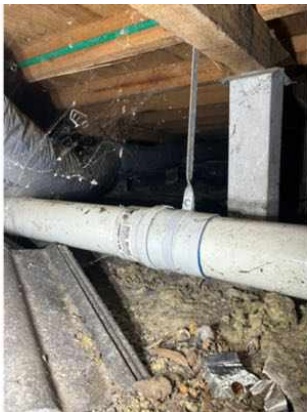
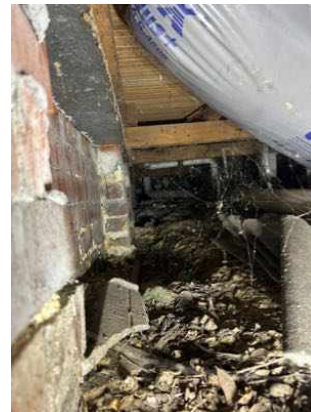
Building:	Main Building
Location:	All Areas
Finding:	Additional Photos - Obstructions and Limitations
Information:	These photographs are an indication of the obstructions and limitations which impeded full inspection of the property at the time of inspection. These obstructions can hide an array of defects and should be removed to allow full inspection to be carried out. A re-inspection is recommended once the areas are made accessible.

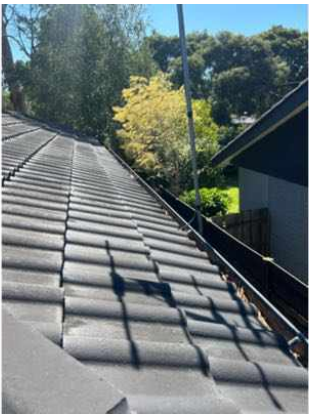
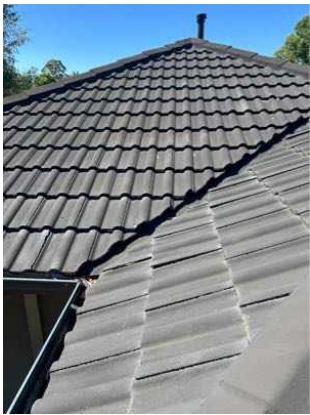
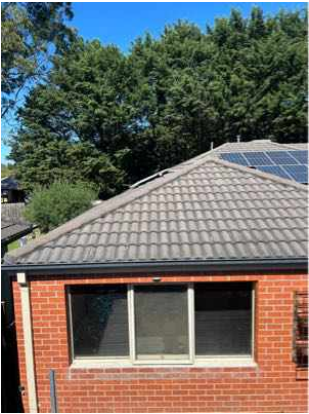
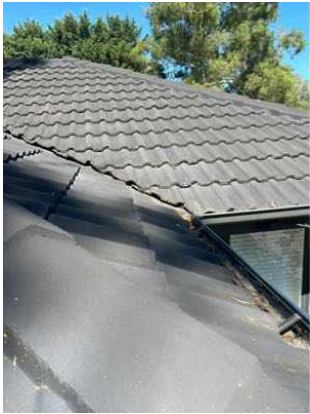
Building:	Main Building
Location:	All Areas
Finding:	For information only
Information:	No remedial works are required at the current time.

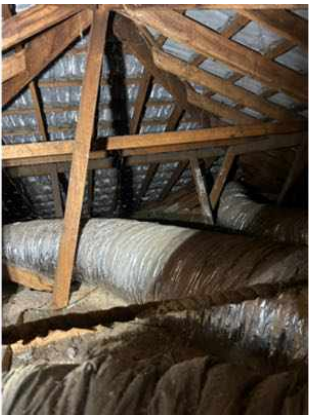
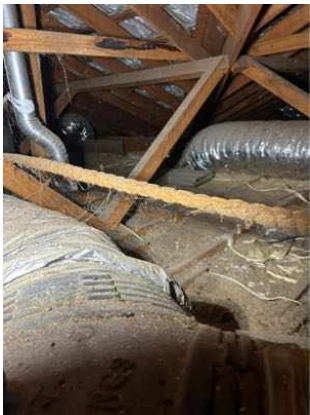
Building: Main Building
Location: All Areas
Finding: Additional Photos - Obstructions and Limitations
Information: These photographs are an indication of the obstructions and limitations which impeded full inspection of the property at the time of inspection. These obstructions can hide an array of defects and should be removed to allow full inspection to be carried out. A re-inspection is recommended once the areas are made accessible.
