# Building Inspection Report

Inspection Date: Thu, 19 Feb 2026

Property Address: 13 Lillie St, Glebe TAS 7000, Australia

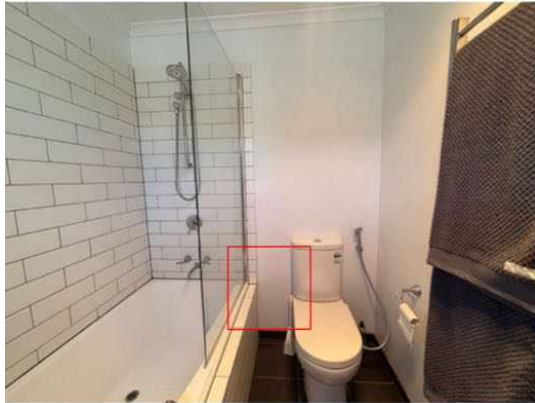
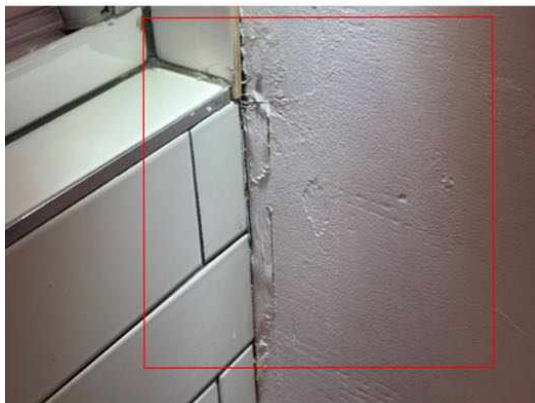
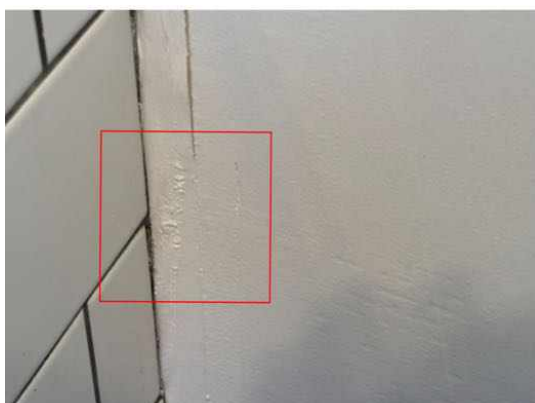
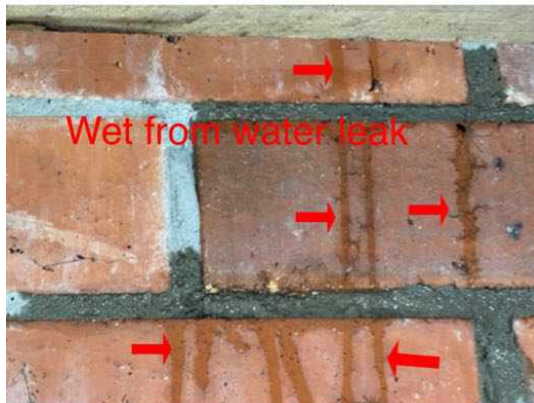
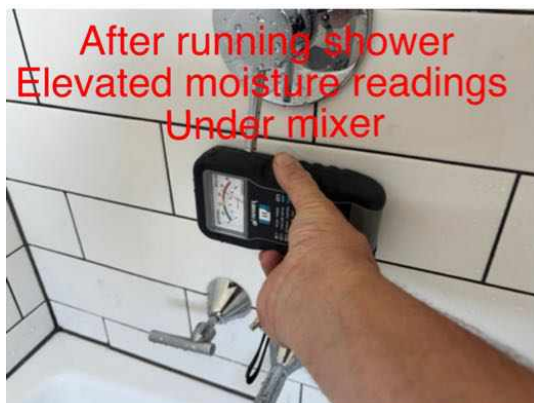
#### Defects 2.01

Building: Main Building  
Location: Bathroom  
Finding: Bathroom  
Information: In the bathroom, there appear to be at least two water leaks to the shower.

There is some damage to the plasterboard beside the shower. There is some efflorescence to the floor tiles, (which indicates moisture under the tiles).

The first leak is suspected from the gap in the shower screen where it pivots. When tested, water ran down to the floor tiles beside the toilet. Also there is damage/cracking to the floor tiles beside the toilet. In the subfloor there is mould and water damage to the flooring underneath this area. Due to the amount of damage under the floor, it does appear to have been leaking and wet for some time. I suspect the cracked tiles next to the toilet are due to the flooring getting wet and soft, and then the movement from someone sitting on the toilet caused the cracks.

The second leak appears to be on the wall where the shower taps are located. I suspect the water is getting into the tap penetrations and may be moving side ways through the tiles via capillary action. There is visible damage beside the bath. I ran the shower for approximately 10 mins directed toward the wall with the taps on it and water was dripping out in the subfloor. The structural timbers appear to be still sound, however there is damage to the chipboard flooring. There were also elevated moisture readings, which indicates water behind the tiles. There is likely to be damage to the wall lining/plasterboard behind the tiles, and possibly mould.

Water leaks can be detrimental to surrounding building elements. Rust, corrosion, decay and water damage are potential outcomes where a water leak is left unattended. In extreme cases, structural damage/subsidence may develop due to a prolonged water leak.

Recommend client firstly engage a Lic Plumber to investigate and rectify the active water leaks immediately. The Plumber may be able to identify the source and apply a short term solution such as silicone to prevent further damage.

After the Plumber has attended, recommend client engage a Lic Builder (who specializes in bathroom renovations), to inspect as soon as possible (perhaps with a camera to view inside the wall void). Partial or full demolition and reconstruction is likely to be required. The full extent of damage is often not apparent until demolition work commences.

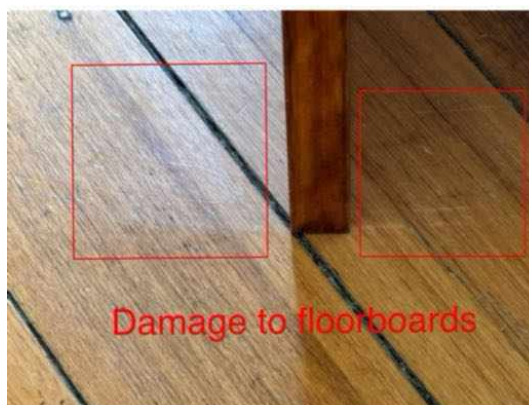
### Defects 3.01

Building: Main Building  
 Location: Master bedroom  
 Finding: Door binding  
 Information: The master bedroom door has some very minor binding on the bottom of the door. This has caused some very minor damage to the floorboards.

Failure to rectify will lead to further deterioration to the floorboards.

Recommend client engage a Handy Person to rectify at clients convenience.

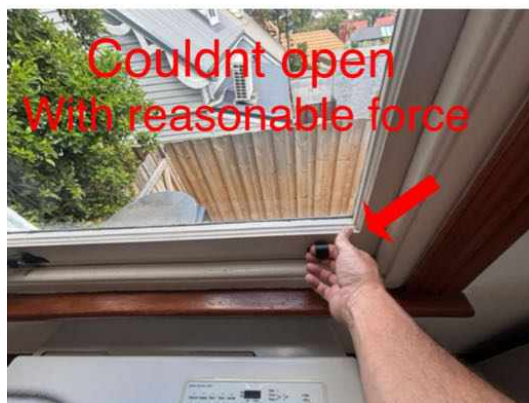
### Defects 3.02

Building: Main Building  
 Location: Living  
 Finding: Window stuck  
 Information: The window in the rear living area (behind the heat pump), was stuck and needs adjustment. The rest of the windows were operating well and they appear well maintained.

Windows provide ventilation to the adjoining area and should be at a fully operational level to ensure user comfort. Restricted function of the window may also pose as a potential safety hazard if required for emergency egress from the building.

Generally, factors such as general age of the building element and a lack of maintenance are the usual causes for this type of defect.

Recommend client engage a Handy Person to rectify at clients convenience.

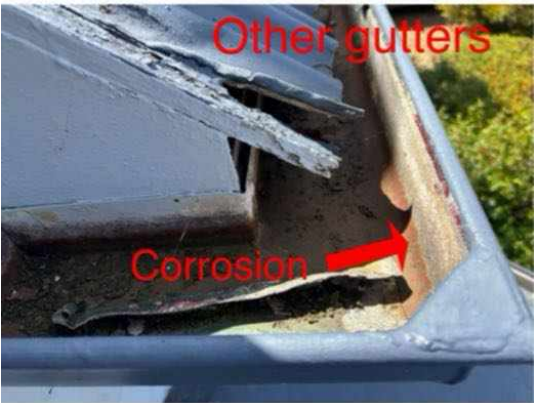
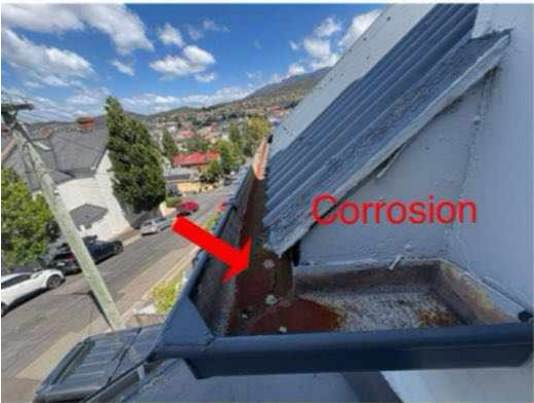
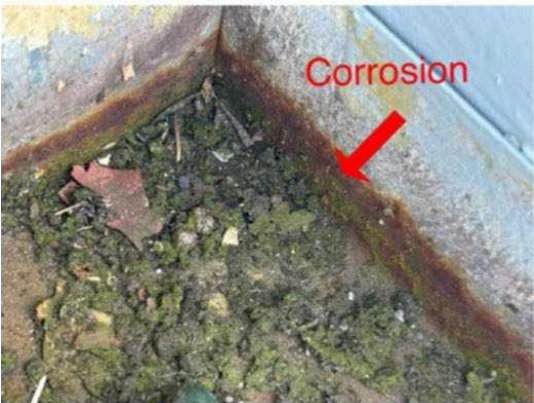
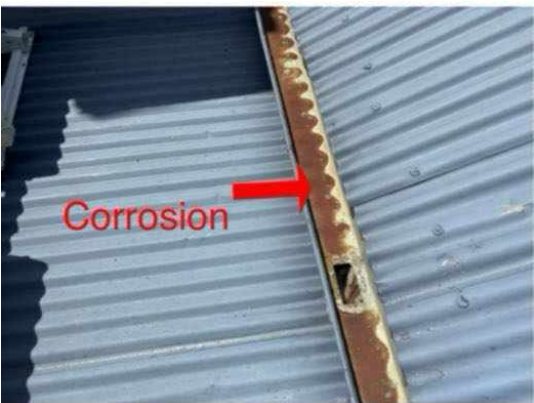
### Defects 3.03

Location: Roof  
 Finding: Corrosion to gutters  
 Information: Some of the gutters show evidence of rusting and corrosion. The gutter to the rear, above the french doors will need replacement in the very near future. The rest are in varying states and this will be part of future maintenance.

This is most likely to have developed due to a age and lack of maintenance/cleaning of debris which then causes water pooling. As surface rust provides no protection to the underlying iron, the deteriorating condition is likely to worsen if not addressed in the short-term future.

Recommend client engage a Lic Plumber to replace the gutter above the french doors, as soon as practicable.

Recommend that the client ensure the gutters be cleaned and maintained on a regular basis to prevent further corrosion.

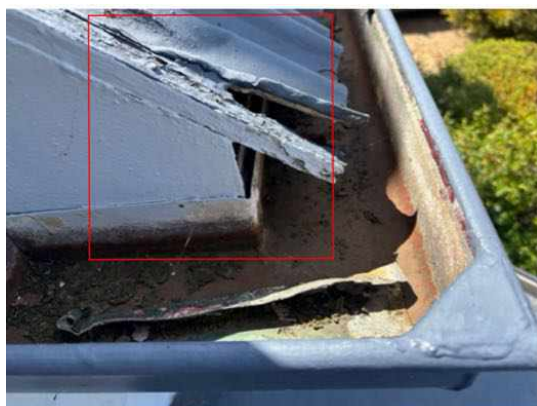
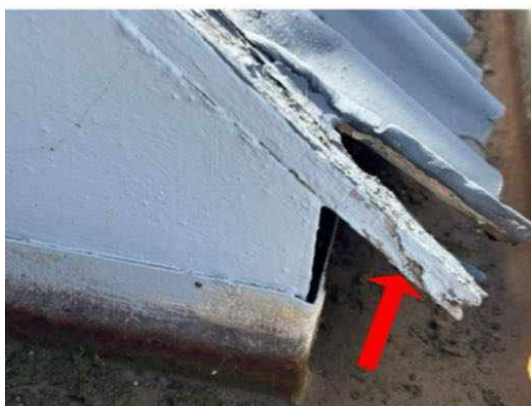
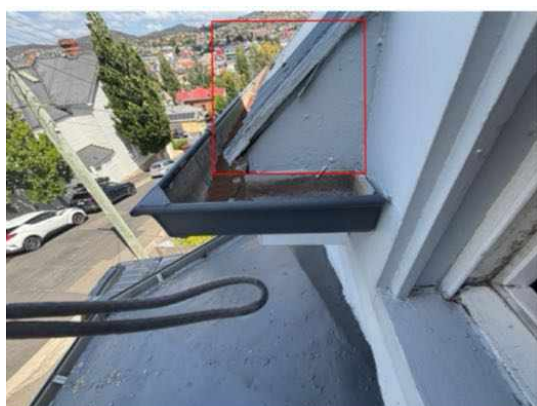
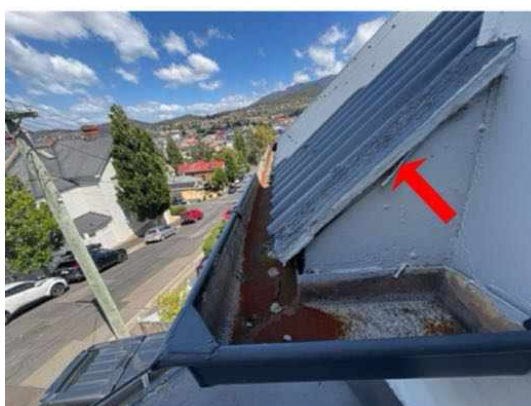
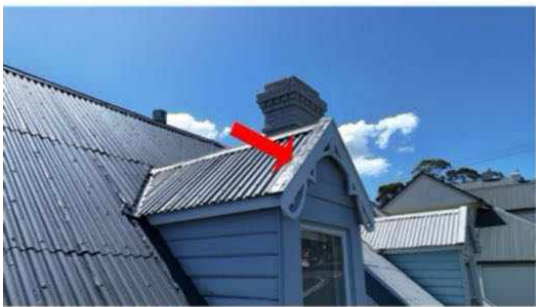
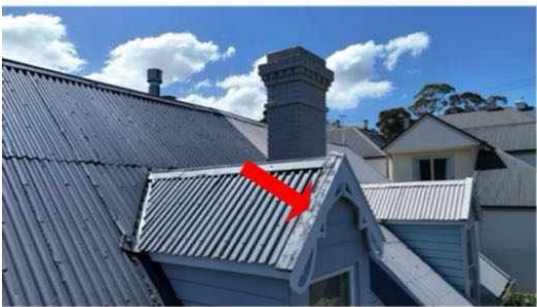
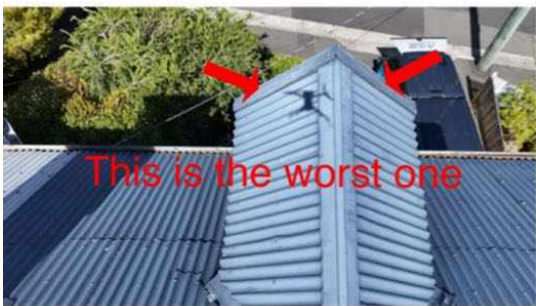
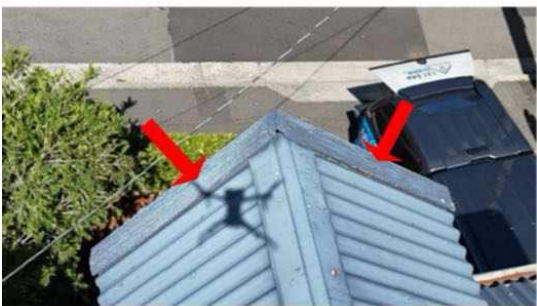
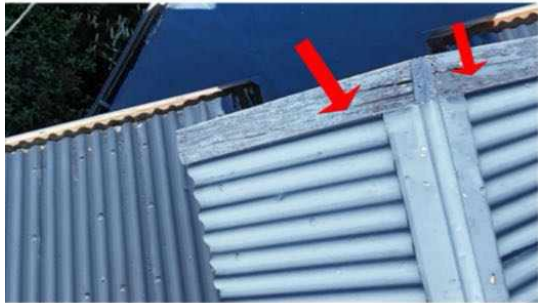
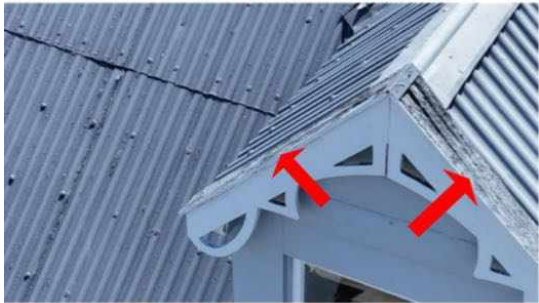
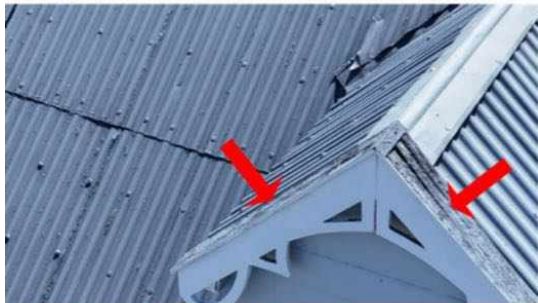
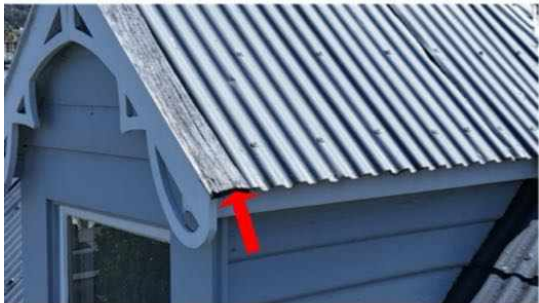
Defects 3.04

Information: On the roof, timber has been used as trims/flashings on the gable ends in various locations. The timber is in various states of repair. Some needs painting and some requires replacement. A better long term solution I would recommend, is that that client engage a Lic Roof Plumber to make and install custom flashings to go over the timbers, covering and encapsulating them. This will reduce future maintenance and prevent further deterioration to the timbers. However this would need to be checked with Heritage Controls, as they may need to approve this first.

Recommend client engage a Lic Roof Plumber to rectify as soon as possible.

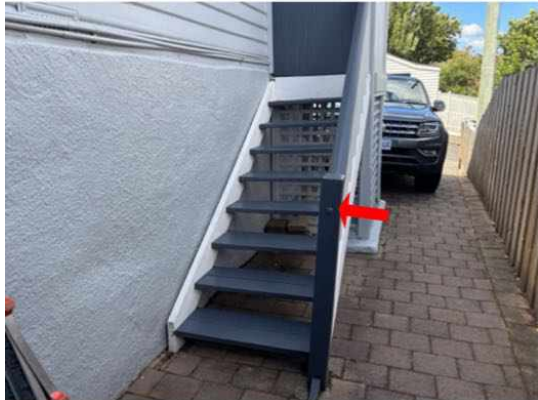
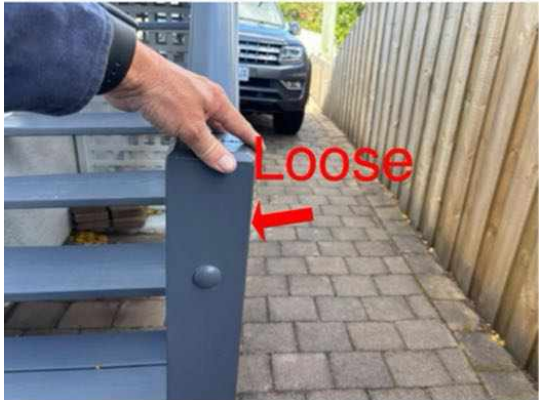
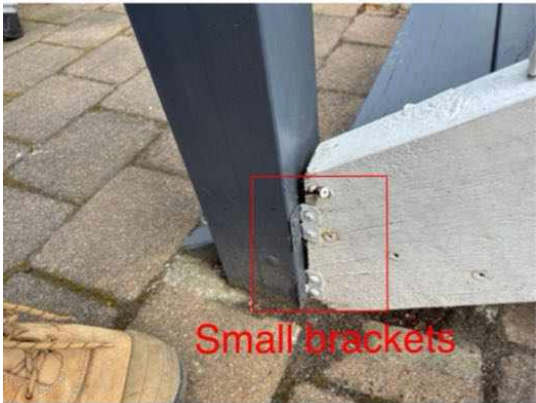
**Defects 3.05**

Building: Main Building  
 Location: Front stairs  
 Finding: Balustrade post  
 Information: The balustrade corner post to the front stairs is loose. There are some small brackets but they need to be reinforced and replaced with something sturdier.

Failure to rectify could cause further deterioration.

Recommend client engage a Handy Person to rectify as soon as possible.

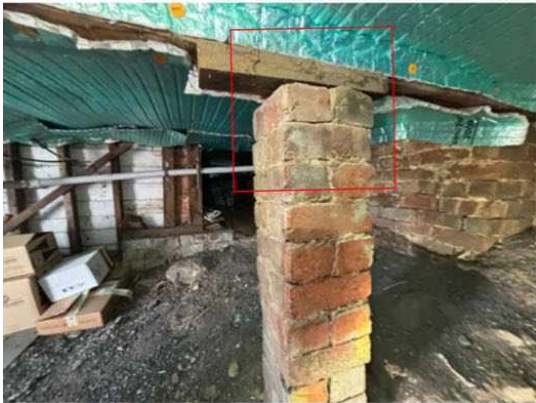
**Defects 3.06**

Building: Main Building  
 Location: Subfloor  
 Finding: Pier  
 Information: In the subfloor, there is a pier under the rear of the house that has become disengaged. The whole pier is loose.

Recommend client engage a Brick Layer to rectify as soon as possible. This pier will likely need to be demolished and rebuilt.

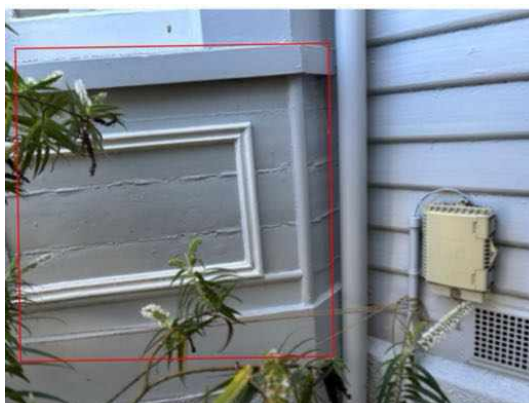
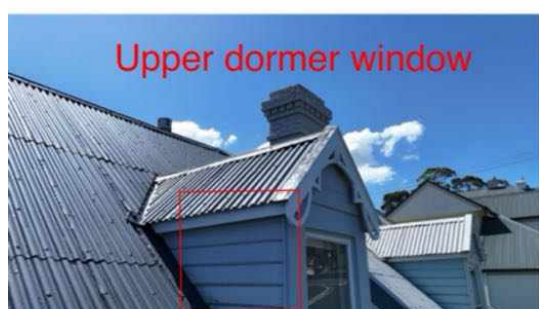
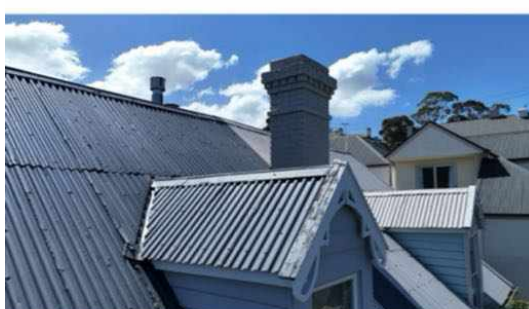
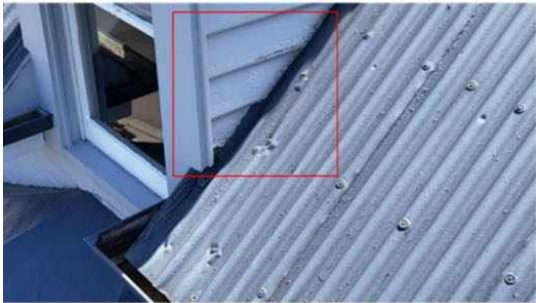
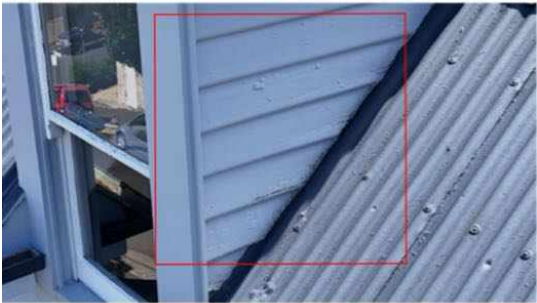
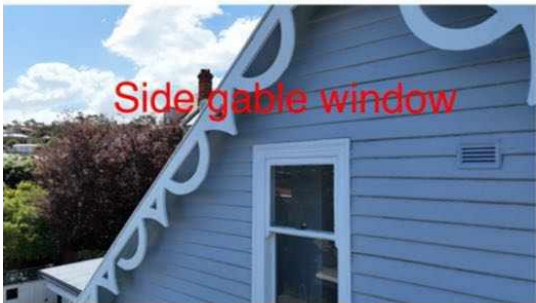
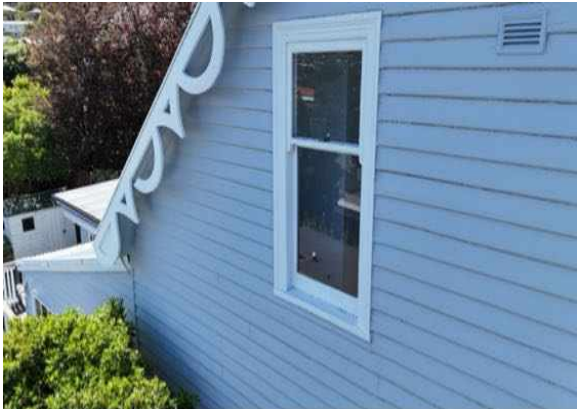
## Defects 3.07

Building:	Main Building
Location:	Roof
Finding:	Minor paint deterioration to some exterior timbers
Information:	There is some minor paint deterioration next to the upper side gable window, front upper dormer window and the front panelling of the bay window down low. Generally the paintwork is in quite good condition. If you are able to get details of the current paint colour that would be helpful.

It is likely that paint deterioration has developed as a result of frequent exposure to rain and other weather conditions. It is suspected that failure to maintain the timbers over a prolonged period has resulted in them deteriorating at an accelerated rate, increasing their susceptibility to the development of wood rot. Early intervention and regular maintenance will prolong the useful life of these building elements.

Recommend client engage a Handy Person/Painter to rectify as soon as practicable.

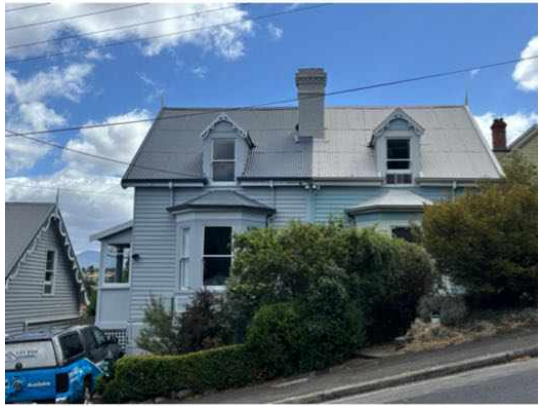
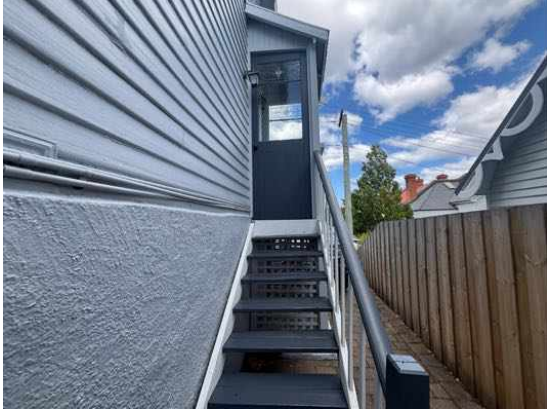
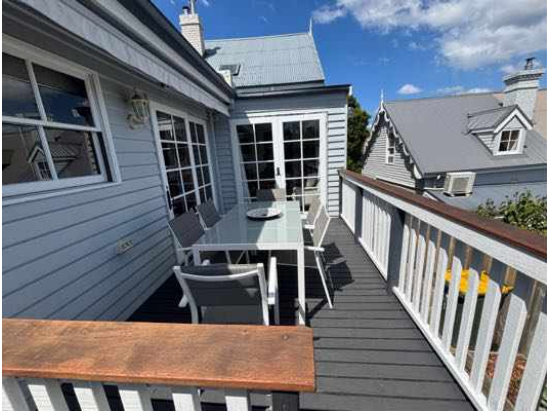
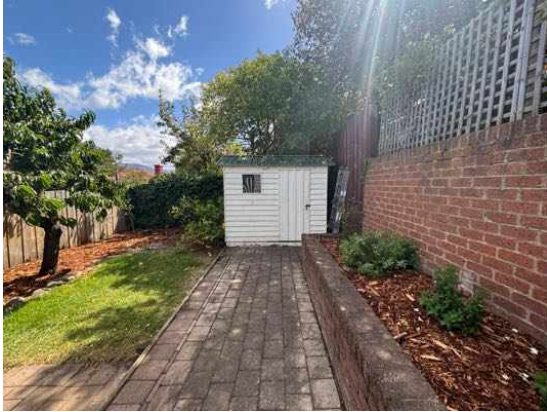
Building: Main Building  
Location: All External Areas  
Finding: Additional Photos - Obstructions and Limitations  
Information: These photographs are an indication of the obstructions and limitations which impeded full inspection of the property at the time of inspection. These obstructions can hide an array of defects and should be removed to allow full inspection to be carried out. A re-inspection is recommended once the areas are made accessible.

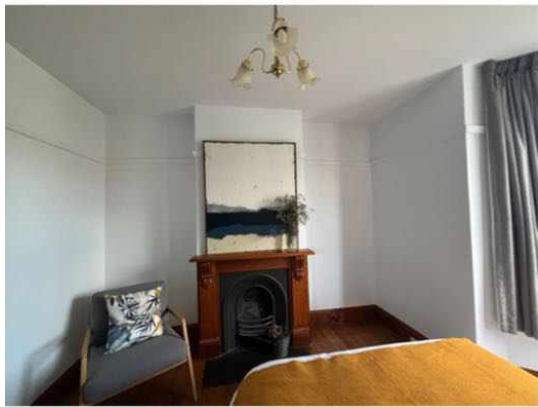
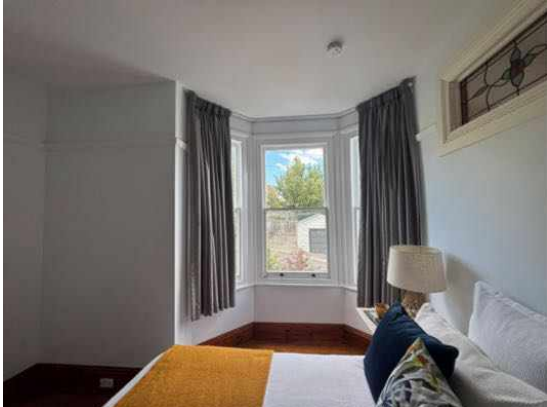
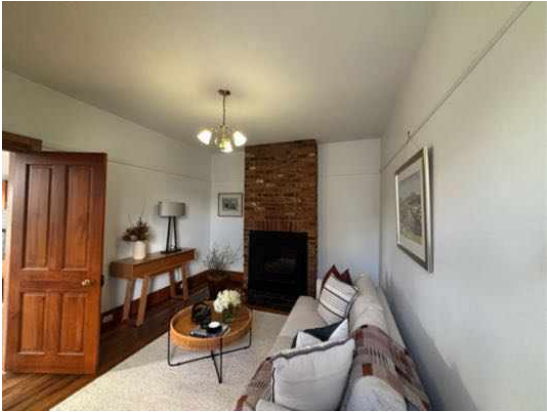
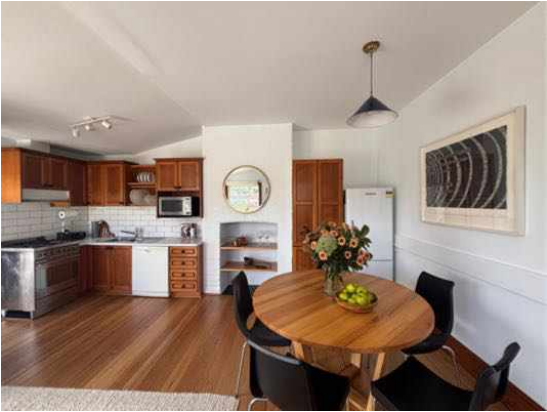
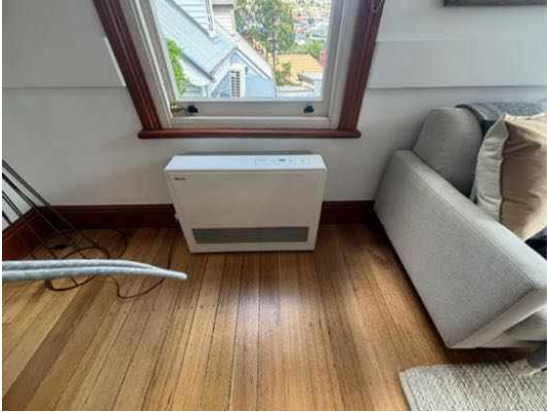
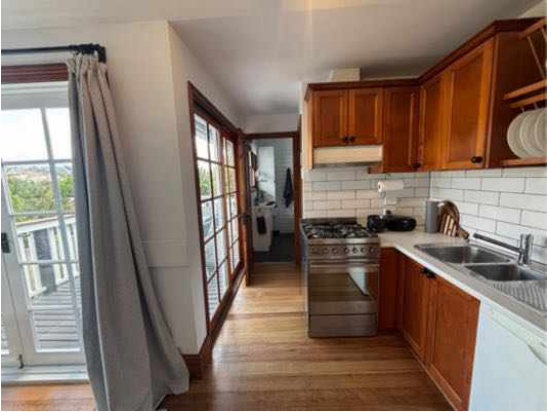
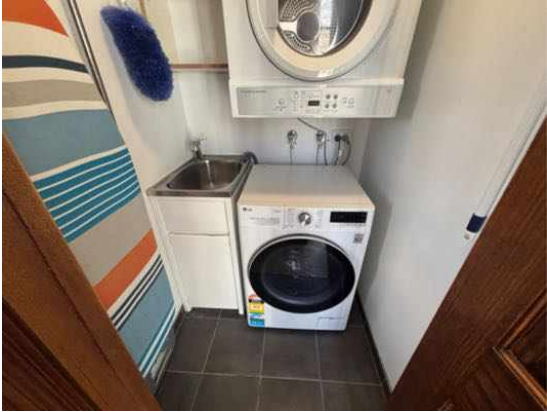
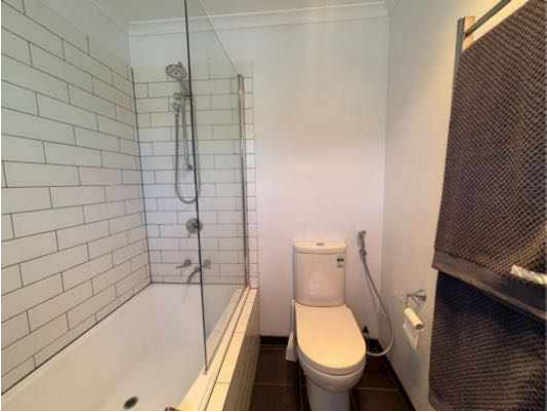
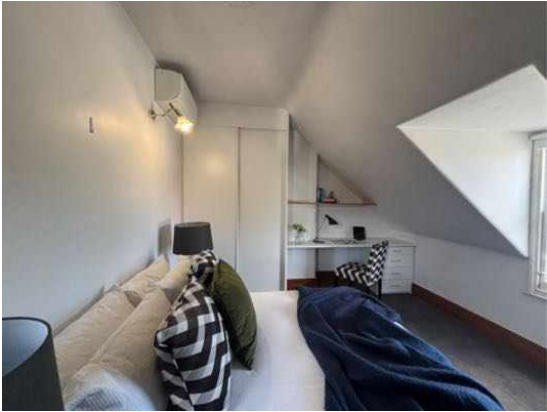
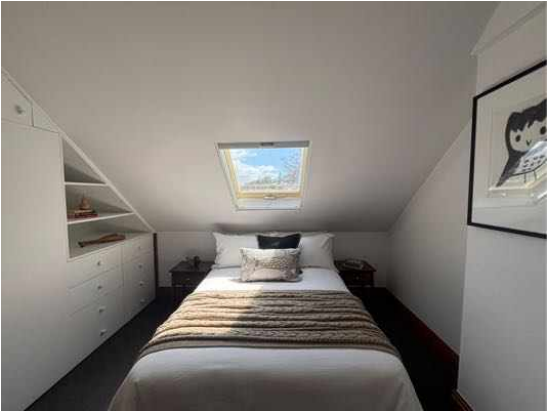
Building: Main Building  
Location: All Internal Areas  
Finding: Additional Photos - Obstructions and Limitations  
Information: These photographs are an indication of the obstructions and limitations which impeded full inspection of the property at the time of inspection. These obstructions can hide an array of defects and should be removed to allow full inspection to be carried out. A re-inspection is recommended once the areas are made accessible.

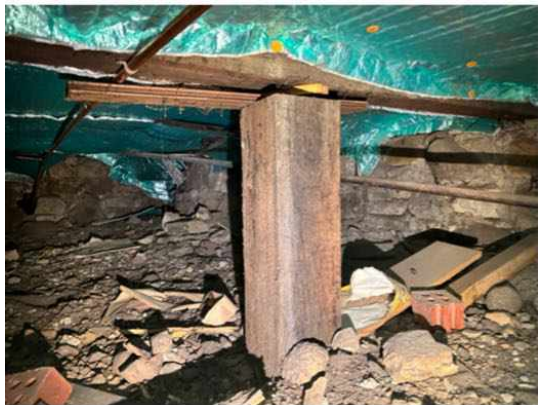
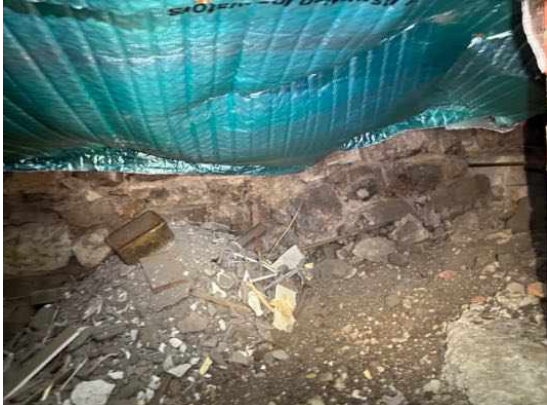
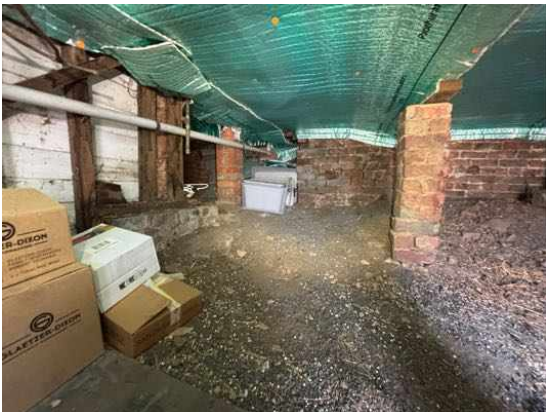
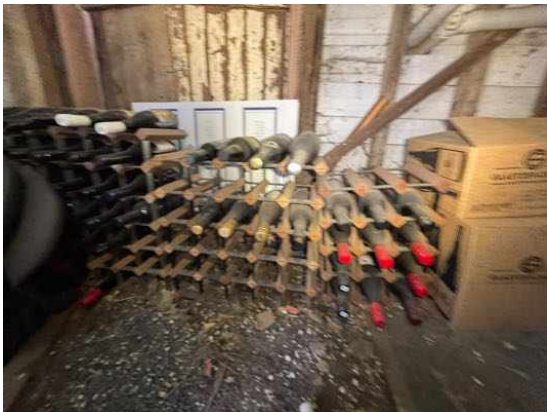
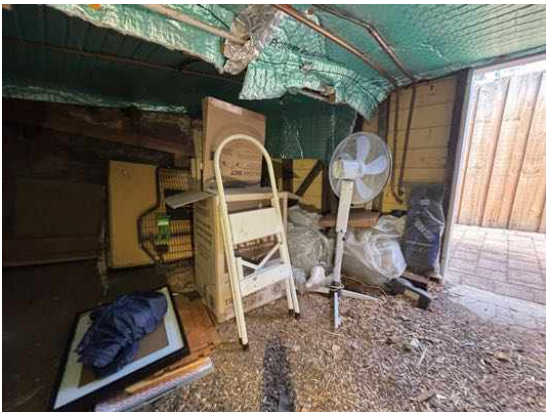
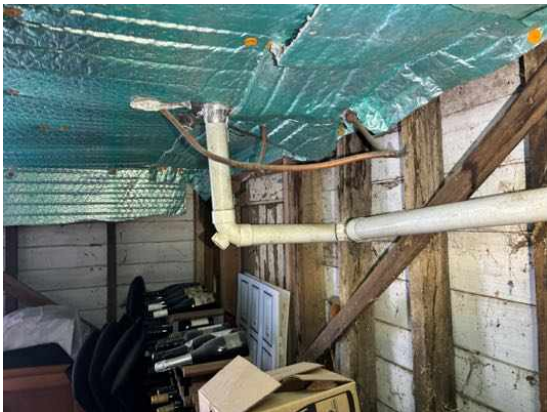
Building: Main Building  
Location: Subfloor  
Finding: Additional Photos - Obstructions and Limitations  
Information: These photographs are an indication of the obstructions and limitations which impeded full inspection of the property at the time of inspection. These obstructions can hide an array of defects and should be removed to allow full inspection to be carried out. A re-inspection is recommended once the areas are made accessible.

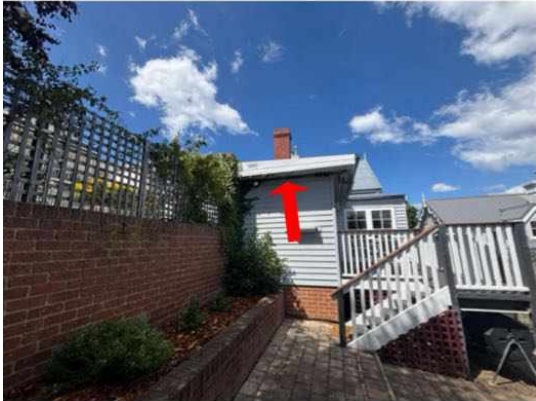
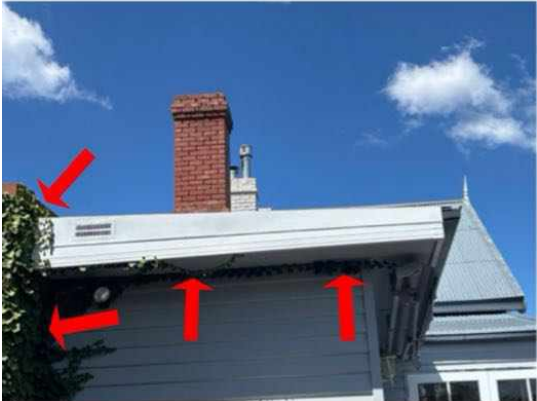
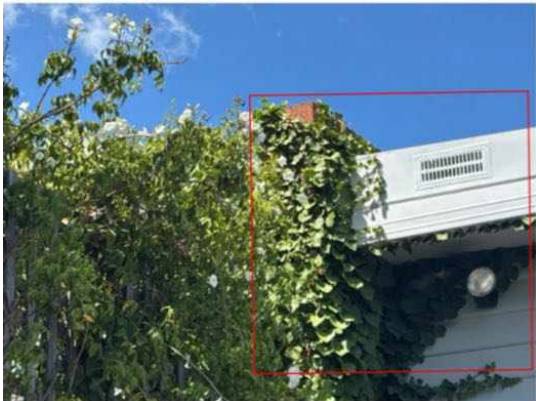
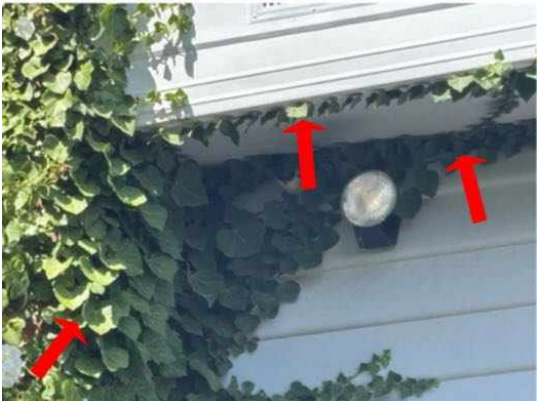
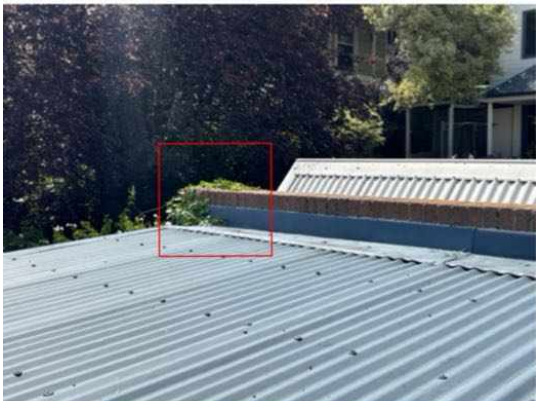
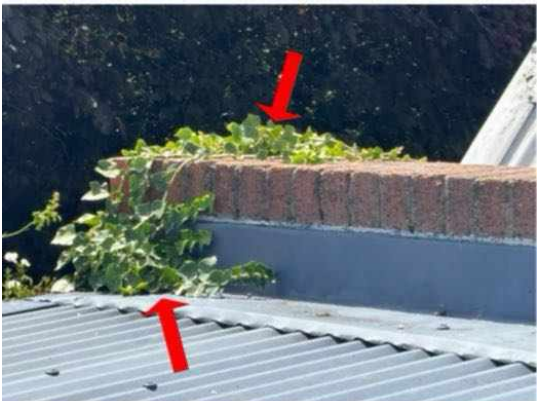
Building: Main Building  
Location: Roof

Finding: FYI Ivy  
Information: There is vegetation (Ivy) growing on the rear of the house. It recommend this to be removed or it will cause damage to the building materials.

Recommend client engage a Handy Person to rectify as soon as possible.

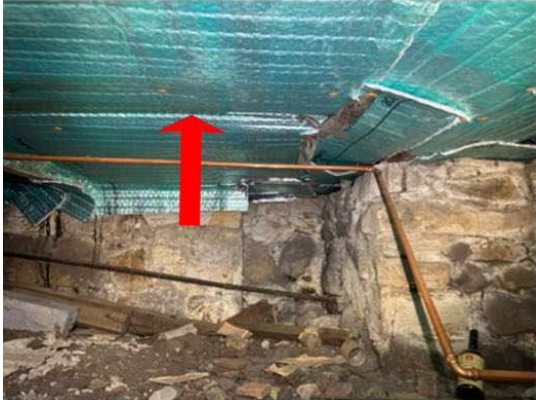
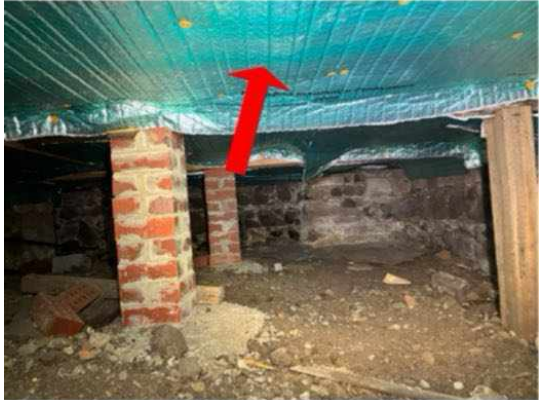
Building: Main Building  
Location: Subfloor  
Finding: FYI under floor insulation  
Information: FYI there is insulation fitted under the floors in the subfloor.

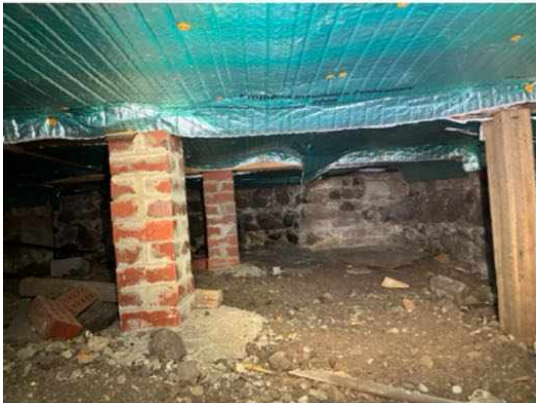
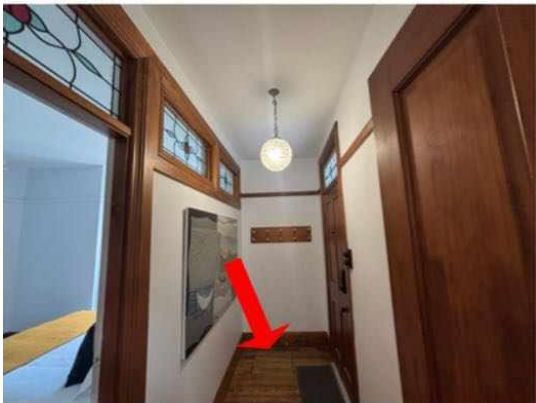
Building: Main Building  
 Location: Subfloor  
 Finding: FYI piers  
 Information: FYI some of the older piers at the front subfloor section have been replaced with brick piers. FYI access to this section is via a hatch in the hallway.

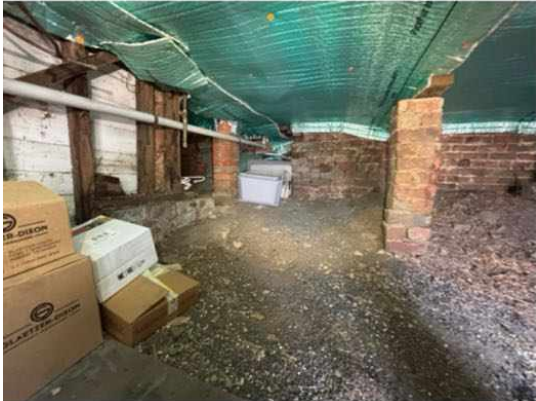
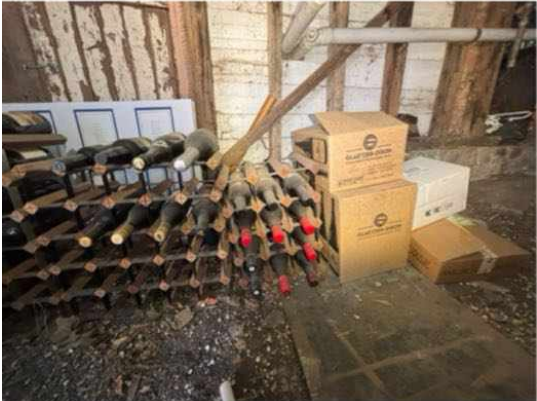
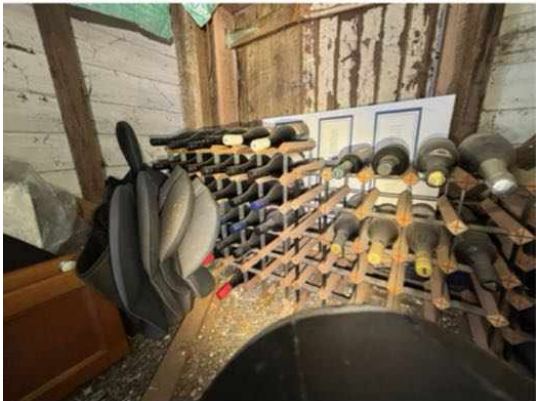
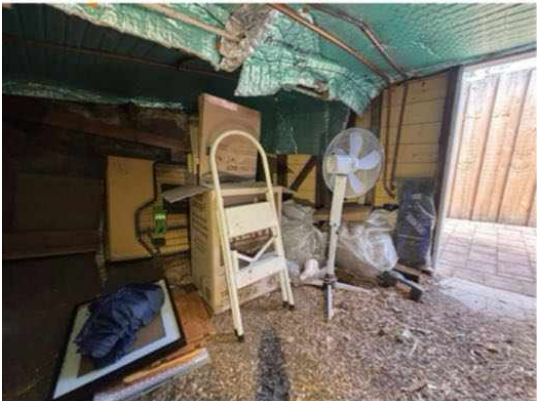
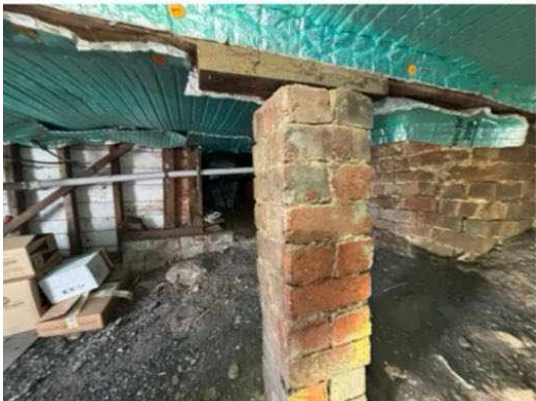
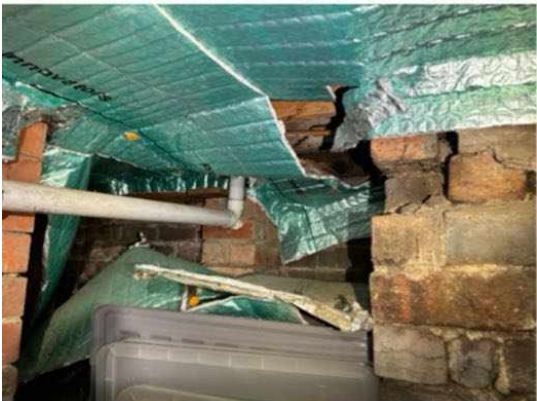
Location: SUbfloor  
Finding: Subfloor stored items  
Information: FYI there are some stored items in the rear subfloor. Recommend client check with the agent, to see if these are being removed prior to settlement. Stored items restricts ventilation and creates potential for concealed pest entry. A clear and empty subfloor will be better ventilated and easier to maintain in a dry condition.

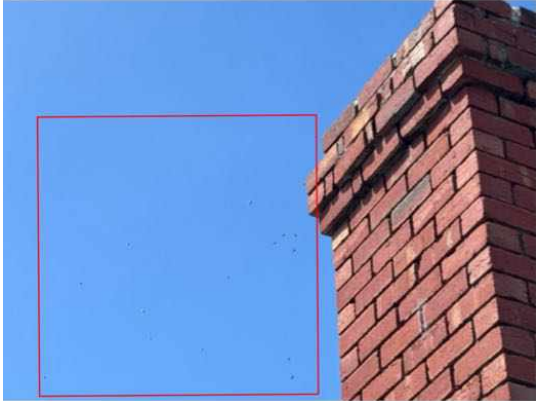
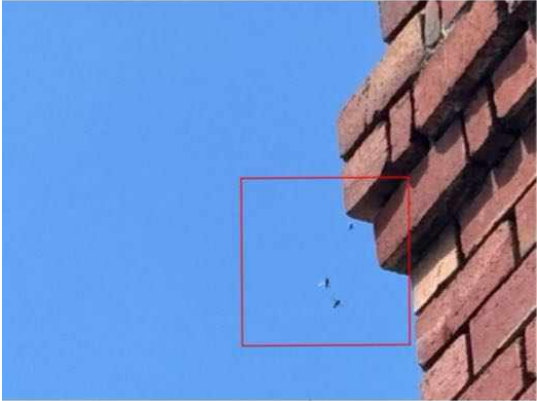
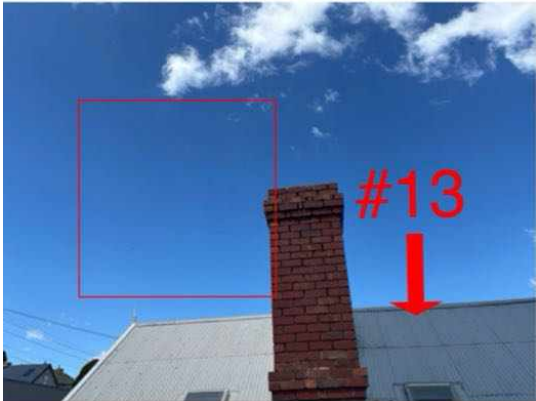
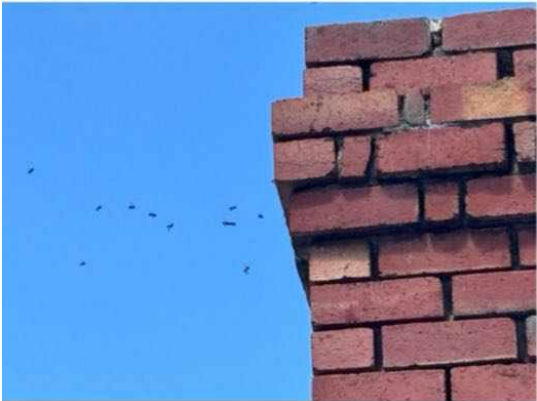
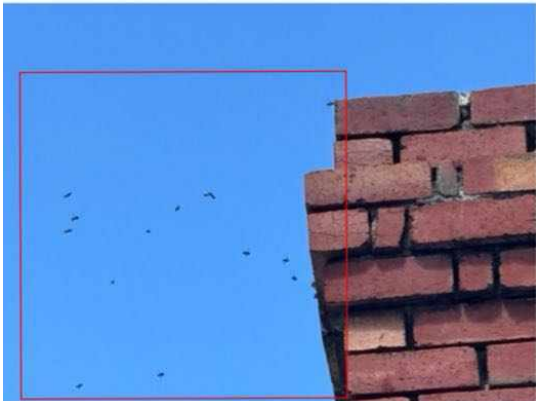
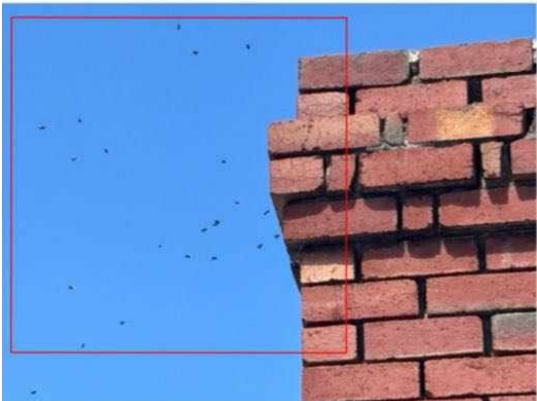
FYI the rear shared chimney may have a bee/wasp nest in it (it appears on the neighbours side). The chimney is capped but they might be entering through a gap in the mortar. Client may want to alert the neighbours. This may be a nuisance for occupants using the outdoor areas to both properties.

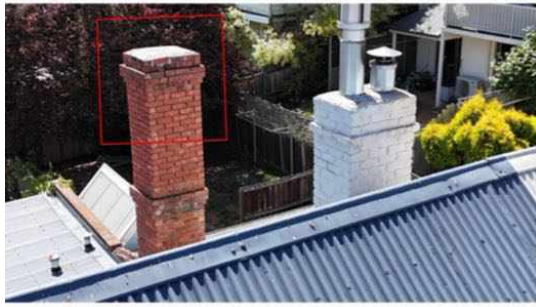
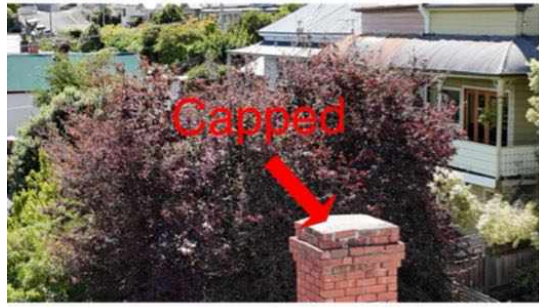
**Noted Item**

Building: Main Building  
Location: Roof  
Finding: FYI front chimney  
Information: FYI the front chimney is uncapped. This is for the fire in the front bedroom. If you are not going to use it then capping the chimney to prevent, bird, vermin, insect and water entry is recommended.

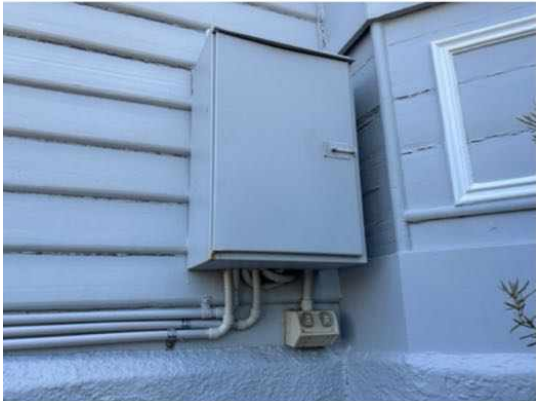
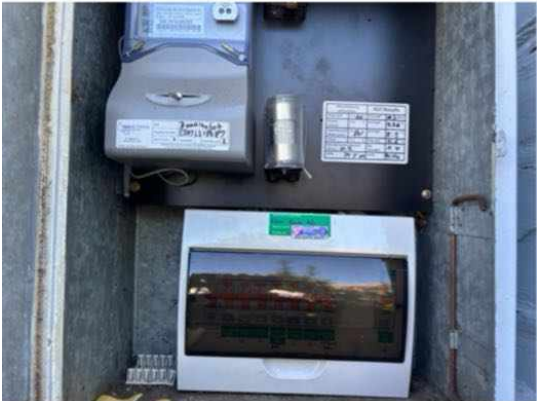
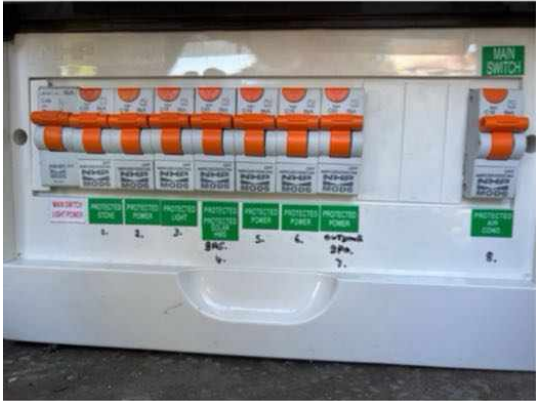
**Noted Item**

Location: Switchboard  
Finding: FYI switchboard  
Information: FYI the switchboard has been upgraded.
