## Building Inspection Report VR

Inspection Date: Thu, 15 Jan 2026

Property Address: 50 Jocelyn Dr, Eumundi QLD 4562,  
Australia

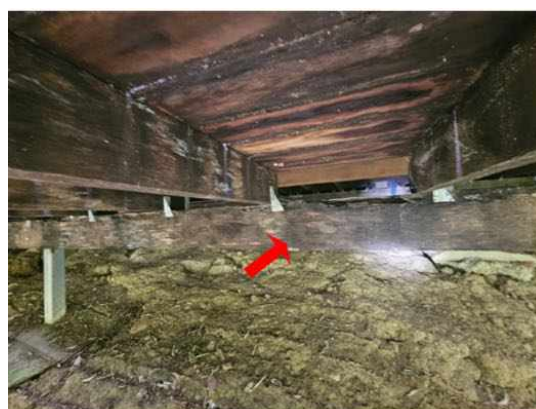
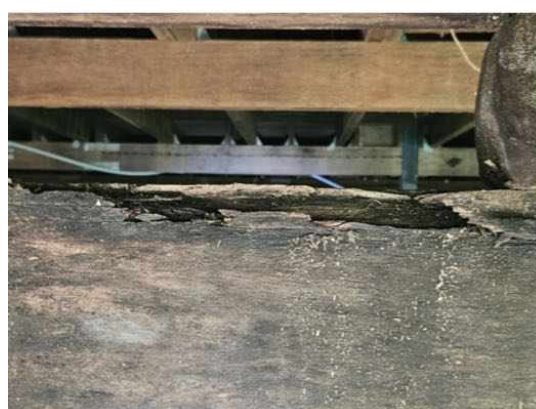
### Defects 3.03

Early intervention and regular maintenance, particularly of exterior timbers, will prolong the useful life of these building elements. Prior to any works being performed, the cause of the moisture that has created the visible wood rot should be identified and addressed in a suitable manner. Replacement of affected timbers may then be a necessary step in protecting surrounding building elements from such deterioration.

A licensed carpenter or licensed builder should be consulted to advise on a solution for the affected building materials.

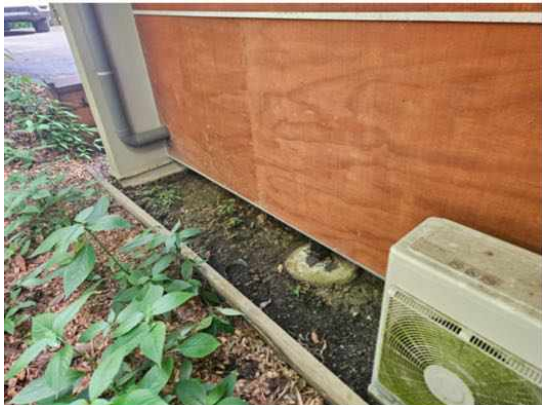
### Defects 3.04

Finding: Post base - rusting.

Information: It was noted at the time of inspection that established rust and surface rust is in the bases of the house subfloor stumps. The severely rusted stumps may require replacement and should be assessed by a licensed builder. The stumps affected by surface rust should be treated and coated to prevent possible further deterioration.

A licensed builder and a licensed painter could be engaged to carry out the required task.

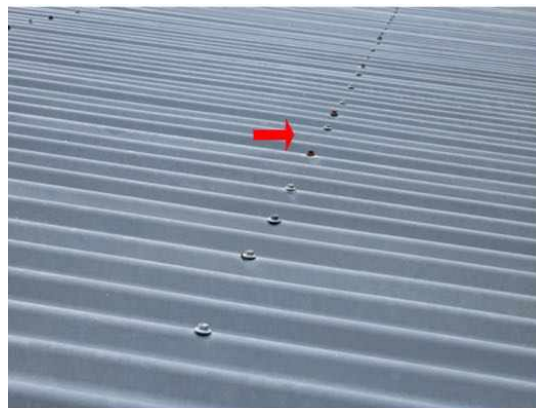
### Defects 3.05

This should be monitored over time, and should the condition worsen, consider replacement of the screws. As roof screws deteriorate they can have an effect on the adjoining roof materials.

A roofing plumber could be appointed at the clients discretion to replace the screws in question.

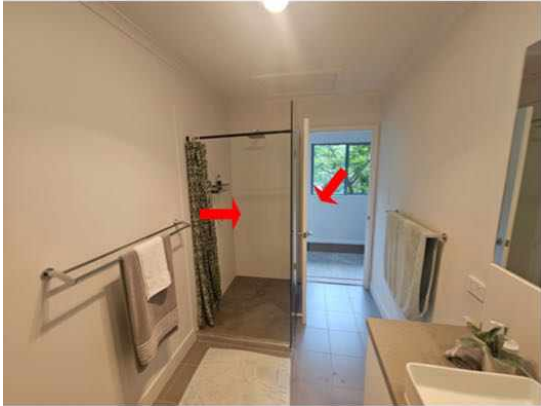
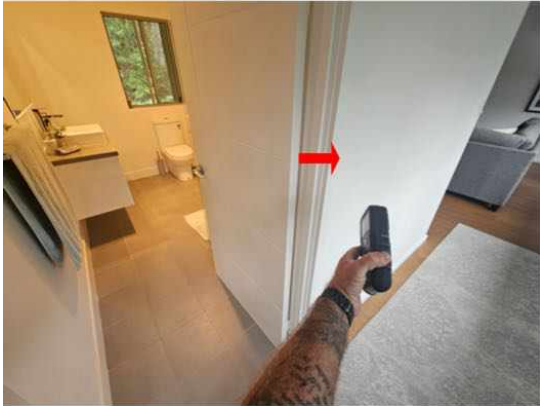
#### Noted Item

Building: Out Building  
Location: Bathroom  
Finding: Residual moisture present  
Information: During the inspection of the bathroom of the secondary unit, residual moisture was noted on the hallway side of the bathroom shower wall. This shower has been recently renovated and it is believed that the moisture measured is residual from the previous moisture issues. This should be monitored over time to gauge effective drying.
