# Building and Timber Pest Inspection Report

Inspection Date: Tue, 03 Feb 2026

Property Address: 163 Charles Ave, Minnamurra NSW,  
Australia

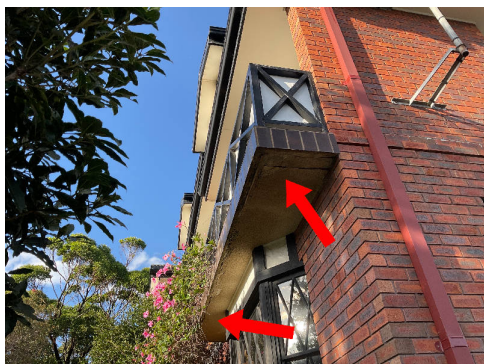
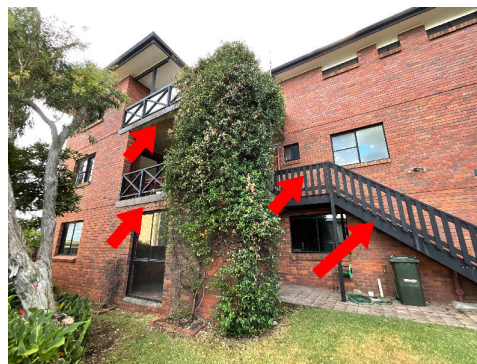
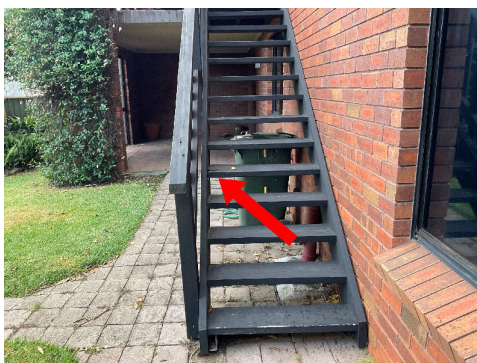
Nothing contained in this report should be taken as an indicator that an assessment has been made, on any elevated structure, as suitable for any specific number of people or purpose. This can only be done by a qualified engineer. For the purpose of this report, the Structure includes the elevated front and rear decks, balconies and handrails that show wood rot to small areas, rust to one upper post and concrete cancer at the front.

You should also arrange annual inspections of the structure by an engineer or other suitably qualified person to ensure any maintenance, that may become necessary, is identified. Care must be taken not to overload the structure.

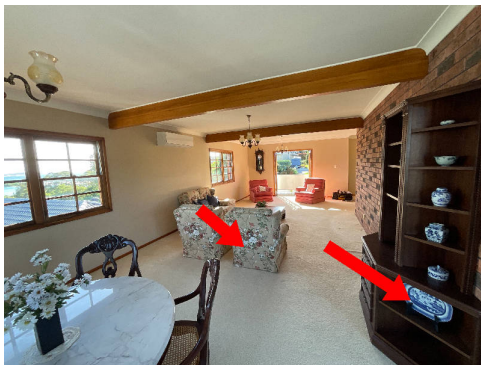
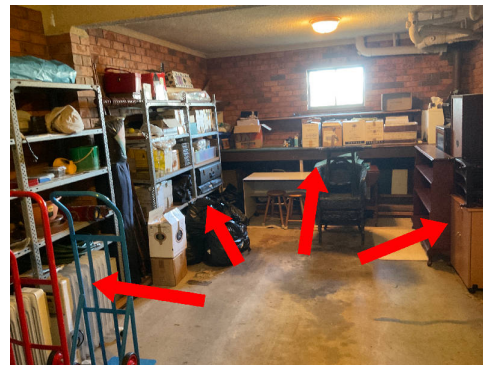
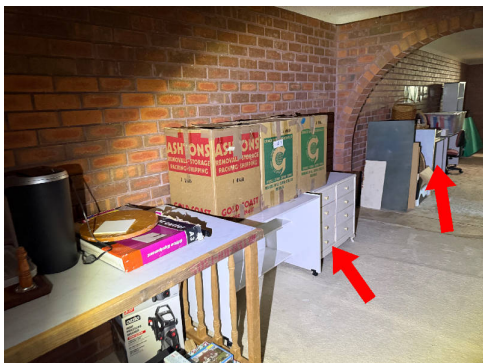
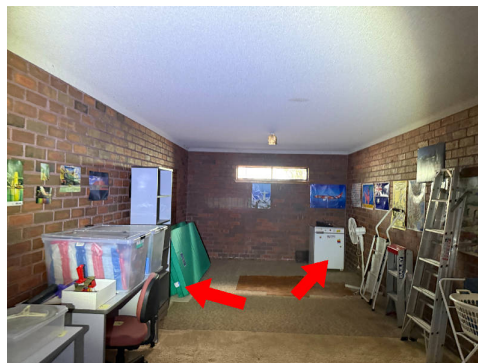
Building: Building 1  
Location: many rooms All Areas  
Finding: Additional Photos - Obstructions and Limitations  
Information: Additional photos for your information

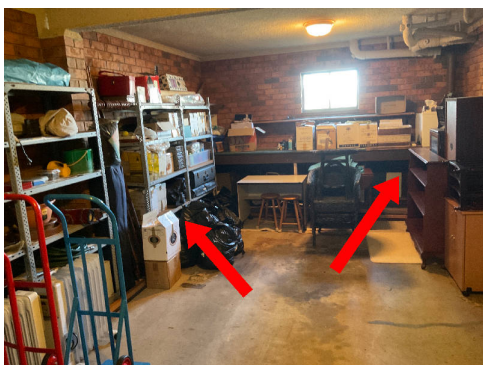
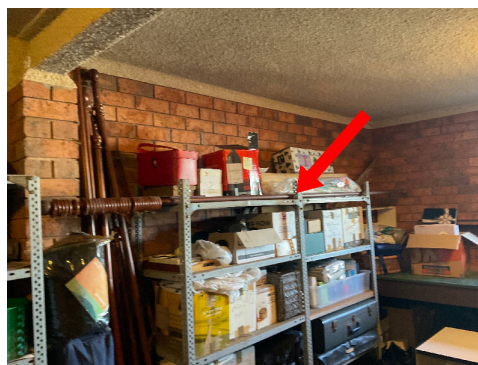
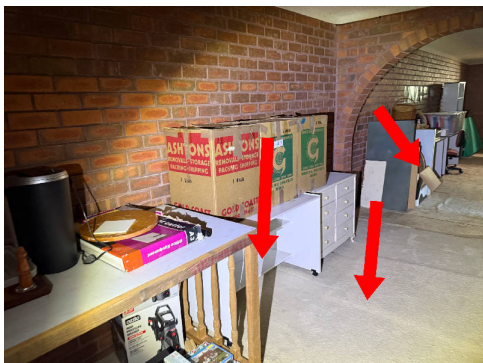
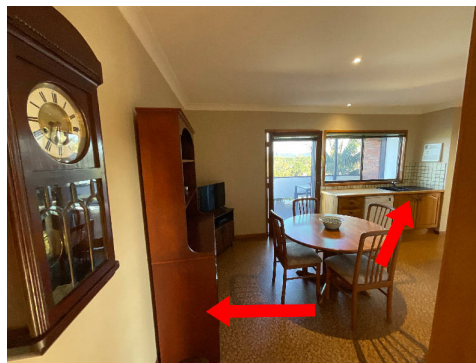
Finding: Additional Photos - Obstructions and Limitations of INTERNAL AREAS

Information: These photographs are an indication of the obstructions and limitations which impeded full inspection of Internal areas at the time of inspection. These obstructions can hide an array of defects and should be removed to allow full inspection to be carried out. A re-inspection is recommended once the areas are made accessible.

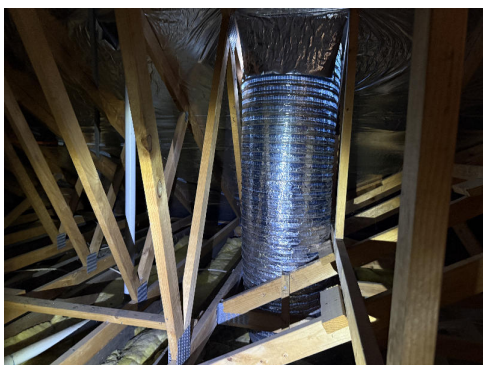
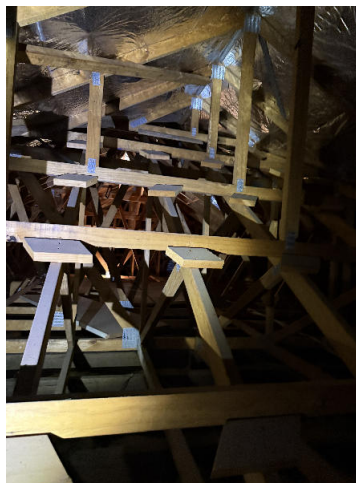
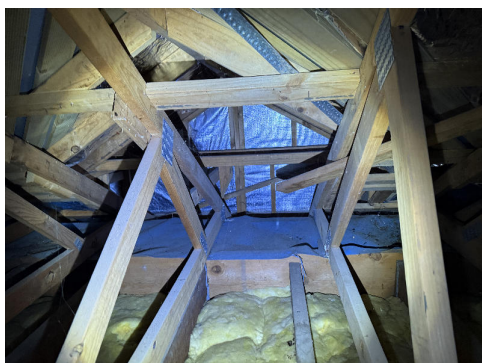
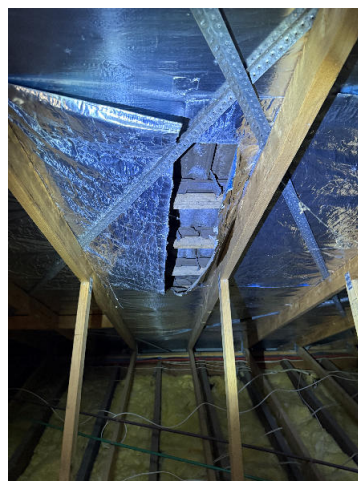
Finding: Additional Photos - Obstructions and Limitations of the ROOF CAVITY

Information: These photographs are an indication of the obstructions and limitations which impeded full inspection of roof cavity areas at the time of inspection. These obstructions can hide an array of defects and should be removed to allow full inspection to be carried out if applicable. A re-inspection is recommended once the areas are made accessible.
