Building and Timber Pest Inspection Report

Inspection Date: Thu, 19 Mar 2026

Property Address: 8 Maple St, Echuca VIC 3564, Australia

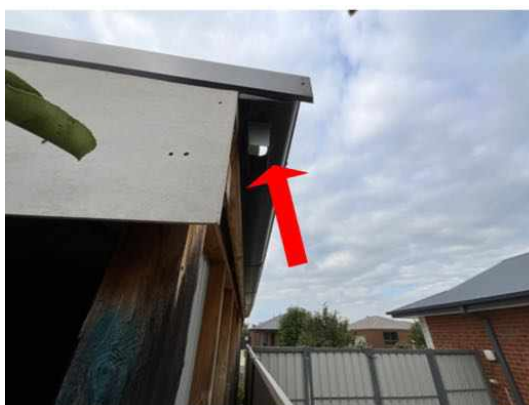
Finding 6.02

Building:	Building 1
Location:	Yard - Back, side, front
Finding:	Untreated or non-durable timbers in a hazardous environment
Information:	To reduce the risk of timber pest attack it is essential that timber used in a hazardous environment (e.g. in direct contact with the ground or frequently exposed to damp conditions) is of sufficient durability and/or is adequately preservative treated.
