Building Inspection Report

Inspection Date: Tue, 20 Jan 2026

Property Address: 6 Crane St, Berwick VIC 3806, Australia

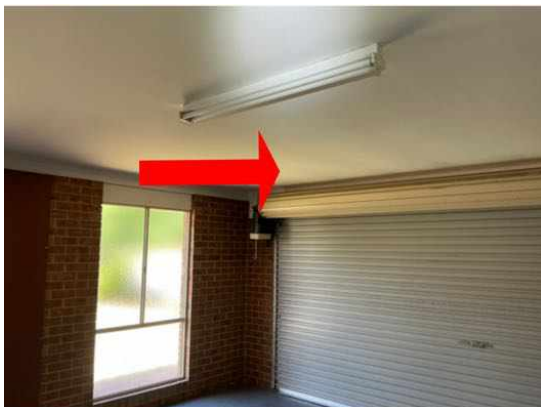
Defects 3.02

Building:	Main Building
Location:	Garage
Finding:	Minor sagging in the ceiling - garage

Information: Sections of the ceiling were found to be sagging slightly at the time of inspection. Sagging in the fixed ceiling structure generally indicates that the building materials have swollen due to contact with water or that fixings (e.g., nails or glue) have become loose and require reattachment. This is a very common defect in garages due to their lack of insulation and susceptibility to moisture. Condensation builds up in the roof and rests on the plasterboard, softening it somewhat, which makes it more likely to sag and release from its fixing points.

While damage is minimal at this stage, a licensed plasterboard contractor should be appointed to repair the ceiling. Insulating the area could be considered by the client once repaired.

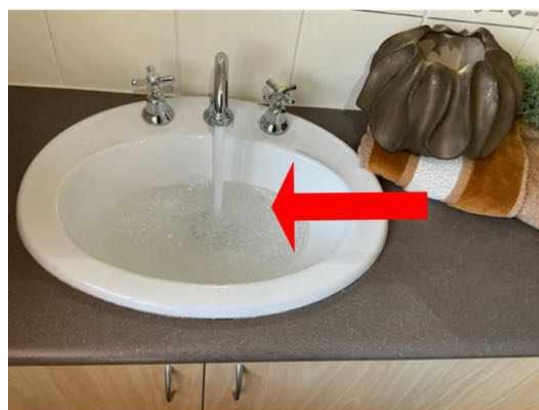
Defects 3.03

Building: Main Building
 Location: Ensuite - Master
 Finding: Slow Drainage in En-Suite Vanity Sinks
 Information: Upon inspection, the en-suite vanity sinks were found to have very slow drainage, resulting in water pooling within the basin during use. This issue is typically associated with a partial blockage within the sink drain, or excessive water flow which may lead to further plumbing complications if left unaddressed. Additionally, prolonged pooling of water can contribute to bacterial growth and potentially cause damage to surrounding cabinetry or surfaces due to excess moisture.

It is recommended that a licensed plumber be engaged to inspect and clear any obstructions within the drainage system as soon as possible to restore proper functionality and prevent further issues. Regular maintenance of sink drains is also advised to ensure efficient water flow.

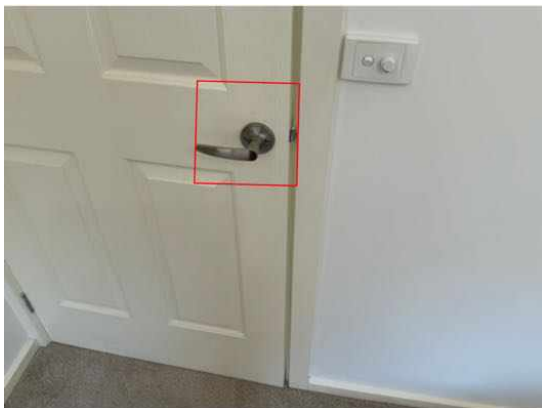
Defects 3.05

Building:	Main Building
Location:	Bedroom - Master
Finding:	Door handle - Not latching
Information:	It was noted that the door the master bedroom was not latching during operation at the time of inspection. Whilst detracting from the functionality of this building element, this minor defect may also be a security risk, and may therefore have serious implications if left unattended.

It is suspected that this defect has occurred due to minor issues with the associated hinges. Such damage is identified as general wear and tear, which is expected for building elements of this age.

A qualified carpenter or general handyperson may be appointed to perform rectification works as necessary, at client discretion. If left unattended, further functional impairment is likely to occur.

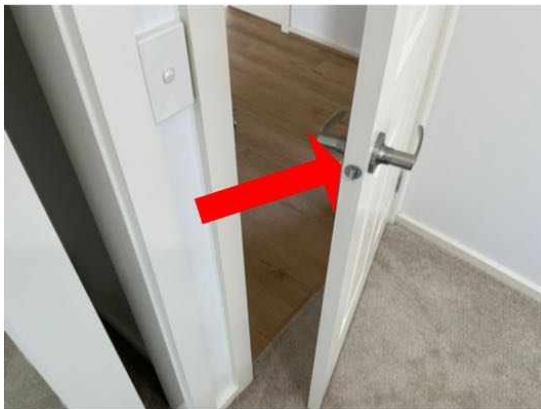
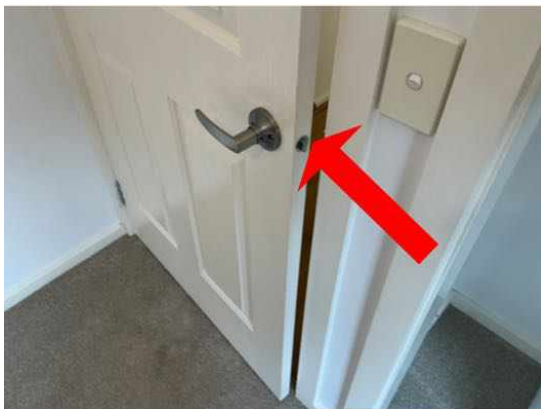
Defects 3.06

Building:	Main Building
Location:	Bedrooms 3 & 4
Finding:	Door handles - Not latching

Information: It was noted that the doors to both bedroom 3 and 4 were not latching during operation at the time of inspection. Whilst detracting from the functionality of this building element, this minor defect may also be a security risk, and may therefore have serious implications if left unattended.

It is suspected that this defect has occurred due to minor issues with the associated hinges. Such damage is identified as general wear and tear, which is expected for building elements of this age.

A qualified carpenter or general handyperson may be appointed to perform rectification works as necessary, at client discretion. If left unattended, further functional impairment is likely to occur.

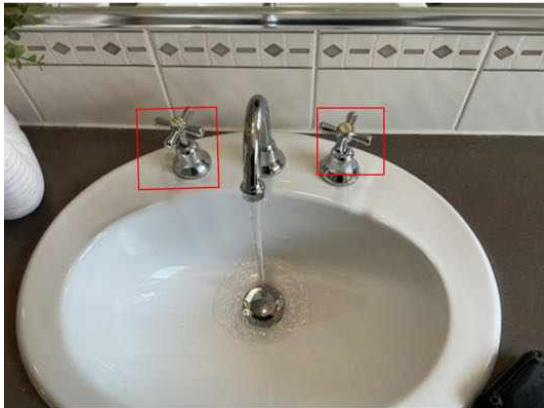
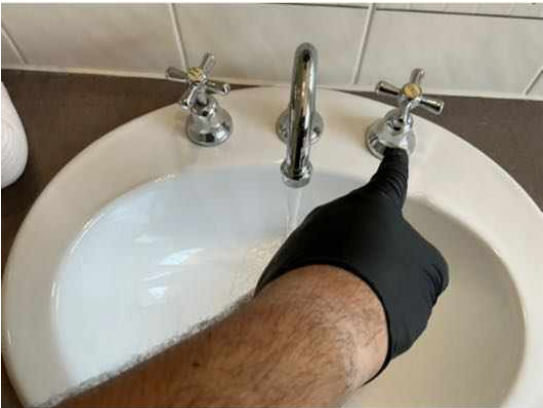
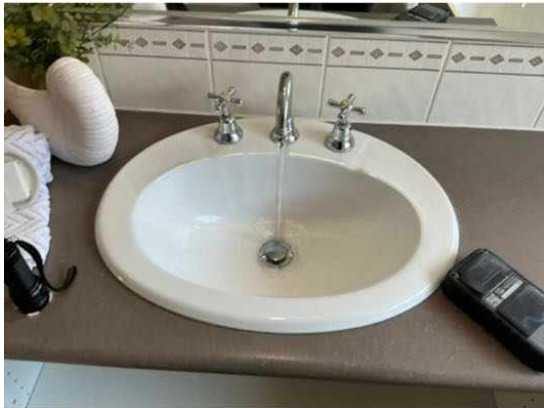
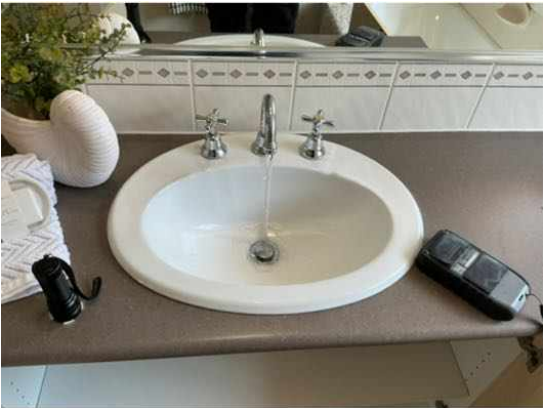
Defects 3.08

During the inspection, the basin taps to Bathroom 2 were found to be stiff to operate and difficult to open and close. The taps did not rotate smoothly through their full range of movement, and a high water flow was released with minimal turning of the tap handle, indicating possible internal wear or deterioration of the tap mechanism.

This condition can reduce user control, place additional strain on the tap assembly, and may worsen over time, potentially leading to leakage or failure of internal components.

It is recommended that a licensed plumber be engaged to assess the condition of the taps and carry out repairs or replacement as required to restore smooth operation and proper flow control.

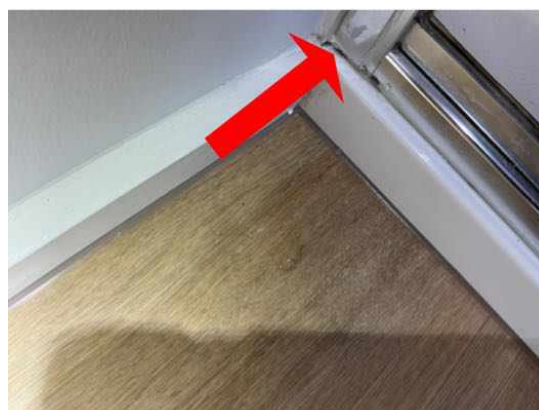
Defects 3.09

Building: Main Building
Location: Bathroom 2

Finding: Shower screen - Leaking

Information: Leaking was evident to the 2nd bathroom's shower screen at the time of inspection. It is suspected that the leaking has occurred as a result of deteriorated or missing caulking to the shower or general ageing of the building elements.

Leaking from the shower where left unattended, is likely to lead to water damage to adjoining flooring and walls. Such damage can lead to water damage and necessitate extensive remedial works being required. Active water leaks may also create an environment that is susceptible to the formation and development of mould.

Appointment of a caulking contractor is required to repair or replace the caulking to the shower area. Such works should be performed as soon as possible to ensure that no further damage occurs.

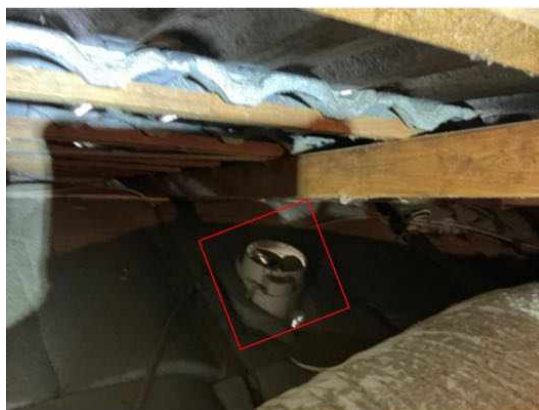
Defects 3.11

Building:	Main Building
Location:	Roof Void
Finding:	Bathroom Exhaust Fans Not Ducted to External Atmosphere
Information:	The exhaust fans installed in the bathrooms were observed to be discharging directly into the roof cavity rather than being ducted to the external atmosphere. This configuration does not comply with best practice ventilation standards, as it allows moist air to accumulate within the roof space.

Prolonged moisture build-up in the roof cavity can lead to elevated humidity levels, which may contribute to mould growth, timber decay, and potential damage to insulation or other roof components over time.

It is recommended that a licensed ventilation specialist or electrician be engaged to install compliant ducting that vents the exhaust air to the outside of the building, in accordance with current building regulations and ventilation standards.

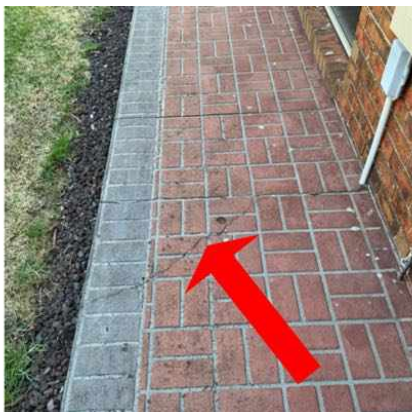
Defects 3.12

Building: Main Building
 Location: All External Areas
 Finding: Cracking - Damage Category 2 - Noticeable (up to 5mm)
 Information: Noticeable cracks are a common occurrence as a result of many primary defects. Such causes may include age, general wear and tear, expected building movement, general expansion/contraction of building materials in different weather conditions, and/or minor failings in the installation or application of building materials.

Noticeable cracks may result in minor sticking or jamming of associated doors and windows, which require easement. However, noticeable cracks are easily filled and repaired. A plasterer can be consulted to install an expansion joint at this point to allow for this movement during different weather conditions.

Monitoring of all cracking should be conducted frequently. Always contact a building inspector should cracks widen, lengthen, or become more numerous. Additionally, your building inspector should also be contacted if associated building elements such as doors and windows become more difficult to operate over time.

Relevant tradespeople, such as carpenters, painters and plasterers, should be appointed to perform remedial works, as deemed necessary.

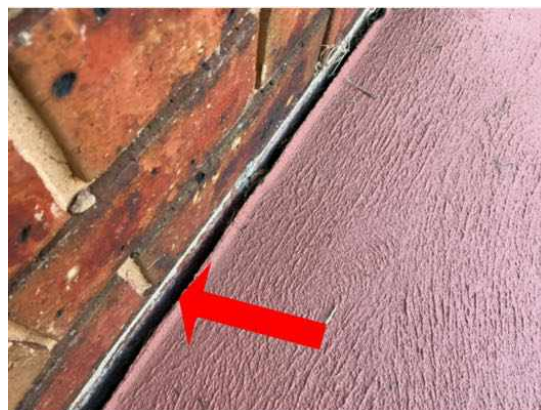
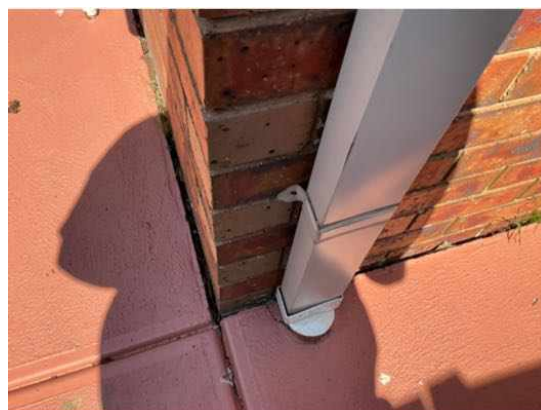
If rainwater penetrates through these gaps, it may lead to moisture accumulation beneath the slab and within the subfloor area, increasing the risk of structural damage and potential termite infestation.

It is recommended that a qualified caulking specialist be engaged to fill these gaps with a flexible, weatherproof sealant to prevent water ingress and help maintain the integrity of the building envelope. Timely remediation of these gaps will reduce the likelihood of associated structural and pest-related issues.

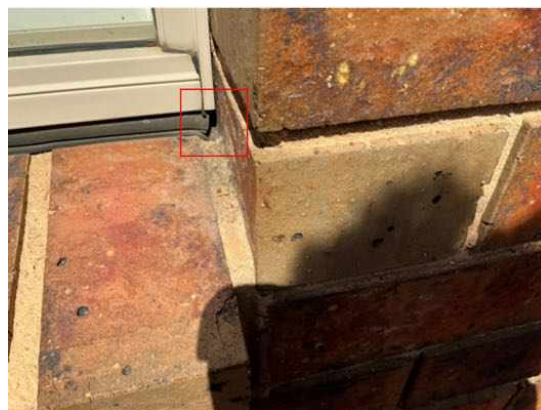
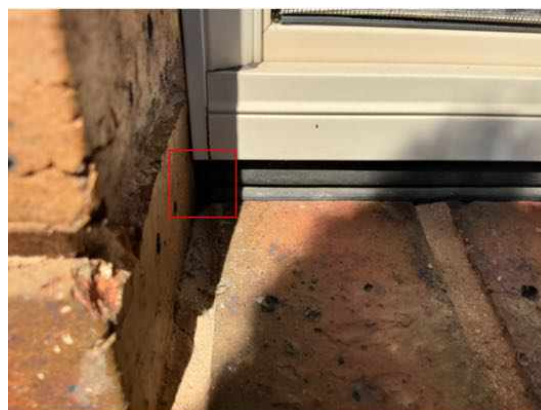
Defects 3.18

Building:	Main Building
Location:	All external areas
Finding:	Gaps Around External Window Frames
Information:	Multiple gaps were identified between the external window frames and the adjoining brickwork across several elevations. These gaps appear to be the result of either poor or inconsistent sealant application during installation, or deterioration of the original sealant over time.

Unsealed or poorly sealed gaps can allow moisture ingress, wind-driven rain, draughts, and provide potential entry points for pests. Ongoing exposure to moisture may also contribute to internal dampness and premature deterioration of surrounding building elements.

A qualified handyman or registered builder should apply a consistent, waterproof, flexible exterior-grade sealant around all affected windows to ensure adequate weatherproofing and protection against moisture and pest entry.

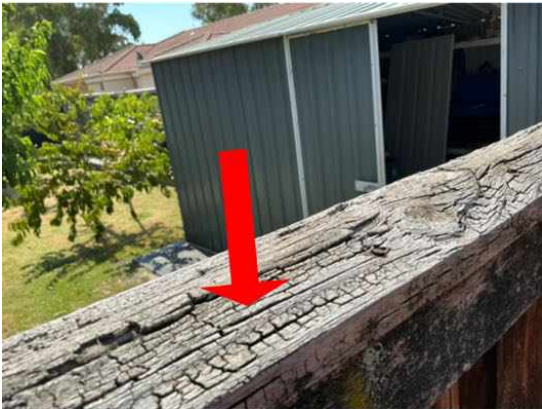
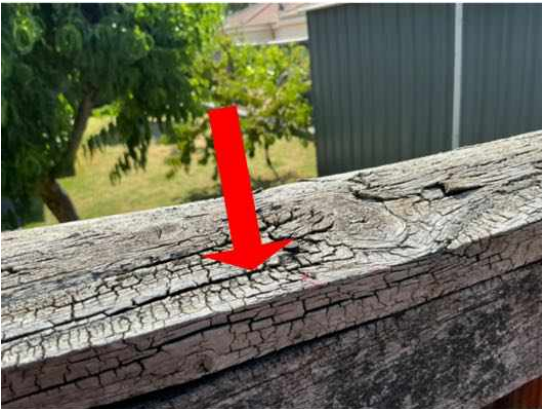
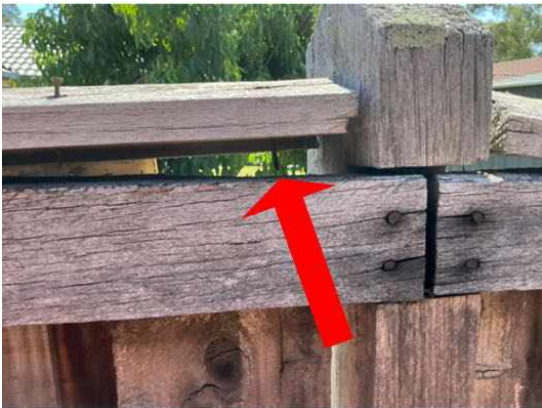
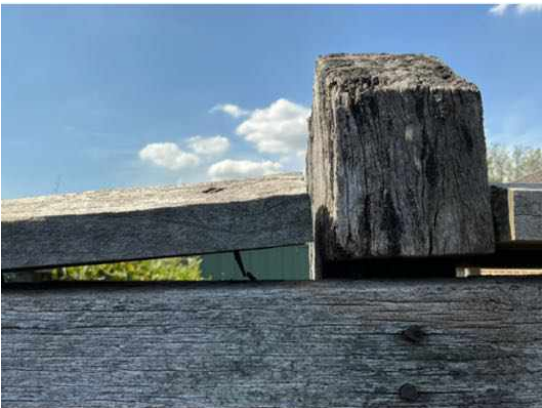
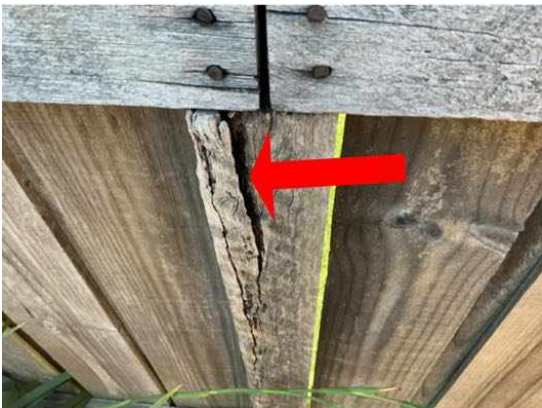
Defects 3.19

Building:	Main Building
Location:	All external areas
Finding:	Fencing - Deteriorated
Information:	It was noted at the time of inspection that sections of the fencing throughout the property have deteriorated and affected by wood rot. Typically fencing deteriorates due to age and or wear, rot and or rust which is generally expected for a structure of this age, due to prolonged exposure to weather conditions and fungal decay. Sometimes inadequate installation or maintenance can be to blame.

A licensed fencing contractor should be appointed to provide further advice and perform rectification works as necessary.

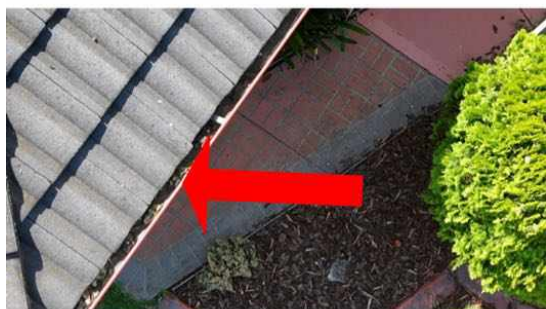
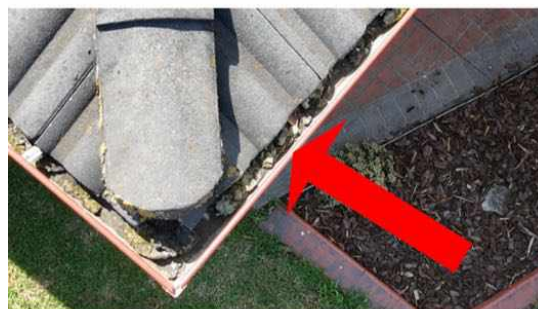
Defects 3.20

Building:	Main Building
Location:	gutters
Finding:	Gutters - Partially Blocked
Information:	Sections of the external gutters were partially blocked with debris, soil and leaves. Roof plumbing structures, such as guttering and downpipes, should be free of all

Blocked gutters are likely to lead to high levels of moisture in the affected areas. Such moisture will not only cause rust and decay of the associated building materials, but can also provide conditions that are conducive to termite and timber pest activity. Blockages in gutters should therefore be removed immediately to ensure dry conditions are maintained.

Consult a Licensed Plumber for further specific advice on remedial works that may be required. In the interim, it is highly advised that blocked gutters be removed by the homeowner or a general handyperson as a matter of urgency.

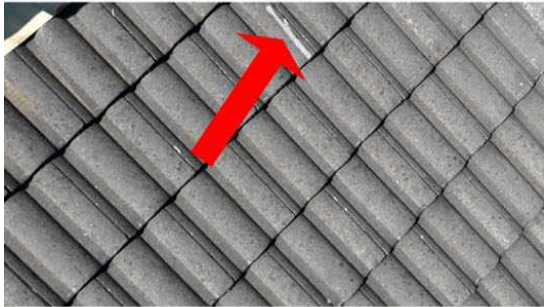
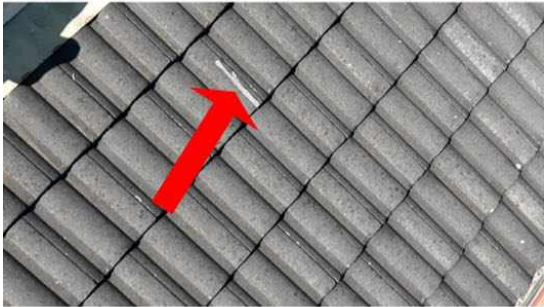
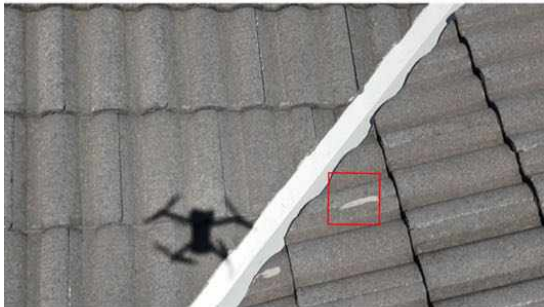
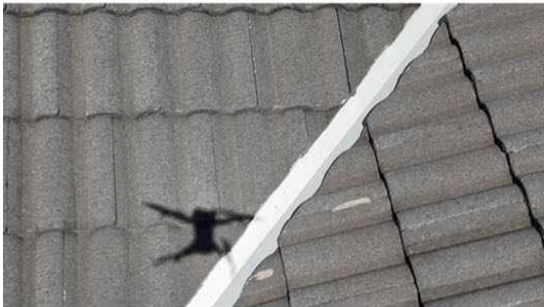
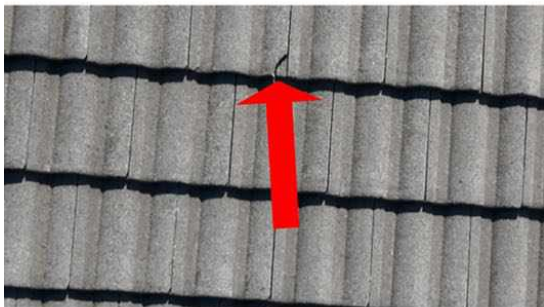
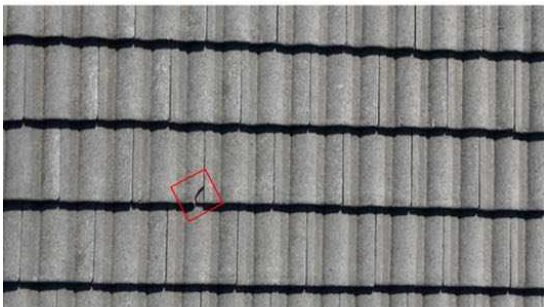
Defects 3.21

Building:	Main Building
Location:	Roof Exterior
Finding:	Roof tiles - Broken
Information:	Upon inspection of the exterior roof covering, broken roofing tiles were identified. Broken and friable roof tiles are generally the result of ageing and weathering of what is essentially a porous material.

If left to further deteriorate, broken and brittle roof tiles are likely to lead to water penetration via the roof into the ceiling space, causing secondary damage to ceiling linings, insulation and roof structures. Broken roof tiles are also likely to detract from the effectiveness of the roof drainage system, creating potential for secondary damage to the exterior roof covering and roof plumbing.

Replacement of broken tiles is required and should be performed by a roofing contractor as soon as possible.

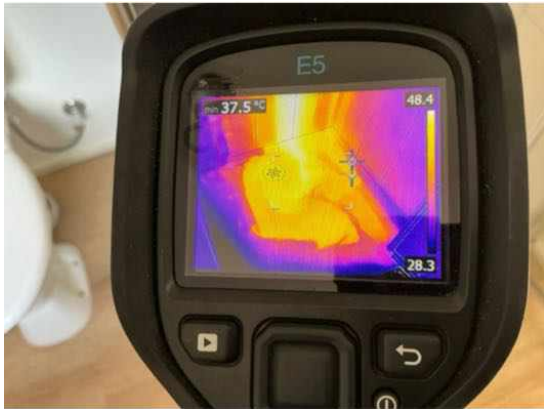
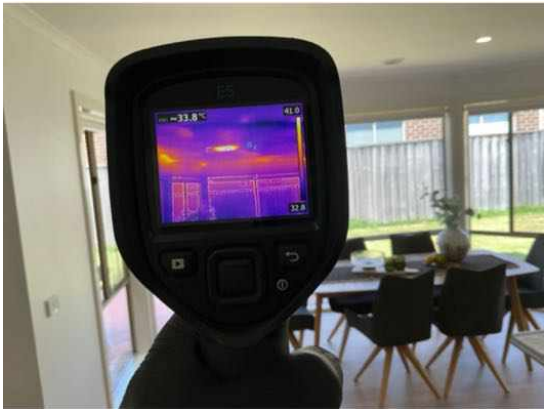
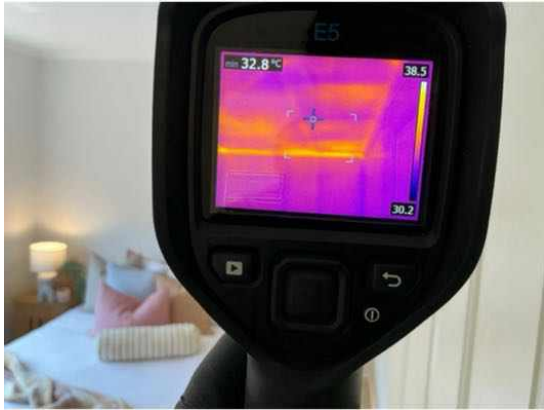
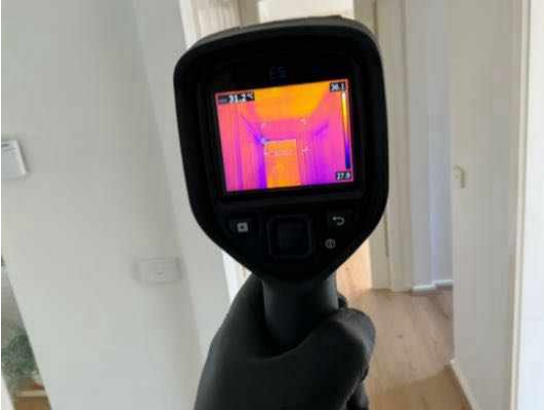
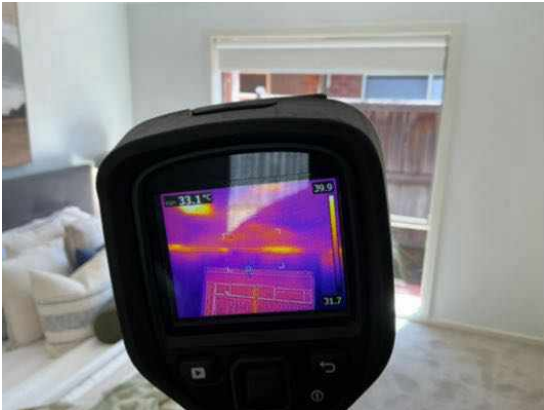
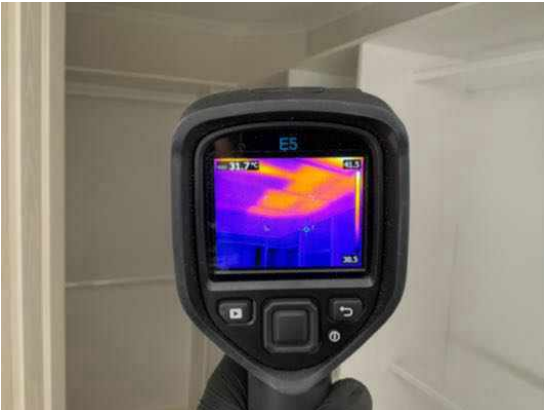
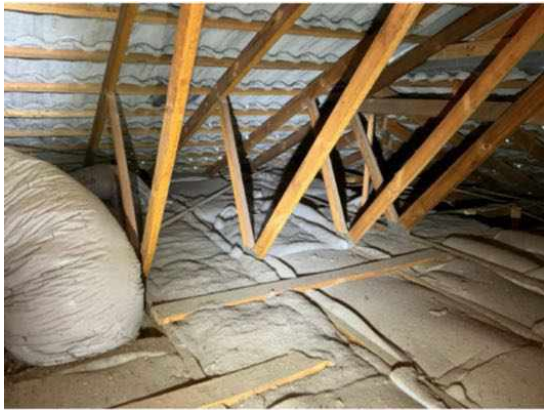
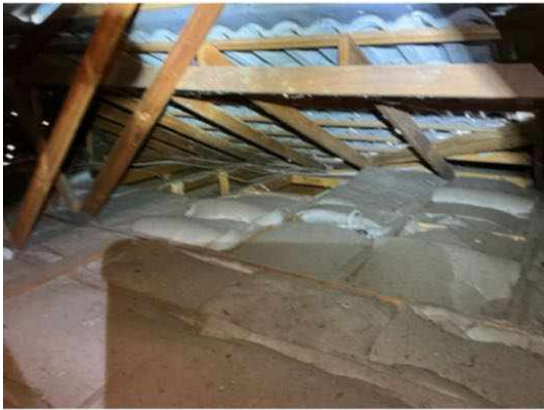
Building: Main Building
Location: All Areas
Finding: Additional Photos
Information: Additional photos are provided for your general reference

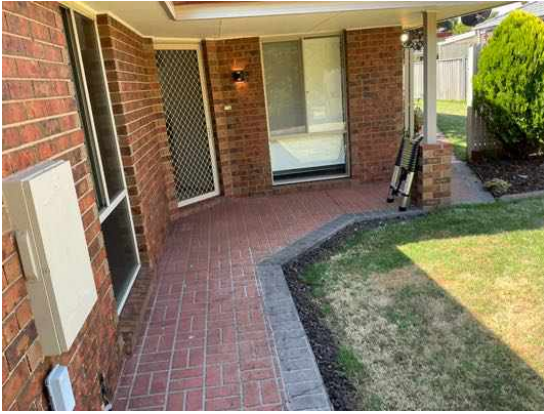
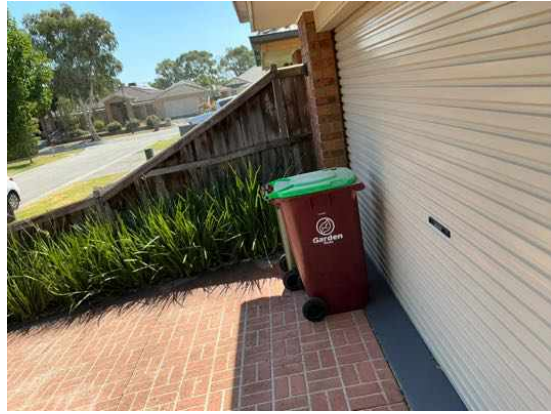
Building: Main Building
Location: All Areas
Finding: Additional Photos - Obstructions and Limitations
Information: These photographs are an indication of the obstructions and limitations which impeded full inspection of the property at the time of inspection. These obstructions can hide an array of defects and should be removed to allow full inspection to be carried out. A re-inspection is recommended once the areas are made accessible.

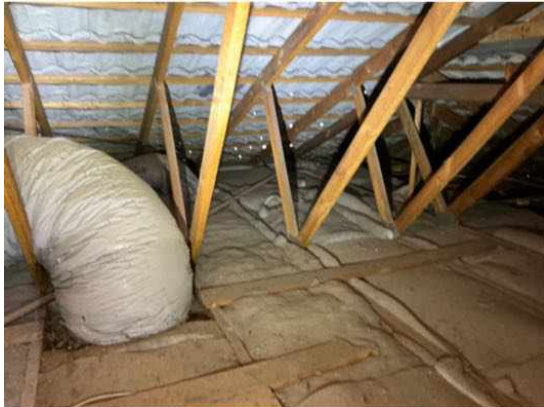
Finding: Obstructions and Limitations - roof cavity

Information: These photographs are an indication of the obstructions and limitations which impeded the inspection of the roof cavity area of the property at the time of inspection. These obstructions can hide an array of defects and should be removed to allow full inspection to be carried out. A re-inspection is recommended once the areas are made accessible.
