Building and Timber Pest Inspection Report

Inspection Date: Thu, 22 Jan 2026

Property Address: 18/38 Stanley Rd, Epping NSW 2121,
Australia

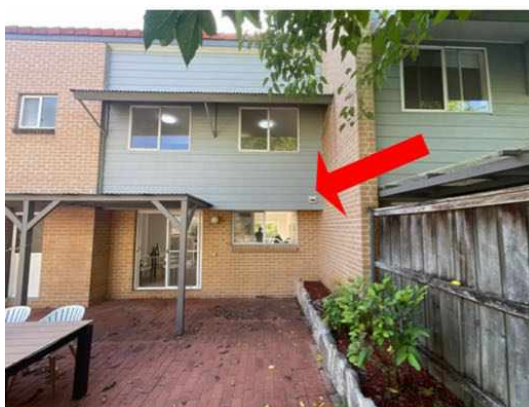
Finding 3.01

Building:	Main Building
Location:	Exterior walls - rear
Finding:	External Cladding - Damaged
Information:	At the time of inspection, the external cladding at the front elevation was found to be damaged. Further inspection by Licensed Building or Qualified Carpenter is highly recommended to ensure its safety and structural integrity of the area. If left unmanaged, the area is likely to deteriorate further, potentially creating not weather tight.

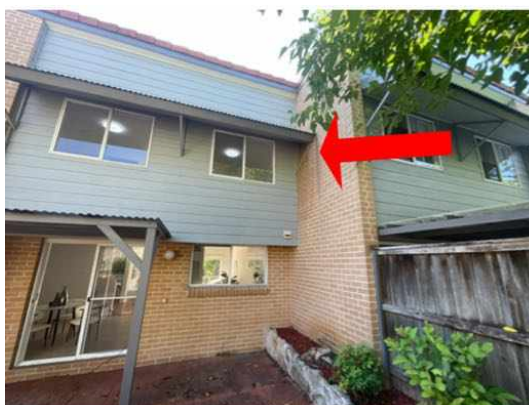
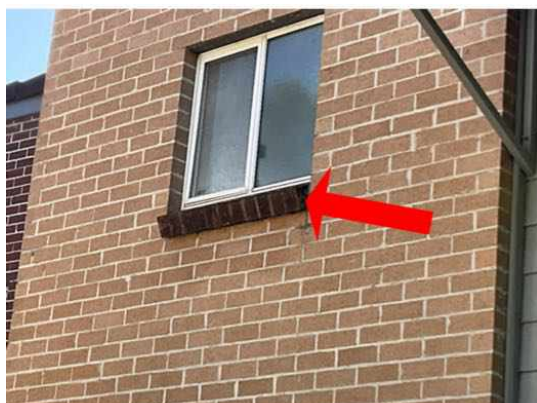
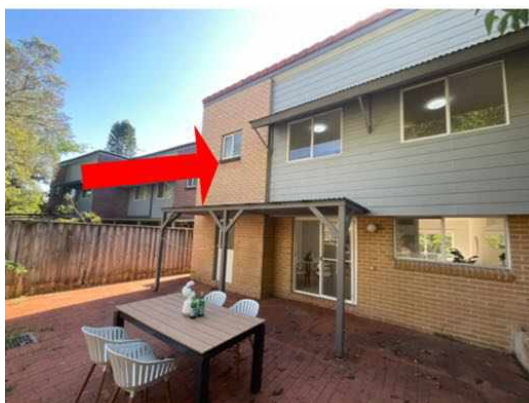
Finding 3.02

Building:	Main Building
Location:	Exterior walls - rear
Finding:	Excessive moisture - identified
Information:	Excessive moisture can attract termites and produce conditions that promote fungal growth and wood decay.

Excessive moisture is generally caused by deteriorated, inadequate or missing roof drainage, leaking plumbing pipes or fixtures, poorly plumbed HWS overflows or condenser units and poor site drainage.

If mould growth has been found there may be environmental biological or health issues involved. In these cases an appropriately qualified inspector should also be contacted.

Prior to any remedial works being performed a qualified plumber should be appointed to further inspect the property and to identify the cause of the excessive moisture. Works to remove affected building elements may then be necessary and should be performed by an appropriate tradesperson.

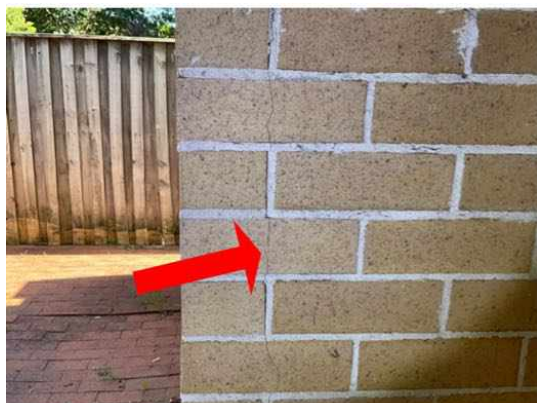
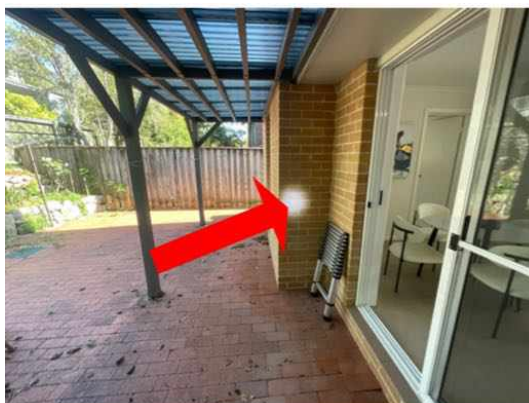
Finding 3.03

Building:	Main Building
Location:	Exterior walls - rear
Finding:	Cracking - Articulation joints absent
Information:	The articulation or control joints throughout the exterior walls were absent at the time of inspection.

When brick cracking occurs due to the absence of expansion joints between external claddings at the junction, it's primarily a consequence of inadequate allowance for the natural movement of materials. Here's a detailed look at this defect:

factors like temperature and moisture variations. Different materials expand and contract at different rates. Without expansion joints, this movement can exert stress on the adjacent render, leading to cracking.

Absence of Buffer Zone: Expansion joints act as buffer zones, allowing for controlled movement and relieving stress on the render. Without these joints, the forces generated by material expansion and contraction have nowhere to dissipate, causing the render to crack as it tries to accommodate the movement.

Structural Integrity Compromised: The absence of expansion joints may indicate a lack of consideration for structural dynamics during the design or construction phase. This oversight can compromise the structural integrity of the building, as unchecked material movement can lead to more significant issues beyond surface render cracks.

To rectify this defect, it's essential to retroactively introduce expansion joints between the external claddings at the junction. This may involve carefully cutting and retrofitting expansion joint materials or implementing alternative solutions, depending on the specific requirements of the building. Additionally, addressing any underlying structural issues and ensuring proper surface preparation before repairing the render can help prevent recurrence of cracking. Regular maintenance and monitoring are also necessary to identify and address any emerging issues promptly.

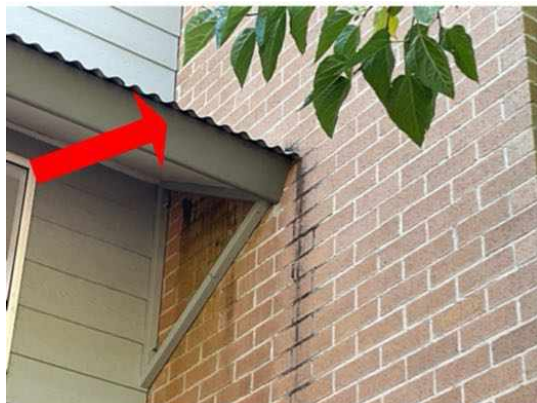
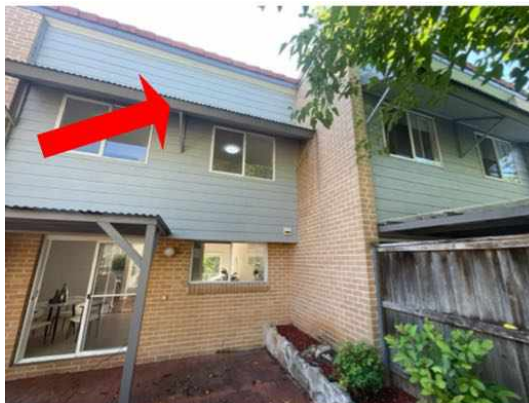
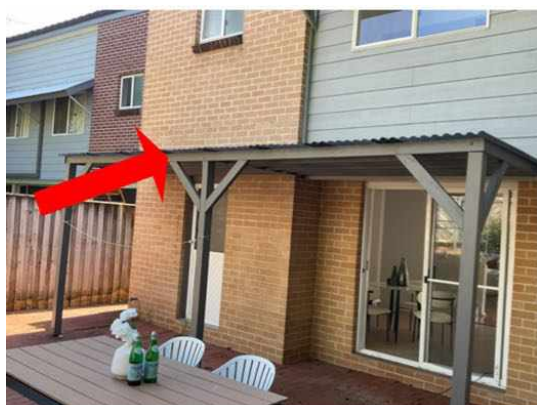
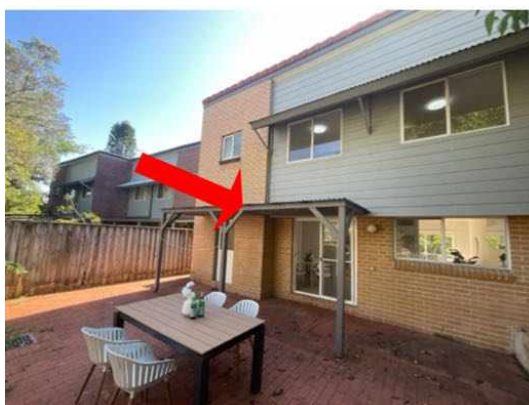
Finding 3.04

Building:	Main Building
Location:	Roof Exterior
Finding:	Building Element (Gutter) - Missing
Information:	Missing gutter were found to be present to roof plumbing work due to incomplete work.

Such missing gutter creates safety hazard and damp conditions in the affected area , causing potential for water pooling and subsequent water damage if left unattended. These conditions may also attract termite attack, particularly if the area is subject to minimal levels of sun throughout daylight hours.

It is highly advised that a licensed roof plumber or proper tradesperson be appointed to rectify any water leaks that may be present. Areas of repair and replacement of plumbing fittings and fixtures may be required and, as such, a quotation should be sought.

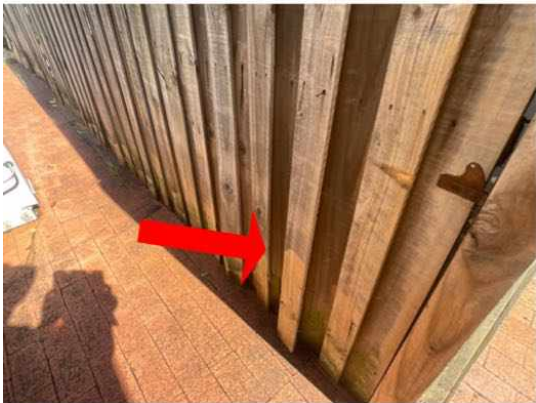
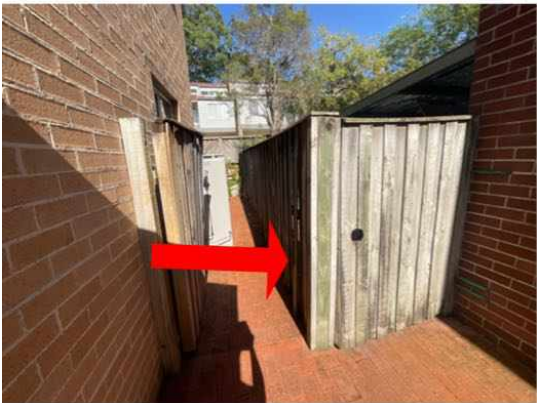
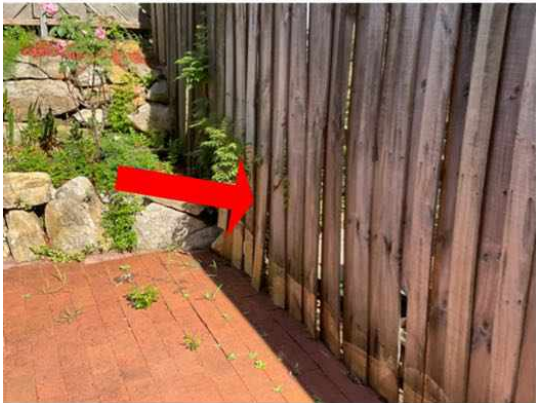
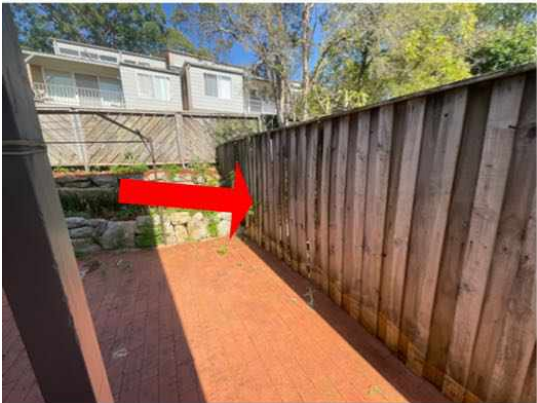
Finding 3.05

Building: Main Building
 Location: All External Areas
 Finding: Fencing - Deteriorated
 Information: It was noted at the time of inspection that sections of the fencing throughout the property have deteriorated. Typically fencing deteriorates due to age and or wear and or rust which is generally expected for a structure of this age, due to prolonged exposure to weather conditions. Sometimes inadequate installation or maintenance can be to blame.

If left unattended, it is likely that further damage will occur. It is suspected that repair of several elements of the fencing may be required however replacement may be a consideration of the client also.

A licensed fencing contractor should be appointed to provide further advice and perform rectification works as necessary.

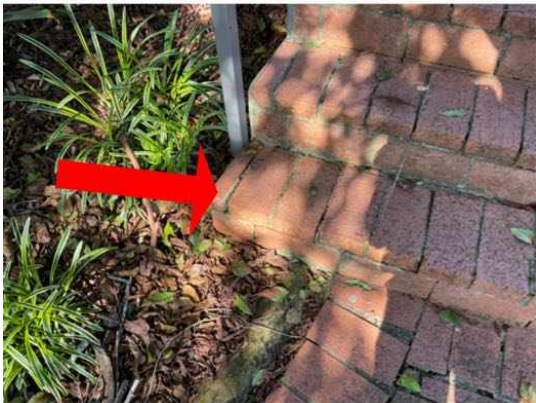
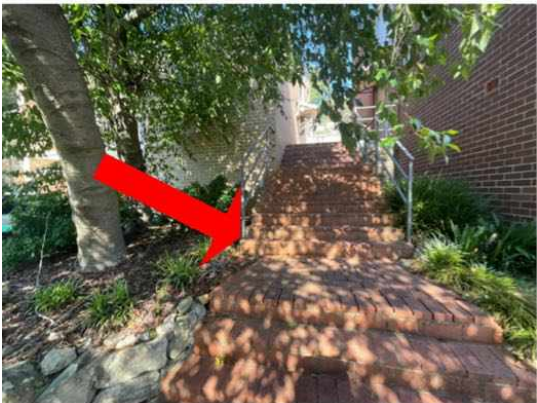
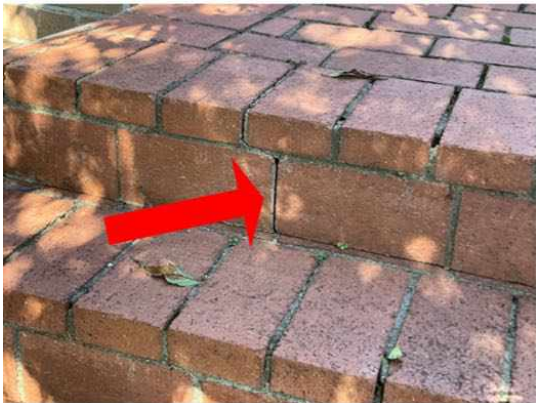
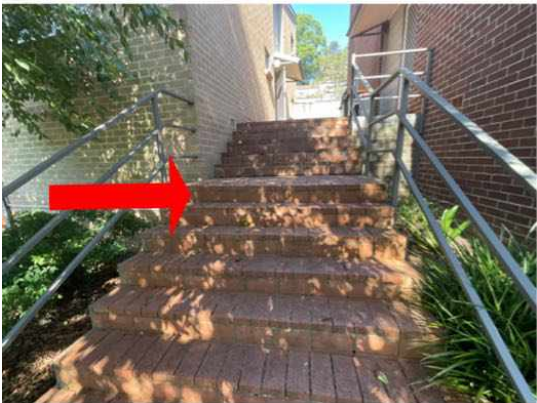
Finding 3.06

Building: Main Building
Location: All External Areas
Finding: Damaged paving
Information: At the time of inspection, damaged or broken paving were identified. Where this is due to the contractor workmanship or damage occurring during construction it is considered a defect. While being an appearance defect, such damage is expected during construction of a property. A relevant tradesperson should be appointed to perform these rectification works at discretion of the client.

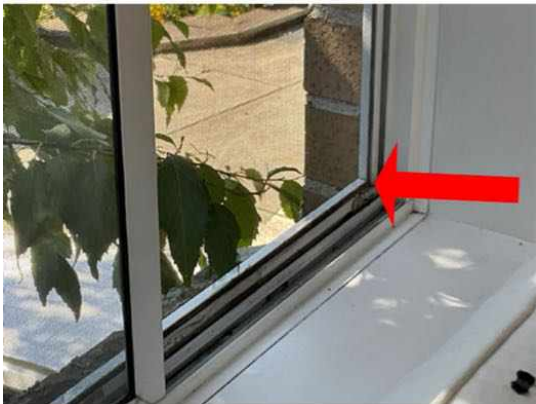
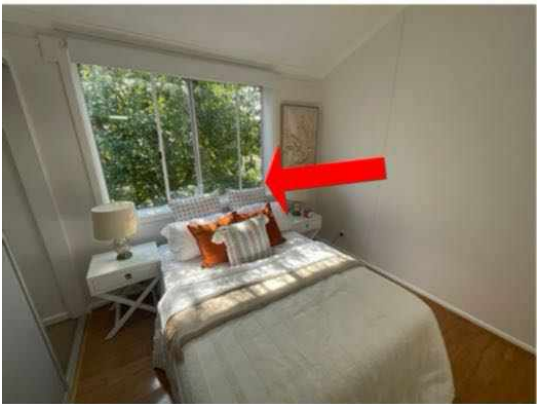
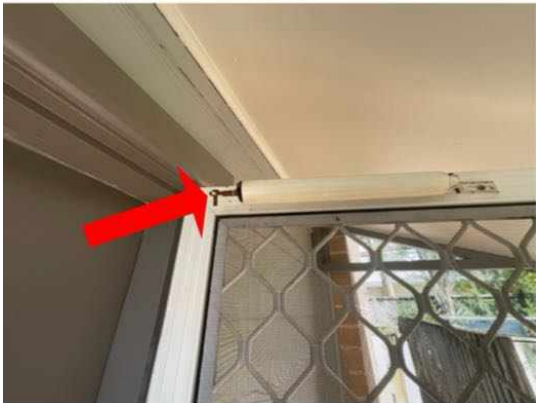
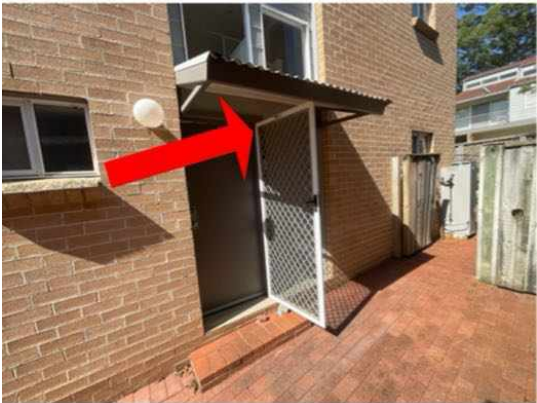
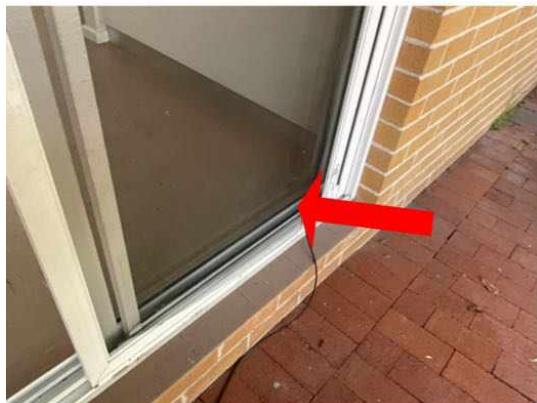
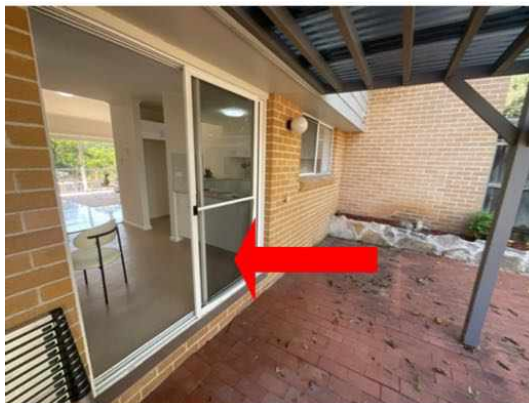
Finding 3.07

Building: Main Building
Location: All External Areas
Finding: Flyscreens - Damaged
Information: Flyscreens were found to be damaged to the windows in this area at the time of inspection. This damaged building element detracts from the operational state of the window. Where not replaced, damaged flyscreens allow pest and insect ingress into the adjoining room/s. It is advised that all damaged building elements be replaced in order to ensure the full function of all building structures. A general handyperson may be appointed to replace flyscreens at the discretion of the client.

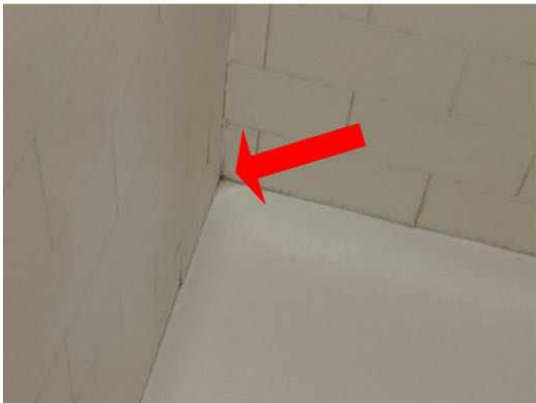
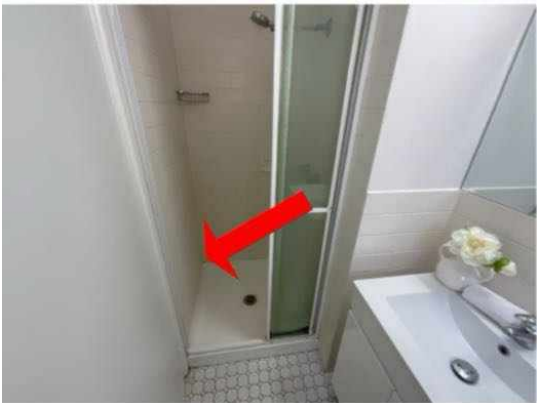
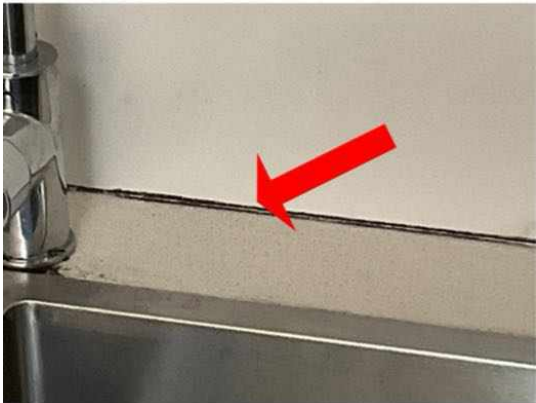
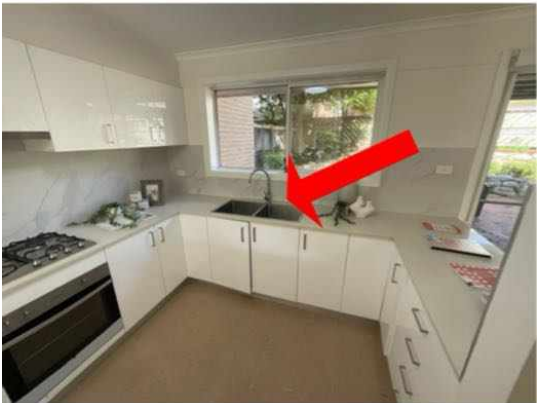
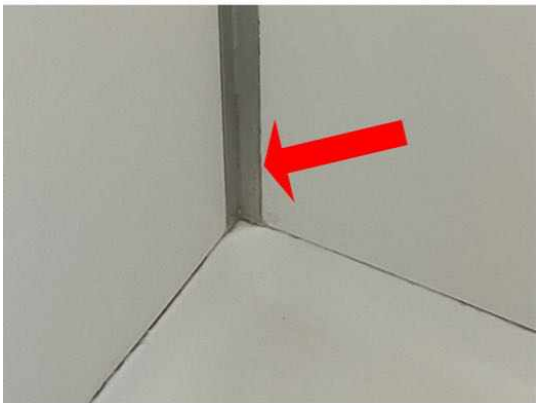
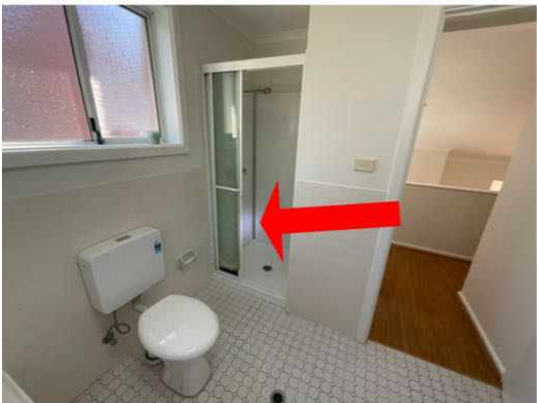
Finding 3.08

Building:	Main Building
Location:	Kitchen / Bathroom / Ensuite
Finding:	Sealant and grouting - Missing or damaged
Information:	It was noted on inspection that sealant or grout is degraded to the tiled shower alcove and or other areas of the bathroom.

Different materials and floor areas move at different rates, generally causing cracking to grout or sealant at this point. A flexible sealant is required to allow for expected expansion and contraction, while keeping the joint water tight and protective of all associated building materials.

There appears to be excessive mould to the sealant and grout which will likely require scraping out and replacement.

Flexible and mould resistant materials should be applied to affected areas to prevent any subsequent water damage that is likely to occur. Regular maintenance and replacement of damage or missing or damaged sealant and grout is highly recommended to the wet areas, as this is a regular wear and tear defect. Sealant and grouting in areas that come into regular contact with water should be maintained for the long term care of your property.

A sealant specialist or tiling contractor should be appointed to complete these works as soon as possible

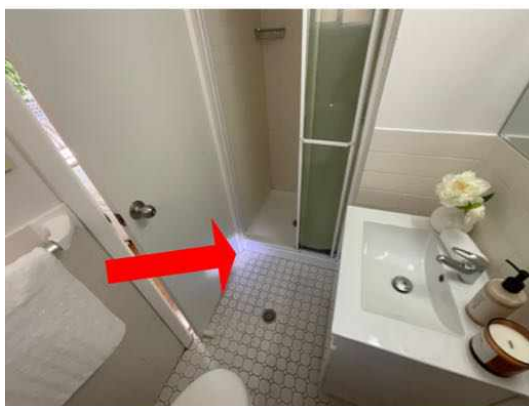
Finding 3.09

Building:	Main Building
Location:	Ensuite
Finding:	Signs of Past Water Damage to Timber Skirting Near Bathroom
Information:	Visible swelling and surface damage were noted to the skirting board and door frame near the recently renovated bathroom. The appearance is consistent with historical water ingress, likely from shower leaks or previous moisture intrusion into the wall/floor junction. No active leak was observed at the time of inspection, but the affected timber and paintwork suggest prolonged prior exposure to moisture.

No urgent repair required if the bathroom waterproofing has been properly upgraded during the renovation. However, the damaged skirting/trim should be monitored and replaced or repaired if deterioration continues. A moisture assessment with a meter is recommended to confirm no ongoing leak.

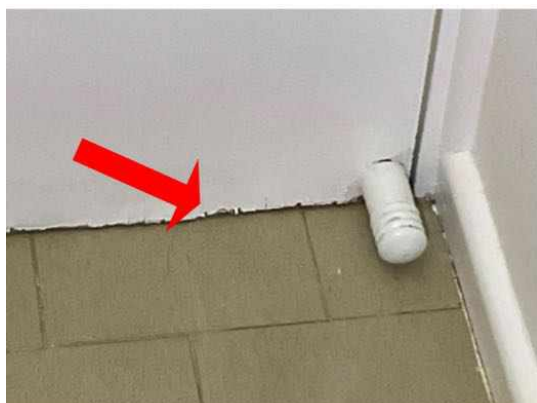
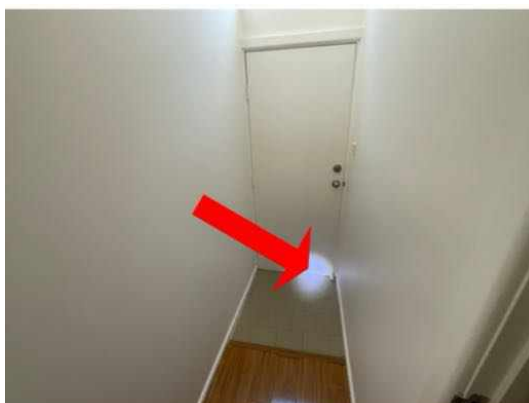
Building:	Main Building
Location:	Entry
Finding:	Door - swelling and damage at the bottom edge
Information:	Swollen and damaged door base in bathroom due to moisture exposure. Edges show fraying and surface degradation.

Replace or seal the affected door. Ensure door edges are properly sealed to prevent future water damage.

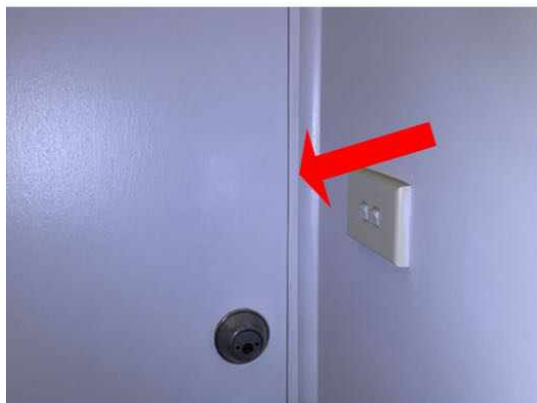
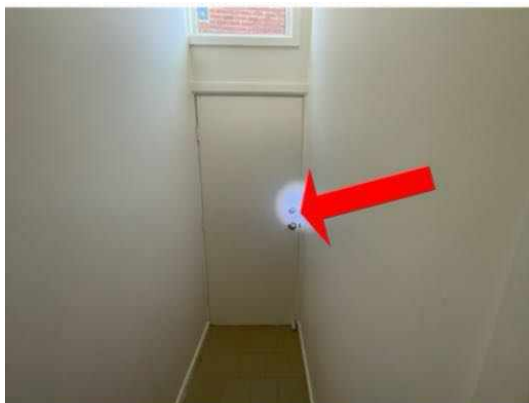
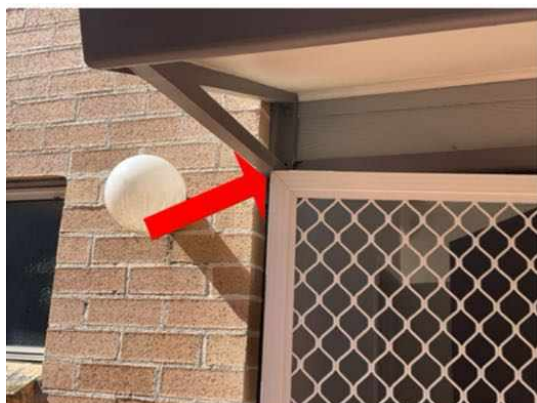
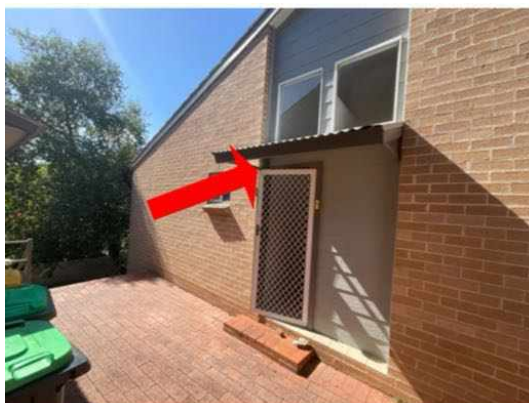
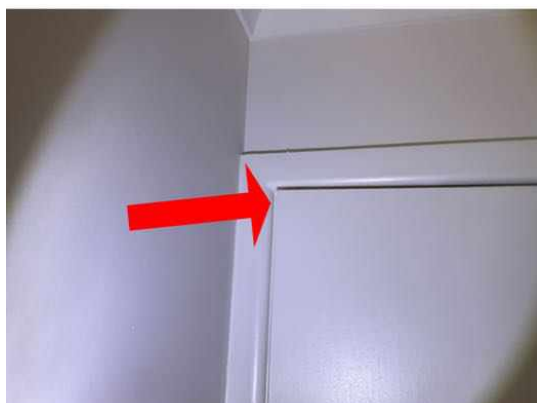
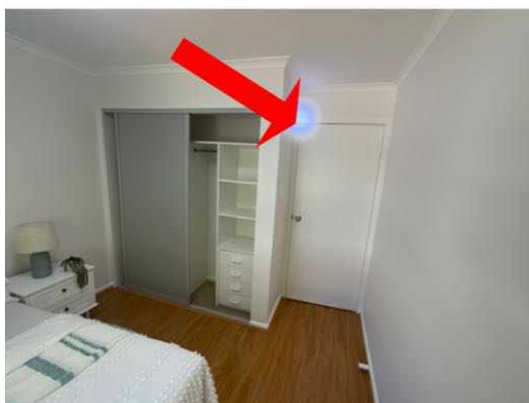
Finding 3.11

Building:	Main Building
Location:	All Internal Areas
Finding:	Door - Jamming or Binding
Information:	Binding and/or jamming of this door is evident during standard operation. This defect inhibits the functionality of the affected door as well as creating potential for secondary defects to associated building elements, such as damage to the floor covering. A door that binds to flooring or to the associated door frame may have several causes, ranging from minor defects, such as poor installation of the door or deteriorated hinges, through to major structural issues, such as damage to subfloor structures. Where door binding/jamming appears to indicate major structural issues, a registered

builder specialising in re-stumping should be appointed to provide an estimate on the cost of rectification. For minor causes, a qualified carpenter or general handyperson should be appointed to perform minor rectification works at client discretion.

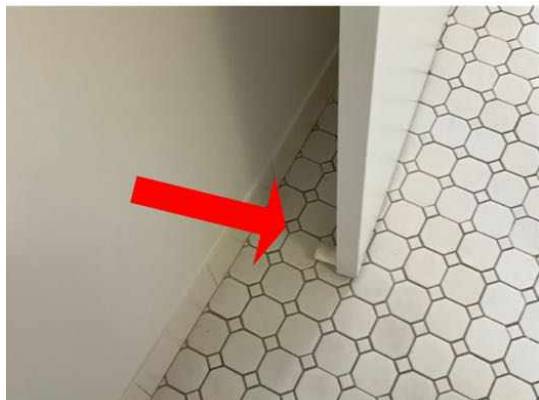
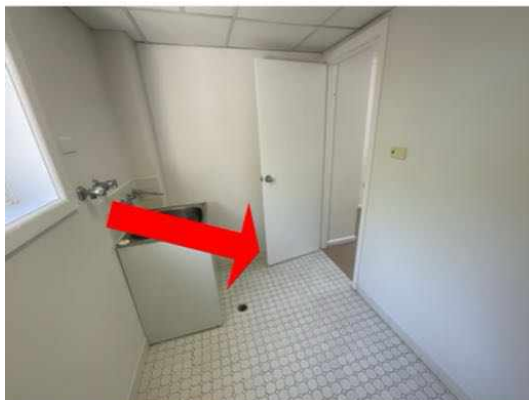
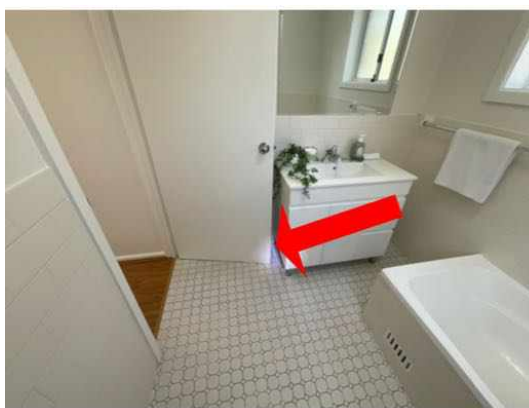
Finding 3.12

Building:	Main Building
Location:	All Internal Areas
Finding:	Door stop - Missing
Information:	The door stop is missing or is inadequate to stop the door handle from damaging the wall. Although some building elements may seem irrelevant or unnecessary, all building elements play a key role in the operation and function of the overall structure

and its performance.

Re-installation or replacement of the door stop is advised as soon as possible to prevent any subsequent damage to the door or associated structures. A general handyman may be appointed to perform these works at client discretion.

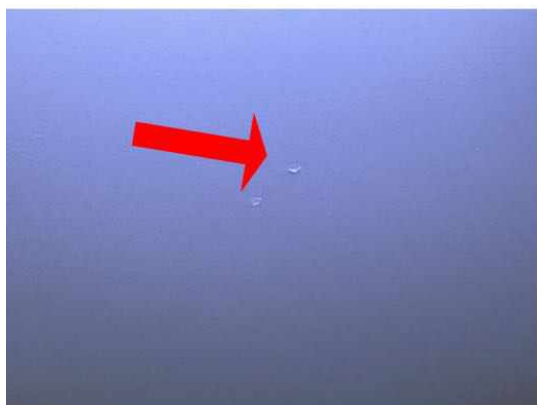
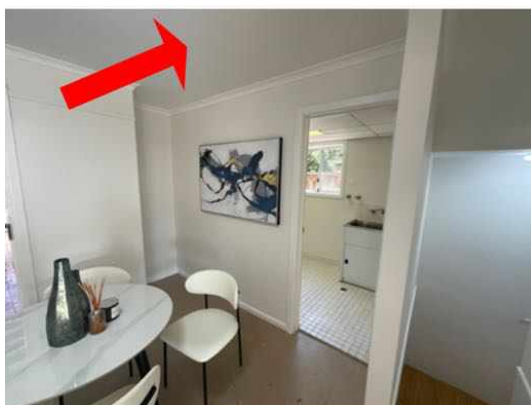
Finding 3.13

Building:	Main Building
Location:	All Internal Areas
Finding:	Ceiling nails - Popping
Information:	Numerous popped nails were identified in the internal ceiling at the time of inspection. Nails and screws hold simply by the friction between them and the surface they are applied to. Over time, the nails and screws can back out, which is often a result of general ageing and deterioration of the building structure.

If left unmanaged, the ceiling sheets may become loose and unstable, increasing the rate of deterioration of the internal ceiling and creating potential for the development of secondary defects.

Re-fastening of popped nails will help to maintain the stability of the internal ceiling and associated building elements. Such minor works will also help to improve the appearance of the affected area and secure the ceiling sheets, so as to prevent the onset of ceiling sagging. These works should be performed by a qualified carpenter or

plasterer at client discretion.

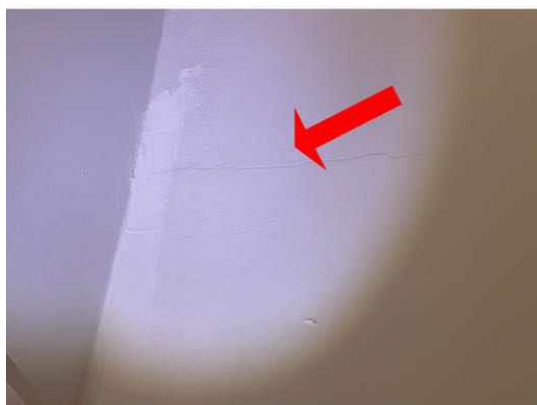
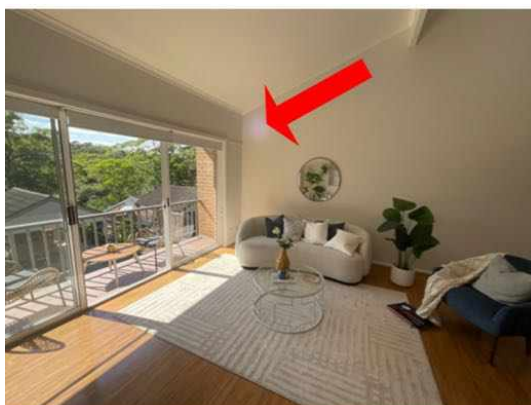
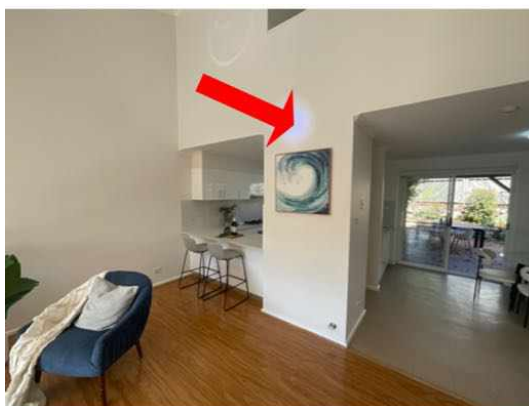
Finding 3.14

Building:	Main Building
Location:	All Internal Areas
Finding:	Cracking - Damage Category 1 - Fine (up to 1mm)
Information:	Although fine cracks are quite noticeable, they are often only considered to be an appearance defect, and usually do not indicate any structural damage. Generally, the cause of a fine crack is indicative of a separation between building materials and finishes (e.g. paint, plaster, etc.) along joins.

Cracking of this nature can generally be repaired with minor sanding, filling and/or repainting. Such works should be performed by a qualified painter or a general handyman.

Monitoring of all cracking should be conducted frequently. Always contact a building inspector should cracks widen, lengthen, or become more numerous.

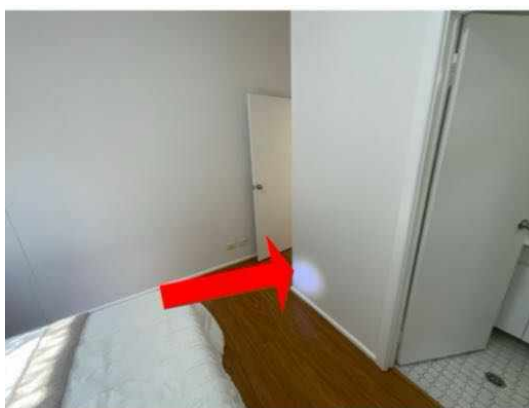
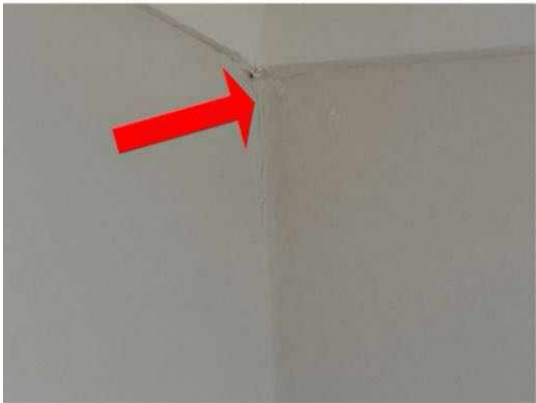
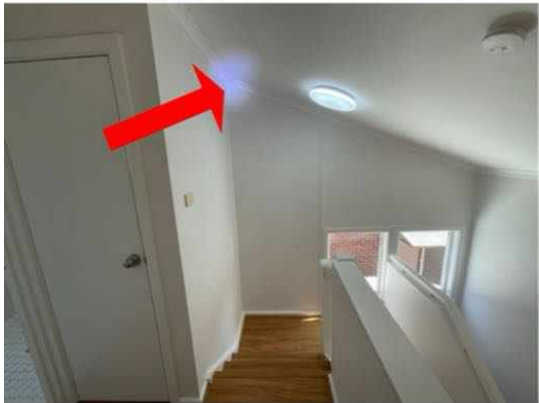
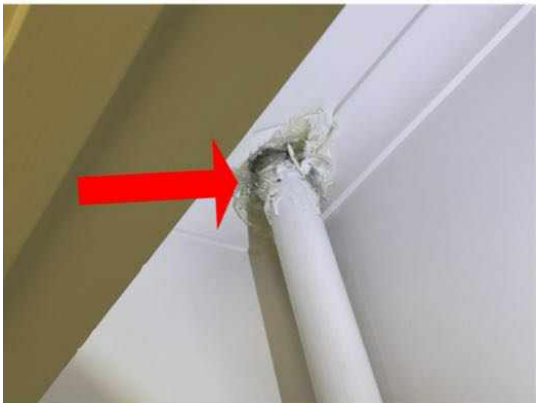
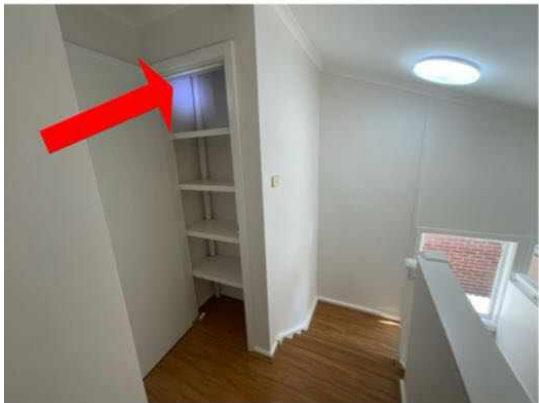
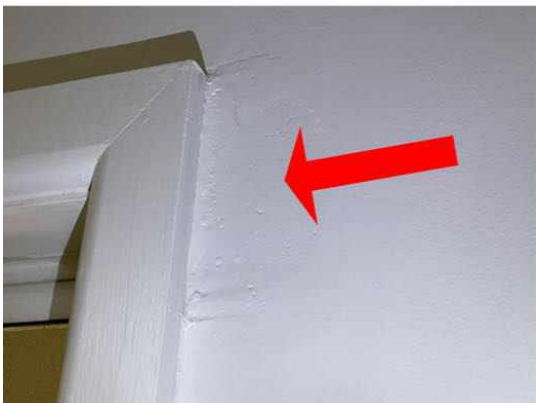
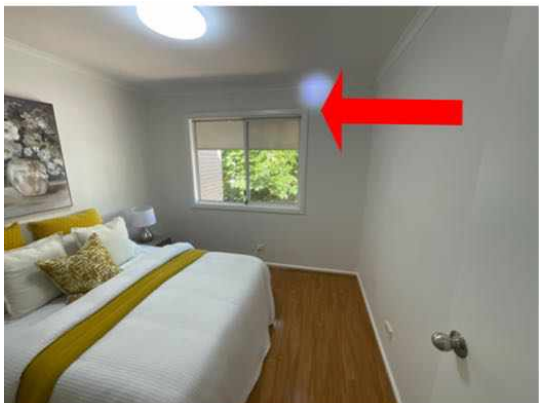
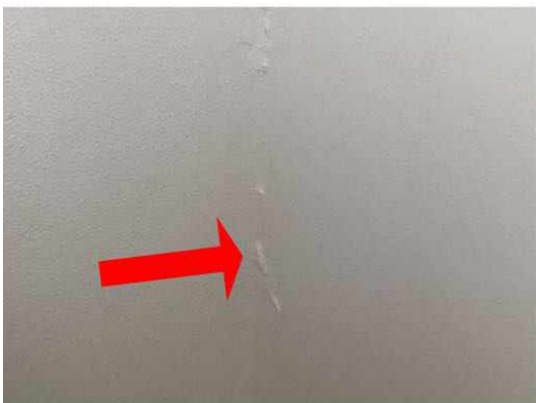
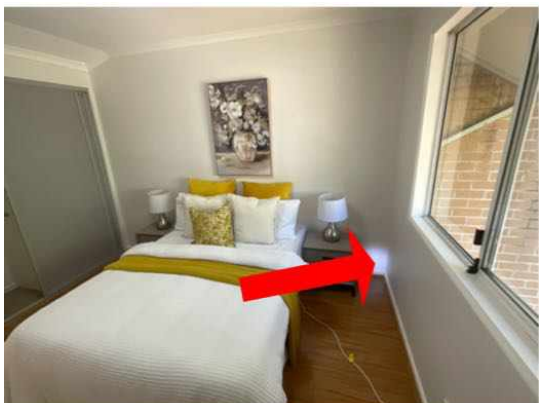
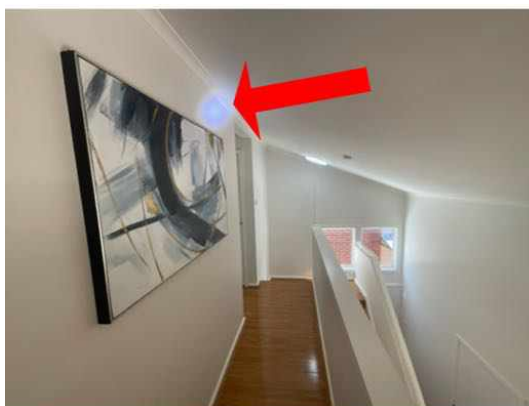
Finding 3.15

Information: The paint finish in this area was found to have been completed to a substandard level. Substandard painting is generally classified as an appearance defect. However, the substandard appearance may also be indicative of poor surface preparation and substandard workmanship.

If this applies, further areas of poor and incomplete finishes could develop over time. Furthermore, substandard paint finishes in areas exposed to moisture, e.g. external areas or wet areas, could lead to deterioration of underlying building materials.

Substandard paint finishes should be sanded back, filled, leveled and repainted, as applicable. Where inadequate paint protection has led to the deterioration of the associated building element, repair and/or replacement of this building element may be required.

A painting contractor should be appointed as soon as possible to perform necessary works to aid the appearance of the affected area and to ensure that the area is protected against further deterioration. Alternatively, the homeowner following manufacturer instructions may be able to provide this service.

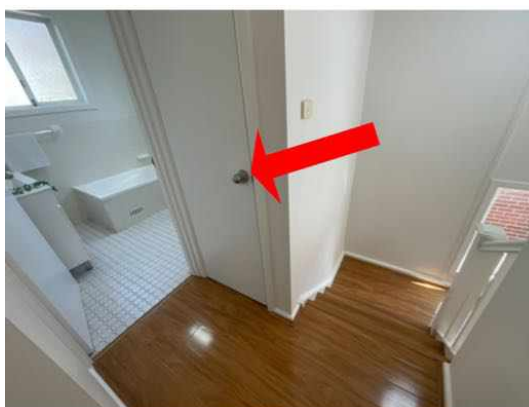
Finding 3.16

Building:	Main Building
Location:	Linen Cupboard
Finding:	Fitting (door handle) - Loose
Information:	The fitting in this area is loose and requires adjustment to tighten.

If left unmanaged, the fitting may further deteriorate, causing potential for the development of other minor secondary defects.

A relevant tradesperson should be appointed to perform these rectification works at discretion of the client.

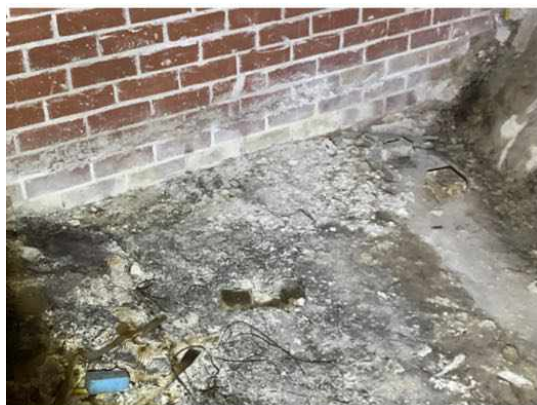
Finding 3.17

Building:	Main Building
Location:	Subfloor
Finding:	Subfloor - Lack of ventilation
Information:	It was noted at the time of inspection that the subfloor area lacks adequate ventilation. Ventilation can be restricted by a variety of minor defects, including obstructions in the subfloor space, a lack of vents or a low clearance.

A well ventilated subfloor aids in maintaining dry conditions, preventing secondary damage such as wood rot and pest activity, as well as preventing the development of

mould and mildew (which can lead to respiratory safety hazards for occupants).

The initial step in improving ventilation is to ensure that the subfloor area is free of any debris or stored items. Where ventilation is still inadequate, it is advised to ensure that all vents are clear of blockages, and additional vents may be installed.

The client may also consider mechanical ventilation (powered fans) to improve subfloor airflow. Remedial works should be conducted as a matter of urgency to protect against the development of potentially harmful subfloor conditions.

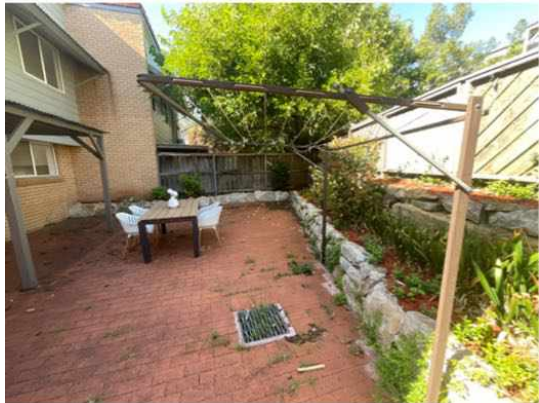
Finding 6.01

Building: Main Building
Location: All Areas
Finding: Garden Beds - Conditions Conducive to Termites
Information: Garden beds were found to be evident in the garden area. These garden beds can include untreated timber, and with a combination of moisture from watering hosing can make conditions conducive to termite activity and termite ingress.

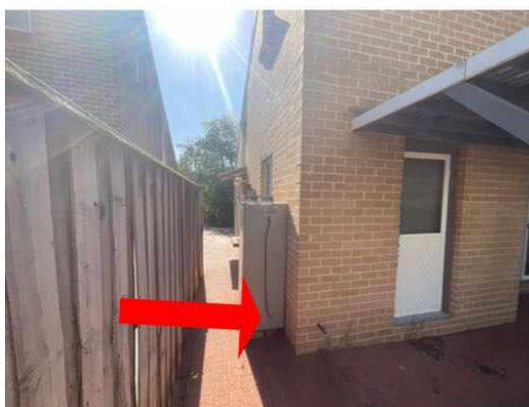
Finding 6.02

Building:	Main Building
Location:	All Areas
Finding:	Gravity-Fed HWS - Disconnected
Information:	It was noted at the time of inspection that a disconnected gravity-fed hot water system (HWS) remains in this area.

Despite this plumbing structure being unused, it is likely to be storing residual water, and is therefore susceptible to rust and corrosion. If allowed to continue, rust and corrosion is likely to lead to damage to adjoining building elements, and may also make the area susceptible to termite or timber pest activity.

While it is a costly exercise to remove the disused gravity-fed HWS, it is advisable in the short-term future to prevent any further damage to the area. Further consultation with a licensed plumber is required to gain further advice on removal of the structure.

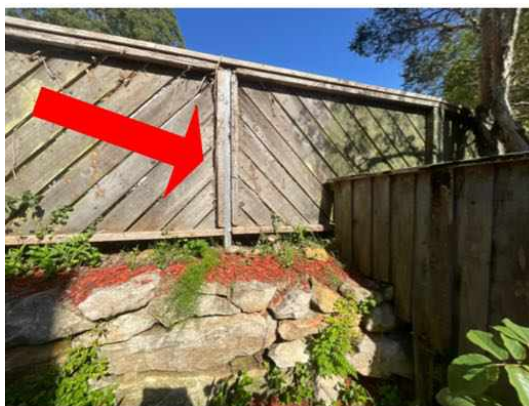
Finding 6.03

Building:	Main Building
Location:	All Areas
Finding:	Timber - exposed to weather
Information:	External timbers that are frequently exposed to harsh weather conditions require

adequate protection in order to maintain their condition. Where timbers have not been painted or treated adequately, general deterioration is likely to occur at an accelerated rate.

If left unattended, replacement of these timbers is likely to be necessary in the short-term future. Adequate treatment of these timbers is required as soon as possible by a painting contractor or general handyman.

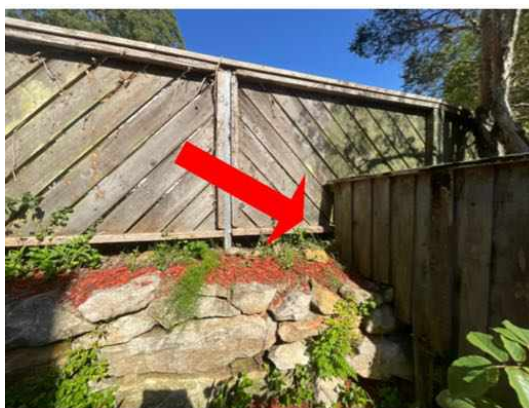
Finding 6.04

Building:	Main Building
Location:	All Areas
Finding:	In ground contact
Information:	Any timbers in direct ground contact provide opportunity for concealed termite entry and are likely to be subject to premature rot and decay as the soil retains moisture or damp conditions against the timbers.

Remove untreated timber that is in direct contact with external grounds. Consider replacement with more durable materials i.e. treated timber or non timber elements. Frequent pest inspections are advised to readily identify any termite activity in these areas.

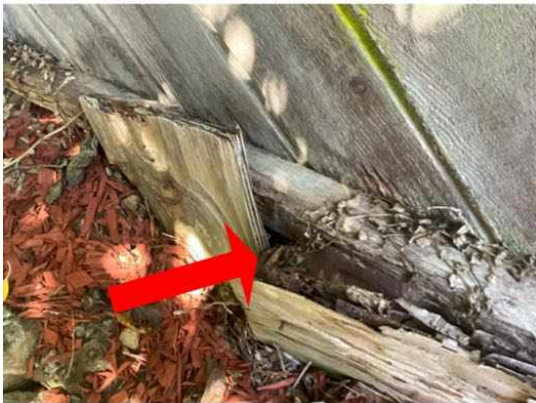
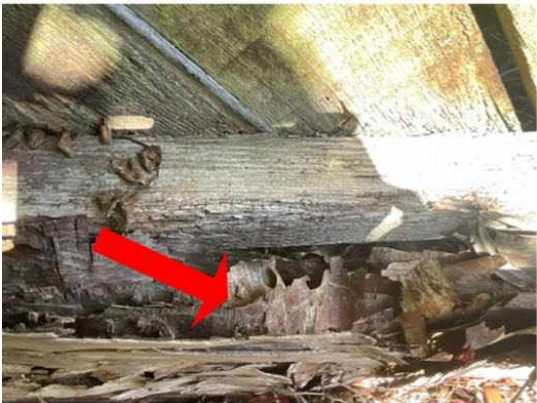
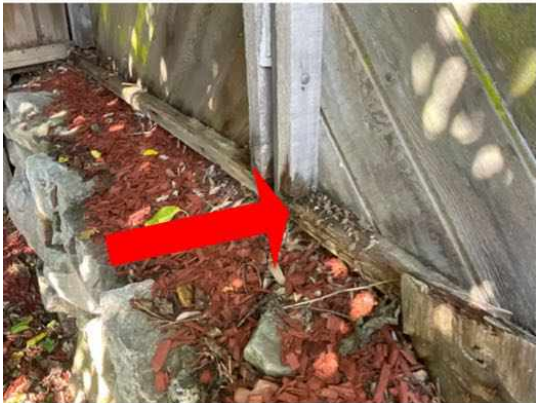
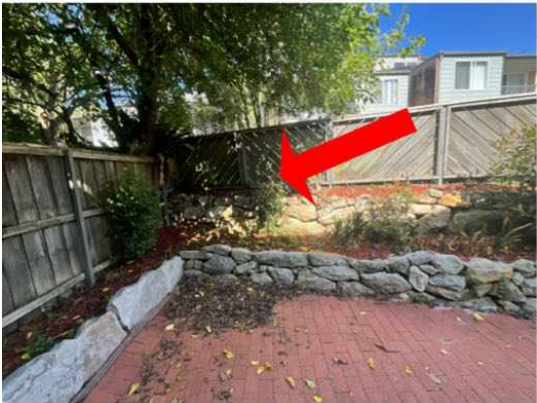
Building:	Main Building
Location:	All Areas
Finding:	Wood rot
Information:	This building element shows evidence of wood rot. Wood rot, also known as Fungal Decay, occurs when timbers and other cellulose building materials are exposed to damp conditions on an ongoing basis. This could be the result of exposure to weathering over a prolonged period of time, or the attraction of excessive moisture from other abutting building materials. Contributing factors also include poor air ventilation in the area.

Wood rot is often associated with general damp problems and is evidenced by a 'musty' smell or mould and mildew occurring on surfaces. If left unmanaged, damp conditions can lead to further health problems and the decay of timbers will continue.

Early intervention and regular maintenance, particularly of exterior timbers, will prolong the useful life of these building elements. Prior to any works being performed, the cause of the moisture that has created the visible wood rot should be identified and addressed in a suitable manner. Replacement of affected timbers may then be a necessary step in protecting surrounding building elements from such deterioration.

A qualified plumber may be appointed to assess the cause of excessive moisture and to provide advice on any remedial works as required. A qualified carpenter or registered builder may also be required to replace affected building materials.

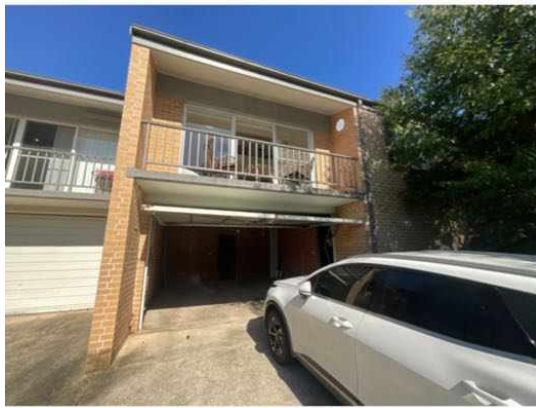
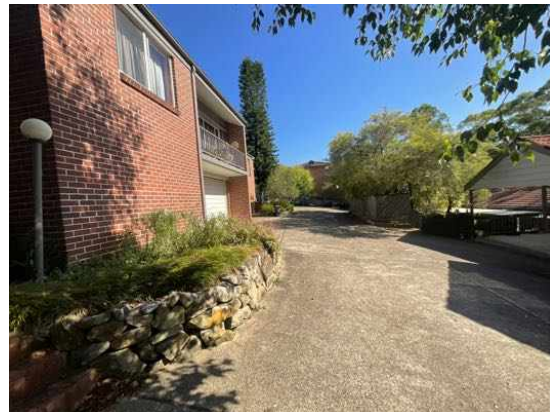
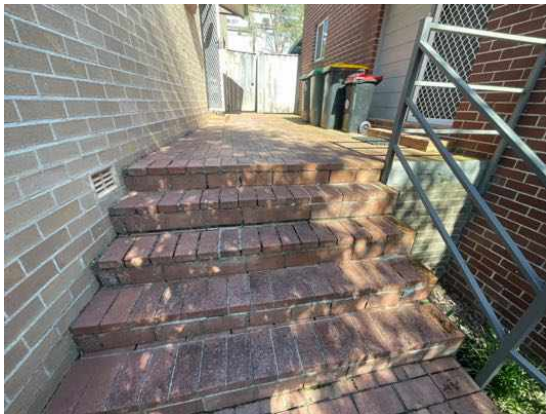
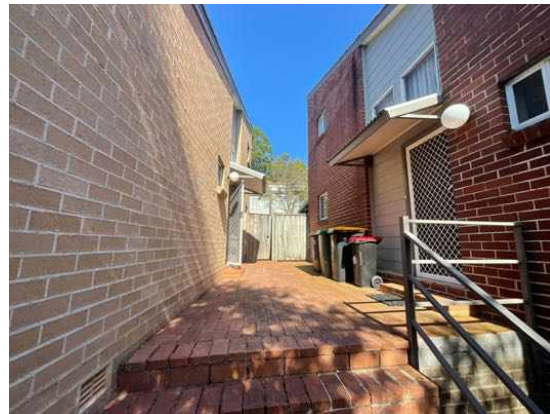
Noted Item

Building: Main Building
Location: All Areas
Finding: Additional Photos - Obstructions and Limitations
Information: These photographs are an indication of the obstructions and limitations which impeded full inspection of the property at the time of inspection. These obstructions can hide an array of defects and should be removed to allow full inspection to be carried out. A re-inspection is recommended once the areas are made accessible.
