Building and Timber Pest Inspection Report

Inspection Date: Thu, 22 Jan 2026

Property Address: 18/38 Stanley Rd, Epping NSW 2121,
Australia

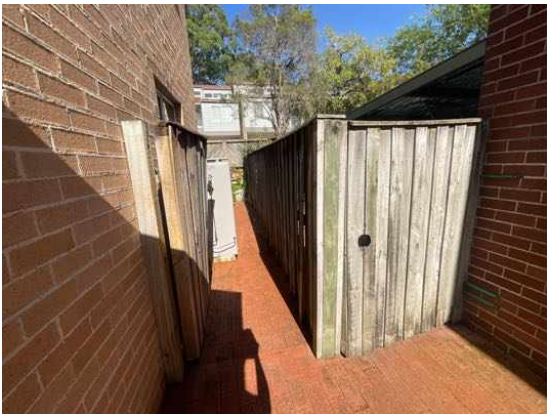
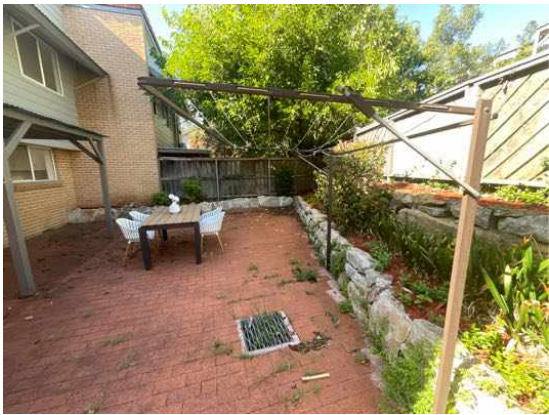
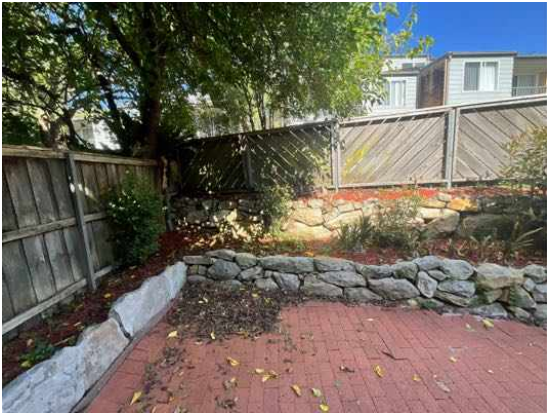
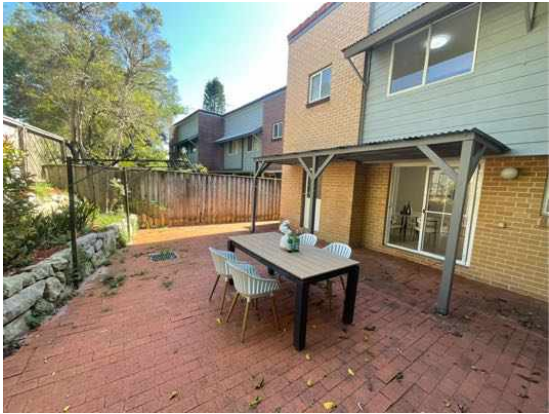
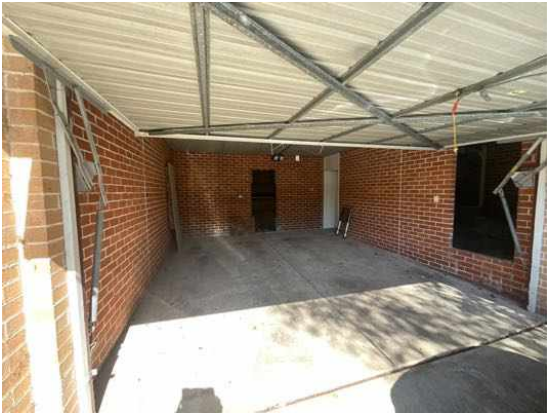
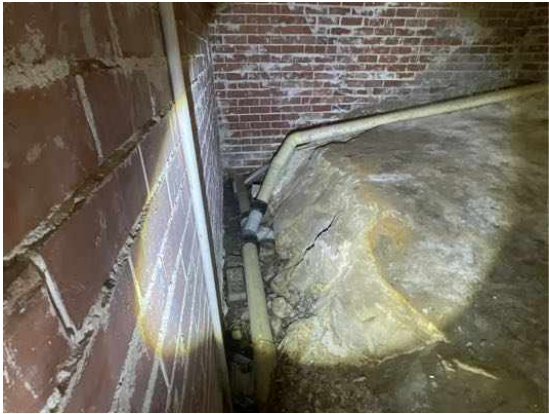
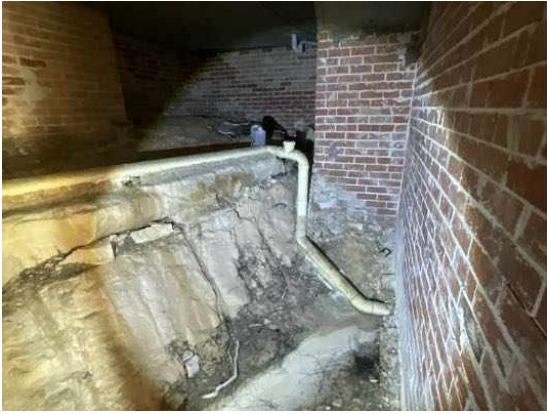
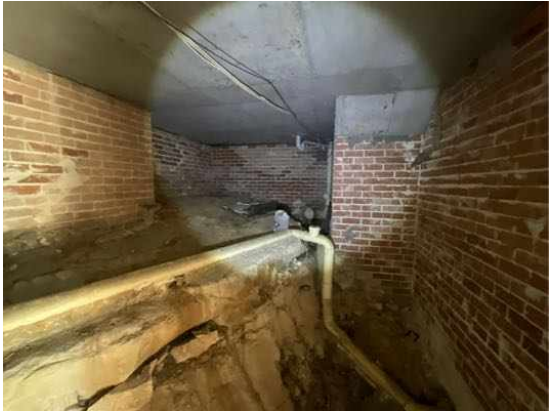
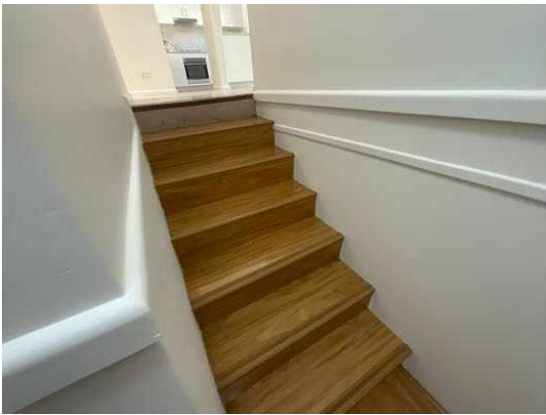
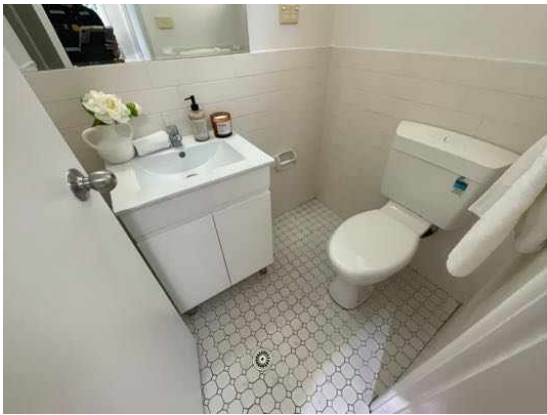
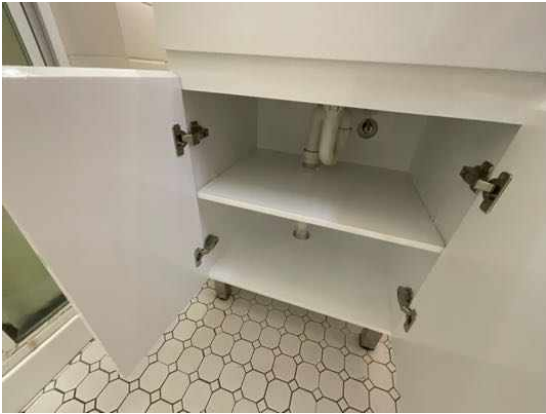
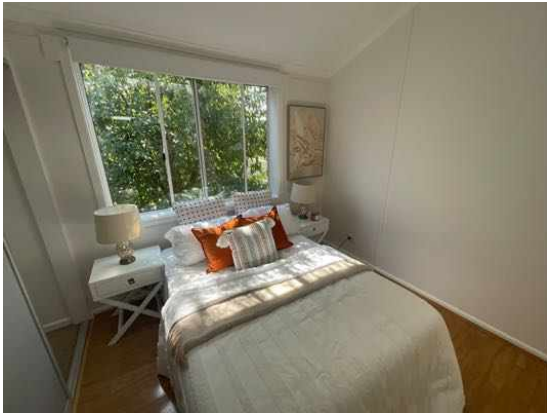
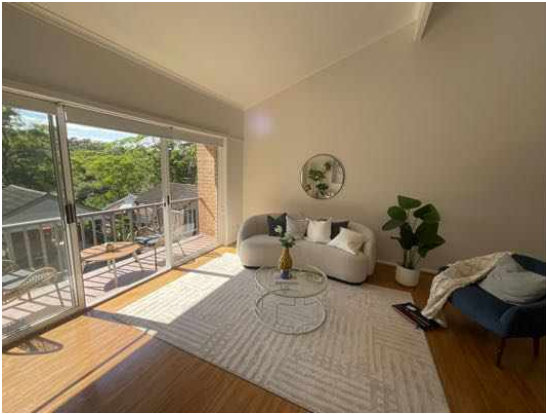
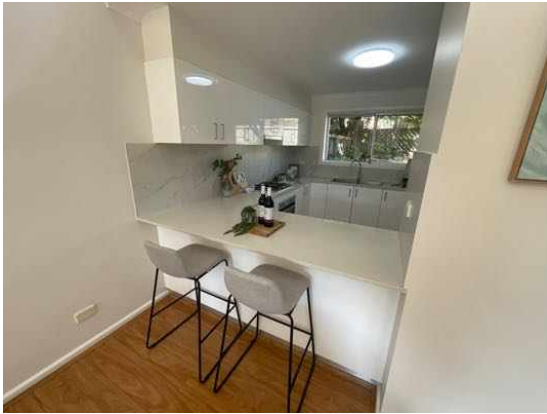
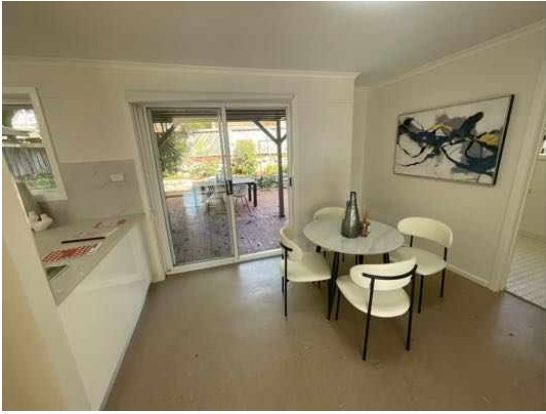
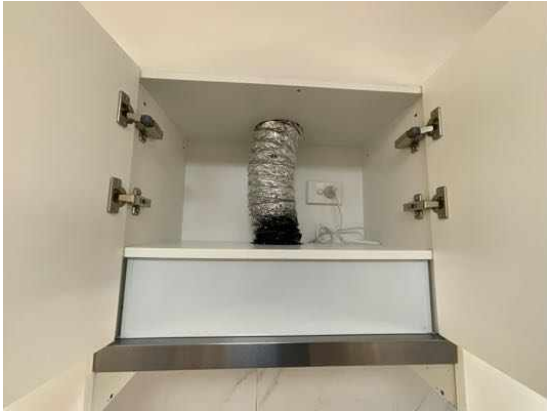
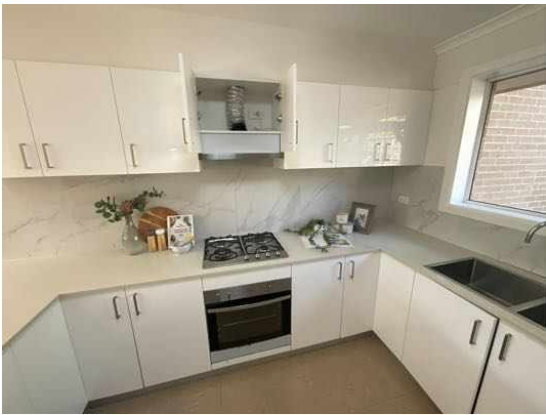
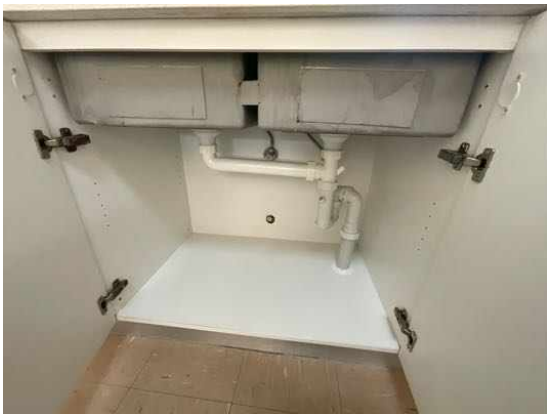
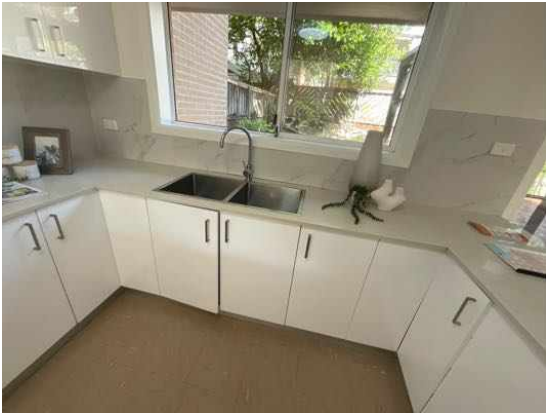
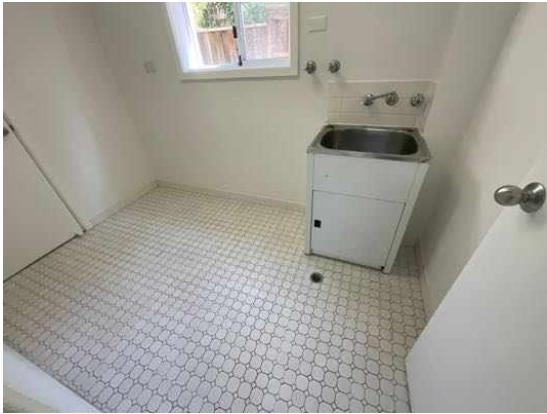
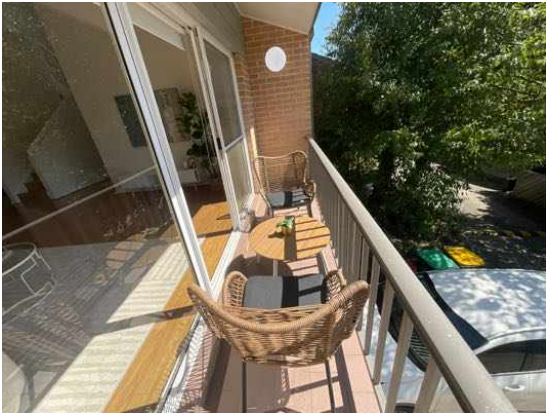
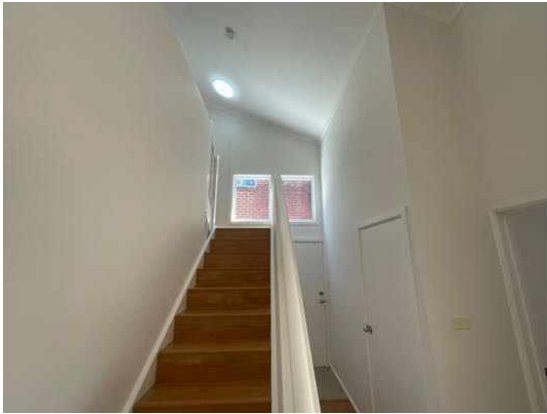
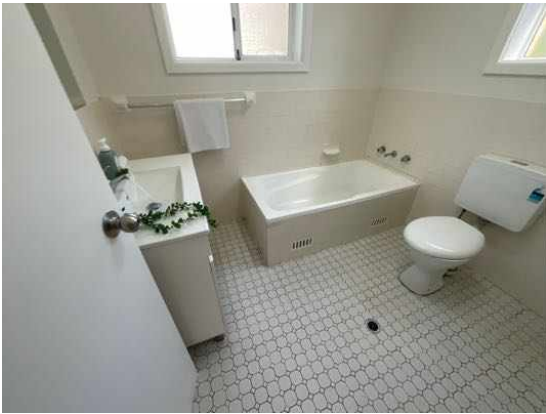
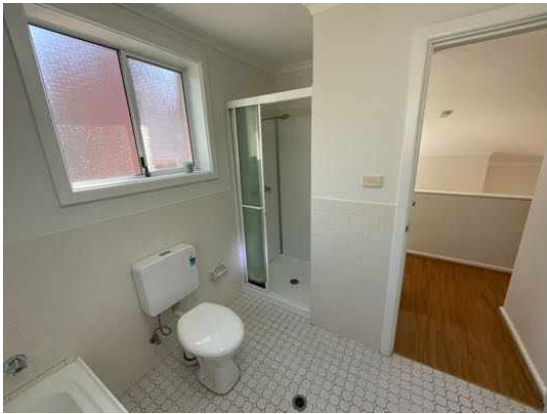
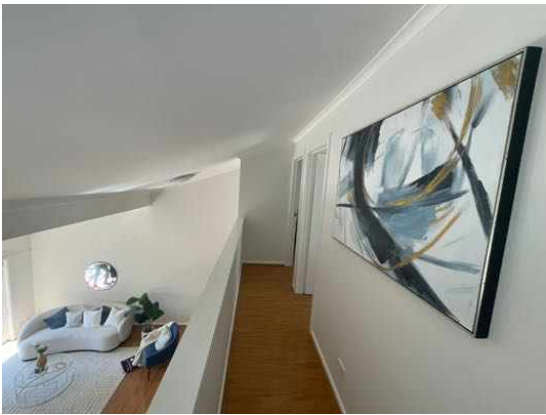
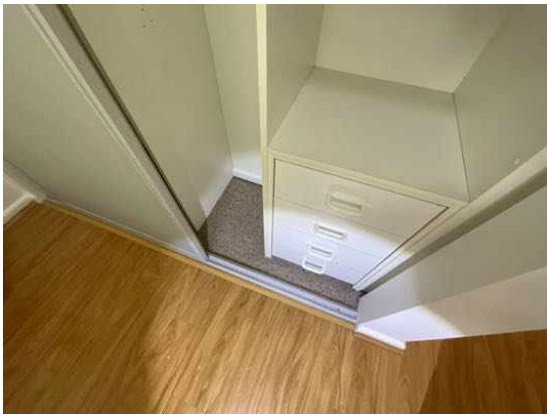
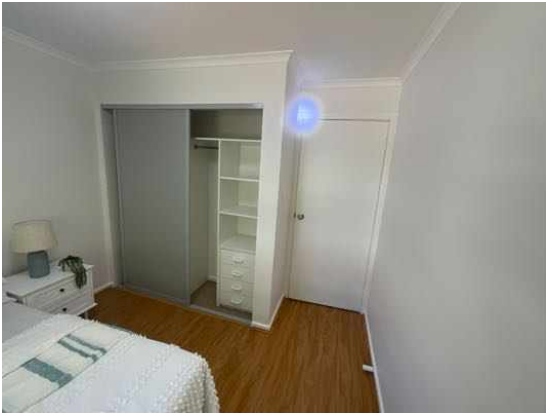
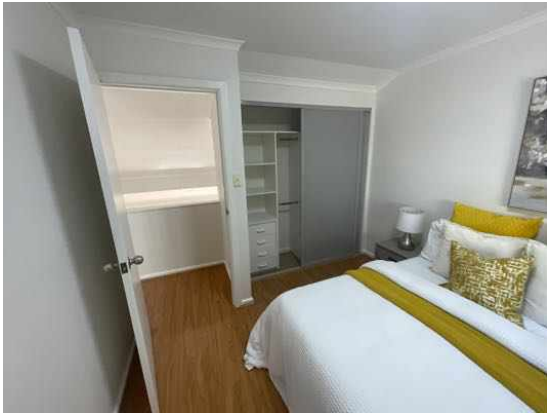
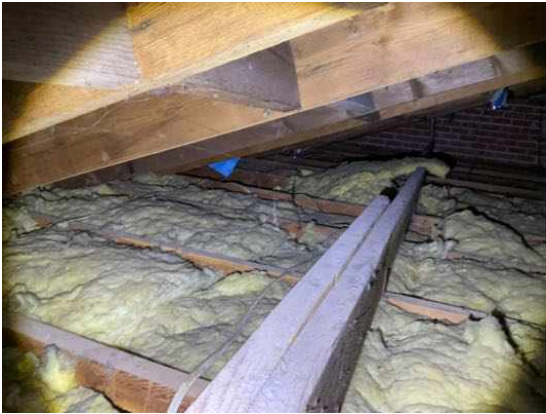
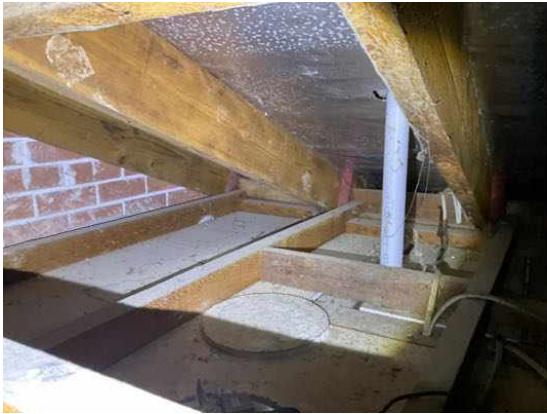
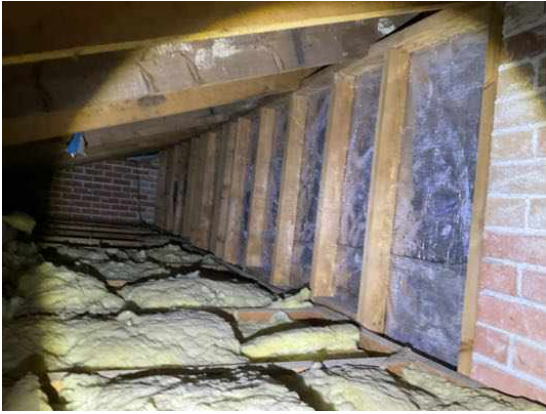
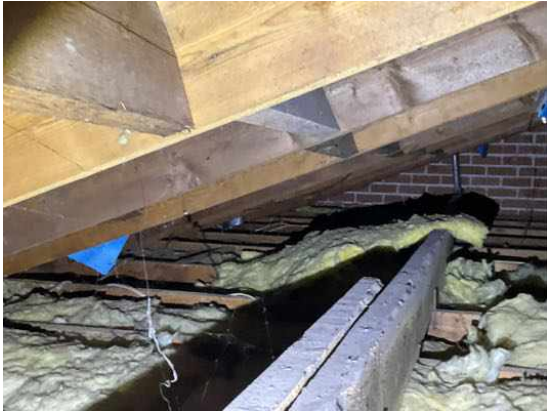
Building: Main Building
Location: All Areas
Finding: Additional Photos - Obstructions and Limitations
Information: These photographs are an indication of the obstructions and limitations which impeded full inspection of the property at the time of inspection. These obstructions can hide an array of defects and should be removed to allow full inspection to be carried out. A re-inspection is recommended once the areas are made accessible.

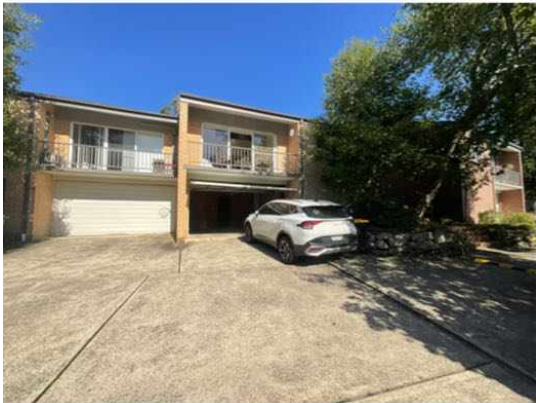
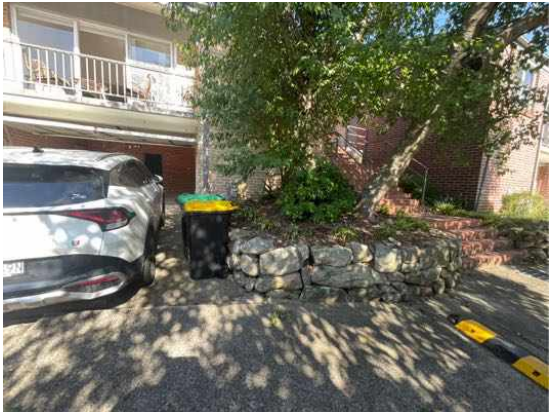
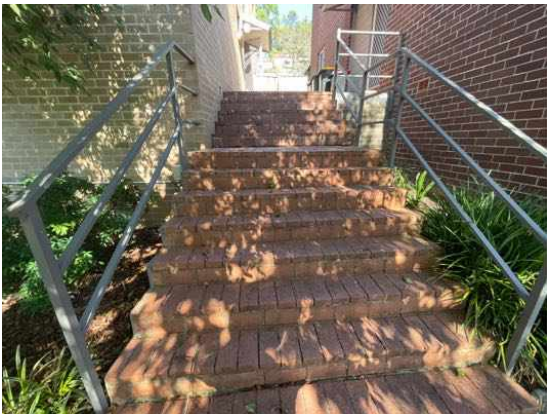
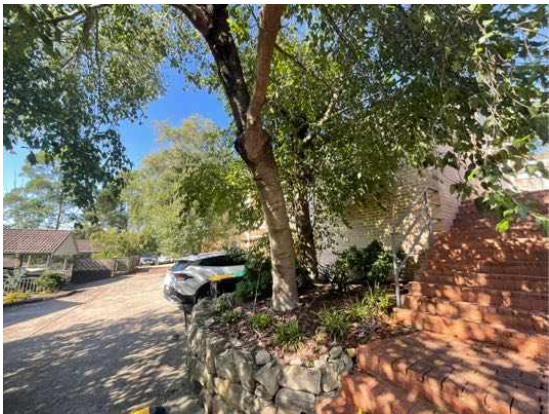
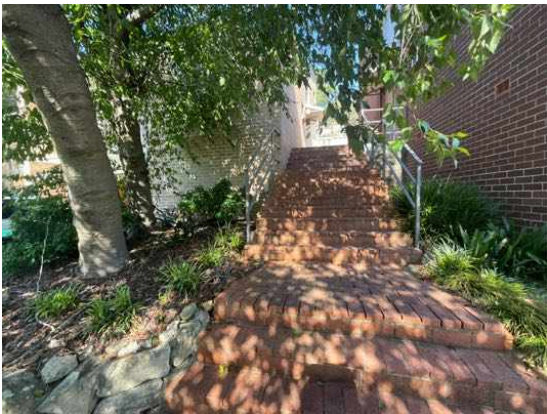
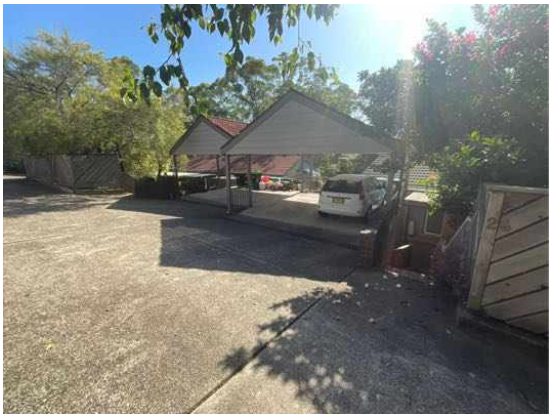
Building: Main Building
Location: All Areas
Finding: Additional Photos
Information: Additional photos are provided for your general reference

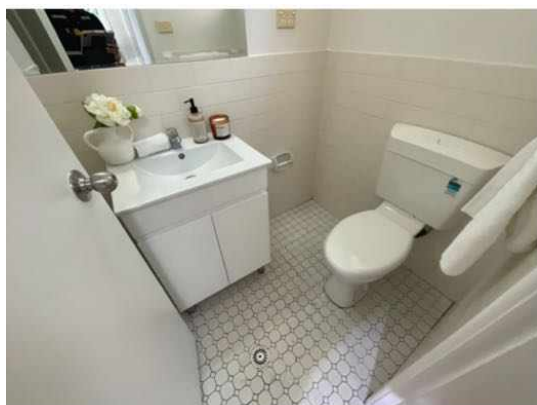
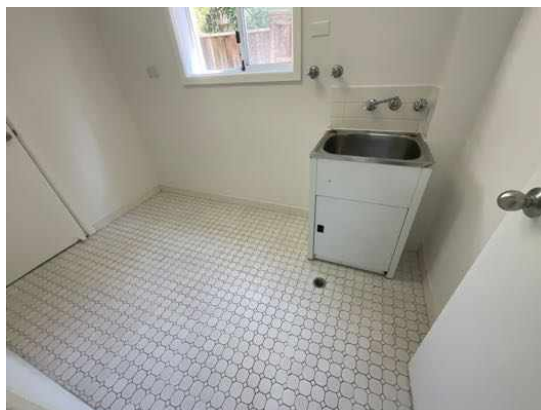
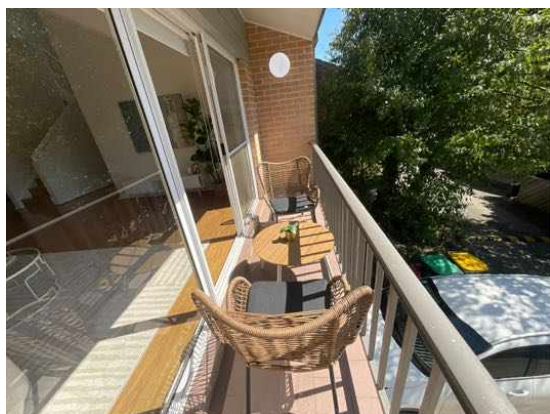
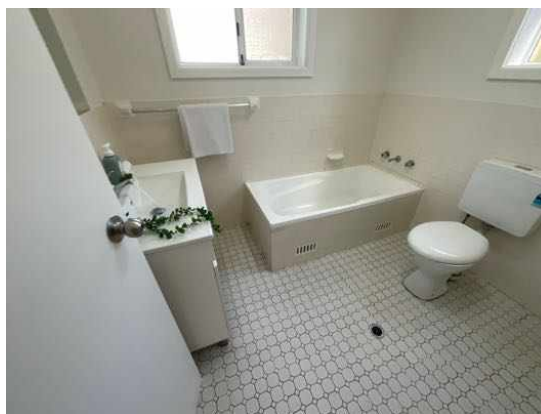
Building: Main Building
 Location: All Areas
 Finding: Water Proofing Membranes - Information Only
 Information: Internal Water Proofing Membranes, are crucial in preventing water ingress into the property is important to know that the Membrane System used is to Australian Standards and has been installed correctly. Please refer to the original Building Documents or Maintenance Schedule for the relevant information including; - Membrane used and Manufacturers Specifications. - The Installer and Installation Certification. Especially with older property's where this information is unavailable, all wet areas should be monitored. Generally new waterproofing with a certificate may

only have a guarantee of 8yrs. If any leaks, water staining, peeling or bubbling of the paint become evident to any adjacent walls or ceilings below a licensed builder or waterproofing specialist is recommended to investigate further.

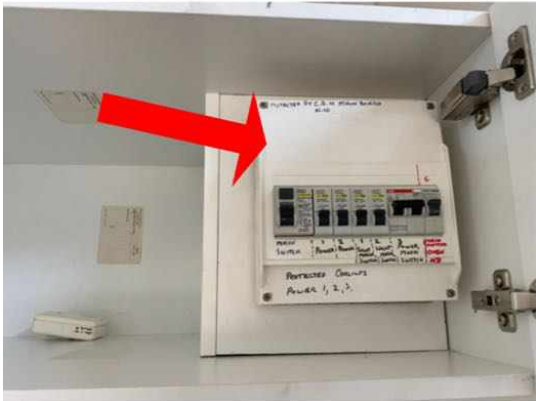
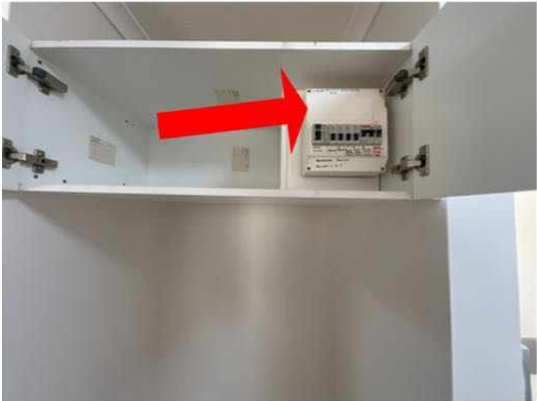
Noted Item

Building:	Main Building
Location:	All Areas
Finding:	Termite Management System - no evidence of a chemical installation
Information:	The application of a post-construction chemical termite barrier is highly recommended for all properties, particularly if live termite activity has been found on the site previously. Such barriers are highly effective in preventing termite attack on any timber building elements throughout the property.

A durable notice should be placed in the switchboard unit to indicate current termite barriers. At the time of inspection, it appeared as though no termite management system has been installed, with no evidence to suggest preventative works taking place.

The client may consider gaining further advice from a pest controller as to the costs and procedures involved with this application. It is recommended that obtaining such advice be a short-term priority.
