# Building and Timber Pest Inspection Report VR

Inspection Date: Mon, 23 Mar 2026

Property Address: 13 Betula Grove, Bundanoon NSW 2578,  
Australia

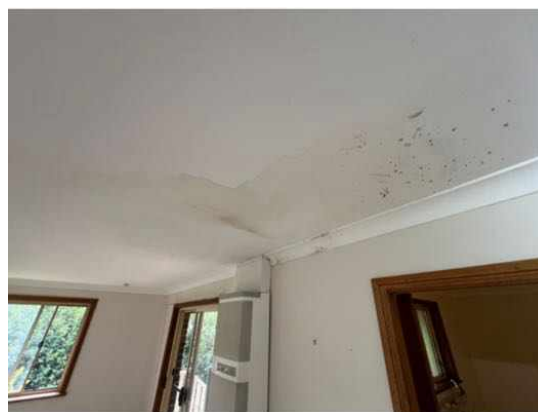
Building: Main Building  
Location: Family Room  
Finding: Ceiling - Water damaged  
Information: Water damage to the ceiling lining is generally an indication of excessive moisture being present in the roof void, usually via a leak to the roof covering.

Where water damage is evident to the ceiling, the primary requirement is to identify and rectify the source of the leak. A roofing plumber should be appointed as soon as possible to identify the leak and perform rectification works as necessary, ensuring the water damage is restricted.

Once the leak is repaired, consultation with relevant tradespeople, including plasterers and painters, is advised. Rectification works may include replacement of ceiling lining or minor repainting, depending on the extent of the damage.

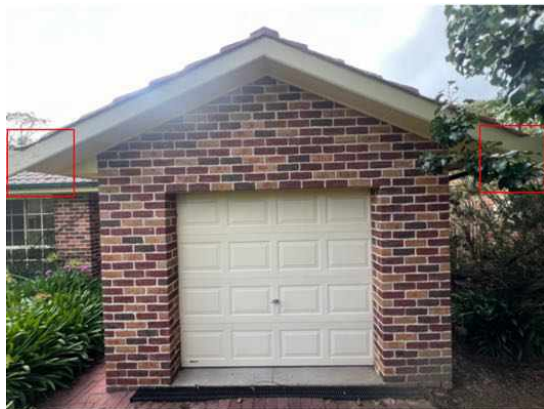
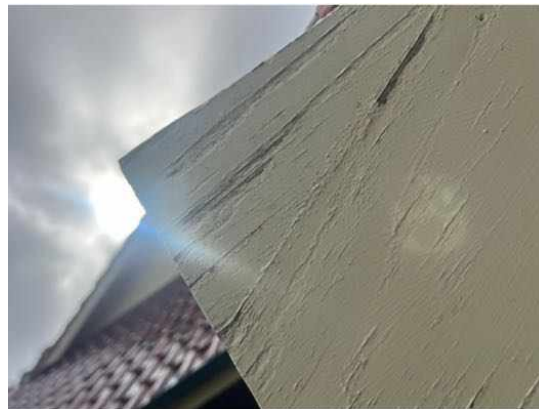
Location: Garage  
Finding: Barge - Wood rot  
Information: Wood rot was found to be affecting fascias and barges in this area, evidenced by the presence of mould on the surface in some areas. Wood rot, also known as Fungal Decay, occurs when timbers and other cellulose building materials are exposed to damp conditions on an ongoing basis.

It is likely that this wood rot has developed as a result of faults in the roof plumbing, creating excessive moisture in this areas. Frequent exposure to rain and other weather conditions also make fascias and barges susceptible to accelerated deterioration.

Early intervention and regular maintenance will prolong the useful life of these building elements. Prior to any works being performed, the cause of the moisture that has created the visible wood rot should be identified and addressed in a suitable manner.

It is advised that a roof plumber be appointed to inspect all roof plumbing and subsequently identify the cause of the wood rot. Replacement of affected fascias and barges may then be a necessary step in protecting surrounding building elements from such deterioration.

A qualified plumber may be appointed to assess the cause of excessive moisture and to provide advice on any remedial works as required. A qualified carpenter or registered builder may also be required to replace affected building materials.

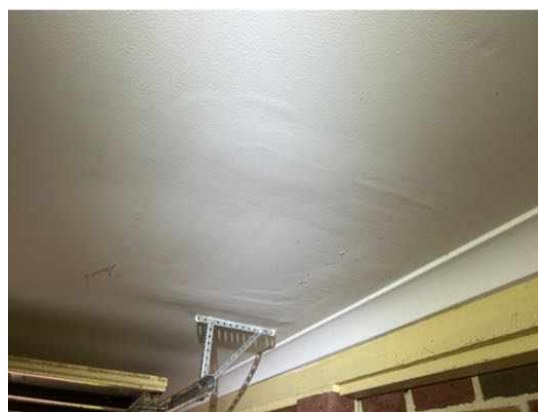
### Finding 3.05

Building:	Main Building
Location:	Garage
Finding:	Ceiling - Incomplete or substandard works
Information:	The works to this area appear to be incomplete or have been completed to a substandard level.

Works that have not been completed to a satisfactory level create potential for the development of building defects and may impede on the safety and integrity of the overall structure.

It is highly recommended that a licensed plasterboard contractor and or painter should be appointed to repair the ceiling. To ensure the safety of the area and the longevity of all associated building elements.

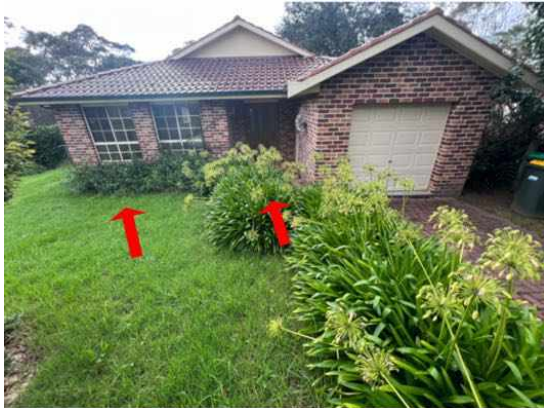
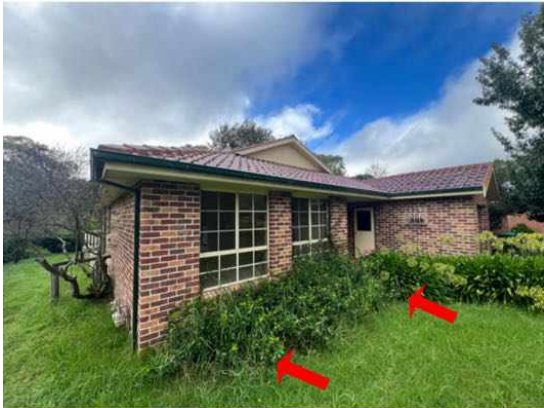
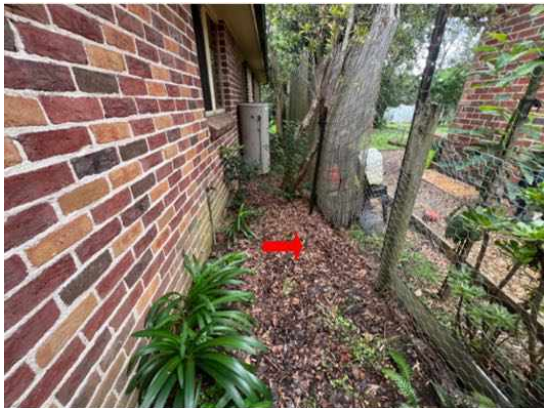
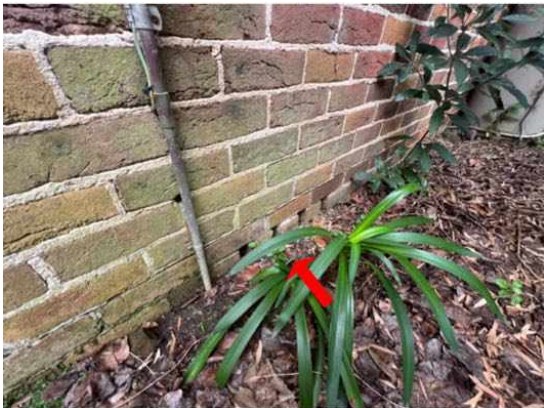
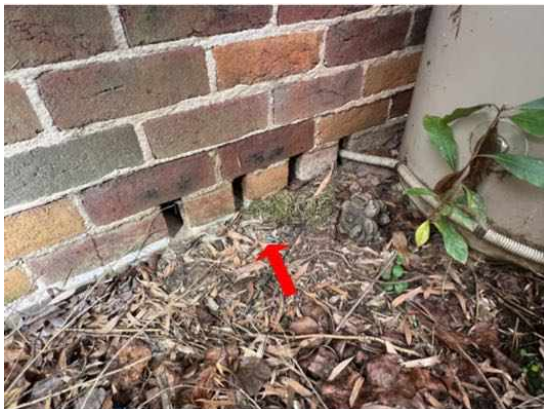
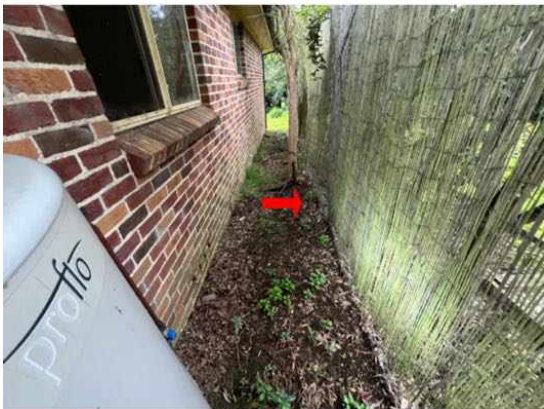
### Finding 3.06

Building:	Main Building
Location:	Exterior walls - front, right
Finding:	Site drainage - Inadequate
Information:	The site drainage in this area was found to be inadequate at the time of inspection, creating potential for subsequent water damage to associated building elements.

It is important that water does not lie against the base of walls; surrounding paths and ground levels should be sloped to drain water away from walls. Downpipes should not discharge stormwater onto lower walls or plinths. Stormwater should be carried away by large, regularly cleaned drains. Ground levels may need to be lowered to expose a buried DPC.

Where site drainage is inadequate, installation of an Agricultural (Aggie) Drain may be required. A qualified plumber should be appointed to further inspect the property and perform any remedial works as necessary. Water damage and secondary defects are likely to occur if left unmanaged.

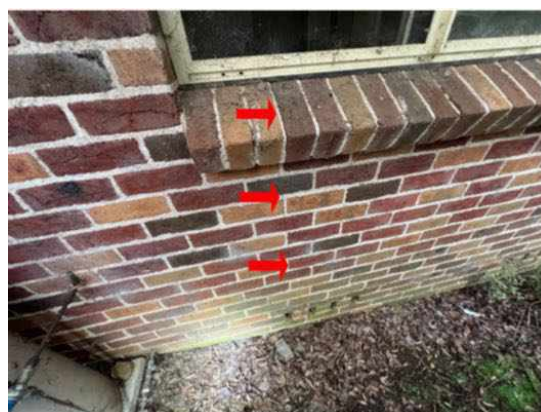
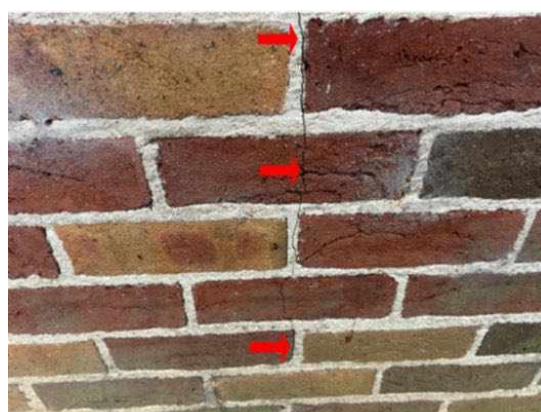
**Finding 3.07**

Building: Main Building  
 Location: Exterior walls - right side  
 Finding: Brickwork - Cracking noticeable  
 Information: There were several cracks and or crack repairs evident to external brickwork.

Noticeable cracks are a common occurrence in external brickwork and are a likely result of age expected building movement, general expansion, and/or contraction of building materials in different weather conditions. Noticeable cracks in brickwork may develop if left unattended, with potential for necessitating major remedial works or

replacement of the brickwork.

It is highly advised that a qualified bricklayer be appointed to provide necessary works to cracked brickwork to prevent any further damage. Such works should be conducted as soon as possible.

Always monitor these cracks and contact a building inspector should cracks widen, lengthen, or become more numerous.

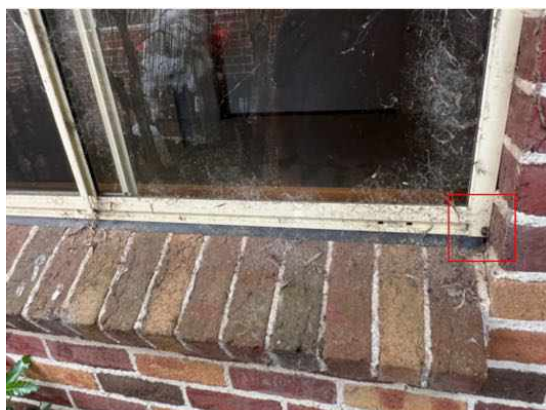
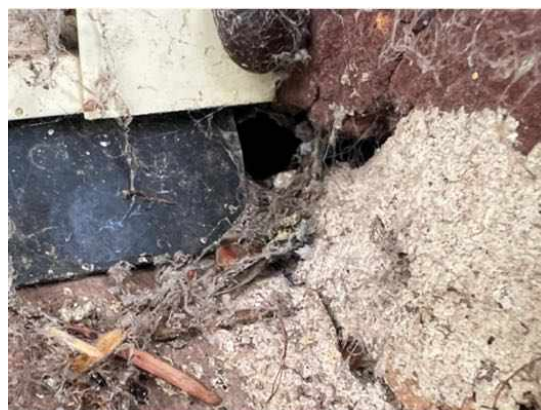
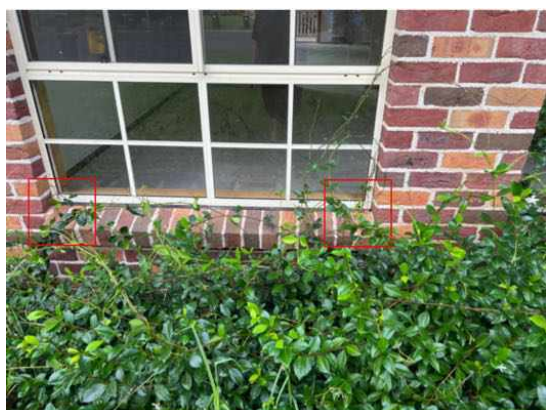
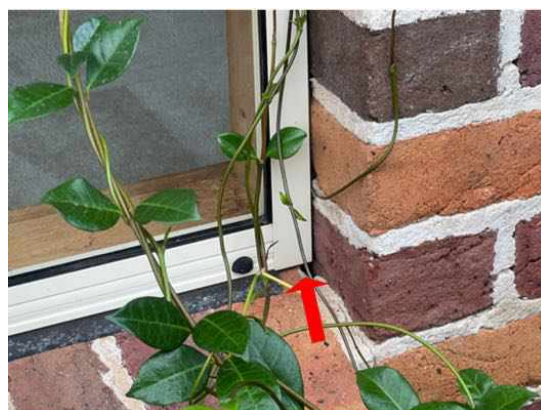
### Finding 3.08

Building:	Main Building
Location:	All External Windows
Finding:	Window Sill Seals - damaged/compromised
Information:	The window seals have been damaged/compromised at the time of installation and subsequent failure to provide adequate protection and coverage. Due to frequent exposure to weather conditions and subsequent moisture, will lead to water ingress, energy loss and even pest entry.

Where window seals have not fully covered the gap between the brickwork and window, the window is no longer weather-tight; rain penetration and subsequent water damage is therefore likely to ensue. Insulation of the area against external weather conditions will also be compromised.

It is recommended that all window sill seals be replaced by a general handyman or sealant expert to prevent any further damage and to restore the window to a fully functional level.

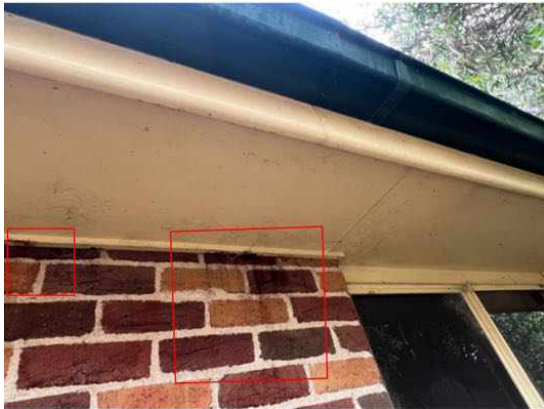
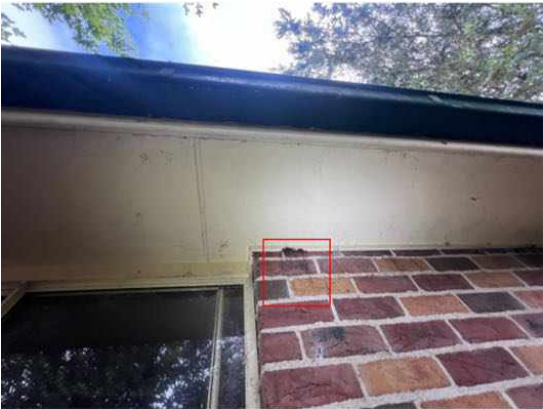
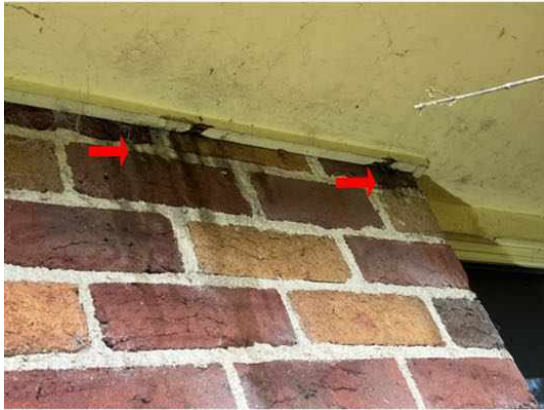
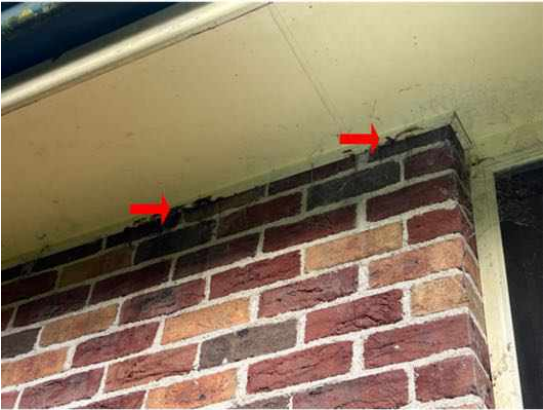
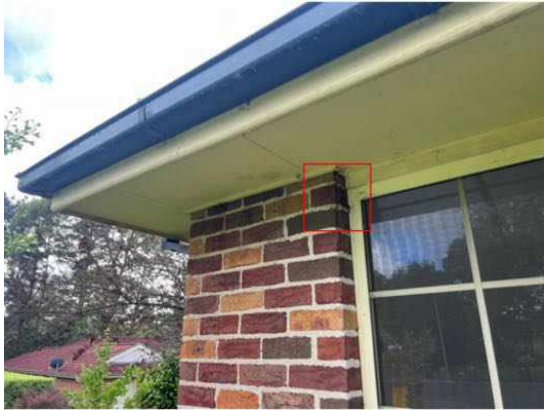
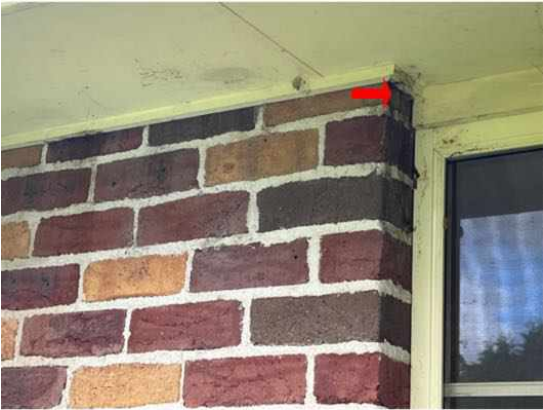
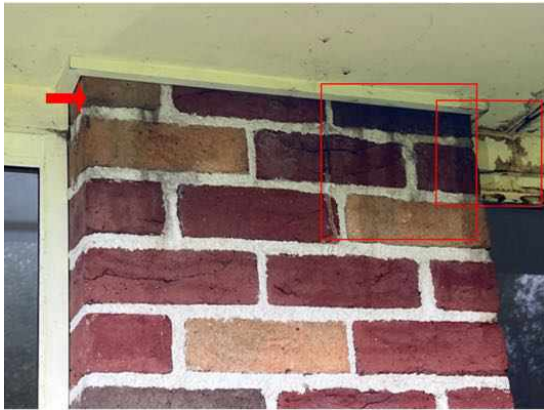
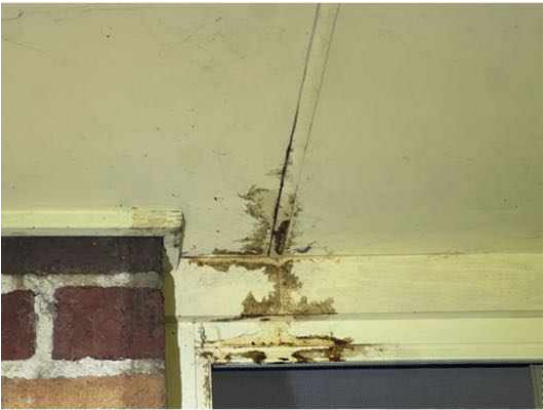
### Finding 3.09

Building:	Main Building
Location:	All External Areas
Finding:	Eaves - Water Staining
Information:	Water staining was observed to sections of the eave lining at the time of inspection. This staining is typically the result of moisture ingress from roof drainage issues, such as blocked or overflowing gutters, damaged flashing, or roof leaks above the affected area.

While no active leak was confirmed, the presence of water staining suggests a history of water exposure that may lead to material deterioration over time if left unaddressed. The appearance of staining also detracts from the overall condition of the eaves and associated roofing structures.

It is recommended that a licensed roof plumber be engaged to assess the area, identify the source of the staining, and carry out any required repairs to prevent further water ingress and deterioration.

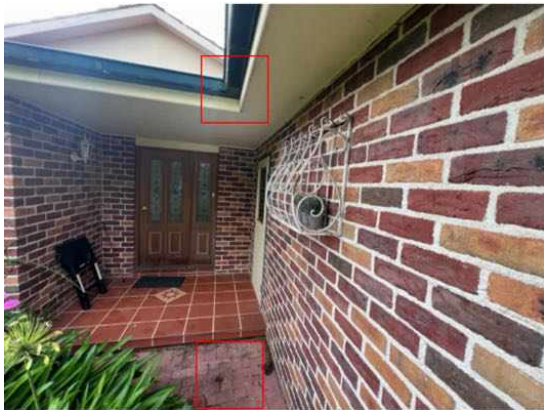
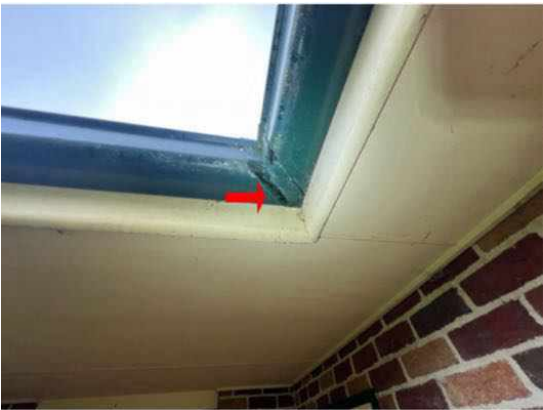
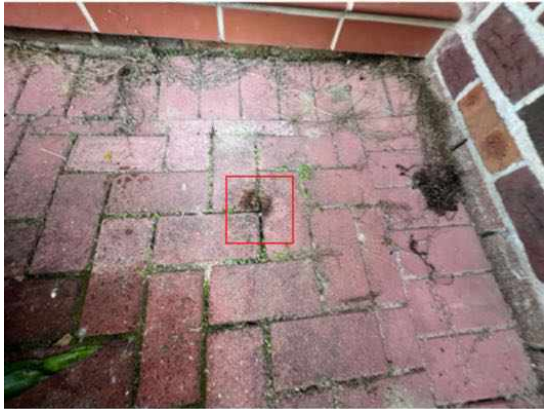
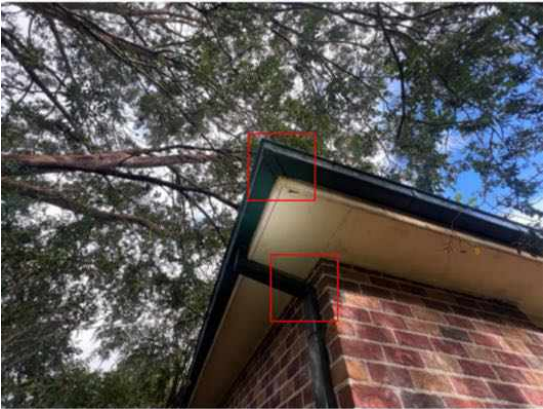
Finding 3.10

Building: Main Building  
Location: All External Areas  
Finding: Water leak - External - Gutters  
Information: Water leaks were found to be present to exterior plumbing work. Leaks are generally caused by deterioration of the plumbing elements over time, due to exposure to weather conditions, but may have also been caused by minor impact damage.

Such leaking creates damp conditions in the affected area, causing potential for water pooling and subsequent water damage if left unattended. These conditions may also attract termite attack, particularly if the area is subject to minimal levels of sun throughout daylight hours.

It is highly advised that a licensed plumber be appointed to rectify any water leaks that may be present. Areas of repair and replacement of plumbing fittings and fixtures may be required and, as such, a quotation should be sought.

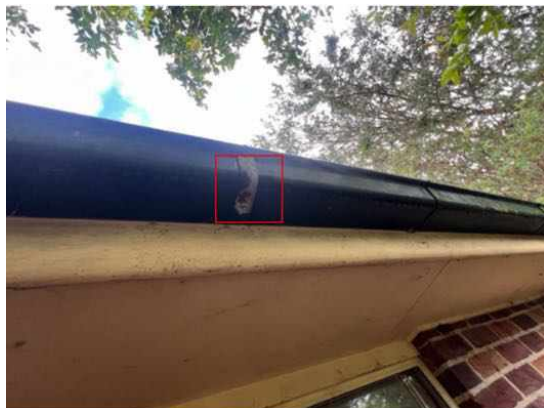
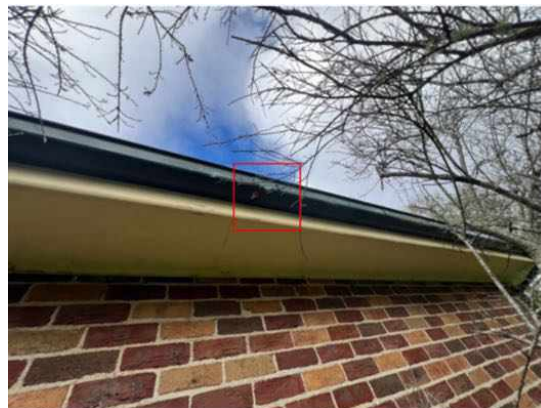
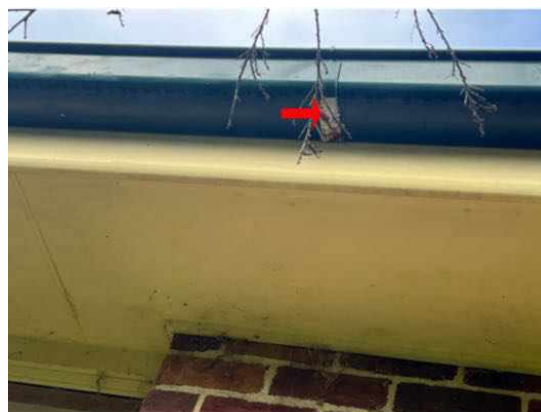
### Finding 3.11

Building:	Main Building
Location:	All External Areas
Finding:	Gutter brackets - Rusted or corroded
Information:	This building element shows evidence of rusting and corrosion, which is likely to have developed as a result of excessive exposure to moisture and or inadequate coatings.

As surface rust provides no protection to the underlying iron, the deteriorating condition is likely to worsen if not addressed in the short-term future.

Where possible, the use of galvanized (treated) metals or aluminium coated metals aid in rust prevention, as does regular general maintenance. Rust formation can be

controlled with coatings, such as paint, that isolate the iron from the environment.

Rusting and corrosion should be managed by ideally removing or limiting the affected surface from exposure to moisture. A registered builder may be appointed to replace any building elements that have been severely affected by rust or water damage.

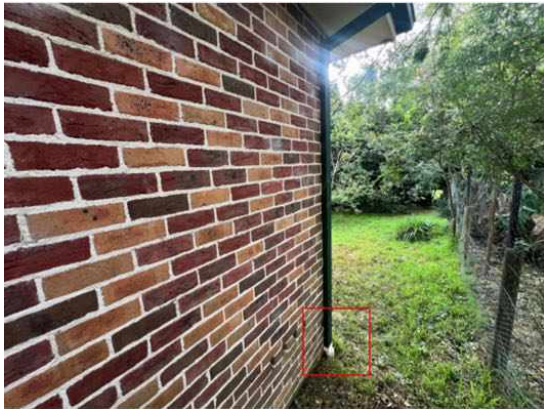
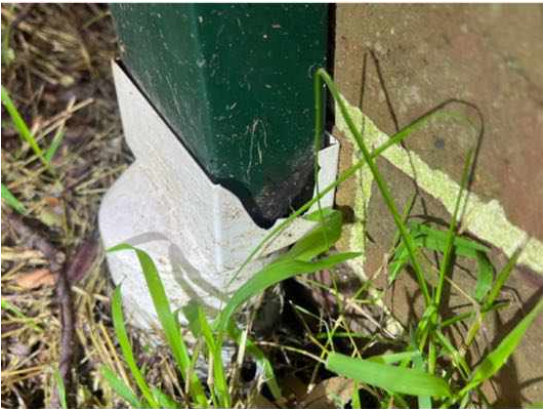
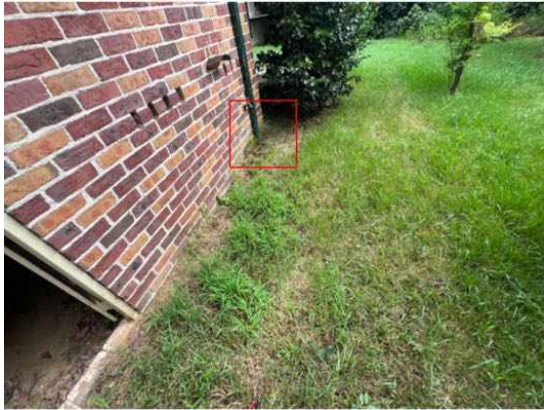
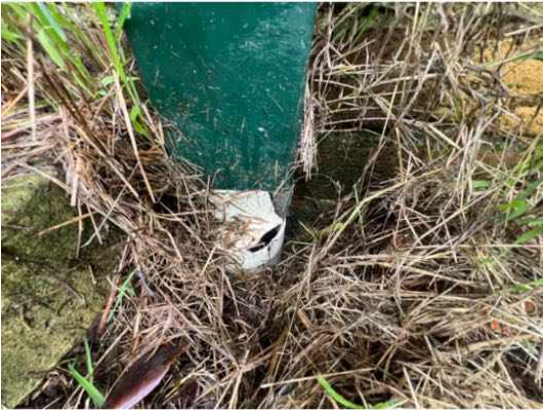
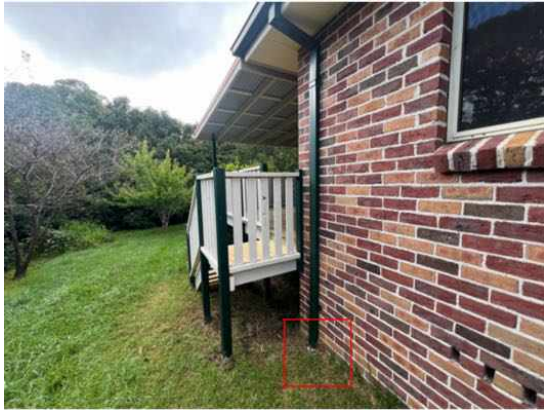
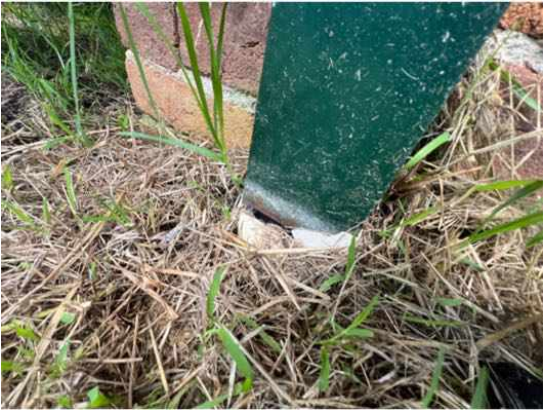
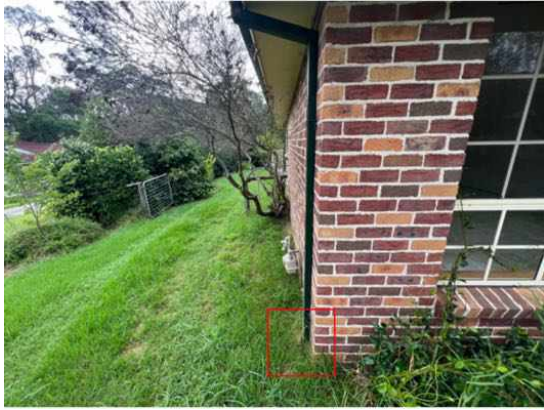
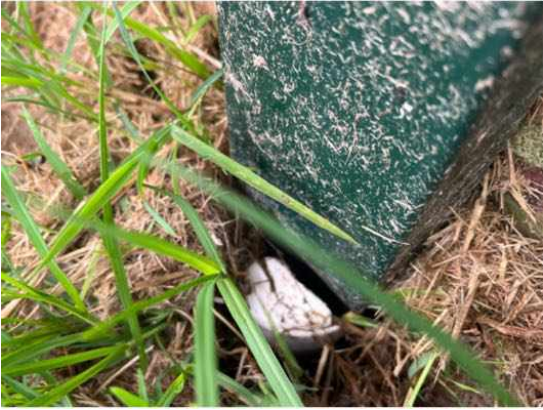
### Finding 3.12

Building:	Main Building
Location:	All External Areas
Finding:	Downpipe - Damage, conditions conducive to termites
Information:	The downpipe in this area shows visible damage, which hinders its ability to effectively direct water away from the building. This creates conditions conducive to termite activity by increasing the likelihood of water pooling around the foundation. Prolonged moisture retention can lead to structural degradation, soil erosion, or water ingress into lower building areas, all of which may attract and sustain termite infestations.

The observed damage may be attributed to impact, corrosion, or general wear. It is recommended that a licensed roof plumber be engaged to inspect the downpipe and carry out necessary repairs or replacement as a priority to mitigate moisture-related risks and potential termite activity.

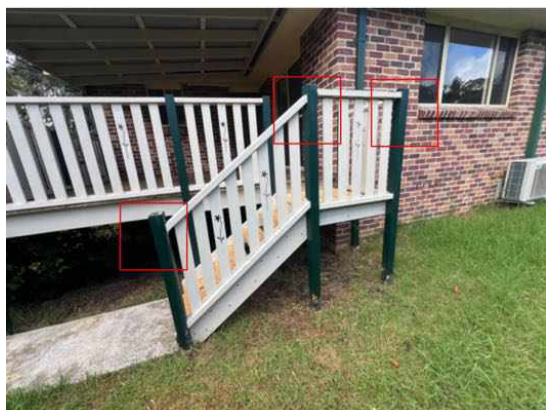
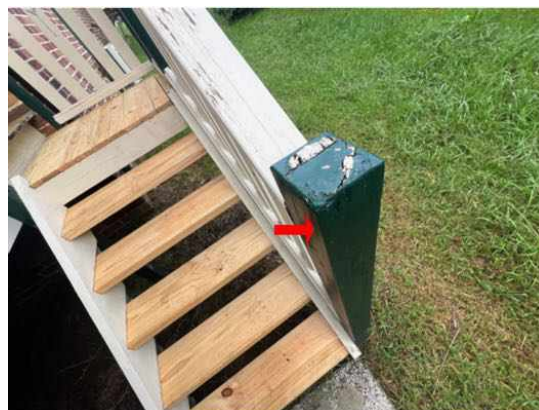
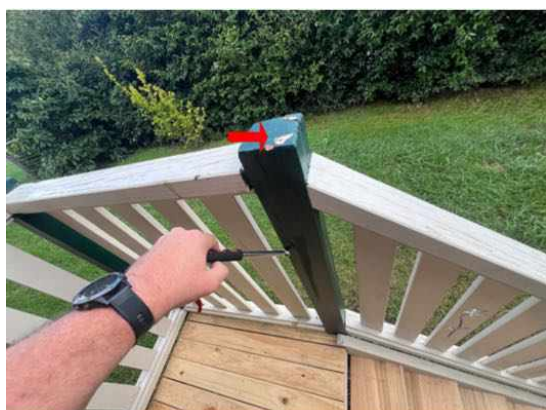
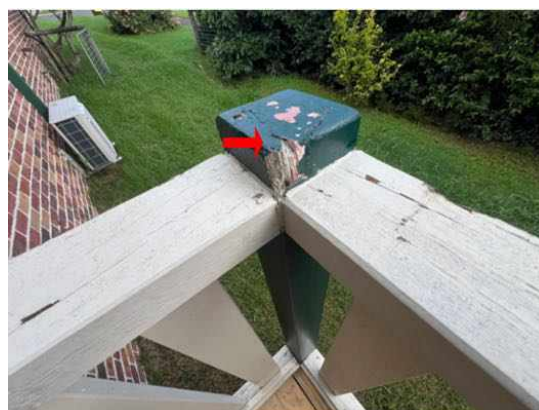
Finding 3.13

Building:	Main Building
Location:	Deck
Finding:	Wood rot - Deck Posts
Information:	This building element shows evidence of wood rot. Wood rot, also known as Fungal Decay, occurs when timbers and other cellulose building materials are exposed to damp conditions on an ongoing basis. This could be the result of exposure to weathering over a prolonged period of time, or the attraction of excessive moisture from other abutting building materials. Contributing factors also include poor air ventilation in the area.

Wood rot is often associated with general damp problems and is evidenced by a 'musty' smell or mould and mildew occurring on surfaces. If left unmanaged, damp conditions can lead to further health problems and the decay of timbers will continue.

Early intervention and regular maintenance, particularly of exterior timbers, will prolong the useful life of these building elements. Prior to any works being performed, the cause of the moisture that has created the visible wood rot should be identified and addressed in a suitable manner. Replacement of affected timbers may then be a necessary step in protecting surrounding building elements from such deterioration.

A qualified plumber may be appointed to assess the cause of excessive moisture and to provide advice on any remedial works as required. A qualified carpenter or registered builder may also be required to replace affected building materials.

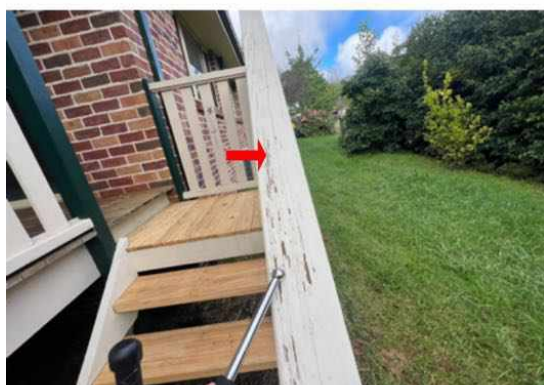
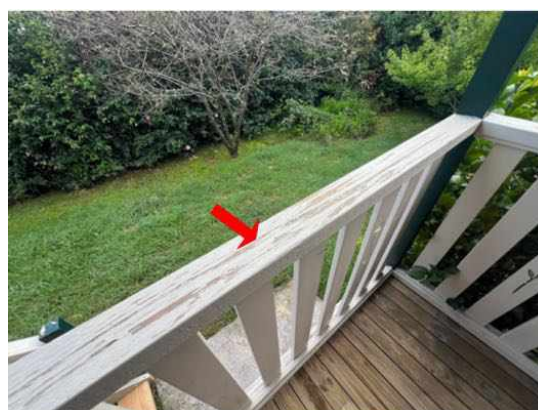
### Finding 3.14

Building:	Main Building
Location:	Deck
Finding:	Painting deteriorated
Information:	The paint work in these areas of the property require attention to prepare and re paint. Whilst incomplete or missing paint finish is generally an appearance defect, it can also lead to the development of secondary building defects over time. Incomplete areas of paint finish exposes the area to moisture, potentially accelerating the deterioration of underlying building materials.

Degraded paint finishes should be sanded back, filled, leveled and painted, as applicable. Where inadequate or missing paint protection has led to the deterioration of the associated building element, repair and/or replacement of this building element may be required.

A painting contractor should be appointed at the clients discretion to perform necessary works to aid the appearance of the affected area and to ensure the area is protected against further deterioration. Alternatively, the homeowner following manufacturer instructions may perform these works

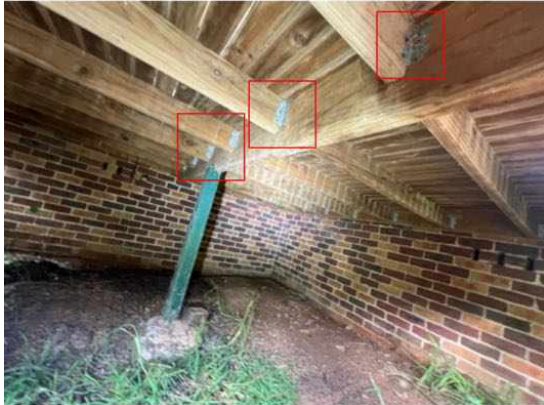
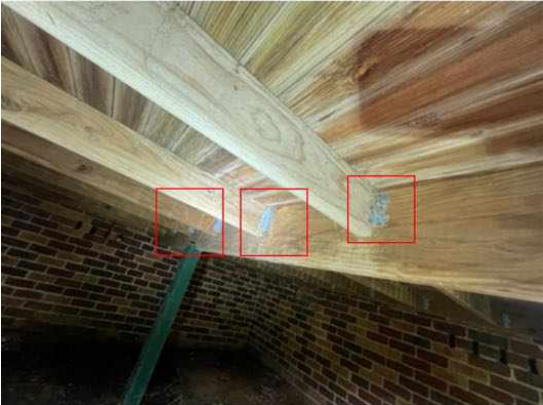
### Finding 3.15

Building:	Main Building
Location:	Deck
Finding:	Nails - Rusted or corroded
Information:	This building element shows evidence of rusting and corrosion, which is likely to have developed as a result of excessive exposure to moisture and or inadequate coatings.

As surface rust provides no protection to the underlying iron, the deteriorating condition is likely to worsen if not addressed in the short-term future.

Where possible, the use of galvanized (treated) metals or aluminium coated metals aid in rust prevention, as does regular general maintenance. Rust formation can be

controlled with coatings, such as paint, that isolate the iron from the environment.

Rusting and corrosion should be managed by ideally removing or limiting the affected surface from exposure to moisture. A registered builder may be appointed to replace any building elements that have been severely affected by rust or water damage.

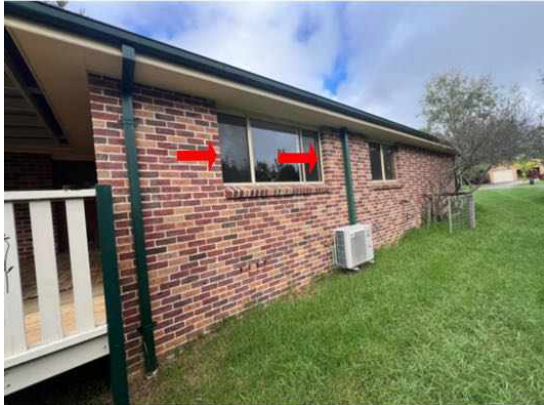
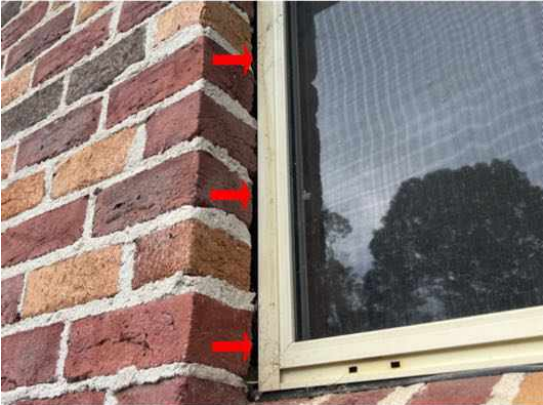
**Finding 3.16**

Building: Main Building  
Location: Exterior walls - left side  
Finding: Window - Gap to brick reveals  
Information: Large gaps were observed between the aluminium window - lintel and/or reveals. It is suspected that the installation of sealant was completed to a substandard level of workmanship or is incomplete.

Gaps and holes makes the area susceptible to insect and vermin ingress, as well as allowing water penetration. As such, associated building elements are likely to deteriorate at an accelerated rate, and major implications are expected if Gaps are left unmanaged.

All excessive holes, gaps or cracks should be adequately filled by a suitable sealant or trimmings as soon as possible to prevent any further damage. Such works may be conducted by a general handyperson or licensed carpenter.

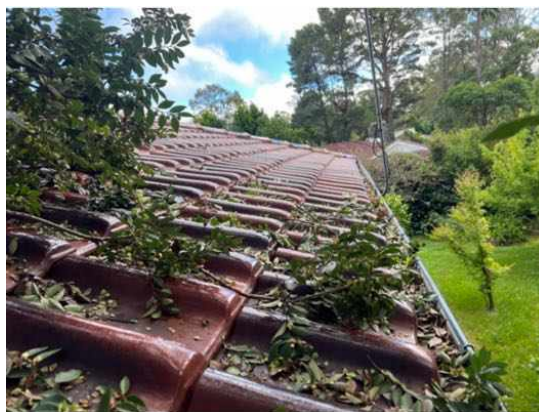
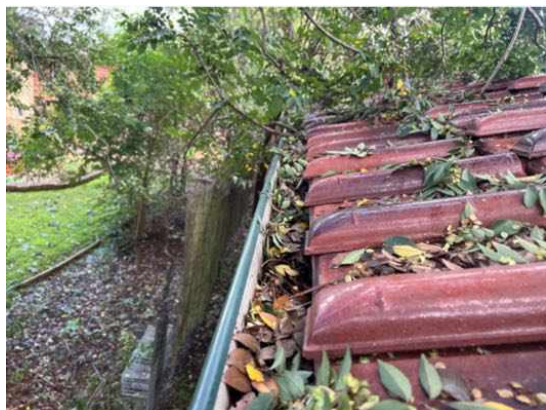
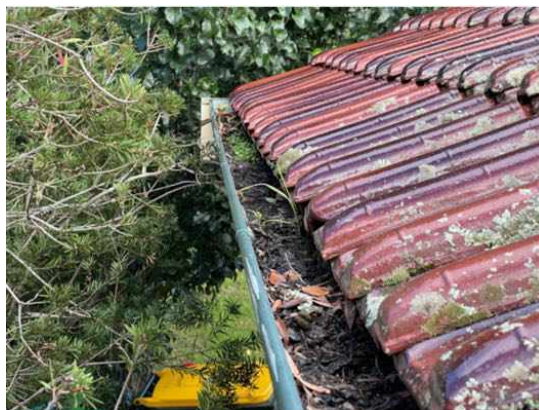
### Finding 3.17

Building:	Main Building
Location:	Roof Exterior
Finding:	Gutters - Blocked
Information:	Roof plumbing structures, such as guttering and downpipes, should be free of all debris to prevent blockages. Blockages of the guttering and downpipes will lead to pooling and accumulated water overflows, which is likely to subsequently flood eaves and exterior walls.

Blocked gutters are likely to lead to high levels of moisture in the affected areas. Such moisture will not only cause rust and decay of the associated building materials, but can also provide conditions that are conducive to termite and timber pest activity. Blockages in gutters should therefore be removed immediately to ensure dry conditions are maintained.

Consult a Licensed Plumber for further specific advice on remedial works that may be required. In the interim, it is highly advised that blocked gutters be removed by the homeowner or a general handyperson as a matter of urgency.

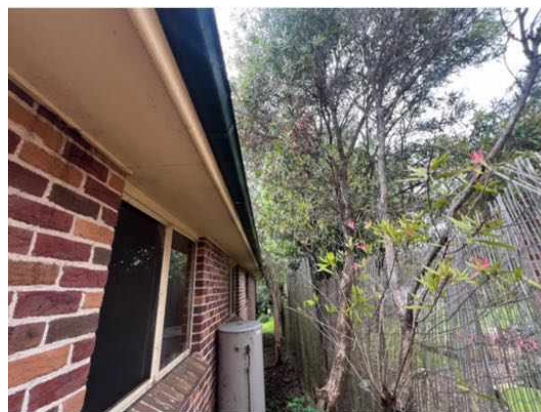
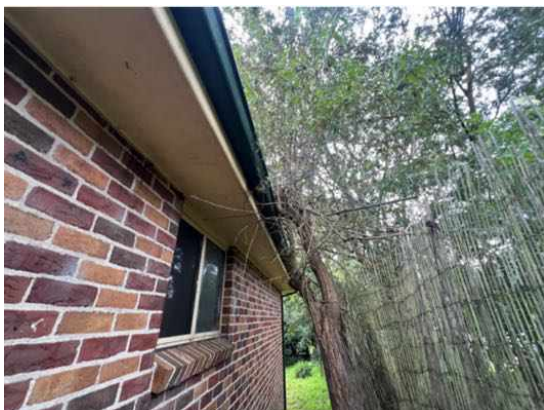
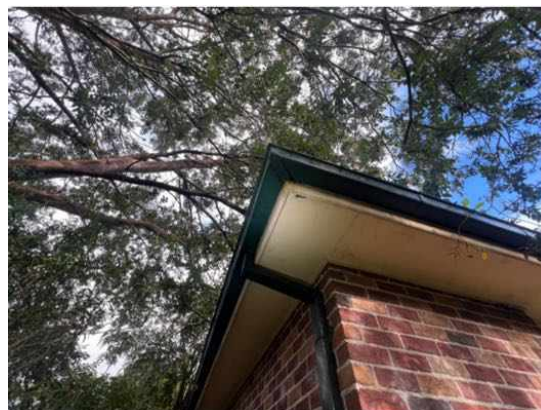
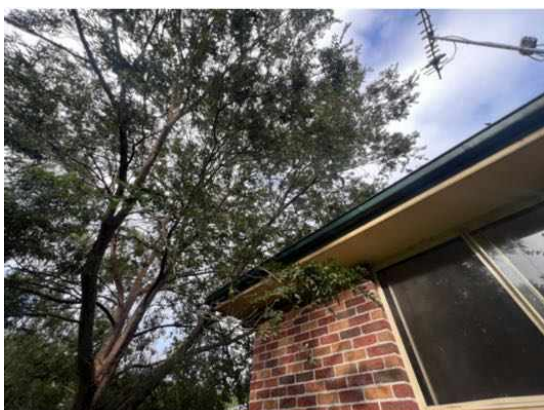
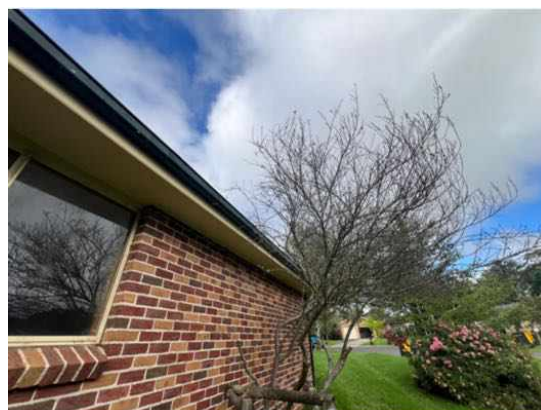
### Finding 3.18

Building:	Main Building
Location:	Roof Exterior
Finding:	Trees - Overhanging and filling gutters
Information:	Overhanging trees often result in excessive amounts of leaf debris accumulating in gutters.

Gutters are a critical part of the building's management of storm water and rain. It is therefore important that they be kept clear to prevent secondary damage to associated building elements, including exterior and interior walls, ceiling linings and any adjoining building elements. Where gutters are blocked, pooling of rainwater is likely to occur, fast-tracking rust and corrosion of the roof plumbing elements.

It is highly advised that all overhanging tree branches be removed as soon as possible to prevent any further damage. Repair and/or replacement of sections of damaged guttering may also be required where the extent of the damage necessitates.

Such works should be performed by the homeowner; however, appointment of a landscape contractor or an arborist may be required. Consultation with a licensed roof plumber is required where guttering has been damaged.

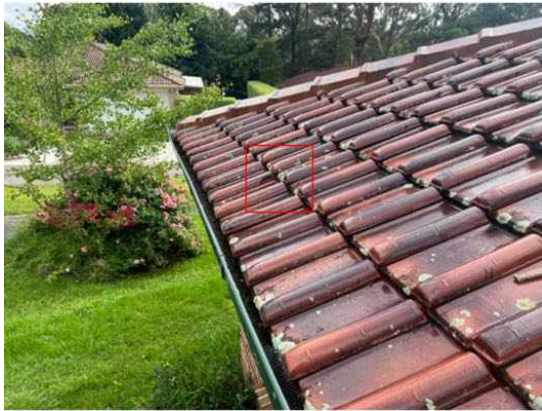
### Finding 3.19

Building:	Main Building
Location:	Roof Exterior
Finding:	Roof tiles - Broken
Information:	Upon inspection of the exterior roof covering, broken roofing tiles were identified. Broken and friable roof tiles are generally the result of ageing and weathering of what is essentially a porous material.

If left to further deteriorate, broken and brittle roof tiles are likely to lead to water penetration via the roof into the ceiling space, causing secondary damage to ceiling linings, insulation and roof structures. Broken roof tiles are also likely to detract from the effectiveness of the roof drainage system, creating potential for secondary damage

to the exterior roof covering and roof plumbing.

Replacement of broken tiles is required and should be performed by a roofing contractor as soon as possible.

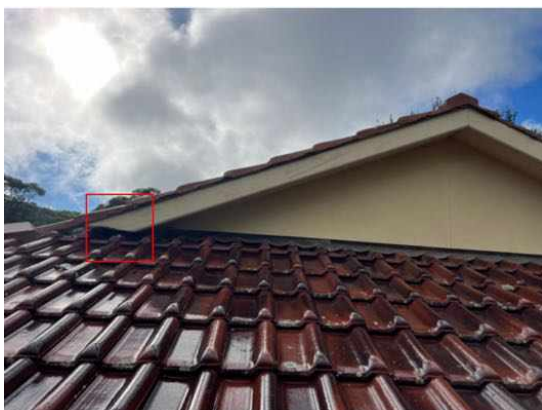
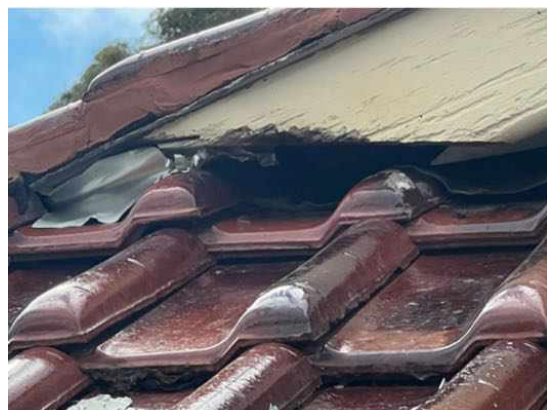
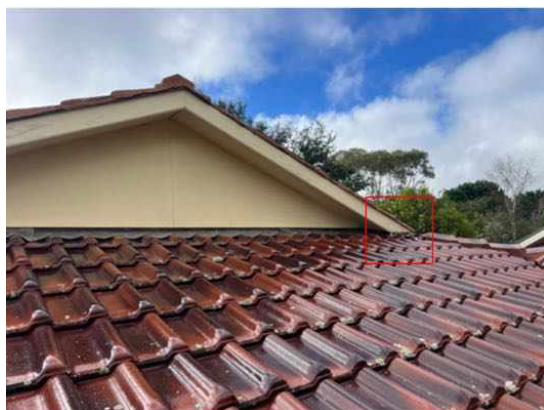
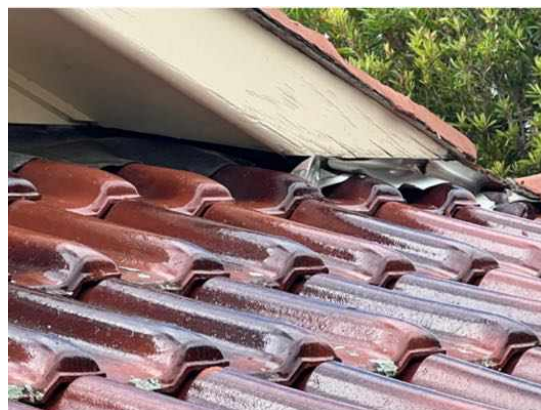
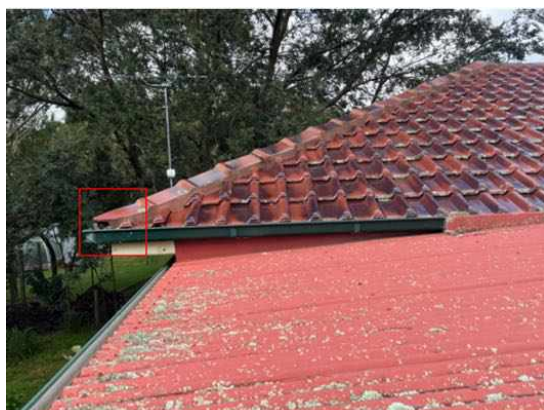
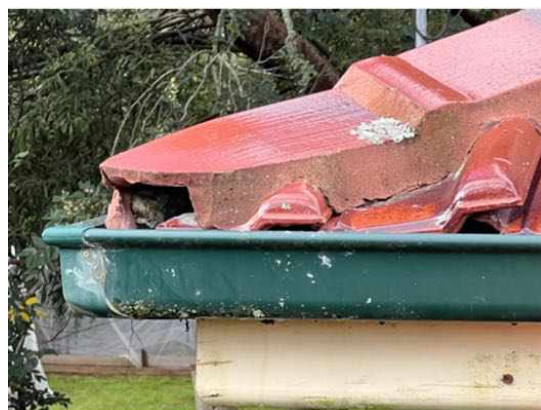
Information: An external hole was located at the time of inspection. This hole appears to be large enough to allow bird rodent or other pest ingress creating the potential for nesting or infestation of live animals.

To ensure no such infestation occurs this hole should be adequately covered. Holes such as these are also likely to attract rain penetration which may lead to subsequent water damage to associated structures if left unmanaged.

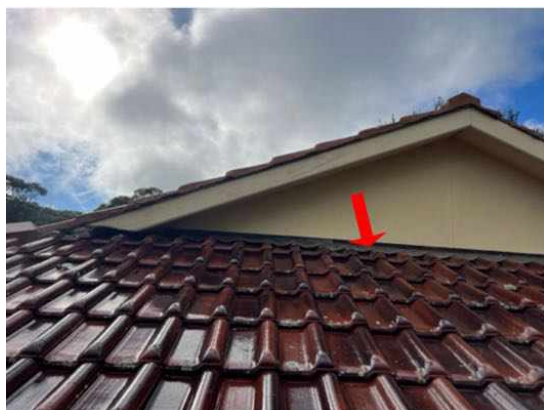
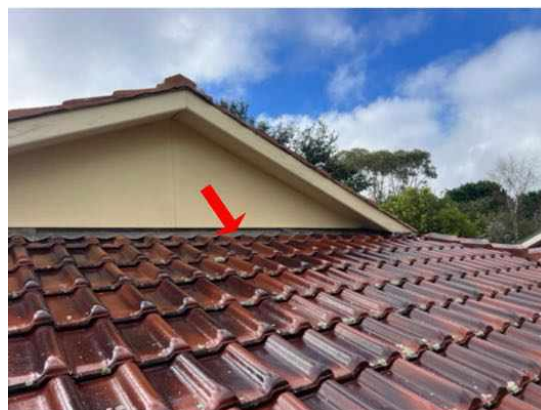
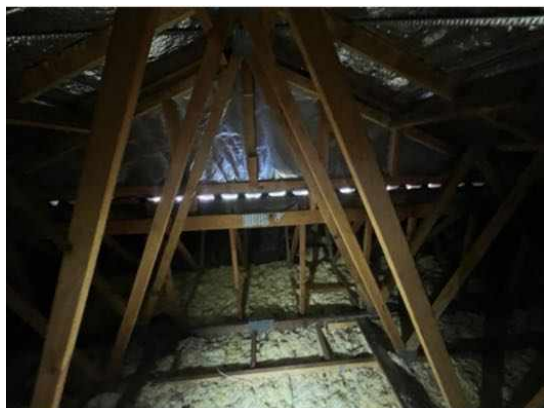
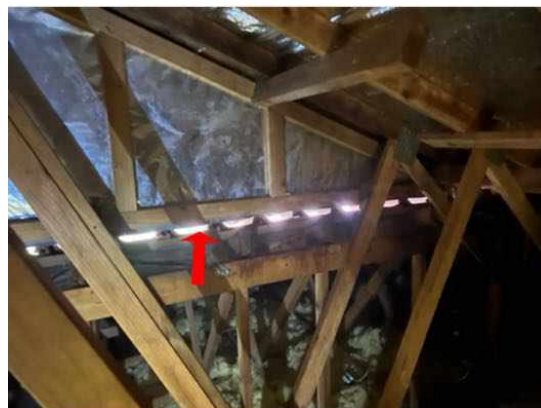
### Finding 3.21

Building:	Main Building
Location:	Roof Exterior
Finding:	Flashing - Lead Not Dressed to Tiles
Information:	Lead flashing was observed to be inadequately dressed to the roof tiles, with visible gaps present between the flashing and tile profile.

Flashings in this condition are unlikely to provide an effective seal against water ingress and may allow moisture to penetrate beneath the roof covering.

If left unmanaged, this condition may result in water ingress and deterioration of underlying building elements.

A licensed roofing plumber should be appointed to assess and rectify the flashing to ensure it is properly fitted and weatherproof,

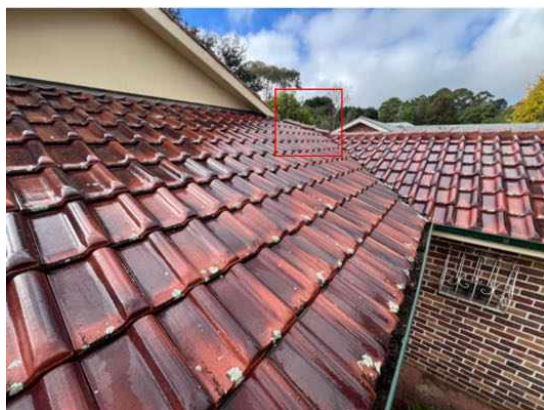
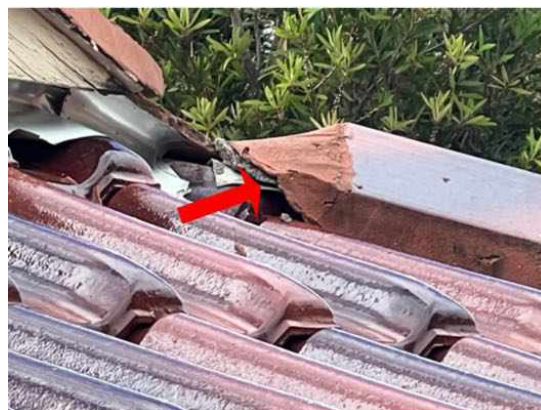
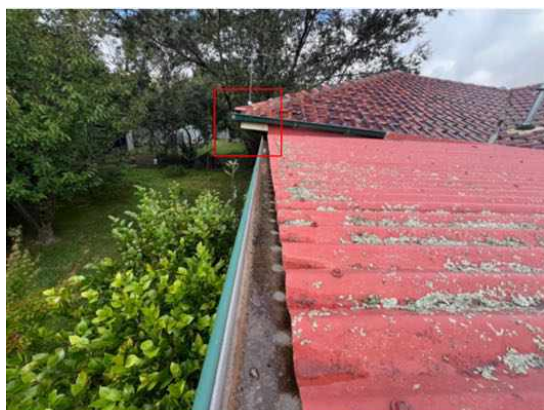
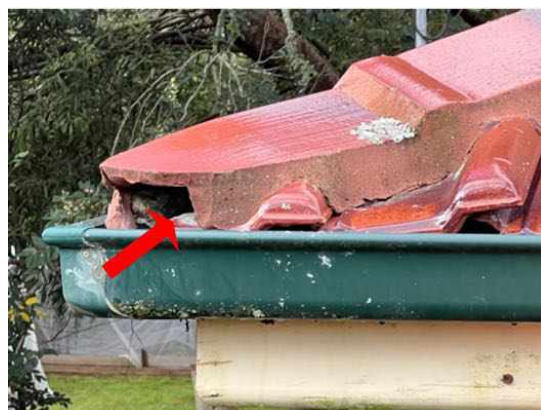
### Finding 3.22

Building:	Main Building
Location:	Roof Exterior
Finding:	Roof Mortar - Deterioration
Information:	Mortar, or 'bedding, is the material which fills joints and intersections between tiles and other building elements on the exterior roof covering, such as gable ends, hip capping and valleys.

Upon inspection of the exterior roof, it was noted that sections of the mortar show varying levels of deterioration.

Mortar generally deteriorates as a result of frequent exposure to weather conditions over a prolonged period of time. Mortar that is deteriorating may allow water ingress into the roof void, putting associated building elements and roofing structures at risk of water damage. Deteriorated mortar also detracts from the functionality of roof tiles and other roofing elements, potentially decreasing weather tightness and roof drainage.

Mortar deterioration can be attended to by a licensed roofing contractor

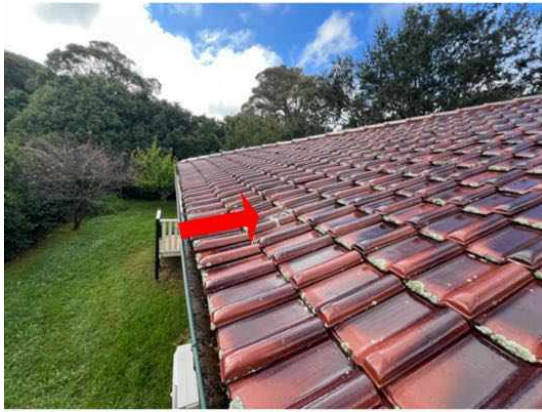
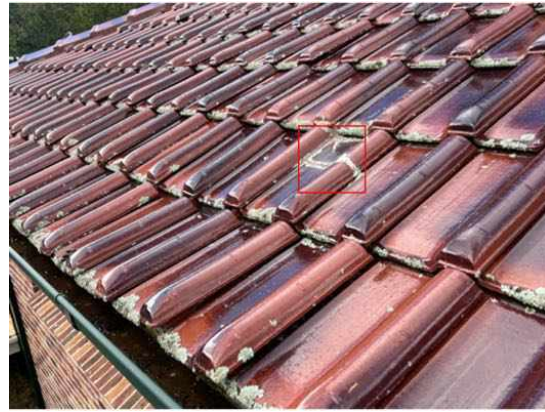
### Finding 3.23

Building:	Main Building
Location:	Roof Exterior
Finding:	Roof tiles - Excessive silicone work
Information:	The silicone repair work performed to the roofing tiles appears to have been completed to an unsatisfactory standard. Excess silicone was evident in many sections of the tiled area providing a blemish on the appearance as well as detracting from the drainage of the area.

While weather-tight the excess silicone should be removed in order to increase roof drainage and to prevent accelerated deterioration of the roof tiles. A roofing contractor or general handyman may be appointed to perform these works at client discretion.

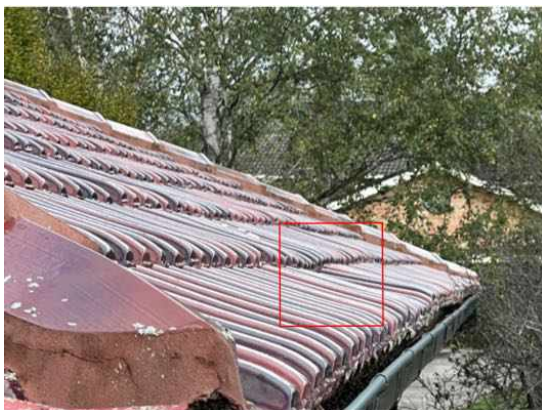
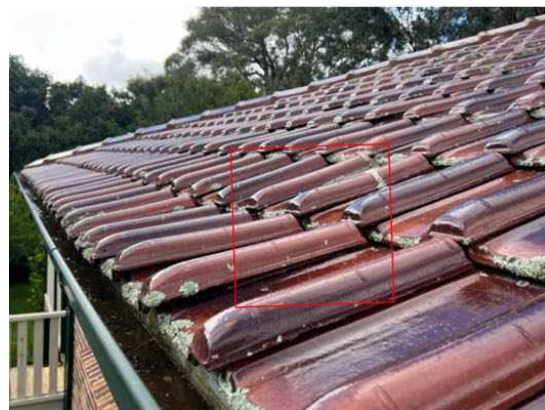
### Finding 3.24

Building:	Main Building
Location:	Roof Exterior
Finding:	Roof - Localised Sagging
Information:	A localised sag was observed to the tiled roof surface, with sections of tiles deviating from the general roof plane.

Sagging of this nature is commonly associated with movement or deflection of supporting elements such as battens or roof framing, or deterioration of underlying components.

If left unmanaged, this condition may result in ineffective water shedding and potential water ingress to underlying building elements.

Appointment of a licensed roofing contractor is advised to inspect the affected area and determine the cause of the sagging and any necessary works required.
