# Building and Timber Pest Inspection Report VR

Inspection Date: Mon, 23 Mar 2026

Property Address: 13 Betula Grove, Bundanoon NSW 2578,  
Australia

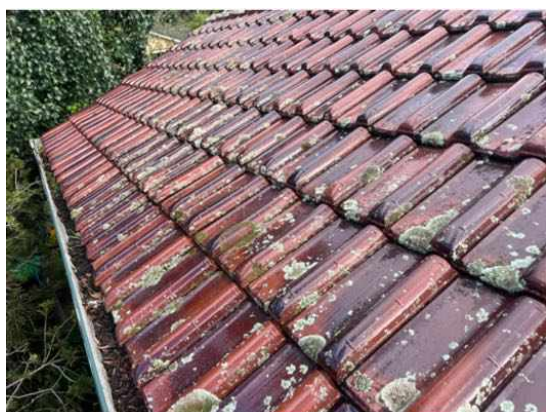
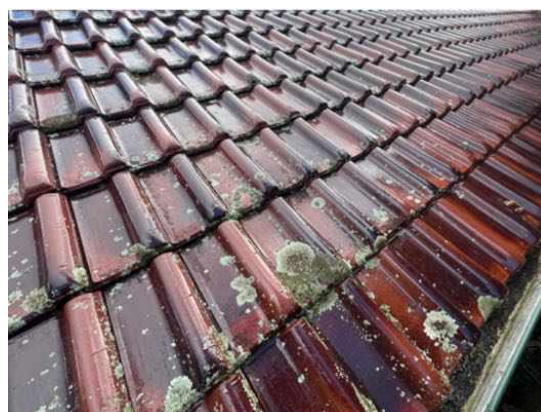
### Finding 3.25

Building:	Main Building
Location:	Roof Exterior
Finding:	Roof tiles weathered - Lichen build up
Information:	Upon inspection of the exterior roofing, the majority of roof tiles were considered to be

in a fair condition. While weathering of the tiles is consistent with the age of the property, maintenance works are required.

Concrete roof tiles are typically cleaned to have the visible moss and lichen removed. Concrete tiles are made from a product which is a naturally moist material. Moss and lichen is attracted to the roof tiles surface, and if left will continue to grow and most likely restrict the flow of rain water over the tiles surface, into the roofs gutters. An application of an environmentally friendly anti-fungal solution should be applied to all moss and lichen, prior to undertaking the roof cleaning process.

A roof restoration company can be contacted for further advice at the clients discretion.

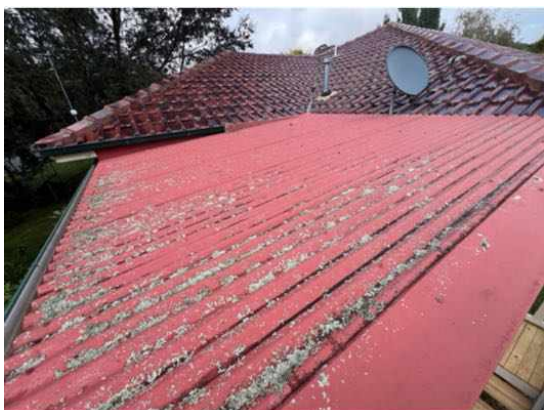
### Finding 3.26

Building:	Main Building
Location:	Roof Exterior
Finding:	Metal Roof - Lichen Growth
Information:	Upon inspection of the exterior roofing, sections of the Colorbond metal roof were observed to have lichen growth present. While the roof sheeting itself appeared to be in generally fair condition, the presence of lichen indicates ongoing exposure to moisture and environmental conditions.

Lichen growth on metal roofing can retain moisture against the roof surface and, if left unmanaged, may contribute to deterioration of protective coatings over time. In addition, accumulated growth may restrict the effective flow of rainwater toward gutters and drainage points.

It is recommended that the roof be cleaned to remove lichen growth using appropriate, non-abrasive methods suitable for metal roofing. A roof maintenance or roof restoration contractor can be consulted for further advice at the client's discretion.

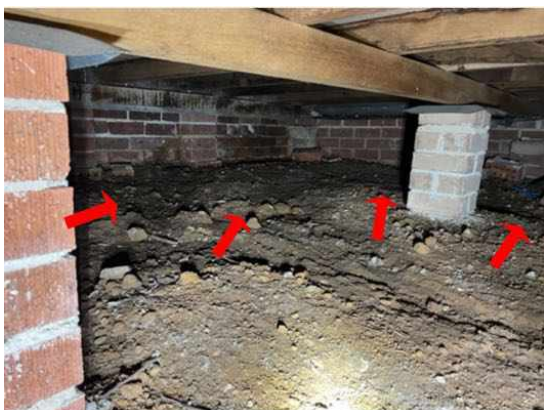
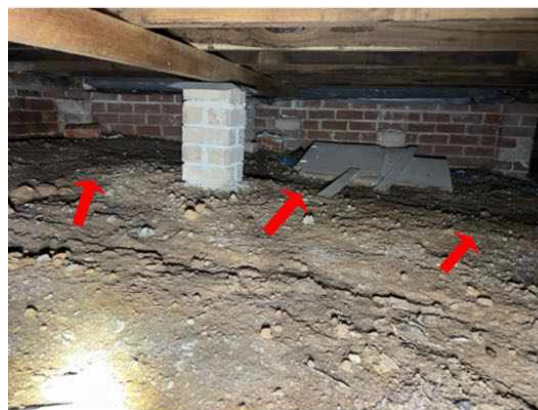
### Finding 3.27

Building:	Main Building
Location:	Subfloor
Finding:	Damp or wet - leak
Information:	Damp or wet conditions are generally a direct result of poor drainage an active leak or poor ventilation (or a combination of the three). Dry conditions should be maintained to prevent secondary building defects from developing.

If left unattended damp or wet conditions may have many consequences including the development of fungal decay and/or wood rot as well as providing an environment that may be conducive to termite or timber pest attack.

A qualified plumber should be appointed immediately to identify the cause of the excessive moisture in order to prevent further damage. The water leak should be resolved prior to any repairs of the damaged area which may require localised replacement of building materials and refinishing..

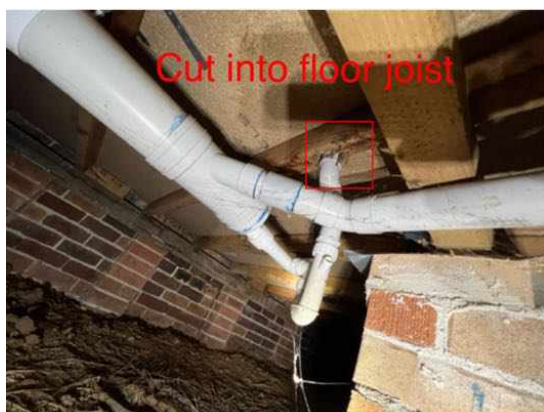
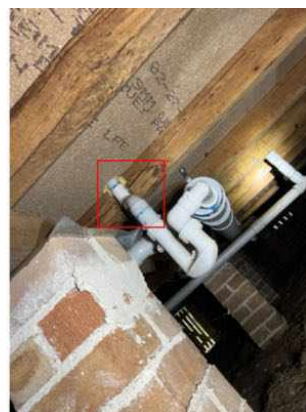
### Finding 3.28

Building:	Main Building
Location:	Subfloor
Finding:	Subfloor support Timbers - alteration/modification

Information: Alterations or modification to the subfloor existing structure have occurred. The modifications do not comply with current building practices and standards and require remedial works to reinstate to a suitable standard.

Replacement of sections of Timbers is likely to be required in order to comply with building regulations. It is recommended that a registered builder or structural engineer be engaged to assess the extent of the modification and determine whether strengthening or replacement of the affected timber is required to maintain the structural integrity of the floor system.

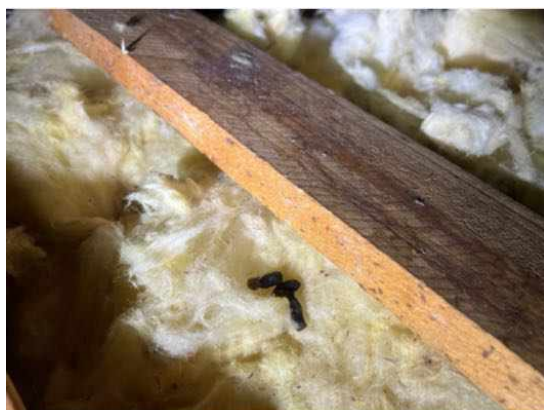
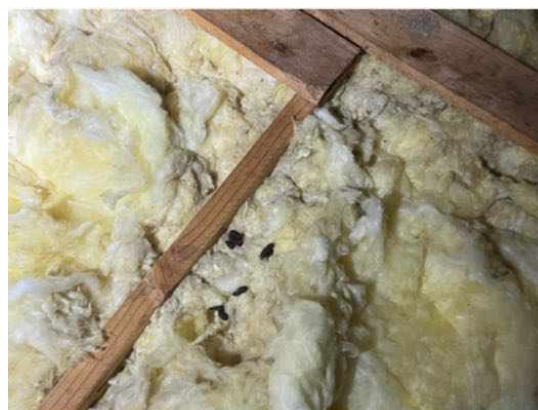
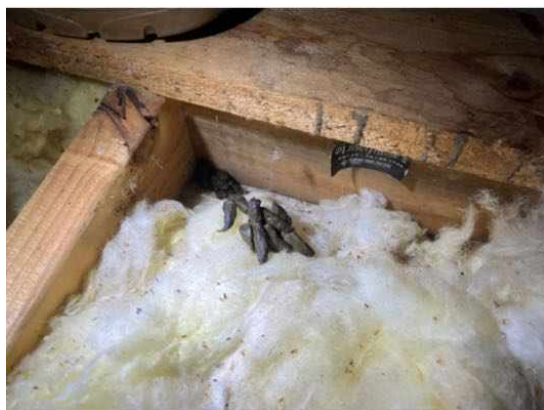
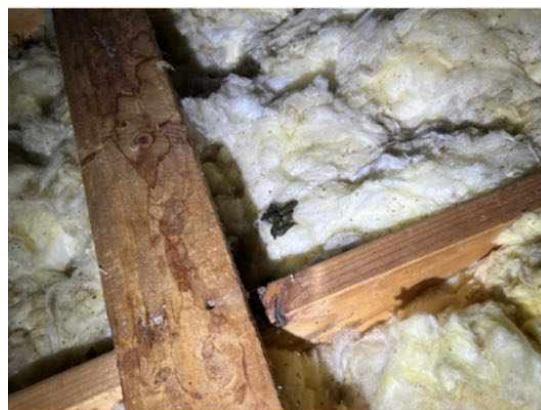
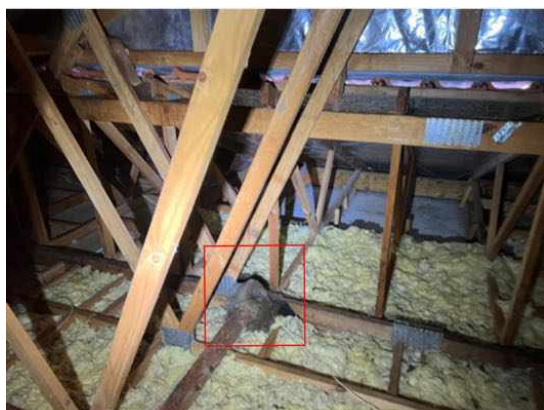
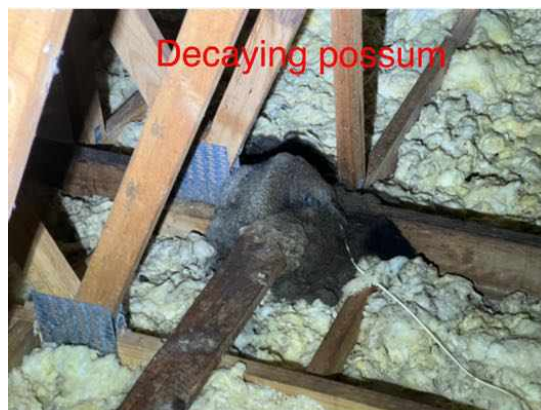
### Finding 3.29

Finding: Evidence of Vermin

Information: Evidence of pests or rodents were present in the roof space at time of inspection including animal pings and odor. Rodents can cause issues ranging from smells and stains through to physical damage to wiring and other elements in the roof void. A licensed pest controller should be appointed to free the roof void of any pests and to install deterrents or seal access points to ensure that rodents can not enter the roof space as easily.

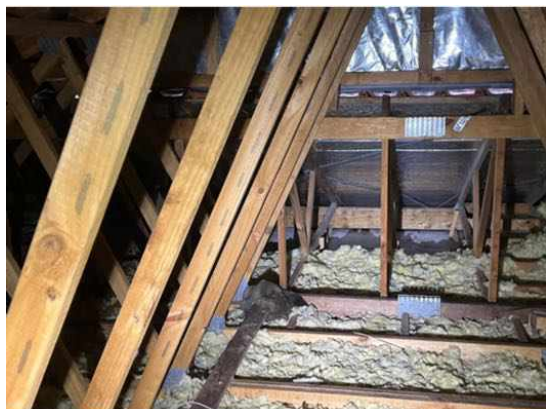
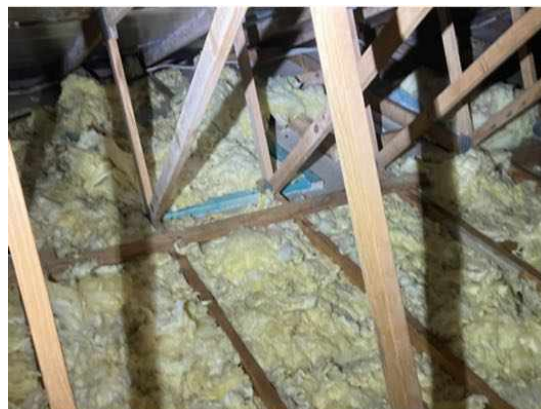
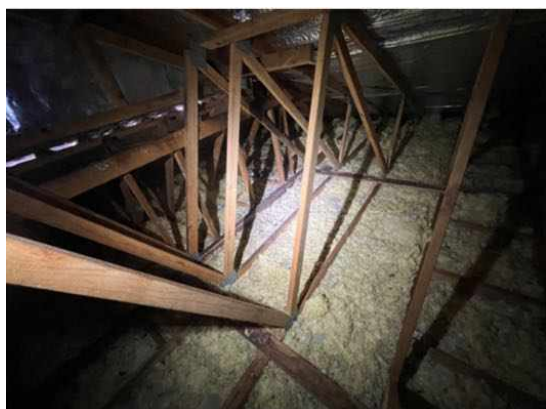
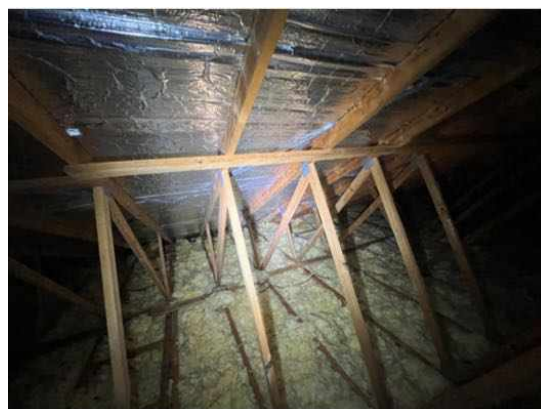
### Finding 3.30

Building:	Main Building
Location:	Roof Void
Finding:	Insulation - Reduced coverage due to vermin activity
Information:	Upon inspection of the roof void it was noted that insulation coverage is reduced and inconsistent, with sections displaced and reduced in volume, likely due to disturbance from vermin activity within the roof space.

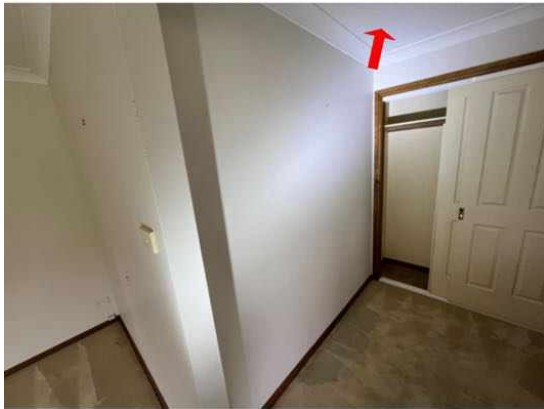
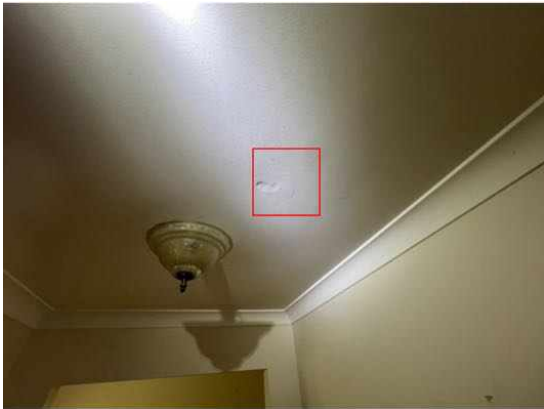
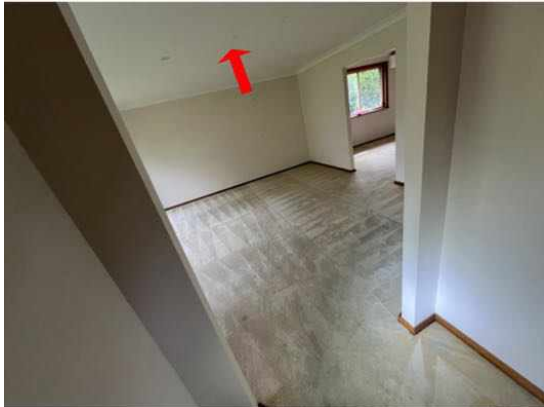
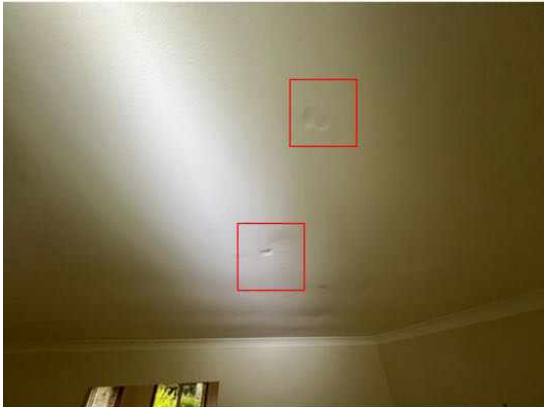
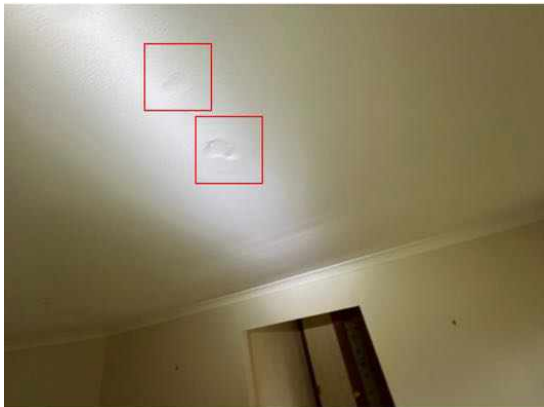
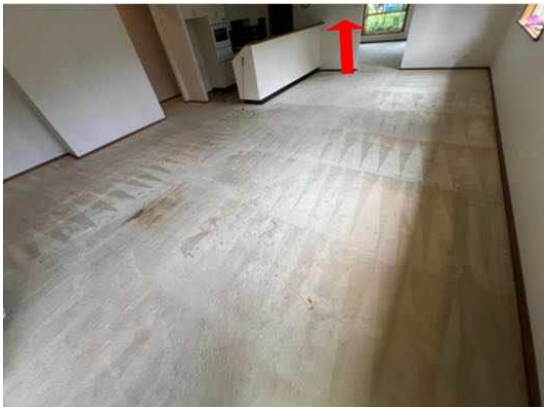
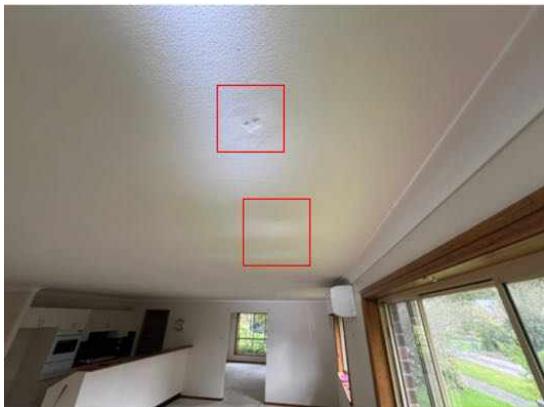
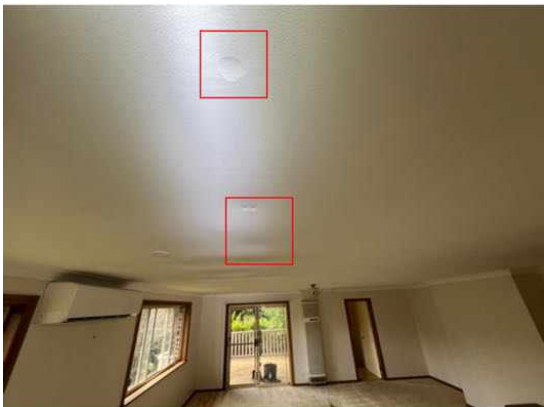
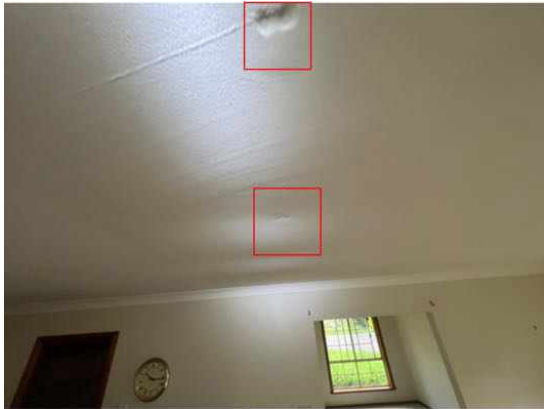
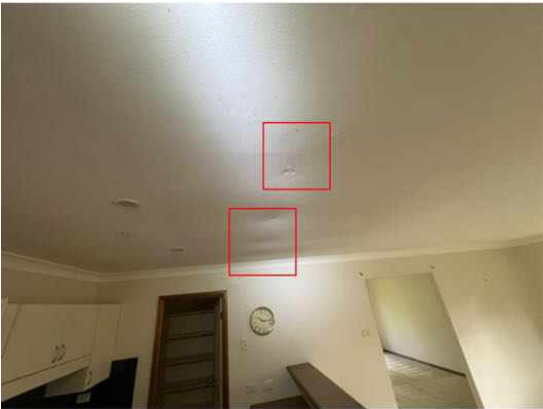
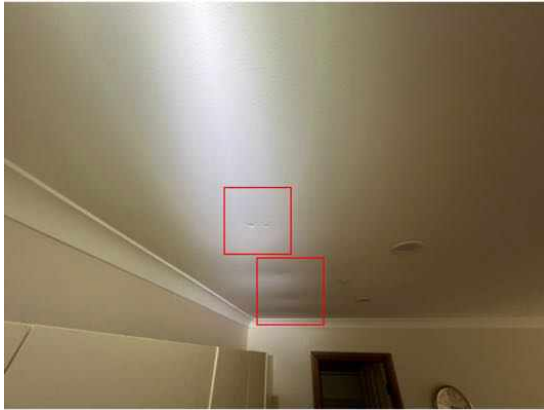
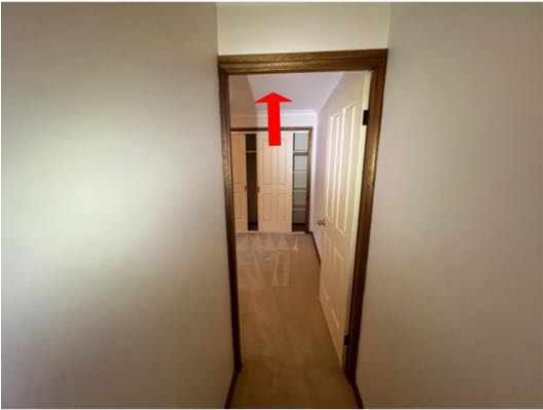
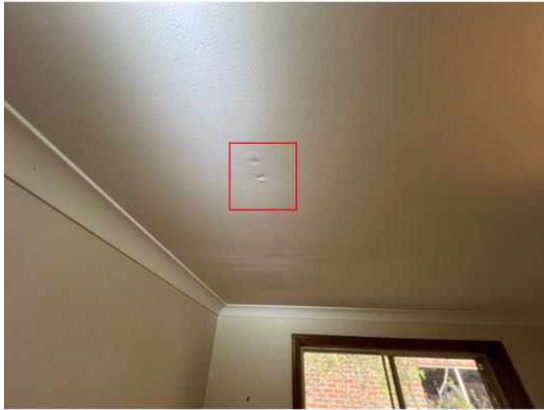
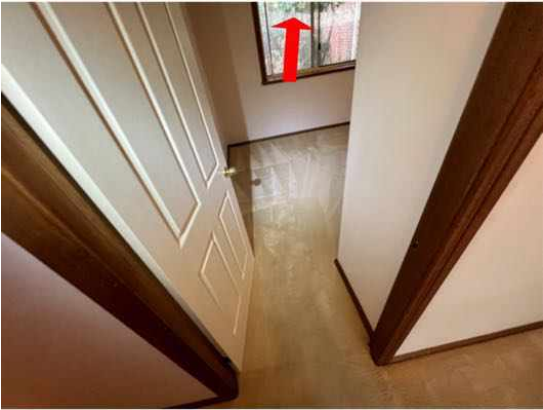
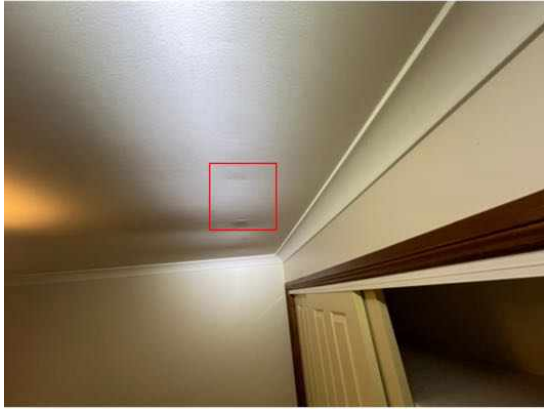
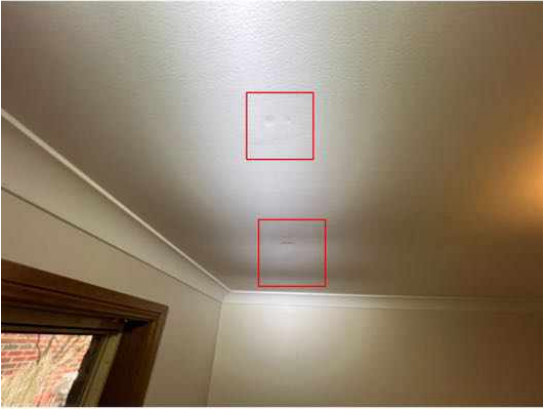
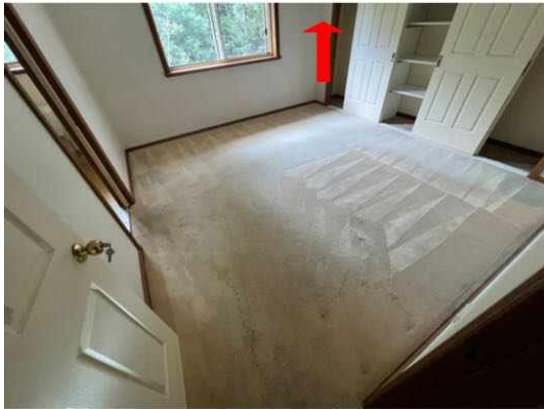
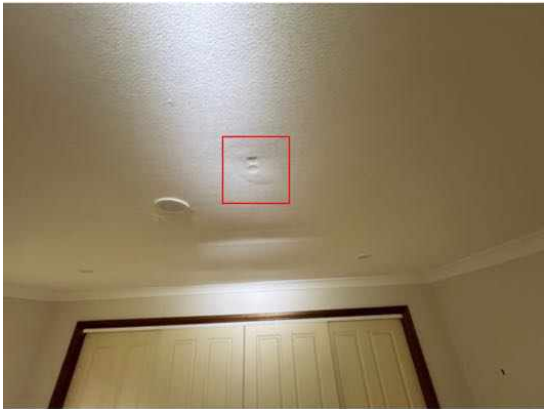
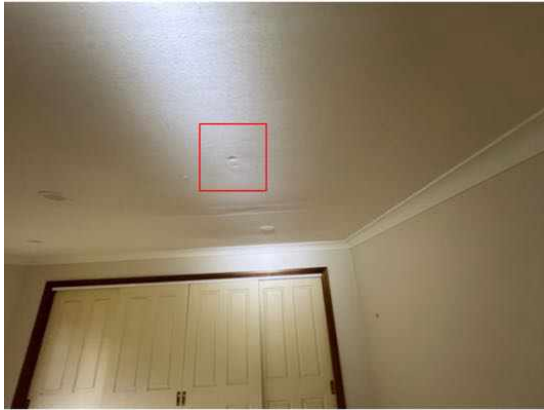
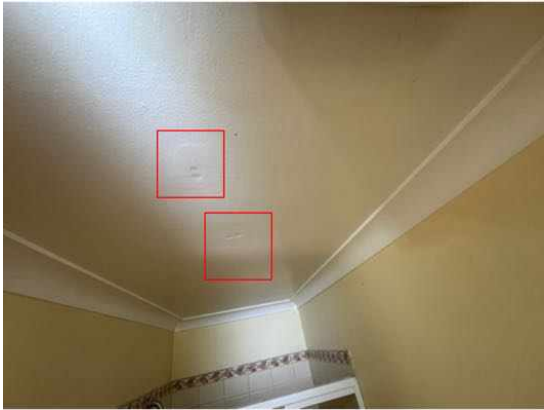
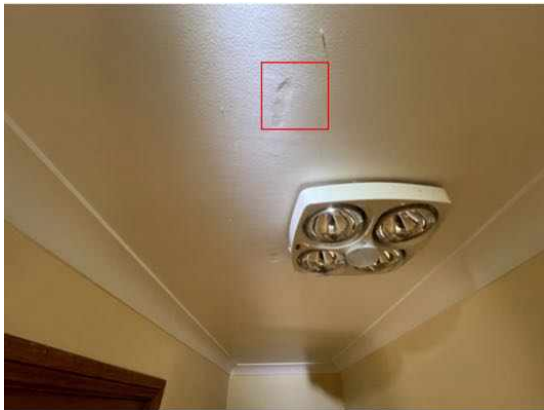
Building:	Main Building
Location:	All Internal Areas
Finding:	Ceiling nails - Popping
Information:	Numerous popped nails were identified in the internal ceiling at the time of inspection. Nails and screws hold simply by the friction between them and the surface they are applied to. Over time, the nails and screws can back out, which is often a result of general ageing and deterioration of the building structure.

If left unmanaged, the ceiling sheets may become loose and unstable, increasing the rate of deterioration of the internal ceiling and creating potential for the development of secondary defects.

Re-fastening of popped nails will help to maintain the stability of the internal ceiling and associated building elements. Such minor works will also help to improve the appearance of the affected area and secure the ceiling sheets, so as to prevent the onset of ceiling sagging. These works should be performed by a qualified carpenter or plasterer at client discretion.

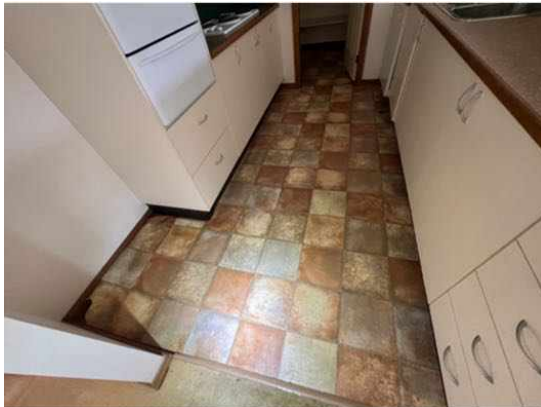
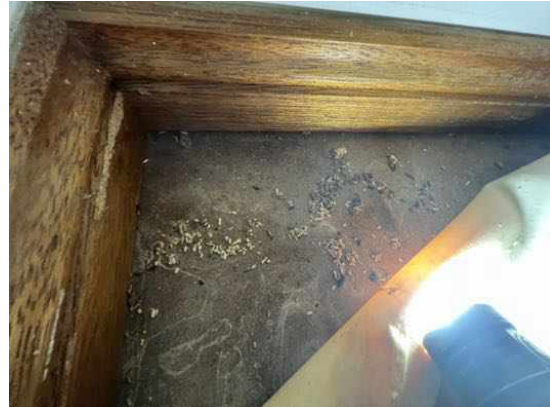
**Finding 3.32**

Building: Main Building  
 Location: Kitchen  
 Finding: Vermin Activity - Evidence Observed  
 Information: Evidence of vermin activity was observed within the property, including droppings and odour in accessible areas.

Vermin presence within a building may lead to contamination, unpleasant odours, and damage to building elements such as insulation, wiring, and linings.

If left unmanaged, vermin activity may continue and result in further deterioration of building materials and hygiene concerns.

It is highly advised that a licensed pest controller be appointed to address the infestation and implement appropriate control measures.

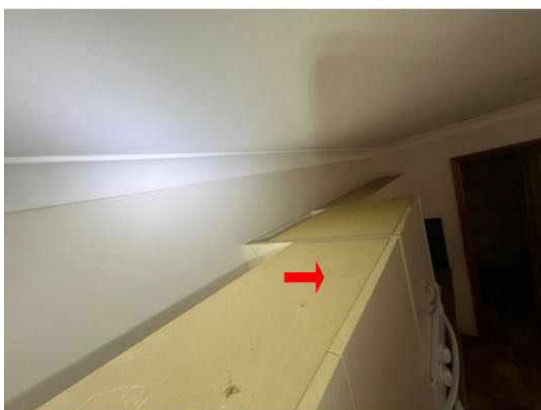
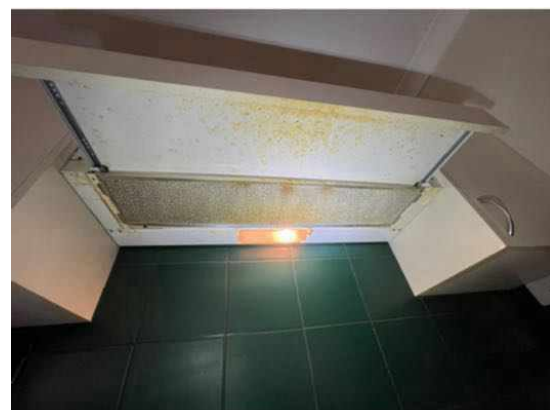
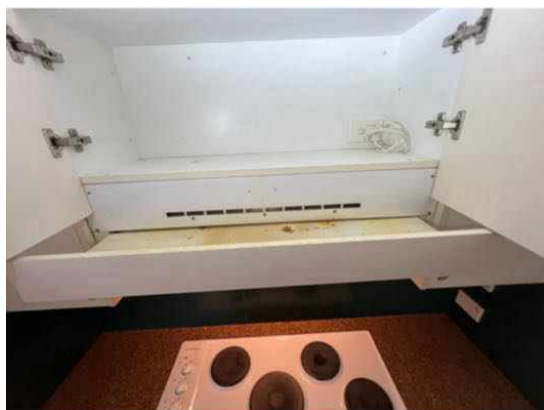
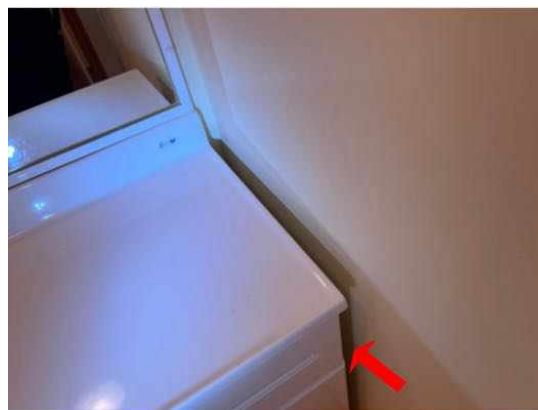
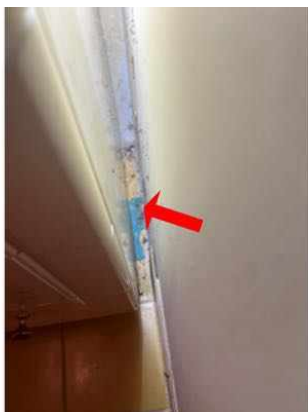
### Finding 3.33

Building:	Main Building
Location:	Kitchen, Bathroom
Finding:	Surface - Requires cleaning
Information:	Regular cleaning and maintenance improves the longevity of all building elements. A build up of dirt and debris can reduce the useful life of building materials and may result in earlier replacement of items being required.

Excessive dirt is also likely to lead to secondary hazards, including potential health hazards, as the building elements begin to harbour bacteria and/or mould.

Remedial cleaning is recommended in order to improve the appearance of this area as well as to counteract the development of bacteria. Such works can be performed by a cleaning contractor and should be completed at the discretion of the client.

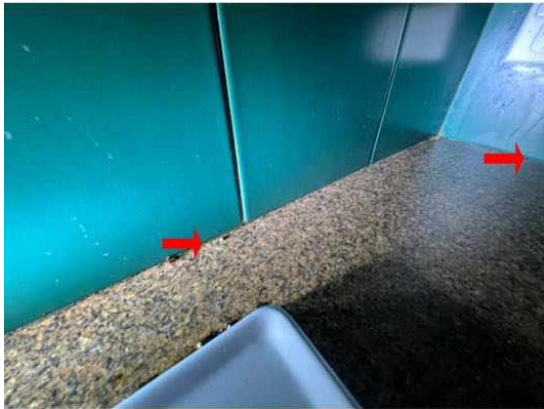
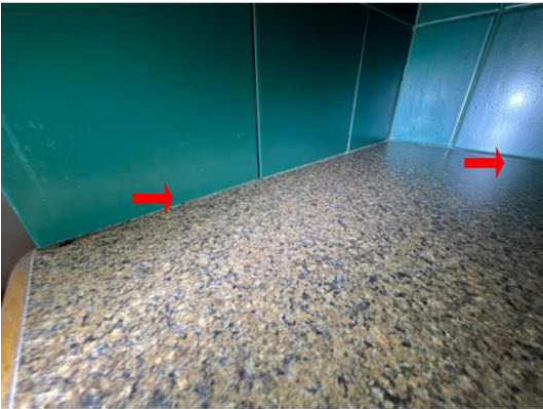
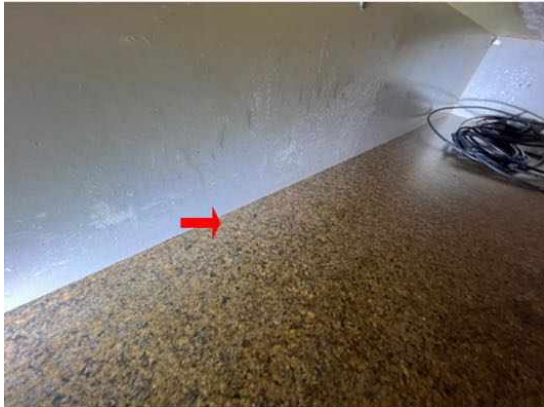
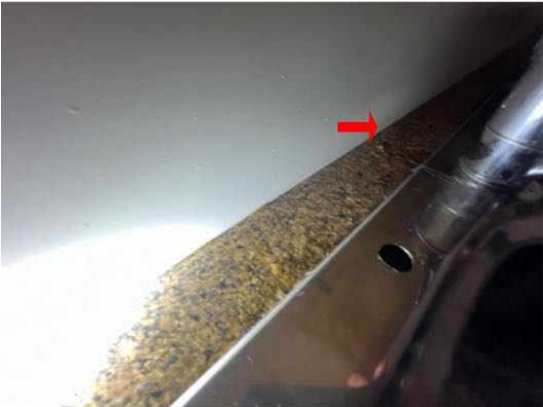
### Finding 3.34

Building:	Main Building
Location:	Kitchen
Finding:	Sealant - missing
Information:	It was noted on inspection that sealant or grout is missing to this area.

Different materials move at different rates, generally causing cracking to grout or sealant at this point. A flexible sealant is required to allow for expected expansion and contraction, while keeping the joint water tight and protective of all associated building materials.

Flexible and mould resistant materials should be applied to affected areas to prevent any subsequent water damage that is likely to occur. Regular maintenance and replacement of damage or missing or damaged sealant and grout is highly recommended to the wet areas, as this is a regular wear and tear defect. Sealant and grouting in areas that come into regular contact with water should be maintained for the long term care of your property.

A sealant specialist or tiling contractor should be appointed to complete these works as soon as possible

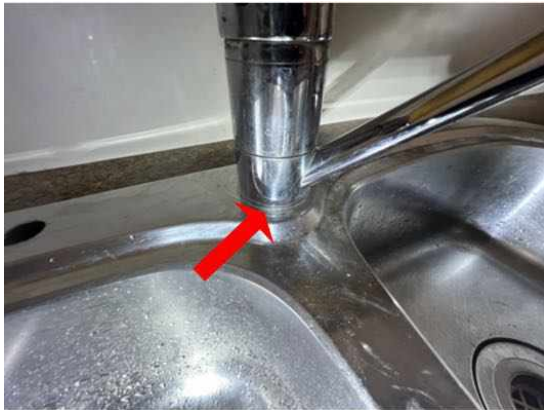
**Finding 3.35**

Building: Main Building  
Location: Kitchen  
Finding: Tap - Loose  
Information: The tap in this area has not been installed correctly, or has deteriorated with age, and is consequently loose. This tap being loose creates potential for water leaks and subsequent water damage to the surrounding area.

Where taps or spouts are loose, a qualified plumber should be appointed to re-fix the plumbing fitting.

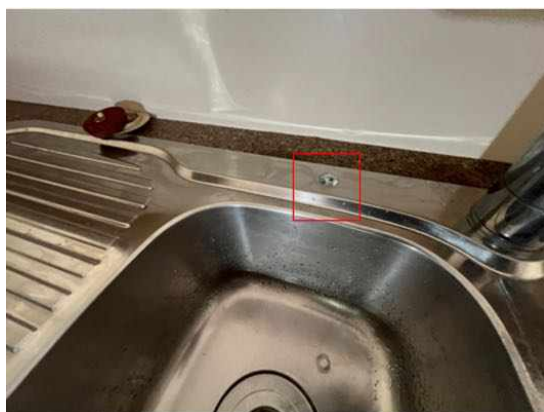
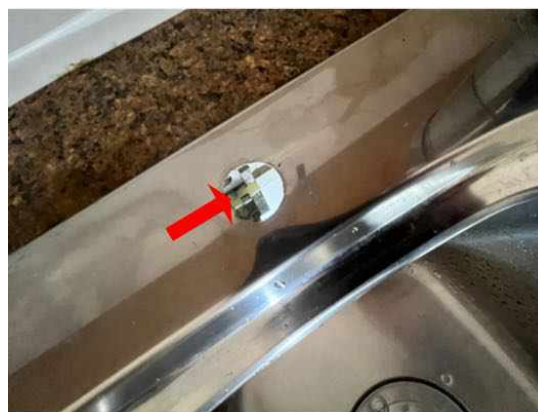
### Finding 3.36

Building: Main Building  
 Location: Kitchen  
 Finding: Sink - Redundant Penetration  
 Information: A redundant penetration was observed to the sink consistent with a previous water filter or similar fixture, with the opening no longer in use.

If left unmanaged, moisture may lead to deterioration of adjacent materials.

It is highly advised that the opening be appropriately sealed to prevent water ingress.

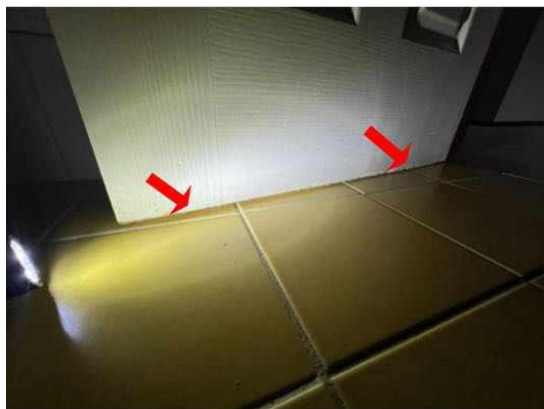
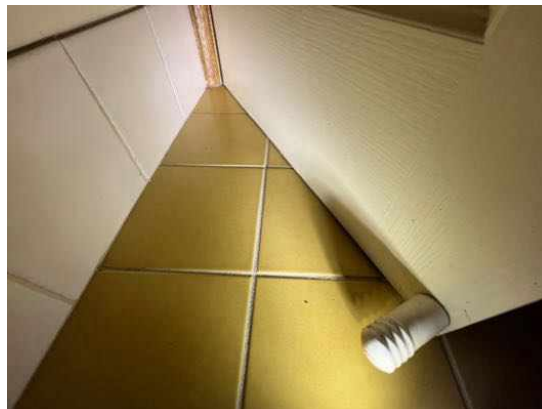
Location: Laundry  
 Finding: Cabinetry and/or building component - Moisture Damage  
 Information: It was observed on inspection that the building component in this area of the property has sustained water damage, evidenced by staining and swelling. This appears to be as a result of exposure to moisture over a number of years.

Rectification by a cabinet maker or relevant trade is recommended at the discretion of the client, however it is advised to inspect the area on a regular basis for any further swelling that could occur.

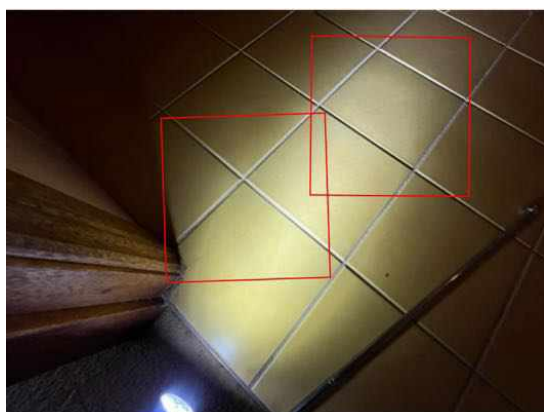
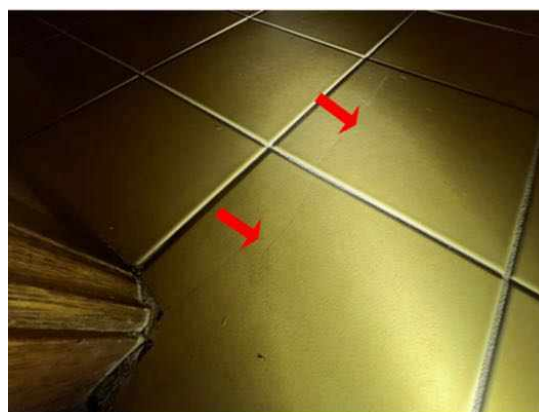
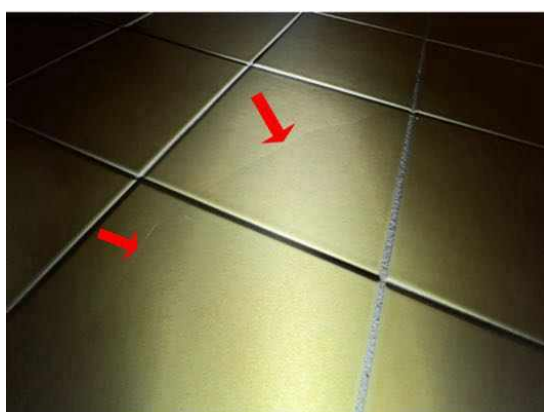
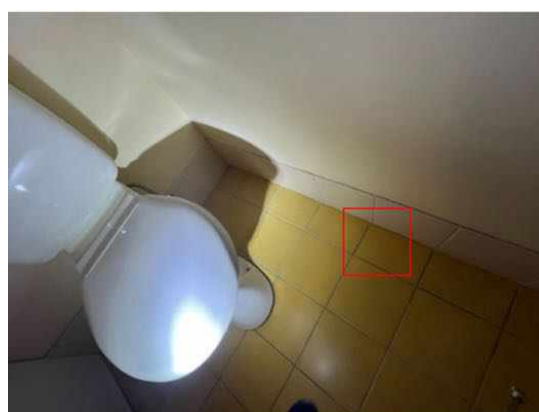
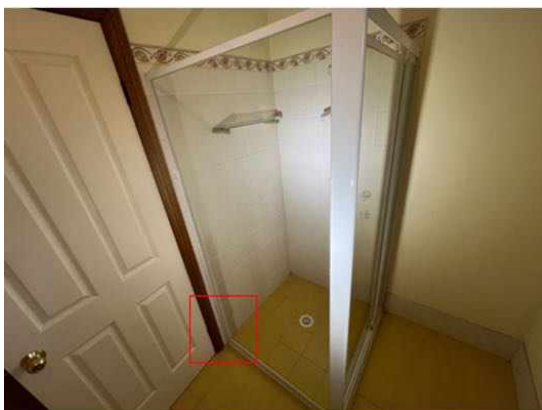
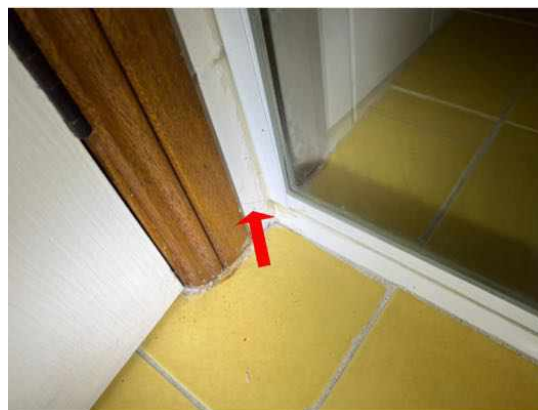
Building: Main Building  
Location: Laundry, Bathroom  
Finding: Tiles - Cracked or damaged  
Information: Cracking was evident to the tiling in this area at the time of inspection. While the cracking appears to be minor, this area is frequently exposed to water, allowing potential for water penetration into adjoining sections of walls or flooring.

If left unmanaged, water penetration to these areas may lead to subsequent water damage, which is likely necessitate repair work to affected building elements.

A tiling contractor should be appointed to ensure that no further water damage occurs. The re-application of silicone and grouting throughout remaining tile work is also advised, to further protect the area against water penetration.

Where water penetration has led to water damage, appointment of a relevant tradesperson may be required to repair damaged building elements.

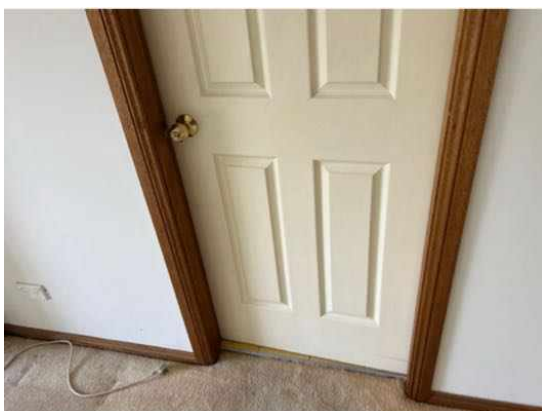
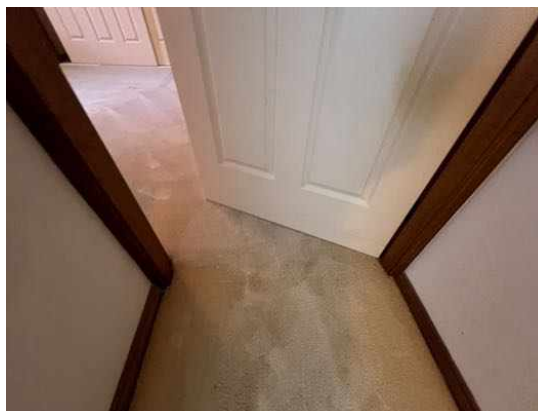
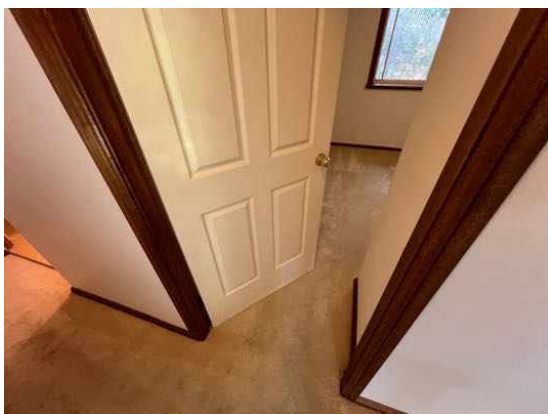
### Finding 3.41

Building:	Main Building
Location:	Laundry, Bedroom 3, Bedroom 2
Finding:	Doors - Binding/Jamming
Information:	Binding and/or jamming of several doors throughout the property were evident during standard operation. This defect inhibits the functionality of affected doors as well as creating potential for secondary defects to associated building elements, such as damage to the floor covering.

A door that binds to flooring or to the associated door frame may have several causes, ranging from minor defects, such as poor installation of the door or deteriorated hinges, through to major structural issues, such as damage to subfloor structures.

Where door binding/jamming appears to indicate major structural issues, a registered builder specialising in re-stumping should be appointed to provide an estimate on the cost of rectification.

For minor causes, a qualified carpenter or general handyman should be appointed to perform minor rectification works at client discretion.

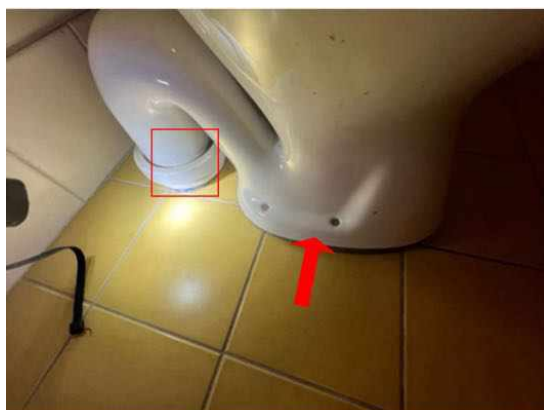
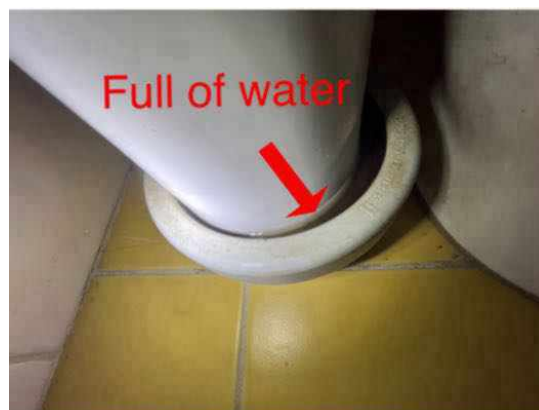
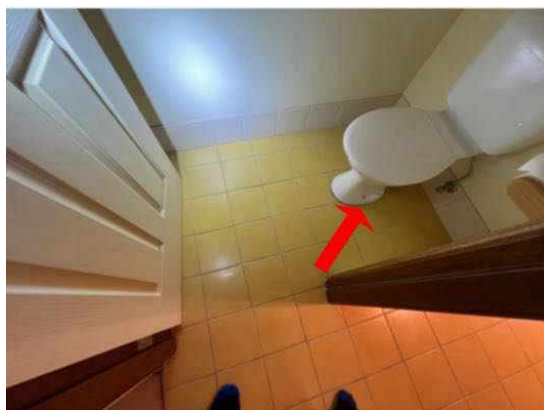
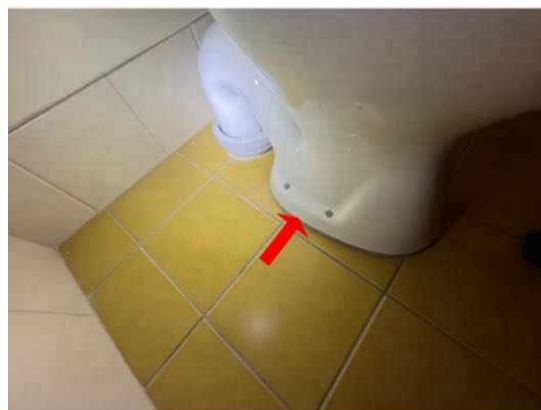
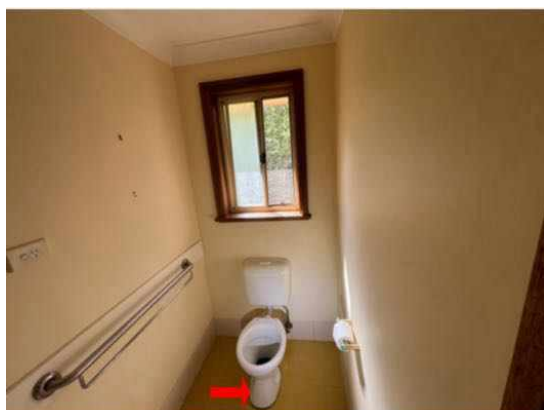
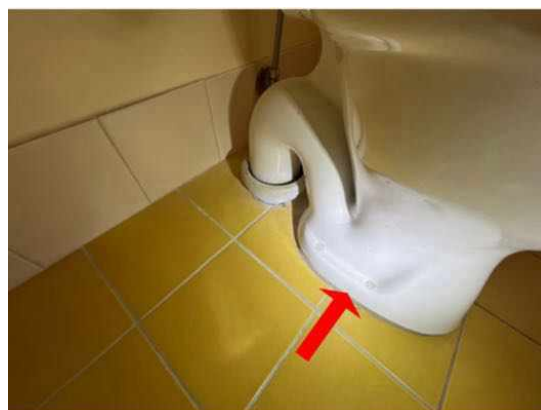
### Finding 3.42

Building:	Main Building
Location:	Laundry, Bathroom, Ensuite
Finding:	Toilet pan - Loose
Information:	The toilet pan was found to be loose and relatively unstable at the time of inspection. It is suspected that this defect has developed due to general aging of the toilet pan and associated materials. However, the loose fixing may also be a result of impact damage.

If left unmanaged, the toilet pan could deteriorate further, leading to greater destabilisation and the potential for water leaks to surrounding building elements.

It is recommended that the pan be refixed to the floor with concrete or silicone by a licensed plumbing contractor.

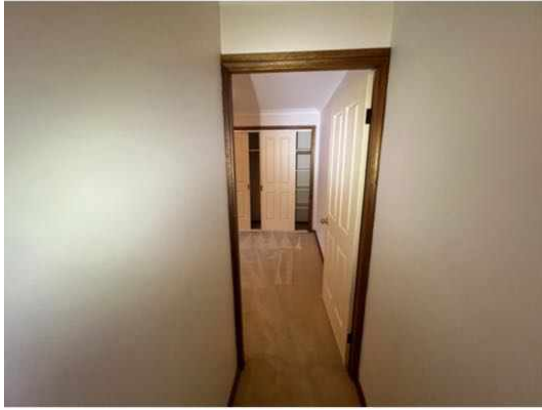
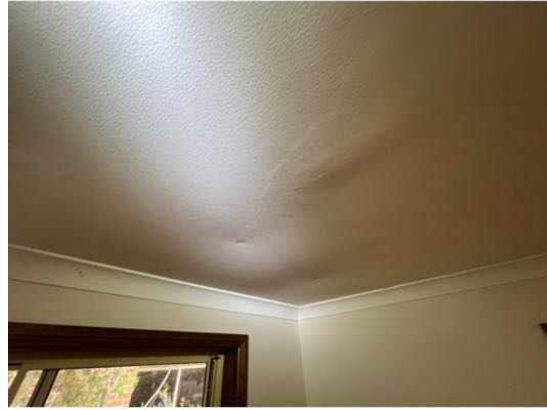
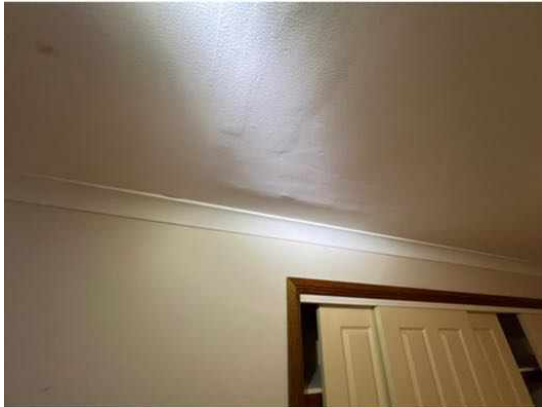
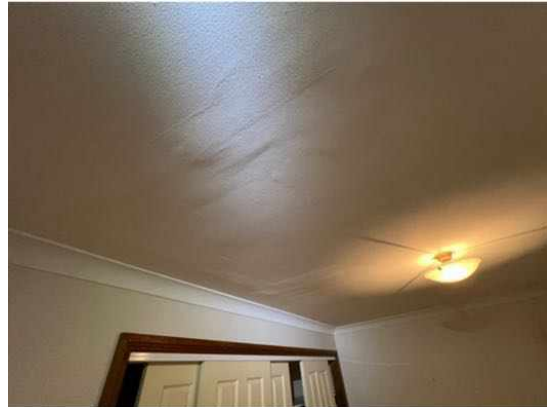
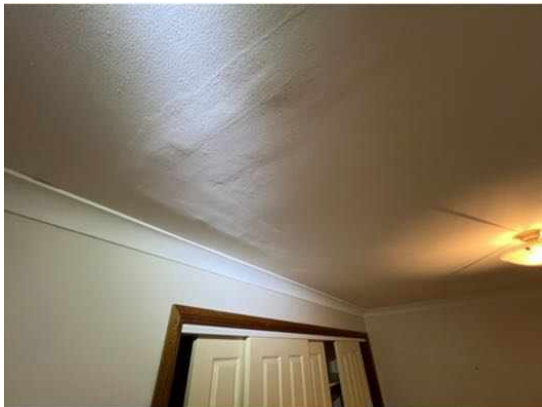
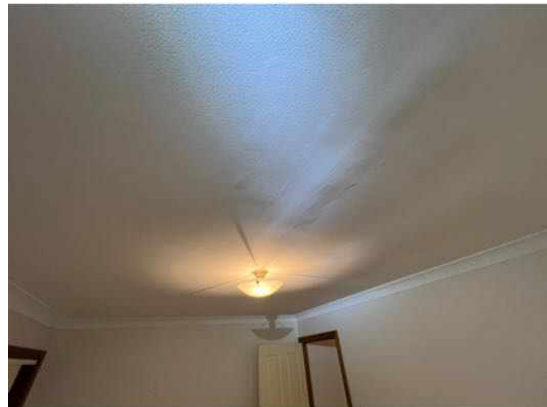
### Finding 3.43

Building:	Main Building
Location:	Bedroom 3
Finding:	Ceiling - substandard or incomplete
Information:	The installation of this ceiling appears to have been completed to a substandard level of workmanship or is incomplete. Generally substandard repairs or installation are related to poor workmanship, the use of inappropriate materials, or a failure to complete installation to a suitable standard.

Where installation is substandard and/or incomplete, the client should contact a plasterer or licensed builder to undertake rectification. Unfinished and substandard building works are likely to degrade more quickly and may create potential for secondary defects to associated building elements.

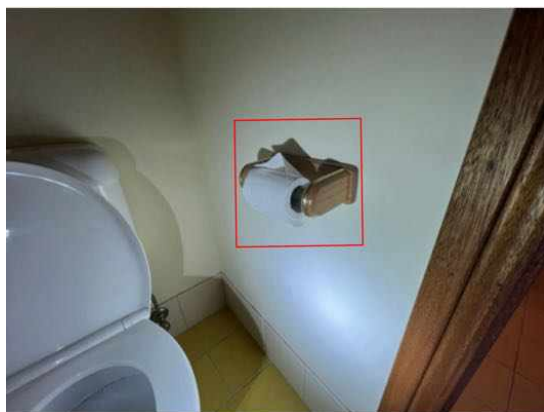
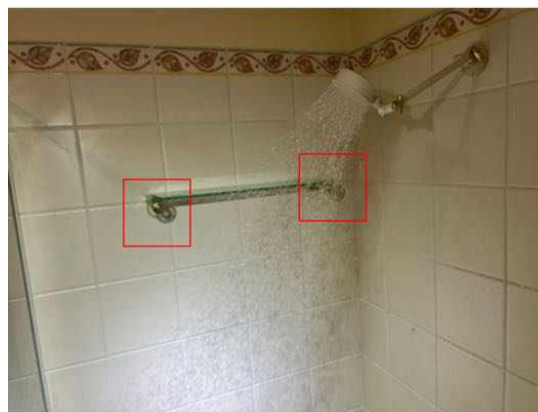
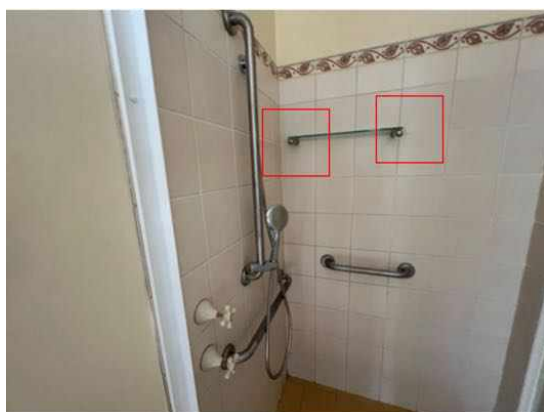
### Finding 3.44

Building:	Main Building
Location:	Toilet (WC), Bathroom, Ensuite
Finding:	Fitting or fixture - Loose
Information:	The fitting in this area is loose and requires adjustment to tighten.

If left unmanaged, the fitting may further deteriorate, causing potential for the development of other minor secondary defects.

A relevant tradesperson should be appointed to perform these rectification works at discretion of the client.

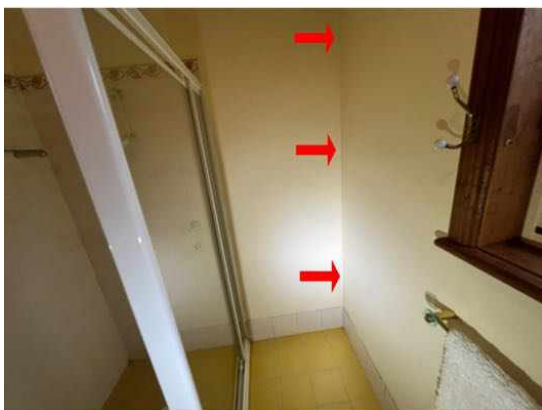
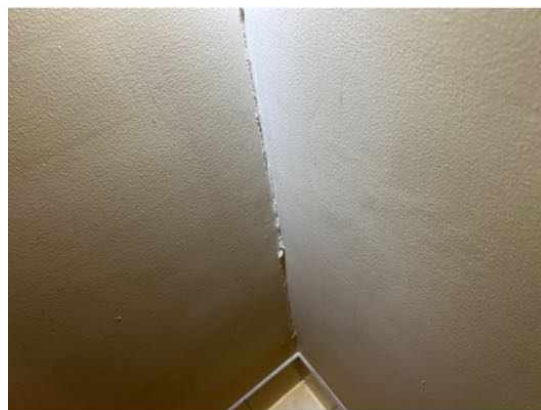
### Finding 3.45

Building:	Main Building
Location:	Bathroom
Finding:	Cracking - Damage Category 1 - Fine (up to 1mm)
Information:	Although fine cracks are quite noticeable, they are often only considered to be an appearance defect, and usually do not indicate any structural damage. Generally, the cause of a fine crack is indicative of a separation between building materials and finishes (e.g. paint, plaster, etc.) along joins.

Cracking of this nature can generally be repaired with minor sanding, filling and/or repainting. Such works should be performed by a qualified painter or a general handyman.

Monitoring of all cracking should be conducted frequently. Always contact a building inspector should cracks widen, lengthen, or become more numerous.

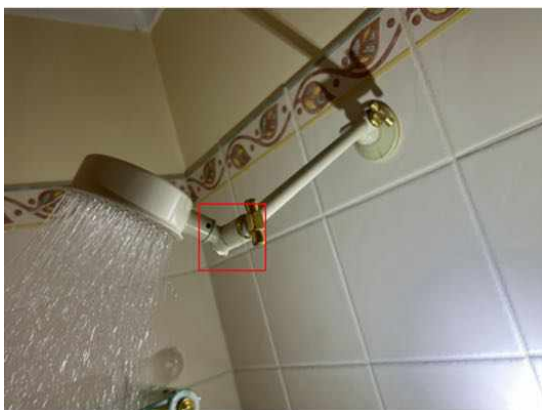
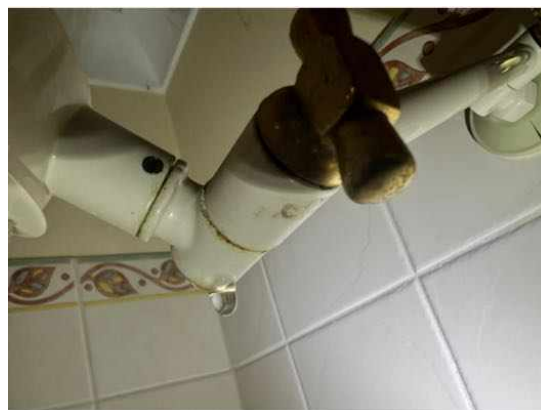
### Finding 3.46

Building:	Main Building
Location:	Bathroom
Finding:	Shower head - Leaking
Information:	The shower head in this area was found to be leaking at the time of inspection. This is a common defect that is consistent with general ageing of the building element. However, it may be indicative of substandard plumbing workmanship if the tap is relatively new.

While this defect only seems minor, if left unmanaged, it is likely to result in the development of rust, water damage and/or extensive water usage.

It is advised that a handyman or licensed plumber be appointed to perform remedial works on the affected tap. Such works should be performed prior to the development of secondary defects to ensure adequate functionality of all associated building elements.

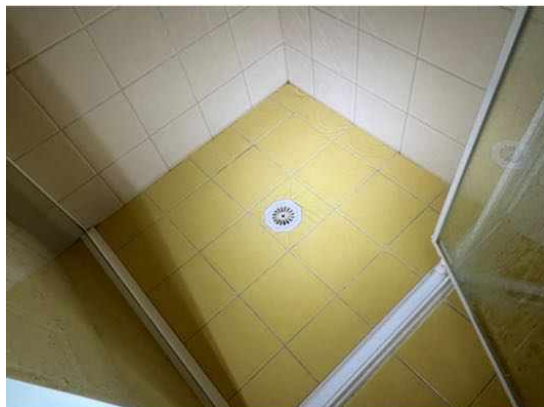
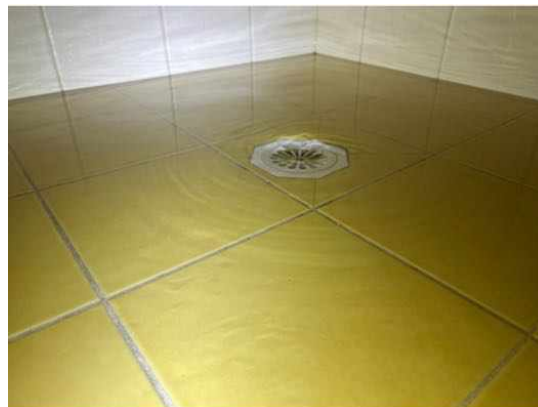
### Finding 3.47

Building:	Main Building
Location:	Bathroom
Finding:	Shower - Slow Drainage

Information: The shower was noted to be draining slowly at the time of inspection. This condition is commonly caused by a partial blockage within the waste pipe or inadequate fall in the plumbing line.

If left unresolved, slow drainage may worsen over time and lead to further blockages or overflows. A licensed plumber should be engaged to investigate the cause and carry out any necessary cleaning or rectification to restore proper function.
