# Building and Timber Pest Inspection Report VR

Inspection Date: Mon, 23 Mar 2026

Property Address: 13 Betula Grove, Bundanoon NSW 2578,  
Australia

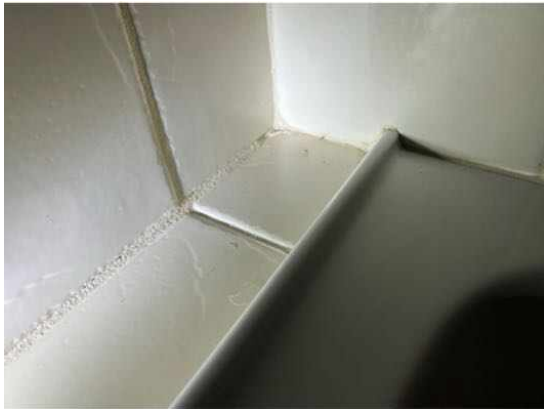
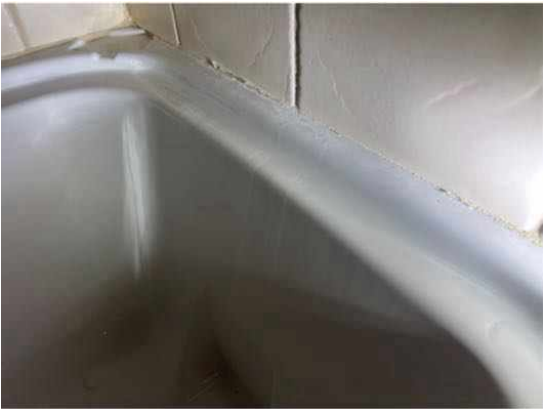
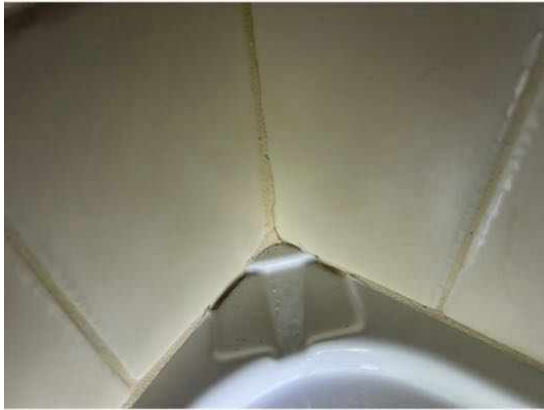
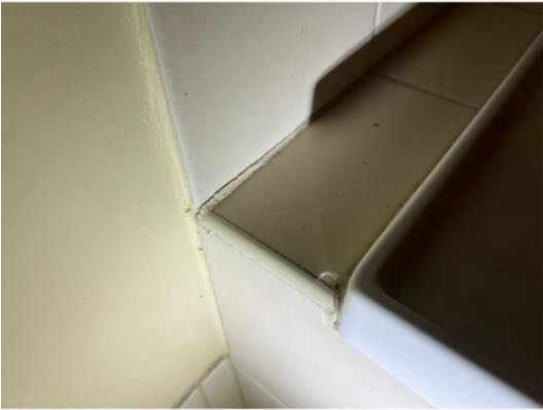
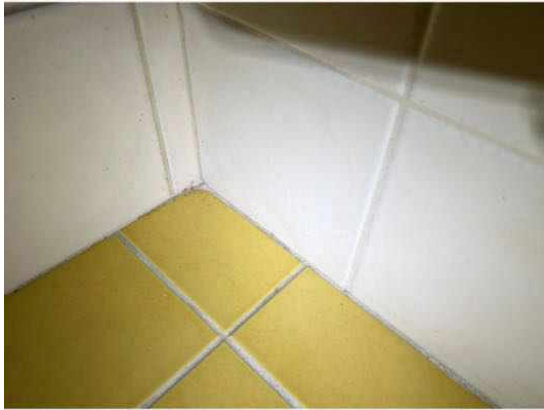
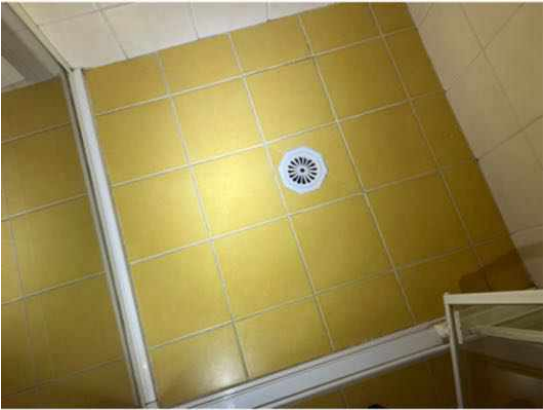
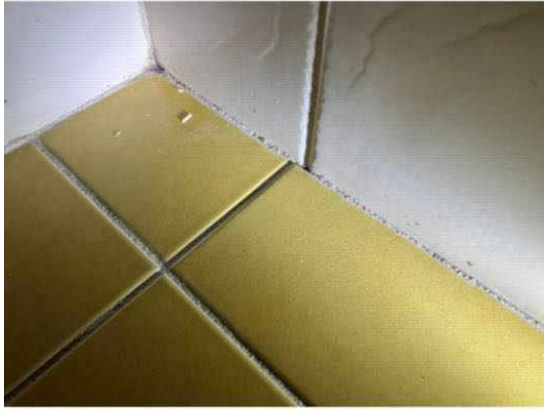
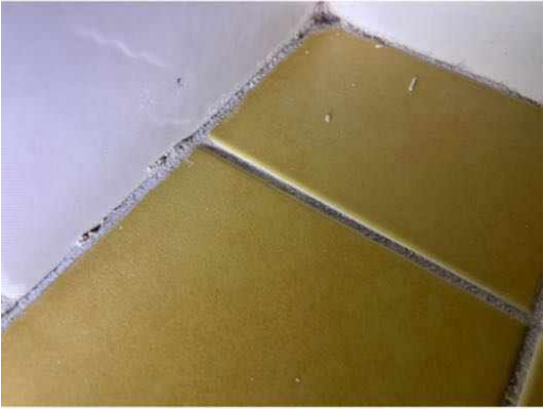
### Finding 3.48

Building: Main Building  
 Location: Bathroom, Ensuite  
 Finding: Sealant and grouting - Missing or damaged  
 Information: It was noted on inspection that sealant or grout is degraded to the tiled shower alcove and or other areas of the bathroom.

Different materials and floor areas move at different rates, generally causing cracking to grout or sealant at this point. A flexible sealant is required to allow for expected expansion and contraction, while keeping the joint water tight and protective of all associated building materials.

There appears to be excessive mould to the sealant and grout which will likely require scraping out and replacement.

Flexible and mould resistant materials should be applied to affected areas to prevent any subsequent water damage that is likely to occur. Regular maintenance and replacement of damage or missing or damaged sealant and grout is highly recommended to the wet areas, as this is a regular wear and tear defect. Sealant and grouting in areas that come into regular contact with water should be maintained for the long term care of your property.

A sealant specialist or tiling contractor should be appointed to complete these works as soon as possible

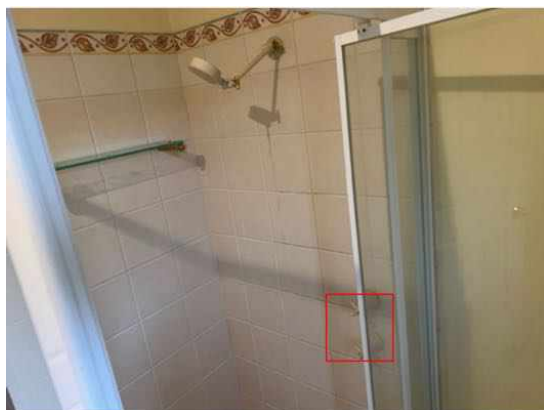
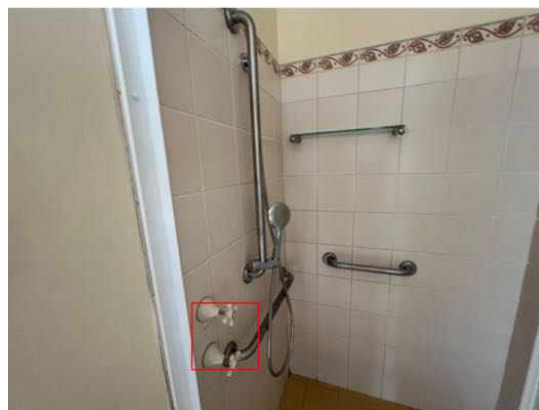
### Finding 3.49

Building:	Main Building
Location:	Bathroom, Ensuite
Finding:	Tap - Water hammer
Information:	This tap shows evidence of water hammer being present. Water hammer, a pressure surge resulting when a fluid is forced to suddenly change direction, is a common defect in plumbing fittings, particularly those that are aged and not frequently maintained. Water hammer is generally caused by factors that create high water pressure in the affected plumbing fixture, usually evidenced by a faint banging noise during operation of the affected tap.

Although water hammer is generally considered to be a minor defect, subsequent damage such as erosion of tap hardware and/or water damage to associated building elements is likely to occur if left unmanaged.

A licensed plumber should be appointed as soon as possible to replace any affected tap hardware and perform any remedial works as necessary. Please be advised that the appointment of a cabinet maker or qualified carpenter may be necessary if water damage to associated building elements has occurred.

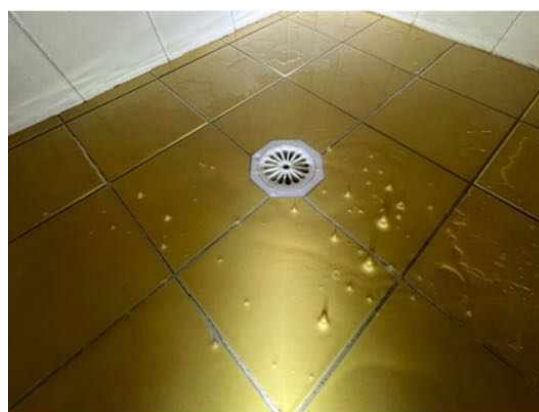
### Finding 3.50

Building:	Main Building
Location:	Bathroom, Ensuite
Finding:	Shower base - Water pooling
Information:	Evidence of water pooling around the floor waste in the shower recess was noticed at the time of inspection. It is suspected that this excessive moisture is attributed to insufficient fall in the shower floor tiles.

This pooling is minor overall but is still considered unsatisfactory, as standard tiling practices would not permit this situation to occur. Pooling water around floor wastes can create a slip hazard in extreme cases and create conditions that are conducive to mould growth over time. Where left unmanaged, the degradation of sealant and grouting is also likely to occur, possibly necessitating further repair works.

Remedial works may involve some sections of tiling and flooring repair and replacement. A tiling contractor or bathroom specialist should be appointed to provide further advice on reparation options and to perform works as necessary.

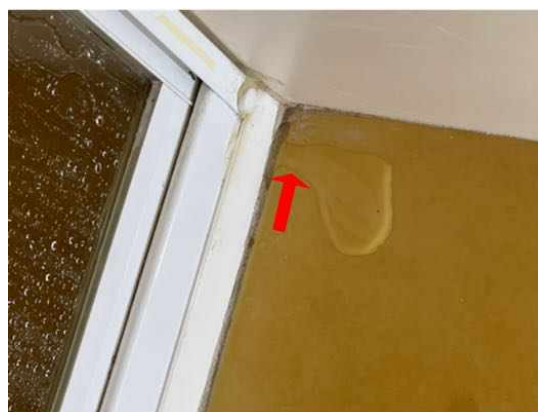
### Finding 3.52

- Building: Main Building
- Location: Ensuite
- Finding: Shower screen - active leak
- Information: A active leak was identified to the shower screen, likely due to deteriorated or inadequate sealant. If left unmanaged, water ingress may lead to damage to adjacent walls and flooring, as well as creating conditions conducive to mould growth.
- Resealing is recommended to restore a watertight seal and prevent further deterioration.

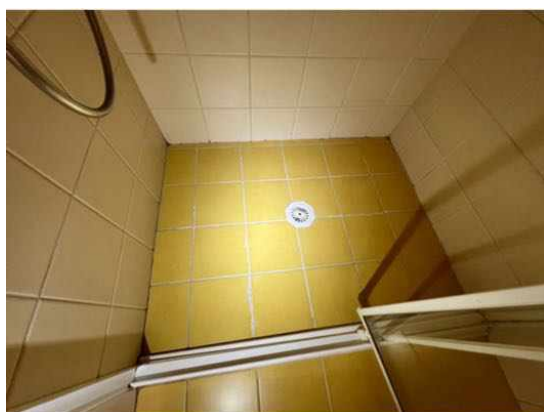
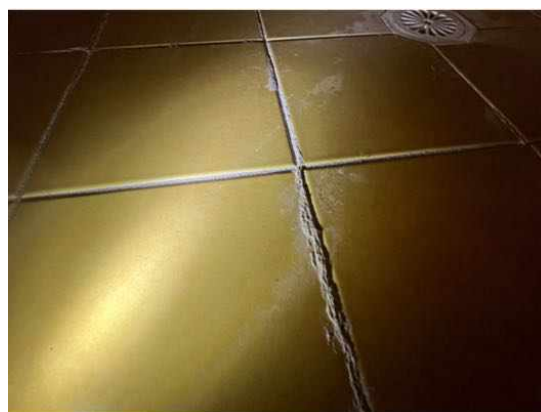
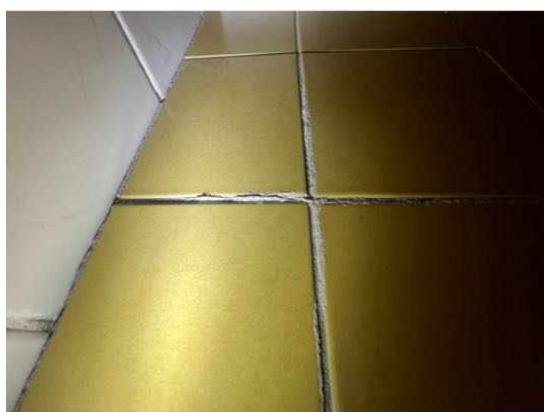
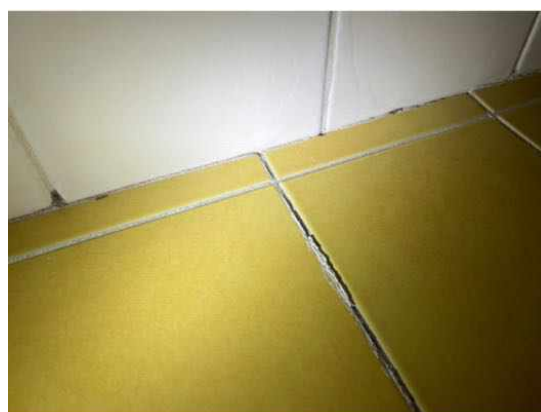
### Finding 3.53

Building:	Main Building
Location:	Ensuite
Finding:	Shower Base - Efflorescence to Tile Joints
Information:	Efflorescence was observed to the tiled shower base, with white crystalline deposits present along grout joints.

Efflorescence in wet areas commonly occurs where moisture migrates through the tile bed and grout, drawing soluble salts to the surface as it evaporates. This is typical in shower bases due to the layered construction including screed, adhesive, tiles, and grout.

If left unmanaged, this condition may contribute to gradual deterioration of grout joints and affect the overall presentation of the surface.

Cleaning and maintenance of the affected areas is advised to manage buildup and maintain the condition of the tiled surface.

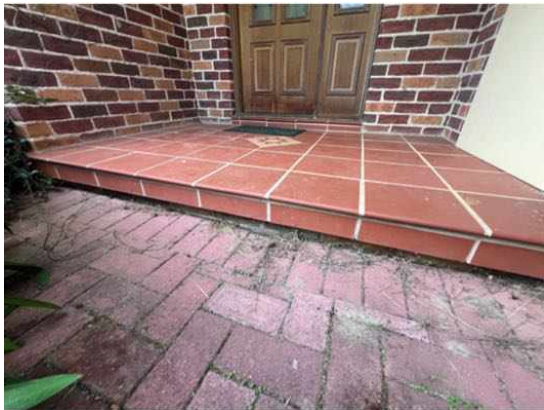
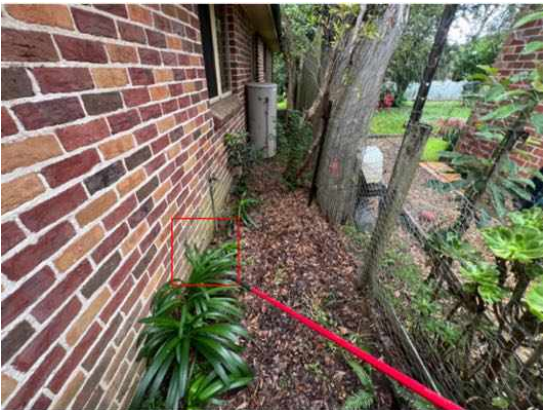
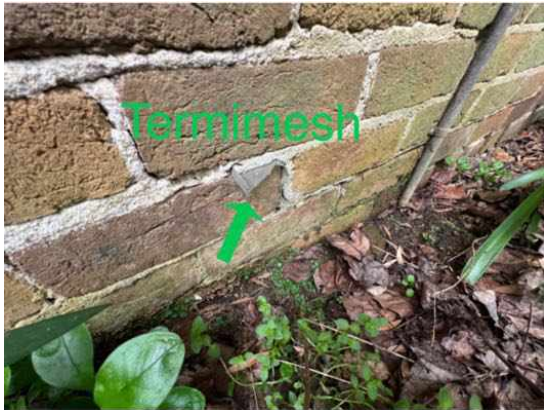
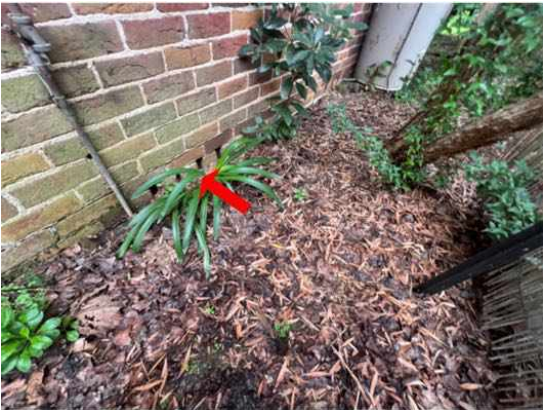
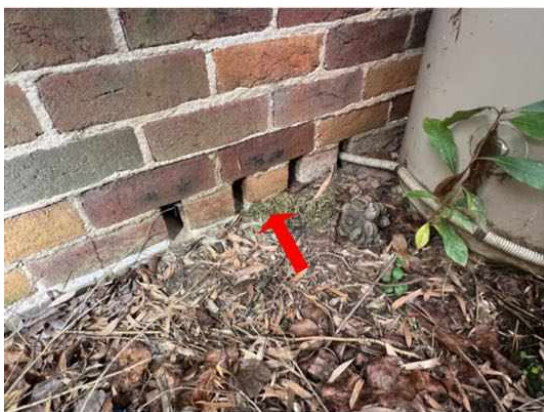
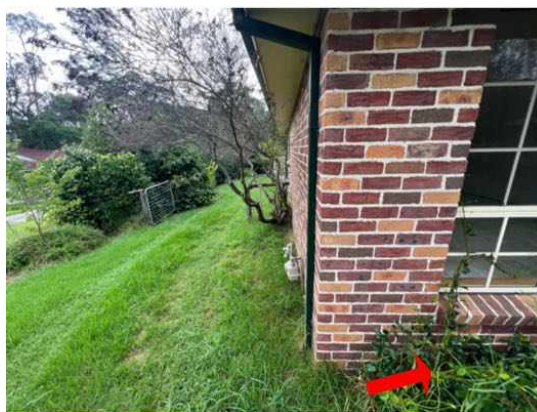
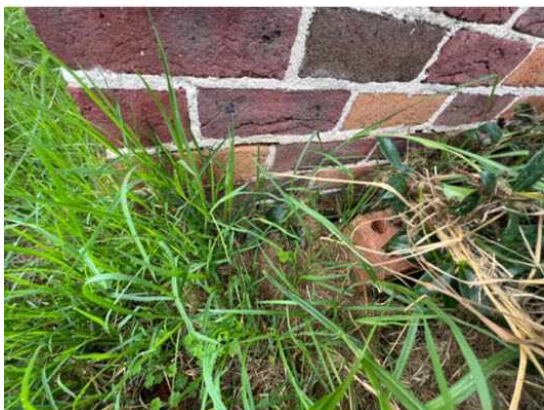
Generally this takes the form of finished ground levels external paving or concrete being retrospectively installed above the damp course level the adjacent internal floor level or weep and ventilation holes.

Where bridging has occurred full inspection is prevented and termites may enter a property in a concealed or undetectable manner.

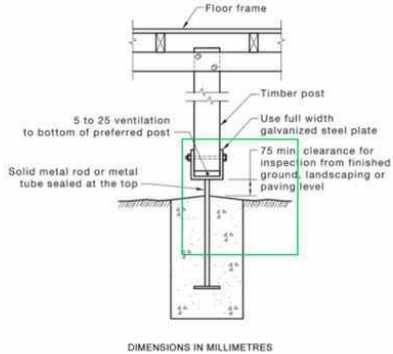
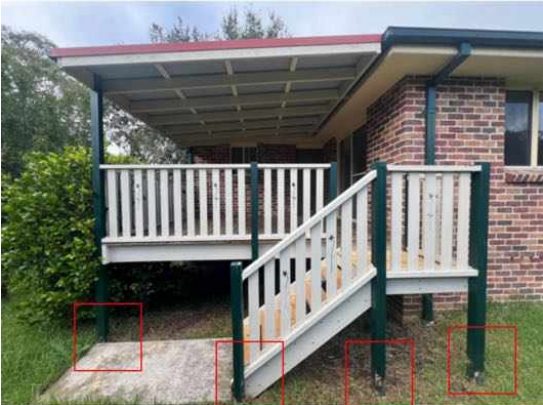
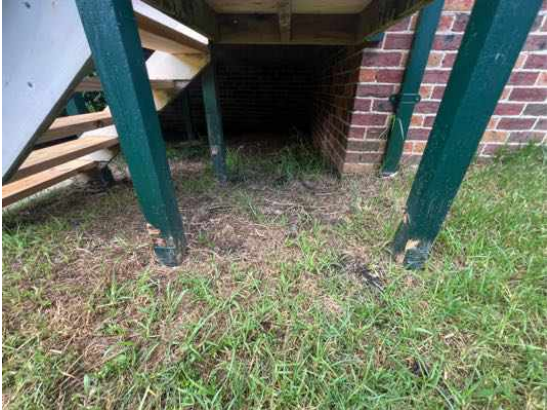
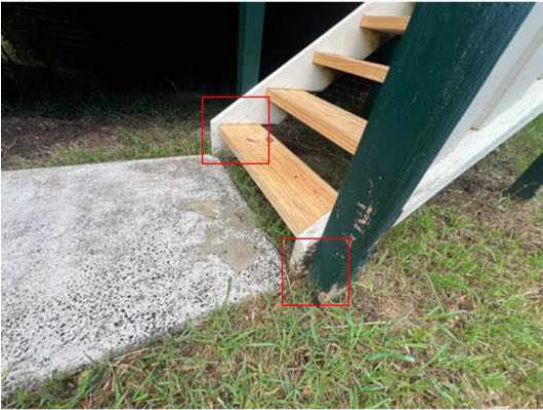
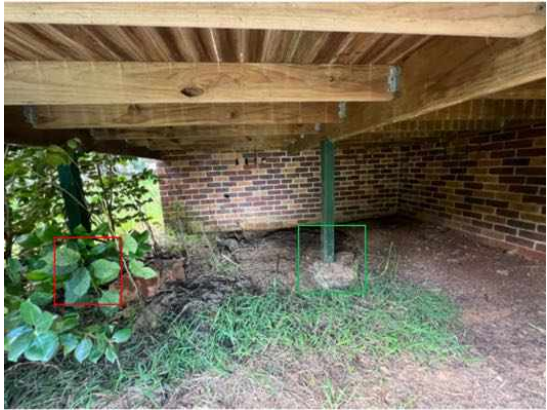
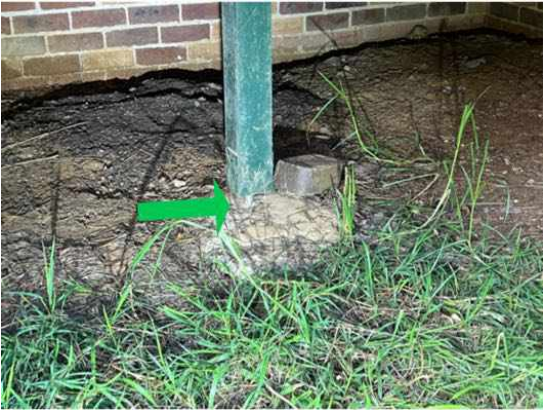
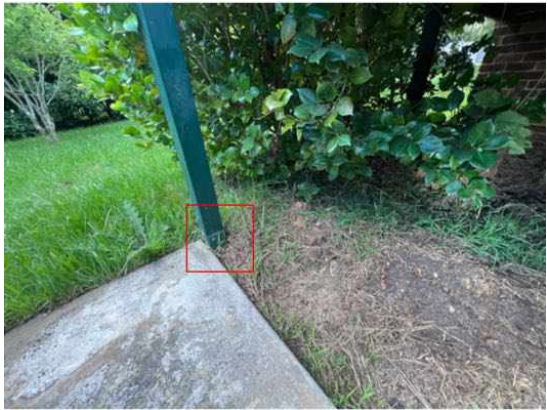
### Finding 6.02

Building:	Main Building
Location:	Porch, Alfresco
Finding:	Bridging of termite barrier - Posts.
Information:	Posts that are attached to home from ground to structure without a 75mm inspection zone (metal stirrup) causes a bridging point. Bridging of termite barriers occurs when termites bridge (usually by building a mud tunnel) a termite barrier or inspection zone or where termites have a passage allowing them to bridge the barrier.

Generally this takes the form of finished ground levels external paving or concrete being retrospectively installed above the damp course level the adjacent internal floor level or weep and ventilation holes.

Where bridging has occurred full inspection is prevented and termites may enter a property in a concealed or undetectable manner.

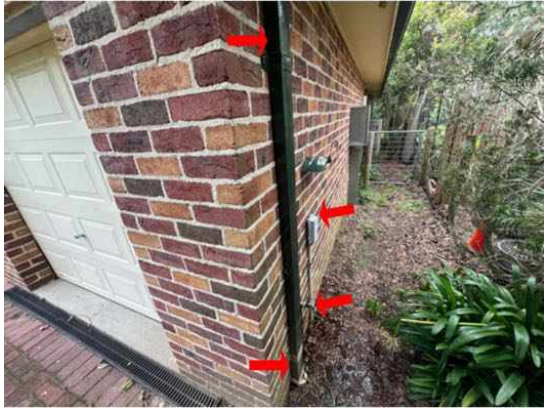
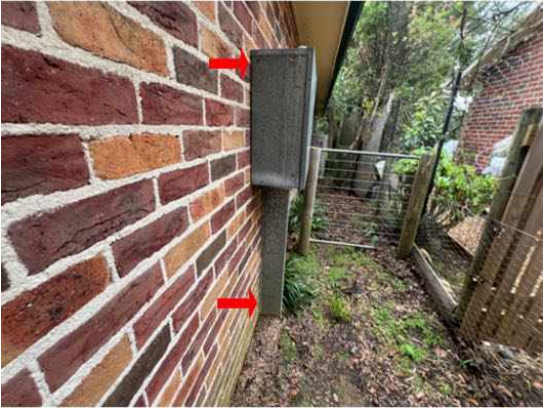
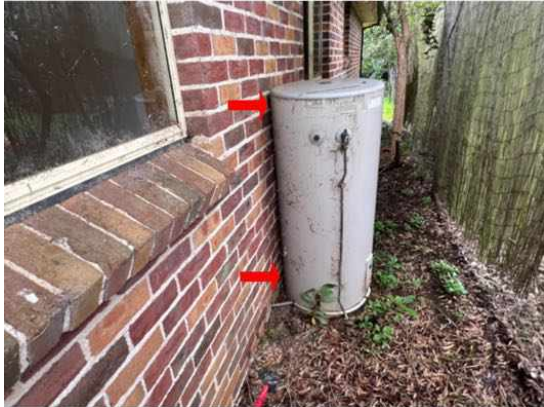
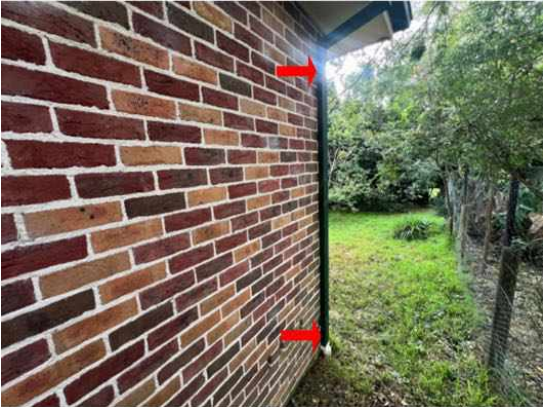
Finding 6.03

Building: Main Building  
Location: All External Areas  
Finding: Bridging - Attachments to Buildings.  
Information: Bridging occurs when items against a building provide a concealed entry point for termites into the building or by passing around a termite management system.

Where any part of an attachment to a building is not isolated and is not provided with a clear gap of not less than 25mm from the building, bridging occurs. Attachments to buildings such as hot water services, downpipes, verandahs, decks, steps, fences, service conduits and the like provide the opportunity for concealed entry.

Building attachments of this nature need to be frequently inspected for termite activity by a qualified inspector

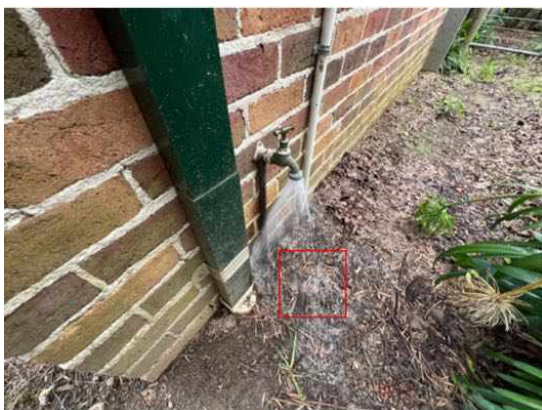
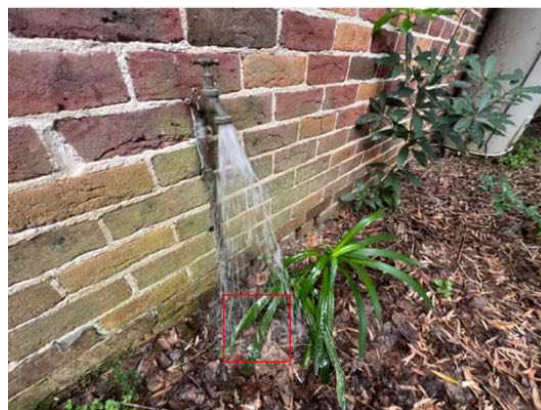
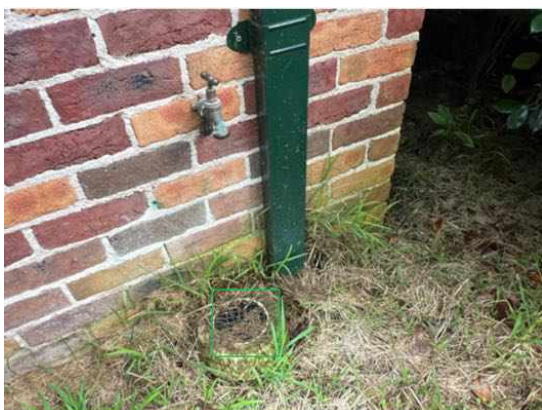
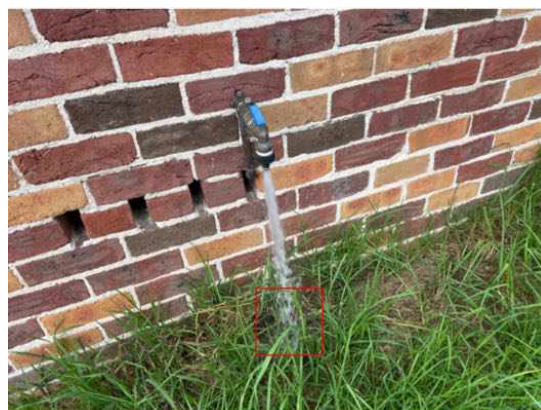
### Finding 6.07

Building:	Main Building
Location:	All External Areas
Finding:	External taps - Not plumbed for drainage
Information:	The External taps is not plumbed or connected to suitable drainage, which has resulted in the surrounding area becoming excessively damp. These damp conditions can lead to secondary defects such as rot, rust or corrosion of associated building elements, the formation of fungal decay, or even the creation of potential slip hazards. When coupled with poor site drainage, pooling of water may also attract termite activity to this area. It is highly recommended that a qualified plumber be appointed to install adequate drainage to the overflow. These works will ensure that the area remains dry and free of any secondary defects.

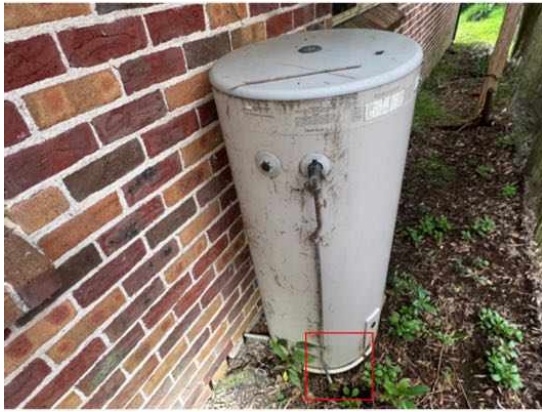
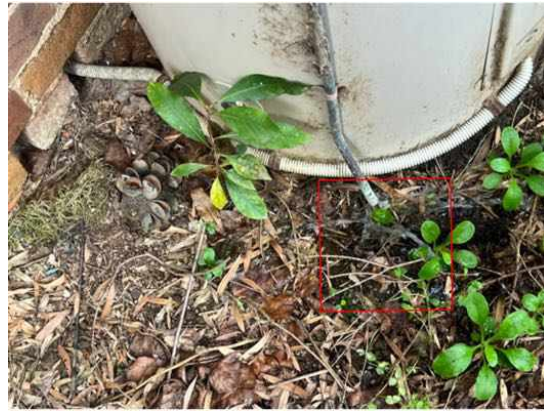
### Finding 6.08

Building:	Main Building
Location:	Exterior walls - right side
Finding:	HWS Overflow - Not Connected
Information:	The Hot Water System (HWS) overflow was found to be disconnected from storm water drainage and is creating excessive moisture in the surrounding area.

These damp conditions can lead to secondary defects such as rot, rust or corrosion of associated building elements, the formation of fungal decay, or even the creation of potential slip hazards. When coupled with poor site drainage, pooling of water may also attract termite activity to this area.

It is highly recommended that a licensed plumber be appointed to connect the HWS overflow in order to prevent such an environment from being created. These minor works should be carried out as soon as possible.

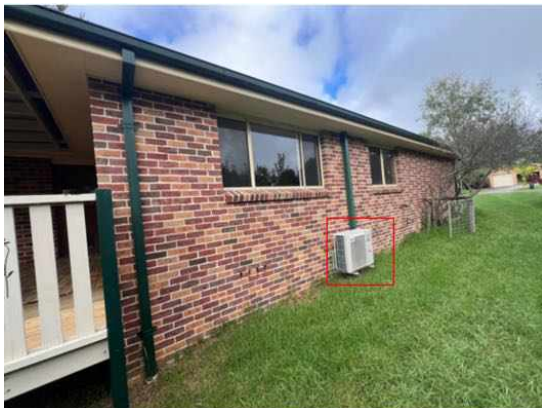
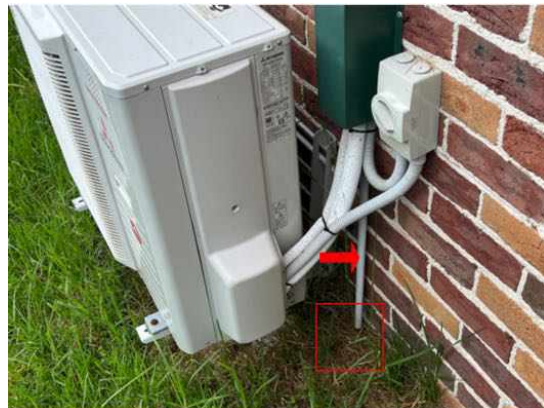
### Finding 6.09

Building:	Main Building
Location:	Exterior walls - left side
Finding:	Air conditioner - Disconnected overflow
Information:	The Air Conditioner (A/C) overflow was found to be disconnected from storm water drainage and is creating excessive moisture in the surrounding area.

Such leaking creates an environment which is conducive to an array of defects, including water damage to associated building elements and the attraction of termite or timber pest infestation.

It is highly recommended that a licensed plumber be appointed to connect the A/C overflow in order to prevent such an environment from being created. These minor works should be carried out as soon as possible.

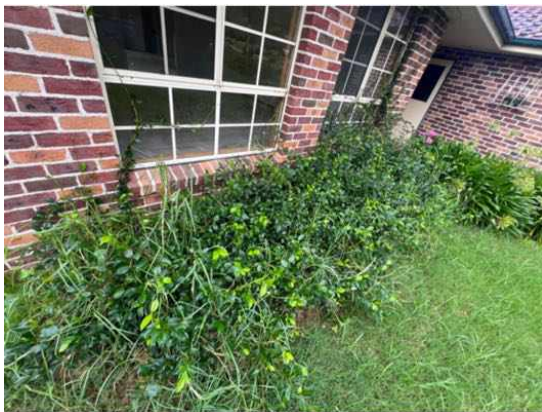
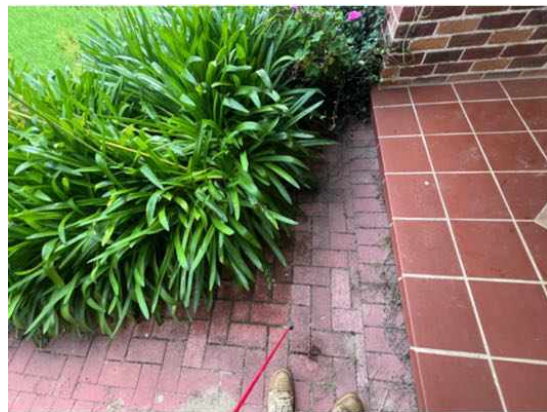
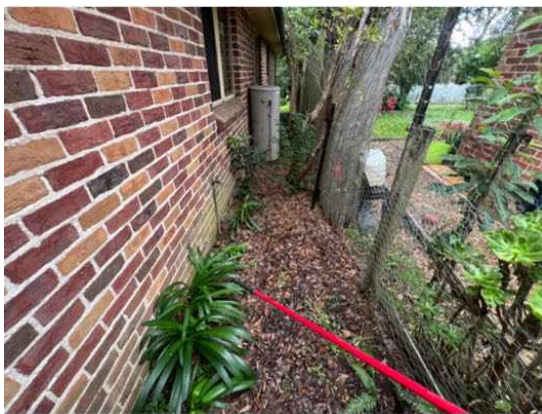
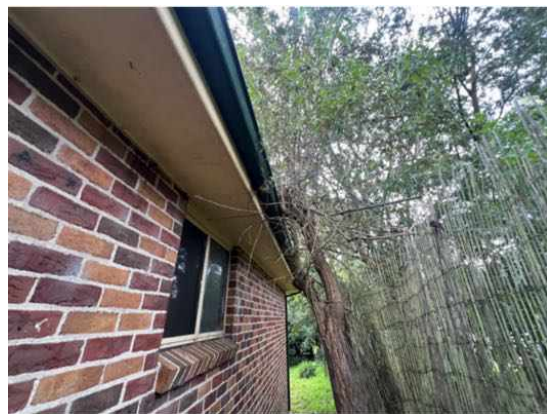
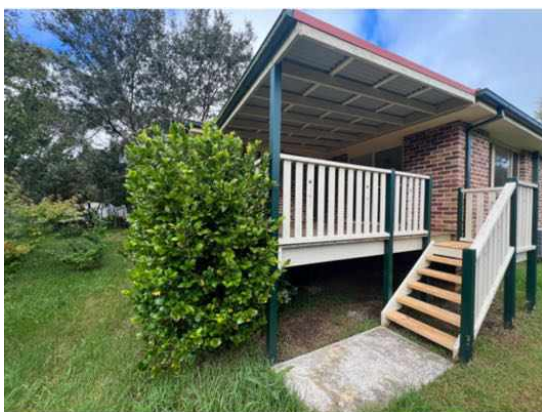
### Finding 6.10

Building:	Main Building
Location:	All External Areas
Finding:	Vegetation Against Building - Conducive to Termite Activity
Information:	Vegetation and trees were observed in close proximity to, and in some areas in contact with, the building. Conditions of this nature are considered conducive to

termite activity, as vegetation may provide concealed access pathways, retain moisture against structural elements, and restrict ventilation around the perimeter of the dwelling. Accumulated organic matter and elevated soil levels adjacent to walls may further increase the risk of undetected termite entry.

Where soil or garden beds are built up against the structure, inspection zones and weep holes may become obscured, reducing the ability to detect early termite activity.

It is recommended that vegetation be cleared back to provide adequate separation from the building and that soil levels be maintained below inspection zones. Ongoing site maintenance and regular timber pest inspections in accordance with AS 4349.3 should be undertaken to monitor and manage termite risk.

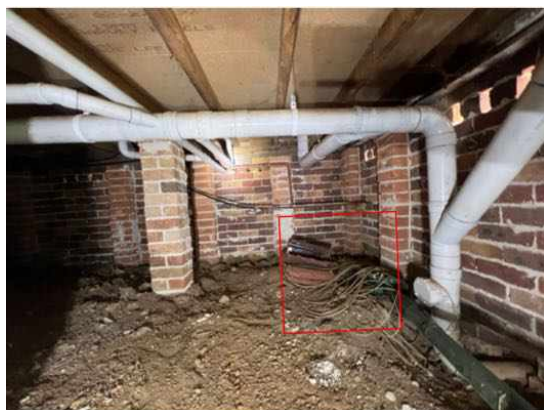
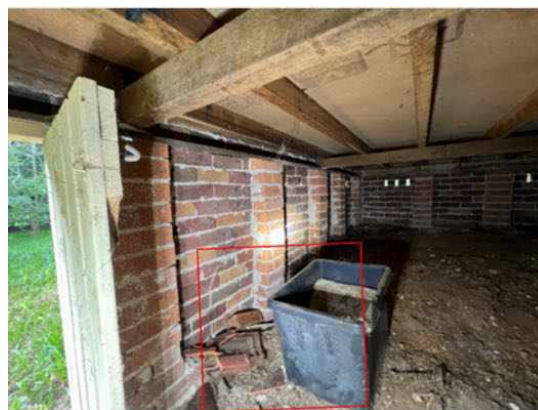
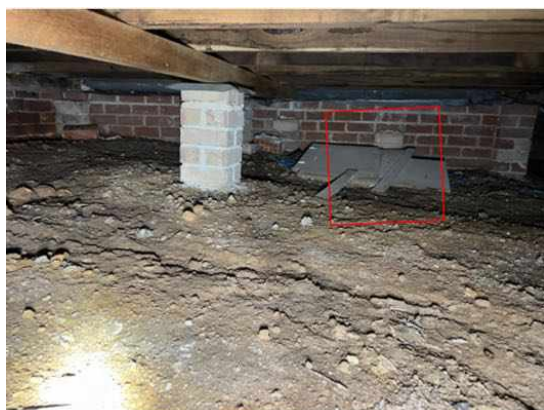
Building:	Main Building
Location:	Subfloor
Finding:	Subfloor - Debris
Information:	An array of debris was found in the subfloor area at the time of inspection. Debris in this area restricts subfloor ventilation and creates potential for concealed pest entry. Stored timbers and other materials may also make the area susceptible to termite activity and wood rot.

A clear and empty subfloor will be better ventilated and easier to maintain in a dry condition. The removal of any timber debris is vital in minimising the risk of termite or wood borer activity.

Debris in the subfloor should be removed as soon as possible. Depending on the location and amount of debris and stored items, the homeowner may elect to undertake this task. Alternatively there are a large number of rubbish removal subcontractors that could undertake these works.

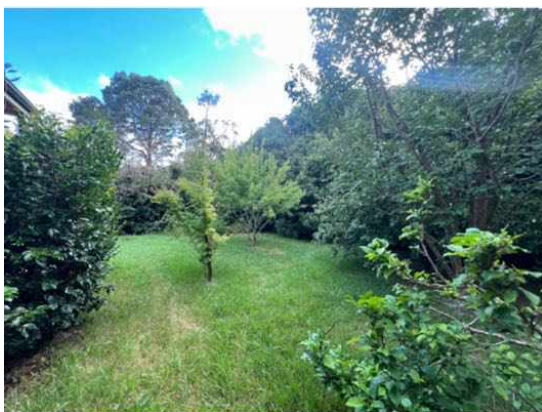
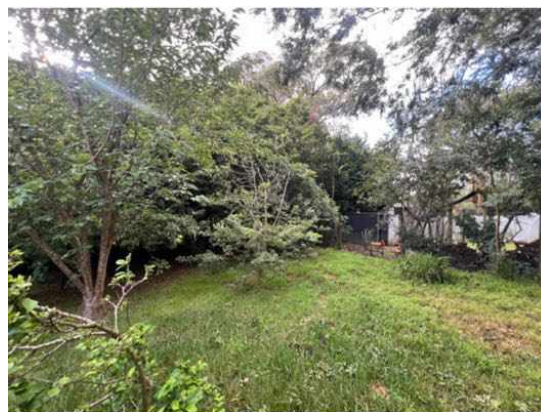
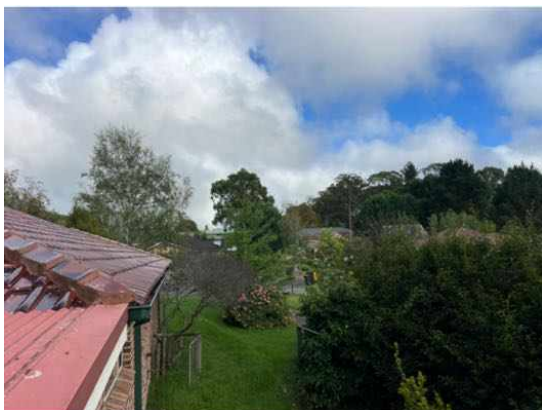
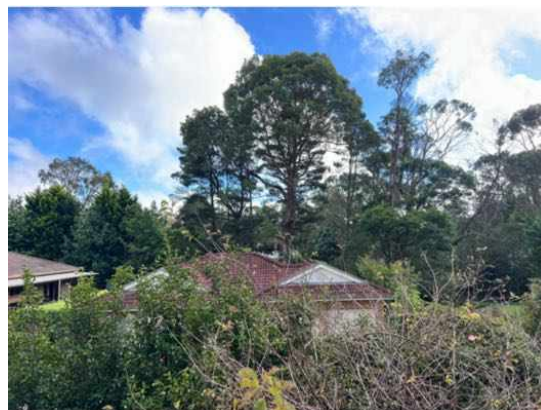
### Finding 6.13

Building:	Yard
Location:	The Site
Finding:	Timber Pest Risk – Trees Within 50m of Dwelling
Information:	Mature trees were identified within 50 metres of the dwelling. The presence of trees in close proximity to the structure increases the risk of termite activity, as trees provide a natural food source and nesting environment for termites. Tree roots can also contribute to excessive moisture retention in the soil, creating conducive conditions for timber pest activity.

Regular monitoring for signs of termite activity is advised. A licensed pest inspector should be engaged to assess the area and provide further recommendations on risk mitigation and management.

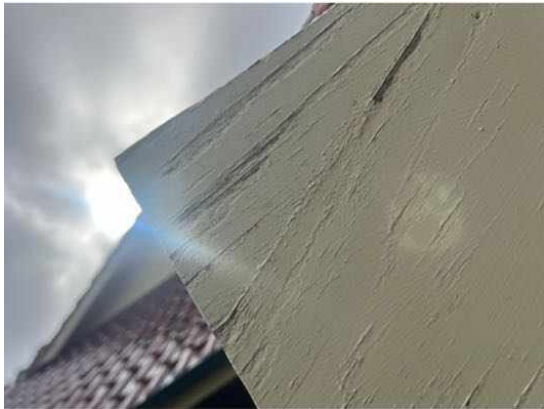
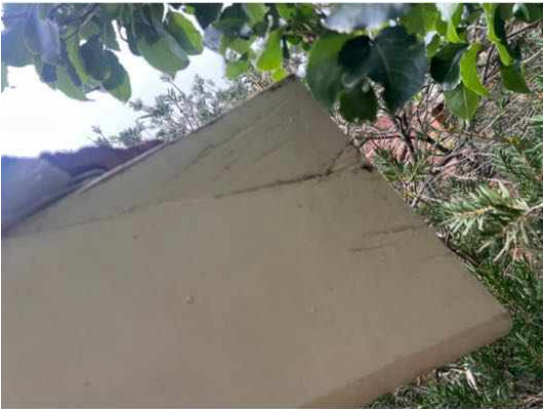
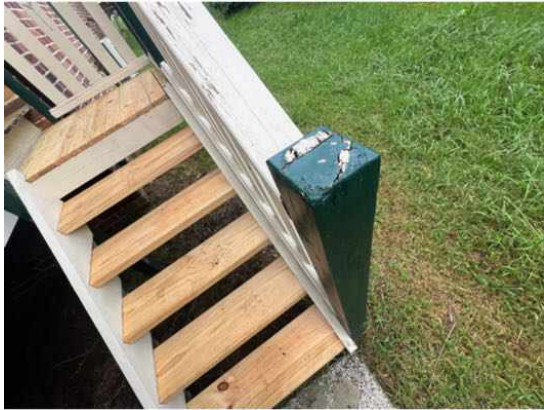
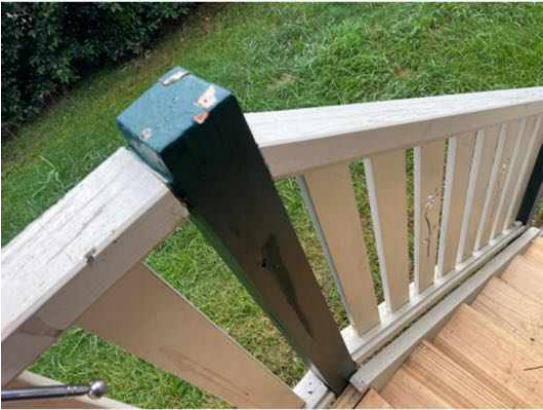
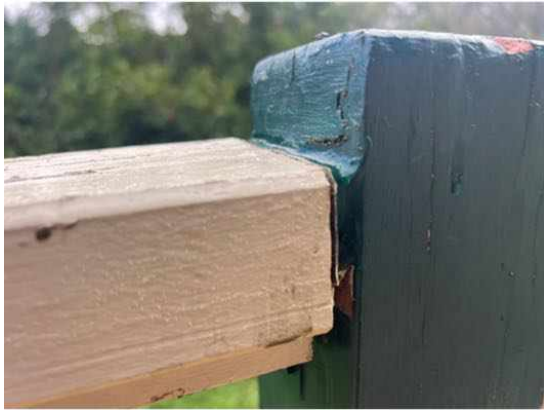
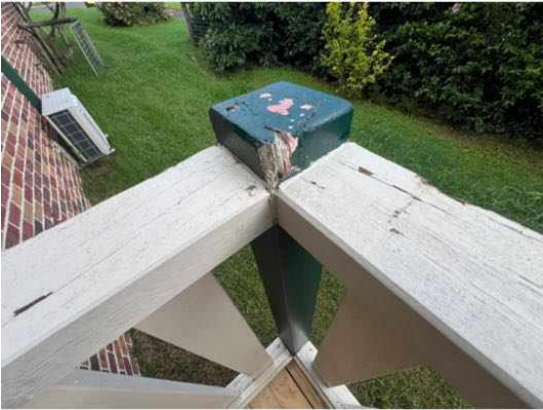
### Finding 7.01

Building:	Main Building
Location:	All External Areas
Finding:	Fungal decay - present (localised)
Information:	Fungal decay also known as wood decay or wood rot generally refers to the deterioration of timber elements when in contact with excessive levels of moisture for a prolonged period of time.

The development of fungal decay is accelerated by temperatures in the range of 5degreeC to 40degreeC as well as the presence of oxygen. Generally fungal decay develops on timber elements that are in use in an external environment which are exposed to rain penetration.

In this case although the affected timber element is in a decaying state the extent of any visible damage appears to be localised to a specific area and is yet to spread to other parts of the building element or affect adjoining structures. The fungal decay is therefore likely to be of a relatively superficial nature with minimal impact on the structural integrity or tensile strength of the timber element.
