# Building and Timber Pest Inspection Report VR

Inspection Date: Mon, 23 Mar 2026

Property Address: 13 Betula Grove, Bundanoon NSW 2578,  
Australia

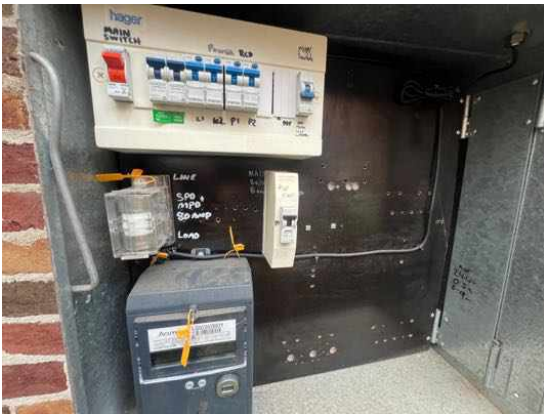
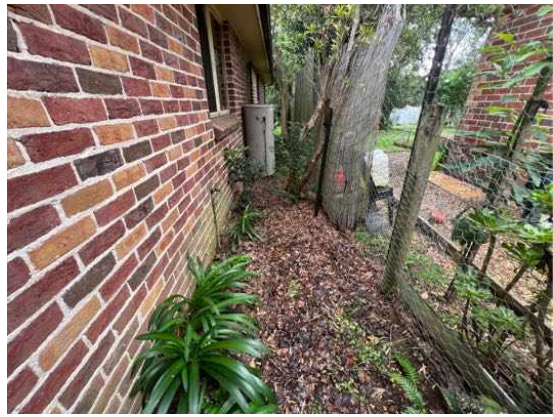
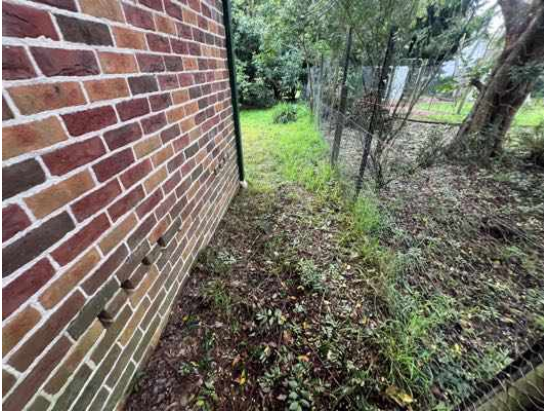
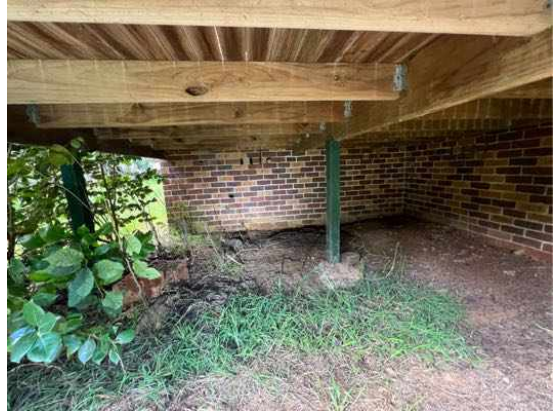
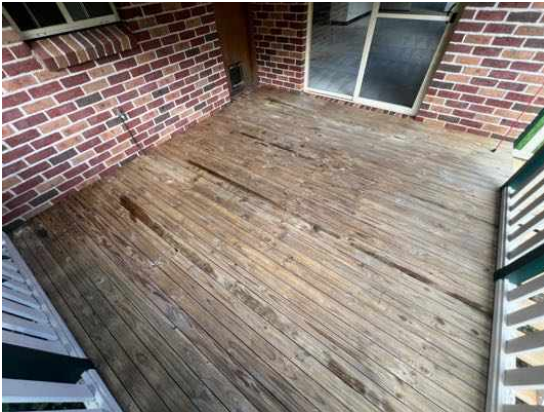
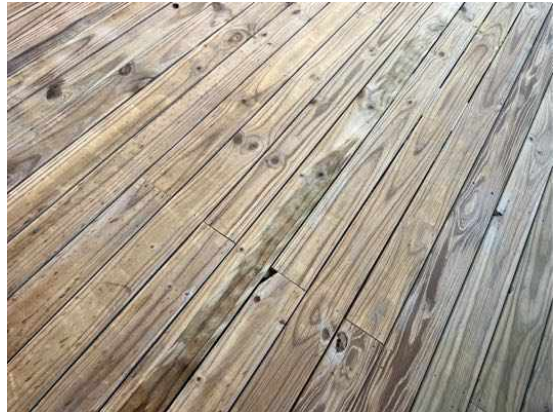
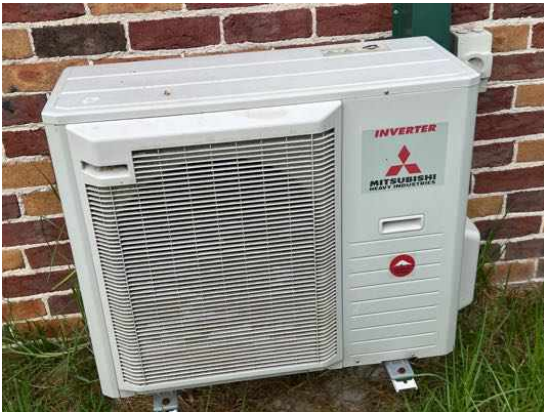
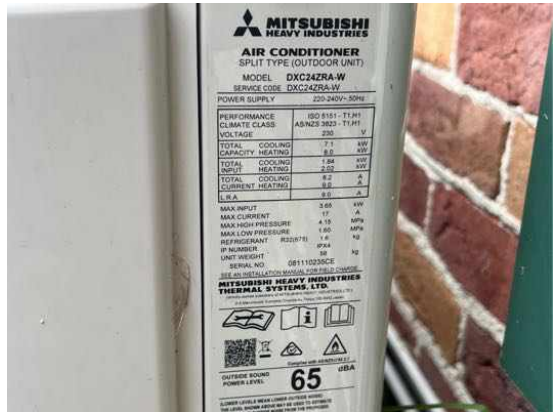
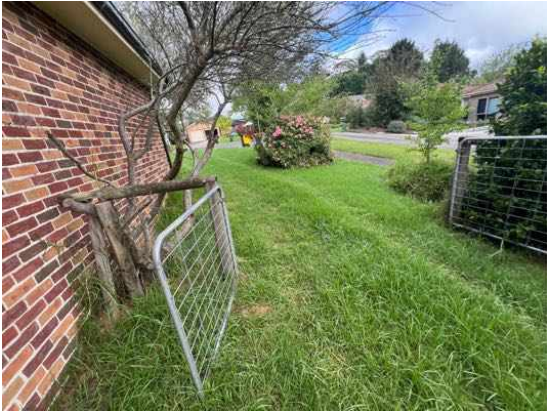
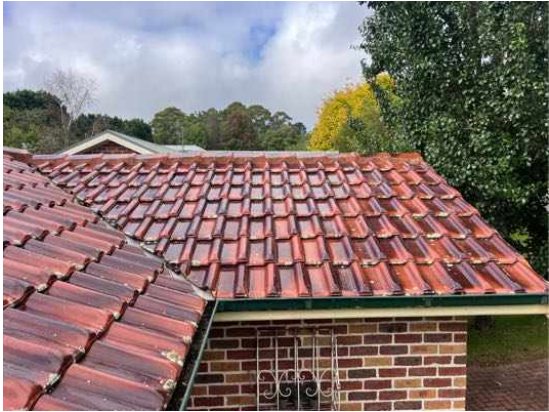
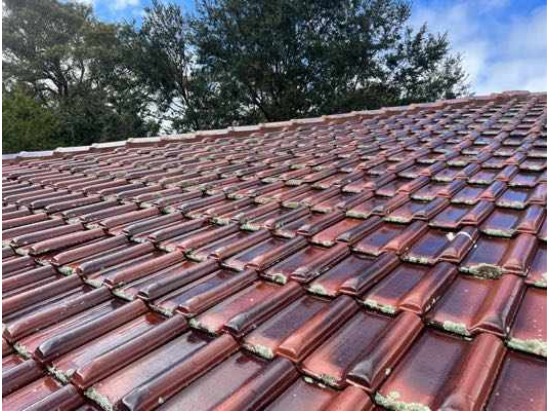
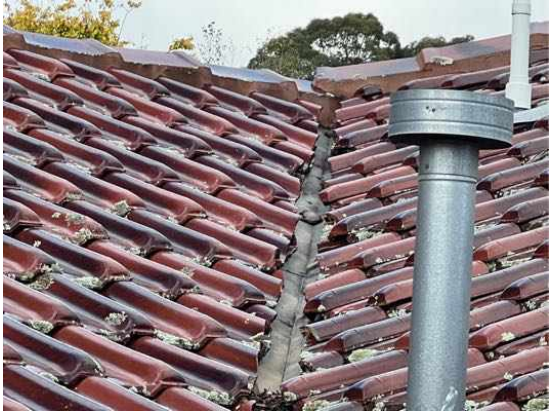
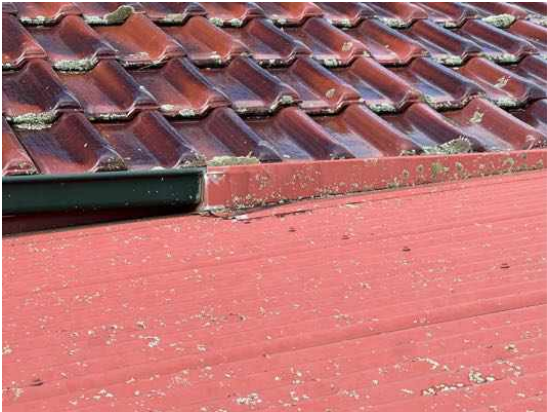
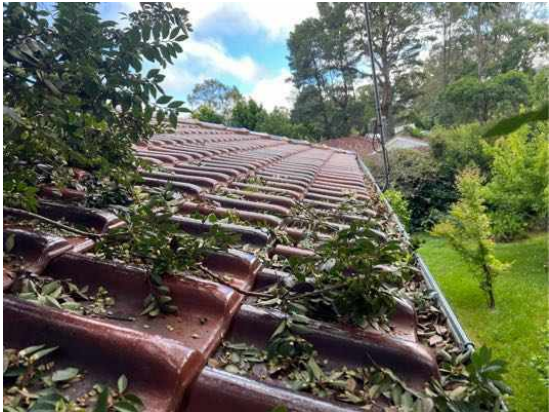
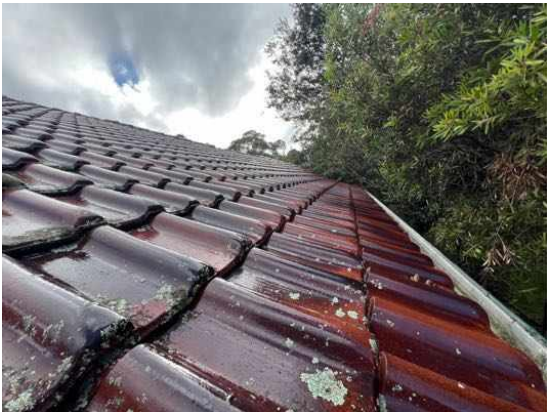
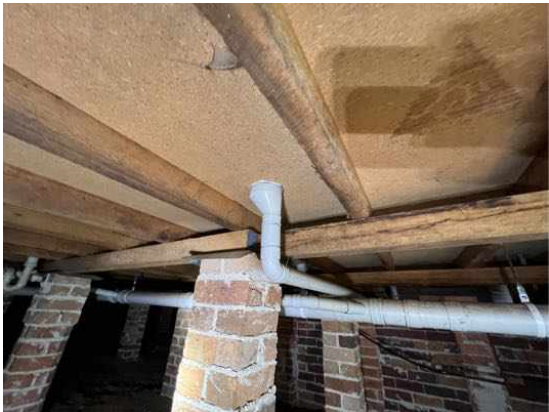
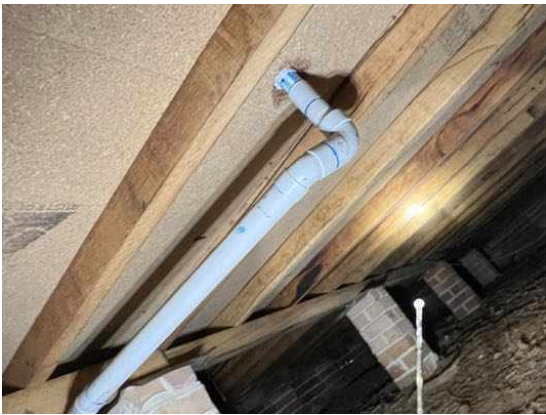
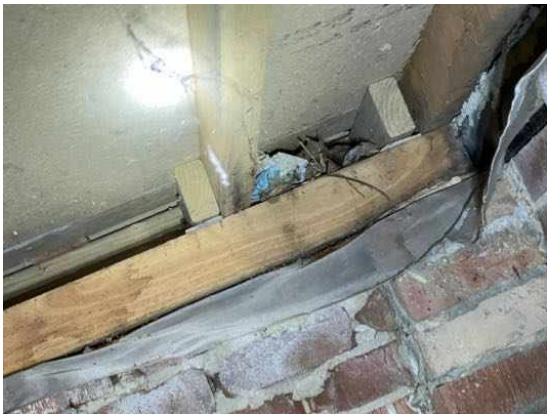
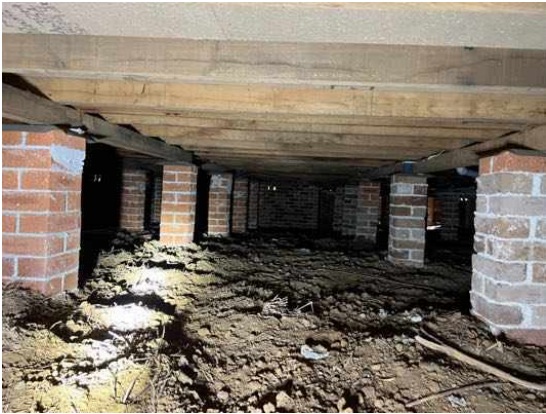
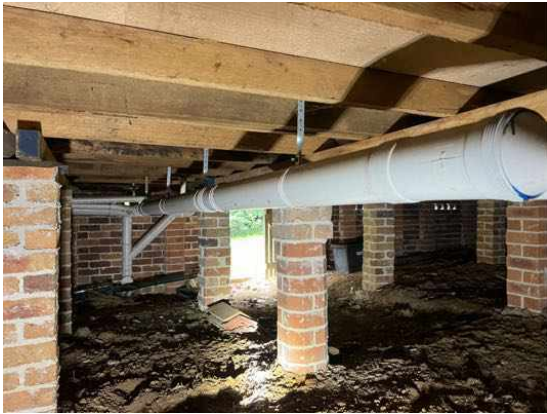
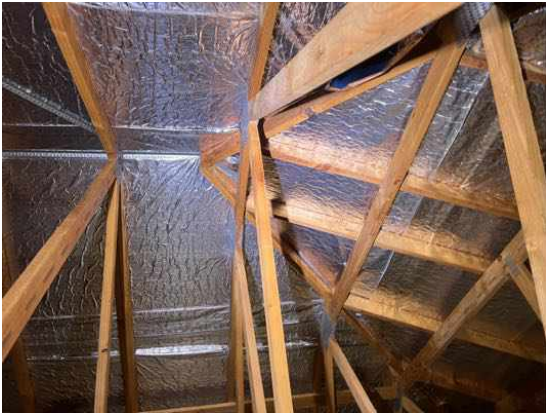
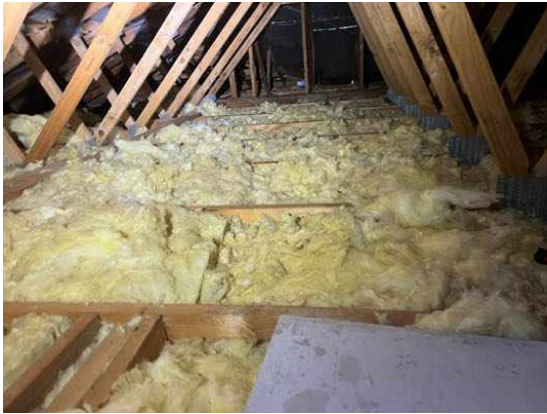
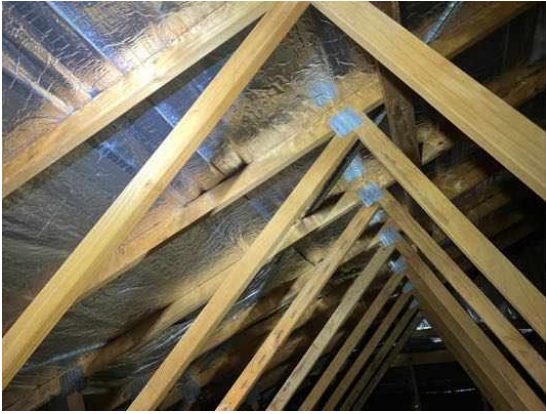
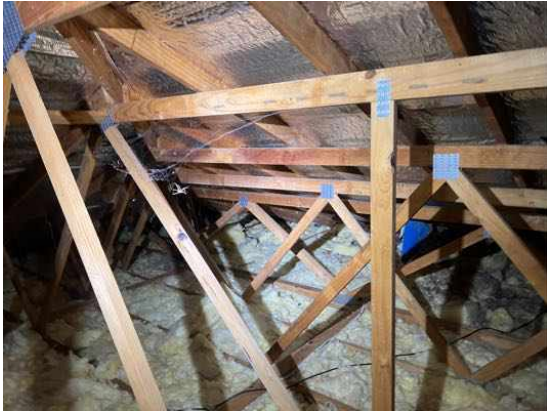
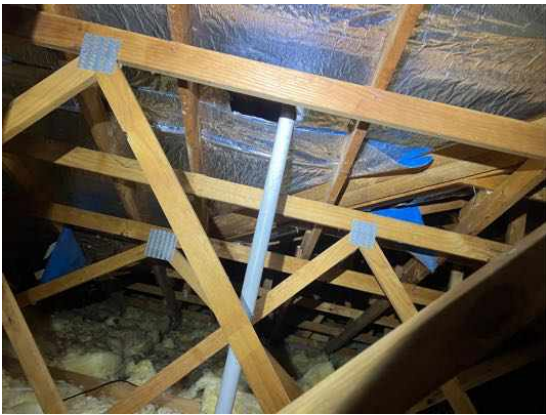
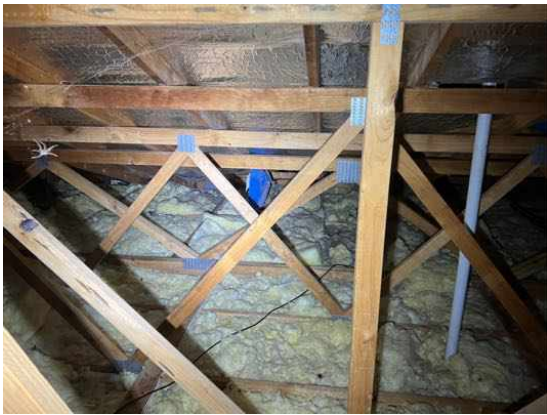
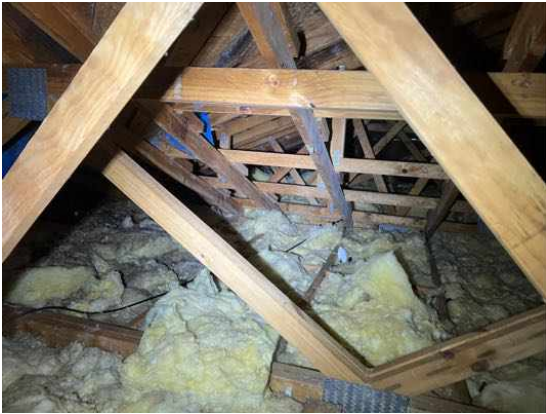
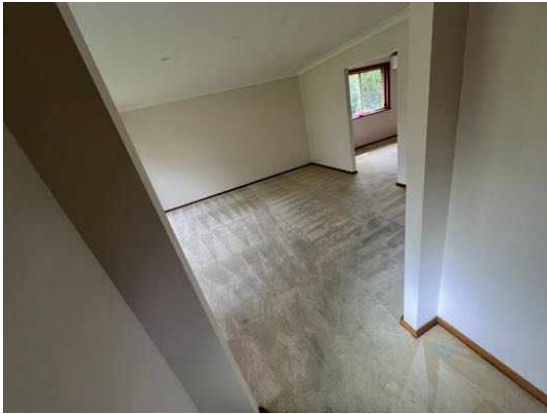
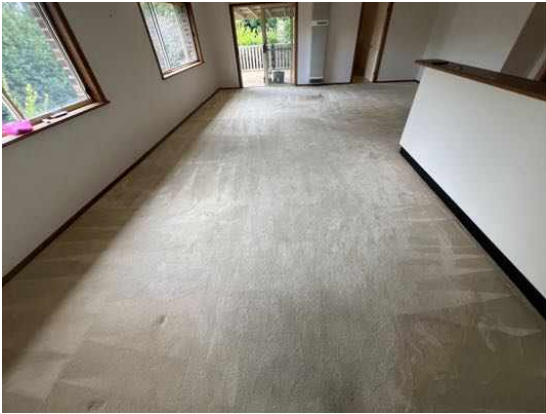
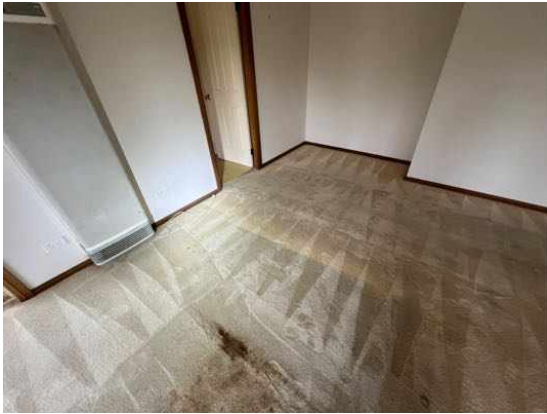
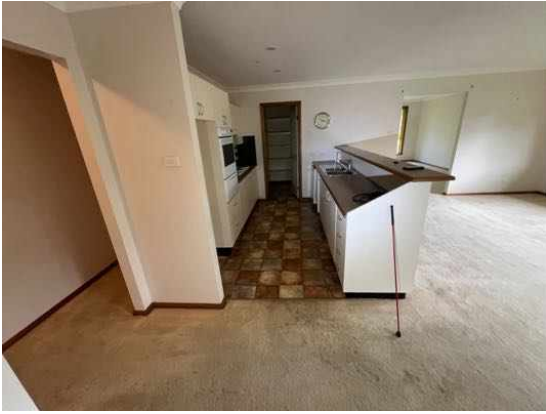
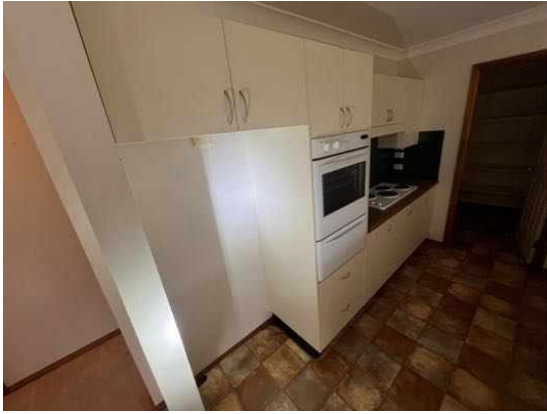
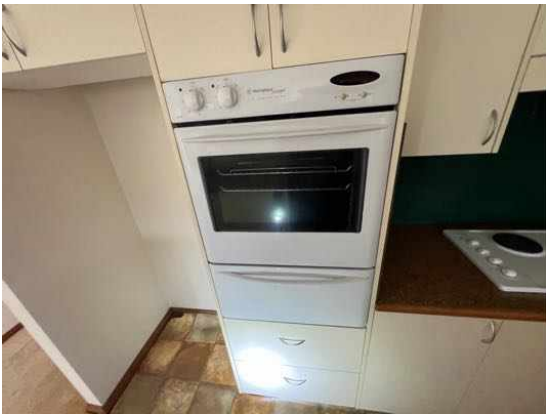
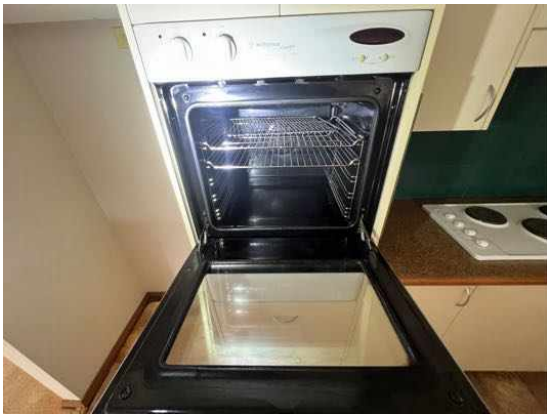
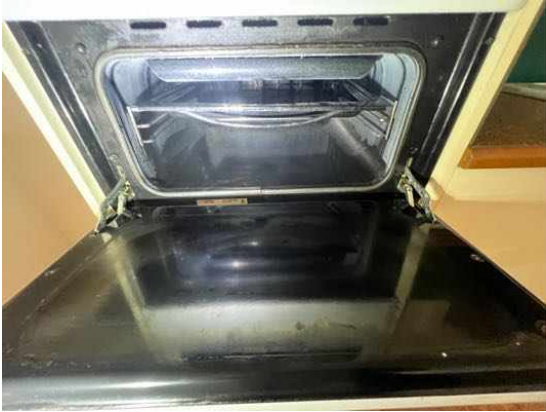
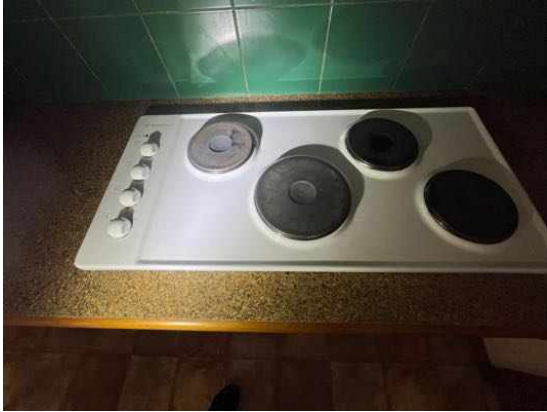
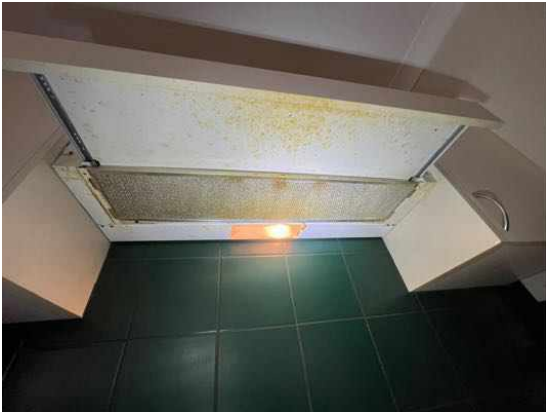
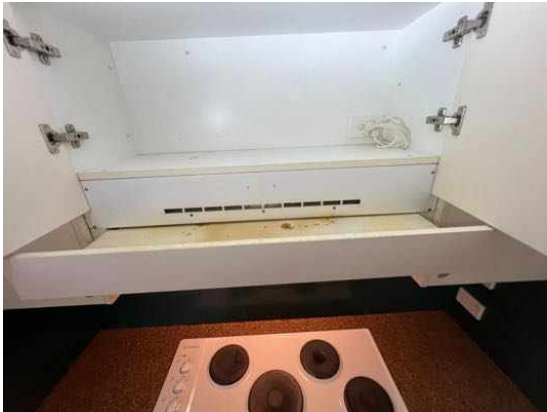
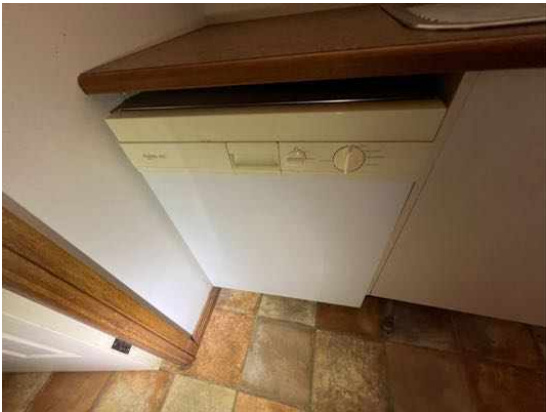
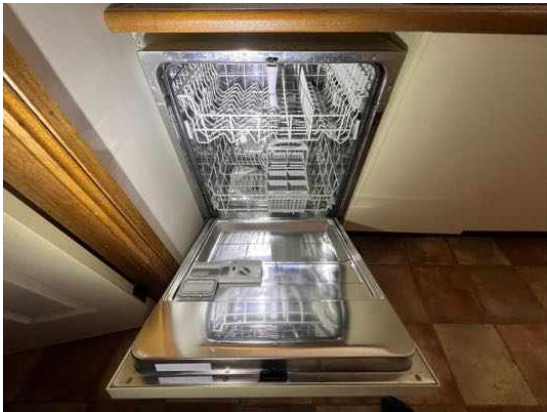
Building: Main Building  
 Location:  
 Finding: FYI - Additional Photos  
 Information: Additional photos are provided for your general reference and may include obstructions, testing of water & windows, moisture readings or minor maintenance items.

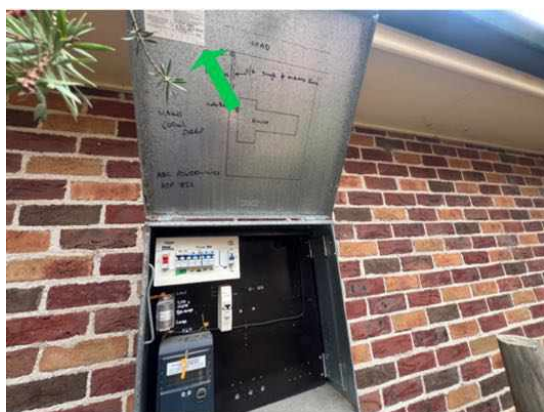
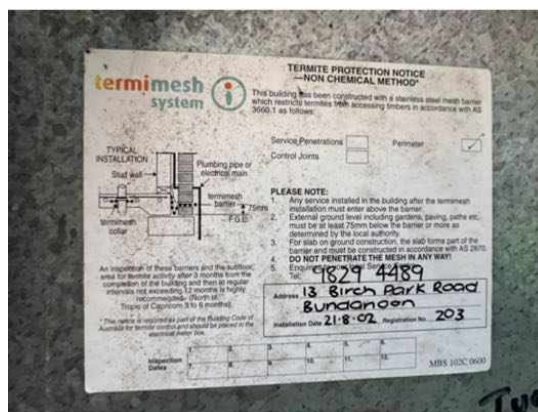
## The following items were noted as - Evidence of a previous termite management program

Where a Termite Management System has been identified you should refer to the type of barrier date of installation warranty conditions and any documentation provided by a builder or past owner. Consult the company who installed the barrier to confirm whether the system is still under warranty.

Most chemical termite management systems expire and require replenishment and all physical systems are primarily designed to prevent concealed entry.
