Building and Timber Pest Inspection Report

Inspection Date: Mon, 23 Feb 2026

Property Address: 5 Lochinvar Rd, Revesby NSW 2212,
Australia

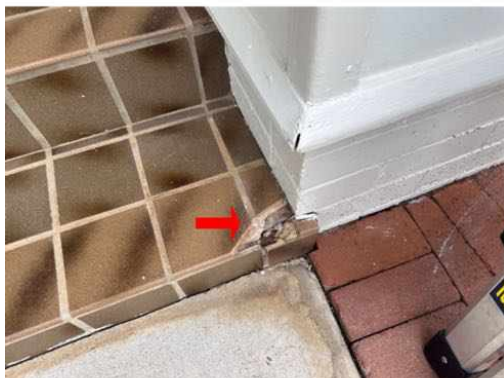
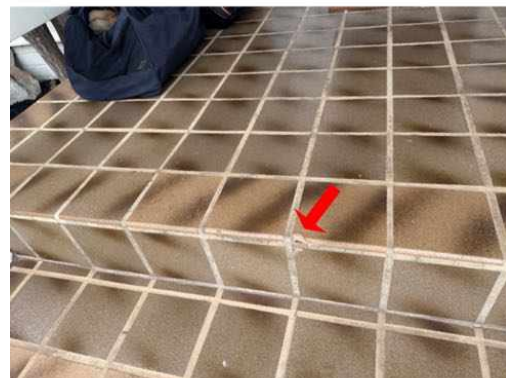
Building: Main Building
 Location: Entry > Centre
 Finding: Tiles - Cracked or damaged
 Information: Cracking was evident to the tiling in this area at the time of inspection. While the cracking appears to be minor, this area is frequently exposed to water, allowing potential for water penetration into adjoining sections of walls or flooring.

If left unmanaged, water penetration to these areas may lead to subsequent water damage, which is likely necessitate repair work to affected building elements.

A tiling contractor should be appointed to ensure that no further water damage occurs. The re-application of silicone and grouting throughout remaining tile work is also advised, to further protect the area against water penetration.

Where water penetration has led to water damage, appointment of a relevant tradesperson may be required to repair damaged building elements.

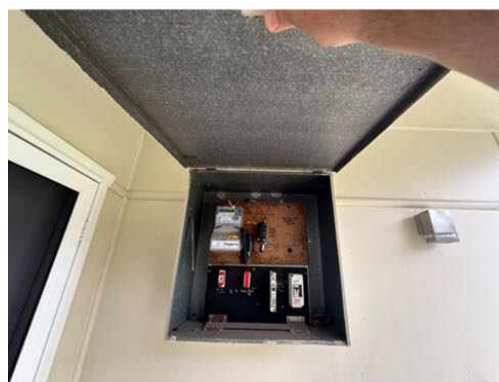
Building: Main Building
 Location: Entry > Centre
 Finding: Termite Management System - no evidence of a chemical installation
 Information: The application of a post-construction chemical termite barrier is highly recommended for all properties, particularly if live termite activity has been found on the site previously. Such barriers are highly effective in preventing termite attack on any timber building elements throughout the property.

A durable notice should be placed in the switchboard unit to indicate current termite barriers. At the time of inspection, it appeared as though no termite management system has been installed, with no evidence to suggest preventative works taking place.

The client may consider gaining further advice from a pest controller as to the costs and procedures involved with this application. It is recommended that obtaining such advice be a short-term priority.

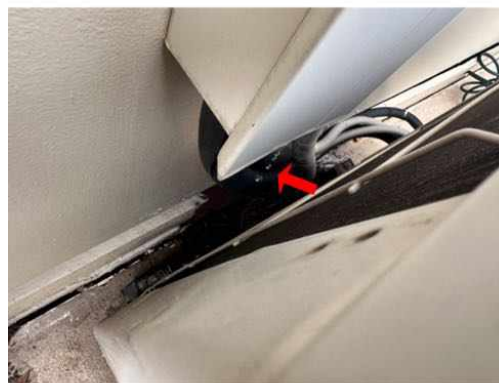
Finding 6.02

Building: Main Building
 Location: All Areas > All Areas
 Finding: Air conditioner - Disconnected overflow
 Information: The Air Conditioner (A/C) overflow was found to be disconnected from storm water drainage and is creating excessive moisture in the surrounding area.

Such leaking creates an environment which is conducive to an array of defects, including water damage to associated building elements and the attraction of termite or timber pest infestation.

It is highly recommended that a licensed plumber be appointed to connect the A/C overflow in order to prevent such an environment from being created. These minor works should be carried out as soon as possible.

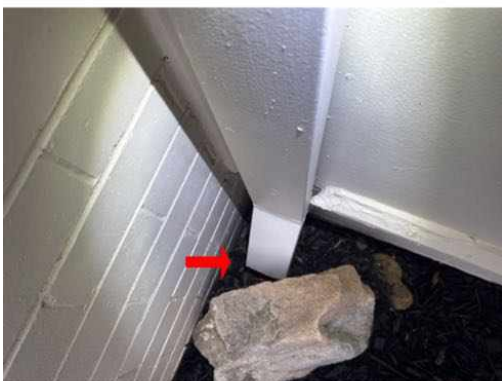
| Finding: | Roof plumbing - Missing |
| Information: | Some sections of the roof are not adequately drained via gutters and downpipes. Gutters and downpipes that are not installed adequately are likely to result in excessively damp conditions against the exterior surfaces and around the base perimeter of the building. |

Excessive moisture creates an environment which accelerates the deterioration of building elements in the area, as well as being conducive to termite and pest infestation. Such an environment is likely to necessitate repair and/or replacement of building elements, which are prone to sustaining wood rot, rust or corrosion.

A roofing plumber should be appointed as soon as possible to install relevant roof plumbing materials. Depending on the extent of the damage, repair and/or replacement of damaged building elements may be required.

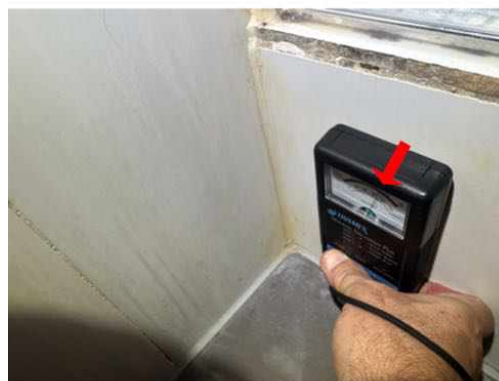
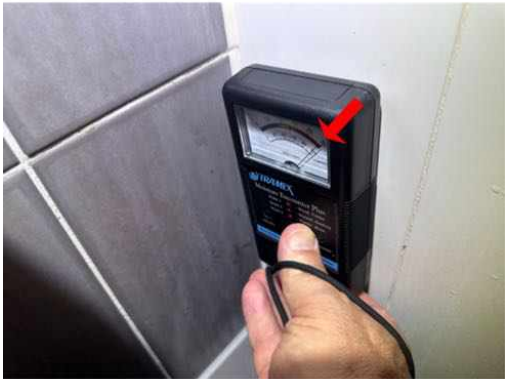
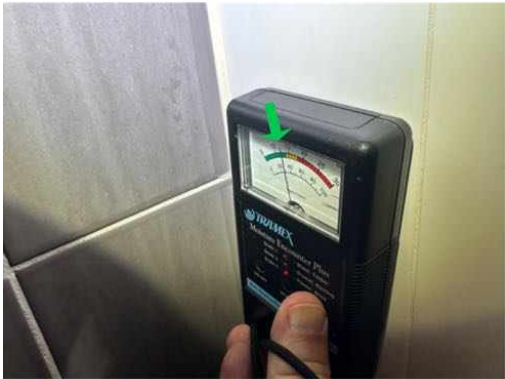
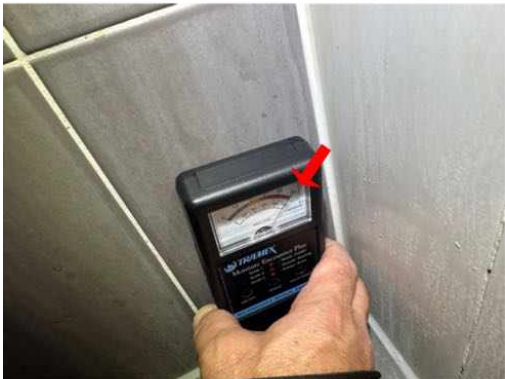
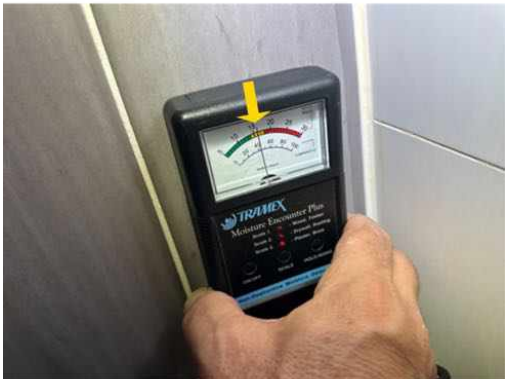
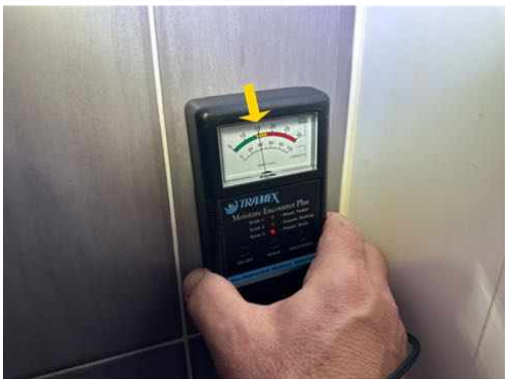
Finding 6.05

Building: Main Building
Location: Bathroom > Centre Right
Finding: Moisture meter: used in Shower area.
Information: A moisture meter was used during the inspection and isolated spots of excessive moisture was detected to accessible walls inside the property at the time of inspection.

It was noted on inspection that sealant or grout is in fair condition to most of the tiled shower alcove, with some areas requiring maintenance.

Different materials and floor areas move at different rates, generally causing cracking to grout or sealant at this point. A flexible sealant is required to allow for expected expansion and contraction, while keeping the joint water tight and protective of all associated building materials.

Flexible and mould resistant materials should be applied to affected areas to prevent any subsequent water damage that is likely to occur. Regular maintenance and replacement of damage or missing or damaged sealant and grout is highly recommended to the wet areas, as this is a regular wear and tear defect. Sealant and grouting in areas that come into regular contact with water should be maintained for the long term care of your property.

Monitoring the area is advised and if any visual signs of excessive moisture appear (peeling paint, mould) then consultation with a qualified plumber or bathroom specialist would be advised to identify the cause of damp and to perform remedial works as required.

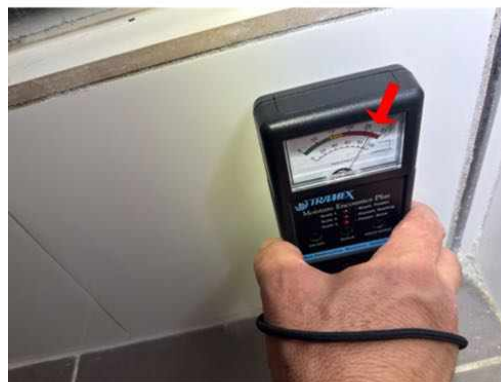
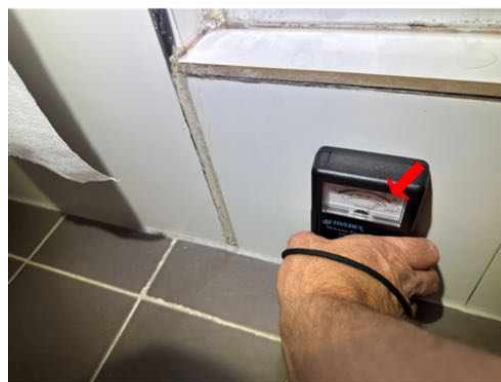
Finding 6.06

| Finding: | Moisture Meter used: minor spot of Moisture Detected outside of shower recess. |

The first step in addressing moisture is to diagnose the cause. The identified cause should be addressed first prior to repairing the appearance and other defects which have resulted from the moisture penetration. If the original cause is not resolved, further cases of moisture penetration are likely to ensue, resulting in secondary defects.

Consultation with a qualified tiller is advised immediately to identify the cause of moisture penetration and perform remedial works as required. Where excessive mould growth is present, further inspection by a specialist environmental health inspector should also be considered.

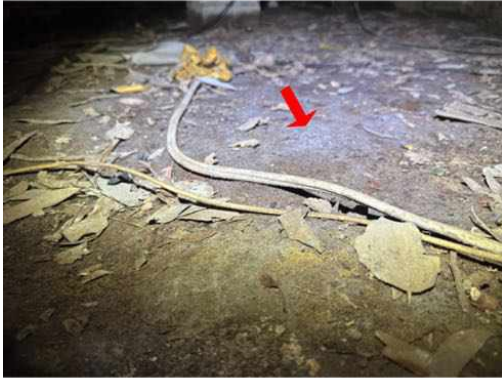
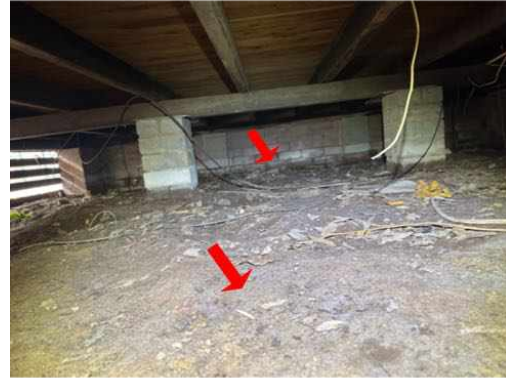
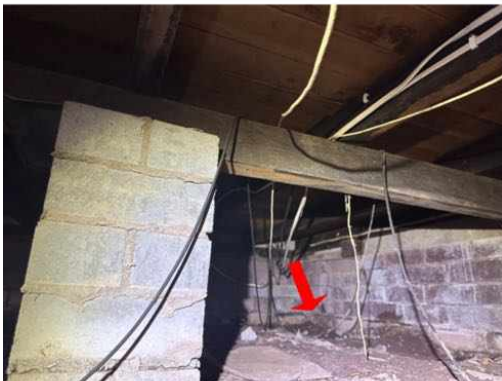
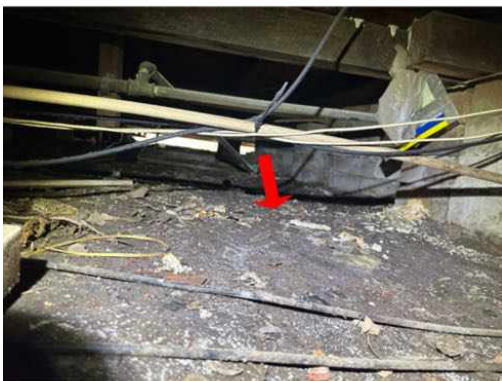
Finding 6.07

Building: Main Building
 Location: All Areas > All Areas
 Finding: Subfloor: Damp.
 Information:

Ventilation can be restricted by a variety of minor defects, including obstructions in the subfloor space, a lack of vents or a low clearance.

A well ventilated subfloor aids in maintaining dry conditions.

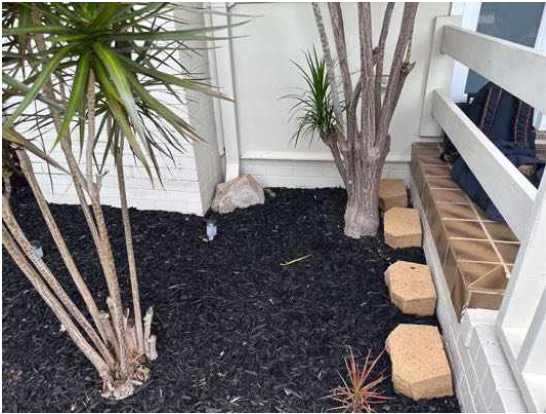
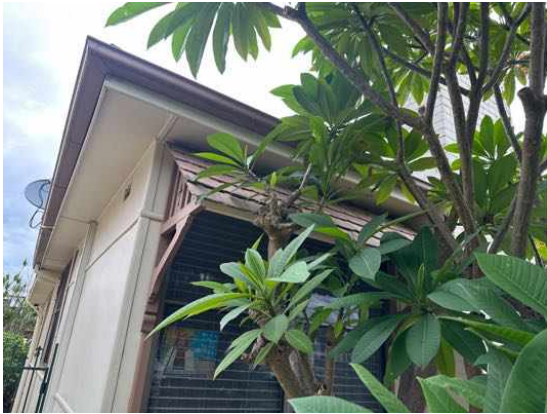
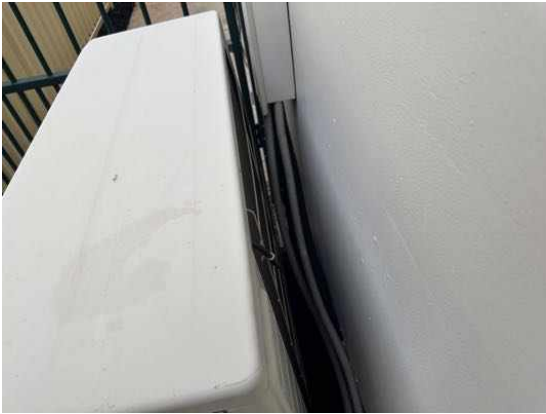
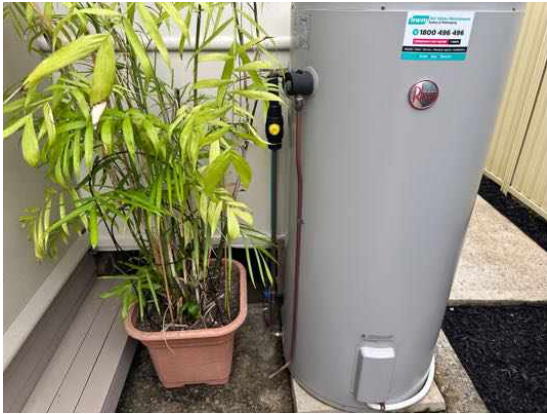
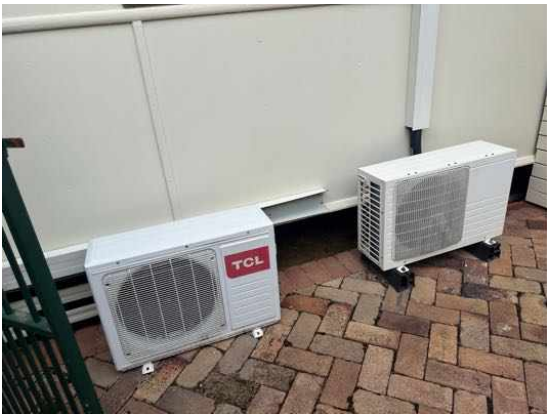
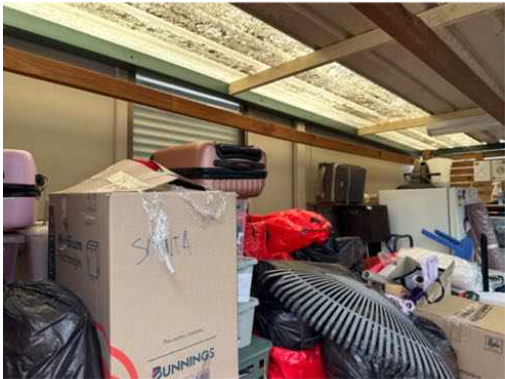
Building: Main Building
Location: All Areas > All Areas
Finding: Additional Photos - Obstructions and Limitations
Information: These photographs are an indication of the obstructions and limitations which impeded full inspection of the property at the time of inspection. These obstructions can hide an array of defects and should be removed to allow full inspection to be carried out. A re-inspection is recommended once the areas are made accessible.

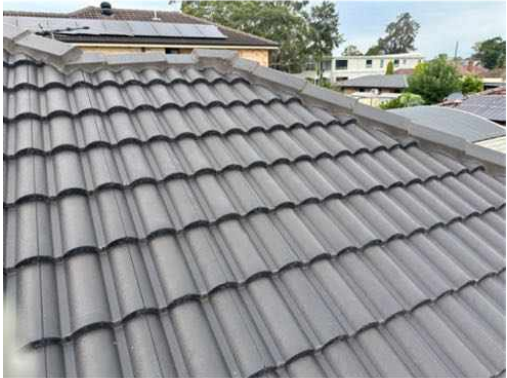
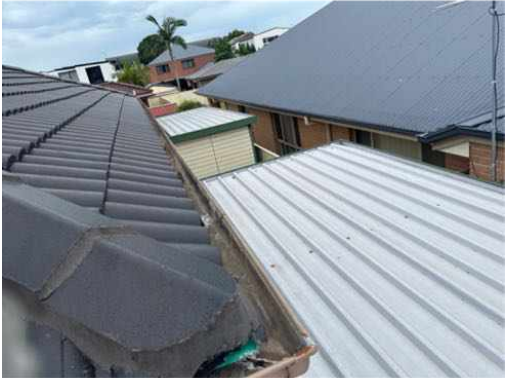
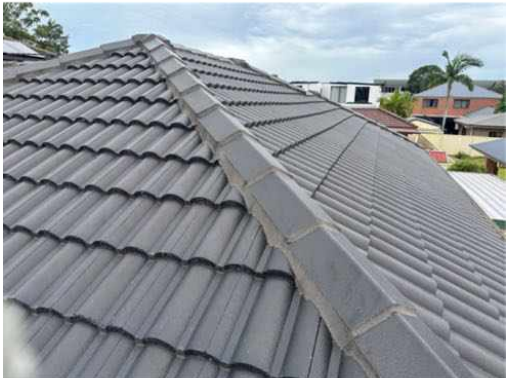
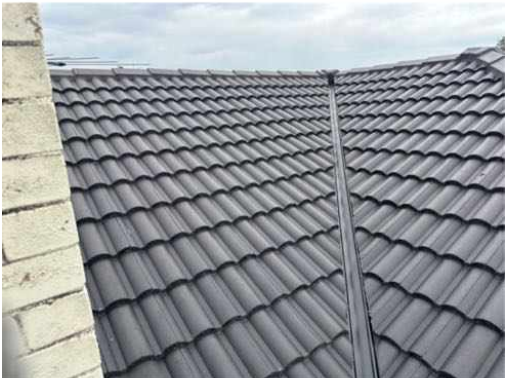
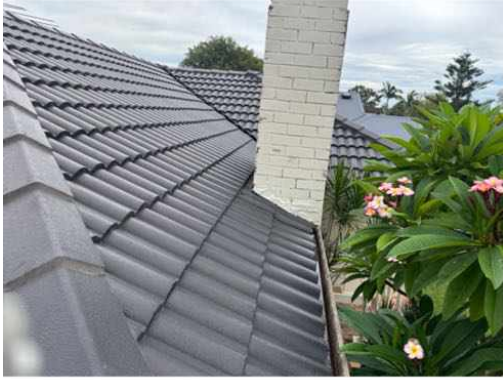
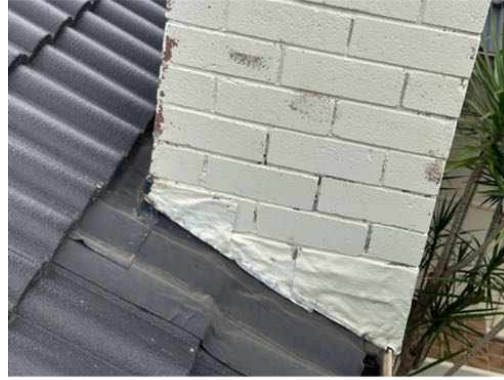
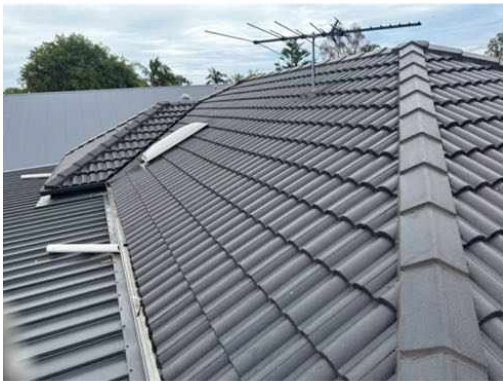
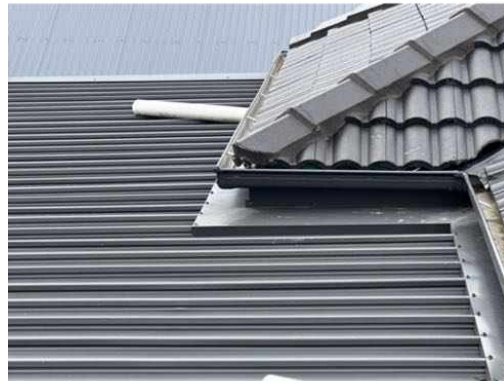
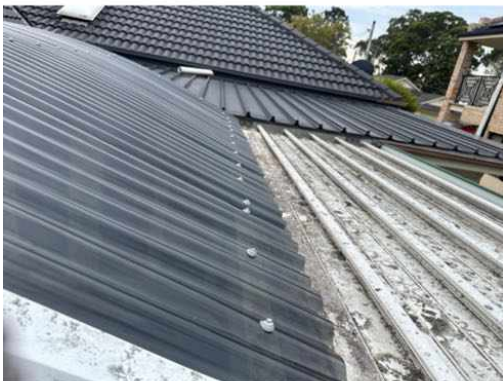
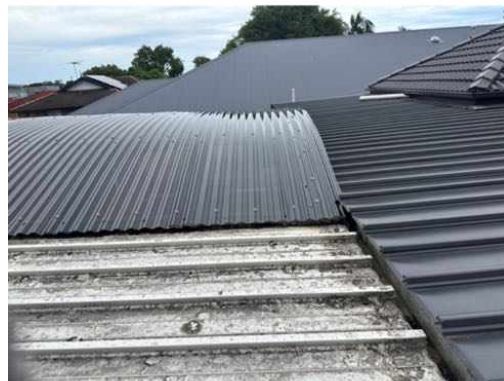
Building: Main Building
Location: All Areas > All Areas
Finding: Additional Photos
Information: Additional photos are provided for your general reference

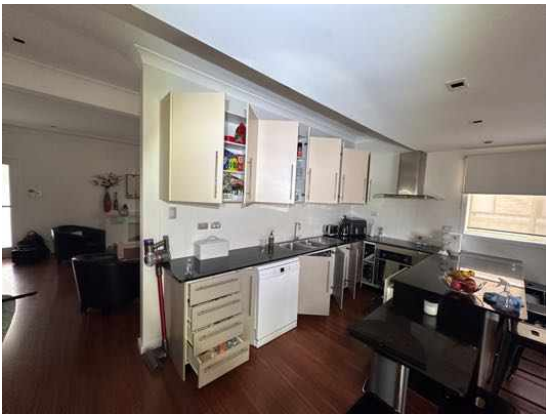
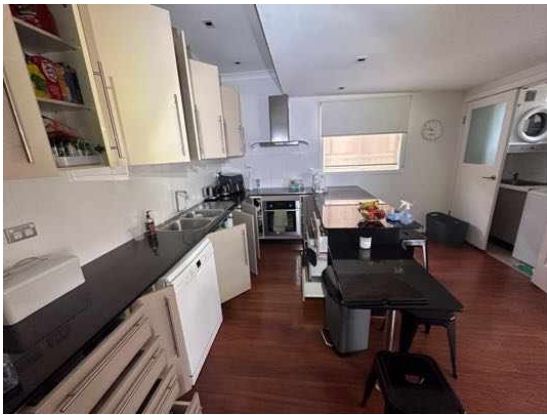
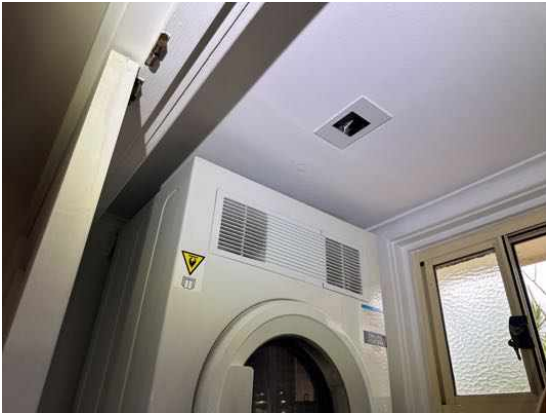
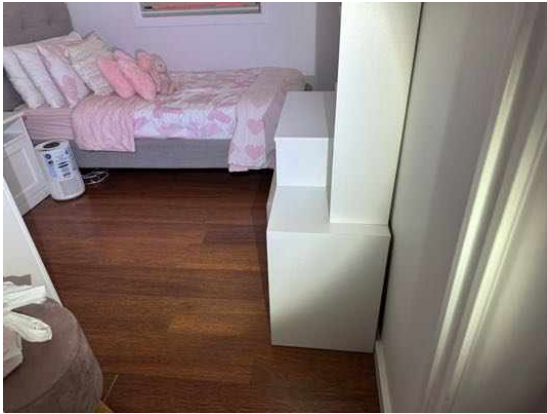
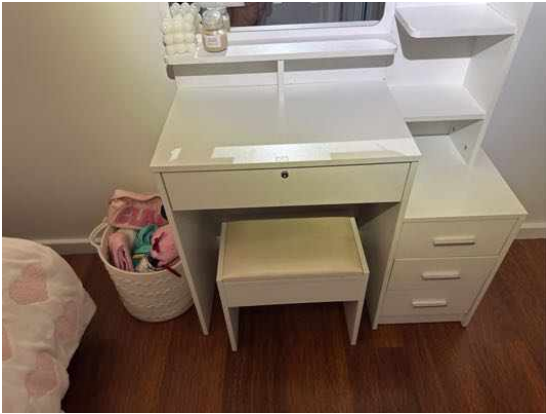
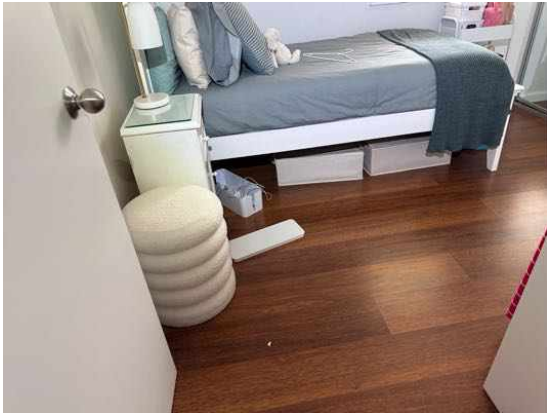
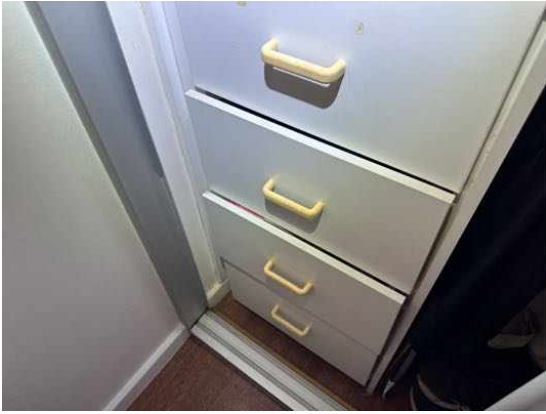
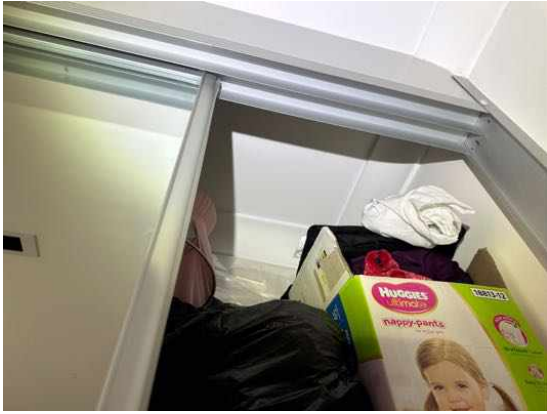
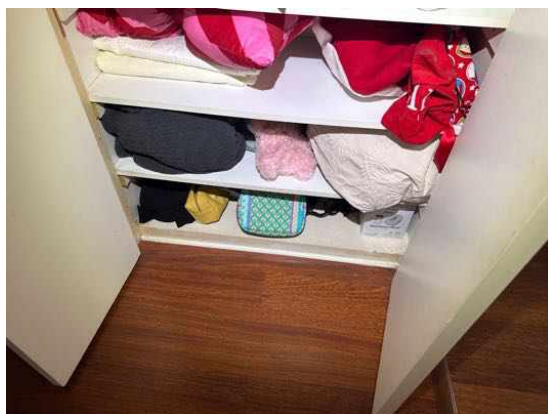
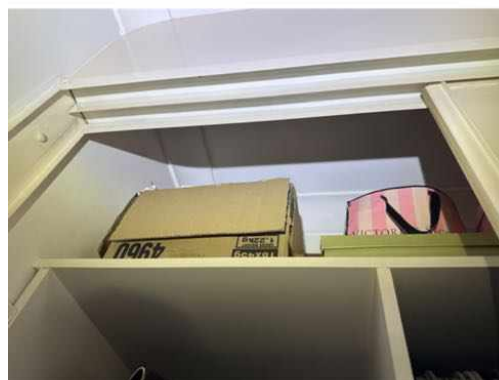
| Finding: | Additional Photos - Obstructions and Limitations |
| Information: | These photographs are an indication of the obstructions and limitations which impeded full inspection of the property at the time of inspection. These obstructions can hide an array of defects and should be removed to allow full inspection to be carried out. A re-inspection is recommended once the areas are made accessible. |

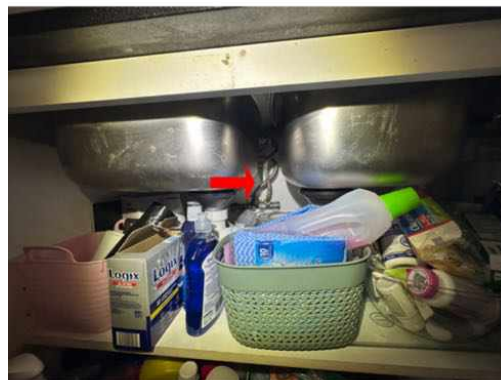
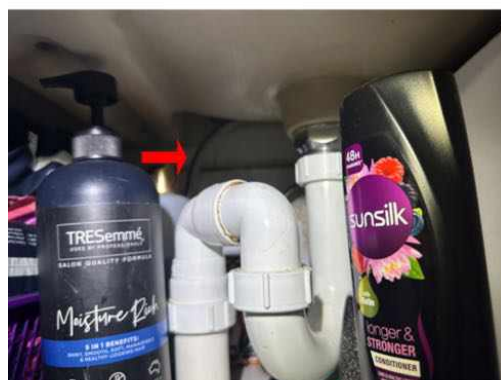
| Information: | Braided Stainless Steel Flexi connector hose are popular in modern home fit outs because they can be bent into shape. They started to be installed in the early two thousands and their use is now extremely widespread in contemporary construction and renovations. |

Flexible braided hoses accounted for more than one in five water damage claims lodged by Australian households according to research released by general insurer IAG.

It is recommended that the Flexi pipes to be replaced at the owners discretion to avoid an "escape water incident" which may lead to water damage to other building elements in the home.

This work can be undertaken by a licensed plumber, general handy person at the owners discretion.

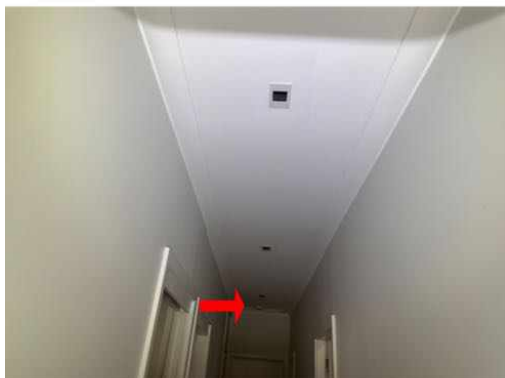
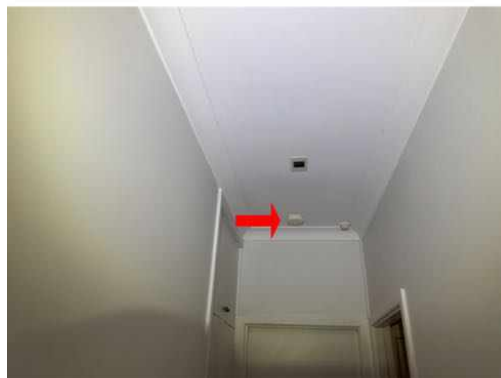
Please note that this defect is highlighted as a caution only. We suspect, based on our experience in the building industry, that the absence of smoke detectors, or their poor condition, should be addressed as a matter of urgency to improve occupant safety.

Always ensure sufficient working and suitable smoke detectors are installed prior to occupying any building. Additionally, it is advised that all smoke detectors be tested by the homeowner on a monthly basis.

Please refer to AS3786 and state based legislation, which may also apply.

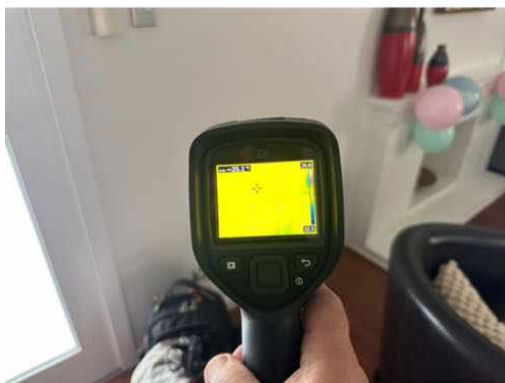
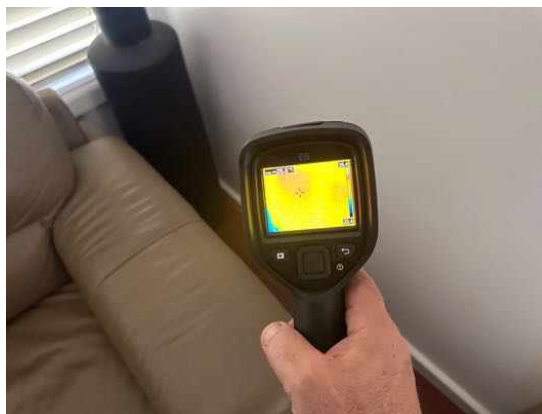
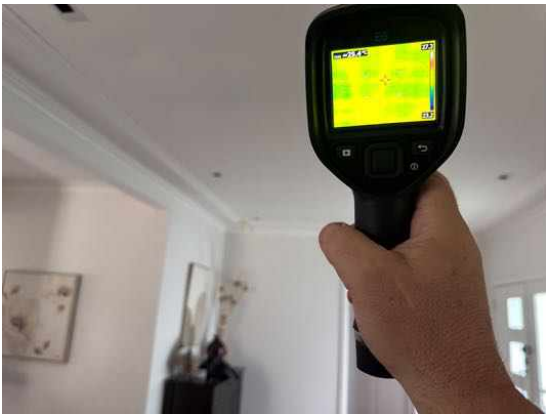
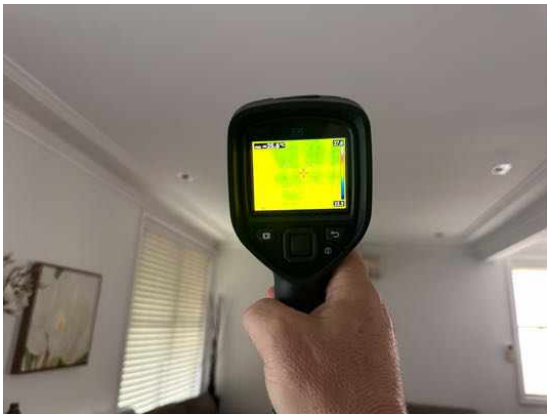
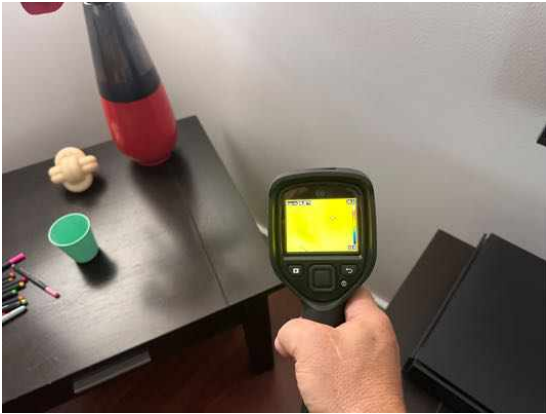
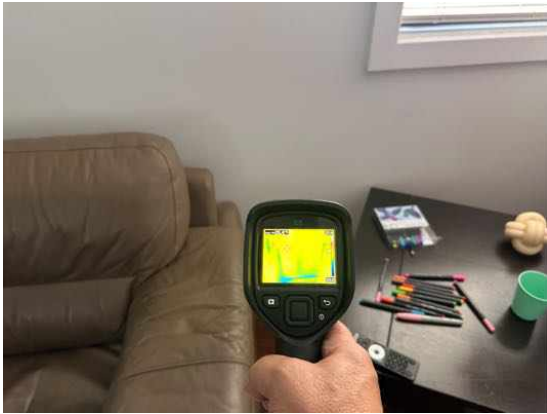
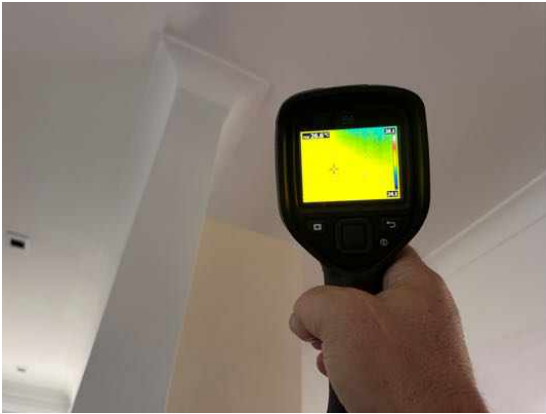
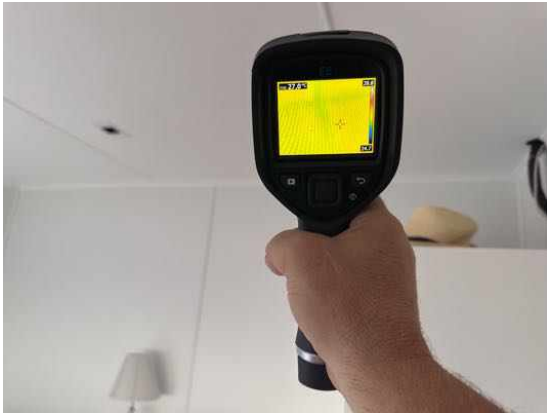
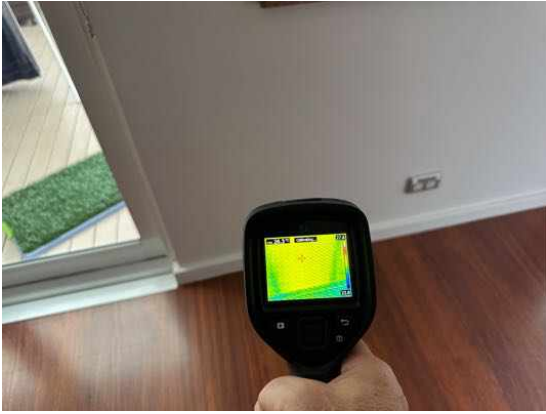
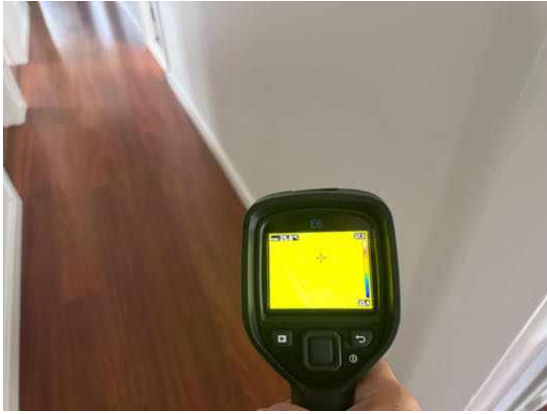
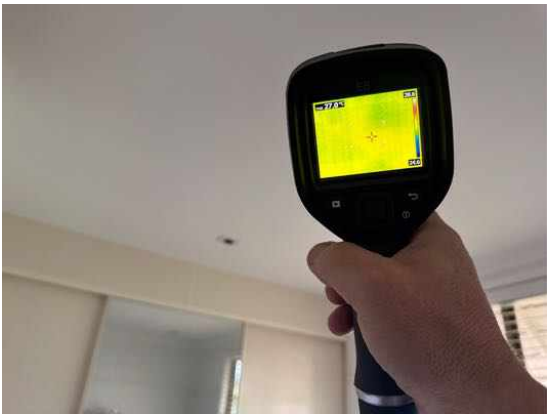
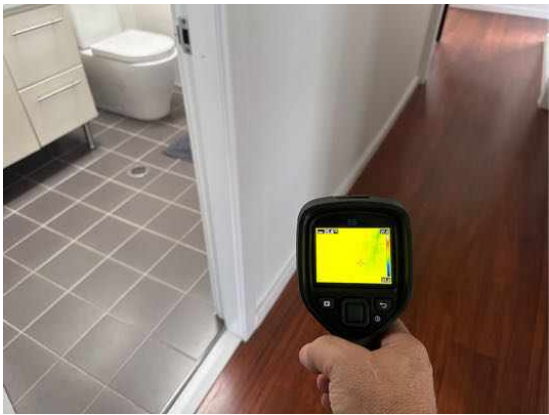
Building: Main Building
Location: All Areas > All Areas
Finding: Thermal imaging: No excessive moisture presentation.
Information: At the time of inspection there appeared to be no excessive moisture presentation in this area.

NOTE: If the Property has been vacant for a period of time or wet areas not used, moisture levels or leaks may not be detectable at the time of the inspection because often only frequent use of water pipes (showers, taps etc) result in a leak being identifiable. We advise further testing on pipes and water susceptible areas (such as the bathroom and laundry) after more frequent use has occurred.

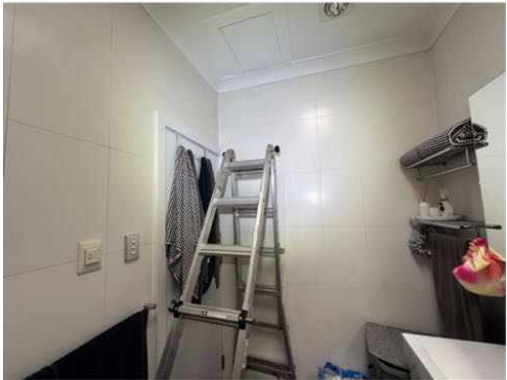
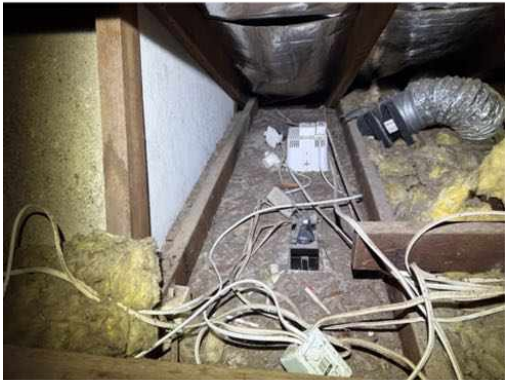
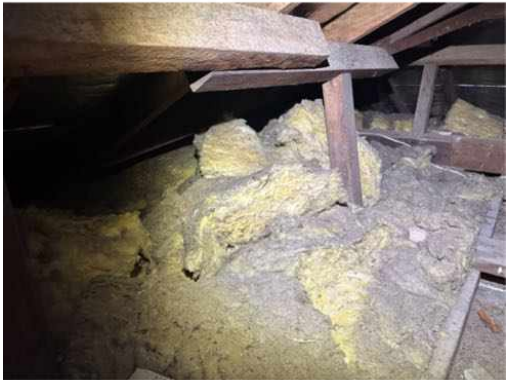
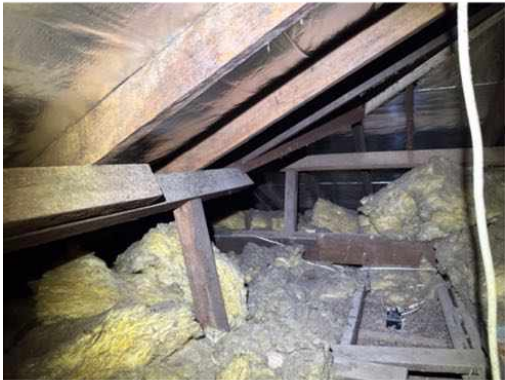
Building: Main Building
Location: All Areas > All Areas
Finding: Roof void: limited access.
Information: Limited access to the roof void was present due to facts including but not limited to access hatch size or placement, insulation, disconnect gravity hot water service, for this reason inspection to the roof void was minimal and a range of defect's from minor to major may not be visible at the time of inspection.

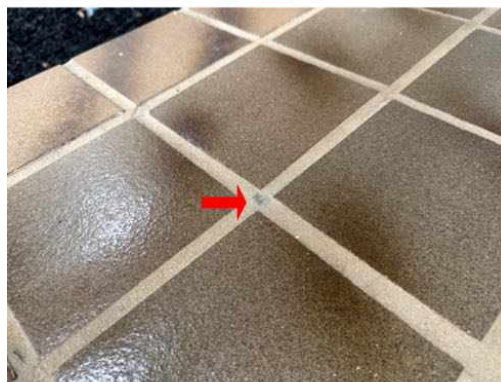
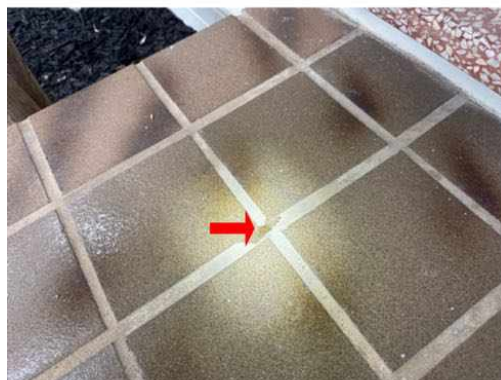
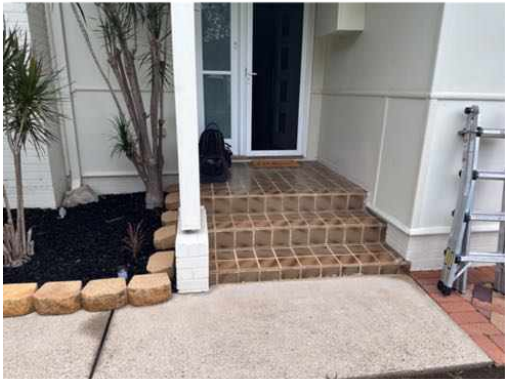
| Information: | During inspection of the property, it was noted that works to install a chemical treated zone barrier had previously been completed. A chemical treated zone barrier is likely to ensure effective protection against termites. |

However, we strongly recommend annual inspections of the barrier and surrounding areas as there are several factors that can lead to deterioration of the barrier and decrease its effectiveness.

Where a Termite Management System has been identified, the client should identify to the type of barrier, date of installation, warranty conditions and any documentation provided by a builder or past owner. Consult the company who installed the barrier to confirm whether the system is still under warranty.
