Building Inspection Report

Inspection Date: Wed, 8 Apr 2026

Property Address: 8/55 Warby St, Campbelltown NSW 2560,
Australia

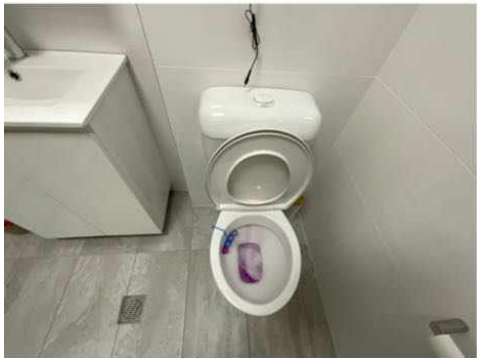
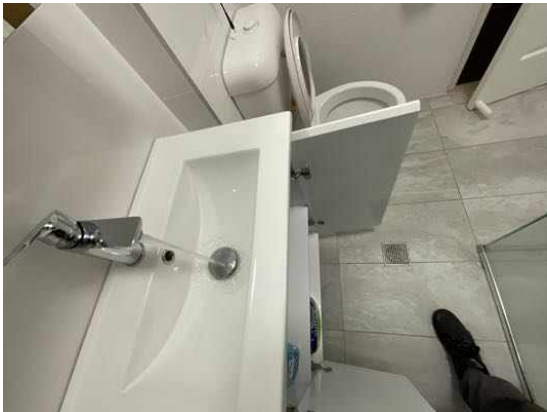
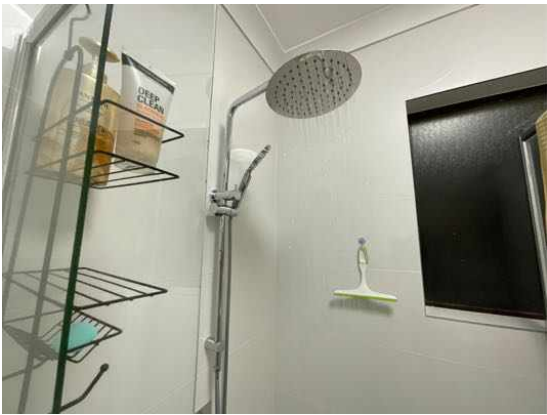
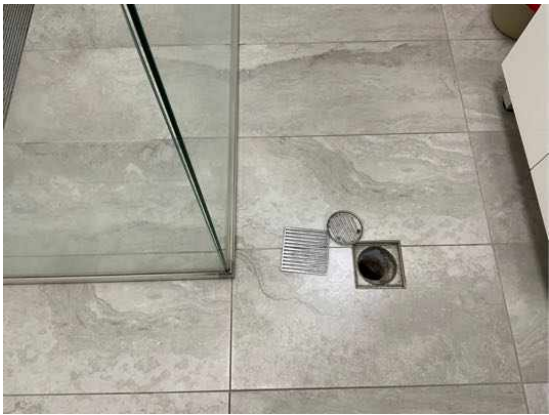
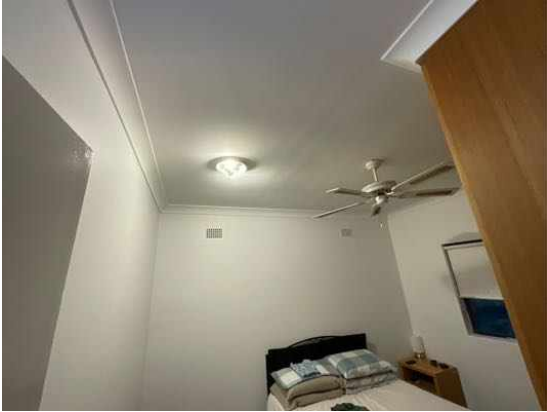
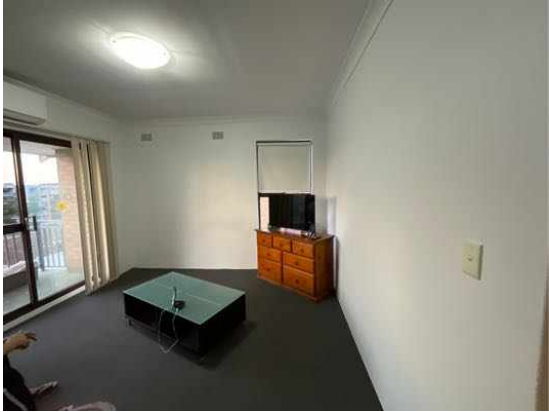
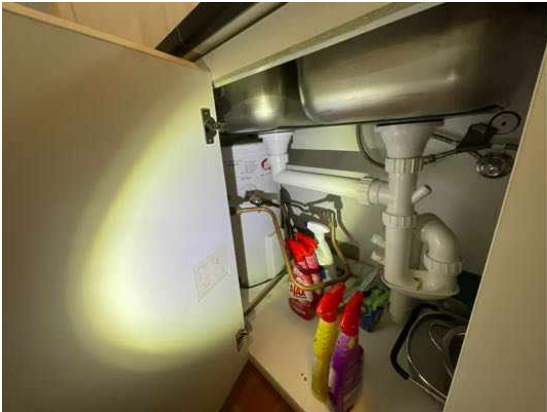
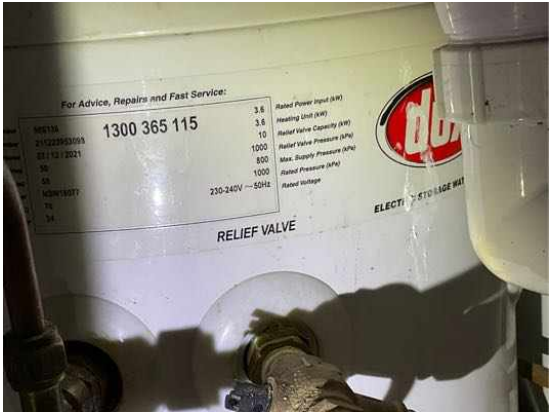
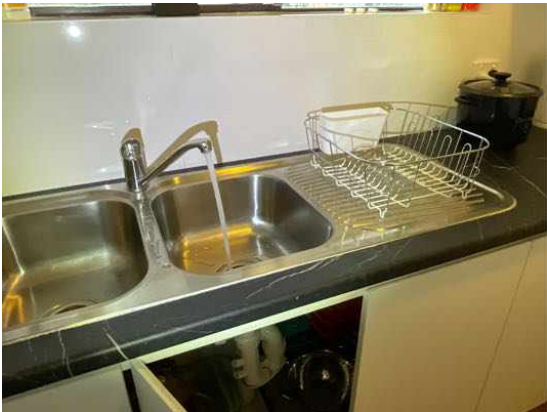
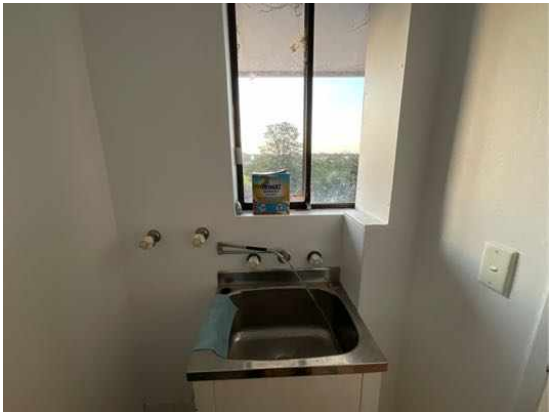
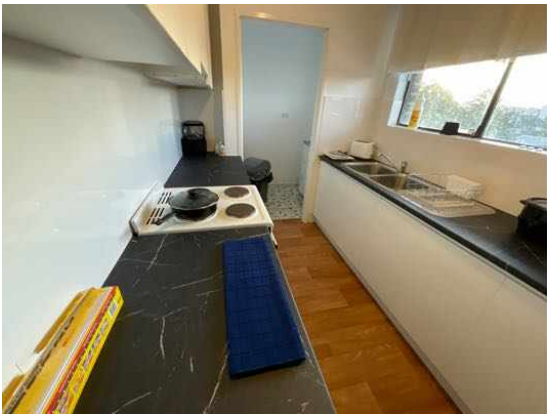
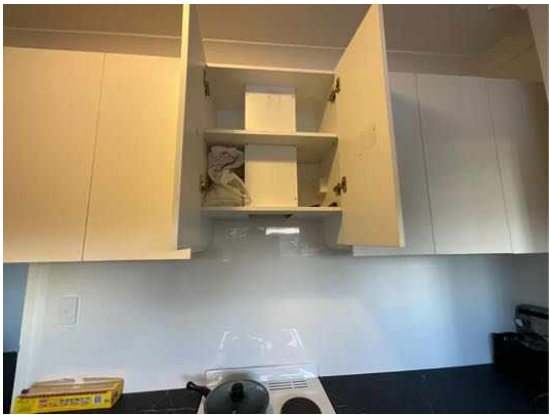
Building: Building 1
Location: Unit
Finding: Additional Photos
Information: Additional photos are provided for your general reference

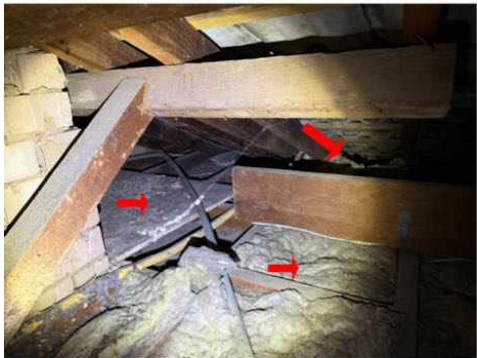
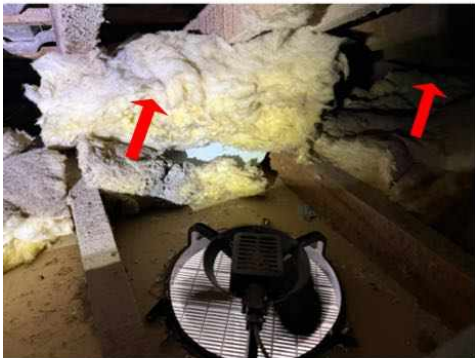
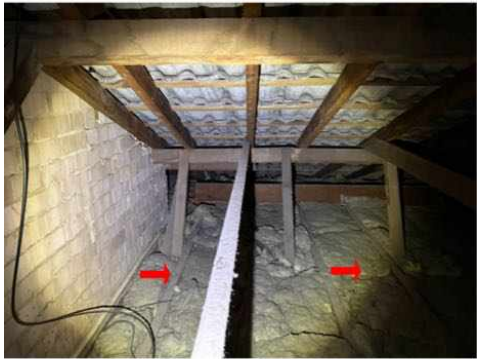
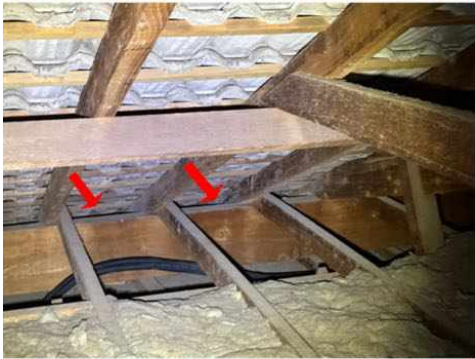
Building: Building 1
 Location: Roof Void
 Finding: Additional Photos - Obstructions and Limitations of the ROOF CAVITY
 Information: These photographs are an indication of the obstructions and limitations which impeded full inspection of roof cavity areas at the time of inspection. These obstructions can hide an array of defects and should be removed to allow full inspection to be carried out if applicable. A re-inspection is recommended once the areas are made accessible.

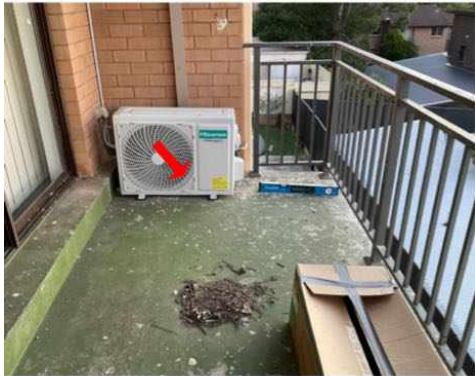
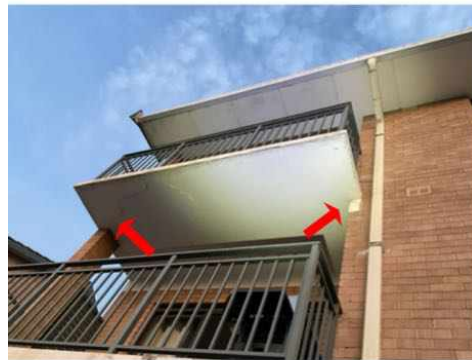
Building: Yard
 Location: External Balcony Areas
 Finding: Additional Photos - Obstructions and Limitations of External areas
 Information: These photographs are an indication of the obstructions and limitations which impeded full inspection of external areas at the time of inspection. These obstructions can hide an array of defects and should be removed to allow full inspection to be carried out. A re-inspection is recommended once the areas are made accessible.

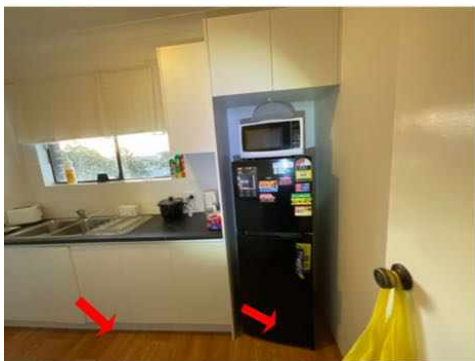
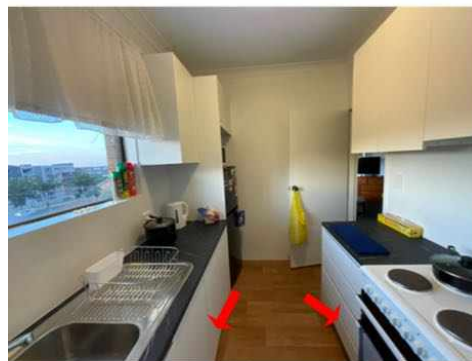
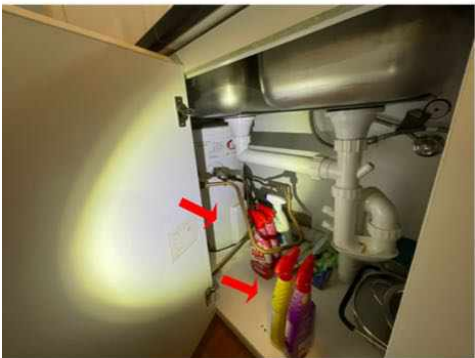
Building: Main Building
 Location: All Internal Areas
 Finding: Additional Photos - Obstructions and Limitations of Internal areas
 Information: These photographs are an indication of the obstructions and limitations which impeded full inspection of Internal areas at the time of inspection. These obstructions can hide an array of defects and should be removed to allow full inspection to be carried out. A re-inspection is recommended once the areas are made accessible.
