Building and Timber Pest Inspection Report

Inspection Date: Wed, 4 Mar 2026

Property Address: 1304/192 Stacey St, Bankstown NSW 2200,
Australia

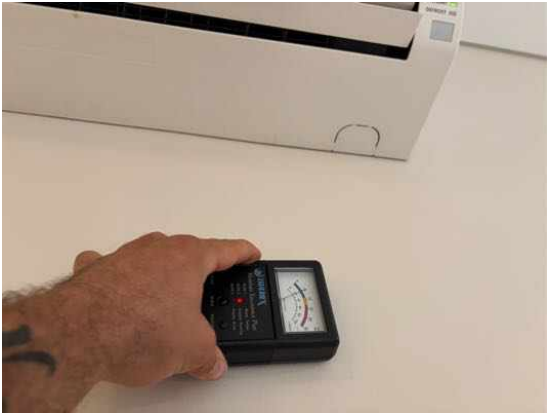
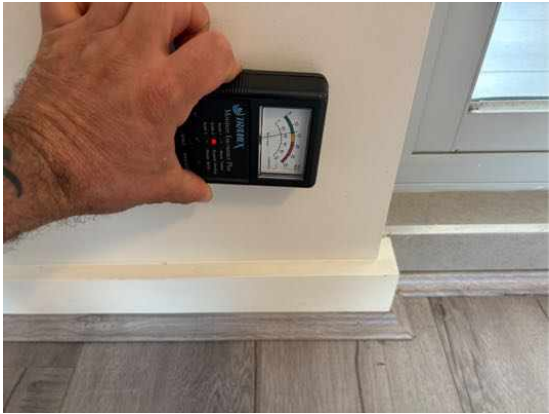
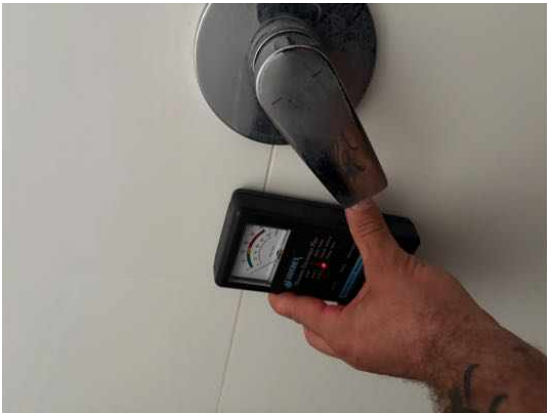
This is for information only.

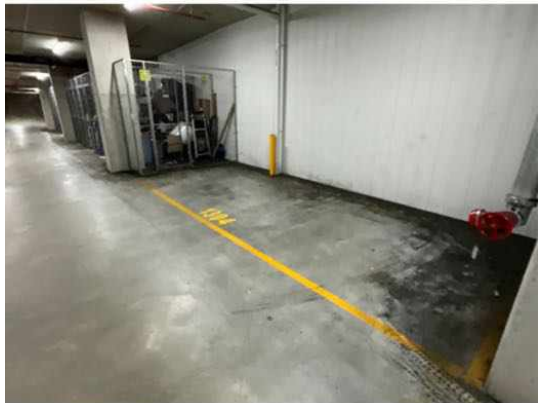
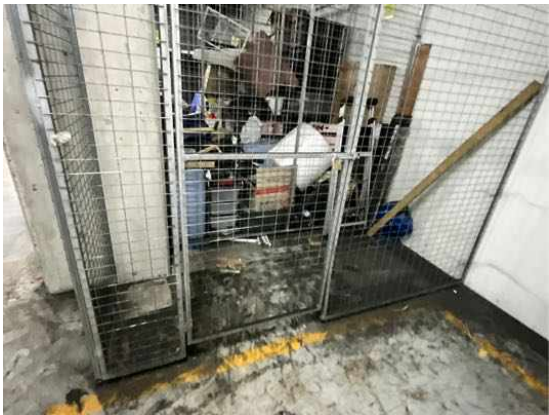
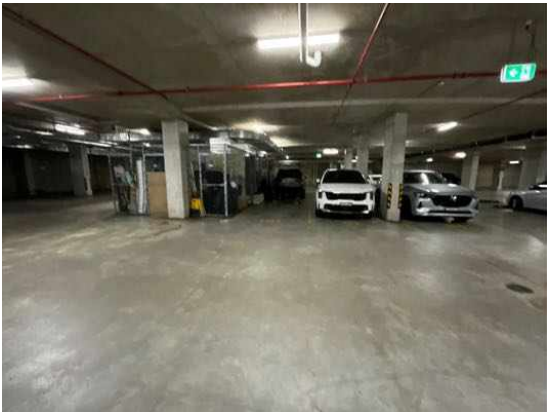
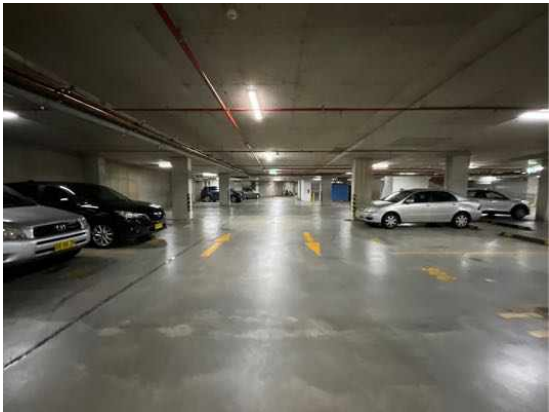
Building: Main Building
Location: Garage
Finding: Additional Photos- Garage
Information: Additional photos are provided for your general reference. Arrows may have been included to highlight areas of importance. Please discuss these photos with your building consultant for clarification.
