Building and Timber Pest Inspection Report

Inspection Date: Thu, 19 Mar 2026

Property Address: 13/21 Edgeworth David Ave, Hornsby NSW
2077, Australia

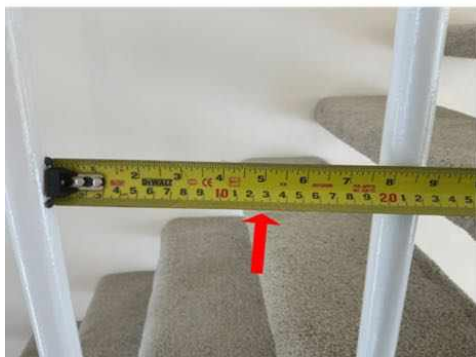
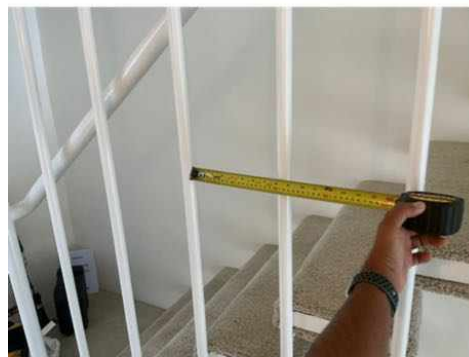
Building:	Main Building
Location:	Stairs - Internal
Finding:	Spacing Between Balusters - Non Compliant
Information:	At the time of inspection, it was observed that the spacing between the balusters exceeds 125 mm. In accordance with the National Construction Code (NCC) 2022 Volume Two and referenced standards, any openings in a balustrade or barrier must be constructed to prevent a 125 mm sphere from passing through, in order to minimise the risk of falls or entrapment, particularly for young children.

The current baluster spacing does not comply with these safety requirements and may pose a fall or injury hazard. While this may have been acceptable at the time of original construction, it does not meet current Australian safety standards.

It is recommended that the balustrade be modified to reduce the openings between balusters to no greater than 125 mm, in accordance with current NCC requirements, to ensure occupant safety and compliance.

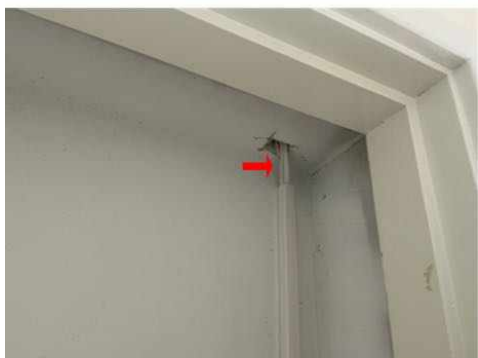
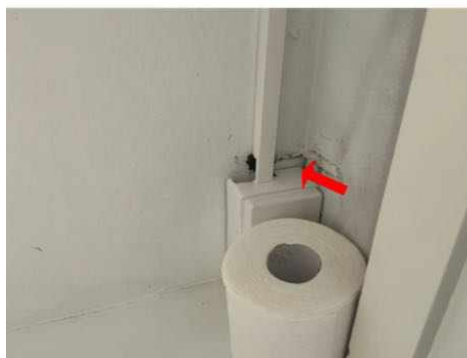
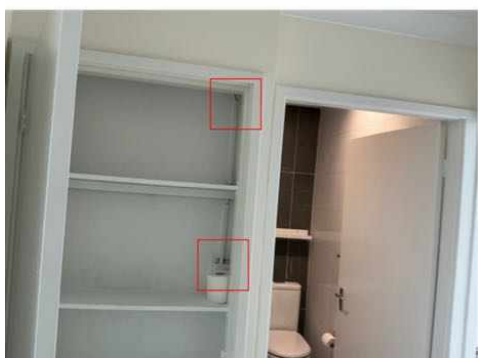
Finding 1.02

Building:	Main Building
Location:	Upstairs Hallway
Finding:	Electrical Wires - Exposed
Information:	During the inspection, exposed electrical wires were noted. This condition poses a significant safety hazard, as it increases the risk of electrical shock, short circuits, and potential fire. It is imperative that a qualified electrician addresses this issue immediately by properly insulating the exposed wires and ensuring all electrical connections comply with safety standards. Prompt action will mitigate the risks associated with exposed wiring and maintain the safety and integrity of the property's

electrical system.

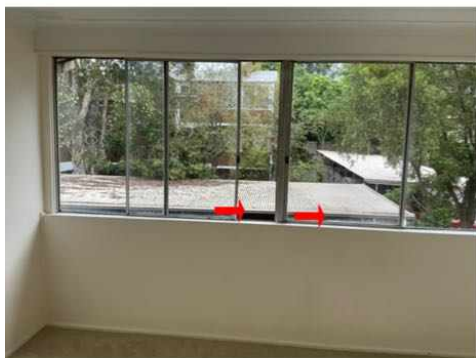
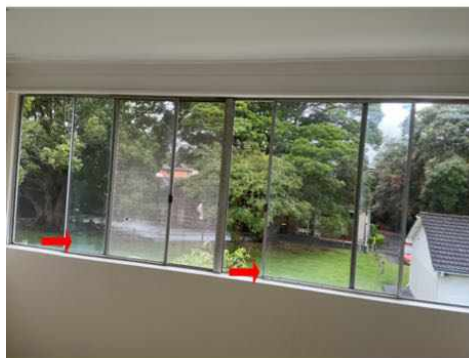
Finding 1.03

Building:	Main Building
Location:	All Areas
Finding:	Window Restrictors - Recommended
Information:	Upstairs windows did not have window restrictors installed. Although not a requirement at the time of construction, it is advisable to install window opening restrictors on all second storey windows with sill heights below 1.7 meter and potential fall of 2 meters or more.

If you live in a strata scheme, window safety devices must be installed on all applicable windows by 13 March 2018. Residents with safety devices installed can still fully open their windows but it's recommended that devices be engaged whenever children are present, to prevent falls.

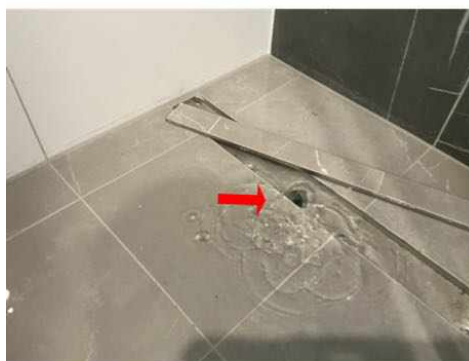
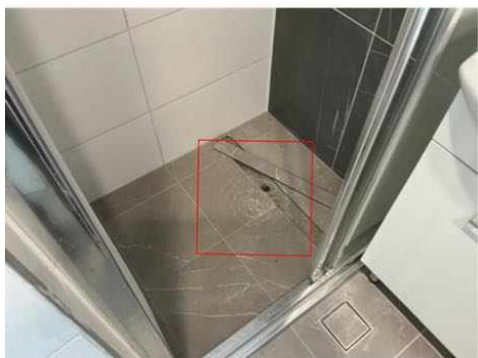
Building:	Main Building
Location:	Bathroom
Finding:	Shower Linear Drain – Restricted Discharge Due to Excess Adhesive
Information:	At the time of inspection, the linear drain within the shower was tested. It was observed that the connection between the linear drain insert and the drainage pipe appears to have been excessively glued. Visible adhesive residue was noted within the pipe, reducing the effective internal diameter of the outlet. This condition is restricting the free flow of water, resulting in a noticeably slower discharge rate. While no significant ponding was observed at the time, water was seen to build up across the shower floor before gradually draining.

The application of adhesive at the connection point is considered excessive and indicative of poor installation practices. Proper installation requires controlled use of adhesive to ensure a secure bond without obstructing the flow path. The current condition reflects a lack of care in workmanship, leading to a functional deficiency in the drainage system.

- Increased risk of water ingress beyond the shower area if drainage capacity is exceeded.
- Ongoing moisture exposure to finishes, which may contribute to deterioration, mould growth, or damage to surrounding materials over time.
- Possible long-term blockage risk if debris accumulates against the adhesive build-up.

- Engage a licensed plumber to further investigate the drain connection.
- Remove the linear drain insert and rectify the connection to ensure that no excess adhesive obstructs the pipework.
- Clean or replace the affected section of pipe as required to restore full internal diameter and proper flow.
- Reinstall the linear drain in accordance with acceptable plumbing practices, ensuring a clear and unobstructed discharge path.
- Upon completion, retest the drainage to confirm adequate flow and performance under normal operating conditions.

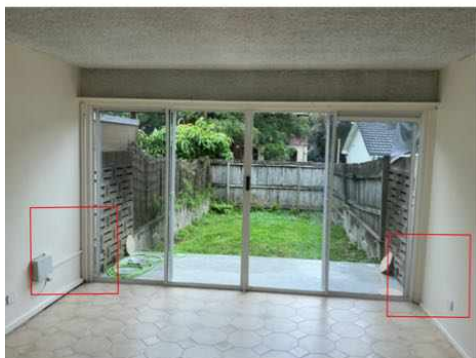
Finding 3.02

Information: At the time of inspection, rising damp was identified within the property. This condition results from the upward movement of moisture through porous building materials, such as bricks, sandstone, or mortar, via capillary action. A damp-proof course (DPC), an impermeable barrier installed at the base of walls above ground level during construction, is typically used to prevent rising damp. However, the absence, deterioration, or bridging of the DPC can compromise its effectiveness, specially in older buildings, leading to moisture ingress. Inadequate site drainage, which allows water to accumulate around the foundation, is a common contributing factor to this issue.

If left unaddressed, rising damp can pose significant health risks due to mould growth and cause extensive damage to building elements, including wall finishes such as paint and plasterwork. The current condition should be monitored over a 12-month period to assess its progression.

It is strongly recommended that the client engage a qualified damp-proofing specialist for remedial actions. Additionally, consulting a qualified plumber or drainage specialist to assess and improve site drainage is advised to mitigate further risks. Monitoring the condition for 12 months is essential to evaluate its status and prevent potential recurrence or further damage.

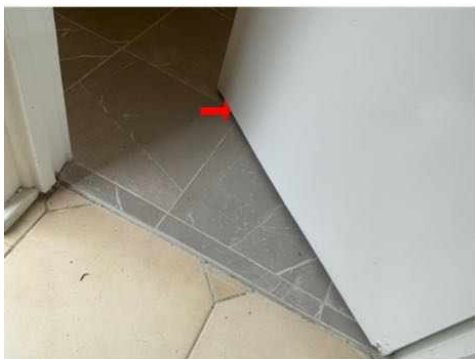
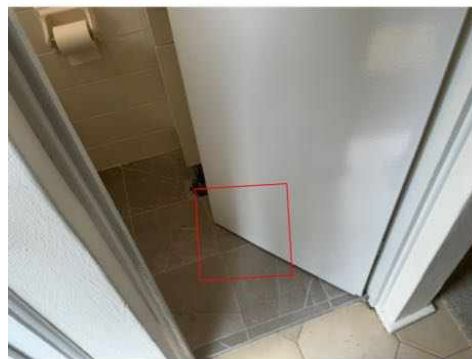
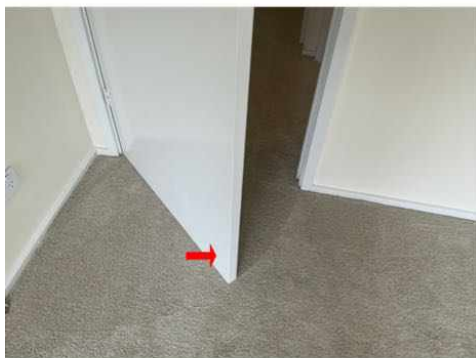
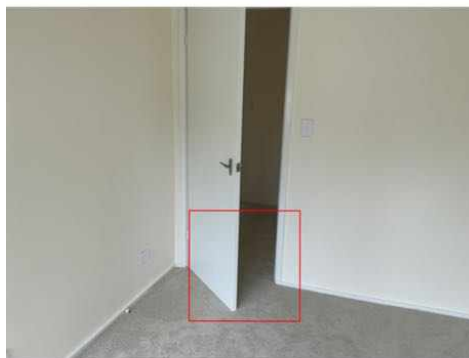
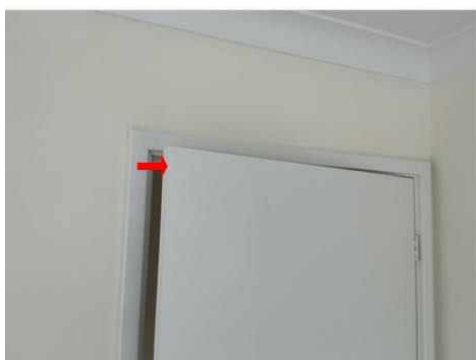
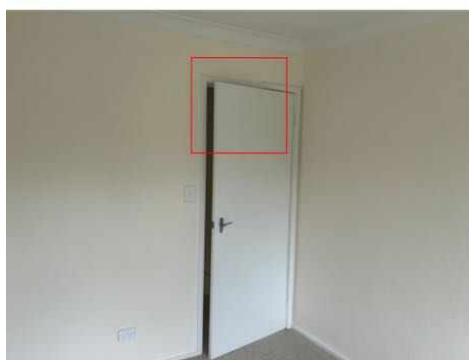
Finding 3.03

Building:	Main Building
Location:	WC, Both Bedrooms
Finding:	Door(s) - Binding/Jamming
Information:	At the time of inspection, it was noted that the door was binding or jamming in this area.

Several factors could contribute to this issue, including swelling due to moisture, which can cause wooden doors to expand and fit tightly in the frame. Misaligned or loose hinges may also result in the door sagging or becoming misaligned, making it difficult to close. Over time, wooden doors may warp due to fluctuations in temperature or humidity, leading to improper closure.

It is recommended that a qualified carpenter or handyman be engaged to carry out the necessary repairs to ensure proper door operation.

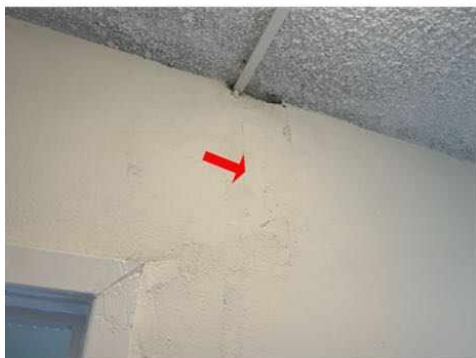
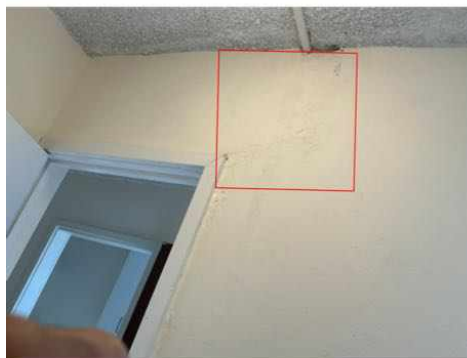
Finding 3.04

Finding: Substandard Repair Work to Wall

Information: At the time of inspection, areas of previous repair work were observed to be of a substandard finish. The affected surfaces displayed uneven textures, visible patching, and inconsistent finishing when compared to surrounding areas, indicating that the repairs have not been completed to an acceptable standard of workmanship.

While this condition is not considered a matter of structural concern, it does impact the overall aesthetic appearance and finish quality of the property.

The client is advised to engage the services of a qualified plastering specialist to properly rectify and refinish the affected areas to achieve a consistent and professional standard of finish.

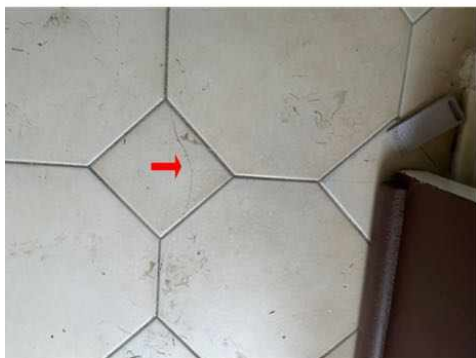
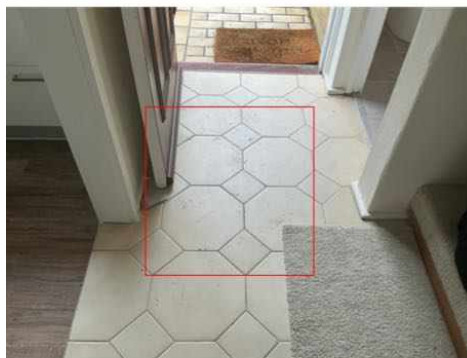
Finding 3.05

Finding: Tiles - Cracked (Common Areas)

Information: At the time of inspection, cracks and damage were noted on floor tiles in this area. The damage may have resulted from a combination of factors, including impact, poor surface preparation during installation, or minor building movement causing stress to the tiled surface. These cracks not only affect the appearance but may allow moisture to penetrate beneath the tiles, potentially leading to further deterioration over time.

It is recommended that a licensed tiler be engaged to replace them at own discretion.

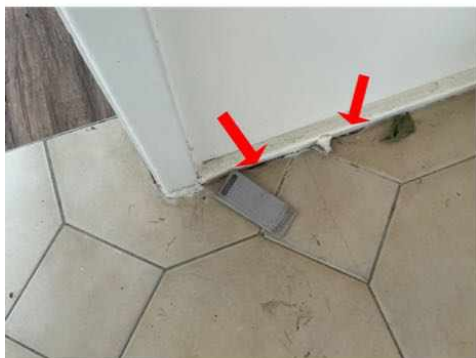
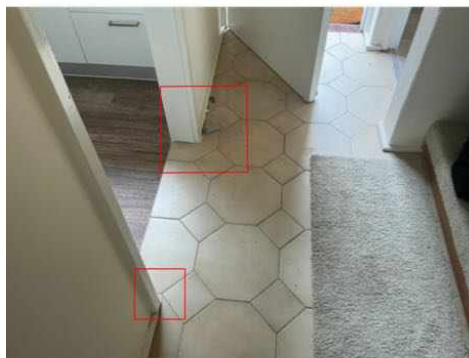
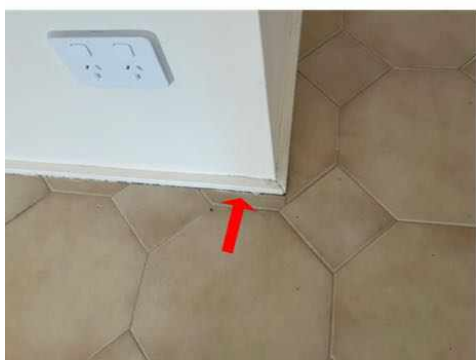
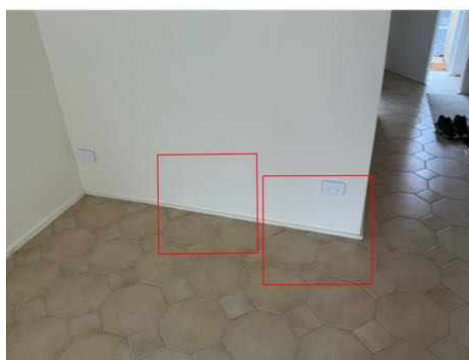
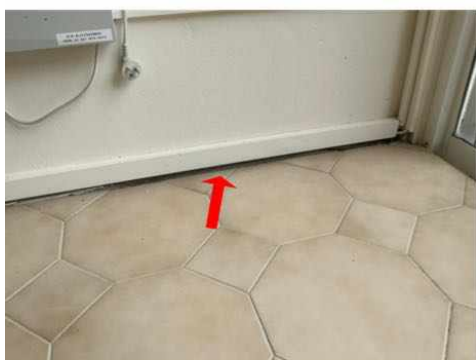
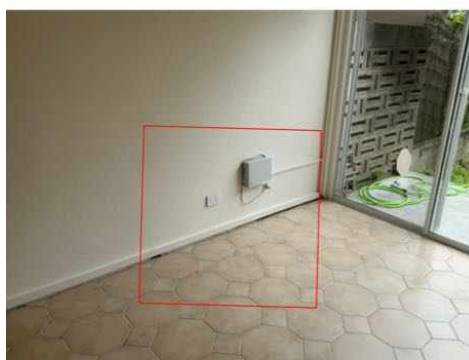
Finding 3.06

Finding: Sealant - Under Skirting Boards (Missing)

Information: At the time of inspection, the sealant was missing beneath the skirting boards. The absence of sealant may allow dirt or moisture ingress into gaps between the skirting and flooring. While not a structural issue, application of sealant is recommended for improved finish and to help prevent potential moisture-related concerns over time.

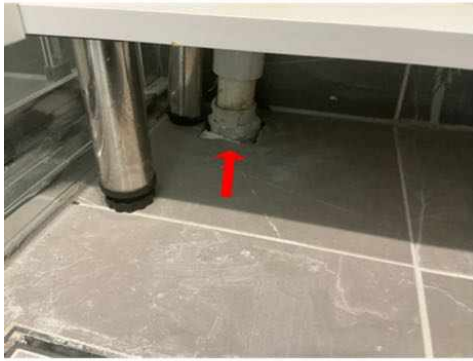
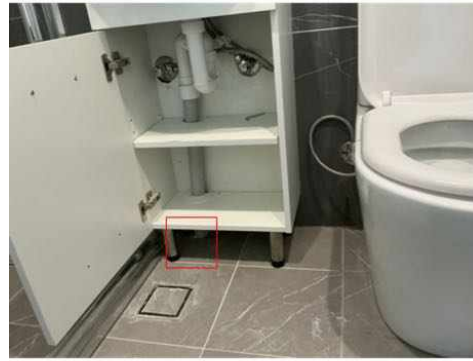
Finding 3.07

Building:	Main Building
Location:	Bathroom
Finding:	Incomplete or substandard works (Sealant around pipe)
Information:	The works to this area appear to be incomplete or have been completed to a substandard level.

Works that have not been completed to a satisfactory level create potential for the development of building defects and may impede on the safety and integrity of the overall structure.

It is highly recommended that the relevant trades be appointed to complete these

works and ensure the safety of the area and the longevity of all associated building elements.

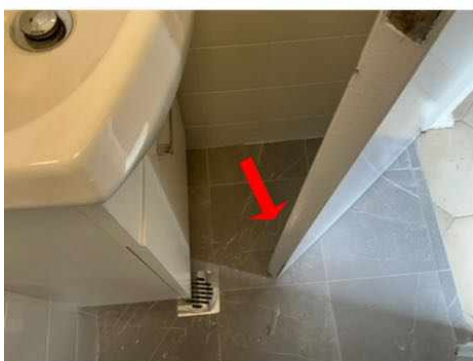
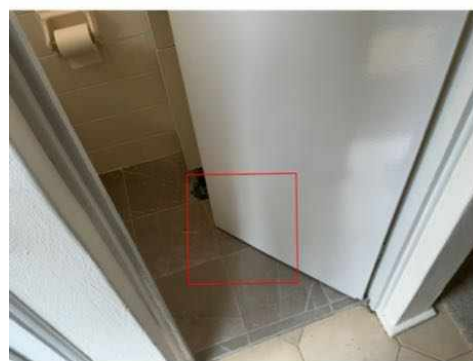
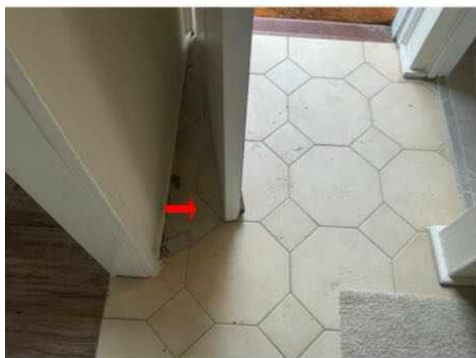
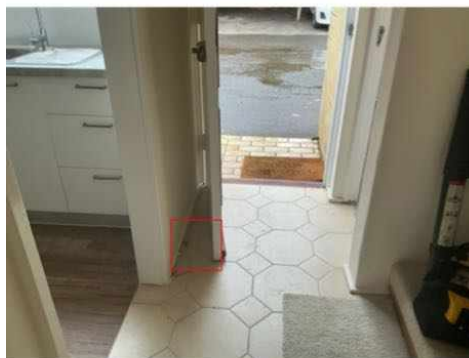
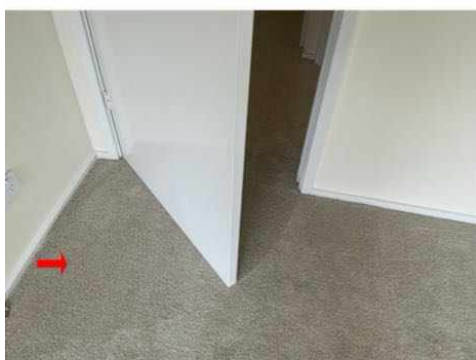
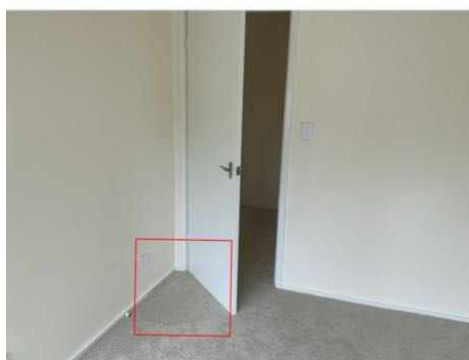
Finding 3.08

Building: Main Building
 Location: All Areas
 Finding: Door Stopper(s) - Missing
 Information: At the time of inspection, it was noted that a door stopper was missing in this area.

The absence of a door stopper can lead to potential damage to the door, wall, or surrounding finishes, as the door may swing open too far and impact the wall or adjacent objects. Over time, this can cause dents, scuffs, or even structural damage to the wall or door. It is recommended that a door stopper be installed to prevent further damage and ensure the protection of both the door and the surrounding area.

The client is advised to engage services of a handyman to install the door stopper.

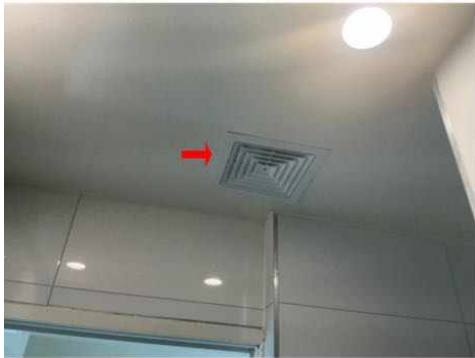
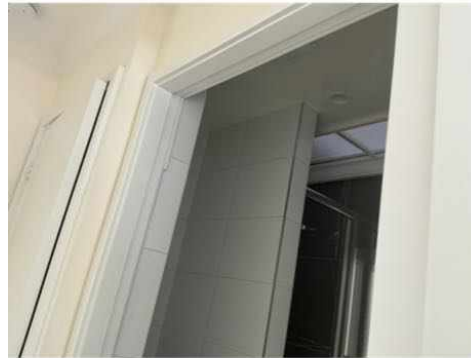
Finding 3.09

Finding: Missing/Unidentified Switch for Exhaust Fan

The inability to readily operate the exhaust fan may impact ventilation performance, particularly in moisture-prone areas, which can contribute to condensation and mould over time.

The client is advised to engage the services of a licensed electrician to verify whether a switch has been installed, confirm the wiring and connection of the exhaust fan, and test the unit to ensure it is functioning correctly and safely.

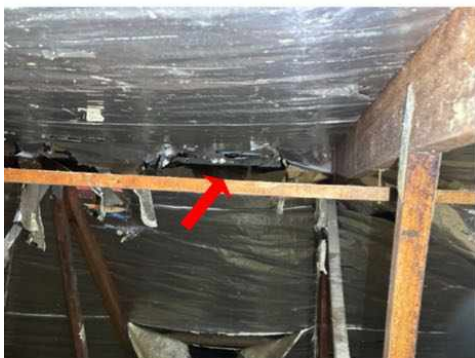
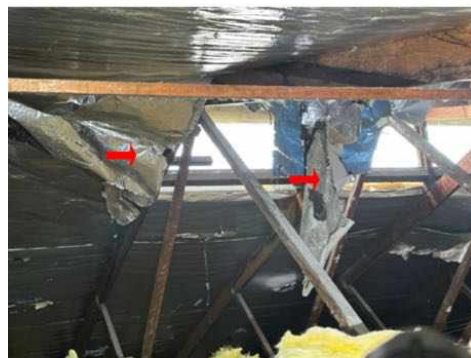
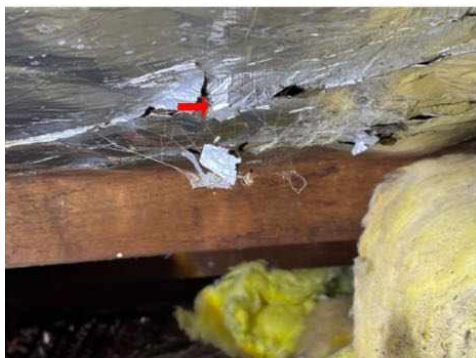
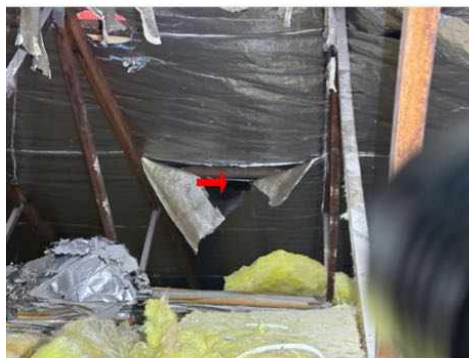
Where sarking is damaged, both insulation and moisture protection of the property are inhibited. This creates a loss of energy and thus negatively impacts the energy efficiency of the property, allowing potential for moisture ingress from condensation or leaking roof tiles.

It is important to repair any holes or damaged sections of sarking to ensure that the building material is fully functional. A registered roofer should be consulted to provide further advice on this defect and to perform rectification works at client discretion.

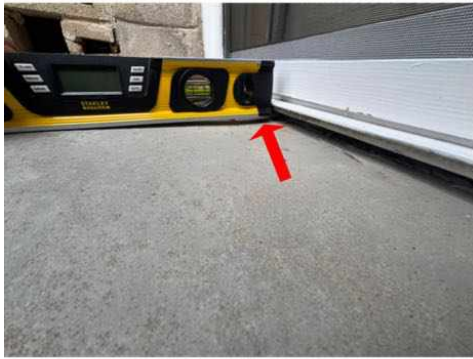
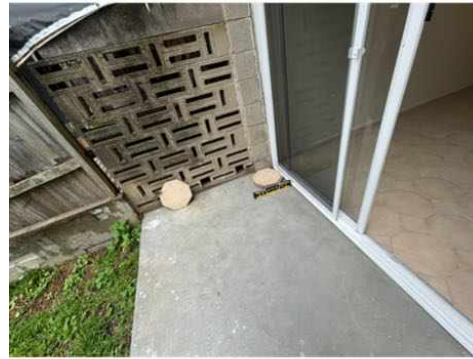
Finding 3.11

Building:	Main Building
Location:	Yard - Back
Finding:	Incorrect Fall
Information:	At the time of inspection, the external concrete surface adjacent to the sliding door was observed to have an uneven fall, with sections sloping towards the property rather than away from it. This condition is likely to result in water pooling near the base of the wall and door threshold during rainfall events.

Poor surface drainage in this area can increase the risk of water ingress into the building over time and may contribute to moisture-related issues affecting internal finishes and structural elements if left unaddressed.

The client is advised to engage the services of a qualified concrete specialist to assess and rectify the fall of the surface, ensuring it is appropriately graded away from the building to facilitate proper drainage and prevent water accumulation near the structure.

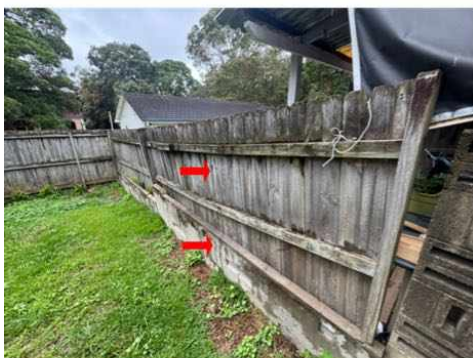
Finding 3.12

Finding: Fencing - Deteriorated & Leaning

Information: At the time of inspection, the boundary timber fence was observed to be leaning and showing signs of deterioration. The fence panels and supporting elements exhibited weathering, timber decay, and loss of structural integrity, contributing to the visible misalignment and instability.

The current condition indicates that the fence has reached the end of its serviceable life in sections and may continue to deteriorate if left unaddressed. While not posing an immediate structural risk to the dwelling, the fence may become unstable over time and could be susceptible to failure, particularly during adverse weather conditions.

The client is advised to engage the services of a qualified fencing contractor to assess the extent of deterioration and carry out necessary repairs or replacement to restore stability, functionality, and durability.

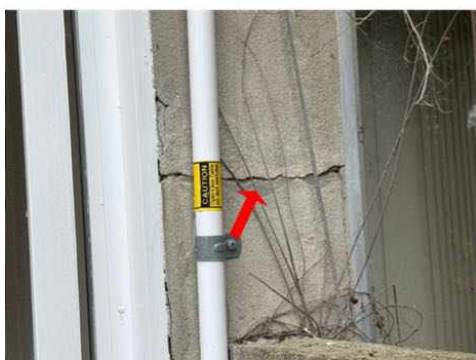
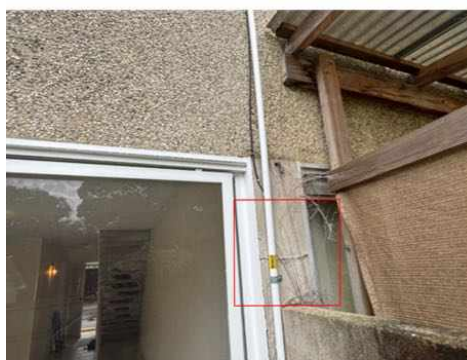
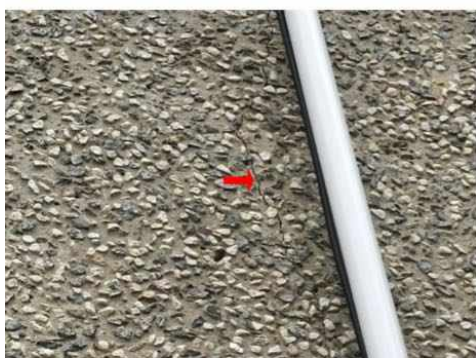
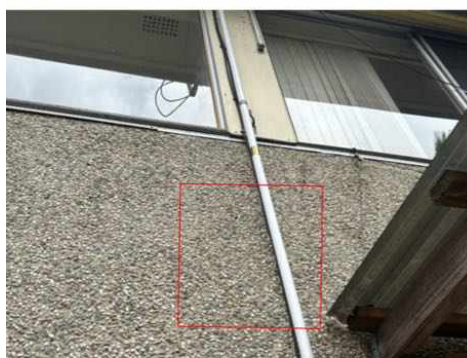
Finding 3.13

Finding: Cracking - Damage Category 2 - Noticeable (up to 5mm)

Information: Noticeable cracks are a common occurrence as a result of many primary defects. Such causes may include age, general wear and tear, expected building movement, general expansion/contraction of building materials in different weather conditions, and/or minor failings in the installation or application of building materials.

Monitoring of all cracking should be conducted frequently. Always contact a building inspector should cracks widen, lengthen, or become more numerous.

Relevant tradespeople, such as painters and plasterers, should be appointed to perform remedial works, as deemed necessary.

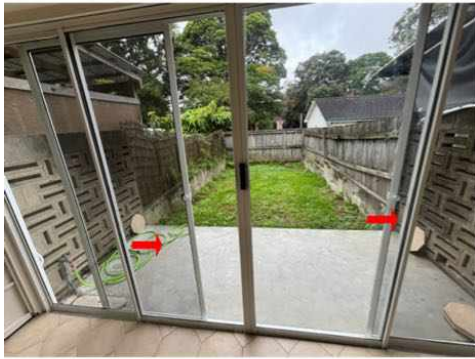
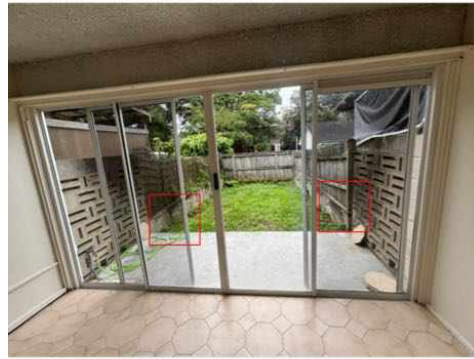
Finding 3.14

Finding: Fly Screen Sliding Door - Stiff to Slide

Information: At the time of inspection, the sliding door was found to be stiff and difficult to operate. This may be due to dirt or debris in the tracks, misalignment of the rollers, or general wear and tear over time. It is recommended that the client engage a handyman or door specialist to clean the tracks, adjust or replace the rollers if required, and ensure the door operates smoothly.

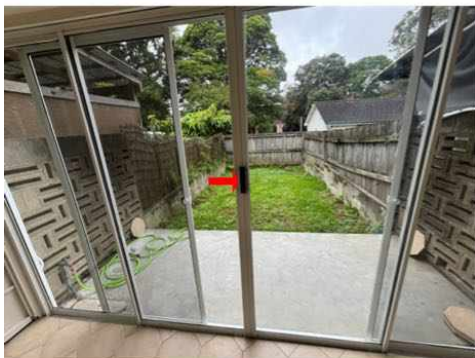
Finding 3.15

Building:	Main Building
Location:	Living Room
Finding:	Door Lock - Missing
Information:	During the inspection, it was noted that a door lock is missing from one of the doors.

This absence not only compromises the security and privacy of the affected area but may also lead to operational issues with the door. It is recommended that the client installs a suitable lock to restore proper functionality and to ensure the safety and security of the property. Addressing this promptly will prevent any potential security risks.

The client is advised to engage services of a locksmith or handyman to install new lock.

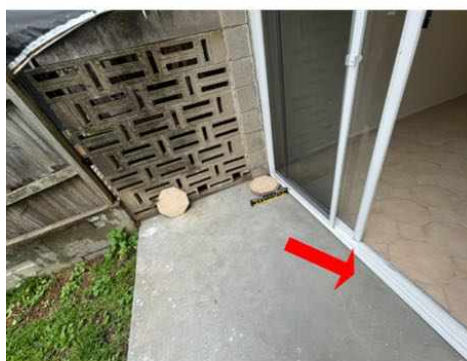
If the slab edge is not properly exposed there is a high risk of termite attack. Sometimes, in order to determine the type of slab, a suitably qualified person such as an architect or builder may be required to consult the construction plans.

Where the slab edge cannot be properly inspected, it is highly recommended that termite or timber pest inspections be carried out every 6-12 months to aid protection of the property against infestation.

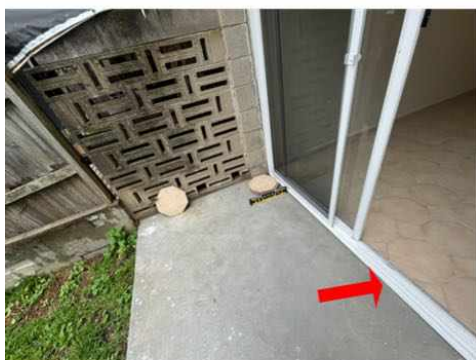
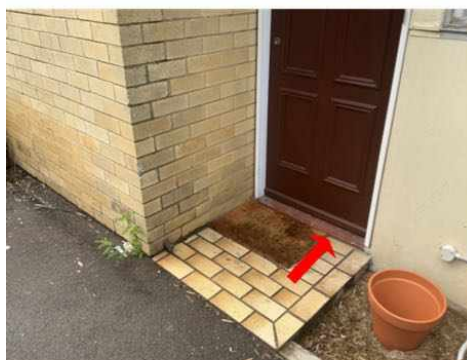
Finding 6.02

Building:	Main Building
Location:	Both Entries
Finding:	Bridging or Breaching of Termite Barriers - Adjacent Internal Flooring
Information:	Bridging is the spanning of a termite barrier or inspection zone so that subterranean termites are provided with passage over or around that barrier.

Where external ground levels are above or same level as internal flooring, water pooling and subsequent internal flooding is likely to occur which may attract termite activity to the internal area.

It is highly advised that a landscaper or relevant tradesperson be appointed to lower external grounds that are raised above or same as adjacent internal flooring. Alternatively if external grounds and internal flooring is level installation of a raised door sill may be appropriate in preventing any water pooling in the area. If the client wishes not to make any changes, then a qualified pest controller is recommended for termite treatment around the perimeter of the house and subfloor (if any) as soon as possible.

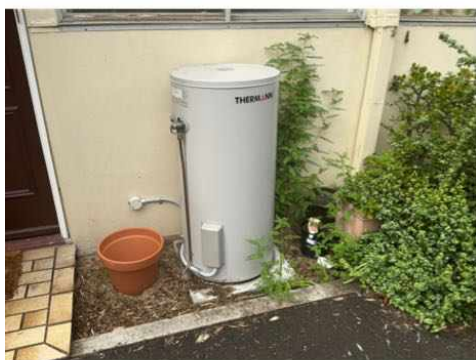
Finding 6.03

Building:	Main Building
Location:	Exterior walls - front
Finding:	Bridging Appliances - Attachment to Buildings
Information:	Bridging occurs when items against a building provide a concealed entry point for termites into the building or by passing around a termite management system.

Where any part of an attachment to a building is not isolated and is not provided with a clear gap of not less than 25mm from the building, bridging occurs. Attachments to buildings such as hot water services, downpipes, verandahs, decks, steps, fences, service conduits and the like provide the opportunity for concealed entry.

Building attachments of this nature need to be frequently inspected for termite activity by a qualified inspector.

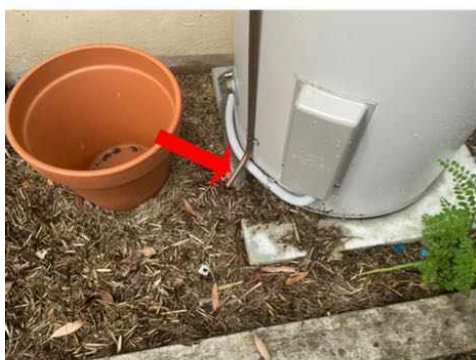
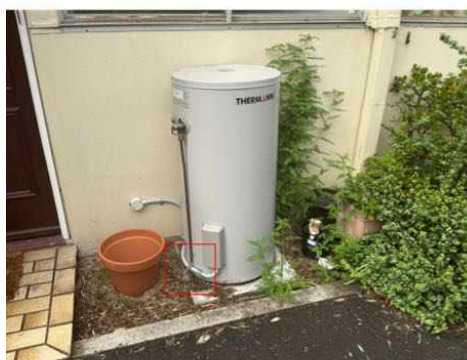
Finding 6.04

Building:	Main Building
Location:	Exterior walls - front
Finding:	Overflow Disconnected - HWS/AC/Gas - Conducive Conditions to Termites
Information:	The overflow to this service was found to be disconnected from stormwater drainage and is creating excessive moisture in the surrounding area.

Such leaking creates an environment that is conducive to an array of defects, including water damage to associated building elements and the attraction of termite or timber pest infestation. These damp conditions can lead to secondary defects such as rot, rust, or corrosion of associated building elements, the formation of fungal decay, or even the creation of potential slip hazards. When coupled with poor site drainage, pooling of water may also attract termite activity to this area.

It is highly recommended that a licensed plumber be appointed to connect the overflow in order to prevent such an environment from being created. These minor works should be carried out as soon as possible.

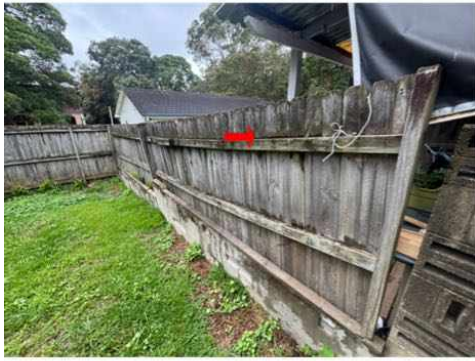
Finding: Fungal Decay - Present (Localised)

Information: Fungal decay, also referred to as wood decay or wood rot, typically occurs when timber elements are exposed to excessive moisture for extended periods. This deterioration process is accelerated by temperatures ranging between 5°C and 40°C, as well as the presence of oxygen. Fungal decay is commonly found in timber components used in external environments, particularly when they are exposed to rain or moisture penetration.

In this instance, although the timber element shows signs of decay, the visible damage appears to be localized to a specific area and has not yet spread to adjoining structures or other parts of the building element. As a result, the fungal decay is likely to be relatively superficial, with minimal impact on the structural integrity or tensile strength of the timber. However, it is advisable to monitor the affected area to prevent further deterioration and address the underlying moisture issue to mitigate future risk.

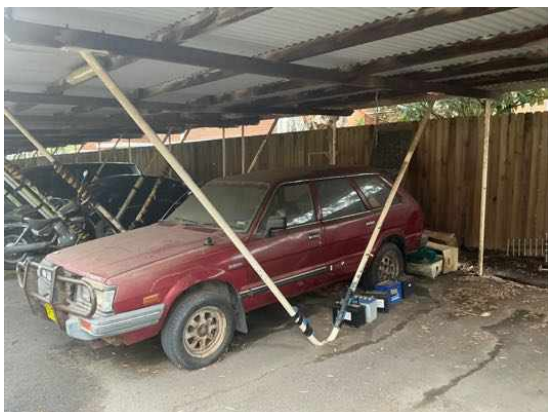
Information: The accompanying photographs provide clear evidence of the obstructions and limitations that restricted a comprehensive inspection of the internal areas of the property at the time of assessment. These obstructions, which may include furniture, personal belongings, stored items, or structural elements such as wall coverings and built-ins, significantly hindered the ability to thoroughly evaluate these areas. It is important to note that such obstructions can potentially conceal a wide array of defects, ranging from hidden structural damage, water leaks, pest infestations, or electrical issues, to deteriorating materials that may not be visible during the initial inspection.

The presence of these impediments means that critical areas of the property were not accessible, and therefore, any underlying defects that may affect the integrity and safety of the property could remain undetected. These hidden defects, if left unaddressed, could worsen over time and may result in costly repairs or pose potential safety hazards to the occupants.

It is highly recommended that all obstructions be cleared to facilitate a complete and thorough inspection of the internal areas. Once the obstructions have been removed and full access is available, a re-inspection should be carried out to ensure that any previously concealed issues can be properly identified and rectified. This follow-up inspection will provide a more accurate assessment of the property's internal condition and help the client make informed decisions about any necessary repairs or maintenance.

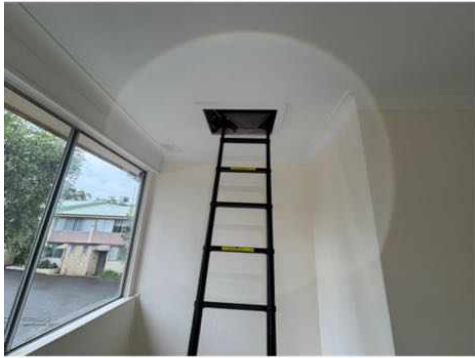
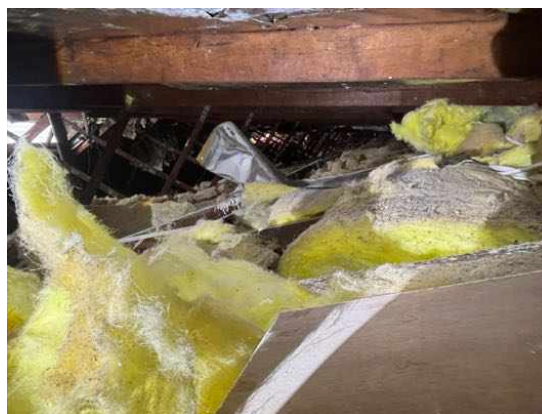
Building: Main Building
 Location: Roof Void
 Finding: Obstructions, Limitations, and General Roof Space Condition
 Information: The photographs provided document both the general condition and the obstructions and limitations that were present in the roof cavity of the main building at the time of inspection. These obstructions—such as insulation materials, stored items, structural elements, or electrical wiring—restricted safe and adequate access to key areas within the roof space. As a result, a comprehensive inspection of all components could not be completed.

Obstructions of this nature may conceal a variety of potential defects, including

damaged framing, compromised insulation, evidence of moisture ingress, pest activity, or electrical hazards. While no major issues were observed in the visible areas, the presence of these limitations means that some defects may remain undetected.

It is recommended that these barriers be removed or repositioned to facilitate full and safe access to the roof space. Once clear, a follow-up inspection should be conducted to allow for a thorough assessment of all concealed areas. This will help ensure that the condition of the roof cavity is accurately evaluated and any hidden issues are appropriately identified and addressed.

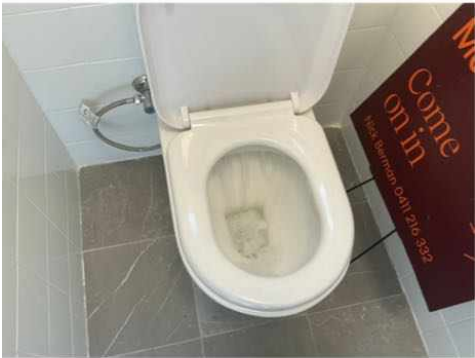
Building: Main Building
 Location: All Areas
 Finding: FYI - Taps, Drainage & Toilets Tested and Cabinetry Obstructions
 Information: During the inspection, all accessible taps, drainage systems, and toilets were tested for water flow and drainage efficiency, and checked for any visible signs of leakage. At the time of the inspection, no issues were noted in these areas. Unless highlighted in a separate defect statement, no immediate remedial work appears necessary. Supporting images may be found in the additional photos section for reference.

It is important to note that while a visual inspection of cupboards and cabinetry beneath sinks and vanities was undertaken, stored personal items and fixtures presented obstructions that limited full visibility of the internal areas. As per standard inspection practices, inspectors are not permitted to move or disturb personal belongings during the inspection process. Therefore, only visible and accessible sections were inspected, and concealed water damage or plumbing defects may not have been detected.

Given this, a re-inspection is recommended after all obstructions have been cleared to allow for a comprehensive assessment of these areas. Regular maintenance and monitoring of plumbing and drainage systems is also advised to ensure ongoing functionality and early detection of potential issues.

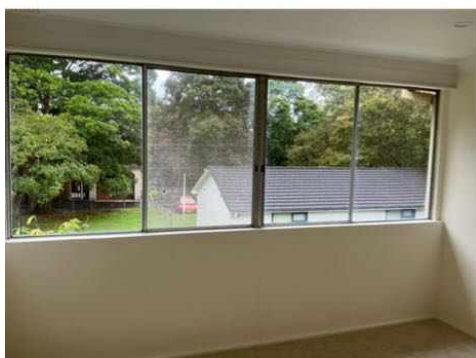
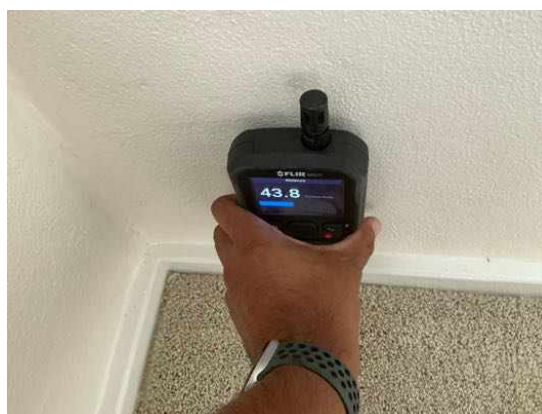
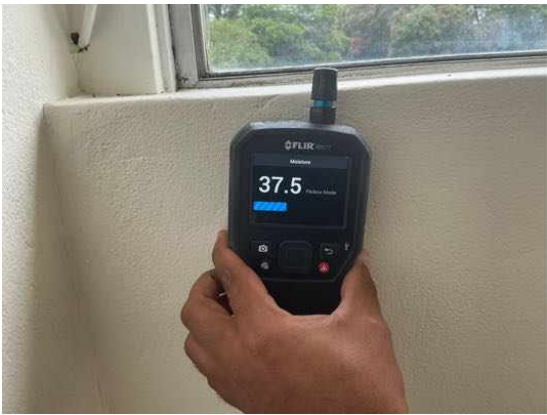
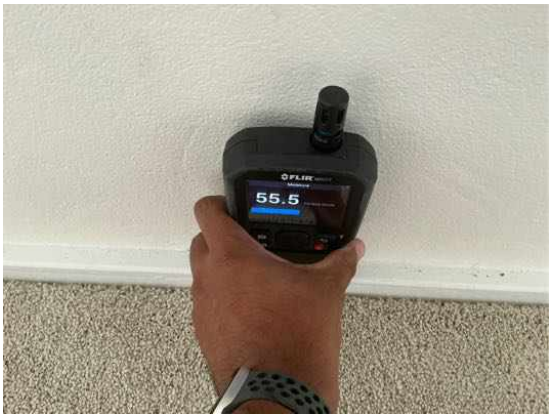
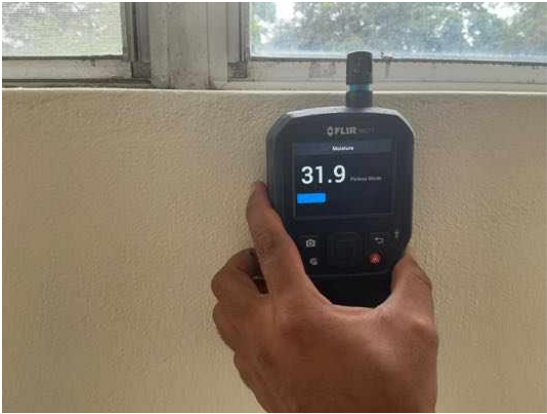
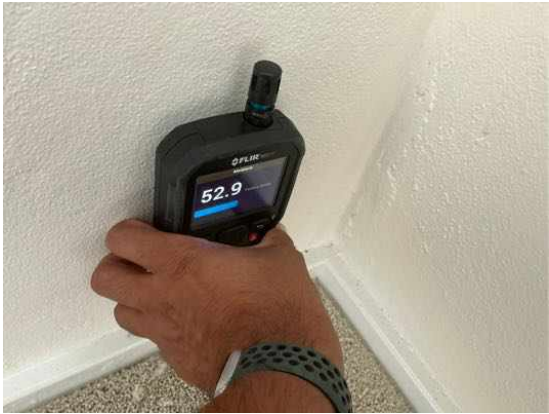
Building: Main Building
Location: All Areas
Finding: Additional Photos - Moisture Meter Readings
Information: Additional moisture meter reading photos have been provided for the property to offer further clarity on areas tested during the inspection. These photos are intended to give a visual reference for the specific locations where moisture levels were measured. These readings were taken at the time of the inspection to assess any potential moisture-related issues within the property. Any defects related to moisture that were identified during the inspection have been separately mentioned in the defect statements within the report.
