Building and Timber Pest Inspection Report

Inspection Date: Thu, 19 Mar 2026

Property Address: 13/21 Edgeworth David Ave, Hornsby NSW
2077, Australia

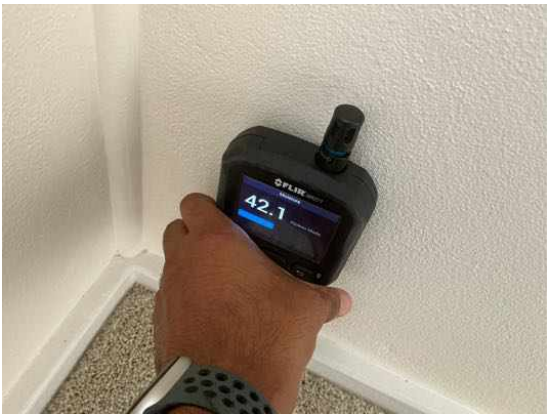
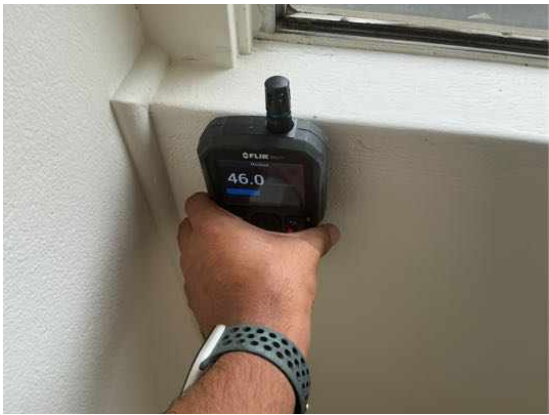
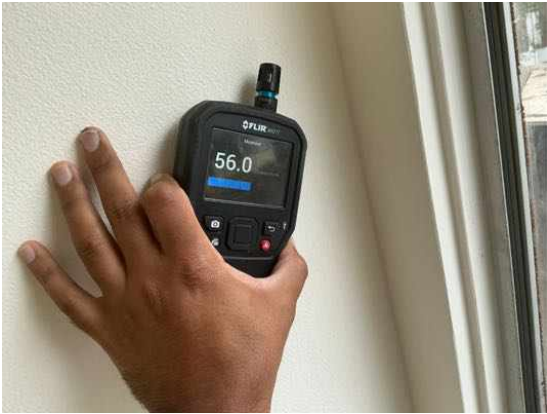
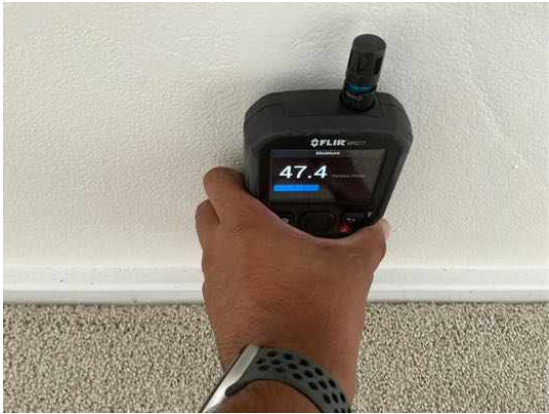
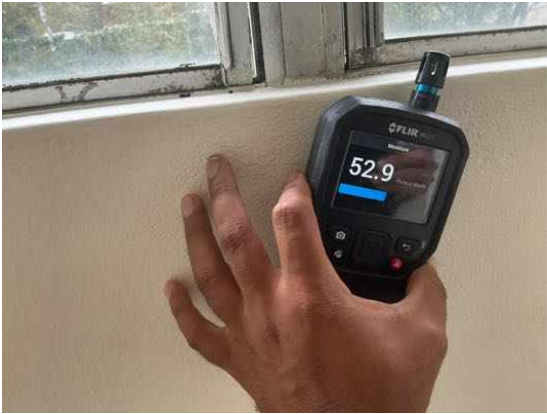
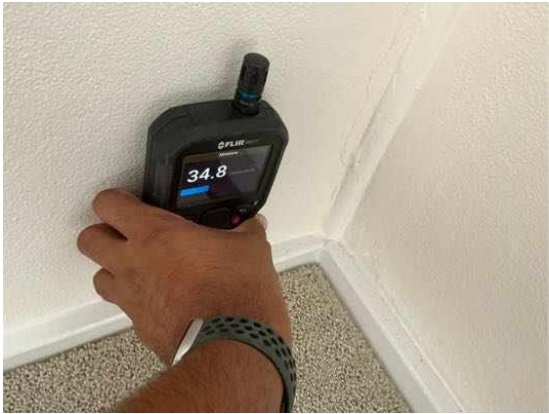
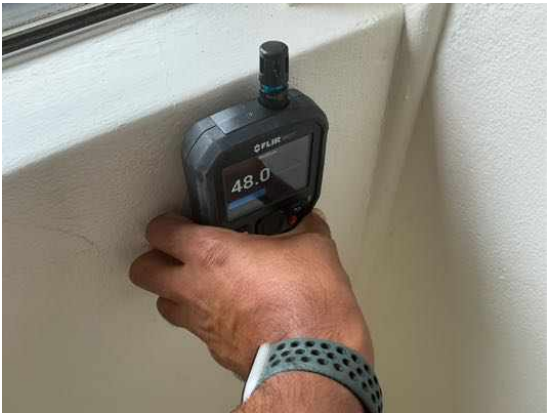
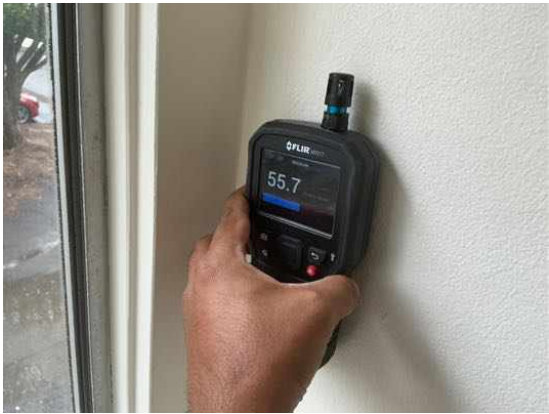
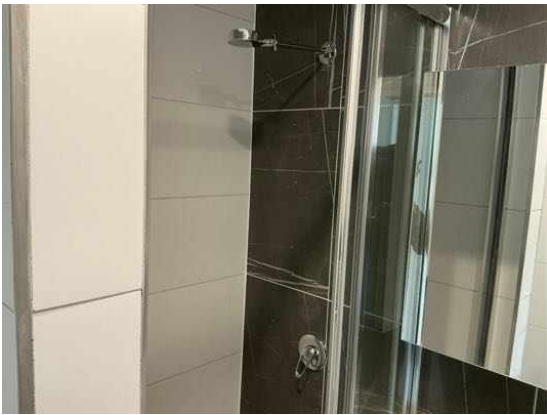
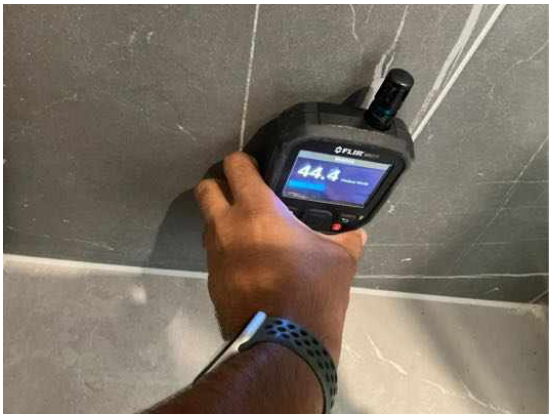
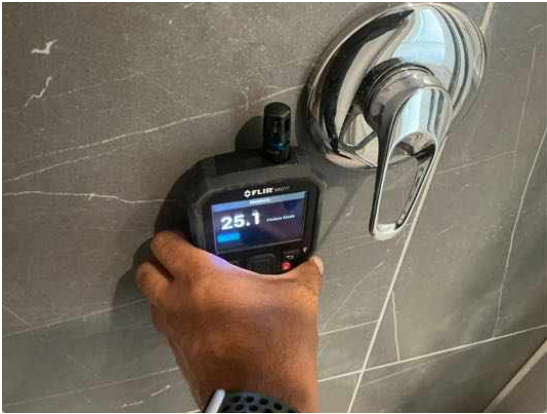
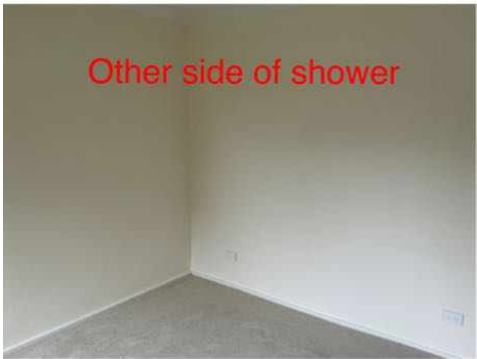
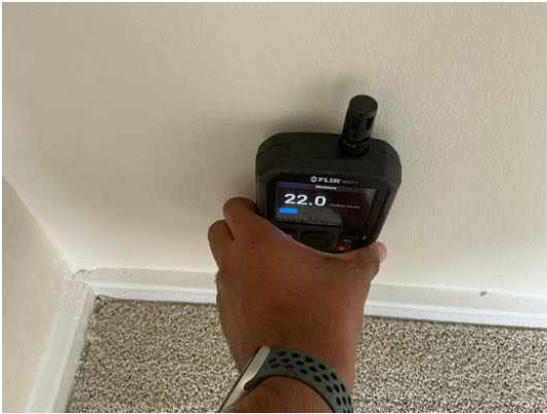
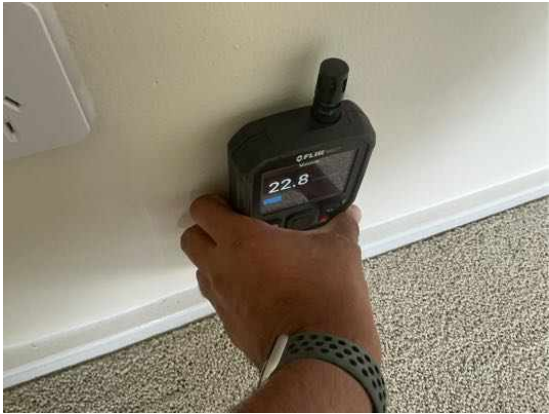
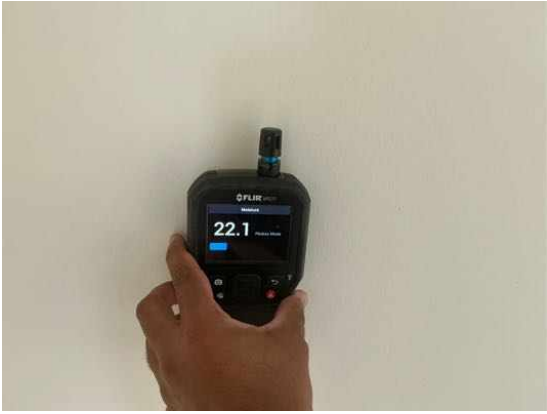
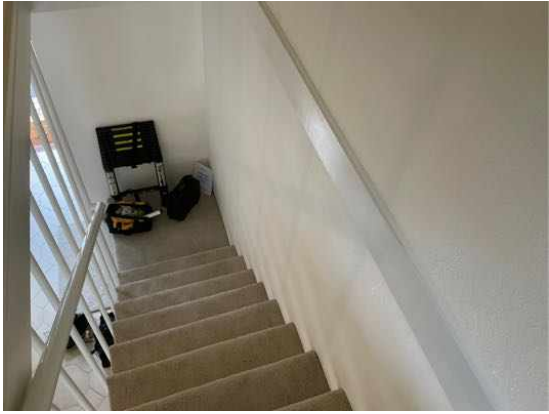
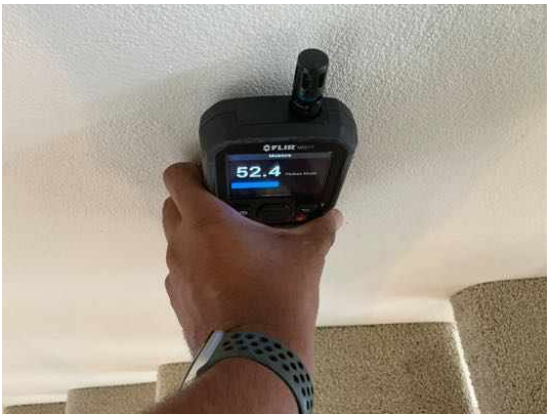
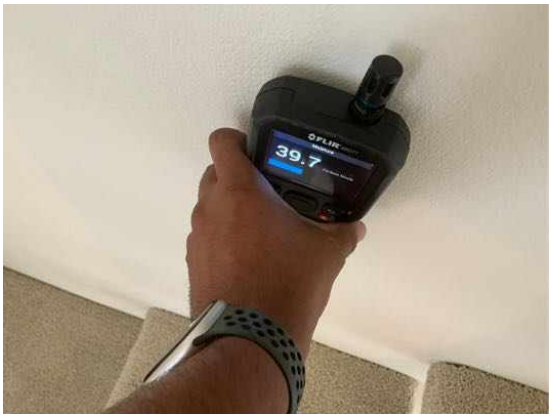
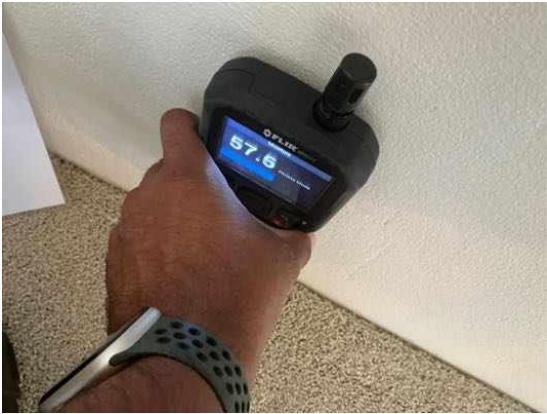
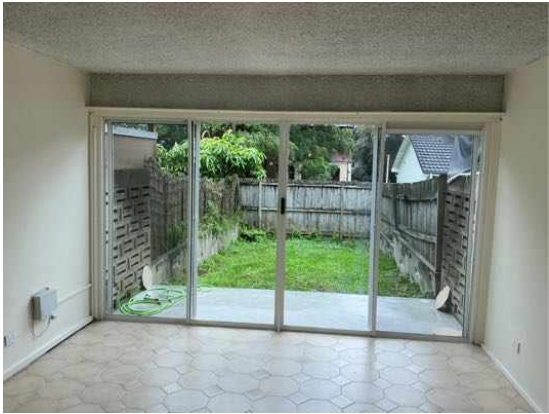
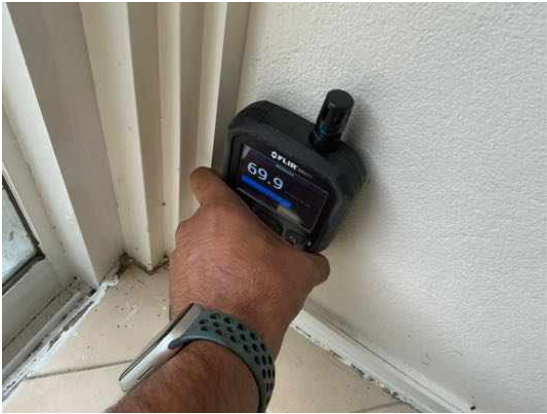
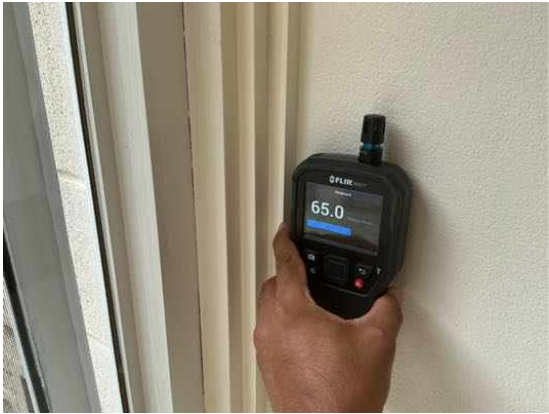
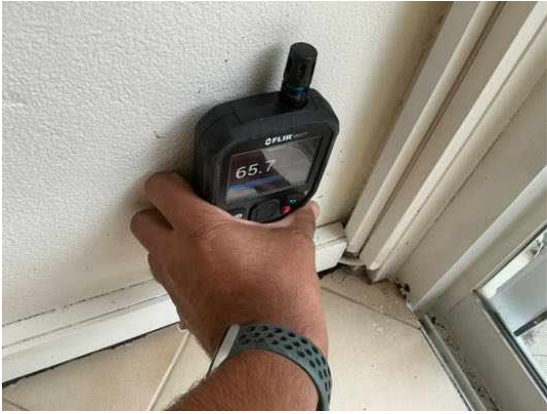
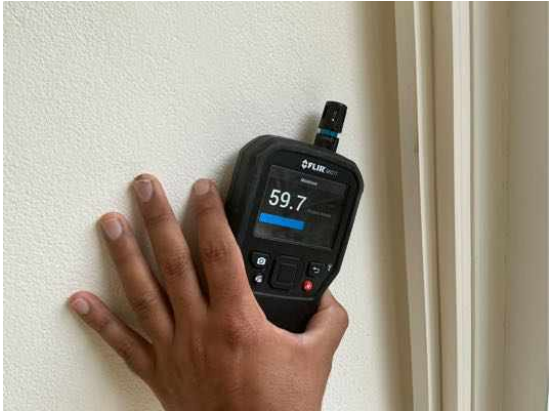
Building: Main Building
Location: All Areas
Finding: Additional Photos - Moisture Meter Readings
Information: Additional moisture meter reading photos have been provided for the property to offer further clarity on areas tested during the inspection. These photos are intended to give a visual reference for the specific locations where moisture levels were measured. These readings were taken at the time of the inspection to assess any potential moisture-related issues within the property. Any defects related to moisture that were identified during the inspection have been separately mentioned in the defect statements within the report.

It is important for the client to understand that moisture levels can fluctuate over time due to various factors, including changes in weather, humidity, and environmental conditions. While the readings reflect the property's moisture levels during the inspection, they may not represent future conditions, and increased moisture could lead to issues such as dampness, mould growth, or deterioration of building materials if left unmonitored.

For further clarification or additional information regarding the moisture readings, the client is encouraged to contact the building inspector directly. Regular monitoring of moisture-prone areas is recommended to ensure any emerging concerns are addressed promptly, particularly during wetter seasons or in high-humidity conditions.

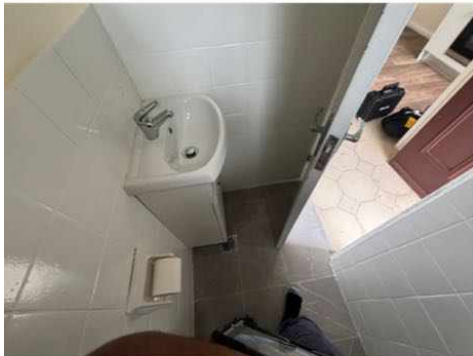
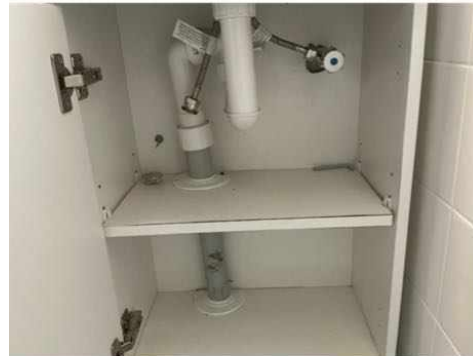
Building: Main Building
 Location: WC
 Finding: Tap - Not Working
 Information: At the time of inspection, one of the taps was found to be non-functional, with no water flow when tested. This may be due to a faulty valve, internal blockage, or

disconnection within the plumbing system. The client is advised to engage a licensed plumber to assess and repair the issue to restore proper function and test the plumbing fixture as well, to make sure there is no leak under the sink.

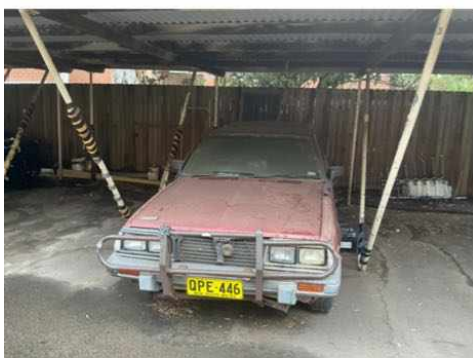
Finding: Allocated Car Spaces

Information: The accompanying photos are provided for your general reference, showcasing the current condition of the car parking spots and storage rooms as observed at the time of inspection. It is important to note that these images are meant to serve as a visual snapshot of the property's features at the time of the assessment. However, the client is strongly advised to confirm all allocations, such as car parking spots, storage rooms, and any associated rights or access, within the terms of the contract. Verifying these allocations through the contract ensures clarity and avoids potential disputes regarding ownership or usage. The photos included are intended to give an overview of the designated areas, but the final details should always be cross-referenced with the contractual agreements for accuracy and completeness.

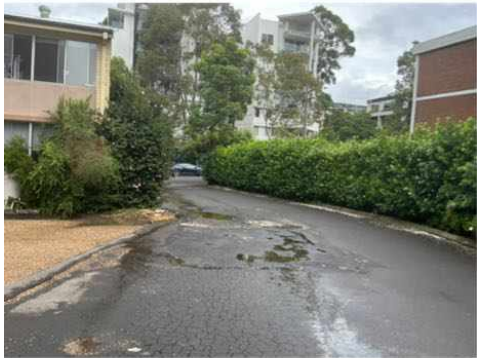
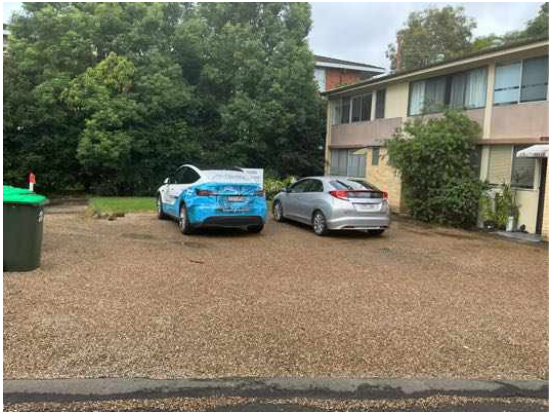
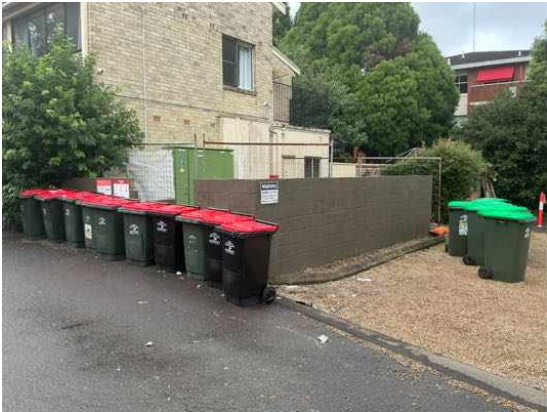
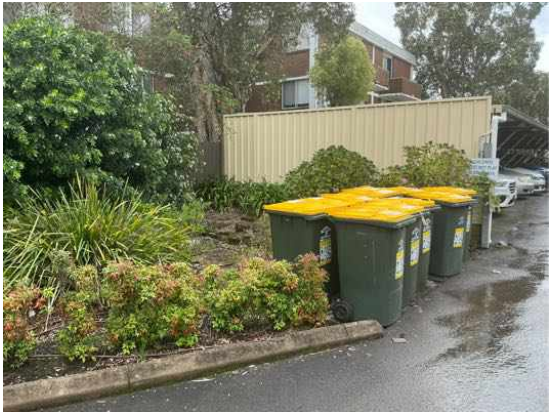
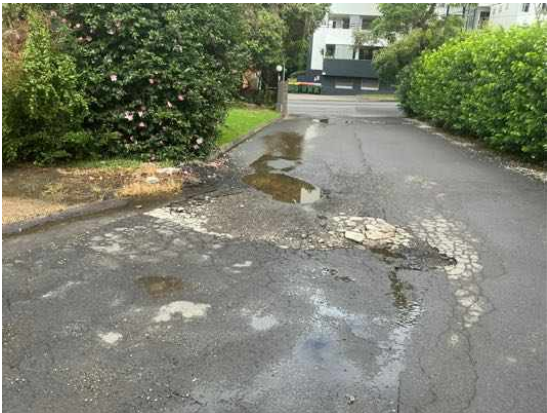
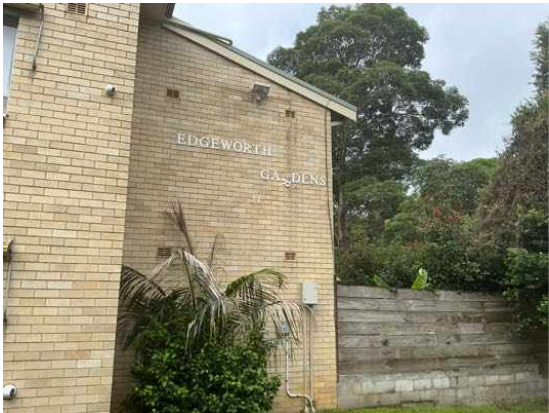
Location: All Areas
Finding: Additional Photos of Common Areas
Information: Additional photos have been provided for your general reference. These images serve as visual documentation of the current condition of the common areas within the building complex at the time of inspection. It is recommended that the client consult with strata management regarding any necessary repairs or maintenance required throughout the complex. These photographs are intended to illustrate the present state of the common areas and should be used as a basis for discussing and prioritizing any needed remedial works with the relevant parties.

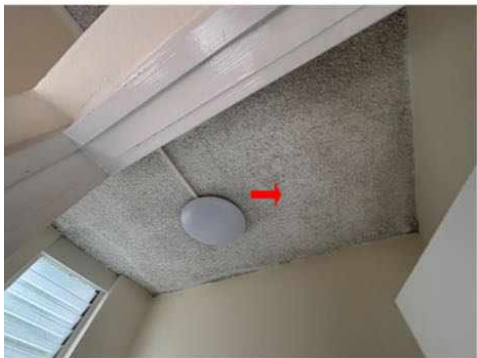
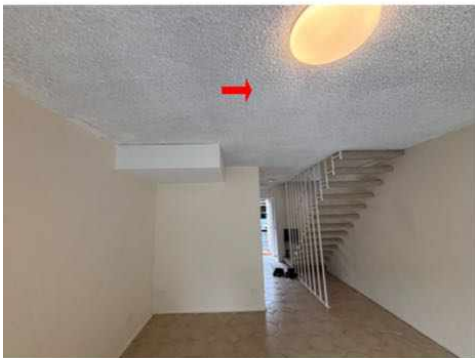
Building:	Main Building
Location:	Ground Floor Ceiling
Finding:	Asbestos - Suspected ACM Identified on Site
Information:	Based on our experience in the building industry, there is an increased likelihood that the identified building element may contain asbestos-containing materials.

The client is also advised to consult the strata management and review the available strata records/report to determine whether any prior asbestos assessments, registers, or remediation works have been undertaken within the building.

In the interim, the client should exercise caution and avoid disturbing the suspected materials. This includes activities such as damage, general wear and tear, renovations, extensions, demolition, or maintenance works, as disturbance of asbestos-containing materials can pose health risks.
