# Building and Timber Pest Inspection Report

Inspection Date: Wed, 14 Jan 2026

Property Address: 27 Chesterfield Parade, Bronte NSW 2024, Australia

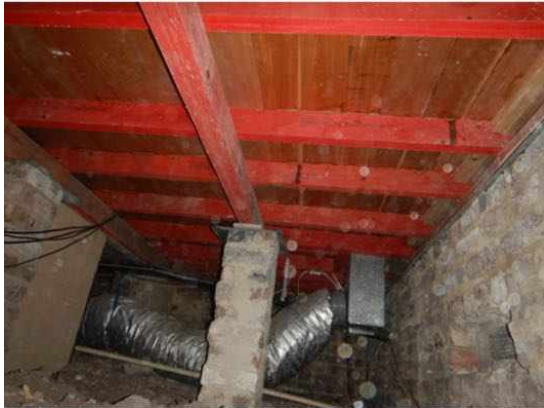
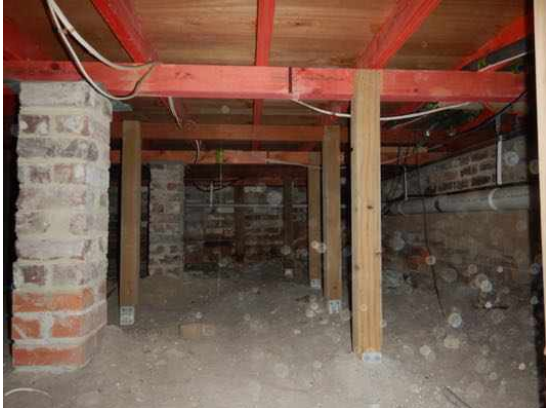
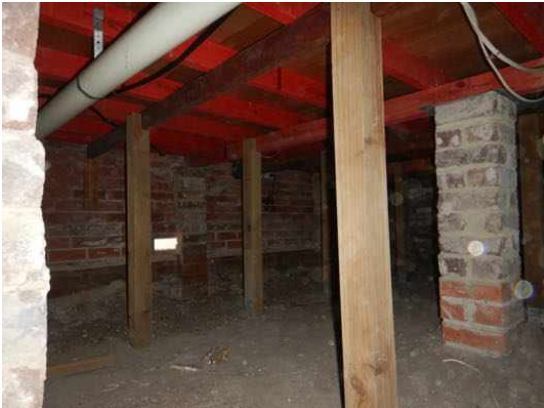
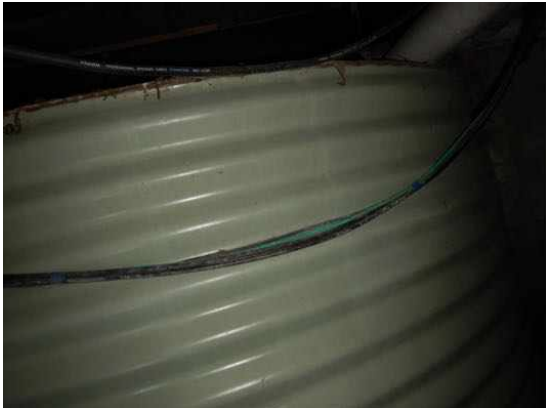
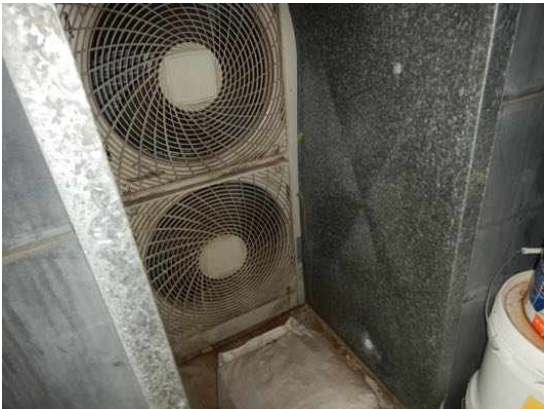
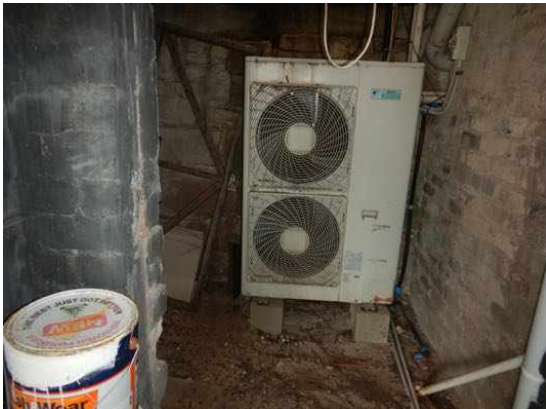
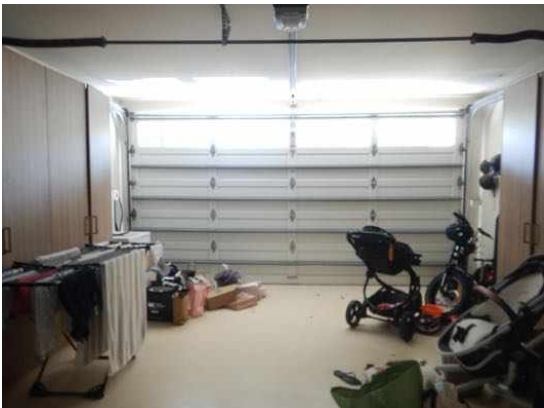
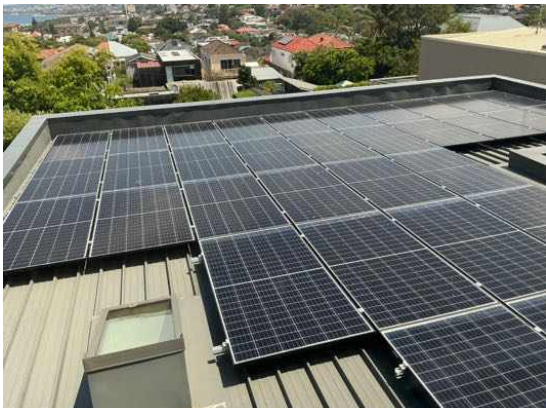
Readings were taken with the moisture meter throughout the interior of the property and no issues such as damp or rising damp were detected at the time of inspection.
