Building and Timber Pest Inspection Report

Inspection Date: Thu, 5 Mar 2026

Property Address: 155 Eglinton St, Kew VIC 3101, Australia

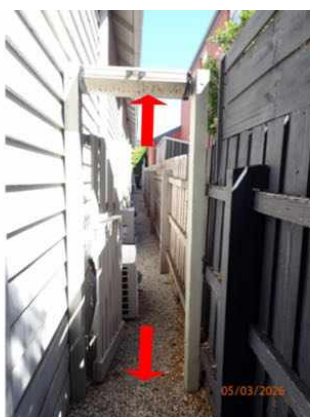
Building:	Main Building
Location:	Yard - Back Left
Finding:	Head Height - Suspected Non Compliance
Information:	The head clearance to the clothesline to the back hard side access in question was measured and found to be less than the present building regulation requirement.

This defect creates a potential safety hazard and should be rectified as soon as possible to ensure the safety of the area and to meet present building standards and regulations.

A registered builder should be contacted to discuss possible rectification solutions b by raising the clothes line high to restrict personal injury.

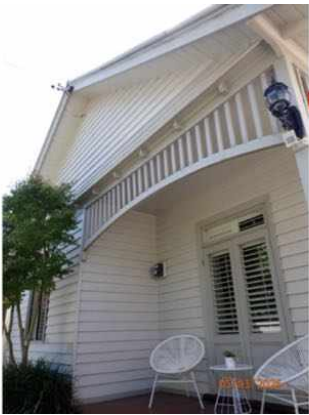
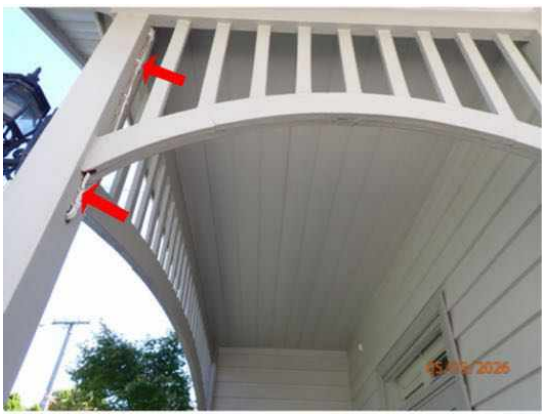
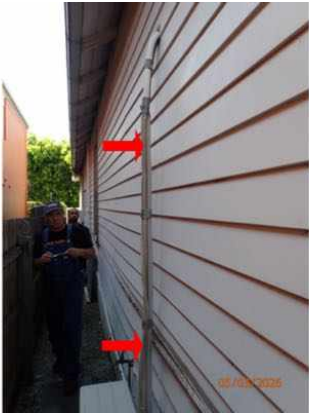
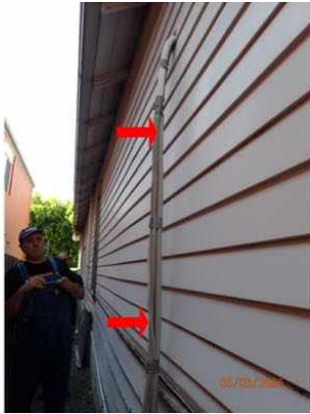
Finding 1.02

Building:	Main Building
Location:	Porch & External Wall > Front Right, Centre Left
Finding:	Electrical Wires Exposed
Information:	Exposed electrical wiring was identified. Exposed electrical wiring represents a potential safety hazard including for fire and personal contact.

Contact a licensed electrician urgently for further inspection investigation and rectification.

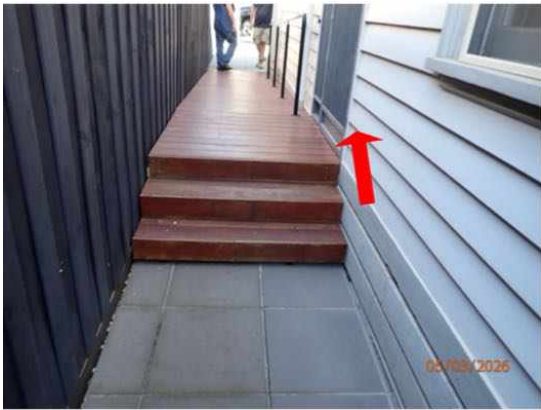
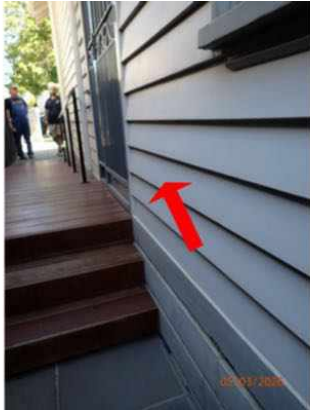
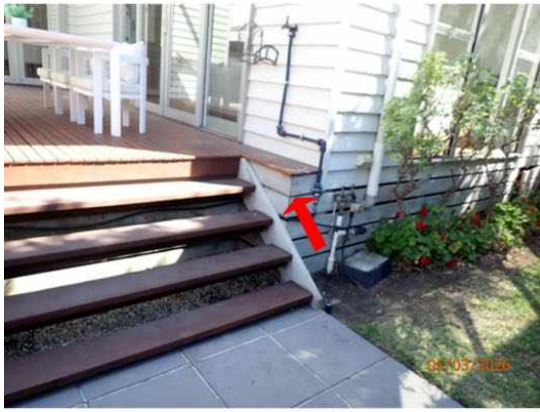
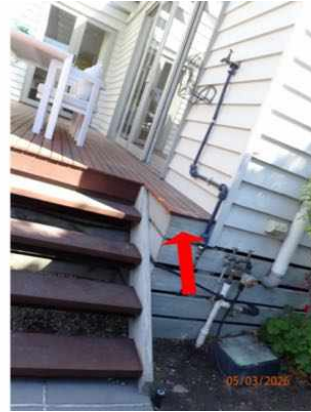
Finding 1.03

Building: Main Building
 Location: Yard - Side & Rear
 Finding: Handrail - Missing
 Information: The handrail to the external stairs was missing at the time of the inspection. Absence of the handle rail limits the operation of the the stairs and may pose as a safety risk.

The installation of the hand rail should be conducted as soon as possible. A general handy person or qualified carpenter should be appointed to perform these works to improve the operational state of the affected stairs and improve the safety of the stairs.

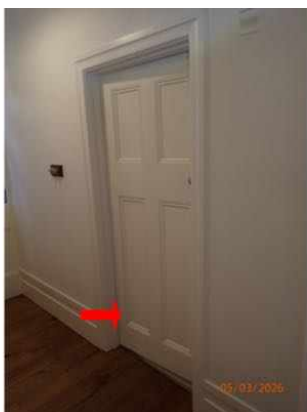
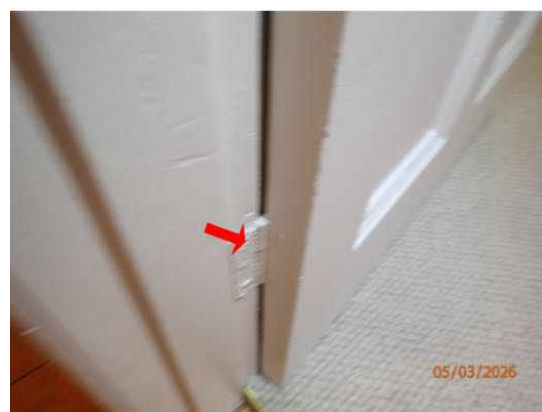
Building: Main Building
 Location: Bedroom 1 > Front Left, Front Right
 Finding: Door Hinges - Loose Hinge
 Information: The hinges to this door appears to be loose and can result in the door's operation being compromised.

This is a common defect and is expected in a property of this age, whether being due to substandard installation or general deterioration of the door hardware.

The re-installation of the hinge is recommended. Works such as these can be completed by a general handyman or qualified carpenter.

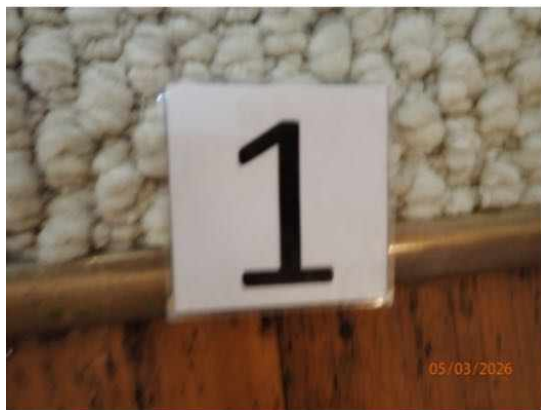
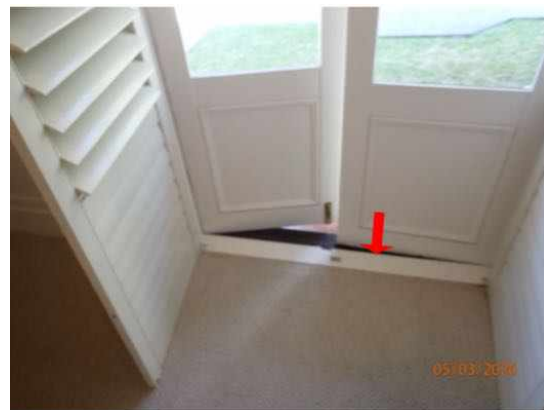
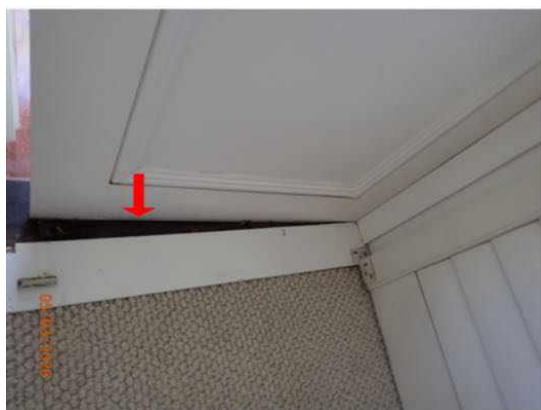
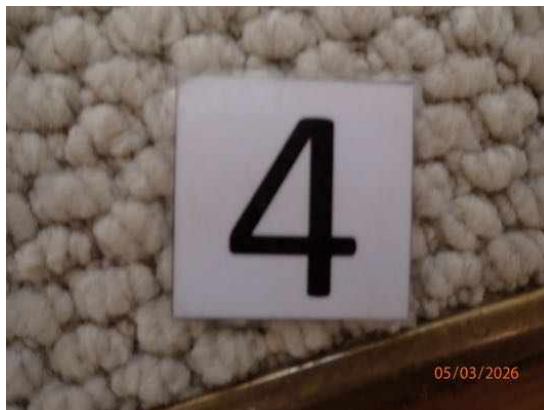
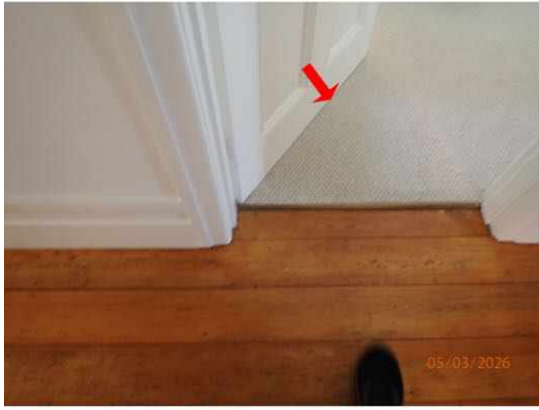
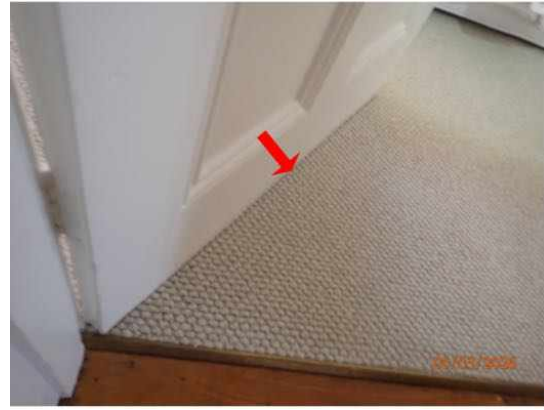
Finding 3.02

Location: Bedroom 1 & 4 > Front Right, Centre Right
Finding: Doors - Binding/Jamming
Information: Binding and/or jamming of doors throughout the property were evident during standard operation. This defect inhibits the functionality of affected doors as well as creating potential for secondary defects to associated building elements, such as damage to the floor covering, doors and door jams.

A door that binds to flooring or to the associated door frame may have several causes, ranging from minor defects, such as poor installation of the door or deteriorated hinges, through to major structural issues, such as damage to subfloor structures.

Where door binding/jamming appears to indicate major structural issues, a registered builder specialising in sub floor foundations may be appointed to provide an estimate on the cost of rectification.

For minor causes, a qualified carpenter or general handyman should be appointed to perform minor rectification works at client discretion.

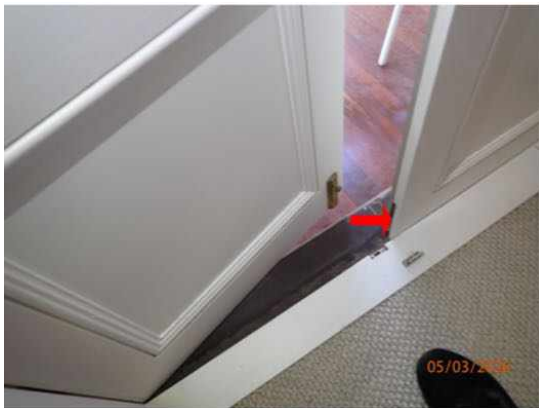
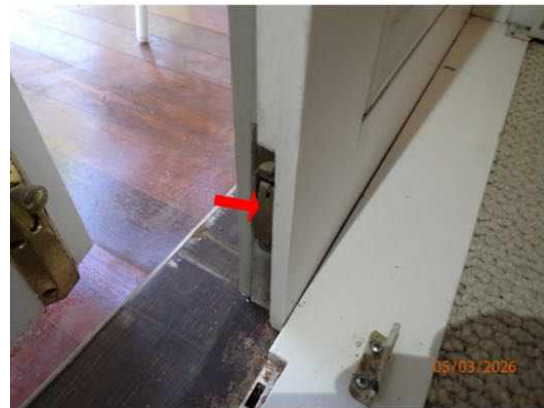
Finding 3.03

Building: Main Building
 Location: Bedroom 1 > Front Right
 Finding: Door Lock Stuck
 Information: The door lock was stuck at the time of the inspection. Absence of the lock limits the operation and security of the door and may pose as a safety risk.

Replacement of the handle should be conducted as soon as possible. A general handy person or qualified carpenter should be appointed to perform these works to improve the operational state of the affected window and improve the safety of the internal area.

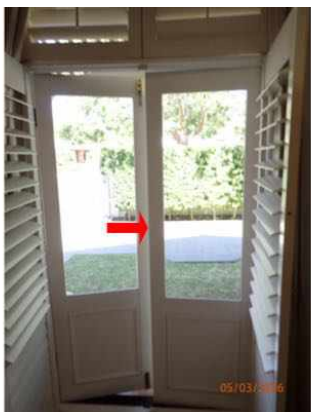
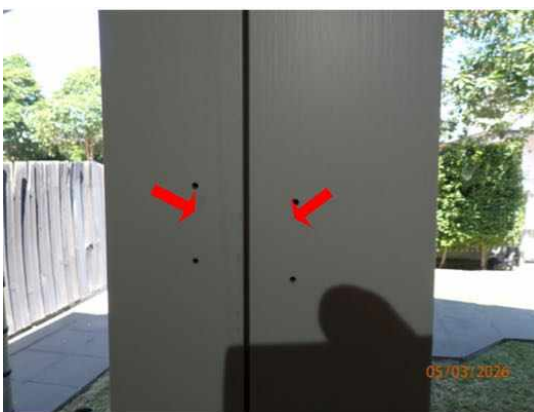
Finding 3.04

Building: Main Building
 Location: Bedroom 1 > Front Right
 Finding: Door Missing Handle
 Information: The door lock/handle was missing at the time of the inspection. Absence of the lock/handle limits the operation and security of the door and may pose as a safety risk.

Replacement of the handle should be conducted as soon as possible. A general

handy person or qualified carpenter should be appointed to perform these works to improve the operational state of the affected window and improve the safety of the internal area.

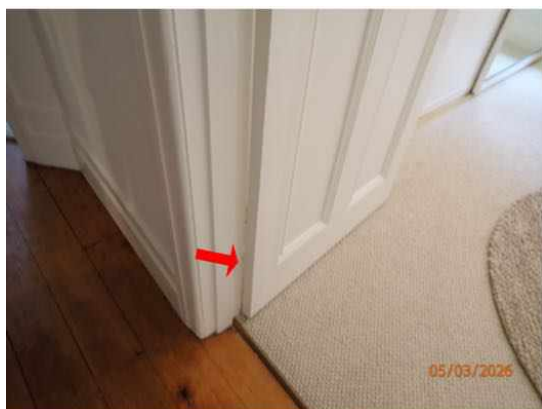
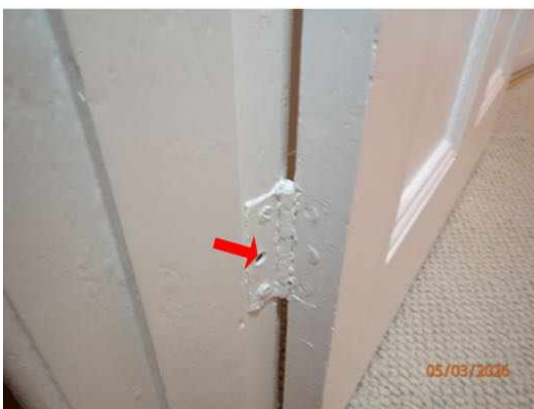
Finding 3.05

Building: Main Building
 Location: Bedroom 3 > Centre Left
 Finding: Door Hinges Missing Screws
 Information: The hinges to this door appears to have screws missing from the hinges and has consequently resulted in the door's operation being compromised.

This is a common defect and is expected in a property of this age, whether being due to substandard installation or general deterioration of the door hardware.

The installation of the missing screw is recommended. Works such as these can be completed by a general handyman or qualified carpenter.

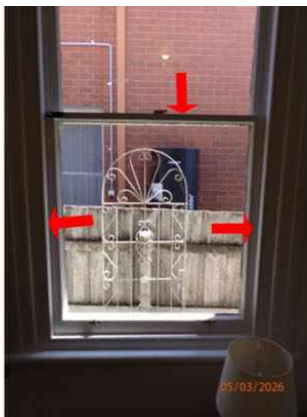
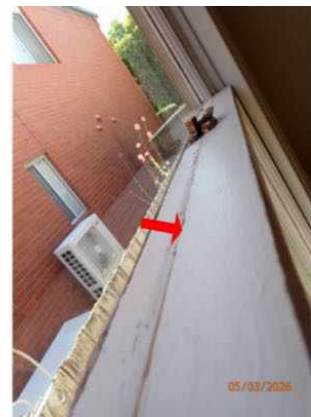
Finding 3.06

Building: Main Building
 Location: Bedroom 3 > Centre Left
 Finding: Windows - Sash painted shut

Windows provide ventilation to the adjoining area and should be at a fully operational level to ensure user comfort. Restricted function of the window may also pose as a potential safety hazard if required for emergency egress from the building.

Where windows have been painted shut the seal of the paint needs to be broken. This is generally done by breaking the seal of the paint and then maintaining the sash tracks clearing and lubricating them with silicone. Remedial paint work will likely be required and can be completed along with the rest of the remedial works necessary by a general handyman.

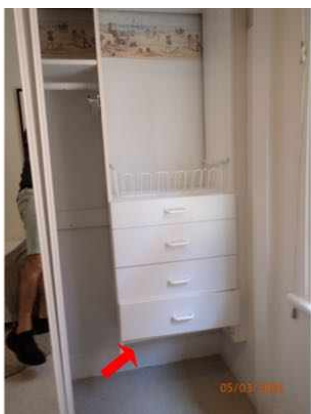
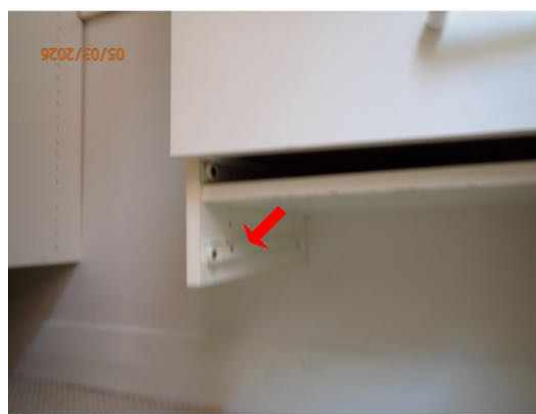
Finding 3.07

Building: Main Building
 Location: Bedroom 3 > Centre Left
 Finding: Building Element Missing Wardrobe Drawer
 Information: The wardrobe drawer within the bedroom which are missing at the timed of the inspection.

It is recommended that the missing building element be installed at the clients discretion.

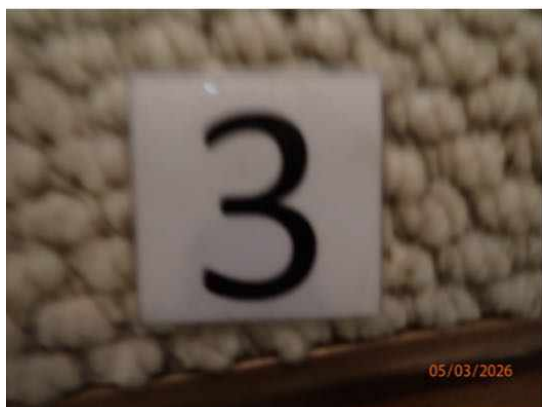
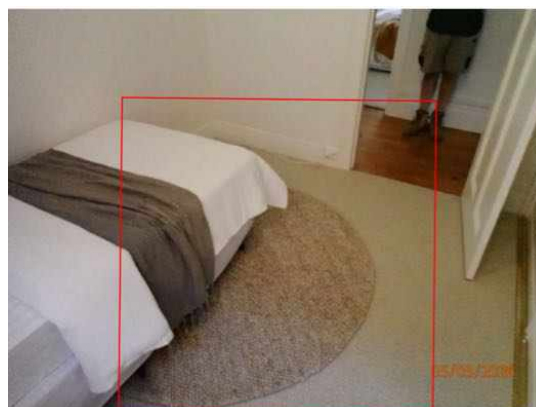
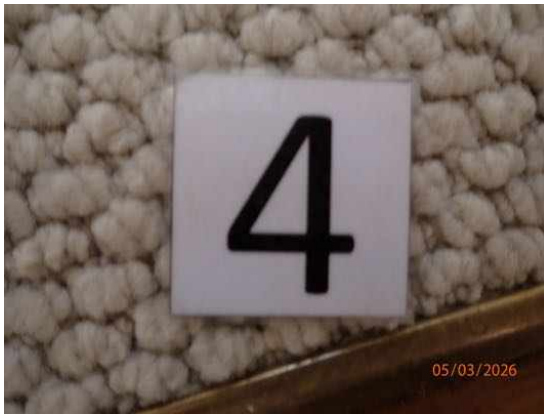
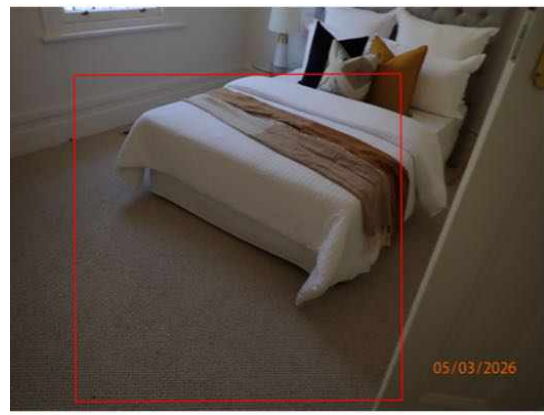
Finding 3.08

Building:	Main Building
Location:	Bedroom 3 & 4 > Centre Left, Centre Right
Finding:	Floors - bouncy
Information:	The internal flooring in this area was identified as being bouncy at the time of inspection. A bouncy floor surface generally presents as a discernible change in level as they are walked across, in noisy or creaking flooring, or in consequent movement of surrounding furniture and fixtures.

Bouncy floors generally indicate that the floorboards or the subfloor structures are coming loose from the joists that they are installed on. Bouncy flooring may also be the result of gaps between flooring and stumps or joist structures, which require packing.

It could also be in extreme circumstances be as a result of a history or current borer or termitate activity.

The client is advised to seek quotations for required repairs from a Registered Builder specialising in stabilisation of footings and packing of floors. The potential resolution may range from packing gaps in subfloor structures through to replacement of subfloors footings and refixing of flooring or the engagement of a pest consultant to review the possibility of maintaining or installing the appropriate timber pest barriers.

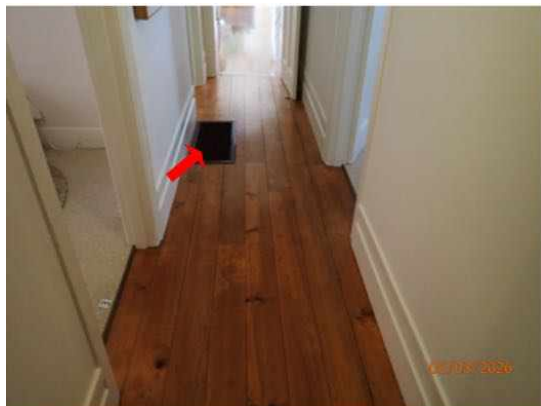
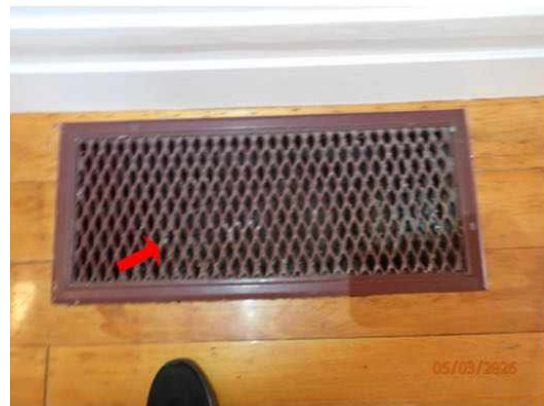
Finding 3.09

Building: Main Building
 Location: Hallway
 Finding: Building Element - AC Return Air - Missing Filter
 Information: Damaged occurs generally when the building materials have either aged and decayed, or as a result of lack of maintenance.

Installation of the return air filter is advised to ensure that additional secondary defects do not arise as a consequence. Such works are necessary, as all building elements play a key role in the operation and function of the overall structure and its performance.

A mechanical ventilation specialist should be appointed to repair or replace the filter to the Air Conditioning unit prior to any subsequent damage being caused.

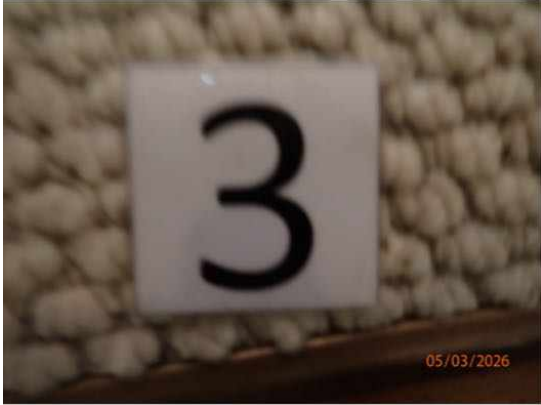
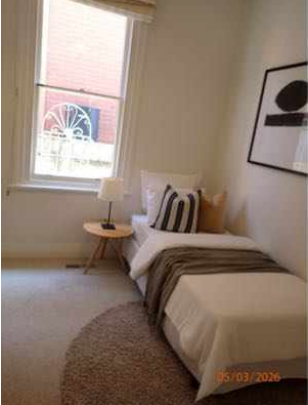
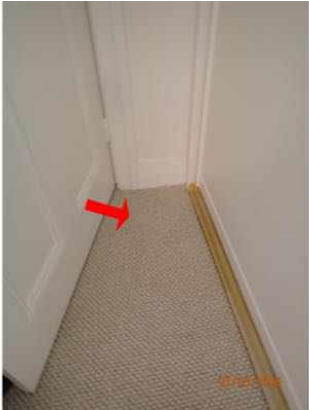
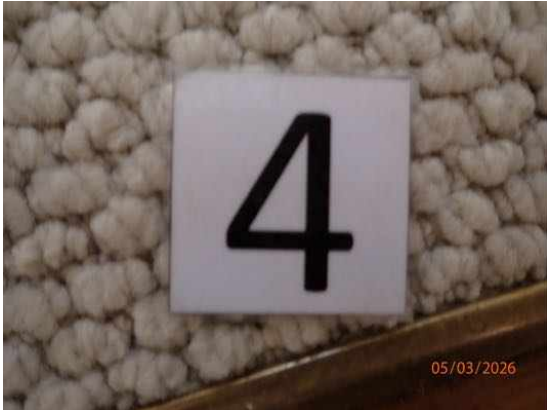
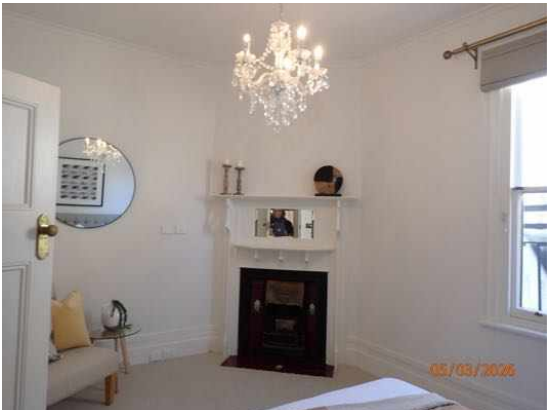
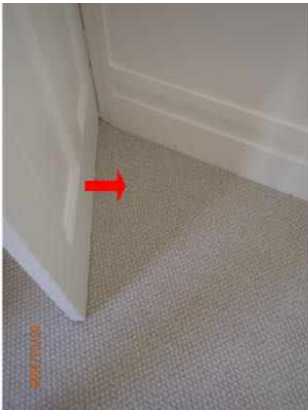
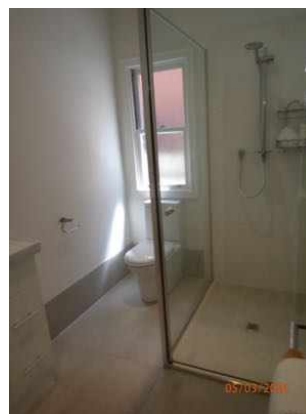
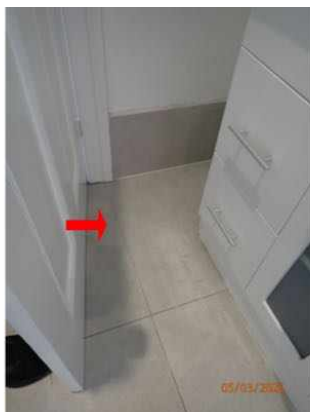
Building: Main Building
 Location: All Internal Areas >
 Finding: Door stop - Missing
 Information: The door stop is missing or is inadequate to stop the door handle from damaging the wall. Although some building elements may seem irrelevant or unnecessary, all

building elements play a key role in the operation and function of the overall structure and its performance.

Re-installation or replacement of the door stop is advised as soon as possible to prevent any subsequent damage to the door or associated structures. A general handyman may be appointed to perform these works at client discretion.

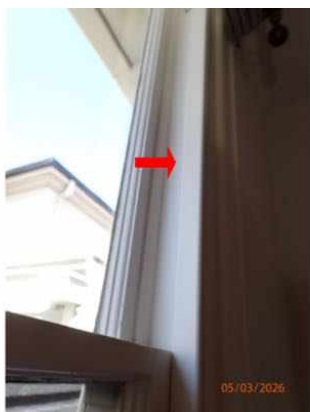
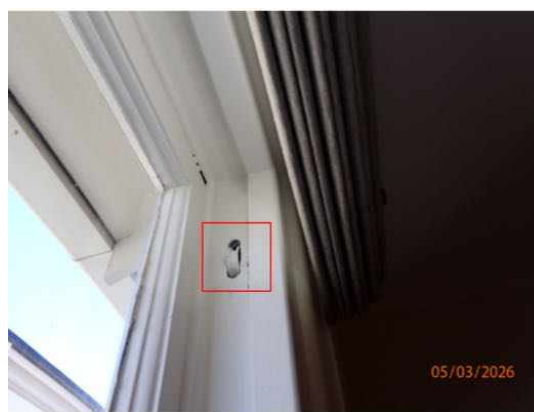
Finding 3.11

Building:	Main Building
Location:	Bedroom 4
Finding:	Windows - Sash cords missing
Information:	Sashes are the moveable panes of windows that primarily slide vertically over each other to expose one half of the window area. Each sash is provided with springs balances and/or compression weather-stripping, which act to hold the window in place in one position.

To facilitate this operation the weight of the glazed panel is usually balanced by steel weights or counterbalances. The sash weight is connected by a cord or chain that runs over a pulley at the top of the frame. These cords are prone to degradation over time and replacement is required.

Repairing or replacing sash cords involves some work and is often best completed by an experienced carpenter or specialist window restorer. It is advised that such works be completed to improve the operational state of the affected window.

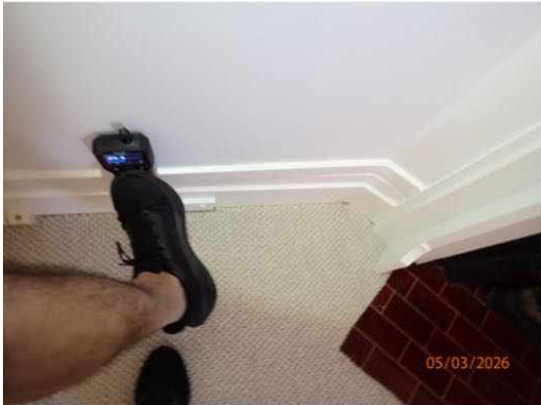
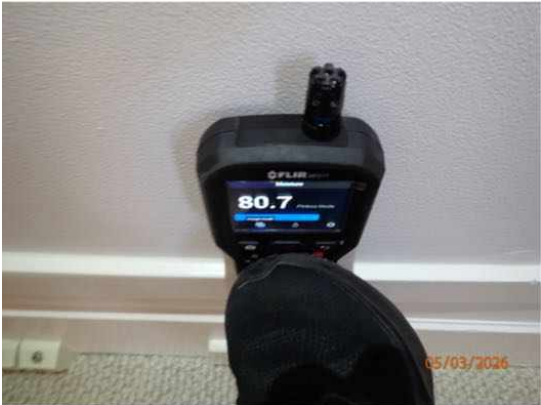
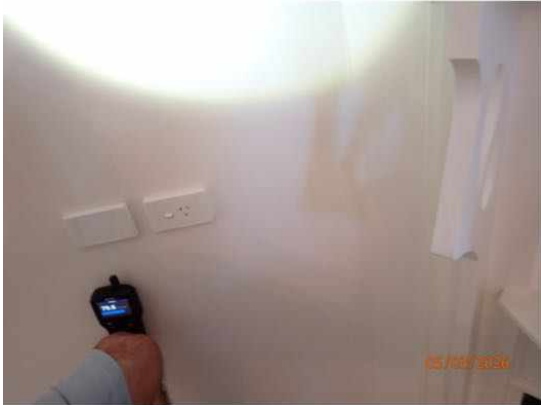
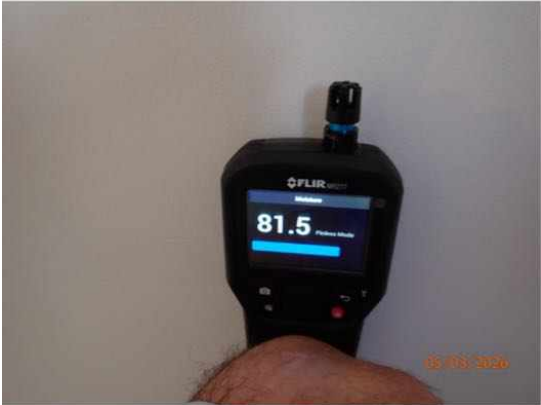
Finding 3.12

Building: Main Building

Information: Damp (or structural damp) refers to the presence of unwanted moisture in the structure of a building, either as the result of intrusion from outside, or condensation from within the structure. Generally, structural damp is caused by rain penetration, rising damp, and leaks from plumbing pipes.

Unmanaged damp facilitates the formation and development of mould, fungi growth and wood rot, decaying associated building materials and compromising their structural integrity. Damage to finishes is also likely to occur, including lifting, bubbling, peeling and staining of paint, plaster and wallpaper.

The first step in addressing damp is to diagnose the cause. The identified cause should be addressed first prior to repairing the appearance and other defects which have resulted from the rising damp. If the original cause is not resolved, further cases of damp are likely to ensue, resulting in secondary defects.

Consultation with a qualified plumber and remedial builder is advised immediately to identify the cause of damp and perform remedial works as required. Where excessive mould growth is present, further inspection by a specialist environmental health inspector should also be considered.

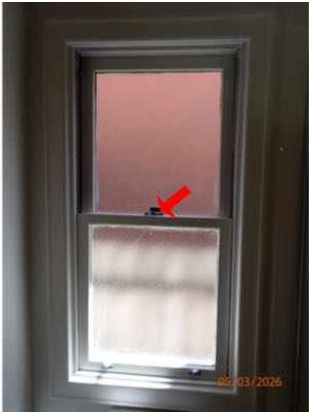
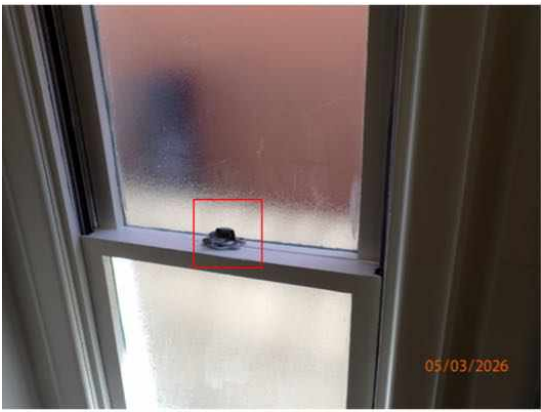
Finding 3.13

Building: Main Building
Location: Bathroom > Centre Left
Finding: Window Missing Lock
Information: The window lock/handle was missing at the time of the inspection. Absence of the lock limits the operation and security of the window and may pose as a safety risk.

Replacement of the lock/handle should be conducted immediately. A general handy person or qualified carpenter should be appointed to perform these works to improve the operational state of the affected window and improve the safety of the internal area.

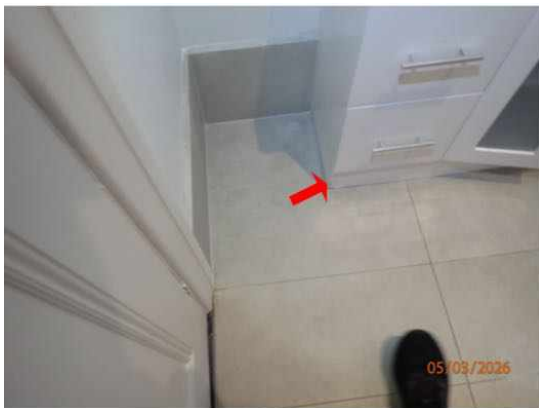
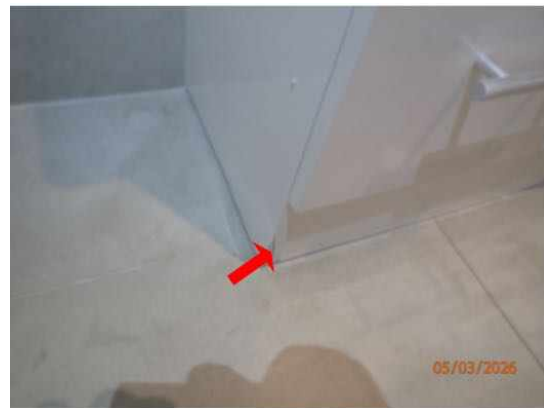
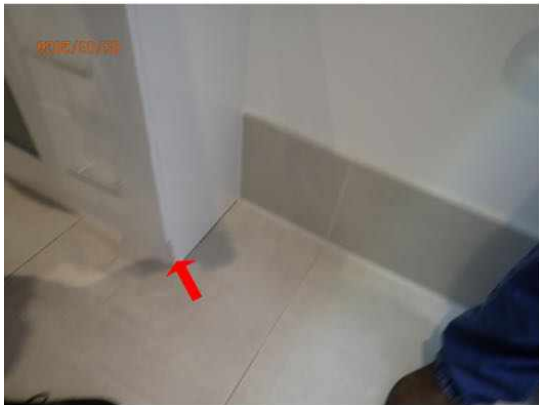
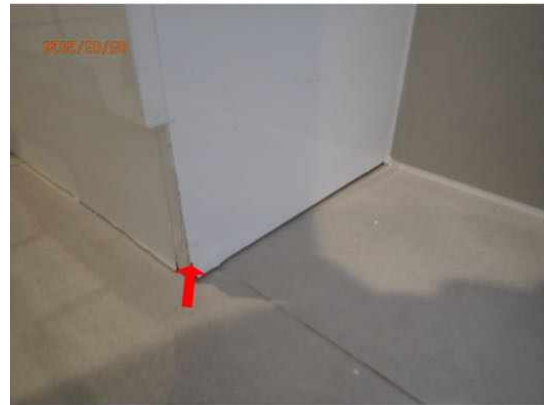
Finding 3.14

Building: Main Building
 Location: Bathroom > Centre Left
 Finding: Cabinetry - Water Damage
 Information: Swollen building elements generally indicate that the building materials have been affected by water / moisture and they have swollen in appearance.

No moisture or water leaks were evident at the time of inspection. Although not urgent replacement or repairs of affected building elements may be done by a cabinet maker at the clients discretion.

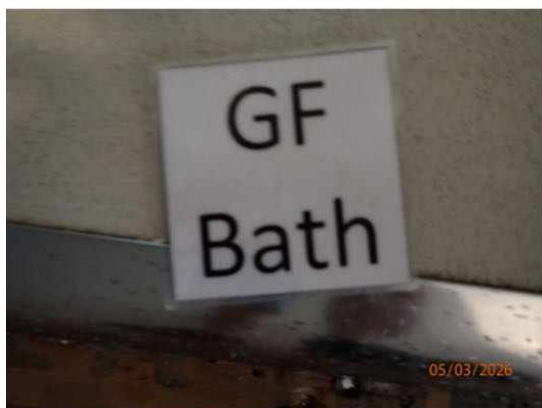
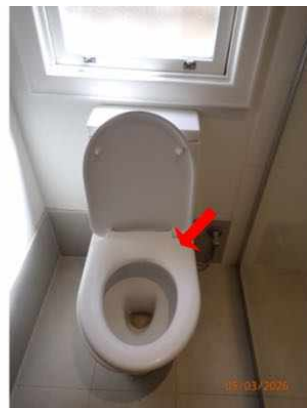
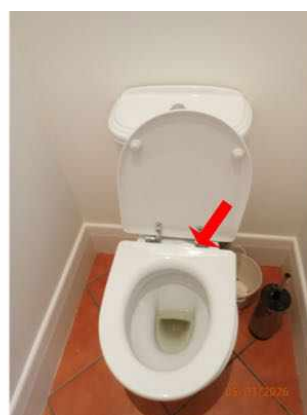
Finding 3.15

Building: Main Building
 Location: Bathroom & WC > Centre Left
 Finding: Toilet Seat - Loose
 Information: The toilet seat was found to be loose and relatively unstable at the time of inspection. It is suspected that this defect has developed due to general ageing of the toilet pan and associated materials. However, the loose fixing may also be a result of impact damage.

If left unmanaged, the toilet seat could deteriorate further, leading to greater

destabilisation and the potential for injury to people.

It is recommended the toilet seat be refixed by a licensed plumbing or qualified handyman immediately.

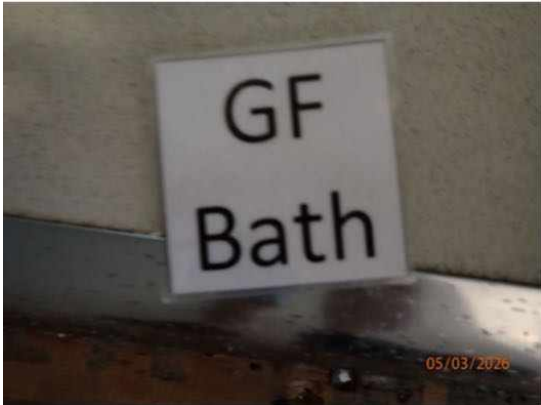
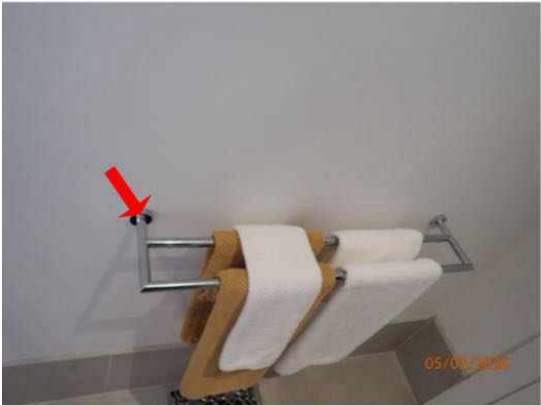
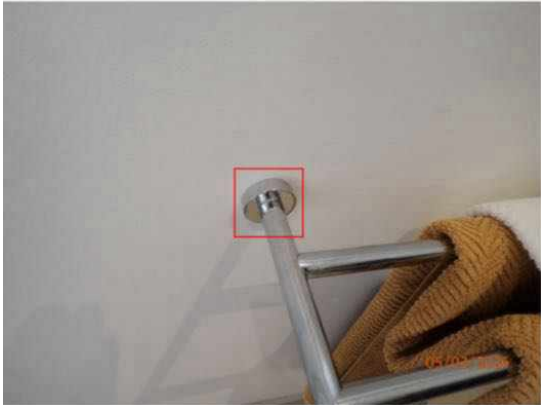
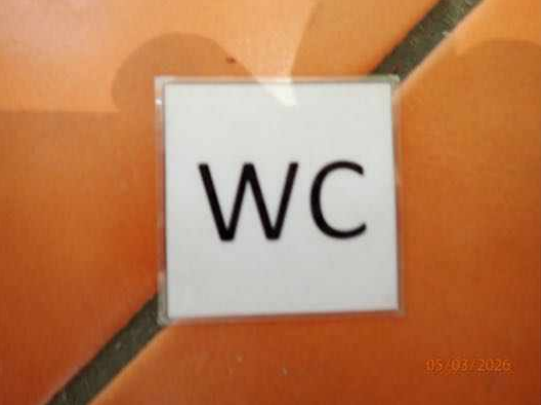
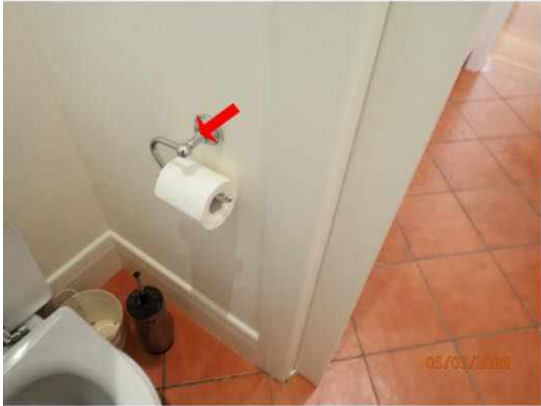
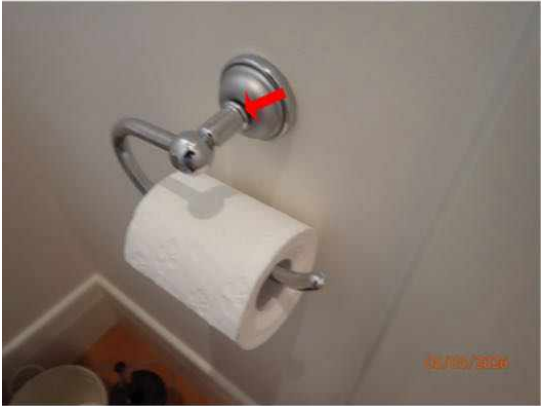
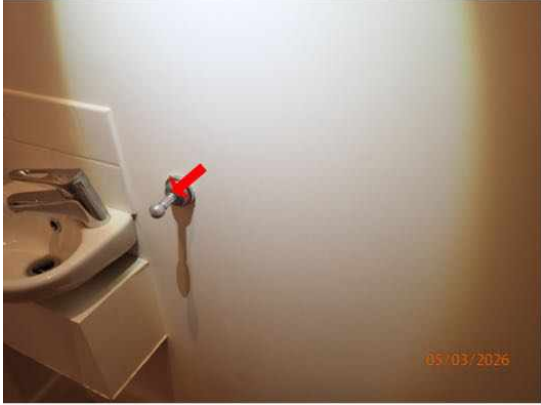
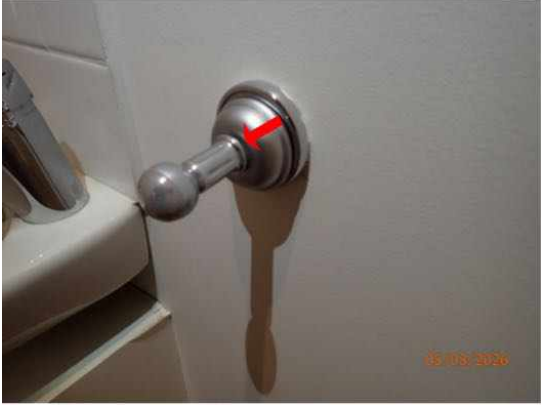
Finding 3.16

Building:	Main Building
Location:	Bathroom & WC > Centre Left
Finding:	Fitting or Fixture - Loose
Information:	The fitting in this area is loose and requires adjustment to tighten.

If left unmanaged, the fitting may further deteriorate, causing potential for the development of other minor secondary defects.

A relevant tradesperson should be appointed to perform these rectification works at discretion of the client.

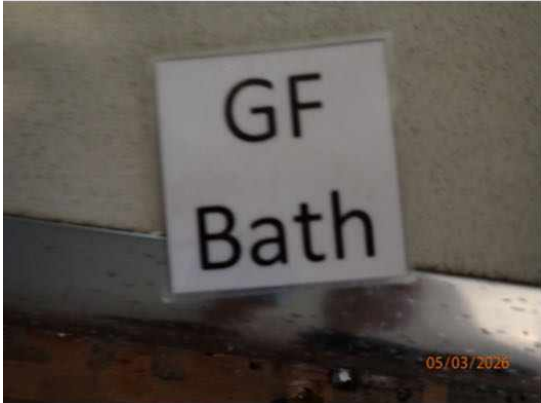
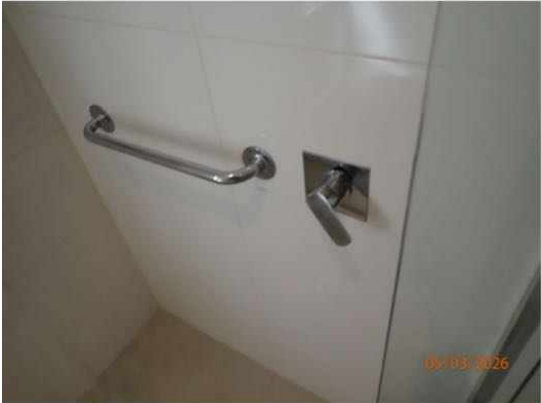
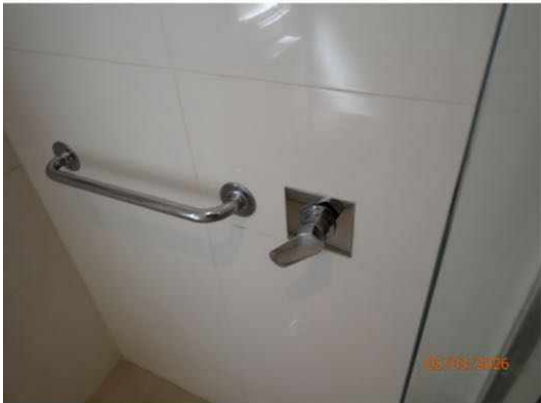
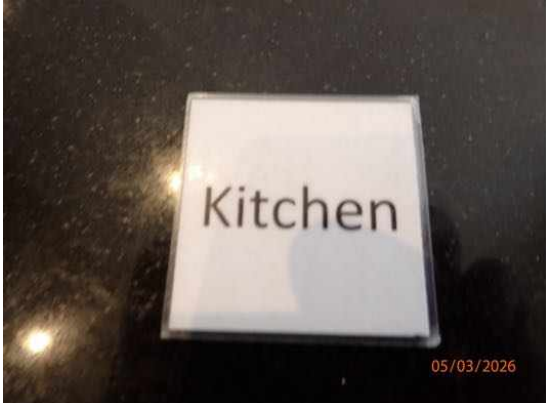
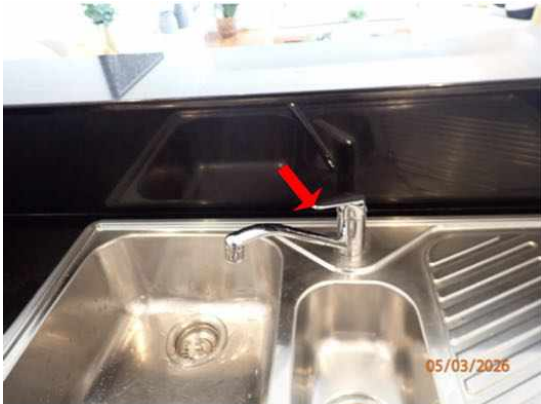
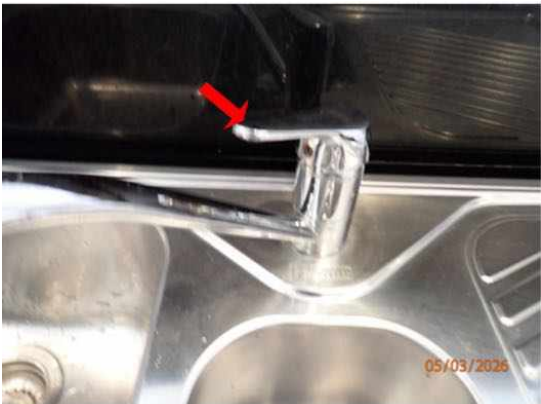
Finding 3.17

Building: Main Building
Location: Bathroom & Kitchen > Centre Left
Finding: Mild Water Hammer
Information: It was observed during inspection that mild water hammer is present. Unless it is caused by the use of a solenoid or ceramic valve in an appliance supplied by the owner it is considered to be a defect with reference to Standards and Tolerances.

This defect is to be reviewed and addressed by a licensed plumber at the owners discretion.

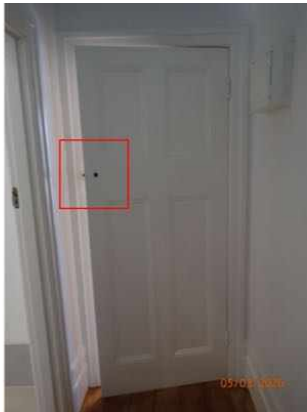
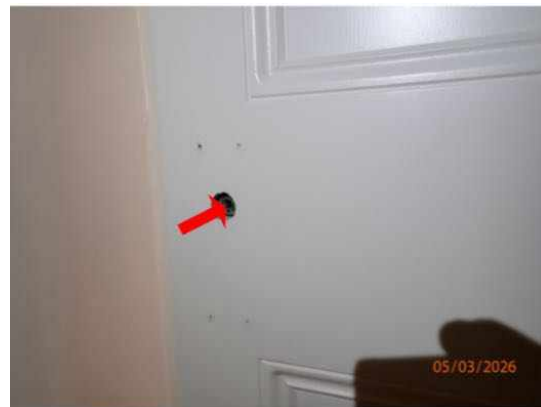
Finding 3.18

Building: Main Building
 Location: Dining Room > Rear Right
 Finding: Door Hardware - Missing
 Information: The door hardware to the door was missing at the time of the inspection. Absence of any of these items the limits the operation of the door and may pose as a safety risk.

Installation of the door hardware should be conducted as soon as possible. A general handy person or qualified carpenter should be appointed to perform these works to improve the operational state of the affected door and improve the safety of the internal area.

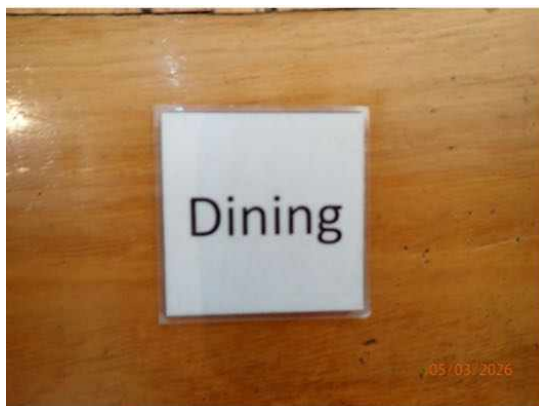
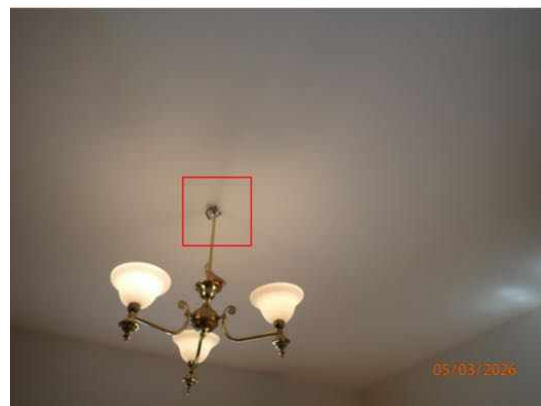
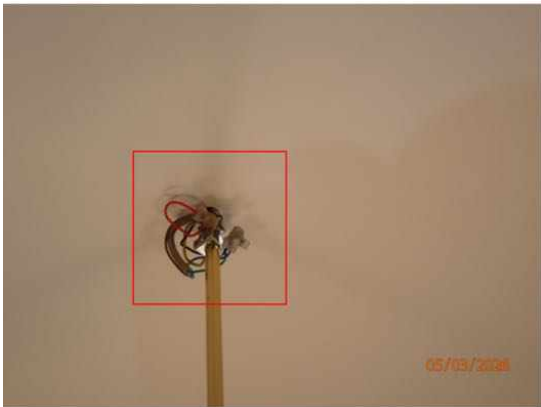
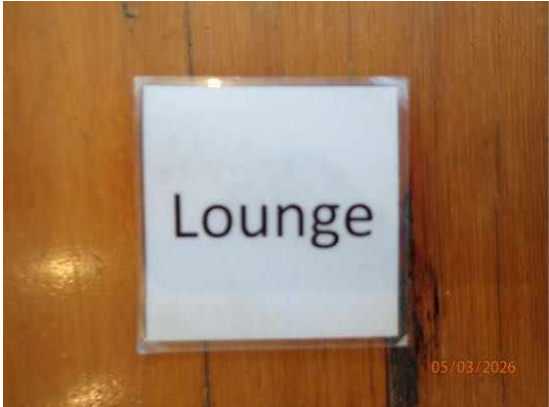
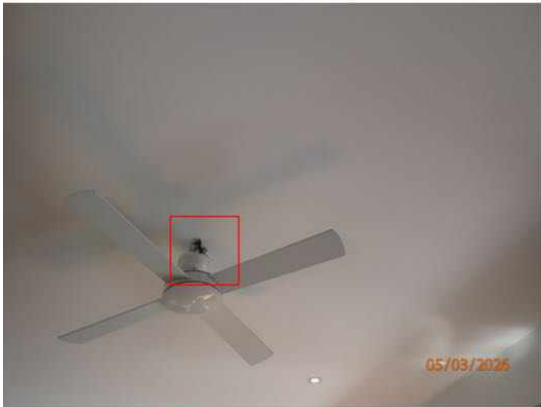
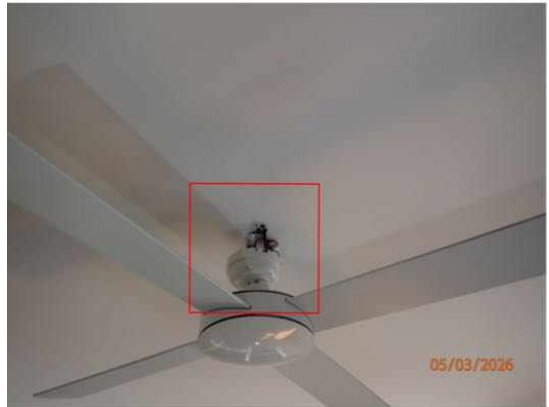
Building: Main Building
 Location: Dining & Lounge
 Finding: Electrical Wires Exposed
 Information: Exposed electrical wiring was identified. Exposed electrical wiring represents a potential safety hazard including for fire and personal contact.

Contact a licensed electrician urgently for further inspection investigation and rectification.

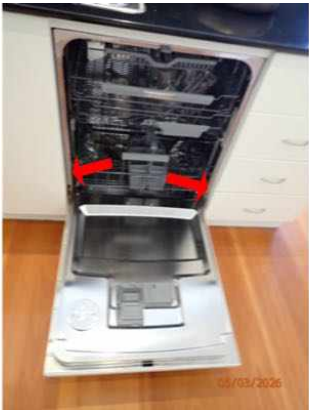
Finding 3.20

Building: Main Building
Location: Kitchen
Finding: Dishwasher Installation
Information: The dishwasher in this area is loose and requires to be securely installed.

If left unmanaged, the fitting may further deteriorate, causing potential for the development of other minor secondary defects.

A relevant tradesperson should be appointed to perform these rectification works at discretion of the client.

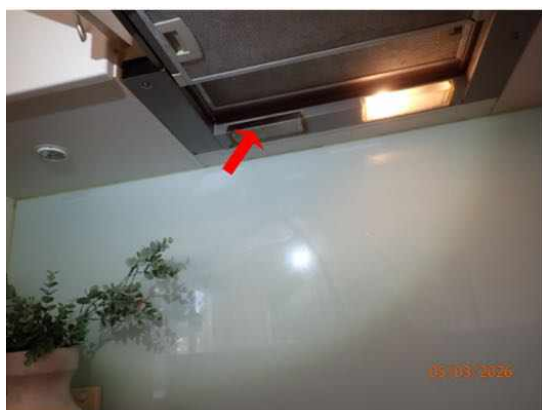
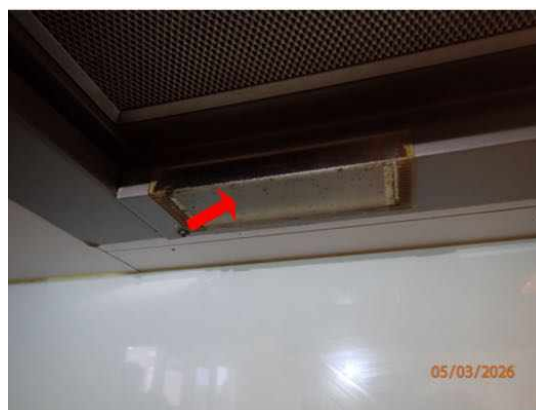
Finding 3.21

Building:	Main Building
Location:	Kitchen
Finding:	Rangehood - Light not working
Information:	While the range hood appears to be working at a satisfactory level, the light to the appliance was not working at the time of inspection.

A licensed electrician should be appointed to replace the light on the range hood to restore it to a fully operational state.

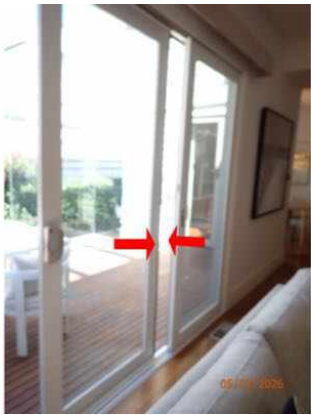
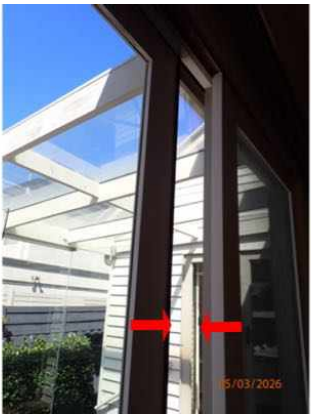
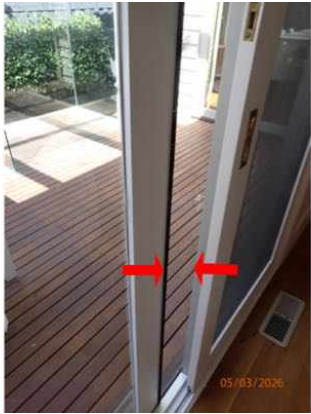
Finding 3.22

Building:	Main Building
Location:	Lounge Room
Finding:	Building Element - Damaged - Sliding Door Stoppers
Information:	Damaged occurs generally when the building materials have either aged and decayed, or as a result of damage (accidental or deliberate).

Installation of the sliding door stops to the sliding leaf is advised to ensure that additional secondary defects do not arise as a consequence and prevent the door from operating in its locked position. Such works are necessary, as all building elements play a key role in the operation and function of the overall structure and its performance.

A qualified carpenter should be appointed to repair or replace the affected building element prior to any subsequent damage being caused.

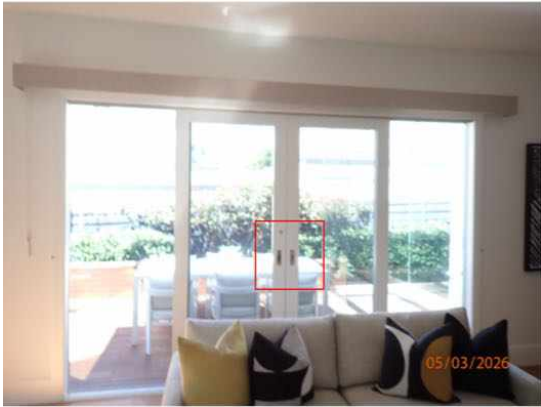
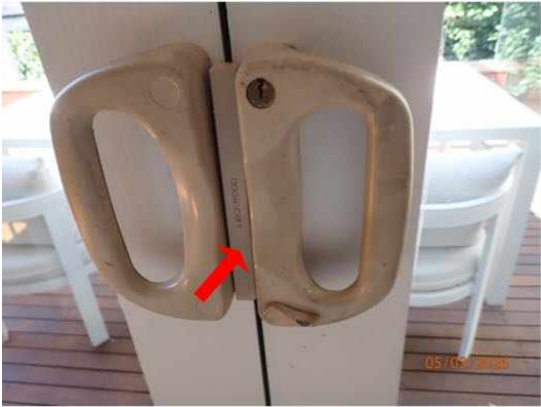
Finding 3.23

Building: Main Building
 Location: Lounge Room
 Finding: Door Lock/Handle - Loose
 Information: The door lock/handle was loose at the time of the inspection. Loose lock/handle limits the operation and security of the door and may pose as a safety risk.

Replacement/Repair of the handle should be conducted as soon as possible. A general handy person or qualified carpenter should be appointed to perform these works to improve the operational state of the affected window and improve the safety of the internal area.

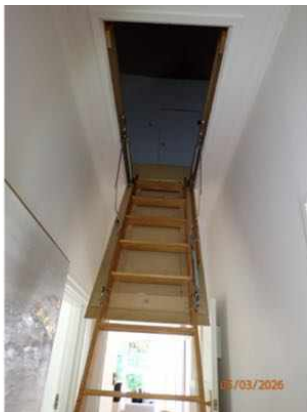
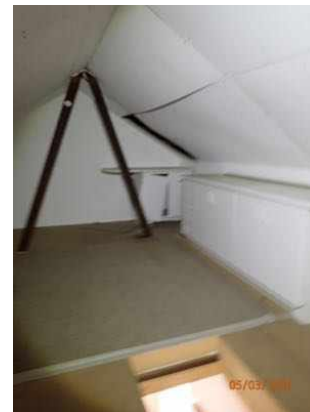
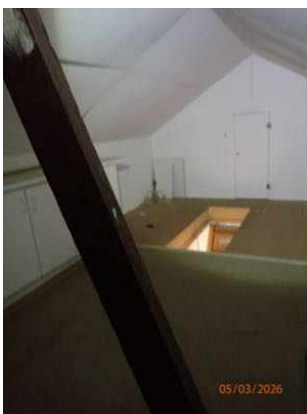
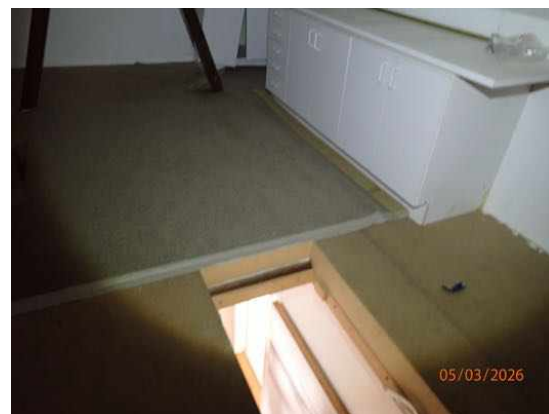
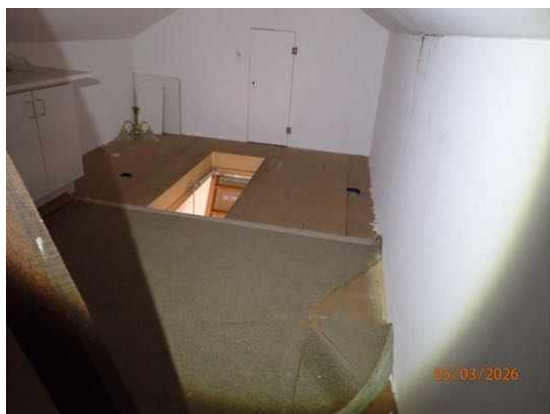
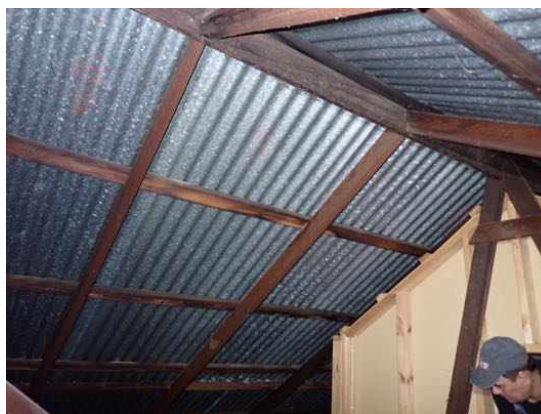
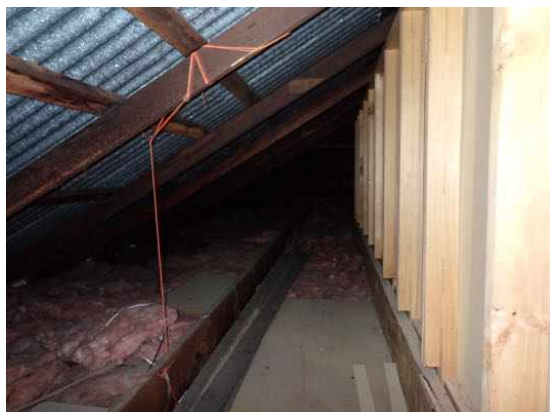
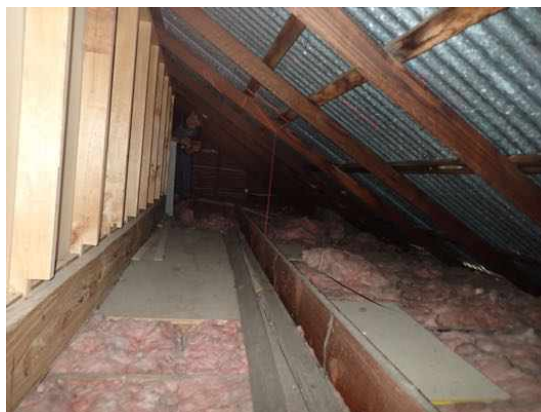
Finding 3.24

Building:	Main Building
Location:	Attic
Finding:	Roof Void Storage Stability
Information:	The load capacity of the roof void area could not be verified during the inspection.

It is highly recommended that a Structural Engineer further assess the roof void area to inform the client of the load rating of the ceiling joists and associated building elements within the roof void to verify structural integrity for the intended use along with review of the attic and whether it forms part of the roof structure. Further assessment and any necessary works should be performed as required by a registered builder.
