Building and Timber Pest Inspection Report

Inspection Date: Thu, 5 Mar 2026

Property Address: 155 Eglinton St, Kew VIC 3101, Australia

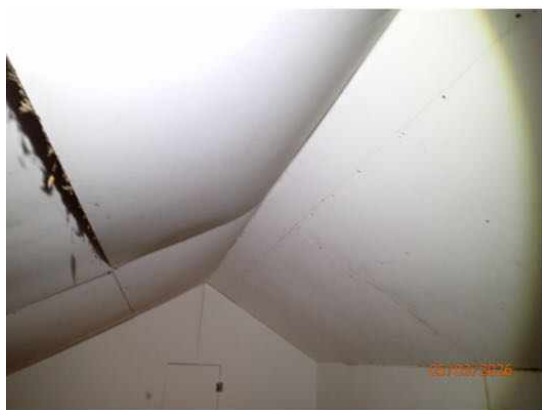
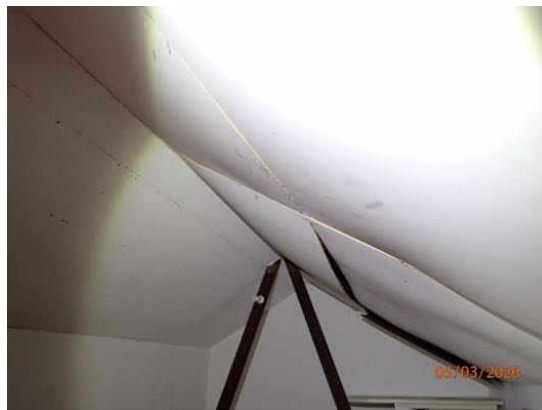
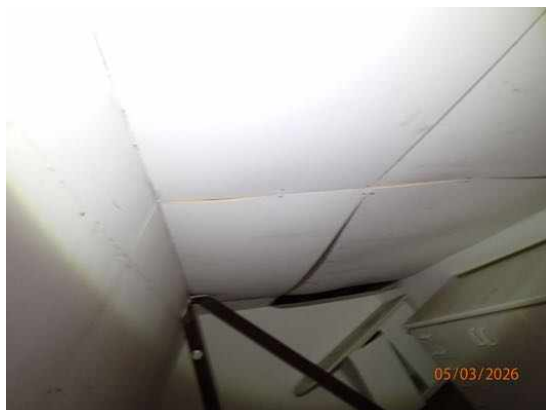
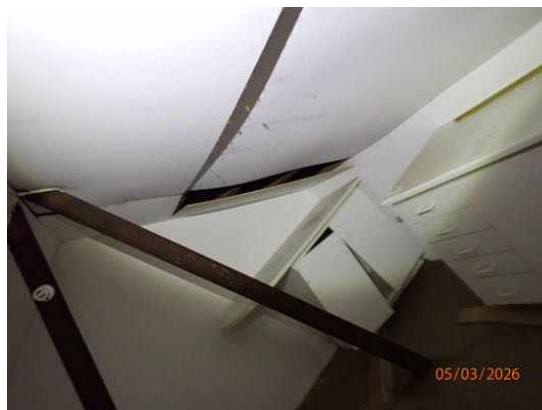
Finding 3.25

Building:	Main Building
Location:	Attic
Finding:	Building Element - Damaged - Wall & Ceiling Linings
Information:	Damaged occurs generally when the building materials have either aged and decayed, or as a result of damage (accidental or deliberate).

Repair and/or replacement of loose wall and ceiling linings in the attic is advised to ensure that additional secondary defects do not arise as a consequence. Such works are necessary, as all building elements play a key role in the operation and function of the overall structure and its performance.

A qualified carpenter should be appointed to repair or replace the affected building element prior to any subsequent damage being caused.

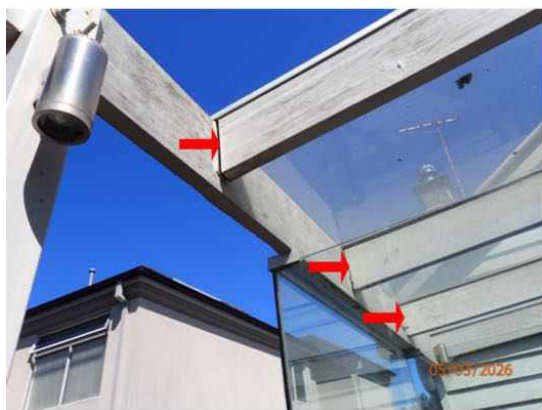
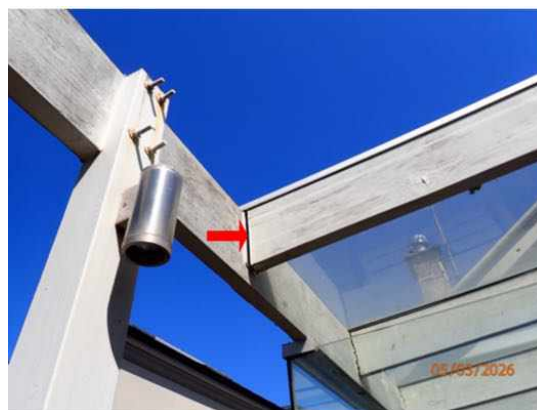
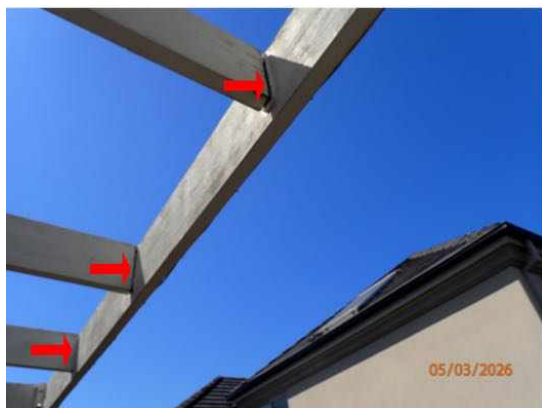
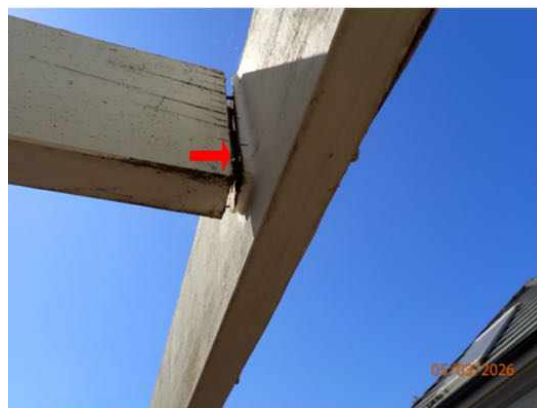
Finding 3.26

Building:	Main Building
Location:	Deck
Finding:	Joist Connection - Insufficient
Information:	The ceiling/floor joist to the whaling plate/beam connection is not sufficient. The joists should be sufficiently fastened with secure connection with joist hangers.

Where fastening is insufficient and there is potential for movement warping or deformation of the joists and potentially structural failures. This generally only occurs in older homes which do not have more contemporary building approaches.

Where the joist to the whaling plate/beam is inadequate repairs are likely to be required as soon as possible. A Registered Builder/Carpenter should be appointed to perform remedial works as soon as possible prior to turning into a major structural defect.

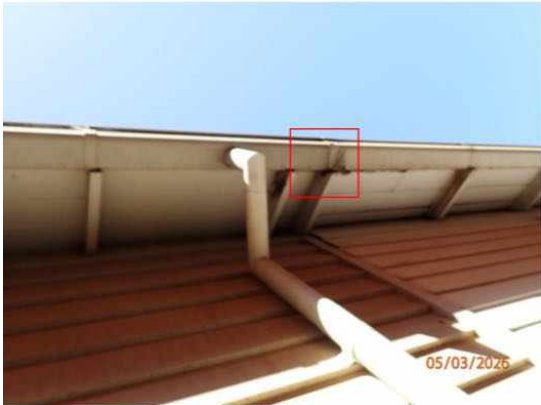
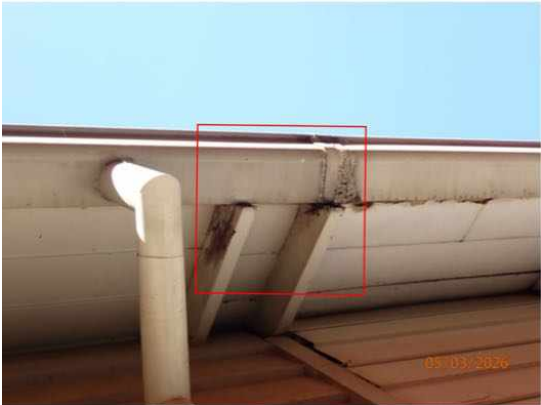
Finding 3.27

Building:	Main Building
Location:	Eaves
Finding:	Eave Lining - Water stained
Information:	Water staining to eave lining board in this area was evident at the time of inspection. Water staining indicates that surfaces have been exposed to excessive moisture over time. The minerals and other elements in the water lead to staining, which may graduate to corrosion and deterioration of the surrounding building elements if left unmanaged.

While mostly an appearance defect, water staining can be indicative of more serious defects such as gutters back charging.

A licensed roofing plumber must be consulted to identify the cause of the staining and to provide advice on any rectification works that may be required. Replacement of any damaged structures may also be required depending on the severity.

This is to be carried out in the very near future to prevent secondary damage.

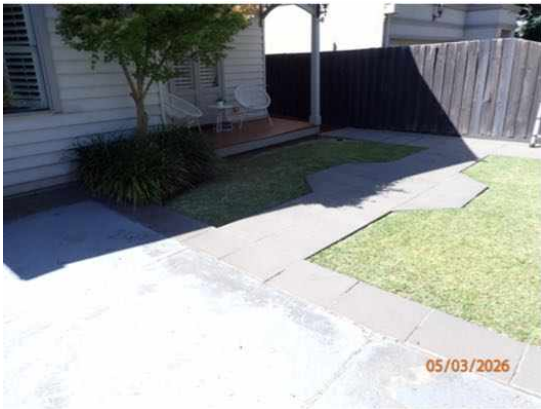
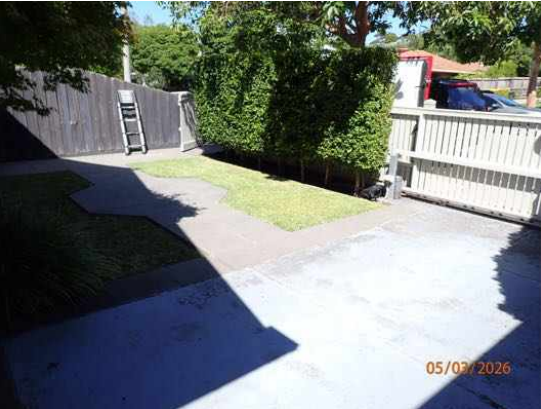
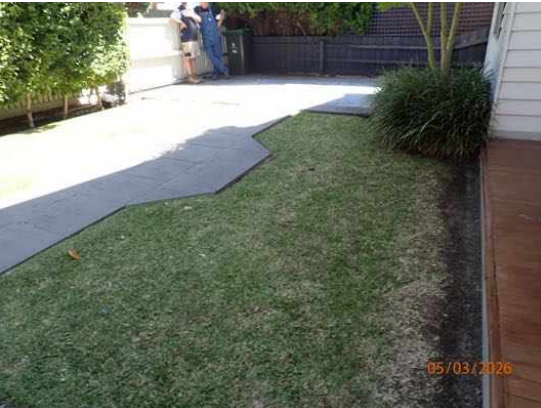
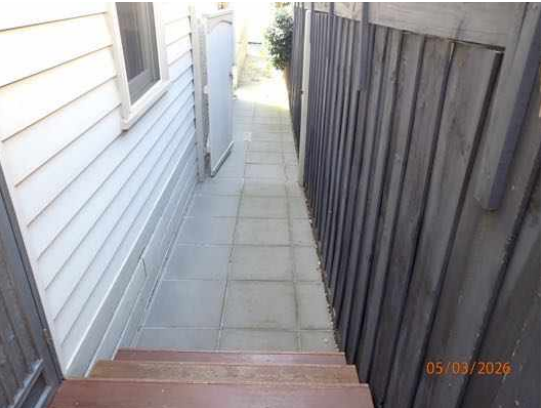
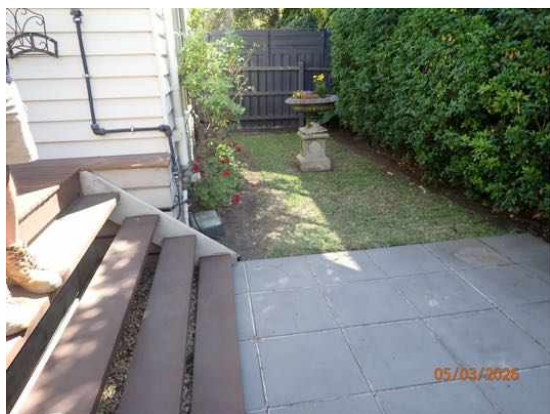
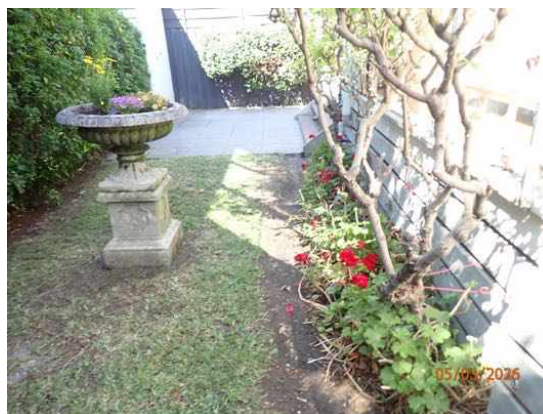
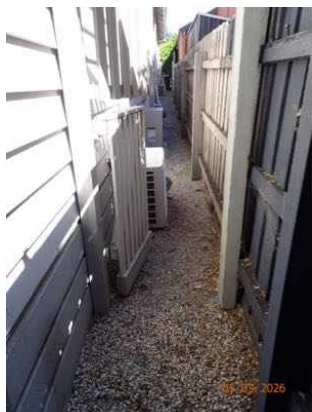
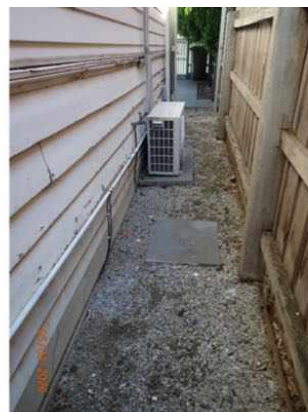
Finding 3.28

Building: Main Building
 Location: All External Areas
 Finding: Site Drainage - Building Inadequate
 Information: The site drainage in this area was found to be inadequate at the time of inspection.

If left unattended excessive moisture and water can pool/pond and lie against building structures and possibly cause secondary defects.

It is strongly advised to engage a licensed builder/plumber to review and advise asap.

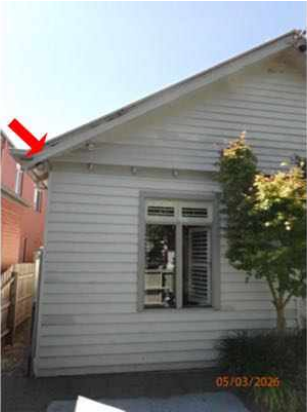
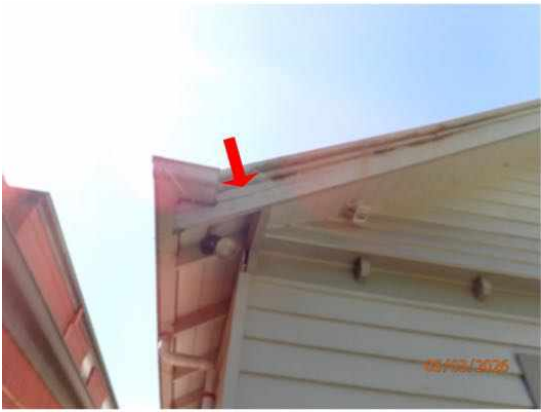
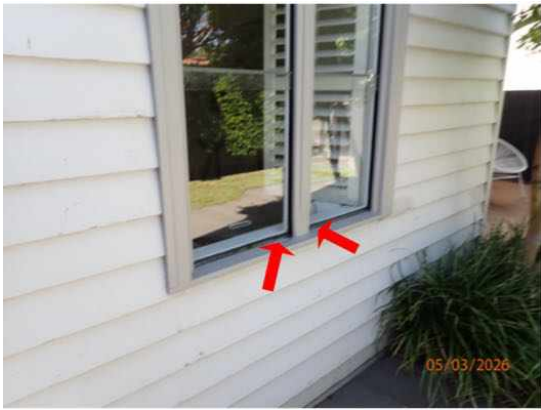
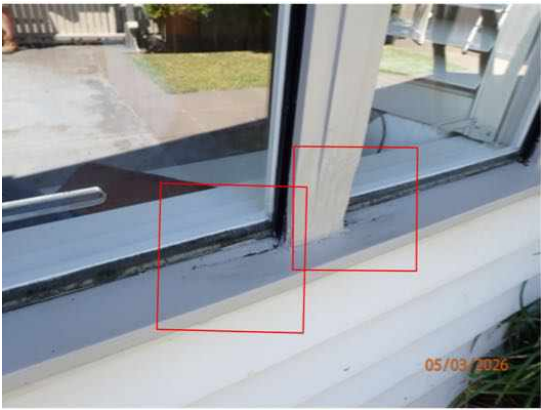
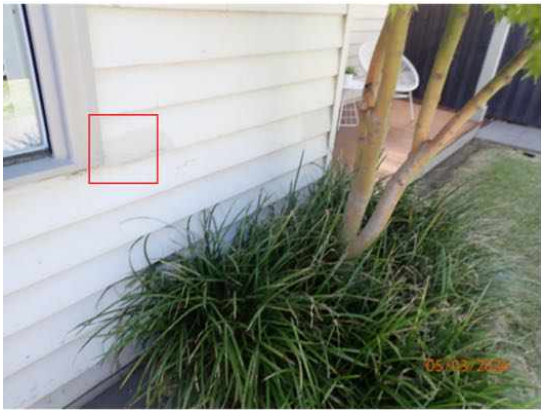
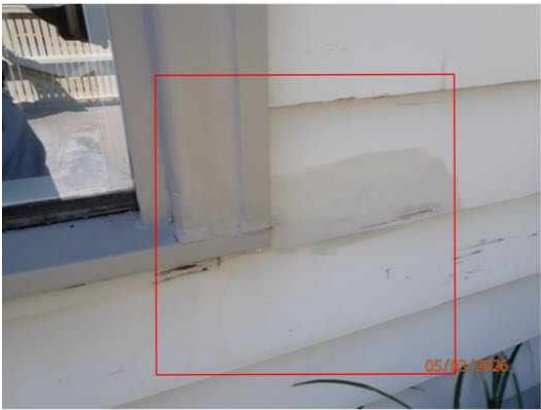
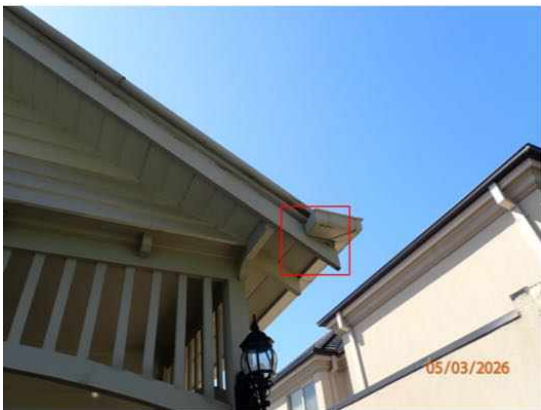
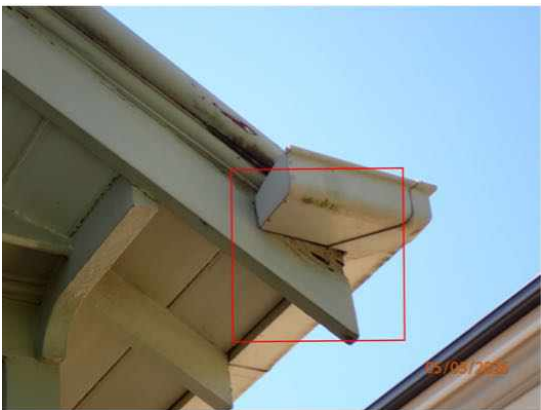
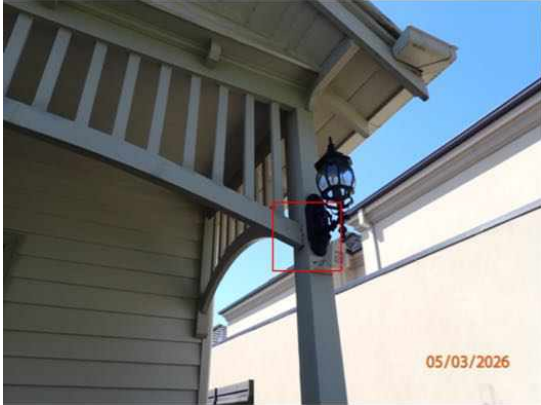
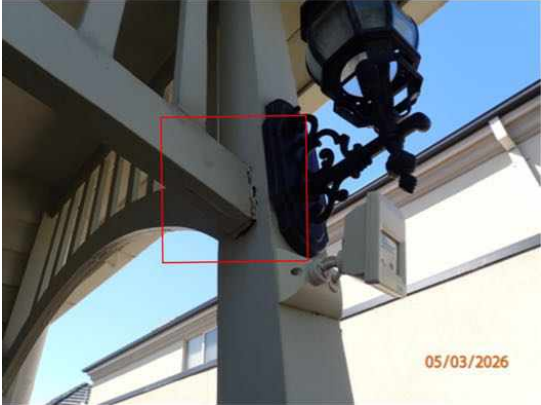
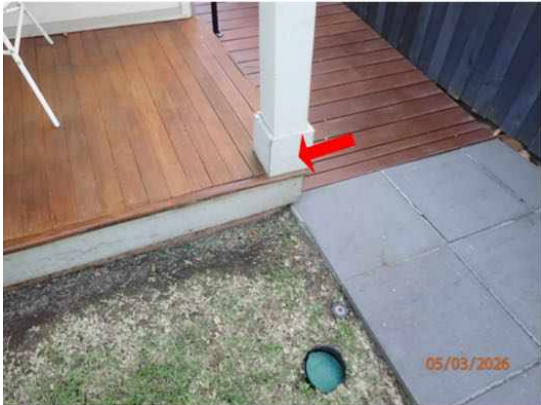
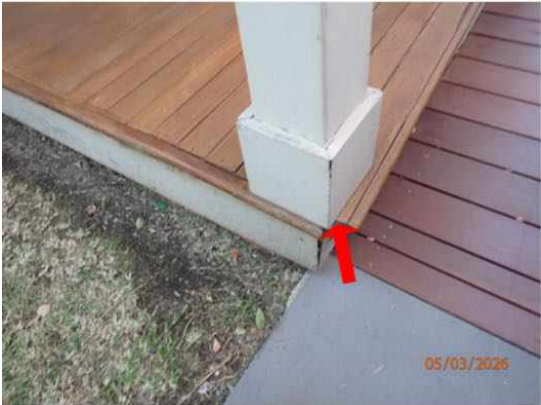
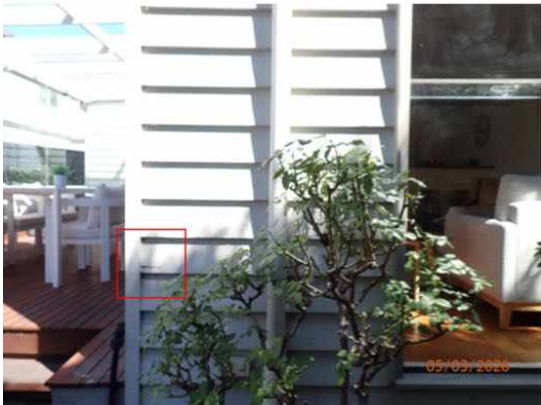
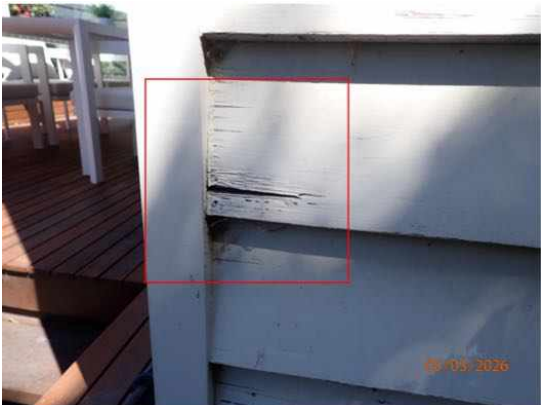
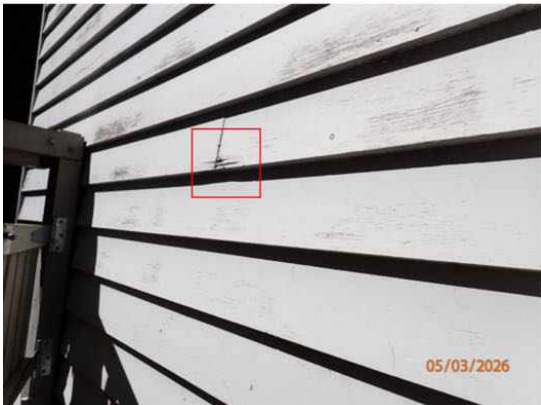
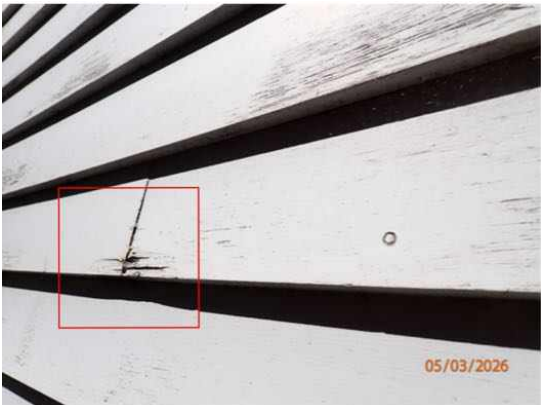
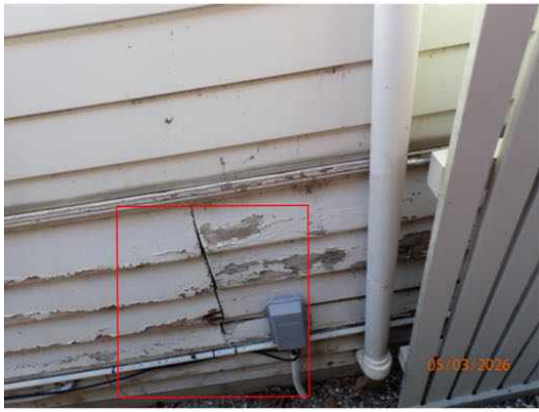
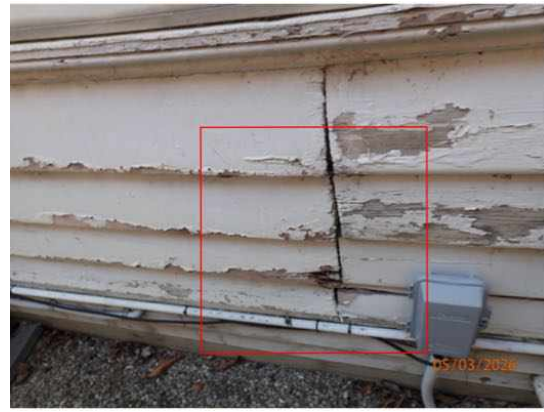
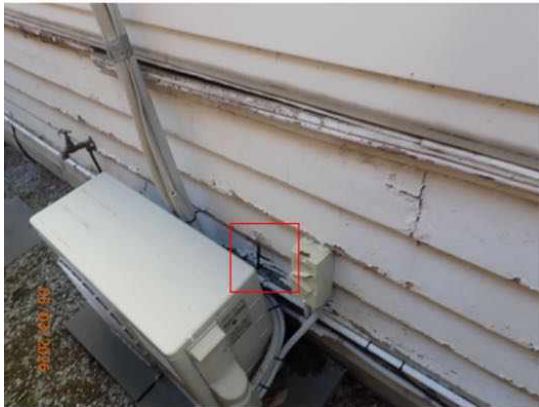
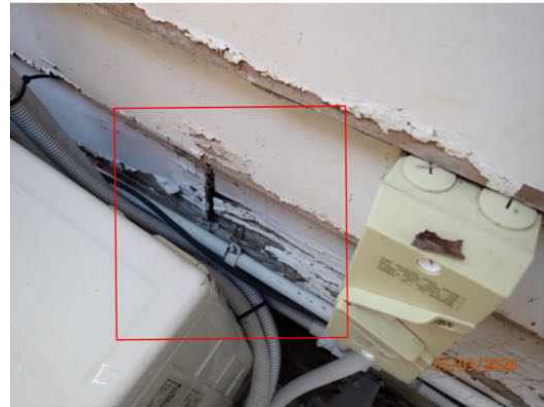
Finding: Wood rot

Information: This building element shows evidence of wood rot. Wood rot, also known as Fungal Decay, occurs when timbers and other cellulose building materials are exposed to damp conditions on an ongoing basis. This could be the result of exposure to weathering over a prolonged period of time, or the attraction of excessive moisture from other abutting building materials. Contributing factors also include poor air ventilation in the area.

Wood rot is often associated with general damp problems and is evidenced by a 'musty' smell or mould and mildew occurring on surfaces. If left unmanaged, damp conditions can lead to further health problems and the decay of timbers will continue.

Early intervention and regular maintenance, particularly of exterior timbers, will prolong the useful life of these building elements. Prior to any works being performed, the cause of the moisture that has created the visible wood rot should be identified and addressed in a suitable manner. Replacement of affected timbers may then be a necessary step in protecting surrounding building elements from such deterioration.

A qualified plumber may be appointed to assess the cause of excessive moisture and to provide advice on any remedial works as required. A qualified carpenter or

registered builder may also be required to replace affected building materials.

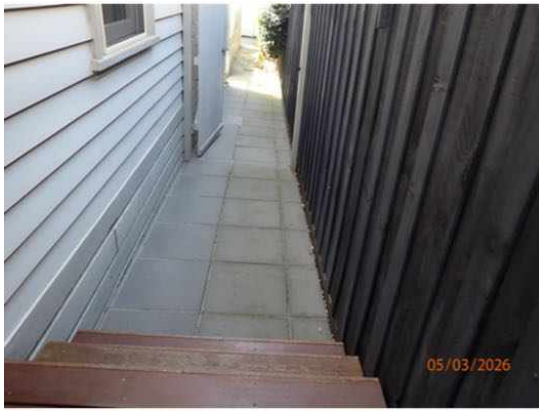
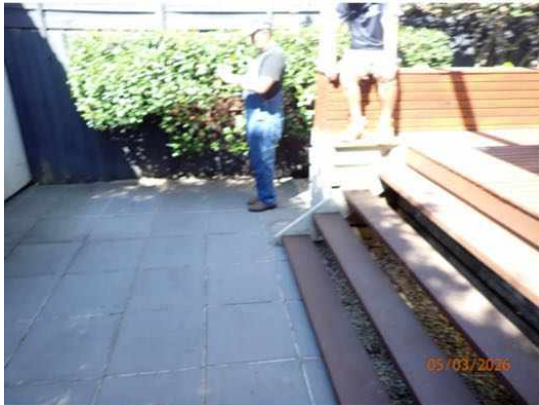
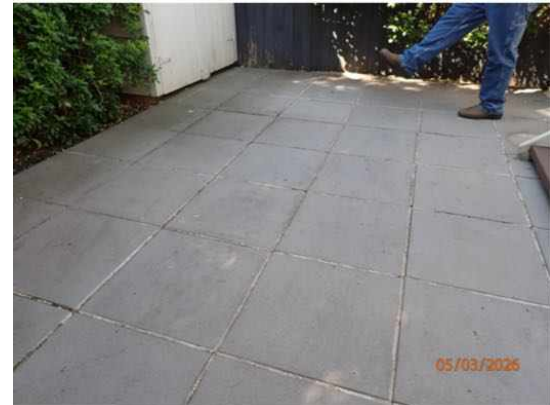
Finding 3.30

Information: Sections of the external paved area are uneven, creating a potential trip hazard. It appears as though the area has been subject to rough installation, or that paving sections have lifted due to movements in the foundation of the property.

Where paving creates a trip hazard, personal injury may ensue if due caution is not taken by all persons within this area.

Re-paving of the area is required as soon as possible to remedy this situation. Further consultation with a specialist paving contractor is advised.

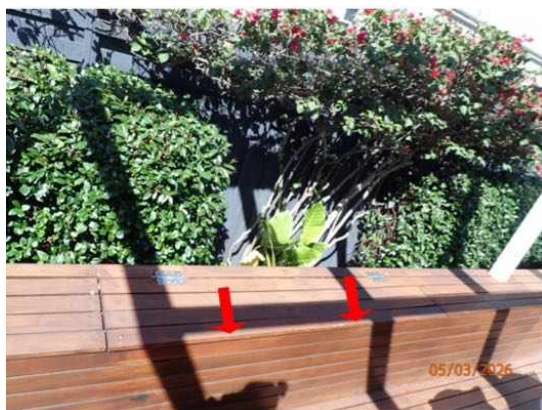
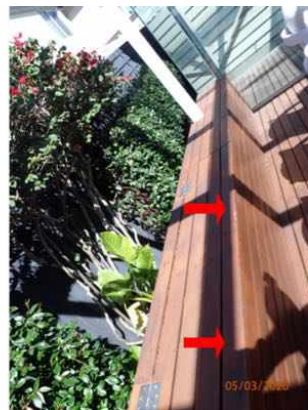
Finding 3.31

Finding: Deck Material to the storage - Loose

Information: It was noted at the time of inspection that sections of the decking material to the storage boxes are beginning to come loose. Typically decking deteriorates due to age and or wear which is generally expected for a structure of this age, due to prolonged exposure to weather conditions. Sometimes inadequate installation or maintenance can be to blame.

If left unattended, it is likely that further damage will occur. It is suspected that repair of several elements of the balustrades may be required however replacement may be a consideration of the client also.

A licensed carpenter contractor should be appointed to provide further advice and perform rectification works as necessary.

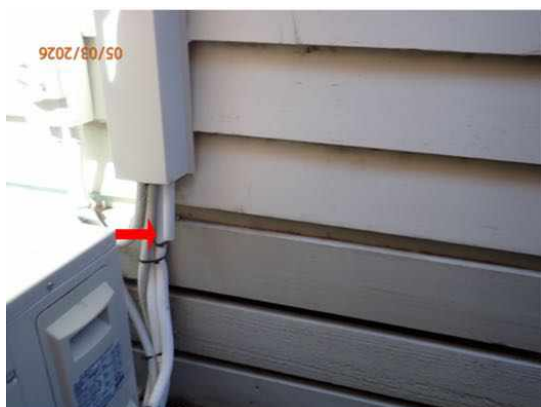
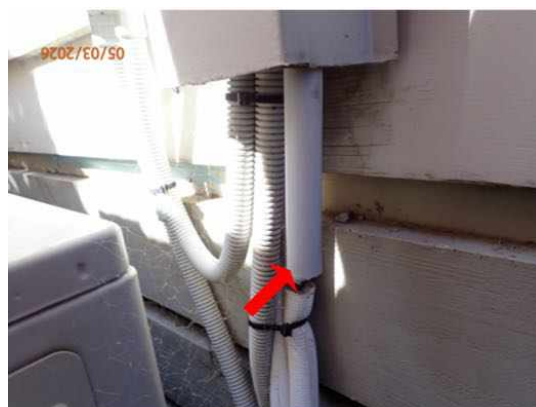
Finding 3.32

Information: The overflow is not plumbed or connected to suitable drainage, which has resulted in the surrounding area becoming excessively damp. These damp conditions can lead to secondary defects such as rot, rust or corrosion of associated building elements, the formation of fungal decay, or even the creation of potential slip hazards.

When coupled with poor site drainage, pooling of water may also attract termite activity to this area. It is highly recommended that a qualified plumber be appointed to install adequate drainage to the overflow.

These works will ensure that the area remains dry and free of any secondary defects.

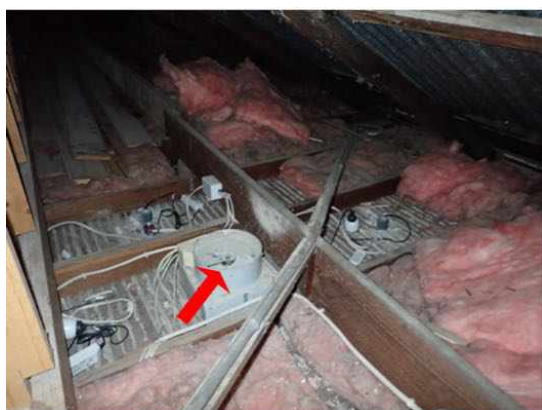
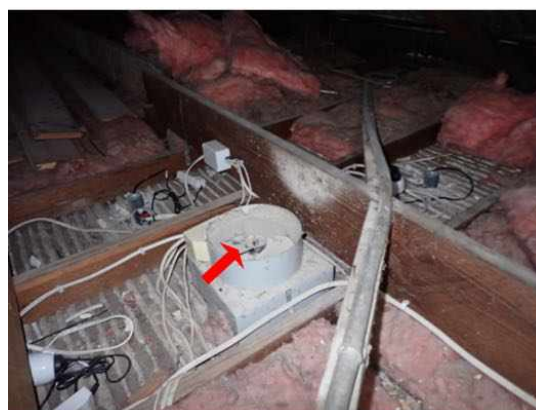
Finding 3.33

Information: The bathroom ventilation was discharging within the roof space was dislodged at the time of the inspection and was found to lead directly into the roof space, rather than

Without re-direction to the exterior of the building, the ventilation is not considered fully operational and is deemed a minor defect. It is therefore preferable that the flue be re-directed to vent into the external environment.

A licensed mechanical ventilation contractor/electrician should be appointed as soon as possible to provide further consultation on the scope of these works and to provide quotations for any necessary works.

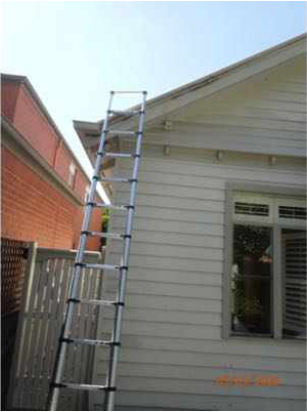
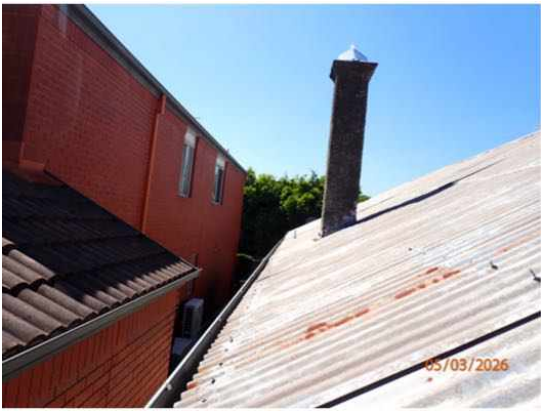
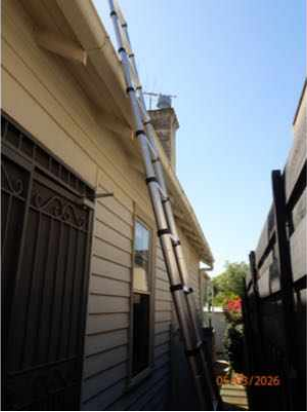
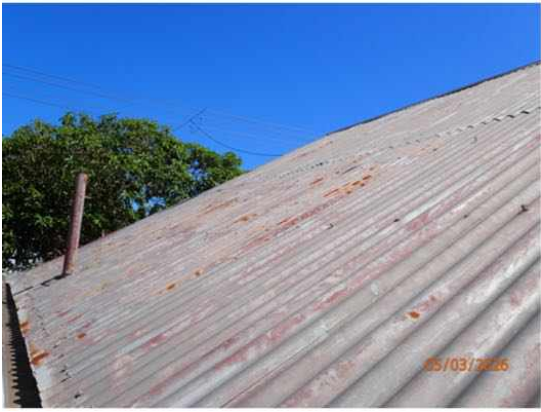
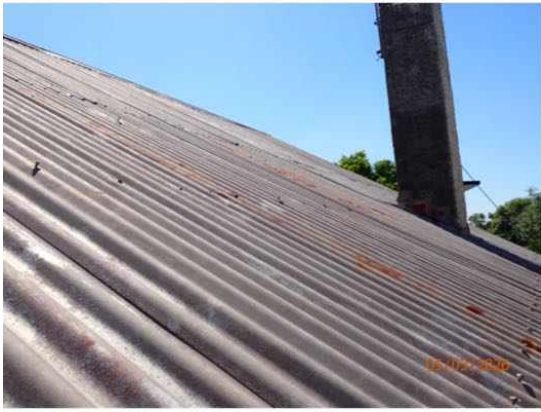
Finding 3.34

Building:	Main Building
Location:	Roof Exterior
Finding:	Roof Sheets - Rusted
Information:	Metal roofs generally comprise numerous individual sheets, which join and overlap. These intersections are particularly prone to lift at the edge and consequently rust at these points.

Upon inspection of the exterior roofing structure, evidence of rust to these sections was identified. If left unmanaged, these degrading joins can allow water ingress to the internal roofing structures, potentially leading to secondary damage of building elements. Accelerated deterioration of the roofing sheets and any associated building elements is also likely to occur.

A roofing contractor should be appointed immediately to assess the damage to the roofing sheets and to perform remedial works as necessary. Works may include replacement of severely affected roofing sheets or minor works such as the application of rust-retardant surface protectors.

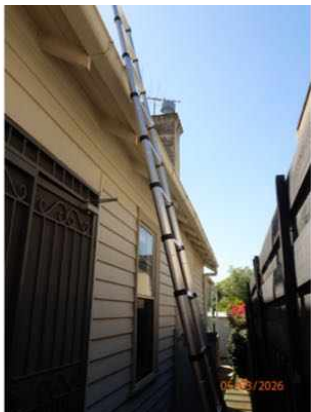
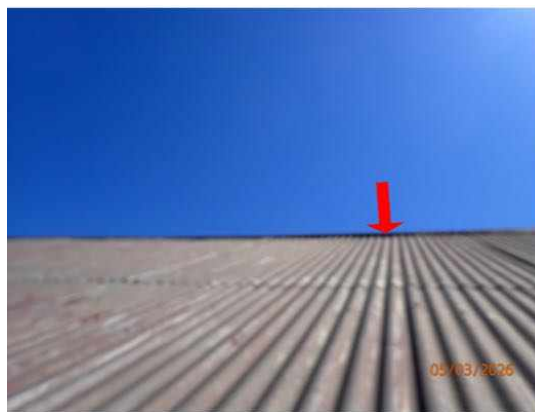
Finding 3.35

Building: Main Building
 Location: Roof Exterior
 Finding: Roof Capping - Loose

Information: Upon inspection of the exterior roof covering, it was noted that some capping pieces have become loose from their original fixings. It is suspected that this defect has developed as a result of a lack of adequate maintenance, but may also have been caused by inappropriate fixings being used in the construction process.

Loose capings detracts from the weather tightness of the roof covering, making the internal roofing structure susceptible to water penetration and subsequent damage. If left unaddressed, it is likely that secondary damage to associated building elements

will develop, potentially necessitating remedial works to these structures.

A roofing restoration contractor should be appointed to advise on rectification options and on the cost of repair. It is advised that remedial works be performed as soon as possible to prevent any further damage.

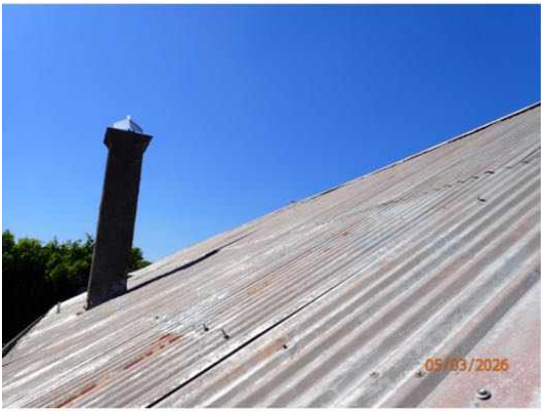
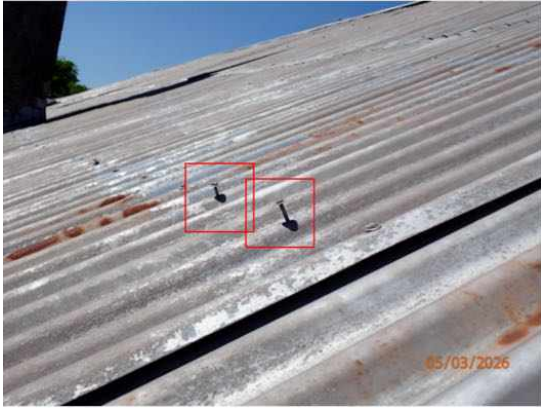
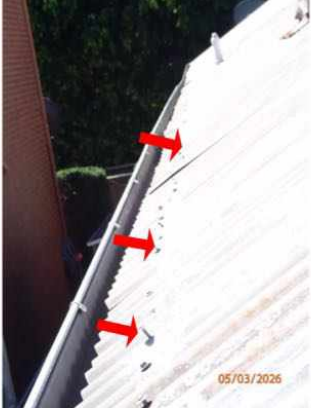
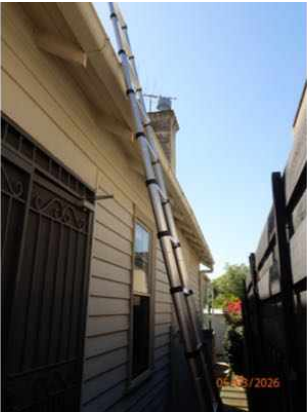
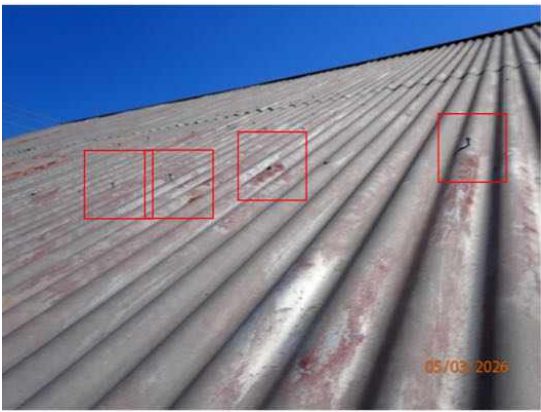
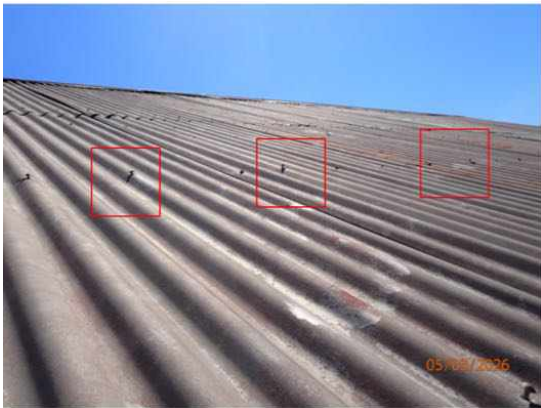
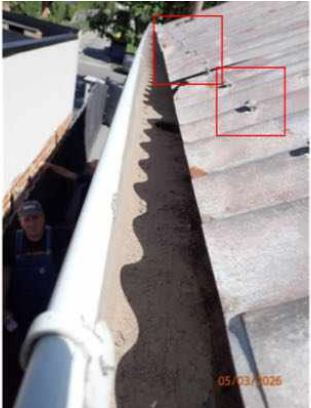
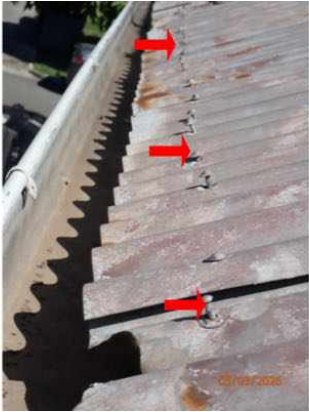
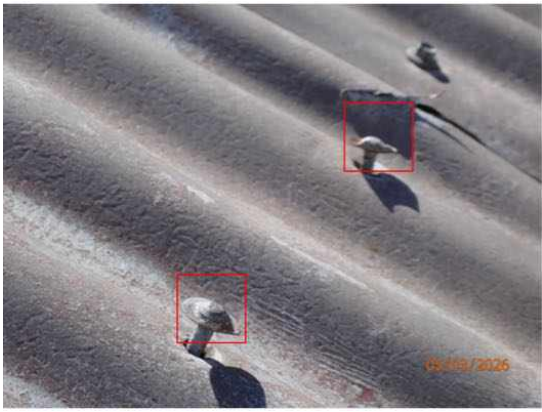
Building:	Main Building
Location:	Roof Exterior
Finding:	Roof Sheets - Missing/Decayed Screws
Information:	Upon inspection of the exterior roof covering, it was noted that capping to the roof sheets were missing/decayed roofing screws.

Screws that are not installed adequately or are missing are likely to result in water penetration to the interior of the property, as well as creating the possibility of the roof sheets lifting and moving.

Premature ageing and secondary building defects are imminent where roof plumbing is missing or inadequately installed. Additionally, water pooling also creates an environment that is susceptible to termite and pest infestation.

A roofing plumber should be appointed as soon as possible to install relevant roof plumbing materials, ensuring that no further damage is sustained.

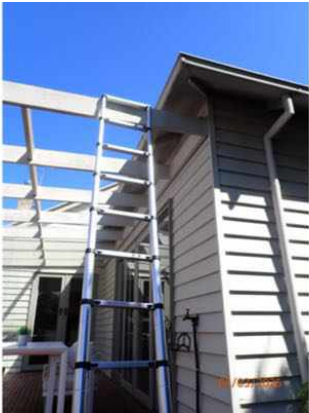
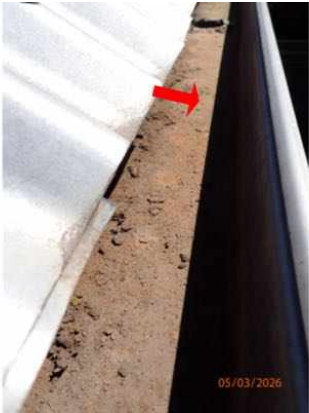
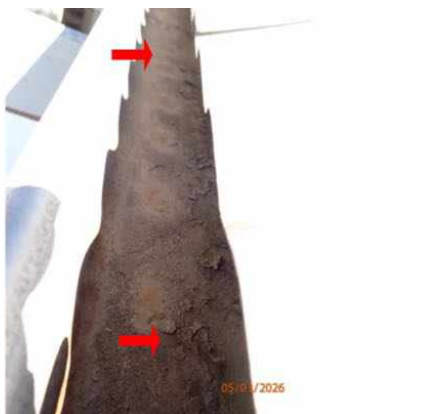
Finding 3.37

Building: Main Building
 Location: Roof Exterior
 Finding: Gutters - Rusted or Corroded
 Information: The roof gutters to these areas have rust. It is suspected that this has been caused by blockages, resulting in pooling or standing water, that have prematurely rusted elements of the roof plumbing.

Rusted gutters will generally develop holes and leaks that can affect other building elements with poor drainage of storm water. Poorly drained roof areas will also lead to damp conditions surrounding the base perimeter of the building which, if left unmanaged, can lead to a range of secondary building defects.

Repair and/or replacement of rusted gutters is required in order to reinstate the roof drainage system to a fully operational level. To further maintain these areas, gutters should be cleaned frequently, allowing the avoidance of any partial blockages.

A licensed roof plumber or specialist roof restoration company should be appointed to undertake these works. It is advised that such works be completed as soon as possible to prevent any further damage and deterioration.

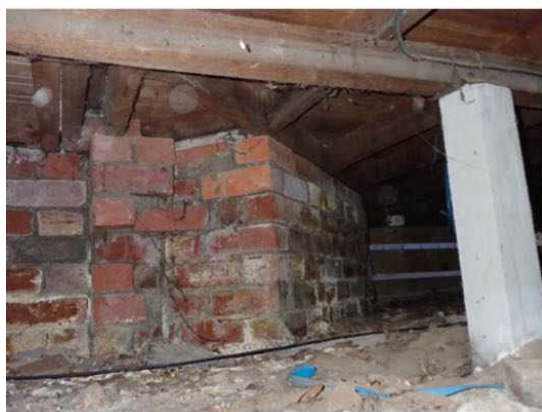
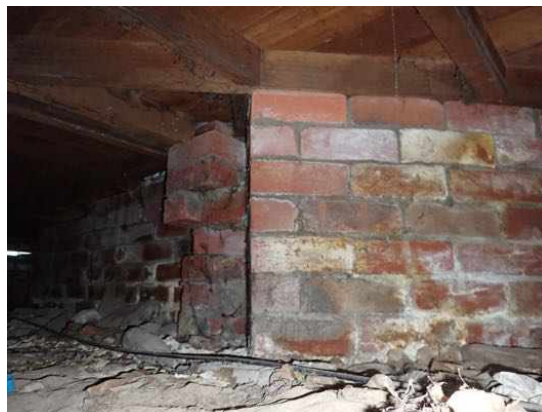
Finding 3.38

Building:	Main Building
Location:	Subfloor
Finding:	Ant Caps - Not Installed
Information:	Ant caps have not been installed in full opt part of the subfloor structure at the time of inspection. Generally, ant caps are installed to the intersection between the top of the stumps (or piers) and the subfloor structures.

Ant caps are generally installed during the construction. Ant caps are designed to easily identify termite or pest ingress from stumps/piers to the adjoining bearers.

Where ant caps have not been installed, frequent monitoring of these areas should be carried out in order to identify any signs of termite or timber pest workings.

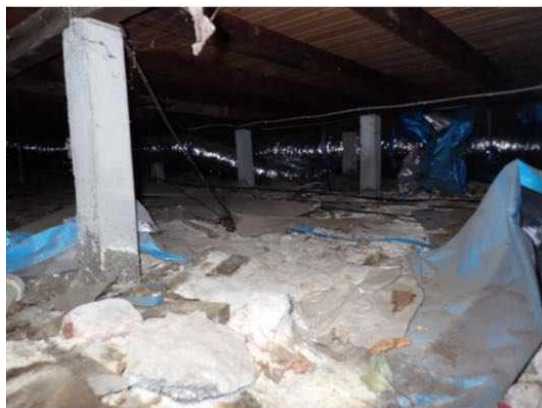
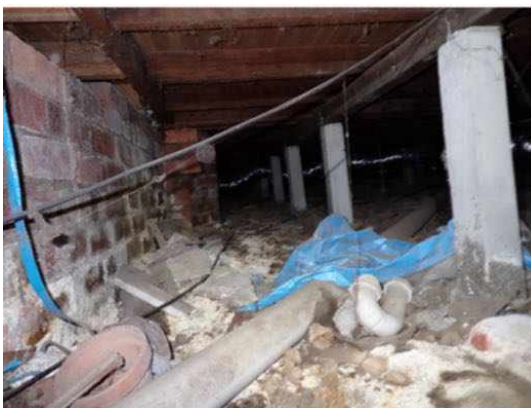
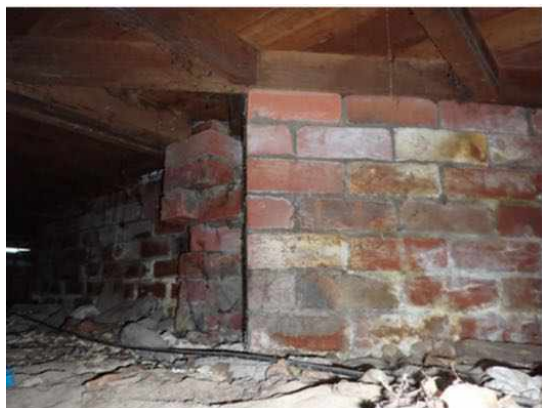
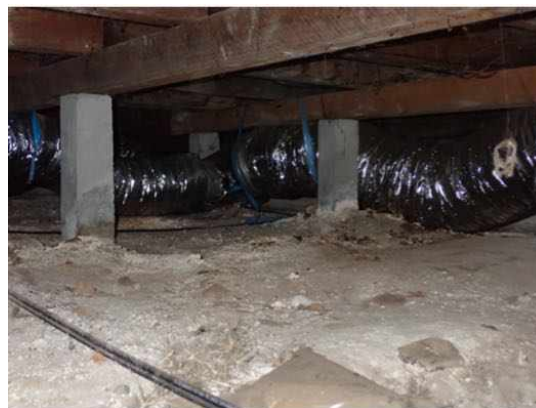
Finding 3.39

Building:	Main Building
Location:	Subfloor
Finding:	Mild Mould - Present to Subfloor
Information:	Where evidence of mould growth was noted to the subfloor, there may be environmental, biological or health issues associated with the report. A specialist inspection by a suitably qualified environmental health inspector is warranted, where

Generally, the client is advised to ensure that the general environment is free of moisture and humidity to aid in the prevention of mould formation and development. Any mould found during the inspection should be cleaned immediately by a cleaning contractor or the homeowner as applicable.

Please note that severely affected building elements may require replacement by a registered builder or qualified carpenter.

Where ventilation is still inadequate, it is advised to ensure that all vents are clear of blockages, additional vents may be installed and external surface and subsurface drainage is reviewed.

The client may also consider mechanical ventilation (powered fans) to improve subfloor airflow. Remedial works should be conducted as a matter of urgency to protect against the development of potentially harmful subfloor conditions and occupants.

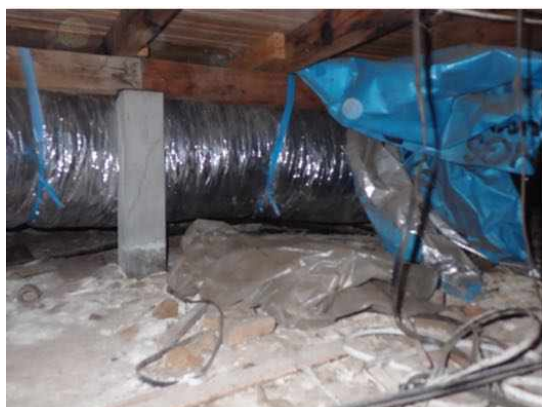
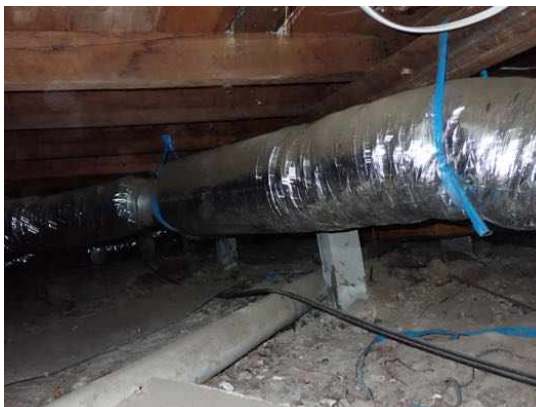
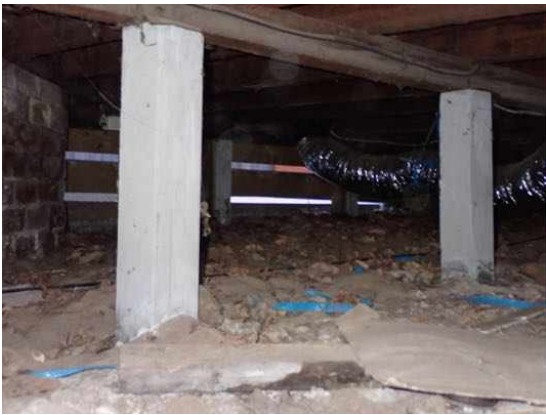
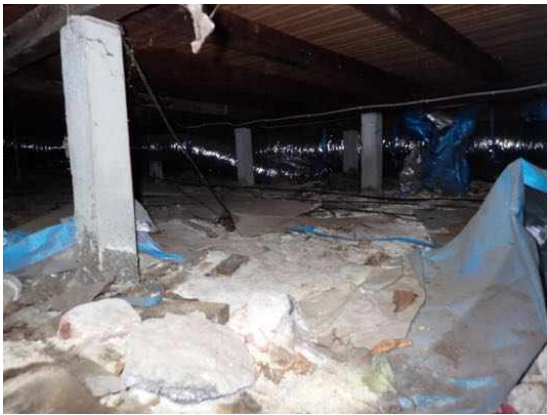
Finding 3.40

Building:	Main Building
Location:	Subfloor
Finding:	Subfloor - Debris/Stored Goods
Information:	An array of debris & stored goods were found in the subfloor area at the time of inspection. Debris in this area restricts subfloor ventilation and creates potential for concealed pest entry. Stored timbers and other materials may also make the area susceptible to termite activity and wood rot.

A clear and empty subfloor will be better ventilated and easier to maintain in a dry condition. The removal of any timber debris is vital in minimising the risk of termite or wood borer activity.

Stored goods in this area restricts subfloor ventilation and creates potential for concealed pest entry. Stored timbers and other materials may also impede the ability to inspect the area.

Debris or stored goods in the subfloor should be removed as soon as possible. Depending on the location and amount of debris and stored items, the homeowner may elect to undertake this task. Alternatively there are a large number of rubbish removal subcontractors that could undertake these works.

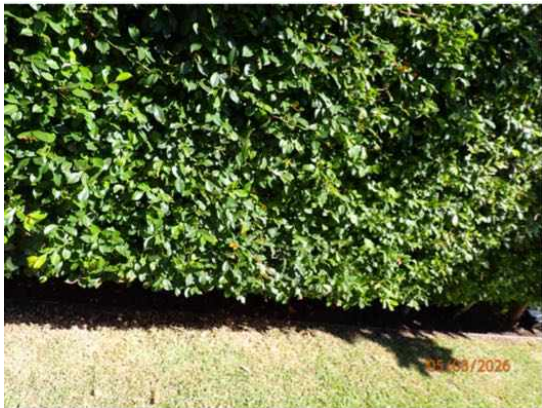
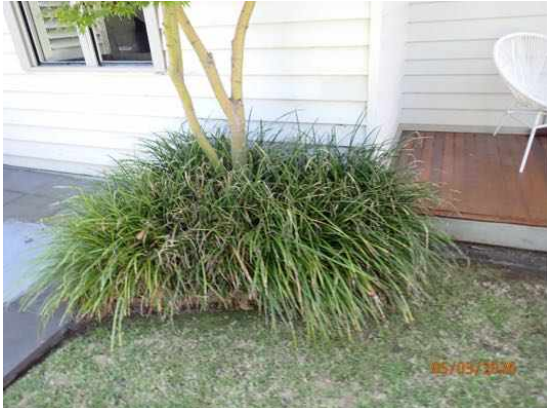
Finding 6.01

Building: Main Building
 Location: All External Areas
 Finding: Garden Beds - Conditions Conducive to Termites
 Information: Garden beds were found to be evident in the garden area. These garden beds can include untreated timber, and with a combination of moisture from watering hosing can make conditions conducive to termite activity and termite ingress.

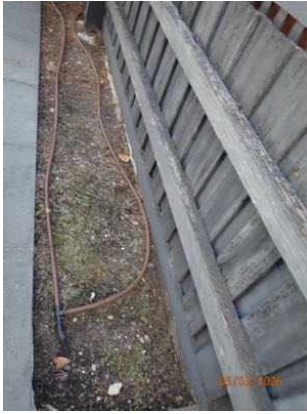
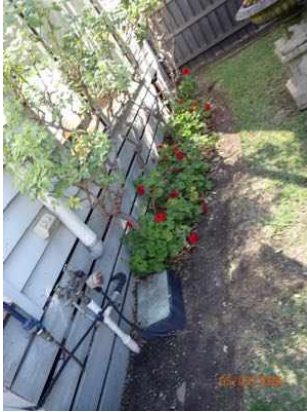
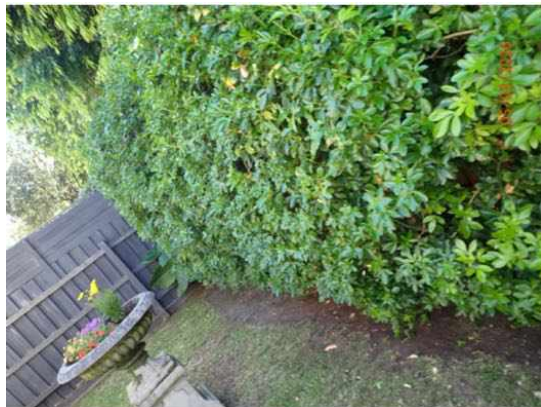
Finding 6.02

Building: Main Building
Location: Bedroom 4 > Centre Left
Finding: Excessive Moisture - Identified
Information: Excessive moisture can attract termites and produce conditions that promote fungal growth and wood decay.

Excessive moisture is generally caused by deteriorated or leaking plumbing pipes or excessive subfloor moisture to the subfloor where a qualified plumber or a mechanical ventilation specialist should be engaged to further inspect the property to identify the cause of the excessive moisture and carry out any necessary repairs.

This is advised to be carried out as soon as possible.

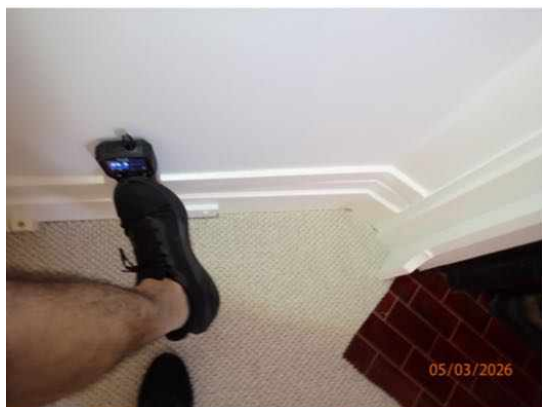
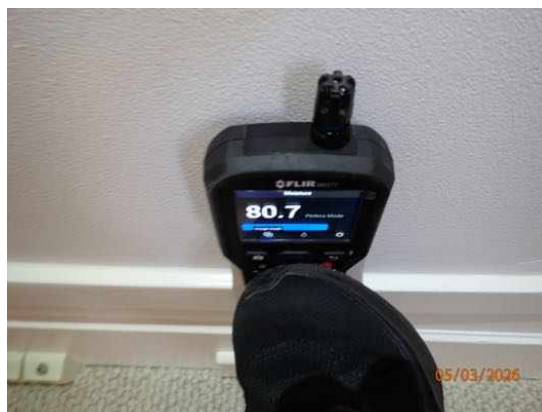
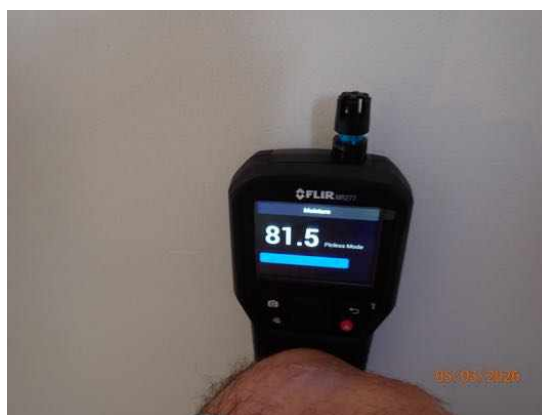
Finding 6.03

Building:	Main Building
Location:	Bathroom > Centre Left
Finding:	Wet Areas - Termite Techniques - Moisture Detected
Information:	Moisture readings was found in the walls of the wet areas which warrants further invasive investigation.

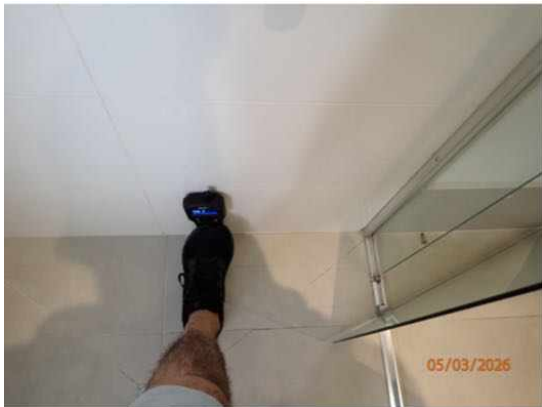
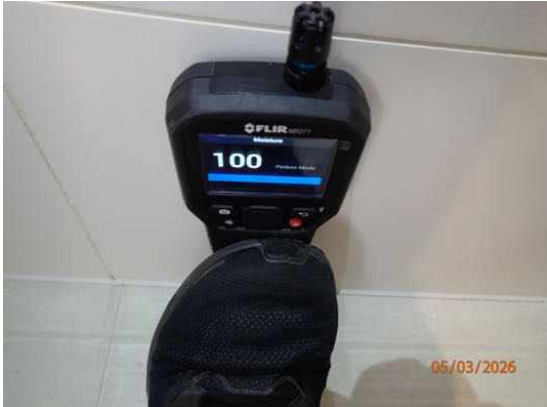
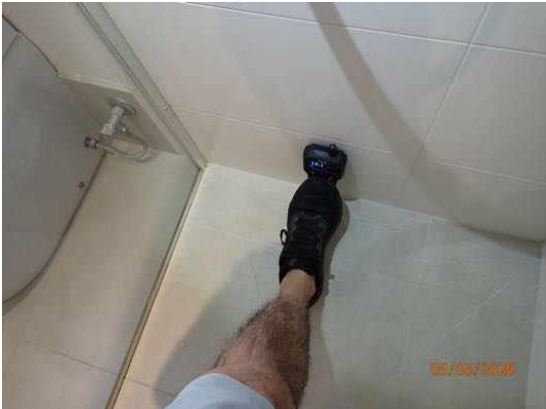
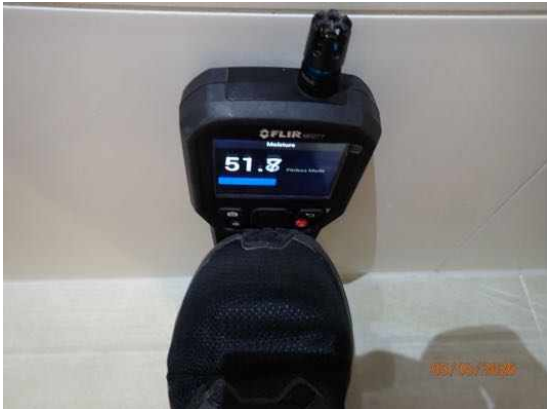
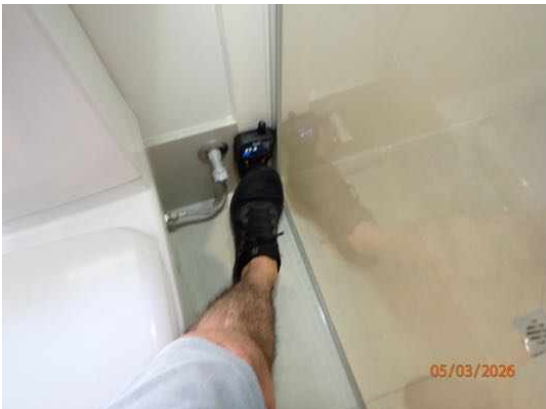
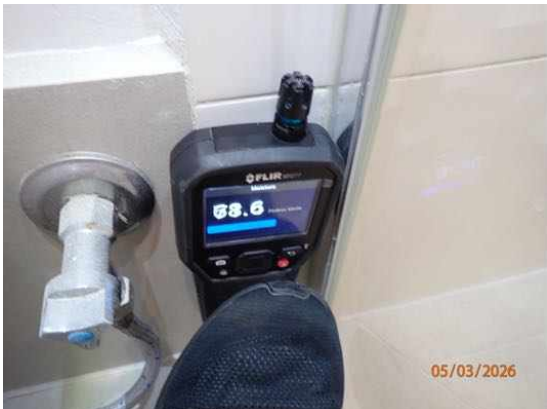
Finding 6.04

Building: Main Building
Location: All External Areas
Finding: Site Drainage - Inadequate Providing Conducive Condition
Information: The site drainage in this area was found to be inadequate at the time of inspection.

If left unattended excessive moisture can attract termites and produce conditions that promote termite attack fungal growth, wood decay.
