Building and Timber Pest Inspection Report

Inspection Date: Thu, 5 Mar 2026

Property Address: 155 Eglinton St, Kew VIC 3101, Australia

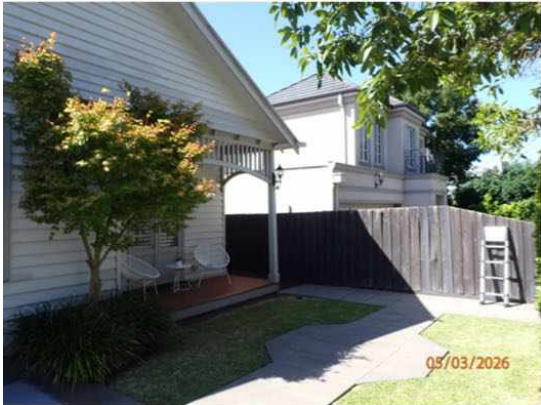
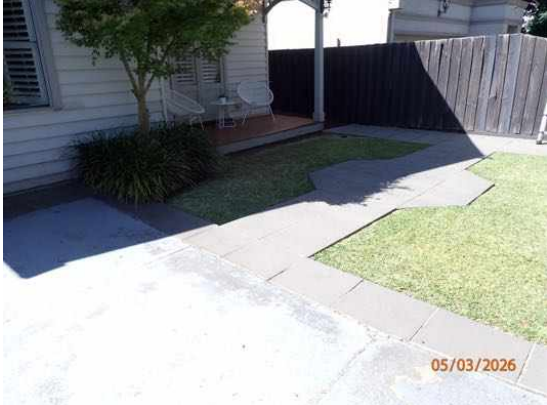
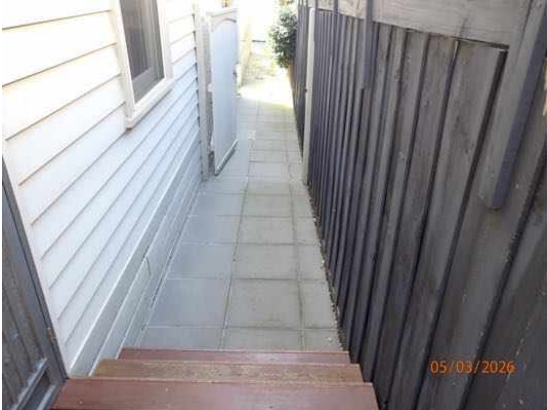
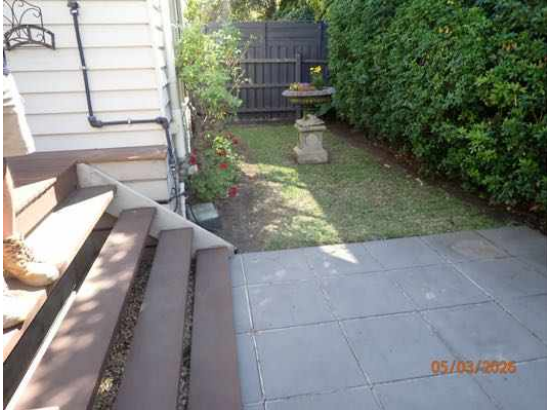
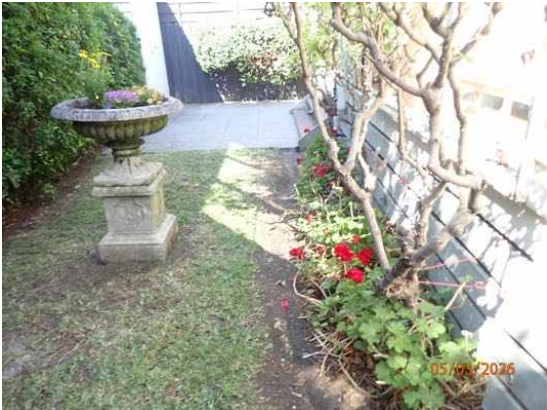
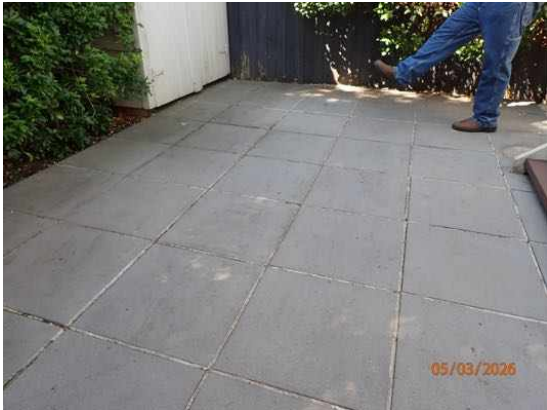
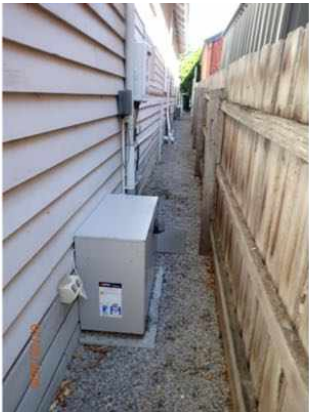
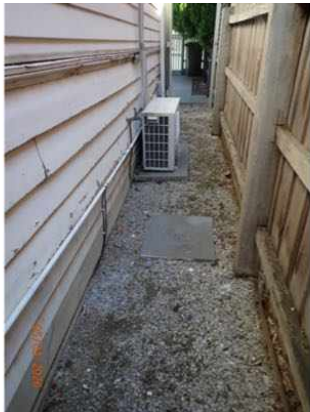
Building: Main Building
Location: All External Areas
Finding: Site Drainage - Inadequate Providing Conducive Condition
Information: The site drainage in this area was found to be inadequate at the time of inspection.

If left unattended excessive moisture can attract termites and produce conditions that promote termite attack fungal growth, wood decay.

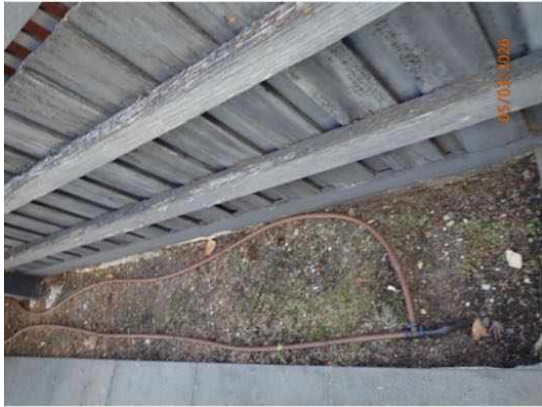
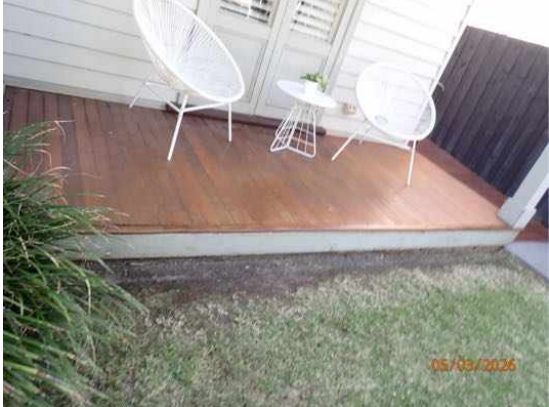
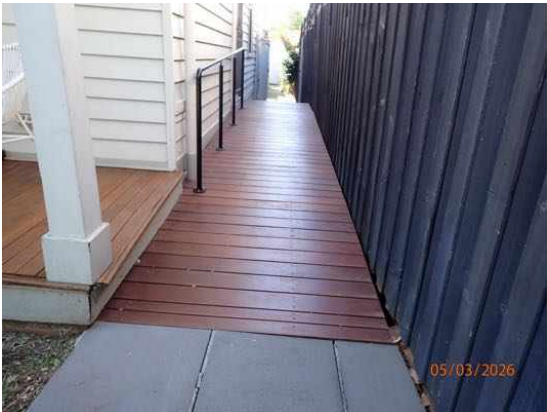
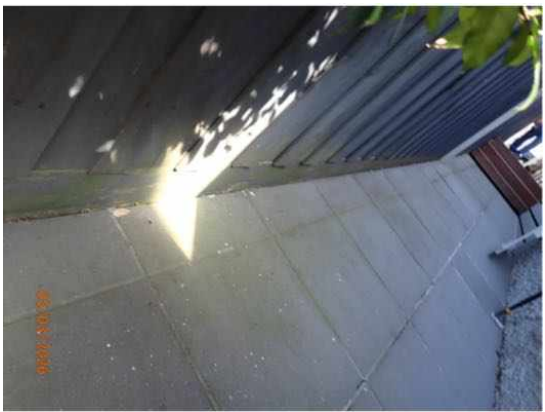
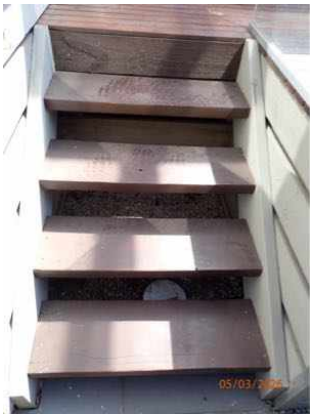
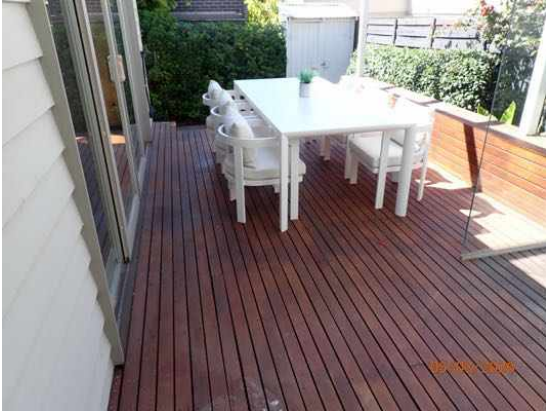
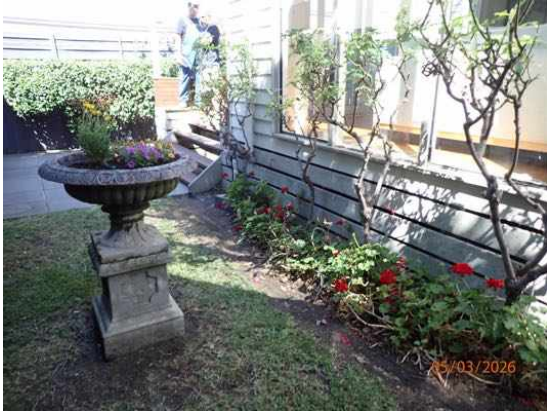
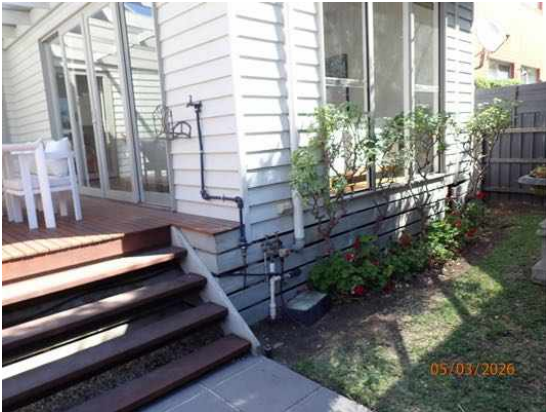
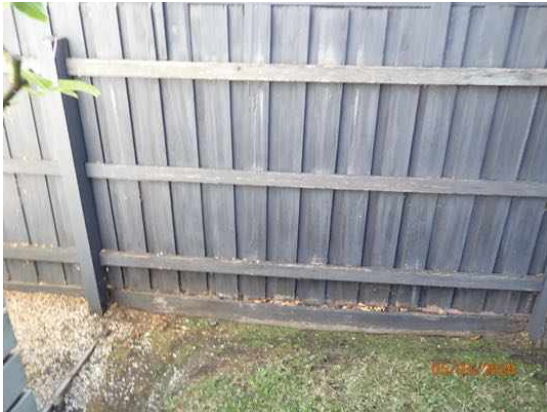
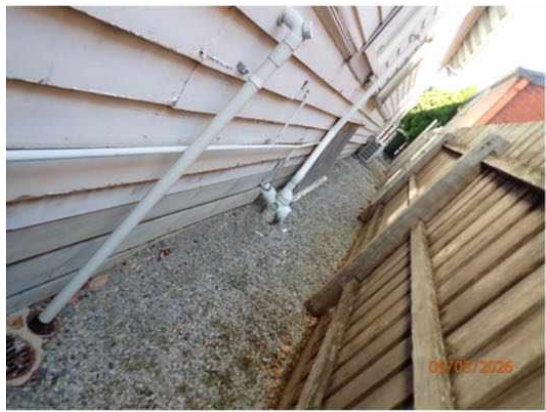
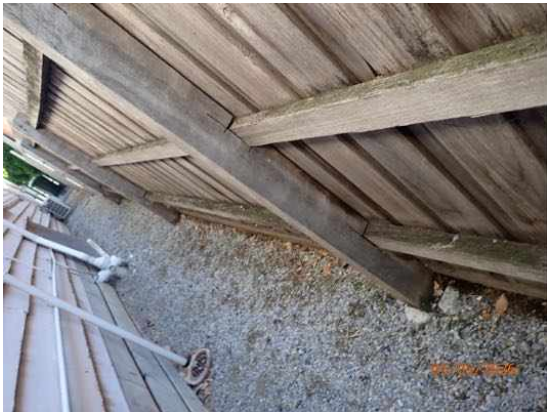
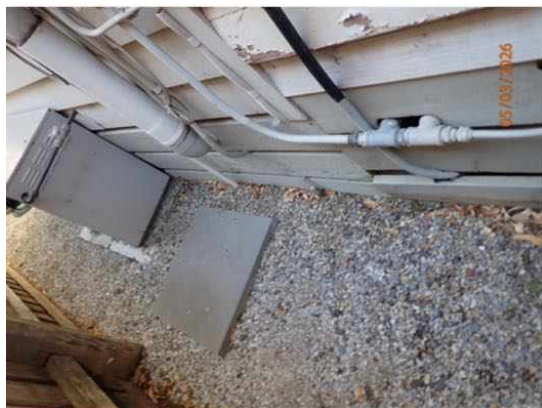
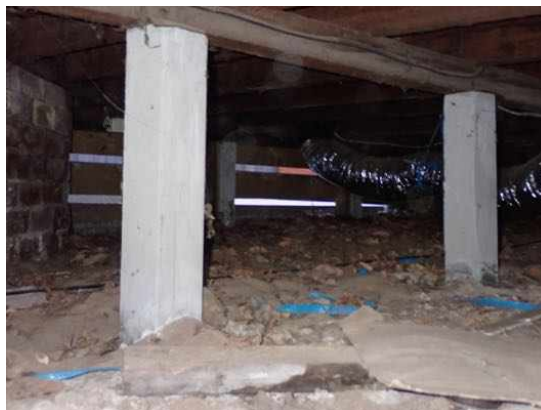
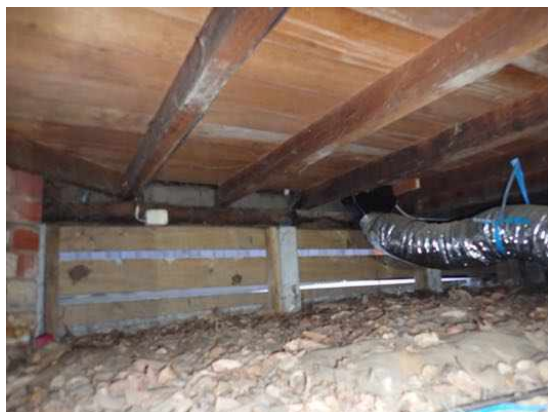
Finding 6.05

Building: Main Building
Location: All External Areas
Finding: Building Materials in Direct Ground Contact - Conducive to Termites
Information: Where timber elements are in direct contact with the ground and consequently moisture or dampness they become conducive to termite activity. Whether timber is used as a building element part of a fencing structure or stored as an unused item they can provide an environment that is attractive to termite infestation.

When met with excessive moisture timber begins to decay and develop wood rot. Any timbers that are in direct contact with external grounds especially if left untreated or non-durable also provide ingress for subterranean termites into that particular element.

The removal of any such materials that may be conducive to termite activity should be removed as soon as possible to minimise the risk of termite attack. All susceptible timbers should be removed and replaced with non susceptible timber.

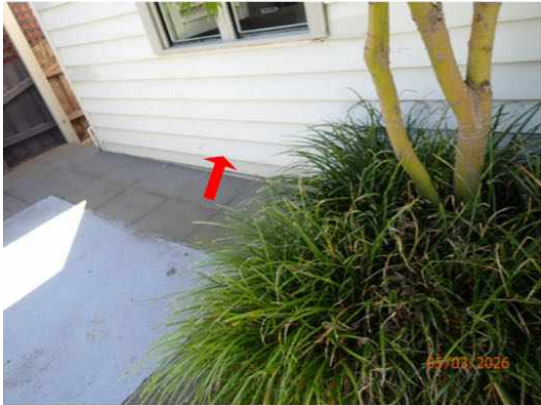
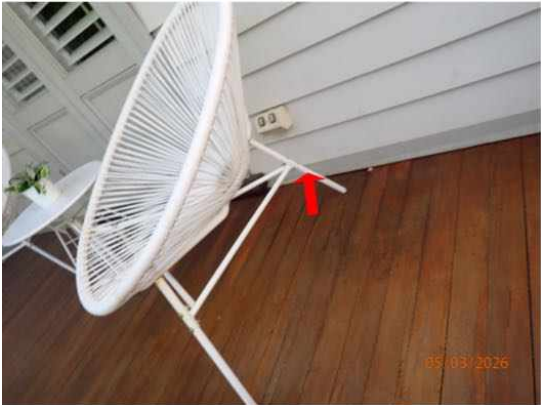
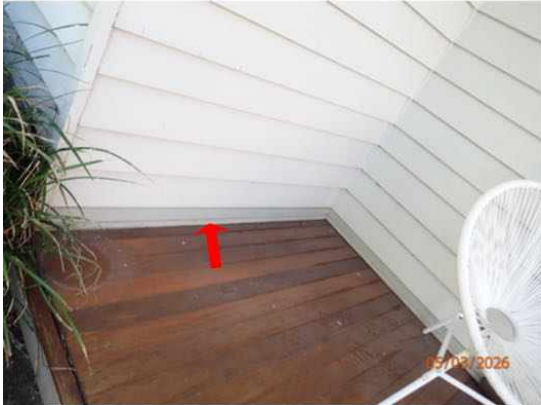
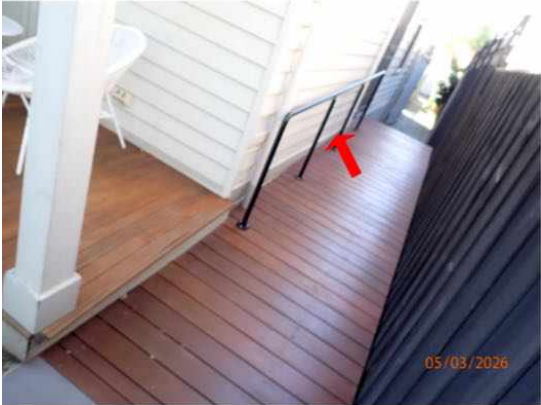
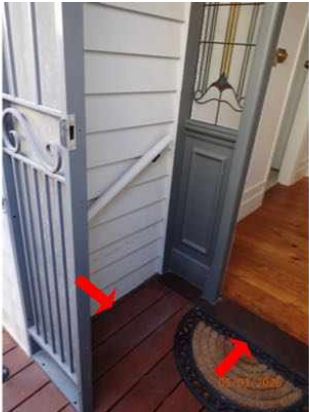
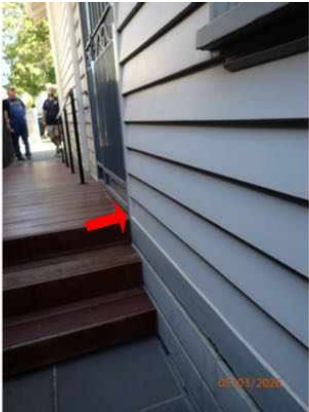
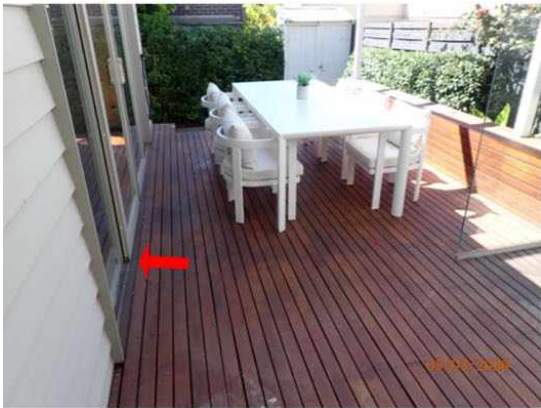
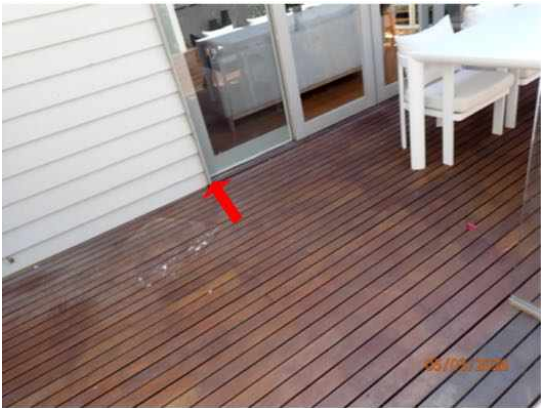
Finding 6.06

Building:	Main Building
Location:	All External Areas
Finding:	Bridging or breaching of termite barriers - adjacent internal flooring
Information:	Bridging is the spanning of a termite barrier or inspection zone so that subterranean termites are provided with passage over or around that barrier.

It is important for internal flooring to be raised above adjacent external ground levels. Where external ground levels are above internal flooring water pooling and subsequent internal flooding is likely to occur which may attract termite activity to the internal area.

It is highly advised that a landscaper or paver be appointed to lower external grounds that are raised above adjacent internal flooring. Alternatively if external grounds and internal flooring is level installation of a raised door sill may be appropriate in preventing any water pooling in the area.

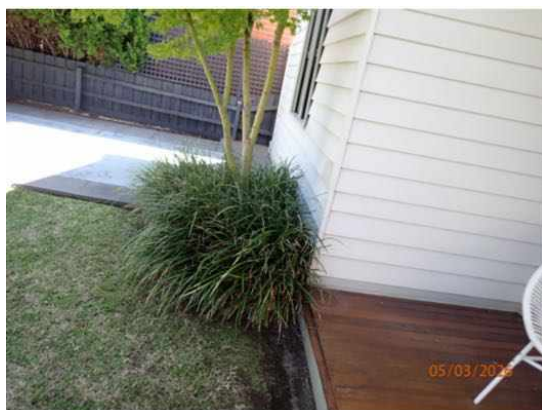
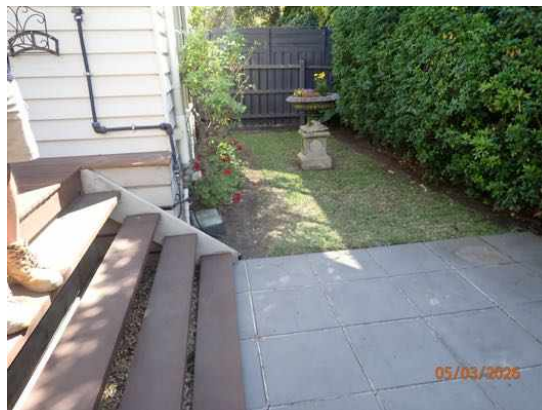
Finding 6.07

Building: Main Building
 Location: All External Areas
 Finding: Bridging - Vegetation
 Information: Where vegetation obstructs inspection of building elements, also known as bridging as it provides a bridging point for the access of termites, full inspection can not be achieved. Consequently moisture or dampness may be present and the areas becomes conducive to termite activity. Plants against or very close to buildings provide cover, shade and can provide an environment that is attractive to termite infestation.

The removal and replanting of species that do not provide "cover" or cutting back of existing vegetation will assist greatly in preventing Bridging from occurring.

The removal of any such materials that may be conducive to termite activity should be carried out as soon as possible and arrange re inspection to minimize the risk of termite attack.

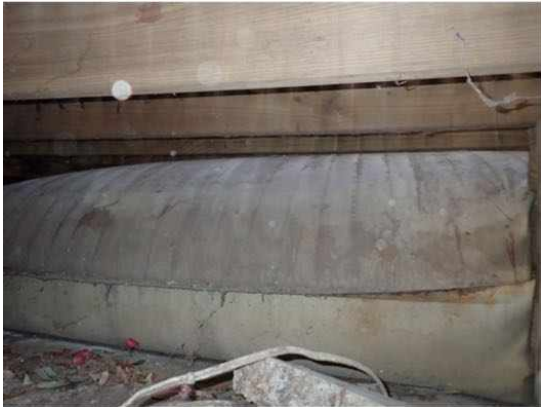
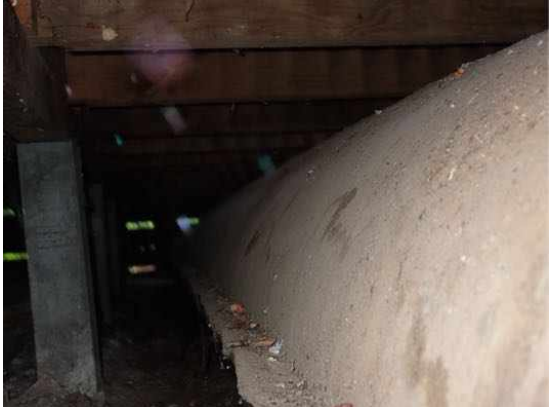
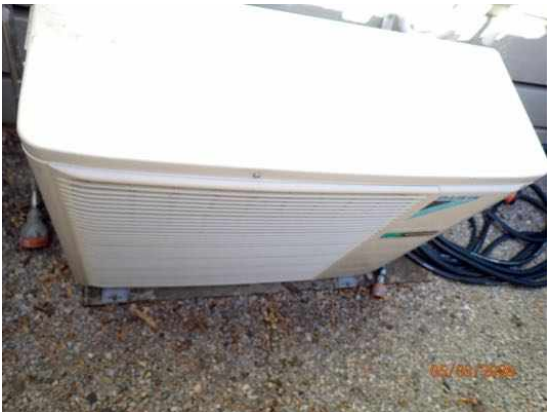
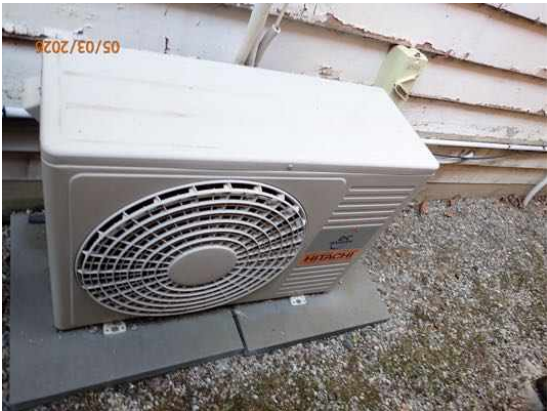
Finding 6.08

Building: Main Building
 Location: All External Areas
 Finding: Bridging or Obstruction - Air Conditioner, Hot Water & Storage
 Information: Bridging of termite barriers occurs when termites bridge (usually by building a mud

Where bridging has occurred full inspection is prevented and termites may enter a property in a concealed or undetectable manner.

Recommend moving obstructions away from the external walls for further and future inspections.

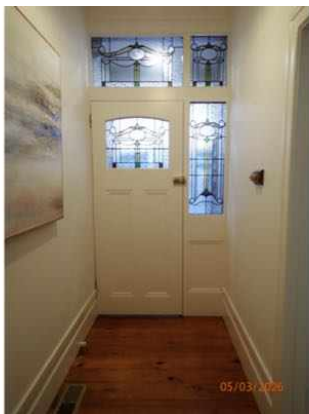
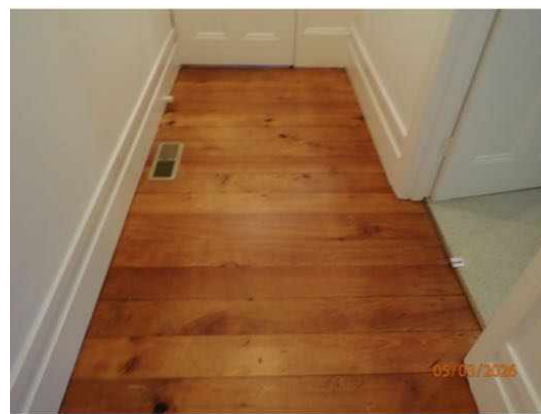
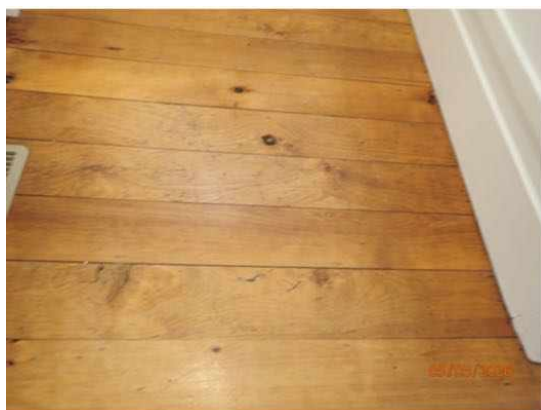
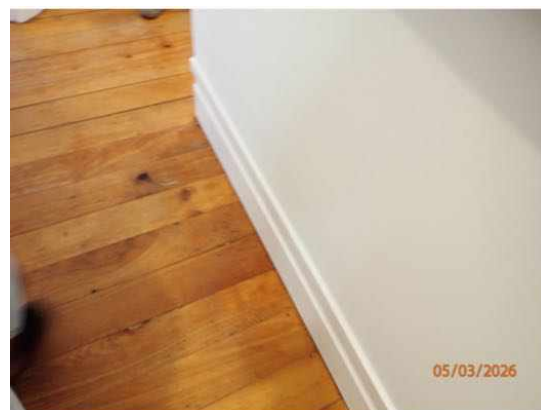
Building: Main Building
 Location: All Internal Areas to the original section of the property
 Finding: Evidence of wood borer activity identified
 Information: Wood borers small beetles that colonise in exposed timber elements are a common timber pest that are regularly mistaken for termites. Although wood borer activity is generally not detrimental to the affected timber they may lead to serious damage and necessitate replacement of certain building elements if left unattended.

The other commonly known borer the Anobium borer is more likely to attack floorboards and may cause severe structural damage to flooring areas.

As no live wood borer activity was identified treatment is not required at this time. Replacement of affected timbers may be considered by the client for superficial reasons.

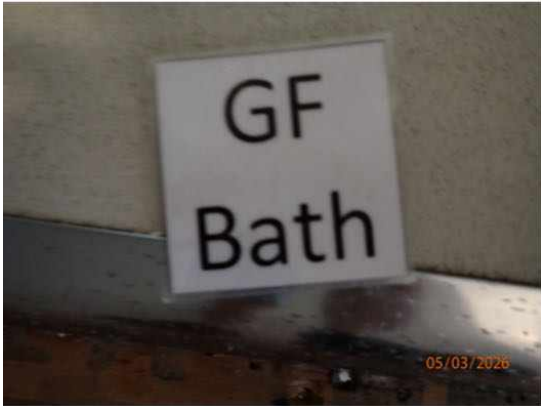
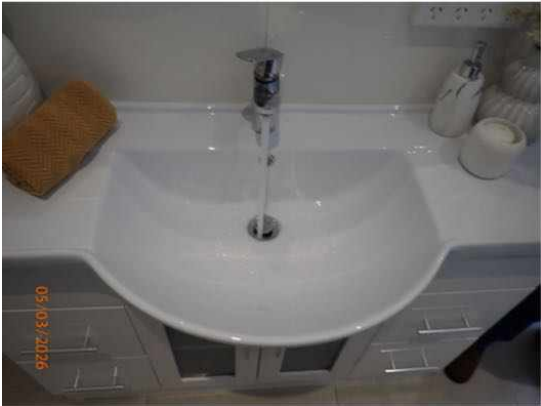
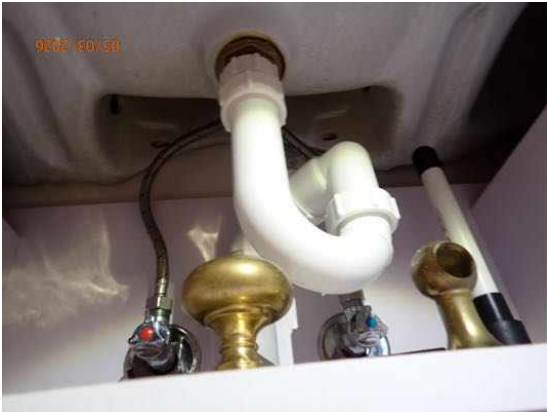
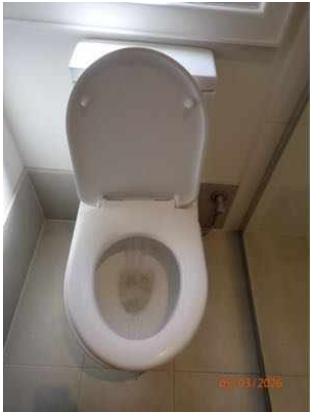
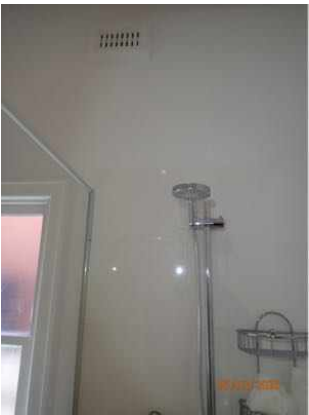
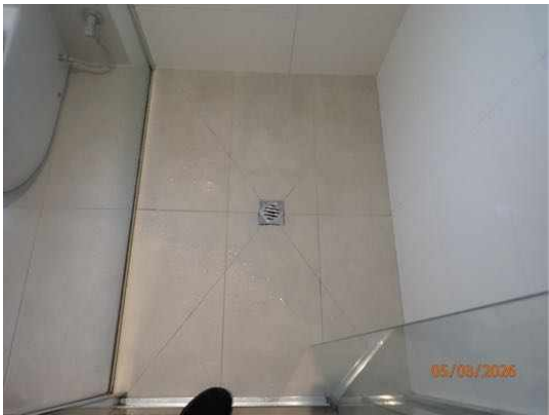
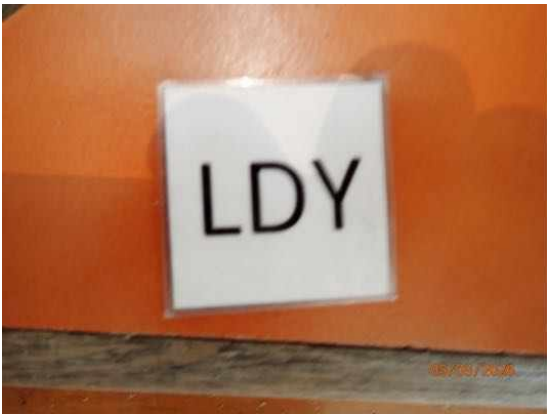
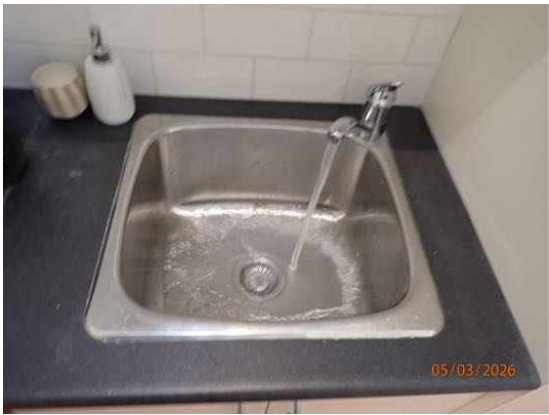
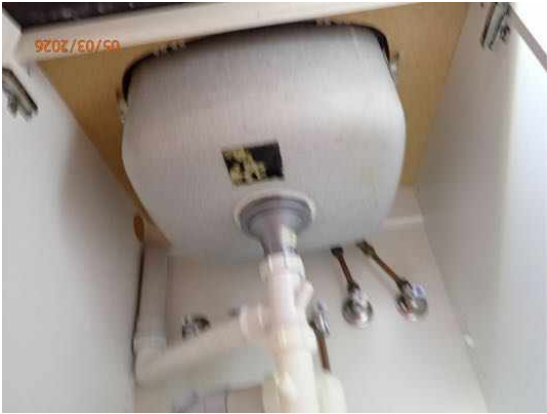
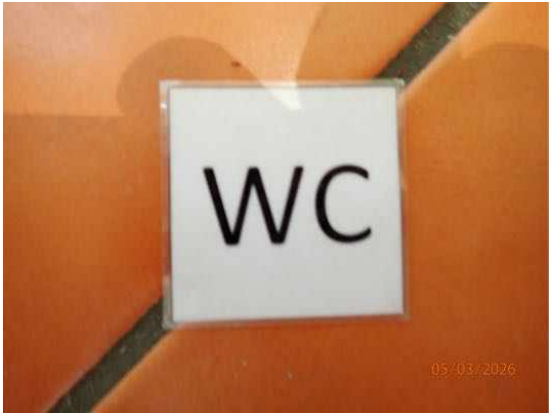
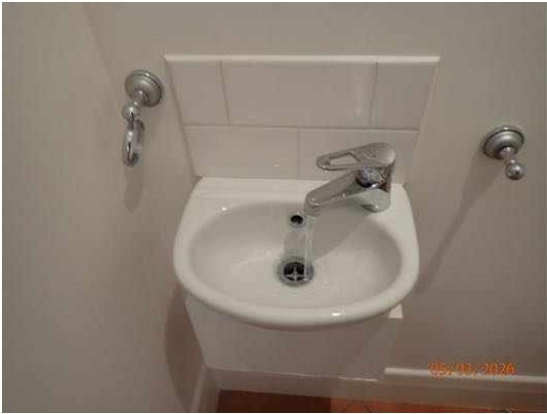
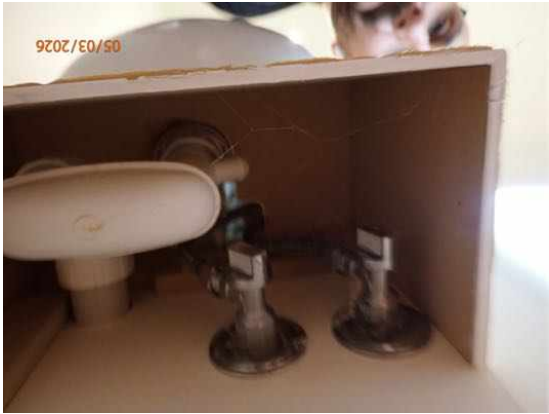
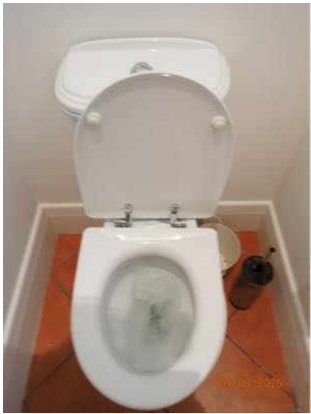
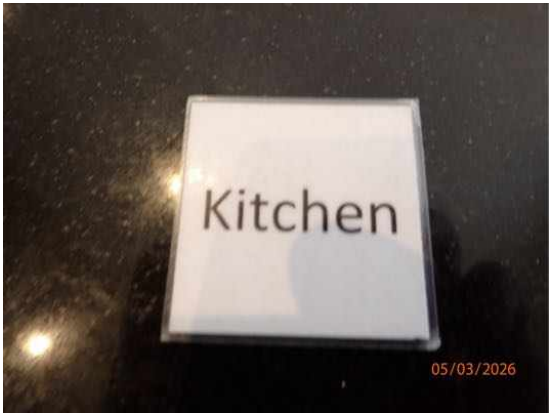
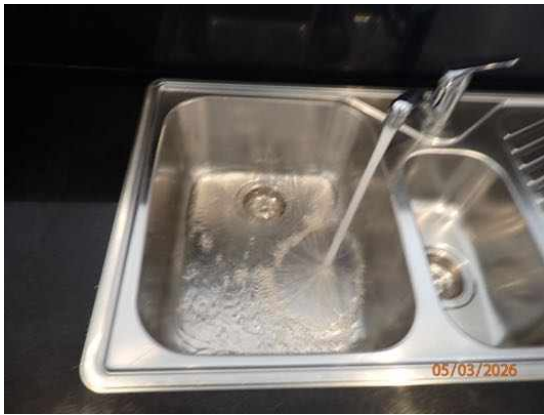
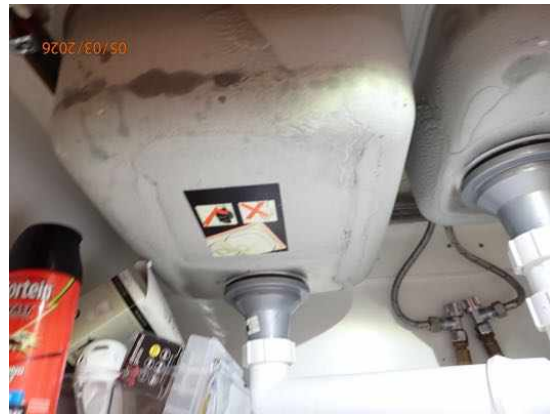
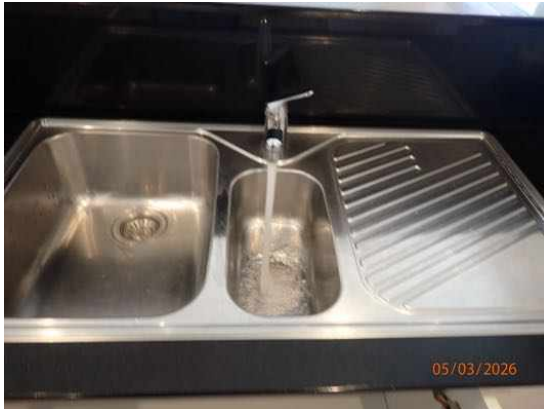
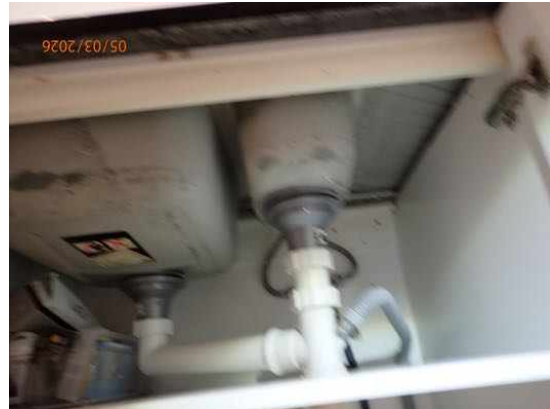
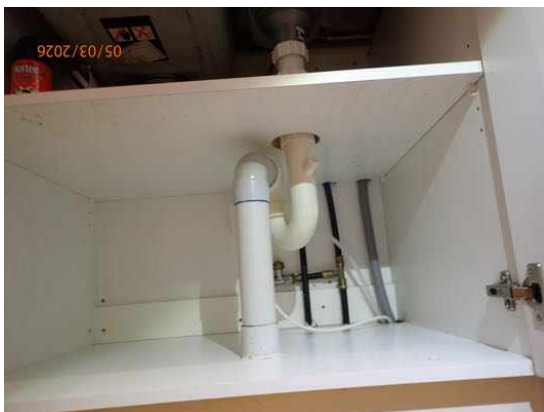
Building: Main Building
 Location: All Internal Areas
 Finding: Shower, Bath, Toilet & Basin Condition
 Information: The shower recess was tested and there was no visible water penetration to surrounding areas unless otherwise stated in a separate defect of the report. The water appeared to flow freely towards the floor waste at the time of inspection. Moisture was detected to the shower walls and the severity is documented within the report. The shower floor waste appeared to be clear at the time of inspection. No leaks were visible during flushing the toilet and appeared to operate as normal unless otherwise stated in a separate defect within the report. No water damage was noted

to the vanity unit at the time of inspection unless otherwise stated in a separate defect within the report. Basins, laundry tubs, vanity's and sinks were water tested and inspected and no evidence of leaks or blockages in the plumbing/drainage was present at the time of inspection unless otherwise stated in a separate defect within the report. All internal taps and shower heads were tested with no leaks unless otherwise stated in a separate defect within the report.

IMPORTANT NOTE: This test may not reveal water leaks until the shower or toilet are put into constant use and surrounding areas monitored over a period of time.

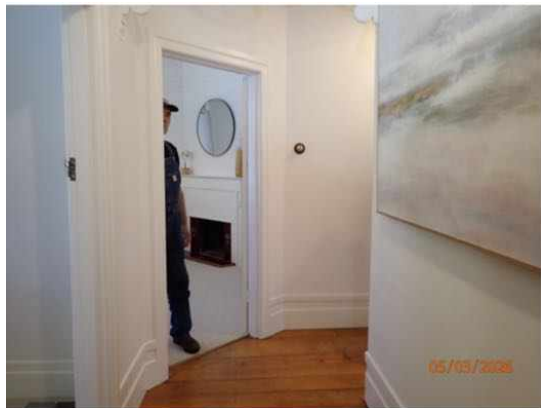
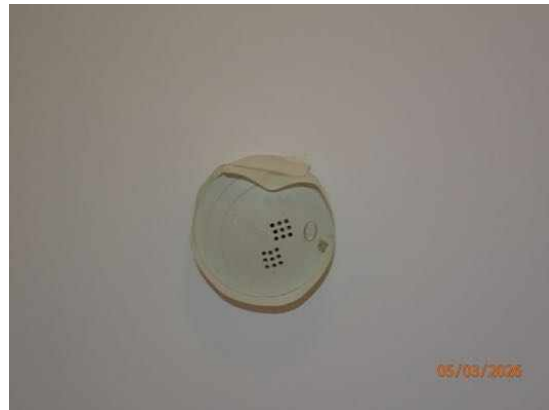
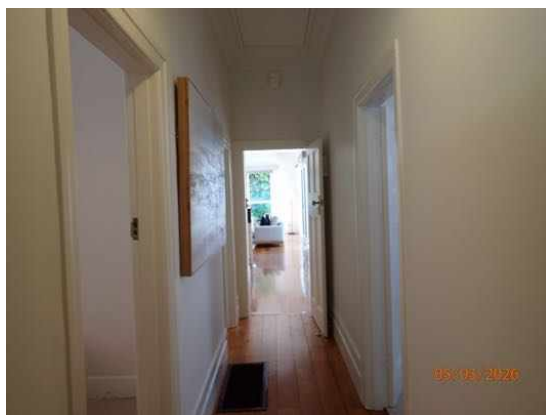
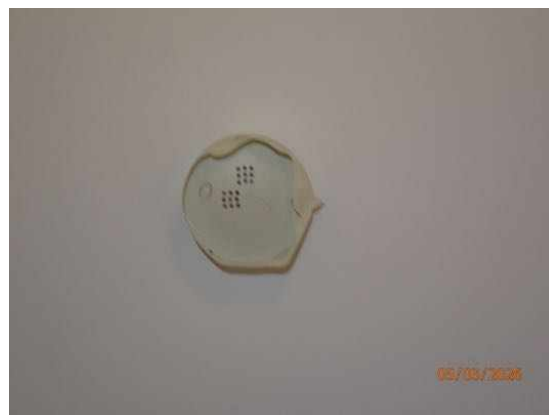
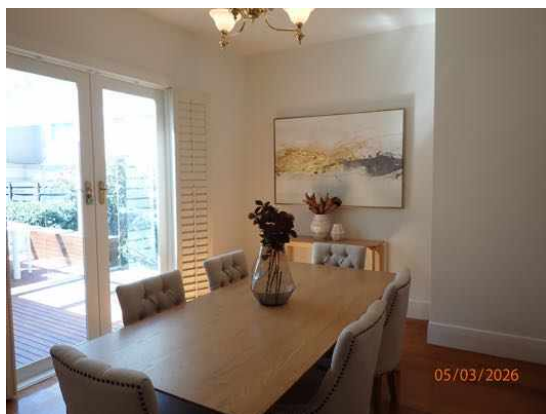
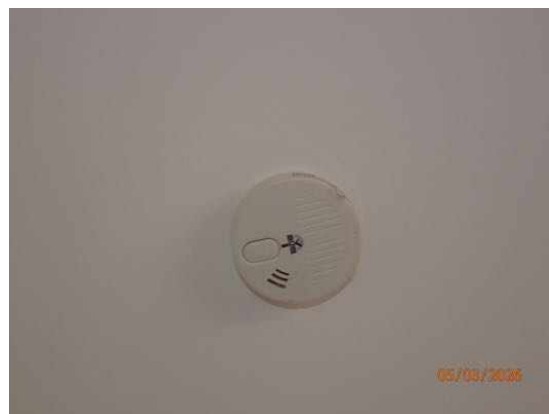
Information: Reporting on Smoke Detectors or Alarms, including hard wired smoke detection systems and their legislative requirements, is outside the Scope of this Report. Please note that this is highlighted as a caution only. Further Inspection and/or advisory services is necessary to provide advice on the sufficiency, type and location of smoke detectors, and to test the functionality of all devices. Always ensure sufficient working and suitable smoke detectors are installed prior to occupying any building. Additionally, it is advised that all smoke detectors be tested by the homeowner on a

monthly basis. Please refer to AS3786 and state based legislation, which may also apply.

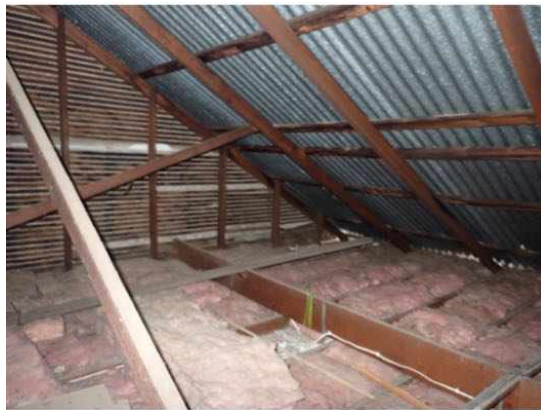
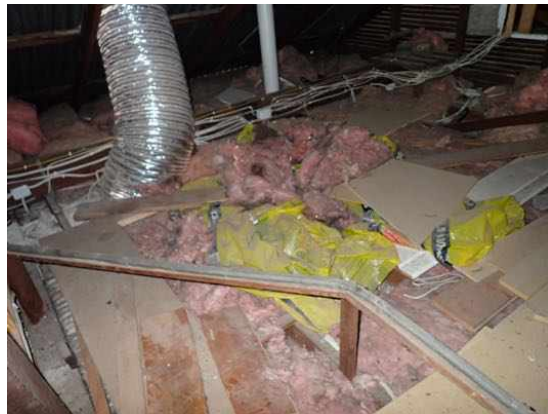
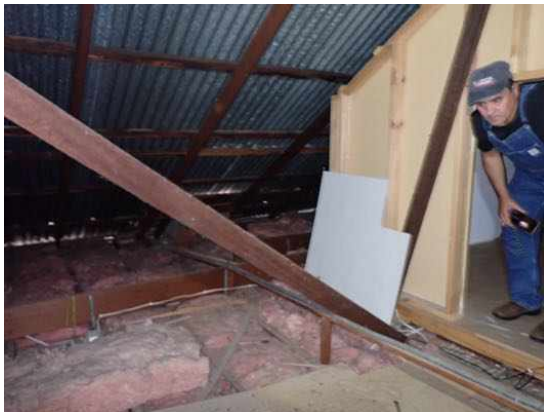
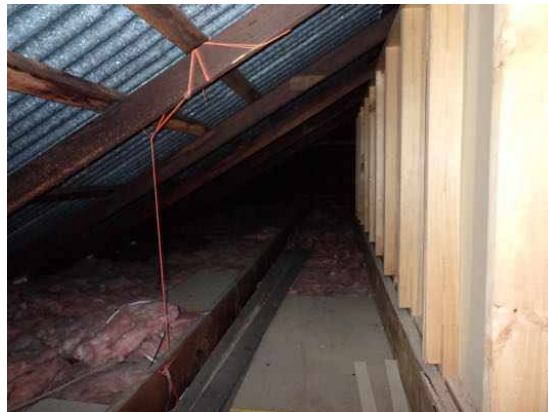
Building: Main Building
Location: Roof Void
Finding: Roof Void - Limited Access
Information: Limited access to the roof void was present due to facts including but not limited to, limited access, insulation, Air condition Unit & ducting, flooring, obstructions or placement of insulation and or sarking, for this reason complete access to the roof void was not possible.

Additional photos are supplied for your general reference.

NOTE: Unless all insulation is removed from the roof space a full inspection is never possible, timber pest or termite activity and/or damage may not be visible.

A visual inspection was carried out from accessible areas only, recommend installing another access hatch in a more accessible area for a re-inspection.

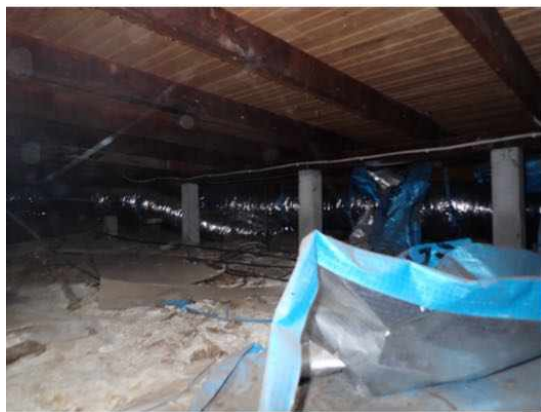
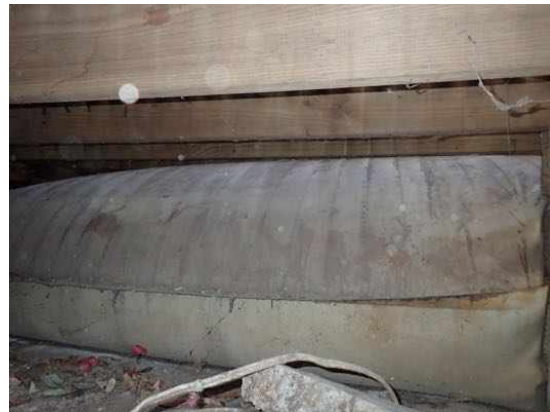
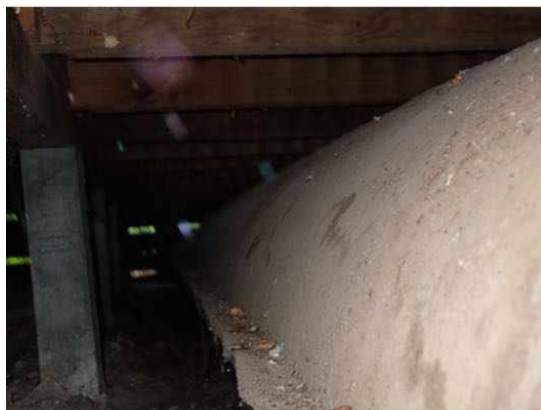
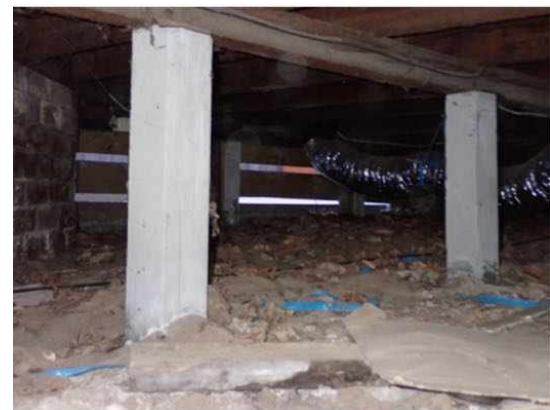
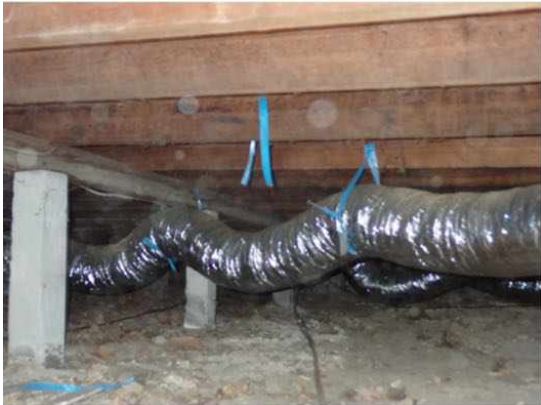
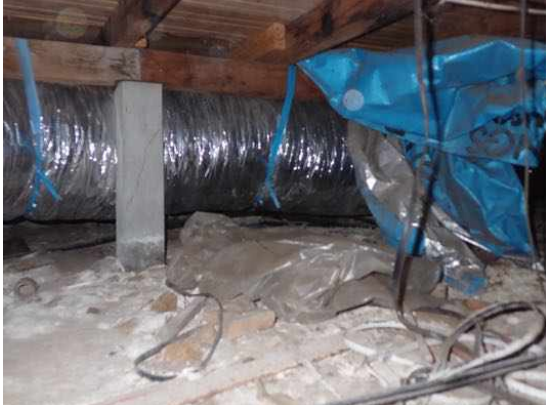
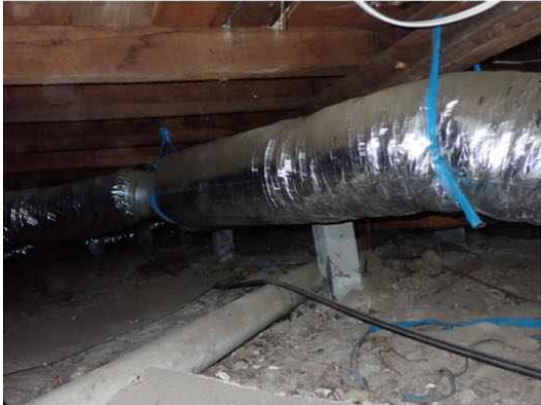
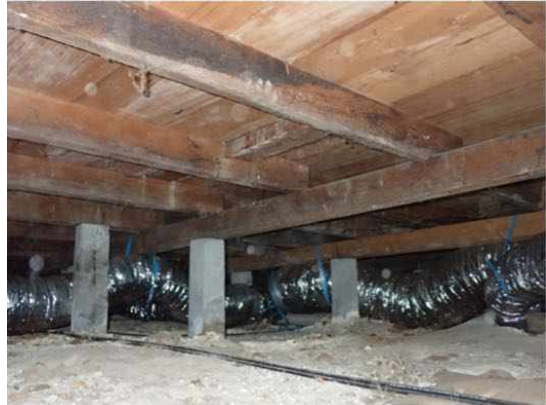
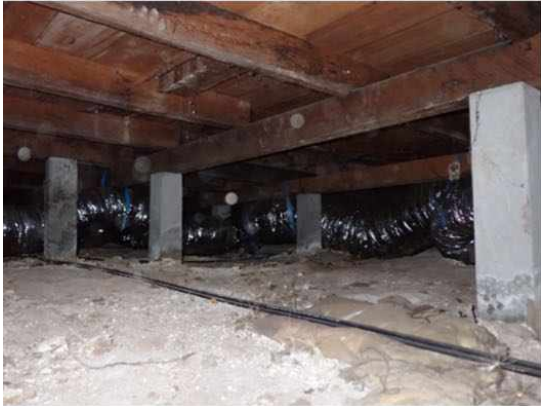
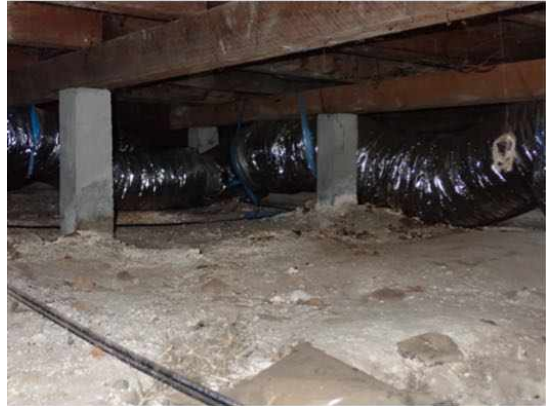
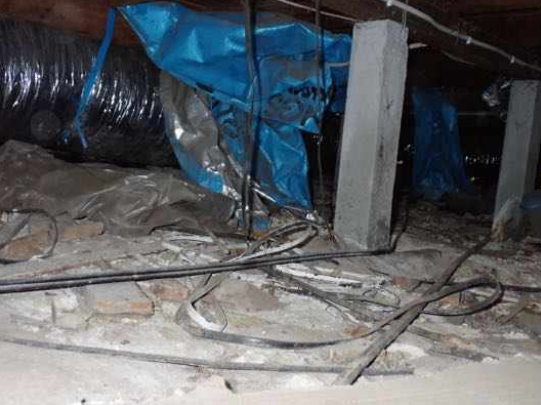
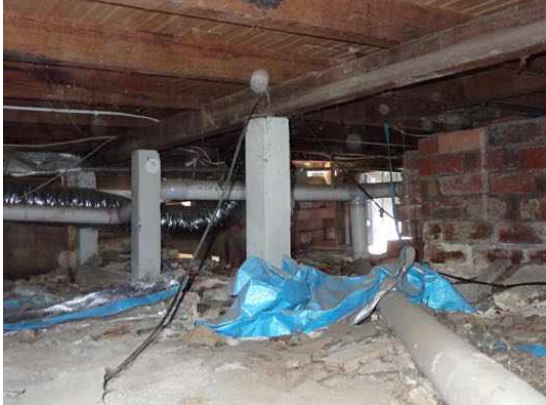
Building: Main Building
Location: Subfloor
Finding: Subfloor - Limited Access
Information: Limited access to the sub floor was present due to facts including but not limited to, limited access, water tank, Air condition ducting, obstructions or restricted crawl space, for this reason complete access to the roof void was not possible.

Additional photos are supplied for your general reference.

NOTE: Unless all insulation and or ducting is removed from the subfloor a full inspection is never possible, timber pest or termite activity and/or damage may not be visible.

A visual inspection was carried out from accessible areas only, recommend installing another access hatch in a more accessible area for a re-inspection.

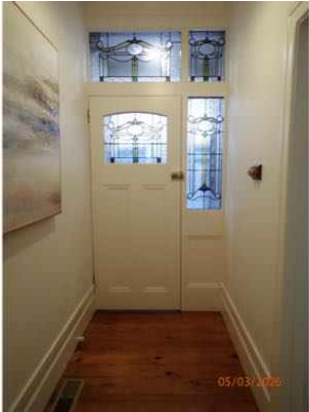
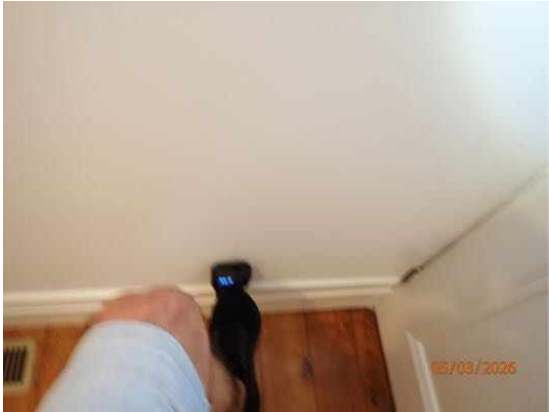
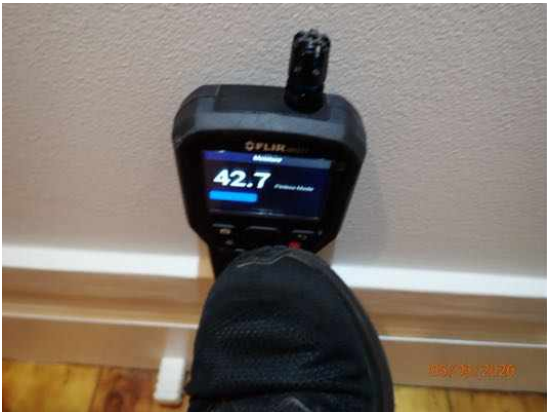
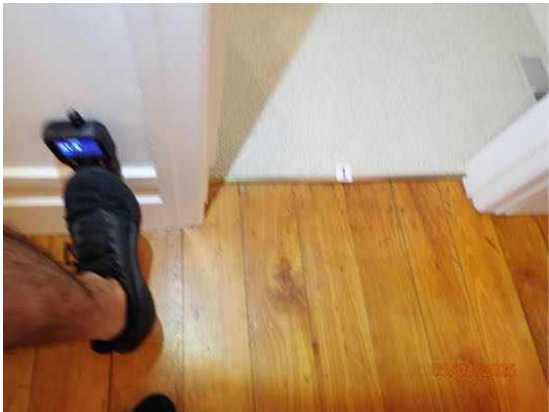
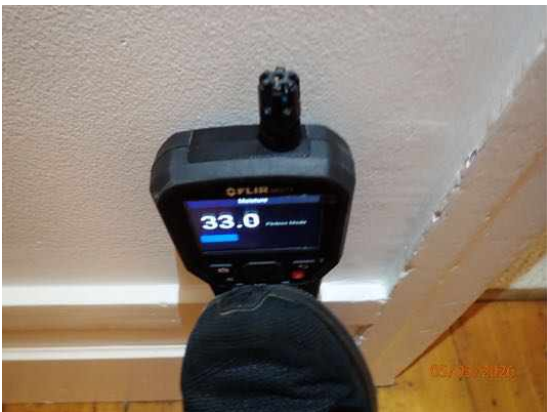
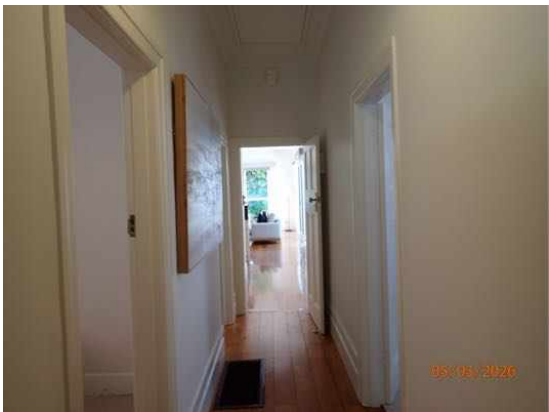
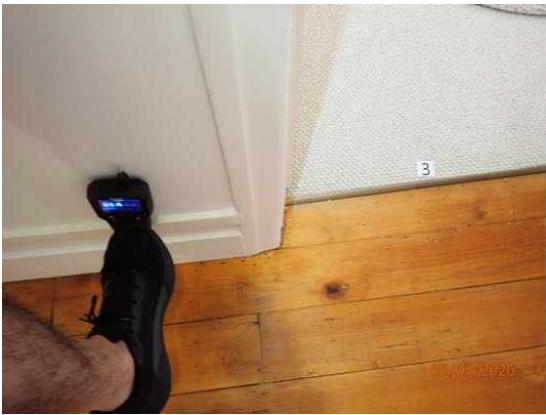
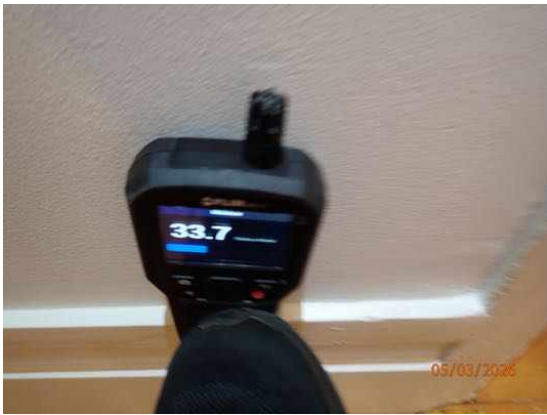
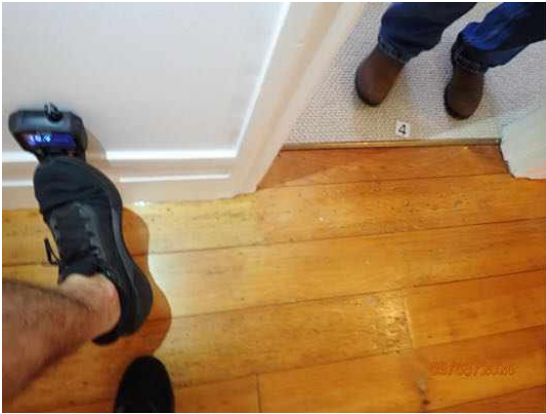
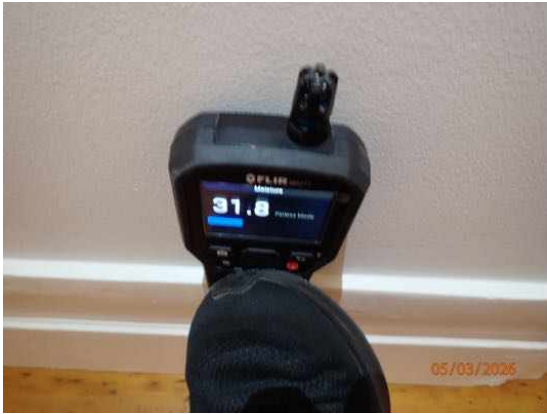
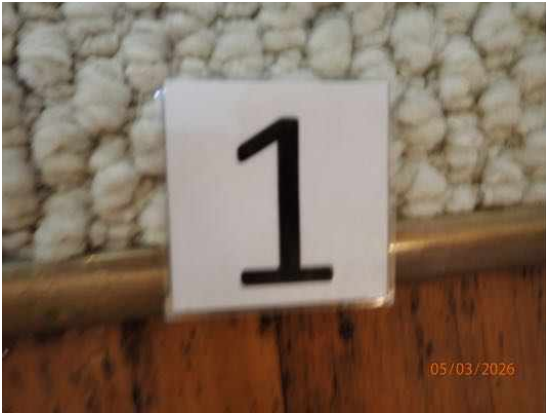
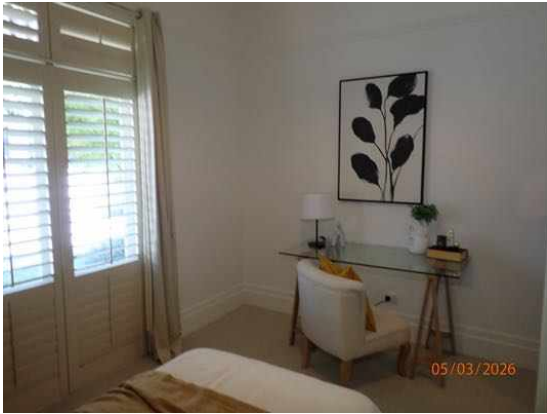
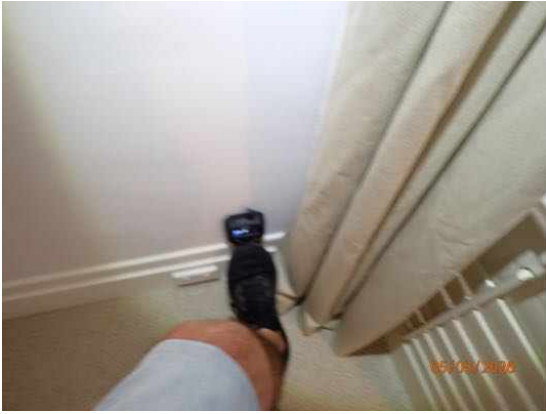
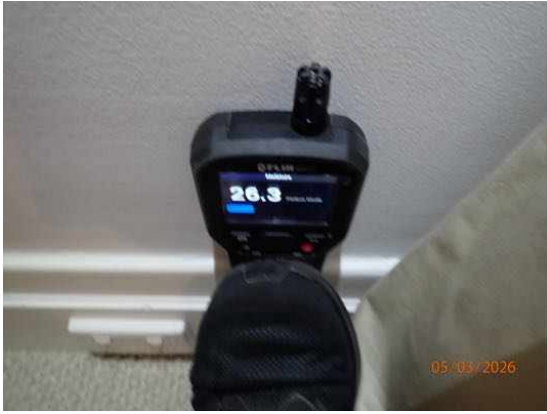
Building: Main Building
Location: All Internal Areas
Finding: Additional Photos Added - Moisture Readings
Information: Additional photos are added for your reference. Where additional moisture readings were made and clear of any elevated moisture present.
