Building and Timber Pest Inspection Report

Inspection Date: Thu, 5 Mar 2026

Property Address: 155 Eglinton St, Kew VIC 3101, Australia

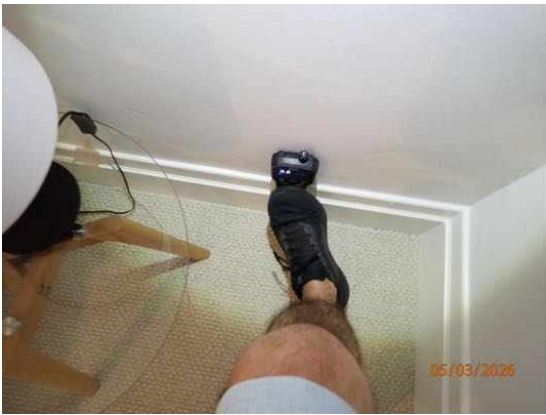
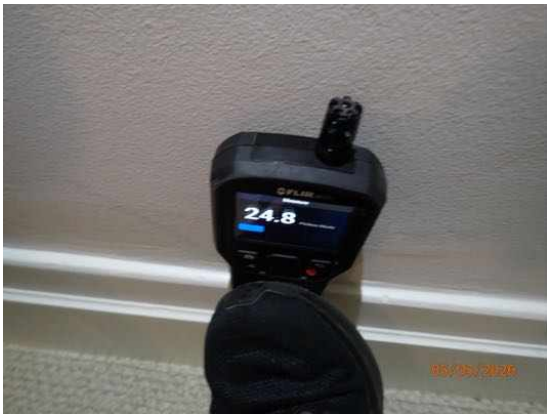
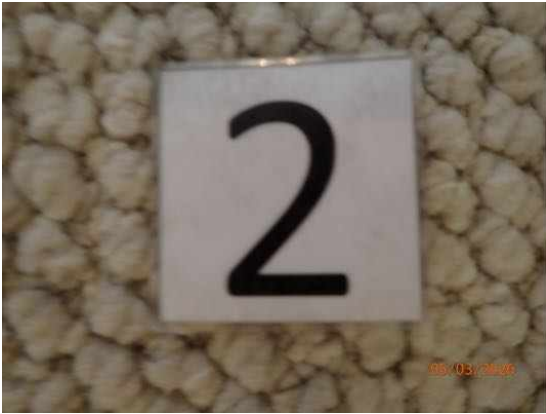
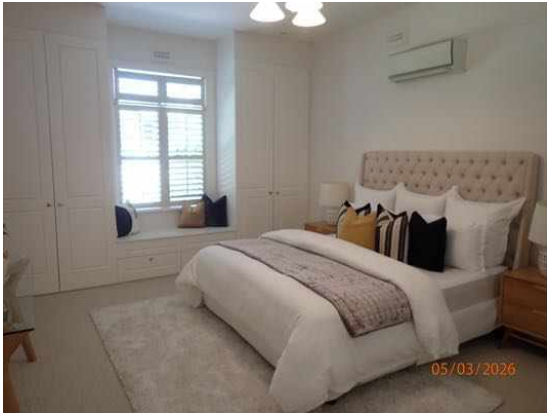
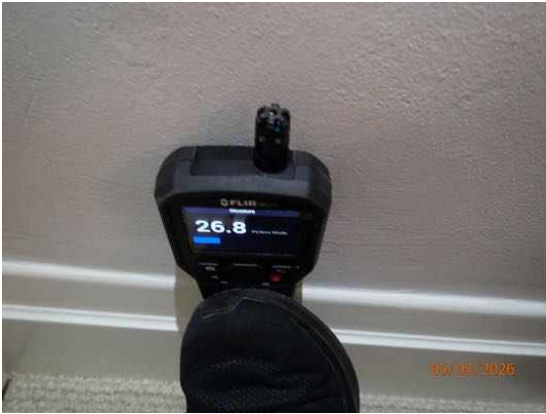
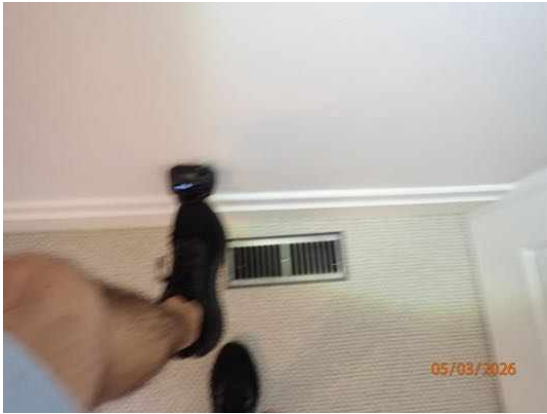
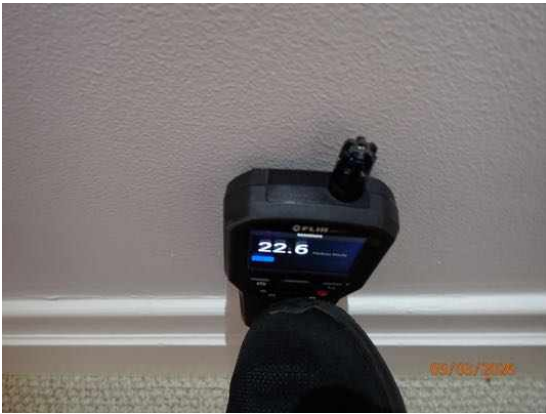
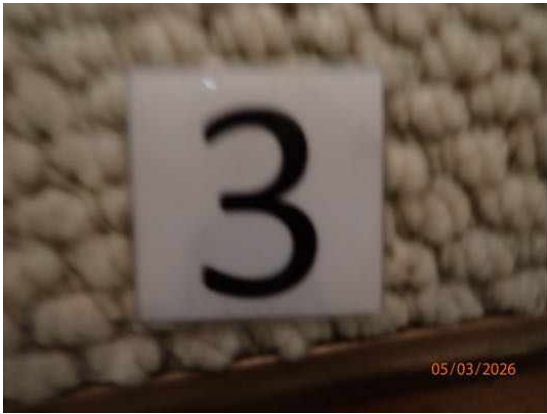
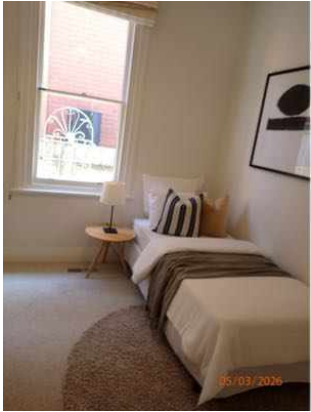
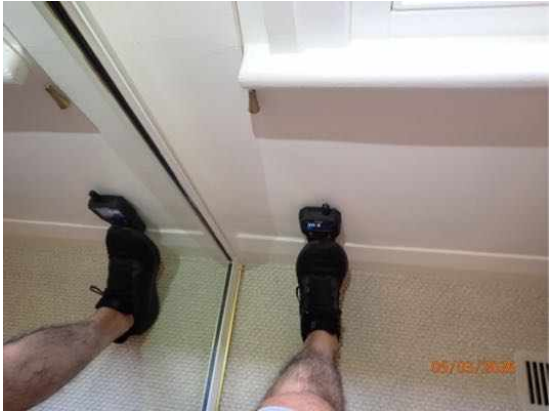
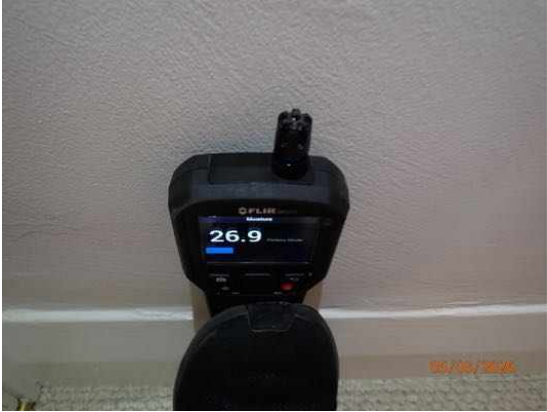
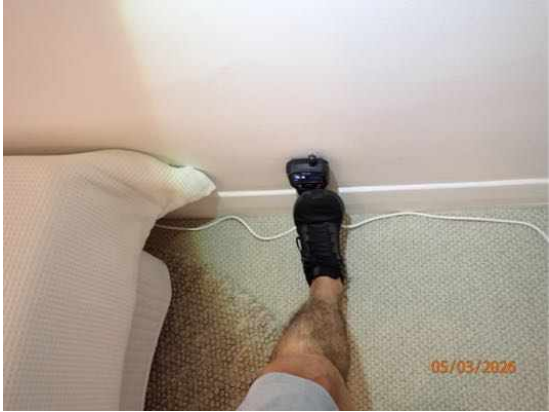
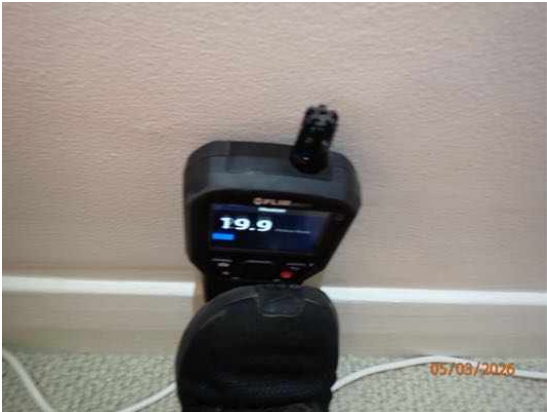
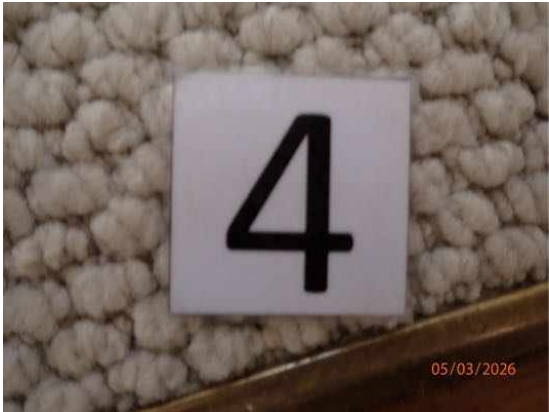
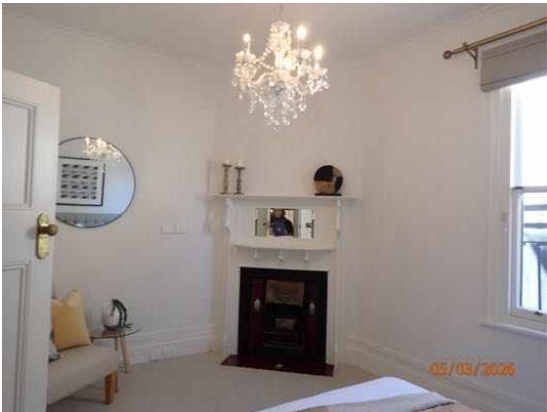
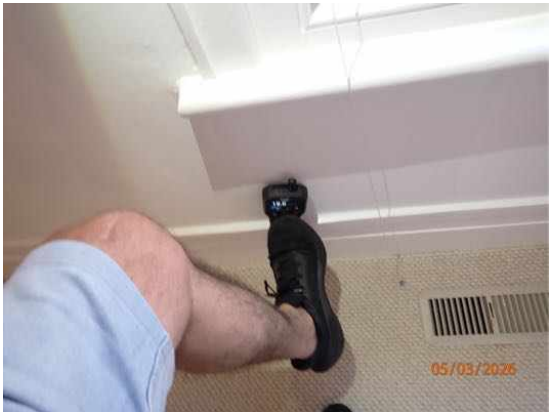
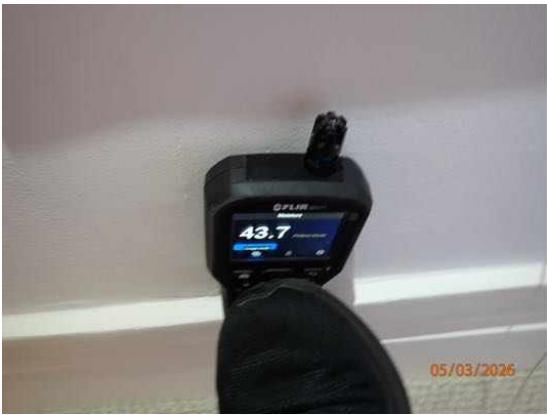
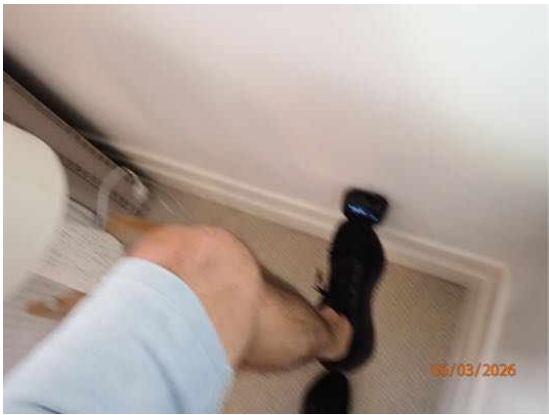
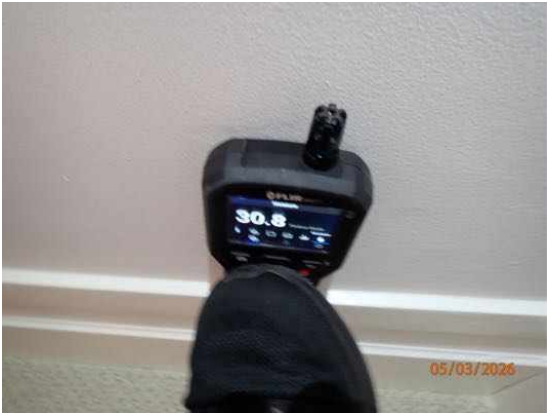
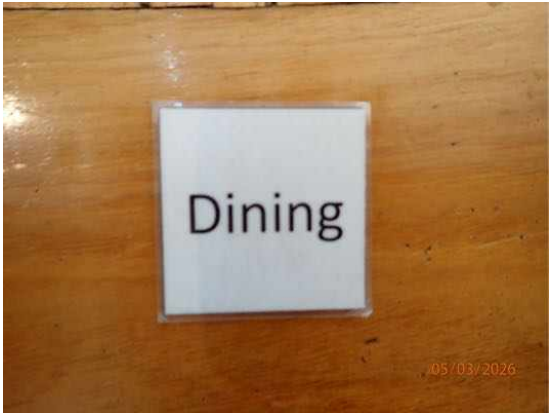
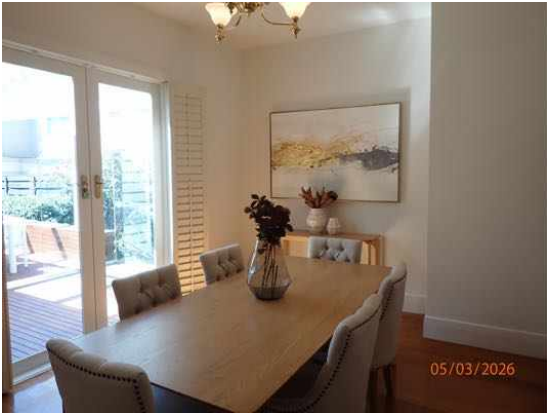
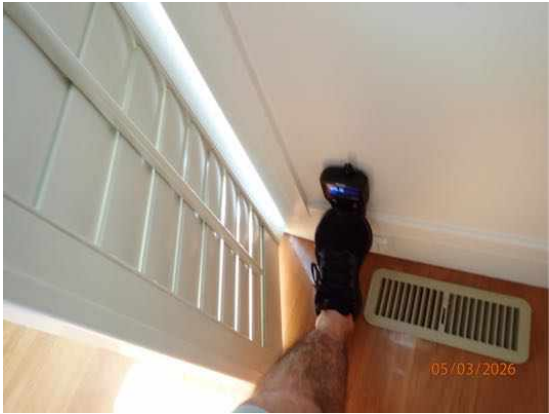
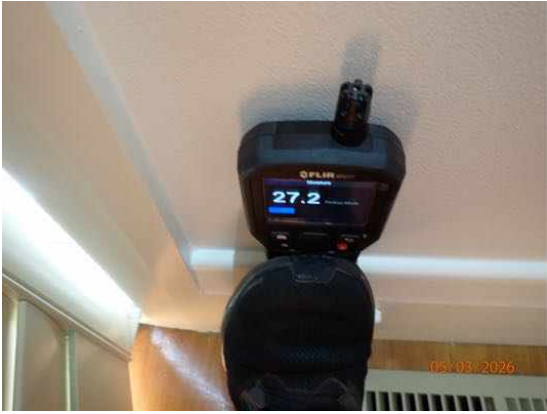
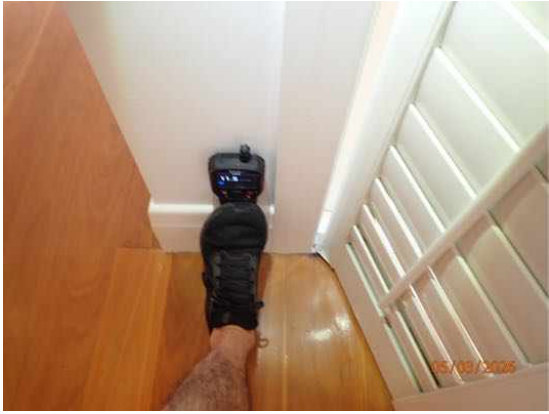
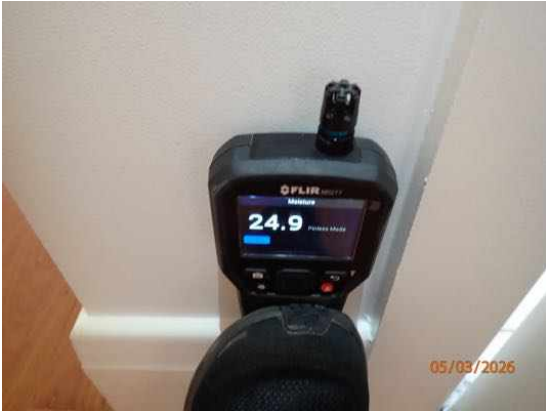
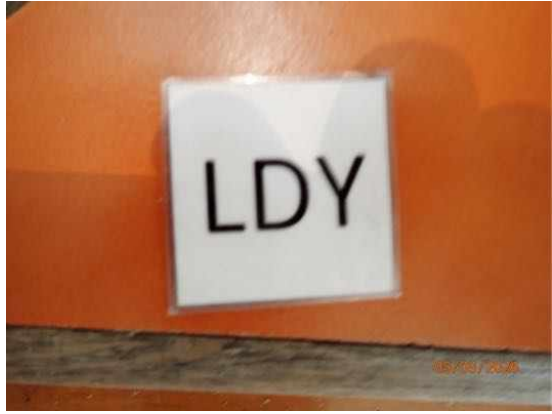
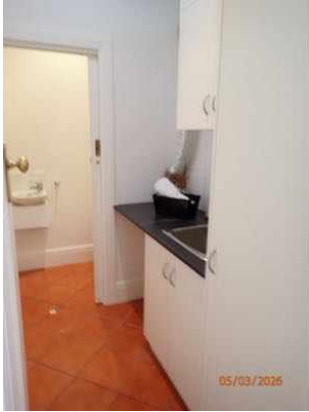
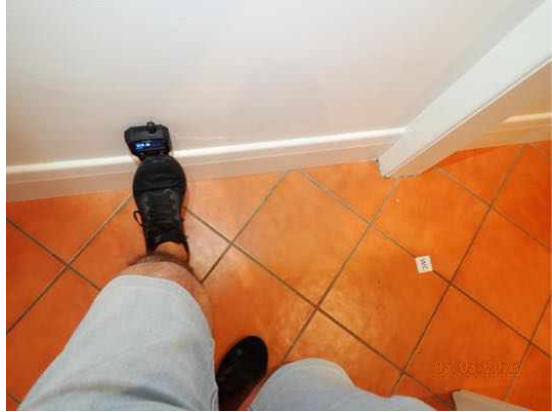
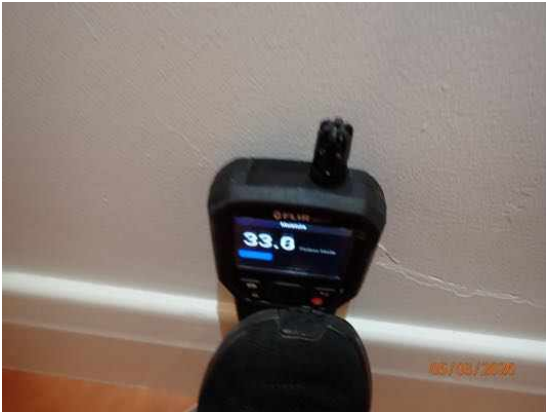
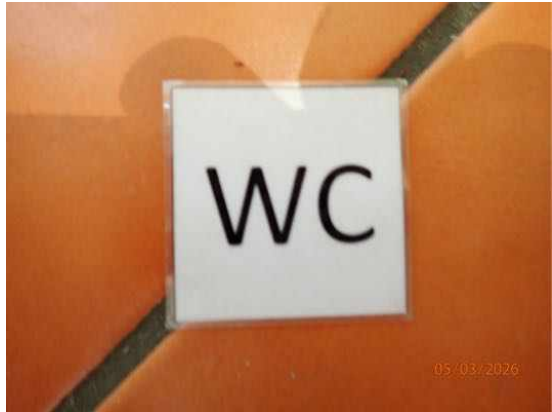
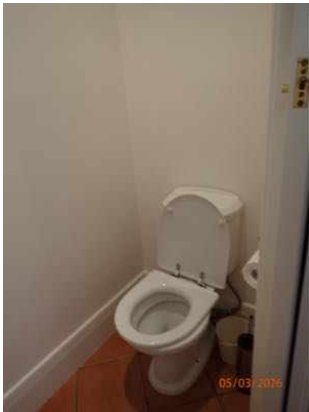
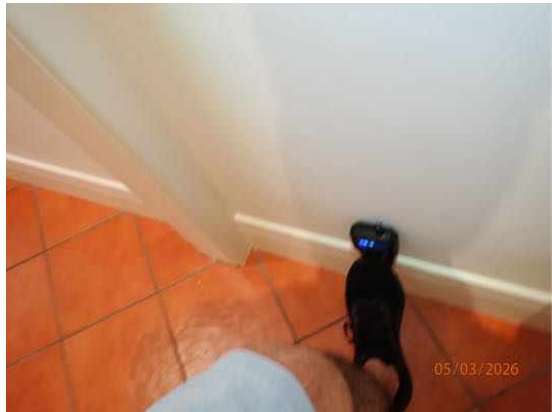
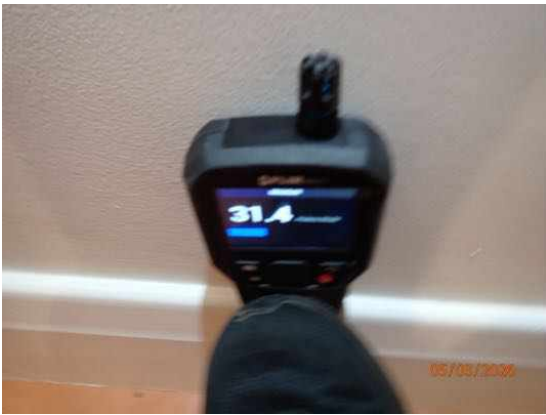
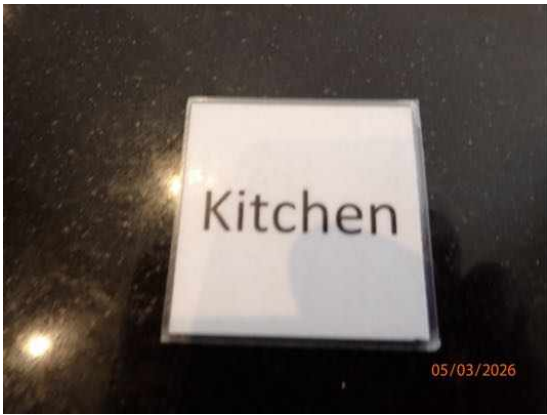
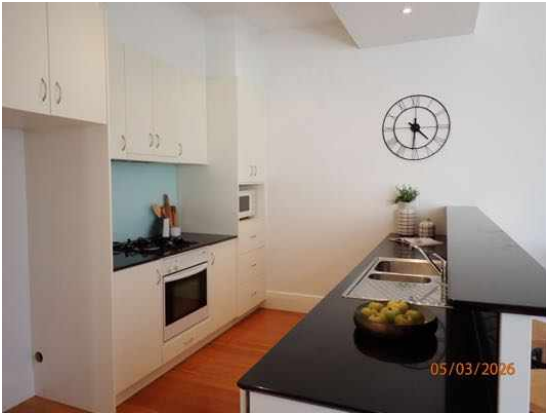
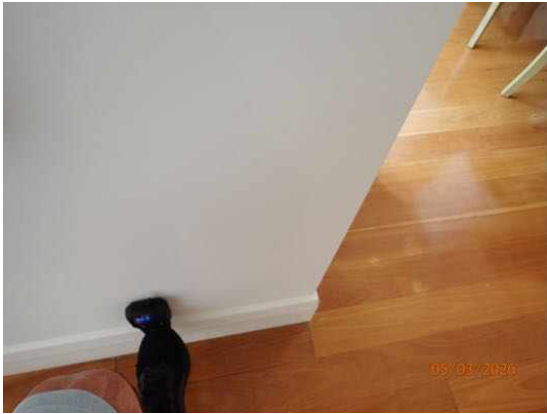
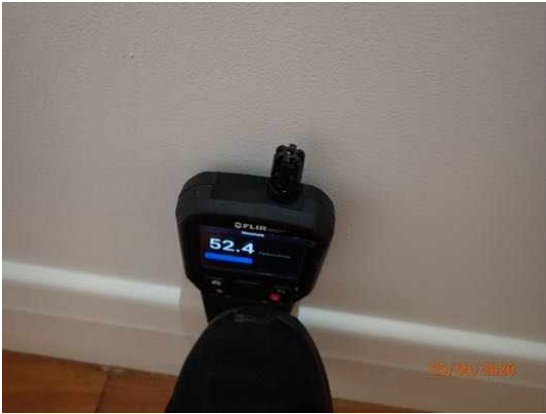
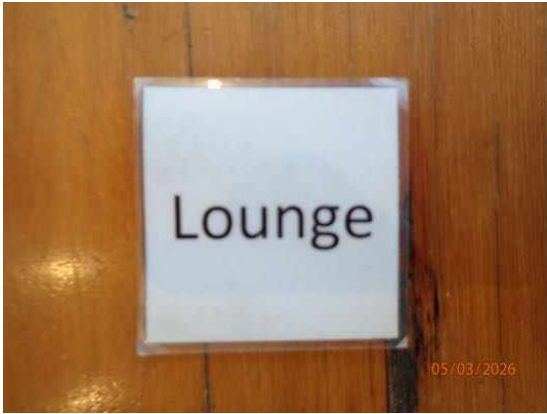
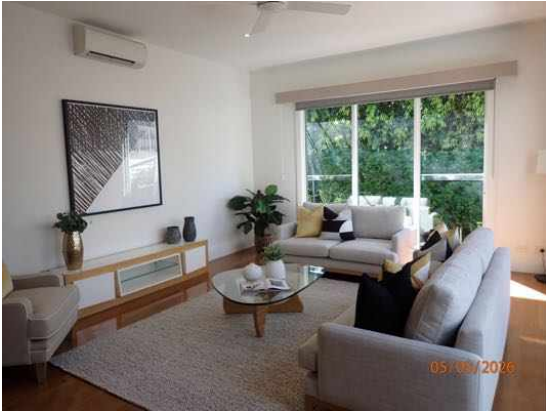
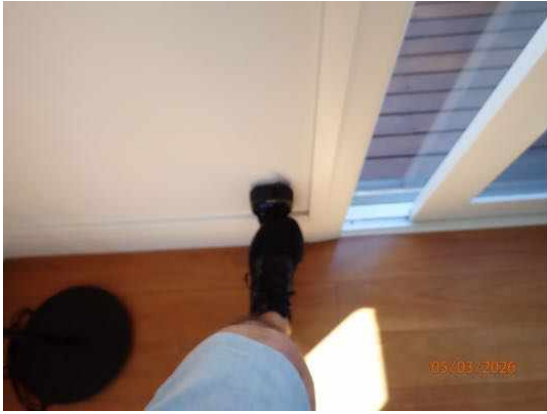
Building: Main Building
Location: All Internal Areas
Finding: Additional Photos Added - Moisture Readings
Information: Additional photos are added for your reference. Where additional moisture readings were made and clear of any elevated moisture present.

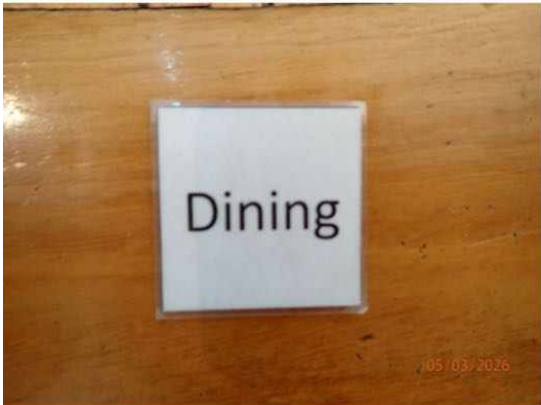
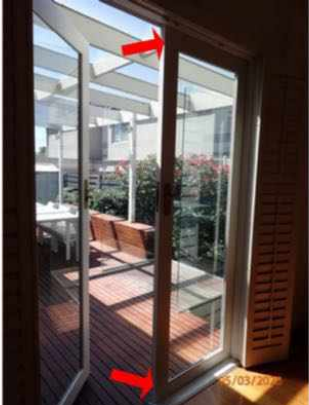
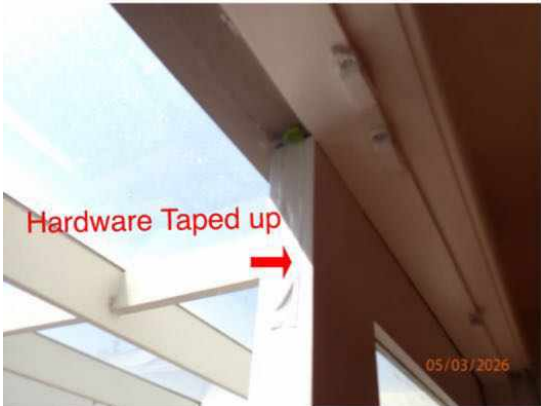
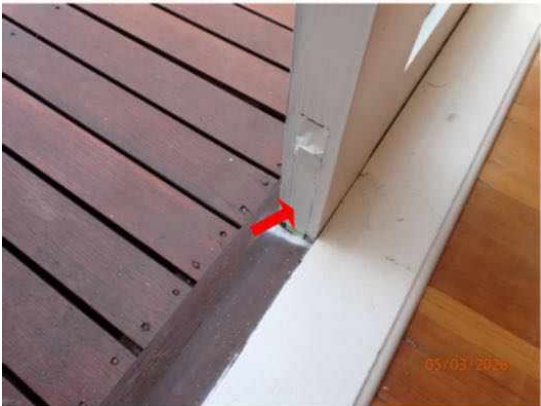
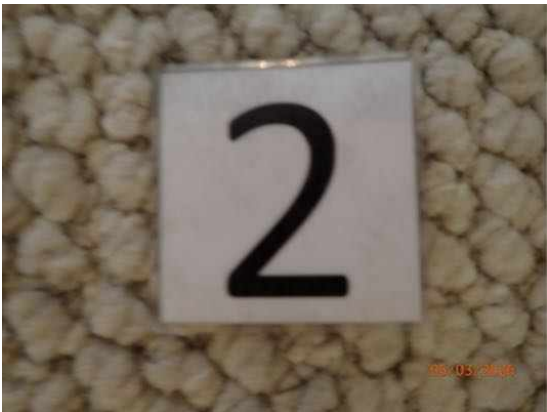
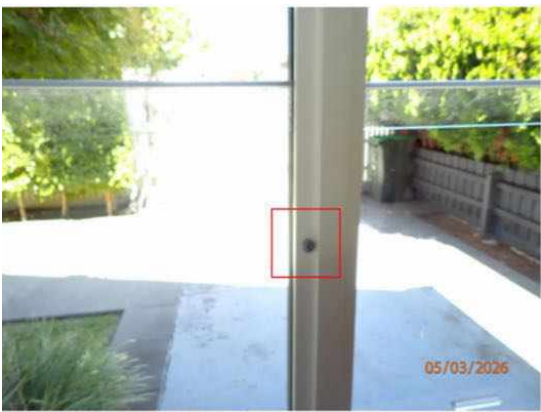
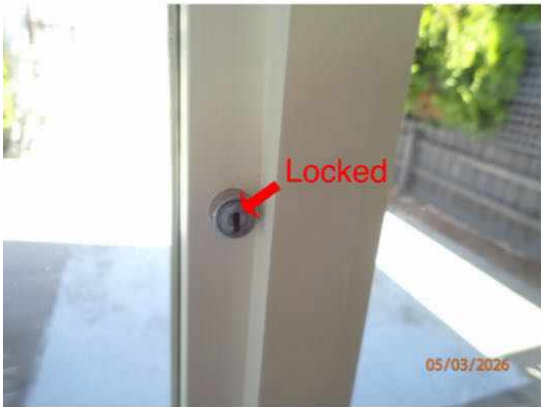
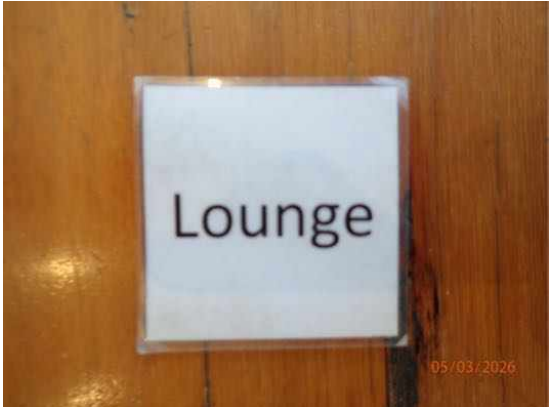
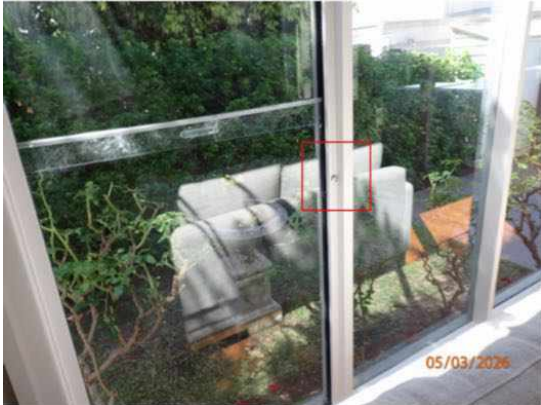
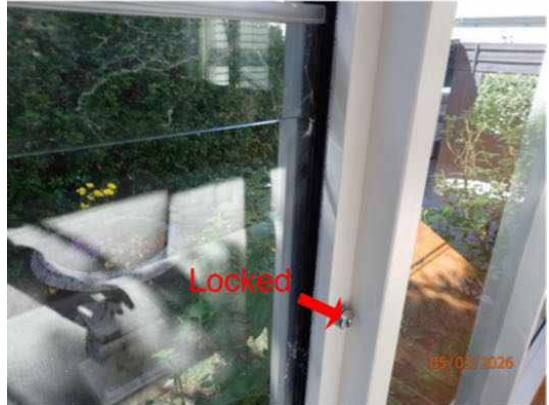
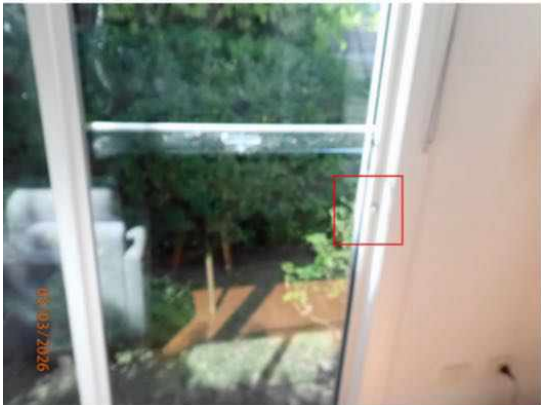
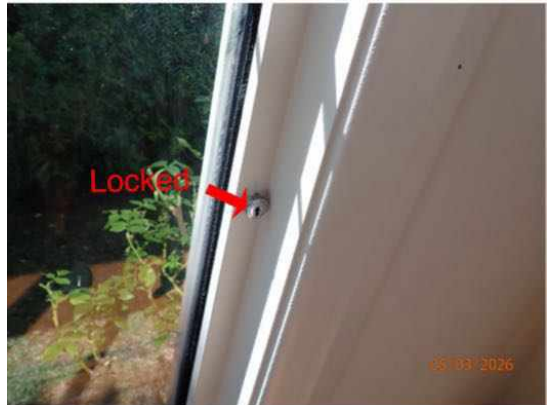
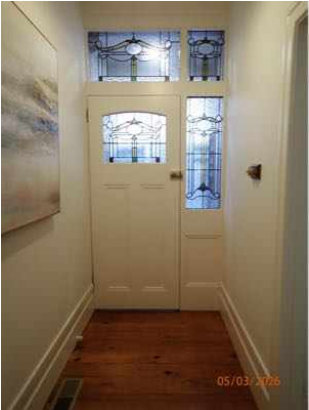
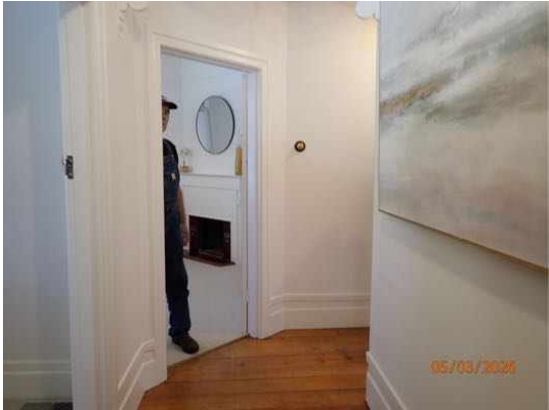
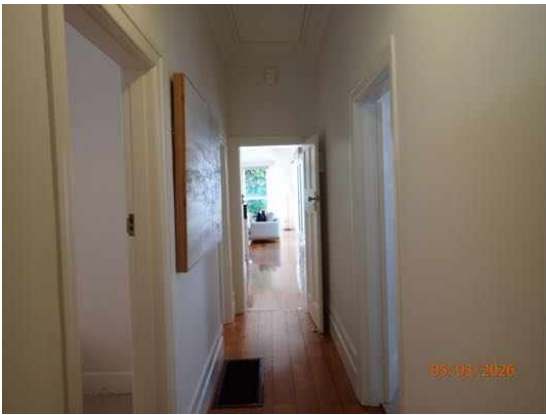
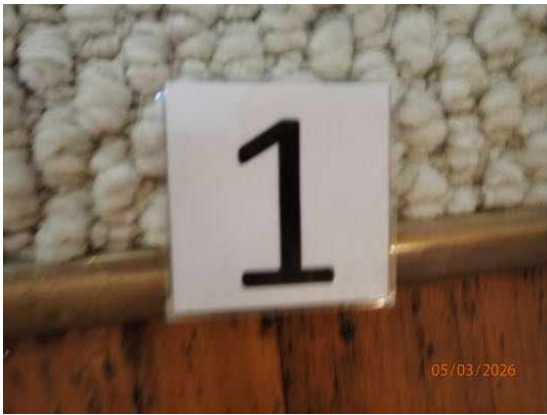
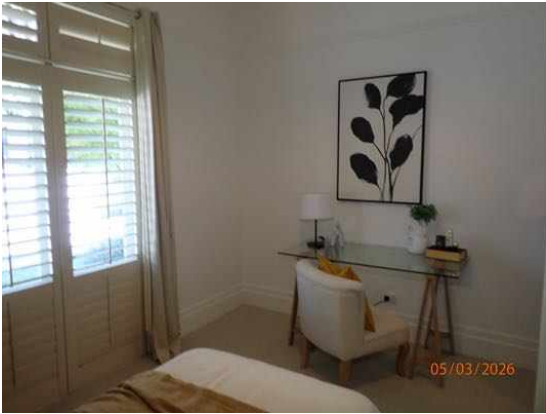
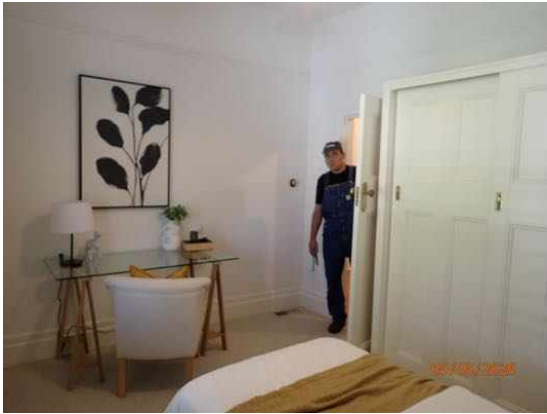
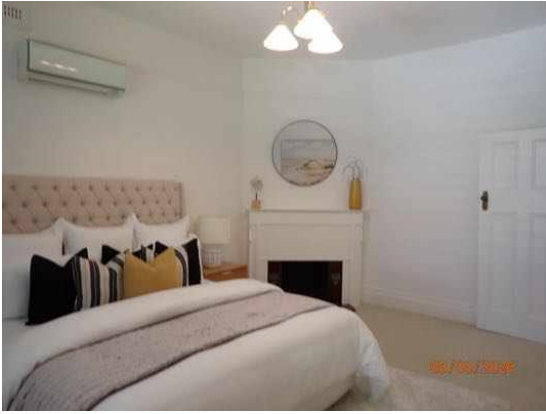
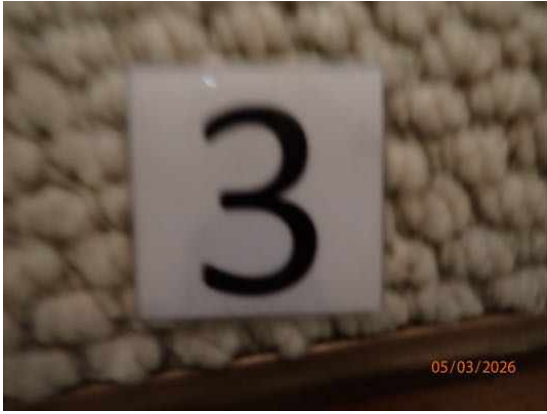
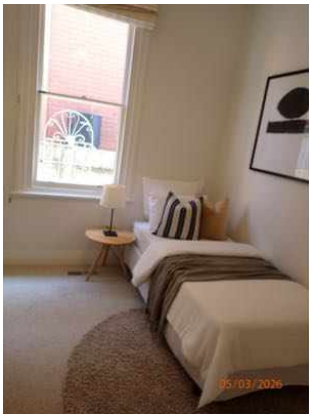
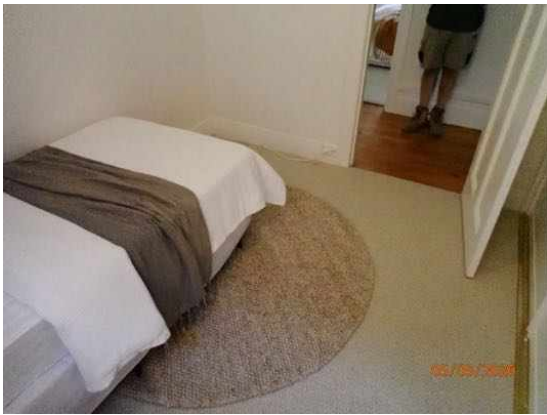
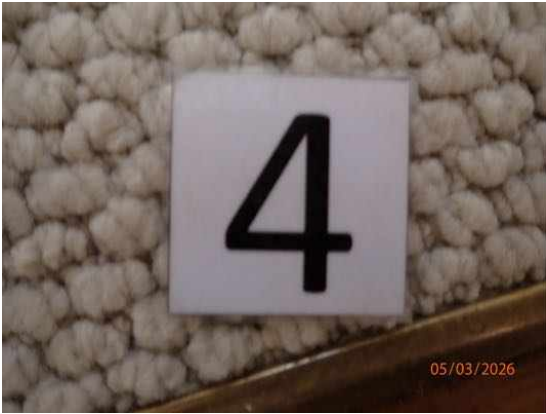
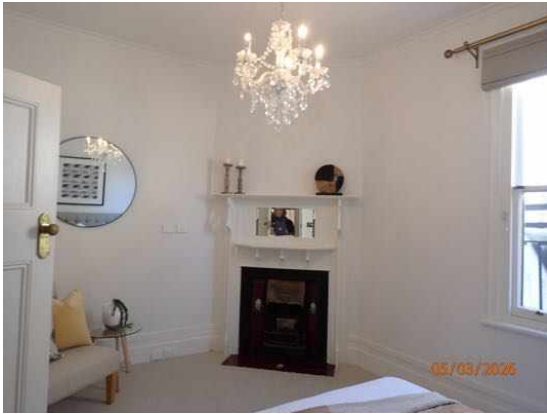
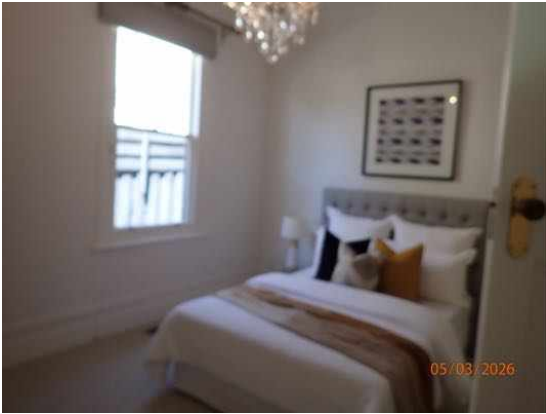
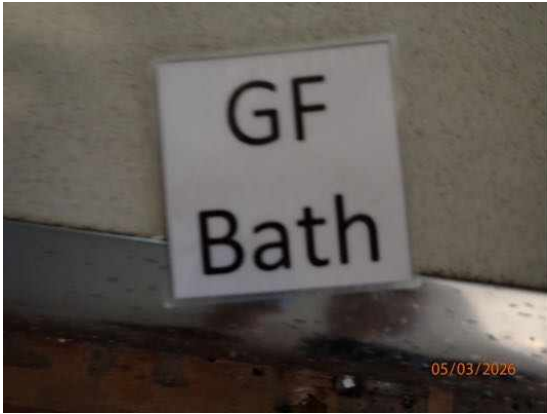
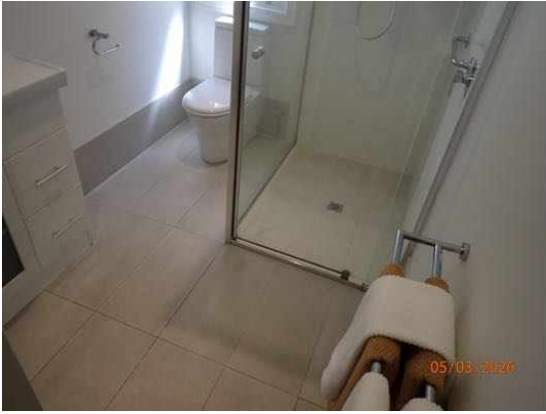
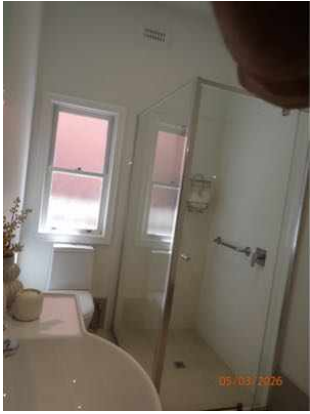
Building: Main Building
Location: All Areas
Finding: Additional Photos - Obstructions and Limitations
Information: These photographs are an indication of the obstructions and limitations which impeded full inspection of the property at the time of inspection. These obstructions can hide an array of defects and should be removed to allow full inspection to be carried out. A re-inspection is recommended once the areas are made accessible.
