Building and Timber Pest Inspection Report

Inspection Date: Tue, 24 Mar 2026

Property Address: 180 Lloyd St, Strathdale VIC 3550,
Australia

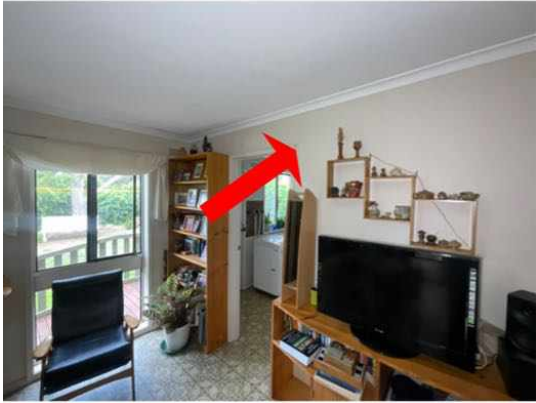
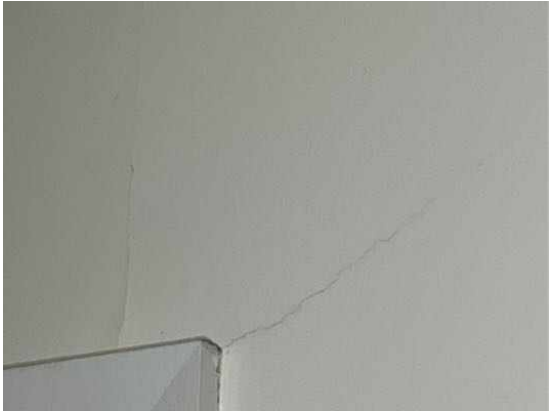
Building:	Building 1
Location:	Dining Room, lounge,
Finding:	Cracking - Damage Category 1 - Fine (up to 1mm)
Information:	Although fine cracks are quite noticeable, they are often only considered to be an appearance defect, and usually do not indicate any structural damage. Generally, the cause of a fine crack is indicative of a separation between building materials and finishes (e.g. paint, plaster, etc.) along joints.

Cracking of this nature can generally be repaired with minor sanding, filling and/or repainting. Such works should be performed by a qualified painter or a general handyman.

Monitoring of all cracking should be conducted frequently. Always contact a building inspector should cracks widen, lengthen, or become more numerous.

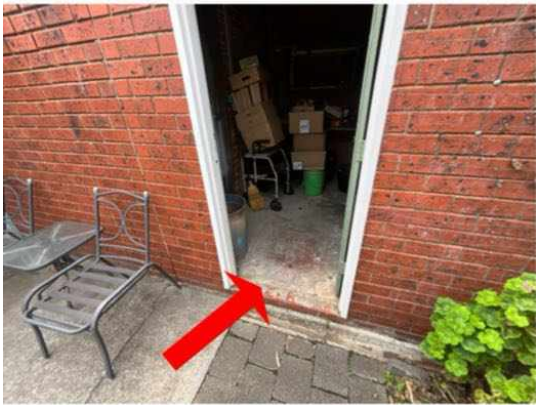
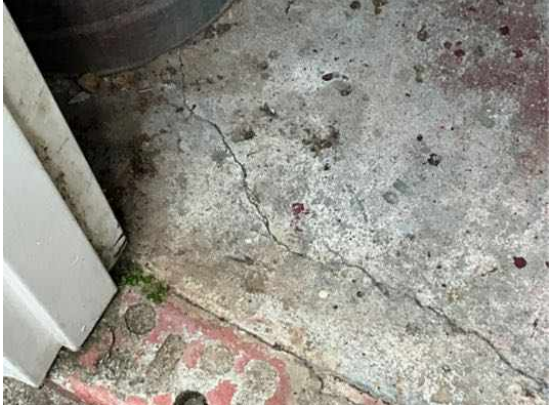
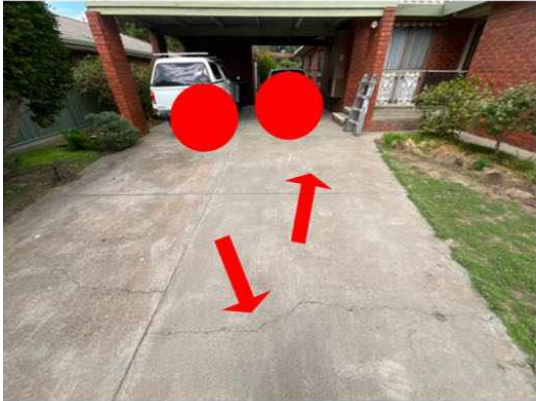
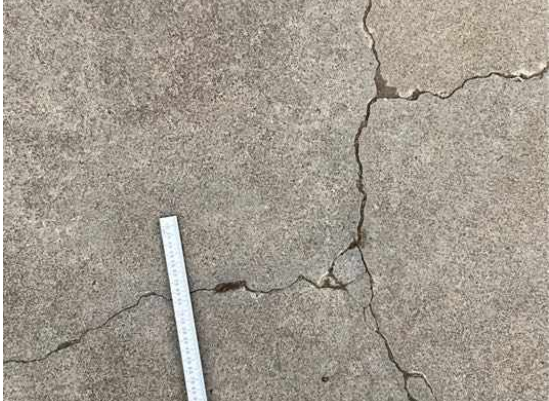
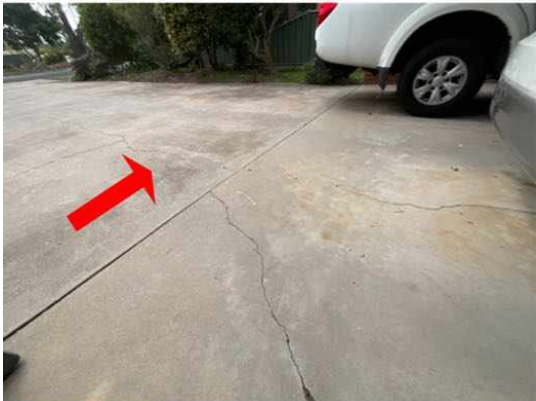
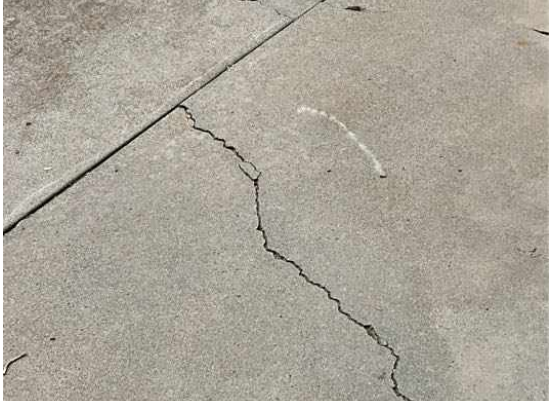
Building:	Building 1
Location:	Back door, yard, shed
Finding:	Cracking - External Concrete Paving Damage Category 3 - Wide Cracks (2mm - 4mm)
Information:	Wide cracks were identified in external concrete paving. Wide cracks are significant and are likely to lead to the development of safety hazards and secondary defects if left unmanaged.

Where the crack is located adjacent to structural elements of the building, the advice

of a Structural Engineer is advisable before undertaking repairs. Significant repair and likely replacement of the concrete paving is probable.

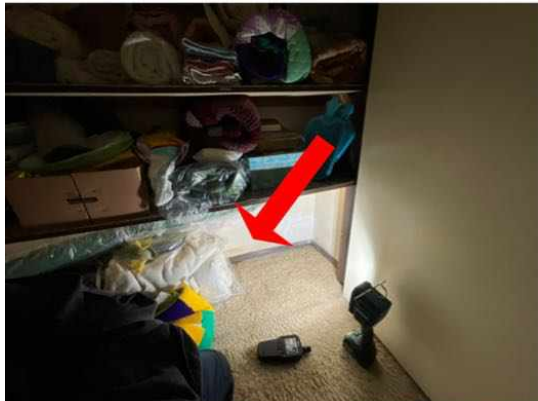
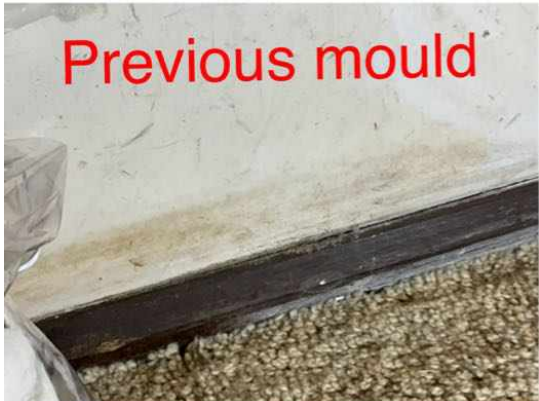
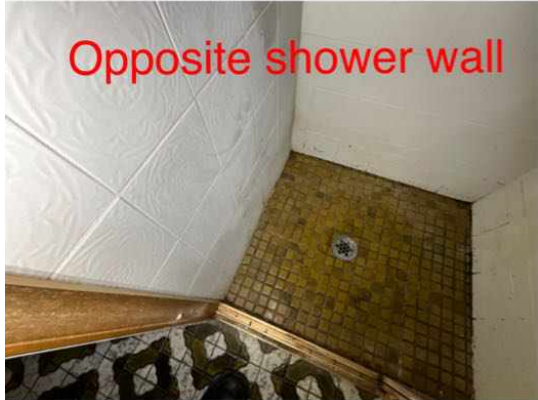
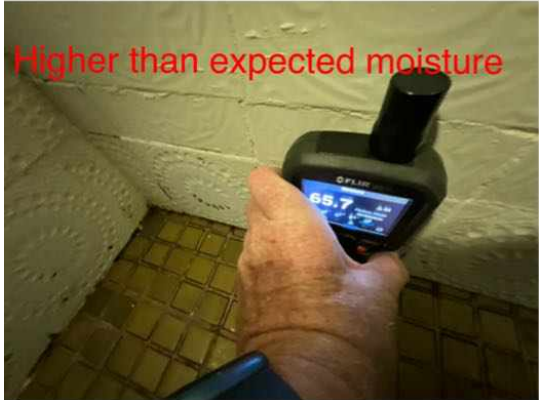
Always ensure that sealant and grout is in good condition to prevent any moisture issues occurring in the future.

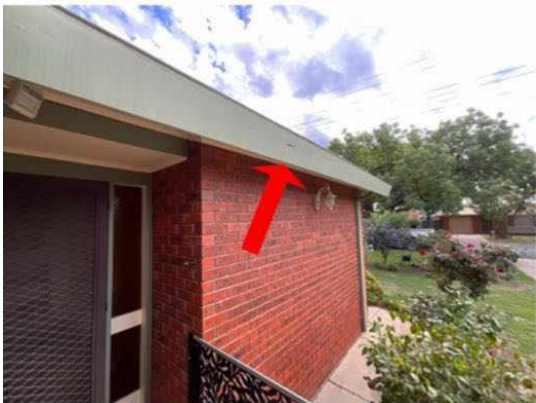
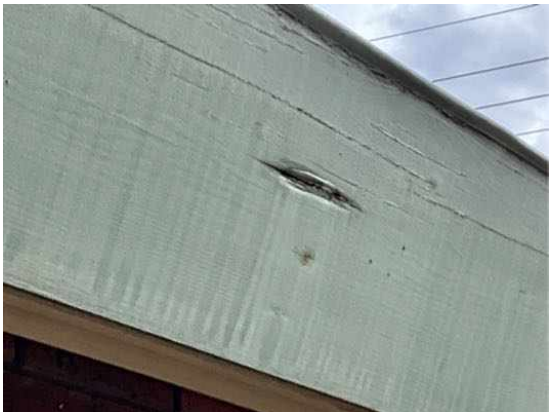
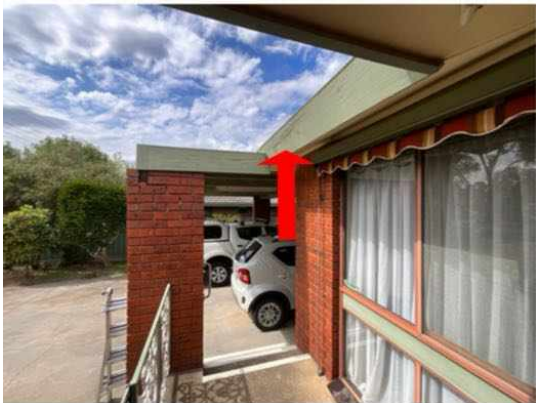
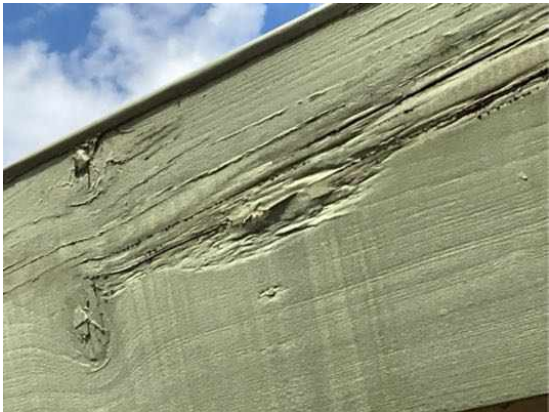
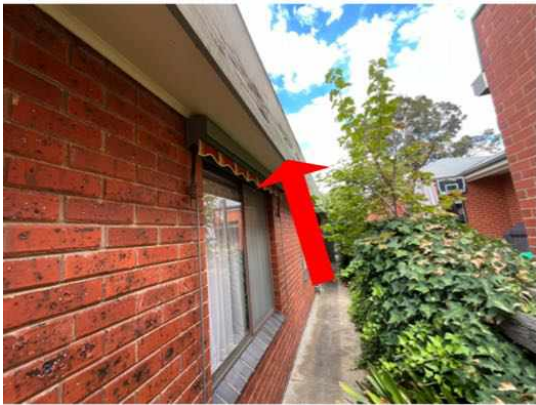
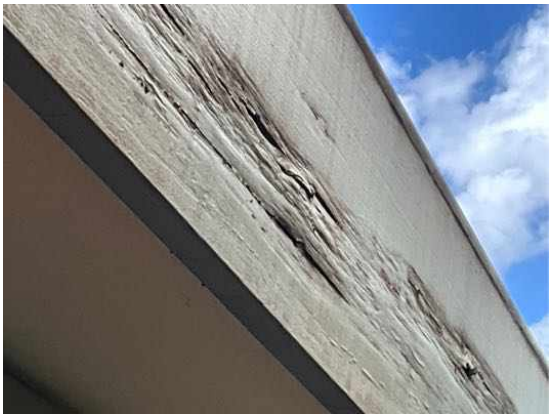
In this case although the affected timber element is in a decaying state the extent of any visible damage appears to be localised to a specific area and is yet to spread to other parts of the building element or affect adjoining structures. The fungal decay is therefore likely to be of a relatively superficial nature with minimal impact on the structural integrity or tensile strength of the timber element.

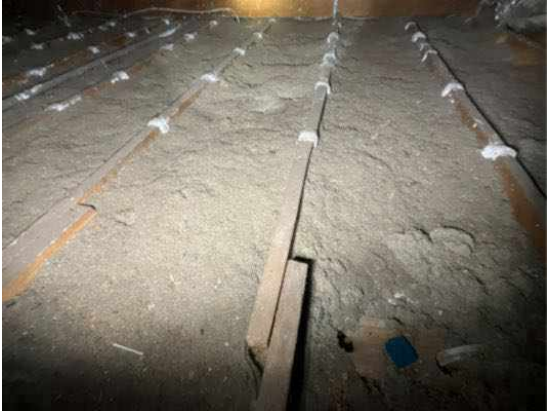
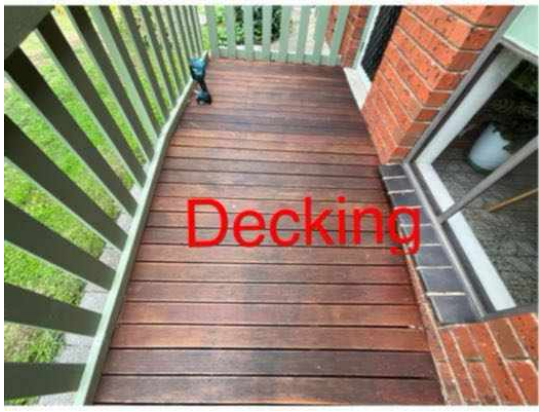
Building: Building 1
Location: All Areas
Finding: Additional Photos - Obstructions and Limitations
Information: These photographs are an indication of the obstructions and limitations which impeded full inspection of the property at the time of inspection. These obstructions can hide an array of defects and should be removed to allow full inspection to be carried out. A re-inspection is recommended once the areas are made accessible.
