## Building Inspection Report

Inspection Date: Fri, 20 Feb 2026

Property Address: 5/10-14 Rodd St, Dandenong VIC 3175,  
Australia

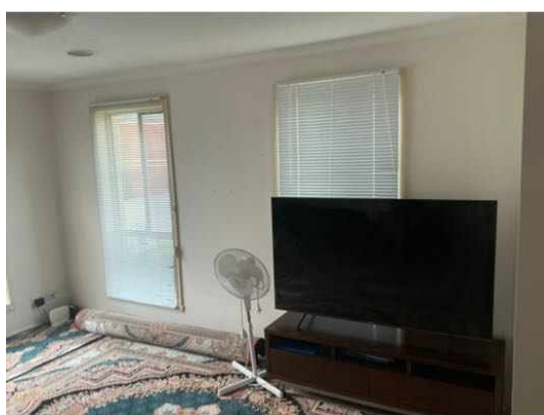
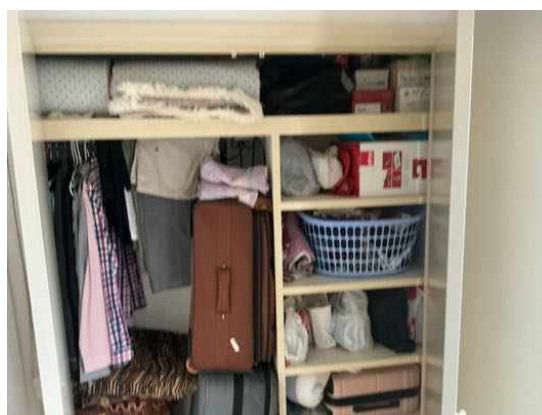
Building: Main Building  
Location: All Internal Areas  
Finding: Obstructions and Limitations - Interior  
Information: These photographs are an indication of the obstructions and limitations which impeded the inspection of the internal areas of the property at the time of inspection. These obstructions can hide an array of defects and should be removed to allow full inspection to be carried out. A re-inspection is recommended once the areas are made accessible.

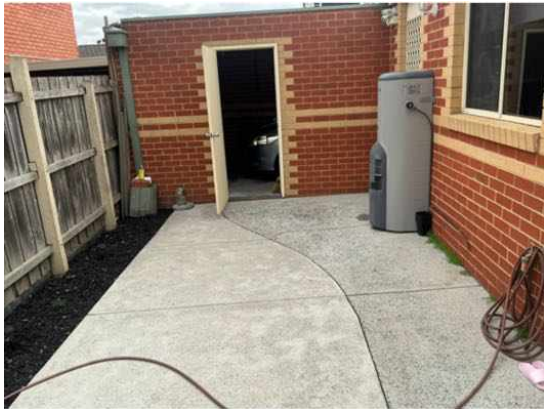
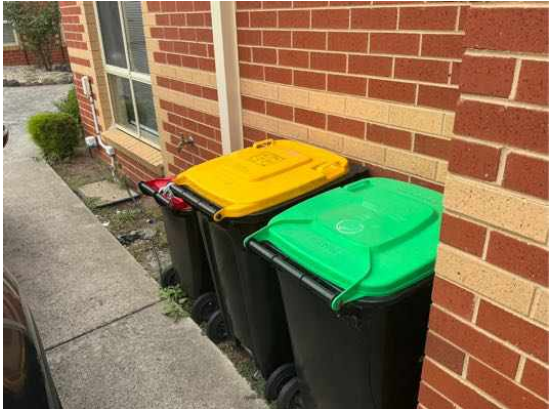
Building: Main Building  
Location: All External Areas  
Finding: Obstructions and Limitations - Exterior  
Information: These photographs are an indication of the obstructions and limitations which impeded the inspection of the external areas of the property at the time of inspection. These obstructions can hide an array of defects and should be removed to allow full inspection to be carried out. A re-inspection is recommended once the areas are made accessible.

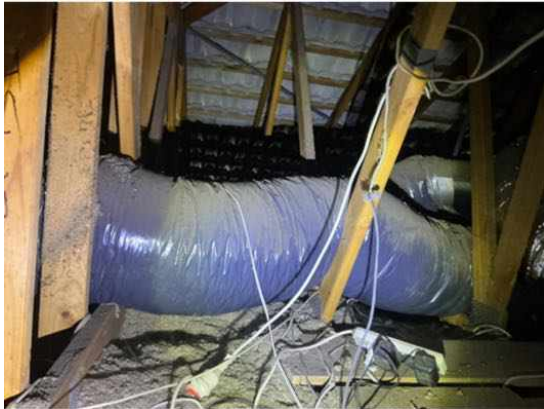
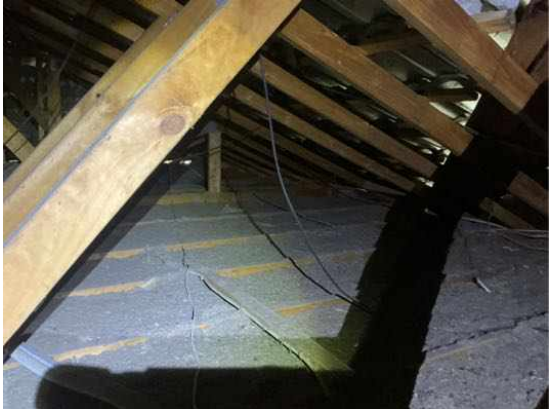
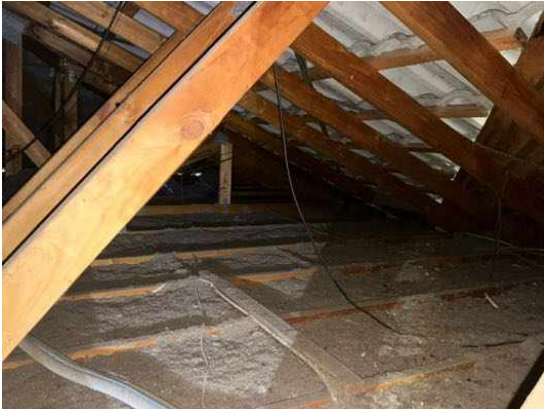
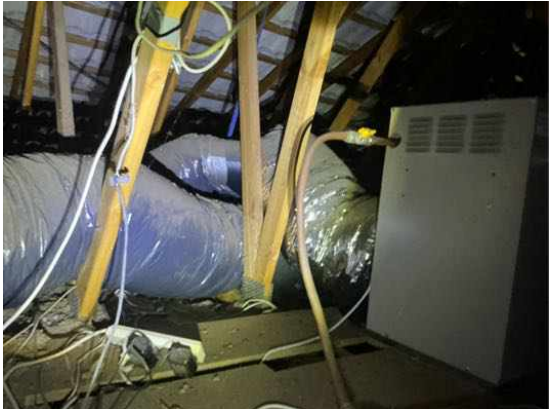
Building: Main Building  
Location: Roof Void  
Finding: Obstructions and Limitations - roof cavity  
Information: These photographs are an indication of the obstructions and limitations which impeded the inspection of the roof cavity area of the property at the time of inspection. These obstructions can hide an array of defects and should be removed to allow full inspection to be carried out. A re-inspection is recommended once the areas are made accessible.
