# Building and Timber Pest Inspection Report

Inspection Date: Tue, 24 Feb 2026

Property Address: 33 Wood St, Drouin VIC 3818, Australia

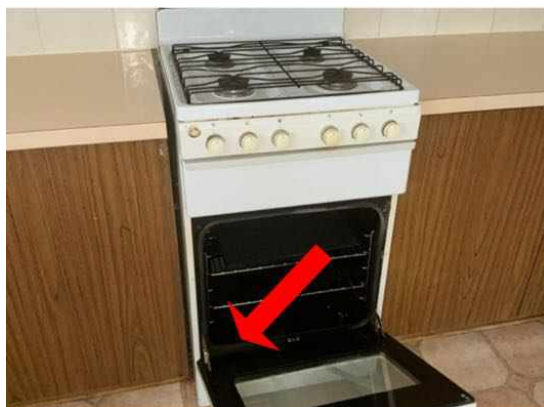
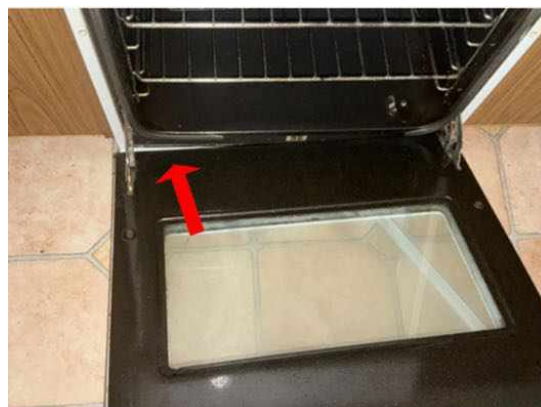
Building: Main Building  
Location: Kitchen  
Finding: Oven door damaged  
Information: It was noted at the time of the inspection that the hinge to the oven door was damaged.

Damage doors to ovens can affect the functionality of the oven, increase heat loss and being dangerous to handle when hot.

An appliance repair contractor should be engaged immediately

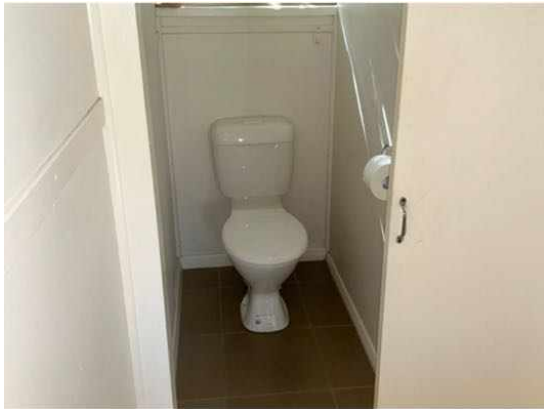
#### Finding 1.02

Building: Main Building  
Location: Toilet (WC)  
Finding: Toilet seat loose  
Information: It was observed that the toilet seat was loose and unstable.

Loose seats can cause fall injury to persons while in use and lead to serious injury

A licensed sanitary plumber should be engaged to review prior to use

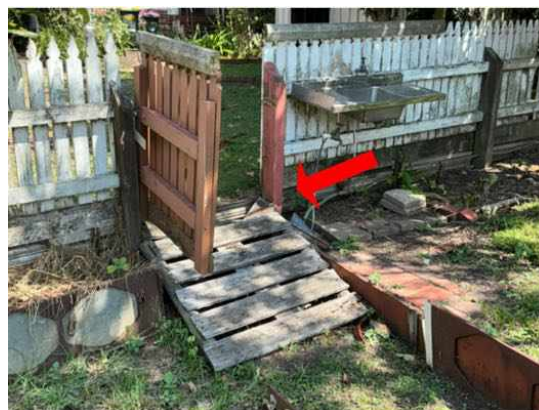
**Finding 1.03**

Building: Main Building  
Location: Yard - Back  
Finding: Timber stairs and ramp  
Information: It was observed at the time of the inspection that the timber stairs to the back door and the ramp in the back garden have become rotten and unstable. The ramps are in such a condition that a person could fall through the treads which are infected wood rot or fungal decay.

It is advised that a qualified carpenter should be engaged to review immediately

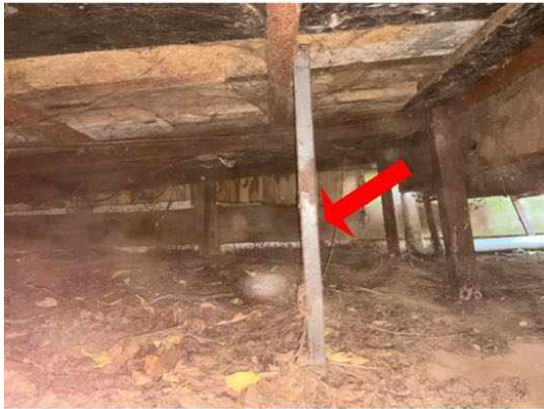
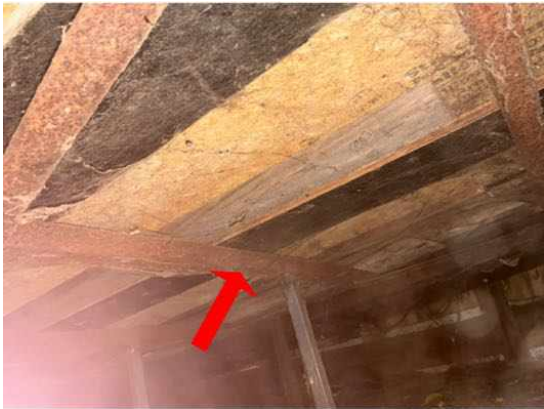
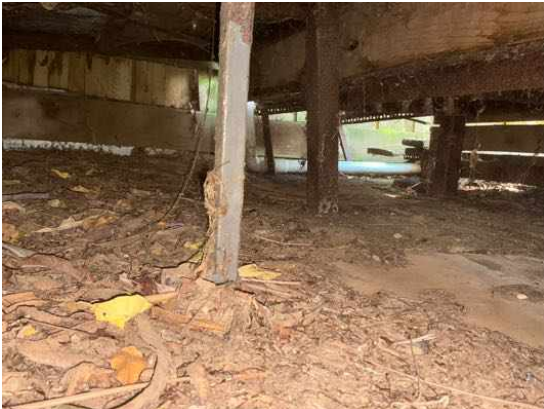
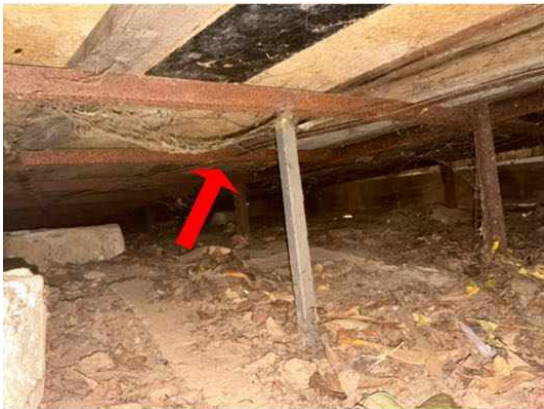
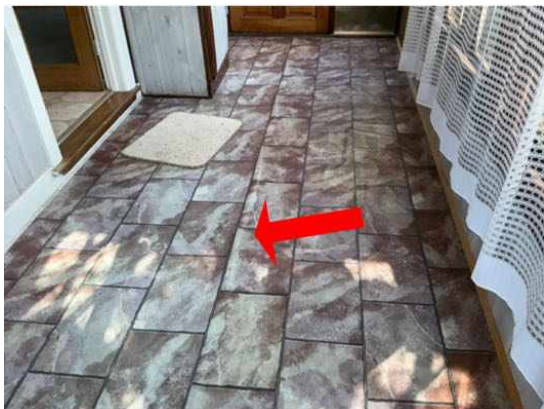
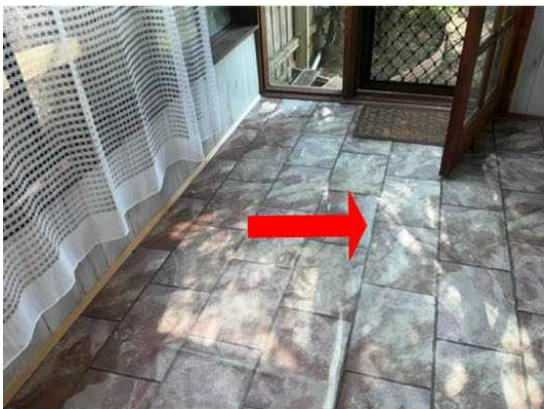
### Finding 2.01

Bouncy floors generally indicate that the floorboards or the subfloor structures are coming loose from the joists that they are installed on. Bouncy flooring may also be the result of gaps between flooring and stumps or joist structures, which require packing.

Upon further inspection it was observed that the subfloor frame was constructed in a non-compliant handyman manner. This appears to be a home-made extension and the client is advised to confirm if a building permit was issued. The work to the floor frame is sub standard. Unattended to the floor could become dangerous in time.

The client is advised to seek quotations for required repairs from a Registered Builder. The potential resolution may range from packing gaps in subfloor structures through to replacement of subfloors stumps and refixing or rebuilding of the floor structure and flooring.

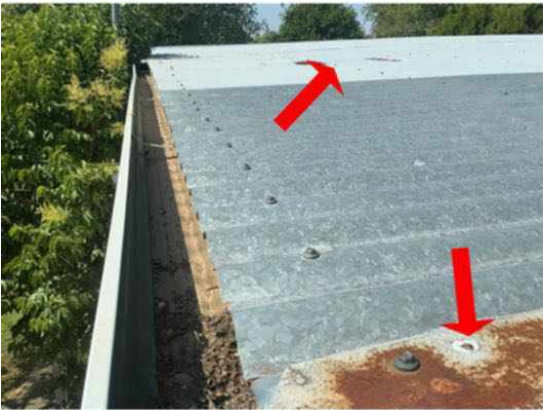
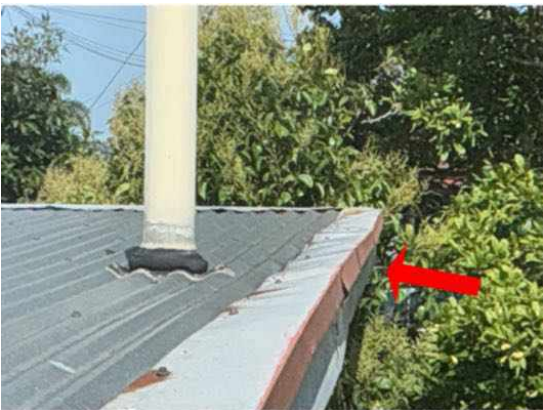
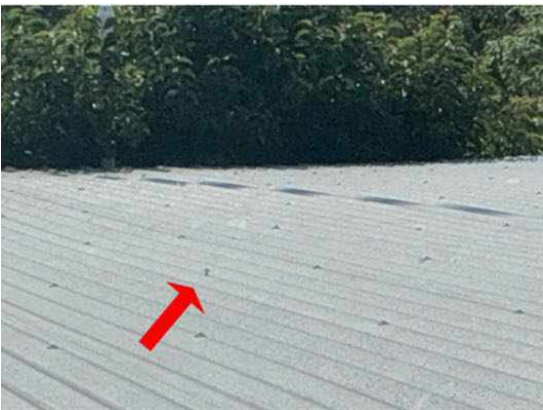
**Finding 2.02**

Building: Main Building  
Location: Roof Exterior  
Finding: Roof exterior – poor condition  
Information: It was observed at the time of the inspection that the metal roof sheet, associated flashings and fixings were in poor condition showing signs of age, rust and deterioration. There were roof leaks suspected to the bedroom areas.

Unattended to the condition of the roof covering could further deteriorate and provide further leaks to the building.

It is advised that a licensed roof plumber being engaged to review the condition of the

roof covering with consideration being given to replacement.

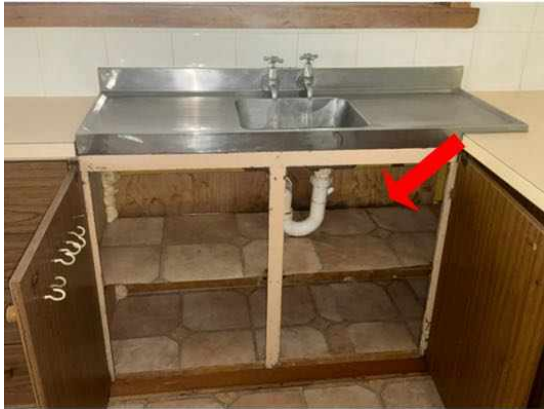
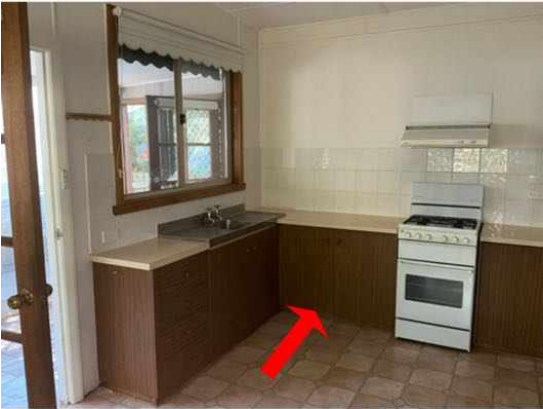
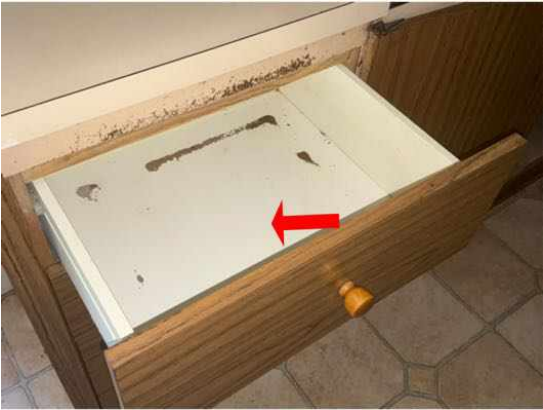
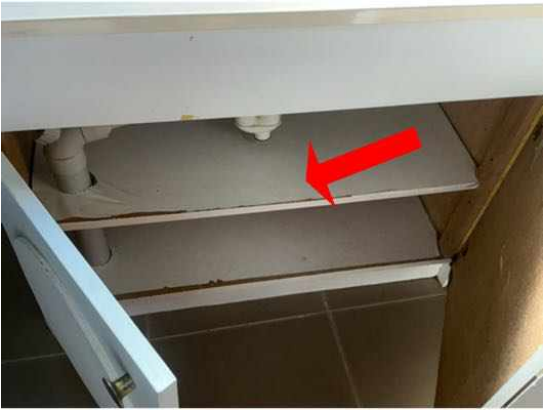
**Finding 3.01**

Building: Main Building  
Location: Kitchen and bathroom  
Finding: Dilapidated cabinets  
Information: It was observed at the time of the inspection that the cabinets in the kitchen and the bathroom were dilapidated. The cabinets were in poor condition with impact

damaged melamine showing excessive wear. The cabinets were also water damaged and swollen.

Damaged water resistant surfaces to cabinets can be un-hygienic and contribute to further deterioration of other cabinet components.

A qualified cabinet maker should review as soon as possible

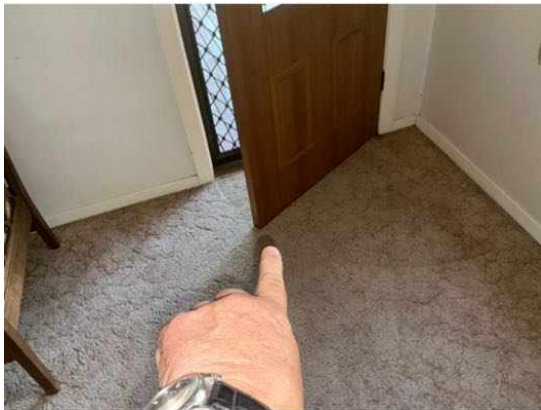
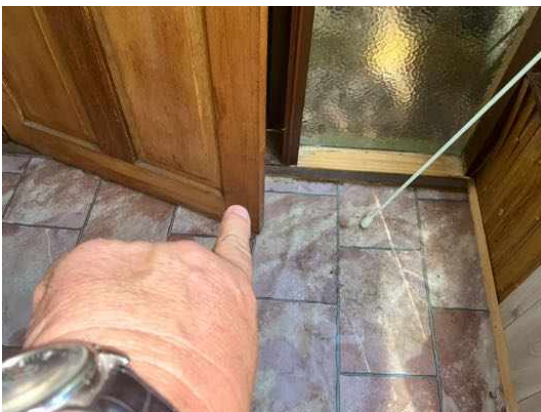
**Finding 3.02**

Finding: Doors - Binding/Jamming  
Information: Binding and/or jamming of several doors throughout the property were evident during standard operation. This defect inhibits the functionality of affected doors as well as creating potential for secondary defects to associated building elements, such as damage to the floor covering.

A door that binds to flooring or to the associated door frame may have several causes, ranging from minor defects, such as poor installation of the door or deteriorated hinges, through to major structural issues, such as damage to subfloor structures.

Where door binding/jamming appears to indicate major structural issues, a registered builder specialising in re-stumping should be appointed to provide an estimate on the cost of rectification.

For minor causes, a qualified carpenter or general handyman should be appointed to perform minor rectification works at client discretion.

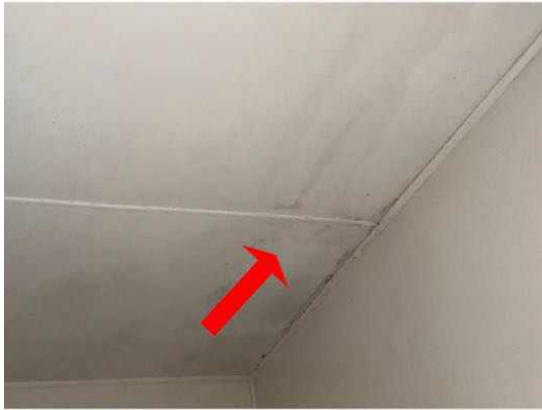
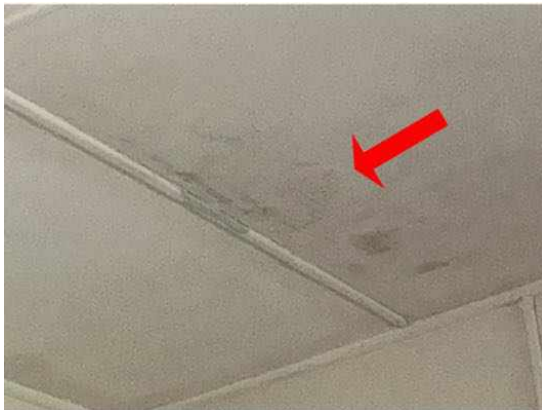
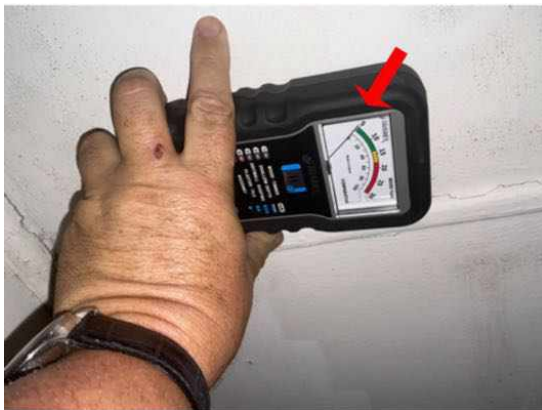
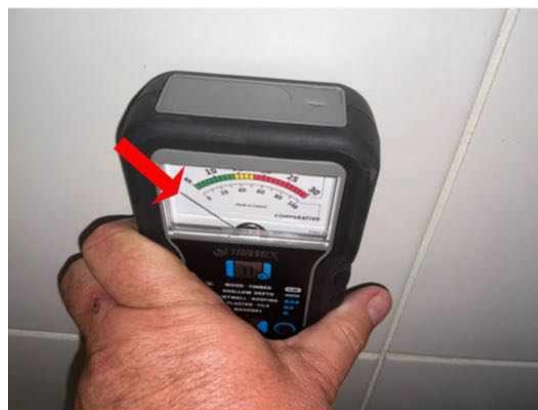
Building:	Main Building
Location:	Roof Exterior
Finding:	Roof covering - Leaking
Information:	An active leak was identified to the roof covering, indicated by water ingress. It is suspected that the condition of the metal roof sheets and fixings are responsible for this leak, Leak staining was evident in the ceilings to the bedroom.

Where water leaks are active, rain penetration is likely to cause water damage to associated structures and building elements in this area, which can have a range of

implications. If left unmanaged, the development of major structural damage to the roofing and associated structures may occur.

The area was tested with a moisture meter and appeared to be dry. This is possibly due to dry conditions at the time of the inspection.

A roofing contractor should be appointed as soon as possible to primarily identify the cause of the leak, and to provide subsequent repair works as necessary. Depending on the extent of the damage, replacement of sections of the roof covering and/or roofing structures may be required.

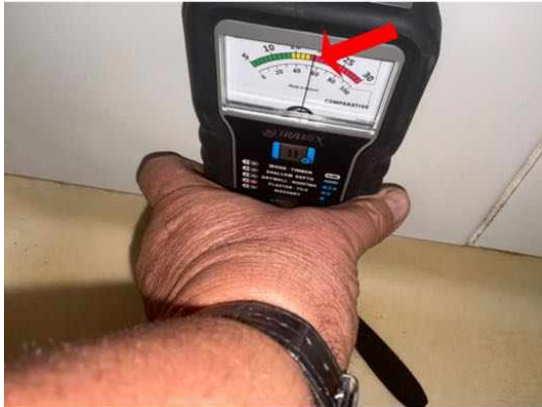
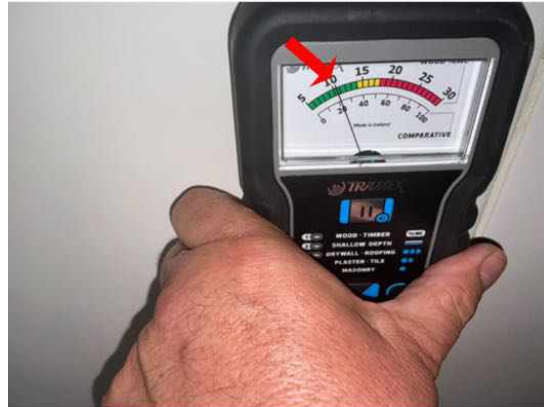
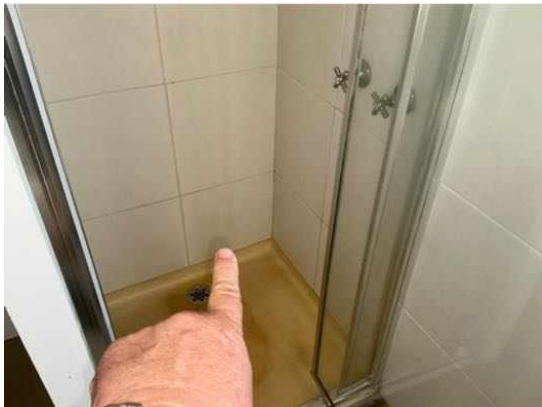
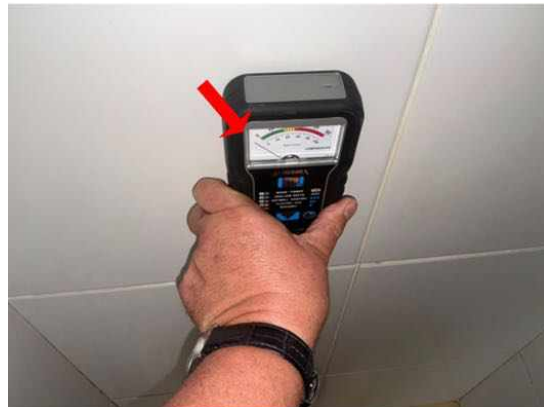
### Finding 3.05

Building:	Main Building
Location:	Bathroom
Finding:	Shower - Damp
Information:	Damp is evident to the lower 300mm of wall to the shower alcove. This defect is quite common, and is suspected to have been caused by moisture permeating through the grouting in this area, which shows evidence of deterioration. Leaking pipes within the adjoining wall is also a possible cause.

Unmanaged damp in the shower recess is likely to facilitate the formation and development of mould and fungi growth, decaying associated building materials and compromising their structural integrity. It is important to address damp conditions, as the World Health Organisation notes that excess moisture leads - on almost all indoor materials - to growth of microbes such as moulds, fungi and bacteria, which subsequently emit spores and other matter into the indoor air. Exposure to these contaminants is associated with a wide range of respiratory and other health-related problems.

Consultation with a qualified plumber or bathroom specialist is advised immediately to identify the cause of damp and to perform remedial works as required. Where excessive mould growth is present, further inspection by a specialist environmental health inspector should also be considered.

Always ensure that sealant and grout is in good condition to prevent any moisture issues occurring in the future.

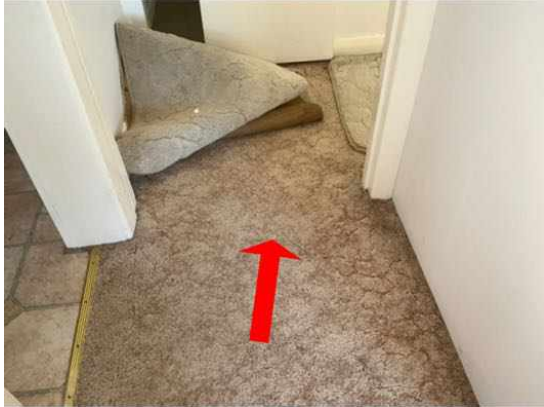
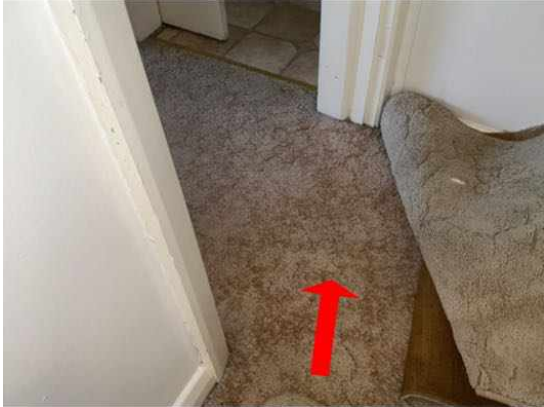
### Finding 3.06

Information: The internal flooring in the hallway is out of level and uneven. Uneven flooring is likely to indicate minor defects such as expected movement of the foundations of the property, but may also indicate subsidence of the associated subfloor stumps.

It is advised that the flooring be closely monitored to identify any further movement. Where flooring remains relatively unchanged for an extended period of time (i.e. several months), it is likely that this defect has been caused by expected movement of the foundations of the property.

However, where flooring is uneven further, potentially invasive inspection of the subfloor structures and stumps in this area is required. In this case, works to repair are likely to be required, and would be carried out by a registered builder specialising in re-stumping.

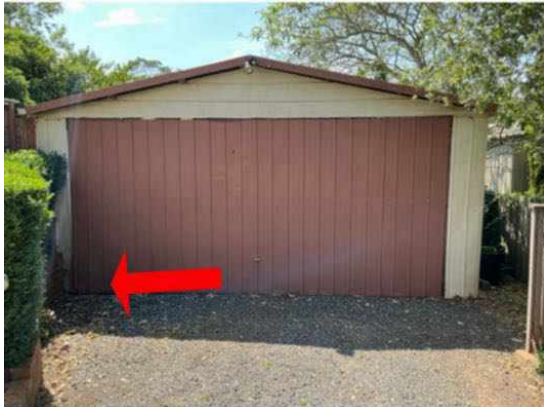
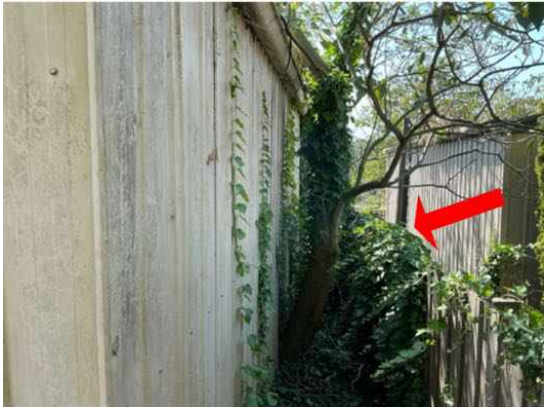
**Finding 3.07**

Building: Main Building  
Location: Metal garage and sheds deteriorated  
Finding: Metal garage and sheds deteriorated  
Information: It was observed at the time of the inspection that the sheds and metal garage were in poor condition. There were many rust damaged sheet and were generally in poor condition. Unattended to these outbuildings could soon be dilapidated.

It is advised that a general handyman be engaged to review at the clients discretion

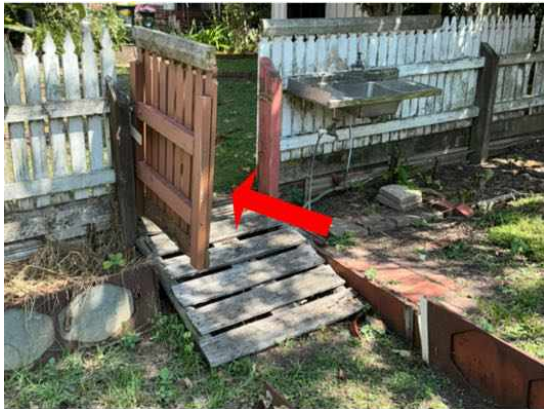
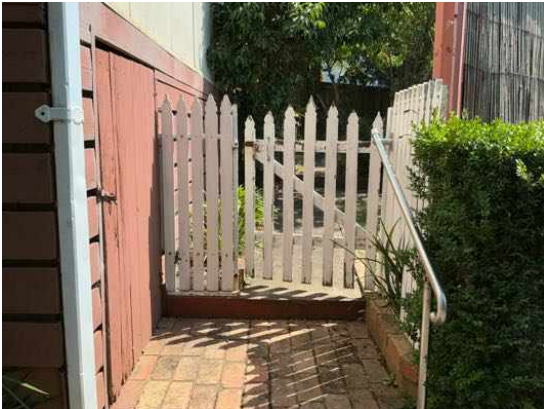
**Finding 3.08**

Building: Main Building  
 Location: Gate and subfloor doors  
 Finding: Gate and subfloor doors dilapidated  
 Information: It was observed at the time of the inspection that the pedestrian gate and the subfloor doors to the property were dilapidated. The hardware was showing signs of severe deterioration and the timber work was presenting with wood rot and fungal decay.

A qualified carpenter should be engaged to review as soon as possible

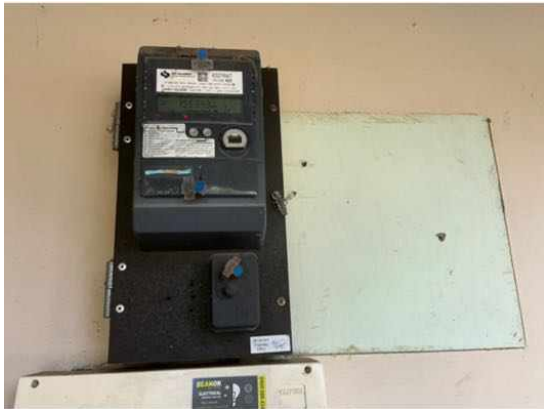
Building: Main Building  
 Location: Meter Box  
 Finding: Termite Management System - no evidence of a chemical installation  
 Information: The application of a post-construction chemical termite barrier is highly recommended for all properties, particularly if live termite activity has been found on the site previously. Such barriers are highly effective in preventing termite attack on any timber building elements throughout the property.

A durable notice should be placed in the switchboard unit to indicate current termite barriers. At the time of inspection, it appeared as though no termite management system has been installed, with no evidence to suggest preventative works taking place.

The client may consider gaining further advice from a pest controller as to the costs and procedures involved with this application. It is recommended that obtaining such advice be a short-term priority.

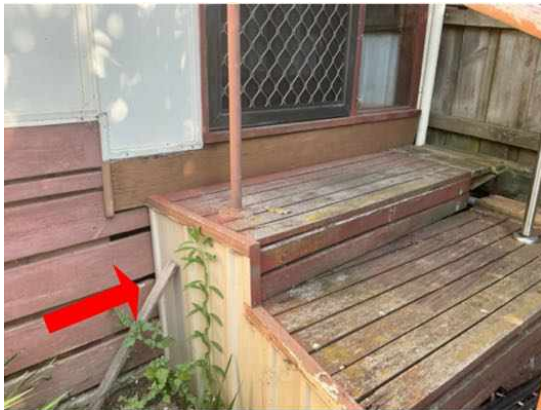
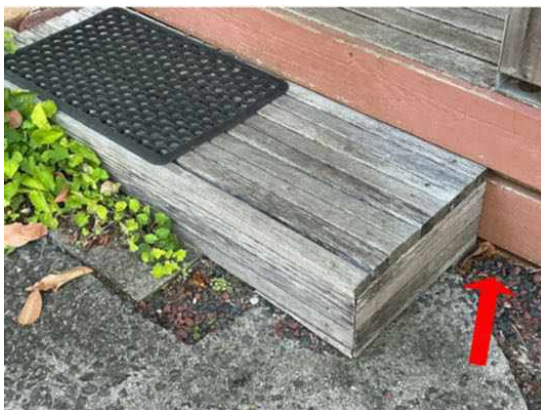
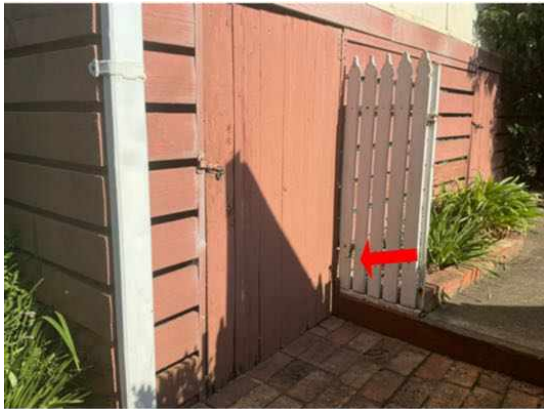
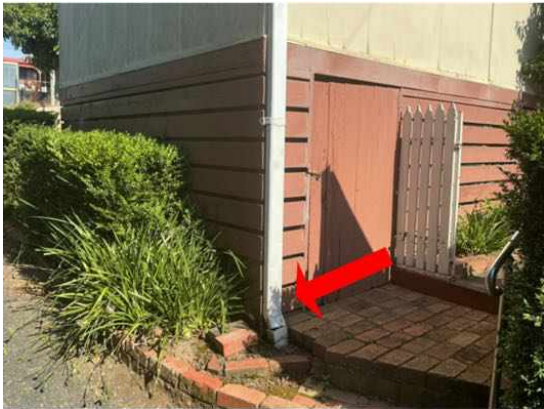
**Finding 6.02**

Building: Main Building  
Location: All External Areas  
Finding: Trees/large/termite  
Information: It was observed that there were several large trees next to or nearby the building.

The trees have the potential to provide conducive conditions for termite infestation

It is recommended that periodic 12 monthly inspections by a registered pest control contractor be undertaken and further reinstatement of outdated termite barriers as soon as possible.

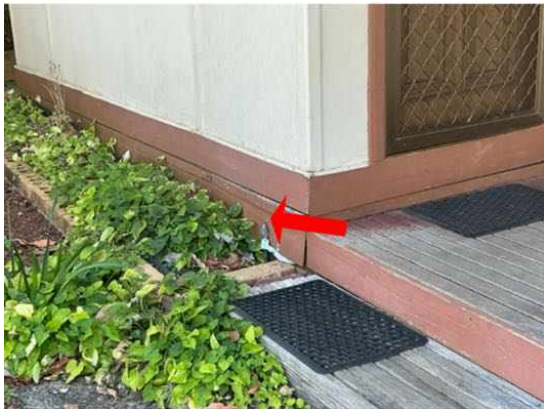
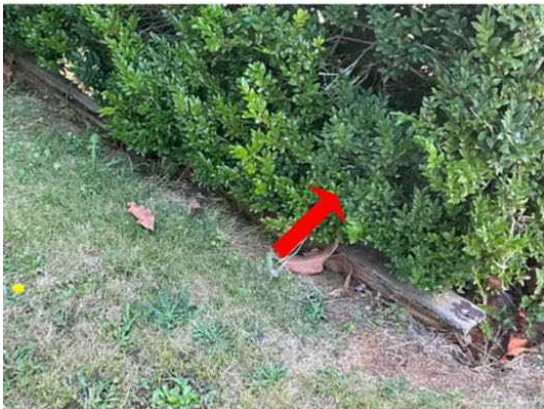
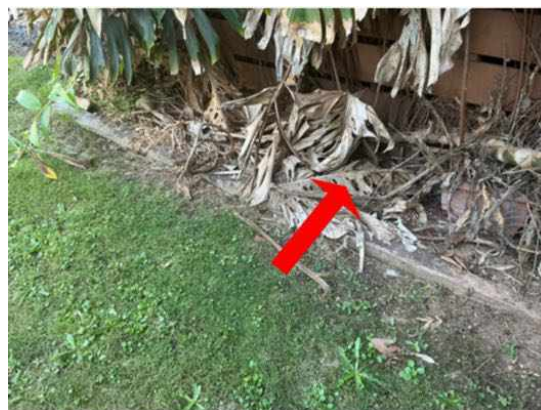
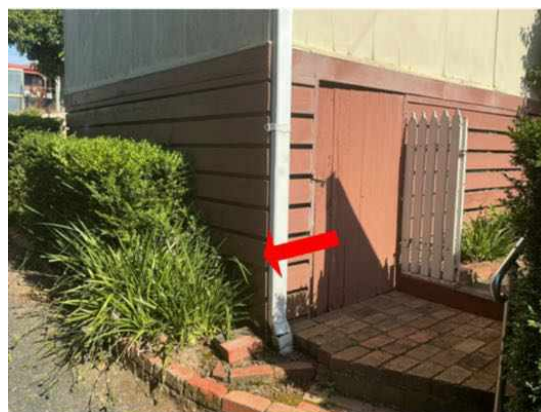
**Finding 6.04**

Building: Main Building  
Location: All External Areas  
Finding: Bridging - Vegetation  
Information: Where vegetation obstructs inspection of building elements, also known as bridging as it provides a bridging point for the access of termites, full inspection can not be achieved. Consequently moisture or dampness may be present and the areas becomes conducive to termite activity. Plants against or very close to buildings provide cover, shade and can provide an environment that is attractive to termite infestation.

The removal and replanting of species that do not provide "cover" or cutting back of existing vegetation will assist greatly in preventing Bridging from occurring.

The removal of any such materials that may be conducive to termite activity should be carried out as soon as possible and arrange re inspection to minimize the risk of termite attack.

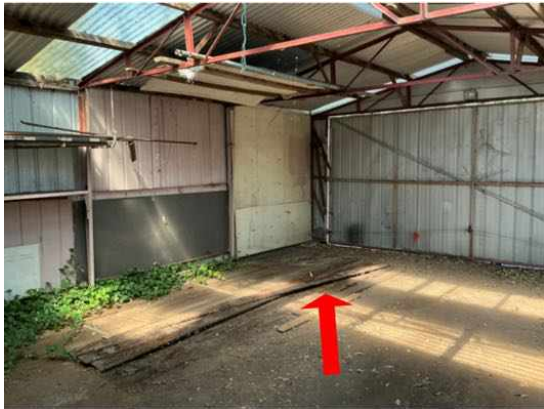
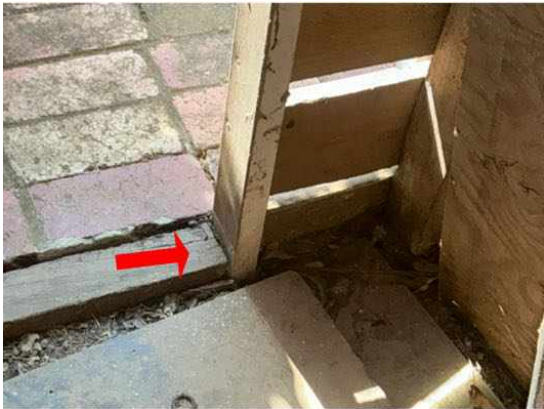
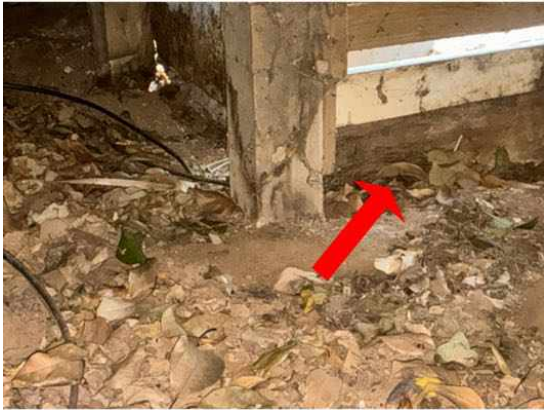
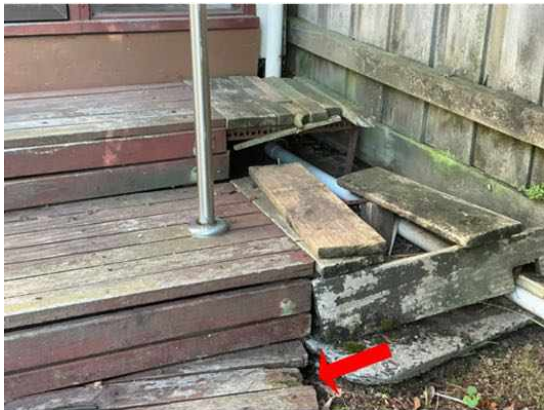
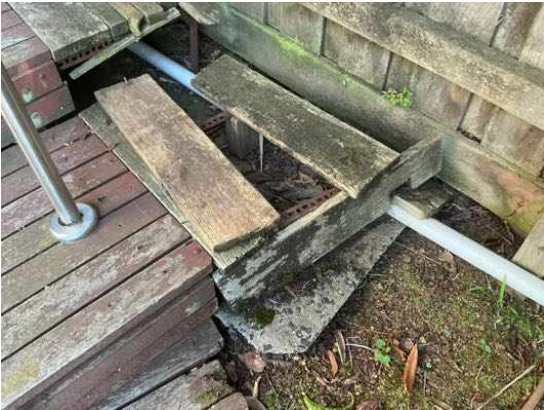
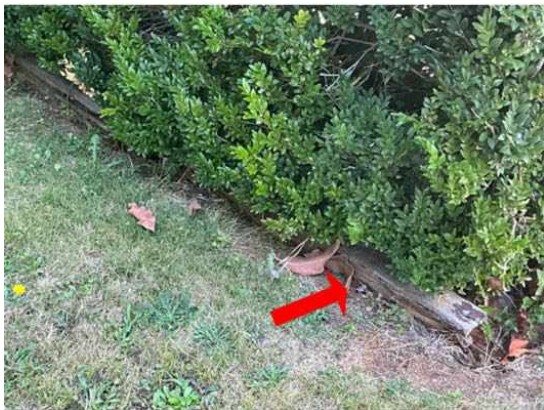
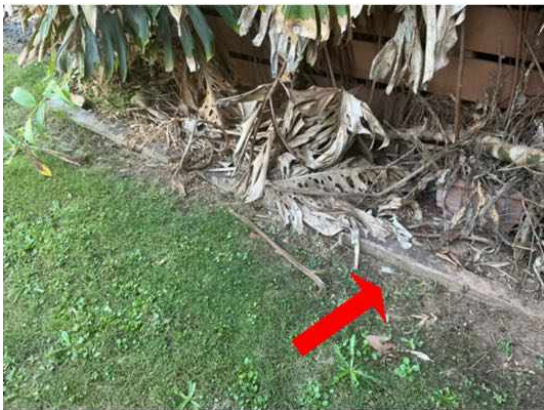
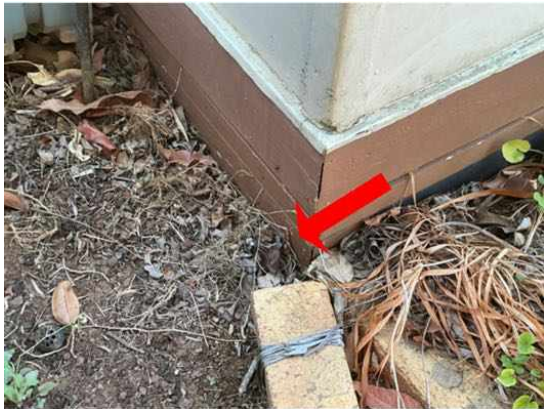
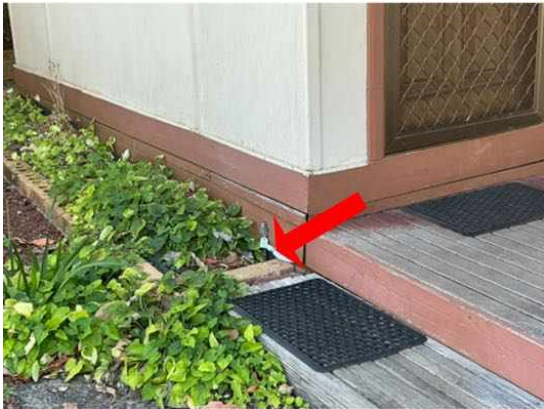
### Finding 6.05

Building:	Main Building
Location:	All External Areas
Finding:	Untreated or non-durable timbers in a hazardous environment
Information:	To reduce the risk of timber pest attack it is essential that timber used in a hazardous environment (e.g. in direct contact with the ground or frequently exposed to damp conditions) is of sufficient durability and/or is adequately preservative treated.

Untreated timbers in direct contact with the ground are likely to develop severe wood rot and/or fungal decay if left unattended creating attraction for subterranean termites to infest the timbers from surrounding areas.

If untreated or non-durable timbers are found to be in a hazardous environment it is highly advised that replacement of these building elements be performed as soon as possible to aid the protection of the property against termite / timber pest attack.

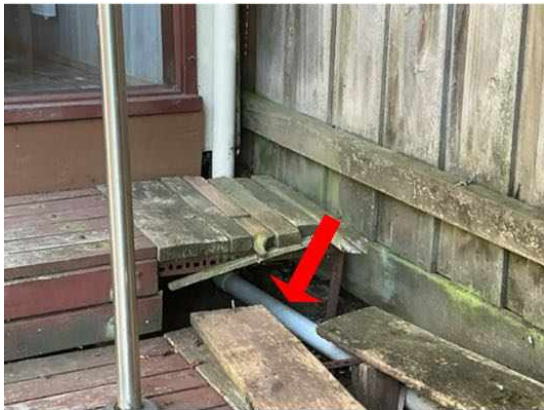
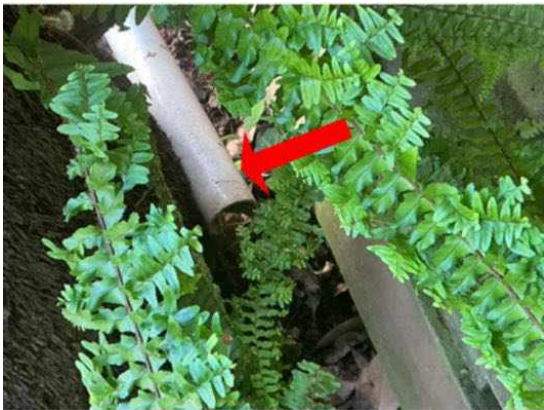
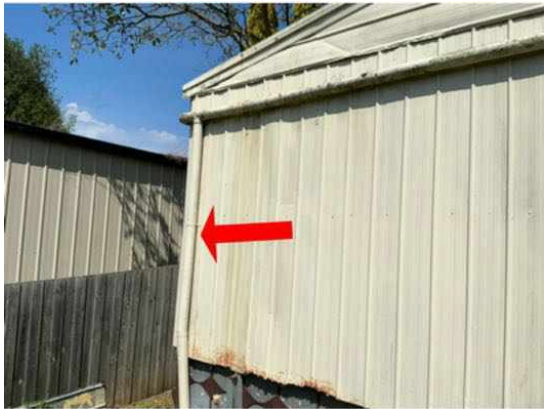
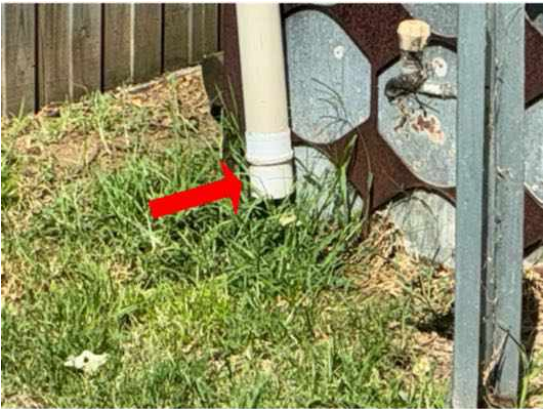
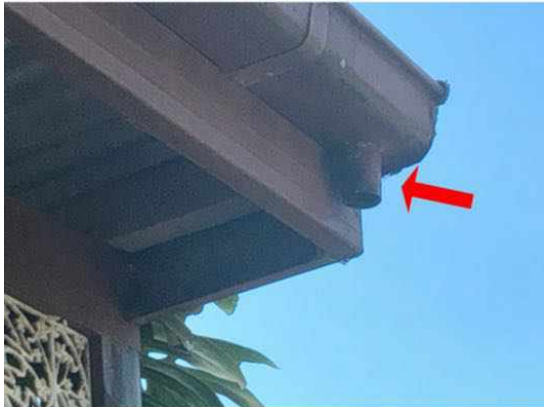
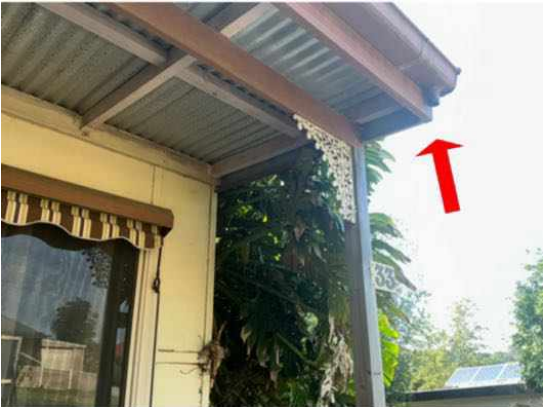
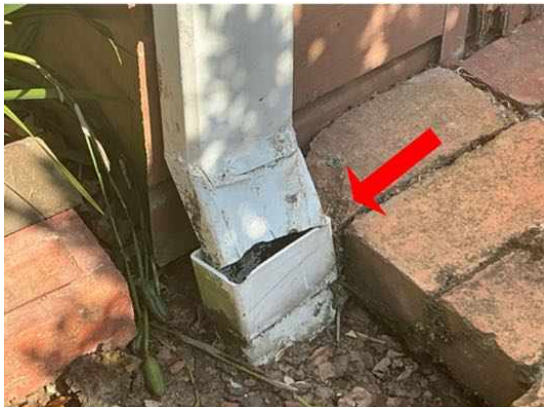
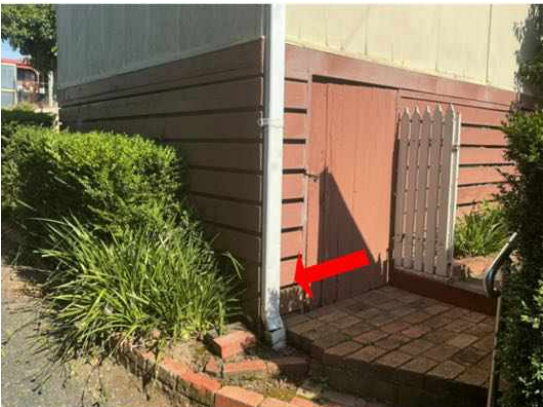
**Finding 6.06**

Building: Main Building  
Location: All External Areas  
Finding: Downpipe disconnected TP  
Information: It was noted that the downpipe to the rear of the patio was disconnected or damaged

Downpipes disconnected can cause flooding and over saturation of the surrounding foundation soils,

Moisture ingress to the building and footing movement may occur should the moisture content of the soil be not be kept constant.

Excessive moisture levels in the soil can be conducive to termite infestation

A licensed plumber should review at the owner discretion.

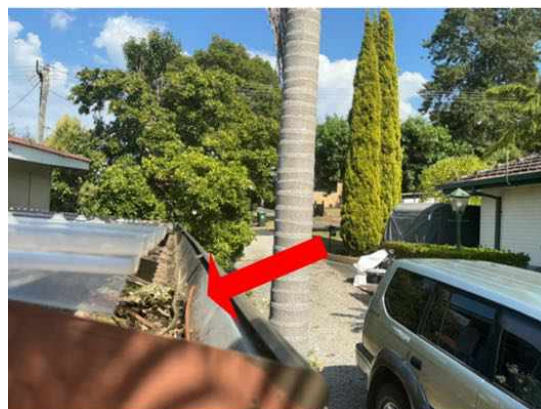
**Finding 6.07**

Building: Main Building  
Location: Roof Exterior  
Finding: Gutters - Blocked  
Information: Roof plumbing structures, such as guttering and downpipes, should be free of all debris to prevent blockages. Blockages of the guttering and downpipes will lead to pooling and accumulated water overflows, which is likely to subsequently flood eaves and exterior walls.

Blocked gutters are likely to lead to high levels of moisture in the affected areas. Such moisture will not only cause rust and decay of the associated building materials, but can also provide conditions that are conducive to termite and timber pest activity. Blockages in gutters should therefore be removed immediately to ensure dry conditions are maintained.

Consult a Licensed Plumber for further specific advice on remedial works that may be required. In the interim, it is highly advised that blocked gutters be removed by the homeowner or a general handyperson as a matter of urgency.

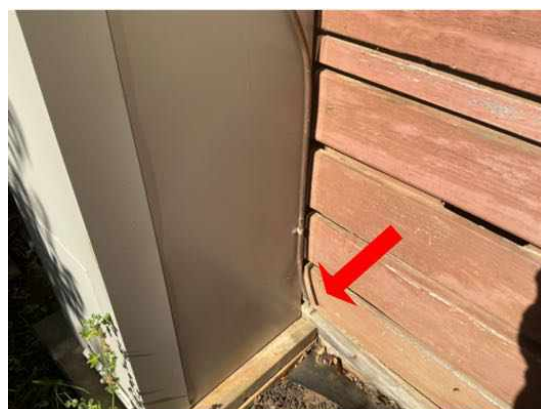
### Finding 6.08

Building: Main Building  
Location: Exterior walls - rear  
Finding: Hot water heater overflow pipe not connected  
Information: The water heater overflow was found to be disconnected from the stormwater system and is creating excessive moisture to the surrounding area.

Such leaking creates an environment which is conducive to an array of defects including water damage to associated building materials and the attraction of termites or timber pest infestation.

A Licensed plumber should be engaged to review as soon as possible

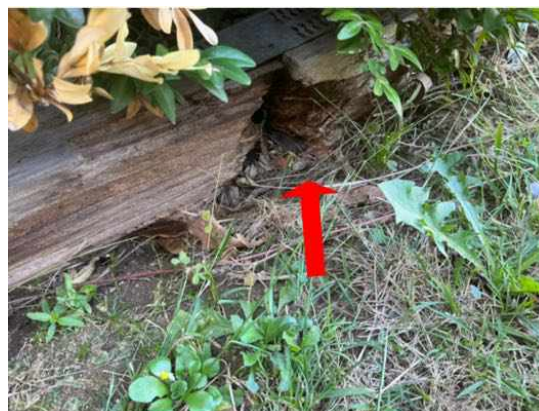
### Finding 7.01

Building:	Main Building
Location:	All External Areas
Finding:	Fungal decay - present (widespread)
Information:	Fungal decay is also known as wood decay or wood rot generally refers to the deterioration of timber elements when in contact with excessive levels of moisture for a prolonged period of time.

In this case, fungal decay appears to have become widespread and is likely to have affected any adjoining timber elements/structures. The widespread development of fungal decay is likely to have heavily impacted the structural integrity and tensile strength of the affected timber elements and the associated structure.

Timbers affected by widespread fungal decay should be replaced immediately. The cause of the moisture that has led to the development of such decay should also be identified and dealt with in an appropriate manner.

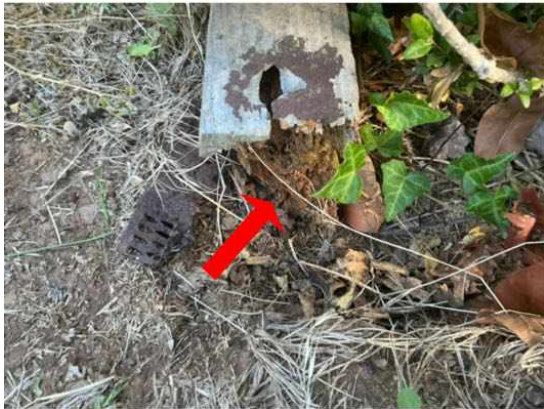
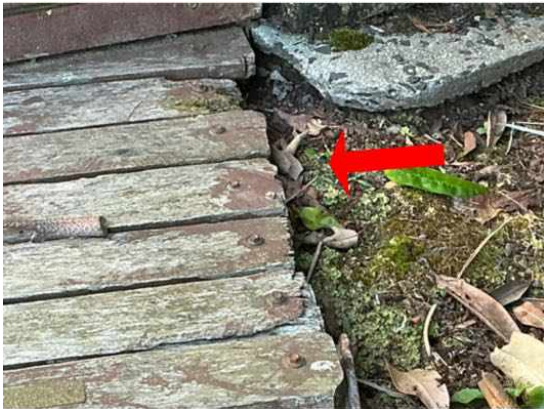
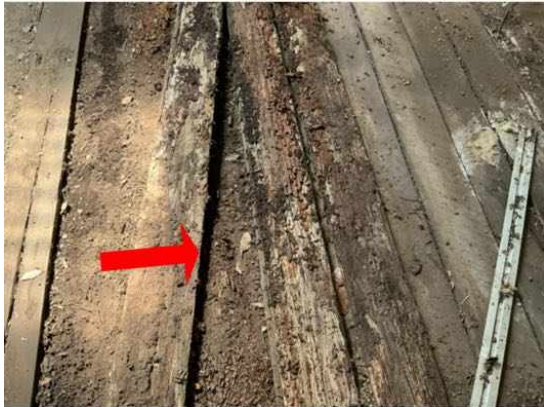
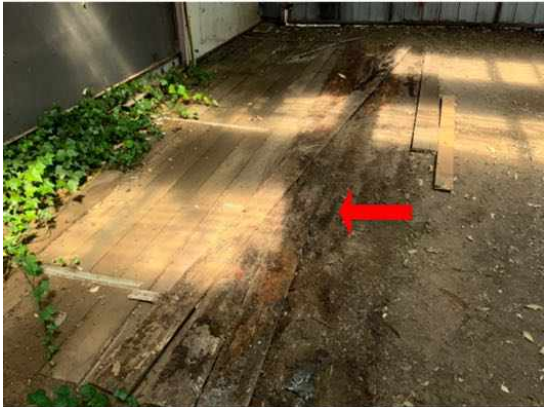
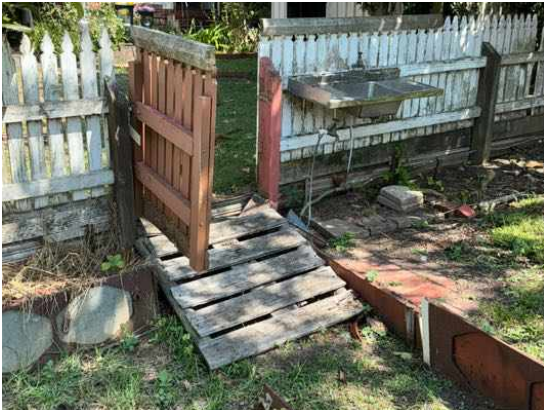
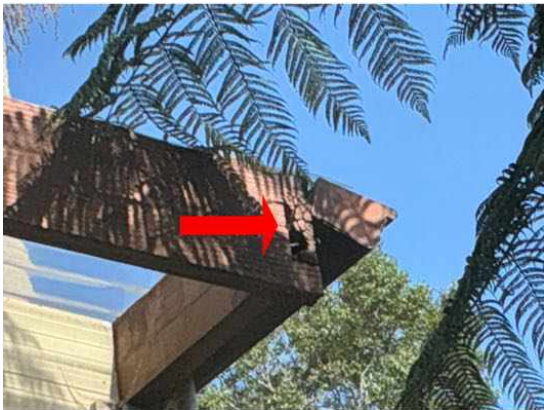
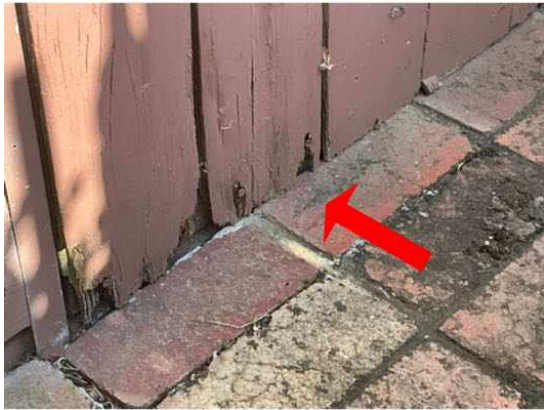
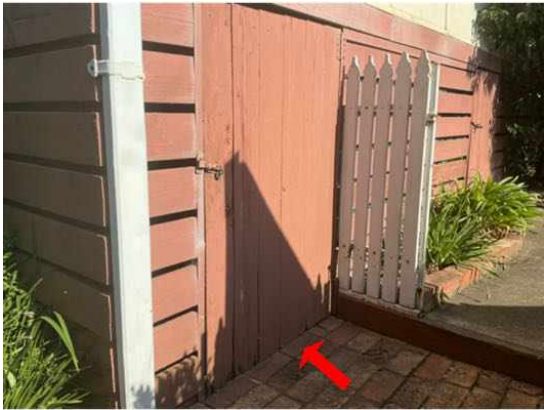
The development of fungal decay is accelerated by temperatures in the range of 5degreeC to 40degreeC as well as the presence of oxygen. Generally fungal decay develops on timber elements that are in use in an external environment which are exposed to rain penetration.

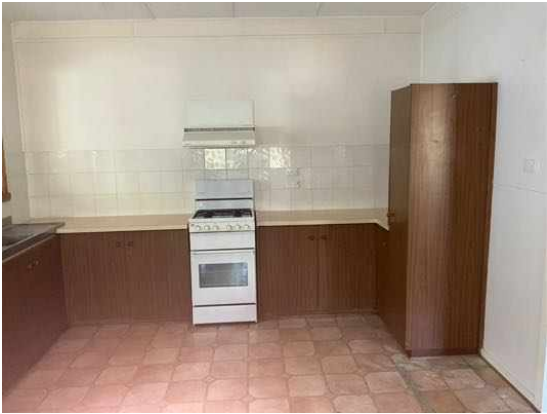
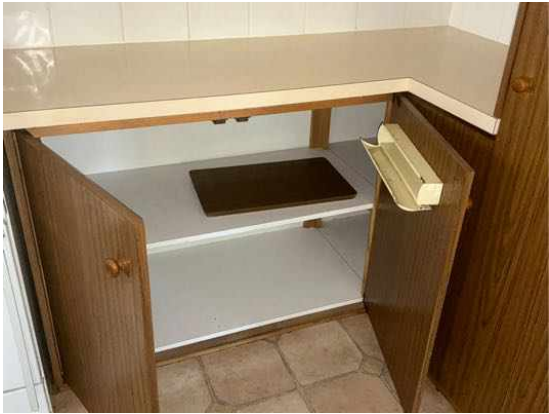
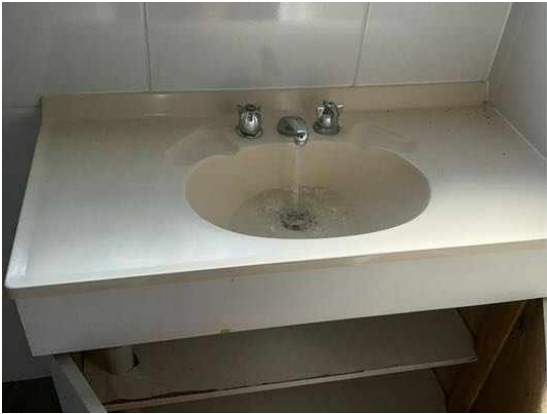
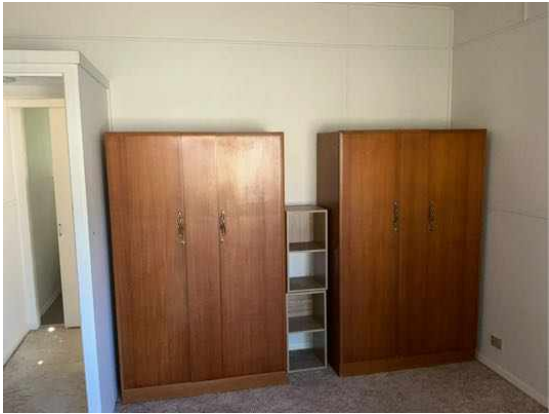
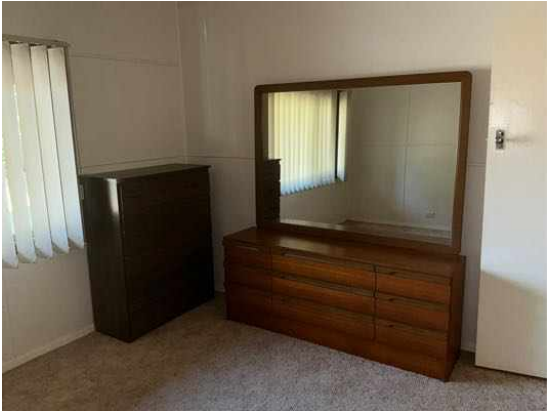
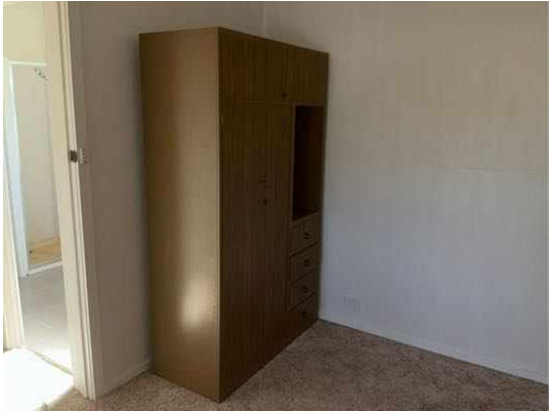
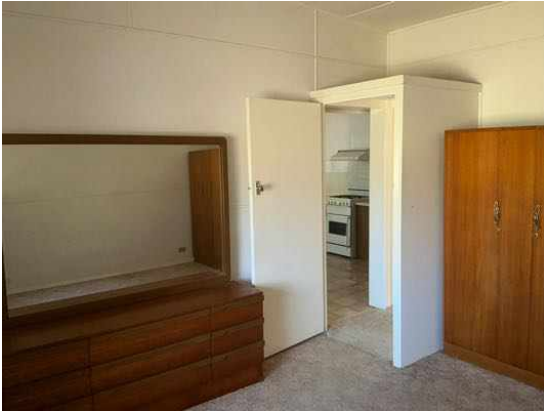
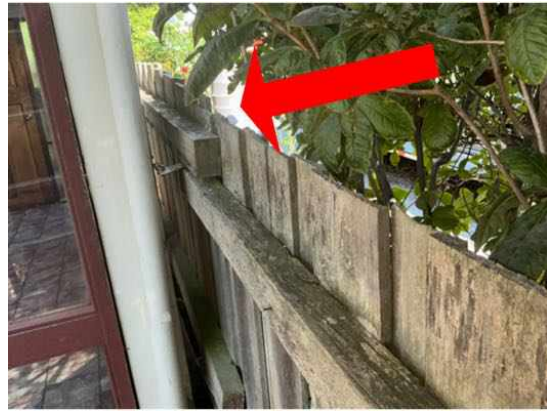
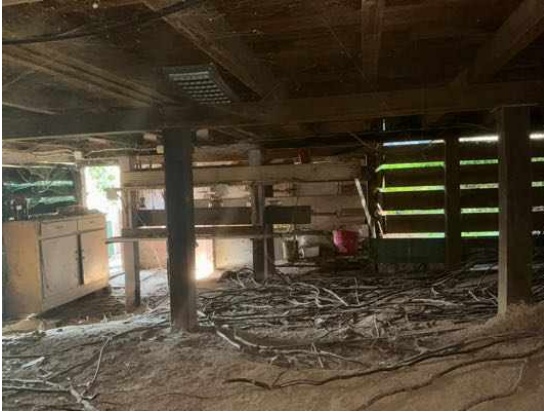
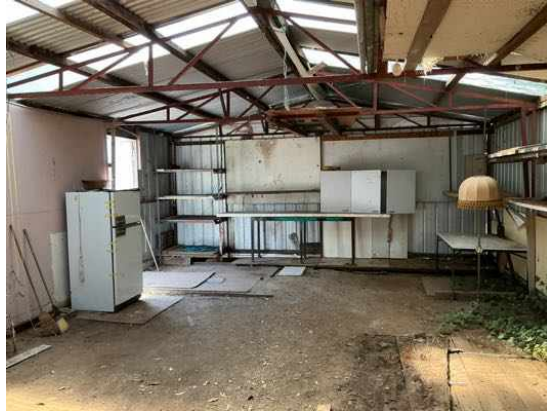
Building: Main Building  
Location: All Areas  
Finding: Additional Photos - Obstructions and Limitations  
Information: These photographs are an indication of the obstructions and limitations which impeded full inspection of the property at the time of inspection. These obstructions can hide an array of defects and should be removed to allow full inspection to be carried out. A re-inspection is recommended once the areas are made accessible.
