# Building and Timber Pest Inspection Report

Inspection Date: Tue, 24 Feb 2026

Property Address: 33 Wood St, Drouin VIC 3818, Australia

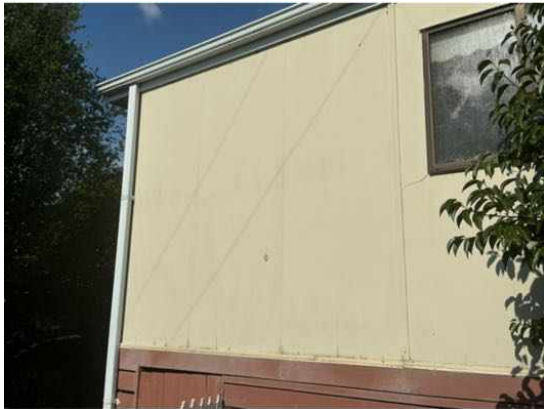
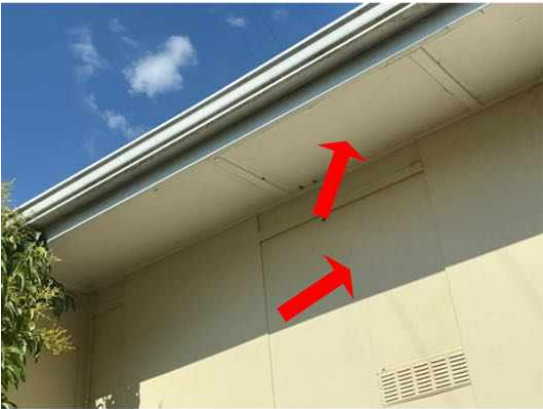
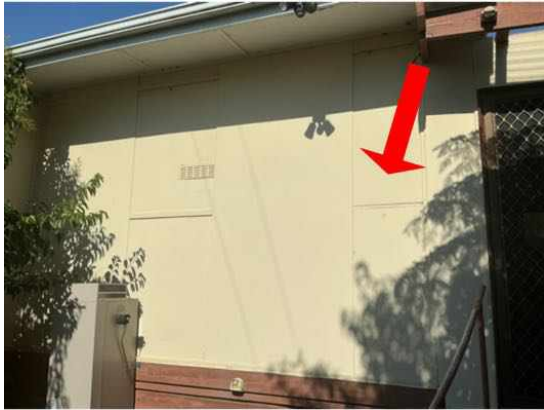
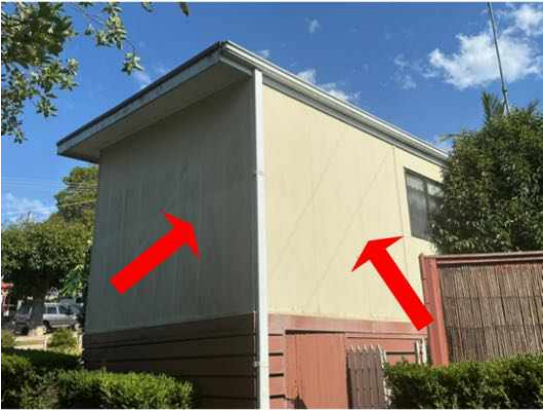
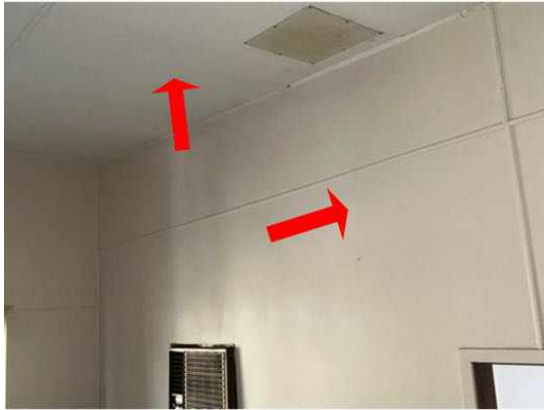
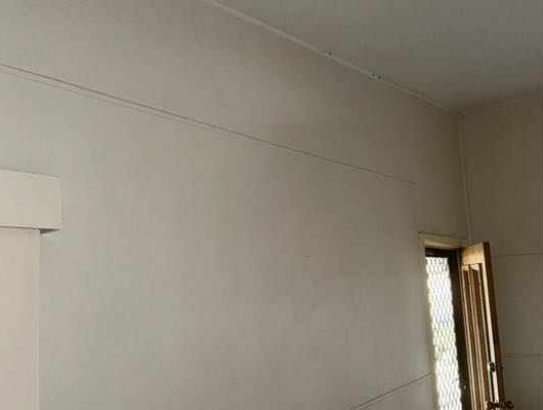
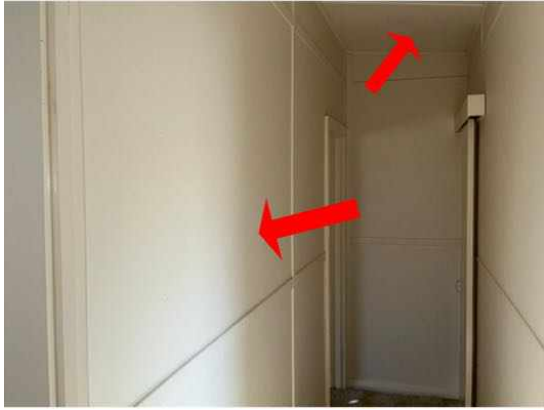
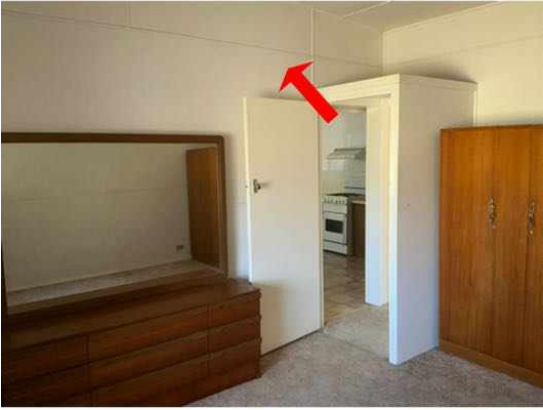
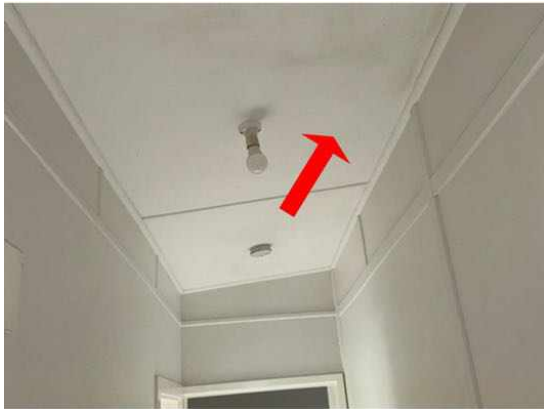
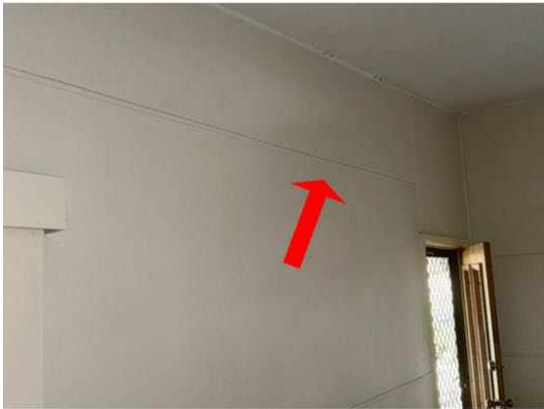
Building:	Main Building
Location:	All Areas
Finding:	Asbestos - Suspected ACM Identified on Site
Information:	Reporting on Asbestos is outside the Scope of this Report. This suspected defect is highlighted as a caution only. We suspect, based on our experience in the building industry, that there is a higher risk of the identified building elements containing asbestos.

As Asbestos Reporting is outside the scope of this report, we advise that you consider a separate Asbestos Inspection and Condition Audit, which can include the taking of samples for definitive confirmation of the presence of Asbestos.

In the interim, the client is advised to act with caution, especially when considering any damage to building materials general wear and tear renovations extensions demolition and general maintenance activities due to the suspected presence of Asbestos.

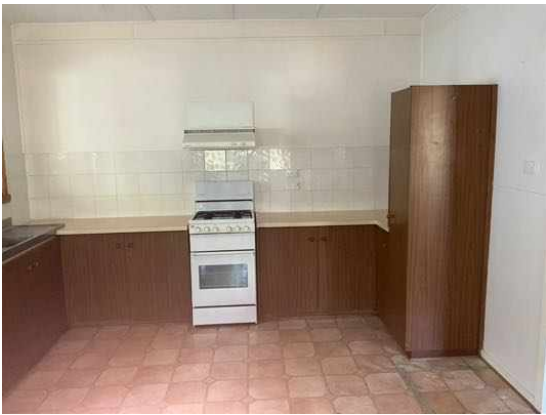
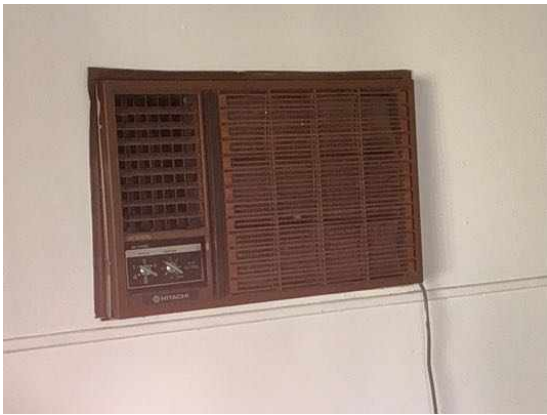
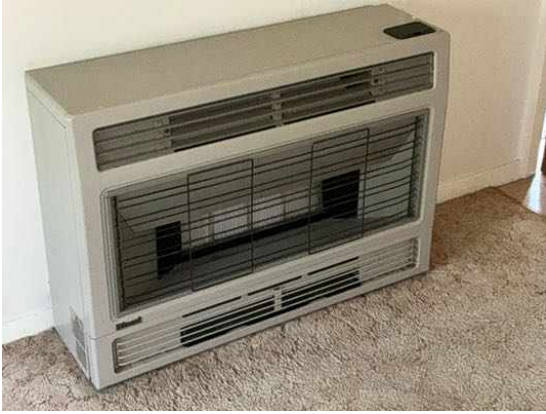
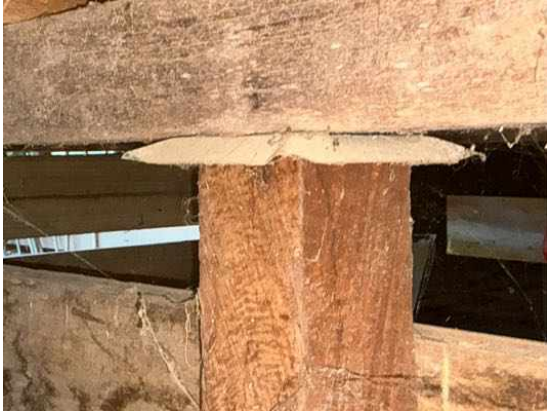
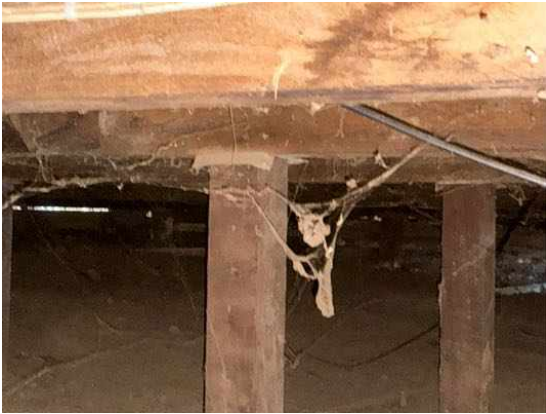
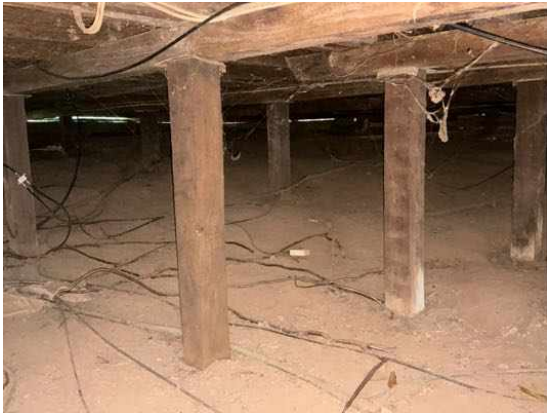
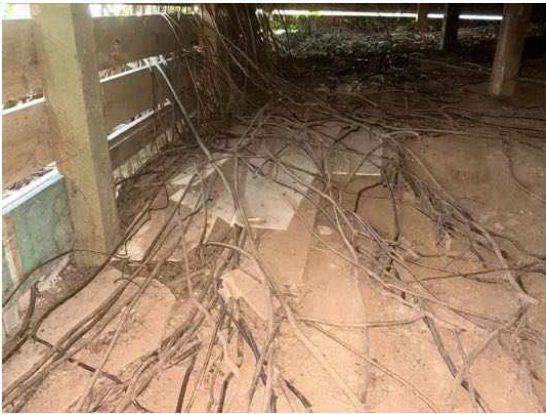
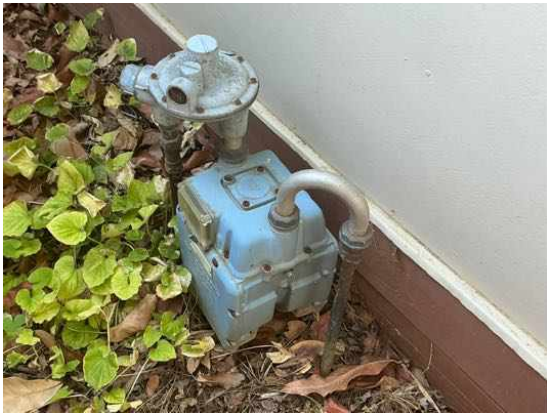
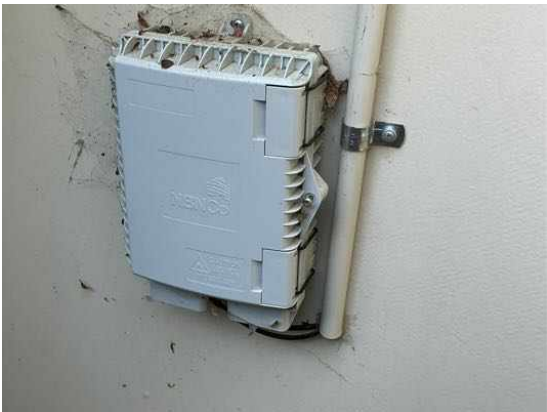
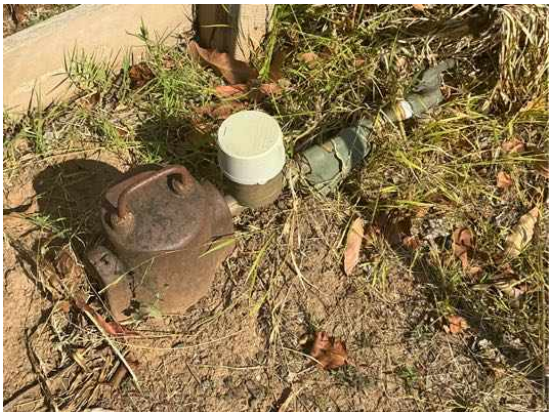
Building: Main Building  
Location: All Areas  
Finding: Additional Photos  
Information: Additional photos are provided for your general reference
