Building and Timber Pest Inspection Report

Inspection Date: Fri, 16 Jan 2026

Property Address: 52 St Leonard Cres, Elizabeth Downs SA
5113, Australia

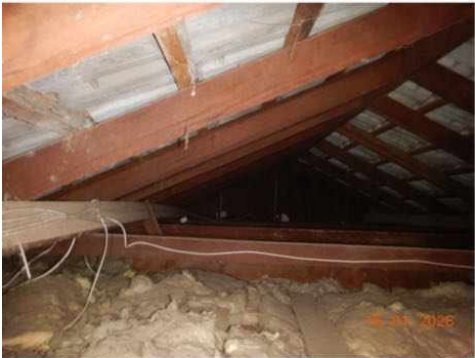
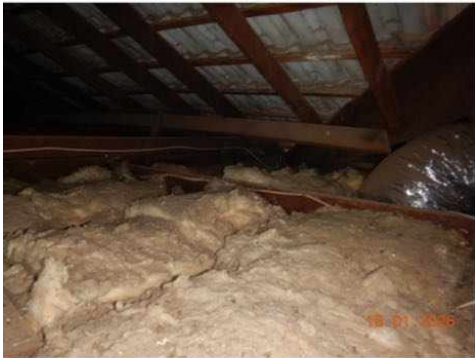
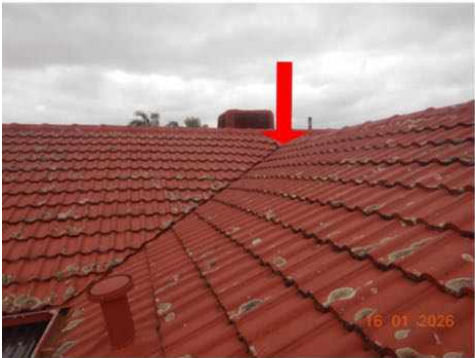
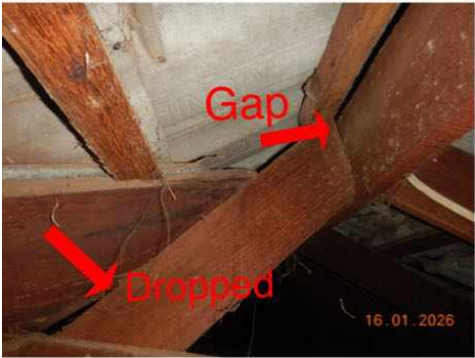
Building:	Building 1
Location:	Roof Void
Finding:	Sagging roof
Information:	The roofing structure was found to be sagging where the front pitch meets the rear pitched roof at the ridge and valley junction, just above the manhole.

This sagging appears to be due to inadequate initial support to the area.

Sagging roof structures are likely to create strain on associated building elements, creating potential for secondary damage including the deterioration of roof coverings. The roof is also unlikely to have sufficient support, which may lead to further sagging if left unmanaged.

It is advised that a licensed builder be appointed to install a new strut in accordance with advice from a structural engineer.

While it would appear that this defect has been present for a long period of time repair is recommended in the short term to ensure the longevity and structural integrity of the dwelling.

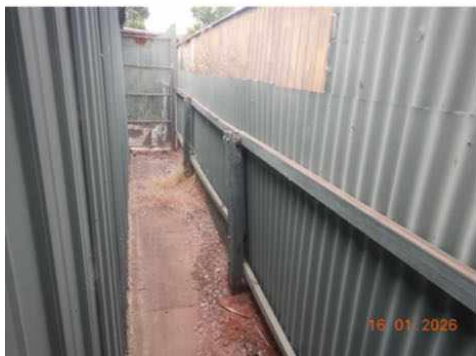
Finding 3.01

Building: Building 1
Location: Yard - Back
Finding: Fencing - Deteriorated
Information: It was noted at the time of inspection that sections of the fencing throughout the property have deteriorated. Typically fencing deteriorates due to age and or wear, rot and or rust which is generally expected for a structure of this age, due to prolonged

exposure to weather conditions. Sometimes inadequate installation or maintenance can be to blame.

If left unattended, it is likely that further damage will occur. It is suspected that repair of several elements of the fencing may be required however replacement may be a consideration of the client also.

A licensed fencing contractor should be appointed to provide further advice and perform rectification works as necessary.

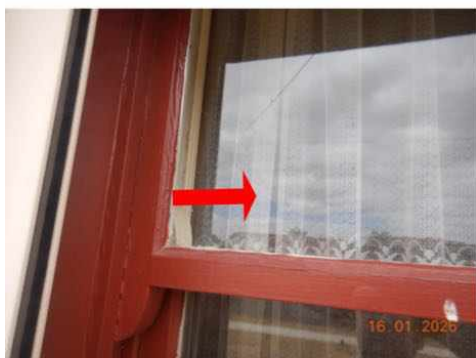
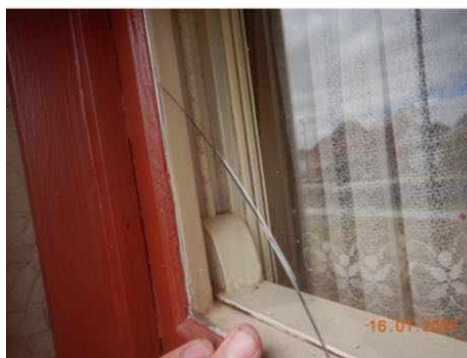
Building:	Building 1
Location:	Lounge Room
Finding:	Window - Cracked
Information:	A cracked window was identified at the time of inspection.

Cracking in windows is generally the result of impact damage, and is likely to develop further when left unmanaged.

The likelihood of this windowpane further cracking and shattering is increased exponentially, providing a safety hazard in the area. The cracked window also impairs the weather tightness of the building, creating potential for minor water leaks.

A qualified glazier is required to repair the window as soon as possible. Depending on the extent of the cracking, replacement of the window may be required. Please be advised that any persons coming into contact with the cracked window should do so with due caution to avoid any personal injury that may ensue.

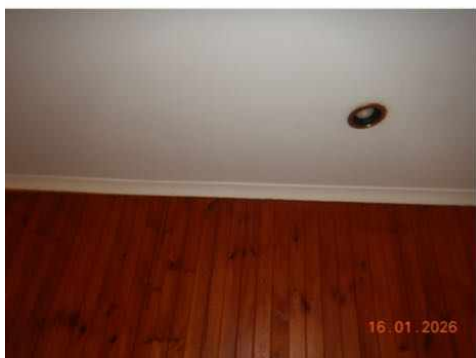
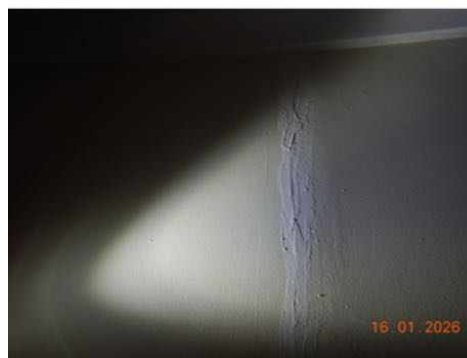
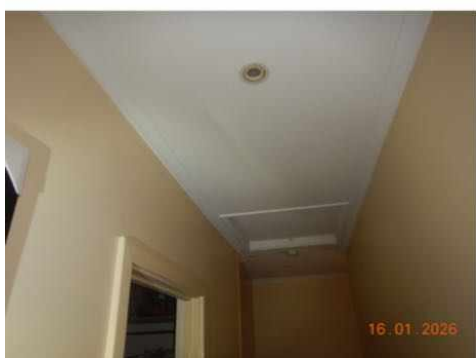
Location: All Internal Areas
 Finding: Cracking - Damage Category 1 - Fine (up to 1mm)
 Information: There are several cracks and crack repairs evident to ceiling and walls of the dwelling at the time of inspection.

Although fine cracks are quite noticeable, they are often only considered to be an appearance defect, and usually do not indicate any structural damage. Generally, the cause of a fine crack is indicative of a separation between building materials and finishes (e.g. paint, plaster, etc.) along joins.

Cracking of this nature can generally be repaired with minor sanding, filling and/or repainting. Such works should be performed by a qualified painter or a general handyman.

Monitoring of all cracking should be conducted frequently. Always contact a building inspector should cracks widen, lengthen, or become more numerous.

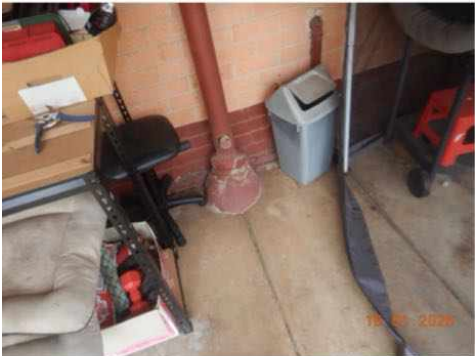
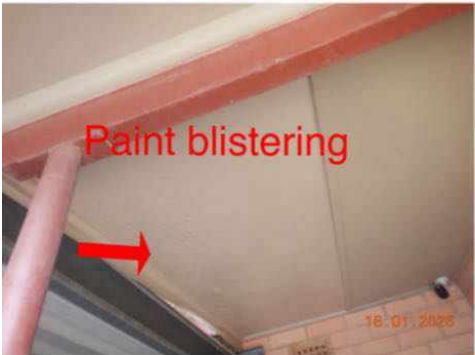
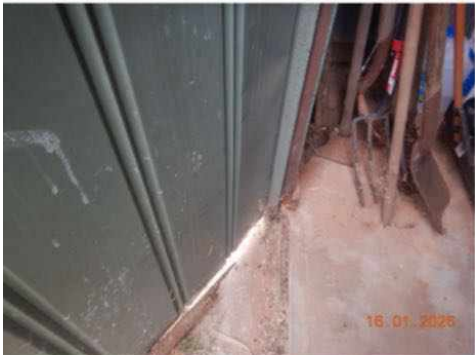
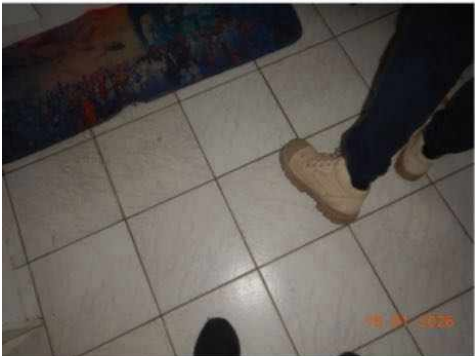
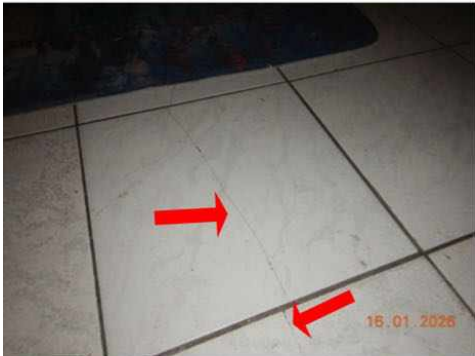
Finding 3.06

Building: Building 1
 Location: All Areas
 Finding: Minor defects present
 Information: There were several age and maintenance related defects evident to the dwelling at the

time of inspection. These defects include but are not limited to

- Plumbing vent is damaged
- Blistering paint to rear porch ceiling
- Shed door damaged
- Several fine cracks to internal tiling.

Appropriate licensed trades people could be appointed to make repairs at the discretion of the client.

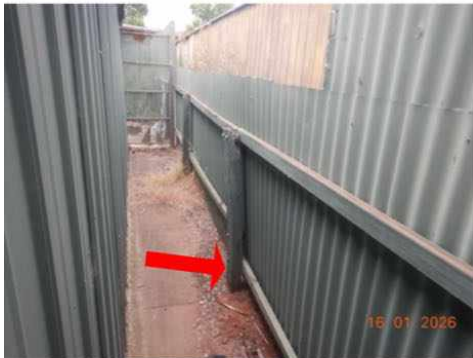
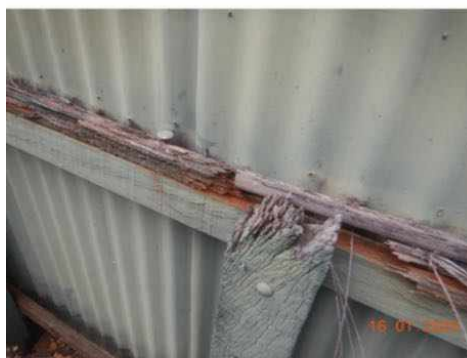
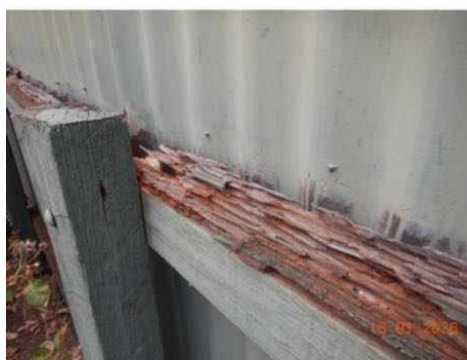
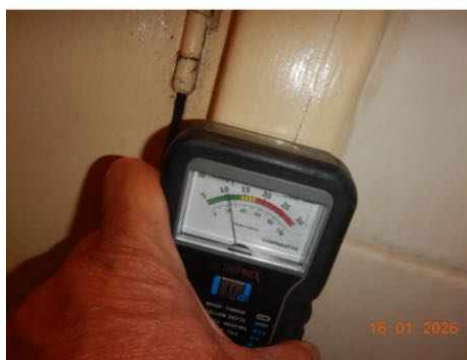
Building: Building 1
Location: Yard - Back
Finding: Evidence of termite damage - minor
Information: Despite no live termite or timber pest activity being indicated, previous termite damage was found to have affected the fencing and also the door frame to the bathroom.

This damage is considered to be inactive and is minor in nature.

It is advised that the area be visually inspected frequently to ensure that the condition of affected building materials does not worsen. At the time of inspection, damage is not structural and is only considered to be superficial.

A building contractor may be appointed to provide a further invasive inspection if further damage is evident.

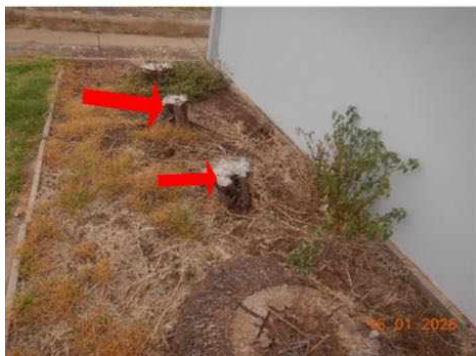
Finding 6.01

Untreated timbers in direct contact with the ground are likely to develop severe wood rot and/or fungal decay if left unattended creating attraction for subterranean termites to infest the timbers from surrounding areas.

If untreated or non-durable timbers are found to be in a hazardous environment it is highly advised that replacement of these building elements be performed as soon as possible to aid the protection of the property against termite / timber pest attack. Failing this close monitoring is recommended in an attempt to identify termite infestation at an early stage.

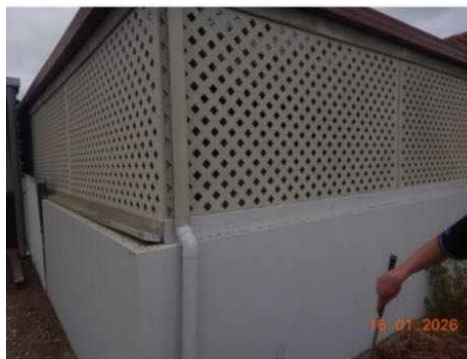
Finding 6.02

Building:	Building 1
Location:	All External Areas
Finding:	Stormwater drain - Not connected or leaking
Information:	The roof plumbing is not adequately connected to stormwater drainage or is leaking in several areas on the site. This issue negatively impacts the functional capacity of the roof plumbing.

Where roof plumbing doesn't drain adequately, the area at the base perimeter can become excessively damp, potentially creating an environment that is susceptible to rust and corrosion of surrounding building elements, as well as attracting termites and other pests.

It is highly recommended that a plumber be appointed to further inspect the area and to install or repair drainage equipment where necessary.

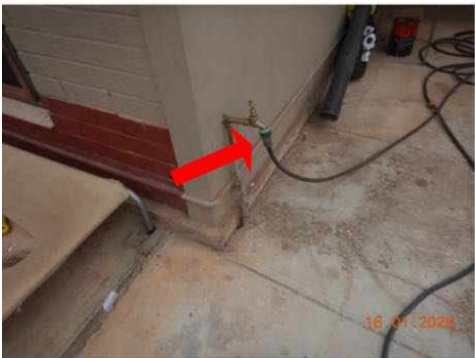
Finding 6.03

Building:	Building 1
Location:	All External Areas
Finding:	Air conditioner and or external tap - No drainage
Information:	Moisture around the perimeter of the building should be minimised to ensure that the area is kept dry and stable which in turn reduces the risk of water damage and termite infestation.

There appears to be no drainage points set up to the air conditioning unit, and or the external tap. While this is not a legal requirement it is recommended to reduce the risk of moisture related issues and the creation of an environment conducive to termite activity.

It is recommended that a licensed plumber be appointed to set up drainage in order to prevent such an environment from being created.

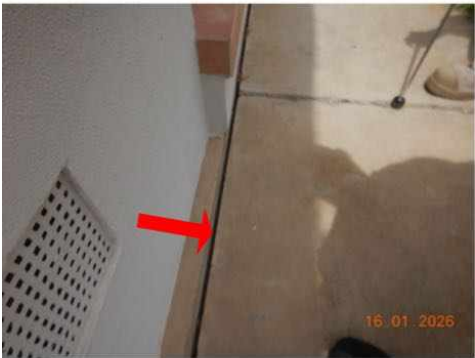
Finding 6.04

Building: Building 1
Location: Front Elevation
Finding: Gaps in footpath
Information: Gaps in the external concrete paving at the front of the dwelling at the junction of pavement to the house slab were identified at the time of inspection.

With reactive clay soils, it is extremely important to ensure that all stormwater flows including roof and ground flows are contained and continually maintained.

A licensed builder may be required to Fill the gap between the pavement and the buildings which is recommended in the short term to prevent unwanted moisture accessing the foundation.

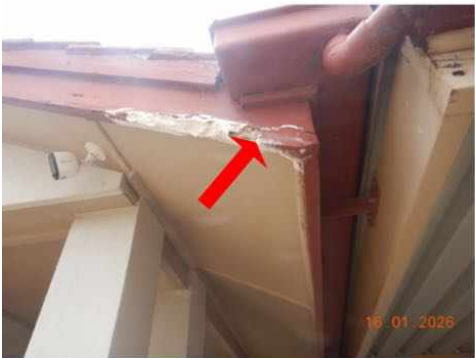
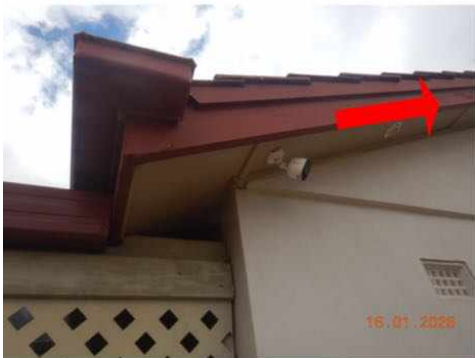
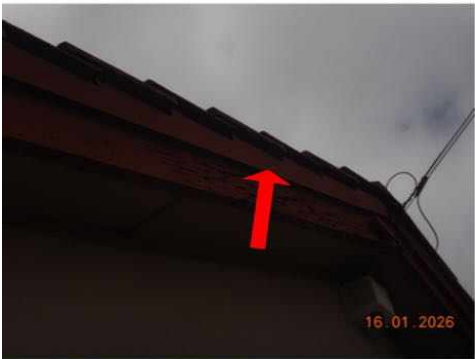
It is likely that this wood rot has developed as a result of faults in the roof plumbing, creating excessive moisture in this areas.

It is advised that a roof plumber be appointed to inspect all roof plumbing and subsequently identify the cause of the wood rot. Replacement of affected fascias and barges may then be a necessary step in protecting surrounding building elements from such deterioration.

A qualified plumber may be appointed to assess the cause of excessive moisture and to provide advice on any remedial works as required. A qualified carpenter or may also be required to replace affected building materials.

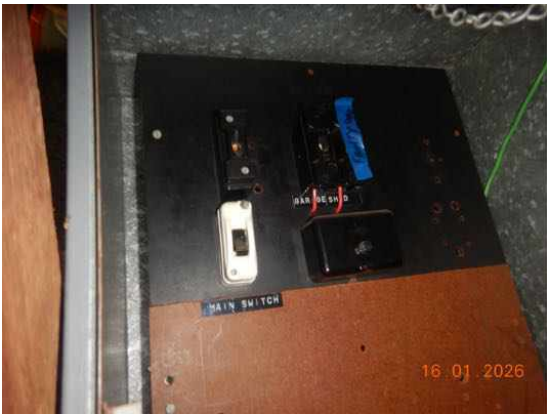
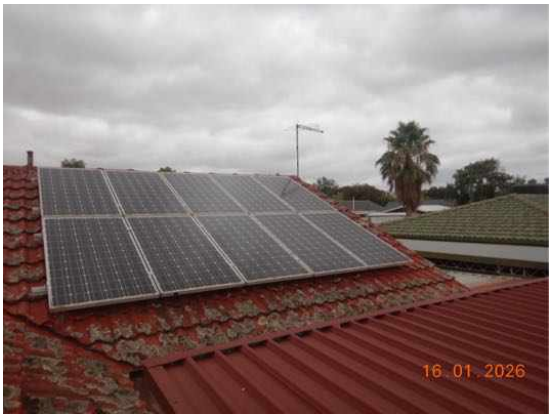
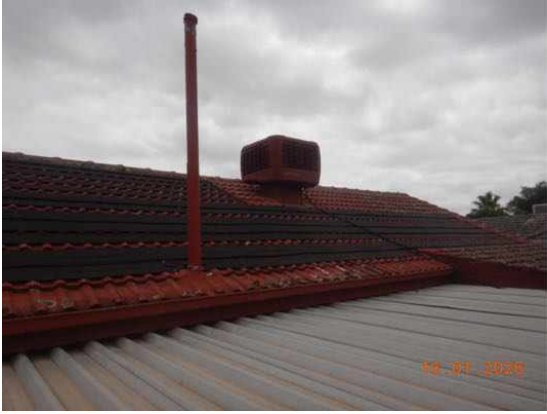
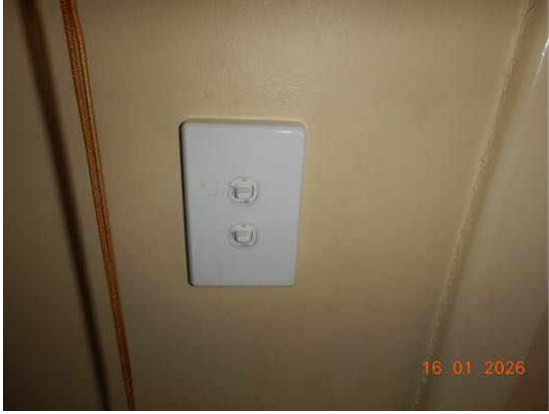
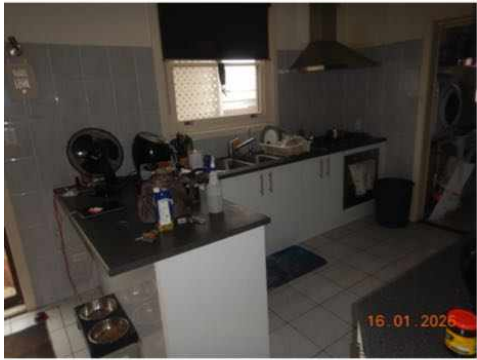
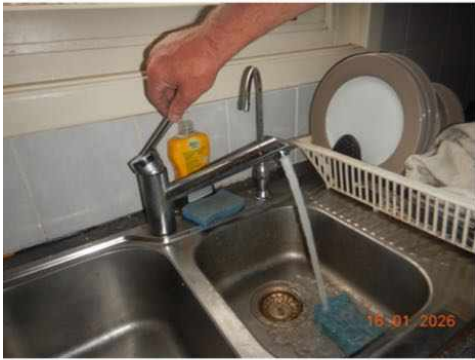
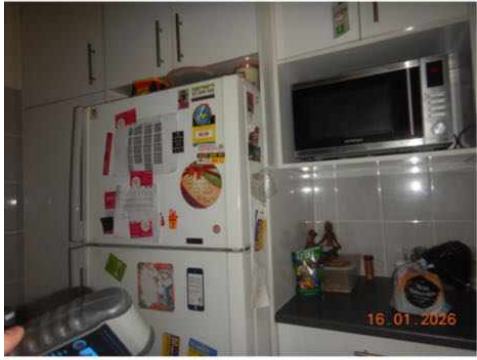
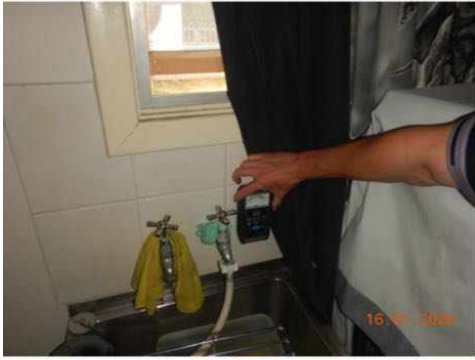
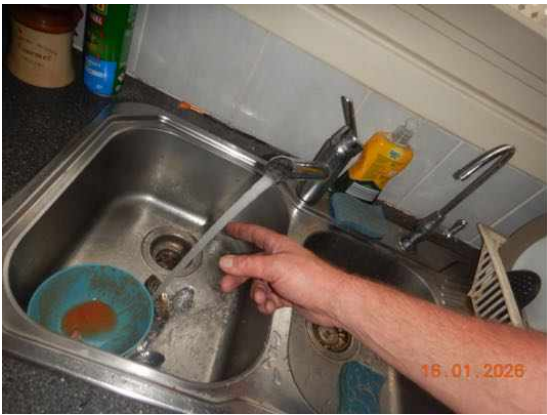
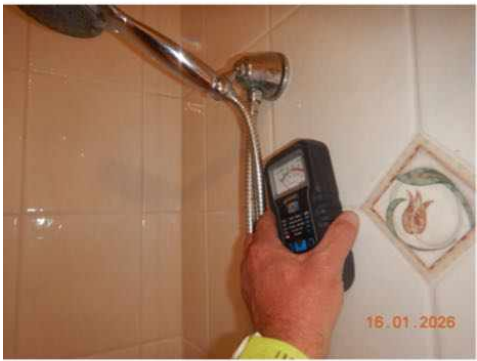
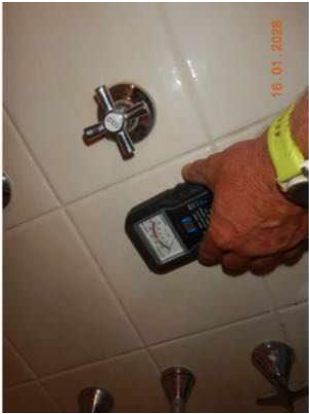
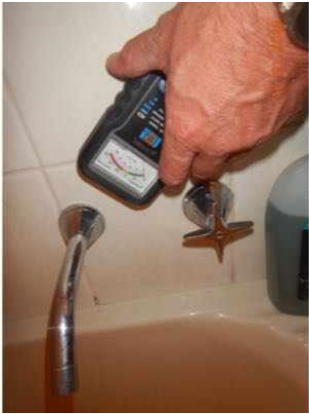
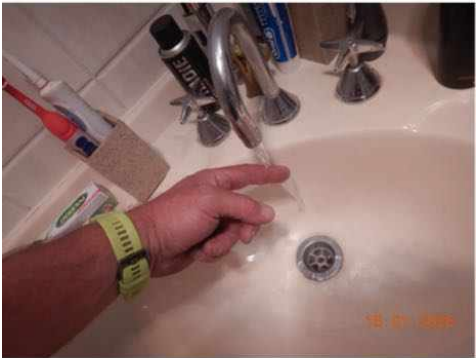
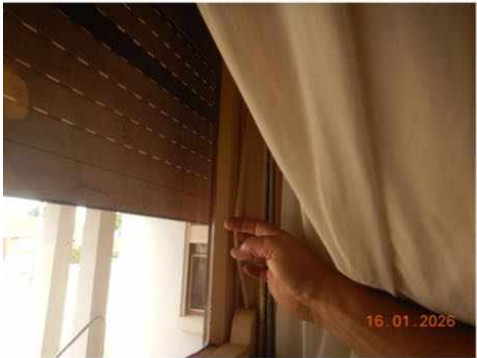
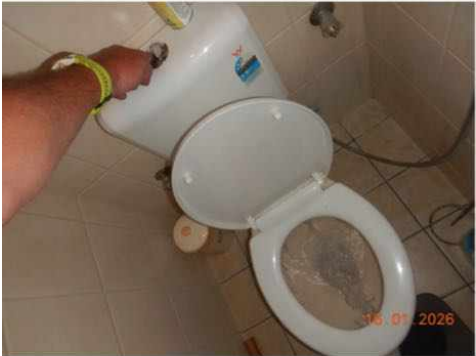
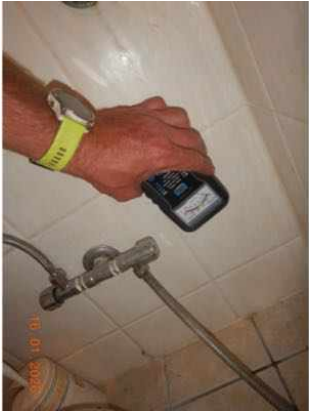
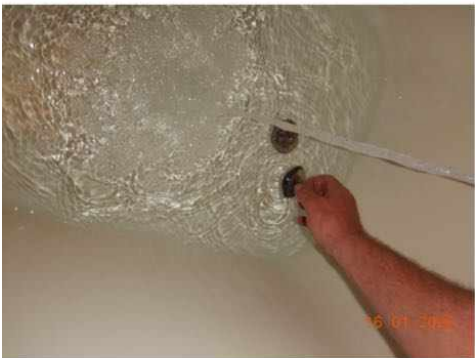
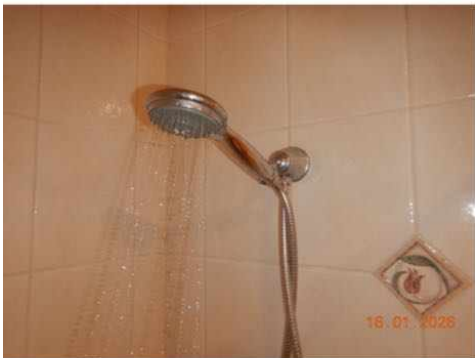
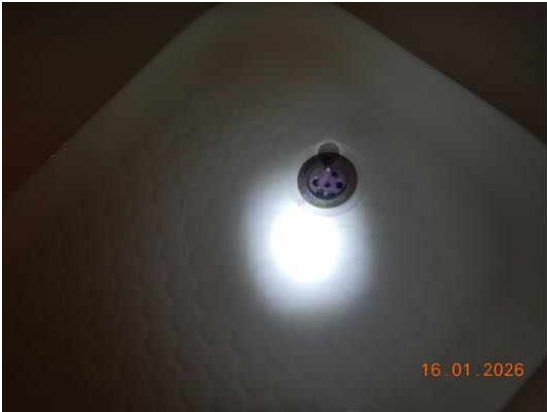
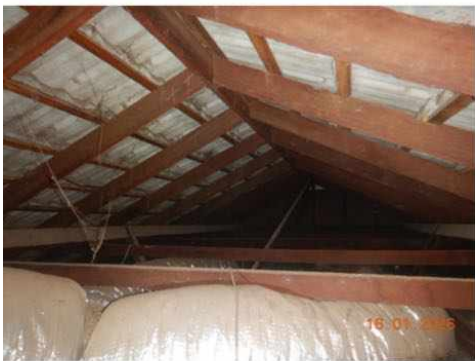
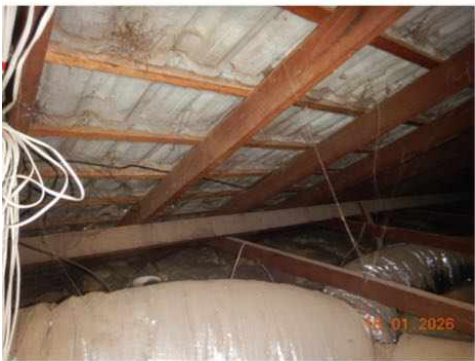
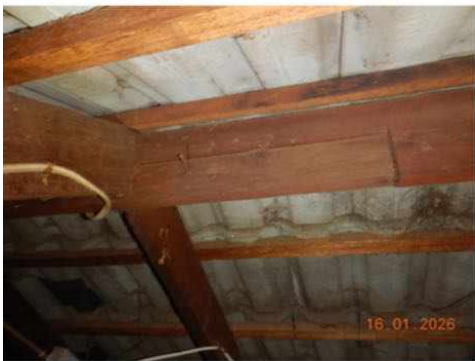
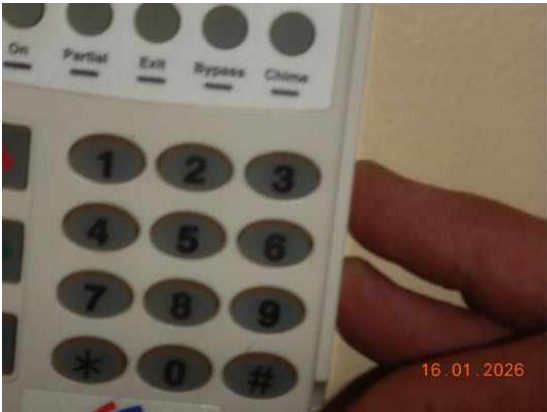
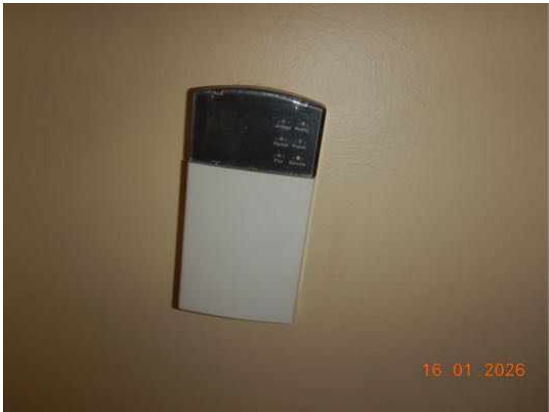
Building: Building 1
 Location: All Areas
 Finding: Additional Photos
 Information: Additional photos are provided for your general reference.

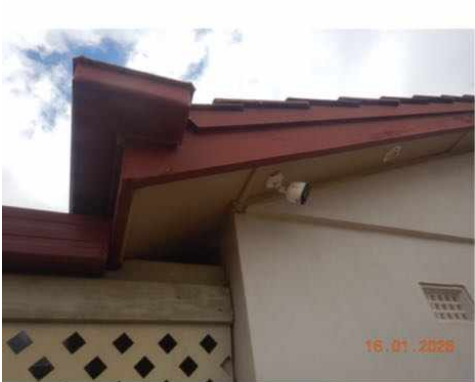
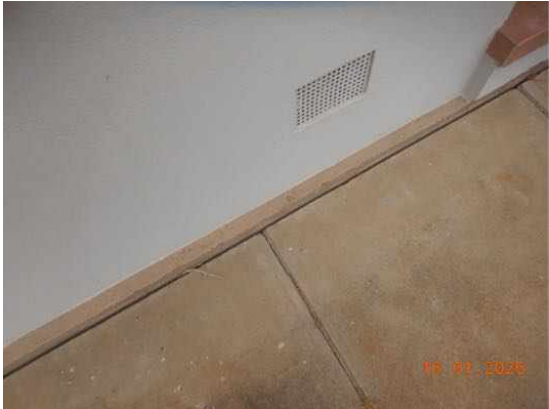
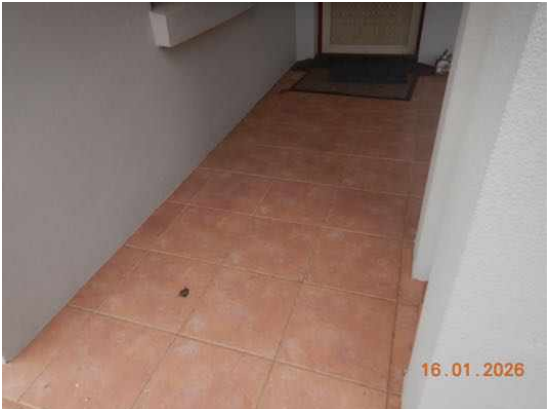
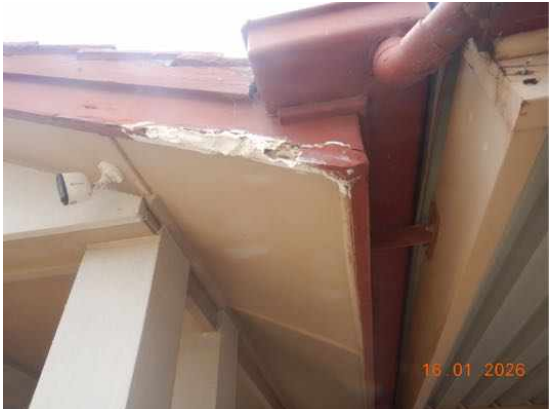
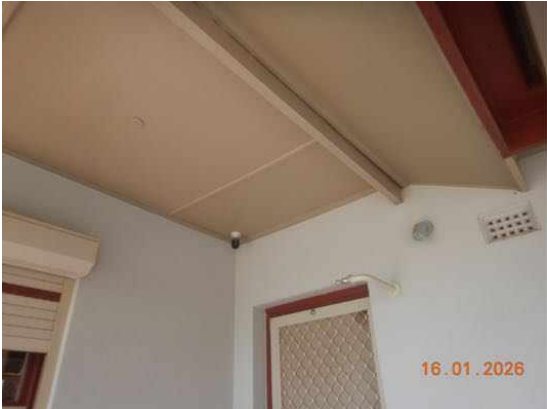
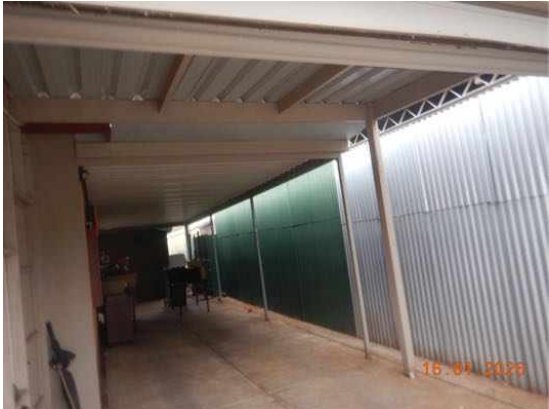
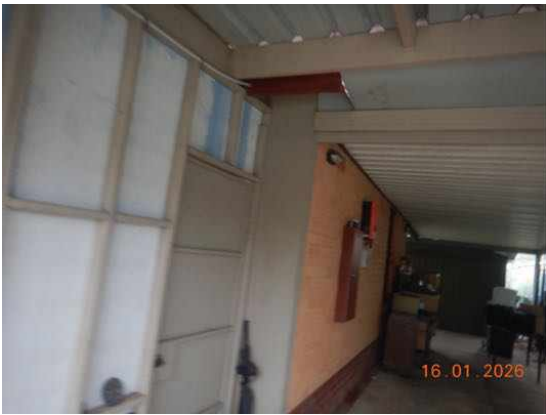
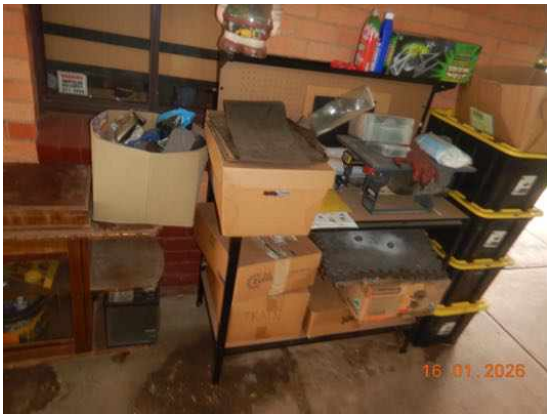
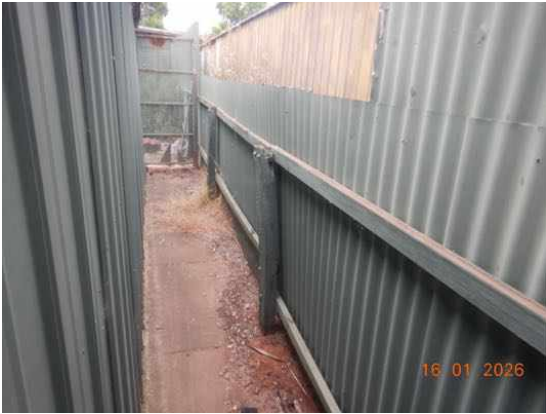
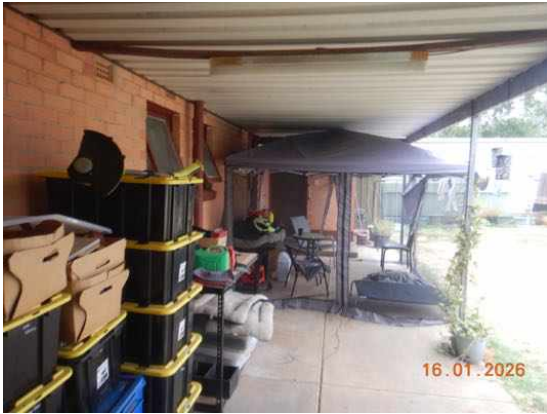
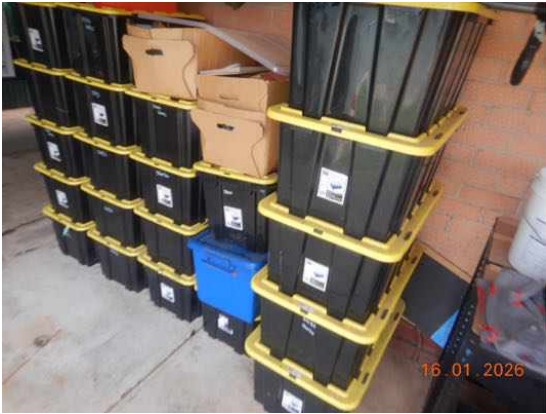
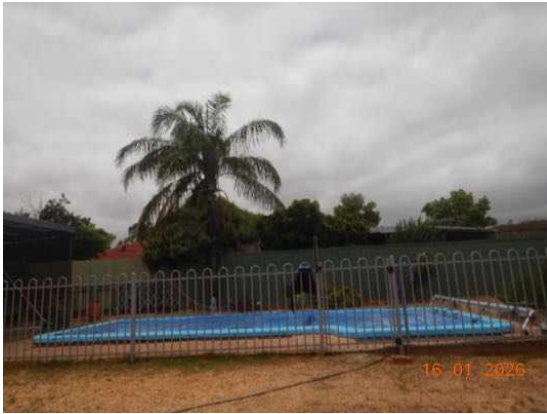
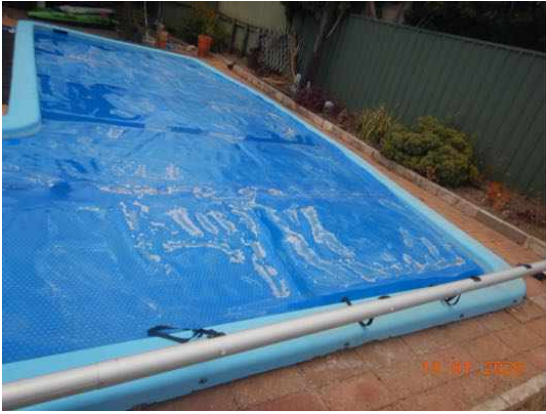
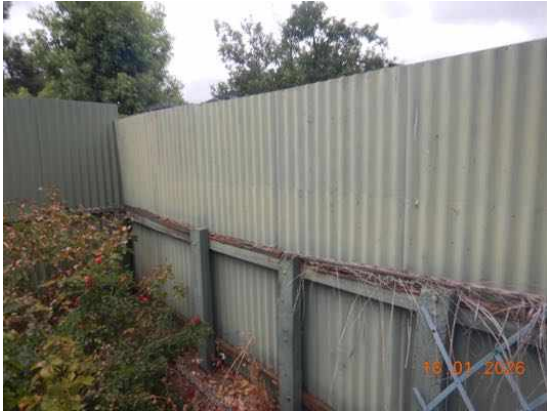
Building: Building 1
Location: All Areas
Finding: Additional Photos - Obstructions and Limitations
Information: These photographs are an indication of the obstructions and limitations which impeded full inspection of the property at the time of inspection.

These obstructions can hide an array of defects and should be removed to allow full inspection to be carried out.

A re-inspection is recommended once the areas are made accessible.

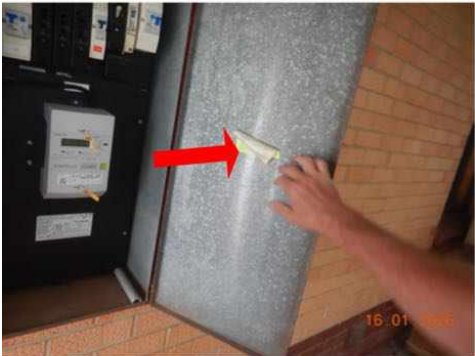
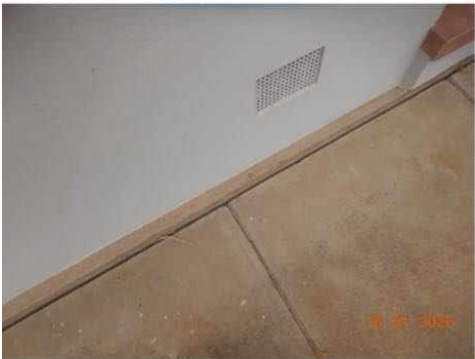
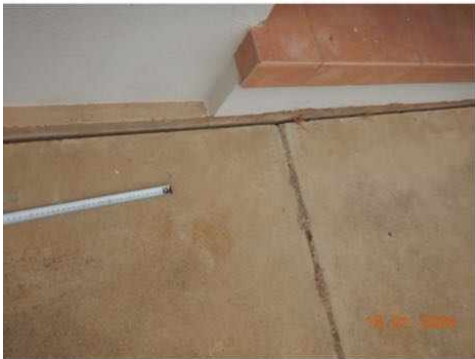
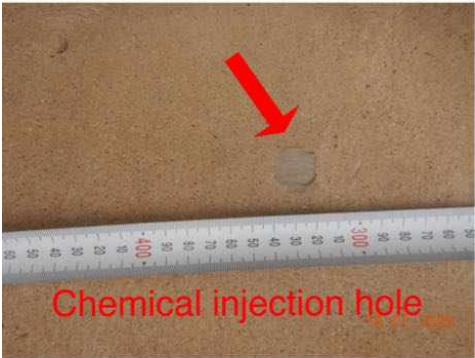
Building:	Building 1
Location:	All External Areas
Finding:	Evidence of a chemical treated zone barrier was identified - drill and inject
Information:	During inspection of the property, it was noted that works to install a chemical treated zone barrier had previously been completed. A chemical treated zone barrier is likely to ensure effective protection against termites.

Drill and inject holes were evident and found at approximately 350mm centres. This indicates that the treatment was done many years ago and would likely be outdated.

We strongly recommend annual inspections of the barrier and surrounding areas as there are several factors that can lead to deterioration of the barrier and decrease its effectiveness.

Where a Termite Management System has been identified, the client should identify to the type of barrier, date of installation, warranty conditions and any documentation provided by a builder or past owner. Consult the company who installed the barrier to confirm whether the system is still under warranty.
