Building and Timber Pest Inspection Report

Inspection Date: Wed, 4 Mar 2026

Property Address: 6 Walsh Cres, North Nowra NSW 2541,
Australia

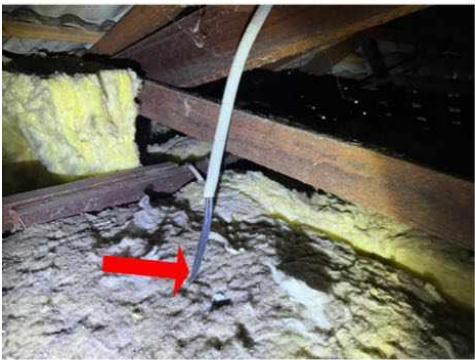
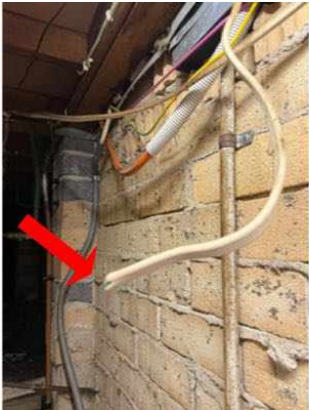
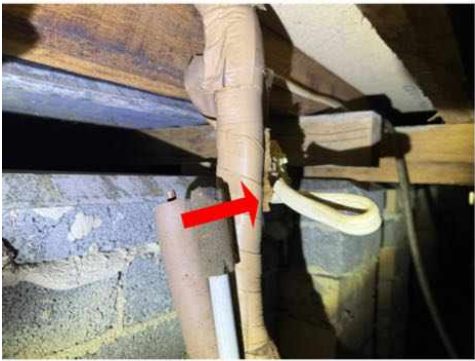
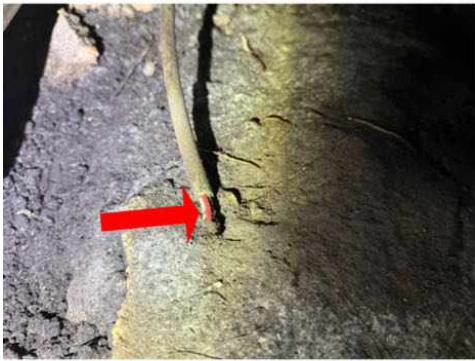
Building: Building 1
Location: Subfloor and Roof Cavity
Finding: Electrical cables missing a junction boxes
Information: These electrical fittings in this roof and subfloor areas was found to be missing a junction boxes at the time of inspection.

This missing fittings and loose cables does expose electrical works, and may create a safety hazard if there is potential contact with persons in the area.

A Licensed electrician should be appointed to rectify these areas immediately.

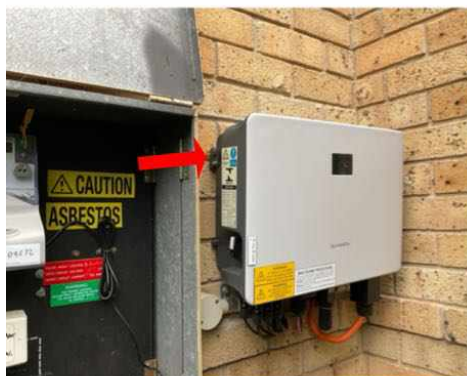
Finding 1.02

Building: Building 1
Location: Pictured area
Finding: Solar control box loose
Information: The solar control board is falling off the wall and could cause an electrical safety issue

if not immediately rectified.

An electrician would be the trade responsible for rectification of this box before it falls off the wall and creates electrical safety issues.

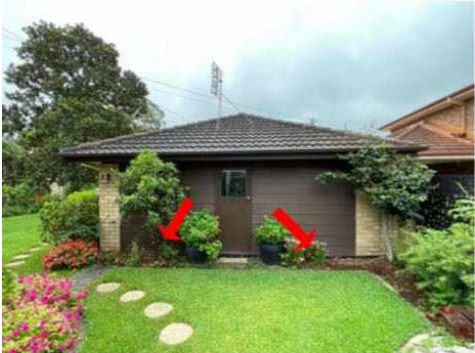
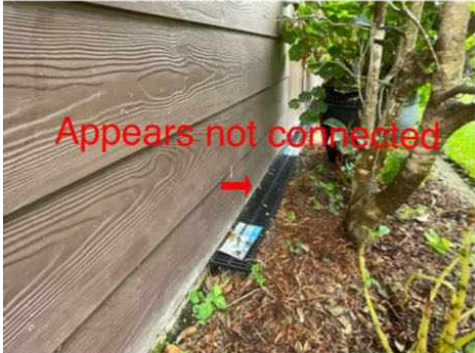
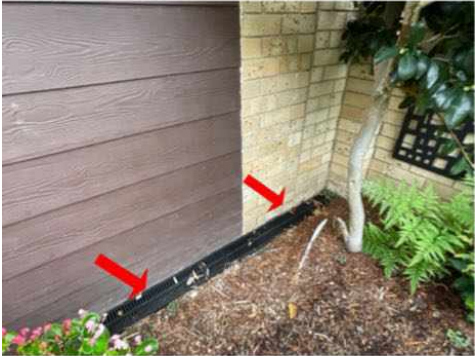
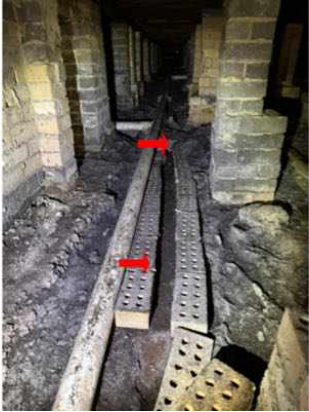
Finding 2.01

Building:	Building 1
Location:	Many pictured walls and subfloor areas
Finding:	Site drainage - Inadequate
Information:	The site drainage in many areas was found to be totally inadequate at the time of inspection, creating potential for subsequent water damage to associated building elements.

New strip drains have been added to the rear garage and rear house but they do not appear to be connected to drainage rendering them pointless. Rainwater is entering the subfloor and 80% + of the subfloor appears damp with many areas mouldy. These damp conditions are causing rising damp to subfloor walls and this damp appears to be starting above the floor in many house walls. This is thought to also cause the step cracking found in the brickwork. This moisture is promoting tree roots growing in the subfloor.

Where site drainage is inadequate, installation of an Agricultural (Aggie) Drain is required. A qualified plumber should be appointed to further inspect the property and perform any remedial works or provide a quote before purchase. Secondary defects are already occurring and this damp may affect the structural stability of subfloor walls

in the future.

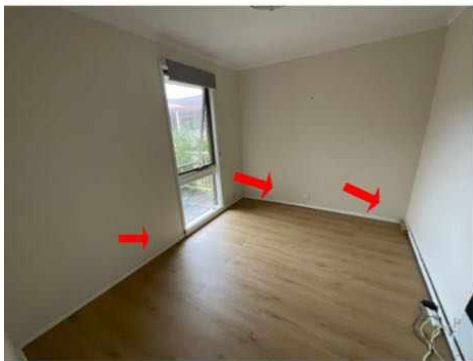
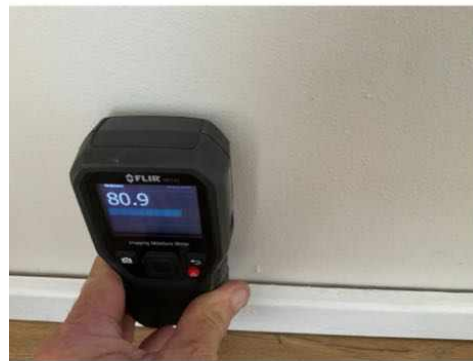
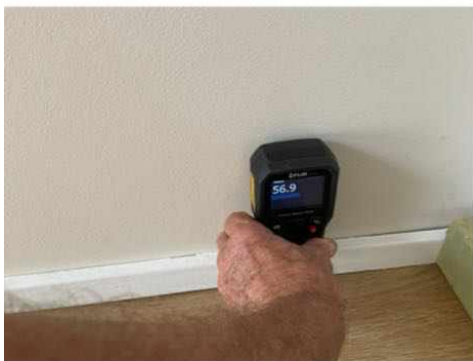
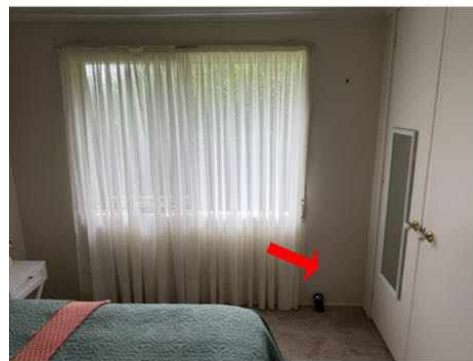
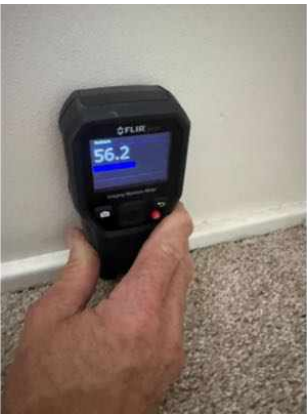
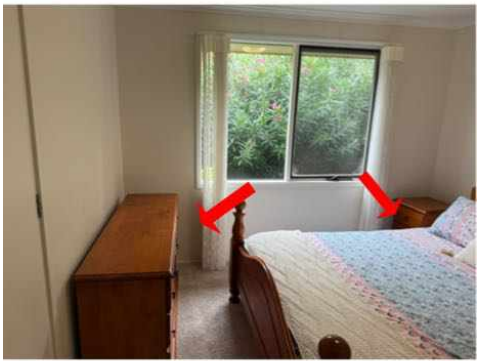
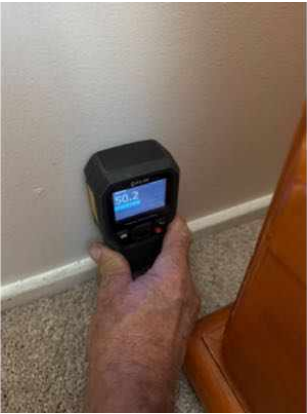
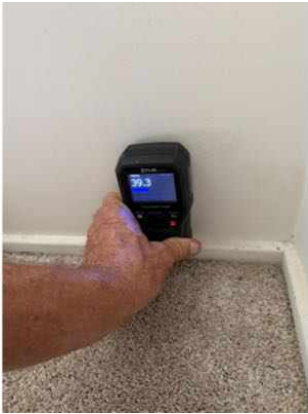
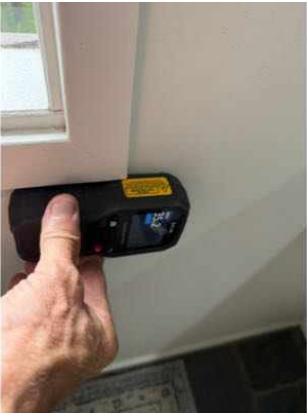
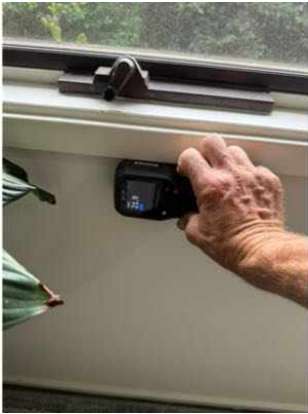
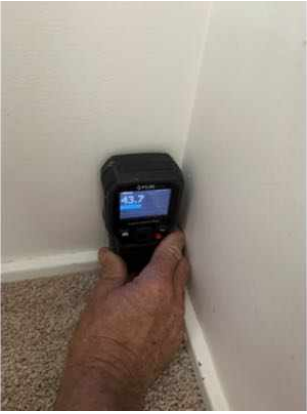
Finding 3.01

Building: Building 1
 Location: All left rooms and some right rooms
 Finding: Evidence of excessive moisture was present at the time of inspection
 Information: Excessive moisture was found in 3 bedrooms and other areas at the time of the inspection. Medium to high readings up to 80.9 were recorded.

This can attract termites and produce conditions that promote termite attack, fungal growth and wood decay. Excessive moisture is normally caused by deteriorated, inadequate or missing roof drainage, damaged wall sealant, leaking plumbing pipes or fixtures, poorly plumbed HWS overflows or condenser units and poor site drainage.

Due to the widespread nature of this moisture, it is suspected the extremely moist subfloor areas are the cause. Most houses have one or no areas of excessive moisture.

It is highly recommended that quotes for drainage be obtained before purchase to rectify the high moisture areas in many rooms .

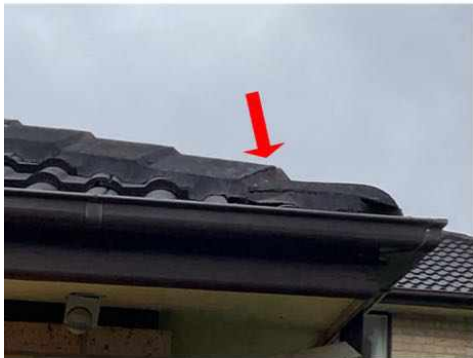
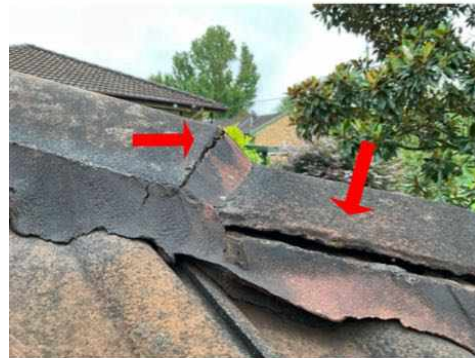
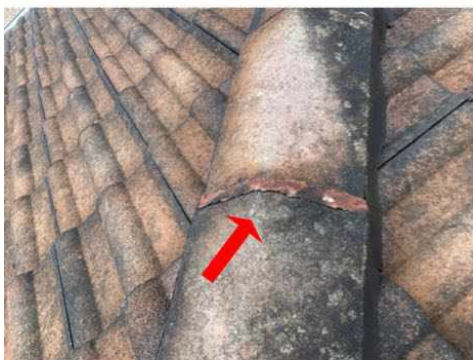
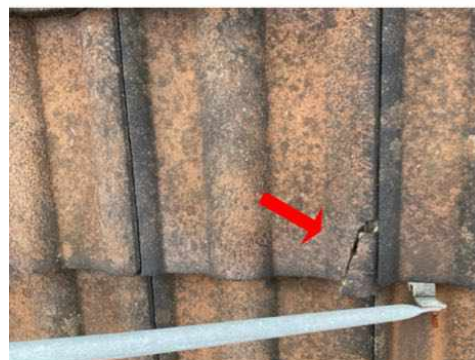
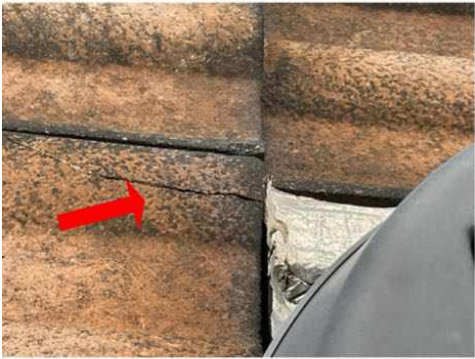
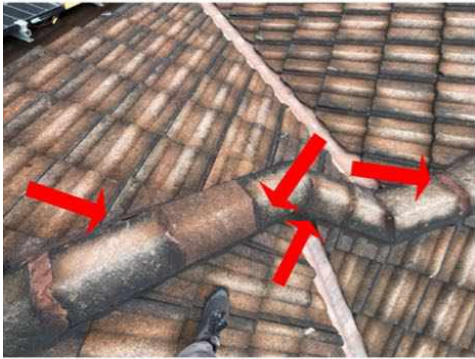
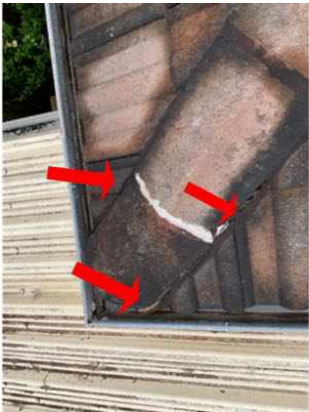
Finding 3.02

Building: Building 2
Location: Roof Exterior
Finding: Roof tiles - Weathered
Information: Upon inspection of the exterior roofing, the majority of the ridge capping roof tiles were considered to be in a poor condition.

Isolated areas of mortar have come loose and cracking is also present. Re-pointing and re-sealing is urgently required to help preserve and extend the life span of the tiles.

Where left unmanaged, deteriorating roof tiles are likely to lead to a number of secondary defects, including minor water leaks and weather exposure to internal roofing structures.

Consultation with a roofing contractor is highly advised to gain advice on cost of remedial works that are required before purchase. Remedial works are likely to increase the longevity of the exterior roofing structure.

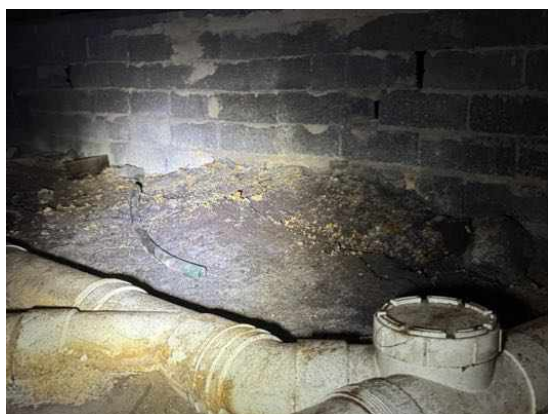
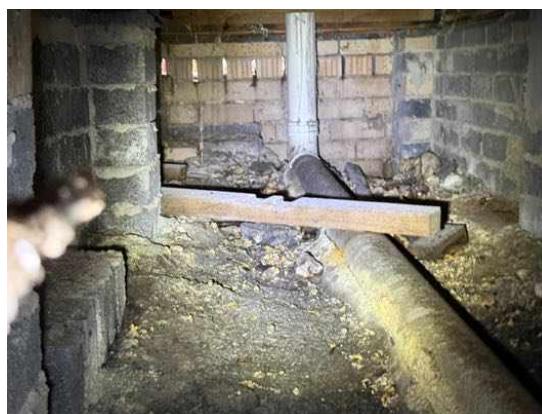
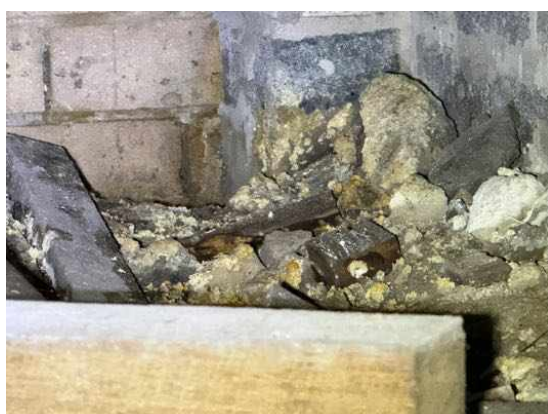
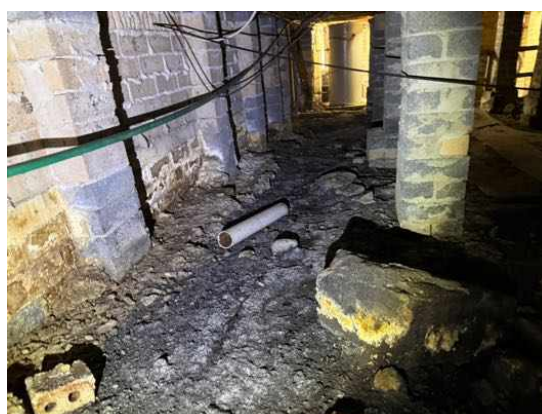
Finding 3.03

Building: Building 1
Location: Subfloor and garage
Finding: Mould - Present in subfloor and garage
Information: Where evidence of extensive mould growth was noted, there may be environmental, biological or health issues associated with the report. A specialist inspection by a suitably qualified environmental health inspector is warranted, where mould is extensive or where any queries regarding air quality spores or other related issues apply.

Subfloor mould is generally caused by moisture ingress, lack of external drainage, lack of adequate ventilation and subfloor debris present. These issues need rectification

Generally, the client is advised to ensure that the general environment is free of moisture and humidity to aid in the prevention of mould formation and development.

to stop mould development. Any mould found during the inspection should be cleaned immediately by a cleaning contractor or the homeowner as applicable.

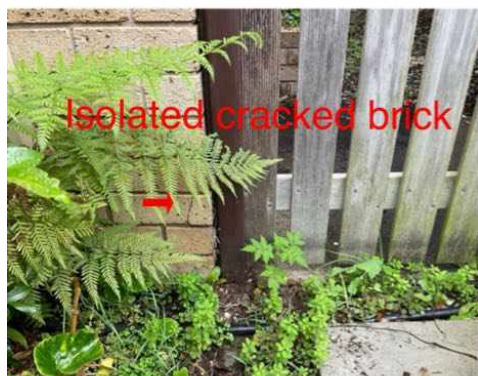
Finding 3.04

Building:	Building 1
Location:	Exterior walls - right & front
Finding:	Step cracking to brickwork (minor)
Information:	Step cracking was identified to the brickwork in this area at the time of inspection. Step cracking, which is similar to other forms of cracking, has a variety of possible causes. However, the most common is the subsidence of adjacent footings.

Step cracking is a relatively common defect, and is most likely to occur adjacent to windows, doors and other openings. Mortar failure in the gaps between affected bricks indicates the stresses and tensions affecting the wall.

Where step cracking is extensive or severe, the client is advised to consult a structural engineer. This minor step cracking can be used as a warning sign to address factors causing stress to the wall, which can include the effect of surrounding trees, water leaks, soil erosion, or even the presence of reactive soils in the surrounding area.

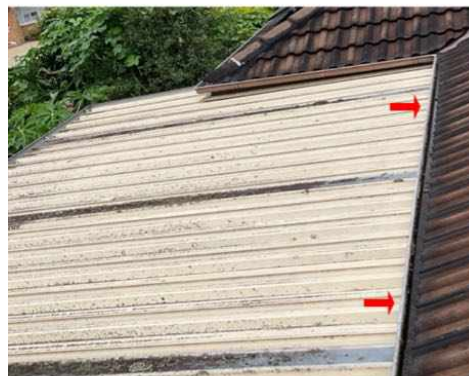
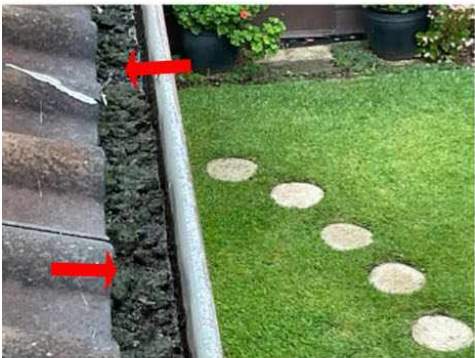
Finding 3.05

Building:	Building 1
Location:	Roof Exterior
Finding:	Roof plumbing - Rusted or corroded
Information:	The roof plumbing has areas of rust and corrosion. It is suspected that this has been caused by blockages, resulting in pooling or standing water, that have prematurely rusted elements of the roof plumbing.

Rusted roof plumbing will generally develop holes and leaks that can affect other building elements with poor drainage of storm water. Poorly drained roof areas will also lead to damp conditions surrounding the base perimeter of the building which, if left unmanaged, can lead to a range of secondary building defects.

Repair and/or replacement of rusted roof plumbing is highly required in order to reinstate the roof drainage system to a fully operational level. To further maintain these areas, gutters should be cleaned frequently, allowing the avoidance of any partial blockages.

A licensed plumber or specialist roof restoration company should be appointed to undertake these works. It is advised that such works be completed as soon as possible to prevent any further damage and deterioration.

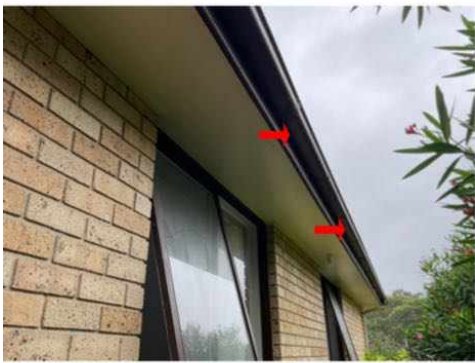
Finding 3.06

Building: Building 1
Location: Exterior gutters
Finding: Water leak - downpipe
Information: Many water leak were found to gutter areas. These leaks are ongoing and hence require urgent action.

Regardless of the location, even minor leaks that are left unmanaged can lead to serious damage of associated building elements.

It is highly advised that the cause of these leaks (likely to be the rusted gutters) be identified and resolved immediately by a roof plumber to prevent any further damage. Depending on the extent of the damage previously sustained, replacement of many gutters may be required.

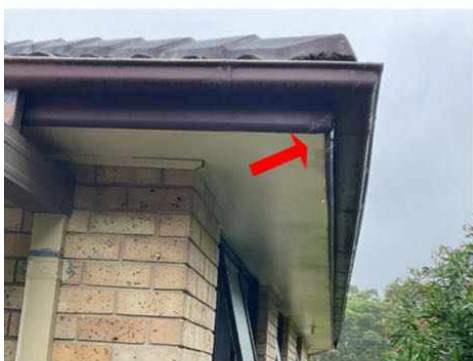
Finding 3.07

Building:	Building 1
Location:	Pictured areas
Finding:	Wood rot
Information:	Some fascia shows evidence of wood rot. Wood rot, also known as Fungal Decay, occurs when timbers and other cellulose building materials are exposed to damp conditions on an ongoing basis. This could be the result of exposure to weathering over a prolonged period of time, or the attraction of excessive moisture from other abutting building materials.

Early intervention and regular maintenance, particularly of exterior timbers, will prolong the useful life of these building elements. Prior to any works being performed, the cause of the moisture that has created the visible wood rot should be identified and addressed in a suitable manner. Replacement of affected timbers may then be a necessary step in protecting surrounding building elements from such deterioration.

A qualified carpenter or registered builder may also be required to replace affected building materials.

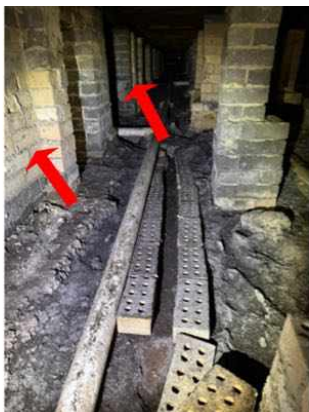
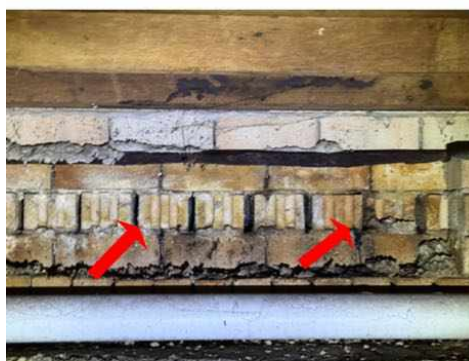
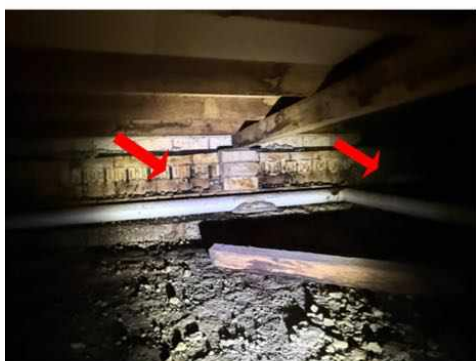
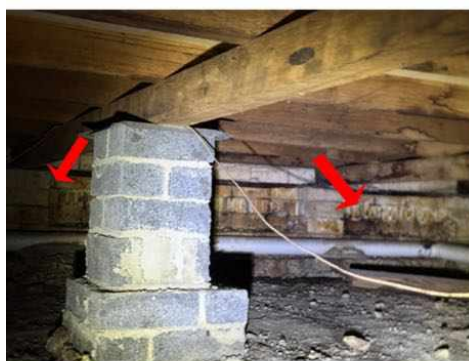
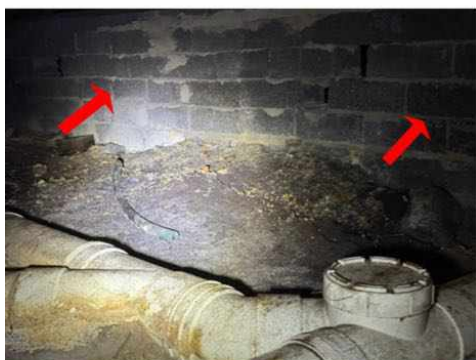
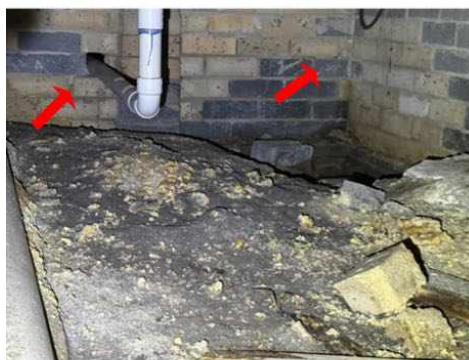
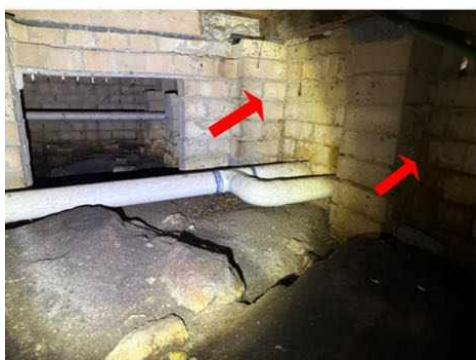
Finding: Subfloor ventilation - Inadequate
 Information: Adequate subfloor ventilation aids in preventing excessive moisture wood rot and termite activity by ensuring a dry subfloor environment.

Where ventilation is substandard or blocked here, it is usually caused by factors such as failure to install adequate vents during construction or earth and vegetation covering vents. Low subfloor clearance and stored items or debris in the subfloor also restricting airflow.

Subfloor ventilation can be improved in most cases by addressing the causes such as exposing subfloor vents, installing additional vents, installing mechanical ventilation and removing debris from the subfloor.

A registered builder should be appointed as soon as possible to install numerous vents on all walls.

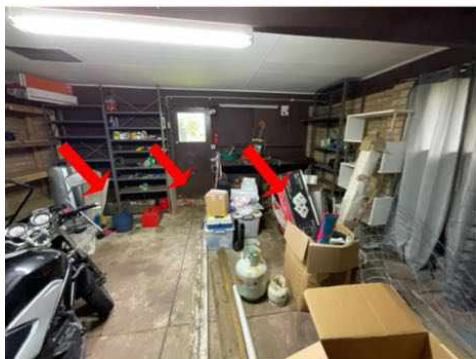
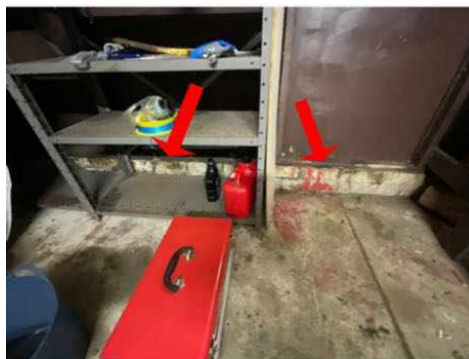
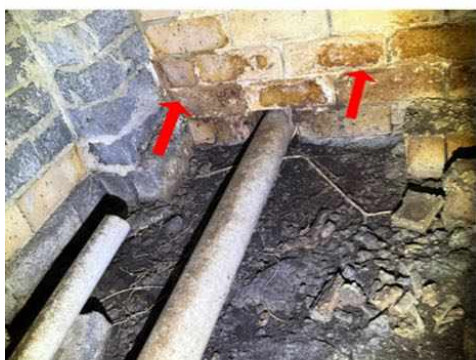
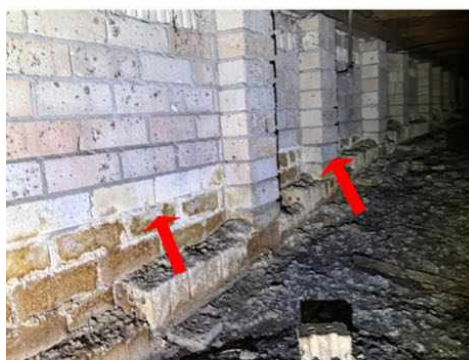
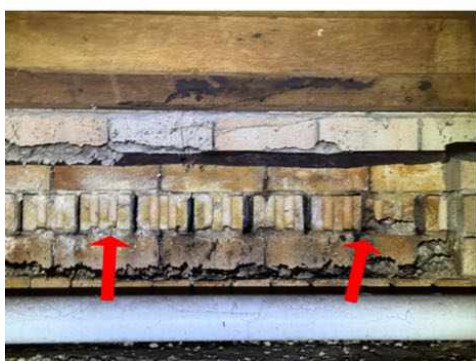
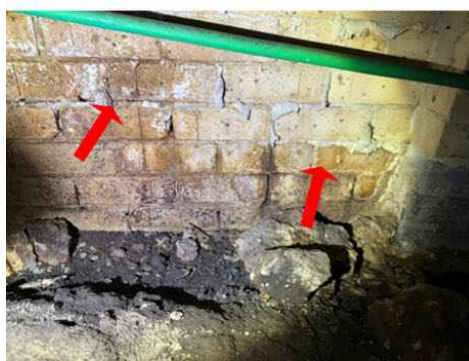
Finding 3.09

Building:	Building 1
Location:	Many subfloor and garage areas
Finding:	Damp - Rising
Information:	Rising damp describes the upward movement of water in low sections of building elements (e.g. walls) by capillary action - the movement of water through porous materials such as bricks, sandstone or mortar.

Rising damp is generally managed by the installation of a damp proof course during construction. A Damp Proof Course (DPC) is an impermeable barrier at the base of the wall above ground level. However, many 19th Century buildings have no damp course installed, or the materials have failed. The DPC may have been omitted as a consequence of poor workmanship, or it may have been bridged where materials built up against the side of the house allow moisture ingress above the DPC level.

The first step in addressing rising damp is to diagnose the cause. The identified cause should be addressed first before addressing the appearance and other defects which have resulted from the rising damp. If the original cause is not resolved, further cases of damp are likely to ensue, resulting in secondary defects.

Consultation with a qualified plumber is advised immediately to identify the cause of the damp and perform remedial works as required.

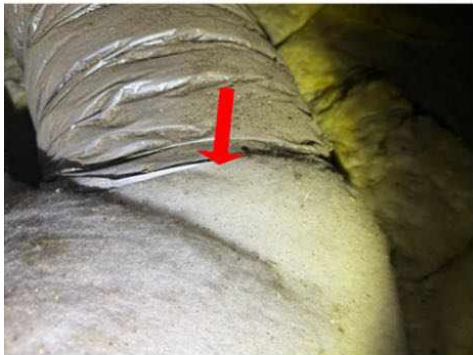
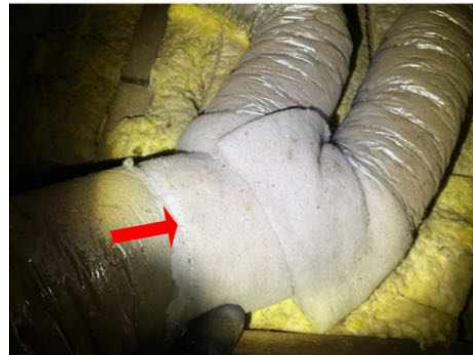
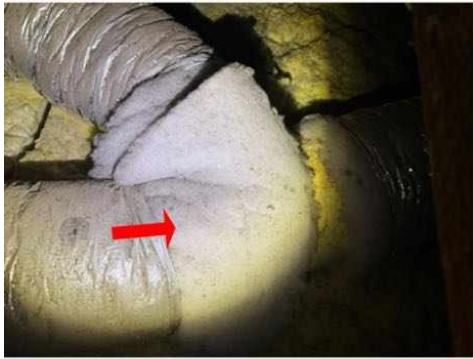
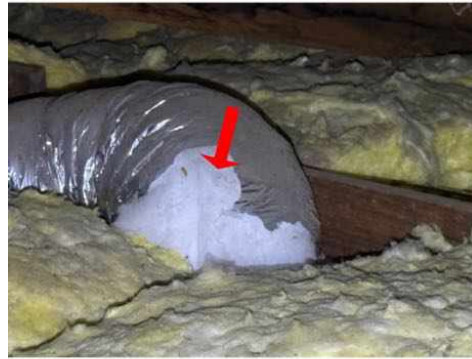
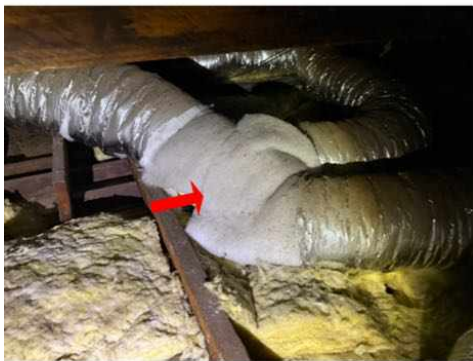
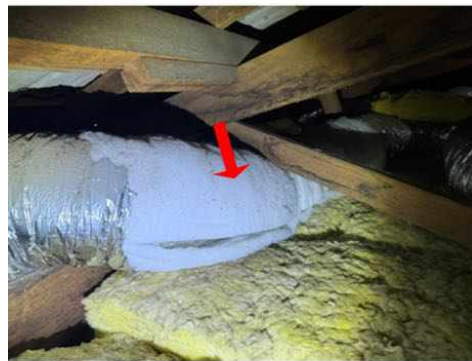
Building:	Building 1
Location:	All Roof cavity areas
Finding:	Air conditioner ducting - Damaged
Information:	The Air Conditioner ducting was found to be disconnected in the roof cavity. This will mean the A/C is not functioning effectively.

It is highly recommended that a handy person or A/c installer be appointed to reconnect the A/C ducting in order to prevent a loss of air into the roof void.

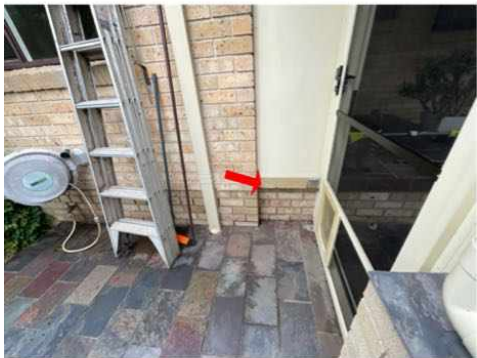
Finding 3.13

Building:	Building 1
Location:	Rear verandah
Finding:	Crack in concrete slab - Category 1
Information:	A crack coded as Category 1 was identified in this slab. A Category 1 crack is described as a fine but noticeable crack, with the slab at an otherwise reasonable level. To be considered Category 1, the approximate width of the crack is less than 1.0mm, or a less than 10mm change in offset when a 3m straight edge is placed over the defect.

Category 1 cracks should be monitored for a period of 12 months. At the end of the monitoring period, identified cracks that are rated greater than Category 2 are considered defects, and require rectification.

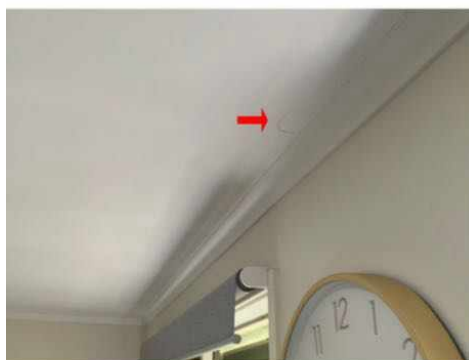
Finding 3.14

Building: Building 1
Location: Lounge Room & kitchen
Finding: Cracking - Damage Category 1 - Fine (up to 1mm)
Information: Although fine cracks are quite noticeable, they are often only considered to be an appearance defect, and usually do not indicate any structural damage. Generally, the cause of a fine crack is indicative of a separation between building materials and finishes (e.g. paint, plaster, etc.) along joins.

Cracking of this nature can generally be repaired with minor sanding, filling and/or repainting. Such works should be performed by a qualified painter or a general handyman.

Monitoring of all cracking should be conducted frequently. Always contact a building inspector should cracks widen, lengthen, or become more numerous.

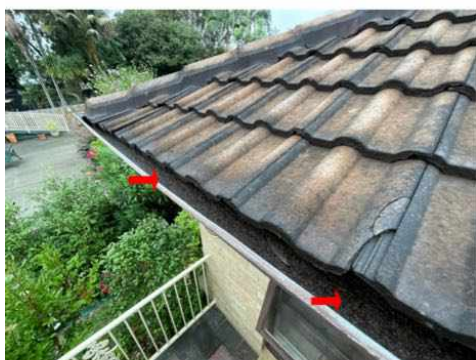
Finding 3.15

Building:	Building 1
Location:	Roof exterior
Finding:	Gutters - Full and blocked
Information:	The guttering on around the roof was found to be blocked at the time of the inspection. Roof plumbing structures, such as guttering and downpipes, should be free of all debris to prevent blockages. Blockages of the guttering and downpipes will lead to pooling and accumulated water overflows, which is likely to subsequently flood eaves and exterior walls.

Blocked gutters are likely to lead to high levels of moisture in the affected areas which can cause rust and decay of the gutters and downpipes and wood rot to adjoining timber areas. Blockages in gutters should therefore be removed immediately to ensure dry conditions are maintained.

It is highly advised that gutters be cleaned by the homeowner or a general handyperson as a matter of urgency.

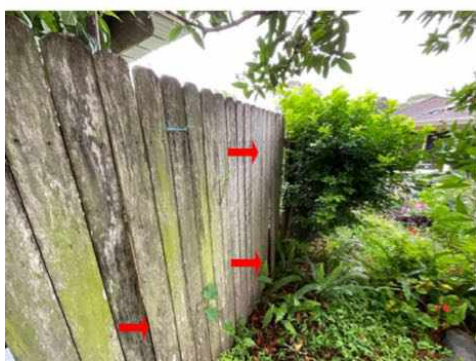
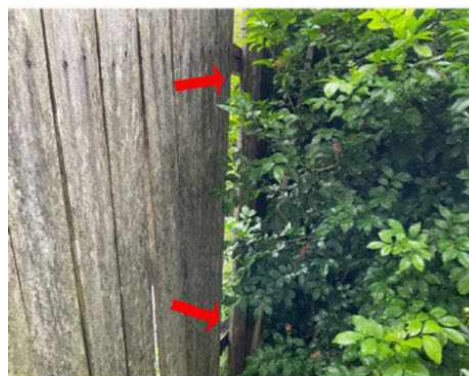
Finding 3.16

Building:	Building 1
Location:	Pictured fences

Finding: Fences damaged and leaning
 Information: Evidence of damage to the pictured rear right fence was identified at the time of the inspection. The likely cause of this fence leaning is not enough concrete used in the post footings. If left unmanaged this fence may deteriorate further.

It is suggest a fencing contractor be engaged for rectification when convenient.

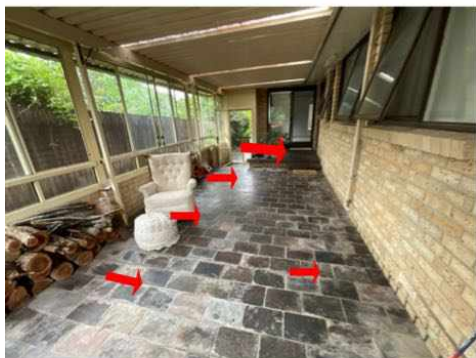
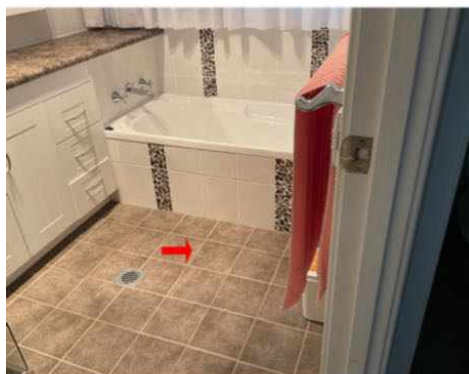
Finding 3.17

Information: Drummy tiled areas were identified at the time of inspection. The term 'drummy' refers to tiles that have become detached from their fixing, despite otherwise being in relatively good condition. Such defects are generally caused by physical or moisture damage to the area. Drummy tiled areas may also be a direct result of poor workmanship during the construction process.

Tiled areas may swell and shrink with changes in air humidity if the area has sustained moisture damage. Any exposure to moisture is capable of causing tiled areas to become drummy and/or cracked over a prolonged period of time. Drummy tiled areas generally require removal and replacement of affected tiles, with adequate sealant and grouting.

Specialist trades are available for these types of services. A registered builder may be required to undertake works if damage is extensive or if secondary building defects have resulted. Otherwise, it is advised that a tiling contractor be appointed to perform works as necessary. Immediate action is recommended to ensure that no further damage is sustained in the affected area.

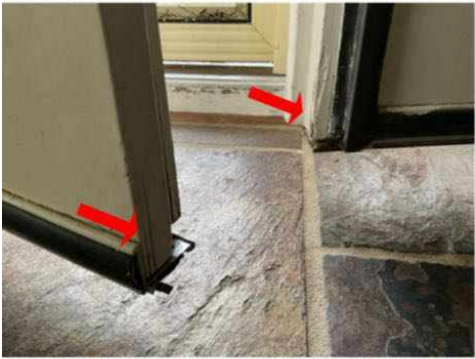
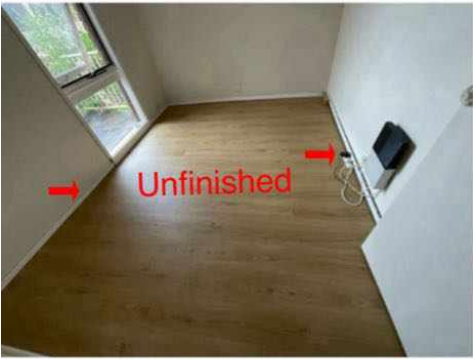
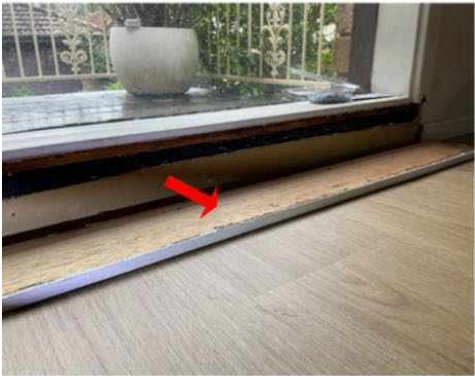
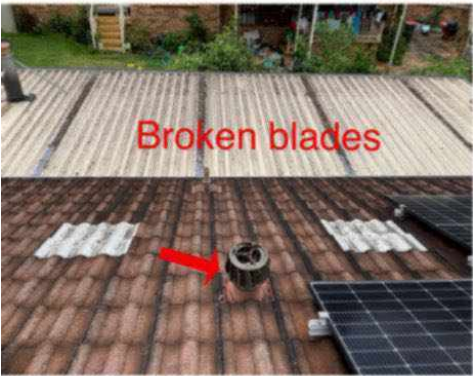
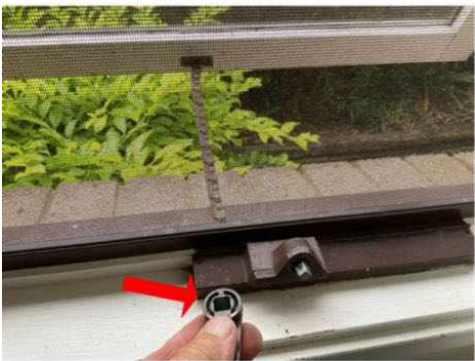
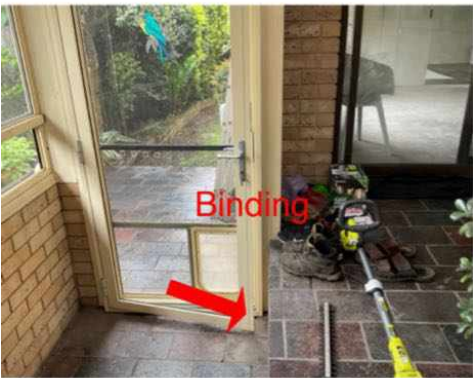
Finding 3.18

Building: Building 1
 Location: Pictured areas
 Finding: Building elements damaged
 Information: Evidence of minor missing or damaged areas was identified at the time of the inspection. These include -

1. The garage and front doors are delaminating and may need replacement in 3-5 years. 4 other doors and the kitchen window are binding requiring adjustment.
2. Some skirting is unfinished
3. The roof fan and one window has broken or loose parts.

A carpenter would be the trade responsible for rectification of these areas when convenient.

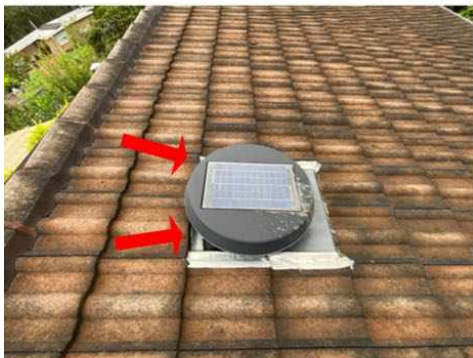
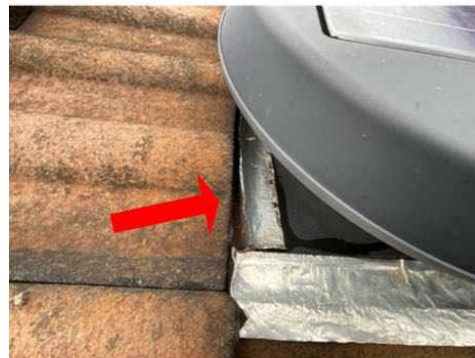
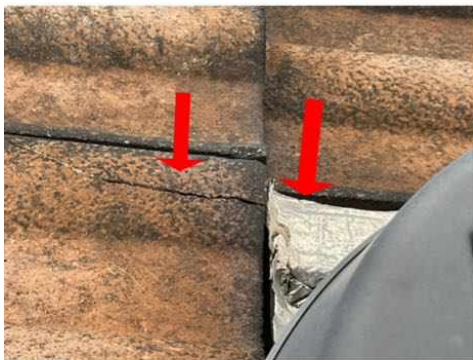
Finding 3.19

Building:	Building 1
Location:	Roof Exterior
Finding:	Incomplete or substandard works
Information:	The works to this roof area appear to be incomplete or have been completed to a substandard level.

Works that have not been completed to a satisfactory level create potential for the development of building defects and may impede on the safety and integrity of the overall structure.

It is highly recommended that a roofing contractor be appointed to seal this area and ensure the safety of the area and the longevity of all associated building elements.

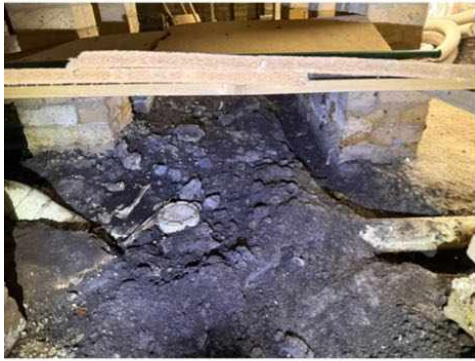
Building:	Building 1
Location:	All Subfloor Areas
Finding:	Subfloor - Debris and tree roots growing
Information:	An array of debris and some tree roots were found in the subfloor area at the time of inspection. Debris in this area restricts subfloor ventilation and creates potential for concealed pest entry. Stored timbers and other materials may also make the area susceptible to termite activity and wood rot.

A clear and empty subfloor will be better ventilated and easier to maintain in a dry condition. The removal of any timber debris is vital in minimising the risk of termite or wood borer activity.

ALL Debris in the subfloor should be removed prior to purchase. Depending on the location and amount of debris and stored items, the homeowner may elect to

undertake this task. Alternatively there are a large number of rubbish removal subcontractors that could undertake these works.

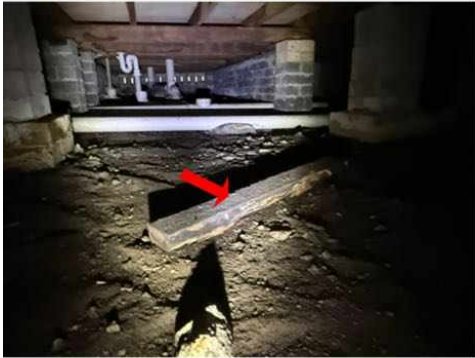
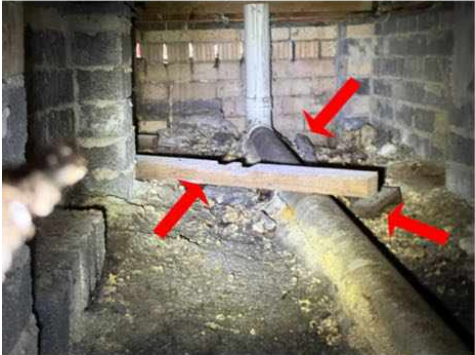
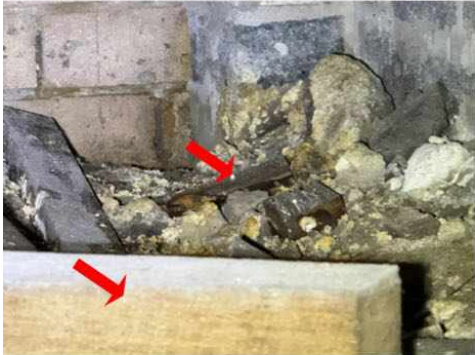
Building: Building 1
Location: Many areas including garage and subfloor
Finding: Timber in contact with the ground
Information: Any timbers in direct ground contact provide opportunity for concealed termite entry and are likely to be subject to premature rot and decay as the soil retains moisture or damp conditions against the timbers.

Removal of all waste timber that is in direct contact with ground is highly advised. This timber is promoting mould and wood rot and is very attractive to termites.

Frequent pest inspections are advised to readily identify any termite activity in these areas.

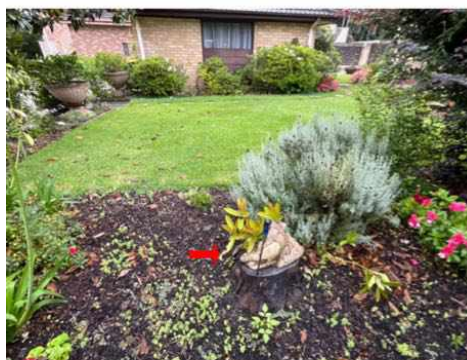
Finding 6.05

Building:	Building 1
Location:	Pictured yard area
Finding:	Tree stumps - left in ground
Information:	Tree stumps left in ground provide opportunity for termite attack as they are likely to be subject to rot and decay providing an attractive food source. Treatment and/or Removal of the stump is highly recommended. A pest controller and tree removalist should be engaged to perform such works.

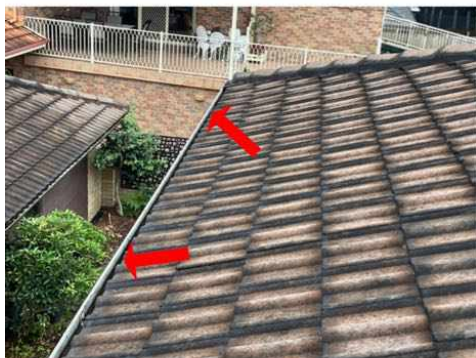
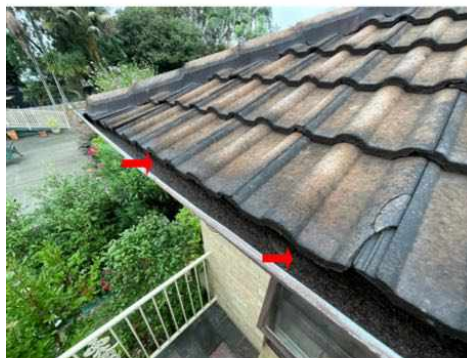
Finding 6.06

Building:	Building 1
Location:	Roof exterior
Finding:	Gutters - Full and blocked
Information:	The guttering on around the roof was found to be blocked at the time of the inspection. Roof plumbing structures, such as guttering and downpipes, should be free of all debris to prevent blockages. Blockages of the guttering and downpipes will lead to pooling and accumulated water overflows, which is likely to subsequently flood eaves and exterior walls.

Blocked gutters are likely to lead to high levels of moisture in the affected areas. Such moisture will not only cause rust and decay of the associated building materials, but can also provide conditions that are conducive to termite and timber pest activity. Blockages in gutters should therefore be removed immediately to ensure dry conditions are maintained.

It is highly advised that gutters be cleaned by the homeowner or a general handyperson as a matter of urgency.

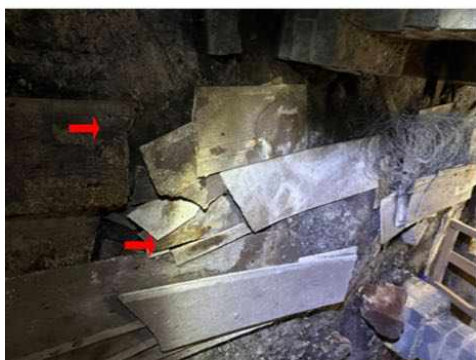
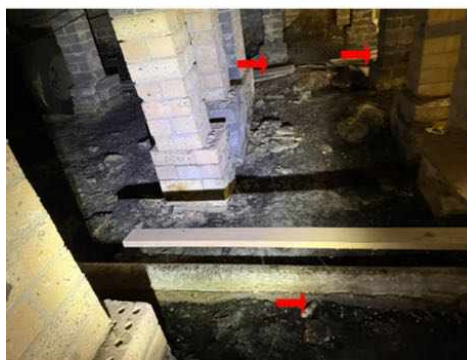
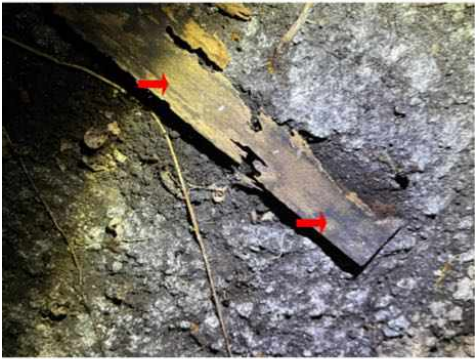
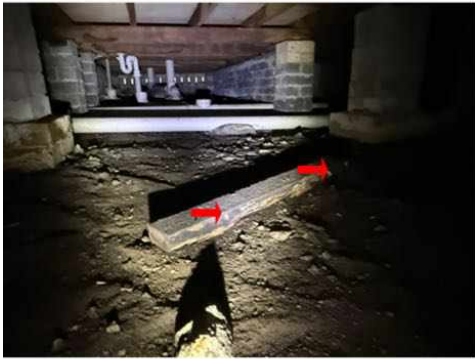
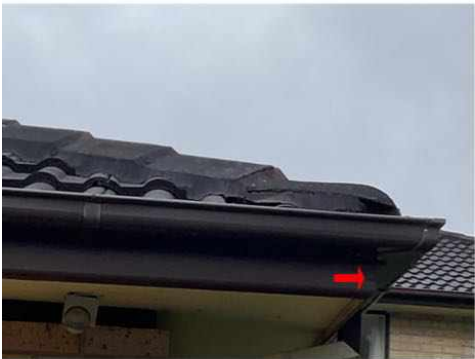
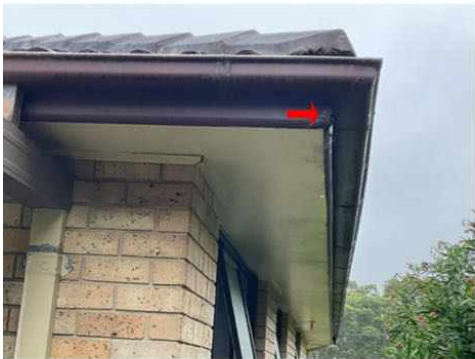
Finding 7.01

Building:	Building 1
Location:	Subfloor and fascia areas
Finding:	Fungal decay - present (localised)
Information:	Fungal decay also known as wood decay or wood rot generally refers to the deterioration of timber elements when in contact with excessive levels of moisture for a prolonged period of time.

The development of fungal decay is accelerated by temperatures from 5degreeC to 40degreeC as well as the presence of oxygen. Generally fungal decay develops on timber elements that are in use in an external environment which are exposed to rain penetration.

In this case, the affected timber element is in a decaying state and will need replacement by a carpenter or licensed builder.

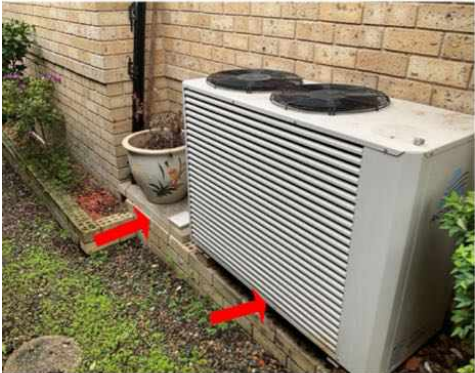
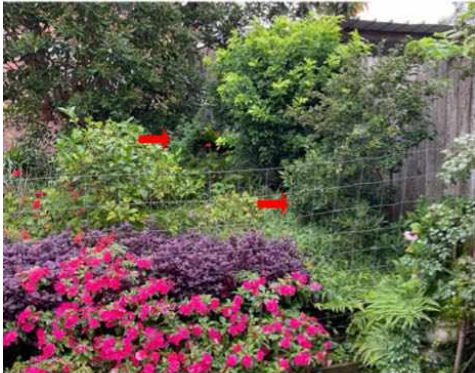
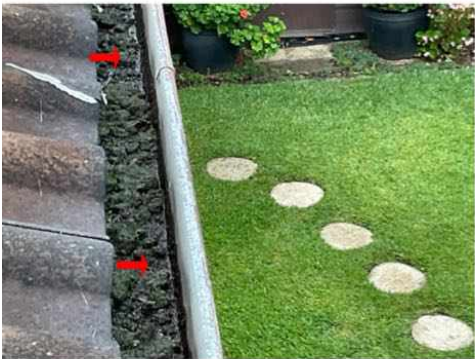
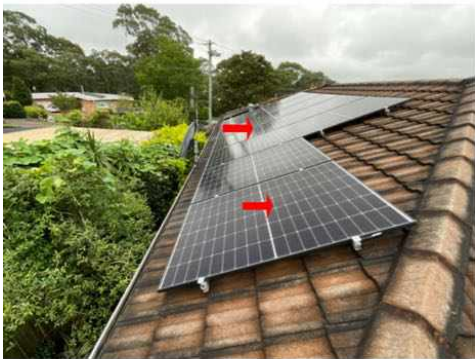
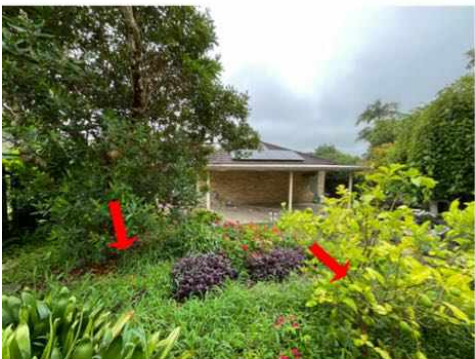
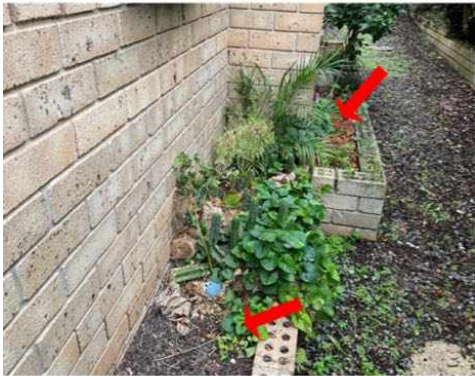
Building: Building 1
 Location: All External Areas
 Finding: Additional Photos - Obstructions and Limitations of EXTERNAL AREAS
 Information: These photographs are an indication of the obstructions and limitations which impeded full inspection of external areas at the time of inspection. These obstructions can hide an array of defects and should be removed to allow full inspection to be carried out. A re-inspection is recommended once the areas are made accessible.

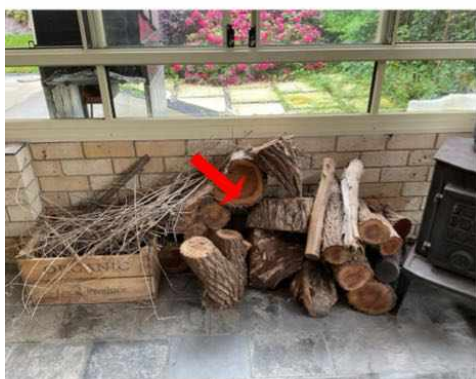
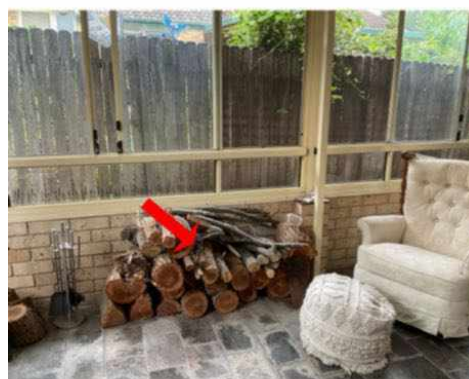
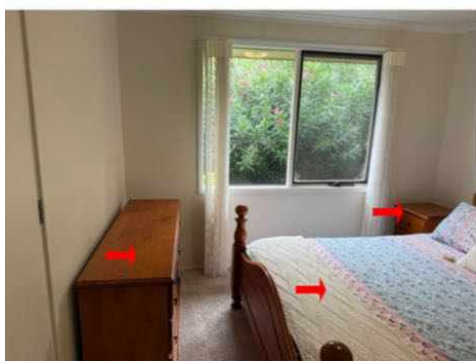
Building: Building 1
 Location: All Internal Areas
 Finding: Additional Photos - Obstructions and Limitations of INTERNAL AREAS
 Information: These photographs are an indication of the obstructions and limitations which impeded full inspection of Internal areas at the time of inspection. These obstructions can hide an array of defects and should be removed to allow full inspection to be carried out. A re-inspection is recommended once the areas are made accessible.

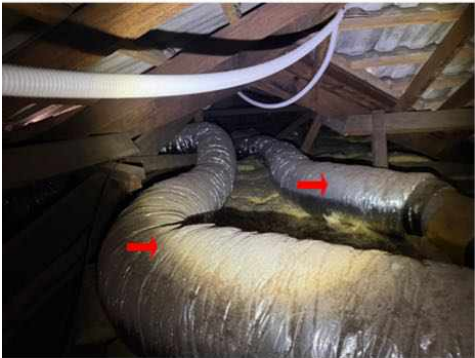
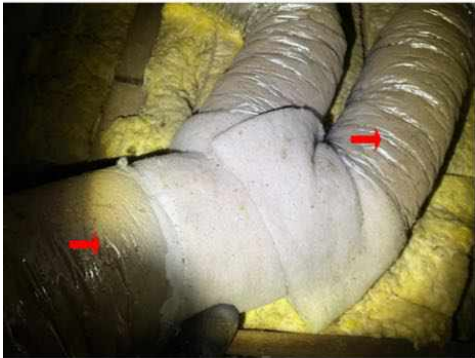
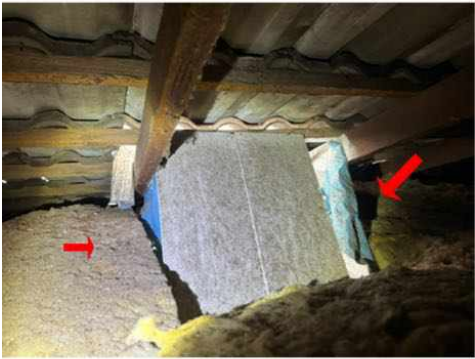
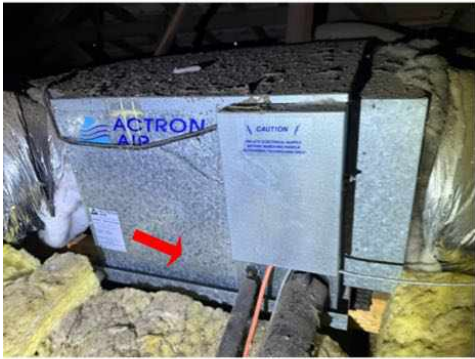
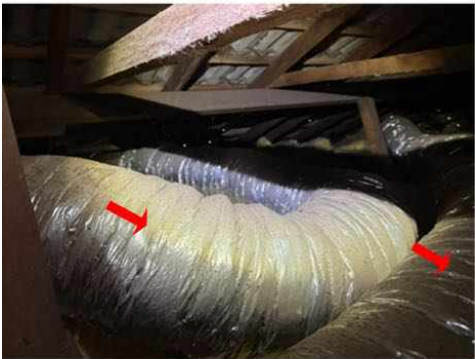
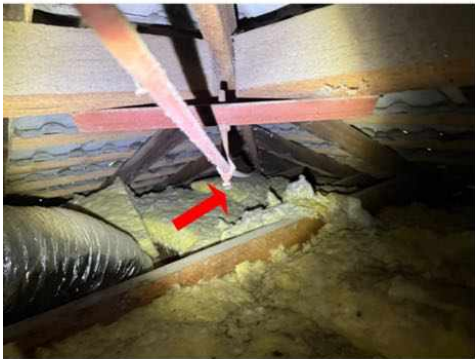
Building: Building 1
 Location: All Roof cavity areas
 Finding: Additional Photos - Obstructions and Limitations of the ROOF CAVITY
 Information: These photographs are an indication of the obstructions and limitations which impeded full inspection of roof cavity areas at the time of inspection. These obstructions can hide an array of defects and should be removed to allow full inspection to be carried out if applicable. A re-inspection is recommended once the areas are made accessible.

The inspection was also limited to areas with an allowable crawl space of 600mm x 600mm, in particular towards the external walls where the roof line diminishes, these areas were not accessible.
