Building and Timber Pest Inspection Report

Inspection Date: Wed, 4 Mar 2026

Property Address: 6 Walsh Cres, North Nowra NSW 2541,
Australia

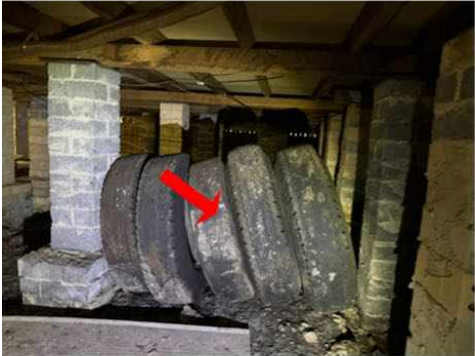
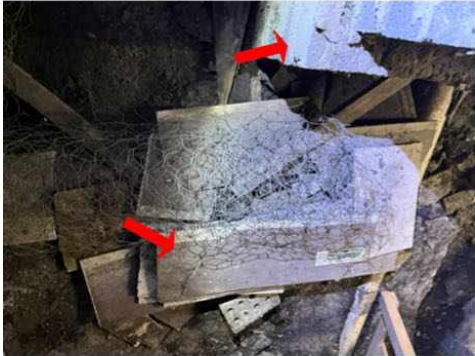
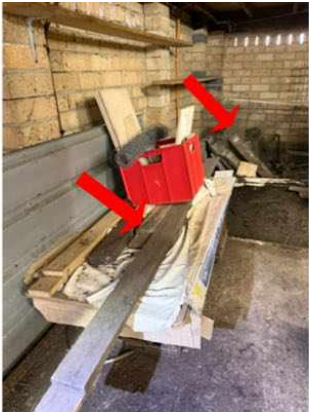
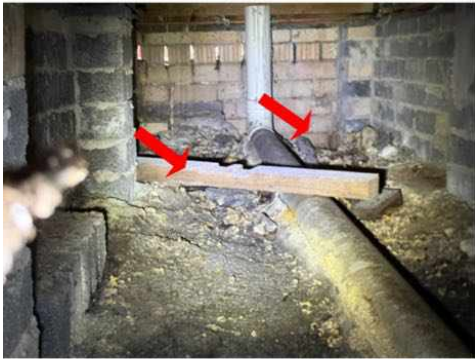
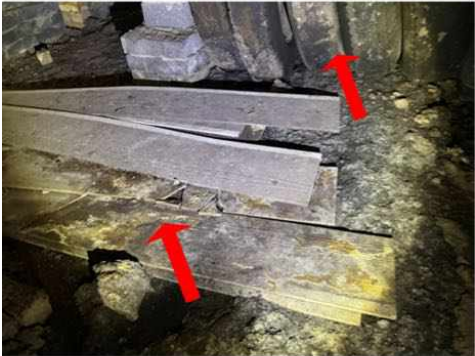
Building: Building 1
Location: All Subfloor Areas
Finding: Additional Photos - Obstructions and Limitations of SUBFLOOR AREAS
Information: These photographs are an indication of the obstructions and limitations which impeded full inspection of subfloor areas at the time of inspection. These obstructions can hide an array of defects and should be removed to allow full inspection to be carried out. A re-inspection is recommended once the areas are made accessible.

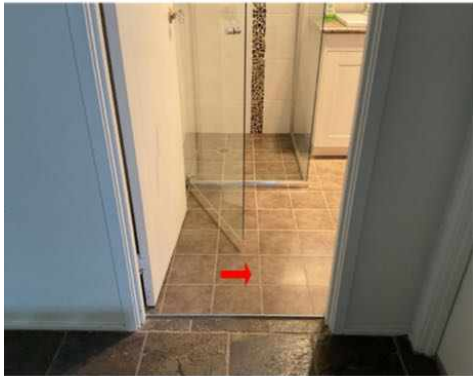
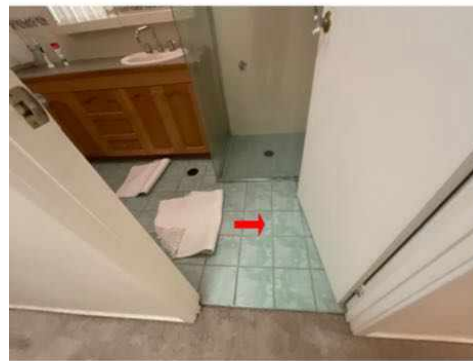
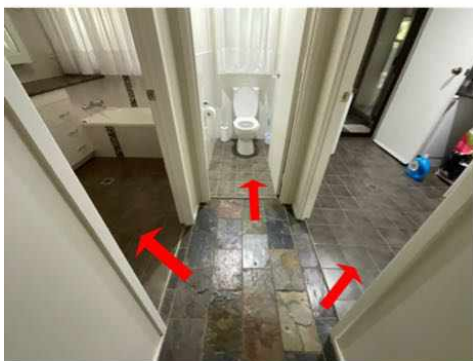
Building: Building 1
Location: Bathrooms and laundry

With older property's where this information is unavailable all wet areas should be monitored. If any leaks, water staining, peeling or bubbling of the paint become evident to any adjacent walls or ceilings below a licensed builder or waterproofing specialist is recommended to investigate further.

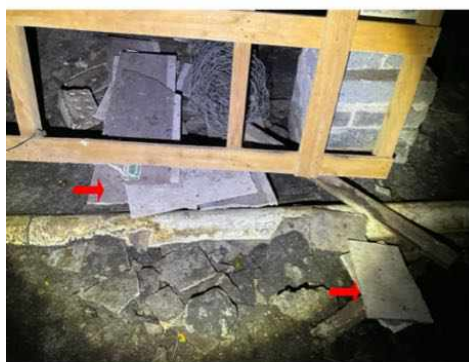
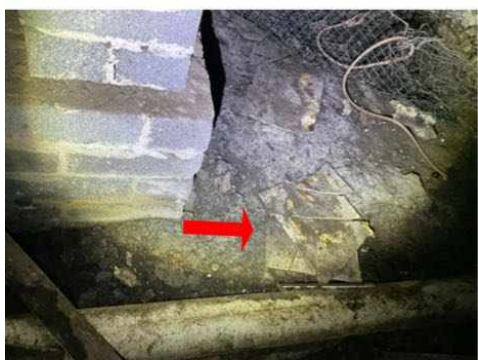
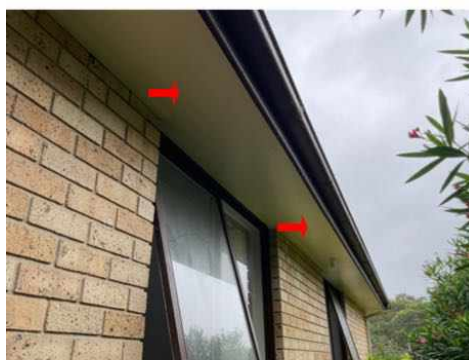
Building: Building 1
 Location: Some areas
 Finding: Asbestos - Suspected ACM Identified on Site
 Information: Reporting on Asbestos is outside the Scope of this Report. This suspected defect is highlighted as a caution only. We suspect, based on our experience in the building

As Asbestos Reporting is outside the scope of this report, we advise that you consider a separate Asbestos Inspection and Condition Audit, which can include the taking of samples for definitive confirmation of the presence of Asbestos.

In the interim, the client is advised to act with caution, especially when considering any damage to building materials general wear and tear renovations extensions demolition and general maintenance activities due to the suspected presence of Asbestos.
