Building and Timber Pest Inspection Report

Inspection Date: Thu, 12 Mar 2026

Property Address: 10/25 St Just Ct, Golden Grove SA 5125, Australia

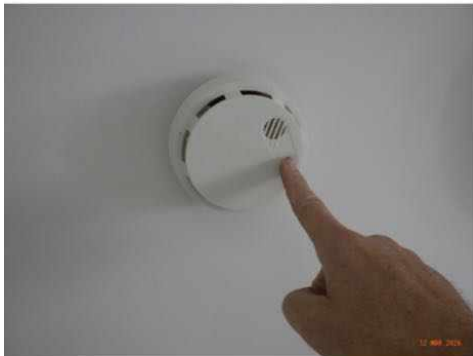
Please note that this defect is highlighted as a caution only. We suspect, based on our experience in the building industry, that the absence of smoke detectors, or their poor condition, should be addressed as a matter of urgency to improve occupant safety.

Always ensure sufficient working and suitable smoke detectors are installed prior to occupying any building. Additionally, it is advised that all smoke detectors be tested by the homeowner on a monthly basis.

Please refer to AS3786 and state based legislation, which may also apply.

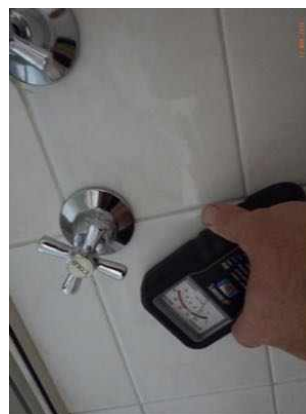
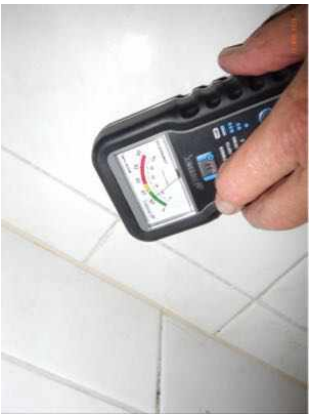
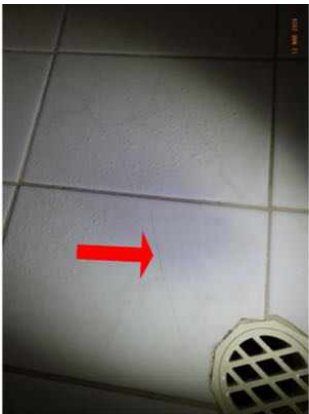
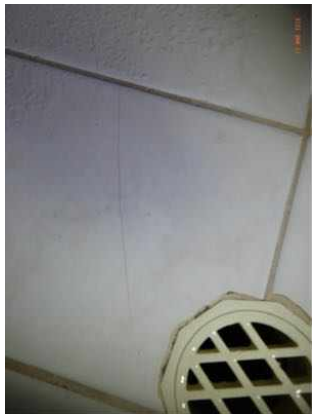
Flexible and mould resistant materials should be applied to affected areas to prevent any subsequent water damage that is likely to occur. Regular maintenance and replacement of damage or missing or damaged sealant and grout is highly recommended to the wet areas, as this is a regular wear and tear defect. Sealant and grouting in areas that come into regular contact with water should be maintained for the long term care of your property.

A sealant specialist or tiling contractor should be appointed to complete these works as soon as possible

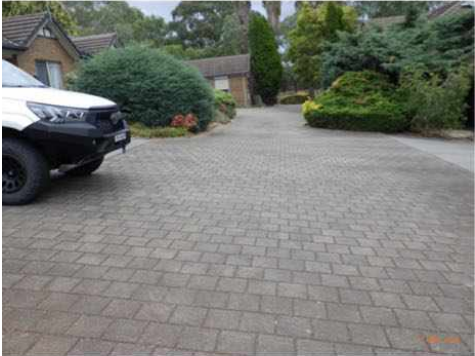
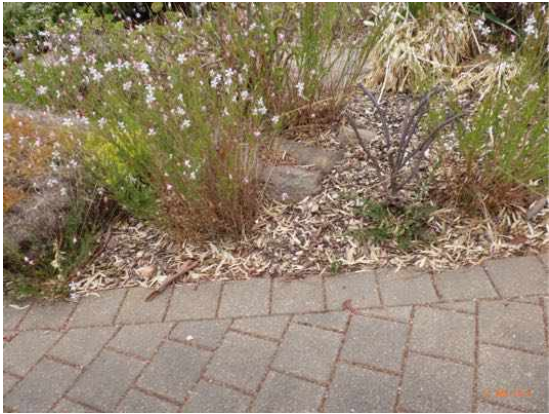
Building: Building 1
Location: All Areas
Finding: Additional Photos - Obstructions and Limitations
Information:

These photographs are an indication of the obstructions and limitations which impeded full inspection of the property at the time of inspection. These obstructions can hide an array of defects and should be removed to allow full inspection to be carried out.
