Building and Timber Pest Inspection Report

Inspection Date: Wed, 25 Mar 2026

Property Address: 2/464 Victoria St, Brunswick West VIC 3055, Australia

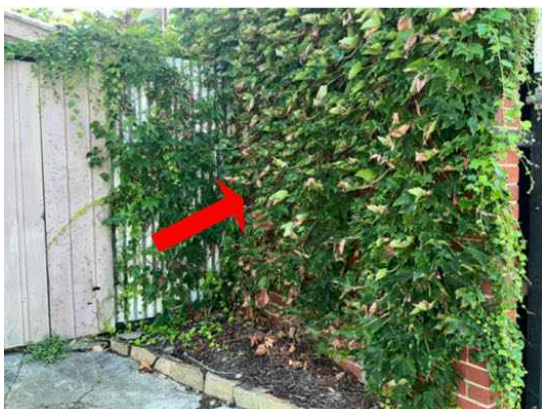
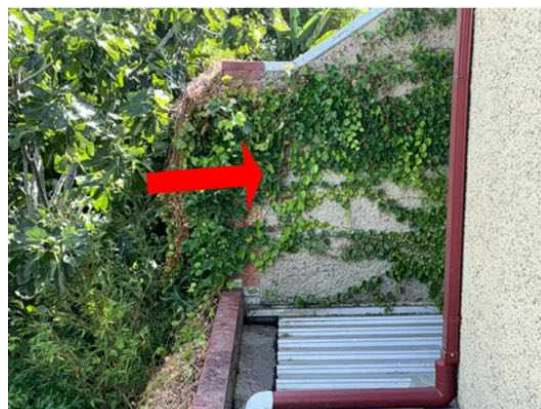
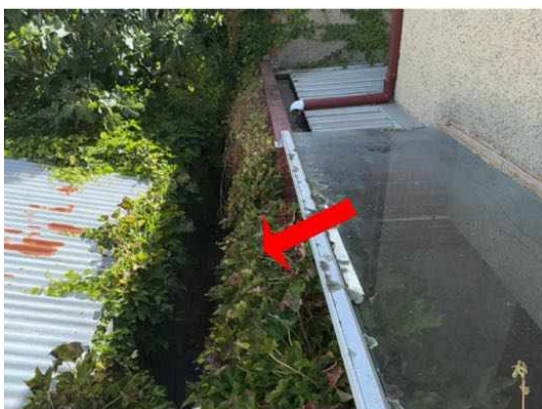
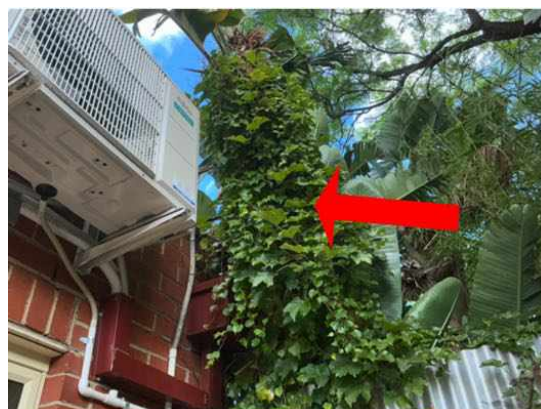
Finding 6.04

Building:	Main Building
Location:	All External Areas
Finding:	Bridging or breaching of termite barriers - adjacent internal flooring
Information:	Bridging is the spanning of a termite barrier or inspection zone so that subterranean termites are provided with passage over or around that barrier.

The removal and replanting of species that do not provide "cover" or cutting back of existing vegetation will assist greatly in preventing Bridging from occurring.

The removal of any such materials that may be conducive to termite activity should be carried out as soon as possible and arrange re inspection to minimize the risk of termite attack.

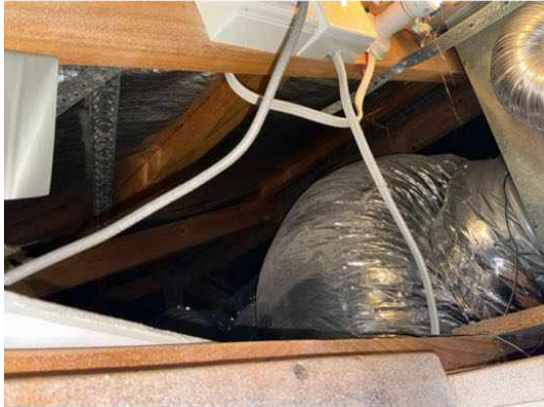
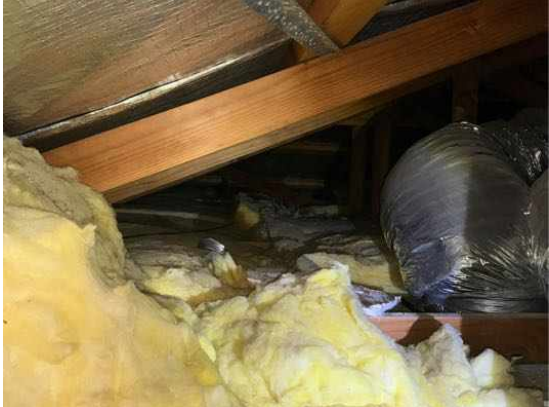
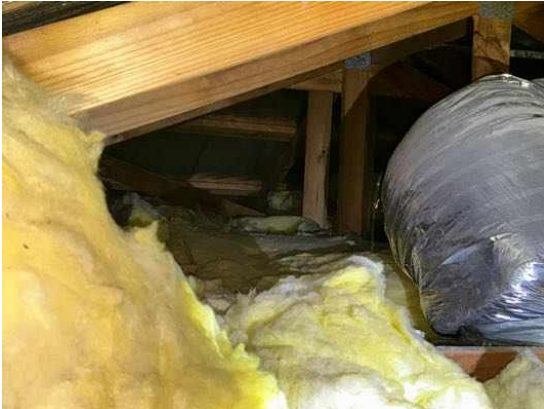
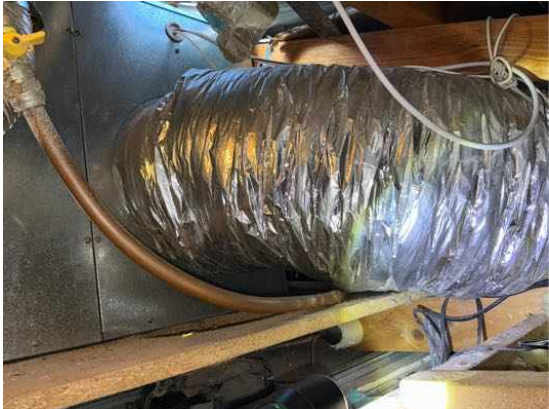
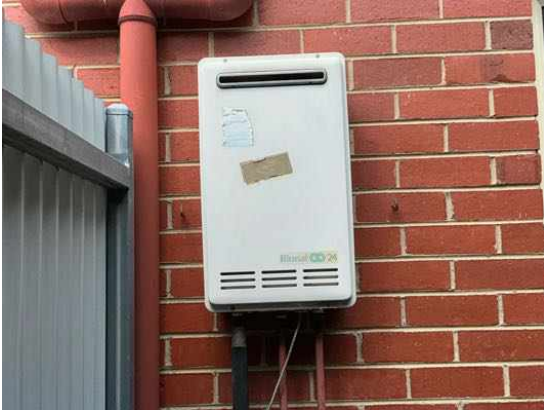
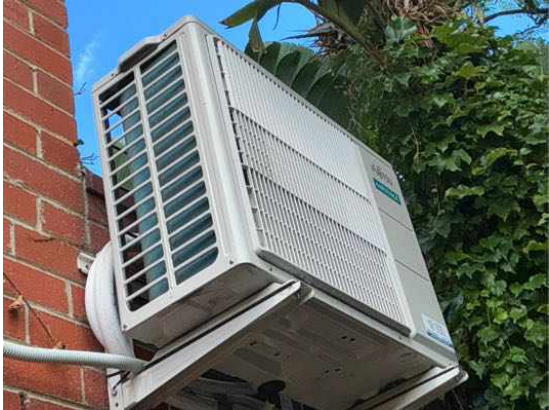
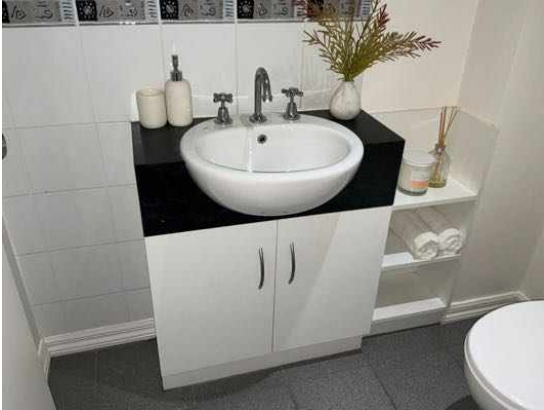
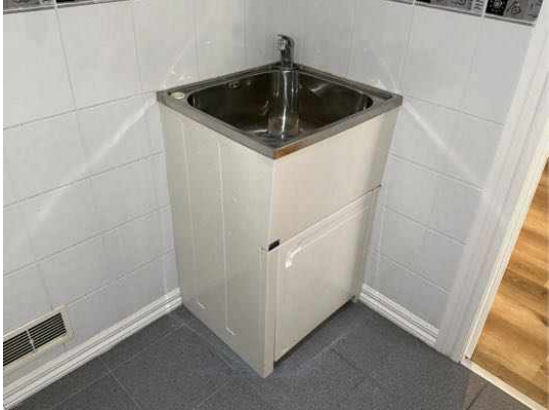
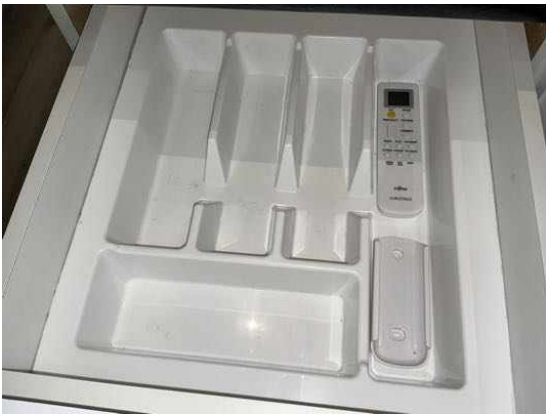
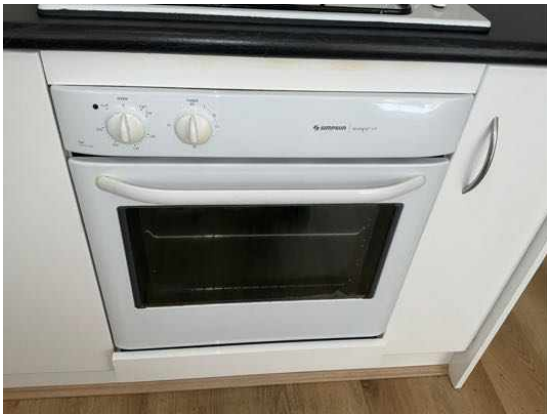
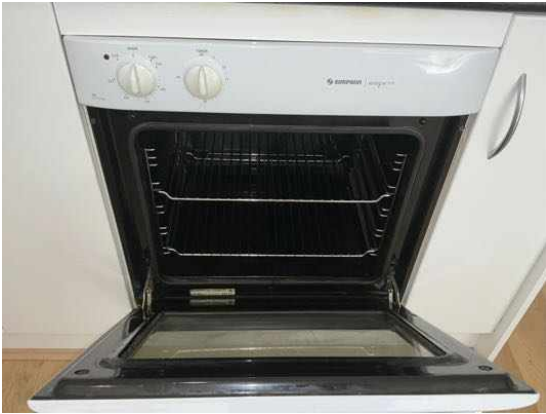
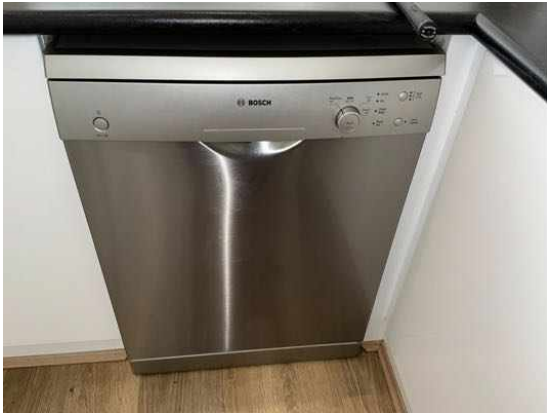
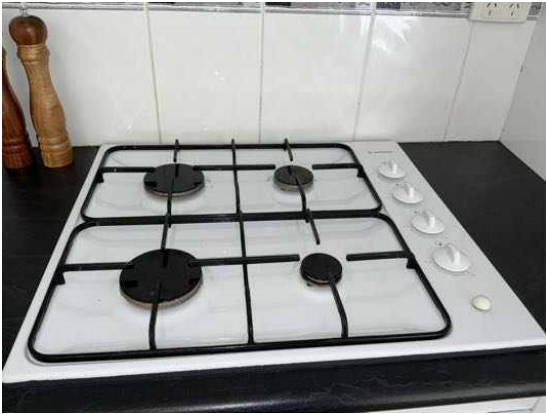
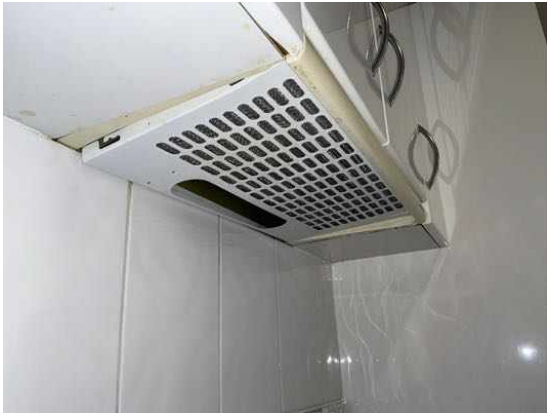
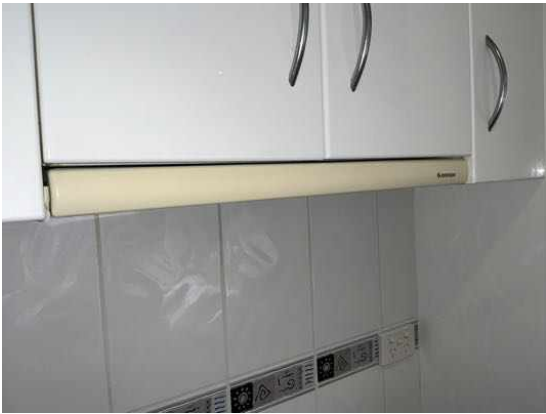
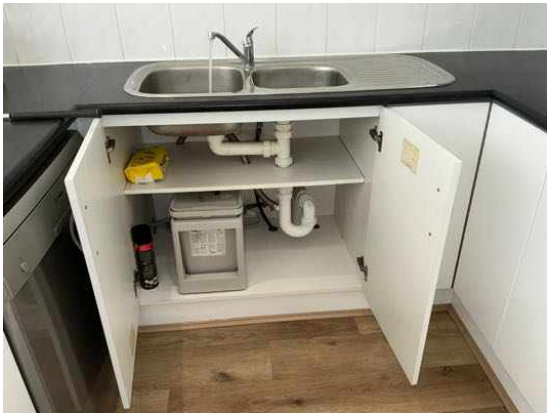
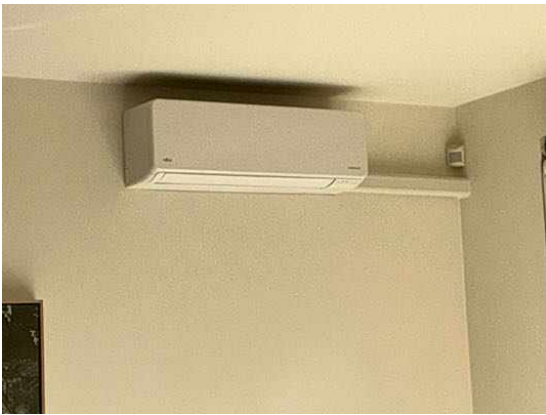
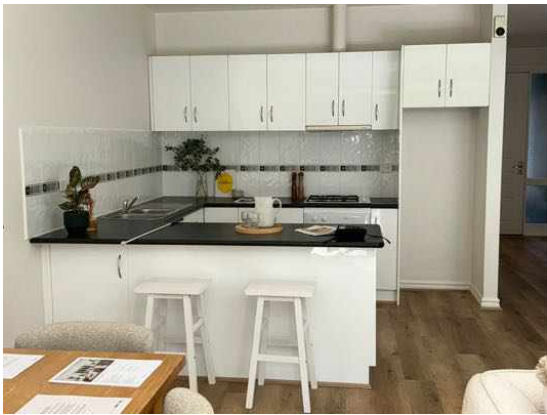
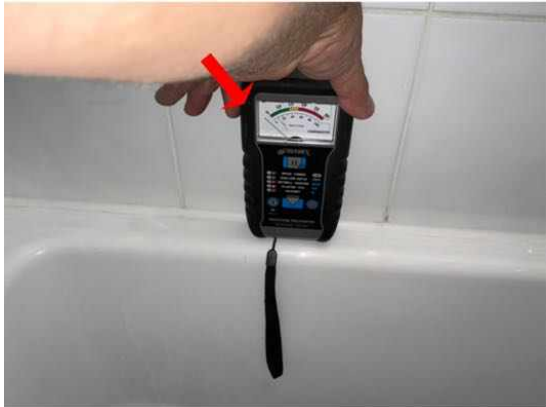
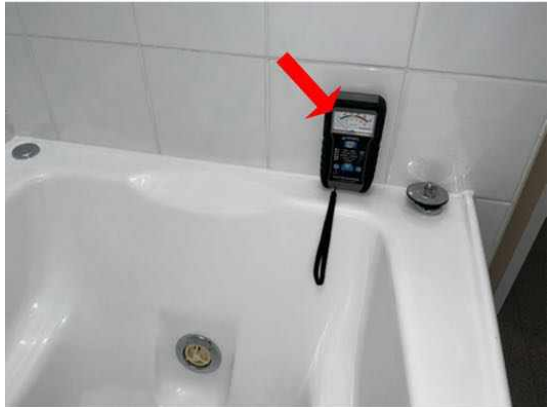
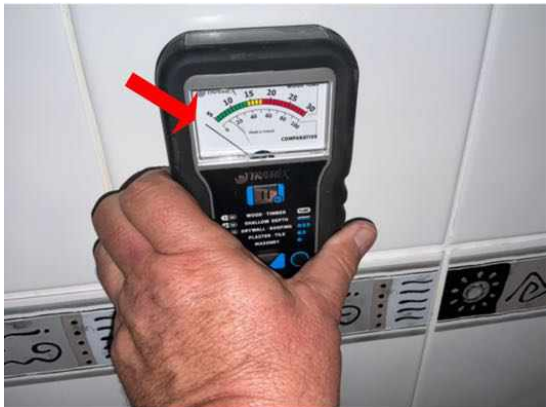
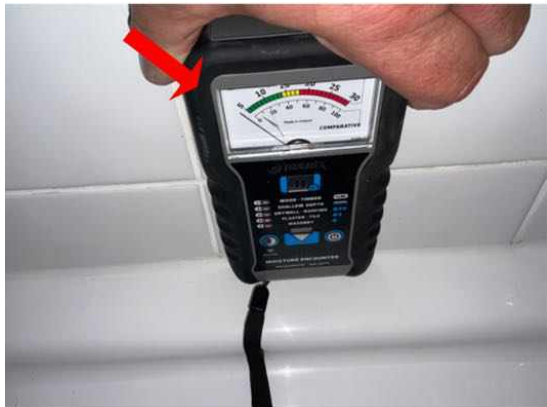
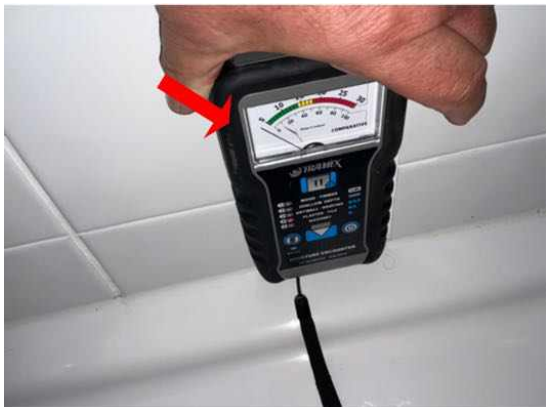
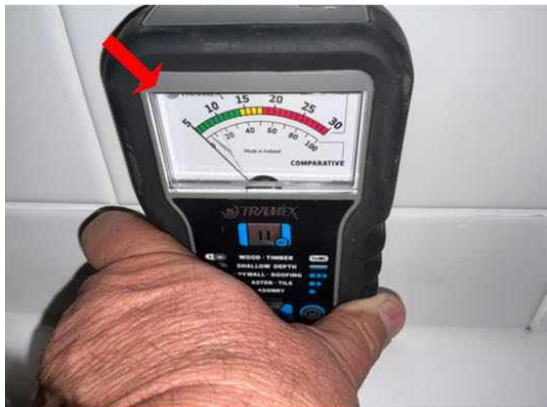
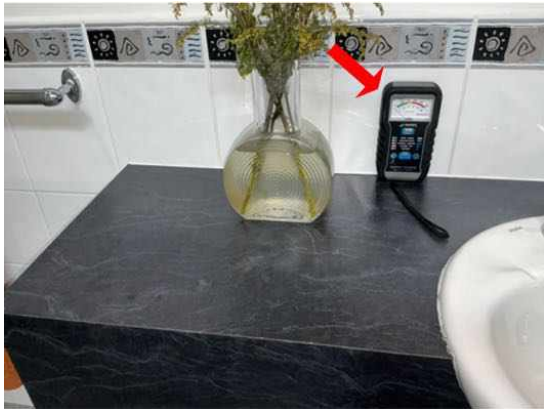
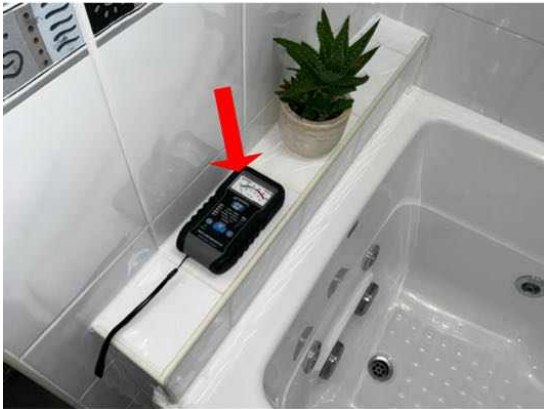
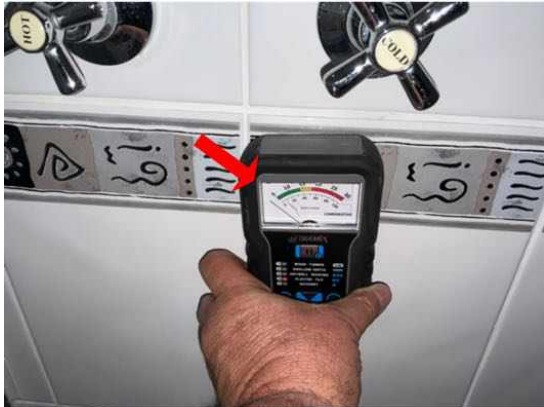
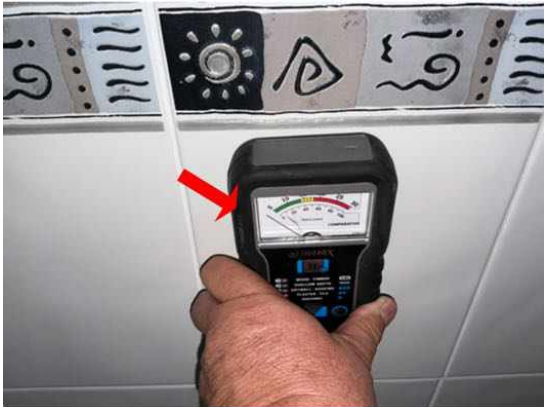
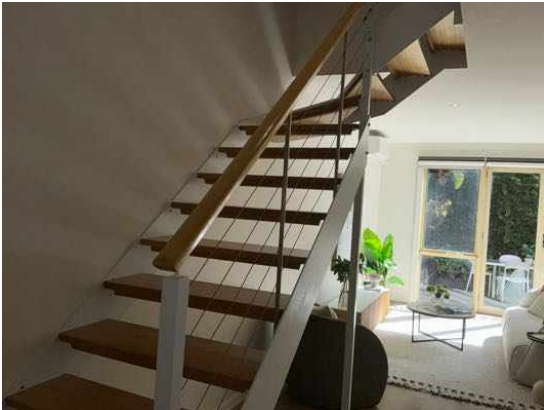
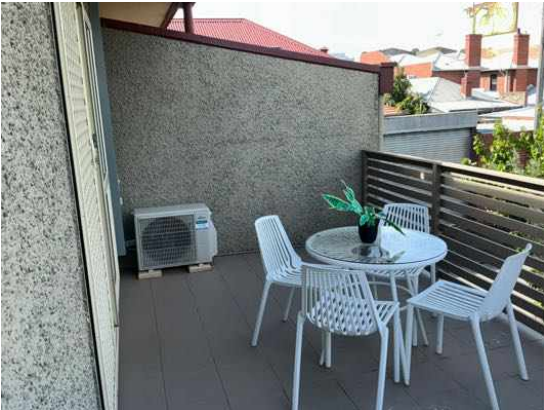
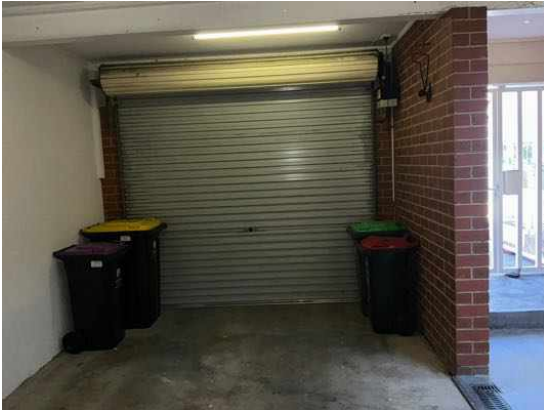
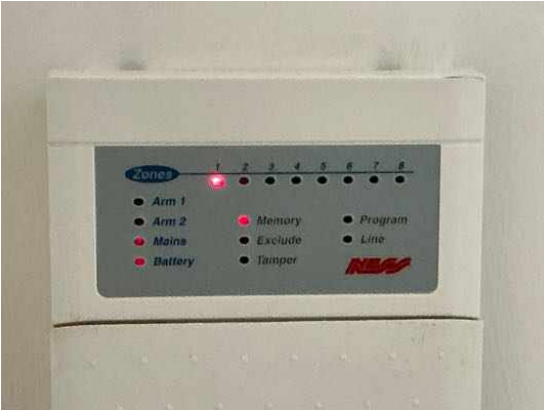
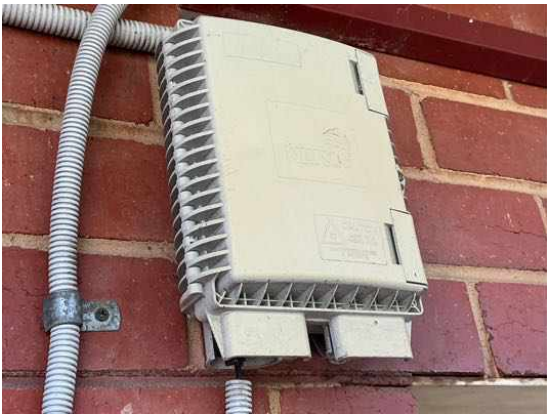
Noted Item

Building: Main Building
 Location: All Areas
 Finding: Additional Photos
 Information: Additional photos are provided for your general reference
