Building and Timber Pest Inspection Report

Inspection Date: Thu, 29 Jan 2026

Property Address: 1A Keysor Rd, Pagewood NSW 2035,
Australia

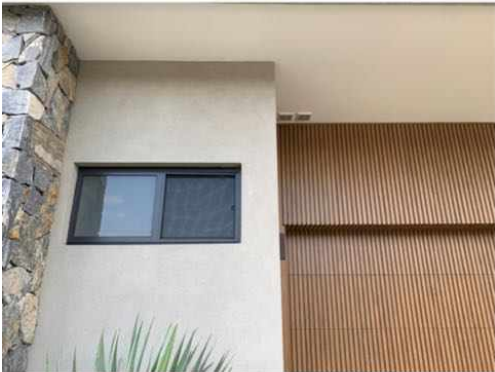
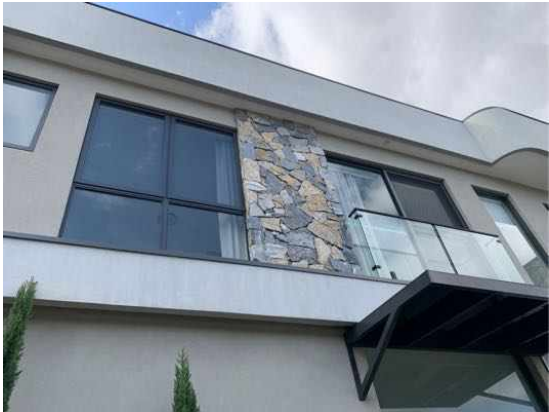
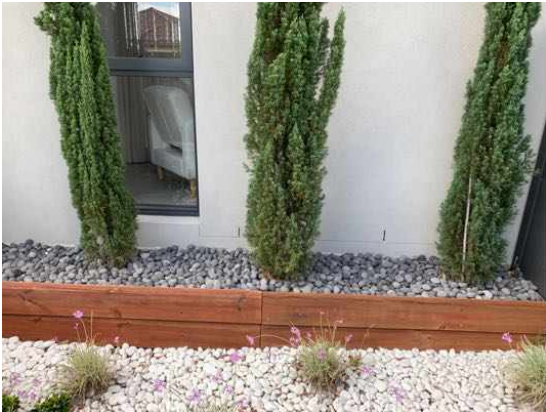
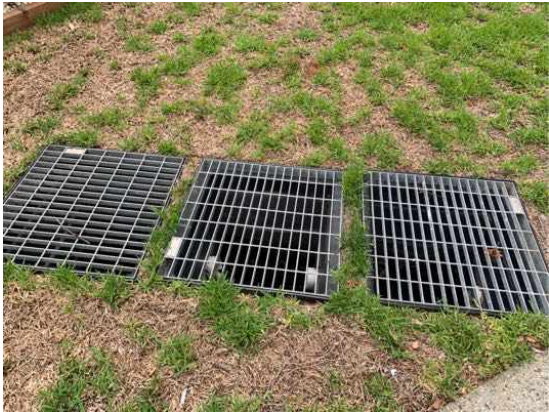
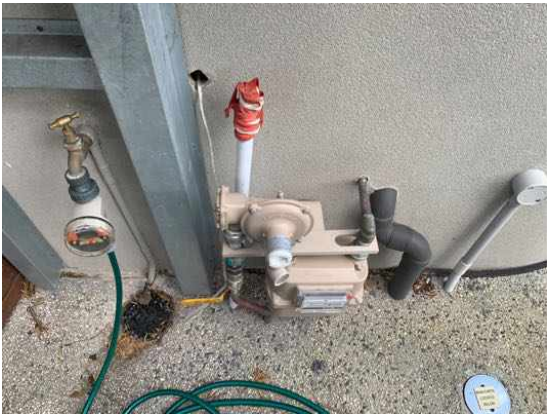
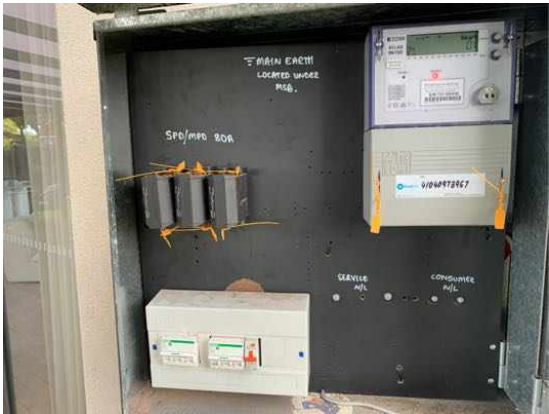
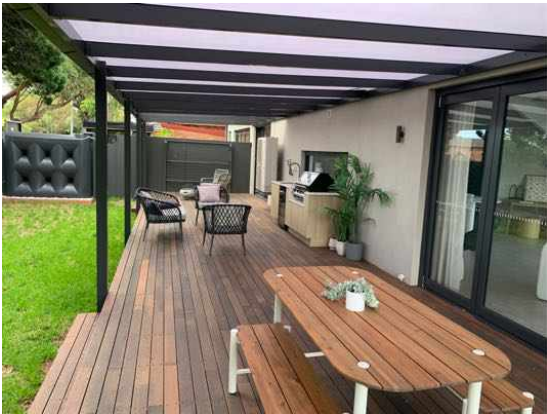
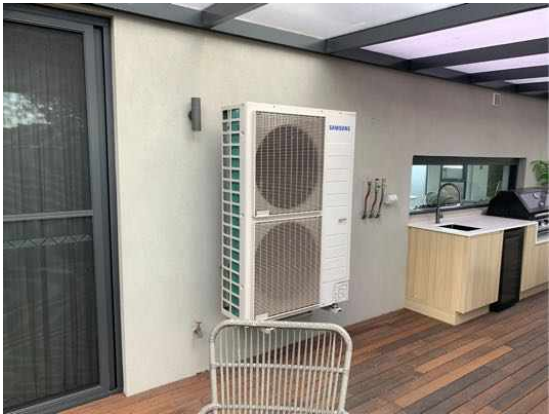
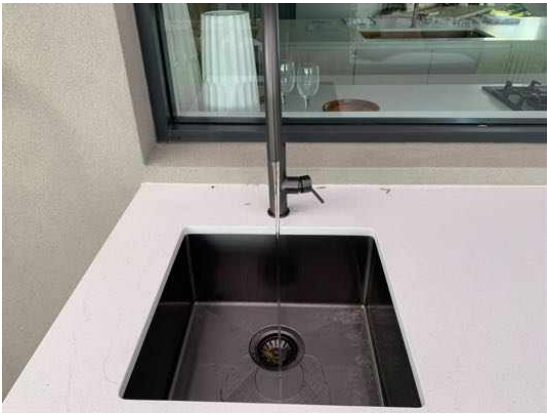
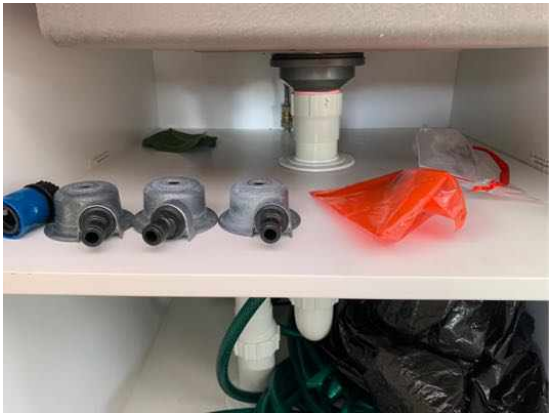
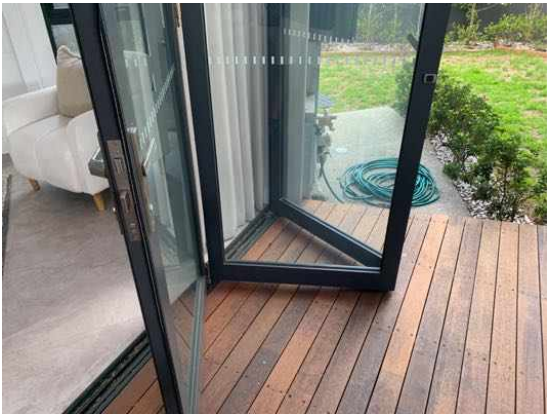
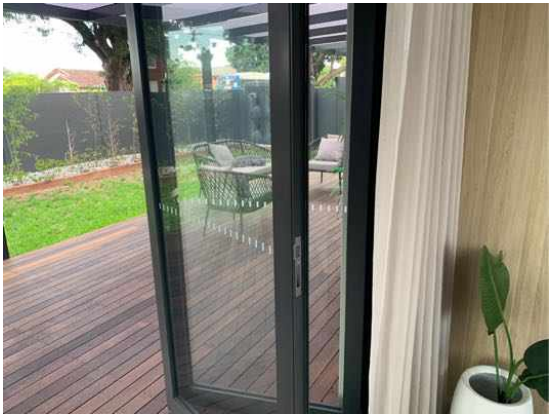
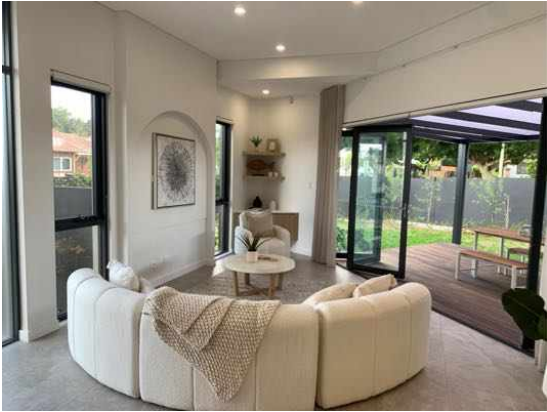
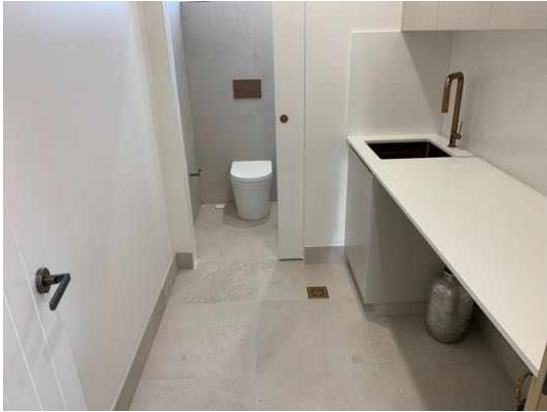
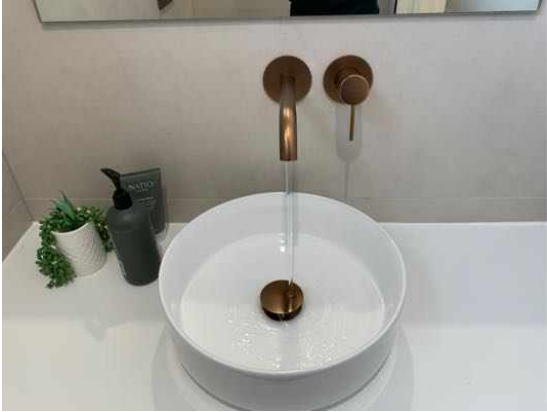
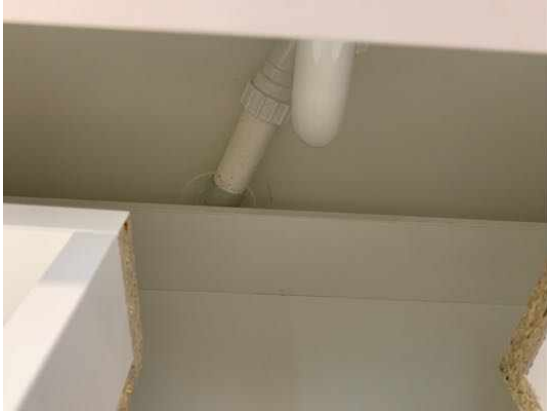
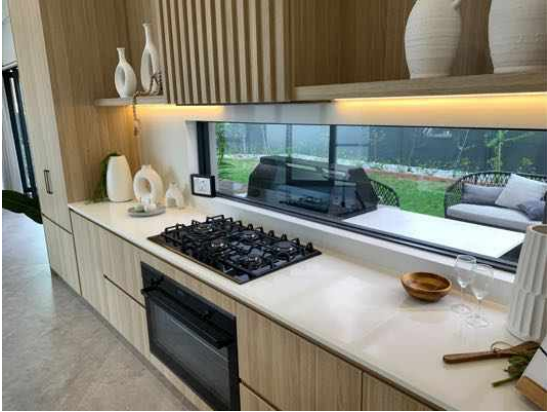
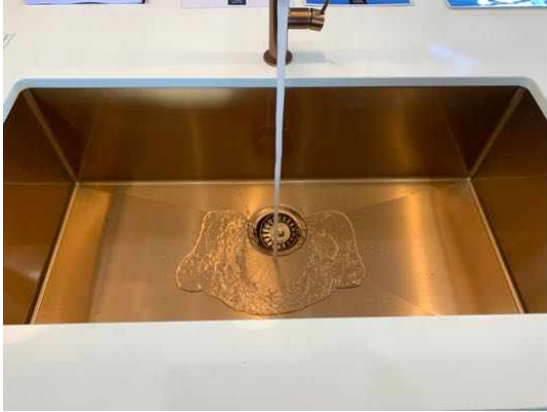
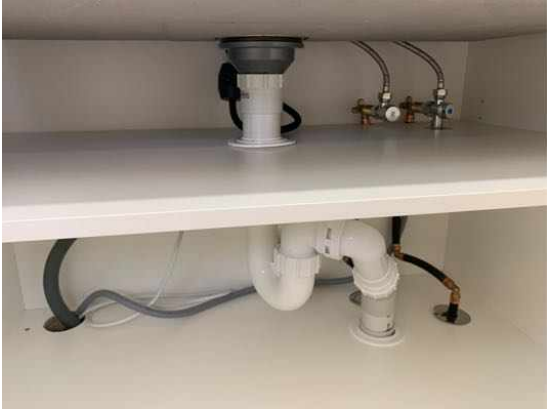
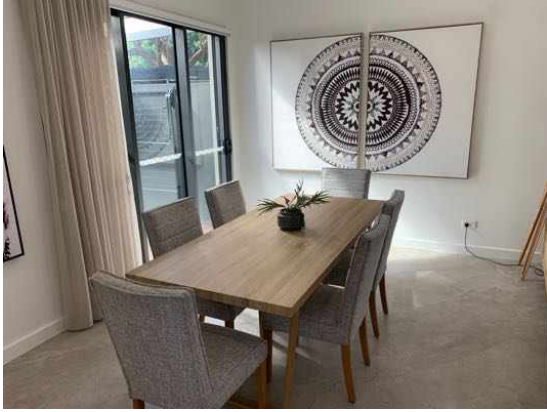
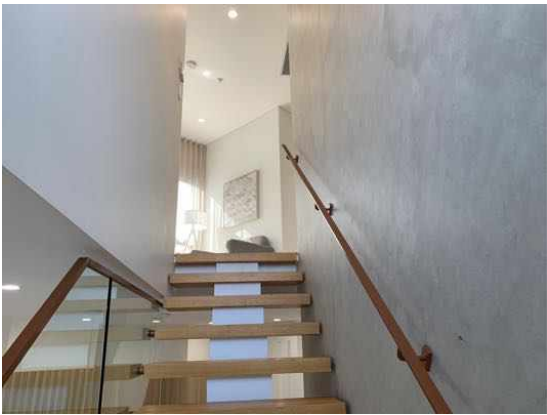
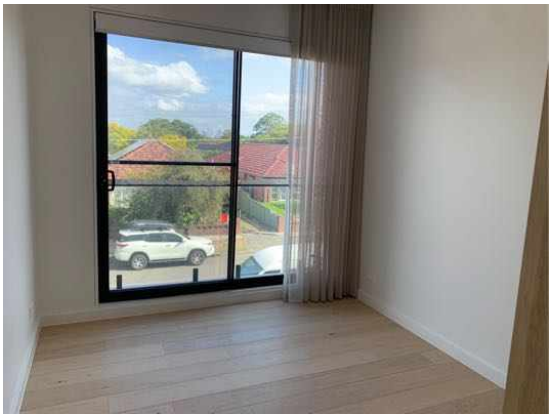
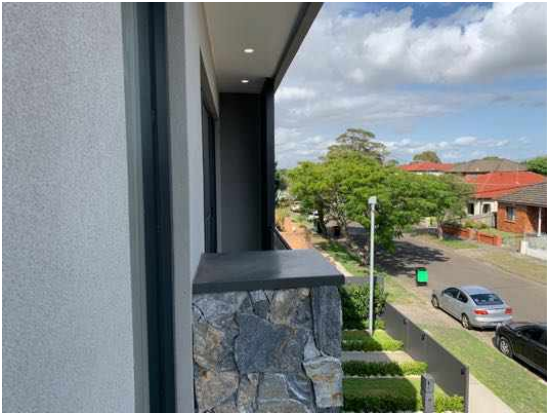
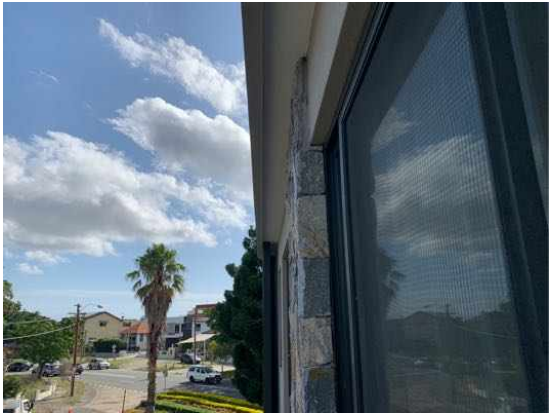
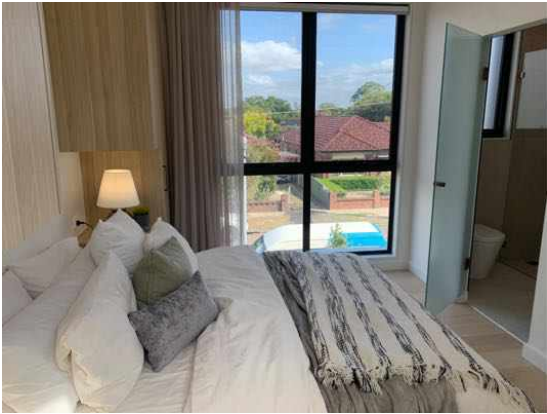
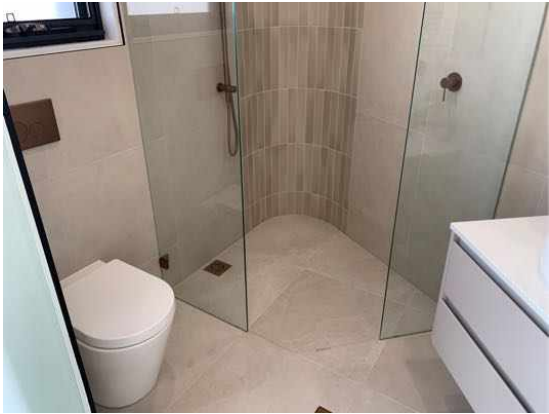
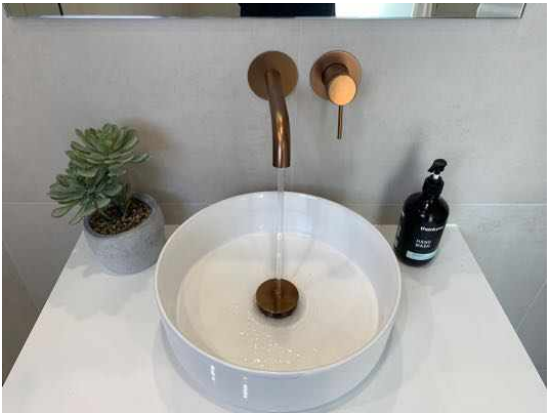
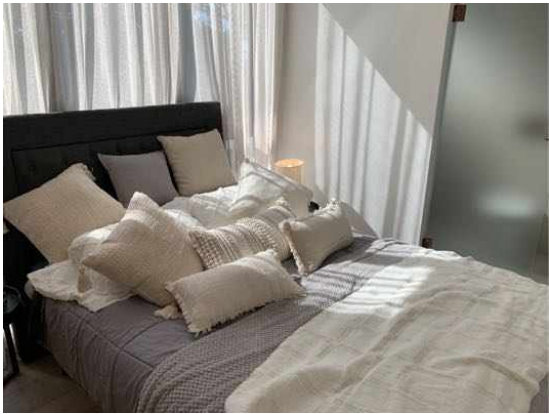
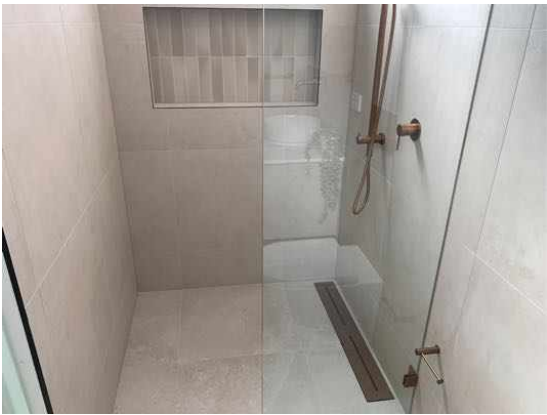
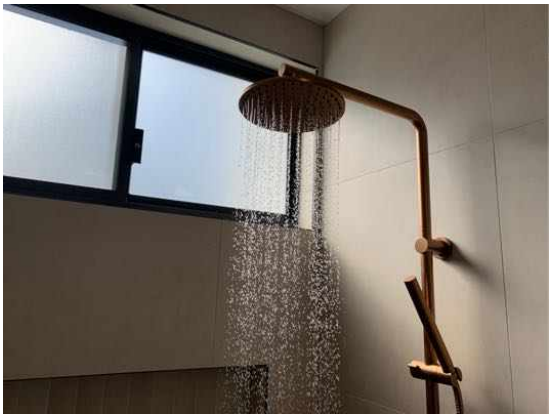
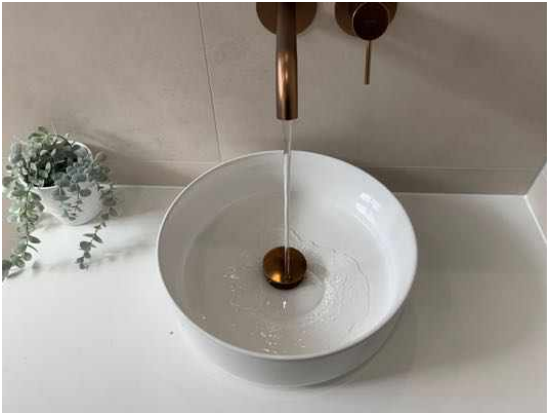
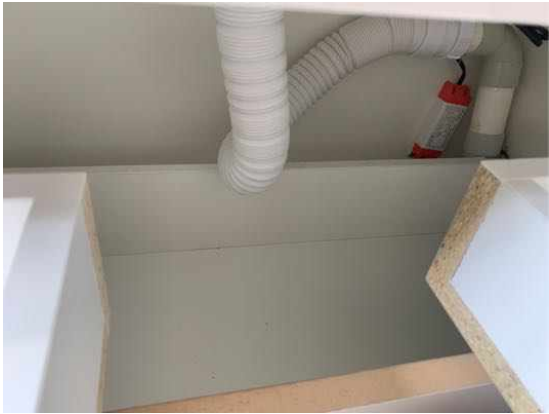
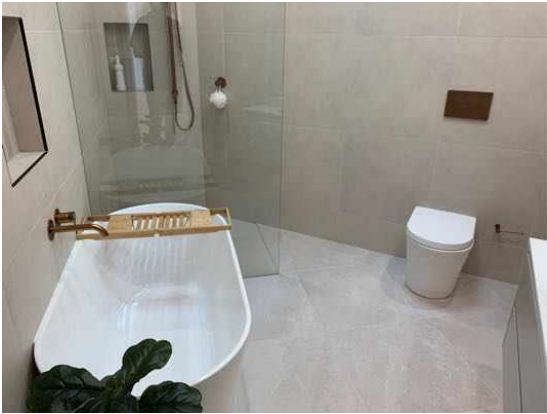
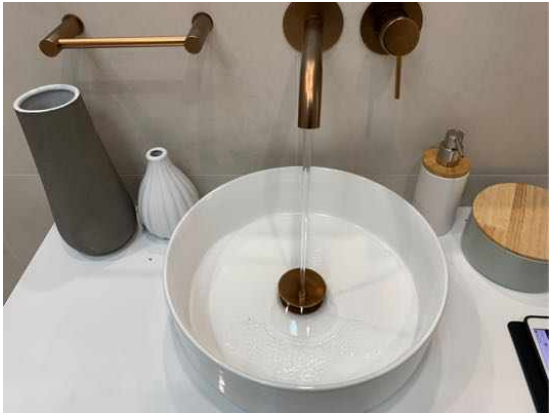
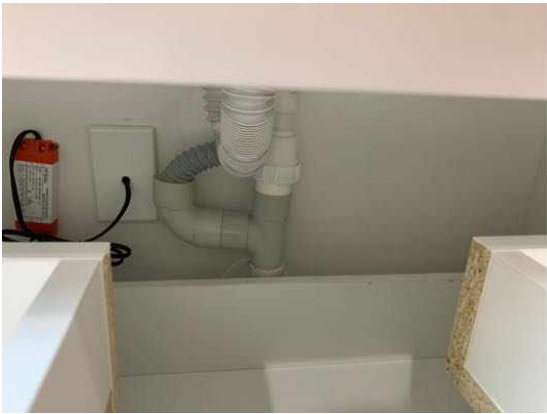
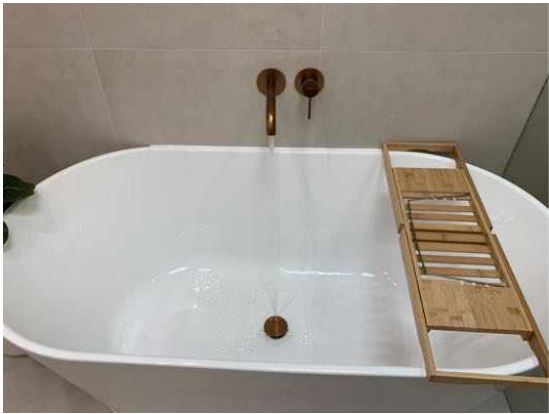
Building: Main Building
 Location: All Areas
 Finding: Additional Photos - Obstructions and Limitations / For Information
 Information: These photographs are an indication of the obstructions and limitations which impeded full inspection of the property at the time of inspection. These obstructions can hide an array of defects and should be removed to allow full inspection to be carried out.

Also, an array of additional photographs have been provided for general information purposes.
