Building and Timber Pest Inspection Report

Inspection Date: Wed, 11 Mar 2026

Property Address: 2/65 Gladstone St, Newport NSW 2106,
Australia

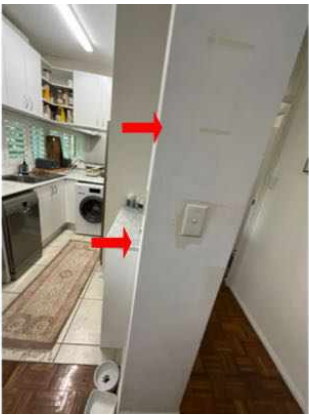
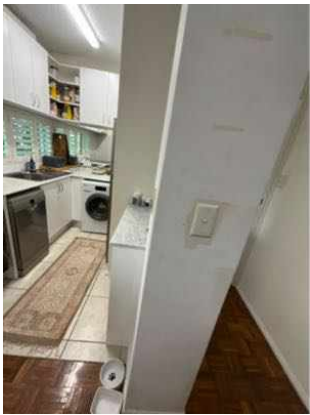
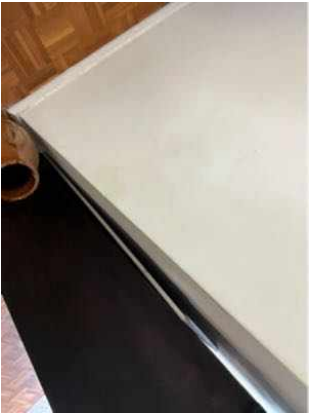
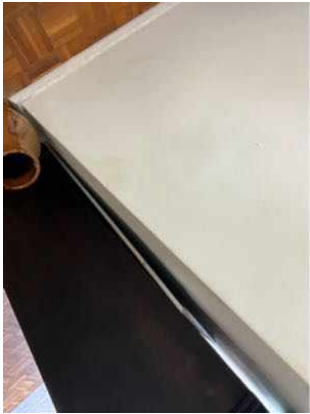
Any irregularity in the surface which is visible from a normal viewing position is considered a defect. Marks may also be a result of fault by other tradespeople throughout the construction process.

Defective surface finish of paintwork is marked with an arrow to the below photos in the following locations.

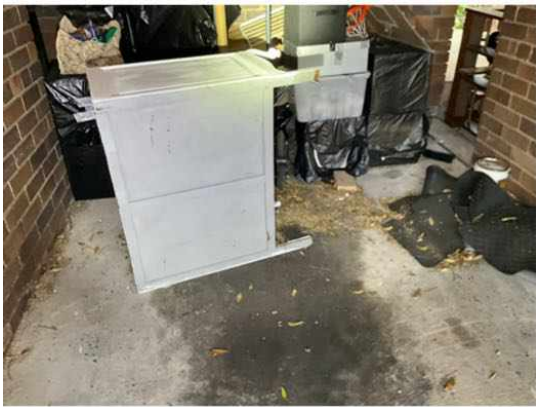
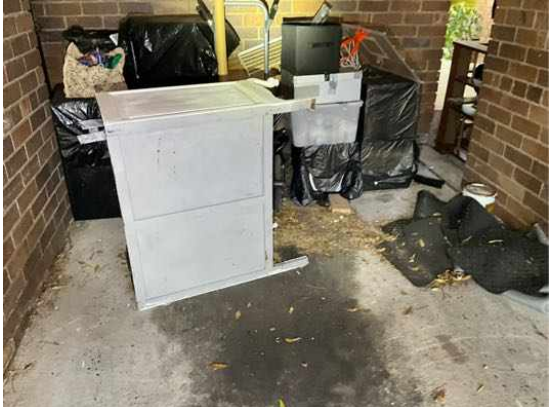
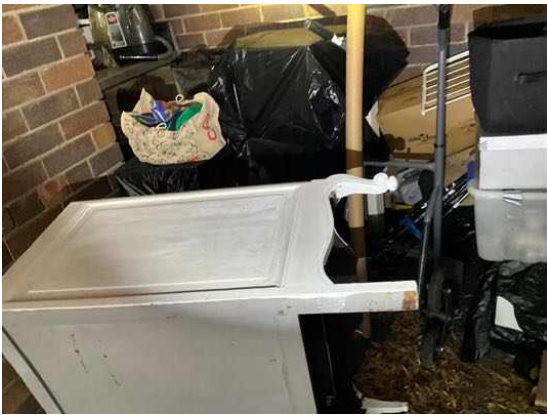
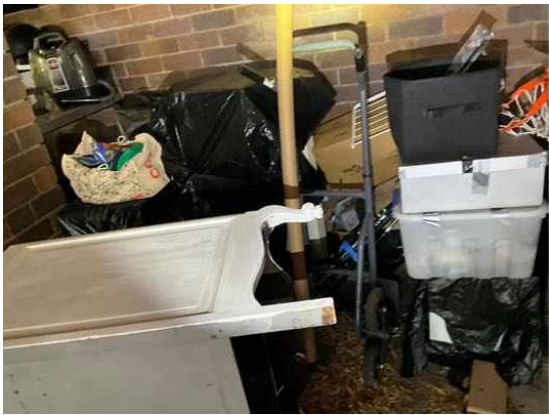
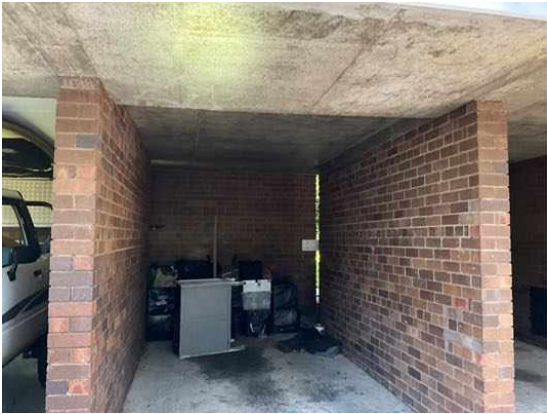
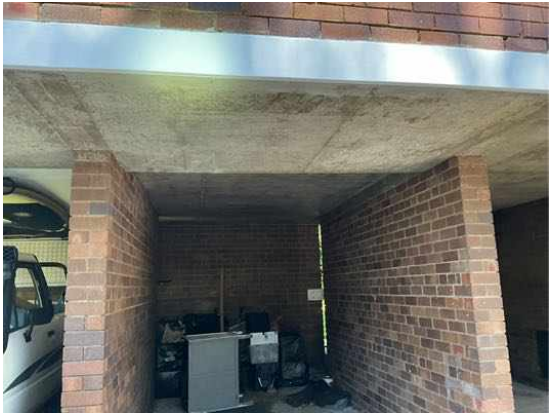
Building: Main Building
Location: All Areas
Finding: Additional Photos - Obstructions and Limitations
Information: These photographs are an indication of the obstructions and limitations which impeded full inspection of the property at the time of inspection. These obstructions can hide an array of defects and should be removed to allow full inspection to be carried out. A re-inspection is recommended once the areas are made accessible.
