Building and Timber Pest Inspection Report

Inspection Date: Mon, 2 Mar 2026

Property Address: 1/14 Xenia St, Pimpama QLD 4209,
Australia

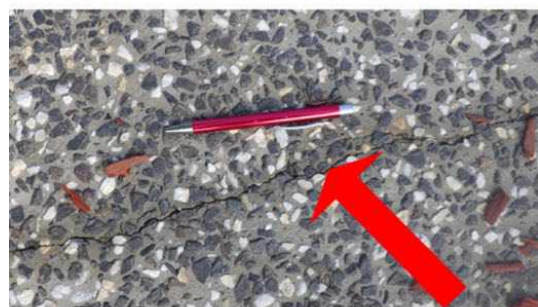
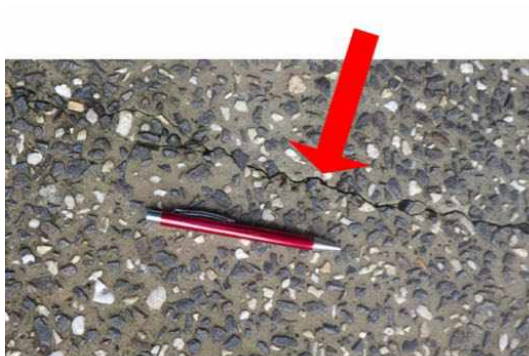
Building: Main Building
Location: Driveway > Ground Level
Finding: Cracking in concrete slab - Category 1
Information: Cracking coded as Category 1 was identified in the driveway and footpaths concrete slab (as per example photos). A Category 1 crack is described as a fine but noticeable crack, with the slab at an otherwise reasonable level.

To be considered Category 1, the approximate width of the crack is less than 1.0mm, or a less than 10mm change in offset when a 3m straight edge is placed over the defect.

Category 1 cracks should be monitored for a period of 12 months. At the end of the monitoring period, identified cracks that are rated greater than Category 2 are considered defects, and require rectification.

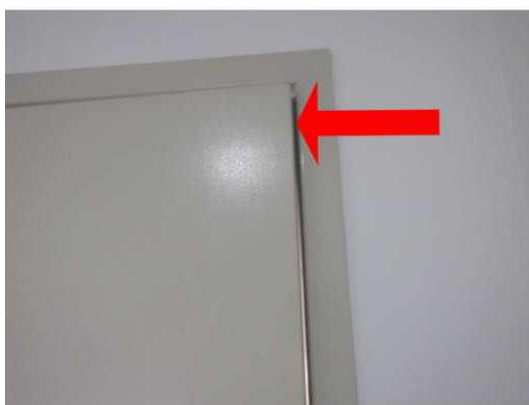
Finding 3.02

Building: Main Building
 Location: Entry > Front
 Finding: Door - Binding/Jamming
 Information: Binding and/or jamming of the entry door on the door frame was evident during standard operation. This defect inhibits the functionality of affected door as well as creating potential for secondary defects to associated building elements, such as damage to the door framing.

A door that binds to the associated door frame or sill may have several causes, such as poor installation of the door or deteriorated hinges.

A qualified carpenter or general handyperson could be appointed to perform minor rectification works at client discretion.

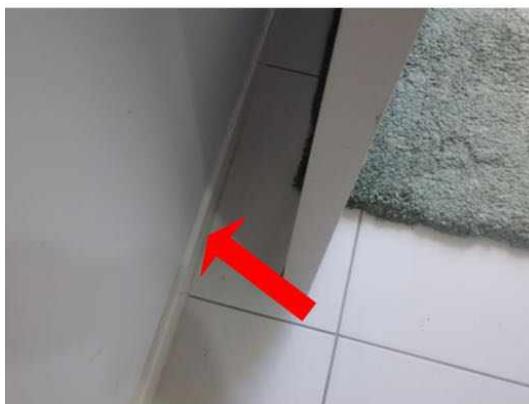
Finding 3.03

Building: Main Building
 Location: Entry > Front Right
 Finding: Door stop - Missing
 Information: The entry door stop is missing or is inadequate to stop the door handle from impacting the wall.

Re-installation or replacement of the door stop is advised to prevent any subsequent damage to the wall linings or associated structures.

A general handyman may be appointed to perform these works at client discretion.

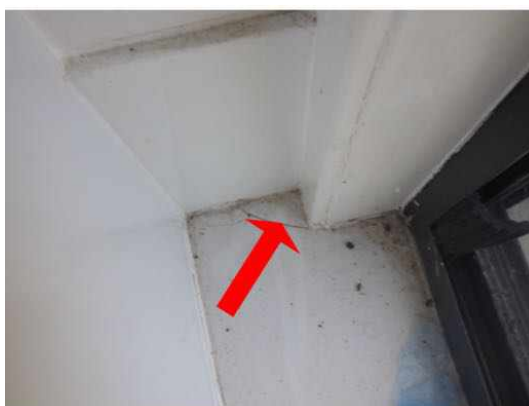
Finding 3.04

Finding: Tile - Cracked

Information: A cracked tile to the laundry floor area was identified at the time of inspection. Such defects are generally caused by impact. Cracked or broken tiled areas may also be a direct result of poor workmanship during the construction process.

A tiling contractor could be appointed to perform repair works at the clients discretion.

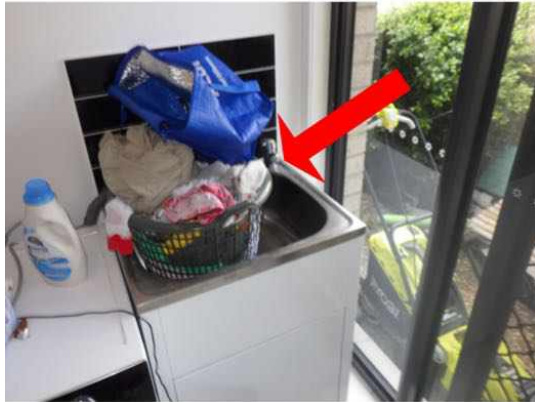
Finding 3.05

Finding: Tap - Loose

Information: The tap in the laundry area has not been installed correctly, or has deteriorated with age, and is consequently loose. This tap being loose creates potential for water leaks

and subsequent water damage to the surrounding area.

Where taps or spouts are loose, a qualified plumber should be appointed to re-fix the plumbing fitting.

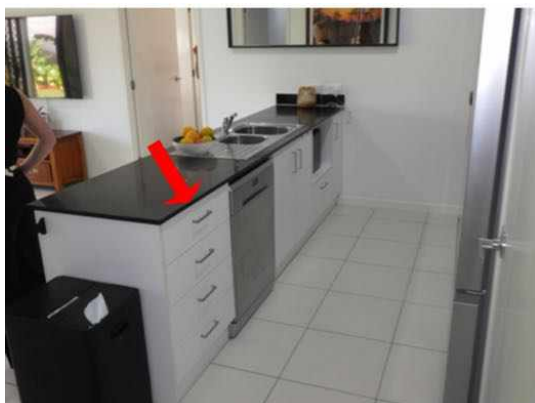
Finding 3.06

Building: Main Building
 Location: Kitchen > Front Left
 Finding: Chipping - Kitchen bench top.
 Information: At the time of inspection there was a small chip to the front edge of the kitchen bench manufactured stone top.

While such chipping may be noticeable in some cases, it is quite common and does not indicate any structural damage.

Chipping of this nature can generally be repaired with minor sanding, filling and/or polishing. Such works should be performed by a qualified stone mason.

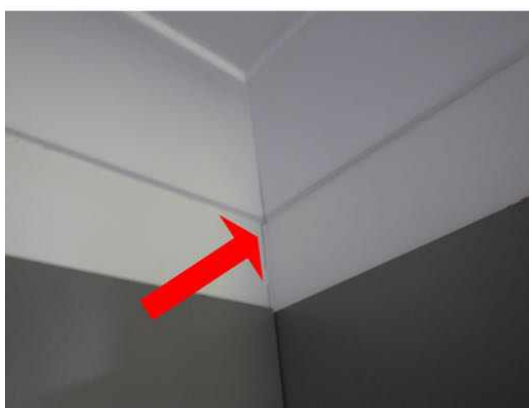
Finding 3.07

Finding: Cracking - Wall
 Information: There is cracking to an area of the wall lining or cabinetry bulkhead in the kitchen area.

The cracking appears minor in nature and is generally only ever an appearance defect. While such cracking may be noticeable in some cases, it is quite common and does not indicate any structural damage.

Cracking of this nature can generally be repaired with minor sanding, filling and/or repainting. Such works should be performed by a qualified painter or a general handyman.

Monitoring of all cracking should be conducted frequently. Always contact a building inspector should cracks widen, lengthen, or become more numerous.

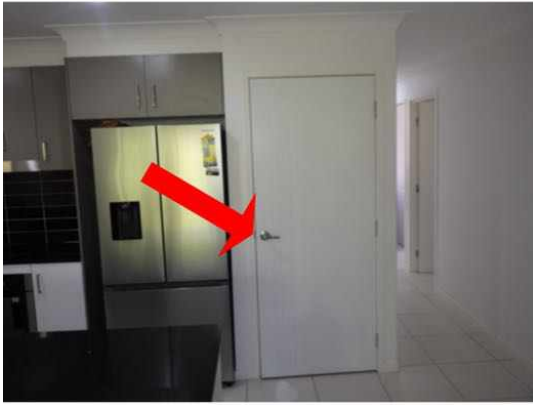
Finding 3.08

Building: Main Building
 Location: Pantry - Walk In > Front
 Finding: Door - Not latching
 Information: The door to the walk in pantry was found to be not latching at the time of inspection. Breakage occurs generally when the building materials have aged and decayed.

A qualified carpenter or general handyman could be appointed to adjust the door handle striker plate at the client's discretion.

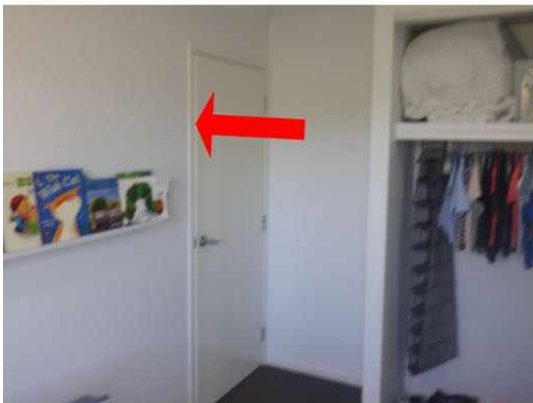
Finding 3.09

Building:	Main Building
Location:	Bedroom 3 > Front
Finding:	Door - Binding/Jamming
Information:	Binding and/or jamming of the bedroom 3 door on the door frame was evident during standard operation. This defect inhibits the functionality of affected door as well as creating potential for secondary defects to associated building elements, such as damage to the door framing.

A door that binds to the associated door frame or sill may have several causes, such as poor installation of the door or deteriorated hinges.

A qualified carpenter or general handyperson could be appointed to perform minor rectification works at client discretion.

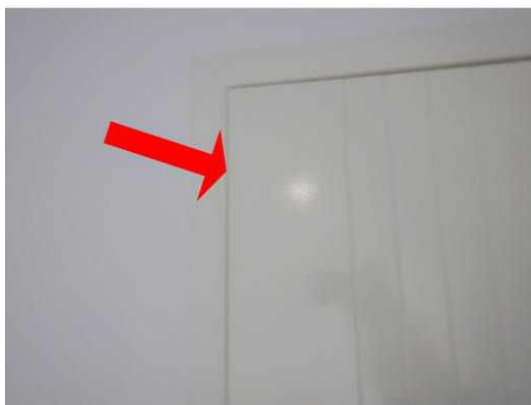
Finding 3.10

Building:	Main Building
Location:	Bedroom - Master > Front
Finding:	Door - Binding/Jamming
Information:	Binding and/or jamming of the main bedroom door on the door frame was evident during standard operation. This defect inhibits the functionality of affected door as well

as creating potential for secondary defects to associated building elements, such as damage to the door framing.

A door that binds to the associated door frame or sill may have several causes, such as poor installation of the door or deteriorated hinges.

A qualified carpenter or general handyperson could be appointed to perform minor rectification works at client discretion.

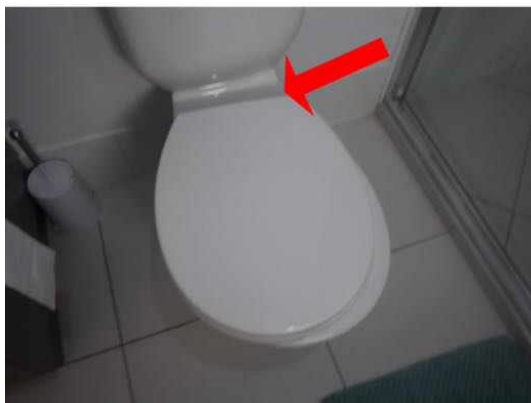
Finding 3.11

Building:	Main Building
Location:	Ensuite > Centre Left
Finding:	Toilet seat - Loose
Information:	The ensuite toilet seat was found to be loose at the time of inspection. It is suspected that this defect has developed due to general wear and tear.

If left unmanaged, the toilet seat could deteriorate further, leading to destabilisation and the potential for water leaks to the toilet pan area.

It is recommended that the seat be repaired by a licensed plumbing or general handyman.

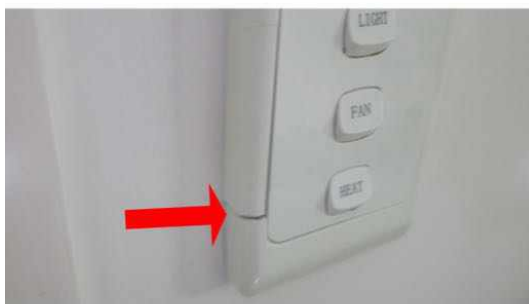
Finding 3.12

Building: Main Building
 Location: Ensuite > Front Left
 Finding: Light Switch
 Information: At the time of inspection the light switch in the ensuite area showed signs of cracking to the cover plate.

A licensed electrician or general handyman could be engaged to replace the light switch cover plate.

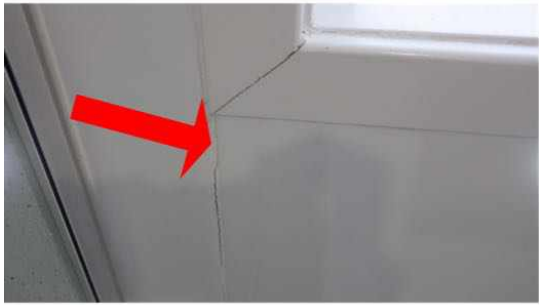
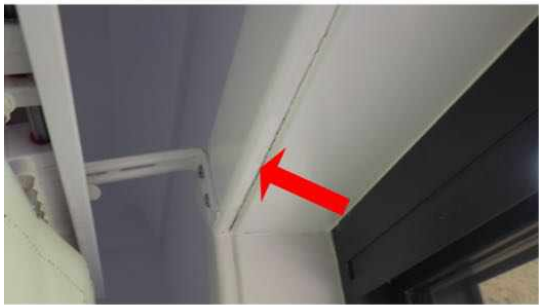
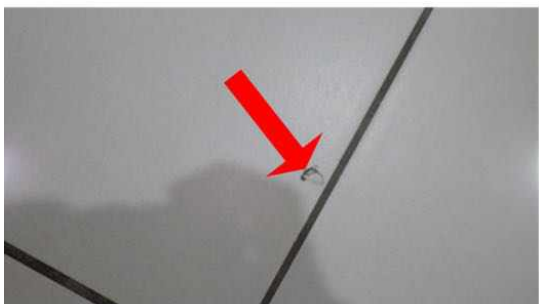
Finding 3.13

Building: Main Building
 Location: Internal Areas > Existing
 Finding: Wear and Tear
 Information: At the time of inspection the building interior showed signs of minor cracking and/or scuffing to floors, walls, ceilings and cornices (as per example photos).

The level of damage appears consistent with general deterioration and/or wear and tear.

The relevant trades people or a general handyman could be engaged to undertake repair work at the clients discretion.

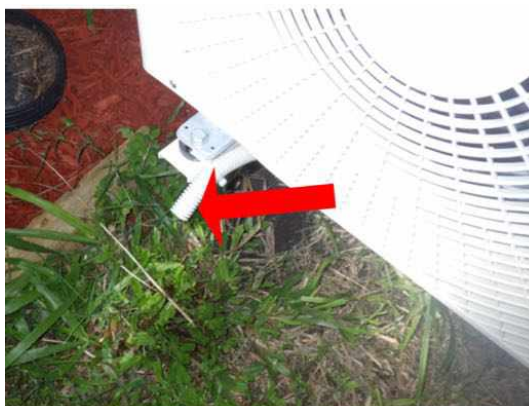
Finding 6.01

Building:	Main Building
Location:	Exterior walls - right side > Centre Right
Finding:	Overflow - Not plumbed for drainage
Information:	The air conditioning unit overflow is not plumbed or connected to suitable drainage, which can result in the surrounding area becoming excessively damp. These damp conditions can lead to secondary defects such as rot, rust or corrosion of associated building elements, the formation of fungal decay, or even the creation of potential slip hazards. When coupled with poor site drainage, pooling of water may also attract termite activity to this area. It is highly recommended that a qualified plumber be appointed to install adequate drainage to the overflow. These works will ensure that the area remains dry and free of any secondary defects.

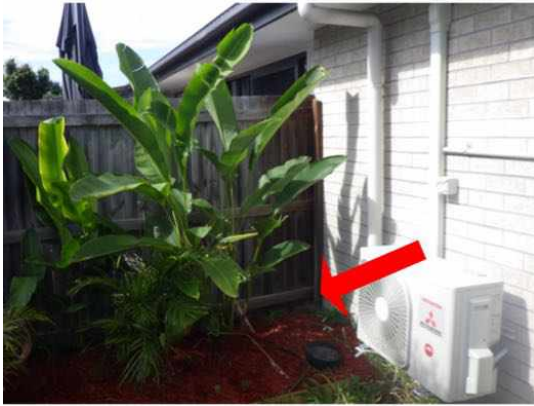
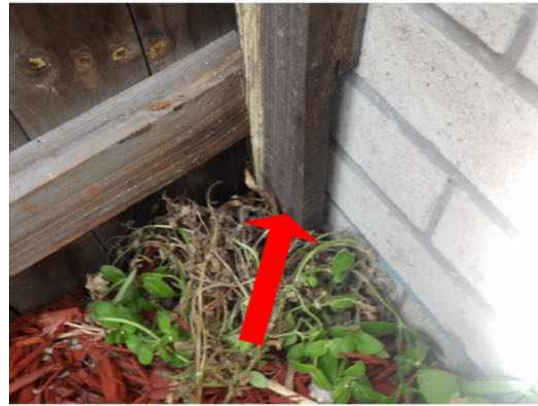
Finding 6.02

Building:	Main Building
Location:	Exterior walls - right side > Centre Right
Finding:	In ground contact
Information:	The timber fence post fixed to the exterior wall brickwork is in direct contact with the finished ground surface.

Any timbers in direct ground contact provide opportunity for concealed termite entry and are likely to be subject to premature rot and decay as the ground retains moisture

or damp conditions against the timbers.

Ideally these types of timber members would be clear of the ground area by a minimum of 50mm to provide a clear inspection zone.

Frequent pest inspections are advised to readily identify any termite activity in these areas.

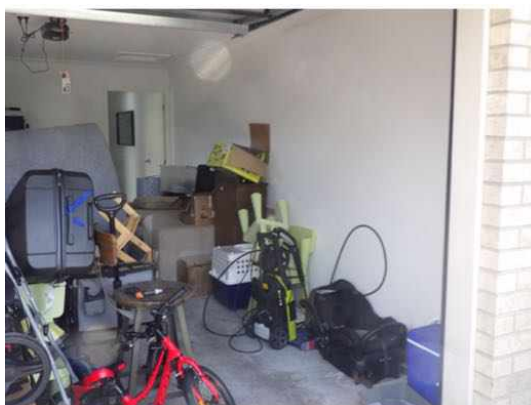
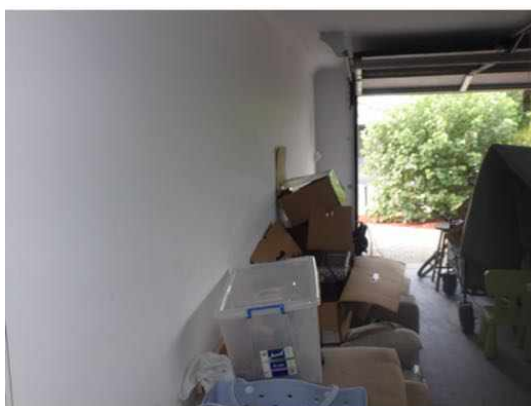
Finding 6.03

Building:	Main Building
Location:	External Areas > Ground Level
Finding:	Stored Items
Information:	At the time of inspection there was stored items against the external walls or on ground areas to the exterior of the property.

These stored items severely limit full inspection of the area and may conceal timber termite pest and or vermin activity.

It is highly recommended the items are removed to allow for complete inspection of the area.

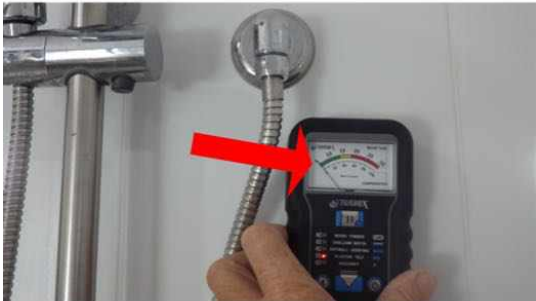
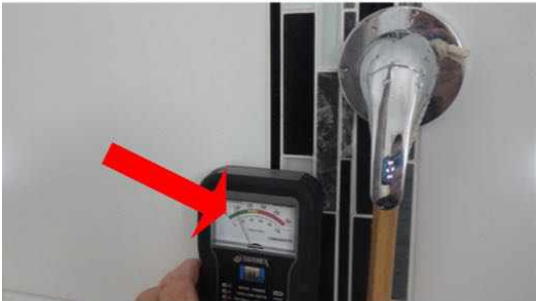
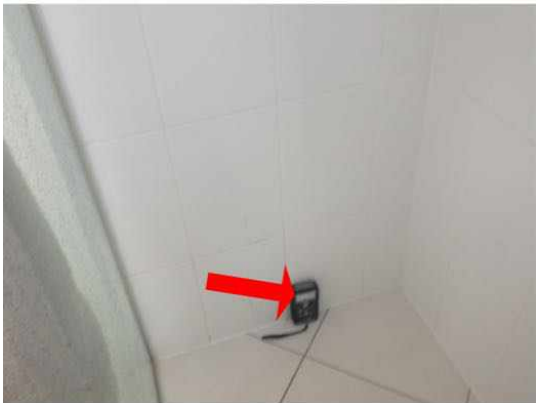
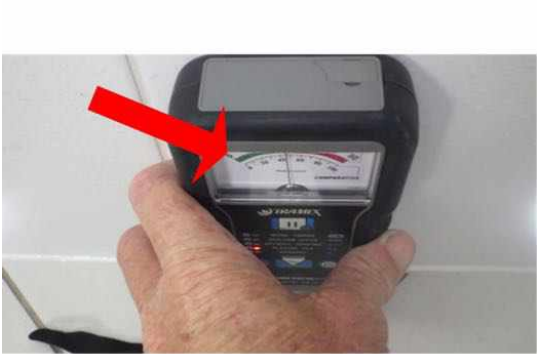
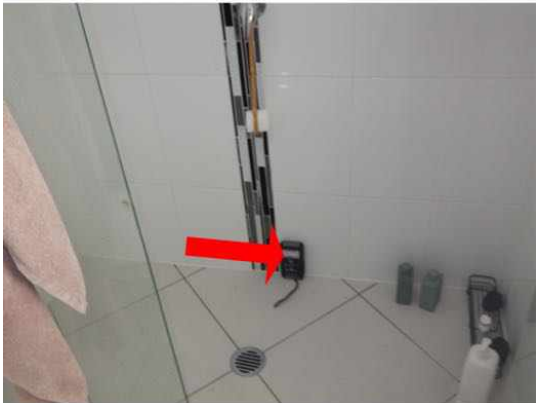
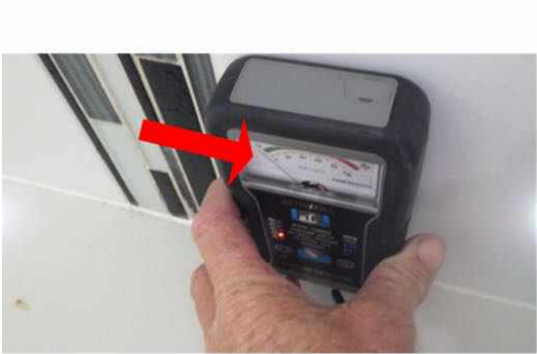
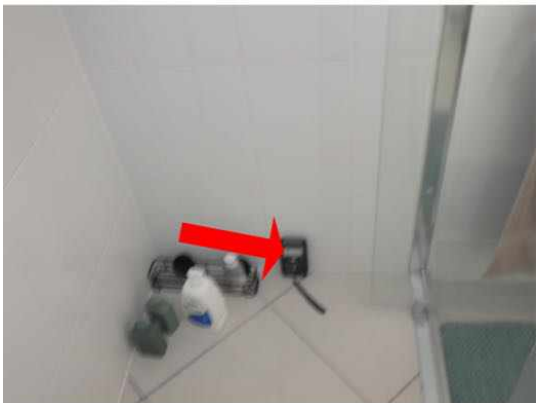
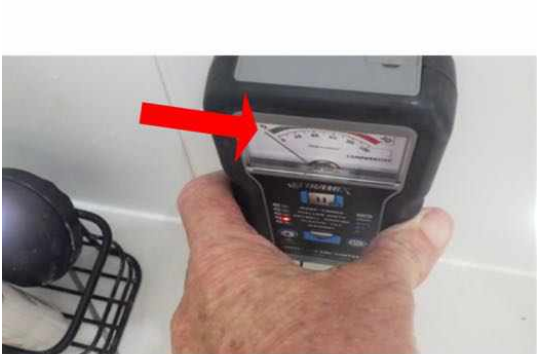
Building: Main Building
Location: Ensuite > Rear
Finding: Moisture Level Readings
Information: At the time of inspection the ensuite shower cubicle areas checked with the Tramex Moisture Meter returned low - normal moisture level readings.

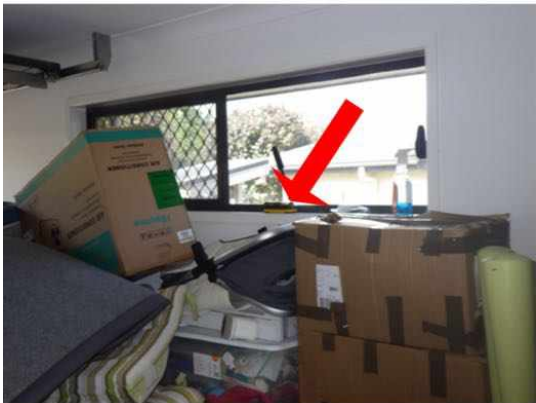
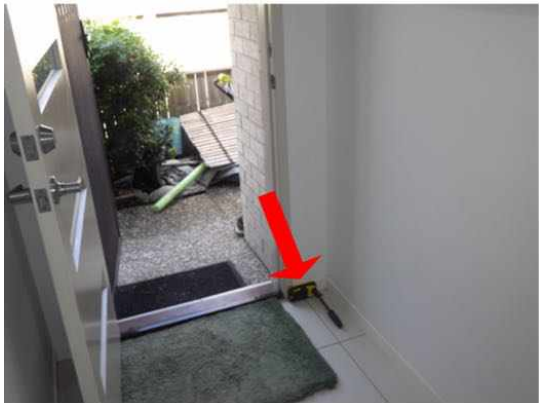
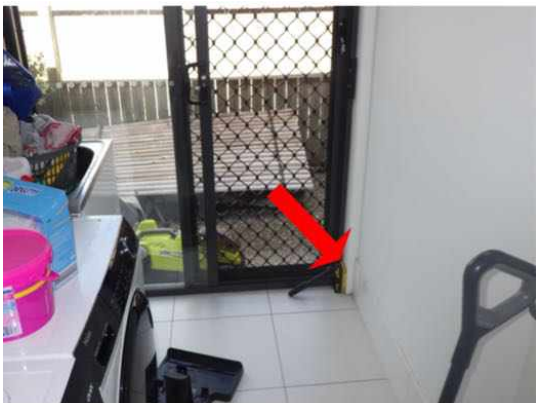
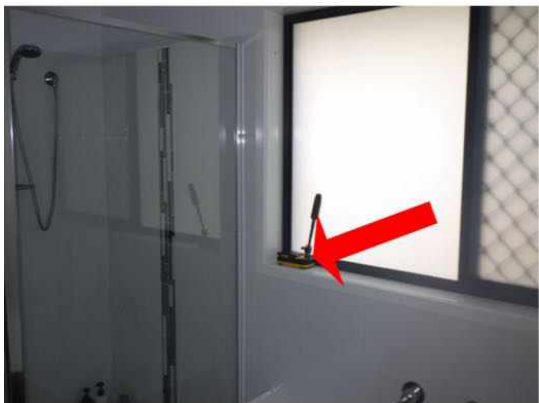
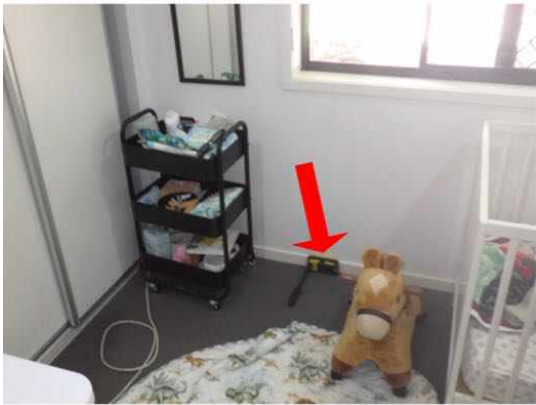
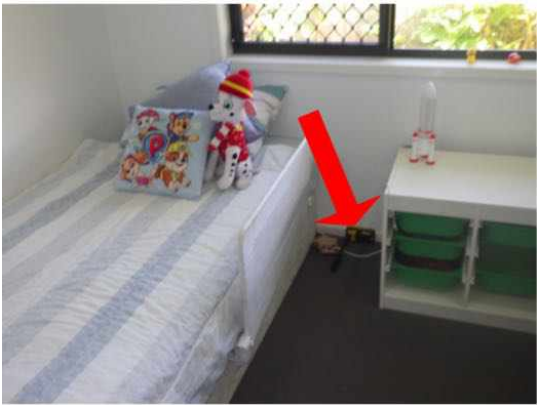
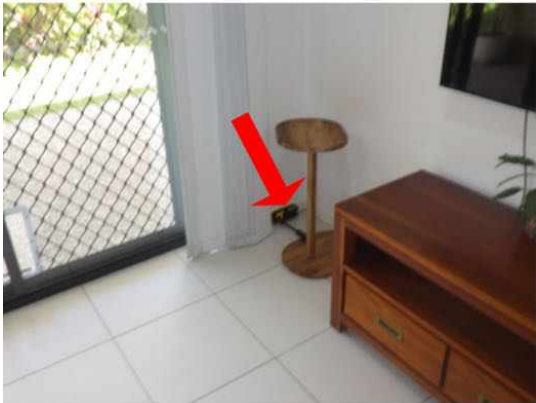
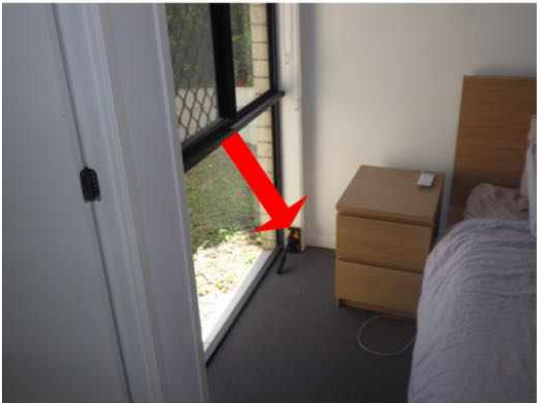
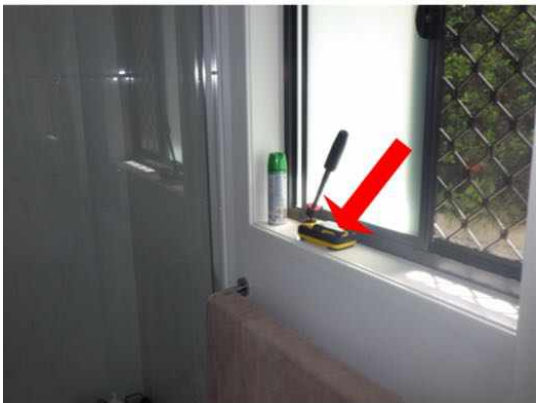
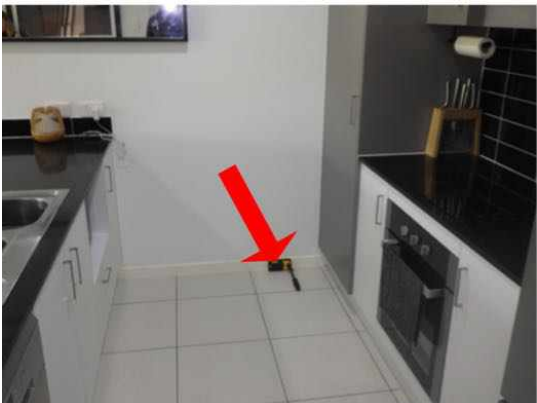
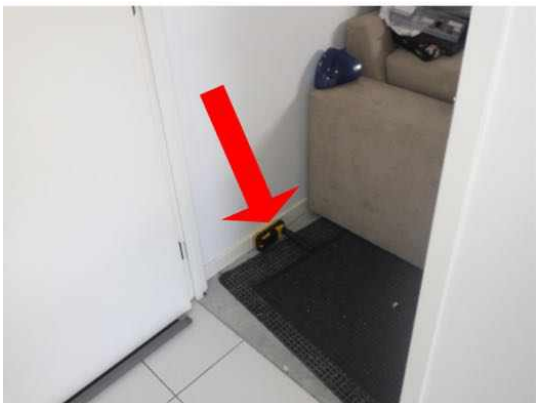
Building: Main Building
Location: Internal Areas > Existing
Finding: Termitracker
Information: The termitracker was positioned randomly to internal wall, timber skirting and window frame areas checking for signs of termite activity.

No activity was recorded at the time of inspection.

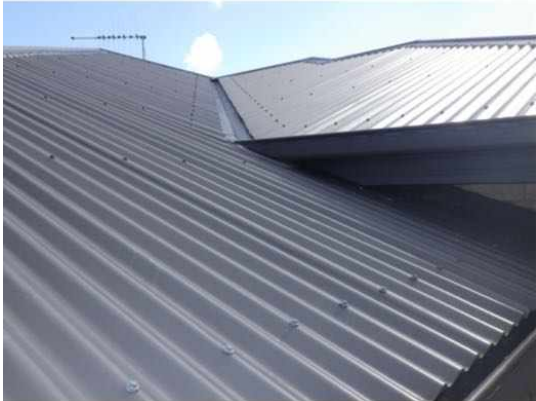
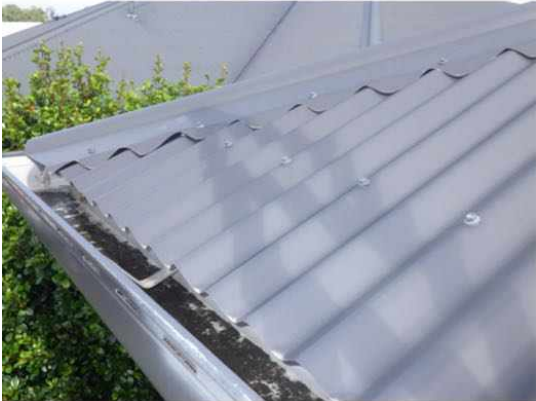
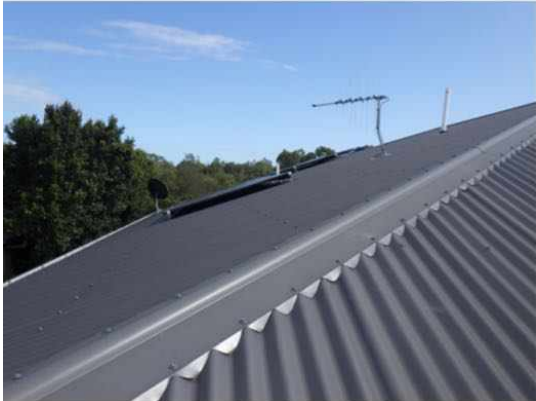
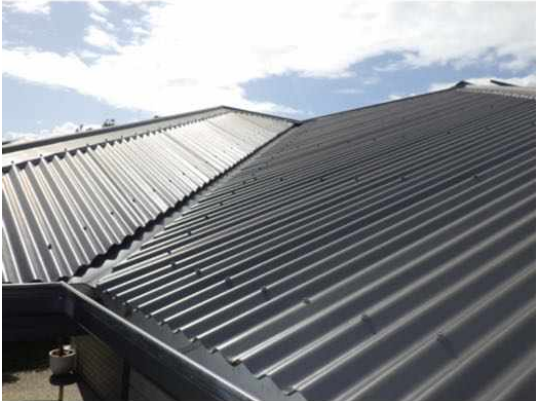
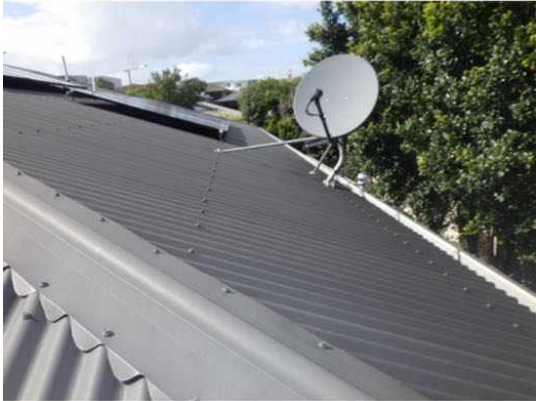
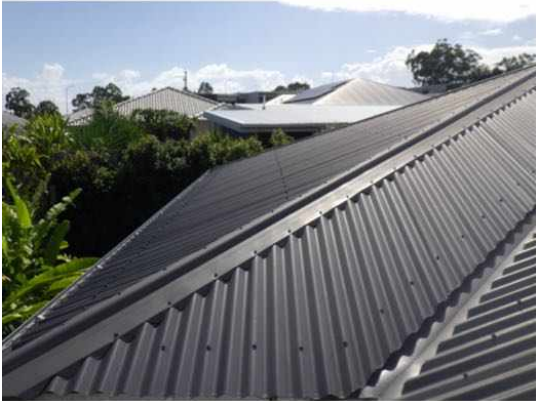
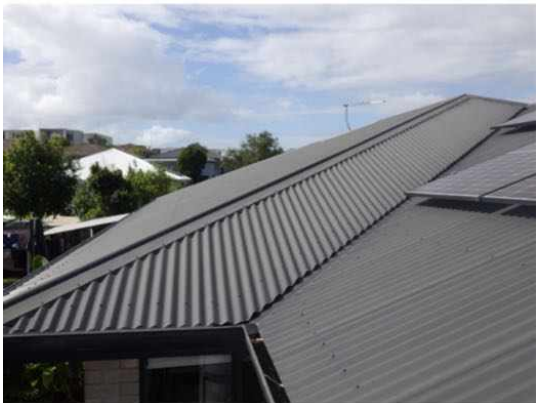
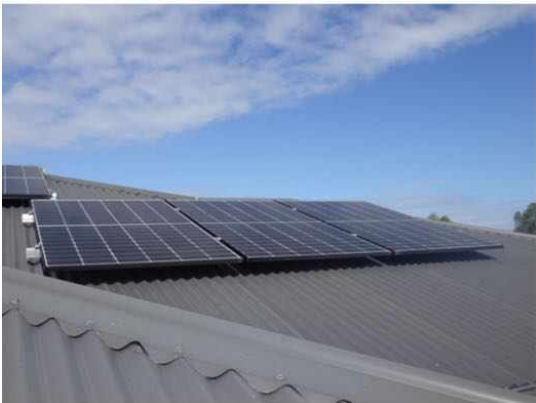
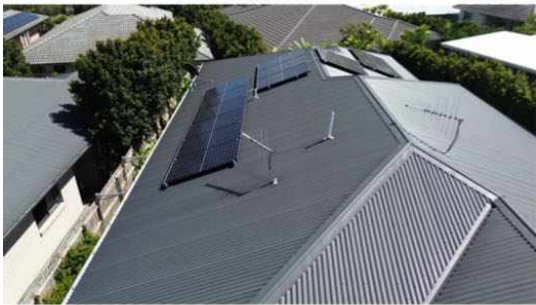
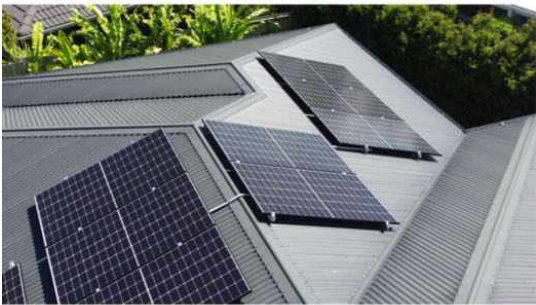
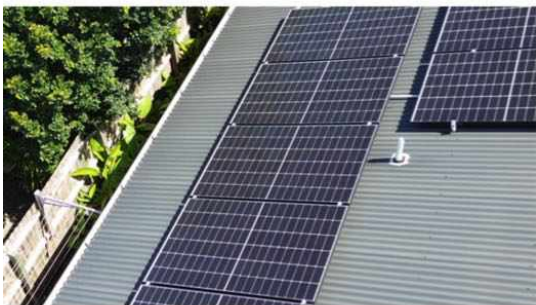
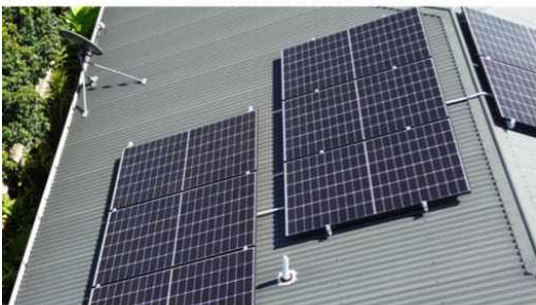
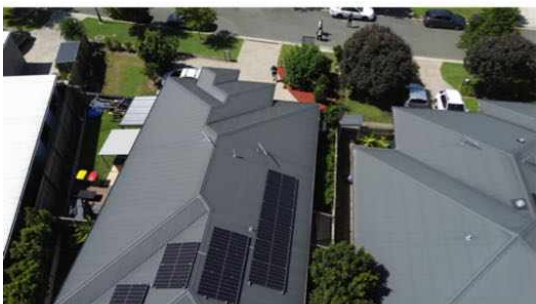
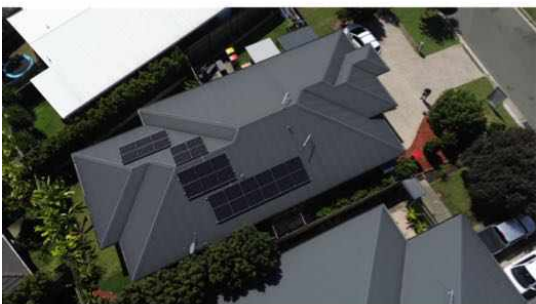
Building: Main Building
Location: Roof Exterior > Existing
Finding: Roof Photos
Information: Roof area photos were taken manually and with the DJI Mini 3 Drone flown over the roof at the time of inspection.

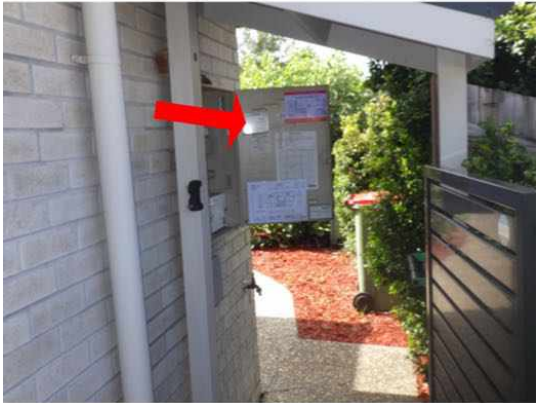
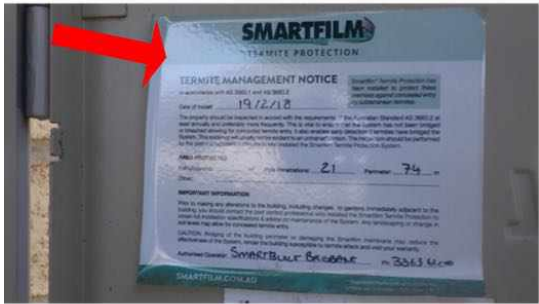
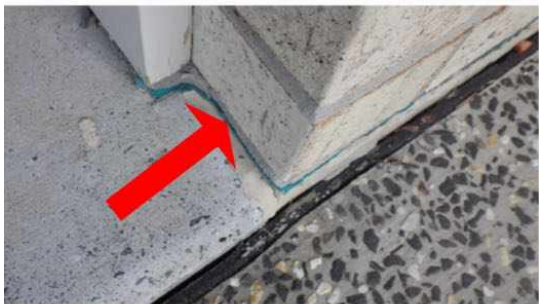
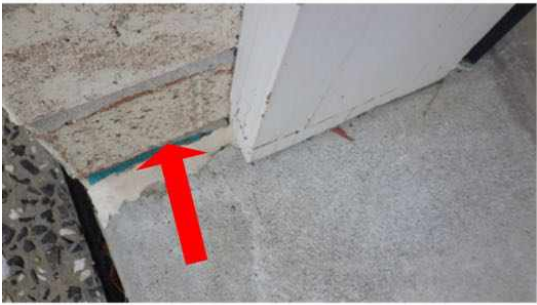
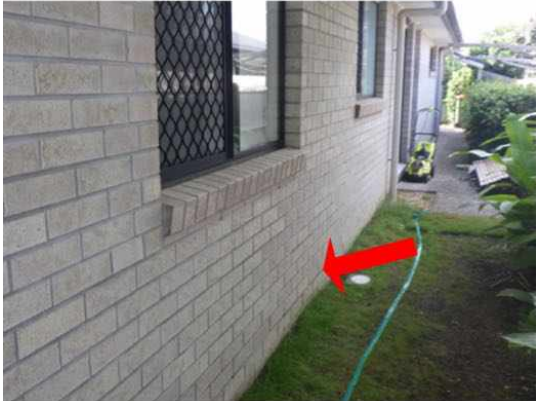
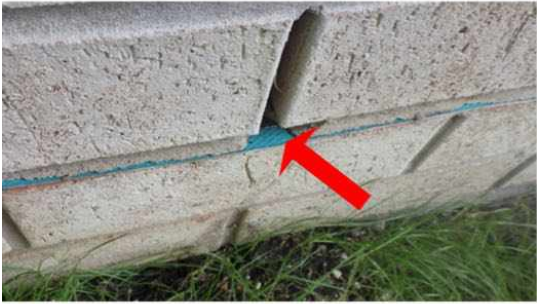
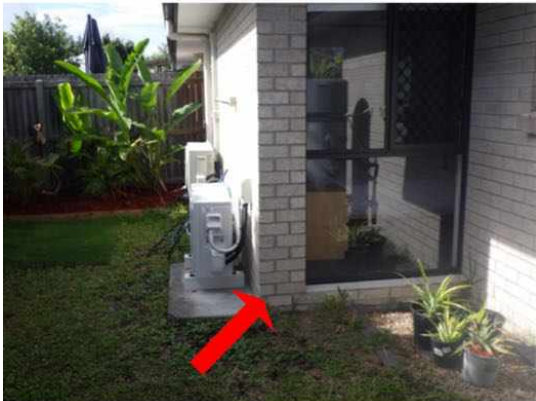
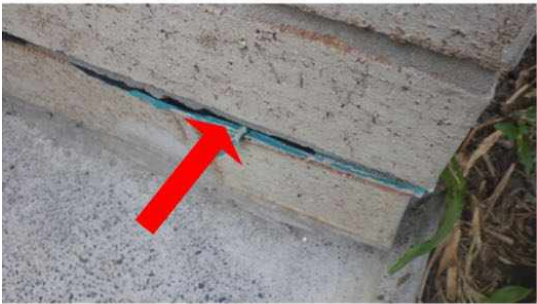
In this instance evidence of a previously installed physical barrier was observed, along with a durable notice inside the electrical meter box. This system requires regular annual inspections.

No evidence of regular or annual inspections was found.

Where a Termite Management System has been identified you should refer to the type of barrier date of installation warranty conditions and any documentation provided by a builder or past owner.
