# Building and Timber Pest Inspection Report

Inspection Date: Mon, 16 Mar 2026

Property Address: 5A Dellwood Ave, Earlwood NSW 2206,  
Australia

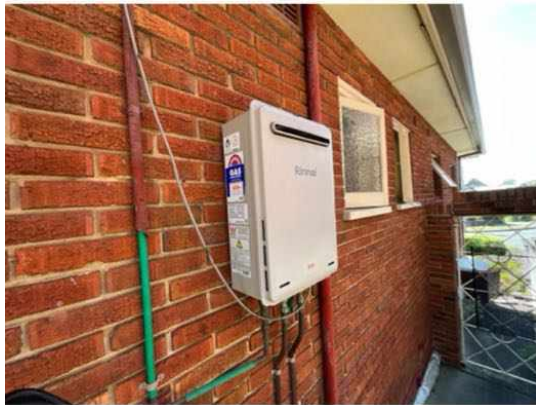
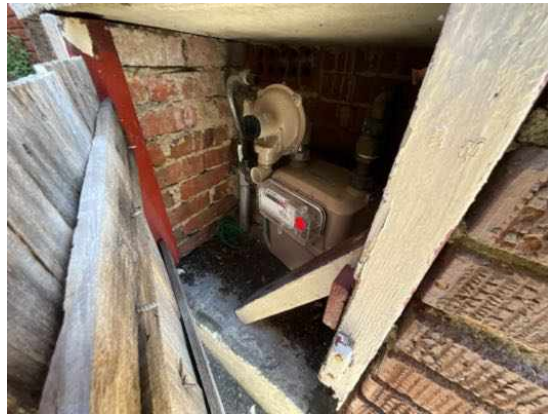
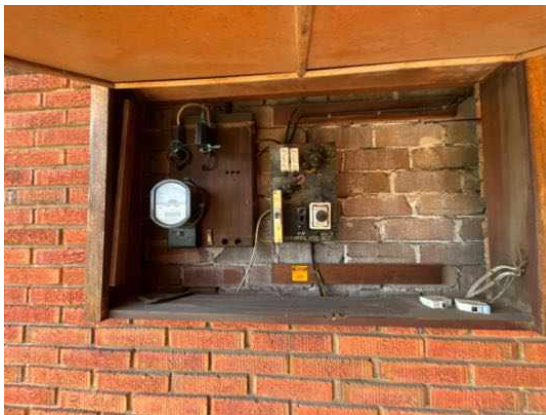
Building: Main Building  
Location: All Areas  
Finding: Photos Added  
Information: Additional photos are provided for your general reference.

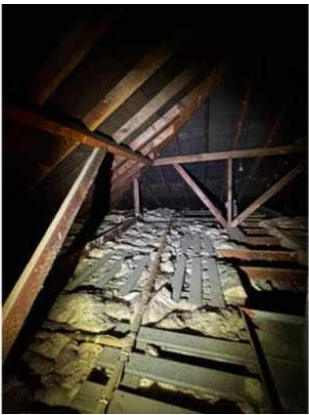
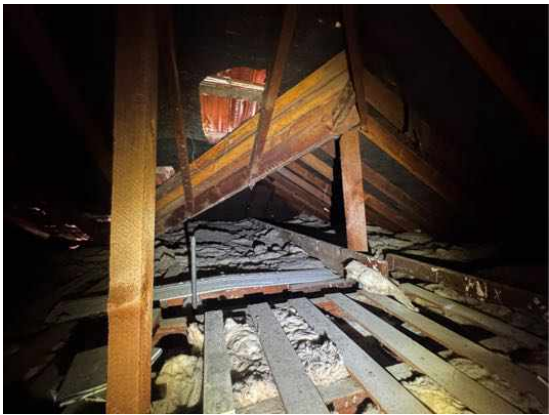
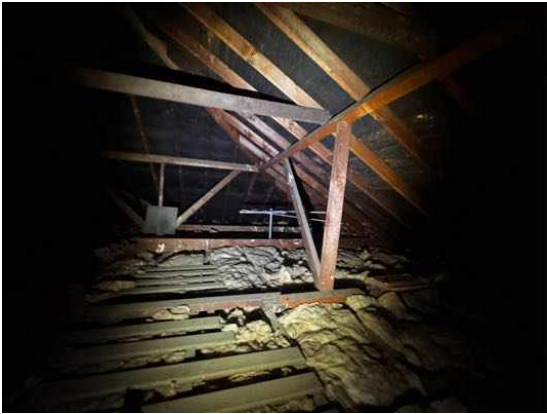
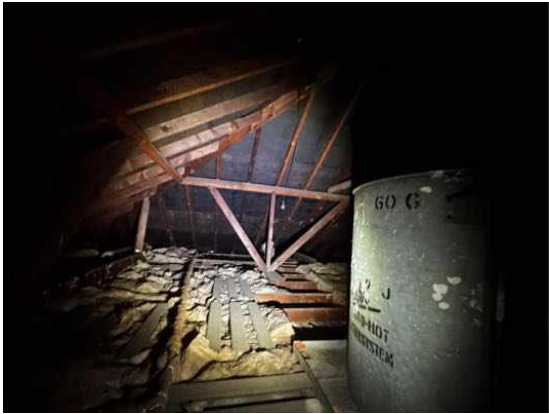
Building: Main Building  
Location: Roof Void  
Finding: Photos Added  
Information: Additional photos are provided for your general reference.
