# Building and Timber Pest Inspection Report

Inspection Date: Tue, 24 Feb 2026

Property Address: 56 Dalton Rd, St Ives Chase NSW 2075, Australia

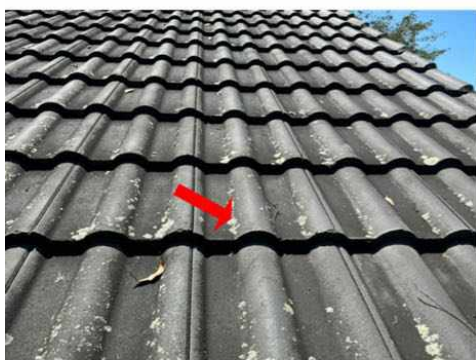
Building: Main Building  
Location: All Areas  
Finding: Roof Tiles Weathered - Lichen Build Up  
Information: Upon inspection of the exterior roofing, the majority of roof tiles were considered to be in a fair condition. While weathering of the tiles is consistent with the age of the property, maintenance works are required.

Concrete roof tiles are typically cleaned to have the visible moss and lichen removed. Concrete tiles are made from a product which is a naturally moist material. Moss and lichen is attracted to the roof tiles surface, and if left will continue to grow and most likely restrict the flow of rain water over the tiles surface, into the roofs gutters. An application of an environmentally friendly anti-fungal solution should be applied to all moss and lichen, prior to undertaking the roof cleaning process.

A roof restoration company can be contacted for further advice at the clients discretion.

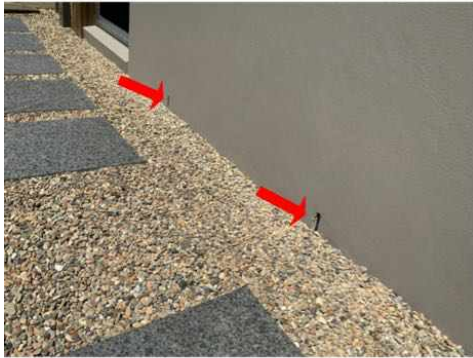
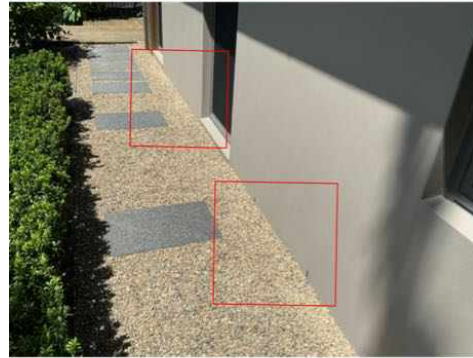
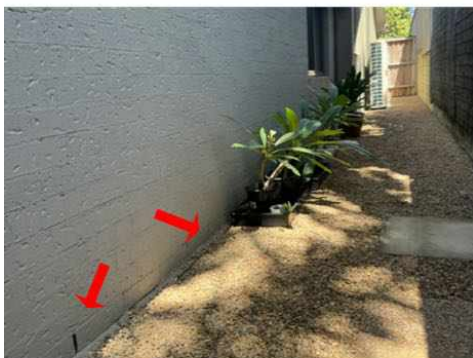
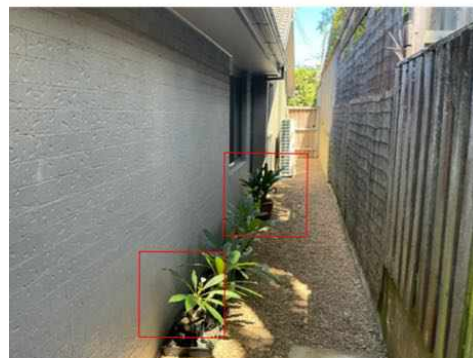
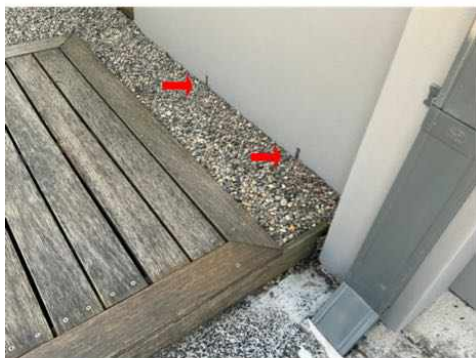
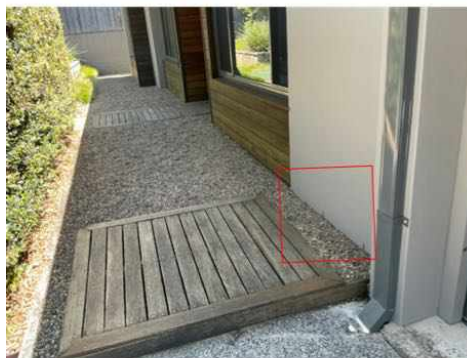
#### Finding 3.02

Location: All Areas  
Finding: Weep Holes - At Ground Level  
Information: It was noted at the time of inspection, the weep holes have been identified at ground level, which constitutes a defect.

According to building standards, weep holes should be positioned above the finished ground level to ensure proper drainage and to prevent water ingress into the wall cavity. Weep holes located at ground level can lead to water entering the structure, causing potential damage to the masonry, insulation, and internal finishes. This placement fails to provide the necessary protection against moisture and does not comply with standard building practices.

The relevant tradesperson must address this issue by ensuring that weep holes are correctly positioned above ground level to meet the required standards and to maintain the integrity of the building.

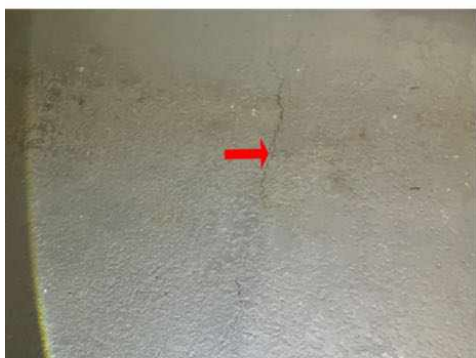
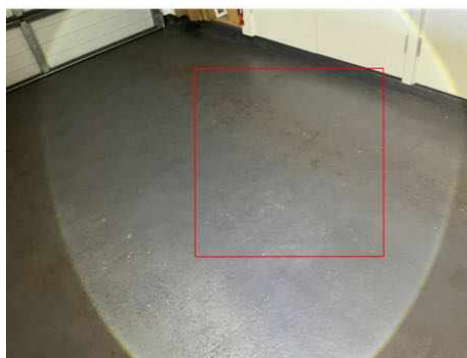
### Finding 3.03

Building: Main Building  
 Location: Garage  
 Finding: Crack in concrete slab - Category 2  
 Information: A crack coded as Category 2 was identified in the slab. A Category 2 crack is described as a distinct crack, with the slab being noticeably curved or changed in level.

To be considered Category 2, the approximate width of the crack is less than 2.0mm, or a change in offset of less than 15mm when a 3m straight edge is placed over the defect.

Category 2 cracks to slabs should be monitored for a period of 12 months. At the end of the monitoring period, cracks rated greater than Category 2 are considered defects that require rectification.

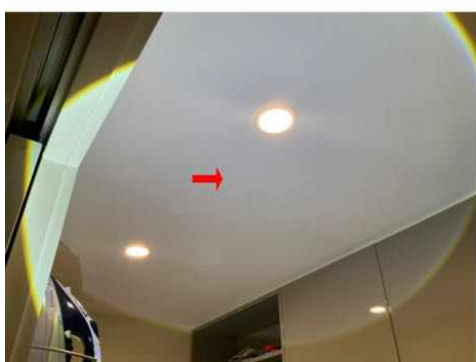
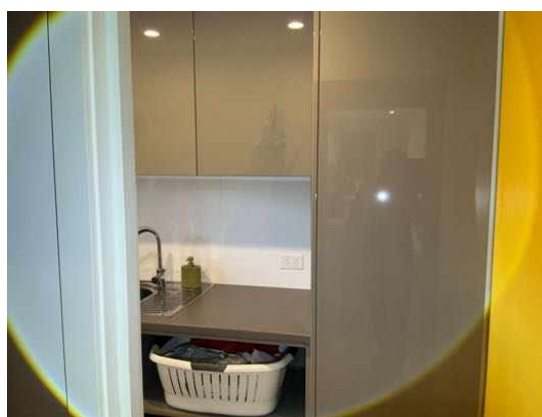
### Finding 3.04

Building: Main Building  
 Location: Laundry  
 Finding: Laundry - No Exhaust Fan Installed  
 Information: At the time of inspection, it was noted that the laundry area is not equipped with an

The absence of mechanical ventilation in a confined space such as a laundry can lead to the accumulation of excess moisture and humidity, particularly during the use of washing machines and dryers. Over time, this can result in condensation build-up on walls and ceilings, increasing the risk of mould and mildew growth, which may cause health issues such as respiratory irritation and allergies. Additionally, persistent damp conditions can contribute to the deterioration of paint, plaster, and other building materials, potentially leading to more extensive and costly repairs.

A licensed electrician should be appointed to carry out this work to ensure the fan is installed safely and in accordance with Australian electrical standards at clients own discretion.

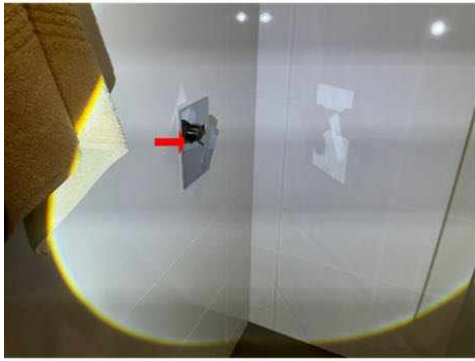
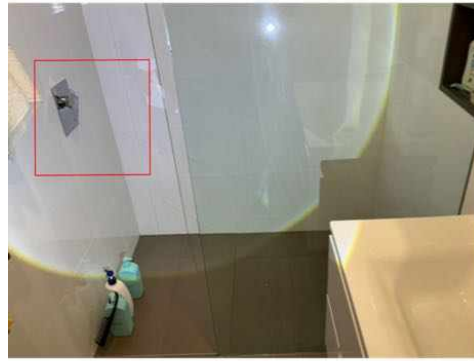
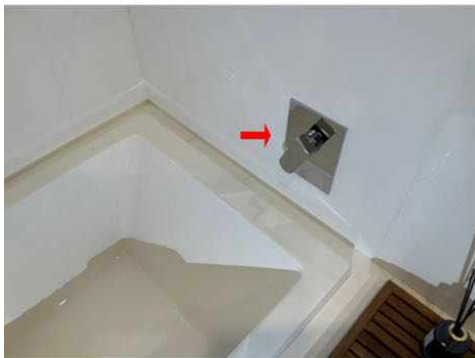
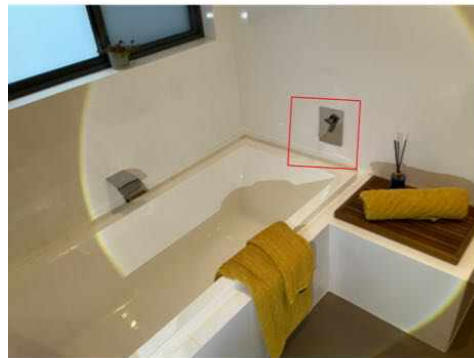
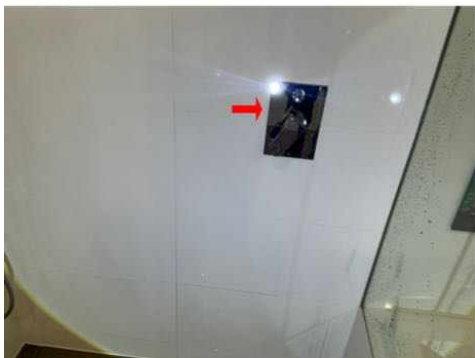
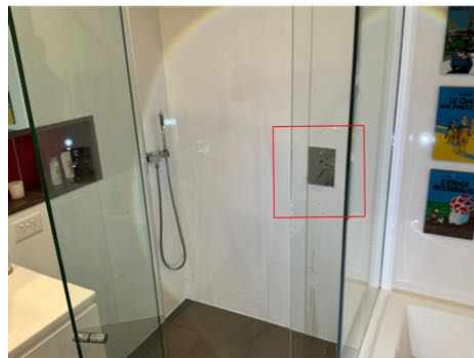
### Finding 3.05

Building:	Main Building
Location:	Both Bathrooms
Finding:	Tap - Water hammer
Information:	This tap shows evidence of water hammer being present. Water hammer, a pressure surge resulting when a fluid is forced to suddenly change direction, is a common defect in plumbing fittings, particularly those that are aged and not frequently maintained. Water hammer is generally caused by factors that create high water pressure in the affected plumbing fixture, usually evidenced by a faint banging noise during operation of the affected tap.

Although water hammer is generally considered to be a minor defect, subsequent damage such as erosion of tap hardware and/or water damage to associated building elements is likely to occur if left unmanaged.

A licensed plumber should be appointed as soon as possible to replace any affected tap hardware and perform any remedial works as necessary. Please be advised that the appointment of a cabinet maker or qualified carpenter may be necessary if water damage to associated building elements has occurred.

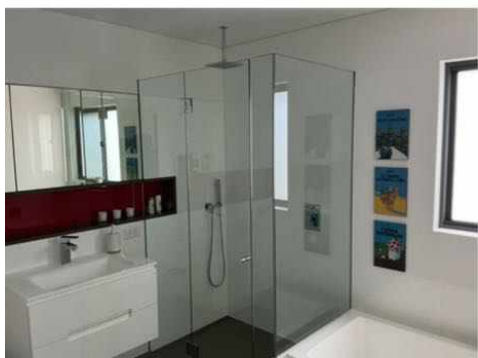
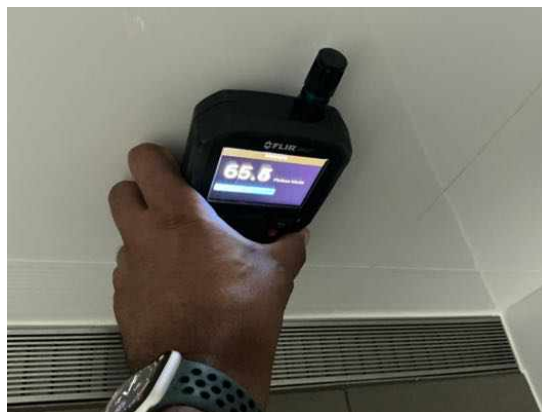
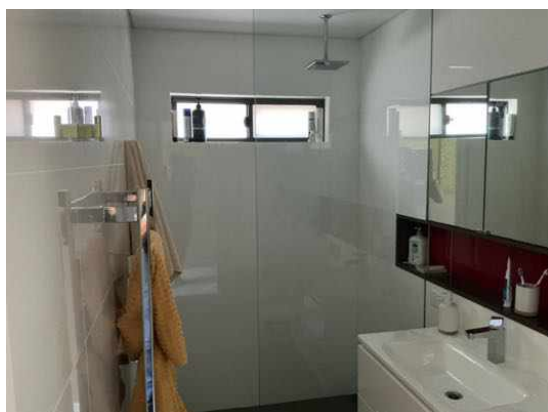
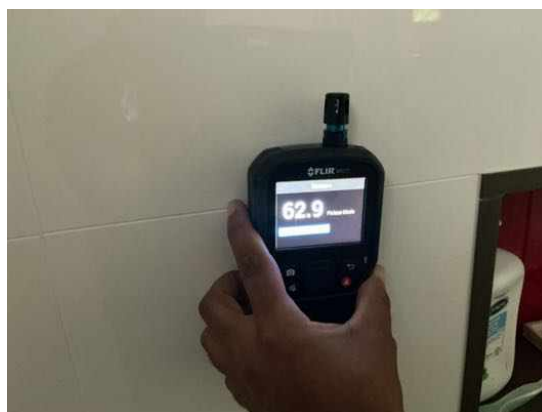
### Finding 3.06

Finding: Excessive Moisture - Shower Damp

Information: At the time of inspection, excessive moisture was noted within the shower area, which is a common issue in wet areas due to the continual exposure to water. This condition is typically caused by moisture seeping through grout lines and settling behind tiles, resulting in localised high-moisture zones. Provided there is no evidence of water staining or elevated moisture readings on the opposite side of the wall, this is considered a minor defect.

However, persistently damp conditions may act as conducive conditions for termite activity, as termites are strongly attracted to moisture-rich environments. It is recommended that the client ensures regular use of the exhaust fan and maintains adequate ventilation after shower use to promote drying and reduce long-term moisture build-up, thereby also reducing the risk of attracting termites.

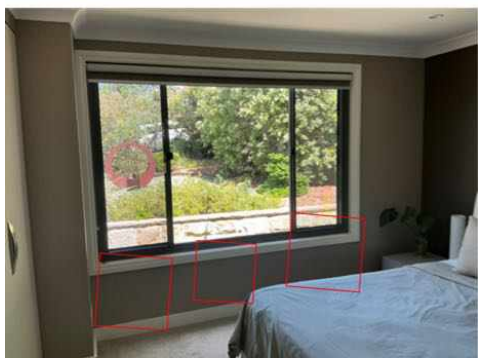
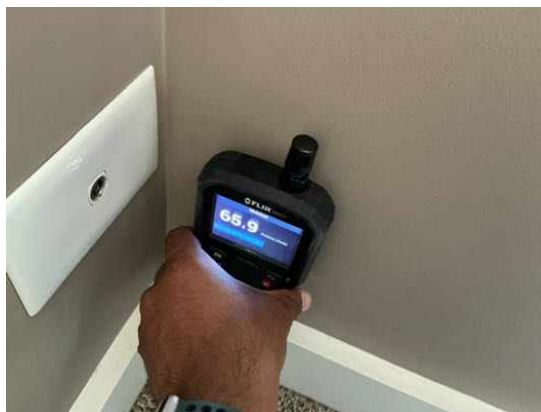
### Finding 3.07

Building:	Main Building
Location:	Bedroom 1
Finding:	Damp - Rising
Information:	At the time of inspection, rising damp was identified within the property. This condition results from the upward movement of moisture through porous building materials, such as bricks, sandstone, or mortar, via capillary action. A damp-proof course (DPC), an impermeable barrier installed at the base of walls above ground level during construction, is typically used to prevent rising damp. However, the absence, deterioration, or bridging of the DPC can compromise its effectiveness, specially in older buildings, leading to moisture ingress. Inadequate site drainage, which allows water to accumulate around the foundation, is a common contributing factor to this issue.

It is strongly recommended that the client engage a qualified damp-proofing specialist for remedial actions. Additionally, consulting a qualified plumber or drainage specialist

to assess and improve site drainage is advised to mitigate further risks. Monitoring the condition for 12 months is essential to evaluate its status and prevent potential recurrence or further damage.

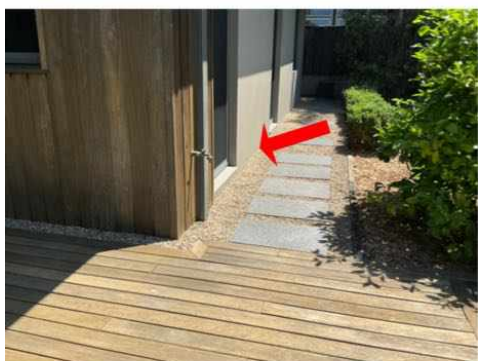
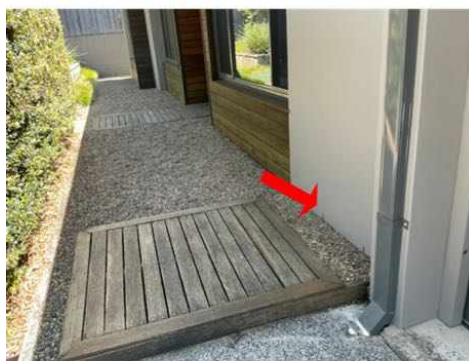
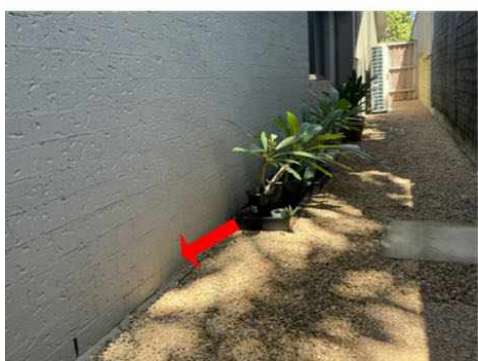
If the slab edge is not properly exposed there is a high risk of termite attack. Sometimes, in order to determine the type of slab, a suitably qualified person such as an architect or builder may be required to consult the construction plans.

Where the slab edge cannot be properly inspected, it is highly recommended that termite or timber pest inspections be carried out every 6-12 months to aid protection of the property against infestation.

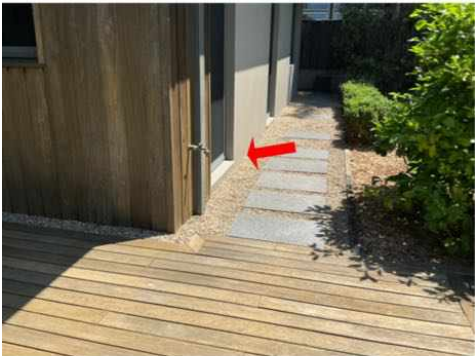
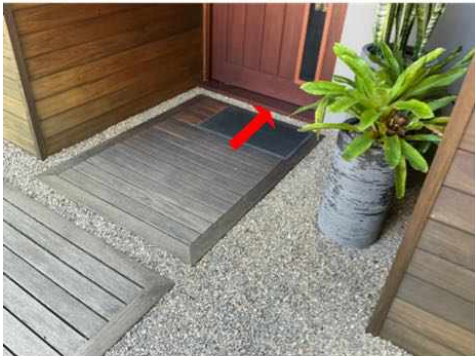
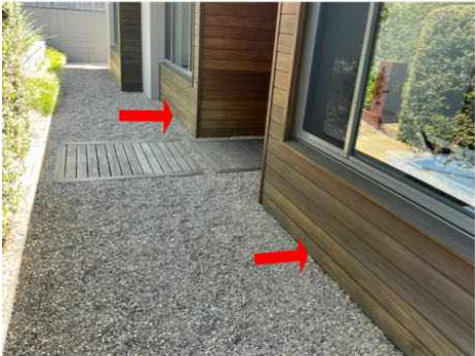
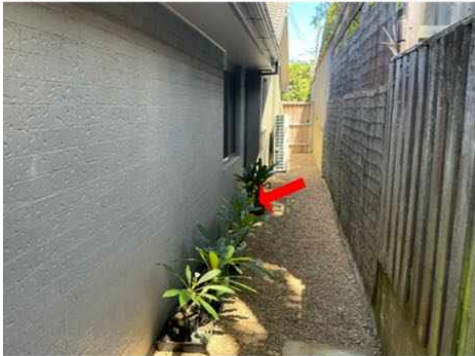
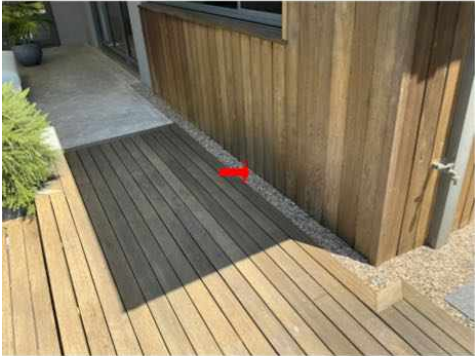
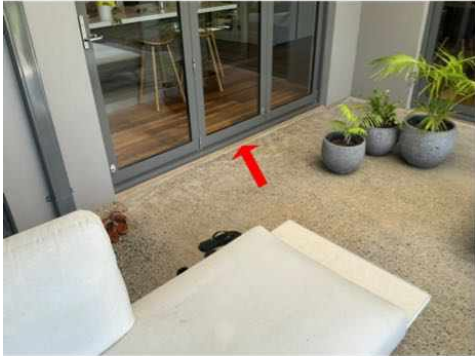
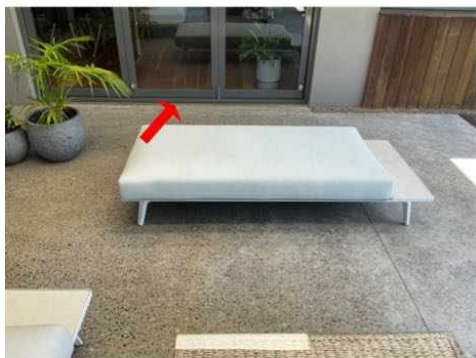
## Finding 6.02

Building:	Main Building
Location:	All Areas
Finding:	Bridging or Breaching of Termite Barriers - Adjacent Internal Flooring
Information:	Bridging is the spanning of a termite barrier or inspection zone so that subterranean termites are provided with passage over or around that barrier.

Where external ground levels are above or same level as internal flooring, water pooling and subsequent internal flooding is likely to occur which may attract termite activity to the internal area.

It is highly advised that a landscaper or relevant tradesperson be appointed to lower external grounds that are raised above or same as adjacent internal flooring. Alternatively if external grounds and internal flooring is level installation of a raised door sill may be appropriate in preventing any water pooling in the area. If the client wishes not to make any changes, then a qualified pest controller is recommended for termite treatment around the perimeter of the house and subfloor (if any) as soon as possible.

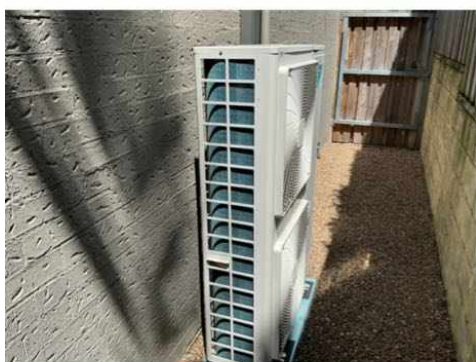
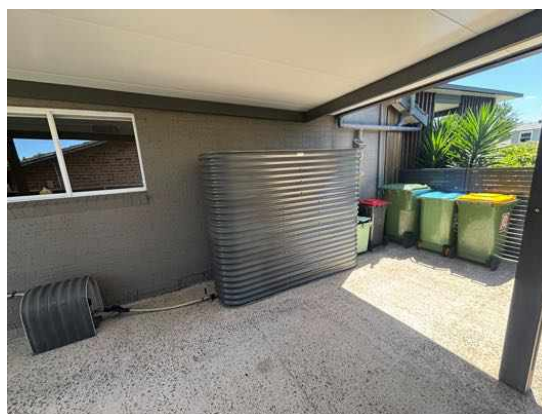
### Finding 6.03

Building:	Main Building
Location:	All Areas
Finding:	Bridging Appliances - Attachment to Buildings
Information:	Bridging occurs when items against a building provide a concealed entry point for termites into the building or by passing around a termite management system.

Where any part of an attachment to a building is not isolated and is not provided with a clear gap of not less than 25mm from the building, bridging occurs. Attachments to buildings such as hot water services, downpipes, verandahs, decks, steps, fences, service conduits and the like provide the opportunity for concealed entry.

Building attachments of this nature need to be frequently inspected for termite activity by a qualified inspector.

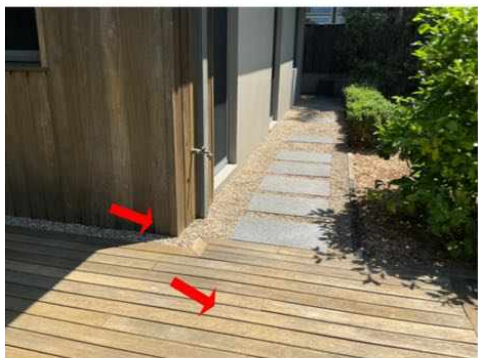
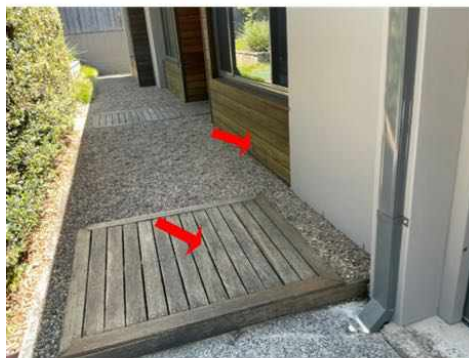
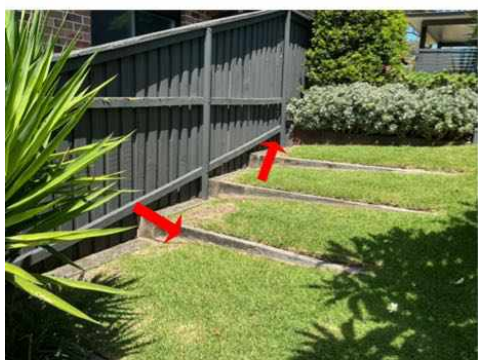
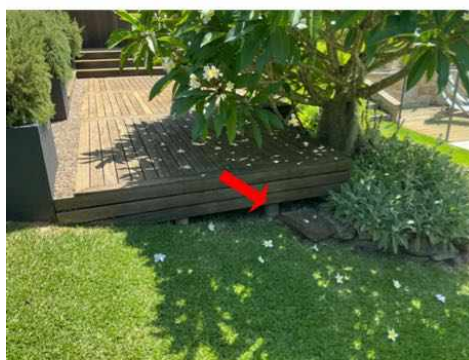
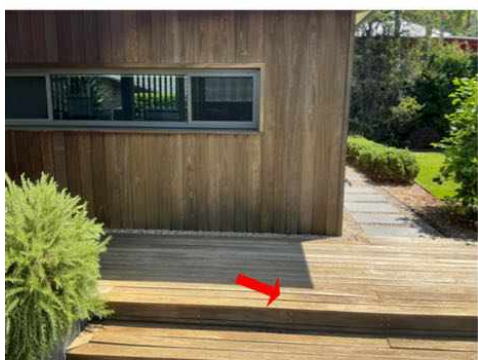
For any timber in direct contact with the external ground, special attention is required. The combination of moisture, untreated wood, and direct ground contact not only accelerates the decay process but also provides subterranean termites with a straightforward means of ingress into the structure. This entry can lead to termites moving undetected into other vulnerable areas, resulting in potentially significant structural issues and costly repairs.

To mitigate the risk of termite activity, it is imperative that any such materials or timber elements be appropriately treated or removed as soon as possible. Timbers that are necessary for use should be made durable through appropriate treatments and maintained to ensure they do not create conditions conducive to termites. Additionally, the client is advised to schedule regular termite treatments to maintain an effective barrier against infestations and ensure ongoing protection.

The client is strongly advised to assess the property for any timber elements that may be in direct contact with the ground and ensure prompt action is taken to remove or treat them effectively. Regular inspections, proactive maintenance, and consistent termite treatment are essential steps in minimising the risk of termite attack and protecting the structural integrity of the property. Taking these preventive measures is crucial for maintaining a termite-free environment and avoiding potentially costly damage and future repairs.

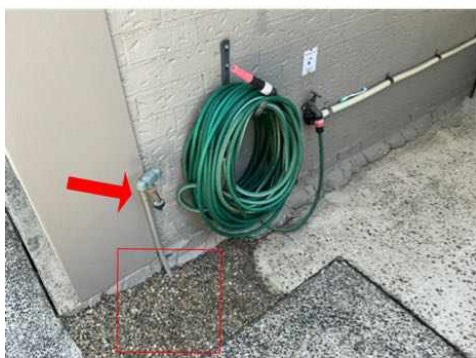
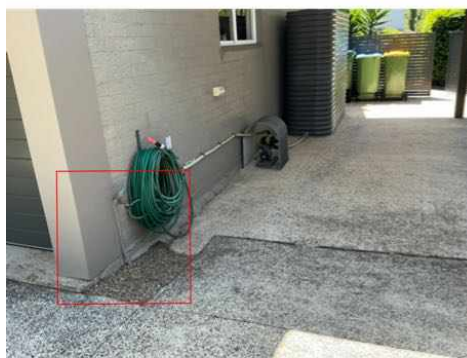
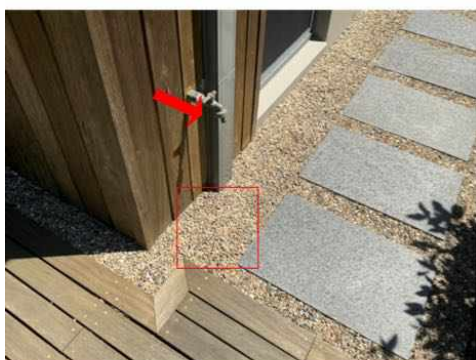
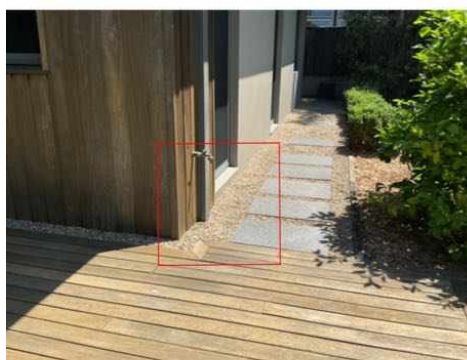
### Finding 6.05

Building:	Main Building
Location:	All Areas
Finding:	No Stormwater Drain - Under Exterior Tap
Information:	The inspection identified that the exterior tap is not connected to a stormwater drainage system, allowing water to pool around the base. This can lead to moisture-related issues such as deterioration of nearby building materials, mould growth, and increased risk of termite activity—each of which may compromise the property's structural integrity and create health or safety concerns.

To prevent these risks, it is strongly recommended that a licensed plumber be engaged to assess the area and install appropriate drainage, such as a stormwater

connection or splash block, to redirect water away from the property. Ongoing maintenance and monitoring of external water sources are also advised to ensure long-term protection.

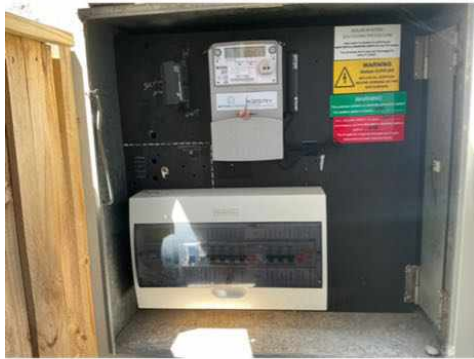
### Finding 6.06

Building:	Main Building
Location:	Meter Box
Finding:	Termite Management System - No Evidence of Installation
Information:	The application of a post-construction chemical termite barrier is strongly recommended for all properties, especially if there has been any history of live termite activity on-site. These barriers are highly effective in protecting timber building elements throughout the property by preventing termite attacks. It is also advisable to install a durable notice within the switchboard unit, indicating the presence of any termite barriers for future reference.

During the inspection, there was no indication that a termite management system had been installed, nor was there any evidence to suggest that preventative measures had previously been undertaken. The client is encouraged to seek further advice from a licensed pest controller regarding the costs and procedures involved in the application of a termite barrier. Prioritizing this step in the short term is strongly advised to ensure long-term protection.

Additionally, the client may want to consult with the vendor to determine whether regular Timber Pest inspections, as per AS4349.3 or AS 3660.2, have been conducted in the past. This will provide further insights into any past termite management practices and help inform the appropriate course of action.

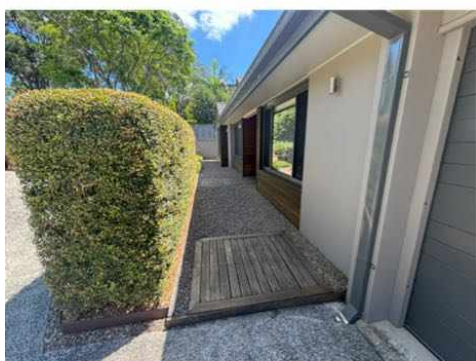
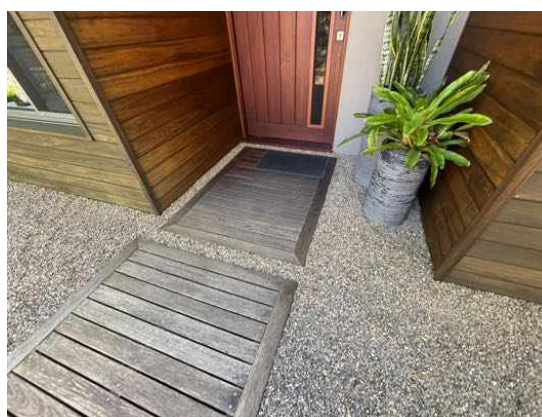
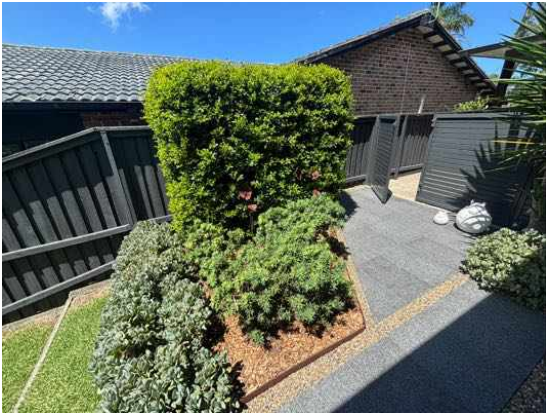
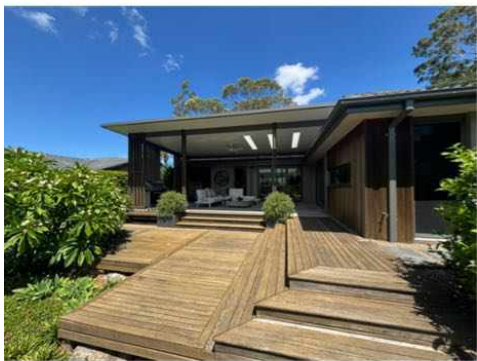
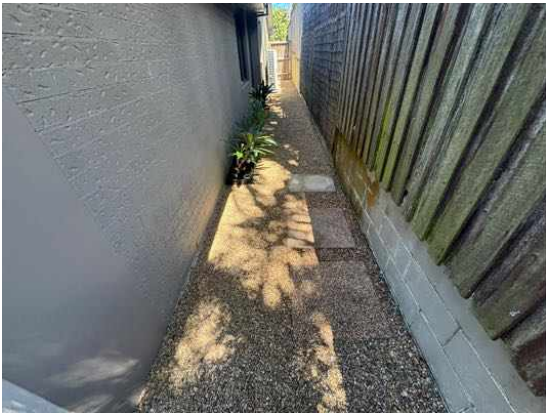
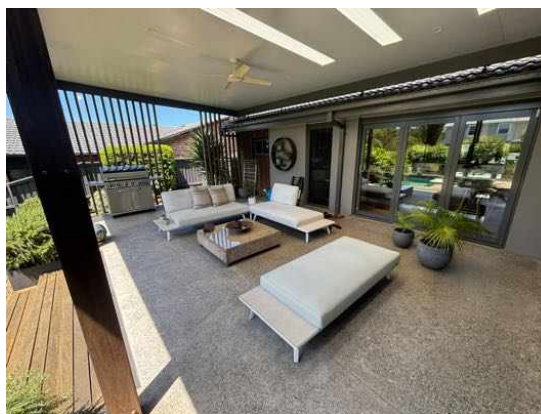
**Building:** Main Building  
**Location:** All External Areas  
**Finding:** Obstructions and Limitations - External Areas  
**Information:** The attached photographs provide a visual representation of the obstructions and limitations that impeded a full inspection of the external areas of the property at the time of assessment. These obstructions, which may include vegetation, stored items, debris, or other physical barriers, can obscure potential defects and prevent a thorough evaluation of the property's condition. Obstructions of this nature can conceal a wide range of issues, such as structural damage, water ingress, pest infestations, or deteriorating building materials, which may not be visible during the initial inspection.

It is essential that these obstructions be cleared to allow for a comprehensive inspection of the external areas. Removing these barriers will enable a more accurate assessment of the property's condition and allow any hidden defects to be identified and addressed promptly. Failure to do so could result in undetected issues worsening over time, potentially leading to more costly repairs in the future.

Therefore, it is strongly recommended that the obstructions be removed and a re-inspection be scheduled once the affected areas are made fully accessible. This will ensure a complete evaluation of the property's exterior and provide the client with a clear understanding of any potential issues that may have been concealed during the initial inspection.

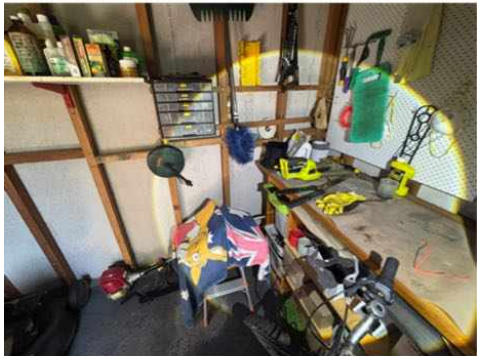
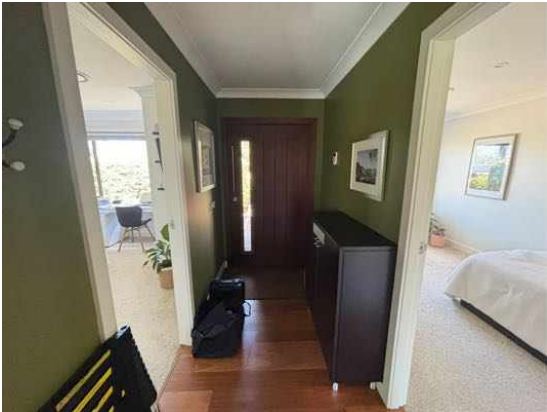
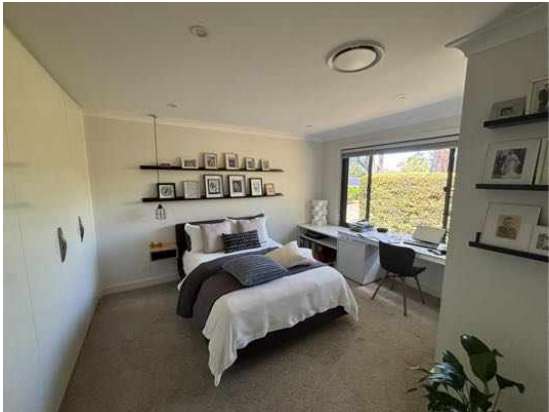
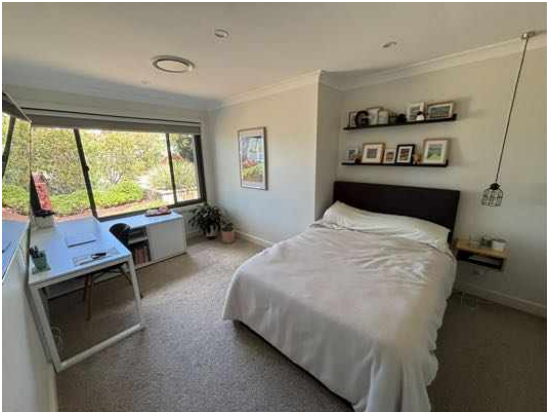
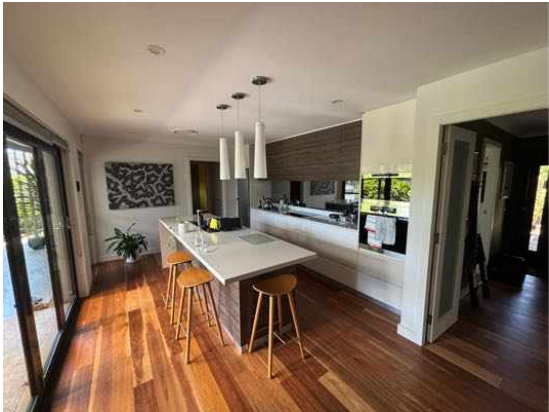
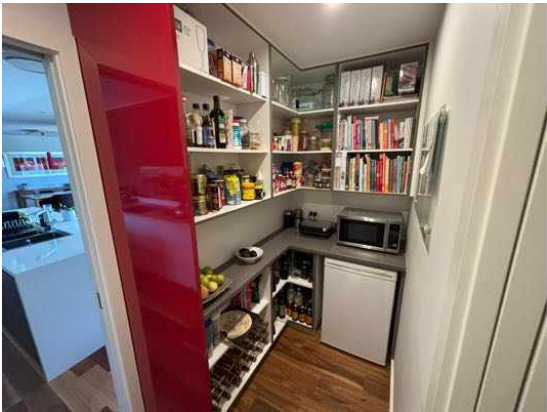
Information: The accompanying photographs provide clear evidence of the obstructions and limitations that restricted a comprehensive inspection of the internal areas of the property at the time of assessment. These obstructions, which may include furniture, personal belongings, stored items, or structural elements such as wall coverings and built-ins, significantly hindered the ability to thoroughly evaluate these areas. It is important to note that such obstructions can potentially conceal a wide array of defects, ranging from hidden structural damage, water leaks, pest infestations, or electrical issues, to deteriorating materials that may not be visible during the initial inspection.

The presence of these impediments means that critical areas of the property were not accessible, and therefore, any underlying defects that may affect the integrity and safety of the property could remain undetected. These hidden defects, if left unaddressed, could worsen over time and may result in costly repairs or pose potential safety hazards to the occupants.

It is highly recommended that all obstructions be cleared to facilitate a complete and thorough inspection of the internal areas. Once the obstructions have been removed and full access is available, a re-inspection should be carried out to ensure that any previously concealed issues can be properly identified and rectified. This follow-up inspection will provide a more accurate assessment of the property's internal condition and help the client make informed decisions about any necessary repairs or maintenance.

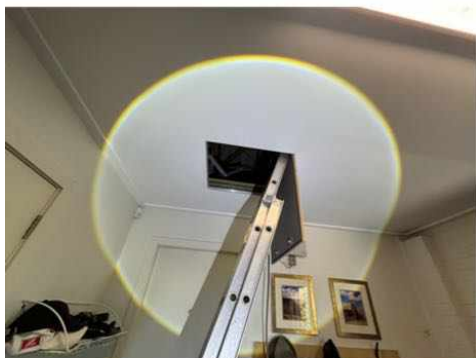
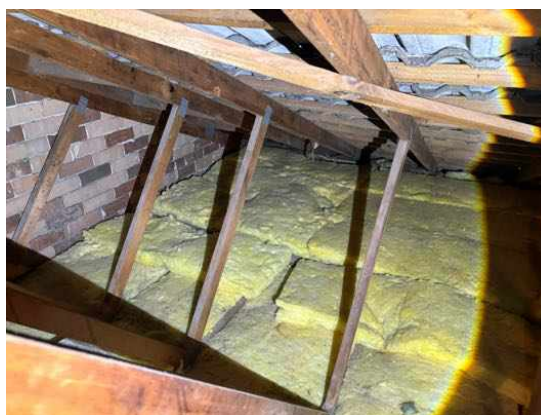
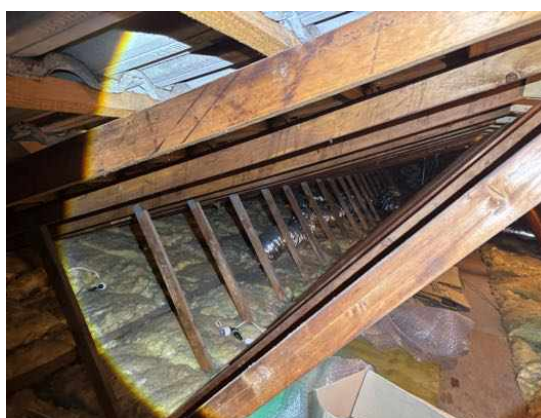
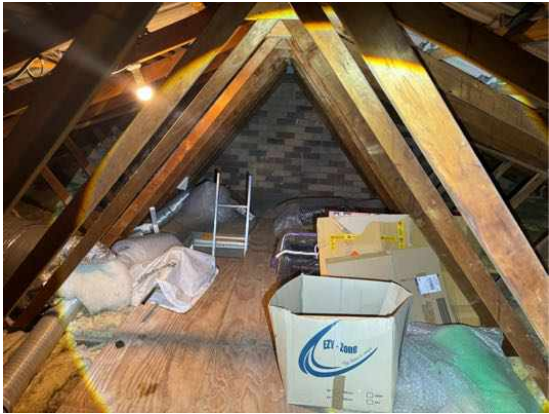
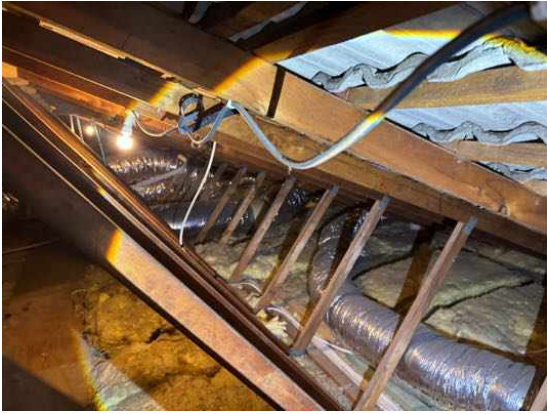
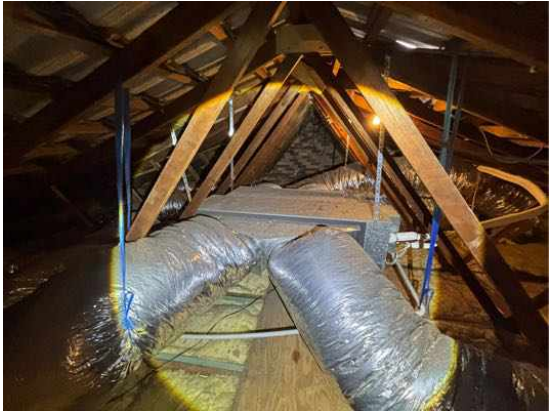
Building: Main Building  
Location: Roof Void  
Finding: Obstructions, Limitations, and General Roof Space Condition  
Information: The photographs provided document both the general condition and the obstructions and limitations that were present in the roof cavity of the main building at the time of inspection. These obstructions—such as insulation materials, stored items, structural elements, or electrical wiring—restricted safe and adequate access to key areas within the roof space. As a result, a comprehensive inspection of all components could not be completed.

Obstructions of this nature may conceal a variety of potential defects, including damaged framing, compromised insulation, evidence of moisture ingress, pest activity, or electrical hazards. While no major issues were observed in the visible areas, the presence of these limitations means that some defects may remain undetected.

It is recommended that these barriers be removed or repositioned to facilitate full and safe access to the roof space. Once clear, a follow-up inspection should be conducted to allow for a thorough assessment of all concealed areas. This will help ensure that the condition of the roof cavity is accurately evaluated and any hidden issues are appropriately identified and addressed.

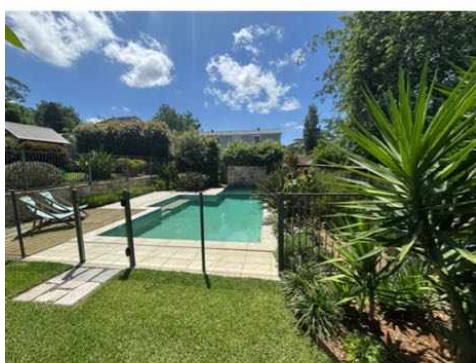
**Building:** Main Building  
**Location:** Pool Area  
**Finding:** FYI - Pool Area  
**Information:** This inspection explicitly excludes any assessment of the pool, spa, associated pool equipment, and the surrounding areas. As a standard building inspection does not encompass these elements, it is crucial for the client to understand that no evaluation has been conducted regarding the condition, functionality, or safety compliance of the pool or its associated systems. This includes, but is not limited to, pumps, filters, heating equipment, and structural integrity of the pool or spa surrounds.

To gain a comprehensive understanding of the condition and compliance of these components, it is highly recommended that the client engages a specialist pool inspector. A pool inspection will evaluate the structural condition of the pool, ensure the functionality of all associated equipment, and assess whether the pool and its surroundings meet current safety regulations. In particular, pool safety requirements, including fencing and access controls, are subject to stringent regulatory standards, which must be verified separately by a qualified pool inspector.

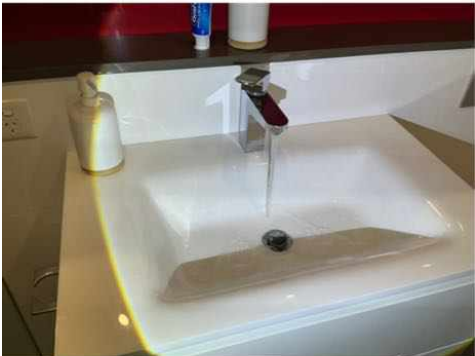
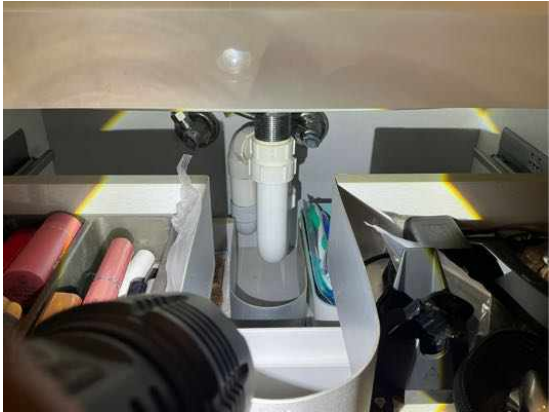
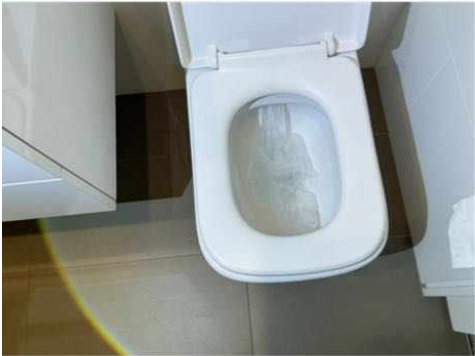
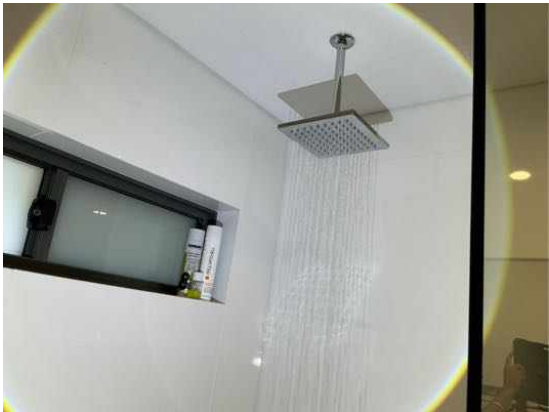
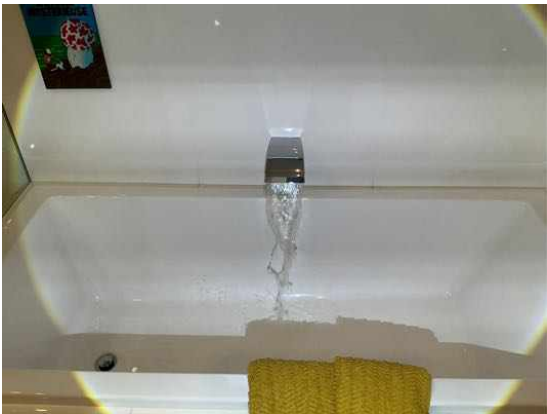
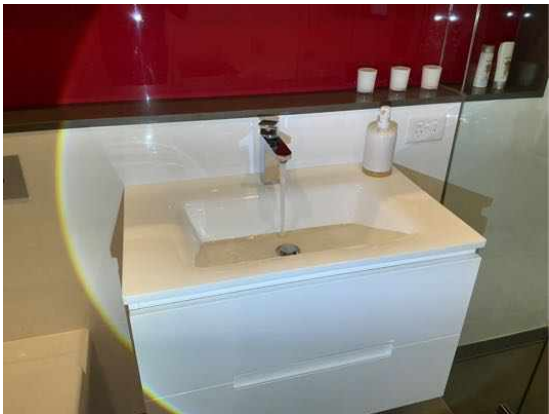
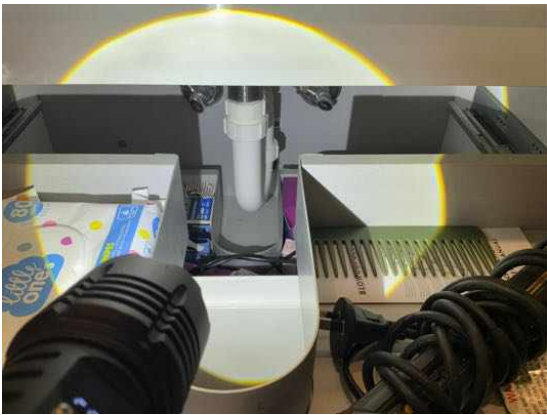
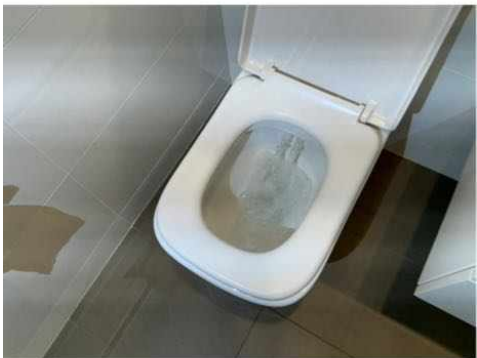
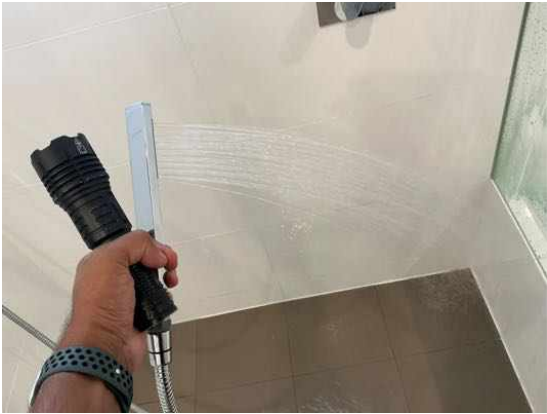
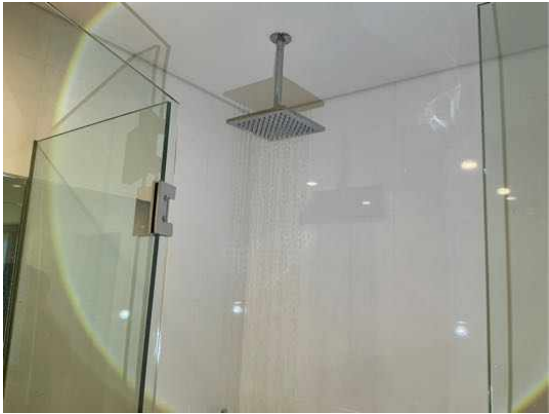
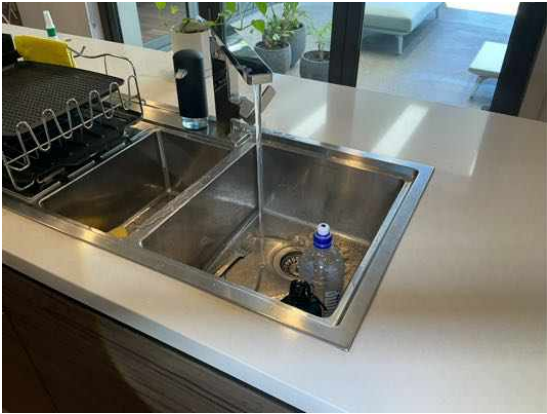
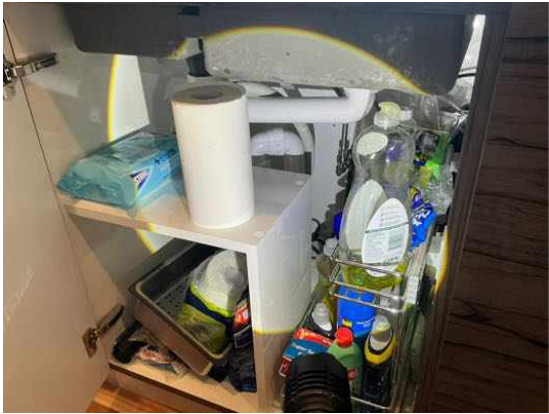
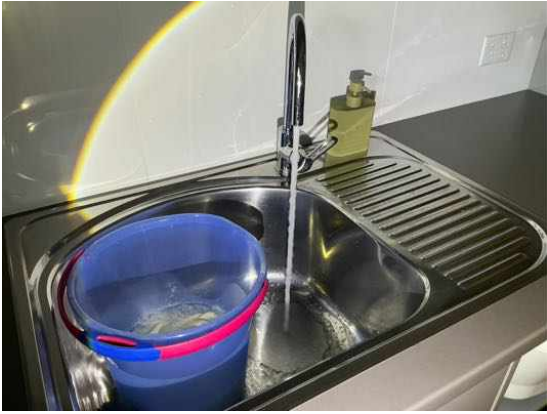
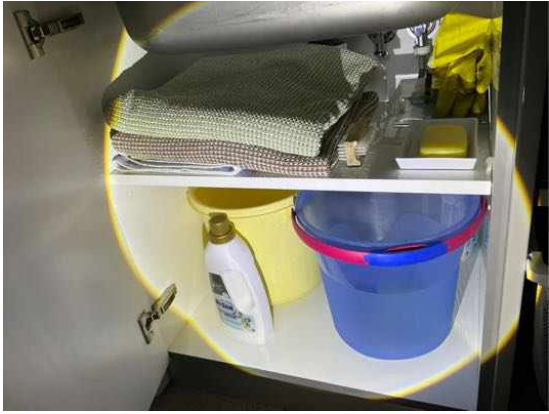
Building:	Main Building
Location:	All Areas
Finding:	FYI - Taps, Drainage & Toilets Tested and Cabinetry Obstructions
Information:	During the inspection, all accessible taps, drainage systems, and toilets were tested for water flow and drainage efficiency, and checked for any visible signs of leakage. At the time of the inspection, no issues were noted in these areas. Unless highlighted in a separate defect statement, no immediate remedial work appears necessary. Supporting images may be found in the additional photos section for reference.

It is important to note that while a visual inspection of cupboards and cabinetry beneath sinks and vanities was undertaken, stored personal items and fixtures presented obstructions that limited full visibility of the internal areas. As per standard inspection practices, inspectors are not permitted to move or disturb personal belongings during the inspection process. Therefore, only visible and accessible sections were inspected, and concealed water damage or plumbing defects may not have been detected.

Given this, a re-inspection is recommended after all obstructions have been cleared to allow for a comprehensive assessment of these areas. Regular maintenance and monitoring of plumbing and drainage systems is also advised to ensure ongoing functionality and early detection of potential issues.
