# Building and Timber Pest Inspection Report

Inspection Date: Tue, 24 Feb 2026

Property Address: 56 Dalton Rd, St Ives Chase NSW 2075, Australia

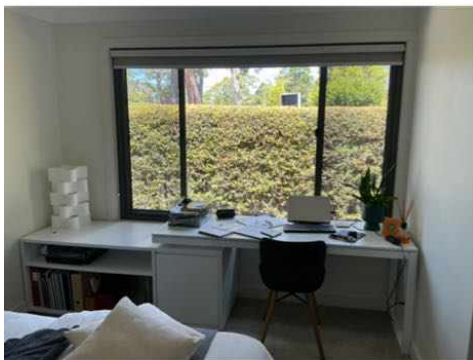
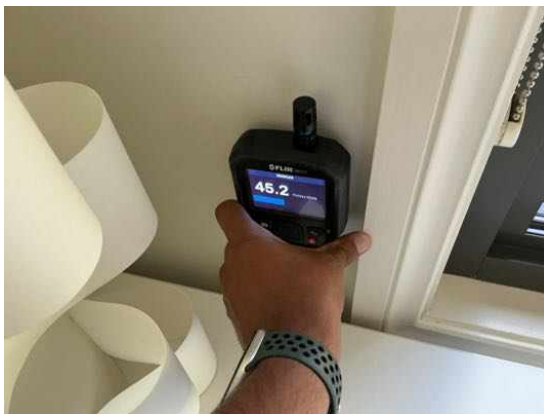
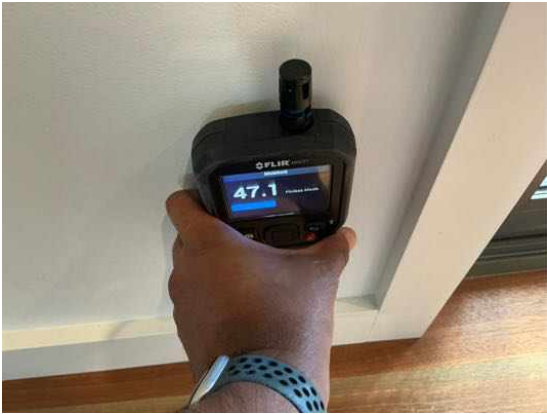
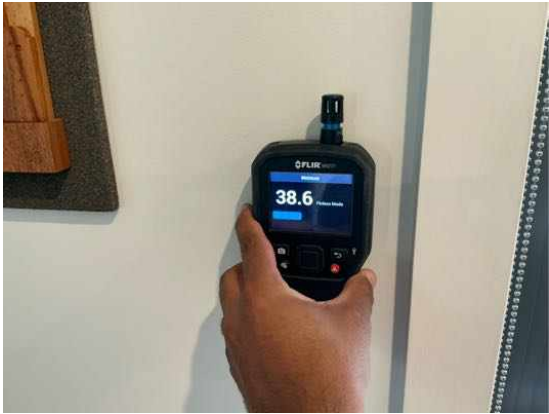
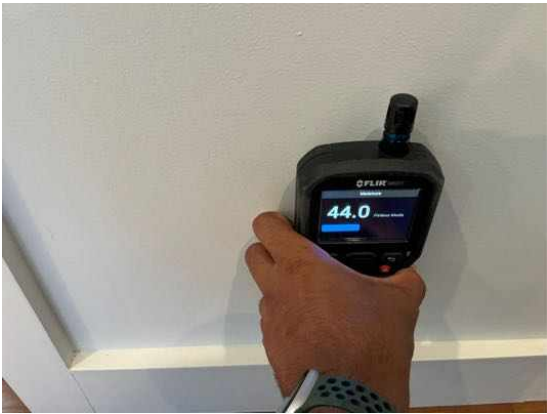
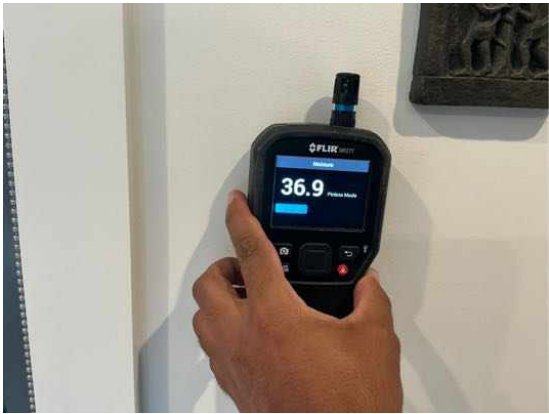
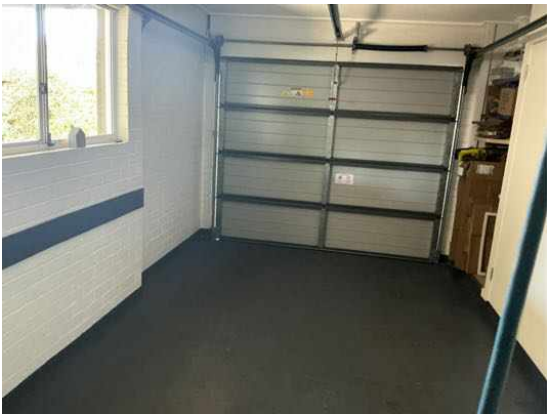
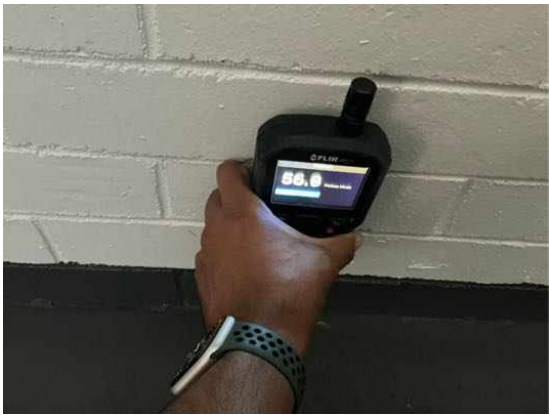
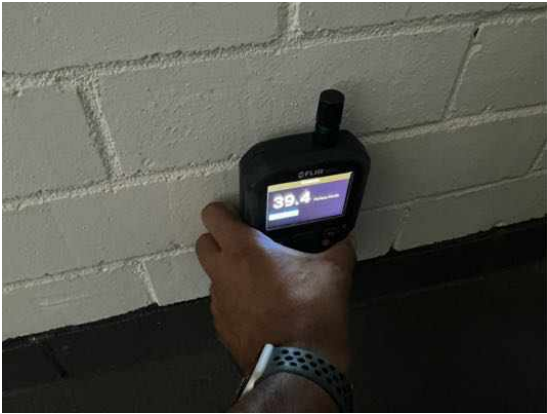
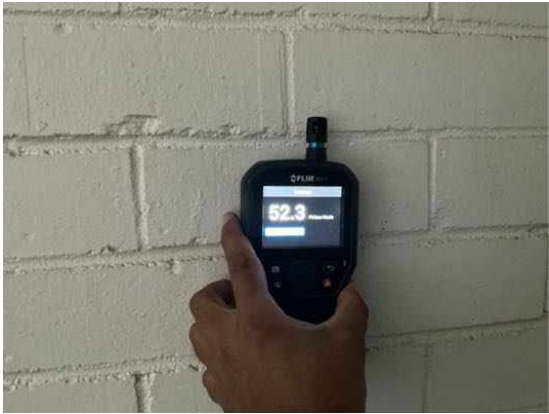
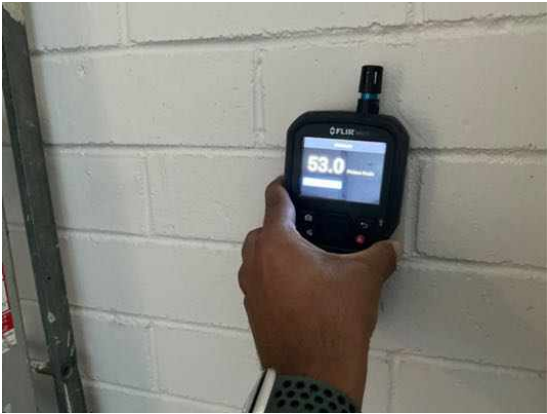
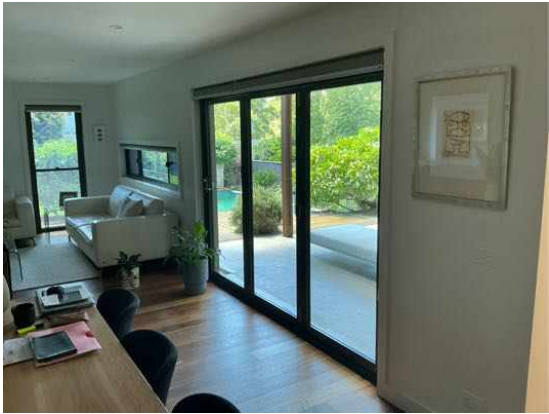
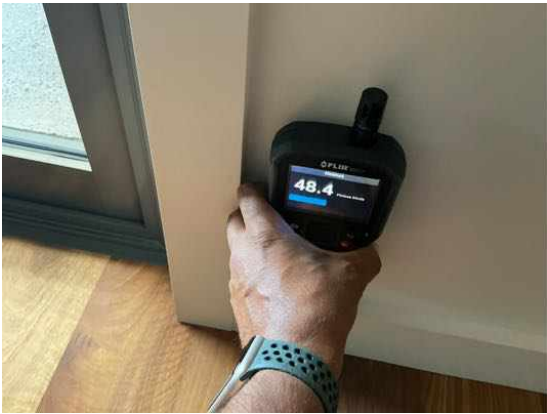
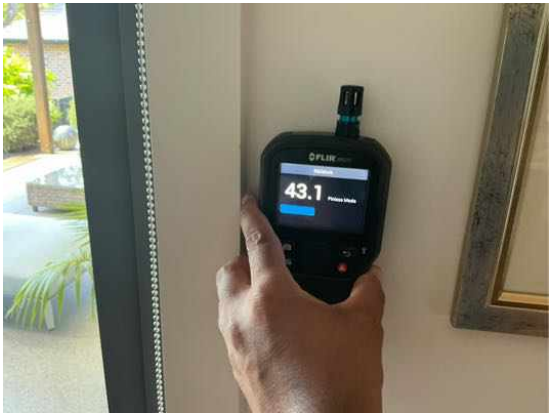
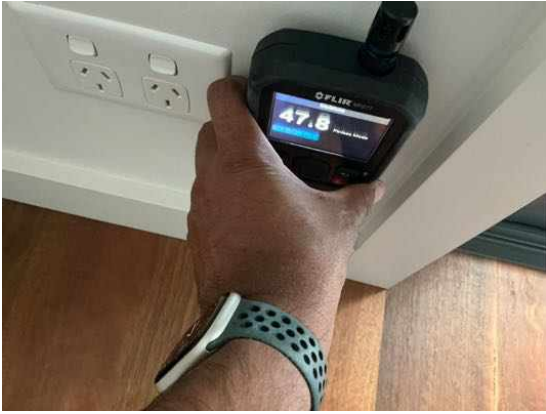
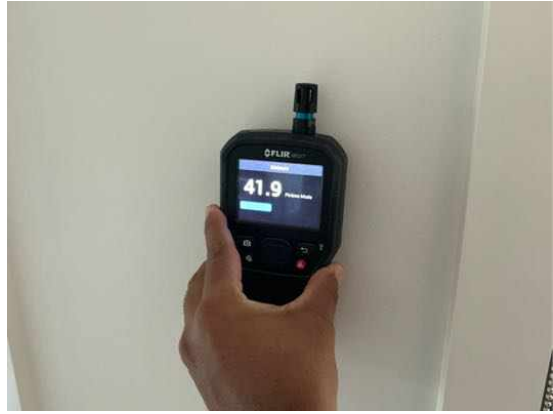
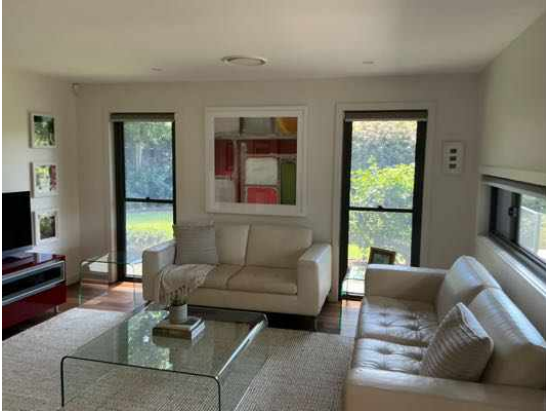
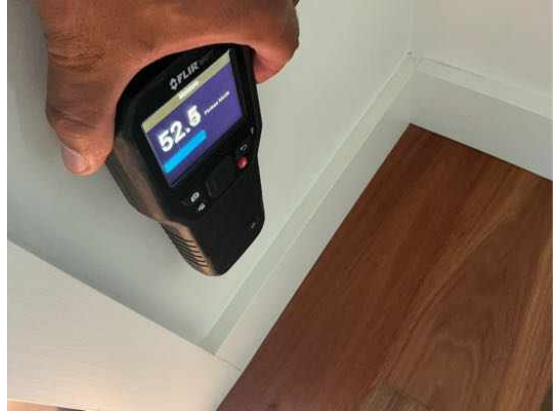
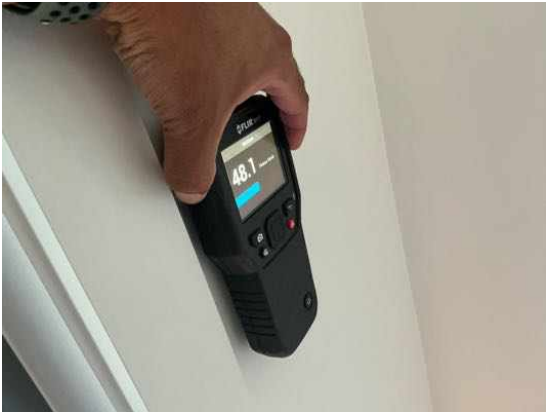
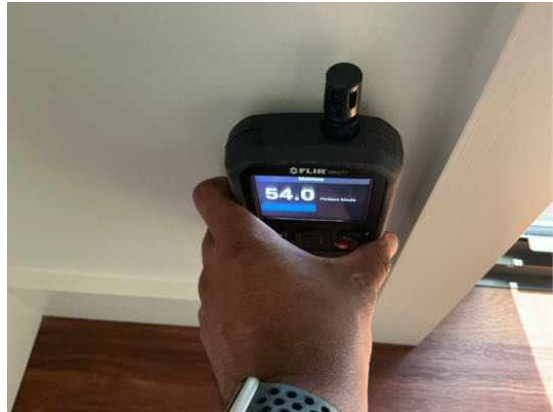
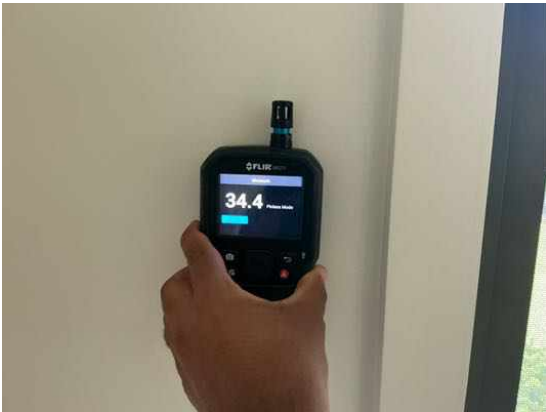
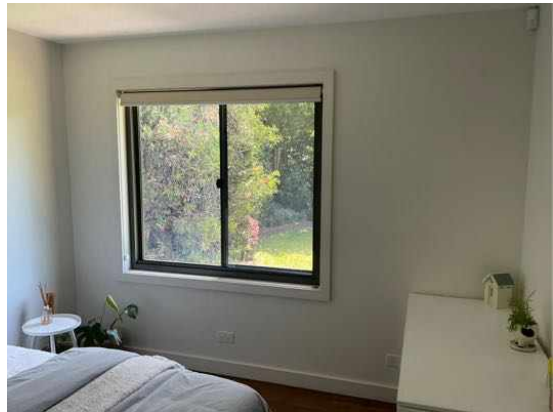
Building: Main Building  
Location: All Areas  
Finding: Additional Photos - Moisture Meter Readings  
Information: Additional moisture meter reading photos have been provided for the property to offer further clarity on areas tested during the inspection. These photos are intended to give a visual reference for the specific locations where moisture levels were measured. These readings were taken at the time of the inspection to assess any potential moisture-related issues within the property. Any defects related to moisture that were identified during the inspection have been separately mentioned in the defect statements within the report.

For further clarification or additional information regarding the moisture readings, the client is encouraged to contact the building inspector directly. Regular monitoring of moisture-prone areas is recommended to ensure any emerging concerns are addressed promptly, particularly during wetter seasons or in high-humidity conditions.

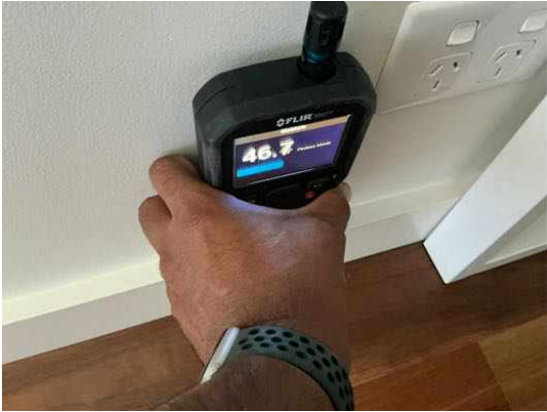
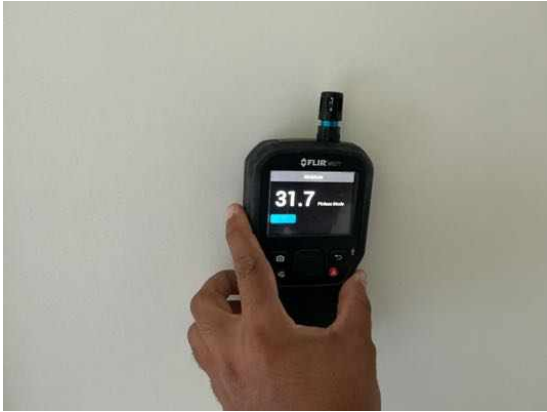
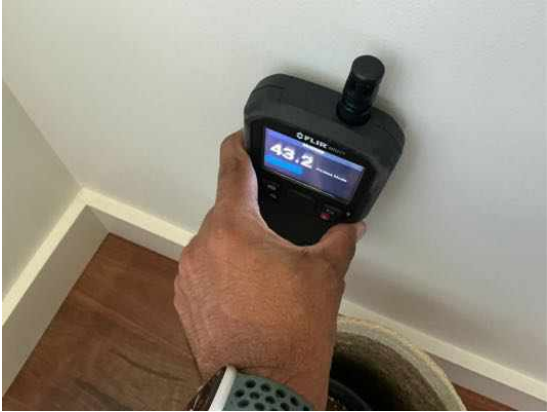
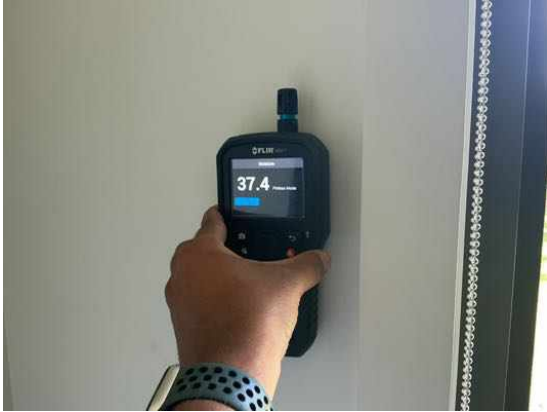
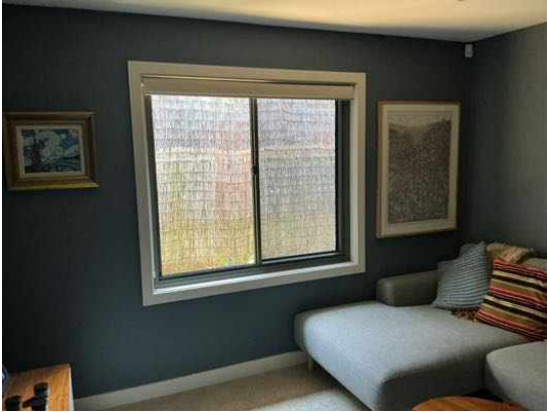
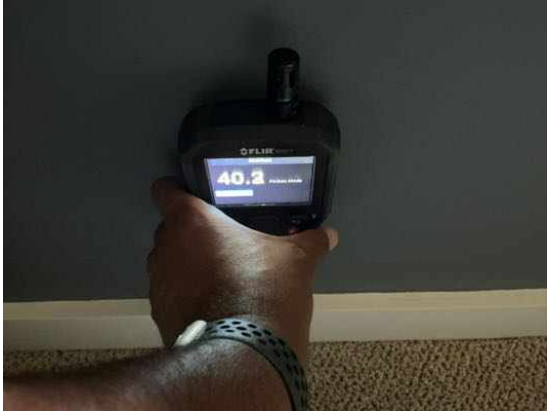
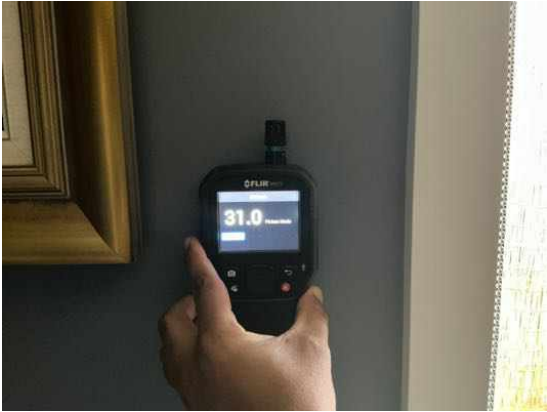
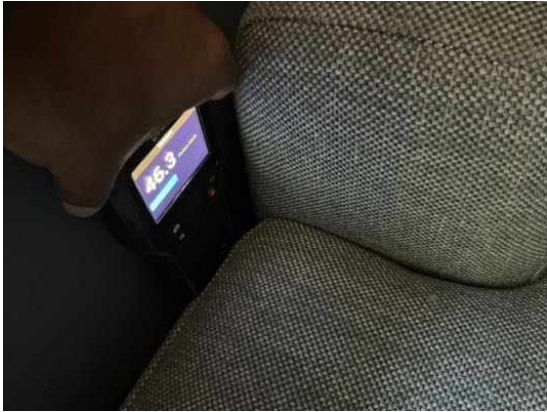
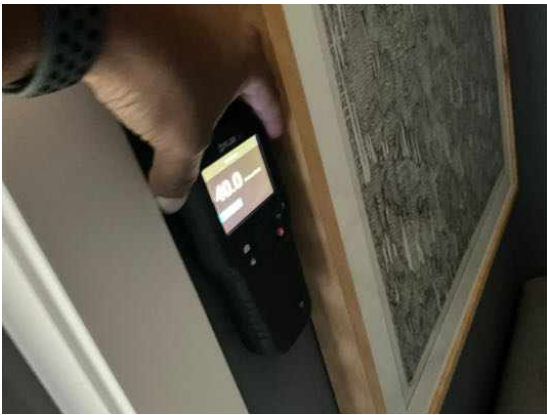
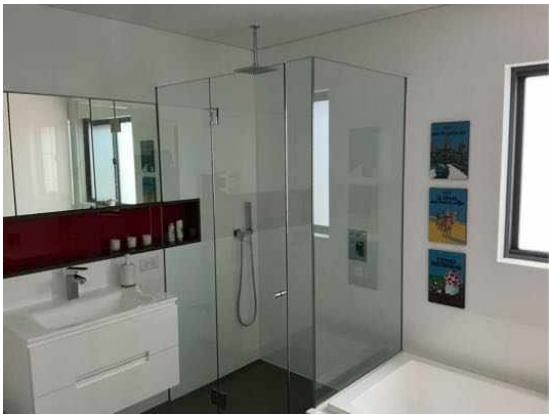
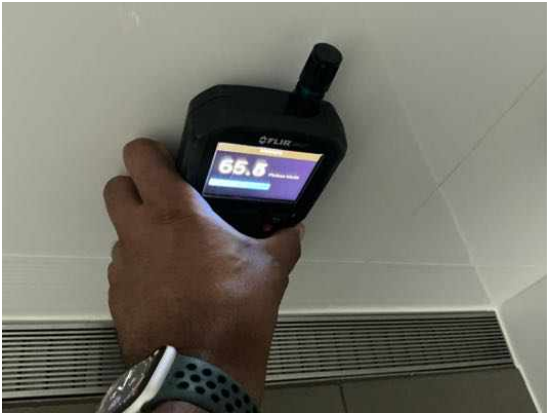
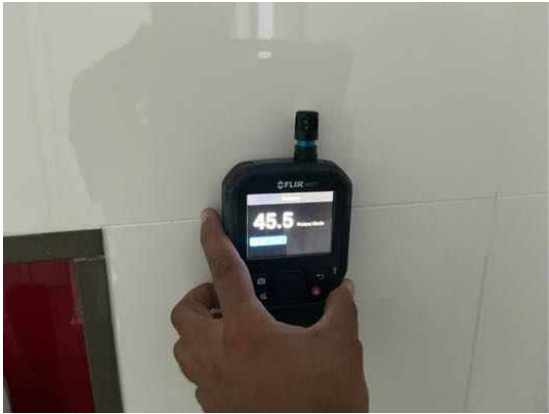
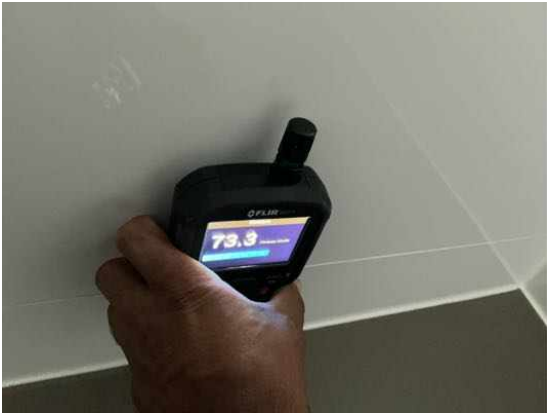
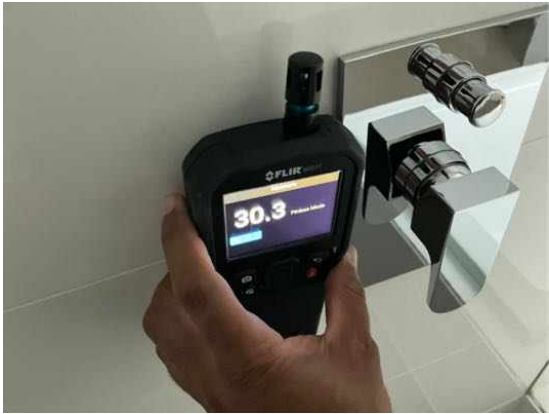
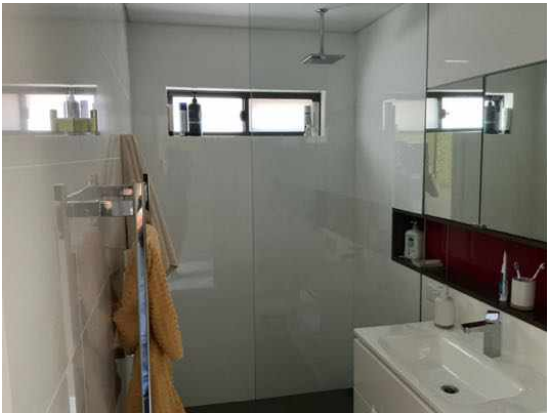
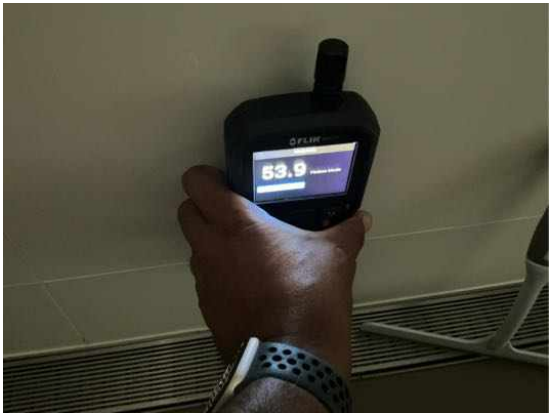
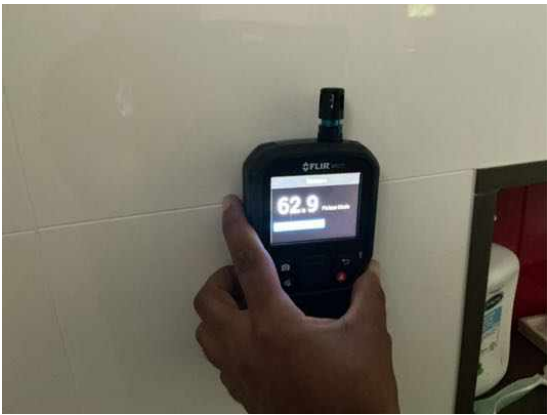
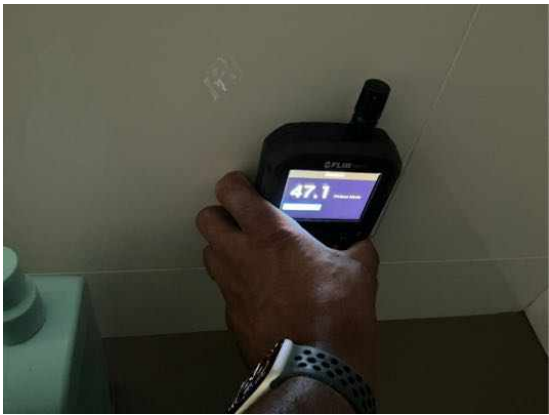
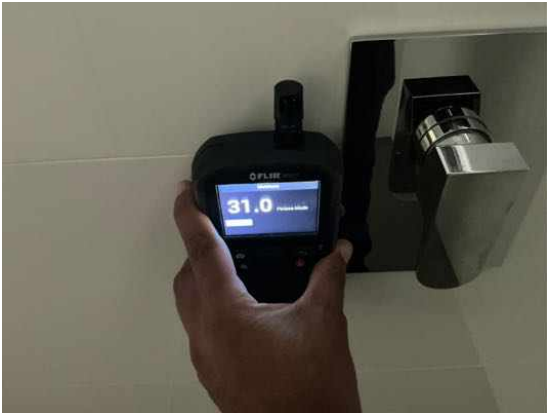
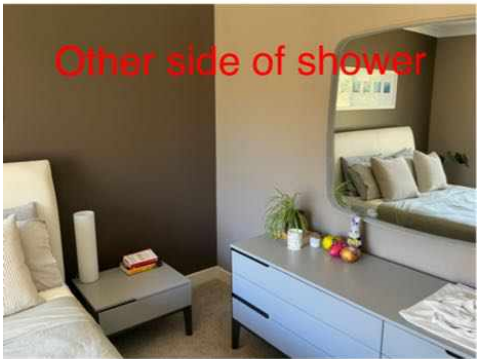
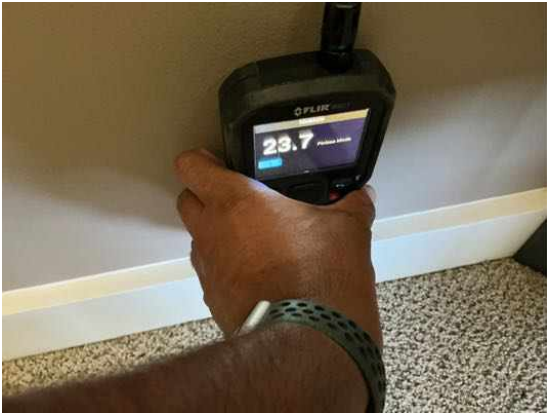
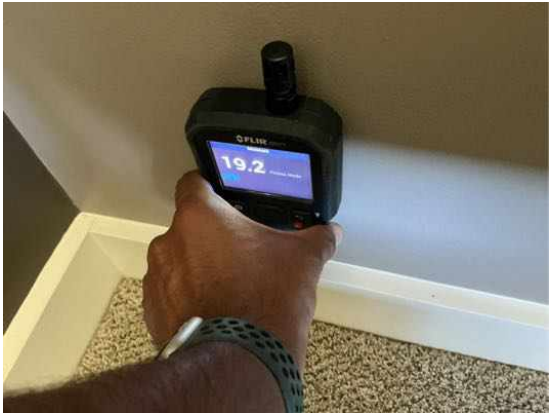
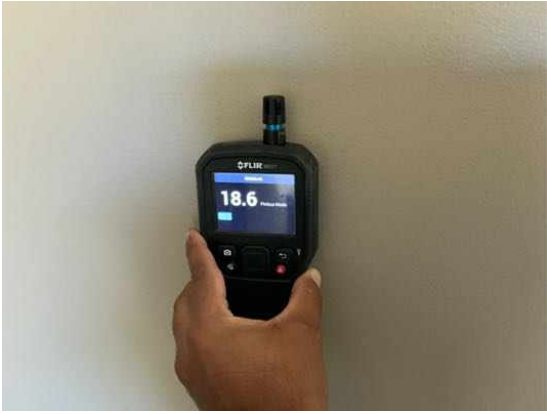
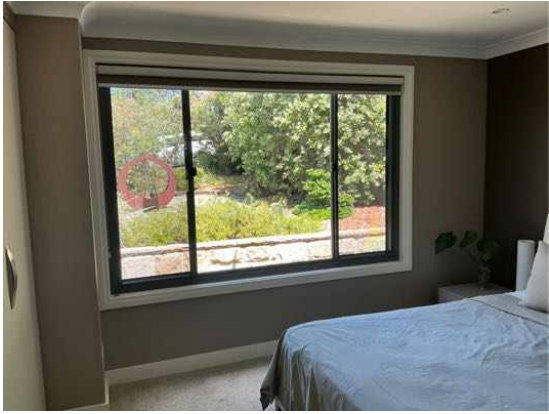
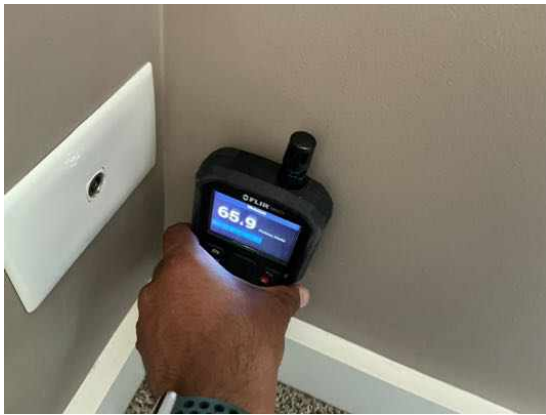
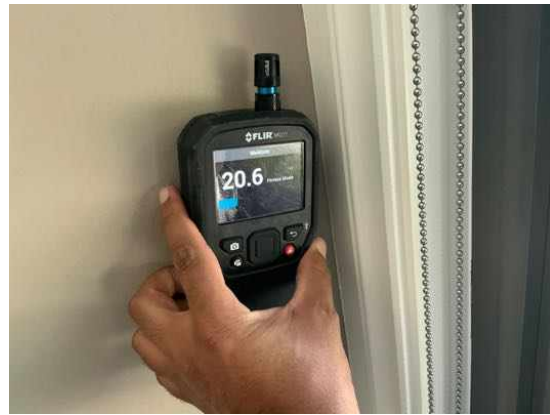
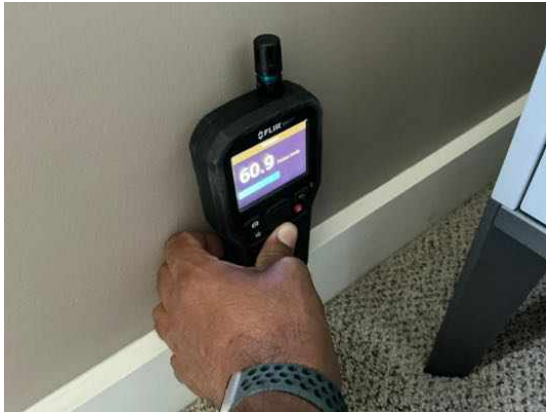
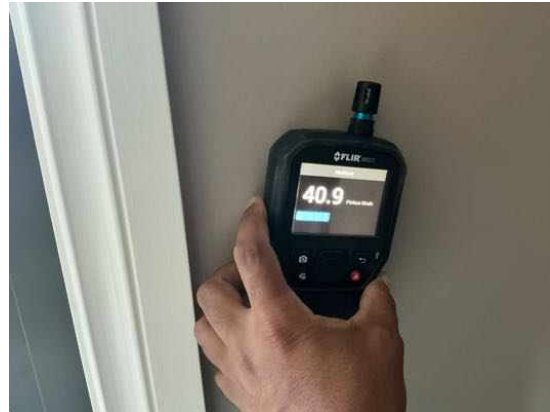
It is important for the client to understand that moisture levels can fluctuate over time due to various factors, including changes in weather, humidity, and environmental conditions. While the readings reflect the property's moisture levels during the inspection, they may not represent future conditions, and increased moisture could lead to issues such as dampness, mould growth, or deterioration of building materials if left unmonitored.

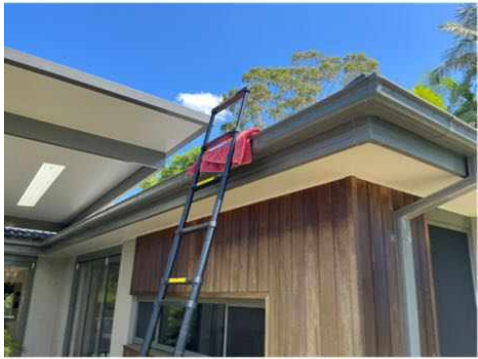
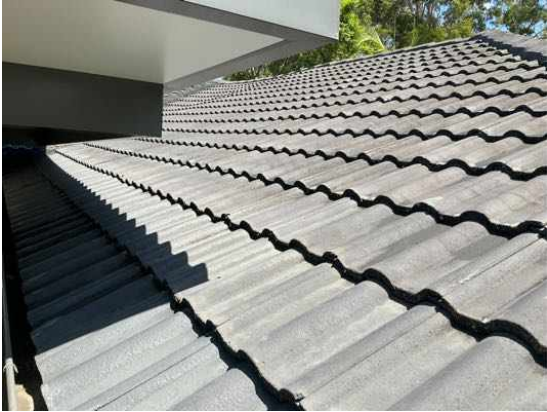
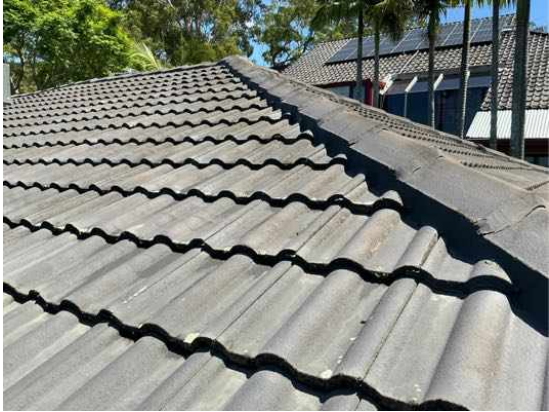
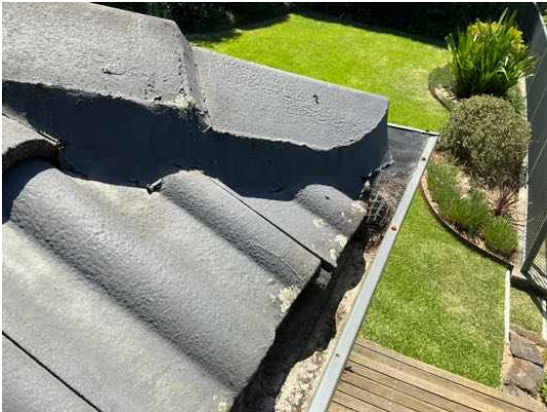
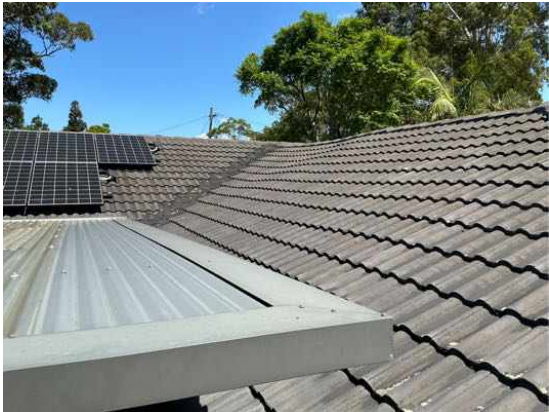
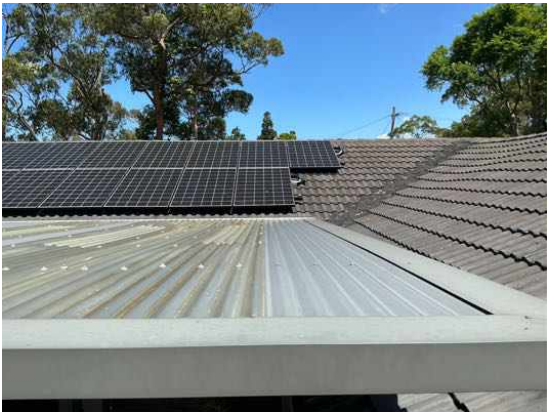
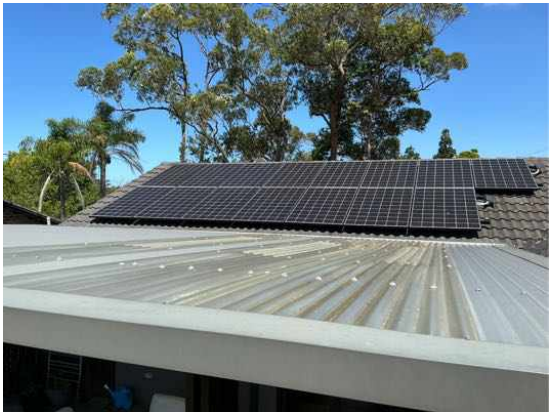
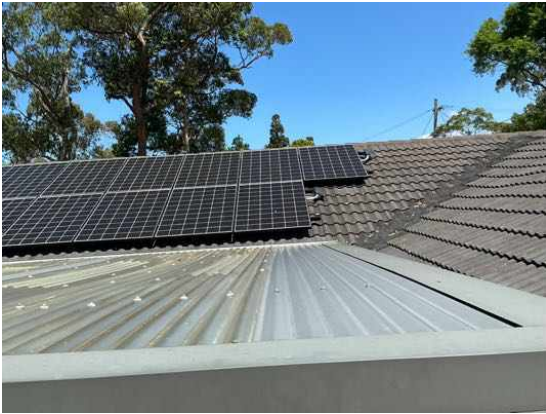
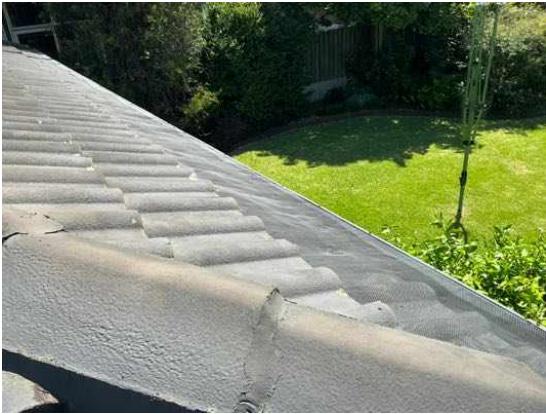
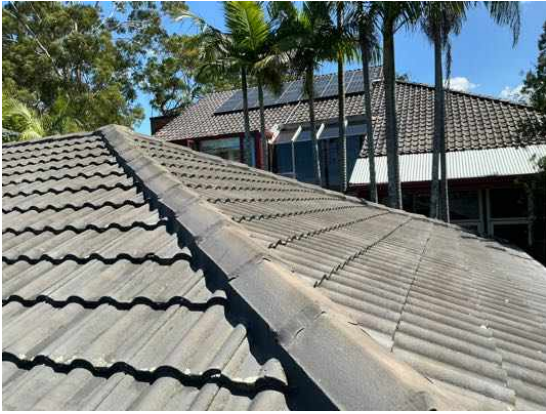
Information: As part of the information provided, please note that the attached roof photos represent the condition of the roof at the time of inspection. These photos are for visual reference only and do not constitute a detailed roofing assessment. Any defects or issues identified with the roof are mentioned separately in the defect statements. It is strongly recommended that the client engage a qualified roofer to conduct a thorough inspection of the roof, ensuring that any potential issues, such as leaks, structural integrity, or wear and tear, are properly identified and addressed.

Additionally, the condition of the roof may change over time due to weather, natural wear, or other unforeseen factors. Regular maintenance and inspections by a licensed professional are advised to ensure the roof remains in good condition and to avoid costly repairs in the future. The information provided in these photos should be considered a snapshot of the roof's condition during the time of inspection and not a guarantee of its future performance.

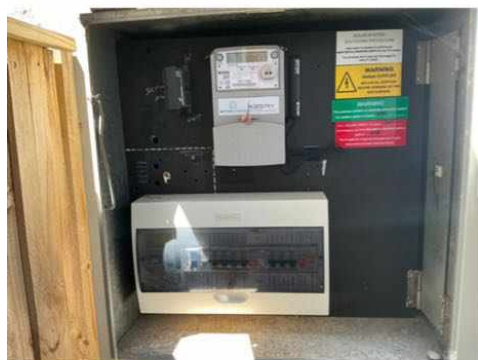
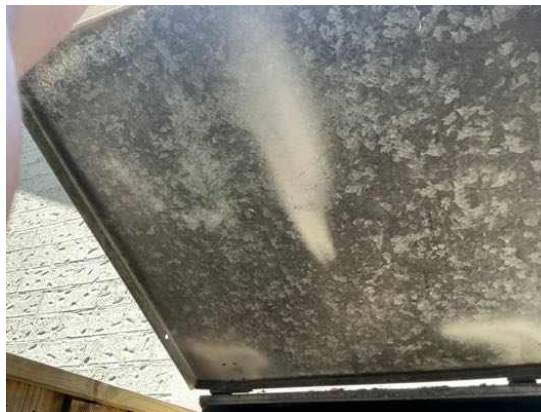
Building: Main Building  
 Location: Meter Box  
 Finding: Termite Management Recommendation – No Evidence of Chemical Installation  
 Information: At the time of inspection, there was no visible evidence of a chemical termite management system installed around the property. Chemical barriers are a key component of termite protection and are particularly important in preventing concealed termite entry into timber elements of the structure.

In accordance with standard requirements, a durable notice should be located within the electrical switchboard to detail any termite protection systems applied, including chemical treatments. No such notice was observed during the inspection.

It is recommended that the client engage a licensed pest controller to assess the suitability of installing a chemical barrier, and to provide advice on associated costs and procedures. This should be considered a short-term priority, particularly if the property has any history of termite activity or is located in a high-risk area.
