Building and Timber Pest Inspection Report

Inspection Date: Fri, 27 Feb 2026

Property Address: 703/8 Ebsworth St, Zetland NSW 2017,
Australia

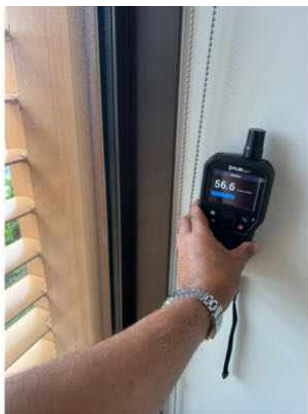
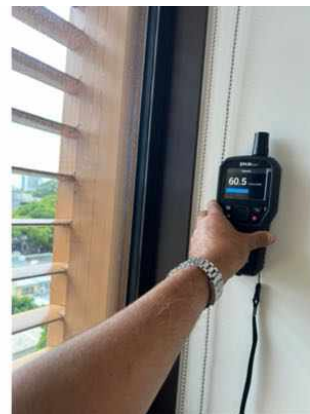
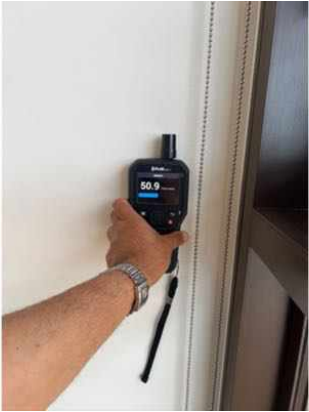
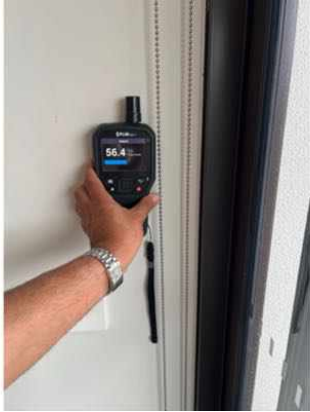
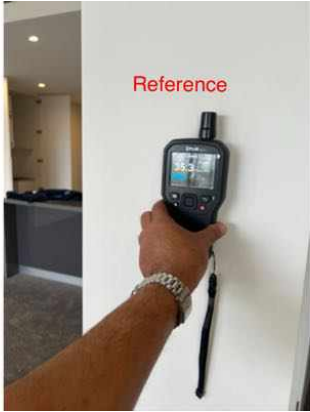
Finding 3.01

Building:	Main Building
Location:	All Internal Areas - Near skirting door and windows (Bedroom , lounge)
Finding:	Elevated Moisture Skirting and bedroom/lounge window wall
Information:	Elevated moisture readings were recorded to wall and skirting areas adjacent to sliding doors and window openings. The distribution of readings suggests possible moisture ingress associated with external door and window assemblies or balcony threshold detailing. No visible deterioration was noted at the time of inspection. Due to the non-invasive nature of the inspection, the precise source could not be determined at the time, however, further investigation by a suitably qualified contractor is recommended to assess external sealing, flashing and waterproofing integrity.

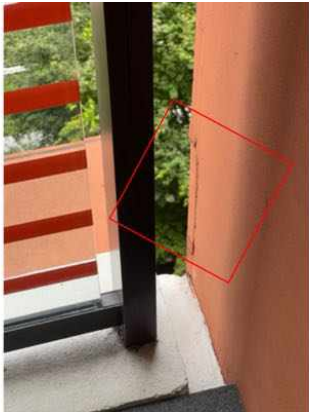
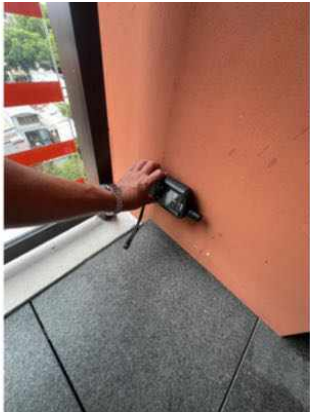
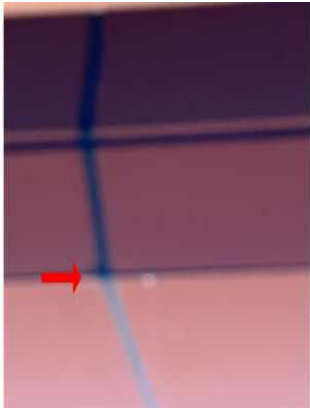
Finding 3.02

Building: Main Building
Location: Balcony
Finding: Elevated Moisture and minor deterioration - Strata
Information: Slightly elevated moisture levels were detected on balcony exterior cladding wall. There was visible signs of paint bubbling and minor deterioration along with water droplets in the bulk head. Further invasive investigation by a licensed plumber or waterproofing specialist is recommended to confirm the source and extent of water ingress. As this relates to a multi-residential building, the source of water ingress may involve common property, a suitably qualified waterproofing contractor is recommended to determine cause, responsibility, and scope if required.

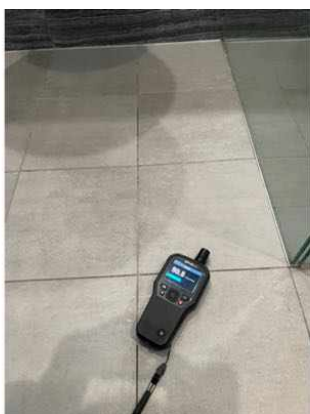
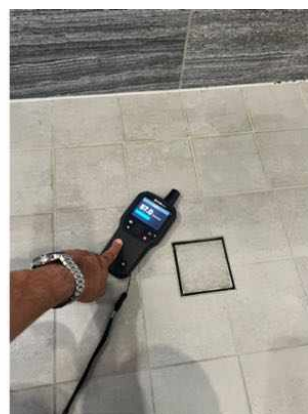
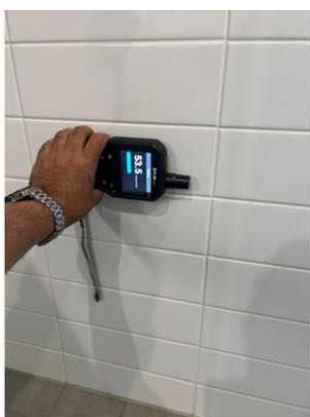
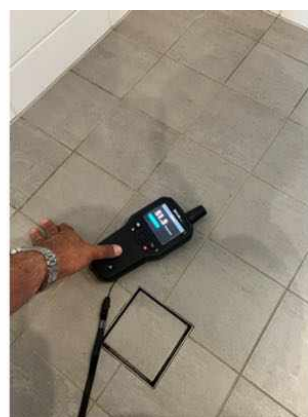
Finding 3.03

Building: Main Building
 Location: Bathroom, Ensuite
 Finding: Slightly Elevated Moisture Bathroom (No visible deterioration noted)
 Information: Slightly Elevated moisture levels were detected to tiled surfaces in bathroom/shower areas. Persistent moisture ingress can lead to concealed damage, including timber rot and mould growth.

Elevated moisture readings in tiled wet areas can occur from normal shower use, age/deterioration of waterproofing membranes, plumbing leaks or moisture absorption through grout lines. While no damage was visible, elevated readings may indicate moisture retention behind tiles, which can be a conducive condition for future deterioration if not monitored.

Monitor the area over time for signs of drumming, efflorescence, tile movement, or grout deterioration. If concerns arise, a licensed waterproofing specialist can perform further investigation (e.g., pressure testing, membrane assessment).

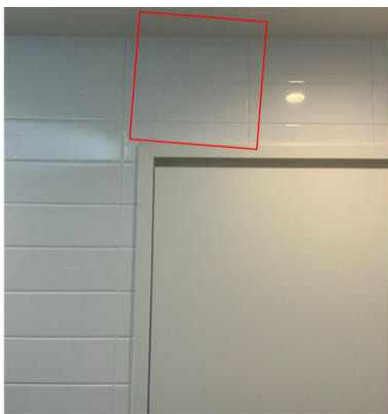
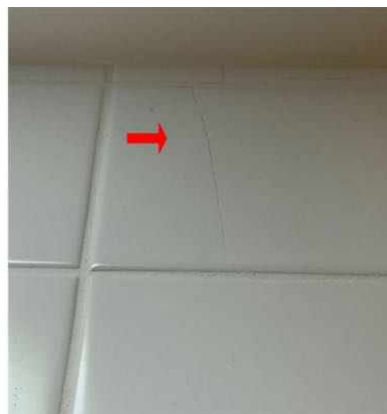
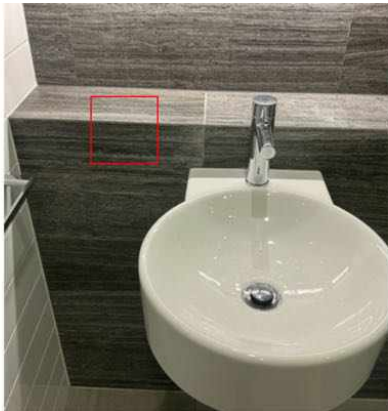
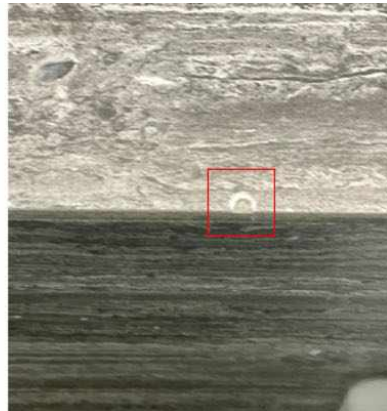
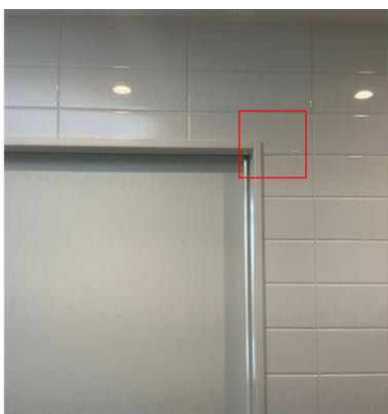
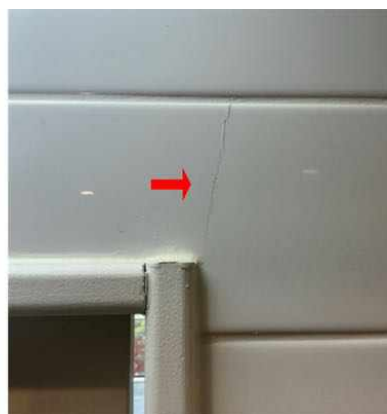
Finding 3.04

Building: Main Building
 Location: Bathroom, ensuite
 Finding: Tiles - Cracked or damaged
 Information: Cracking was evident to the tiling in this area at the time of inspection. While the

cracking appears to be minor, this area is frequently exposed to water, allowing potential for water penetration into adjoining sections of walls or flooring.

If left unmanaged, water penetration to these areas may lead to subsequent water damage, which is likely necessitate repair work to affected building elements.

A tiling contractor should be appointed to ensure that no further water damage occurs. The re-application of silicone and grouting throughout remaining tile work is also advised, to further protect the area against water penetration.

Where water penetration has led to water damage, appointment of a relevant tradesperson may be required to repair damaged building elements.

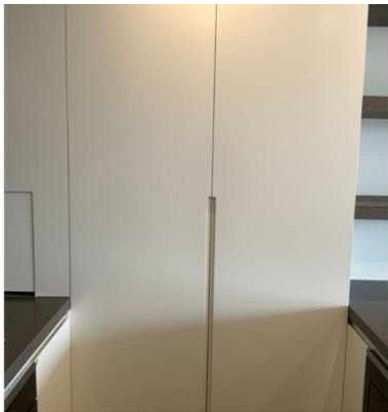
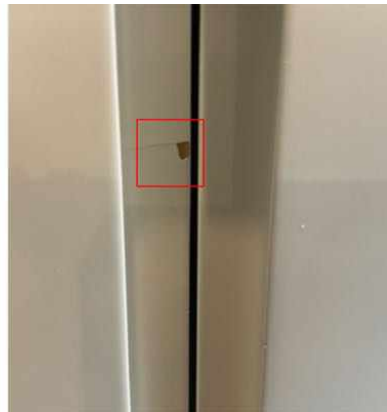
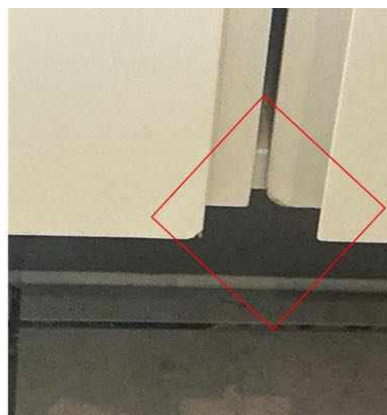
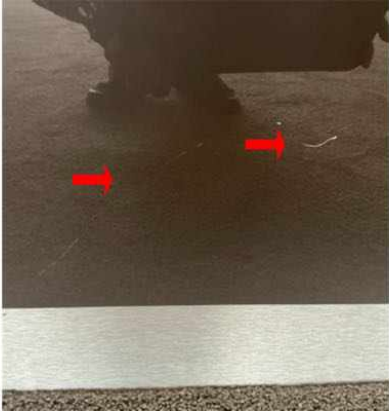
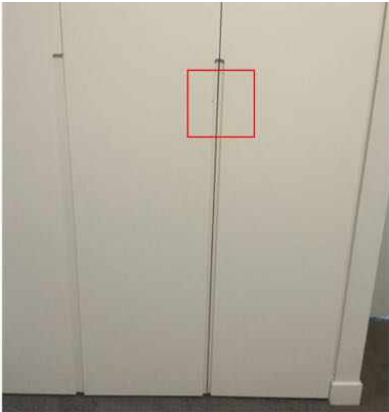
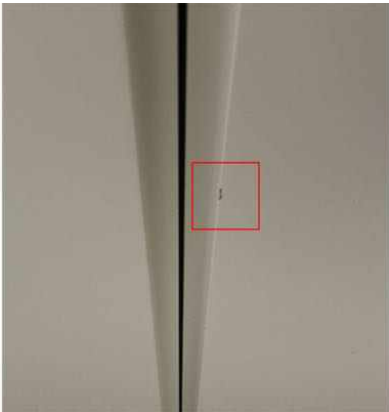
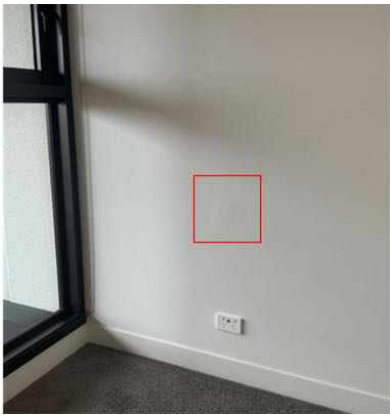
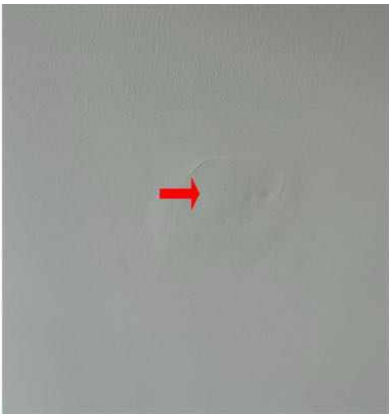
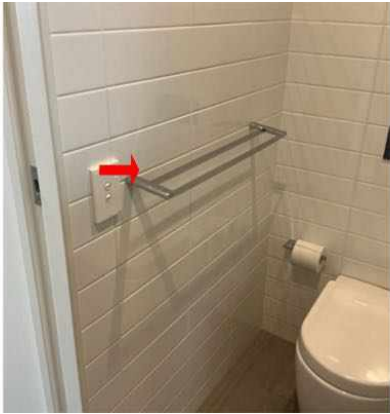
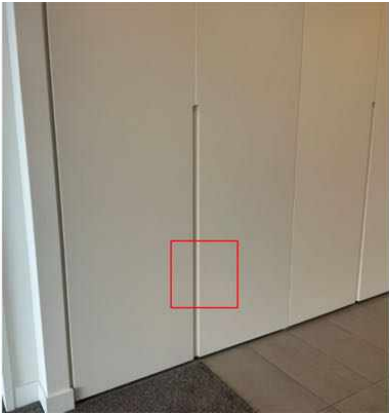
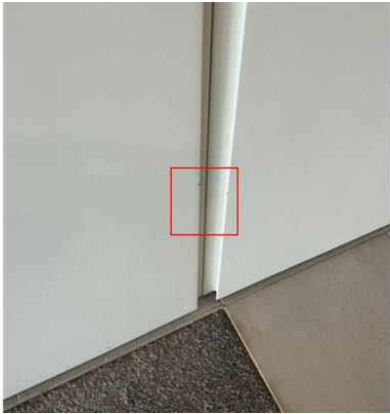
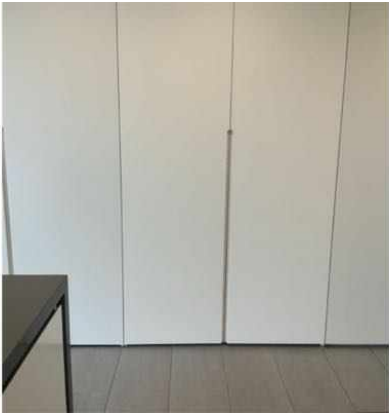
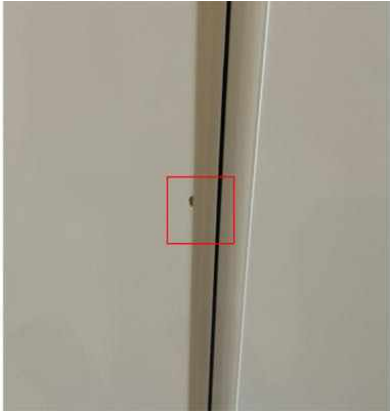
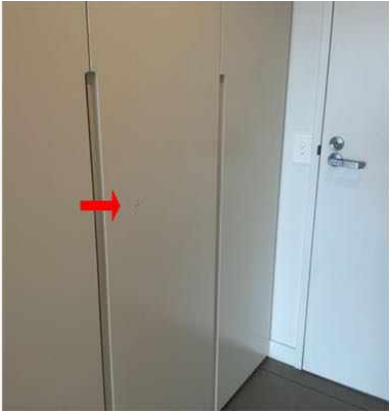
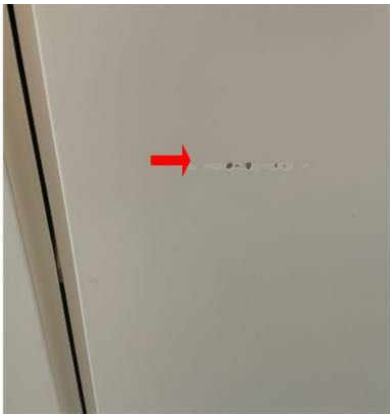
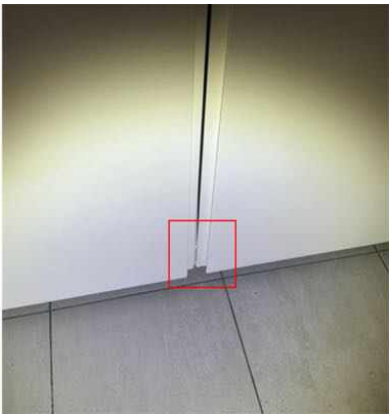
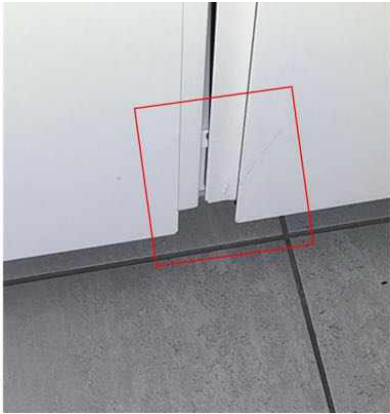
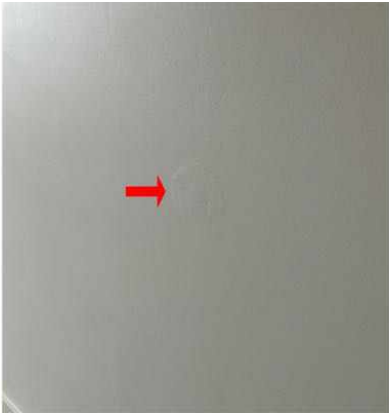
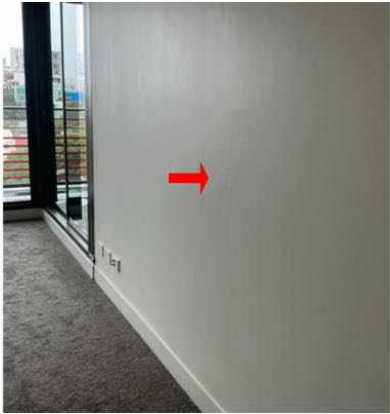
Finding 3.05

Building:	Main Building
Location:	All Internal Areas
Finding:	Building element - Damaged - Cupboard chipping kitchen/Hallway , bedroom built in chipping , plaster damaged master bedroom/lounge , loose towel rail ensuite
Information:	Breakage occurs generally when the building materials have either aged and decayed, or as a result of damage (accidental or deliberate).

Repair and/or replacement of broken elements is advised to ensure that additional secondary defects do not arise as a consequence. Such works are necessary, as all building elements play a key role in the operation and function of the overall structure and its performance.

A relevant tradesperson should be appointed to repair or replace the affected building element prior to any subsequent damage being caused.

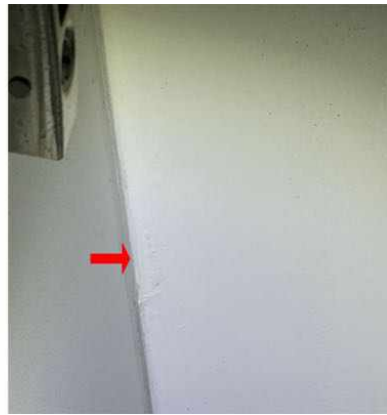
Building: Main Building
Location: Bathroom, Laundry
Finding: Water Staining - Humidity or Ventilation
Information: The ceiling surface shows peeling paint and water staining on the walls faint commonly consistent with humidity-related staining, often found in bathroom or wet areas with insufficient ventilation. While there is no visible sagging or major water damage, the pattern suggests prolonged moisture exposure, possibly due to steam accumulation or minor condensation issues. According to AS 4349.1–2007 (Appendix C), this would be classified as a minor defect unless further deterioration or active leaks are found. Recommend improving mechanical or natural ventilation, cleaning the surface with mould treatment, and monitoring for recurrence.

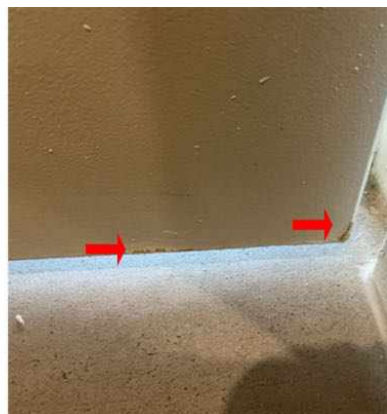
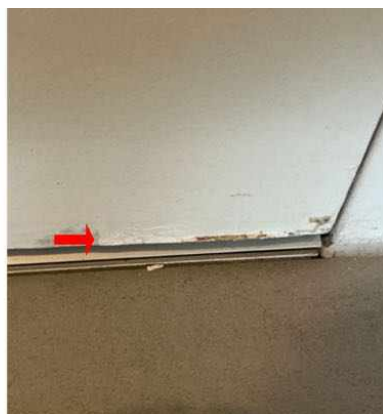
Building:	Main Building
Location:	Bathroom, Main door
Finding:	Delamination of timbers
Information:	Delamination is one means by which composite materials (e.g. layered timber composites) may fail over time. In laminated materials, repeated cyclic stresses may lead to the formation of mini-structures of separate layers, with significant loss of mechanical toughness. Water penetration or the presence of excessive moisture also generally contributes to delamination.

Where building materials have become delaminated, they lose their structural strength, and are likely to have a variety of appearance and serviceability defects as a result.

Delamination of timbers may be repaired where the area affected is minor and/or easily accessible, by gluing and screwing layers back together. However, this is an interim repair, and where delamination has occurred, the client should plan for the replacement of affected timbers sooner than would otherwise be expected.

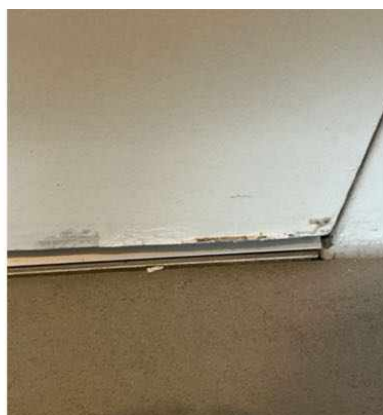
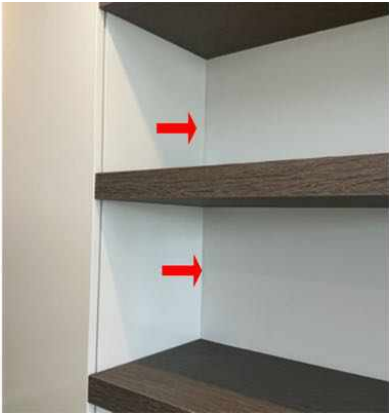
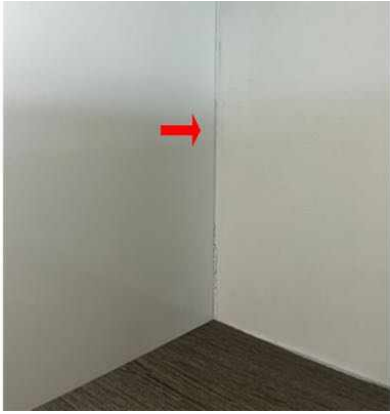
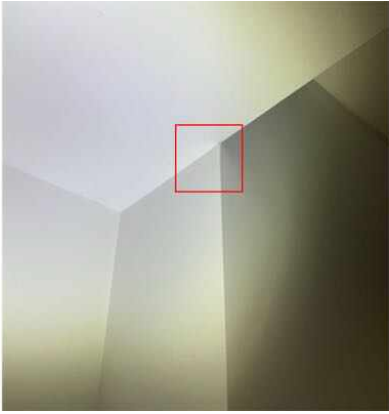
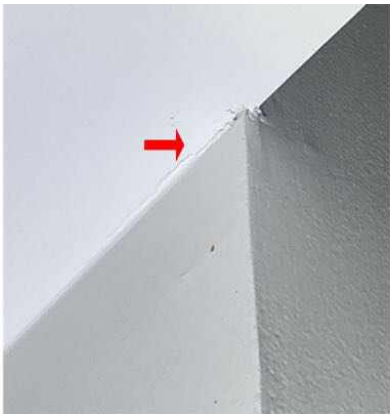
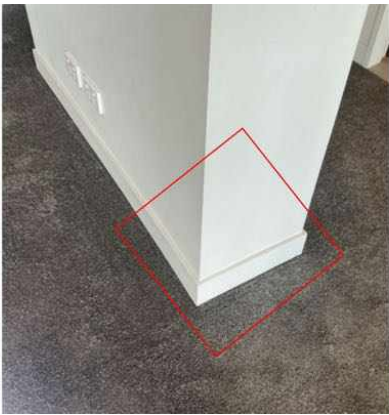
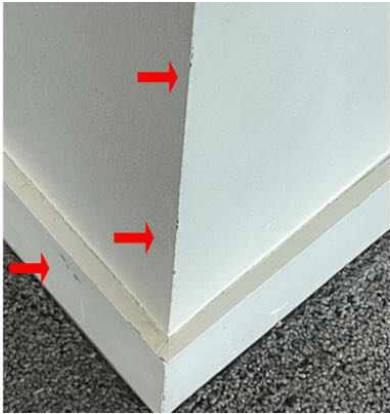
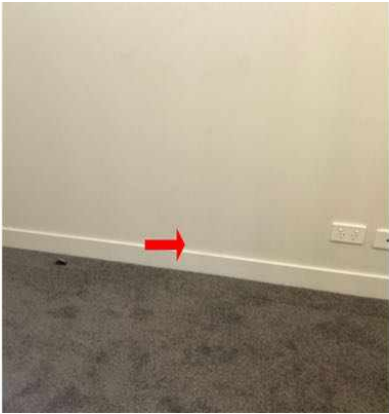
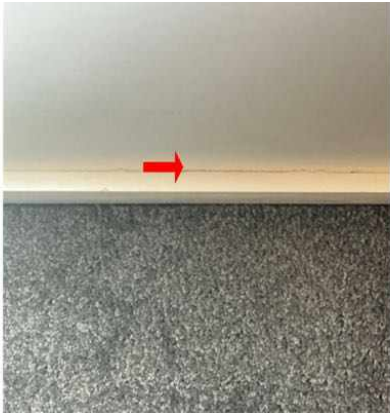
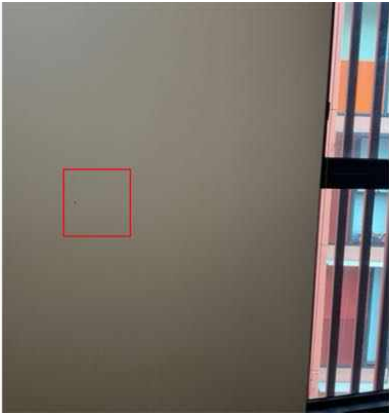
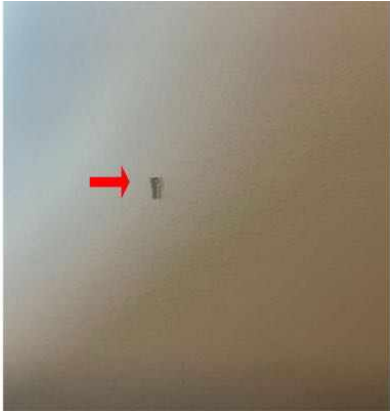
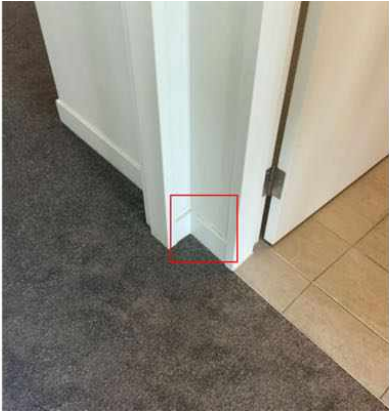
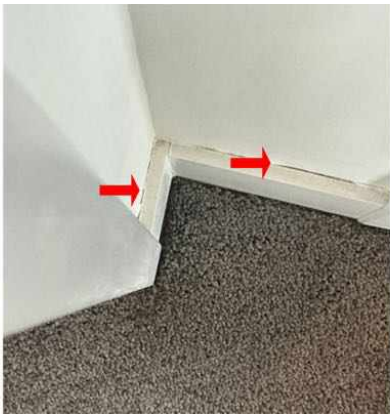
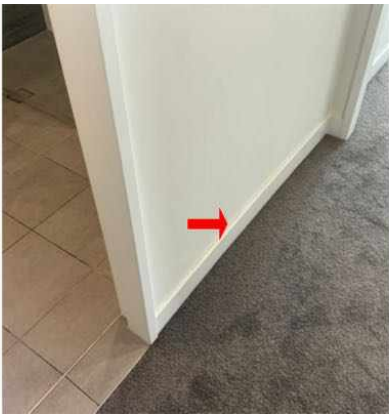
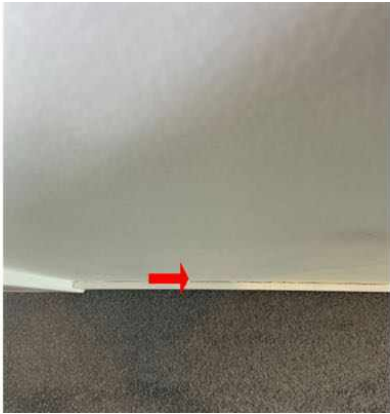
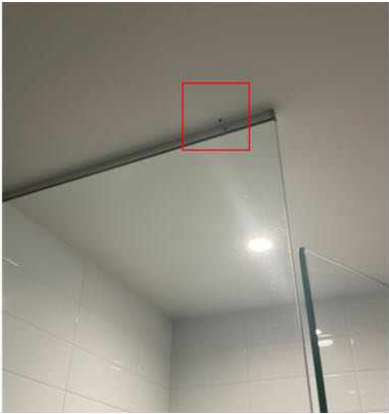
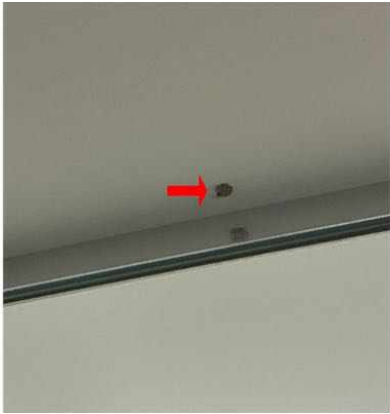
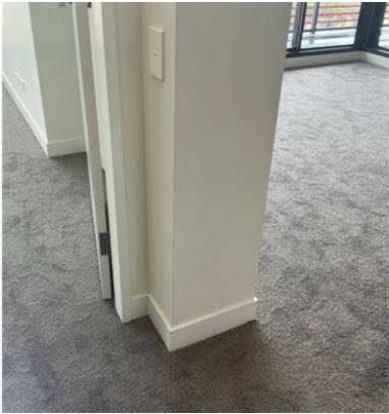
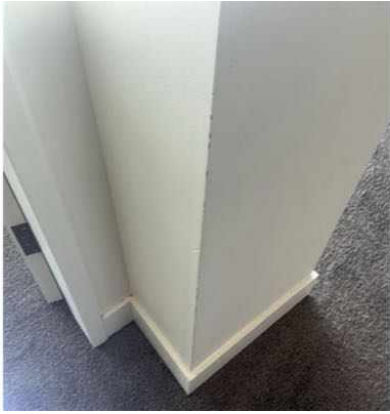
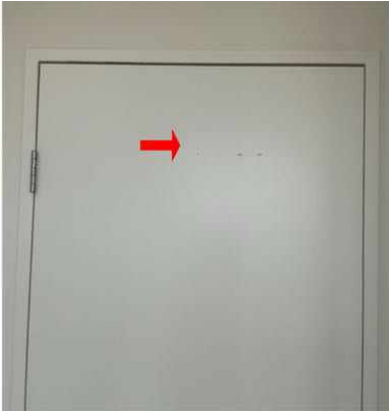
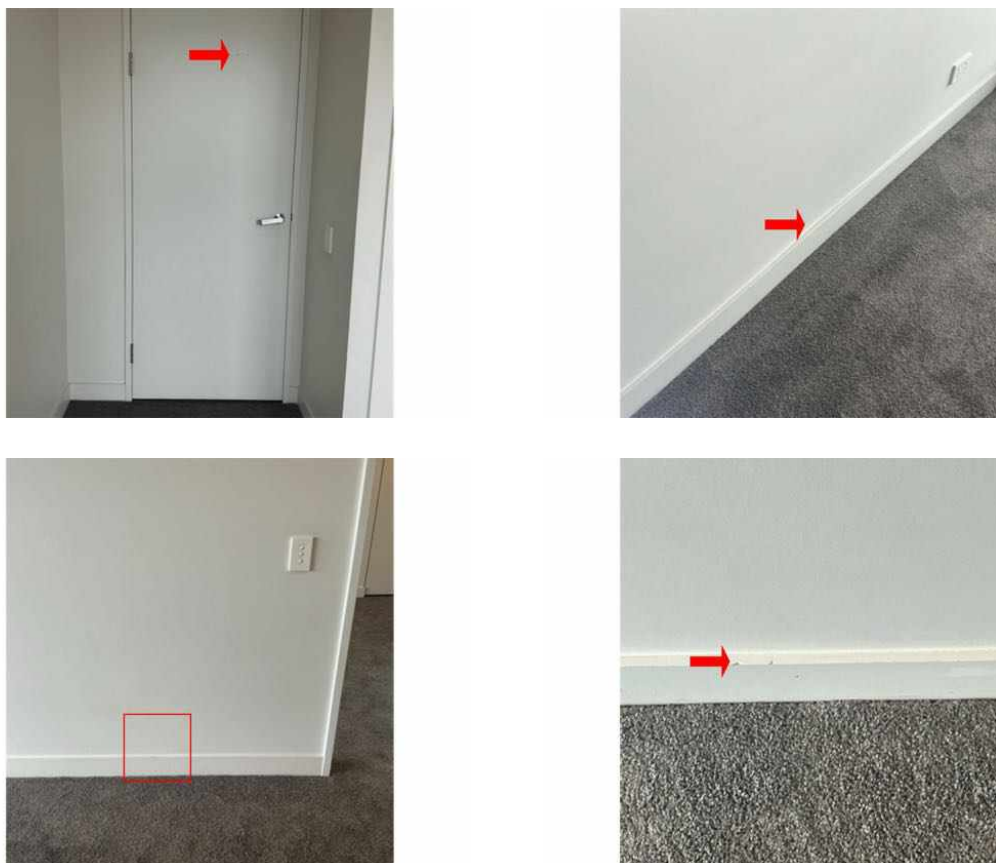
Finding 3.09

Building:	Main Building
Location:	All Internal Areas
Finding:	Paint finish and hairline cracking to some areas
Information:	The paint finish in this area was identified as being incomplete at the time of inspection including some hairline minor cracking.

Whilst incomplete or missing paint finish is generally an appearance defect, it can also lead to the development of secondary building defects over time. Incomplete areas of paint finish expose the area to moisture, potentially accelerating the deterioration of underlying building materials.

Incomplete paint finishes should be sanded back, filled, leveled and painted, as applicable. Where inadequate or missing paint protection has led to the deterioration of the associated building element, repair and/or replacement of this building element may be required.

A painting contractor should be appointed as soon as possible to perform necessary works to aid the appearance of the affected area and to ensure the area is protected against further deterioration. Alternatively, the homeowner following manufacturer instructions may perform these works.

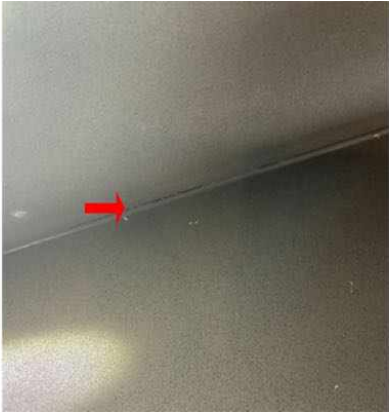
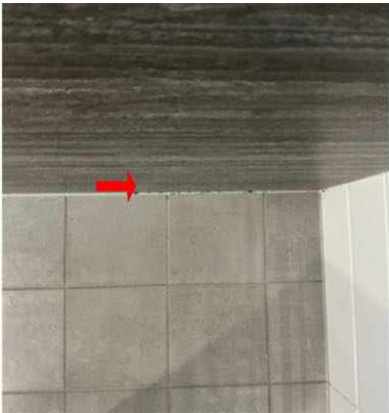
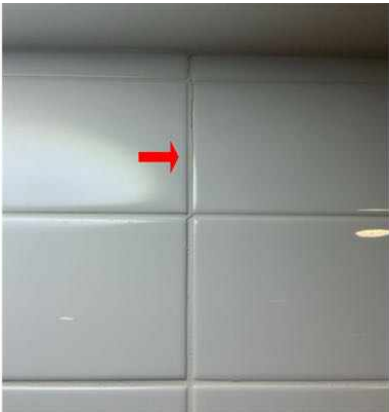
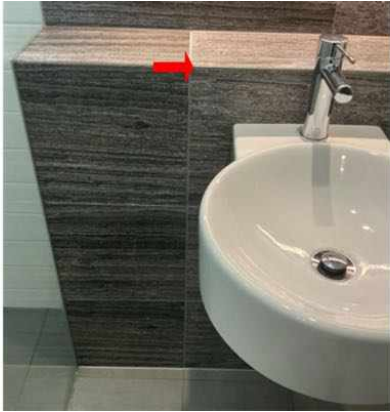
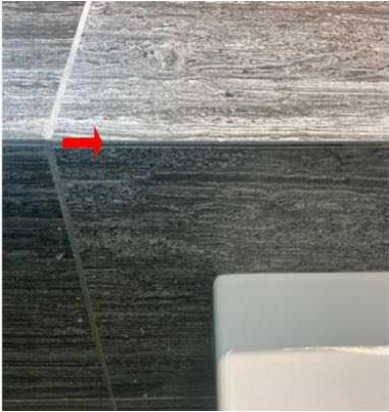
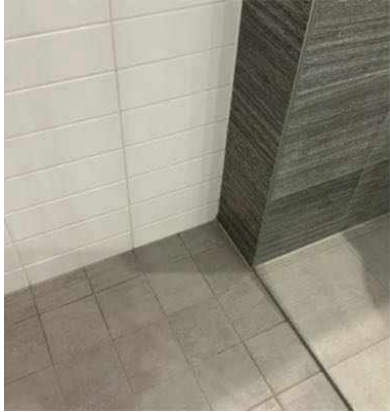
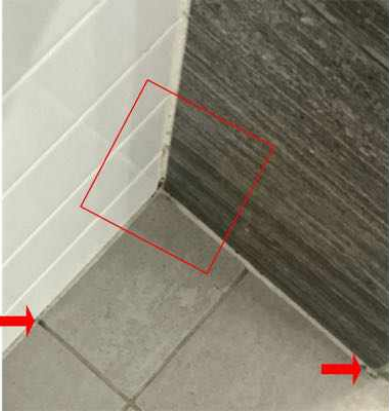
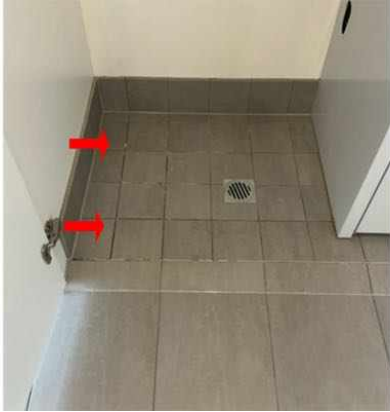
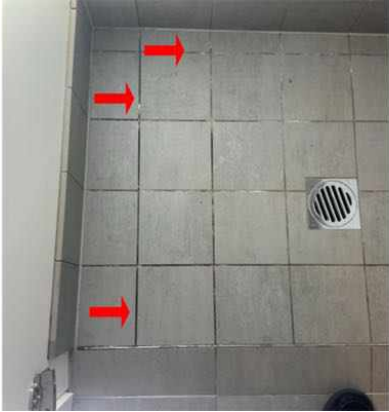
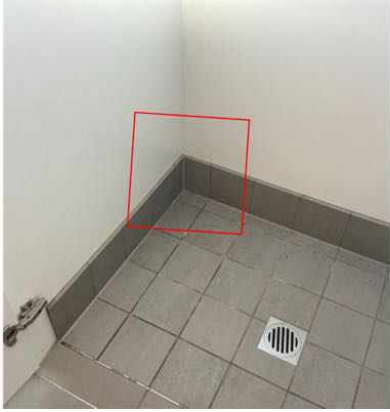
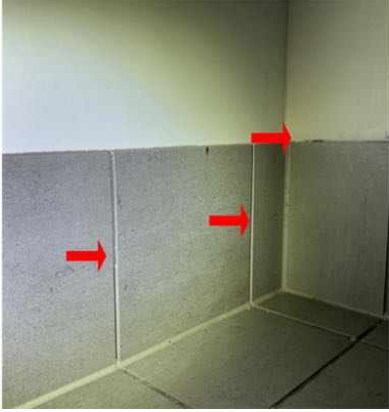
Finding 3.10

Building:	Main Building
Location:	All Internal Areas
Finding:	Sealant and grouting - Missing or degraded
Information:	It was noted on inspection that sealant or grout is degraded. There is also evidence of poor workmanship and excessive use of sealant. Silicone should never be used as a first line of defence against waterproofing. Further inspection by a licensed waterproofing contractor is highly recommended.

Different materials and floor areas move at different rates, generally causing cracking to grout or sealant at this point. A flexible sealant is required to allow for expected expansion and contraction, while keeping the joint water tight and protective of all associated building materials.

There appears to be excessive mould to the sealant and grout which will likely require scraping out and replacement.

Flexible and mould resistant materials should be applied to affected areas to prevent any subsequent water damage that is likely to occur. Regular maintenance and replacement of damage or missing or damaged sealant and grout is highly recommended to the wet areas, as this is a regular wear and tear defect. Sealant and grouting in areas that come into regular contact with water should be maintained for the long term care of your property.

A sealant specialist or tiling contractor should be appointed to complete these works as soon as possible

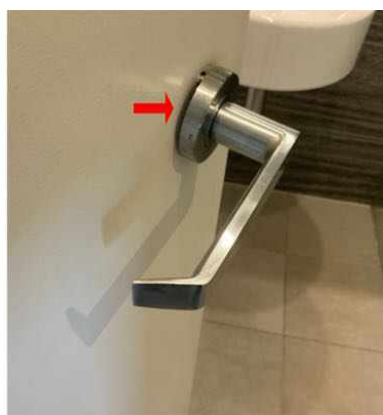
Finding 3.11

Building: Main Building
Location: Bathroom
Finding: Door - Broken handle
Information: The door handle in this area was found to be broken at the time of inspection. Breakage occurs generally when the building materials have aged and decayed, but may be indicative of impact damage (accidental or deliberate).

Repair and/or replacement of the broken door handle is advised to improve the operational state of the associated door.

A qualified carpenter or general handyman should be appointed to repair/replace the door handle at the client's discretion.

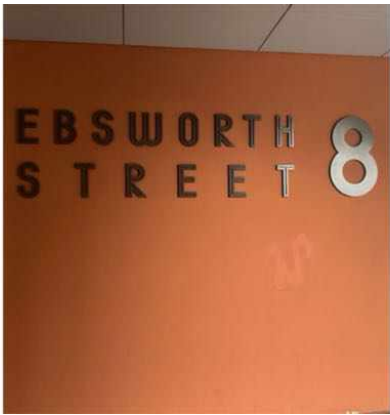
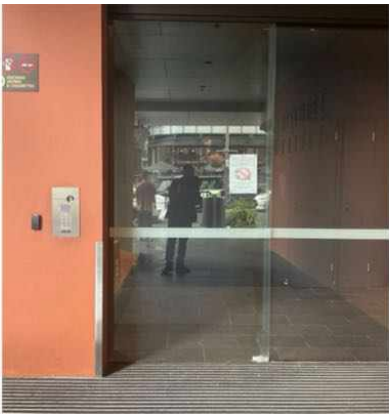
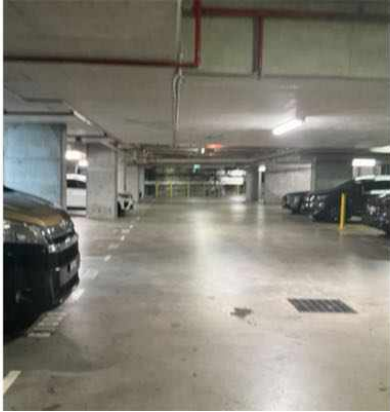
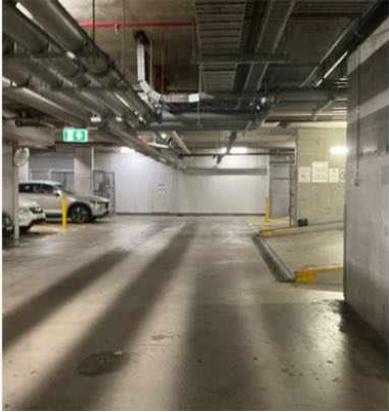
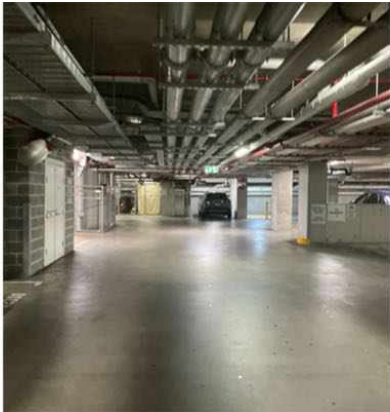
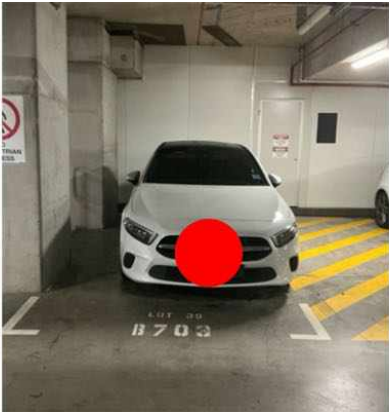
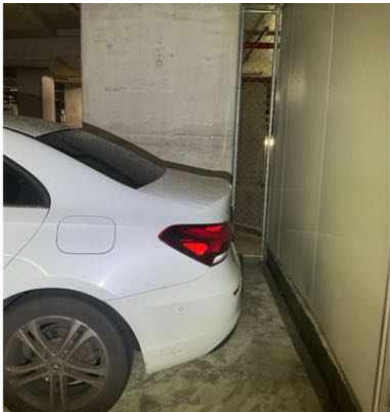
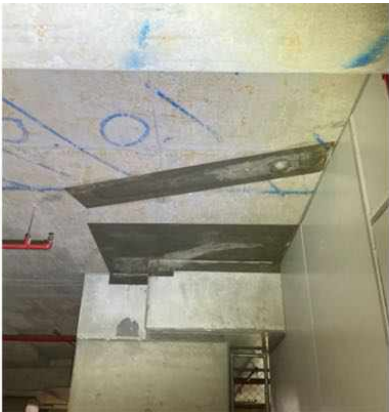
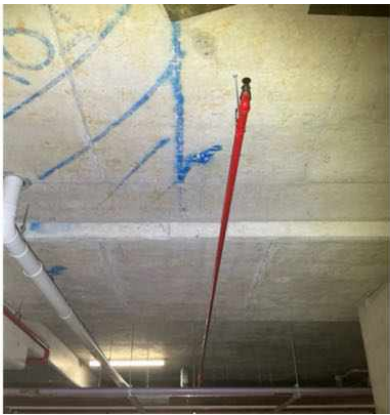
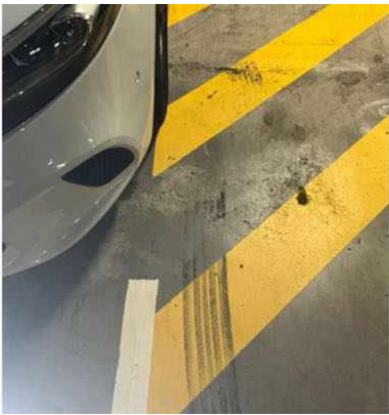
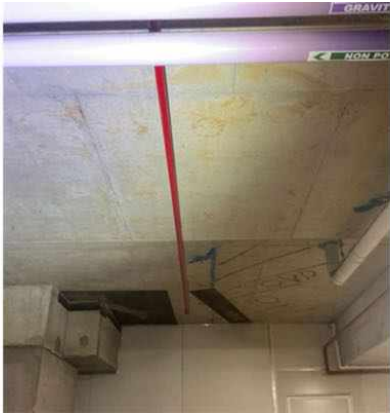
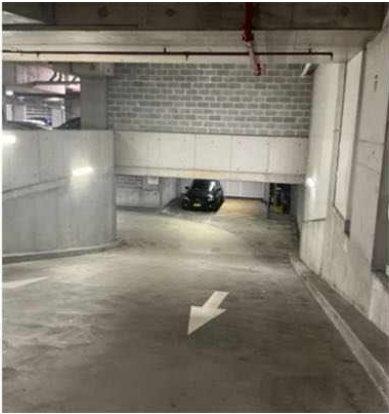
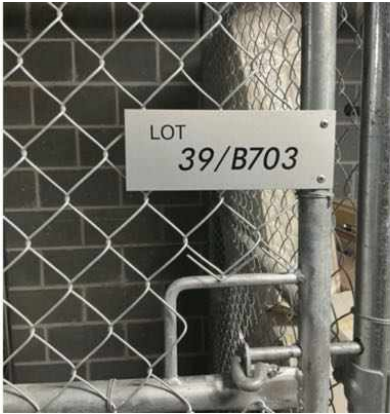
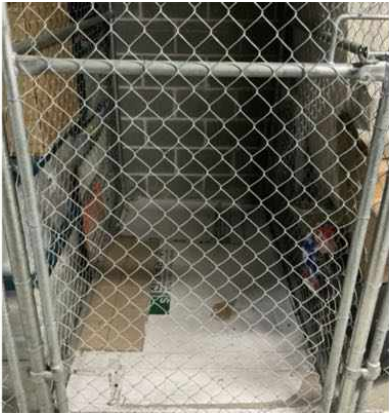
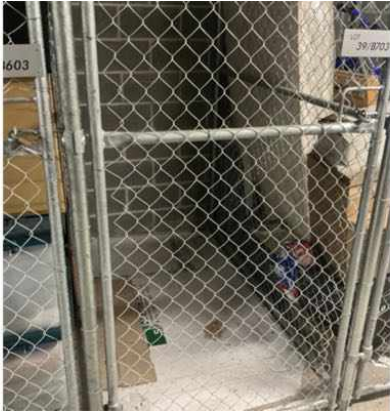
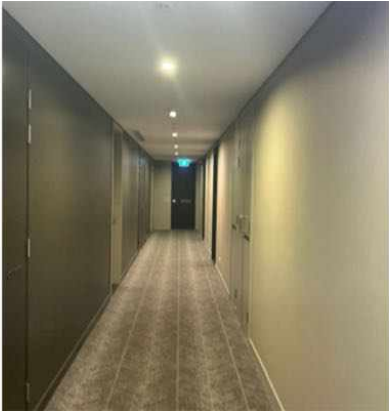
Building:	Main Building
Location:	All External Areas
Finding:	Additional Photos - Obstructions and Limitations
Information:	These photographs are an indication of the obstructions and limitations which impeded full inspection of the property at the time of inspection. These obstructions can hide an array of defects and should be removed to allow full inspection to be carried out. A re-inspection is recommended once the areas are made accessible.

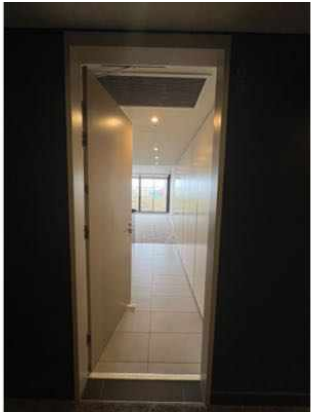
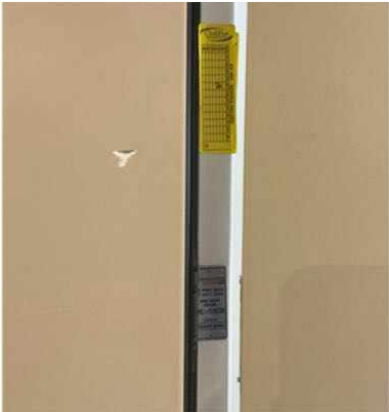
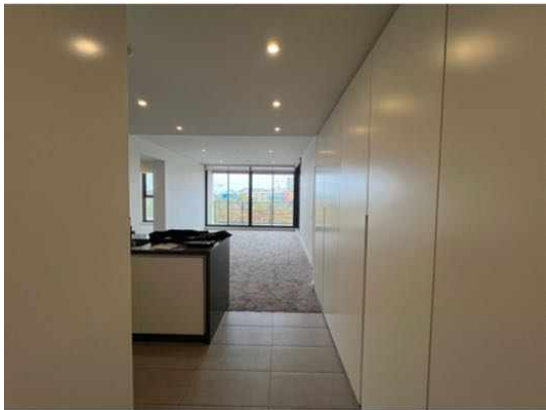
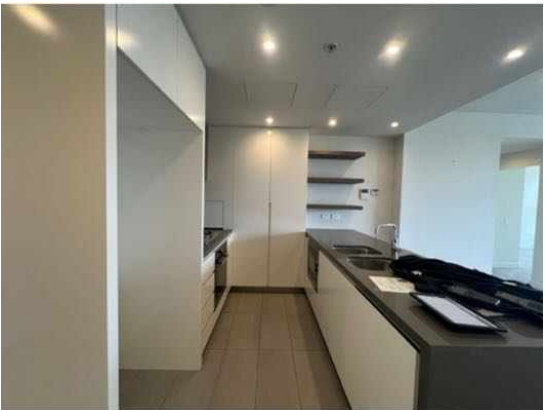
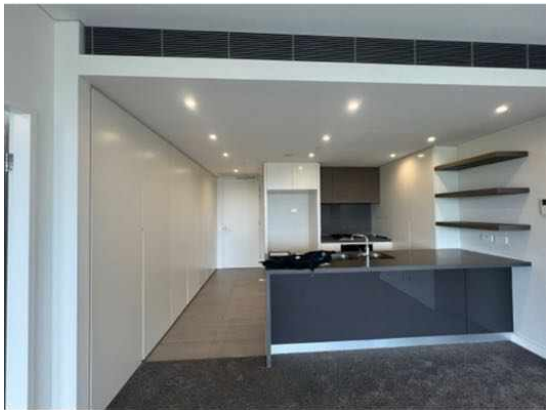
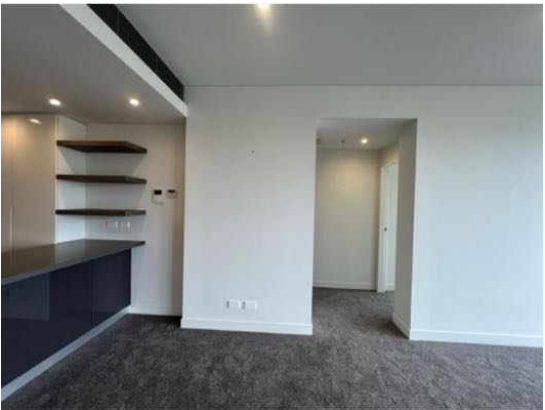
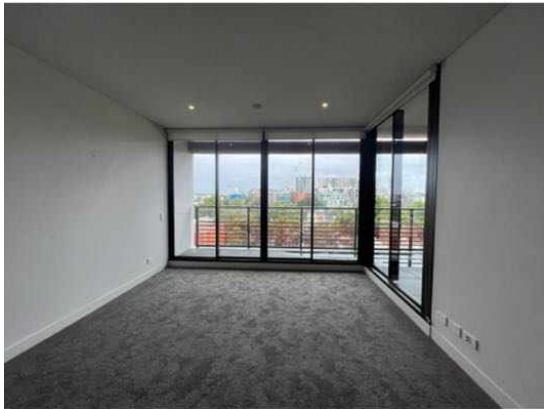
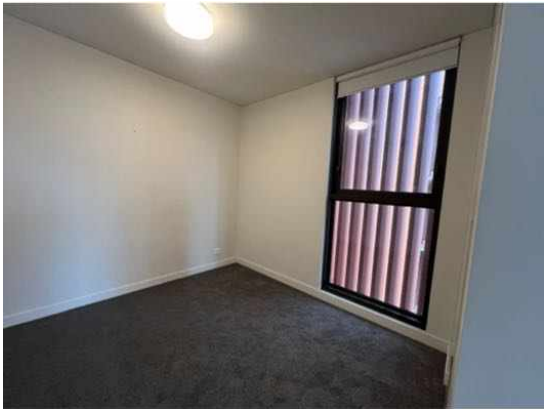
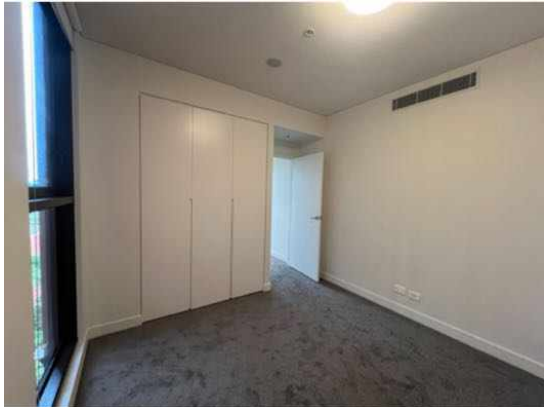
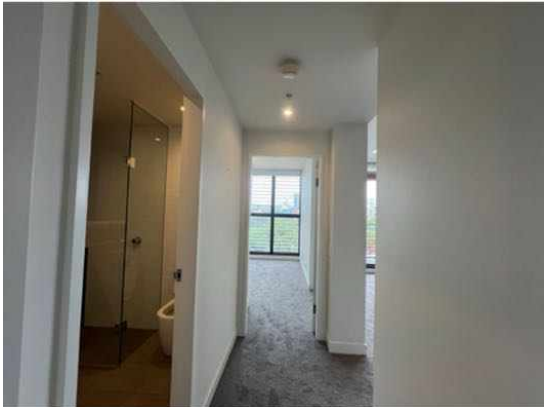
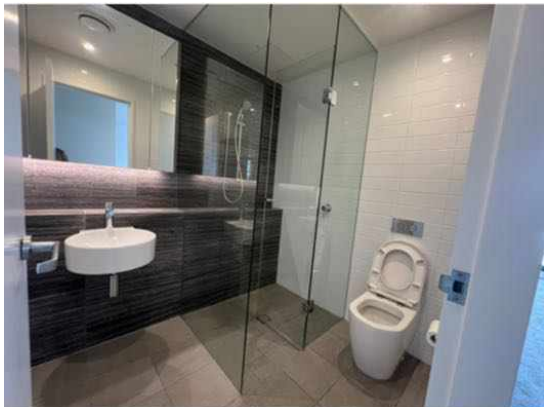
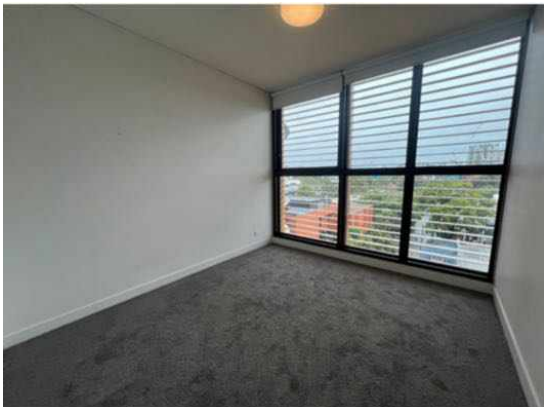
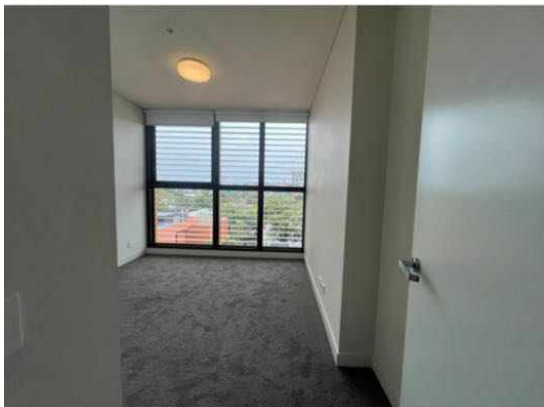
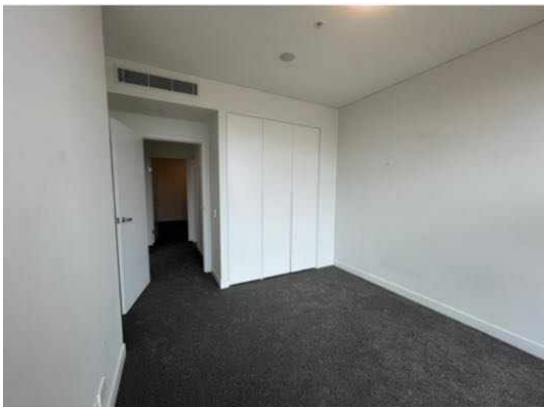
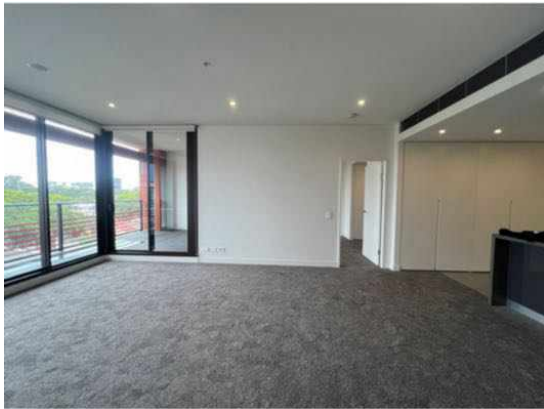
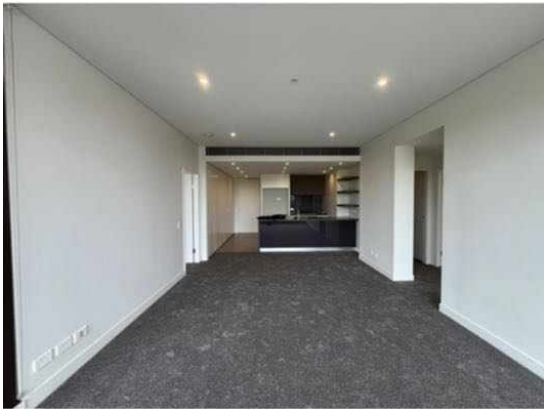
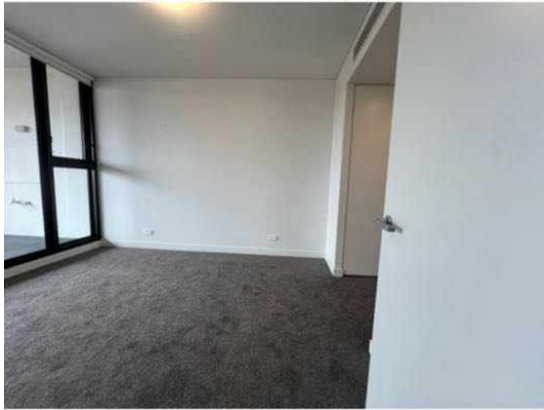
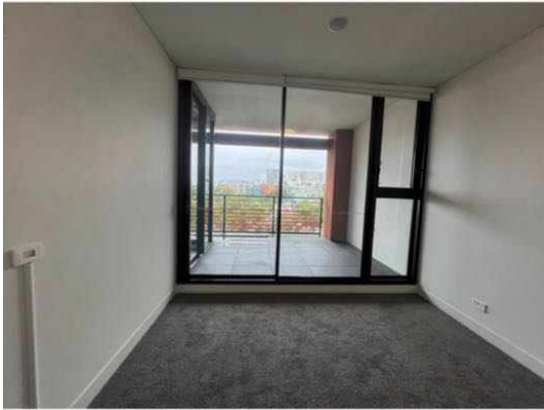
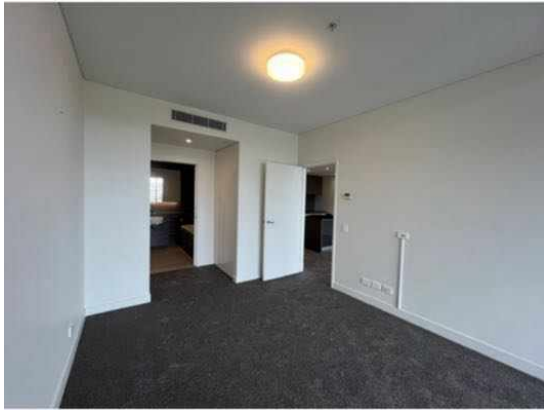
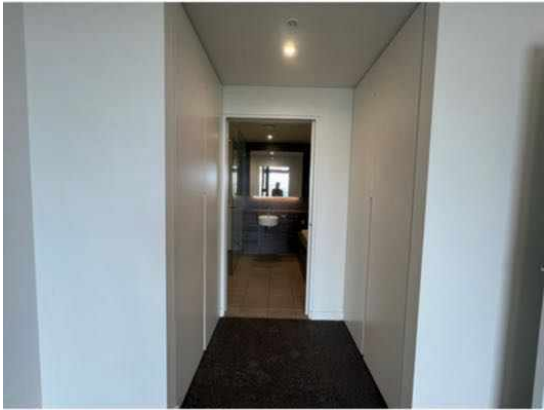
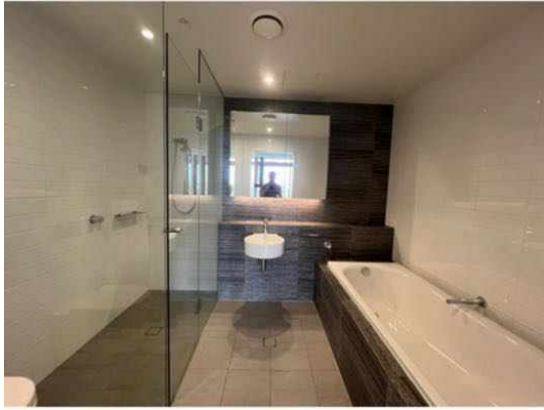
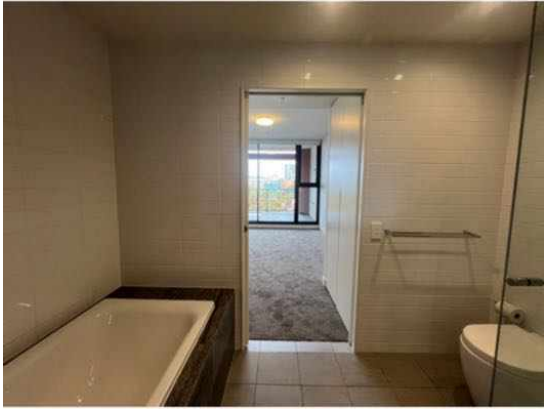
Building: Main Building
Location: All Internal Areas
Finding: Additional Photos - Obstructions and Limitations
Information: These photographs are an indication of the obstructions and limitations which impeded full inspection of the property at the time of inspection. These obstructions can hide an array of defects and should be removed to allow full inspection to be carried out. A re-inspection is recommended once the areas are made accessible.
