Building and Timber Pest Inspection Report

Inspection Date: Fri, 27 Feb 2026

Property Address: 703/8 Ebsworth St, Zetland NSW 2017,
Australia

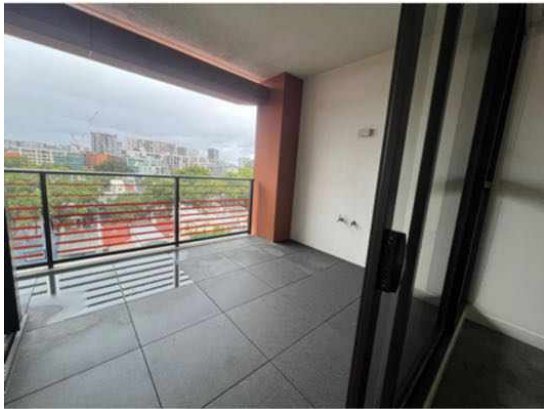
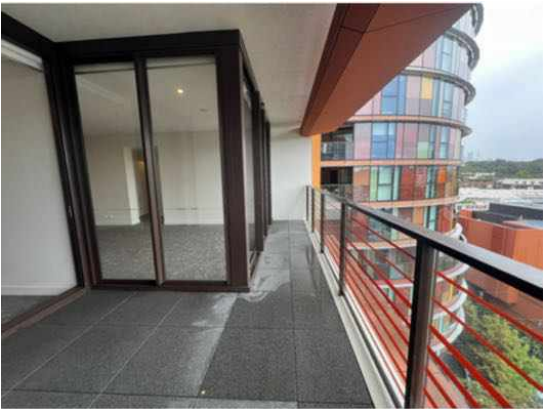
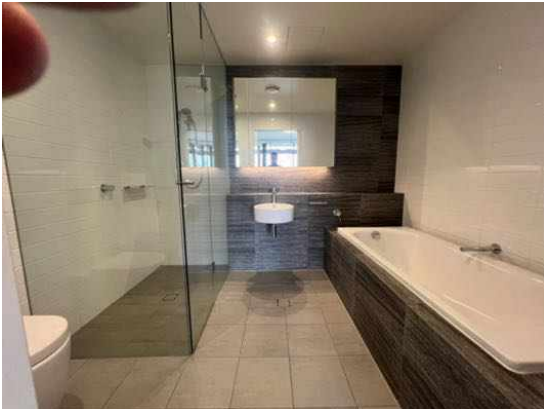
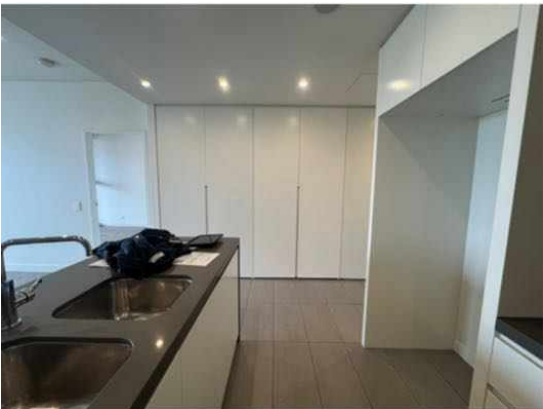
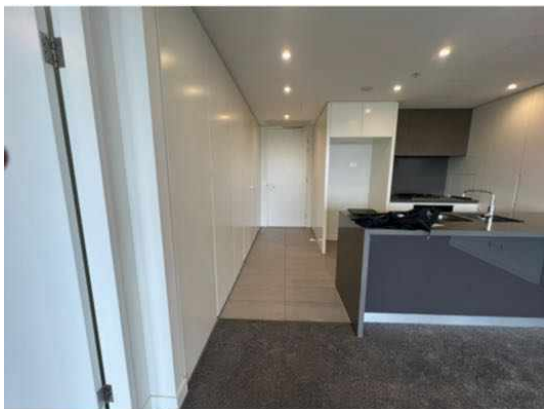
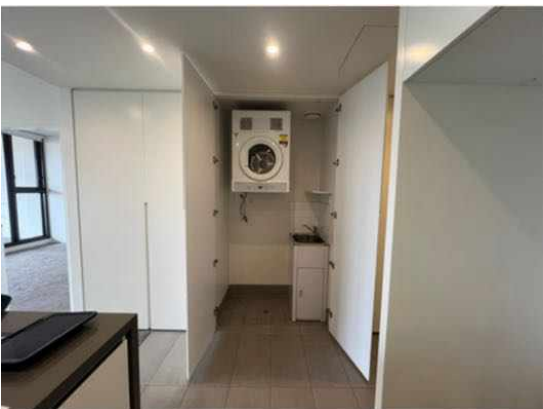
Building: Main Building
Location: All Internal Areas
Finding: Additional Photos - Obstructions and Limitations
Information: These photographs are an indication of the obstructions and limitations which impeded full inspection of the property at the time of inspection. These obstructions can hide an array of defects and should be removed to allow full inspection to be carried out. A re-inspection is recommended once the areas are made accessible.
