# Building and Timber Pest Inspection Report

Inspection Date: Wed, 11 Mar 2026

Property Address: 3/64 Hazel Grove, Ridgehaven SA 5097,  
Australia

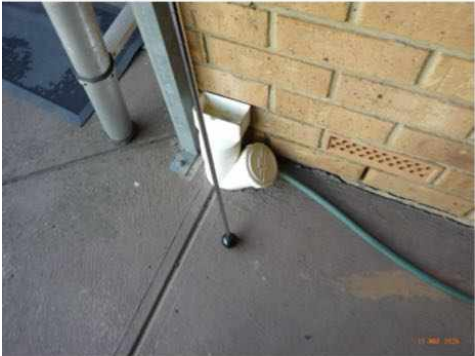
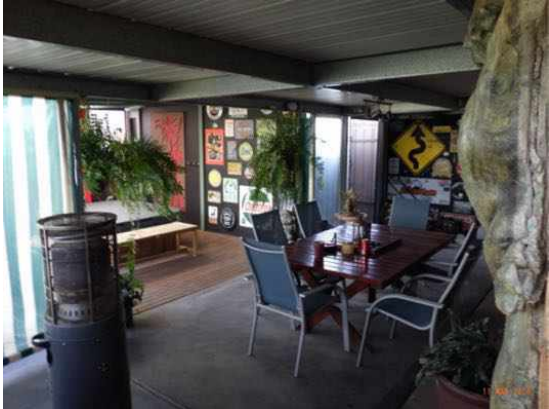
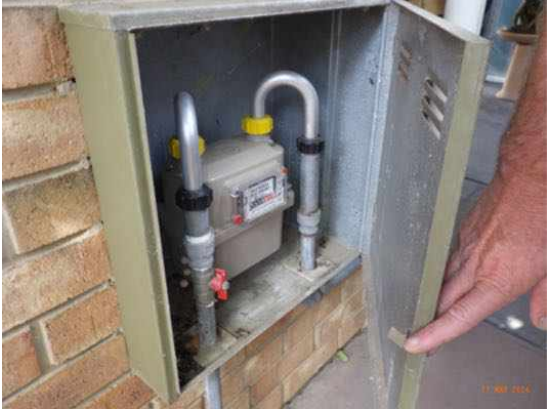
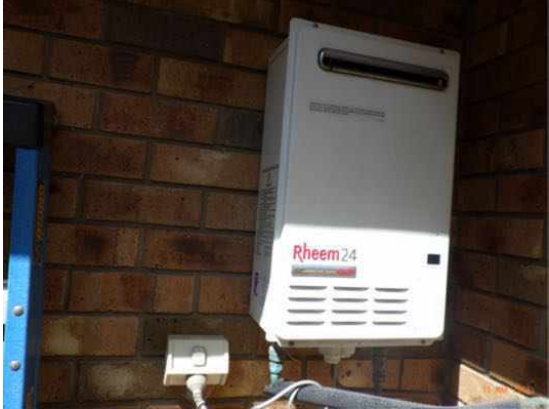
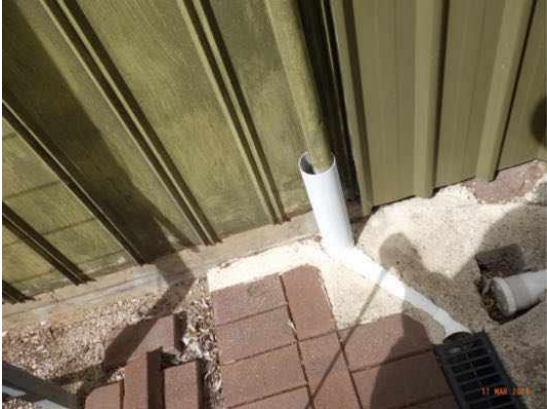
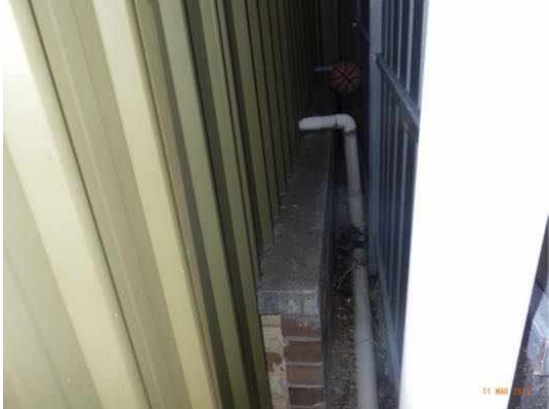
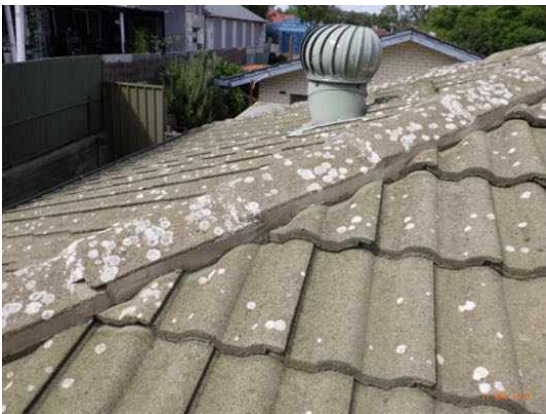
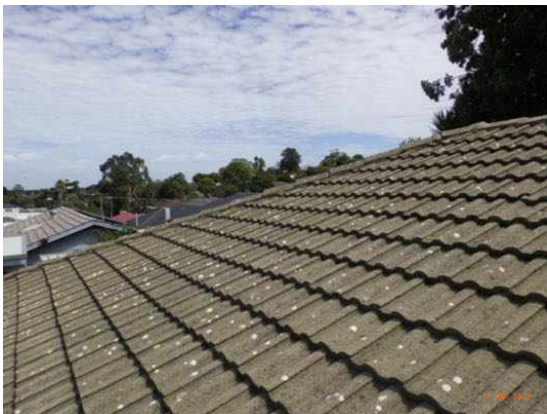
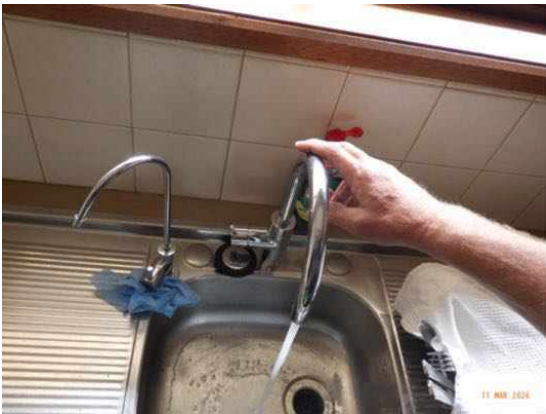
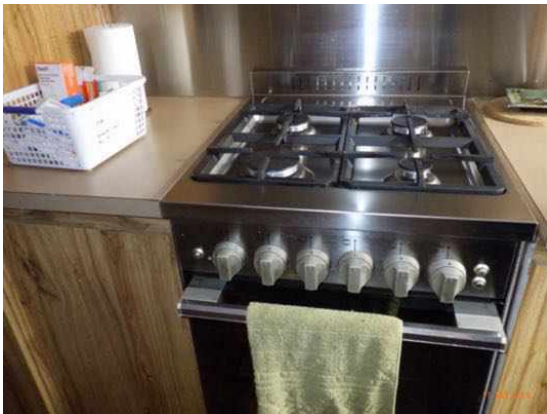
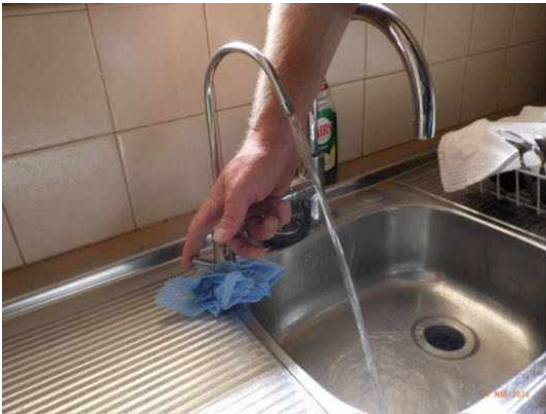
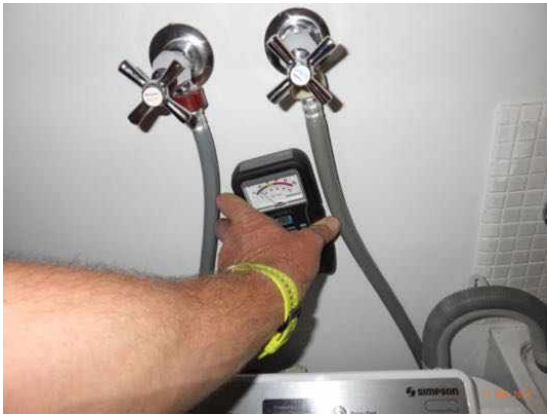
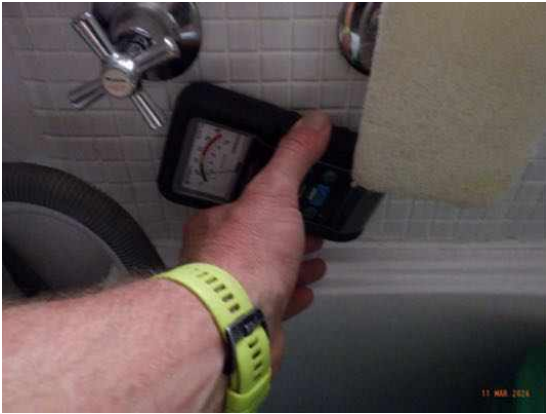
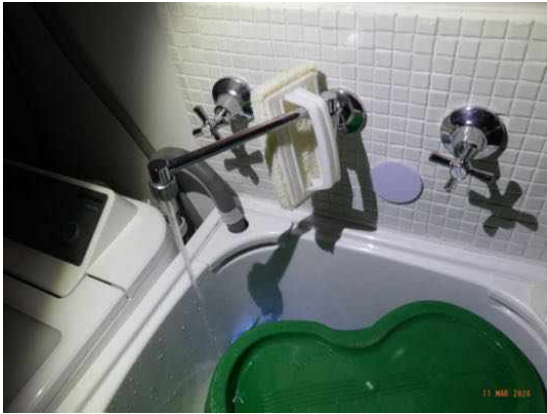
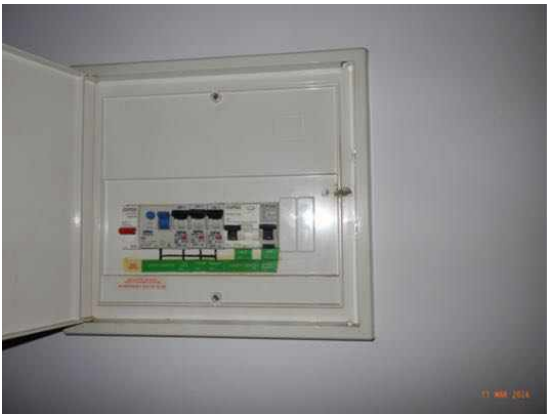
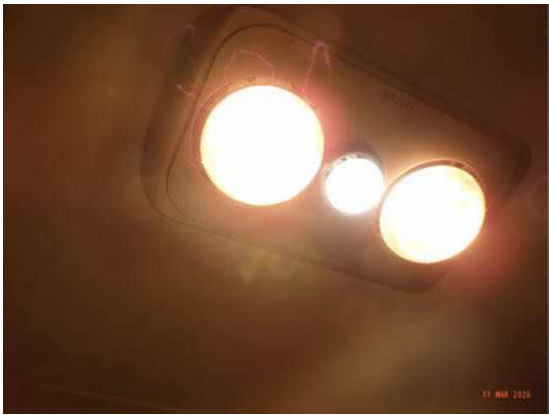
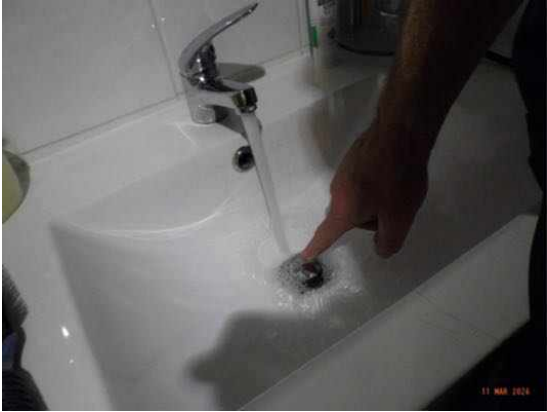
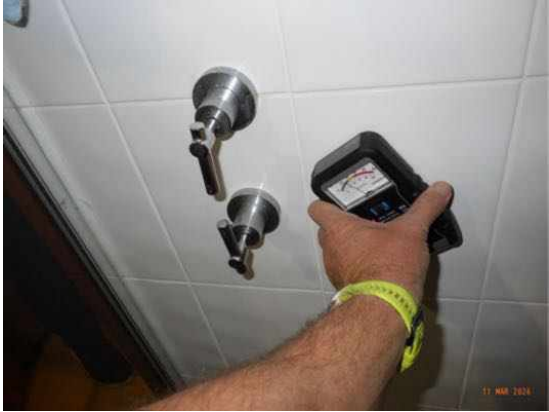
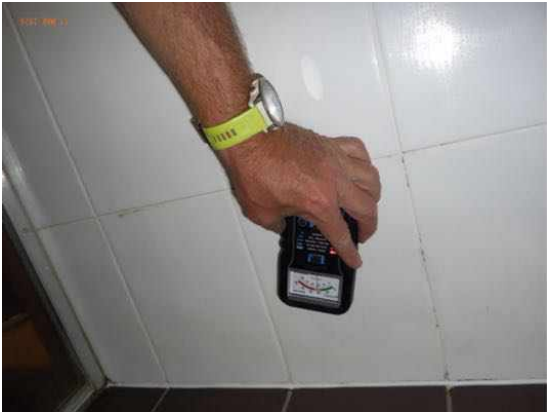
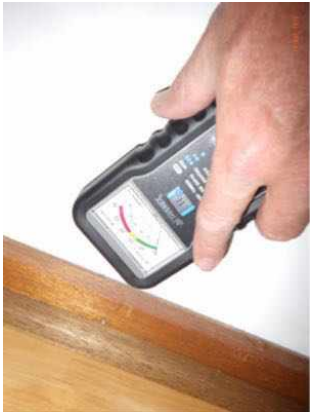
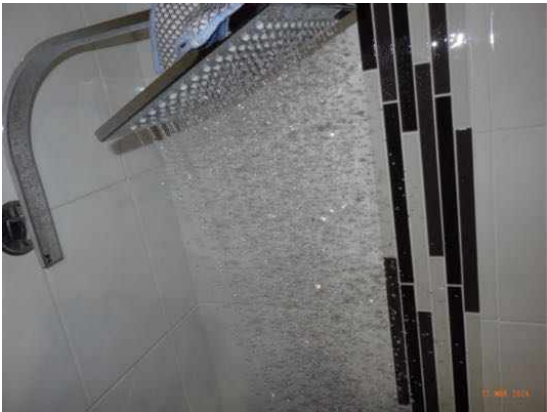
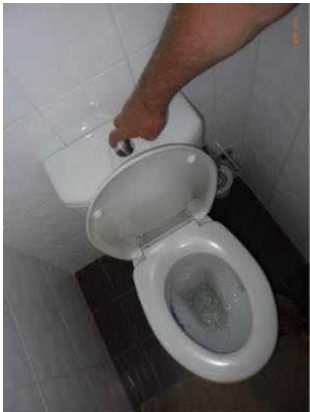
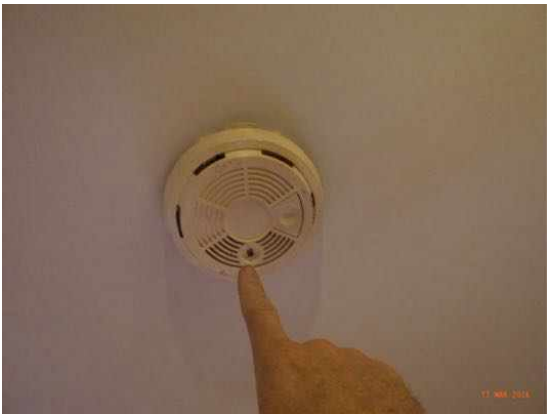
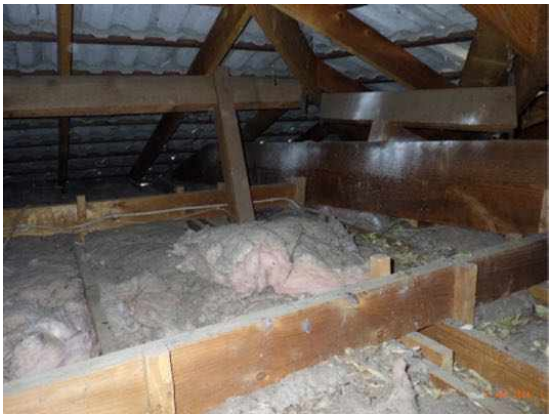
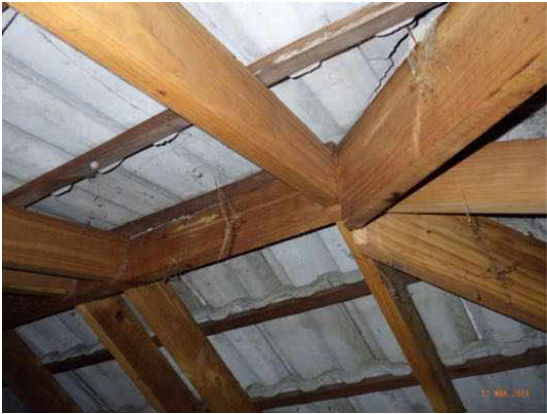
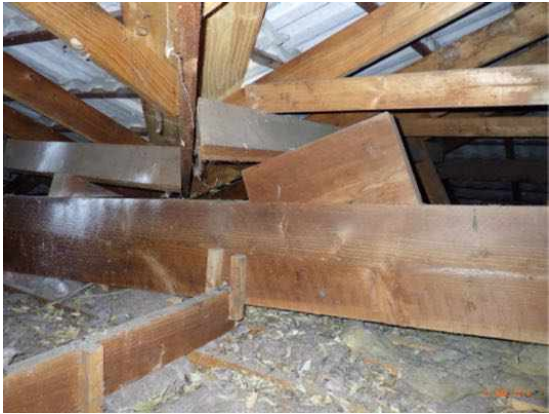
Building: Building 1  
Location: All Areas  
Finding: Additional Photos  
Information:

Additional photos are provided for your general reference.

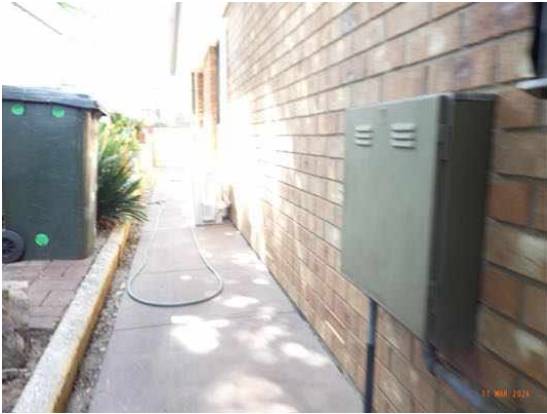
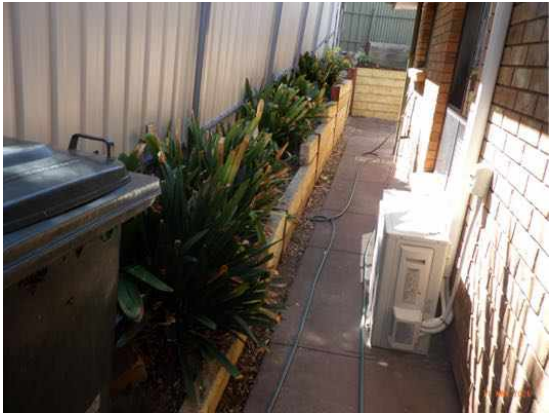
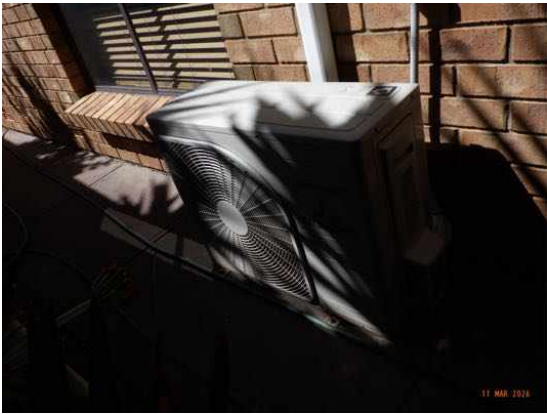
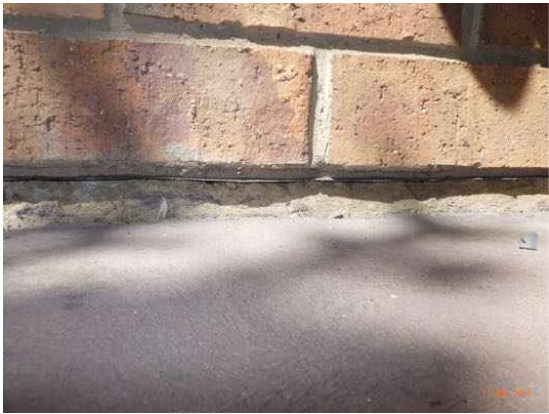
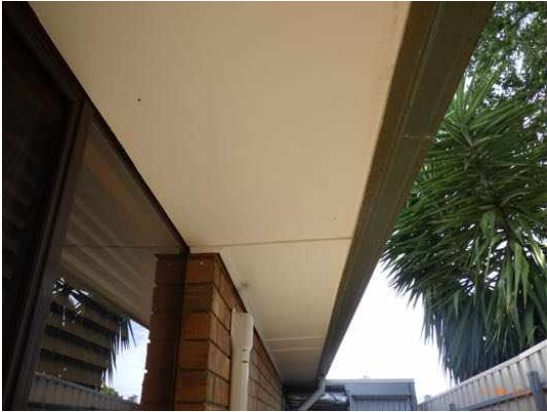
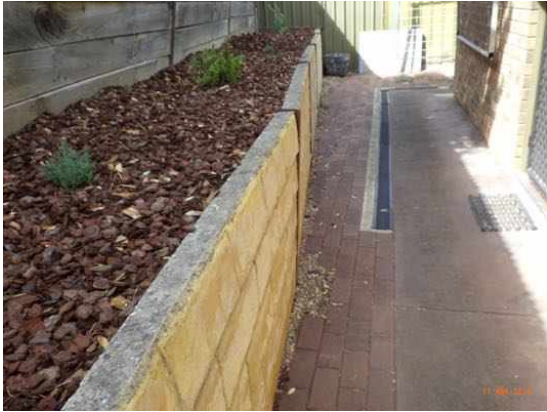
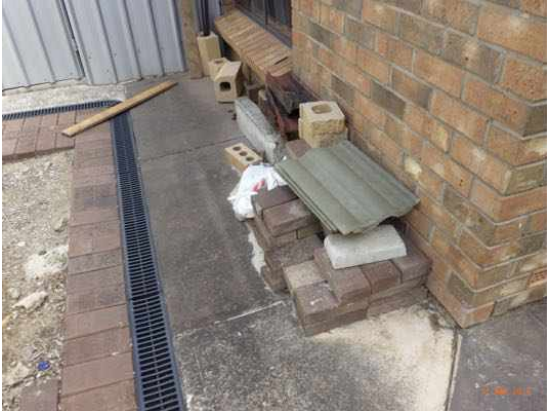
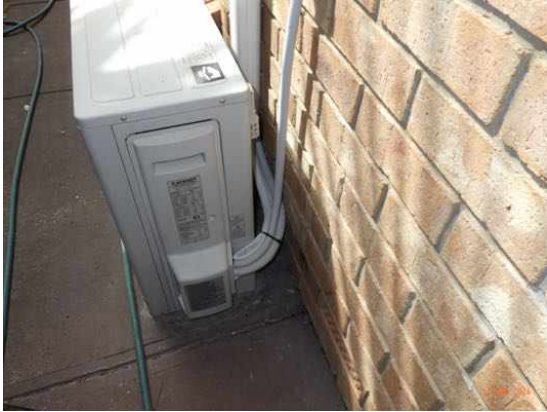
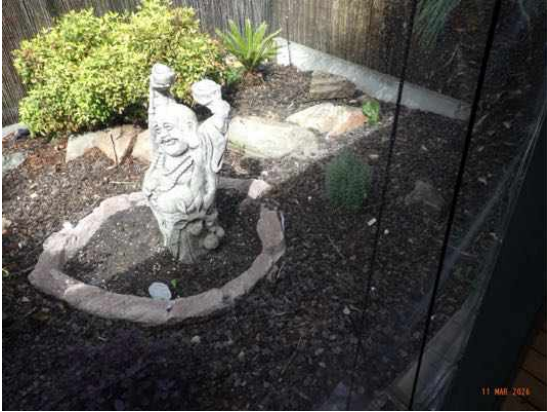
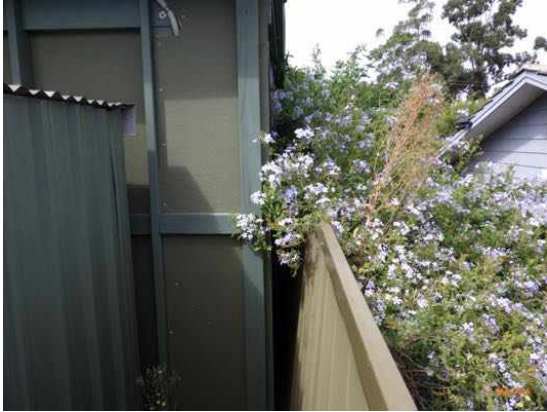
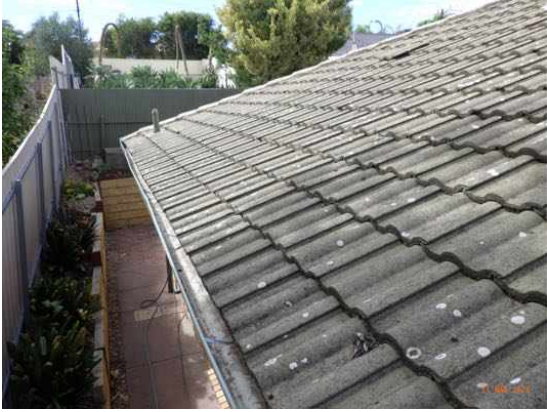
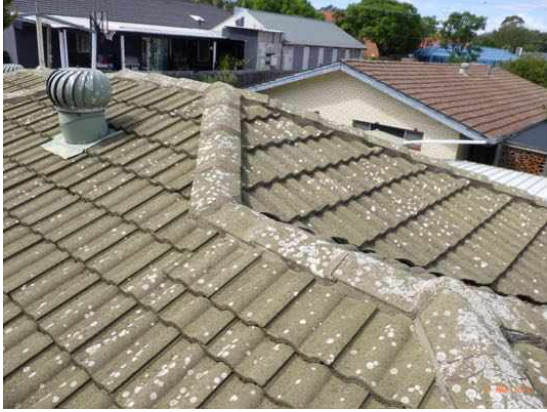
Building: Building 1  
Location: All Areas  
Finding: Additional Photos - Obstructions and Limitations  
Information:

These photographs are an indication of the obstructions and limitations which impeded full inspection of the property at the time of inspection. These obstructions can hide an array of defects and should be removed to allow full inspection to be carried out.
