Building Inspection Report

Inspection Date: Tue, 24 Mar 2026

Property Address: 1407/112 Talavera Rd Macquarie Park,
NSW 2113.

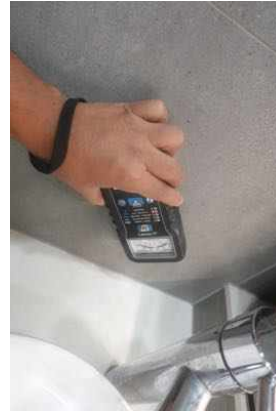
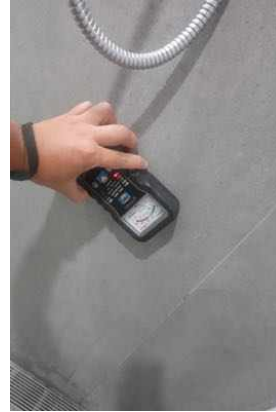
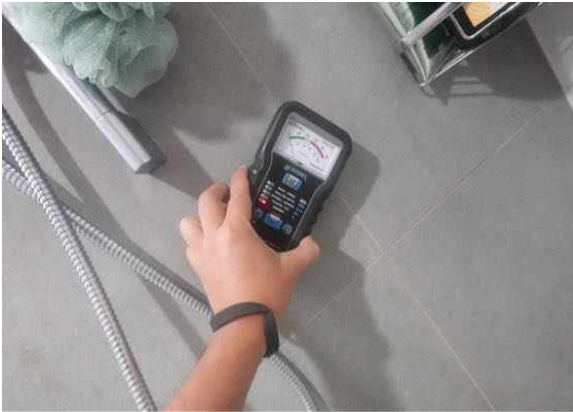
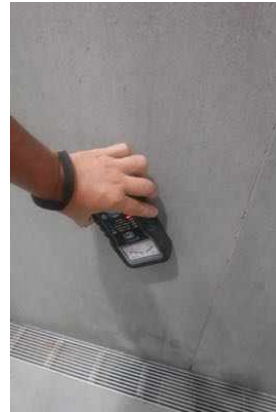
Noted Item

Building: Main Building
Location:
Finding: Moisture check
Information: During inspection, moisture meter was used and no high moisture detected at the time of inspection.

Please note if the wet areas have not been used for some time, moisture readings would not vary significantly and this can lead to erroneous results.

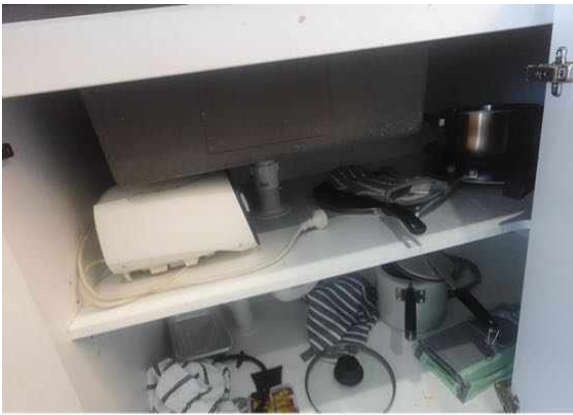
Noted Item

Building: Main Building
 Location: All internal areas
 Finding: Taps, toilets and sinks tested : Visual only
 Information: Taps, drainage and toilets were checked for water flow and drainage was checked for leakage.

Whilst we note and comment of visually apparent defects that present during the building inspection, legislation requires the checking and documenting of compliance for plumbing be done by licensed plumber to ensure they are functioning correctly.

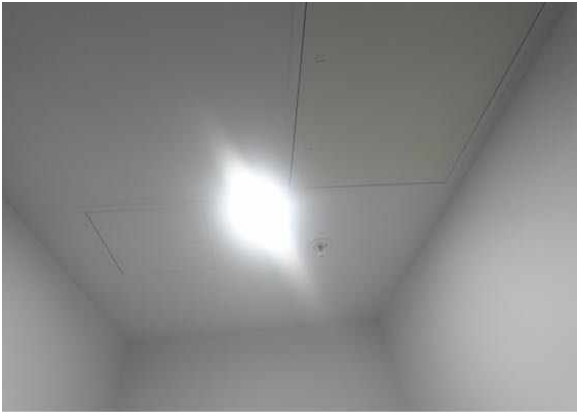
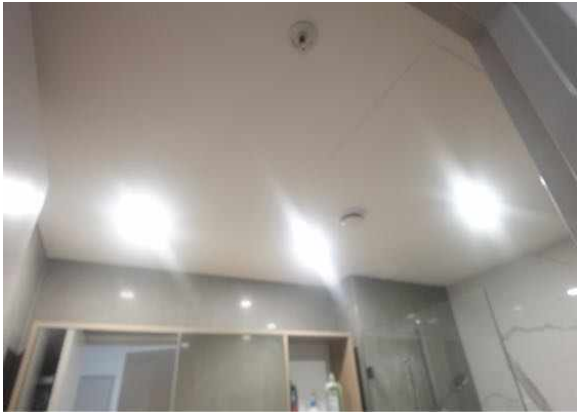
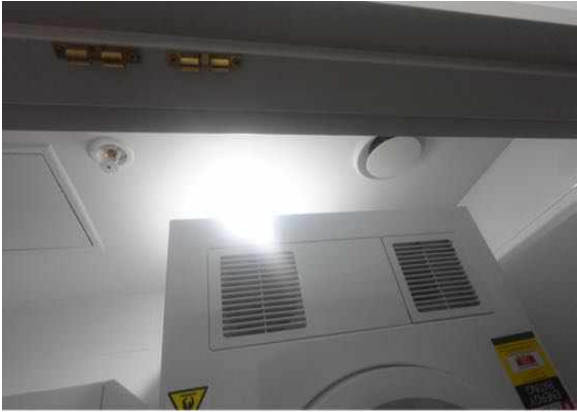
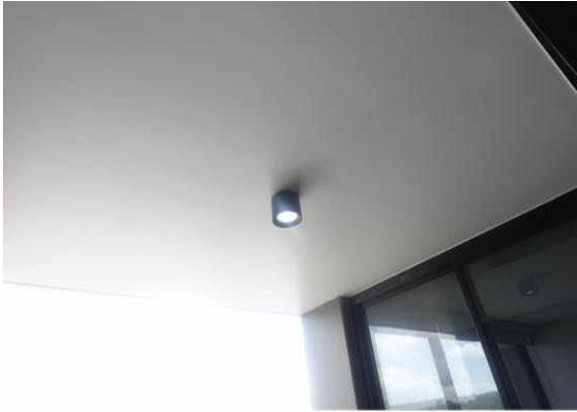
Noted Item

Building:	Main Building
Location:	All Lights
Finding:	Electrical switches and light tested : Visual only
Information:	Electrical inspections are outside the scope of the building inspection and must be conducted by a Licensed and registered Trades person.

It is highly recommended that the client makes arrangements to have the electrical checked by a licensed tradesperson to ensure that they are working safely and efficiently.
