Building and Timber Pest Inspection Report

Inspection Date: Sat, 7 Mar 2026

Property Address: 40C Stoney Creek Rd, Bexley NSW 2207,
Australia

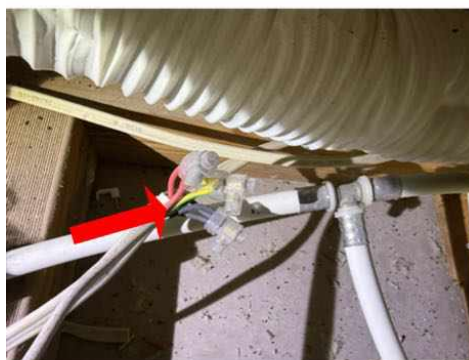
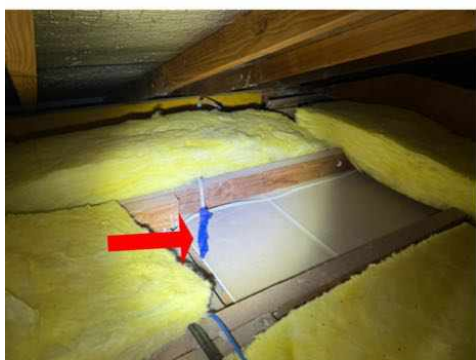
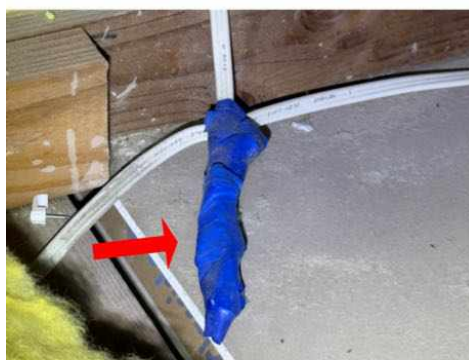
Building:	Building 1
Location:	Roof Cavity - Front and rear
Finding:	Electrical cables missing a junction boxes
Information:	The electrical fittings in these roof areas were found to be missing a junction boxes at the time of inspection.

These pictured missing fittings and loose cables expose electrical works, and may create a safety hazard if there is potential contact with persons in the area.

A Licensed electrician should be appointed to rectify these areas immediately.

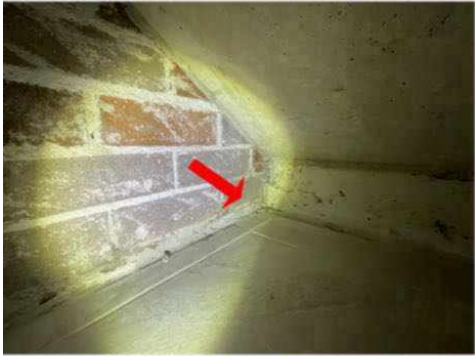
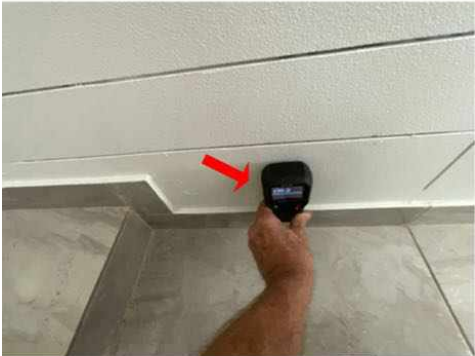
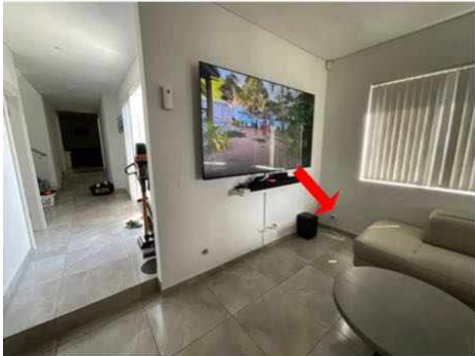
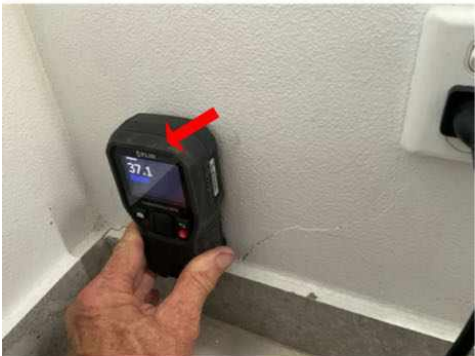
Finding 2.01

Moisture readings of 100 and 69.4 were recorded along with paint damage either side of the central hall area. Staining was also visible under the stairs.

Moisture readings of 1 and 3.3 were recorded above the damaged areas for reference, indicating the damage appeared to be coming from the slab.

The first step in addressing rising damp is to diagnose the cause. The identified cause should be addressed first before addressing the appearance and other defects which have resulted from the rising damp. If the original cause is not resolved, further cases of damp are likely to ensue, resulting in secondary defects.

Consultation with a qualified plumber is advised immediately to identify the cause of the damp and perform remedial works as required.

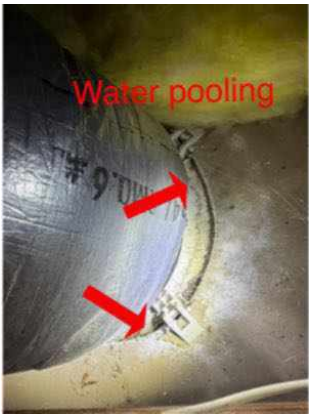
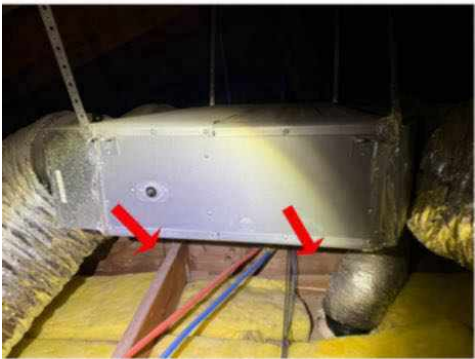
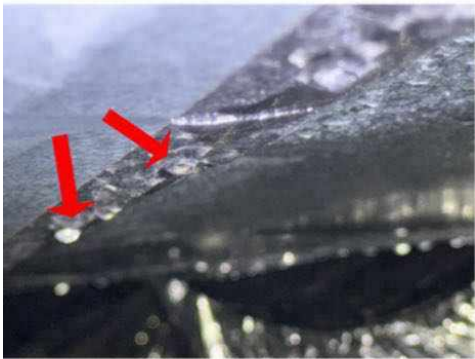
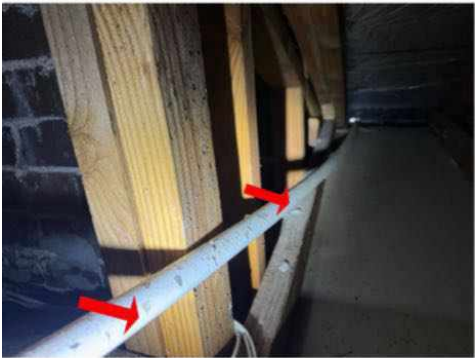
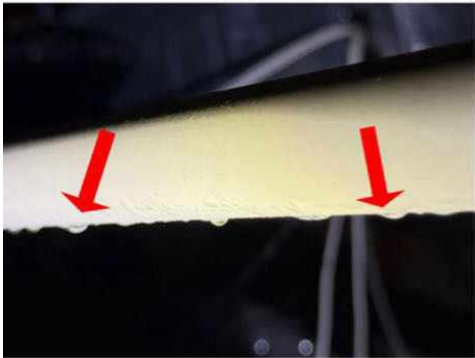
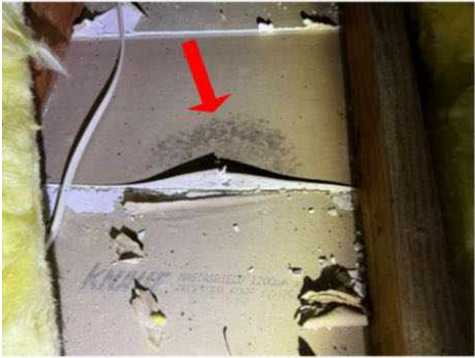
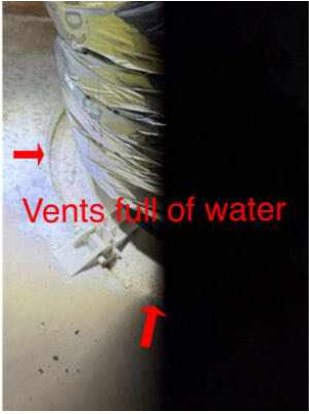
Finding 2.02

Building: Building 1
Location: Roof Cavity - all upper areas
Finding: Air Conditioning Condensation Damage to Ceilings
Information: Evidence of damage to internal ceilings was observed and is consistent with air-conditioning condensation issues. The mould resulting from these damp conditions may affect the health of the occupants. Moisture was found to be dripping off many areas of the main AC unit, pipe and ducting in the roof void. Moisture staining and deterioration indicate that condensate is not being adequately drained or managed, which may be due to blocked or incorrectly installed condensate drains, insufficient insulation to pipework, or unit malfunction. Ongoing moisture exposure has lead to ceiling damage, mould developing and deterioration of building materials.

A licensed air-conditioning contractor should inspect the system, rectify the cause of the condensation, and ensure condensate is correctly discharged. Affected ceiling linings should be repaired or replaced once the moisture issue has been resolved.

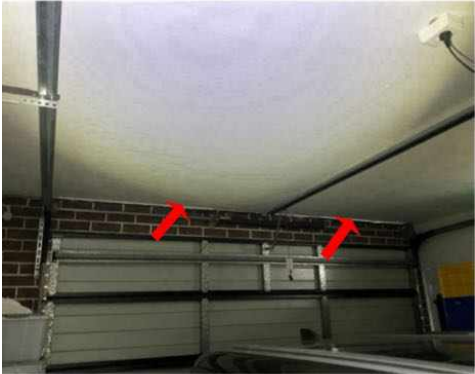
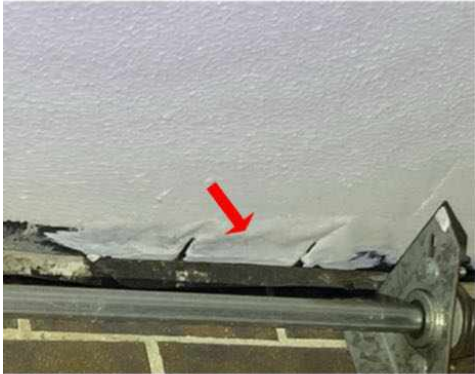
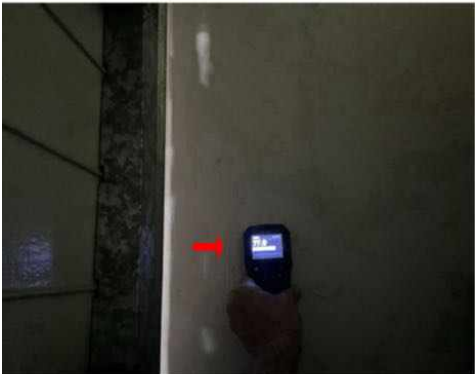
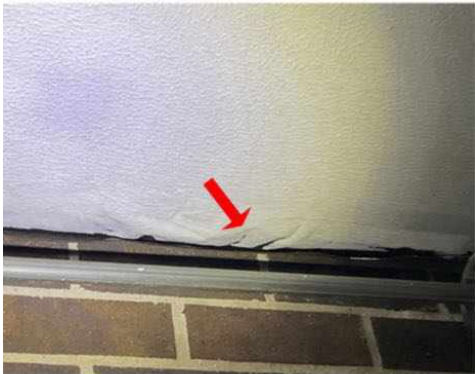
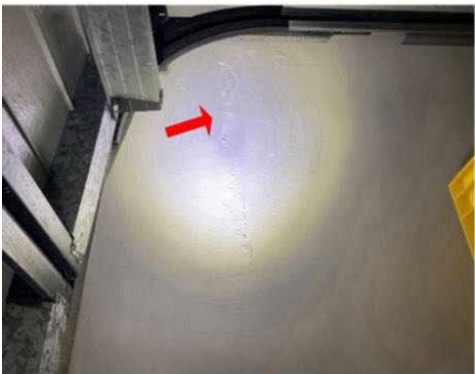
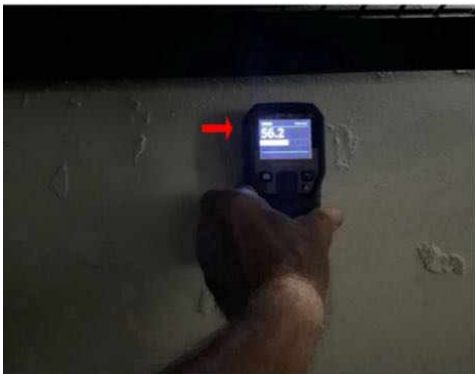
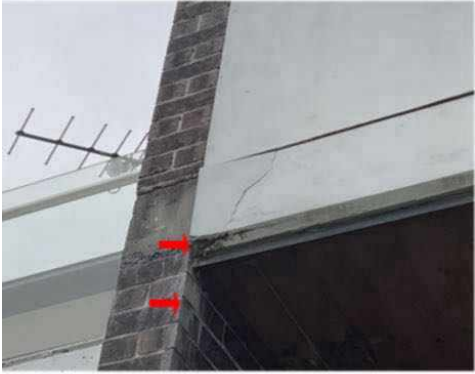
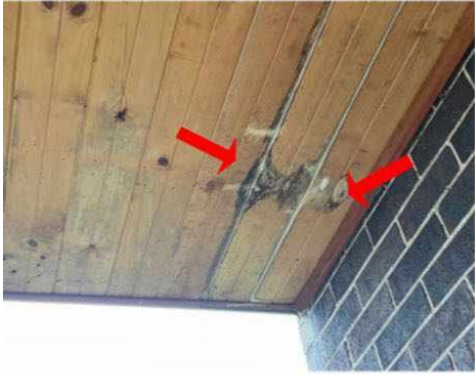
Finding 2.03

Building: Building 1
 Location: Balconies
 Finding: Waterproofing of balconies
 Information: On inspection of the front and rear balconies, it appeared as though the waterproofing has failed. Staining, bubbling and cracking paint was evident in many areas. As water is ingressing through these concrete balconies, there is a risk of concrete cancer developing where the metal reinforcing in the concrete starts to rust, then expand and break apart the concrete. This is listed as a major defect in this report as it is highly likely that it will lead to further damage over time.

On the rear balcony, water appears to be leaking through the balcony damaging the wooding ceiling cladding and rear wall render (see safety defects - loose cladding)

All elevated balconies, stairs and landings need urgent attention to stop further damage.

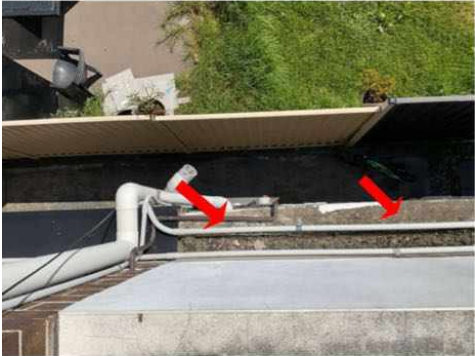
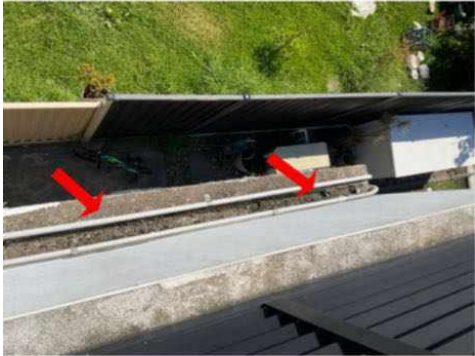
Finding 2.04

Building: Building 1
Location: Pictured rear left pergola wall
Finding: Flashing missing
Information: The roof flashing was missing on the left rear wall at the time of inspection. A channel exists in the rear brickwork for water to pool and create further damage to adjoining walls.

Regardless of the location, if left unmanaged, even minor leaks can lead to serious damage of associated building elements, potentially resulting in the need for replacement of building materials. Here, water is entering the internal left pergola wall. Damage to wall mortar, timber pergola ceiling and wood rot may also arise if this missing flashing is left unmanaged.

A roofing contractor should be engaged to install this missing flashing as soon as possible. This should have been installed before handover by the builder.

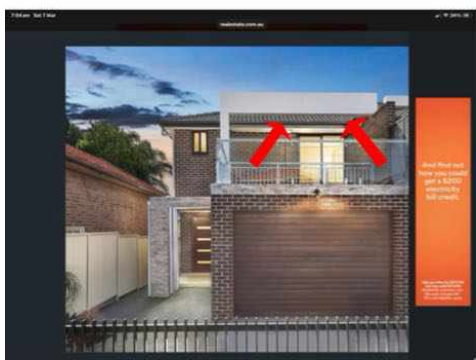
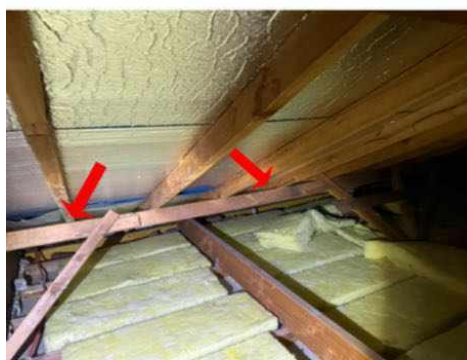
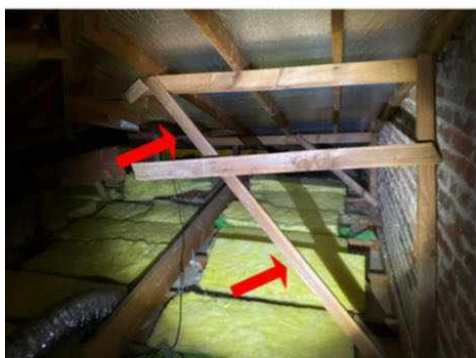
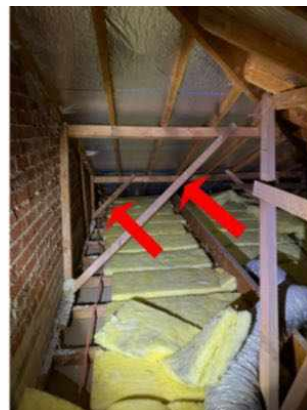
Building:	Building 1
Location:	Roof Void
Finding:	Incomplete / Substandard construction
Information:	These front, front right and rear right roof void areas shows a lack of support which is highly likely to result in further defects over time.

Where a building element is installed in such as way that it fails to achieve the required minimum standard at the time of the inspection, a structural engineer should be sought for advice on these and all internal roofing framing areas.

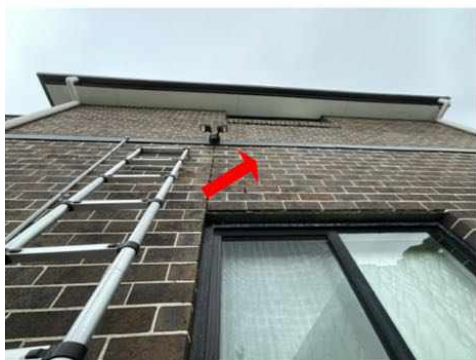
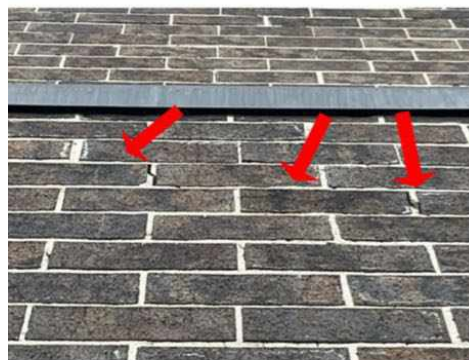
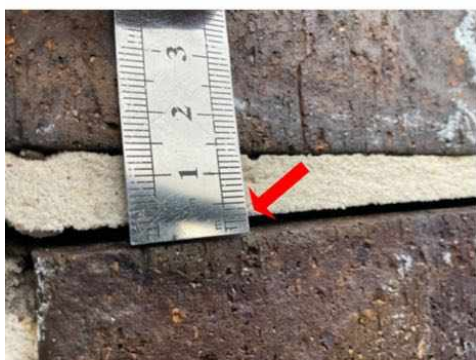
Finding 3.03

Building:	Building 1
Location:	Exterior left upper wall
Finding:	Step cracking to brickwork (minor)
Information:	Step cracking of 3mm was identified to the brickwork in this left area at the time of inspection. Step cracking, which is similar to other forms of cracking, has a variety of possible causes. However, the most common is the subsidence of adjacent footings.

Step cracking is a relatively common defect, and is most likely to occur adjacent to windows, doors and other openings. Mortar failure in the gaps between affected bricks indicates the stresses and tensions affecting the wall.

Where step cracking is extensive or severe (5mm or greater) the client is advised to consult a structural engineer. This minor step cracking can be used as a warning sign to address factors causing stress to the wall, which can include the effect of surrounding trees, water leaks, soil erosion, or even the presence of reactive soils in the surrounding area.

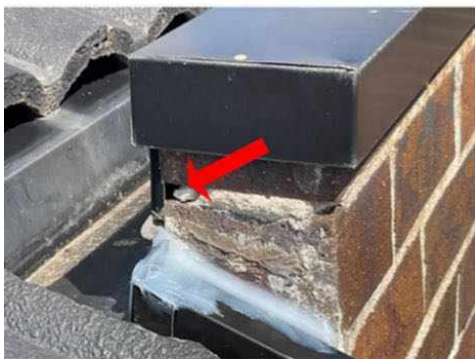
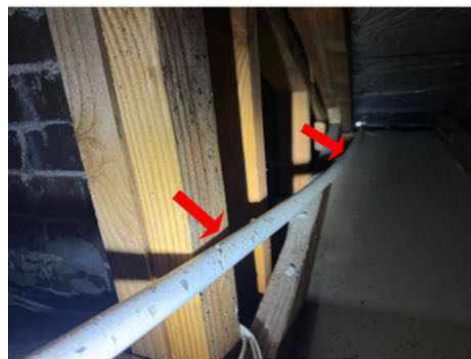
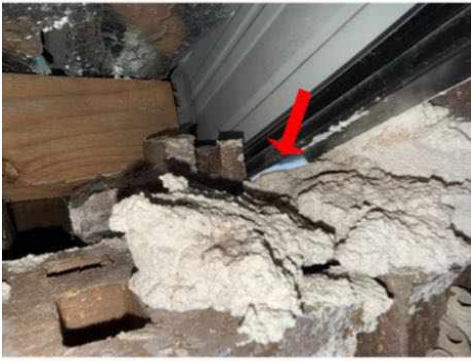
Finding 3.04

Finding: Roof sealant (external) - missing
Information: It was noted on inspection that areas of external sealant was missing to small areas of the left upper middle roof.

It is not clear whether this missing sealant or the adjacent gutter being overwhelmed in large rain events is causing the mould and wall damage in the adjoining internal wardrobe.

Flexible sealants or flashings should be applied to these affected areas to prevent any subsequent water damage that is likely to occur.

A sealant specialist or roofing contractor should be appointed to complete these works as soon as possible. Adjacent roof tiles may be required to be removed to access these areas. If damage continues in the adjacent wardrobe after these repairs, the other possible sources of moisture need to be further investigated.

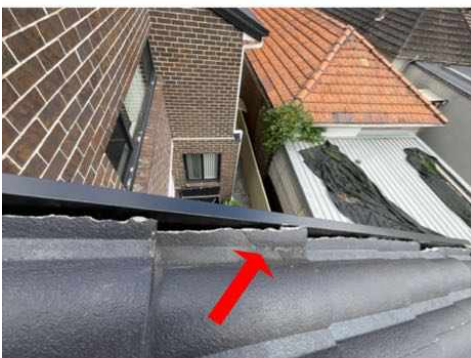
Finding 3.05

Building:	Building 1
Location:	Roof Exterior
Finding:	Roof tiles - weathered
Information:	Upon inspection of the exterior roofing, the majority of roof tiles were considered to be in a good condition. While weathering of the tiles is consistent with the age of the property, maintenance works are required.

Isolated areas of mortar show minor cracking is present. Re-pointing and re-sealing the may be considered as an interim solution by the client to help preserve and extend the life span of the tiles. Where left unmanaged, deteriorating roof mortar and tiles are likely to lead to a number of secondary defects, including minor water leaks and weather exposure to internal roofing structures.

Consultation with a roofing contractor is highly advised to gain advice on cost of remedial works that may be required in the short to medium term. Remedial works are likely to increase the longevity of the exterior roofing structure.

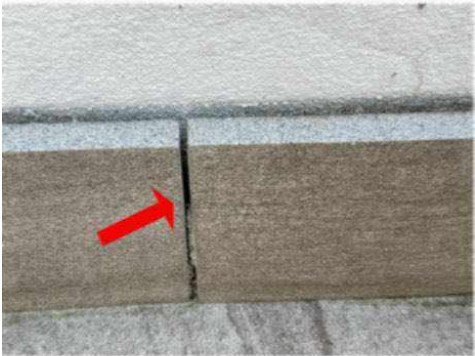
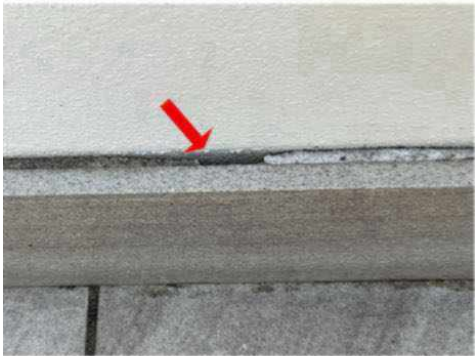
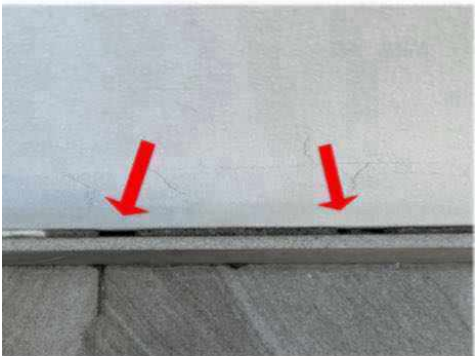
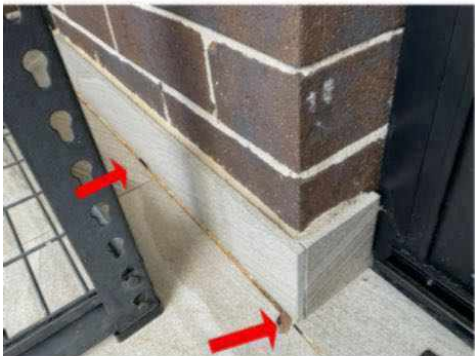
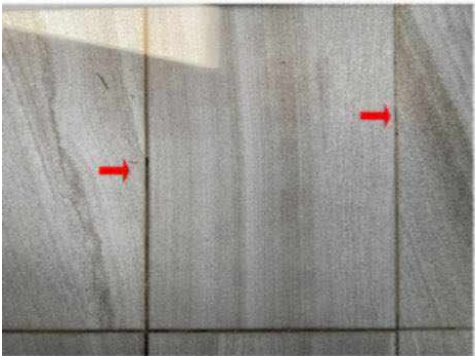
Building: Building 1
Location: Exterior balcony
Finding: Sealant (external) - missing
Information: It was noted on inspection that areas of external sealant was missing to many front and rear balcony areas.

A flexible sealant is required to protect the associated building materials from rainwater ingress. Excessive moisture was found in many garage areas and moisture damage was found on the underside of the rear balcony.

Flexible sealants should be applied to these affected balcony areas to prevent any subsequent water damage that is likely to occur. Both the front cladding sealant and rear balcony sealant appear to be very substandard.

A sealant specialist or should be appointed to complete these works as soon as possible to stop the water damage that's occurring to the lower areas.

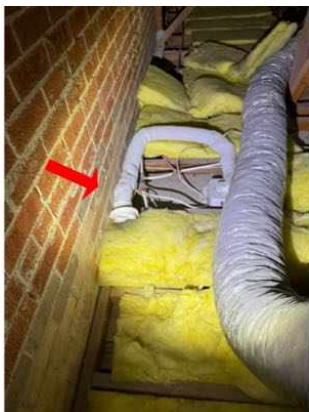
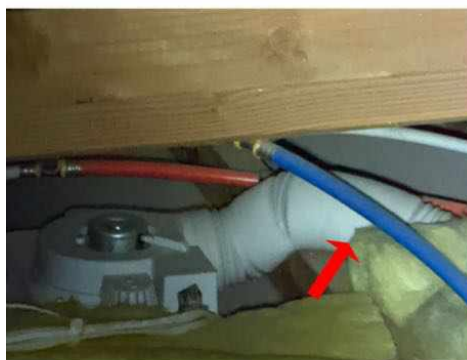
Finding 3.09

Building:	Building 1
Location:	Roof Void
Finding:	Exhaust fan - sarking on roof
Information:	On inspection of the roof void, it was observed that the exhaust fans to the bathroom and ensuite do not exhaust directly to the outside of the building, which is required by the NCC if sarking has been fitted, as it has in this home.

This should be rectified by the builder.

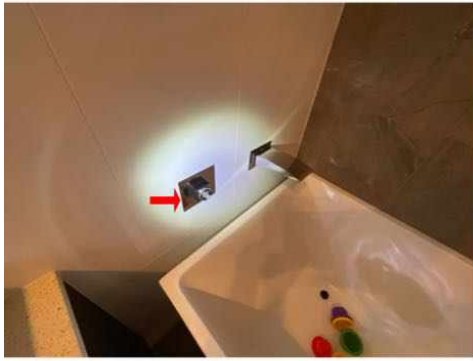
Building:	Building 1
Location:	Pictured external areas
Finding:	Tap missing
Information:	The bath tap handle is broken and missing over the bath.

A licensed plumber would be the trade responsible for rectification of this tap when convenient.

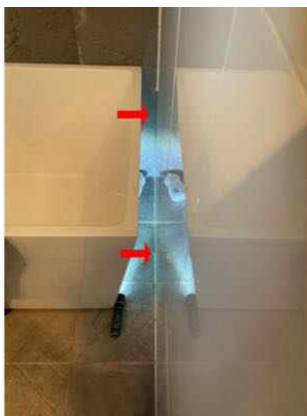
Finding 3.12

Building:	Building 1
Location:	bathroom and other areas
Finding:	Sealant and grouting - Missing or damaged
Information:	It was noted on inspection that sealant or grout is degraded to these pictured areas.

Different materials and floor areas move at different rates, generally causing cracking to grout or sealant at this point. A flexible sealant is required to allow for expected expansion and contraction, while keeping the joint water tight and protective of all associated building materials.

Flexible and mould resistant materials should be applied to affected areas to prevent any subsequent water damage that is likely to occur. Regular maintenance and replacement of damage or missing or damaged sealant and grout is highly recommended to the wet areas, as this is a regular wear and tear defect. Sealant and grouting in areas that come into regular contact with water should be maintained for the long term care of your property.

A sealant specialist or tiling contractor should be appointed to complete these works as soon as possible

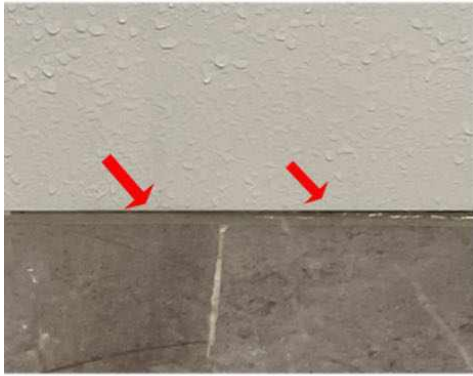
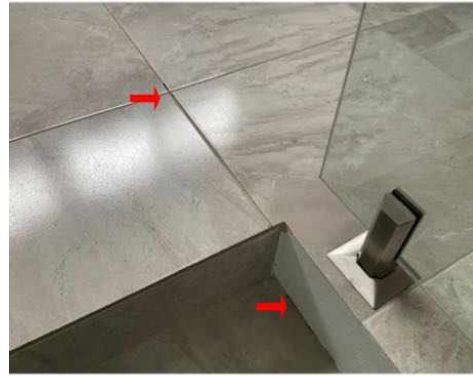
Finding 3.13

Finding: Shower screens - Leaking

Information: Leaking was evident to two shower screens at the time of inspection. It is suspected that the leaking has occurred as a result missing sealant. Leaking from the showers, where left unattended, is likely to lead to water damage to adjoining flooring and walls. Such damage can lead to water damage and necessitate extensive remedial works being required. Active water leaks may also create an environment that is susceptible to the formation and development of mould.

Appointment of a sealant expert is required to repair or replace this missing sealant. Such works should be performed as soon as possible to ensure that no further damage occurs.

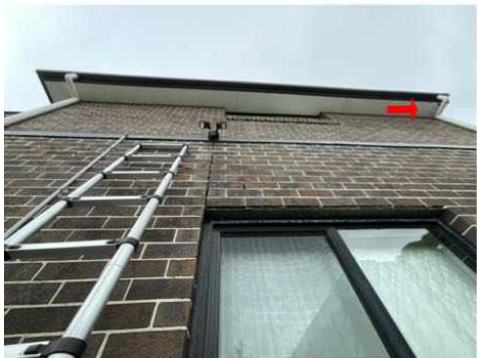
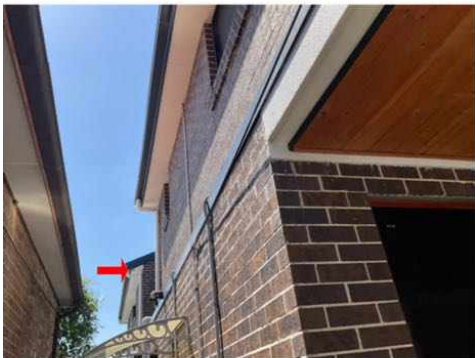
Where evidence of mould growth was noted in the eaves, it is suspected the size of the gutters is insufficient in heavy rain events. It is thought rainwater is overflowing back into these eave areas during these events. It is recommended to consult a roofing contractor for further advice. No roof tile damage was evident in these areas of mould.

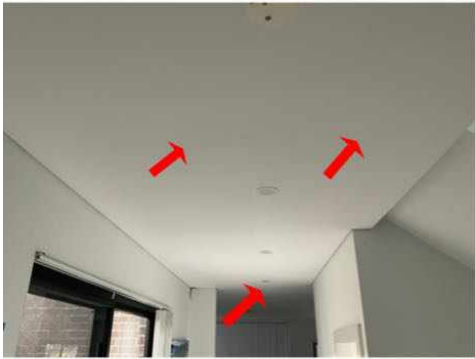
Building:	Building 1
Location:	Some areas
Finding:	Cracking - Damage Category 1 - Fine (up to 1mm)
Information:	Although fine cracks are quite noticeable, they are often only considered to be an appearance defect, and usually do not indicate any structural damage. Generally, the cause of a fine crack is indicative of a separation between building materials and finishes (e.g. paint, plaster, etc.) along joins.

Cracking of this nature can generally be repaired with minor sanding, filling and/or repainting. Such works should be performed by a qualified painter or a general handyman.

Monitoring of all cracking should be conducted frequently. Always contact a building inspector should cracks widen, lengthen, or become more numerous.

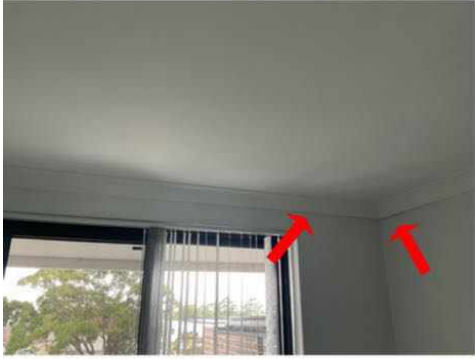
Building: Building 1
Location: Many rooms
Finding: Cracks to internal render - Category 1
Information: It has been observed that many areas of cracking to internal rendered surfaces has occurred. The degree of damage falls within Category 1, described as fine cracks that do not need repair and which are less than 1.0mm in width limit. (See also step cracking defect)

Damage of this category is not considered a defect for rectification. Always contact your building inspector should cracks widen, lengthen, or become more numerous.

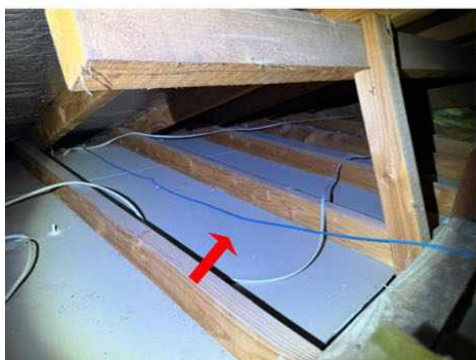
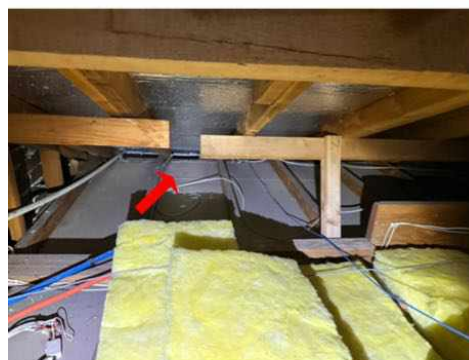
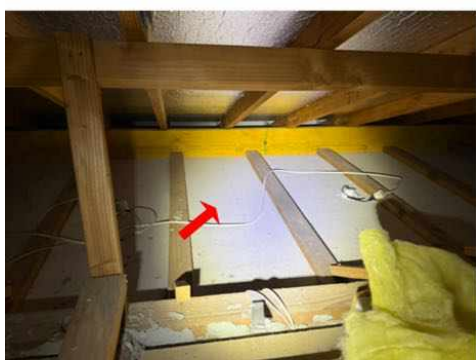
Building:	Building 1
Location:	Roof Void
Finding:	Insulation - Missing in some areas
Information:	Upon inspection of the roof void it was noted that insulation is not present to some roof void areas.

Insufficient insulation will result in a comparatively higher cost to heat and cool a property as there is a lack of Insulation (or uneven coverage of insulation) which works as a barrier to heat transfer. This helps to keep out unwanted heat in summer and preserves warmth inside your home in winter. It can also help soundproof your home from unwanted airborne noise transfer.

Where insulation is absent, the area does not meet current Australian Standards. Installation of adequate insulation is required and should be conducted as soon as possible.

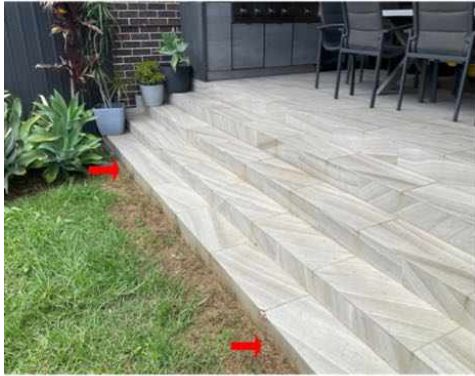
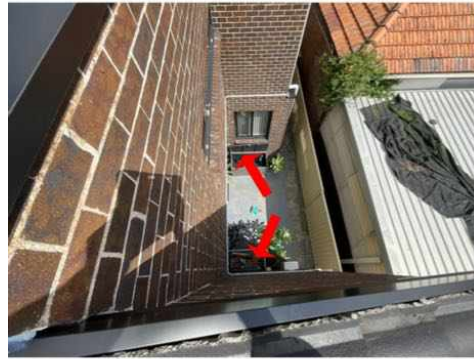
Building:	Building 1
Location:	Meter Box
Finding:	Termite Management System - no evidence of a chemical installation
Information:	The application of a post-construction chemical termite barrier is highly recommended for all properties. Such barriers are highly effective in preventing termite attack on any timber building elements throughout the property.

If the slab edge is not properly exposed there is a high risk of termite attack. Sometimes, in order to determine the type of slab, a suitably qualified person such as an architect or builder may be required to consult the construction plans.

The client may consider gaining further advice from a pest controller as to the costs and procedures involved with a 'chemical' application. It is recommended that obtaining such advice be a short-term priority.

Where the slab edge cannot be properly inspected, it is highly recommended that termite or timber pest inspections be carried out every 6-12 months to aid protection of the property against infestation.

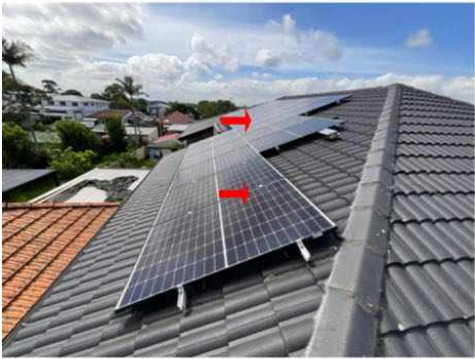
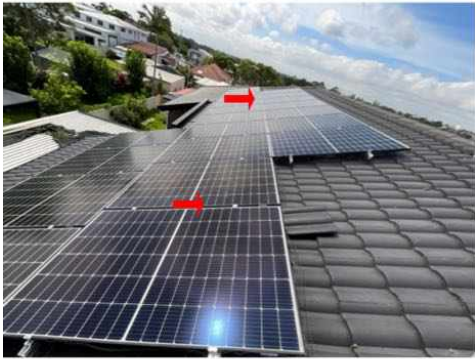
Building: Building 1
 Location: All External Areas
 Finding: Additional Photos - Obstructions and Limitations of EXTERNAL AREAS
 Information: These photographs are an indication of the obstructions and limitations which impeded full inspection of external areas at the time of inspection. These obstructions can hide an array of defects and should be removed to allow full inspection to be carried out. A re-inspection is recommended once the areas are made accessible.

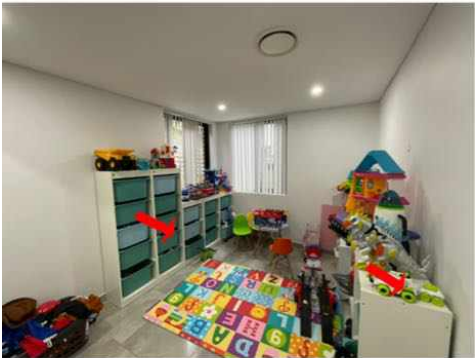
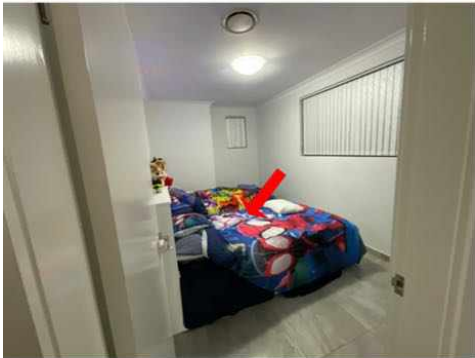
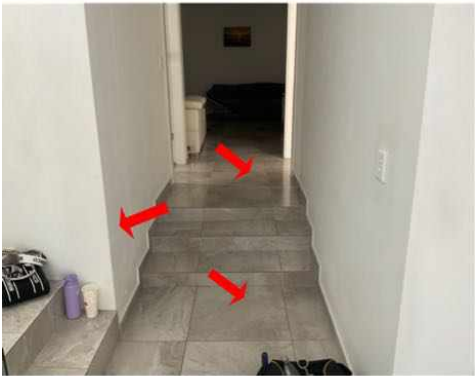
Building: Building 1
Location: All Internal Areas
Finding: Additional Photos - Obstructions and Limitations of INTERNAL AREAS
Information: These photographs are an indication of the obstructions and limitations which impeded full inspection of Internal areas at the time of inspection. These obstructions can hide an array of defects and should be removed to allow full inspection to be carried out. A re-inspection is recommended once the areas are made accessible.

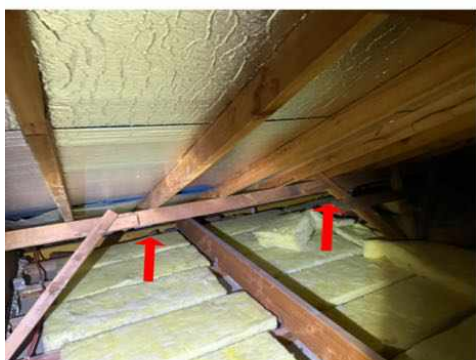
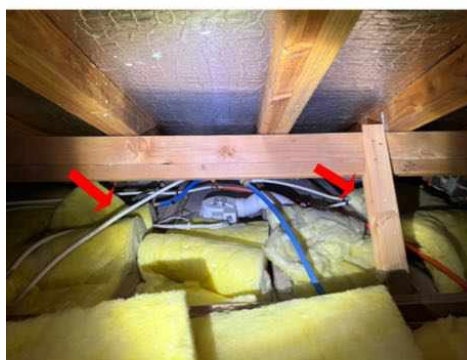
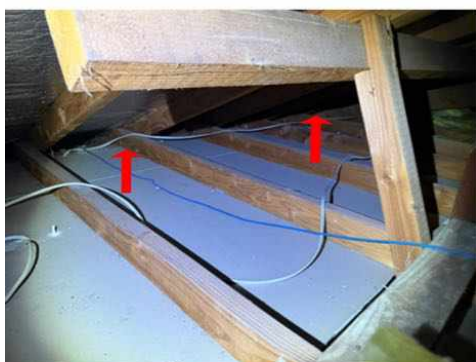
Building: Building 1
 Location: All Roof cavity areas
 Finding: Additional Photos - Obstructions and Limitations of the ROOF CAVITY
 Information: These photographs are an indication of the obstructions and limitations which impeded full inspection of roof cavity areas at the time of inspection. These obstructions can hide an array of defects and should be removed to allow full inspection to be carried out if applicable. A re-inspection is recommended once the areas are made accessible.

The inspection was also limited to areas with an allowable crawl space of 600mm x 600mm, in particular towards the external walls where the roof line diminishes, these areas were not accessible.

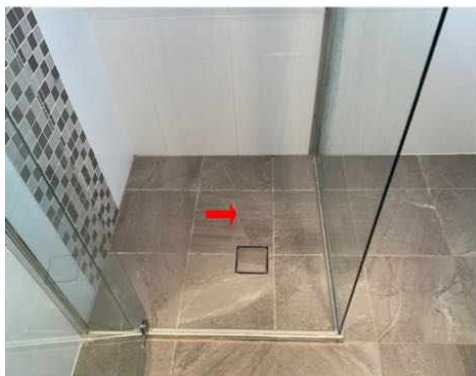
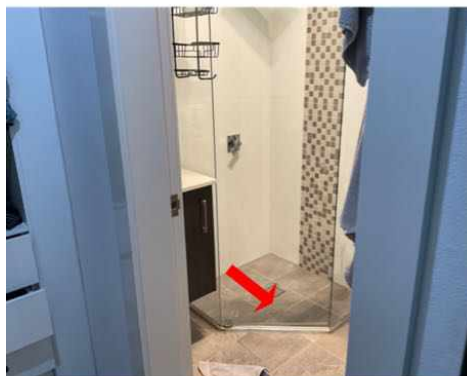
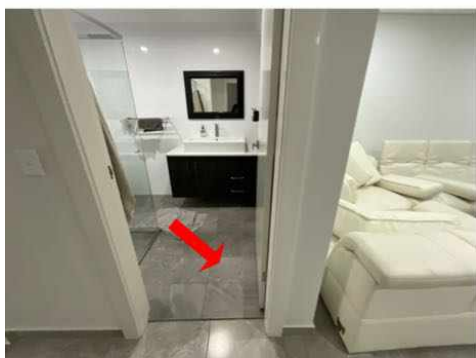
Building: Building 1
 Location: Bathrooms and laundry
 Finding: Waterproofing membranes - Information Only
 Information: Internal Water Proofing Membranes, are crucial in preventing water ingress into the property is important to know that the Membrane System used is to Australian Standards and has been installed correctly.

With older property's where this information is unavailable all wet areas should be monitored. If any leaks, water staining, peeling or bubbling of the paint become evident to any adjacent walls or ceilings below a licensed builder or waterproofing specialist is recommended to investigate further.

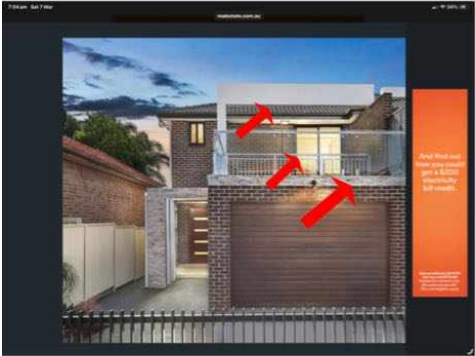
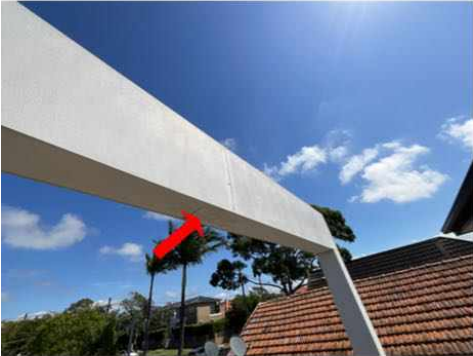
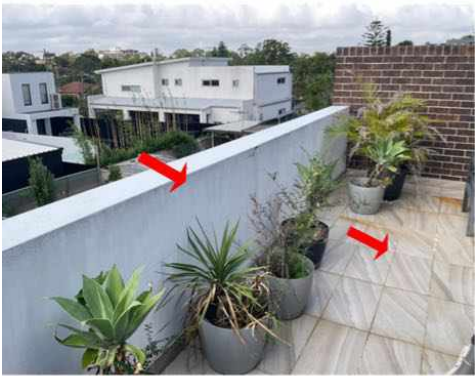
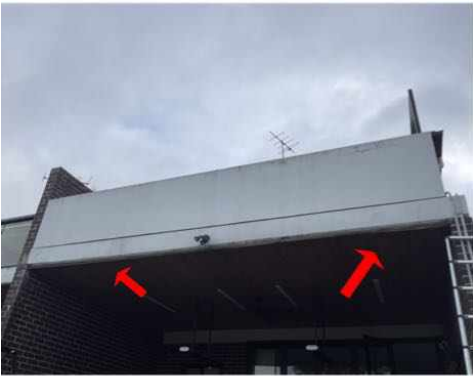
Building: Building 1
 Location: Verandahs
 Finding: Elevated structure inspections
 Information: Where any elevated Structure (deck, balcony, verandah etc) is present, and this elevated structure is designed to accommodate people, you MUST have this structure checked by an engineer or other suitably qualified person.

has been made, on any elevated structure, as suitable for any specific number of people or purpose. This can only be done by a qualified engineer. For the purpose of this report, the Structure includes the elevated verandahs and handrails that show water damage areas and appear to have failed waterproofing membranes.
