Building and Timber Pest Inspection Report VR

Inspection Date: Thu, 5 Feb 2026

Property Address: 8 Moyston Ct, Thornlands QLD 4164,
Australia

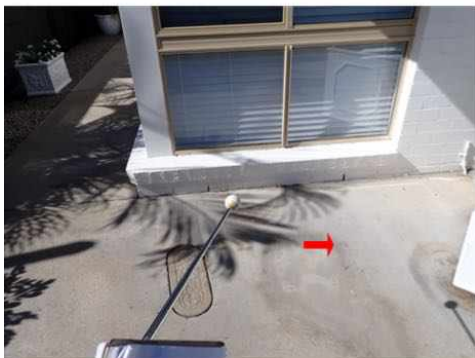
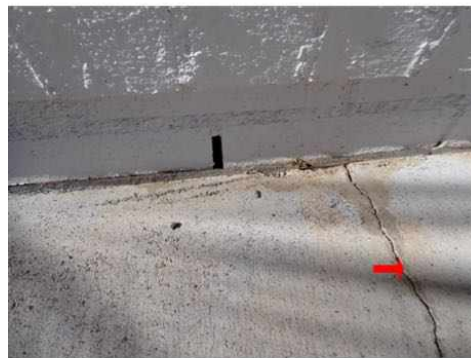
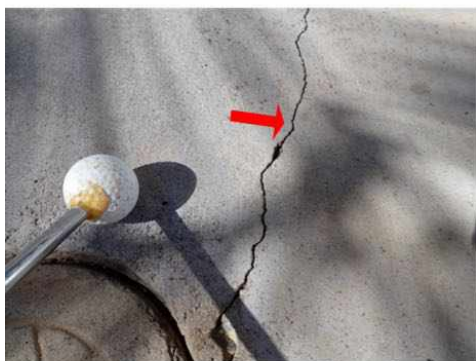
Building: Main Building
Location: Yard - Front > Front Left
Finding: Cracking - External Concrete Paving Damage Category 1 - Fine (less than 2mm)
Information: Fine cracks were identified in the front left side external concrete paving, and other areas of this building. Although fine cracks are quite noticeable, they are often only considered to be an appearance defect, and usually do not indicate any structural damage. To be considered a Category 1 or fine crack, the crack is found to be less than 2mm in width.

Generally the cause of a hairline crack in existing concrete paving such as driveways and pathways is indicative of the expansion and contraction of the concrete. Such causes are generally due to environmental factors, such as moisture levels, weather conditions, root systems of nearby trees or the soil types on which they are laid.

Fine cracks may also be due to poor original installation of the concrete. Factors such as poor compaction of the sub surface and/or inadequate reinforcing of the slab may create cracking and other secondary defects.

Monitoring of all cracking should be conducted frequently. Always contact a building inspector should cracks widen, lengthen, or become more numerous.

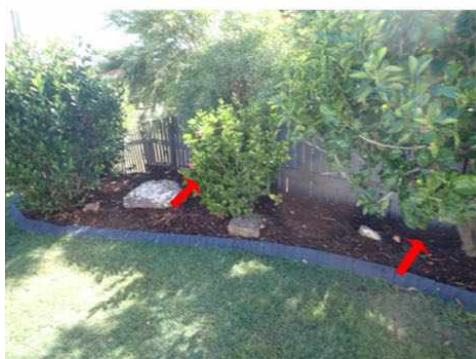
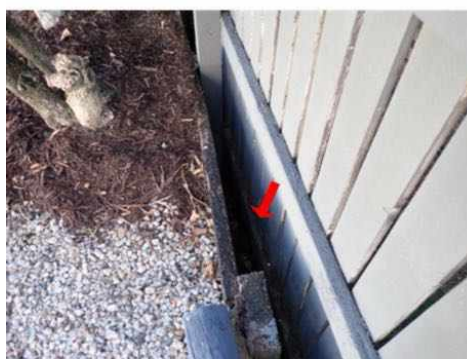
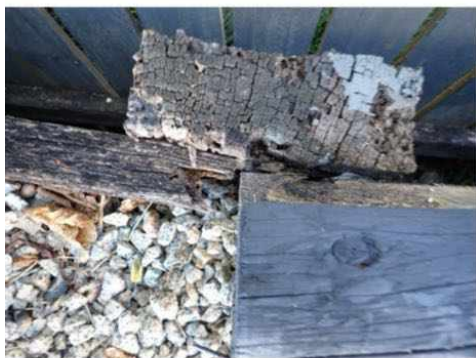
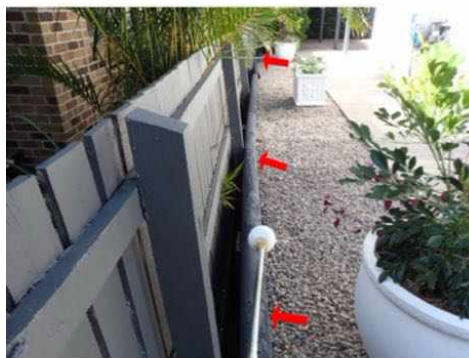
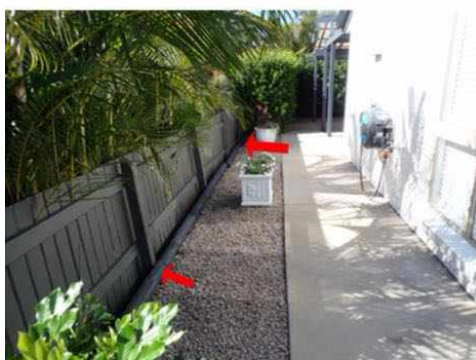
Finding 3.02

Building:	Main Building
Location:	Yard -Left > All Areas
Finding:	Retaining wall - Defective
Information:	The side boundary retaining wall was found to be noticeably leaning and in a minor deteriorated condition, and is defective at the time of inspection. Generally, defective retaining walls are caused by poor original design or material use. However, deteriorated retaining walls may also be a result of substandard construction, poor site drainage or unmanaged stormwater flows.

If left unmanaged, the retaining wall may become a safety hazard if it continues to destabilise. Where retaining walls further rot and decay, an environment is created that is conducive to termite and pest infestation.

Significant repair and replacement should be expected. Where retaining walls are considered structural walls, a structural engineer / surveyor should be consulted regarding required remedial works. Otherwise, a landscaper or retaining wall installer may be appointed to repair or replace the wall, at the discretion of the client.

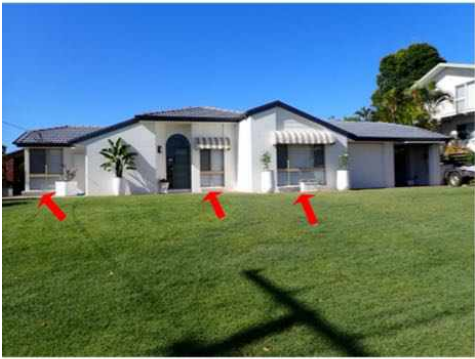
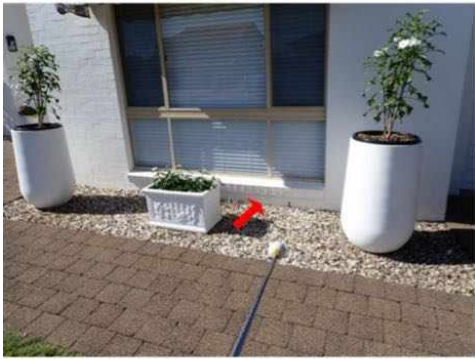
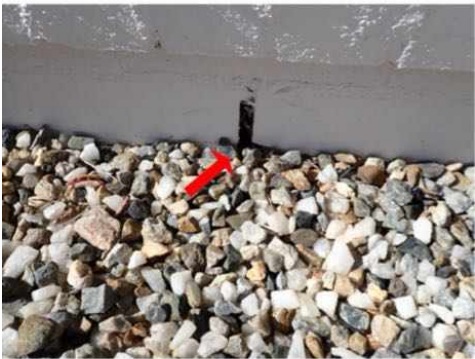
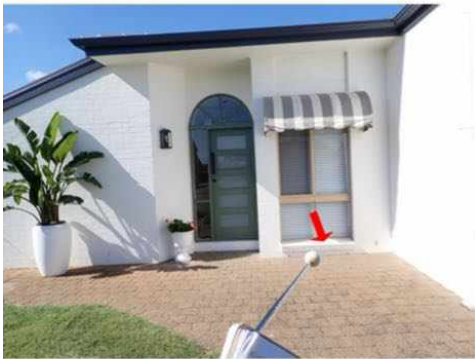
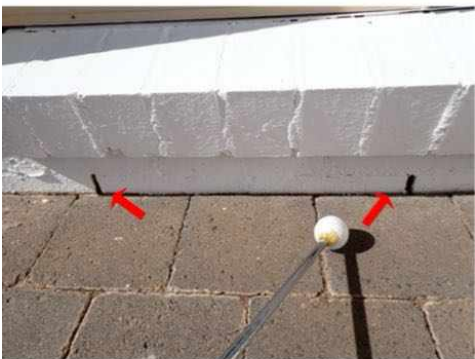
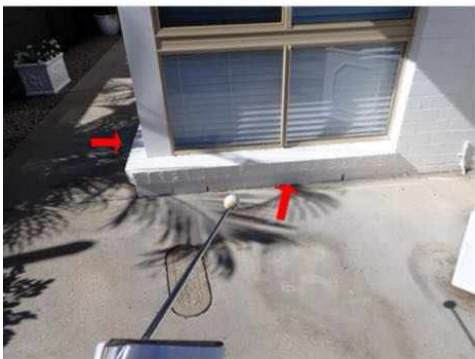
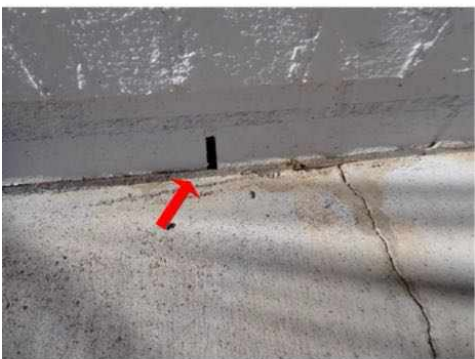
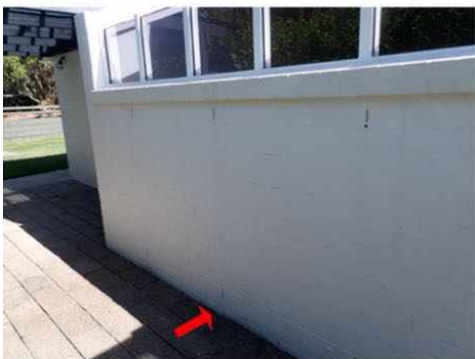
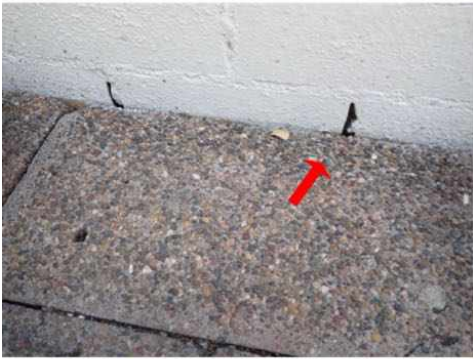
Finding 3.03

Building:	Main Building
Location:	Exterior walls Front/Rear > All Areas
Finding:	Weep holes - Blocked
Information:	It was noted during the time of inspection that some of the weep holes to areas of the brickwork were blocked or covered by landscaping or paving. Weep holes are designed to allow water from leaks or seepages in brickwork to be directed to the external environment, prior to entering the wall cavity or associated building materials. Weep holes should therefore be kept clean and free of debris or blockages.

Blocked weep holes are likely to result in the presence of excessive moisture within the brickwork and associated structures, creating potential for water damage and moisture problems.

Depending on the nature of the blockage, the homeowner may be able to undertake remedial works to remove blockages. Alternatively, appointment of a registered builder may be required to remove blockages. Preventative works are necessary in ensuring the structural integrity of the affected brickwork and should be performed as soon as possible.

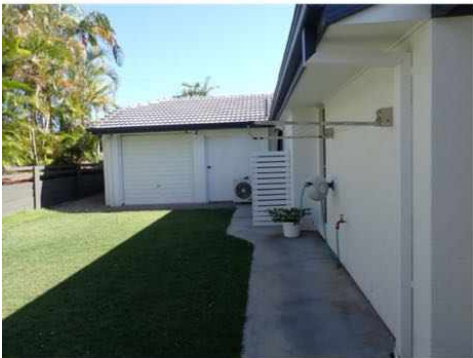
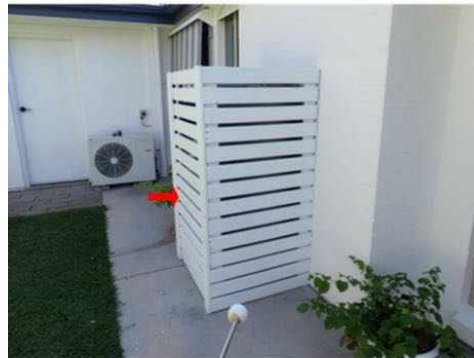
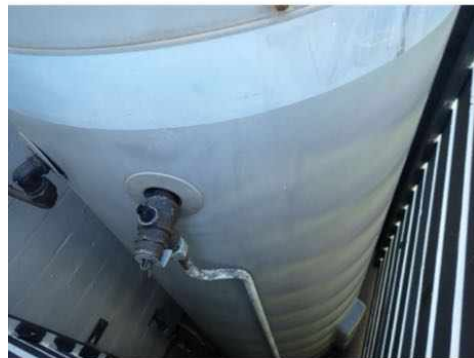
Finding 3.04

Building:	Main Building
Location:	Exterior walls - right side > Centre Right
Finding:	Hot water unit to close to wall.
Information:	The electrical hot water unit has been installed too close to the external wall and enclosed in a fixed timber screen that restricts inspection for termite activity and general servicing. This is conducive to termite activity, and it is recommended it be moved away from the wall to create a visual barrier for inspection purposes. A plumbing contractor could complete this task.

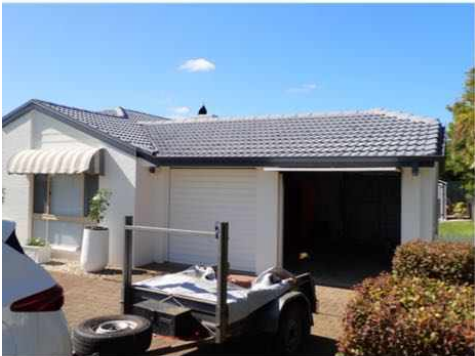
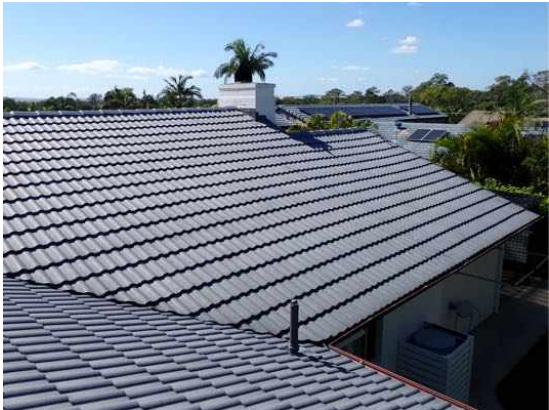
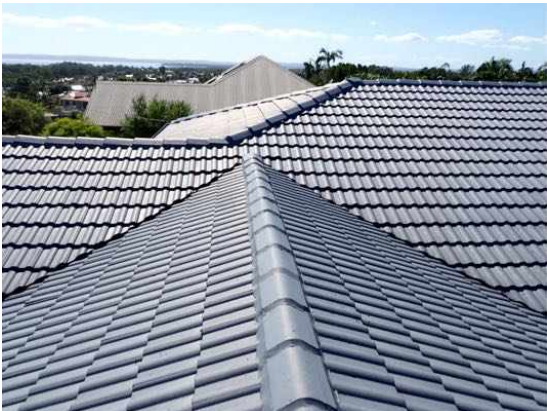
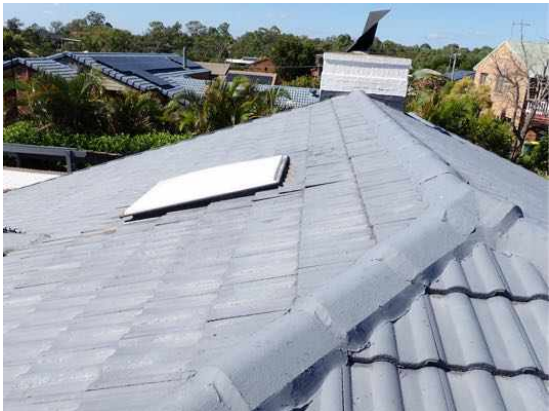
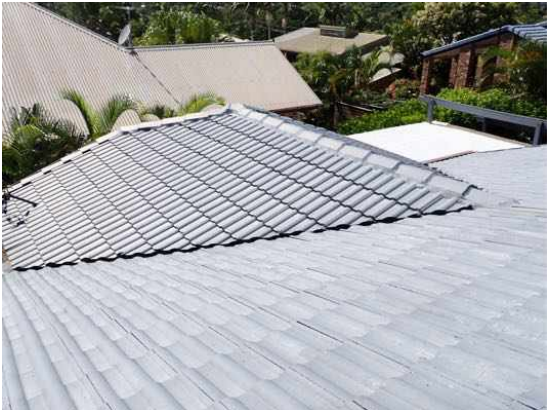
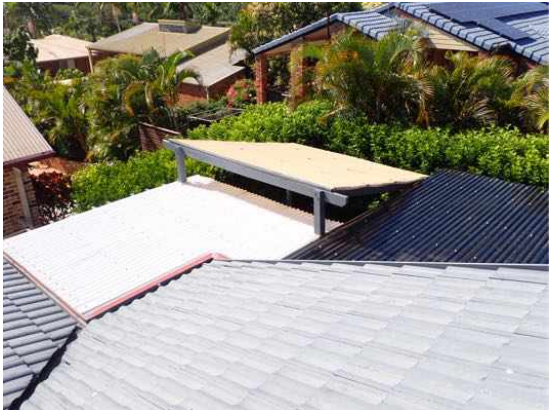
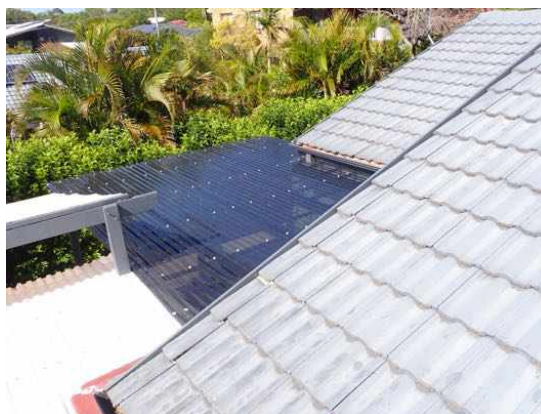
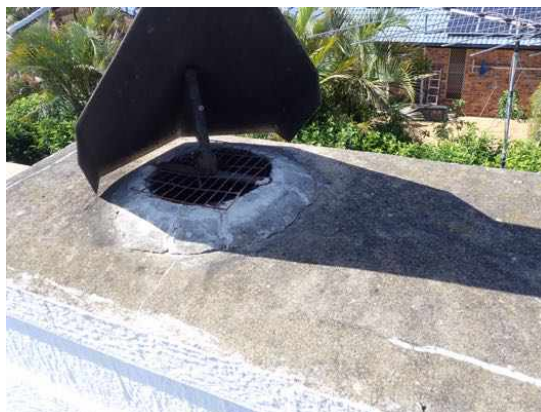
Finding 3.05

Building: Main Building
Location: Roof Exterior > All Areas
Finding: Roof Condition
Information:

The concrete tiled roof on this building appears to have been fully serviced and re coated in the past many years, and is in fair condition at the time of this inspection.

Isolated areas of the painted tile surfaces are showing signs of minor environmental deterioration, and should be recoated to reduce the risk of further deterioration occurring.

A handyman can complete this job.

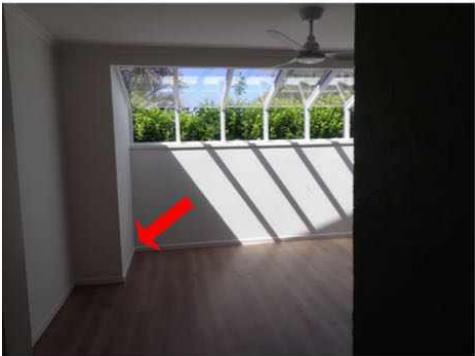
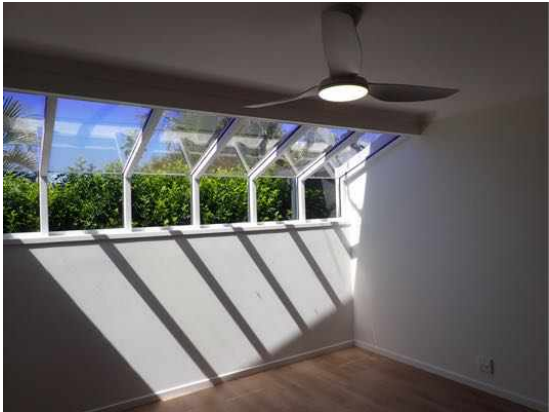
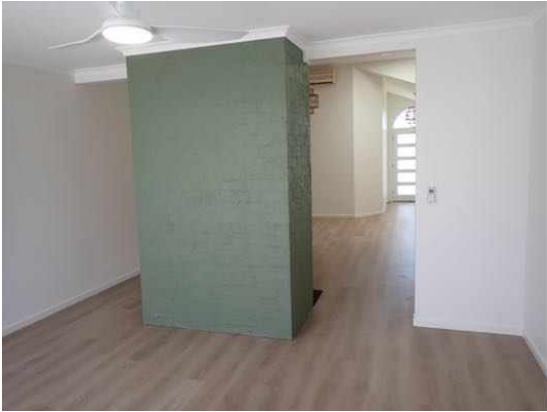
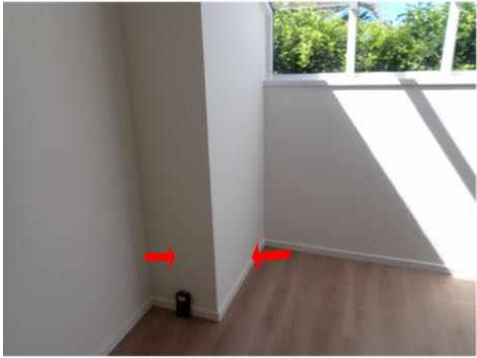
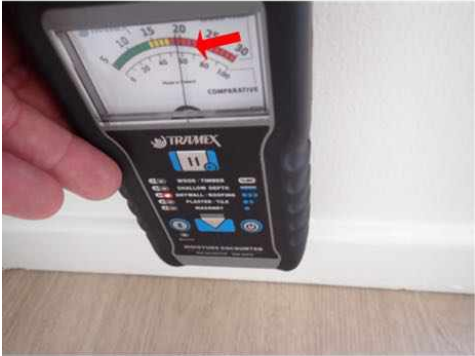
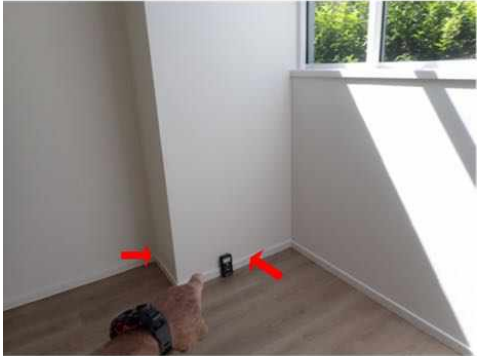
Finding 3.06

Building: Main Building
 Location: Sunroom > Rear Left
 Finding: moisture meter readings
 Information: There was a slightly high moisture meter reading of between 20/22 % in the rear left side sunroom external wall area at the time of this inspection. This can be caused by water ingress into the wall cavity from external sources or a possible plumbing leak . Wet areas can also have a potential failure to the water proofing membrane causing potential water issues.

This can also be conducive to termite activity, and this area should be monitored for any changes .

A licensed plumbing contractor or waterproofing contractor should inspect this area and report .

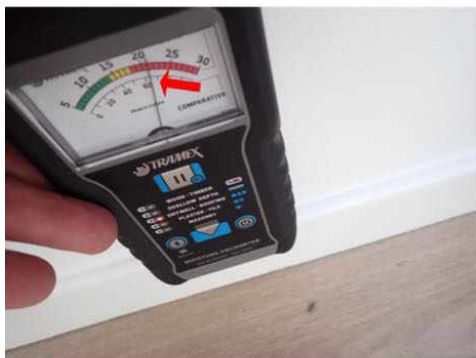
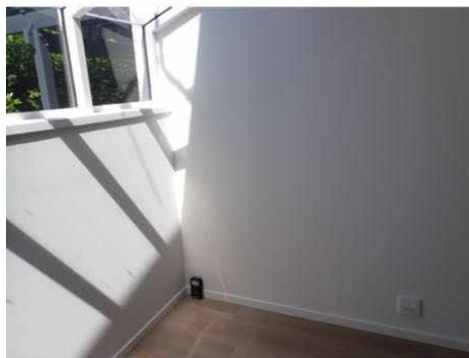
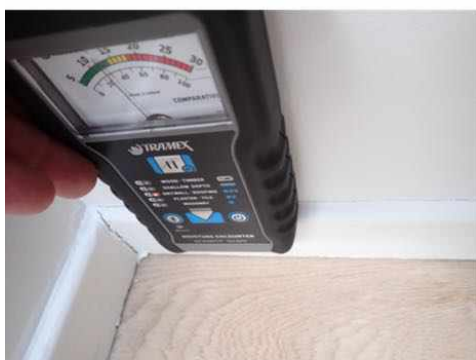
Finding 3.07

Building: Main Building
 Location: Bedroom - Master > Front Right
 Finding: moisture meter readings
 Information: There was a slightly high moisture meter reading of 22 % in the master bedroom front right side entry wall area that backs onto the master bedroom ensuite shower area at the time of this inspection. This can be caused by water ingress into the wall cavity from external sources or a possible plumbing leak . Wet areas can also have a potential failure to the water proofing membrane causing potential water issues. A licensed plumbing contractor or waterproofing contractor should inspect this area and report .

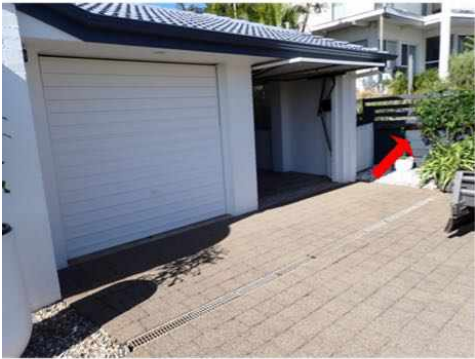
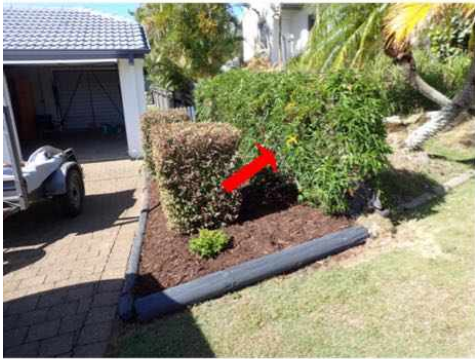
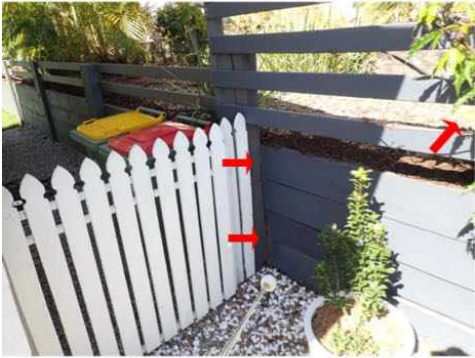
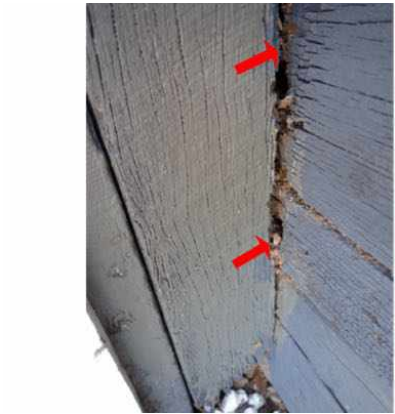
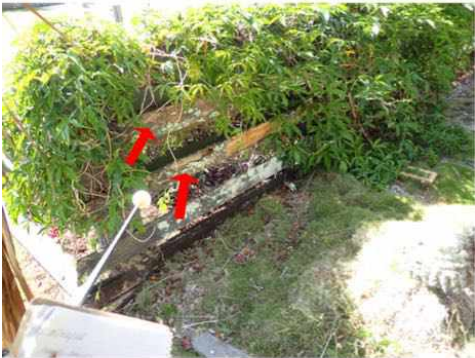
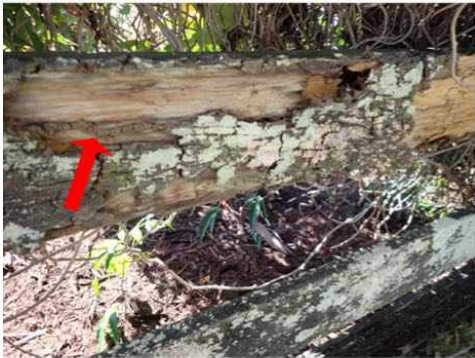
Building: Main Building
 Location: Yard - Front > Front Right
 Finding: Evidence of termite damage - minor
 Information: Despite no live termite or timber pest activity being indicated, previous termite damage was found to have affected the front right side boundary timber fencing and retaining walls area. This damage is suspected to be inactive and is suspected to be minor in nature.

It is advised that the area be visually inspected frequently to ensure that the condition of affected building materials does not worsen. At the time of inspection, damage is not structural and is only considered to be superficial.

A building contractor may be appointed to provide a further invasive inspection if further damage is evident.

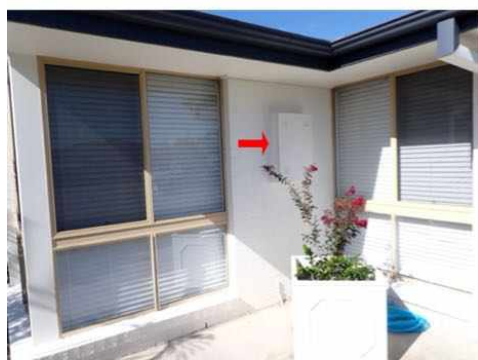
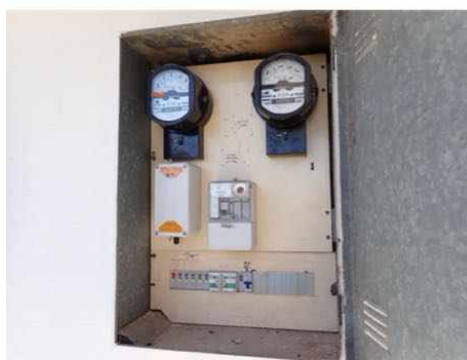
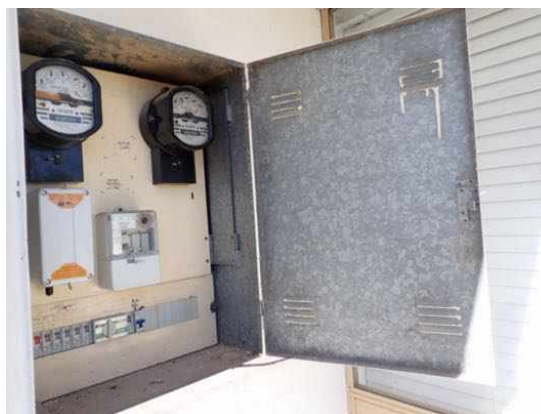
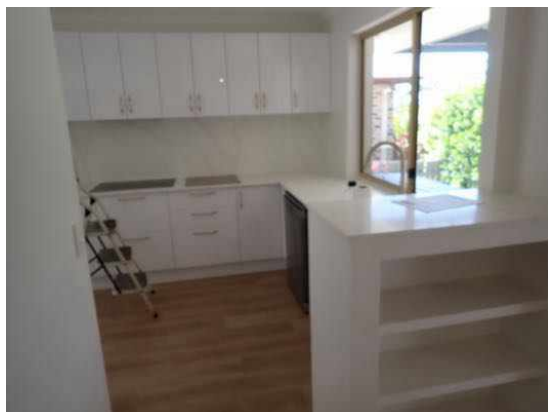
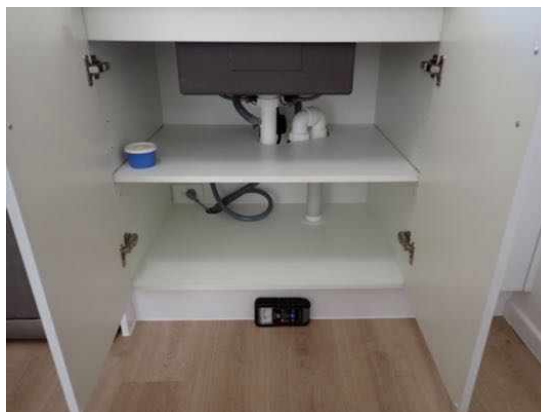
Finding 6.01

There was no evidence found to indicate that this property has been inspected or treated for general pest or timber pest (termites) within the past 12 months as recommended.

A durable notice should be placed in the switchboard unit to indicate current termite barriers. At the time of inspection, it appeared as though no termite management system has been installed, with no evidence to suggest preventative works taking place.

The client should produce any relevant paperwork to confirm these inspections have been conducted, otherwise a general pest treatment and termite visual inspection at a minimum requirement with a chemical termite barrier area recommended as soon as possible.

The application of a post-construction chemical termite barrier is highly recommended for all properties, particularly if live termite activity has been found on the site previously. Such barriers are highly effective in preventing termite attack on any timber building elements throughout the property.

The client may consider gaining further advice from a pest controller as to the costs and procedures involved with this application. It is recommended that obtaining such advice be a short-term priority.

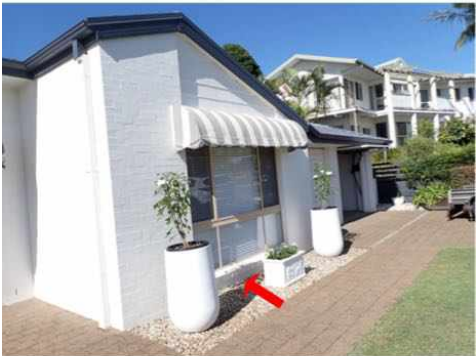
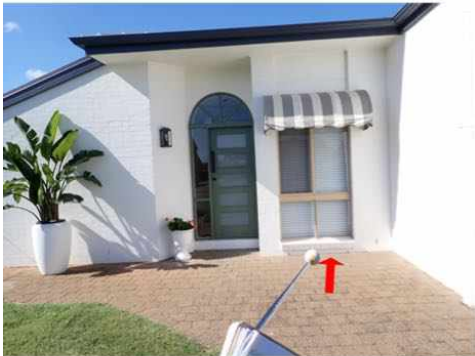
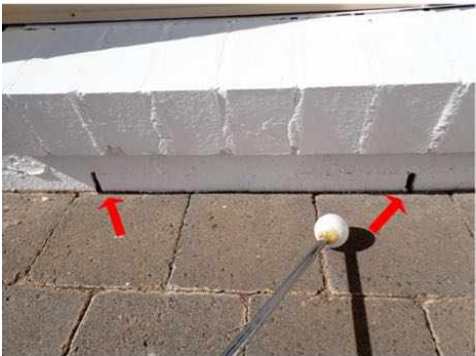
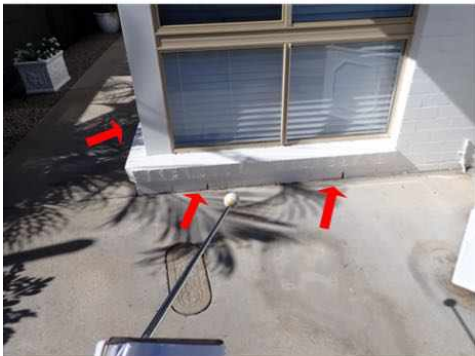
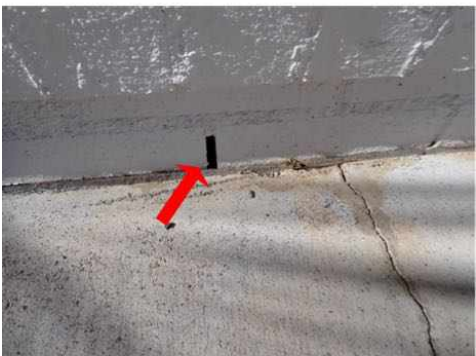
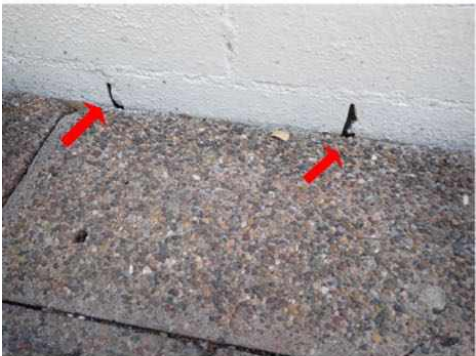
Finding 6.02

Building:	Main Building
Location:	Exterior walls > All Areas
Finding:	Slab Edge - Exposure
Information:	Masonry wall weep holes throughout areas of this building were found to be blocked or below finished natural ground or paving levels .

If the slab edge or weep hole line is not properly exposed there is a high risk of termite attack. Sometimes, in order to determine the type of slab, a suitably qualified person such as an architect or builder may be required to consult the construction plans.

Where the slab edge or weep hole line cannot be properly inspected, it is highly recommended that termite or timber pest inspections be carried out every 6-12 months to aid protection of the property against infestation.

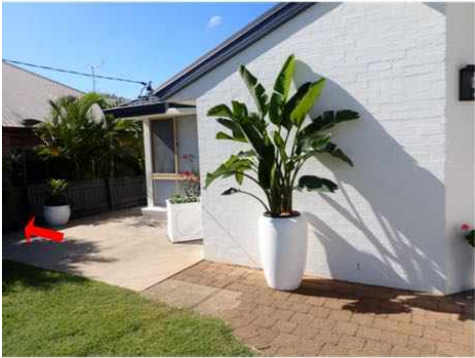
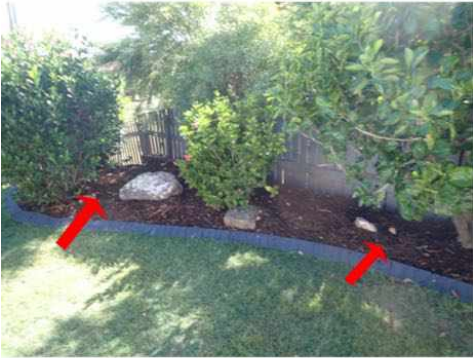
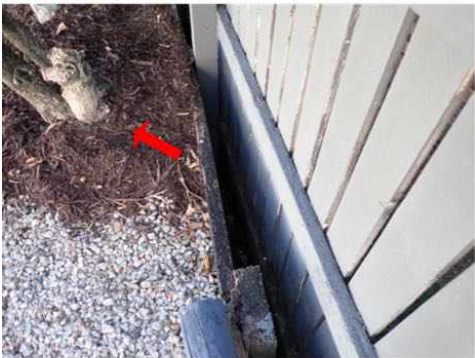
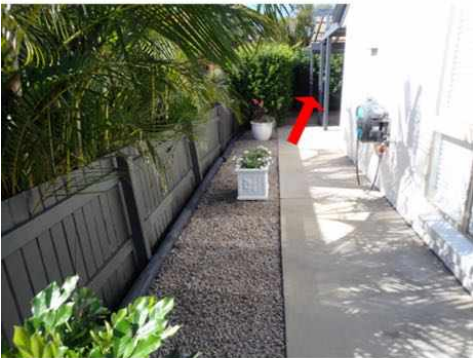
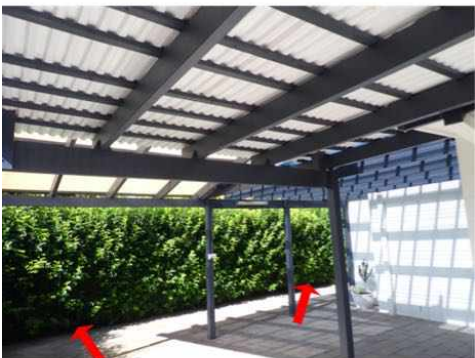
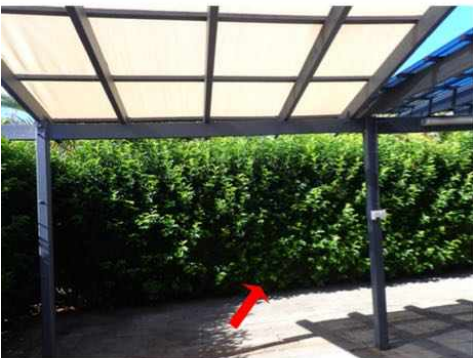
Finding 6.03

Building: Main Building
Location: Yard > All Areas
Finding: Garden Beds - Conditions Conducive to Termites
Information: Garden beds were found to be evident in most of the garden areas. These garden beds can include untreated timber, and with a combination of moisture from watering hosing can make conditions conducive to termite activity and termite ingress.

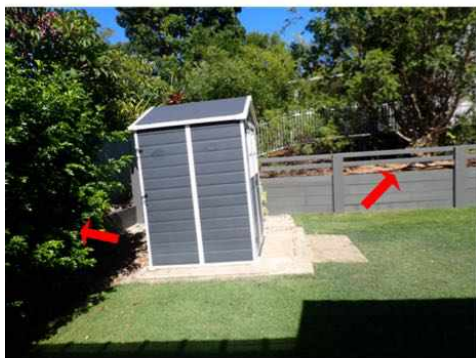
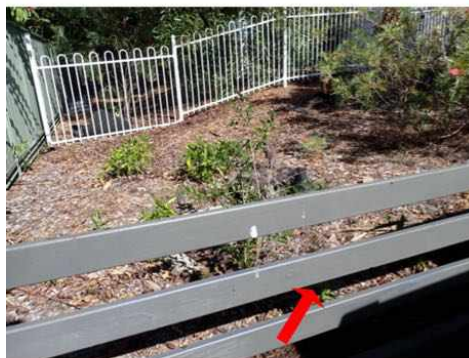
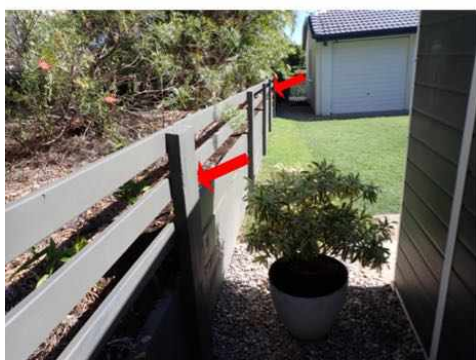
Finding 6.04

Building:	Main Building
Location:	Yard - Back > Rear Left
Finding:	Building materials in direct ground contact - conducive to termites
Information:	Timber posts at the rear alfresco structure were found to be in direct or close contact with the natural ground or paved surfaces .

Where timber elements are in direct contact with the ground and consequently moisture or dampness they become conducive to termite activity. Whether timber is used as a building element part of a fencing structure or stored as an unused item they can provide an environment that is attractive to termite infestation.

When met with excessive moisture timber begins to decay and develop wood rot. Any timbers that are in direct contact with external grounds especially if left untreated or non-durable also provide ingress for subterranean termites into that particular element.

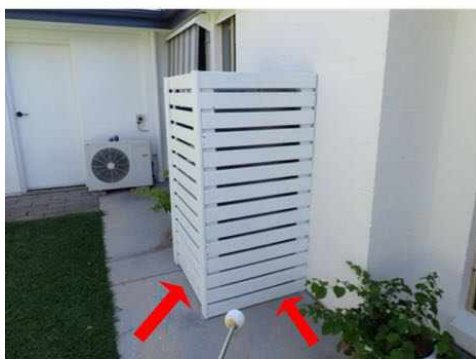
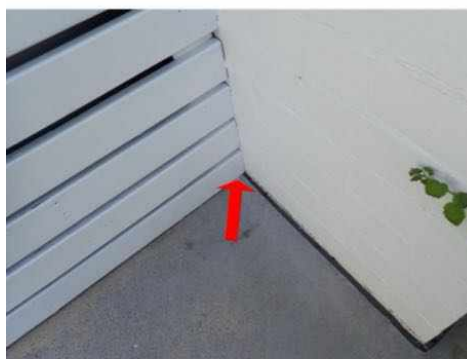
Finding 6.05

Building:	Main Building
Location:	Exterior walls - right side > Centre Right
Finding:	Building materials in direct ground contact - conducive to termites
Information:	The right side hot water storage unit has had a timber flexed screen installed that is in direct contact with the paving and slab joint surfaces.

Where timber elements are in direct contact with the ground and consequently moisture or dampness they become conducive to termite activity. Whether timber is used as a building element part of a fencing structure or stored as an unused item they can provide an environment that is attractive to termite infestation.

When met with excessive moisture timber begins to decay and develop wood rot. Any timbers that are in direct contact with external grounds especially if left untreated or non-durable also provide ingress for subterranean termites into that particular element.

The removal of any such materials that may be conducive to termite activity should be removed as soon as possible to minimise the risk of termite attack.

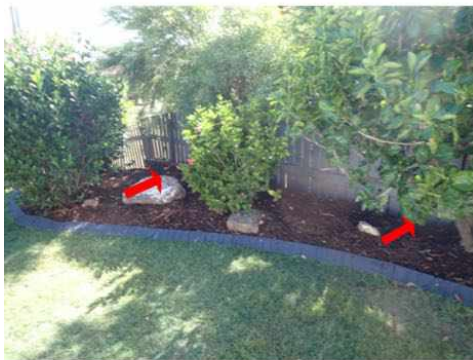
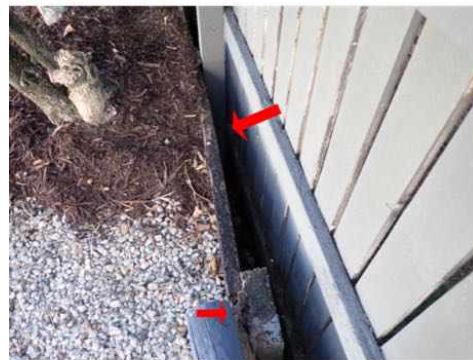
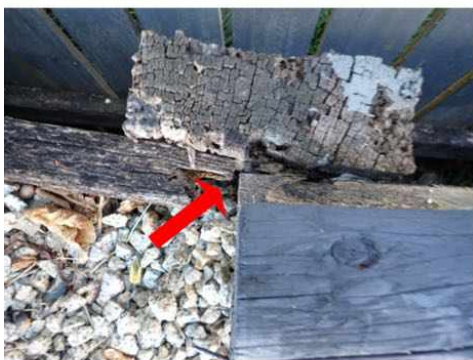
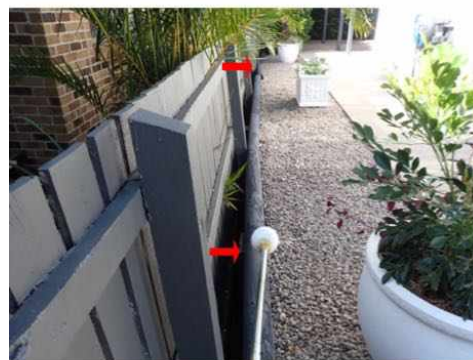
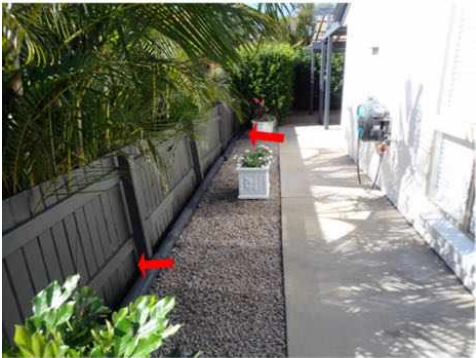
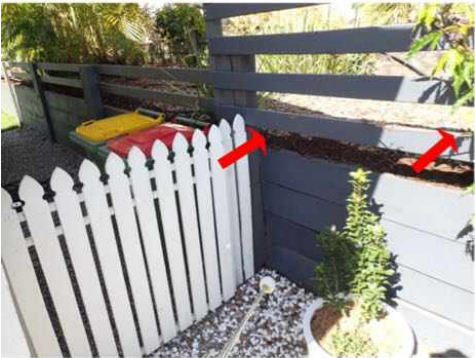
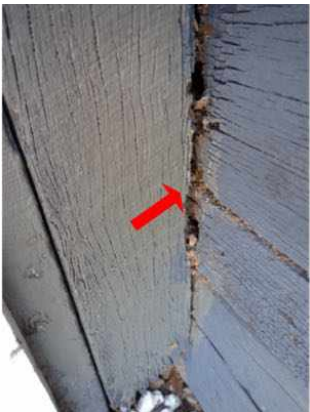
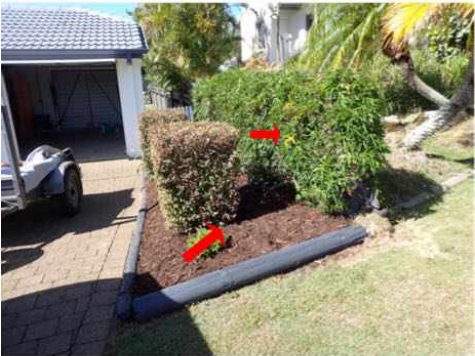
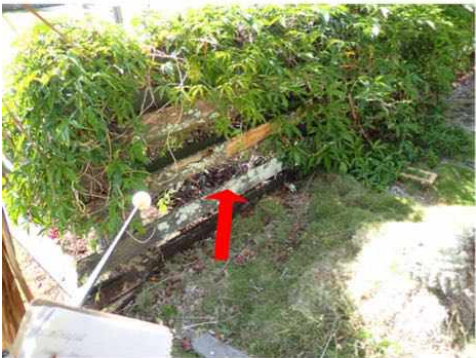
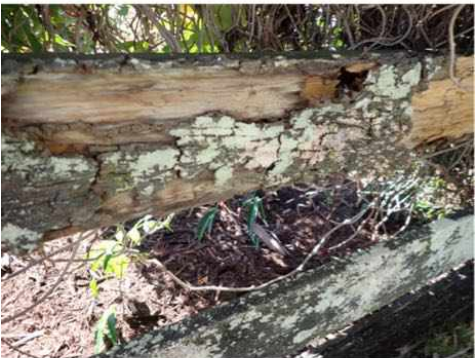
Finding 7.01

Building:	Main Building
Location:	Yard > All Areas
Finding:	Fungal decay - present (widespread)
Information:	Fungal decay was identified throughout most timber retaining walls and areas of timber fencing in this property.

Fungal decay is also known as wood decay or wood rot generally refers to the deterioration of timber elements when in contact with excessive levels of moisture for a prolonged period of time.

The development of fungal decay is accelerated by temperatures in the range of 5degreeC to 40degreeC as well as the presence of oxygen. Generally fungal decay develops on timber elements that are in use in an external environment which are exposed to rain penetration.

In this case, fungal decay appears to have become widespread and is likely to have affected any adjoining timber elements/structures. The widespread development of fungal decay is likely to have heavily impacted the structural integrity and tensile strength of the affected timber elements and the associated structure.

Timbers affected by widespread fungal decay should be replaced immediately. The cause of the moisture that has led to the development of such decay should also be identified and dealt with in an appropriate manner.

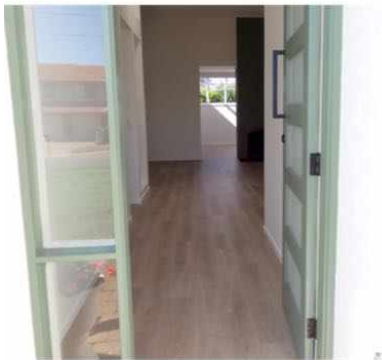
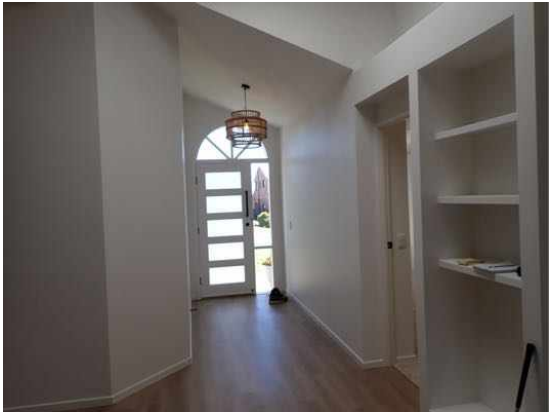
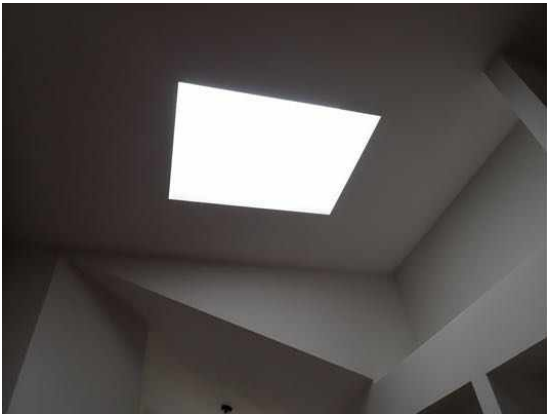
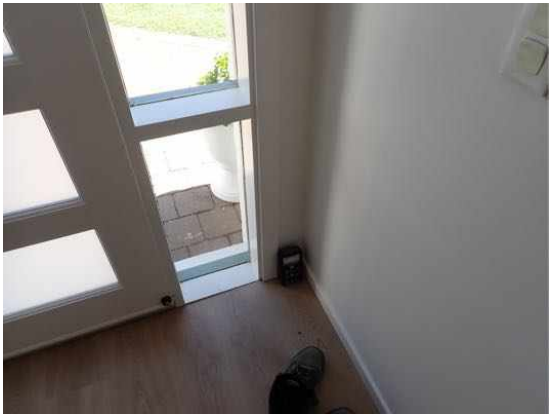
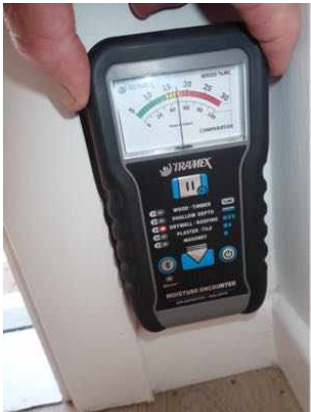
Building: Main Building
Location: Entry > All Areas
Finding: No obvious defects identified
Information: There were no obvious defects found in the main front entry area on a visual inspection at this time.

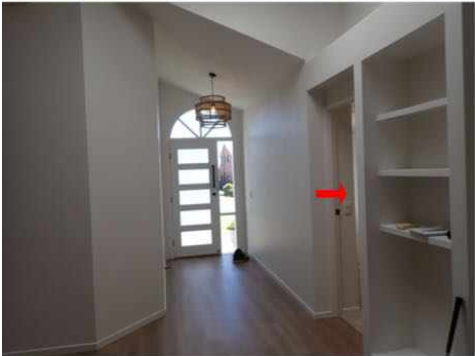
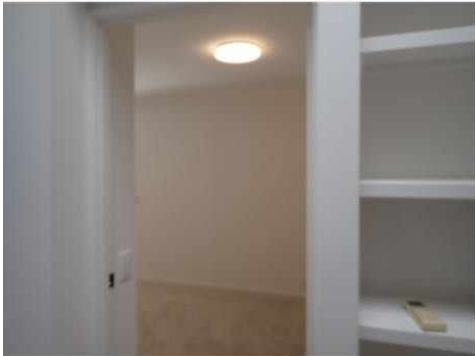
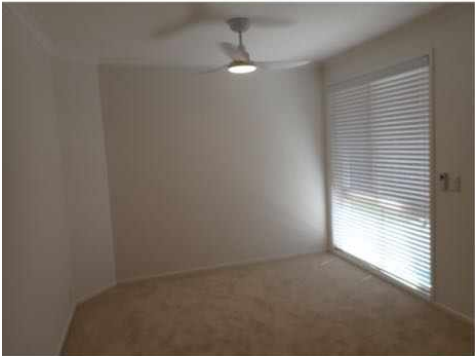
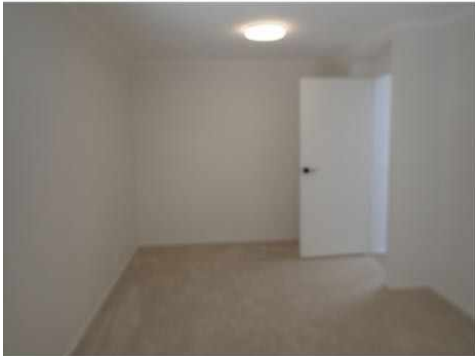
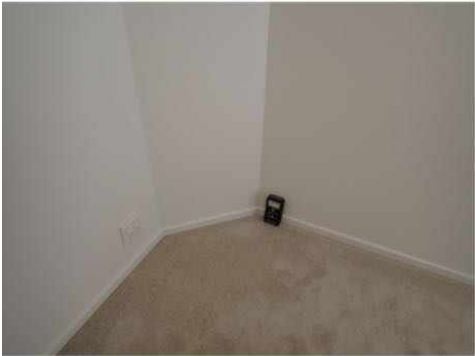
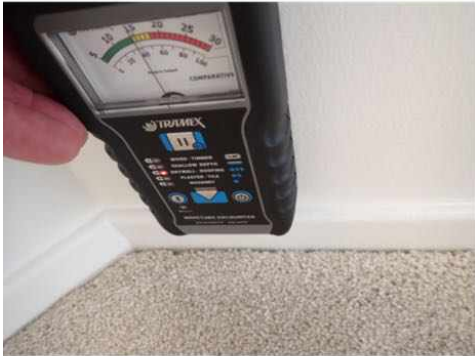
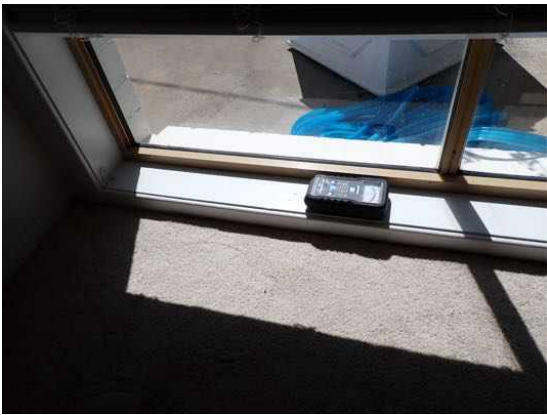
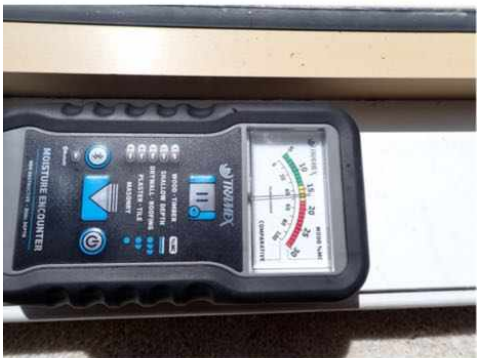
Building: Main Building
Location: Bedroom 4 > All Areas
Finding: No obvious defects identified
Information: There were no obvious defects found in bedroom-4 on a visual inspection at this time.

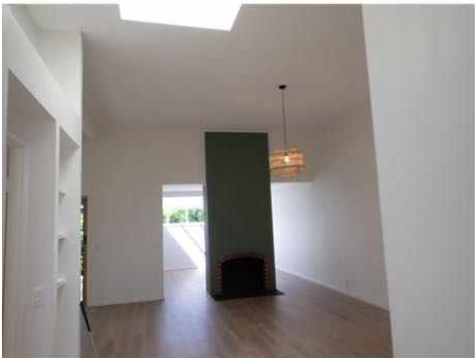
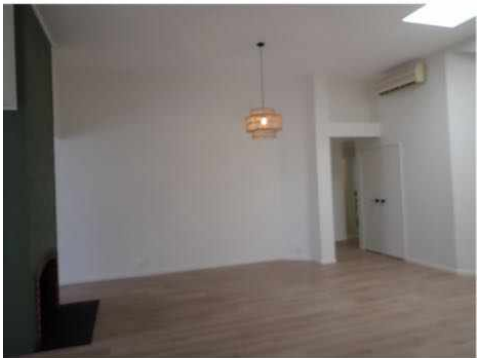
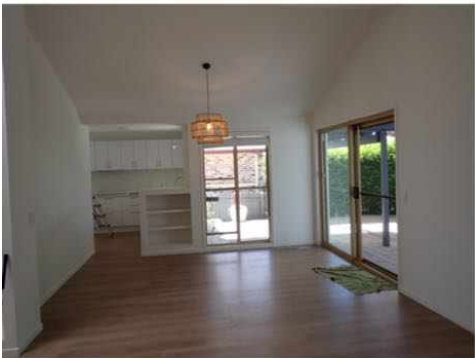
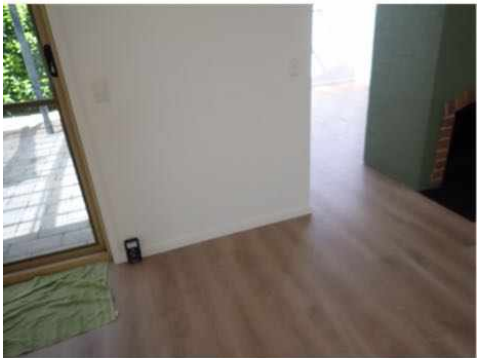
Building: Main Building
 Location: Living / Meals Room > All Areas
 Finding: No obvious defects identified
 Information: There were no obvious defects found in the living/meals room on a visual inspection at this time.
