Building and Timber Pest Inspection Report VR

Inspection Date: Thu, 5 Feb 2026

Property Address: 8 Moyston Ct, Thornlands QLD 4164,
Australia

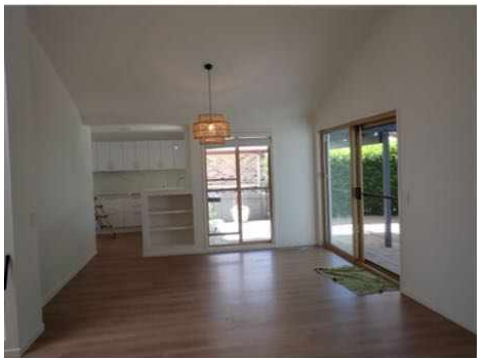
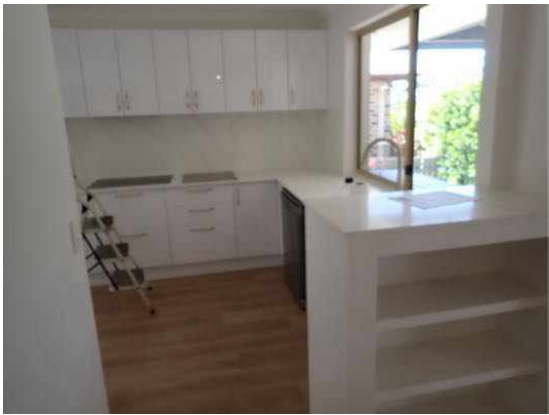
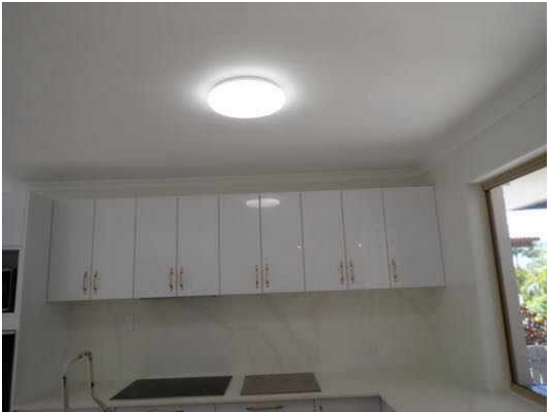
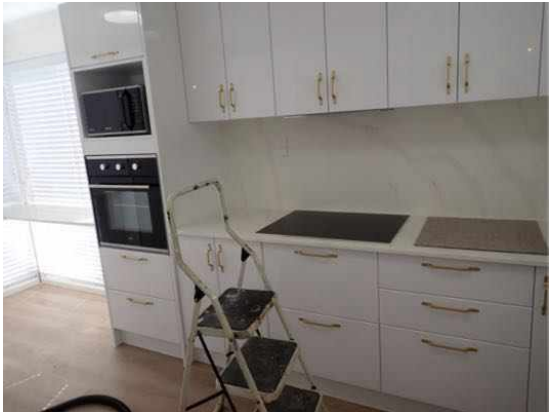
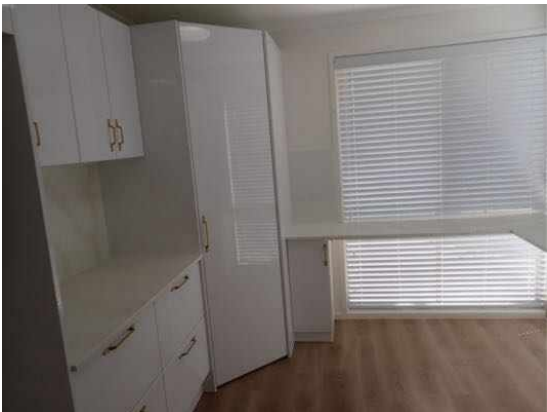
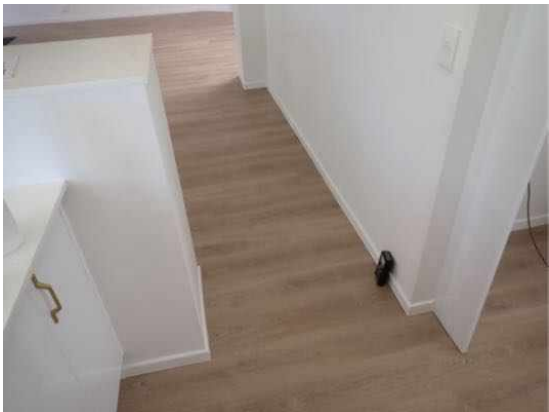
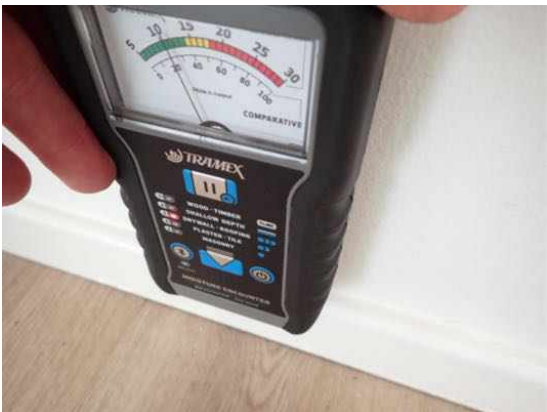
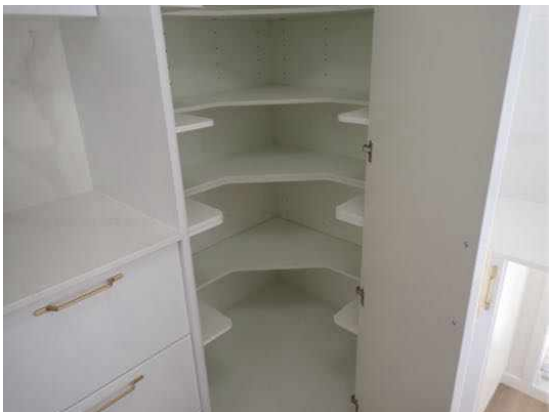
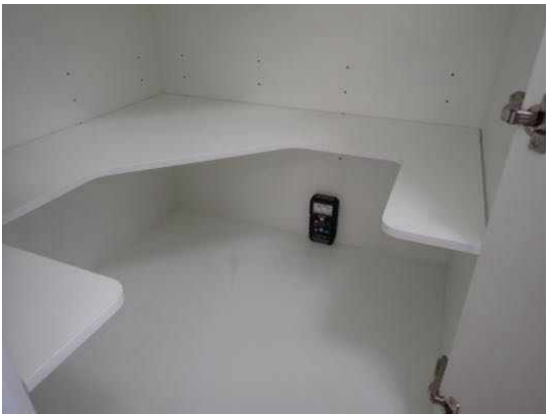
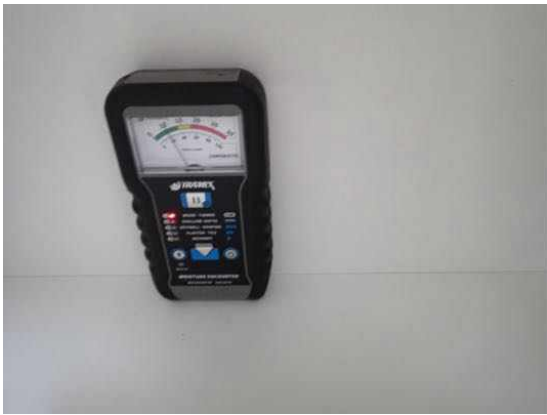
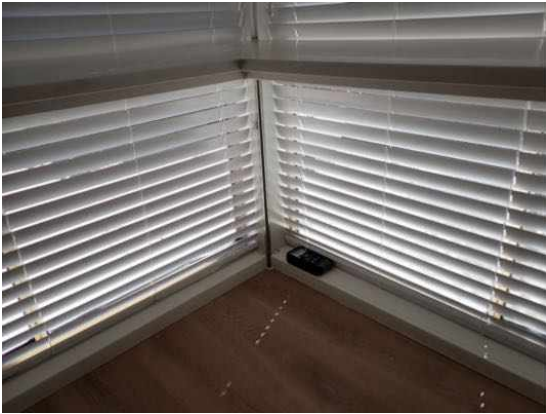
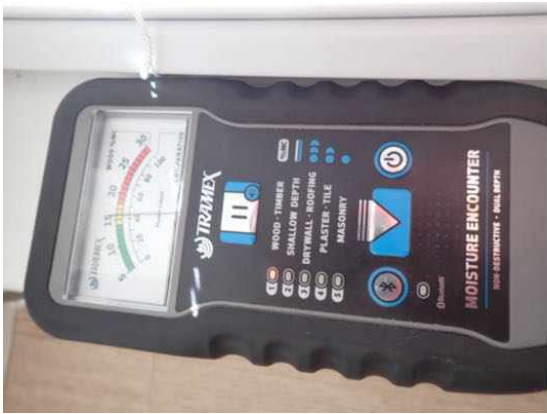
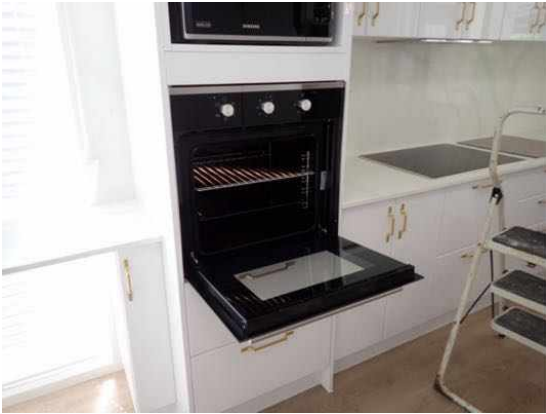
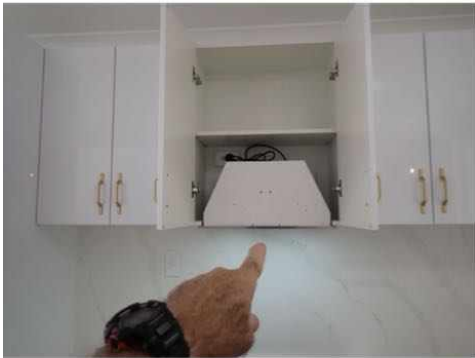
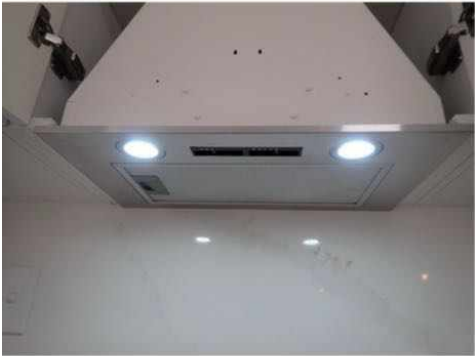
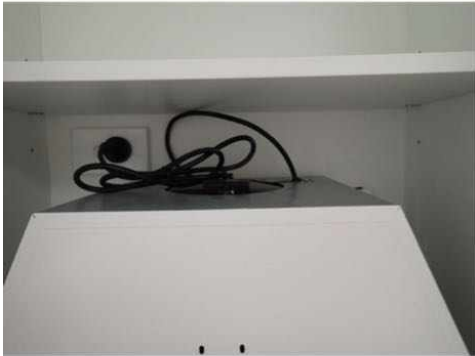
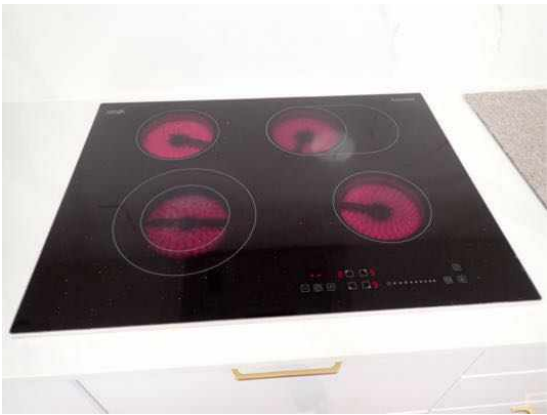
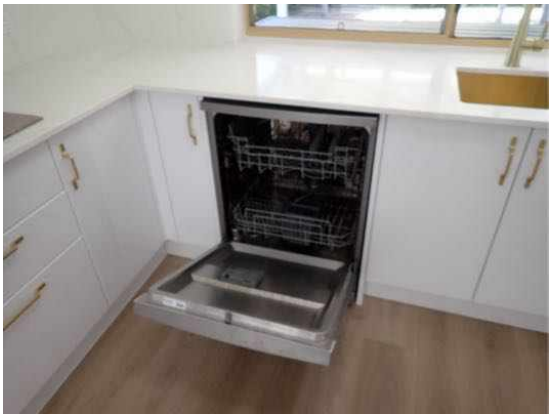
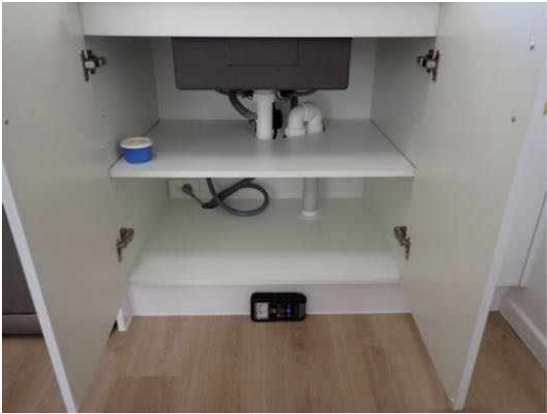
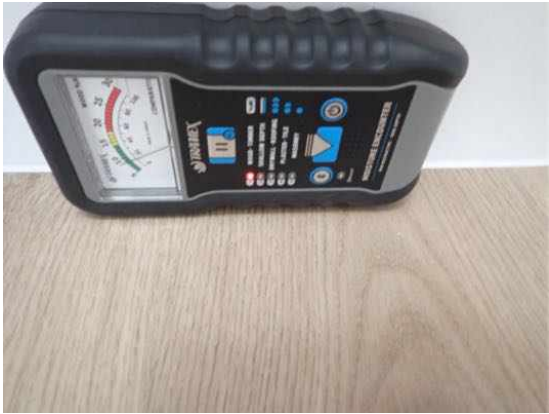
Building: Main Building
Location: Kitchen > Rear
Finding: No obvious defects identified
Information: There were no obvious defects found in the kitchen area on a visual inspection at this time.

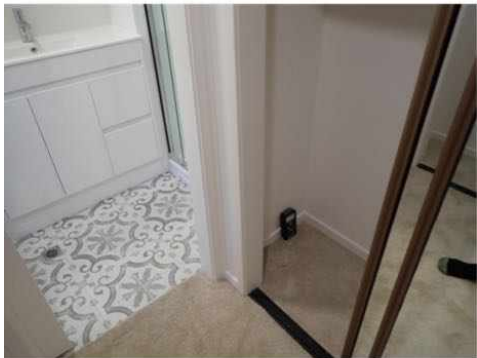
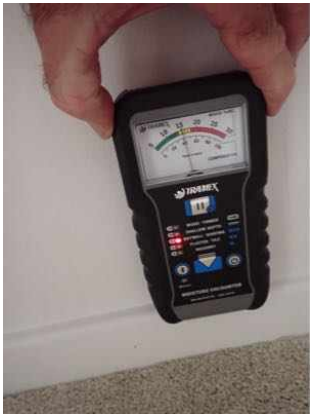
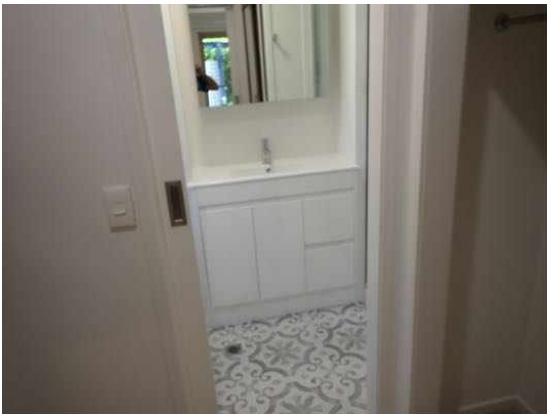
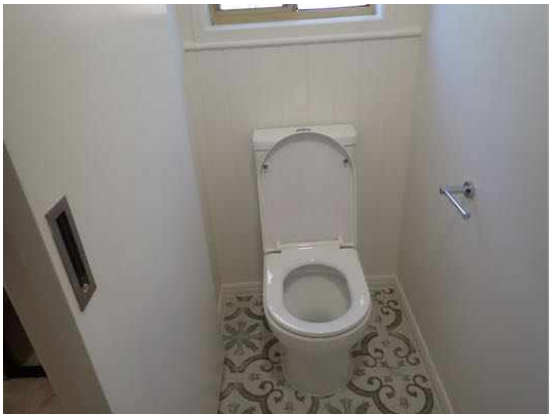
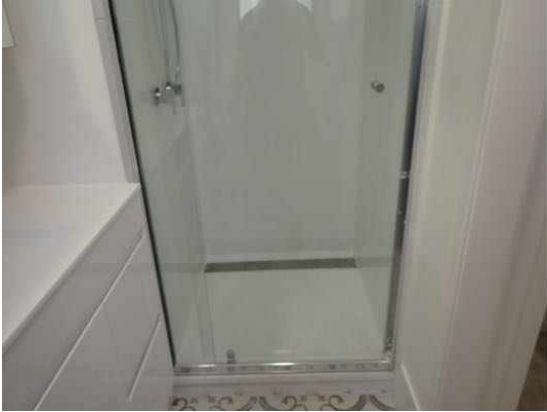
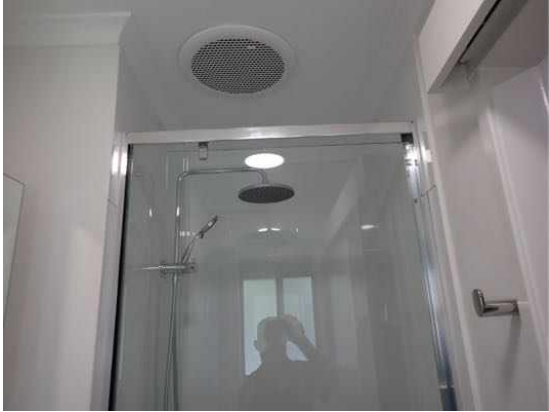
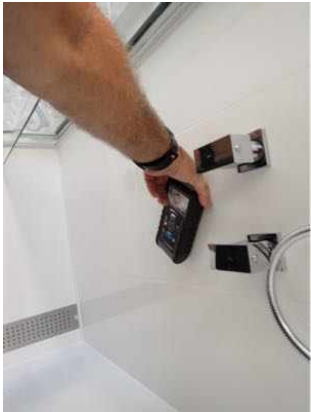
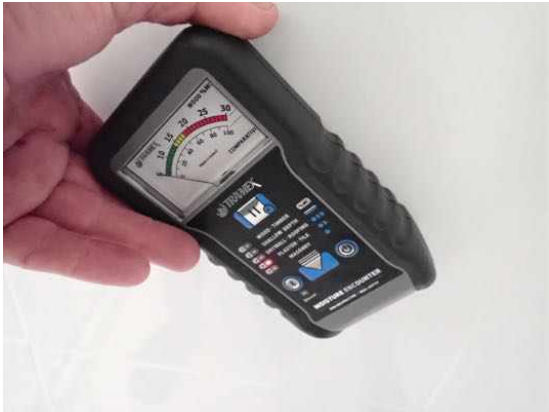
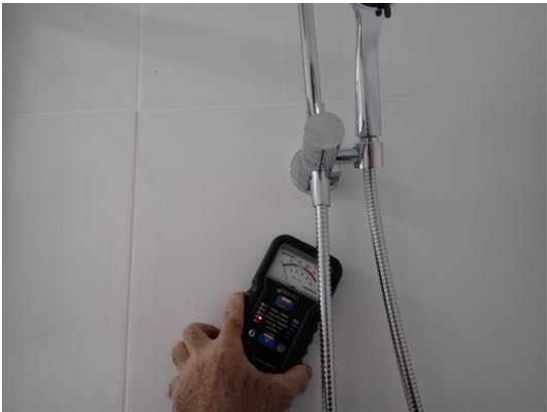
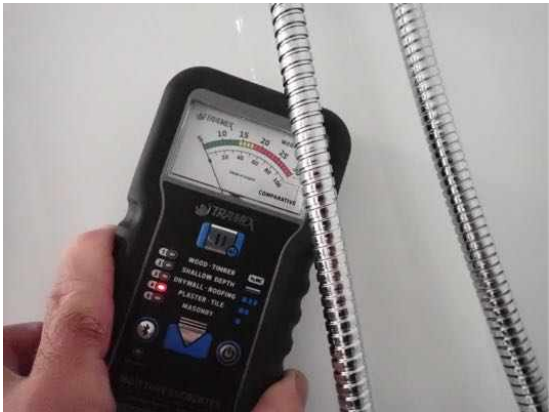
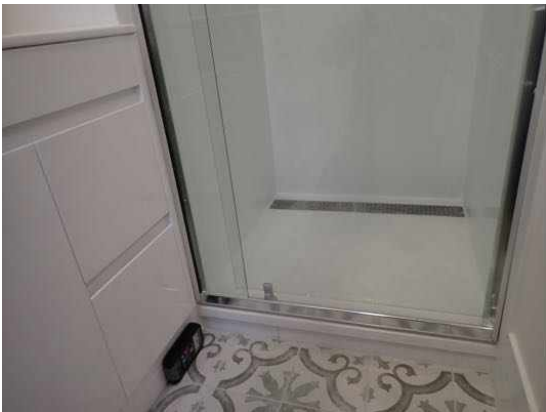
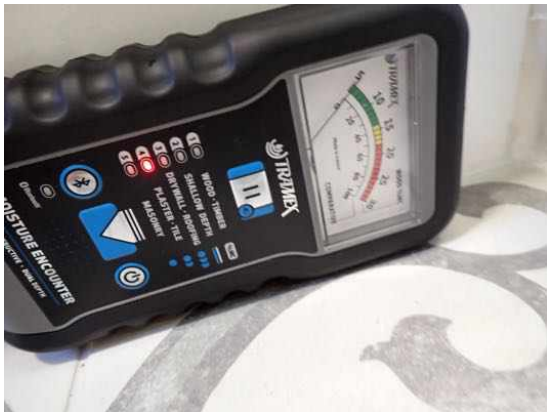
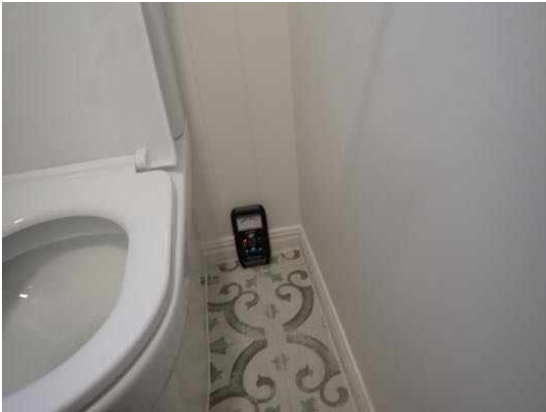
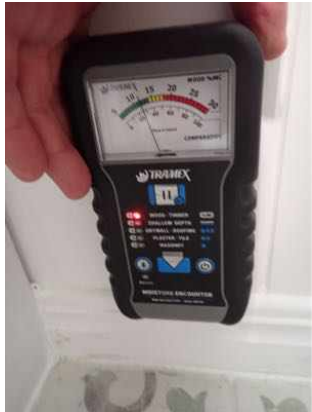
Building: Main Building
 Location: Bedroom - Master/ Ensuite > All Areas
 Finding: No obvious defects identified
 Information: There were no obvious defects found in the master bedroom ensuite room on a visual inspection at this time.

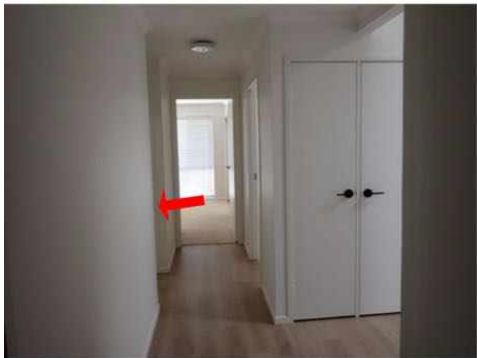
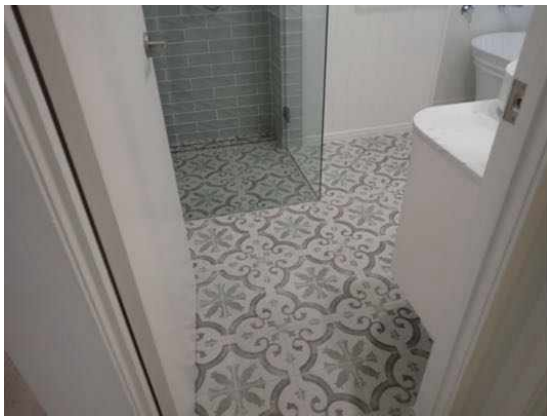
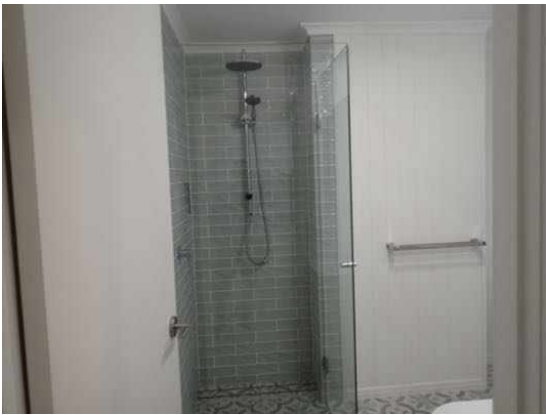
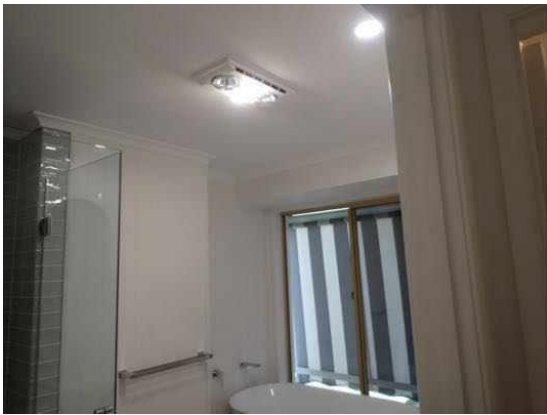
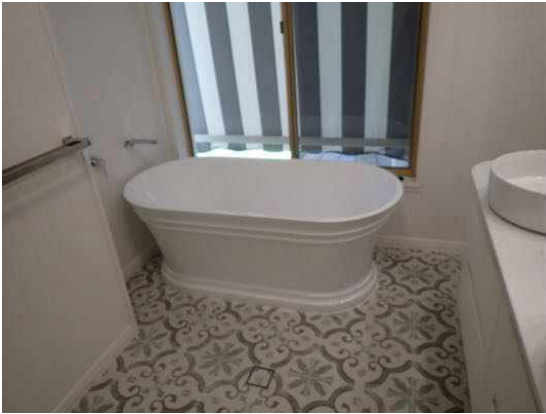
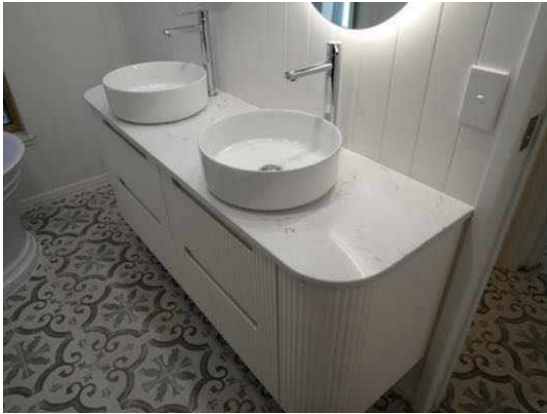
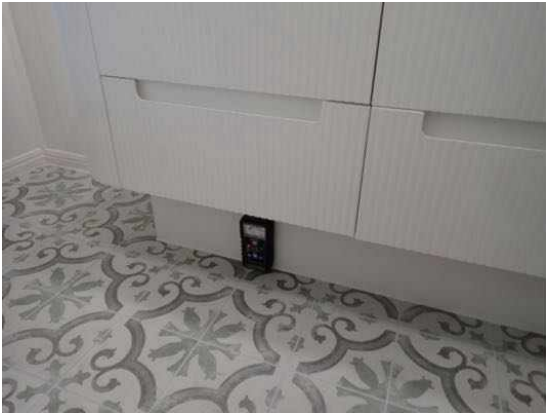
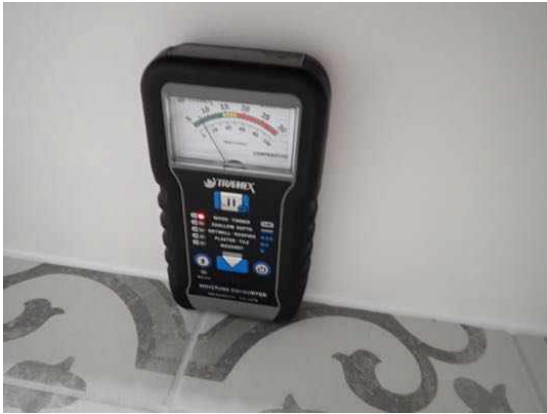
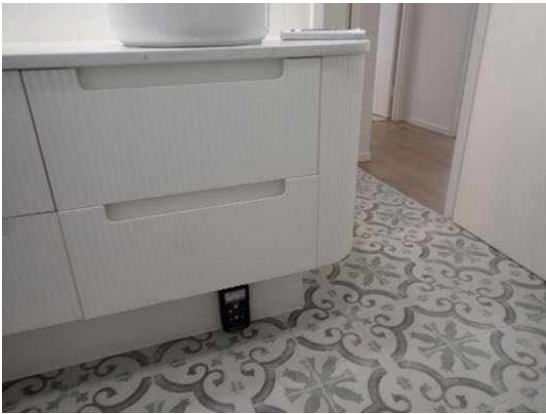
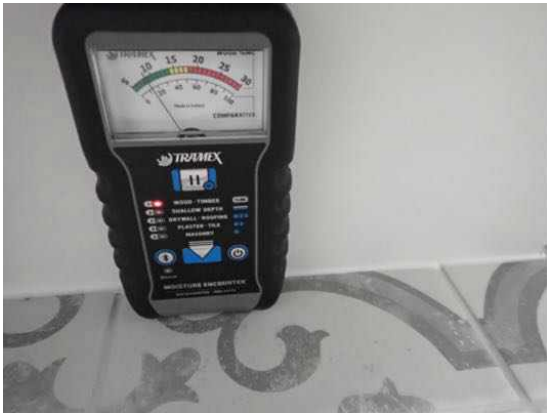
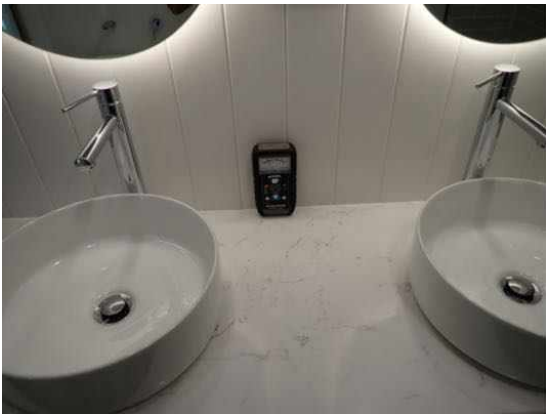
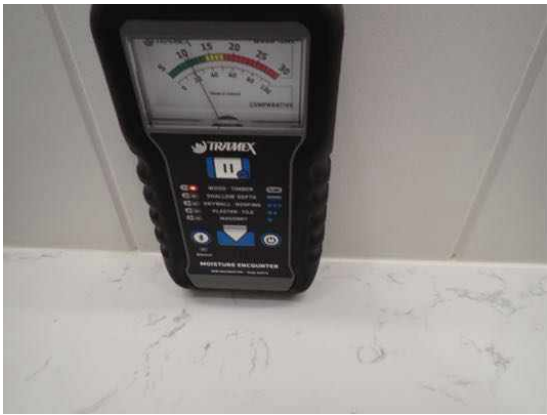
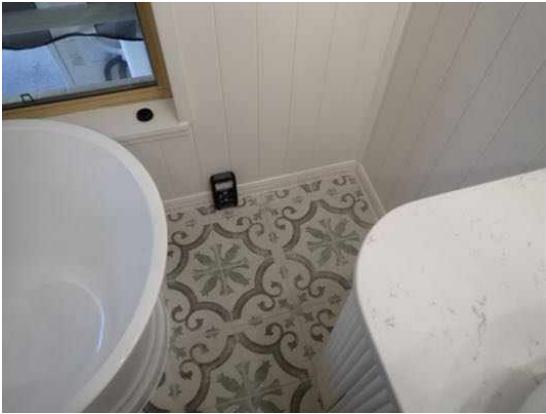
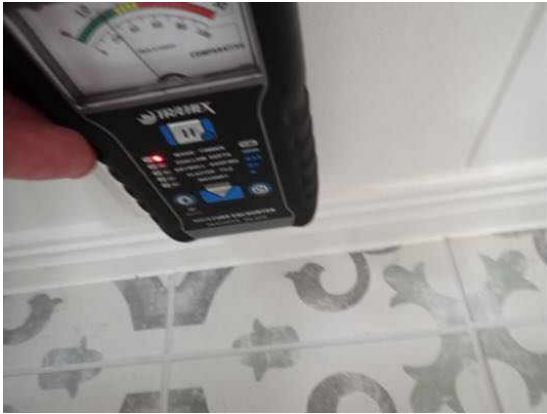
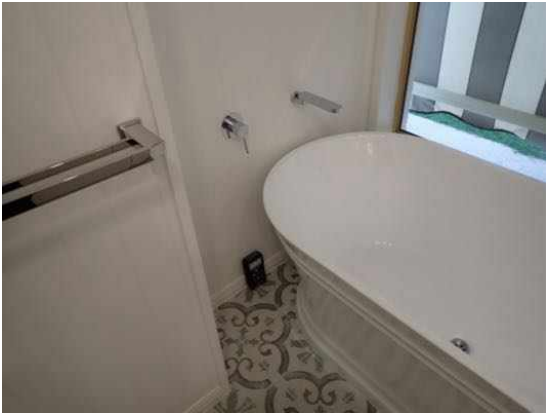
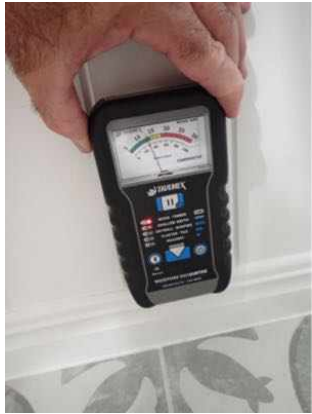
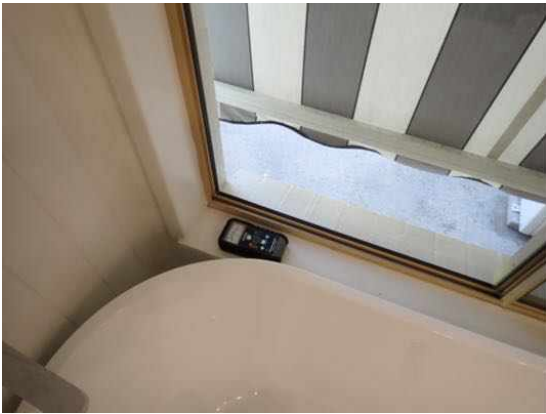
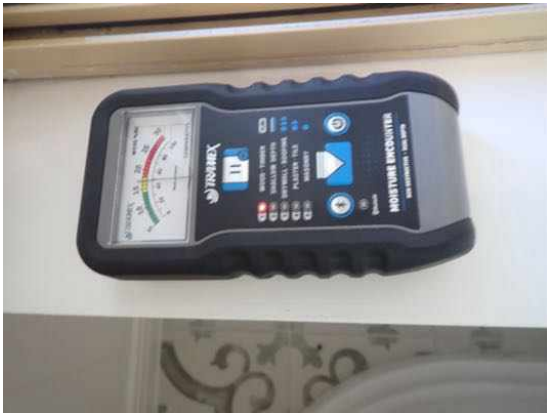
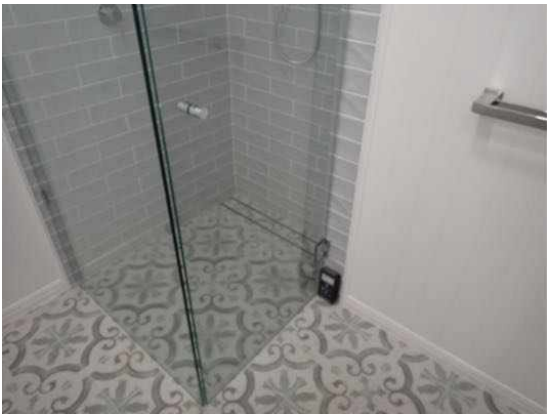
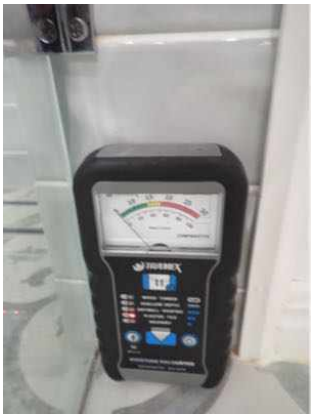
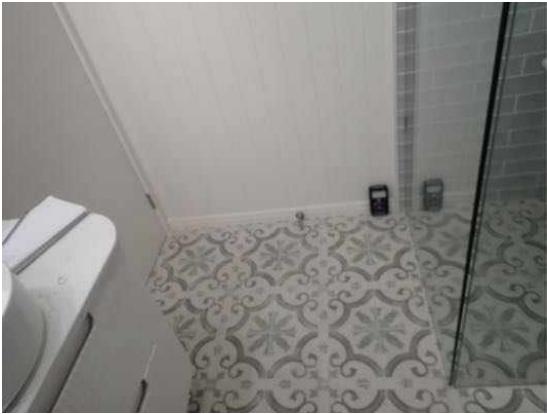
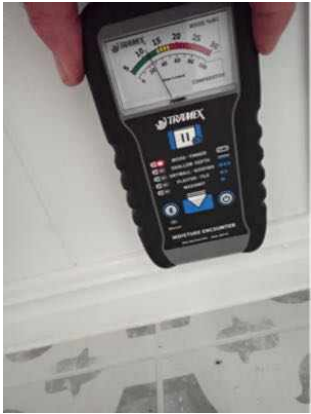
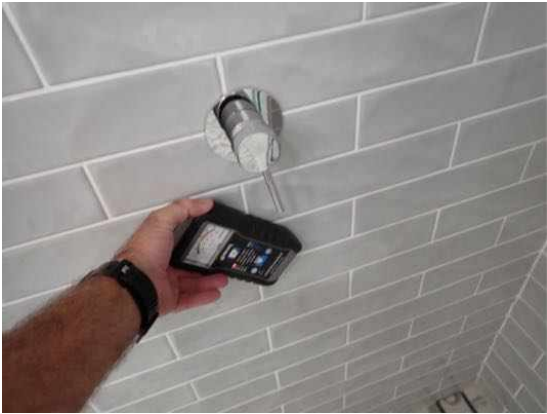
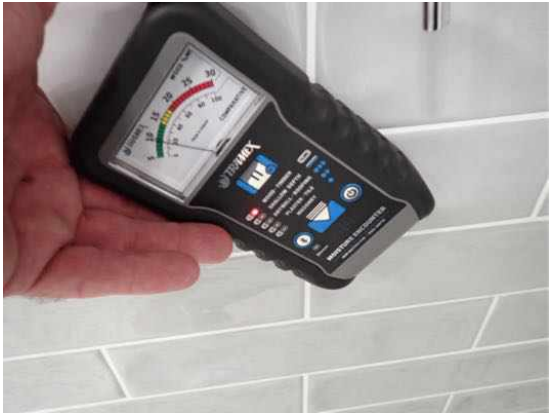
Building: Main Building
 Location: Bathroom > All Areas
 Finding: No obvious defects identified
 Information: There were no obvious defects found in the main bathroom on a visual inspection at this time.

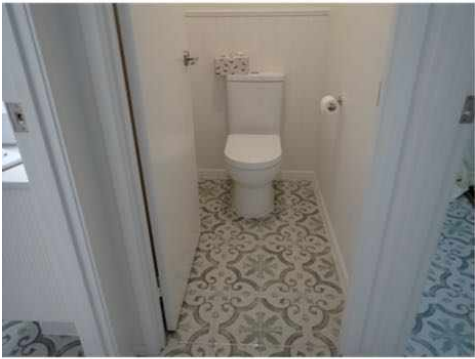
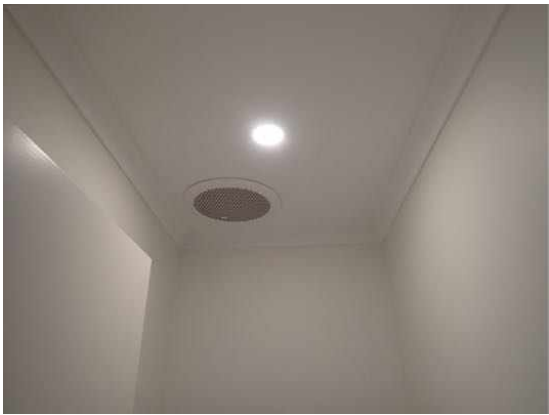
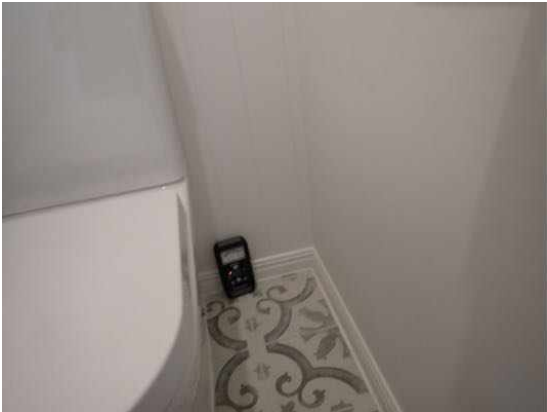
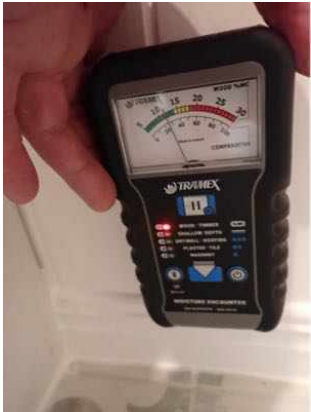
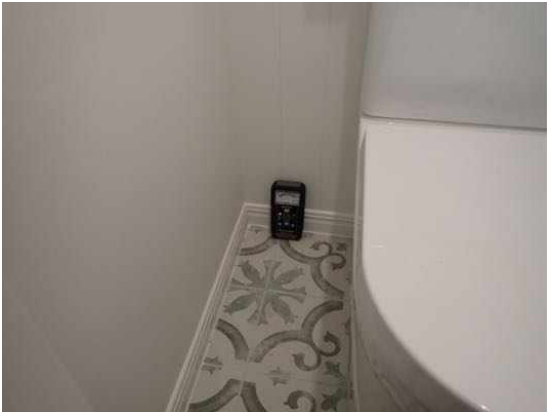
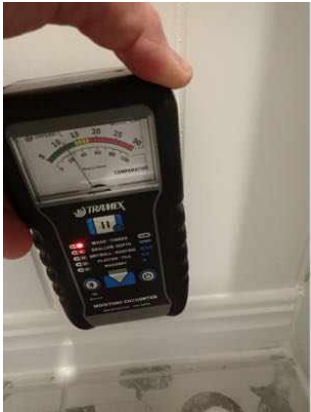
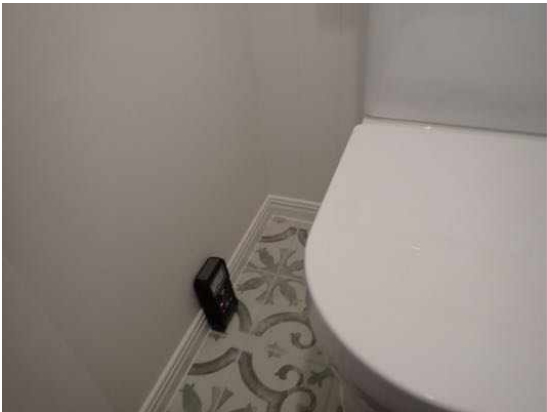
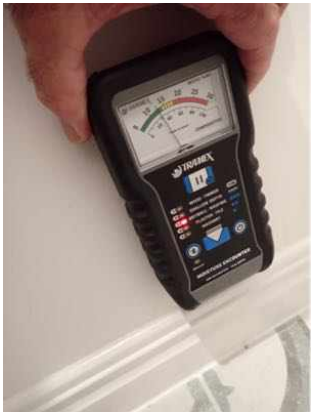
Building: Main Building
Location: Toilet (WC) > All Areas
Finding: No obvious defects identified
Information: There were no obvious defects found in the main toilet room on a visual inspection at this time.

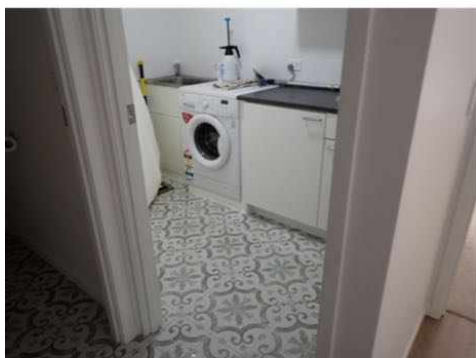
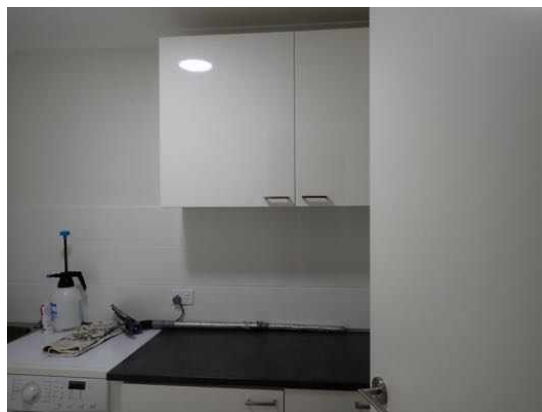
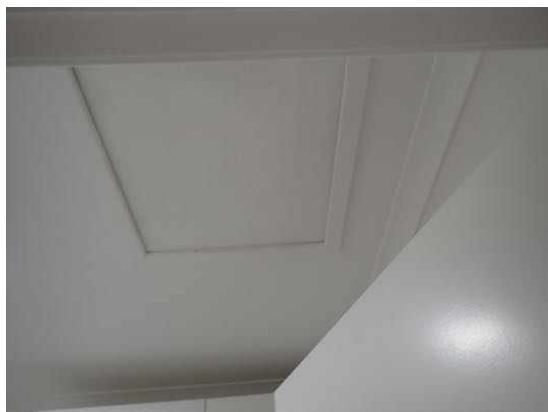
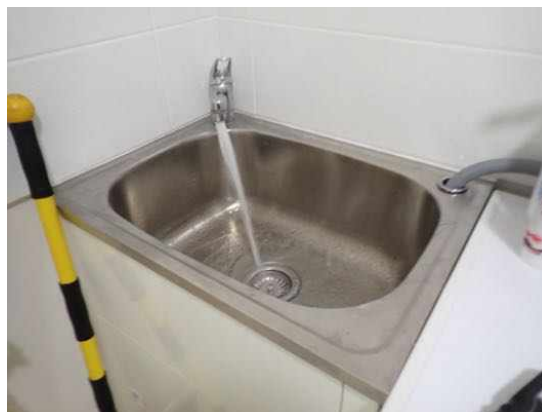
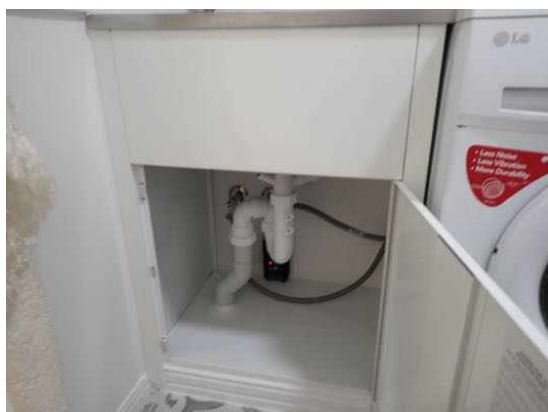
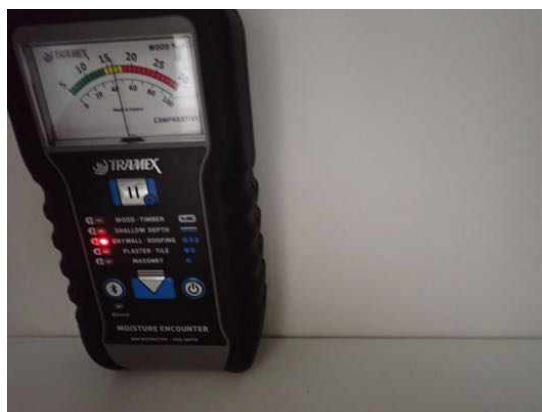
Building: Main Building
 Location: Laundry > All Areas
 Finding: No obvious defects identified
 Information: There were no obvious defects found in the laundry room on a visual inspection at this time.

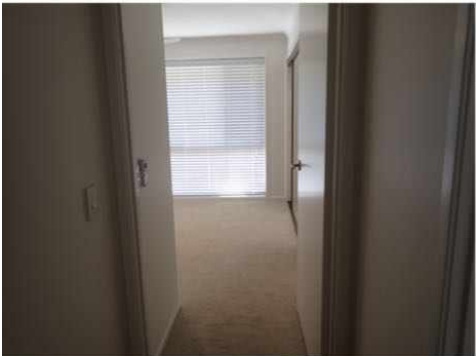
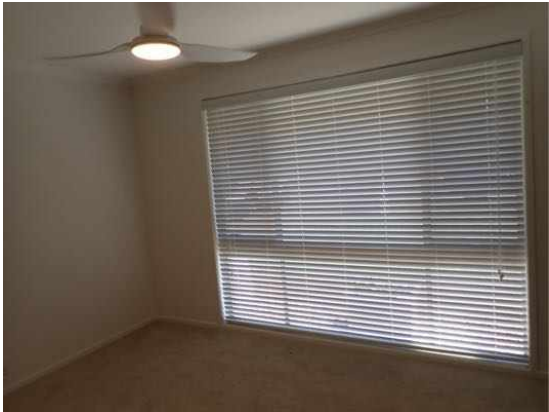
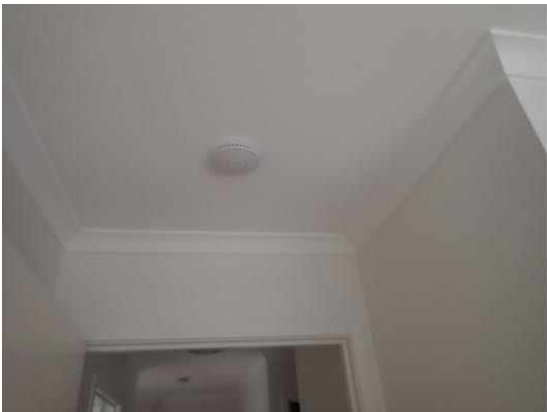
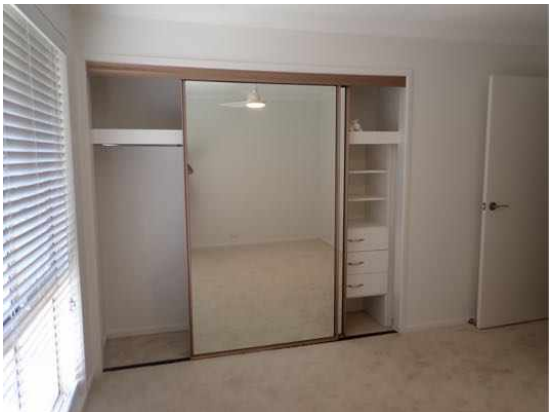
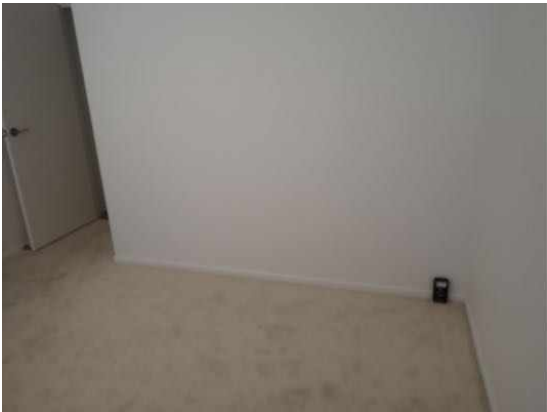
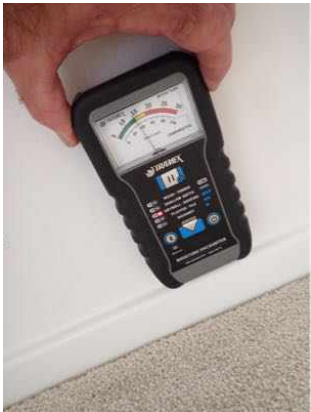
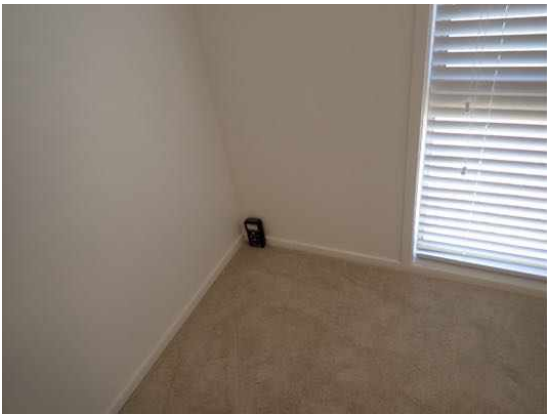
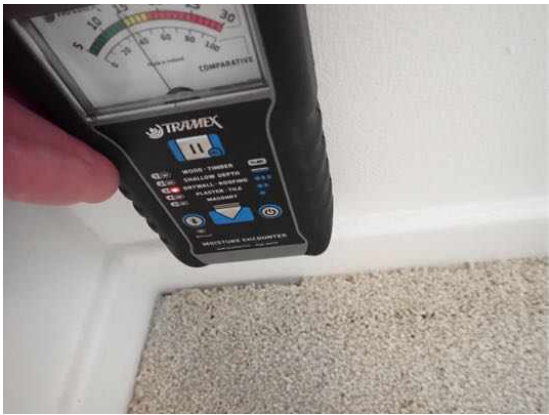
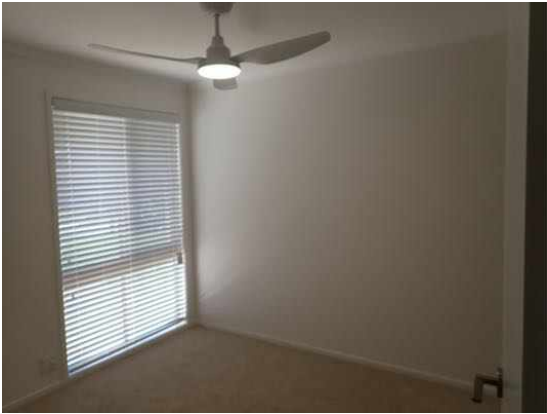
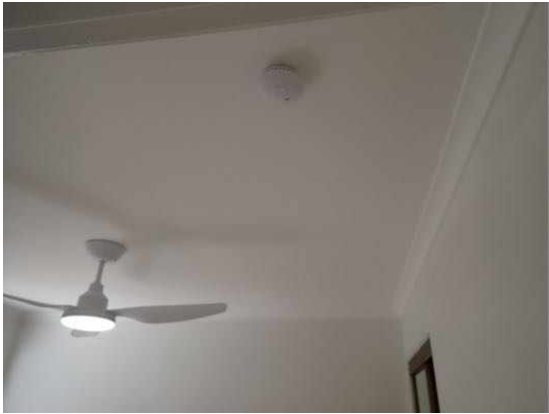
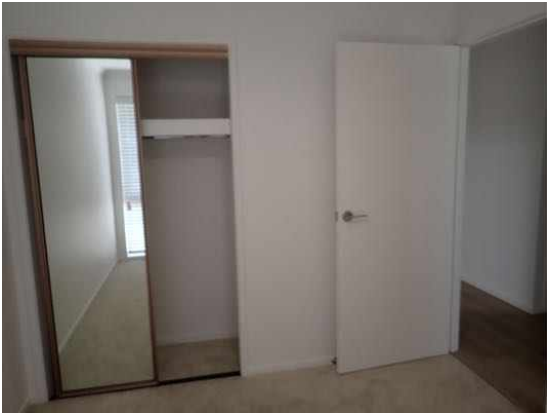
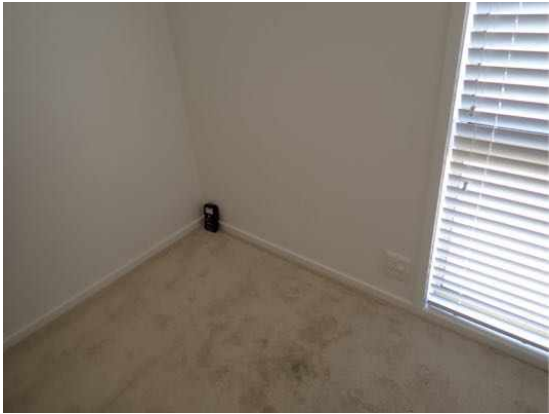
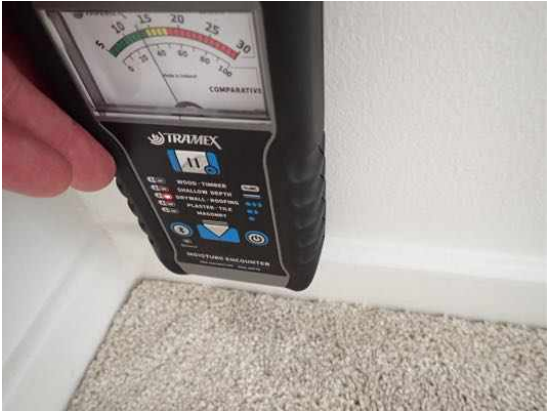
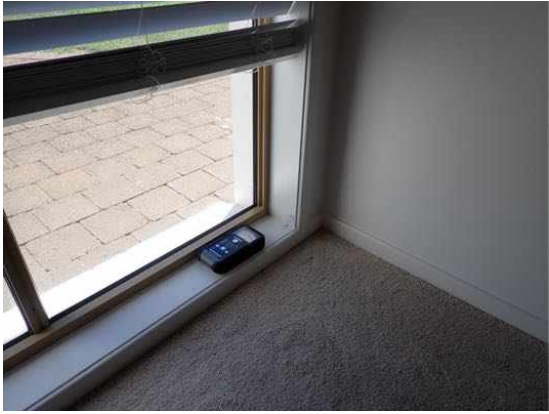
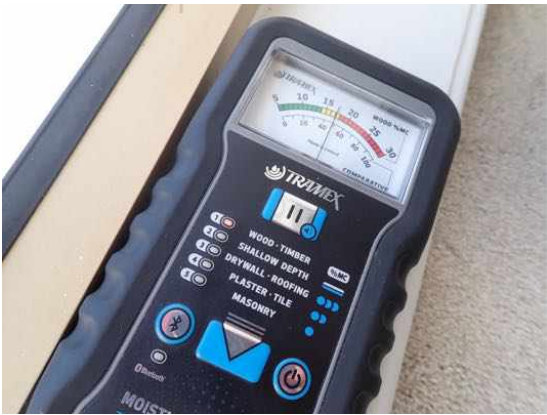
Building: Main Building
 Location: Bedroom 2/3 > All Areas
 Finding: No obvious defects identified
 Information: There were no obvious defects found in bedrooms-2/3 on a visual inspection at this

time.

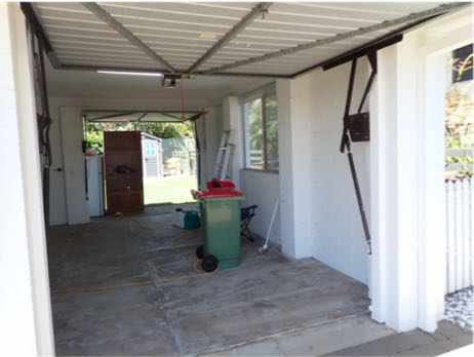
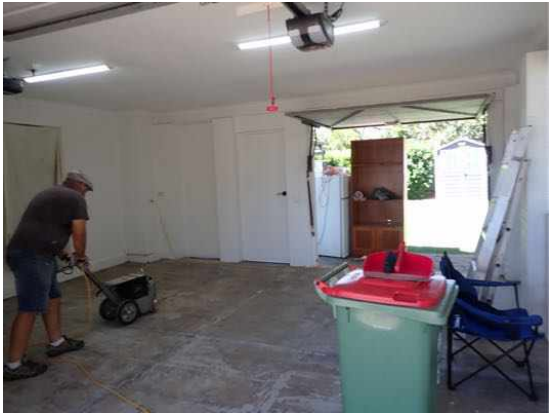
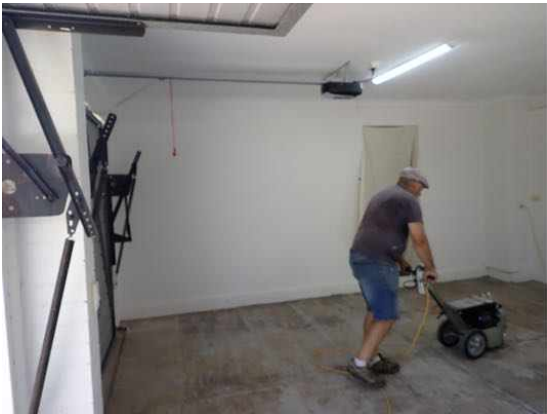
Building: Main Building
 Location: Garage > All Areas
 Finding: Additional Photos - Obstructions and Limitations
 Information: These photographs are an indication of the obstructions and limitations which impeded full inspection of the property at the time of inspection. These obstructions can hide an array of defects and should be removed to allow full inspection to be carried out. A re-inspection is recommended once the areas are made accessible.

No obvious defects were identified in this area .

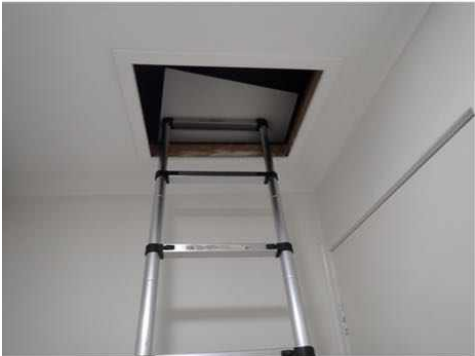
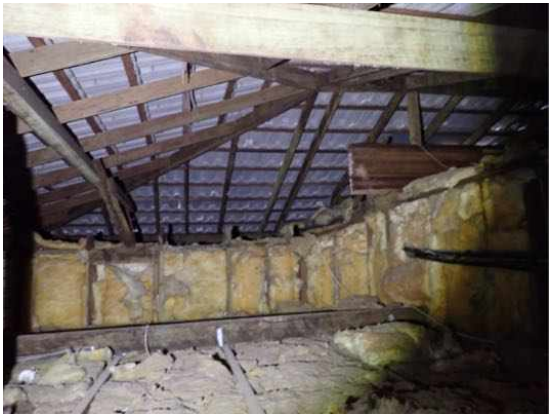
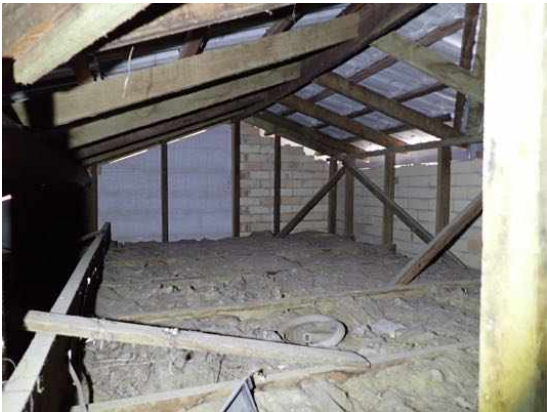
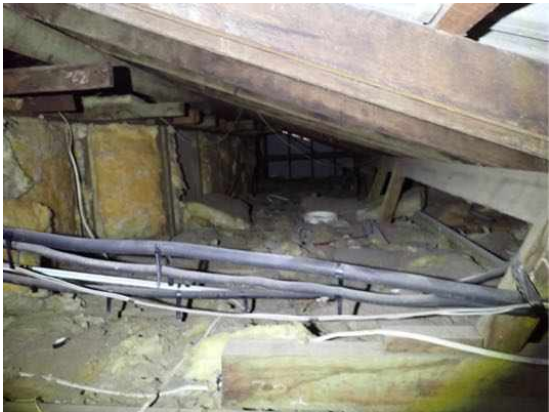
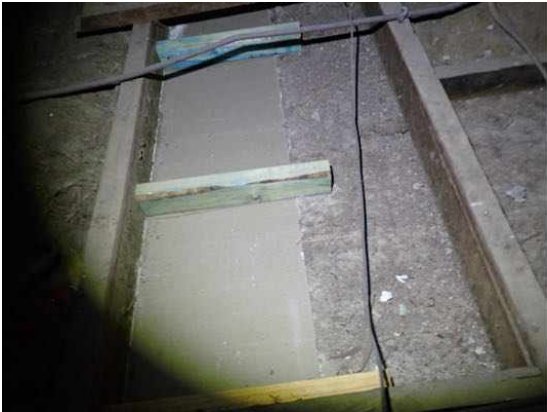
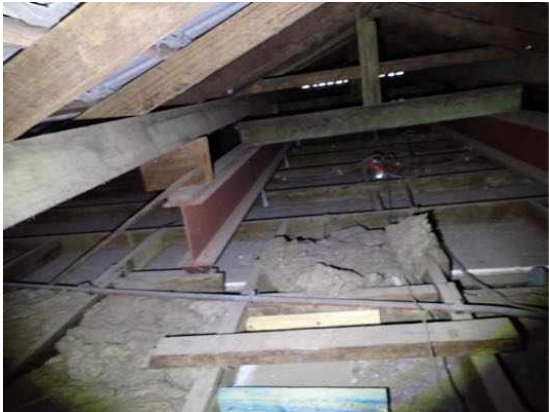
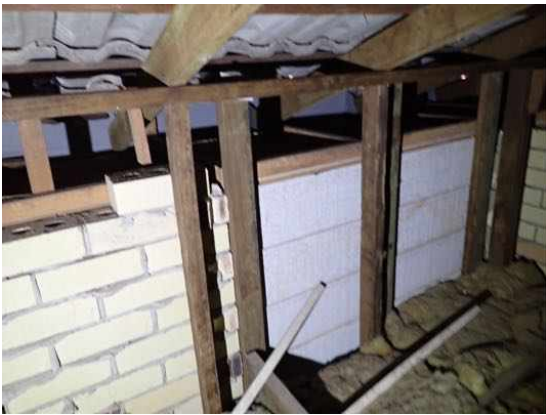
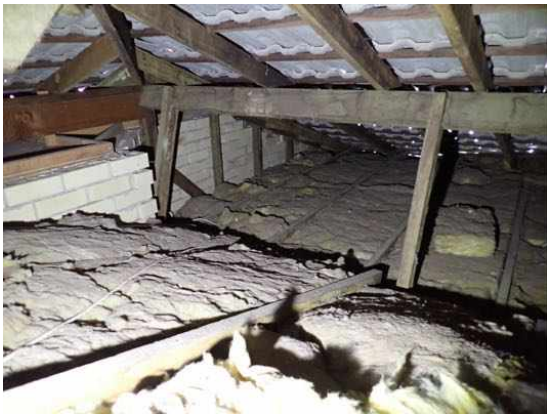
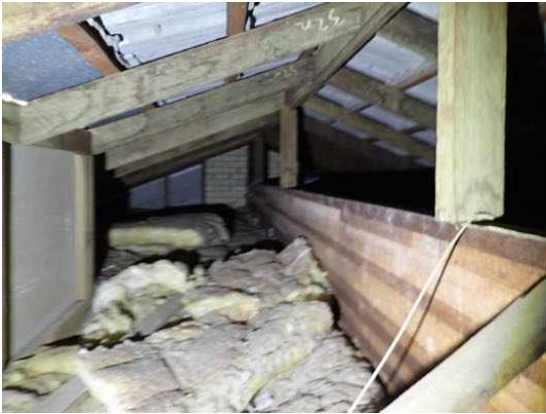
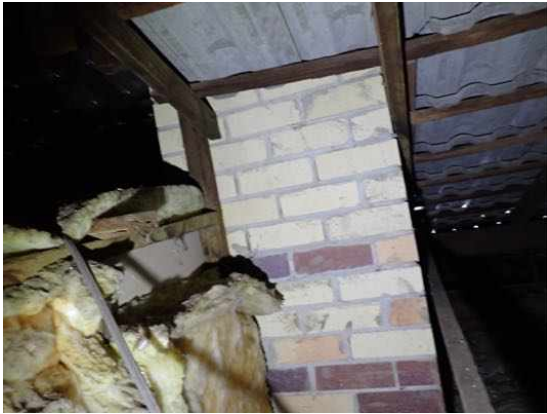
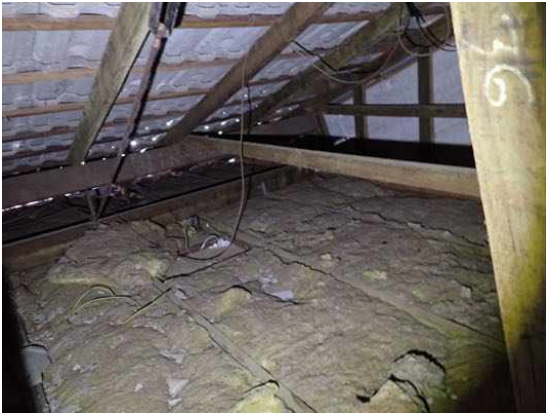
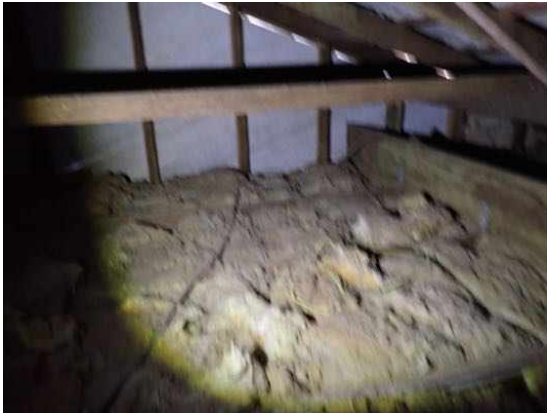
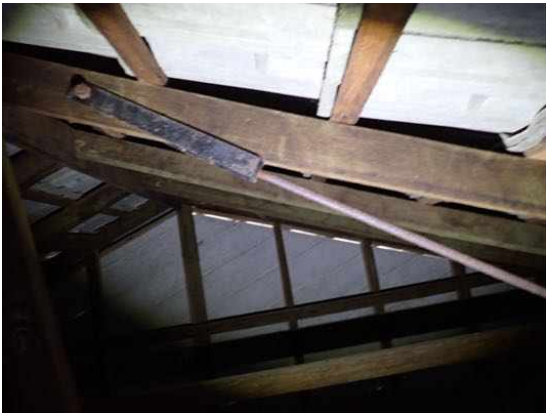
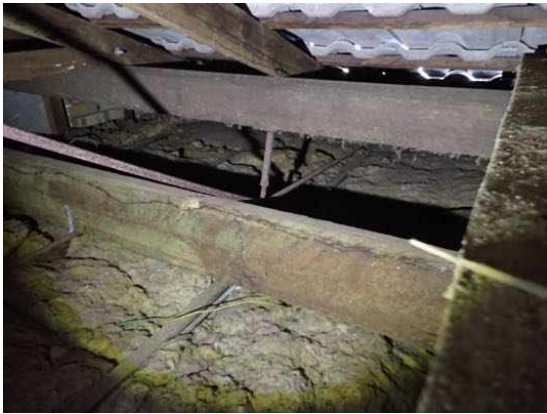
Building: Main Building
Location: Roof Void > All Areas
Finding: Roof void Inspected
Information: The roof void was inspected for timber pest activity.

No Evidence of timber pest activity was identified at the time of this inspection.
