Building and Timber Pest Inspection Report

Inspection Date: Wed, 11 Mar 2026

Property Address: 10/6 Mary St, Wiley Park NSW 2195,
Australia

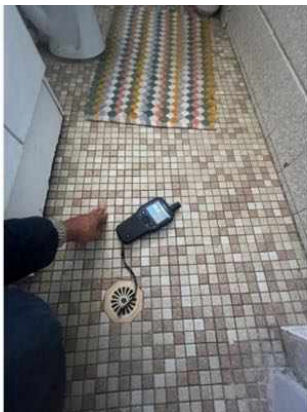
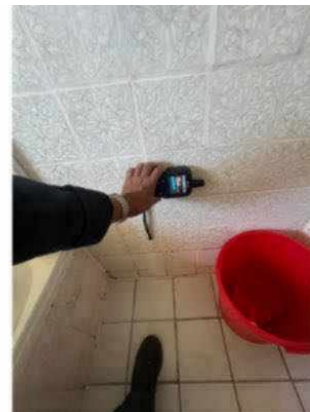
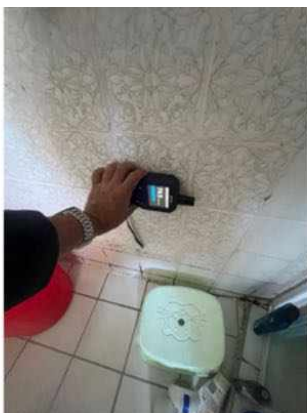
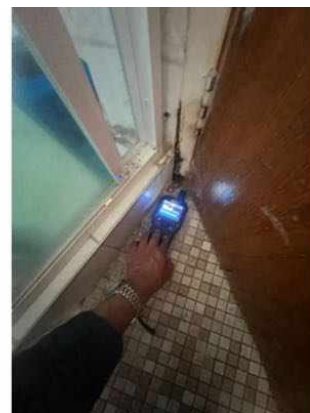
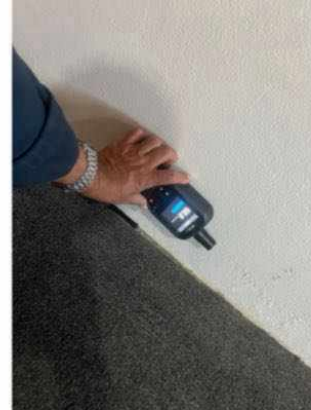
Finding 2.01

Building: Main Building
Location: Bathroom (back of kitchen)
Finding: Elevated Moisture Bathroom & Back of shower with deterioration
Information: Elevated moisture levels were detected to tiled surfaces in bathroom/shower areas. This may be due to porous or missing grout, cracked tiles or recent use, however the possibility of waterproofing membrane failure or plumbing leaks cannot be excluded. Persistent moisture ingress can lead to concealed damage, including timber rot and mould growth. Further investigation by a licensed plumber and/or waterproofing contractor is recommended as soon as possible. The back of shower area also showed elevated moisture with visible deterioration evident at the time of inspection.

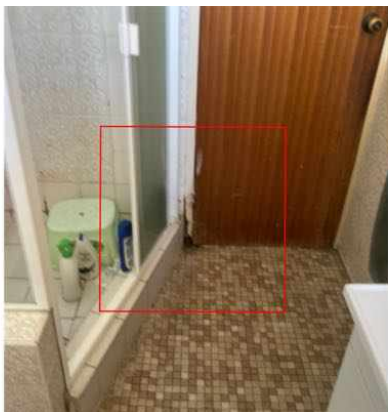
Finding 2.02

Finding: Wet-Area Door Jambs – Moisture Staining / Decay

Information: moisture staining and deterioration were observed at the base of the wet-area door jamb and architraves. This is commonly due to water splashing or moisture tracking from the bathroom floor into adjacent joinery or inadequate waterproof transition at the bathroom threshold.

Further inspection by a licensed waterproofing contractor is recommended to verify exact cause and remedial measures

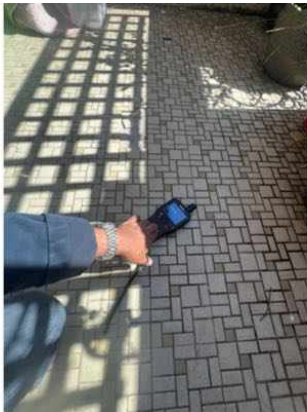
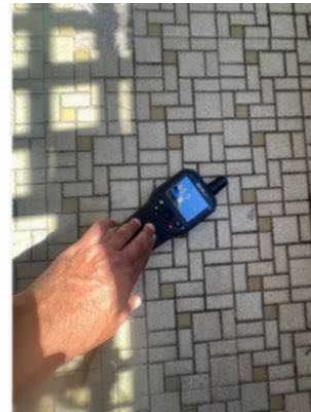
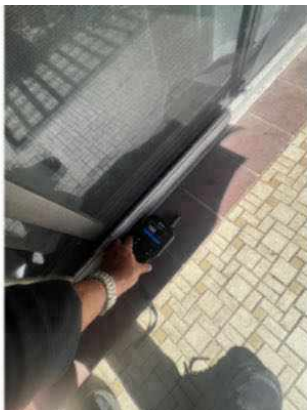
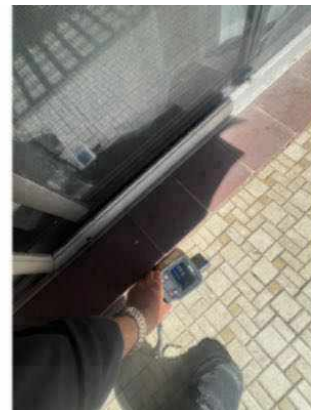
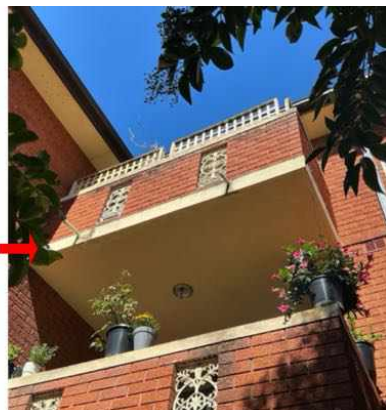
Finding 2.03

Finding: Balcony Elevated Moisture - Strata

Information: Elevated moisture was recorded at the base of the balcony wall and tiles, with associated staining consistent with water exposure under balcony soffit. While no internal damage was visible at the time of inspection, balconies in multi-unit dwellings are high-risk areas for waterproofing failure, which can lead to leaks into adjoining units and significant rectification costs. Further investigation by a licensed waterproofing contractor is strongly recommended.

Depending on the strata plan, this area may form part of the common property, in which case remedial responsibility may rest with the owners corporation (strata). Purchasers should seek clarification from the strata manager and legal adviser prior to purchase.

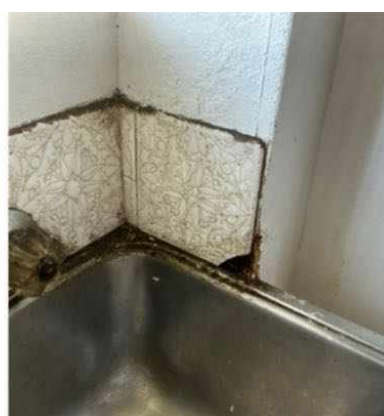
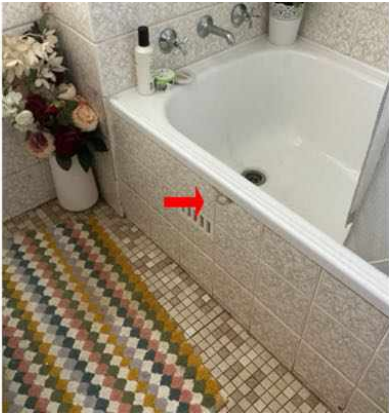
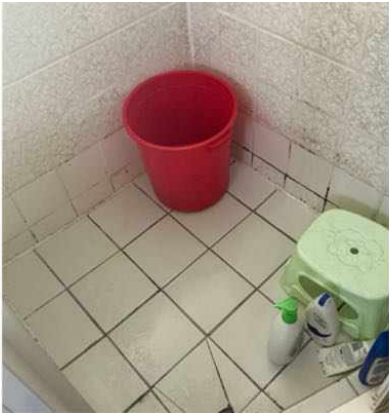
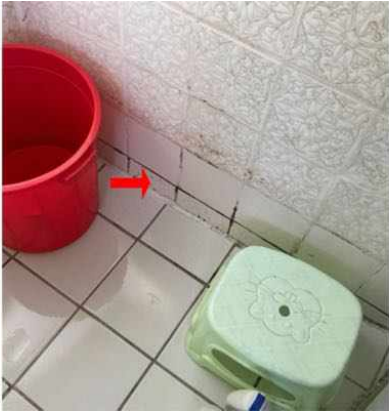
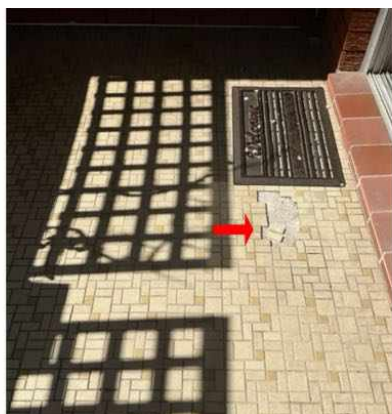
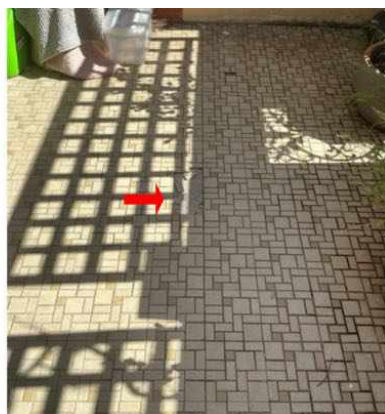
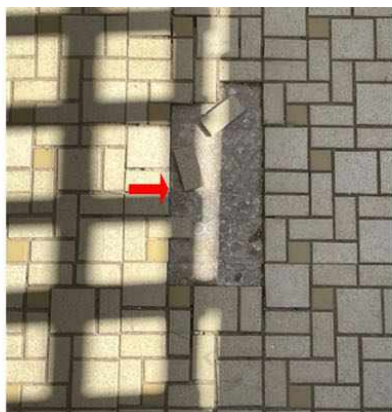
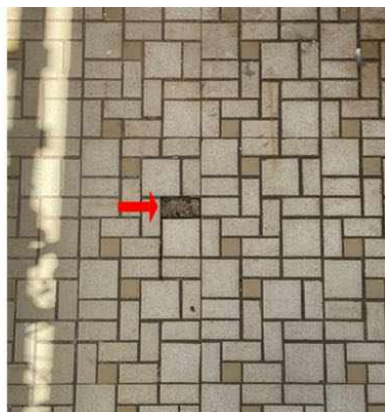
Building:	Main Building
Location:	All Internal Areas
Finding:	Painted surface - Bubbling & elevated moisture - Further investigation required
Information:	Sections of paint in this area was found to have bubbled and deteriorated. Paint bubbling is generally an indication of excessive moisture in the area, that is currently hidden by the painted surface.

The presence of excessive moisture can have major implications on associated building elements if left unattended. While only seemingly minor at this stage, the damage cannot be determined due to the paint obstructing any further inspection of the damage.

Building:	Main Building
Location:	All Internal Areas
Finding:	Tiles - Cracked or damaged
Information:	Cracking was evident to the tiling in this area at the time of inspection. While the cracking appears to be minor, this area is frequently exposed to water, allowing potential for water penetration into adjoining sections of walls or flooring.

If left unmanaged, water penetration to these areas may lead to subsequent water damage, which is likely necessitate repair work to affected building elements.

It is highly advised that the affected paint be cleaned to allow a further, more invasive inspection by a licensed plumber. Failure to act on this defect may necessitate major works in the future.

A tiling contractor should be appointed to ensure that no further water damage occurs. The re-application of silicone and grouting throughout remaining tile work is also advised, to further protect the area against water penetration.

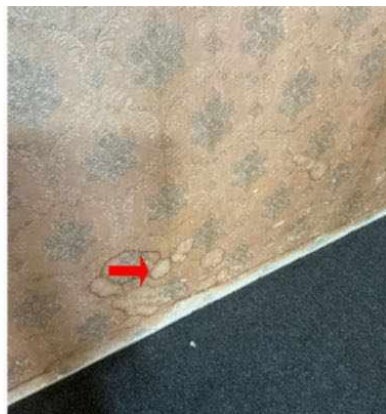
Finding 3.03

Building:	Main Building
Location:	All Internal Areas - Lounge
Finding:	Water staining
Information:	Water staining was evident in this area at the time of inspection. Water staining indicates that surfaces have been exposed to excessive moisture over time. The minerals and other elements in the water lead to staining, which may graduate to corrosion and deterioration if left unmanaged.

While mostly an appearance defect, water staining can be indicative of more serious defects, which may be currently concealed by other building elements.

Where water staining is active, a licensed plumber must be consulted to identify the cause of the staining and to provide advice on any reparation works that may be required. Replacement of any broken or damaged structures is advised.

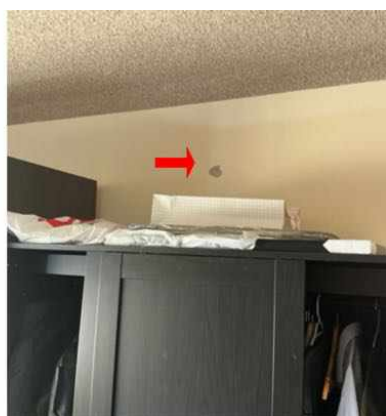
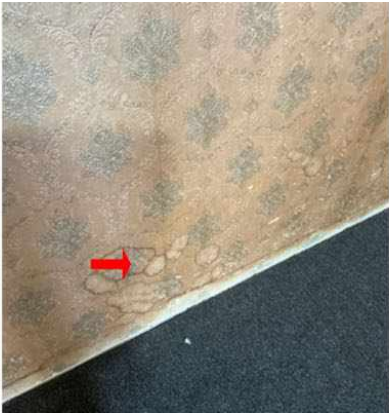
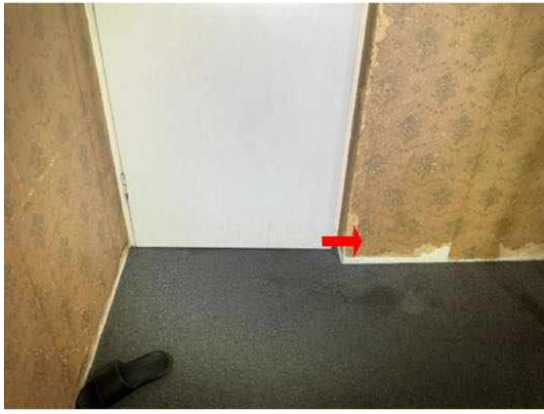
Finding 3.04

Building:	Main Building
Location:	All Internal Areas
Finding:	Building element - Damaged - Wall paper damaged , fly screen damaged , window seal damaged (Possible moisture ingress)
Information:	Breakage occurs generally when the building materials have either aged and decayed, or as a result of damage (accidental or deliberate).

Repair and/or replacement of broken elements is advised to ensure that additional secondary defects do not arise as a consequence. Such works are necessary, as all building elements play a key role in the operation and function of the overall structure and its performance.

A relevant tradesperson should be appointed to repair or replace the affected building element prior to any subsequent damage being caused.

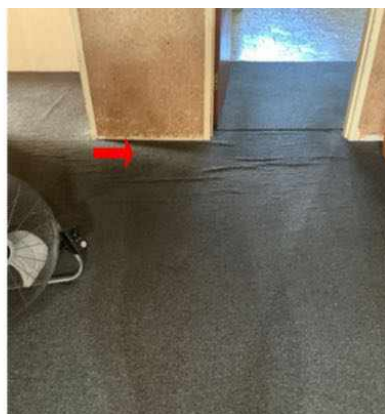
Building:	Main Building
Location:	All Internal Areas
Finding:	Building element - Damaged - Deteriorated carpet
Information:	Breakage occurs generally when the building materials have either aged and decayed, or as a result of damage (accidental or deliberate).

Repair and/or replacement of broken elements is advised to ensure that additional secondary defects do not arise as a consequence. Such works are necessary, as all building elements play a key role in the operation and function of the overall structure and its performance.

A relevant tradesperson should be appointed to repair or replace the affected building element prior to any subsequent damage being caused.

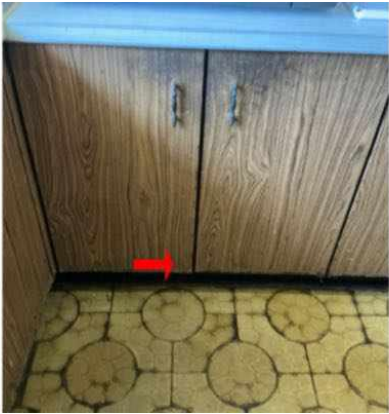
Finding 3.07

Building:	Main Building
Location:	All Internal Areas
Finding:	Building element - Damaged - Cabinetry deteriorated
Information:	Breakage occurs generally when the building materials have either aged and decayed, or as a result of damage (accidental or deliberate).

Repair and/or replacement of broken elements is advised to ensure that additional secondary defects do not arise as a consequence. Such works are necessary, as all building elements play a key role in the operation and function of the overall structure and its performance.

A relevant tradesperson should be appointed to repair or replace the affected building element prior to any subsequent damage being caused.

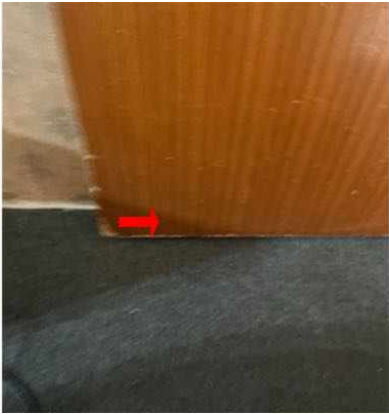
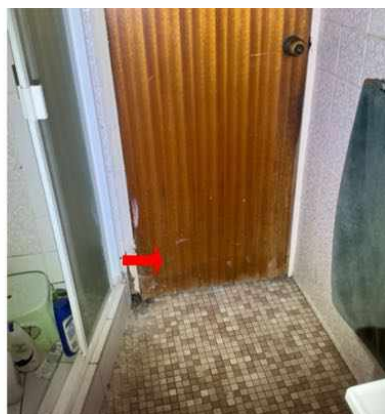
Finding 3.08

Building: Main Building
Location: All Internal Areas
Finding: Delamination of timbers to some areas
Information: Localised delamination and surface deterioration were observed to sections of laminated joinery panels. This condition commonly occurs where moisture exposure or wear causes separation of laminate finishes from the underlying substrate. The defect is generally cosmetic in nature but may worsen over time if moisture exposure continues. Repair or replacement of affected joinery components may be considered as part of routine maintenance.

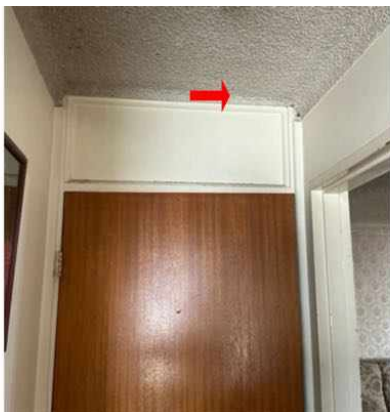
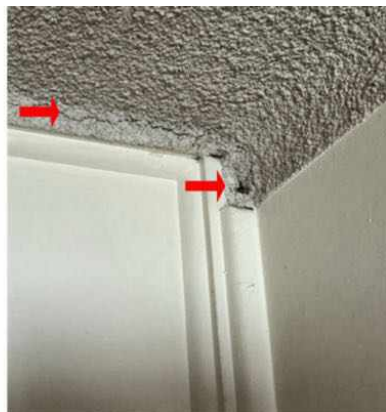
Finding 3.09

Building:	Main Building
Location:	All Internal Areas - Kitchen , laundry
Finding:	Cracking - Damage Category 2 - Noticeable (up to 5mm)
Information:	Noticeable cracks are a common occurrence as a result of many primary defects. Such causes may include age, general wear and tear, expected building movement, general expansion/contraction of building materials in different weather conditions, and/or minor failings in the installation or application of building materials.

Noticeable cracks may result in minor sticking or jamming of associated doors and windows, which require easement. However, noticeable cracks are easily filled and repaired. A plasterer can be consulted to install an expansion joint at this point to allow for this movement during different weather conditions.

Monitoring of all cracking should be conducted frequently. Always contact a building inspector should cracks widen, lengthen, or become more numerous. Additionally, your building inspector should also be contacted if associated building elements such as doors and windows become more difficult to operate over time.

Relevant tradespeople, such as carpenters, painters and plasterers, should be appointed to perform remedial works, as deemed necessary.

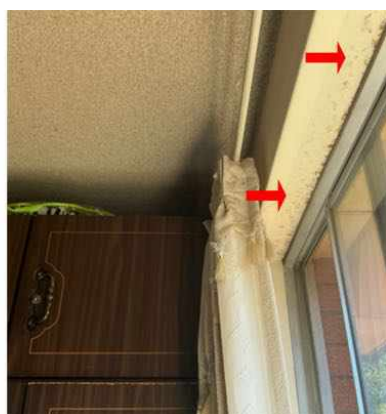
Finding 3.10

Building:	Main Building
Location:	Bedroom
Finding:	Building element - Rusted or corroded - Window sill rusted possible moisture
Information:	This building element shows evidence of rusting and corrosion, which is likely to have developed as a result of excessive exposure to moisture and or inadequate coatings.

As surface rust provides no protection to the underlying iron, the deteriorating condition is likely to worsen if not addressed in the short-term future.

Rusting and corrosion should be managed by ideally removing or limiting the affected surface from exposure to moisture. A registered builder may be appointed to replace any building elements that have been severely affected by rust or water damage.

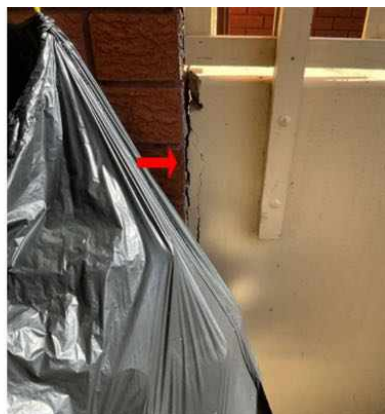
Finding 3.11

Building:	Main Building
Location:	Balcony
Finding:	Separation at Wall Junction – External Wall

Information: A vertical gap was observed at the junction between the brickwork and the adjacent rendered wall surface. The separation appears associated with differential movement between materials and is considered minor at the time of inspection. Sealing the joint with an appropriate flexible sealant is recommended to prevent moisture ingress. Further inspection by a licensed builder is recommended if gap widens or existing conditions worsen.

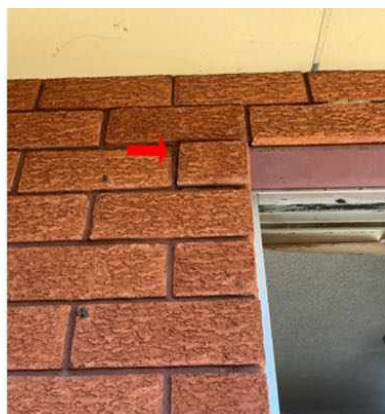
Finding 3.12

Building: Main Building
 Location: Balcony
 Finding: Building element - Damaged - Loose brick
 Information: Breakage occurs generally when the building materials have either aged and decayed, or as a result of damage (accidental or deliberate).

Repair and/or replacement of broken elements is advised to ensure that additional secondary defects do not arise as a consequence. Such works are necessary, as all building elements play a key role in the operation and function of the overall structure and its performance.

A relevant tradesperson should be appointed to repair or replace the affected building element prior to any subsequent damage being caused.

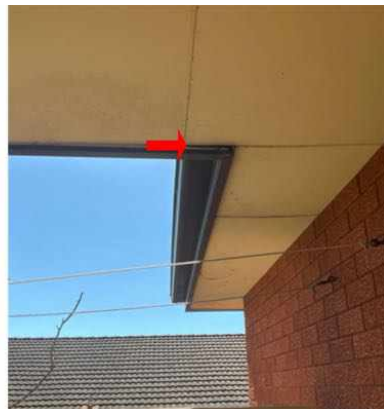
Finding 3.13

Building:	Main Building
Location:	Bedroom
Finding:	Eave Trim Separation
Information:	The external timber trim at the eaves corner displays a visible separation crack, likely due to minor building movement or timber shrinkage over time. While not structurally significant on its own, the gap may allow moisture ingress and should be sealed with a flexible exterior-grade sealant to prevent further deterioration.

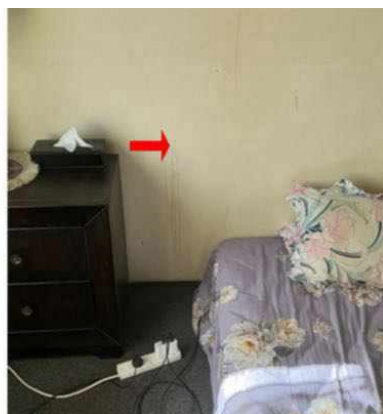
Finding 3.14

Building:	Main Building
Location:	All Internal Areas
Finding:	Paint finish and hairline cracking
Information:	The paint finish in this area was identified as being incomplete at the time of inspection including some hairline minor cracking.

Whilst incomplete or missing paint finish is generally an appearance defect, it can also lead to the development of secondary building defects over time. Incomplete areas of paint finish expose the area to moisture, potentially accelerating the deterioration of underlying building materials.

Incomplete paint finishes should be sanded back, filled, leveled and painted, as applicable. Where inadequate or missing paint protection has led to the deterioration of the associated building element, repair and/or replacement of this building element may be required.

A painting contractor should be appointed as soon as possible to perform necessary works to aid the appearance of the affected area and to ensure the area is protected against further deterioration. Alternatively, the homeowner following manufacturer instructions may perform these works.

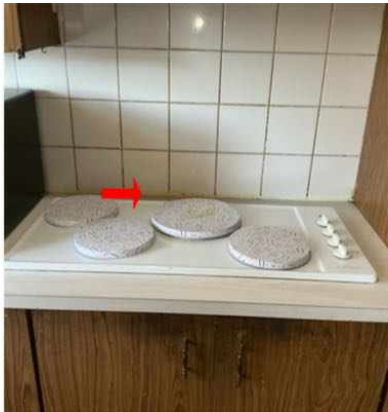
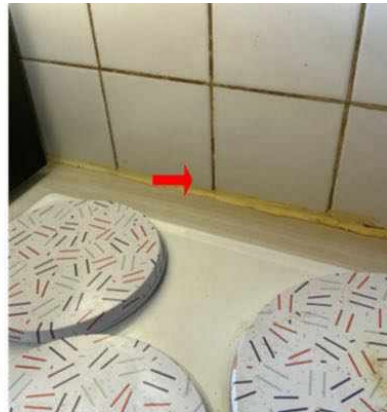
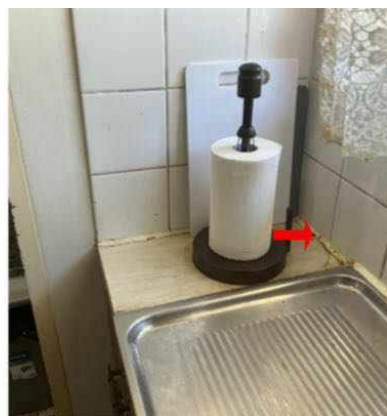
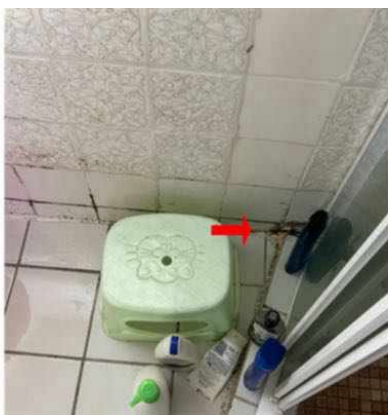
Finding 3.15

Building:	Main Building
Location:	All Internal Areas
Finding:	Sealant and grouting - Missing or degraded
Information:	It was noted on inspection that sealant or grout is degraded. There is also evidence of poor workmanship and excessive use of sealant. Silicone should never be used as a first line of defence against waterproofing. Further inspection by a licensed waterproofing contractor is highly recommended.

Different materials and floor areas move at different rates, generally causing cracking to grout or sealant at this point. A flexible sealant is required to allow for expected expansion and contraction, while keeping the joint water tight and protective of all associated building materials.

There appears to be excessive mould to the sealant and grout which will likely require scraping out and replacement.

Flexible and mould resistant materials should be applied to affected areas to prevent any subsequent water damage that is likely to occur. Regular maintenance and replacement of damage or missing or damaged sealant and grout is highly recommended to the wet areas, as this is a regular wear and tear defect. Sealant and grouting in areas that come into regular contact with water should be maintained for the long term care of your property.

A sealant specialist or tiling contractor should be appointed to complete these works as soon as possible

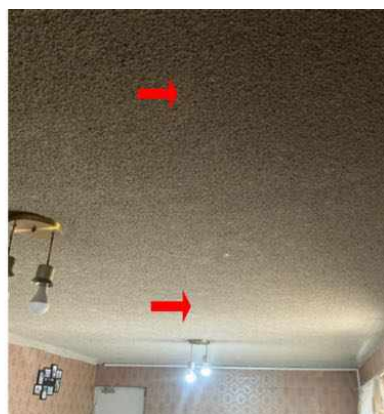
Building:	Main Building
Location:	All Internal Areas - Kitchen ,
Finding:	Asbestos - Suspected ACM Identified on Site
Information:	Reporting on Asbestos is outside the Scope of this Report. This suspected defect is highlighted as a caution only. We suspect that there is a higher risk of the identified building element containing asbestos.

As Asbestos Reporting is outside the scope of this report, we advise that you consider a separate Asbestos Inspection and Condition Audit, which can include the taking of samples for definitive confirmation of the presence of Asbestos.

In the interim, the client is advised to act with caution, especially when considering any damage to building materials general wear and tear renovations extensions demolition and general maintenance activities due to the suspected presence of Asbestos.

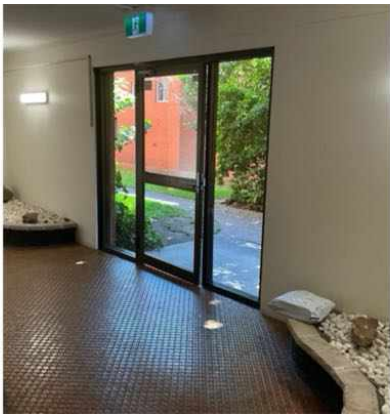
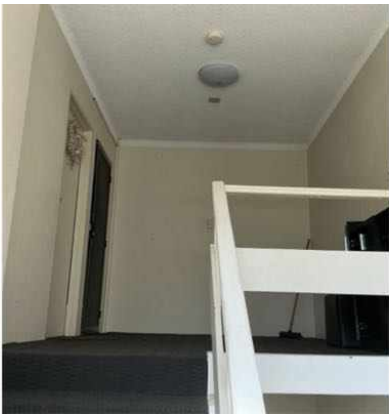
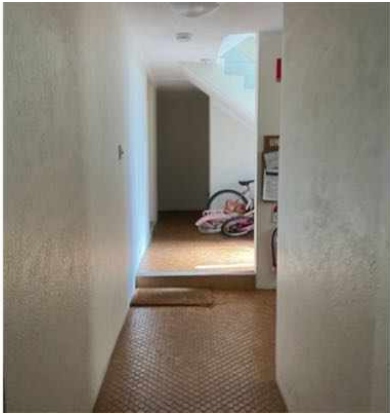
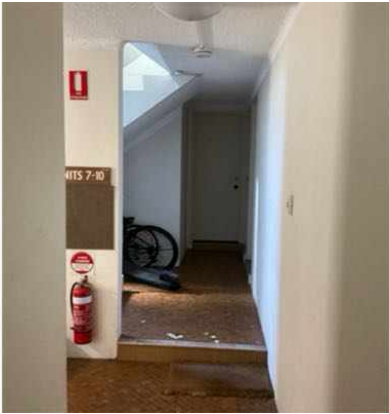
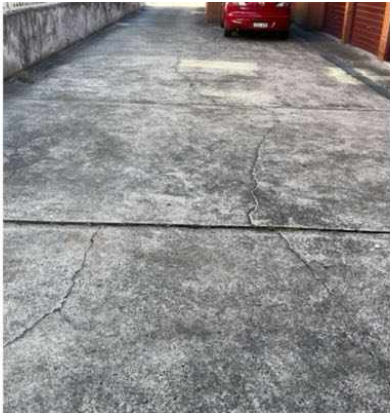
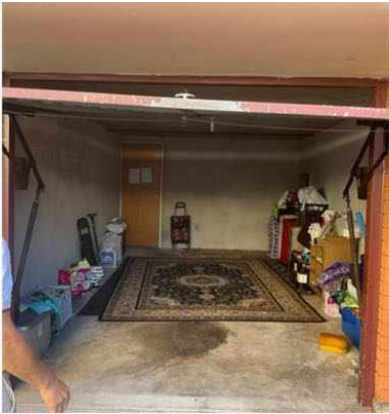
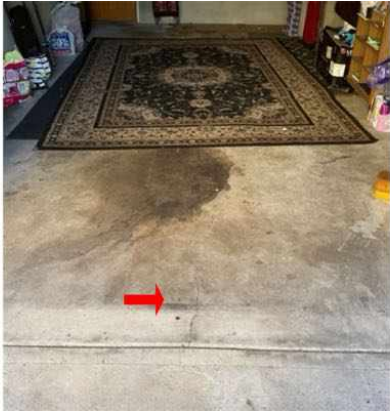
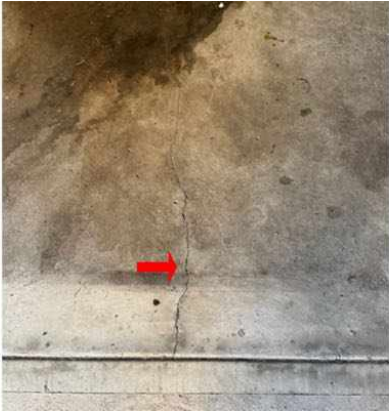
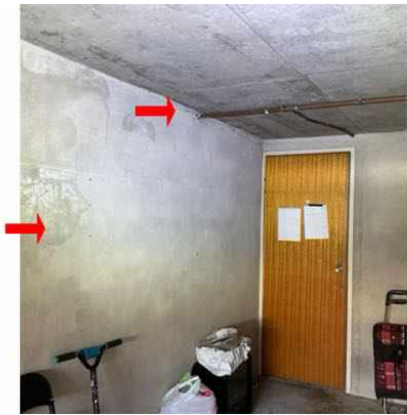
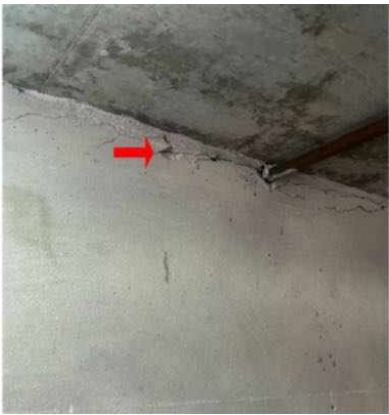
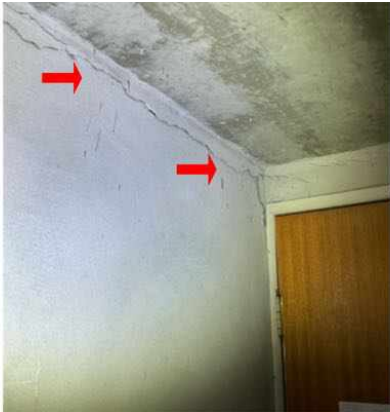
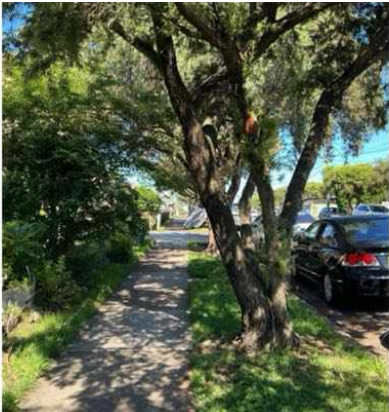
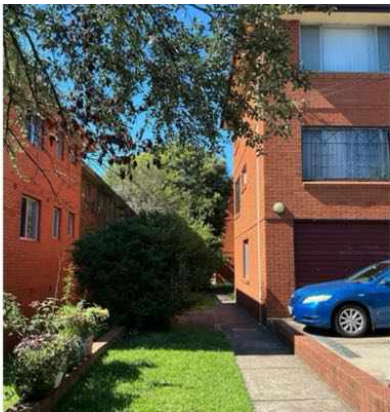
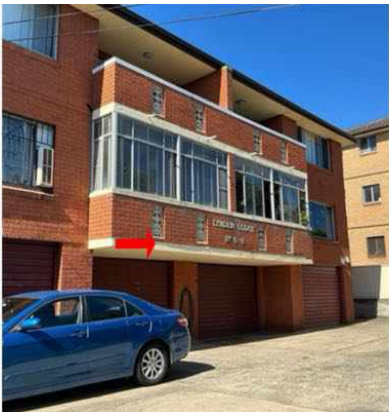
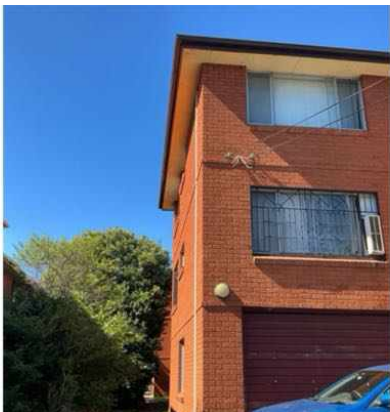
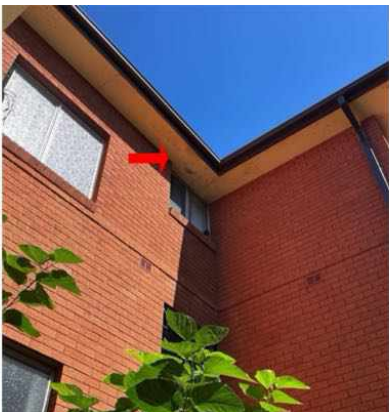
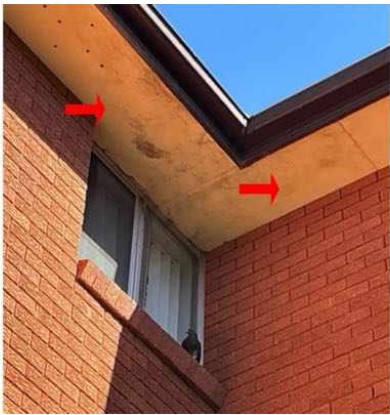
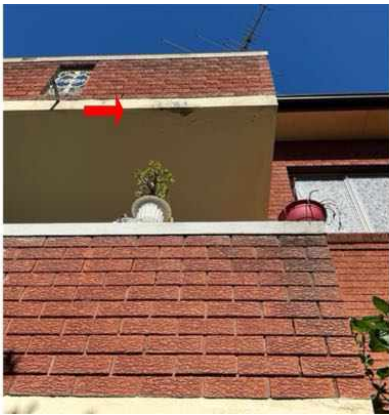
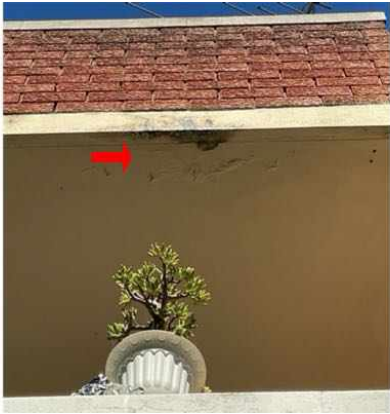
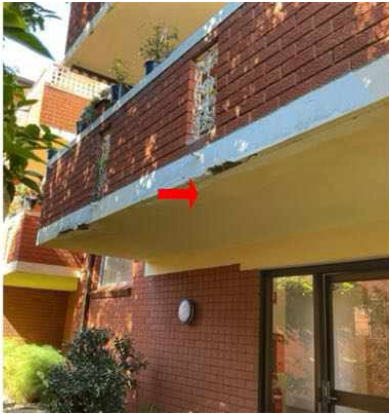
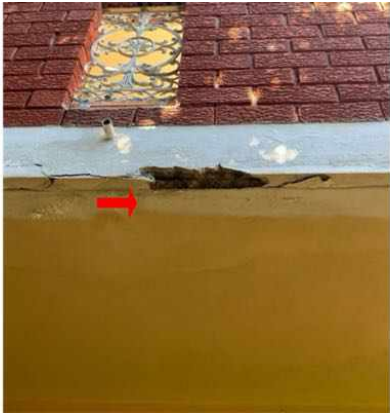
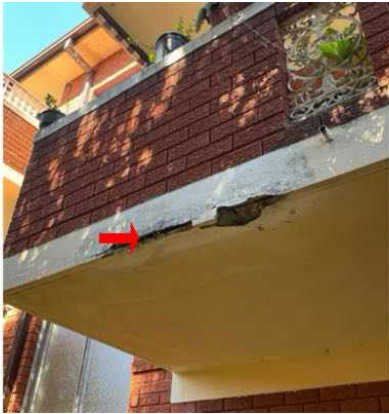
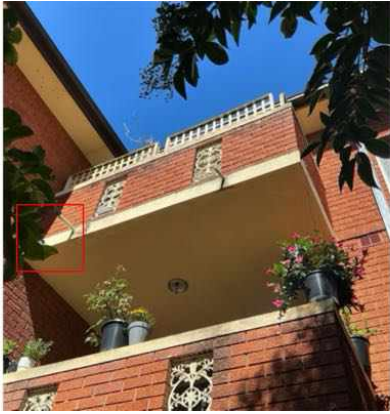
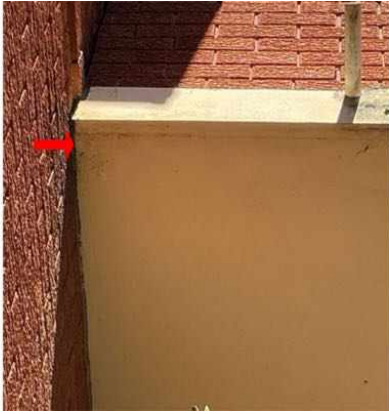
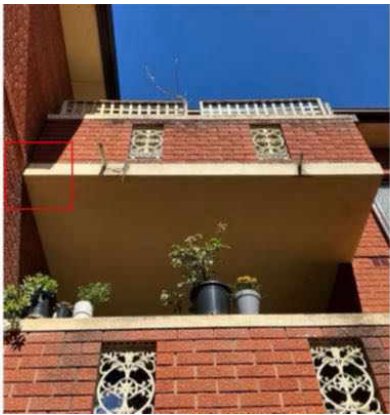
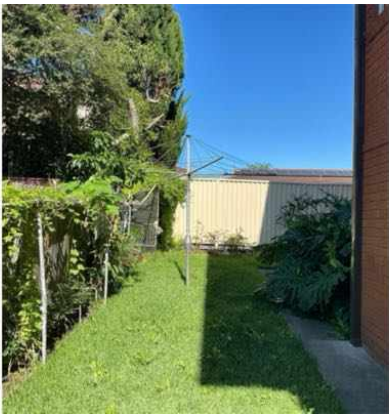
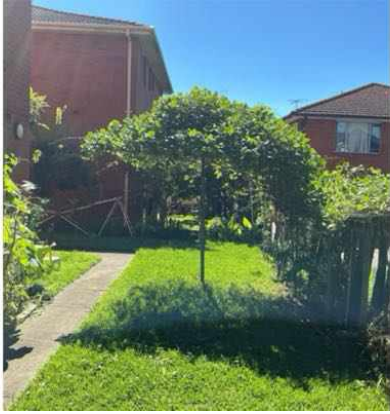
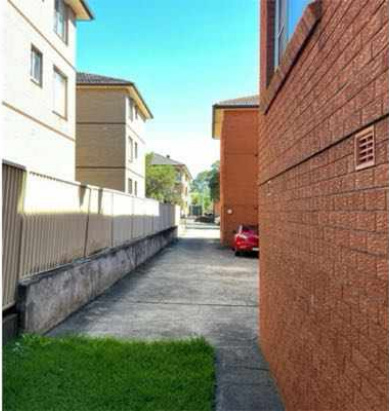
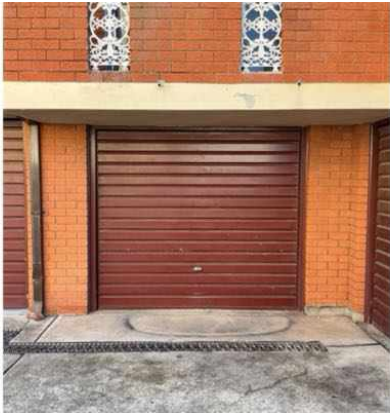
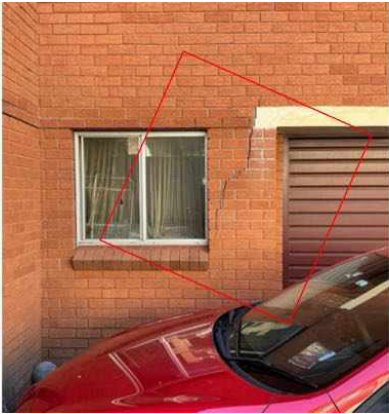
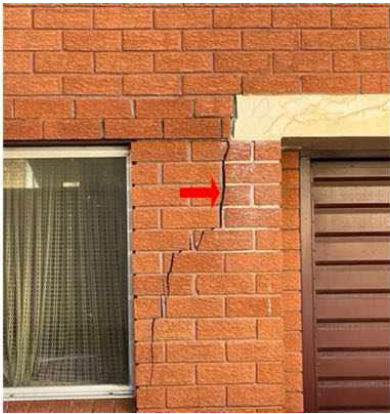
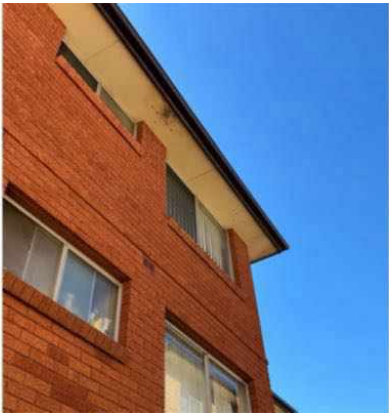
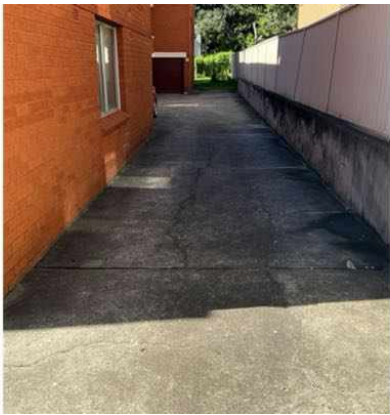
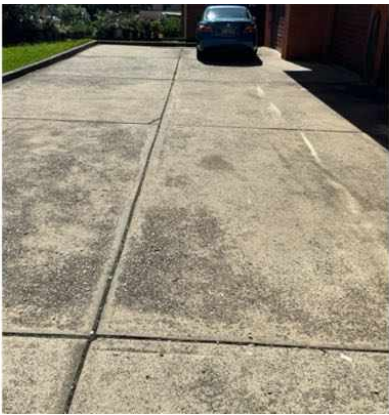
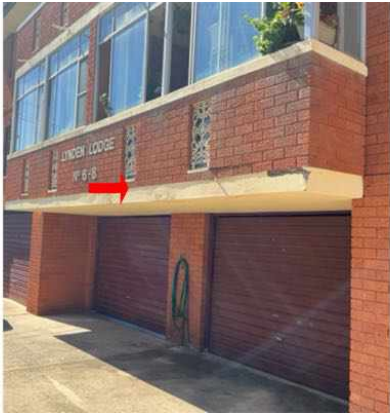
Building:	Main Building
Location:	All External Areas
Finding:	Additional Photos - Obstructions and Limitations
Information:	These photographs are an indication of the obstructions and limitations which impeded full inspection of the property at the time of inspection. These obstructions can hide an array of defects and should be removed to allow full inspection to be carried out. A re-inspection is recommended once the areas are made accessible.

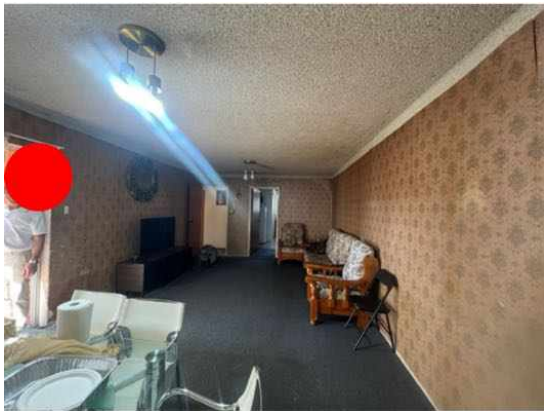
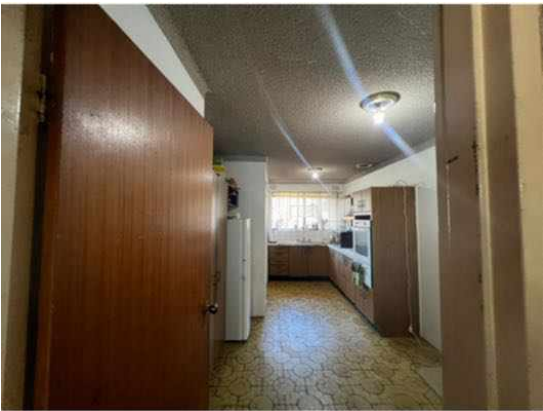
Building: Main Building
Location: All Internal Areas
Finding: Additional Photos - Obstructions and Limitations
Information: These photographs are an indication of the obstructions and limitations which impeded full inspection of the property at the time of inspection. These obstructions can hide an array of defects and should be removed to allow full inspection to be carried out. A re-inspection is recommended once the areas are made accessible.
